# Hammer Consulting Services Observation Report

SITE NAME: <u>Bridgeton Landfill</u>	CLIENT: <u>Missouri DNR</u>	DATE: <u>08/22/12</u>
ADDRESS: <u>Saint Charles Rock Rd, Bridgeton, MO</u>	IMPACTS: <u>St Louis International Airport</u>	REPORT NO. <u>1</u>
STATUS: <u>Closed Facility</u>	<u>St. Rams Training Facility, Commercial,</u>	PAGE <u>1 of 3</u>
	<u>Industrial and Residential areas</u>	<b>HIGH</b>

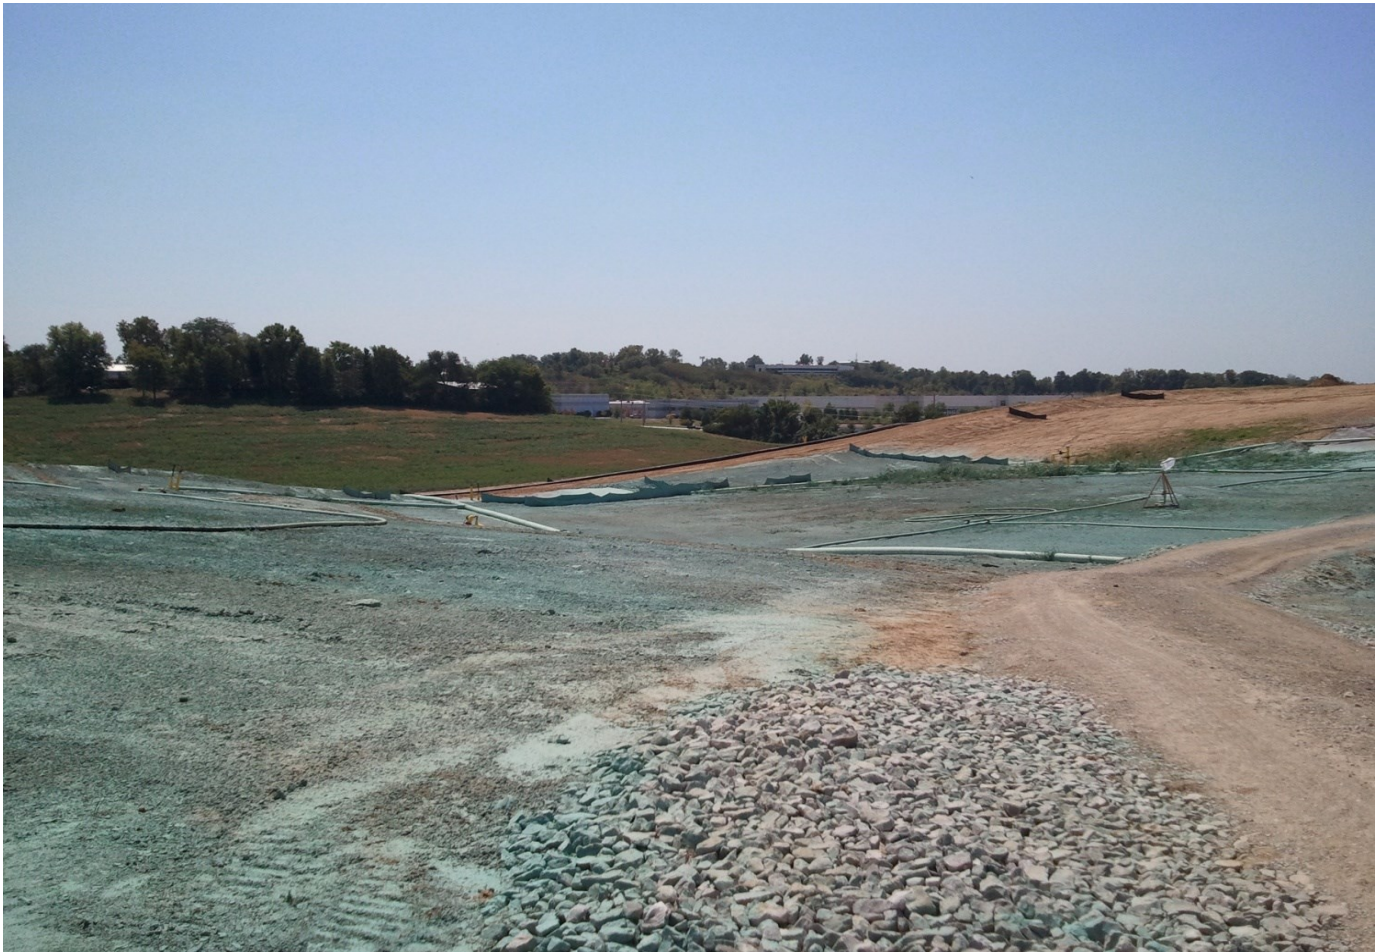
Performed a site visit and observed site conditions. Based upon the field observations, Bridgeton Landfill is experiencing two distinct areas of subsidence. The first area is called the west bowl (Northwest corner of the solid waste facility) and the second area is called the east bowl (Southeast corner of the solid waste facility).

Settlement areas have increased and gas temperatures are increasing to temperatures over 200F.

Photo 1: Bridgeton Landfill, St. Louis Area, Missouri, Todd Thalhamer, August 22, 2012.  
Photos shows the area of the east bowl settlement and additional cover construction.
