# Hammer Consulting Services Observation Report

SITE NAME: Bridgeton Landfill CLIENT: Missouri DNR DATE: 06/14/12  
ADDRESS: Saint Charles Rock Rd, Bridgeton, MO IMPACTS: St Louis International Airport REPORT NO. 1  
STATUS: Closed Facility St. Rams Training Facility, Commercial, PAGE 1 of 4  
Industrial and Residential areas **HIGH**

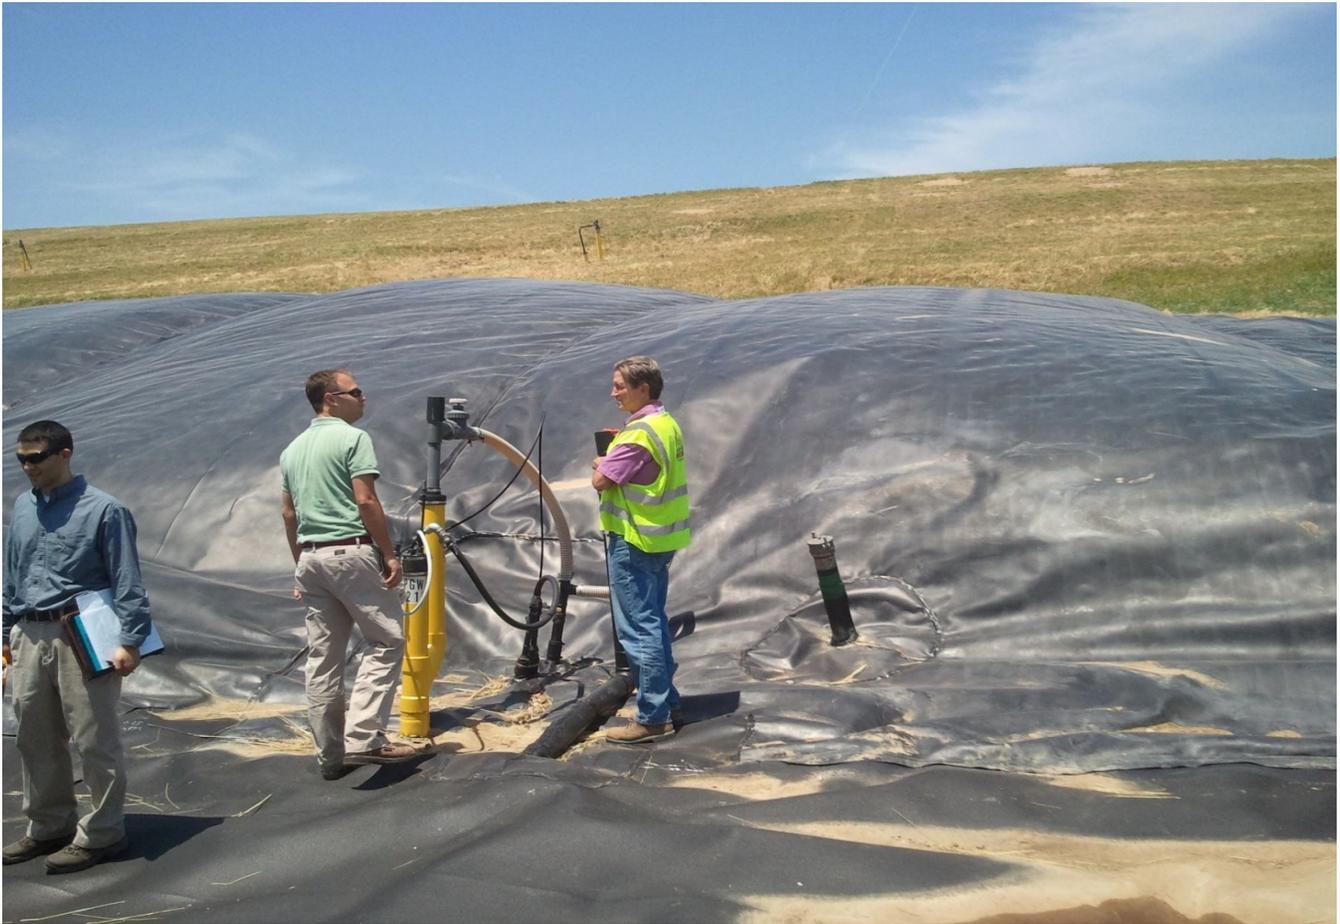
General odor locations noted.

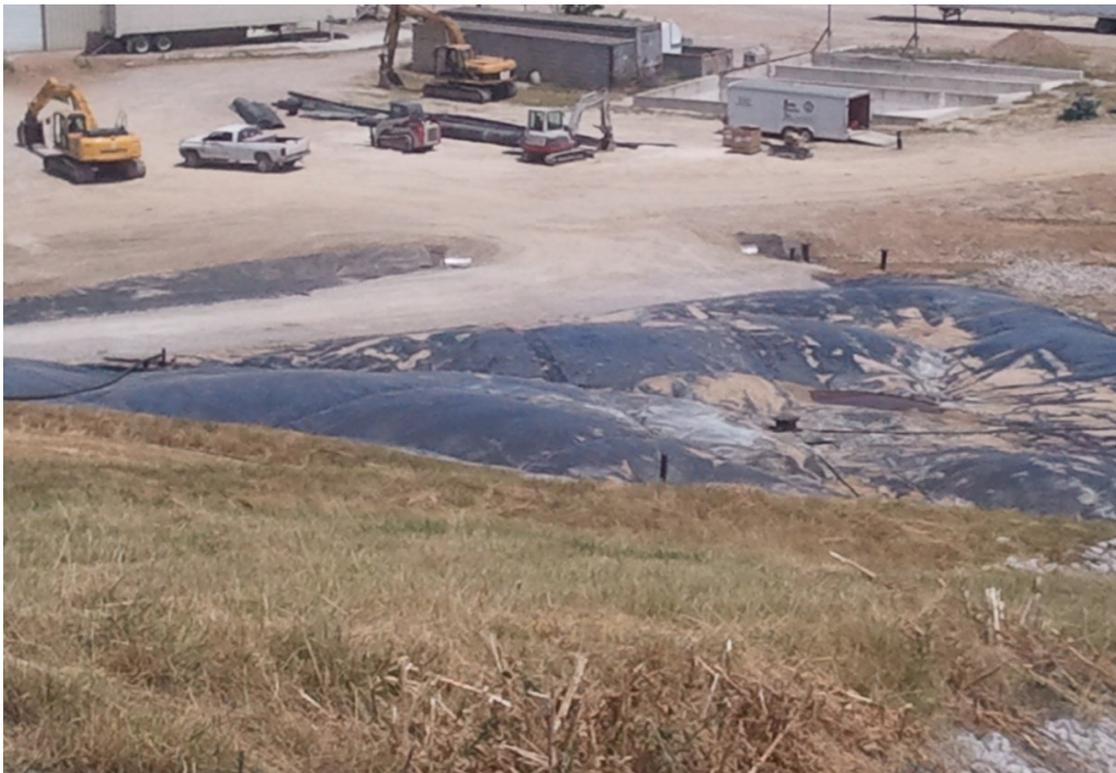
Photo 1: Bridgeton Landfill, St. Louis Area, Missouri, Todd Thalhamer, June 14, 2012.  
Inflated geomembrane cover in the east bowl settlement area. Significant odors observed.

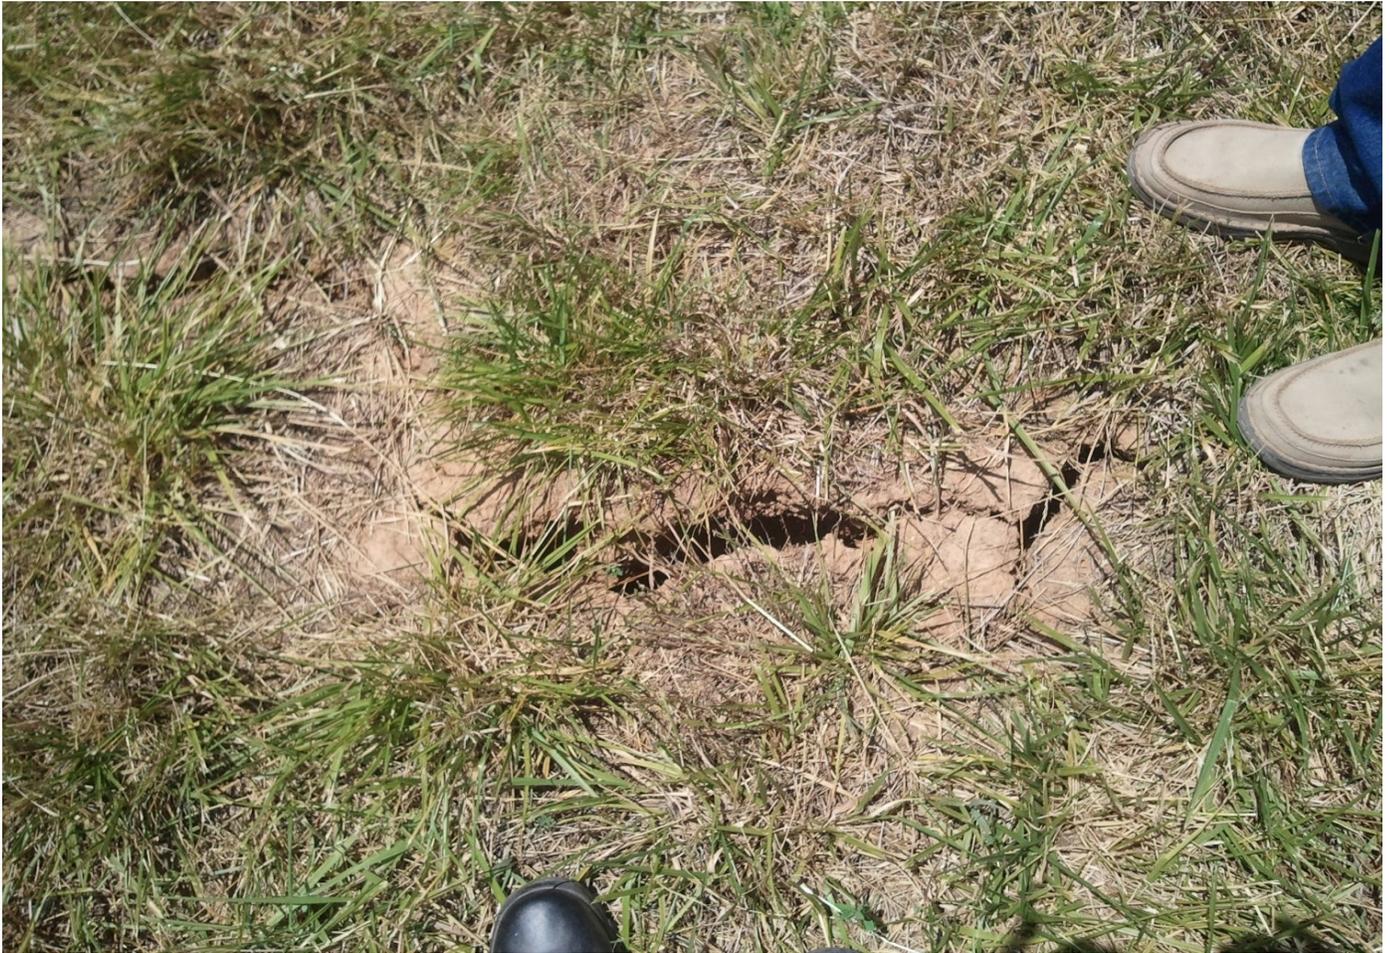
Photo 2: Bridgeton Landfill, St. Louis Area, Missouri, Todd Thalhamer, June 14, 2012.  
Inflated geomembrane cover in the west bowl settlement area. Significant odors observed.

Photo 3: Bridgeton Landfill, St. Louis Area, Missouri, Todd Thalhamer, June 14, 2012.  
Fissure located in east bowl area due to settlement. Approximate length is 24 inches, depth was observed to be over 12 inches.

1. Repair and cover all fissures in the areas around settlement
2. Evaluate settlement daily, look for fissures
3. Hydrate the soil cover to repair and prevent fissures
4. Relocated the two power pole in the west bowl
5. Implement incident command system and develop an incident action plan
6. Collect air samples of the odor
  - A. Evaluate the odors for toxic and/or hazardous gases
  - B. Collect a minimum of three air samples in a summa canister from each odor location
    - i. Up wind of the odor (background)
    - ii. At the odor location
    - iii. Under the cover
  - C. Air sampling plan should be designed by an industrial hygienist
7. Reduce oxygen to less than 1% on all interior gas extraction wells
