TIMOTHY D. STARK, Ph.D., P.E., D.GE

RE: Slope Stability Inspection 13 May 2014 – Bridgeton Landfill – Permit No. 0118912

RE: Field Reconnaissance: January 8, 2015–Bridgeton Landfill–Permit No. 0118912

RE: Field Reconnaissance: July 21 and 22, 2015–Bridgeton Landfill–Permit No. 0118912

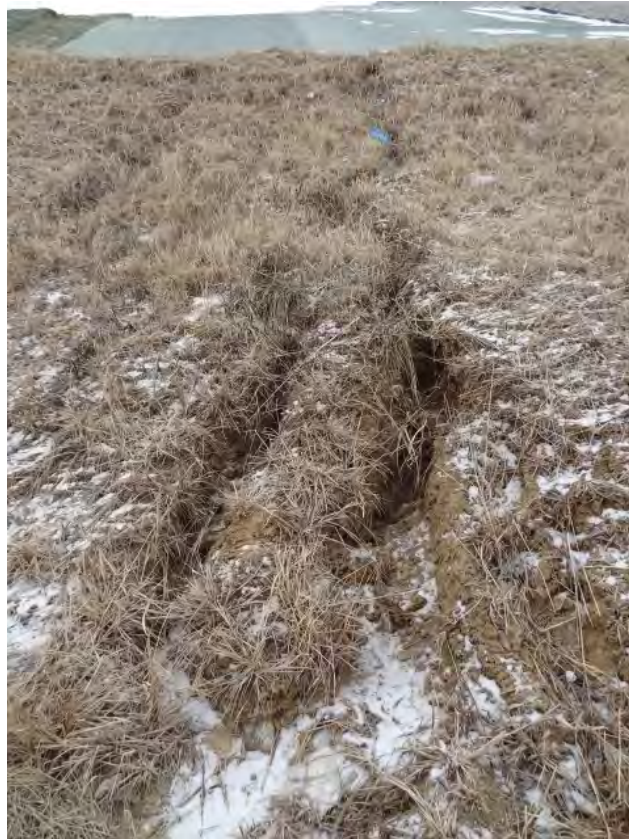
Figure 1 shows erosion gullies in the soil cover on the southwest side of the north quarry near the maintenance building. Erosion of the soil cover can lead to air/oxygen intrusion especially when gas extraction activities are occurring. Other instances of possible oxygen intrusion were encountered during my field reconnaissance and are discussed below. Introduction of oxygen to the waste mass in the presence of elevated temperatures can lead to a reduction in waste due to consumption and/or combustion. As a result, oxygen intrusion to the waste mass should be minimized if not eliminated. Landfill personnel during their quadrant checks should be alert for these erosion features and other sources of possible oxygen intrusion.

Figure 1. Photograph of erosion of the soil cover near the maintenance building on northwest side of north quarry.

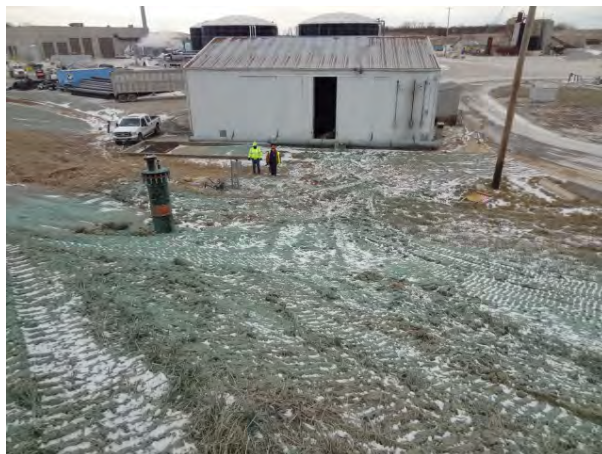
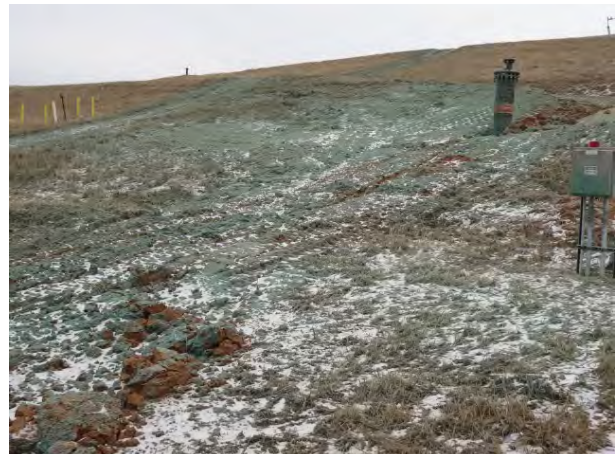
- Figure 2 shows slope and soil cover repair on the southwest side of the north quarry near the maintenance building. It appeared the area was recently seeded to promote vegetation growth.

Figure 2. Photographs near maintenance building on northwest side of north quarry showing: (a) overview and (b) close-up of slope and vegetation repair.

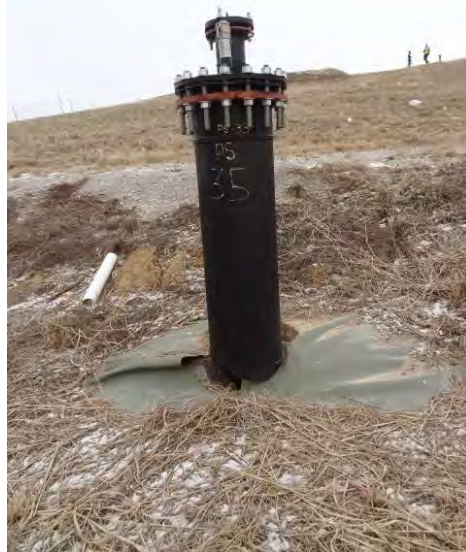
- Figure 3 shows geosynthetics not sealed to Perimeter Sump 35 (PS-35) near the transfer station. The opening around PS-35 is a source of oxygen intrusion, which could be significant if a vacuum is applied in this area. During my site visit I did not hear or feel a vacuum being applied around PS-35.

Figure 3. Photograph of geosynthetics around PS-35 not sealed to piping near maintenance building on northwest side of north quarry.

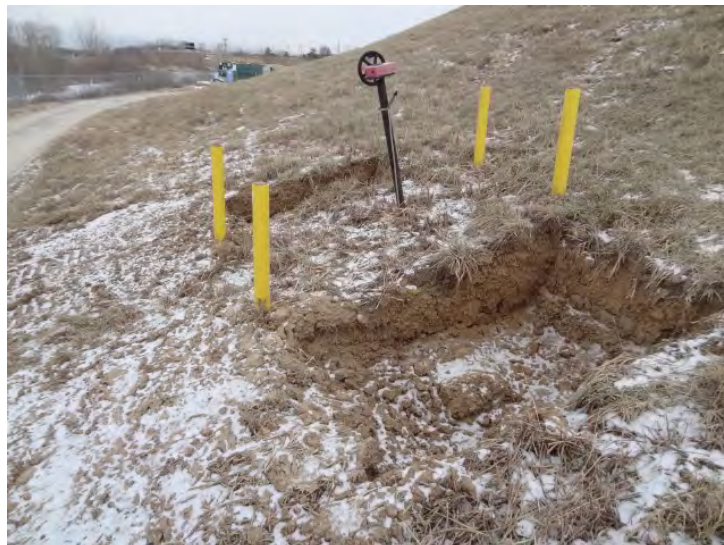
- Figure 4 shows excavations in soil cover on the north slope of north quarry. Excavation or erosion of the soil cover can lead to oxygen intrusion especially when gas extraction activities are occurring. Other instances of possible oxygen intrusion were encountered during my field reconnaissance and are discussed below.

Figure 4. Photograph of excavations in soil cover on the north slope of north quarry.

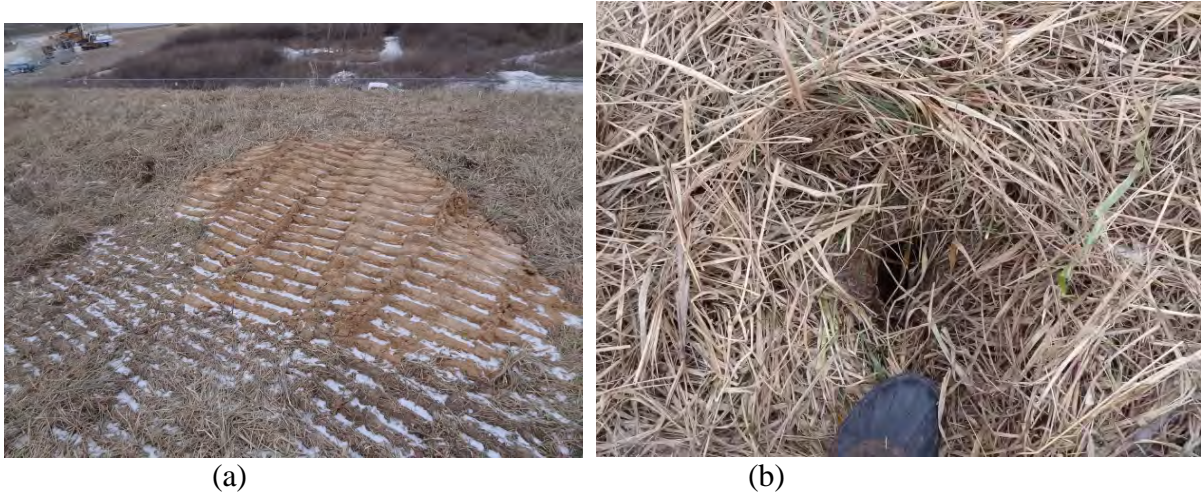
- Figure 5 shows soil cover repair at the top of north slope on north side of north quarry. The area was remediated with some additional cover soil (Figure 5(a)) but a nearby hole was not filled in. Holes in the soil cover can lead to oxygen intrusion especially when gas extraction activities are occurring.

Figure 5. Photographs at top of north slope on north side of north quarry showing: (a) overview of repair area and (b) close-up of remaining hole in soil cover.

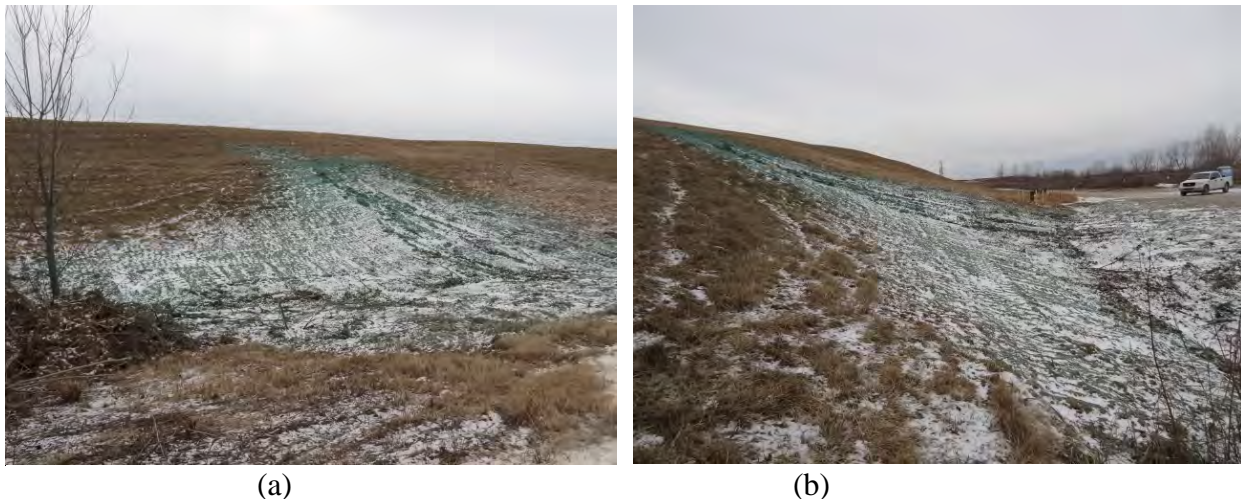
- Figure 6 shows slope repair and soil cover repair on the north side of the north quarry. It appeared the area was recently seeded to promote vegetation growth.

Figure 6. Photographs on north side of north quarry showing: (a) overview and (b) side view of slope and vegetation repair.

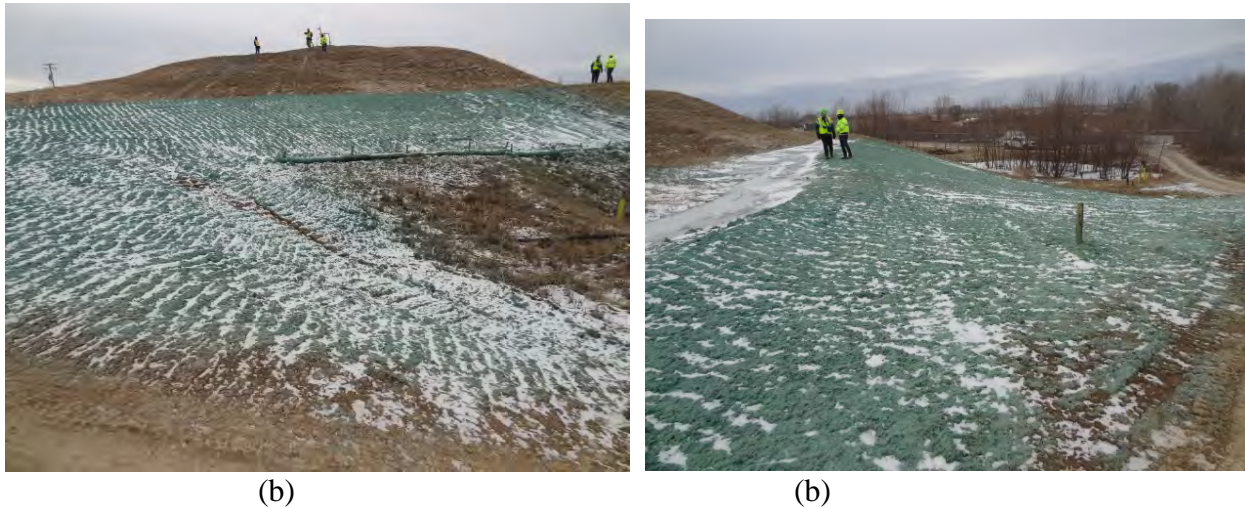
- Figure 7 shows slope repair and soil cover repair along the northeast corner of the north quarry. It appeared the area was recently seeded to promote vegetation growth.

Figure 7. Photographs on northeast corner of north quarry showing: (a) overview and (b) side view of slope and vegetation repair.

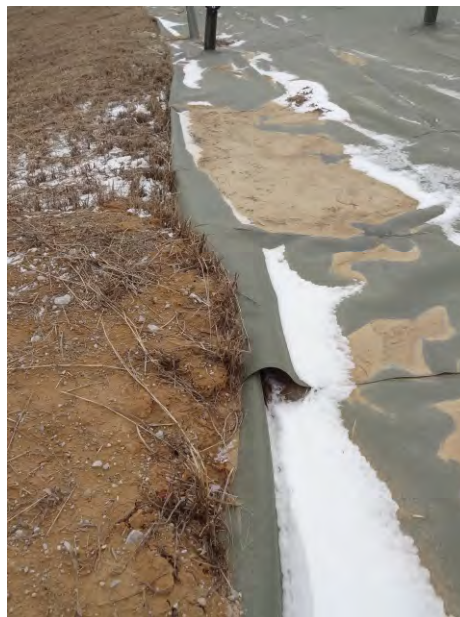
- Figure 8 shows a geomembrane panel not welded on northeast side of the north quarry near the large flare station. This opening is a source of oxygen intrusion, which could be significant if a vacuum is applied in this area. During my site visit I did not hear or feel a vacuum being applied at this location.

Figure 8. Photograph of unwelded geomembrane on northeast side of the north quarry near large flare station.

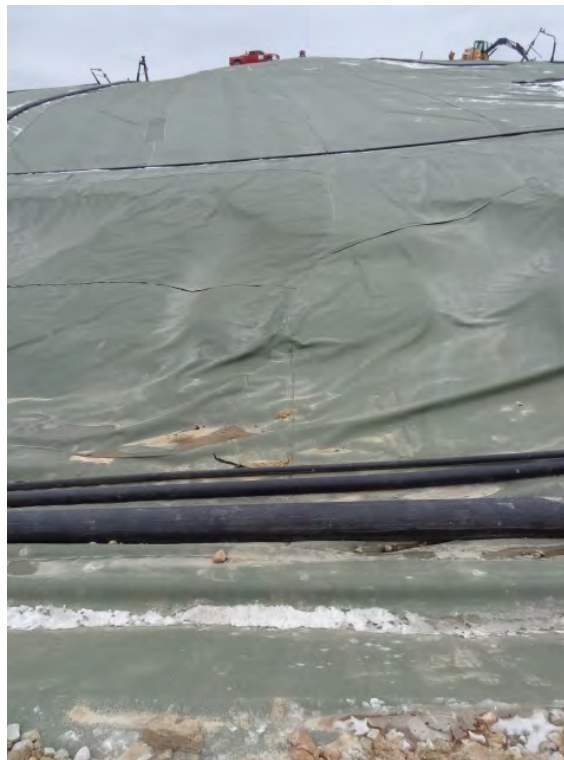
- In the southwest corner there is still evidence of slope movement near the slope toe that was observed in my 13 May 2014 slope reconnaissance. The movement still appeared to be confined to the lower one-third of the slope and it does not appear that significant additional movement has occurred since my 13 May 2014 site visit. Slope movement was also observed at the Countywide Recycling and Disposal Facility (CWRDF) near Cleveland.
- Along the southern end of the landfill, new slope movement and collapse features were observed (see Figure 9). The isolated collapse features are probably due to sinkholes developing due to waste consumption from below. The larger and longer features are probably due to slope movement but my inspection was limited by the presence of the geomembrane.

Figure 9. Photograph along south slope of south quarry showing slope collapse and/or slope movement features.

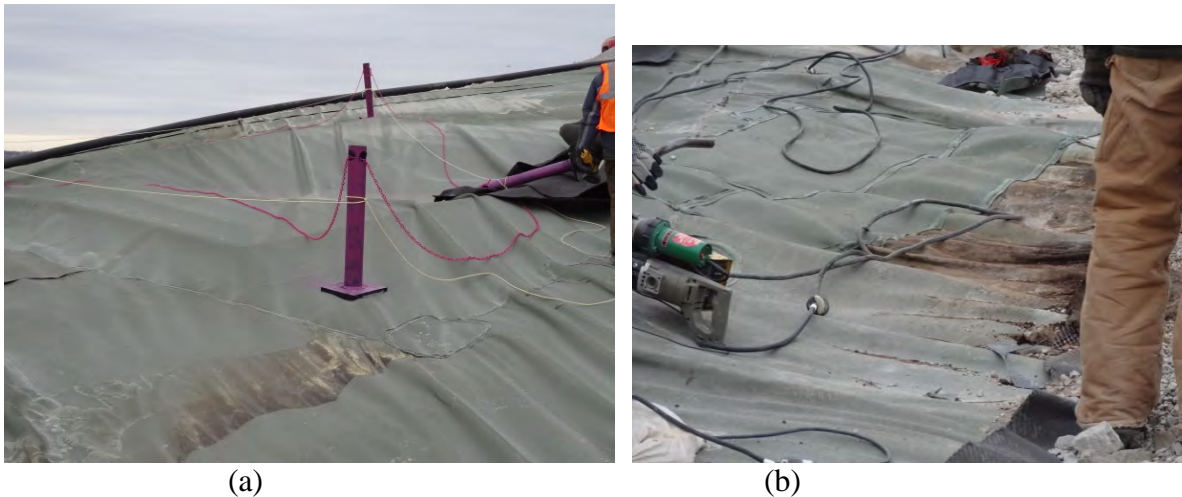
- In the southeast corner of the landfill, Figure 10 shows repair of an area where the geomembrane cover was burned/melted through near Surface Extraction Well 2 (SEW-2). This is an indication of elevated temperatures in this area.

Figure 10. Photographs along south slope of south quarry showing: (a) overview of burned/melted geomembrane near Surface Extraction Well (SEW-2) and (b) close-up of burned geomembrane.

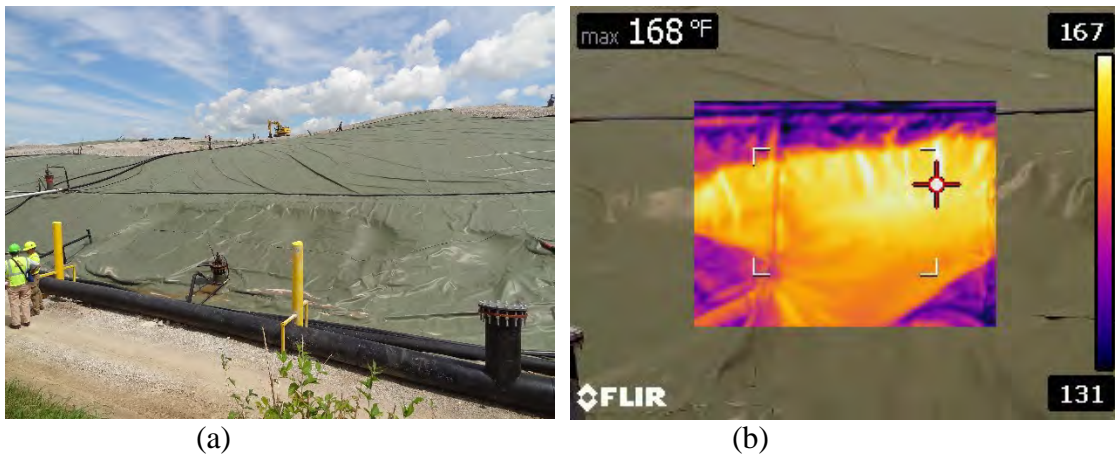
- Along the southern end of the landfill, larger slope movement and collapse features were observed (see Figure 1(a) and other photographs are available). Given the elevated temperatures measured using an infrared camera in the collapse zones (see Figure 1(b)), the isolated collapse features are probably due to sinkholes developing due to waste consumption from below. The larger and longer features are probably due to slope movement but my inspection was limited by the presence of the geomembrane. This is also an area of leachate outbreaks as evidenced by considerable liquid under the geomembrane as discussed below.

Figure 1. Photographs along south slope of south quarry showing: (a) slope collapse and/or slope movement features and (b) measured elevated temperatures.

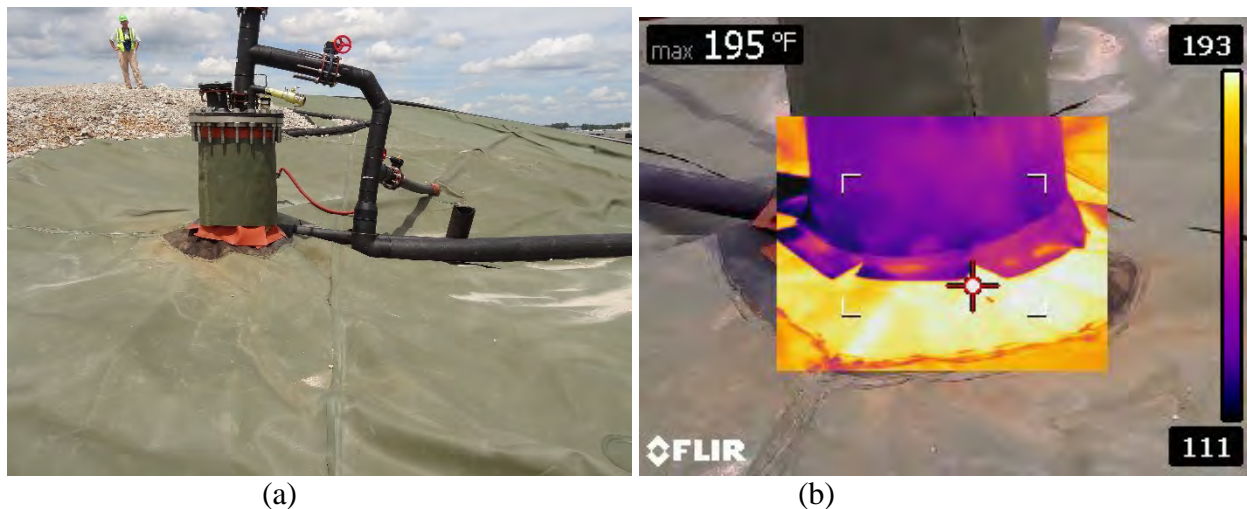
- In the southeast corner of the landfill, high elevated temperatures and large settlements were observed. Figure 2(a) shows Surface Extraction Well 2 (SEW-2) and temperatures of 195°F measured using an infrared camera on the piping associated with SEW-2 (see Figure 2(b)).

Figure 2. Photographs along south slope of south quarry showing: (a) overview of SEW-2 and (b) measured elevated temperatures.

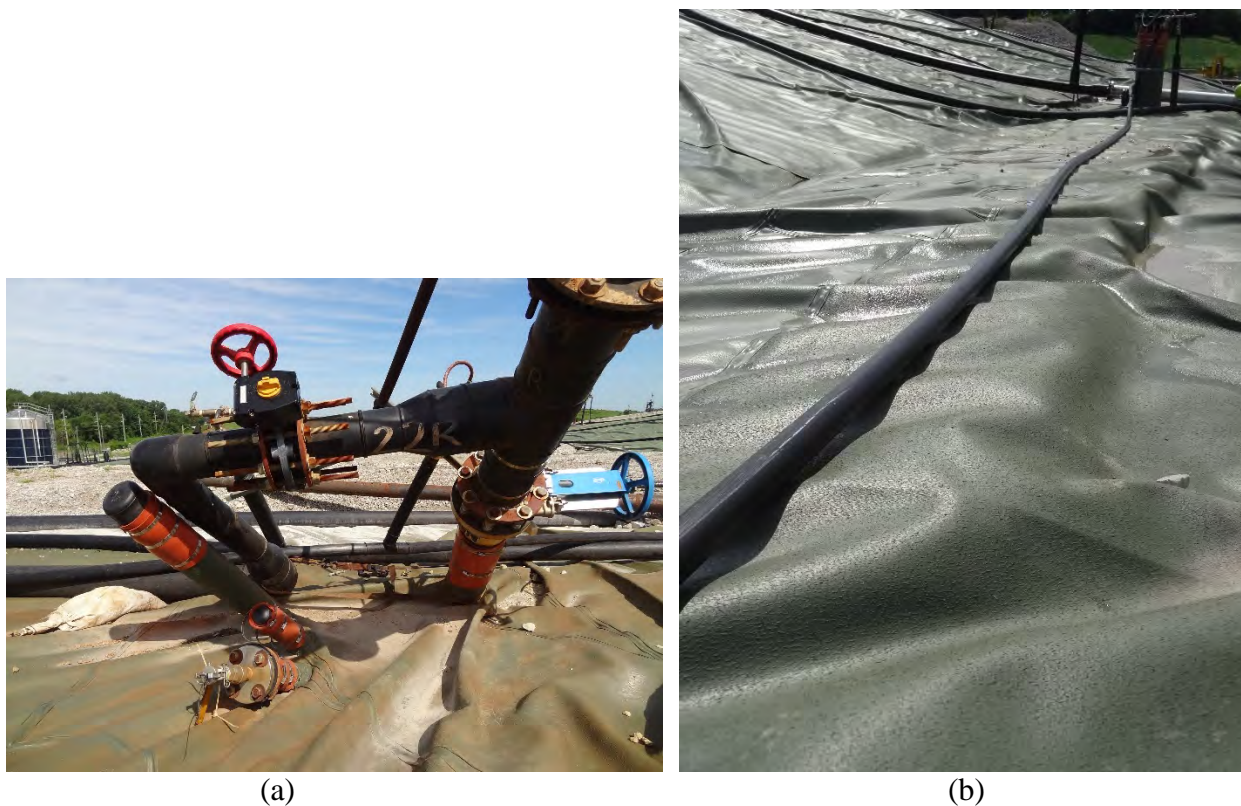
- The elevated temperatures measured along the south slope are causing distress in some of the surrounding infrastructure as shown in Figure 3(a) and in the southeast corner. Elevated temperatures are also associated with elevated pressures that are causing leachate outbreaks along the slopes. Figure 3(b) shows liquid buildup underneath the geomembrane that felt like walking on a waterbed. Figure 4 shows remnants of leachate outbreaks around various wells and piping along the south slope. Similar leachate outbreaks and distressed infrastructure was observed at the CWRDF near Cleveland.

Figure 3. Photographs along south slope of: (a) distressed or leaning infrastructure and (b) liquid build-up below geomembrane.

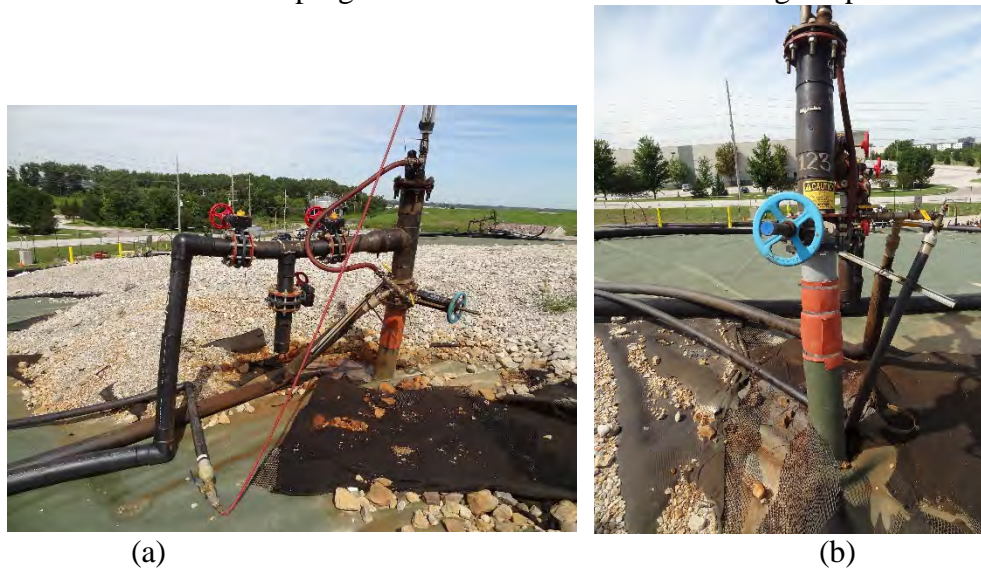
Figure 4. Photographs along south slope of south quarry showing remnants of leachate outbreaks.

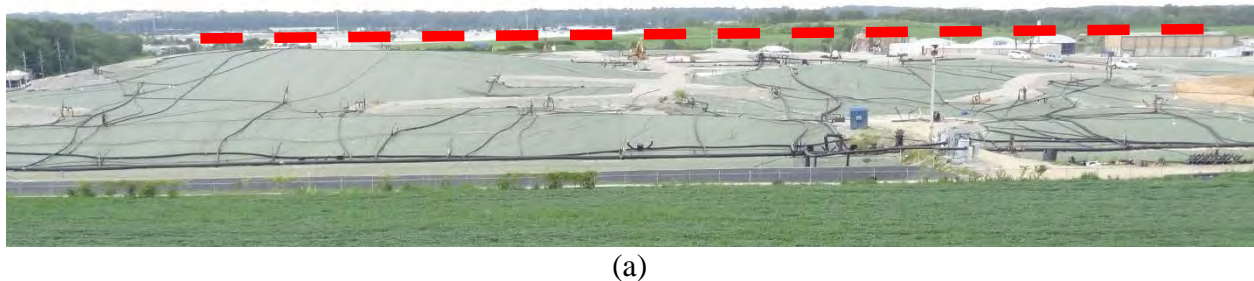
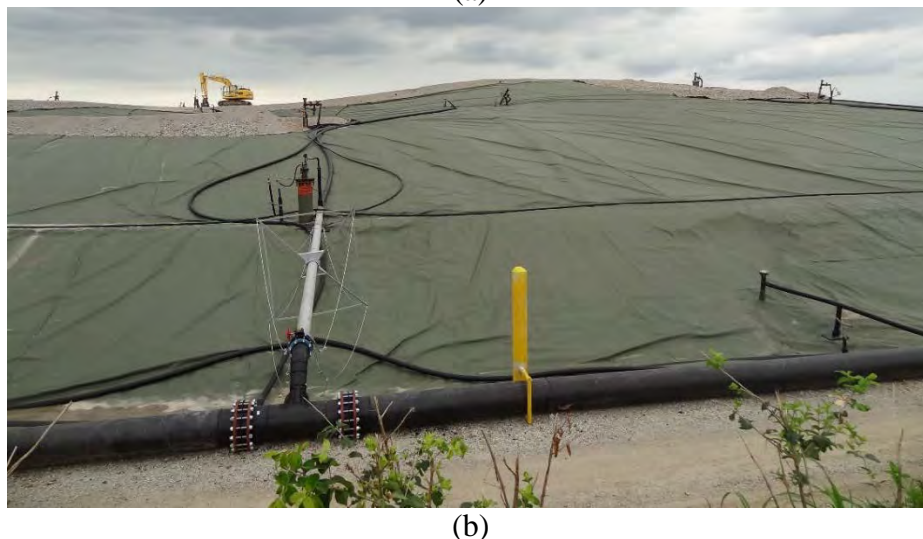
- Another manifestation of elevated temperatures is the consumption of waste, which results in significant landfill settlements after the consumption. Figure 5(a) shows a profile of the south quarry and the highest point being the southeast corner on the left. The north end of the south quarry used to be at least the same height or elevation as the southeast corner (see dashed red line) which indicates the magnitude of waste consumption and settlement that has occurred during this heating event. This settlement is probably larger because soil has been added at the north end of this profile. Figure 5(b) shows a bulge at the top of the southeast corner because the elevated temperature have not consumed as much of the waste as towards the southwest. This progression of settlement was also observed at the CWRDF

near Cleveland where settlement progressed from east to west in the original portion of the landfill.

Figure 5. Photographs of south quarry showing: (a) settlement progression from north (right) to southeast corner (left) and (b) close-up of settlement progression from southwest to southeast corner.

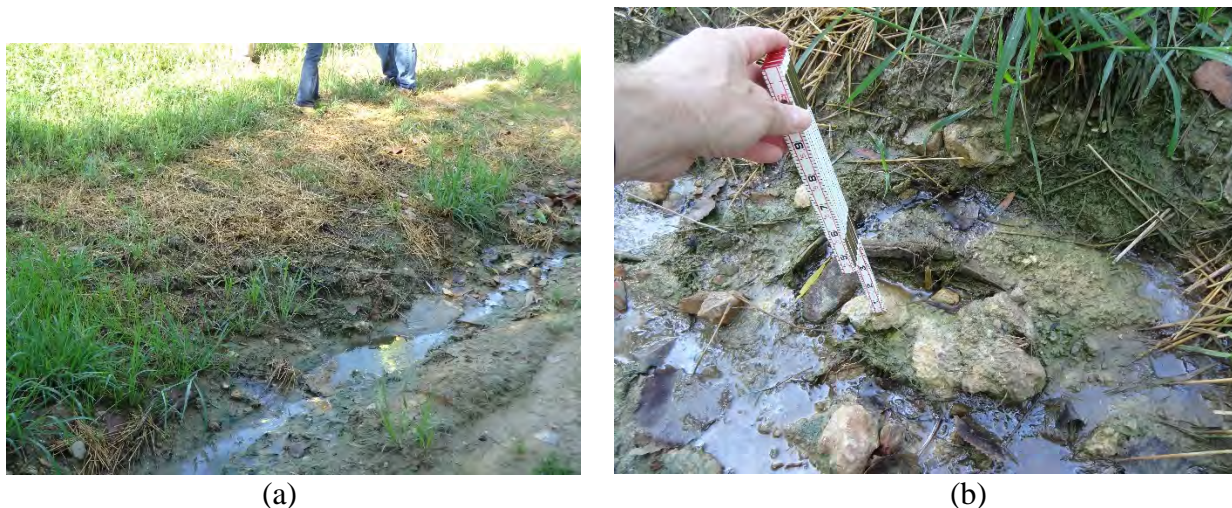
- Along the northern end of the north quarry, a leachate outbreak and the associated dead vegetation was observed (see Figure 6) along the slope toe. The resulting leachate appeared to be flowing to a ponded area near the northeastern corner of the north quarry. Landfill personnel during their quadrant checks should be alert for these leachate outbreaks.

Figure 6. Photographs along north slope of north quarry showing: (a) overview of leachate outbreak and (b) close-up of leachate outbreak.

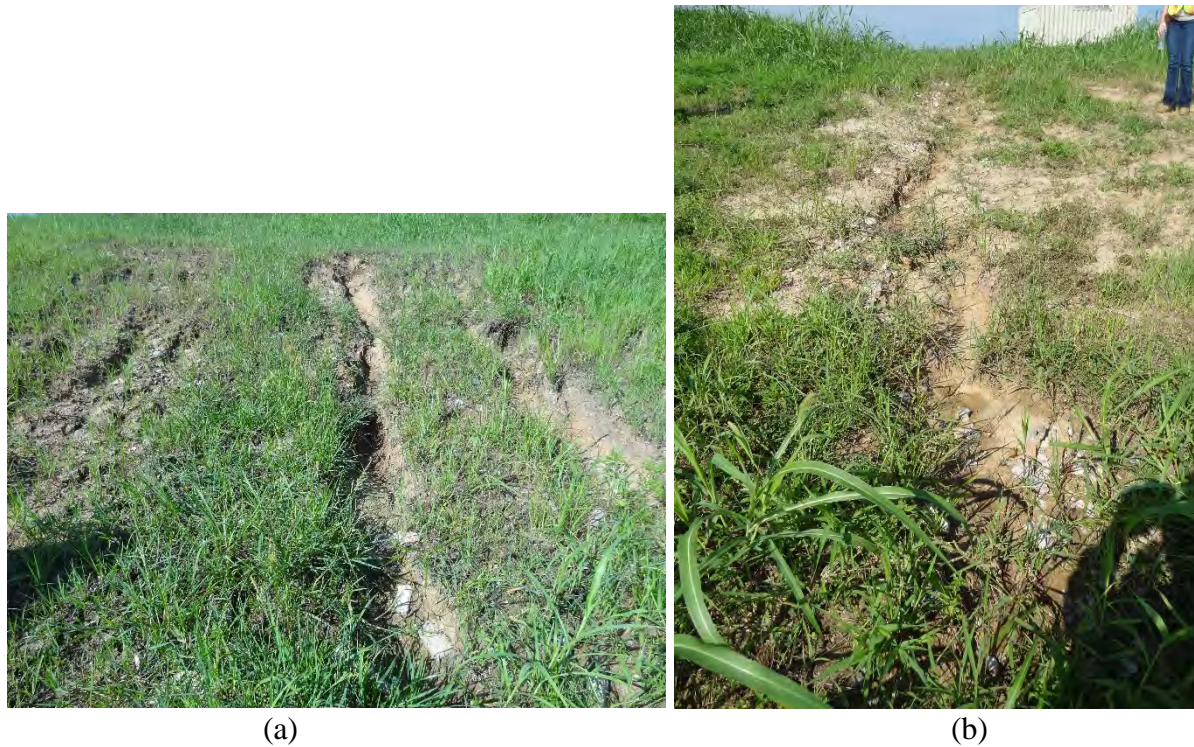
- Figure 7 shows erosion gullies in the soil cover near the northeast corner of the north quarry. Erosion of the soil cover can lead to air/oxygen intrusion especially when gas extraction activities are occurring to control odors and other aspects of elevated temperatures. Other instances of possible air/oxygen intrusion were encountered and discussed below during my field reconnaissance. Introduction of oxygen to the waste mass in the presence of elevated temperatures can lead to a reduction in waste due to consumption and/or combustion. As a result, oxygen intrusion to the waste mass should be minimized if not eliminated as soon as possible to limit oxygen intrusion.

Figure 7. Photographs in north quarry showing erosion of soil cover: (a) near northeast corner and (b) on northeast side.

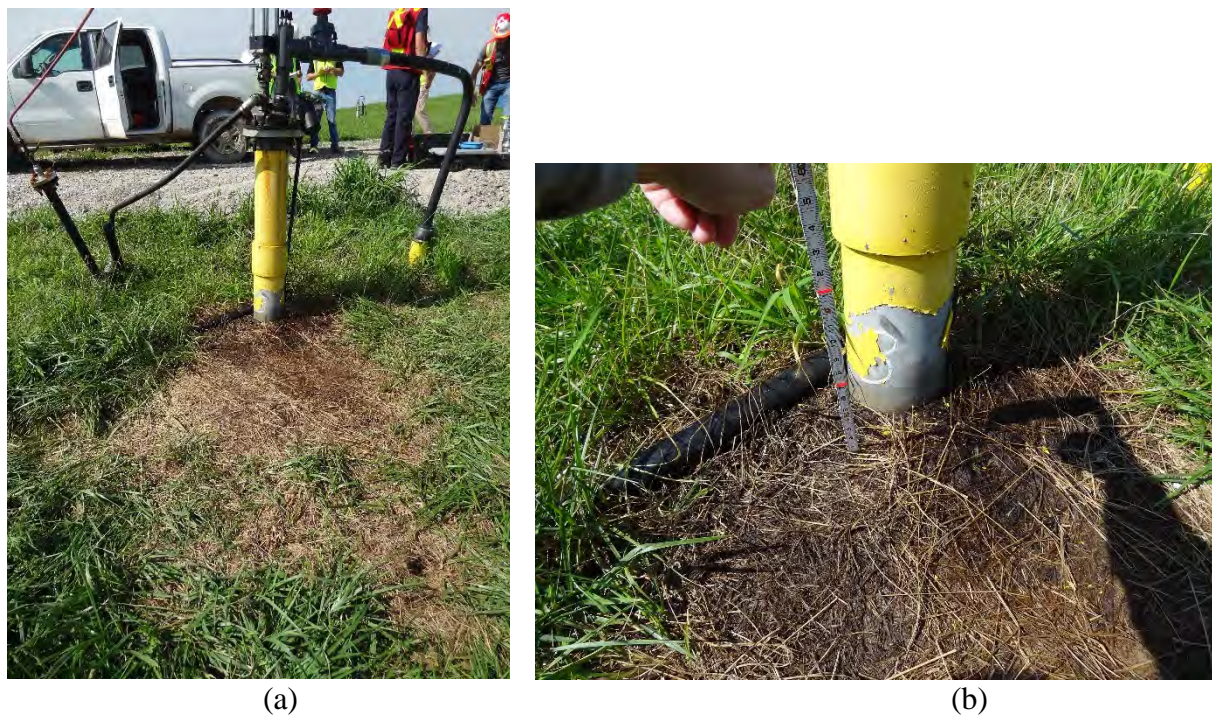
- Figure 8 shows dead vegetation and a leachate outbreak around Gas Extraction Well 3 (GEW-3). Figure 8(a) is an overview that shows the area of dead vegetation, which is probably due to fugitive gas. The temperatures measured using an infrared camera on and around GEW-3 approached 120°F. Figure 8(b) shows a small leachate outbreak around the GEW. This is important because the well is located in the northeast corner of the north quarry, which is a significant distance from the south quarry.

Figure 8. Photographs of dead vegetation and leachate outbreak around GEW-3 in north quarry: (a) overview and (b) close-up.

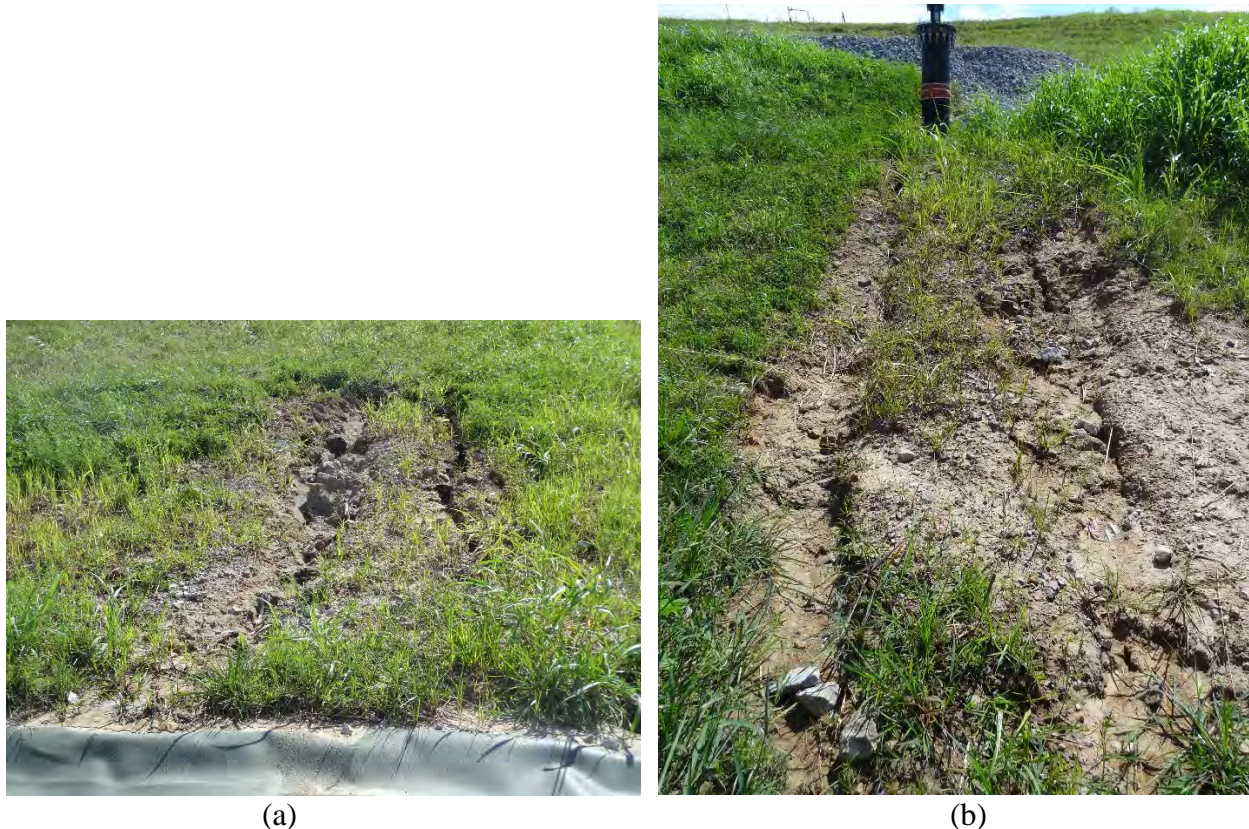
- Figure 9 shows erosion gullies in the soil cover on the southwest side of the north quarry near the maintenance building. Erosion of the soil cover can lead to oxygen intrusion especially when gas extraction activities are occurring. Other instances of possible oxygen intrusion were encountered during my field reconnaissance and are discussed below.

Figure 9. Photographs of erosion of the soil cover near the maintenance building on northwest side of north quarry.

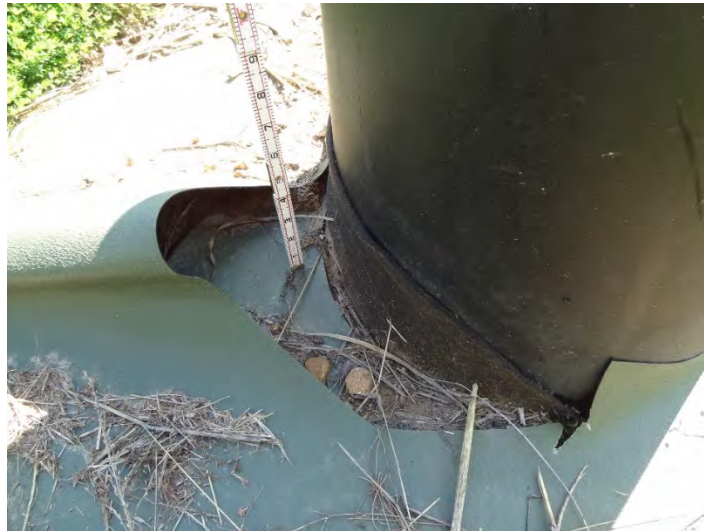
- Figure 10 shows geosynthetics still not sealed to Perimeter Sump 35 (PS-35) near the transfer station. The opening around PS-35 is a source of oxygen intrusion, which could be significant if a vacuum is applied in this area. During my site visit I did not hear or feel a vacuum being applied at PS-35.

Figure 10. Photograph of geosynthetics around PS-35 not sealed to piping near maintenance building on northwest side of north quarry.

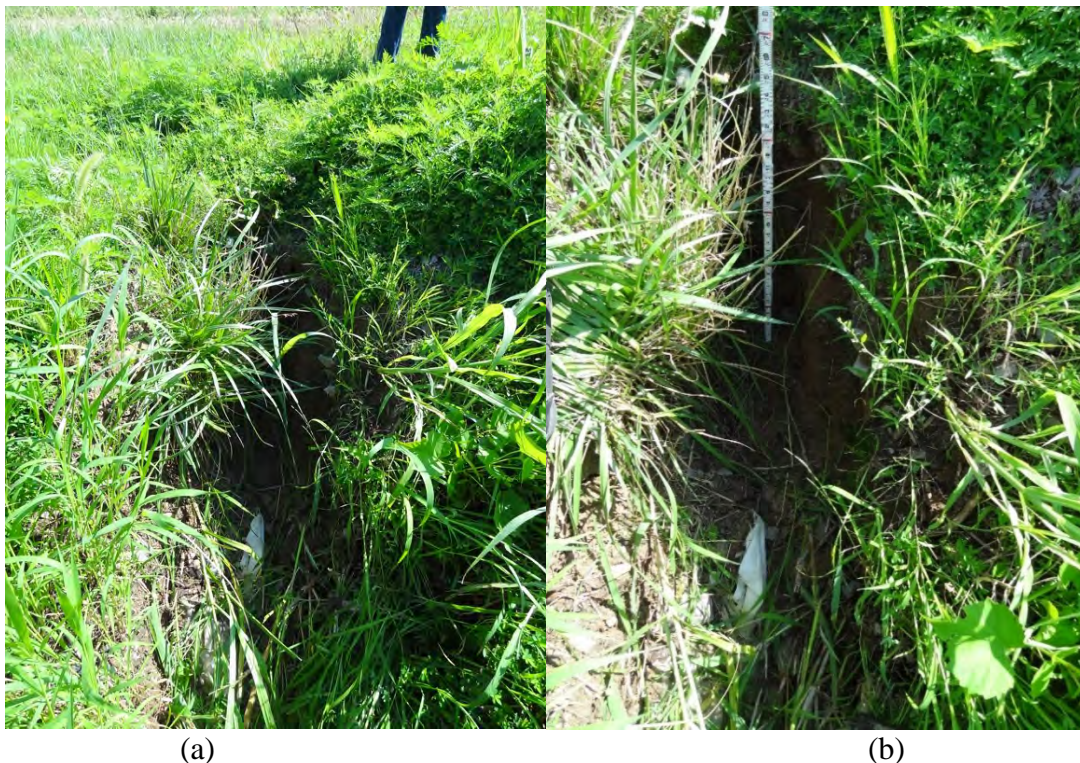
- Figure 11(a) shows a deep erosion gully near the transfer station. This erosion gully has a depth of over two feet. More importantly, a significant aroma of landfill gas was present which alerted me to further investigate this area. Landfill personnel during their quadrant checks should be alert for these erosion features and aromas. Upon clearing some of the vegetation that was covering the opening of the gully, a depth of over two feet was visible as shown in Figure 11(b). Figure 11(b) also shows partially buried waste at the bottom of the erosion gully. Given the presence of exposed waste and a significant landfill gas aroma, this area is probably a source of oxygen intrusion to the waste. Introduction of oxygen to

Figure 11. Photographs of significant erosion of the soil cover near transfer building showing: (a) overview of erosion gulley and (b) depth of erosion of over two feet and exposed waste at the bottom of the erosion gulley.

the waste mass in the presence of elevated temperatures can lead to a reduction in waste mass via consumption and/or combustion of the waste. As a result, this and other erosion features should be remediated as soon as possible to limit oxygen intrusion.

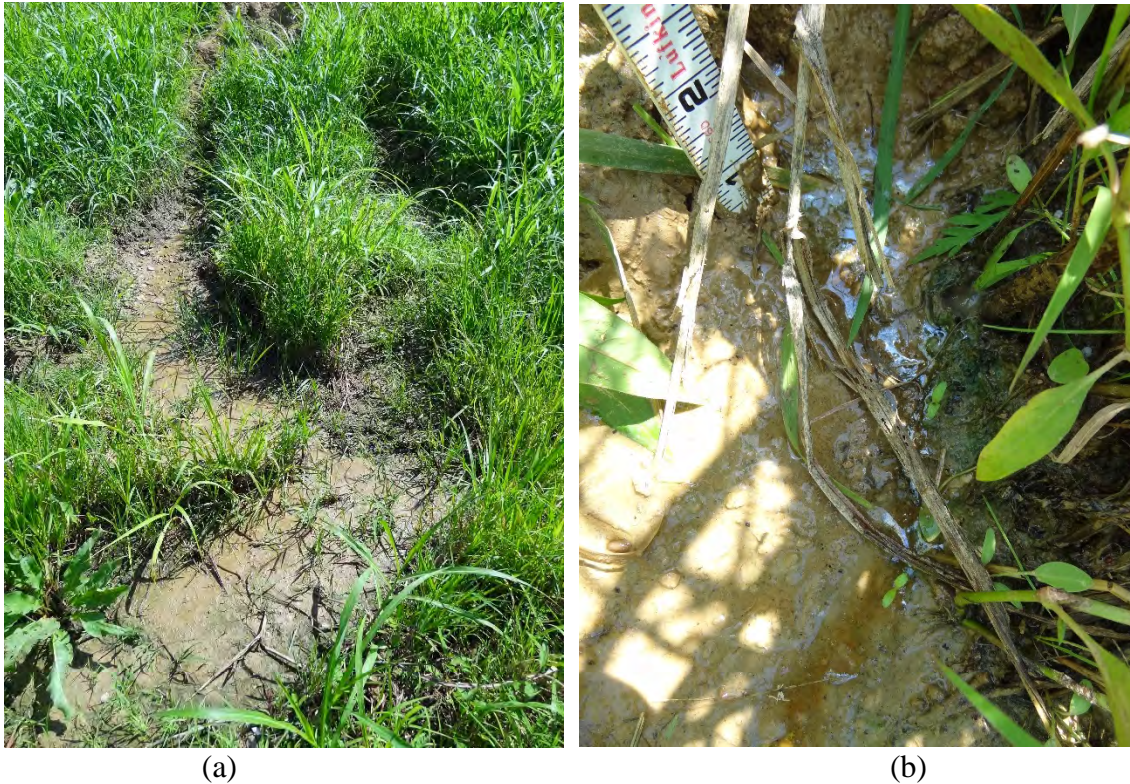
- Finally alongside the transfer station, another erosion area (see Figure 12(a)) was observed but this erosion feature also exhibited a visible leachate outbreak. Figure 12(b) is a close-up of the outbreak with a scale. This area should also be remediated and is close to the erosion gully in Figure 11.

Figure 12. Photographs along northwest slope of north quarry near transfer station: (a) overview of soil erosion and (b) close-up of leachate outbreak.
