Report: BC 4802 - SR

**A** FDID: 09503 State: MO Incident Date: MM 11 DD 02 YYYY 2018 Station: Incident Number: 18-4804366 Exposure: 0

Fire Investigation of incident 18-4804366.  
11/5/18. I, Laurie Taylor (4803) responded to 13570 St Charles Rock Road to investigate a fire that occurred on the evening of 11/02/2018. I was accompanied by Matt LaVanchy (4801) to interview employees of Republic services who were present at the time of the event and to inspect the area where the fire occurred. Erin Fanning of Republic Services gave a presentation of the timeline of events and activities that occurred during the event. Ms. Fanning stated that at approximately 1615 she requested employee Matt to inspect the area for any problems from the thunderstorm that was in the area. There were no alarms of any kind going off. No one observed a lightning strike either visually or audibly. No one observed any trespassers or vandals inside the fenced area. System had been running normally. No issues over the weekend. Blankets had been installed 3 weeks earlier for insulation. CT25 had passed its daily inspection. A pneumatic pump is used to move liquid and gas through the condensate trap. No electr

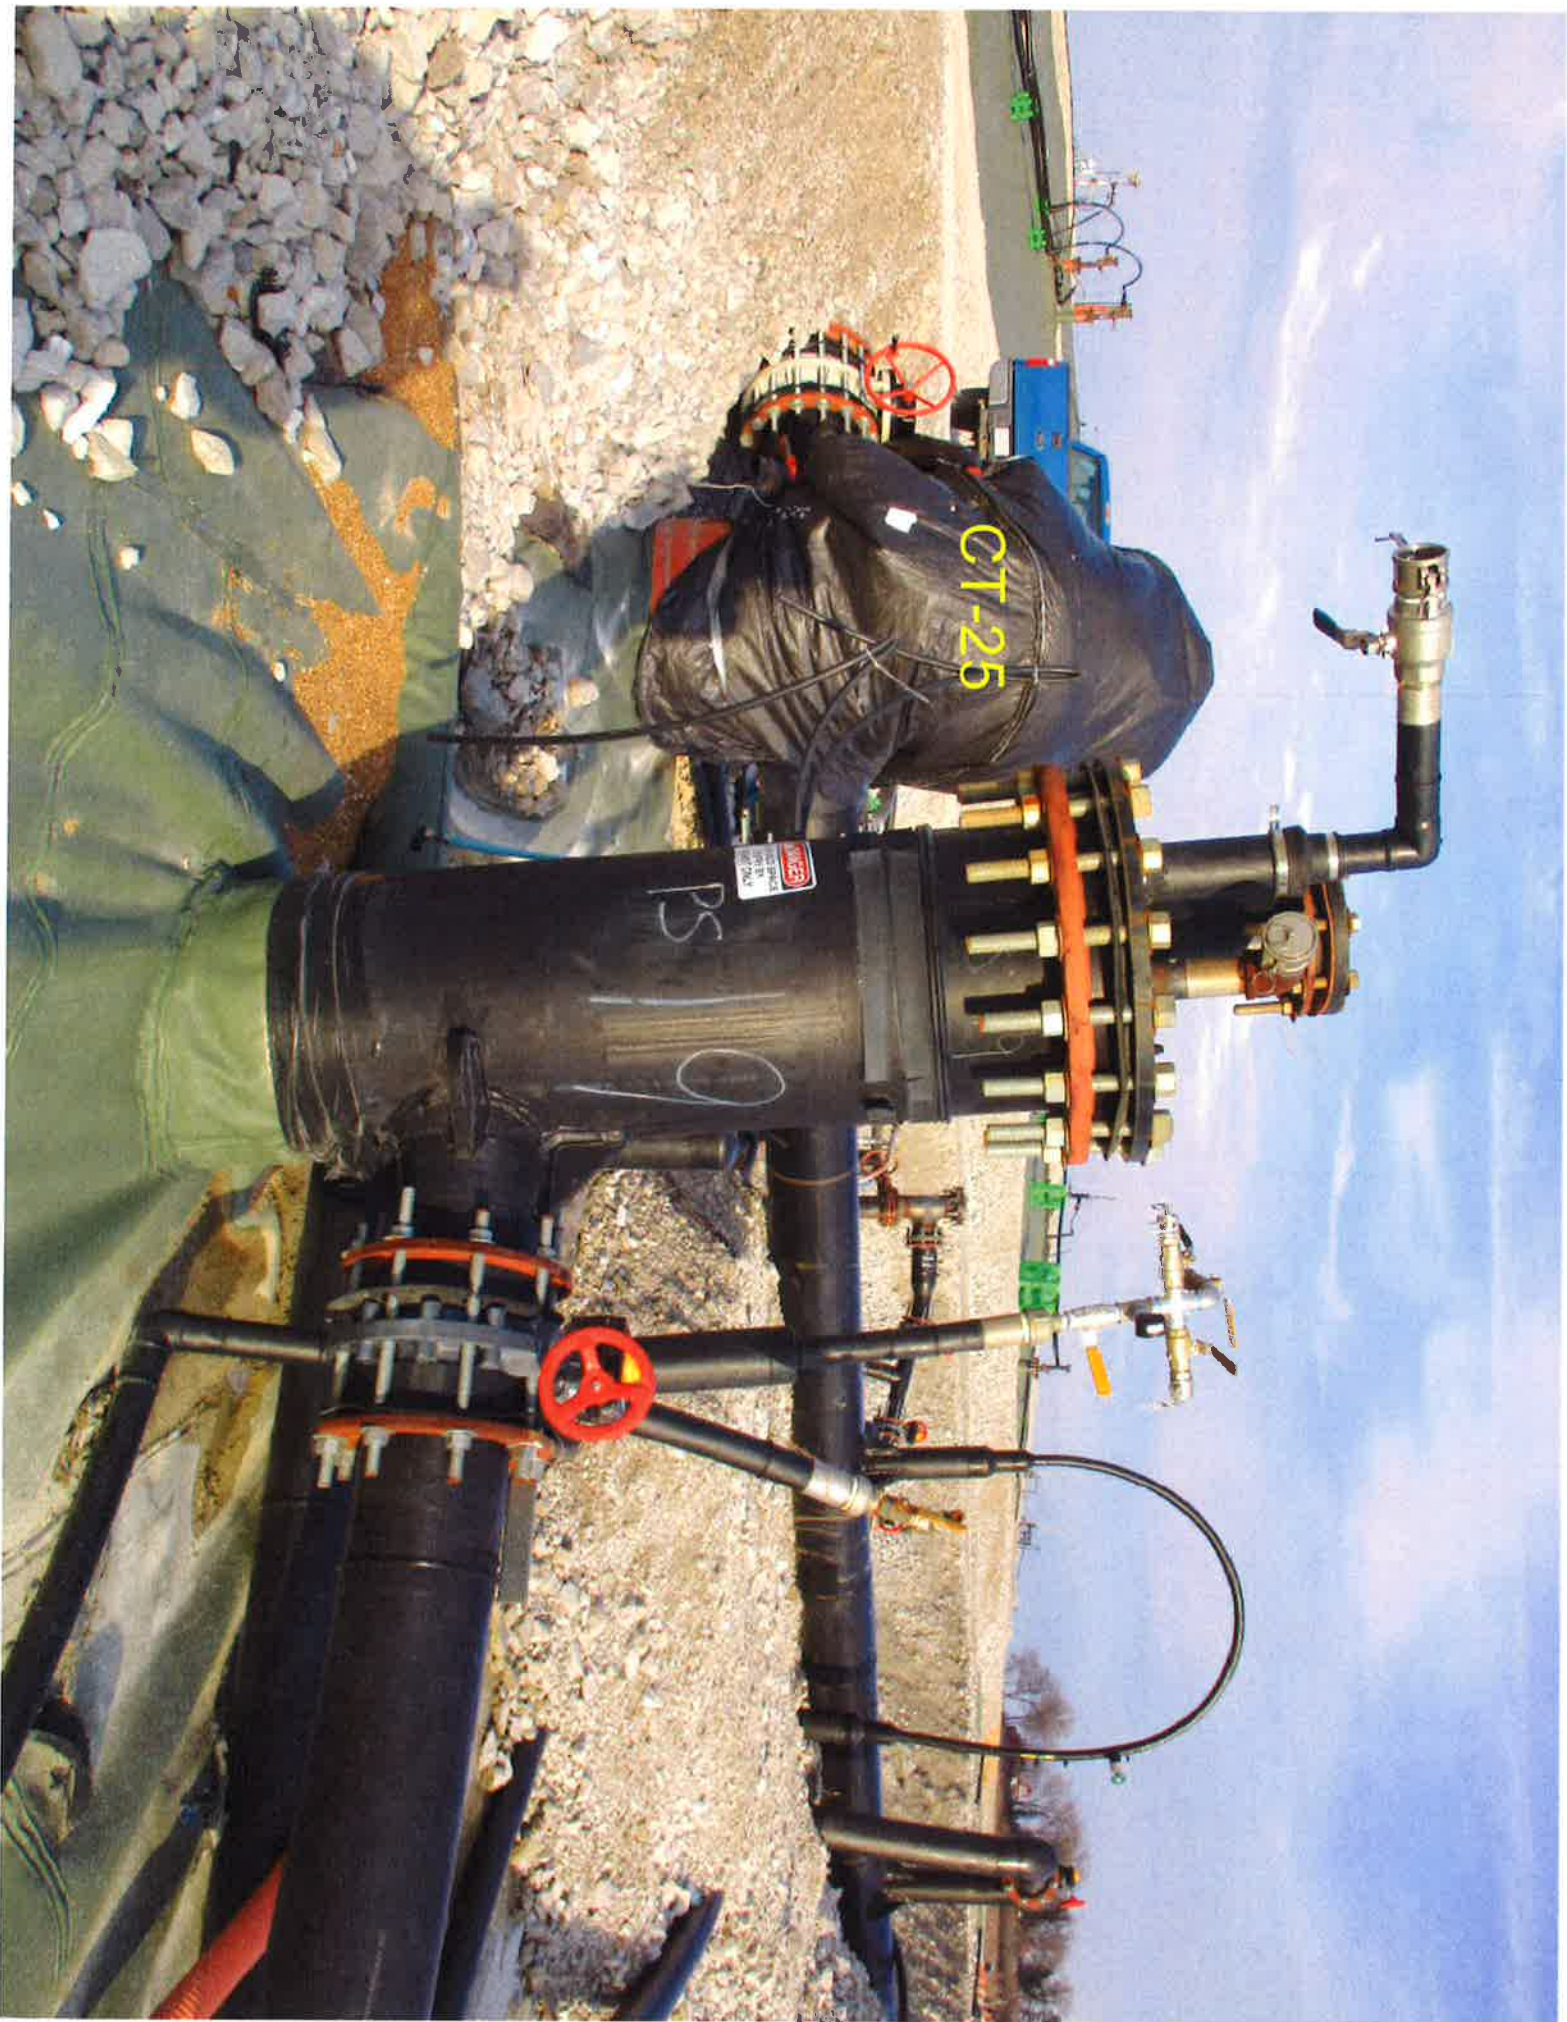
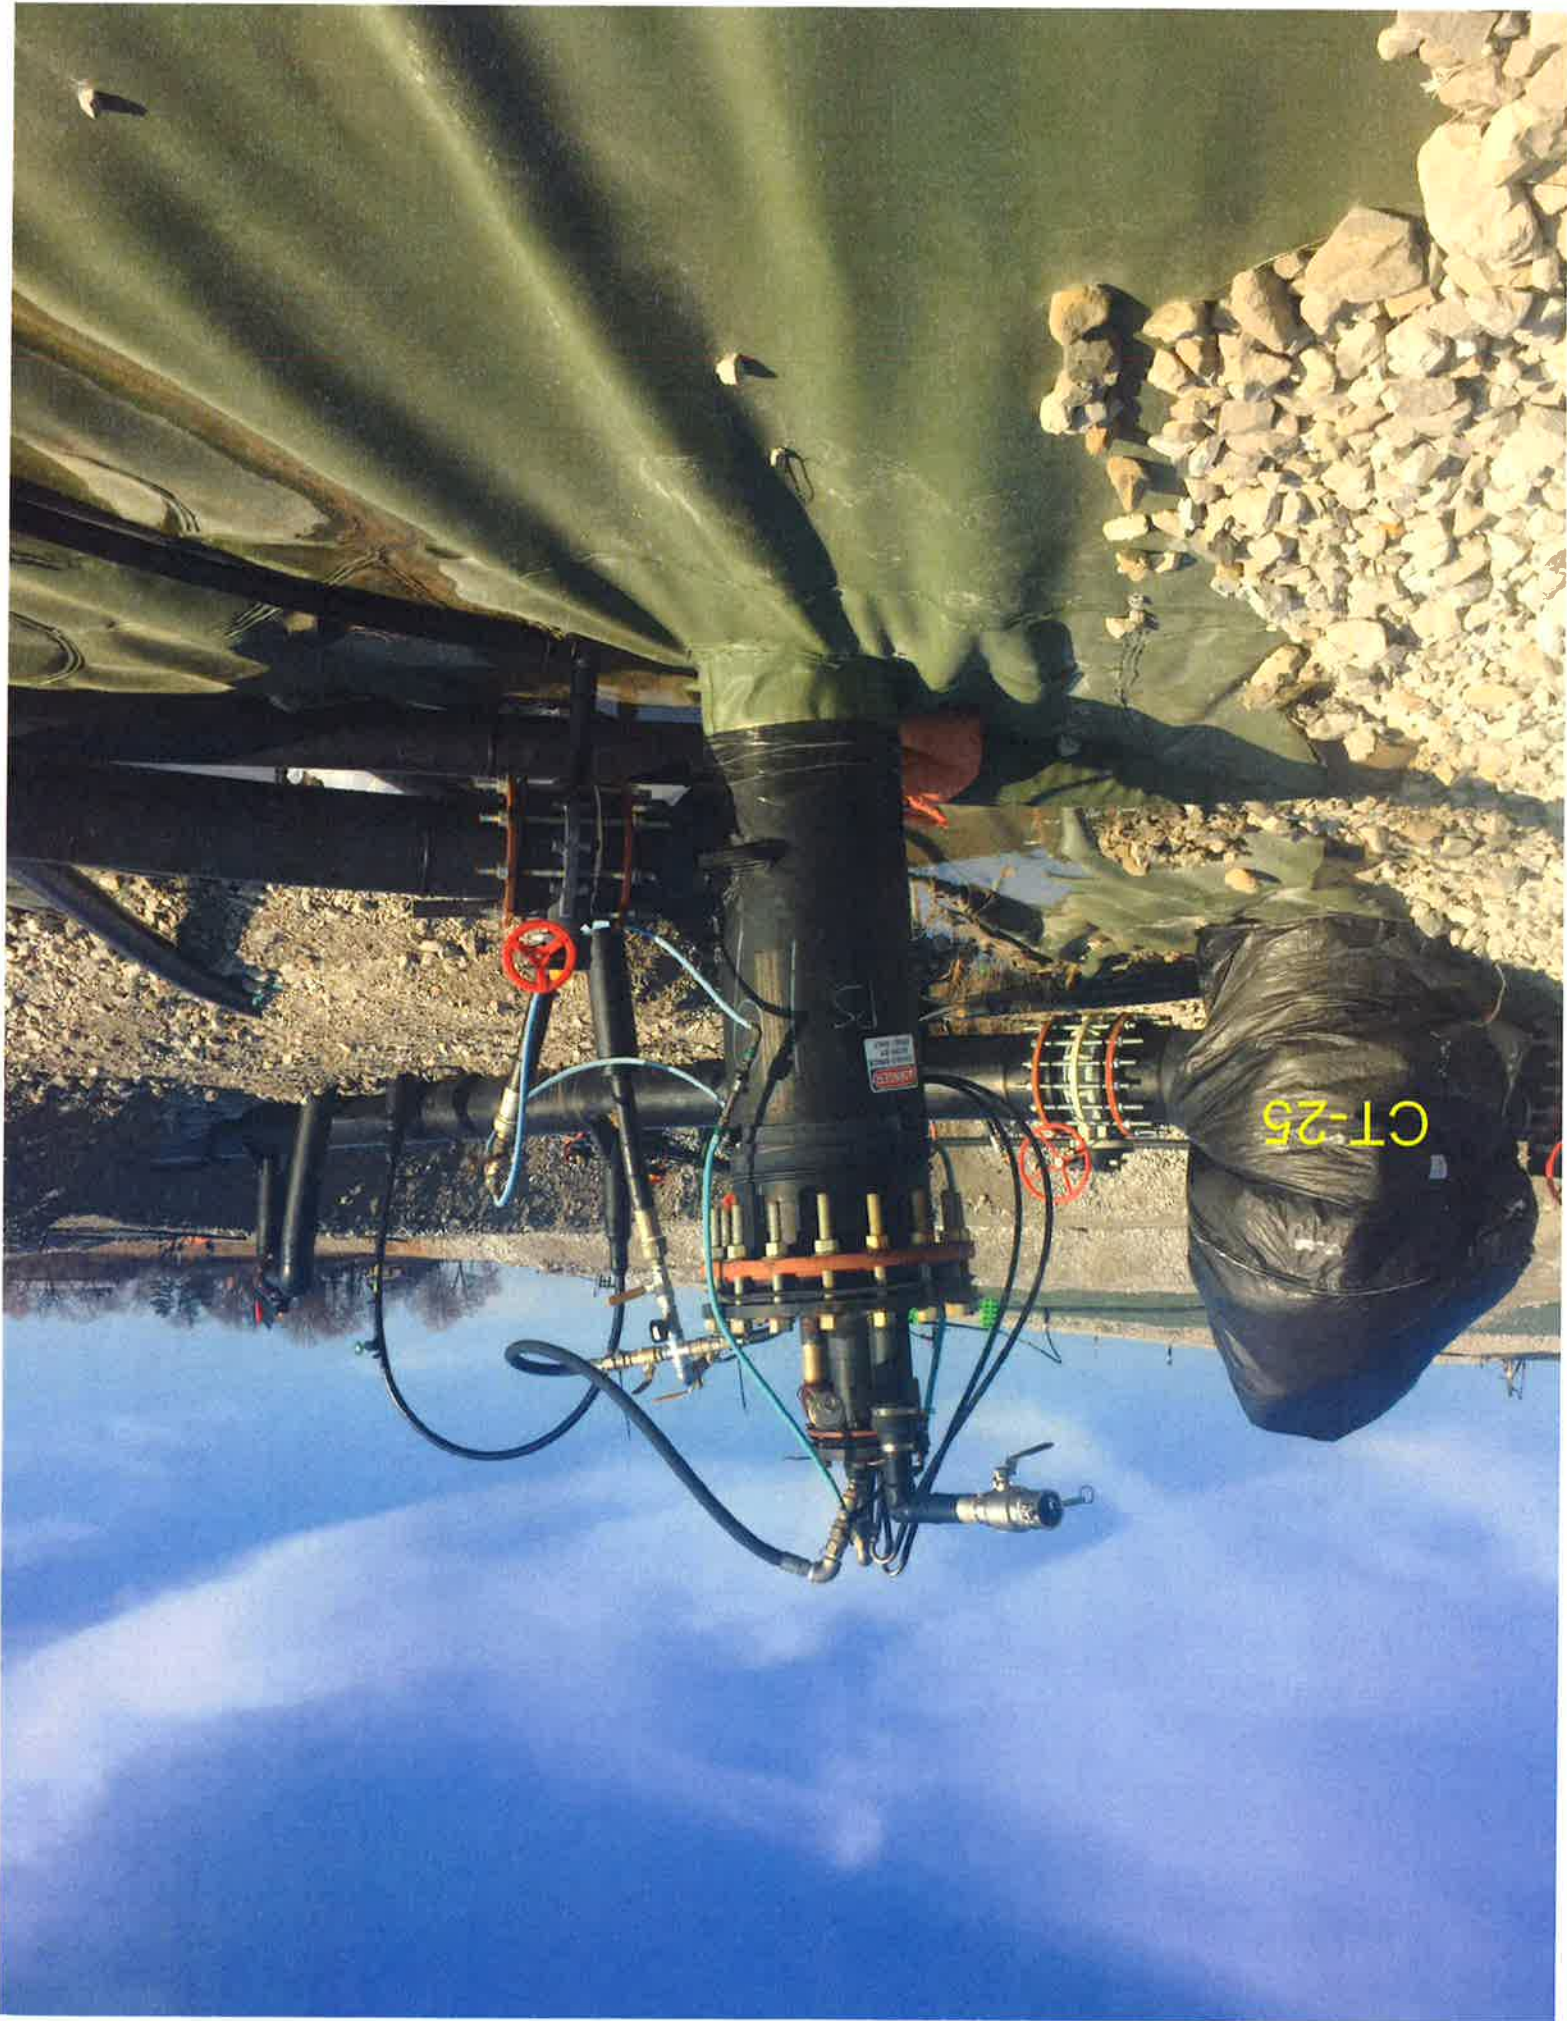
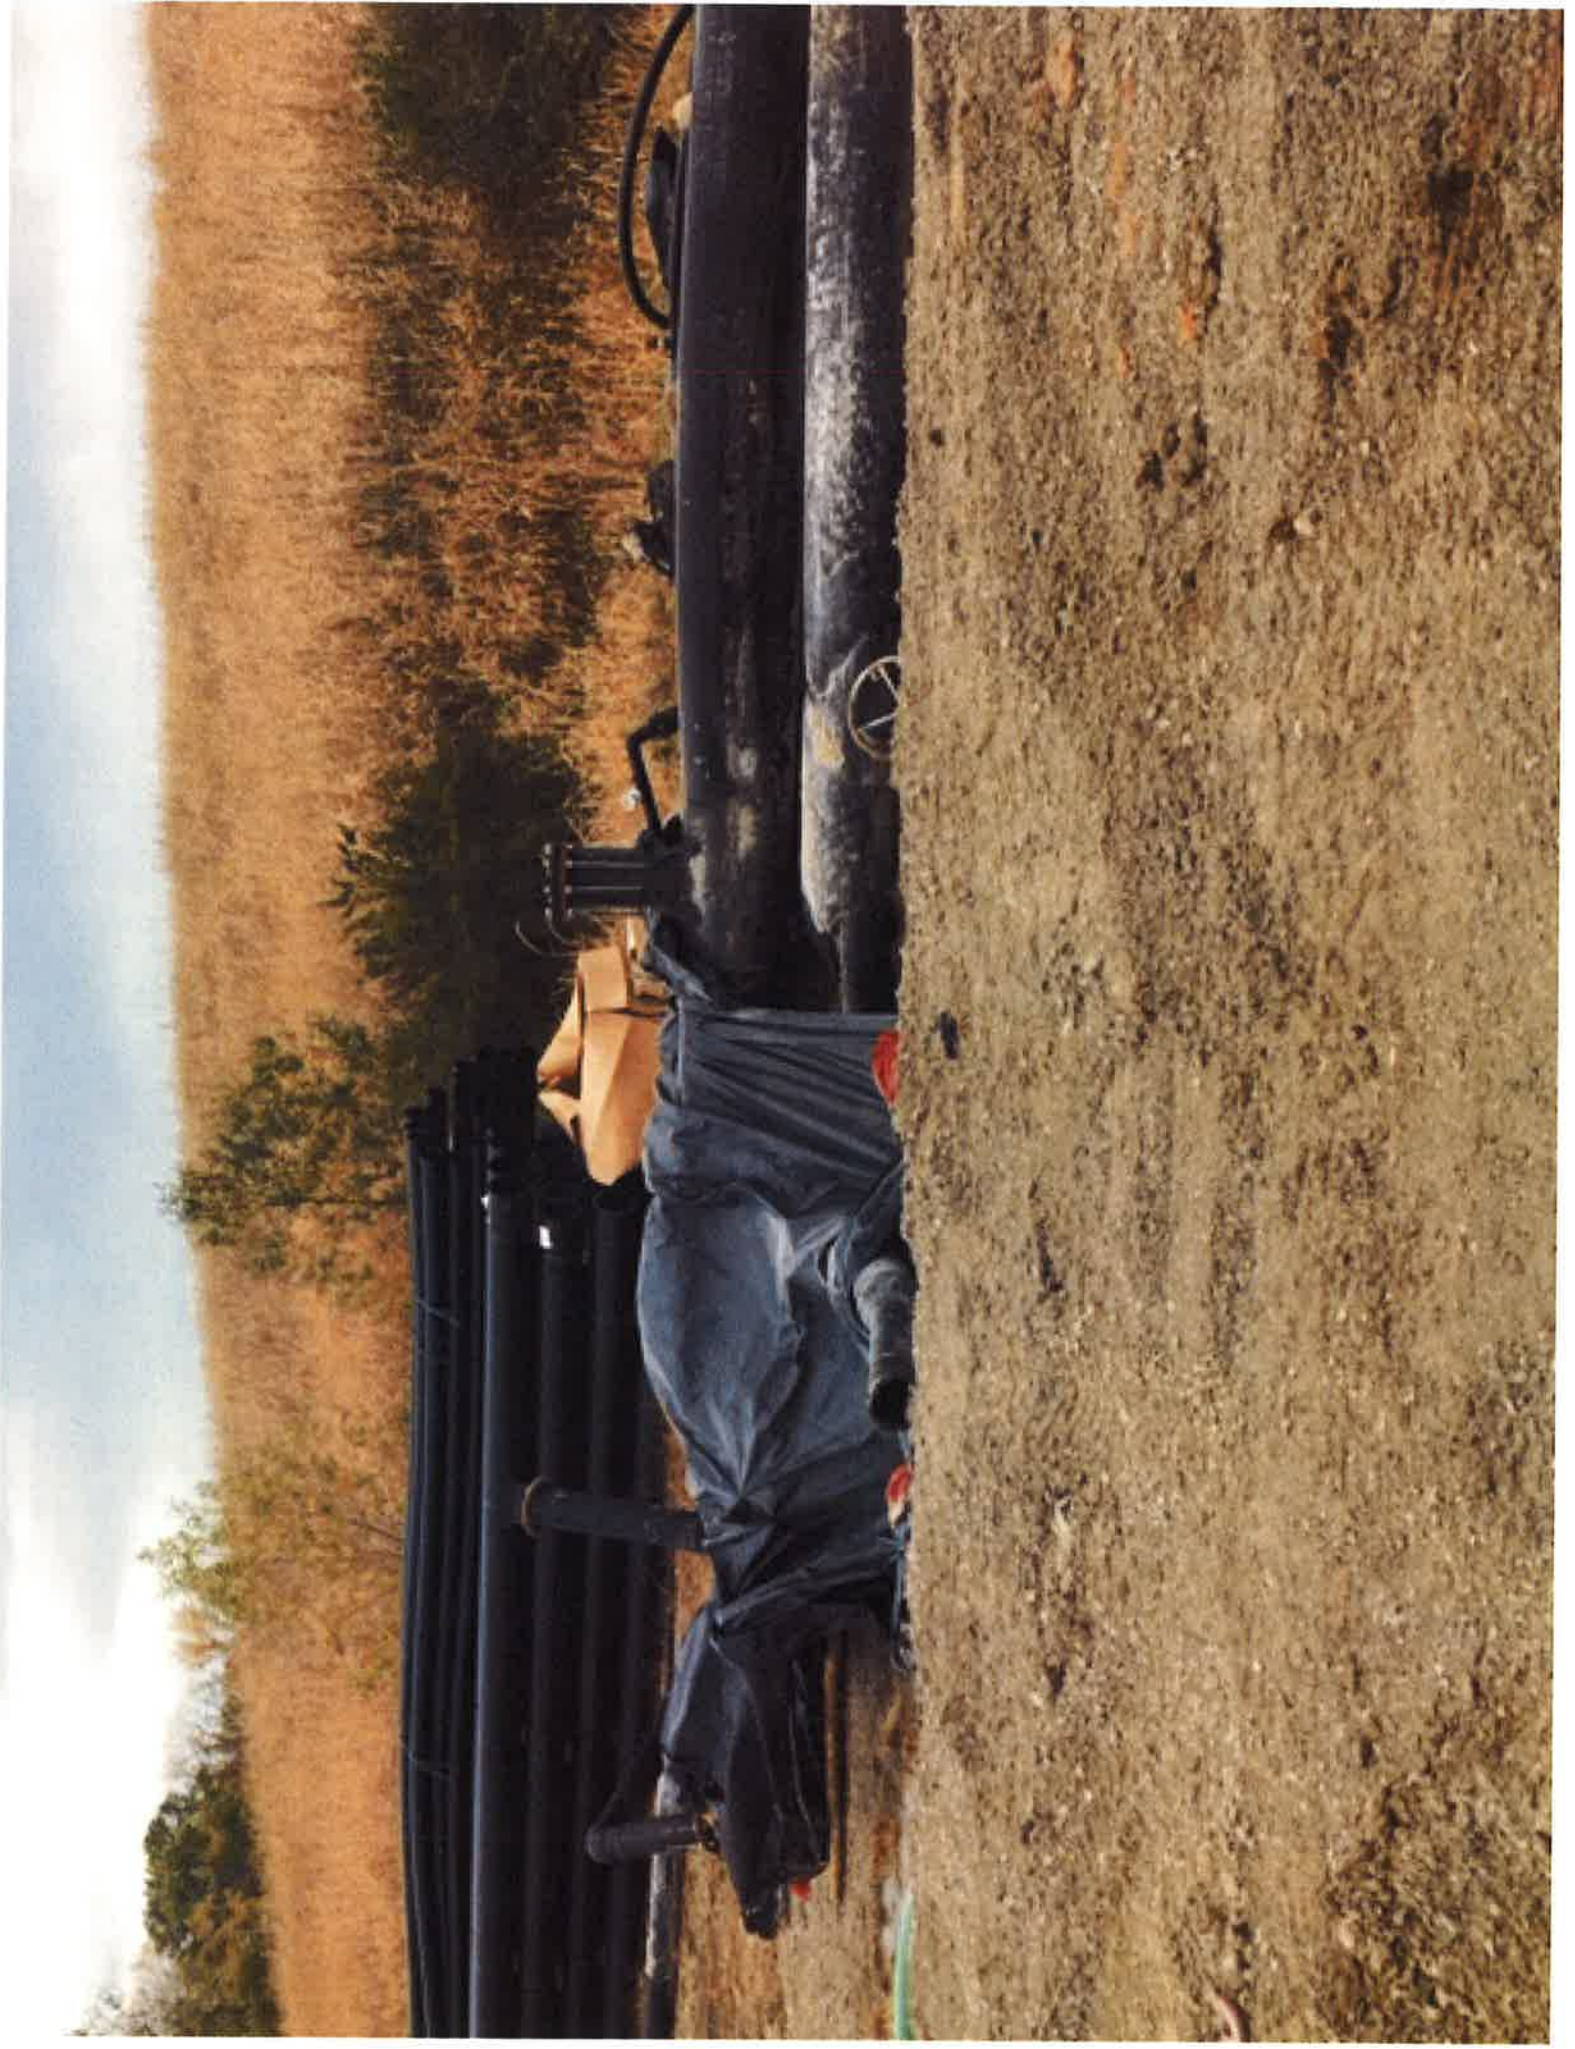
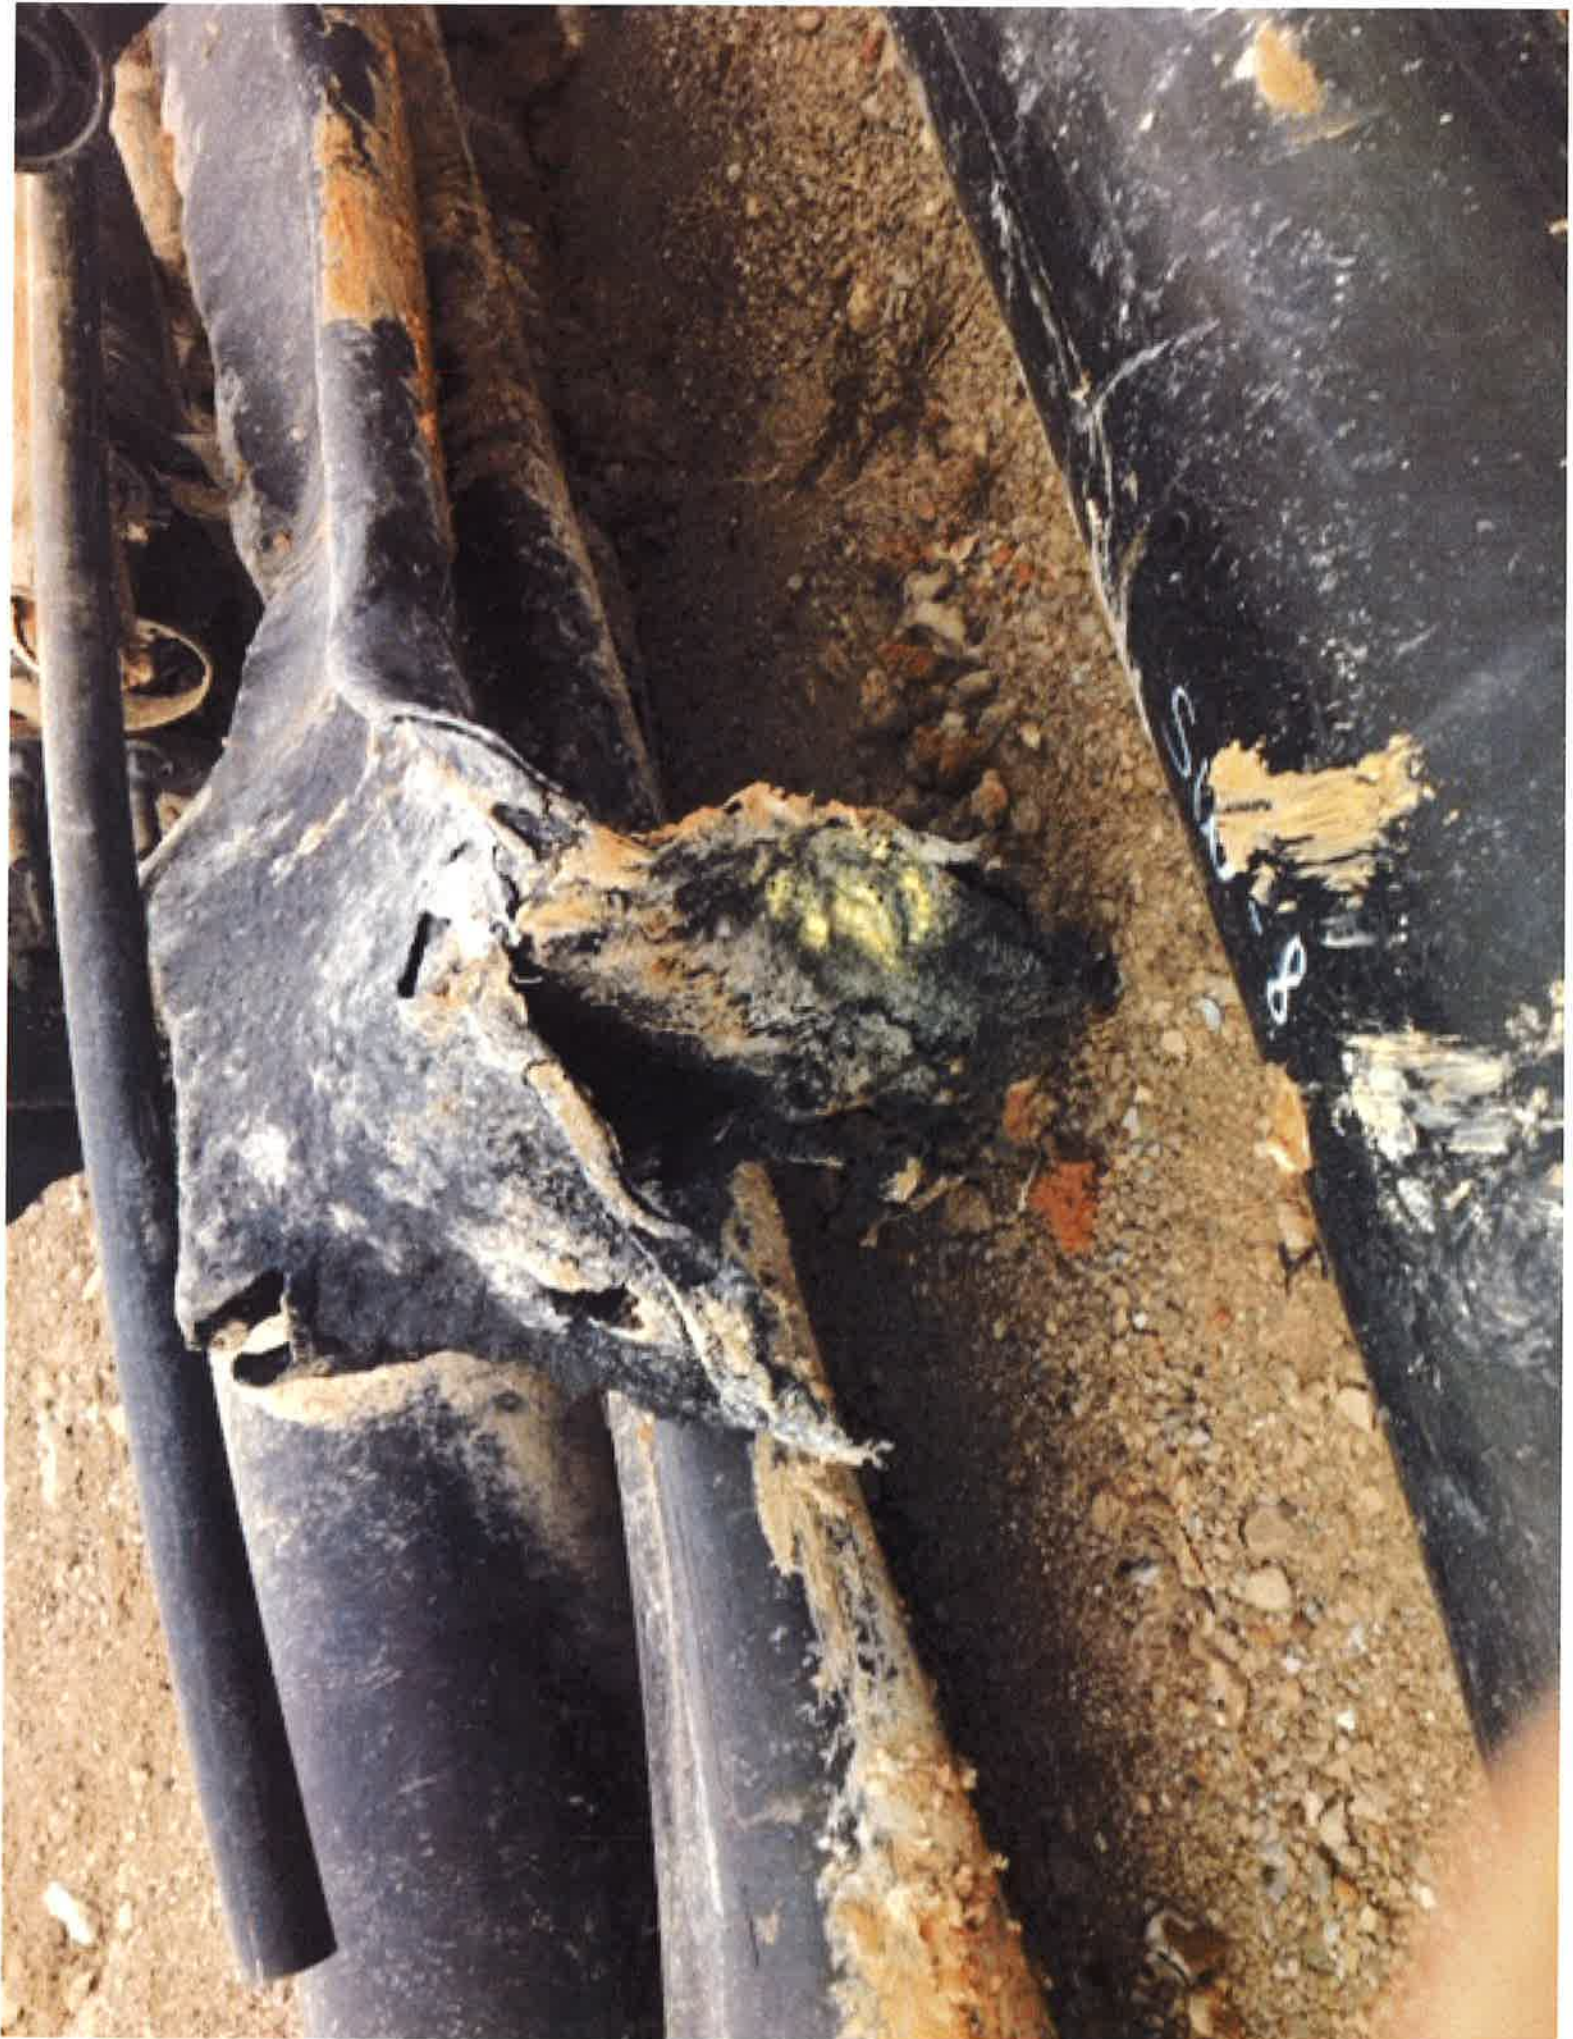
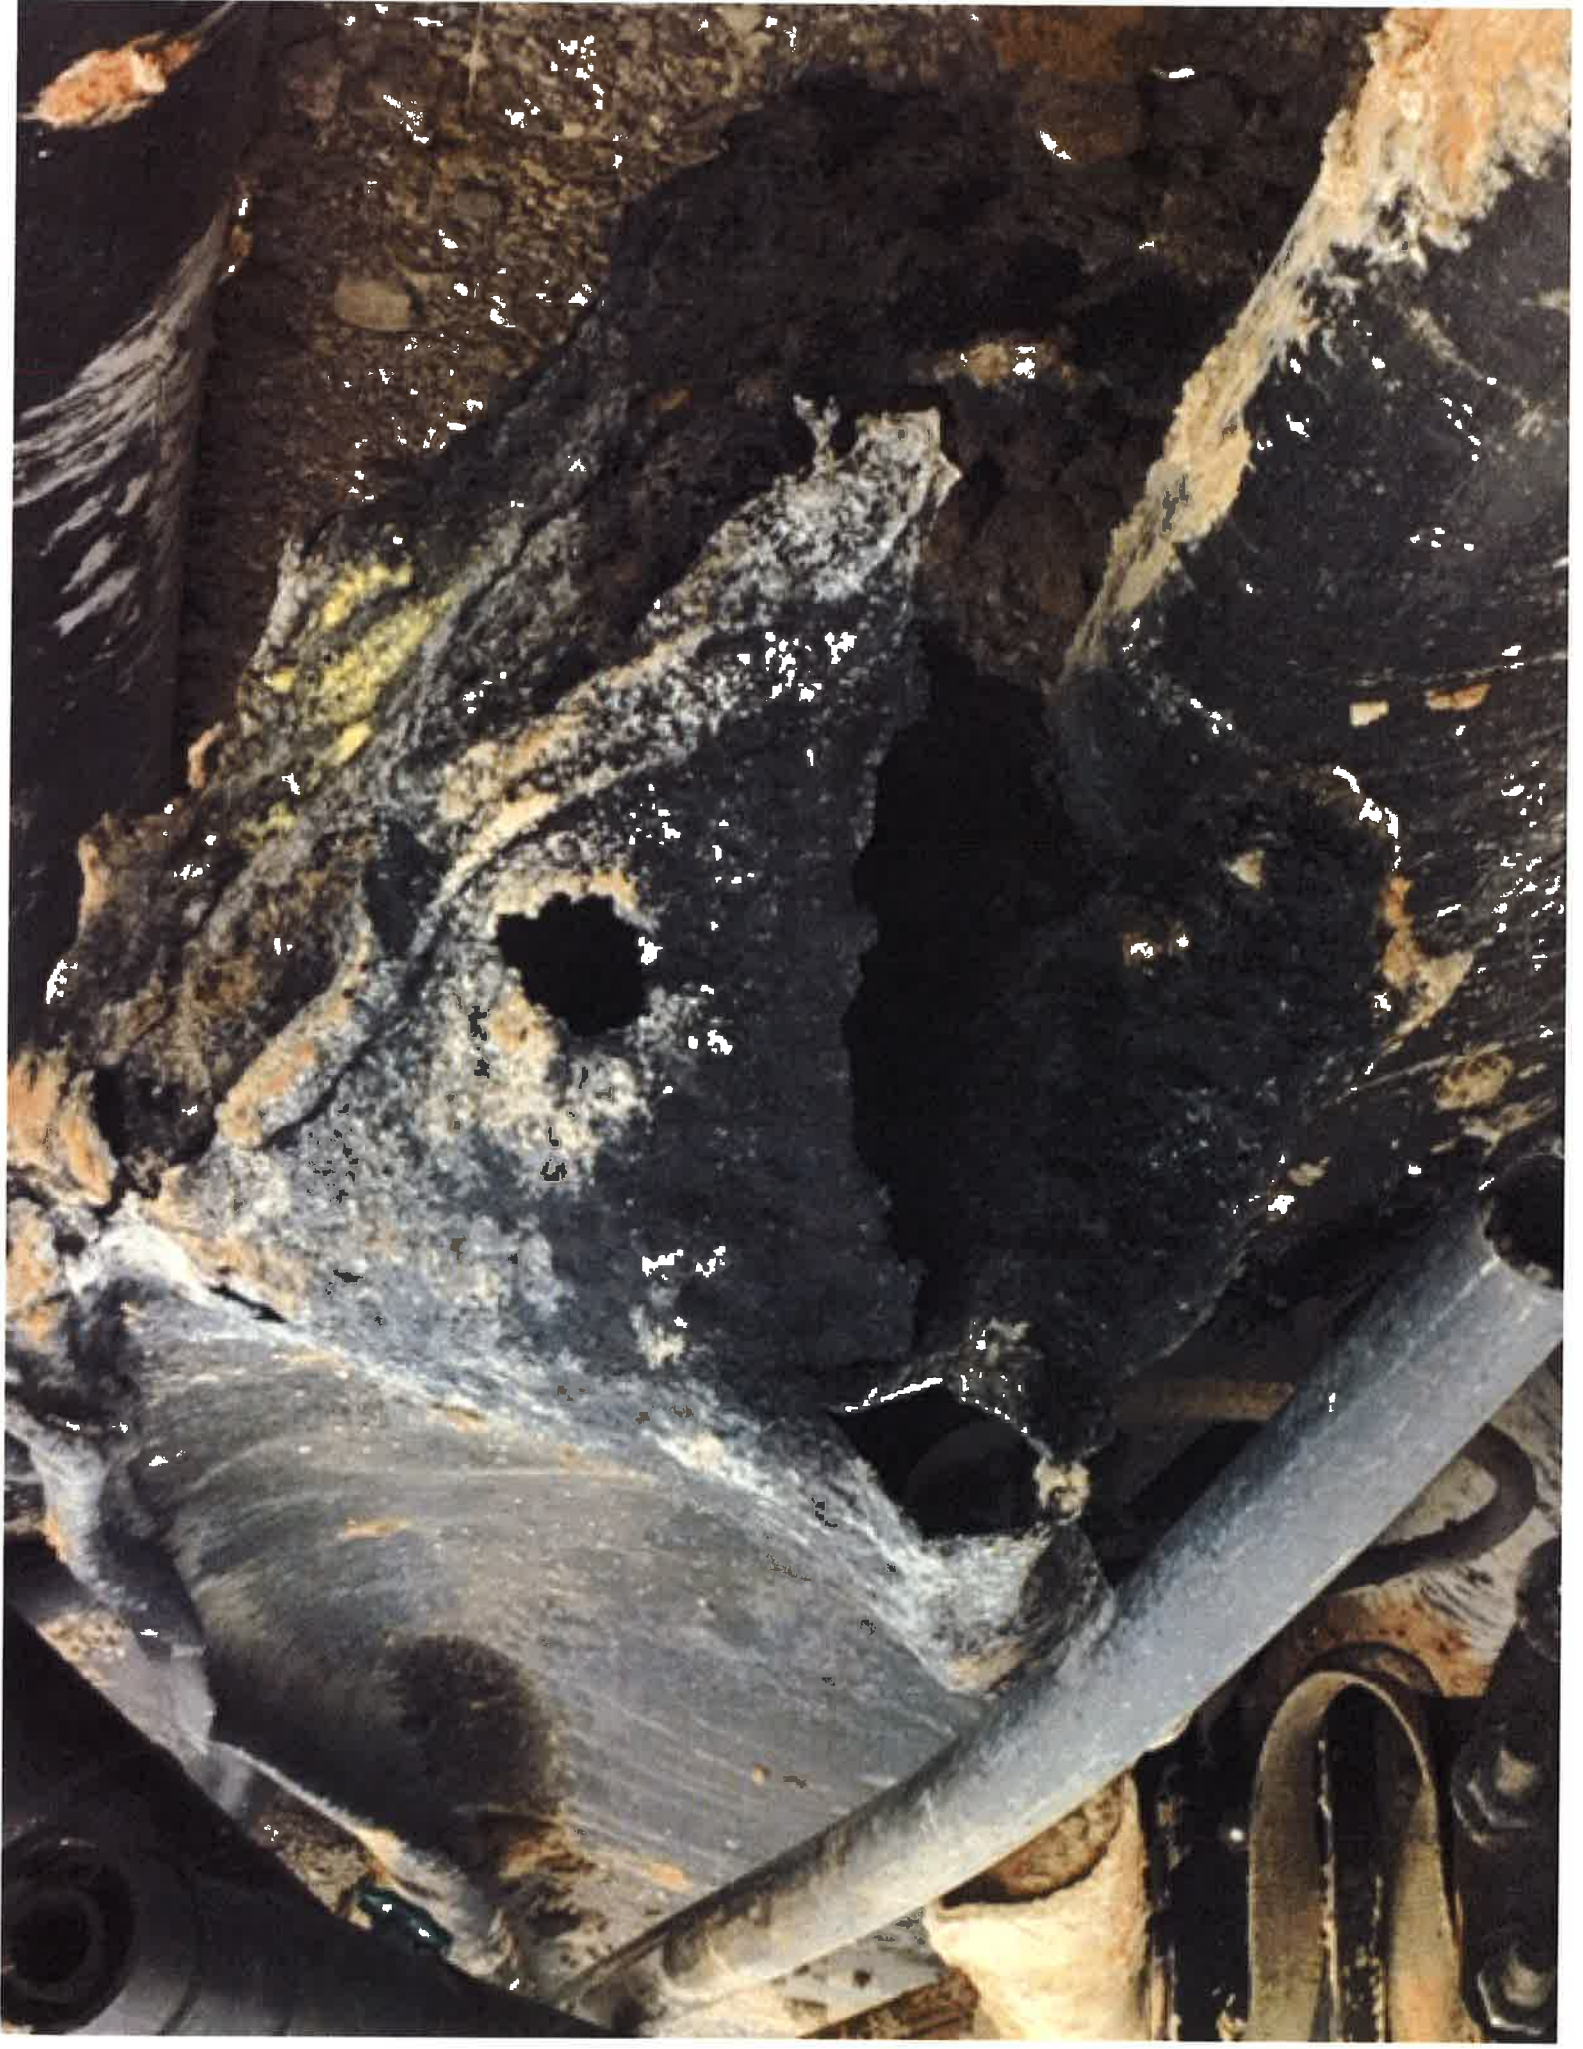
Landfill  
and Site

Observation and inspection of incident site. This is a known landfill with long term subsurface smoldering event. A system of barriers (tarps/berms) and gas/liquid removal system has been in place for some time. The fire event that occurred 11/2/2018 happened in the southwest corner of the landfill. This area is close in proximity to Gate #2. No damage or failure of the fencing or gate at gate #2 observed. A large pile of black HDPE pipe is located under a tarp across the gravel service road from the event. These are sections of CT25 and headers connecting to CT25 as described by Erin Fanning. Several pieces have extensive charring and melting. A section of pipe identified as the header that "daylighted" has charring and has melted together. See image IMG\_2603 and IMG\_2634. Fire and heat damage observed to the "connection flange" identified as CT25 on the interior surface with damage heavier on one side than the other. Unable to determine which way it was oriented as it is no longer attached. The entire interior surface of CT25 is melted and charred below the section that was removed. See IMG\_2613. Several sections of removed pipe have evidence of burning to the interior surface. See IMG\_2630. Sections of the pipe that were identified as the area of "daylighting" have dry chemical extinguishing agent coating. See IMG\_2634. No evidence of mechanical impact in the area observed. No evidence or witness statements of intentionally set fire, mischief, or vandalism. The area is monitored by video camera. No evidence of lightning strike. Refer to CoreLogic Strike.net report #5416454. One cloud to ground strike was recorded approximately .5 miles from area of origin at 1615 on 11/2/2018. No electrical equipment in use or power lines down in or near the area of origin. No evidence of careless disposal of smoking products. While the exact ignition source and sequence is beyond the expertise of this investigator, the first fuel ignited is the gases contained within the pipes. The gases were heated to their ignition temperature below grade inside the pipes and sustained the flames that erupted from the surface header pipes. The "daylighted" pipe section allowed for air to be entrained into the lower pipes to sustain the fire. Once the flare system and compressors were shut down, as described by Erin Fanning, the fire was extinguished a short time after. The flammable gasses involved in this event may have come from the landfill or the pipes in use at the landfill itself or a combination. Heating of the pipe above 300 degrees Celcius (572-degrees F) causes decomposition of the pipe and flash of fumes may occur. This information is taken from the Safety date sheet provided by Republic services. The area of origin of this fire is CT25 and connecting header pipes. The cause of this fire is accidental by unknown system failure. Laurie Taylor Deputy Chief Fire Marshal

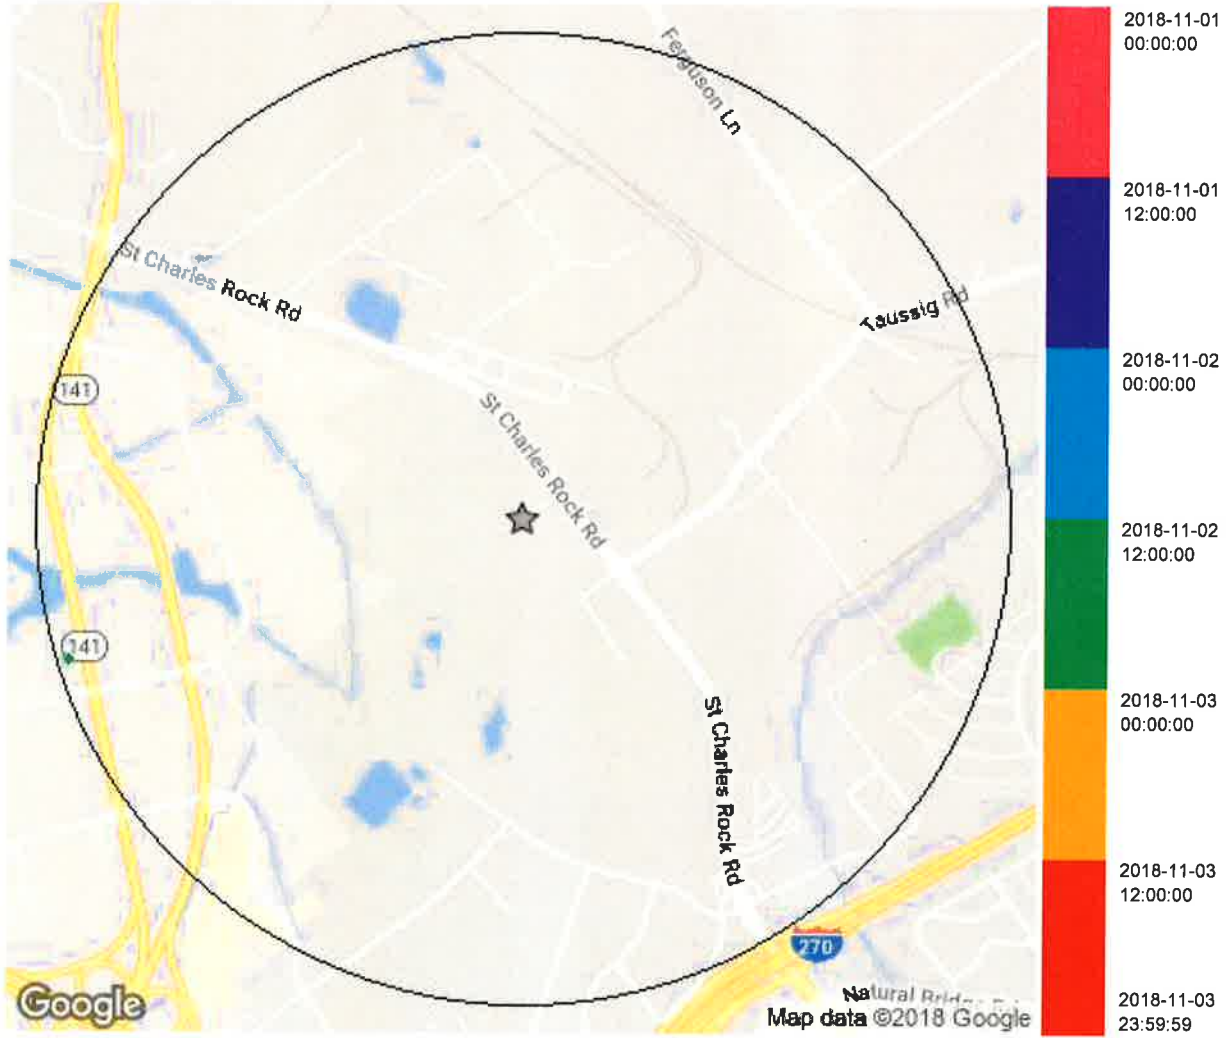
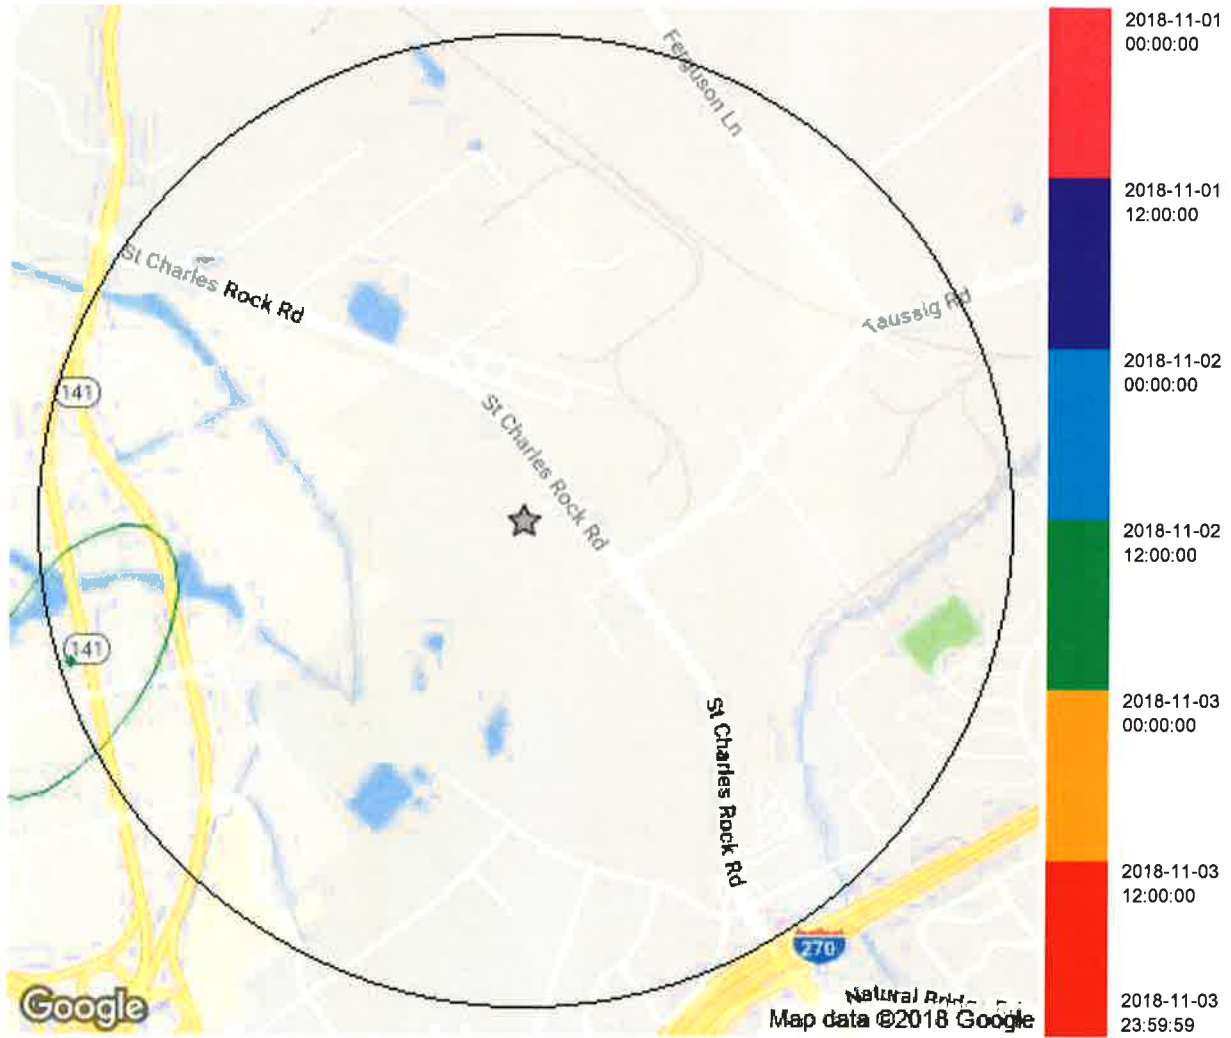
# Lightning Stroke Map

STRIKEenet verified the presence of 1 cloud-to-ground lightning strokes detected within 1 mile of the property for the dates inquired.

Date	Time (CDT)	Peak Current (kA)	Distance from Center (mi/km)	Latitude	Longitude
Nov 2, 2018	16:15:35	-9.1	1/1.6	38.7666	-90.46062
