# Bridgeton Landfill, LLC

# Weekly Data Submittal

Week of March 21, 2021 – March 27, 2021

Required by Section IX.33.g of Final Consent Judgment, Case No. 13SL-CC01088-01 Effective June 29, 2018

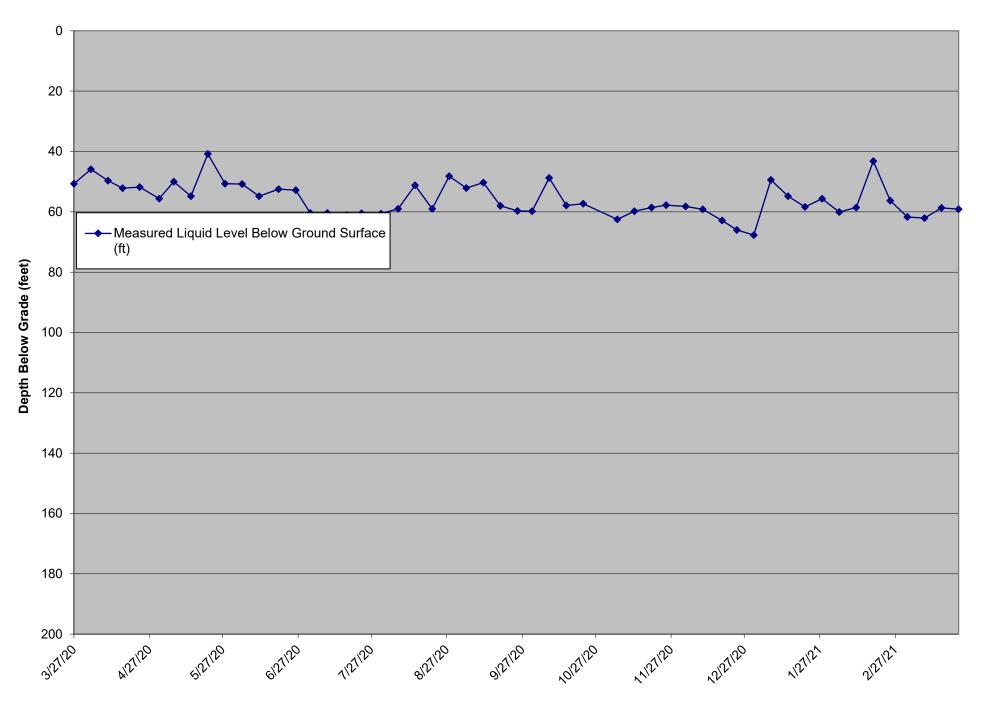
## LCS-4B Liquid Level Below Ground Surface

The level sensor in LCS-4B is currently operational and responsive. Liquid level was not recorded by the level sensor during the weekly reporting period. LCS-4B is equipped with a flow meter that displayed no flow during the weekly reporting period. Therefore, it can be concluded that the liquid level was below the bottom of the pump and level sensor in LCS-4B.

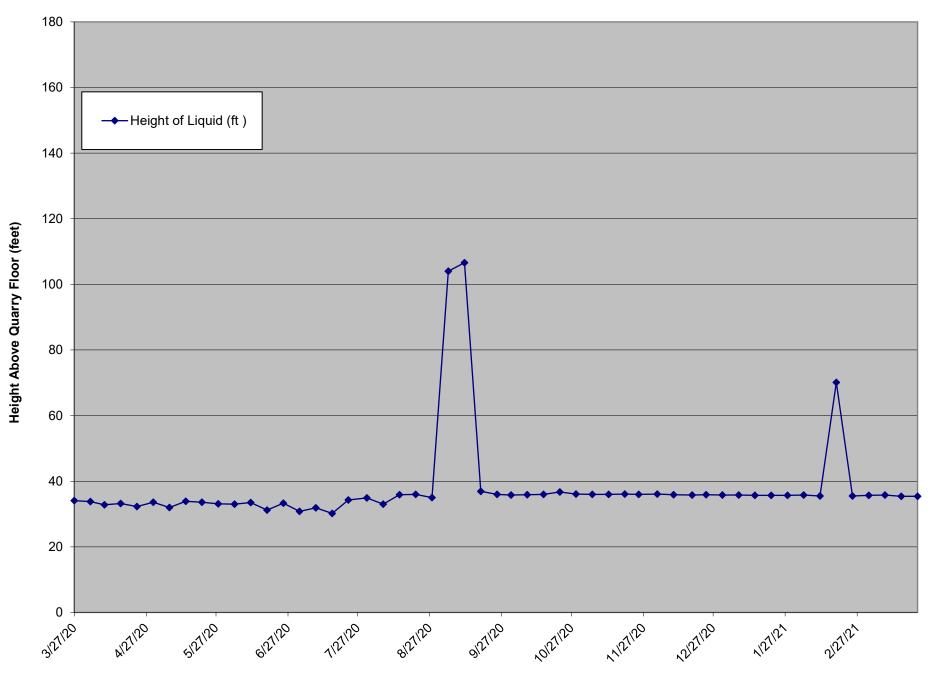
LCS-5B Liquid Level Above Quarry Floor

level. The electric pump was converted to a pneumatic pump on 9/30/20.

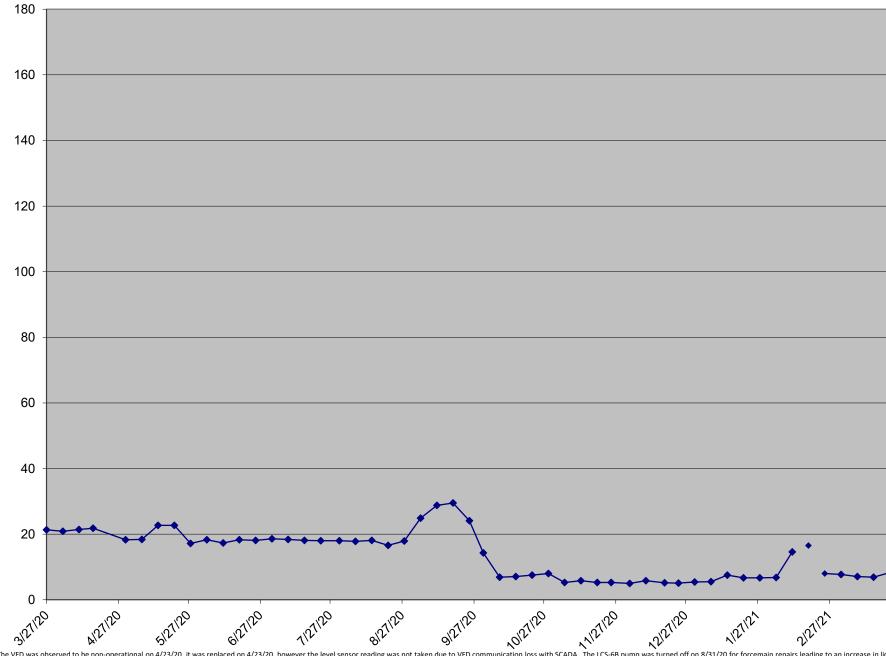
LCS-6B Liquid Level Above Quarry Floor

The VFD was observed to be non-operational on 4/23/20, it was replaced on 4/23/20, however the level sensor reading was not taken due to VFD communication loss with SCADA. The LCS-6B pump was turned off on 8/31/20 for forcemain repairs leading to an increase in liquid
