# ***Bridgeton Landfill* LLC**

Please find enclosed the Slope Stability Assessment summarizing the slope stability analysis for third quarter of 2015, conducted pursuant to Paragraph 10 of the Second Amendment of the First Agreed Order.

RE: Bridgeton Stability

On July 21 and 22, 2015 I performed an inspection of the Bridgeton Landfill for the purpose of identifying any visual evidence of instability or incipient failure. The inspection included the north and south quarry fill areas. This inspection was for the third quarter of 2015. The previous inspection was performed on June 3, 2015.

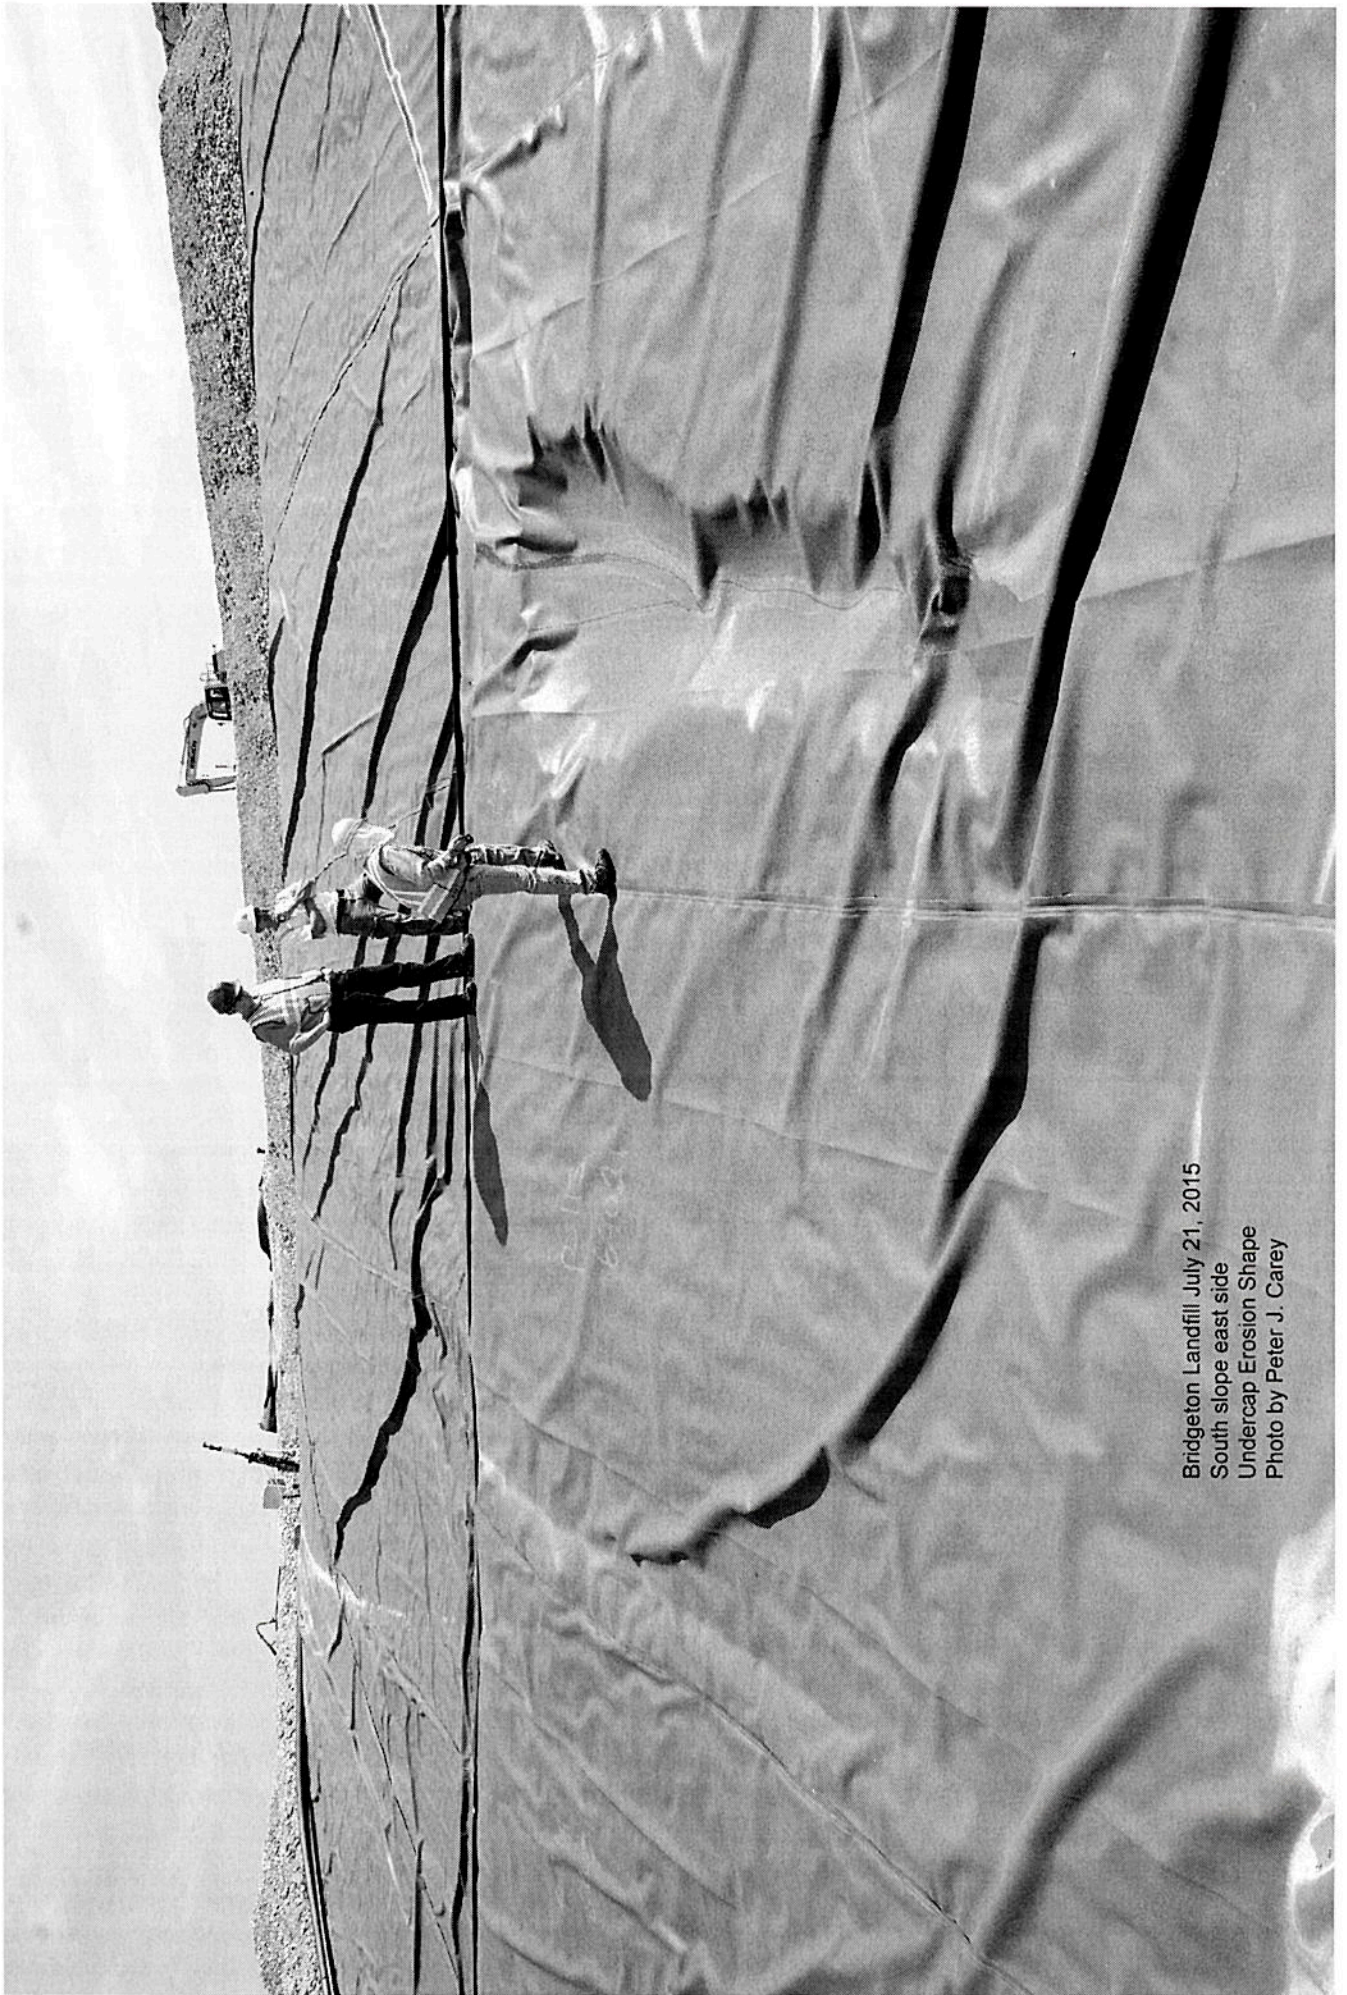
The inspection revealed the presence of surficial slumps in the south east edge of the landfill, between the perimeter ditch and perimeter liquid collection trench installed at the time of capping. These slumps were observed during the previous 3 inspections and have not progressed uphill into the general slope. No indications of instability were noted uphill of this location. The slump shapes suggest they are the result of daylighting of seepage under the cap membrane and subsequent erosion/or slippage of the surficial soils downslope being transported and deposited at the perimeter uncap swale below. The slumps, as seen in the attached photograph, have a shape that is wider at the top and narrow at downslope, indicative of a shallow seepage driven event. Given that these slump shapes have not progressed up slope it is not necessary to repair them at this time.

Bridgeton Landfill July 21, 2015  
South slope east side  
Undercap Erosion Shape  
Photo by Peter J. Carey
