**STORMWATER MANAGEMENT SUBSEQUENT EVALUATION
REPORT**

**FOR
BRIDGETON LANDFILL
LOCATED AT
13570 SAINT CHARLES ROCK ROAD, BRIDGETON, MISSOURI 63044**

**CEC Project No. 180-128
Task 2009**

Date: MAY 2020

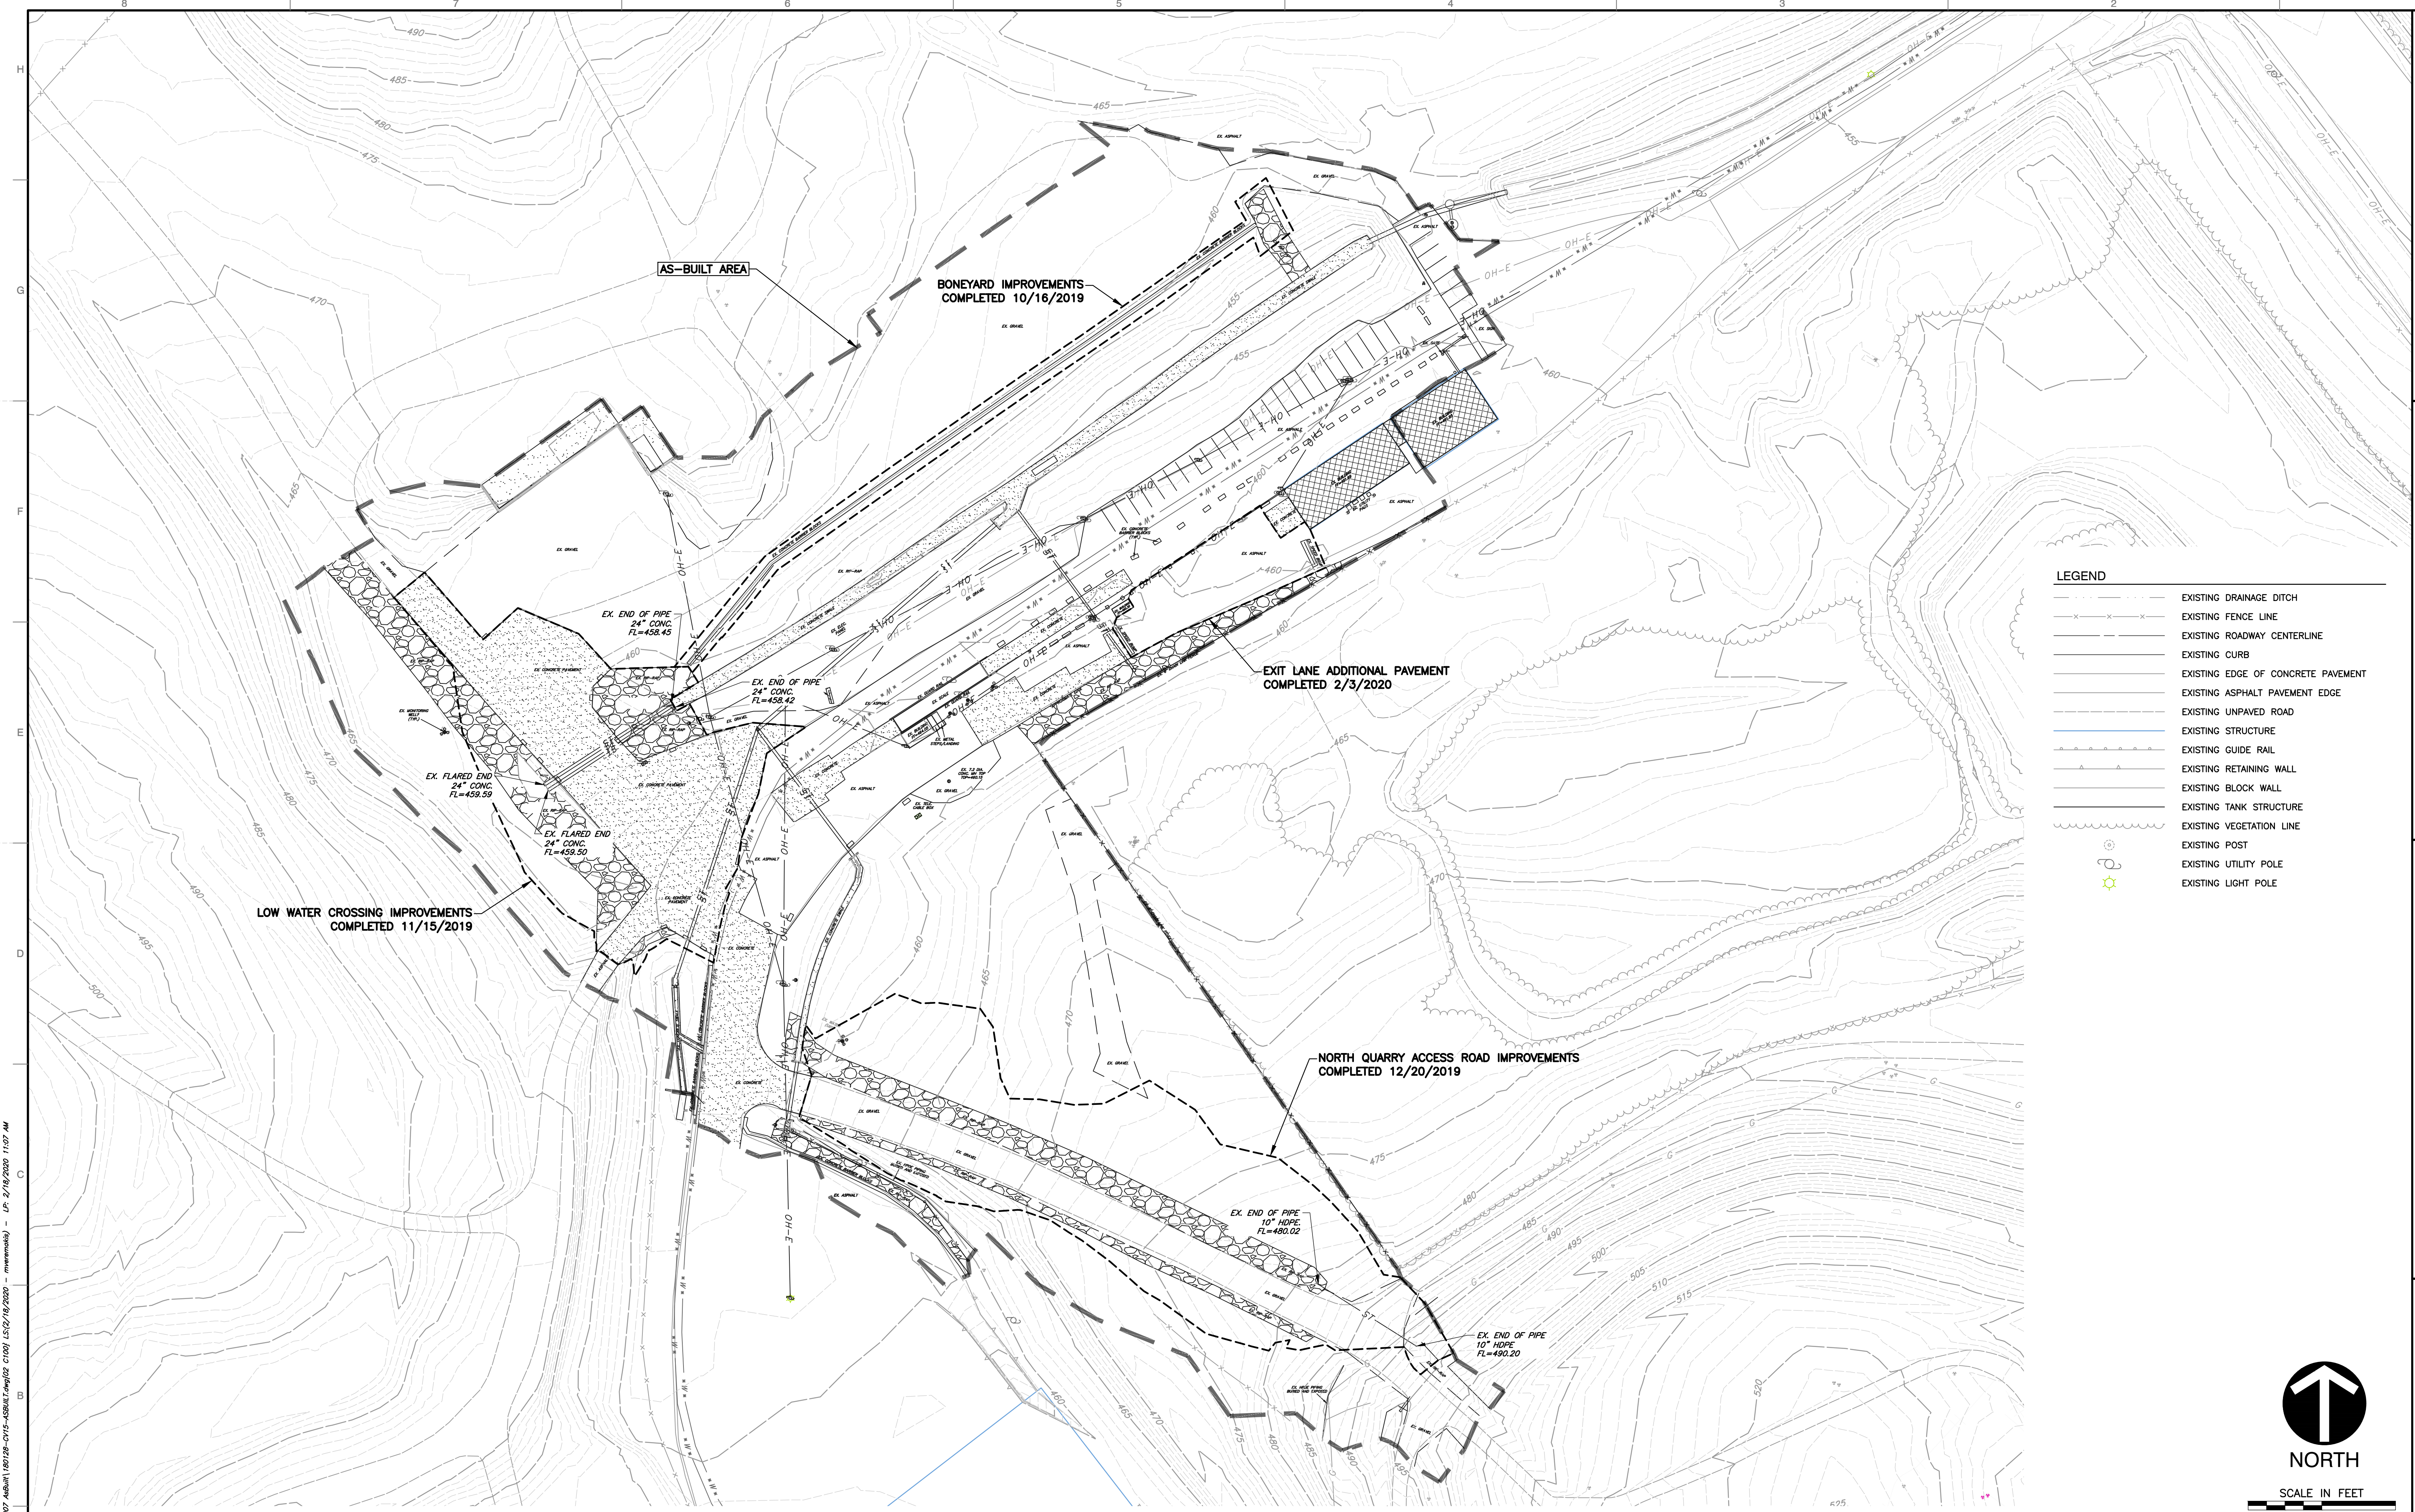
DRAWING NO.: **FIGURE 2**

These improvements have helped reduce the transmission of sediment and trash from the drainage area to Outfall #007. Overall, the above improvements have resulted in decreased concentrations of permitted constituents. However, periodic NPDES exceedances continue to occur at Outfall #007 including biochemical oxygen demand (BOD), chemical oxygen demand (COD), TSS, aluminum and iron. Periodic exceedances have also occurred at Outfalls #003, 004, 005, and 009. As such, and based on provisions in the June 2018 Final Consent Judgment, in May 2020, CEC, Inc. performed a subsequent stormwater management evaluation of the permitted outfalls to further isolate the exceedances and formulate solutions to capture any high concentrations of constituents upstream of the outfalls. A summary of recent sampling results is tabulated below in Section 1.2 with a full summary shown in *Appendix A*. The results of the subsequent evaluation are shown below in Section 2.0.

Though recent improvements as shown on *Figure 2* have helped reduce the transmission of sediment from the drainage area to Outfall #007, the outfall continues to experience recurring NPDES exceedances including BOD, COD, TSS, aluminum and iron. The main remaining contributing factor to the BOD and COD exceedances is the concentrated flows from the transfer station pad. To bring this outfall into compliance, we recommend the following new improvements:

2. Construction of New Improvements in the Outfall #007 Watershed – see enclosed *Figure 2* for the as-built location of improvements:
 - a. Low Water Crossing Pavement – a 0.5-acre area of gravel lot was paved between the main road and the roll-off storage area and the pavement

- constructed above new storm culverts to convey runoff under the access road to Outfall #007. These improvements reduced the potential for transmission of dust and total suspended solids (TSS) to the channels and Outfall #007.

- b. Roll-off Storage Area – the storage area was stabilized in some areas with gravel in lieu of exposed dirt. Concrete blocks were placed as a diversion berm to contain and channelize site runoff to controlled let-down areas. These changes reduced the total amount of sediment from reaching the concrete swale and Outfall #007 sampling point.

- c. North Quarry Access Road – The access road was regraded at a uniform slope with an armored swale to channelize flows to a controlled let-down area. All disturbed areas were stabilized with turf reinforcement mats and vegetated. This work was coordinated with the United States Environmental Protection Agency (USEPA) Region 7 and no excavation or cut was performed.

- d. Exit Lane Pavement – Additional pavement was placed along the transfer truck exit lane to raise the elevation of the pavement to provide positive drainage to the adjacent storm swale and inlet. This work was coordinated with the United States Environmental Protection Agency (USEPA) Region 7 and no excavation or cut was performed. This pavement reduced the ponding of stormwater runoff and tracking of debris out of the site.

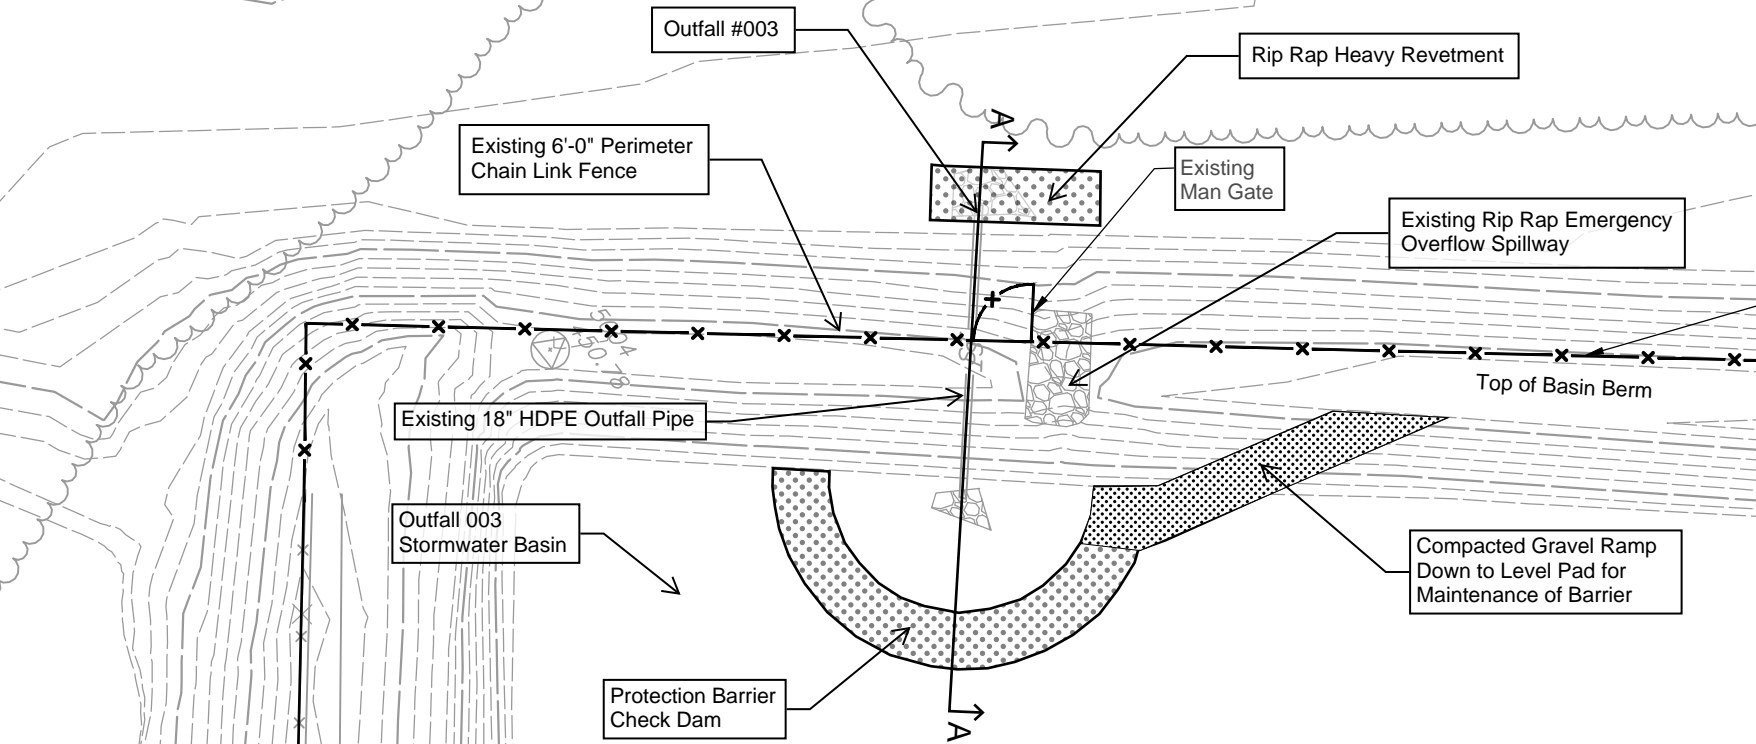
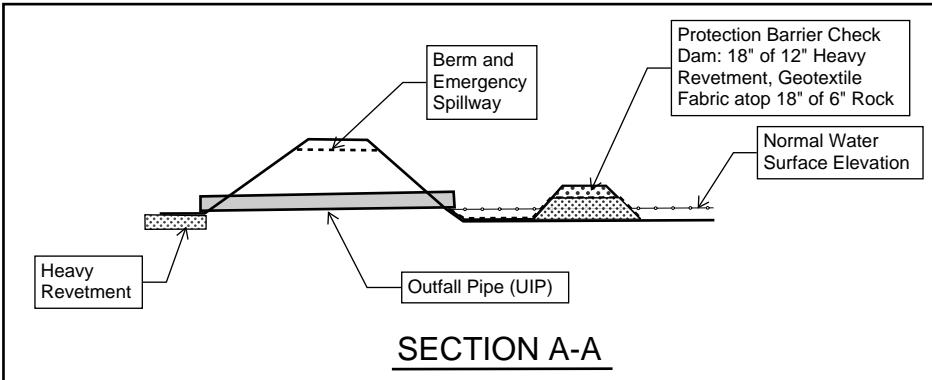
FIGURE 3
OUTFALL #003
PROPOSED IMPROVEMENTS
N.T.S.

The stormwater pond is designed to contain and filter stormwater runoff that flushes off the landscape. As such, some routine maintenance is needed including sediment removal in the - upstream lined channels and swales. Sediment was last removed in the upstream channels and swale in 2019Q4. During a stormwater basin inspection performed in 2019Q4, muskrat dens were found constructed within the shallow pond. No burrows were observed in the berms themselves, however we recommend trapping and removing these animals to reduce the risk of burrows in the berms and to reduce sediment and reed accumulation in the outfall pipe associated with muskrat activity.

In addition, we recommend the construction of a semi-circular protection barrier check dam near the outfall pipe – see enclosed *Figure 3*. This barrier is designed to further filter sediment from reaching the outfall and reduce concentrations of constituents. The area behind the barrier adjacent to the outfall pipe should be annually maintained to remove vegetation or debris that may collect. Heavy rip rap revetment should be placed to provide positive drainage away from the outfall and minimize erosion.

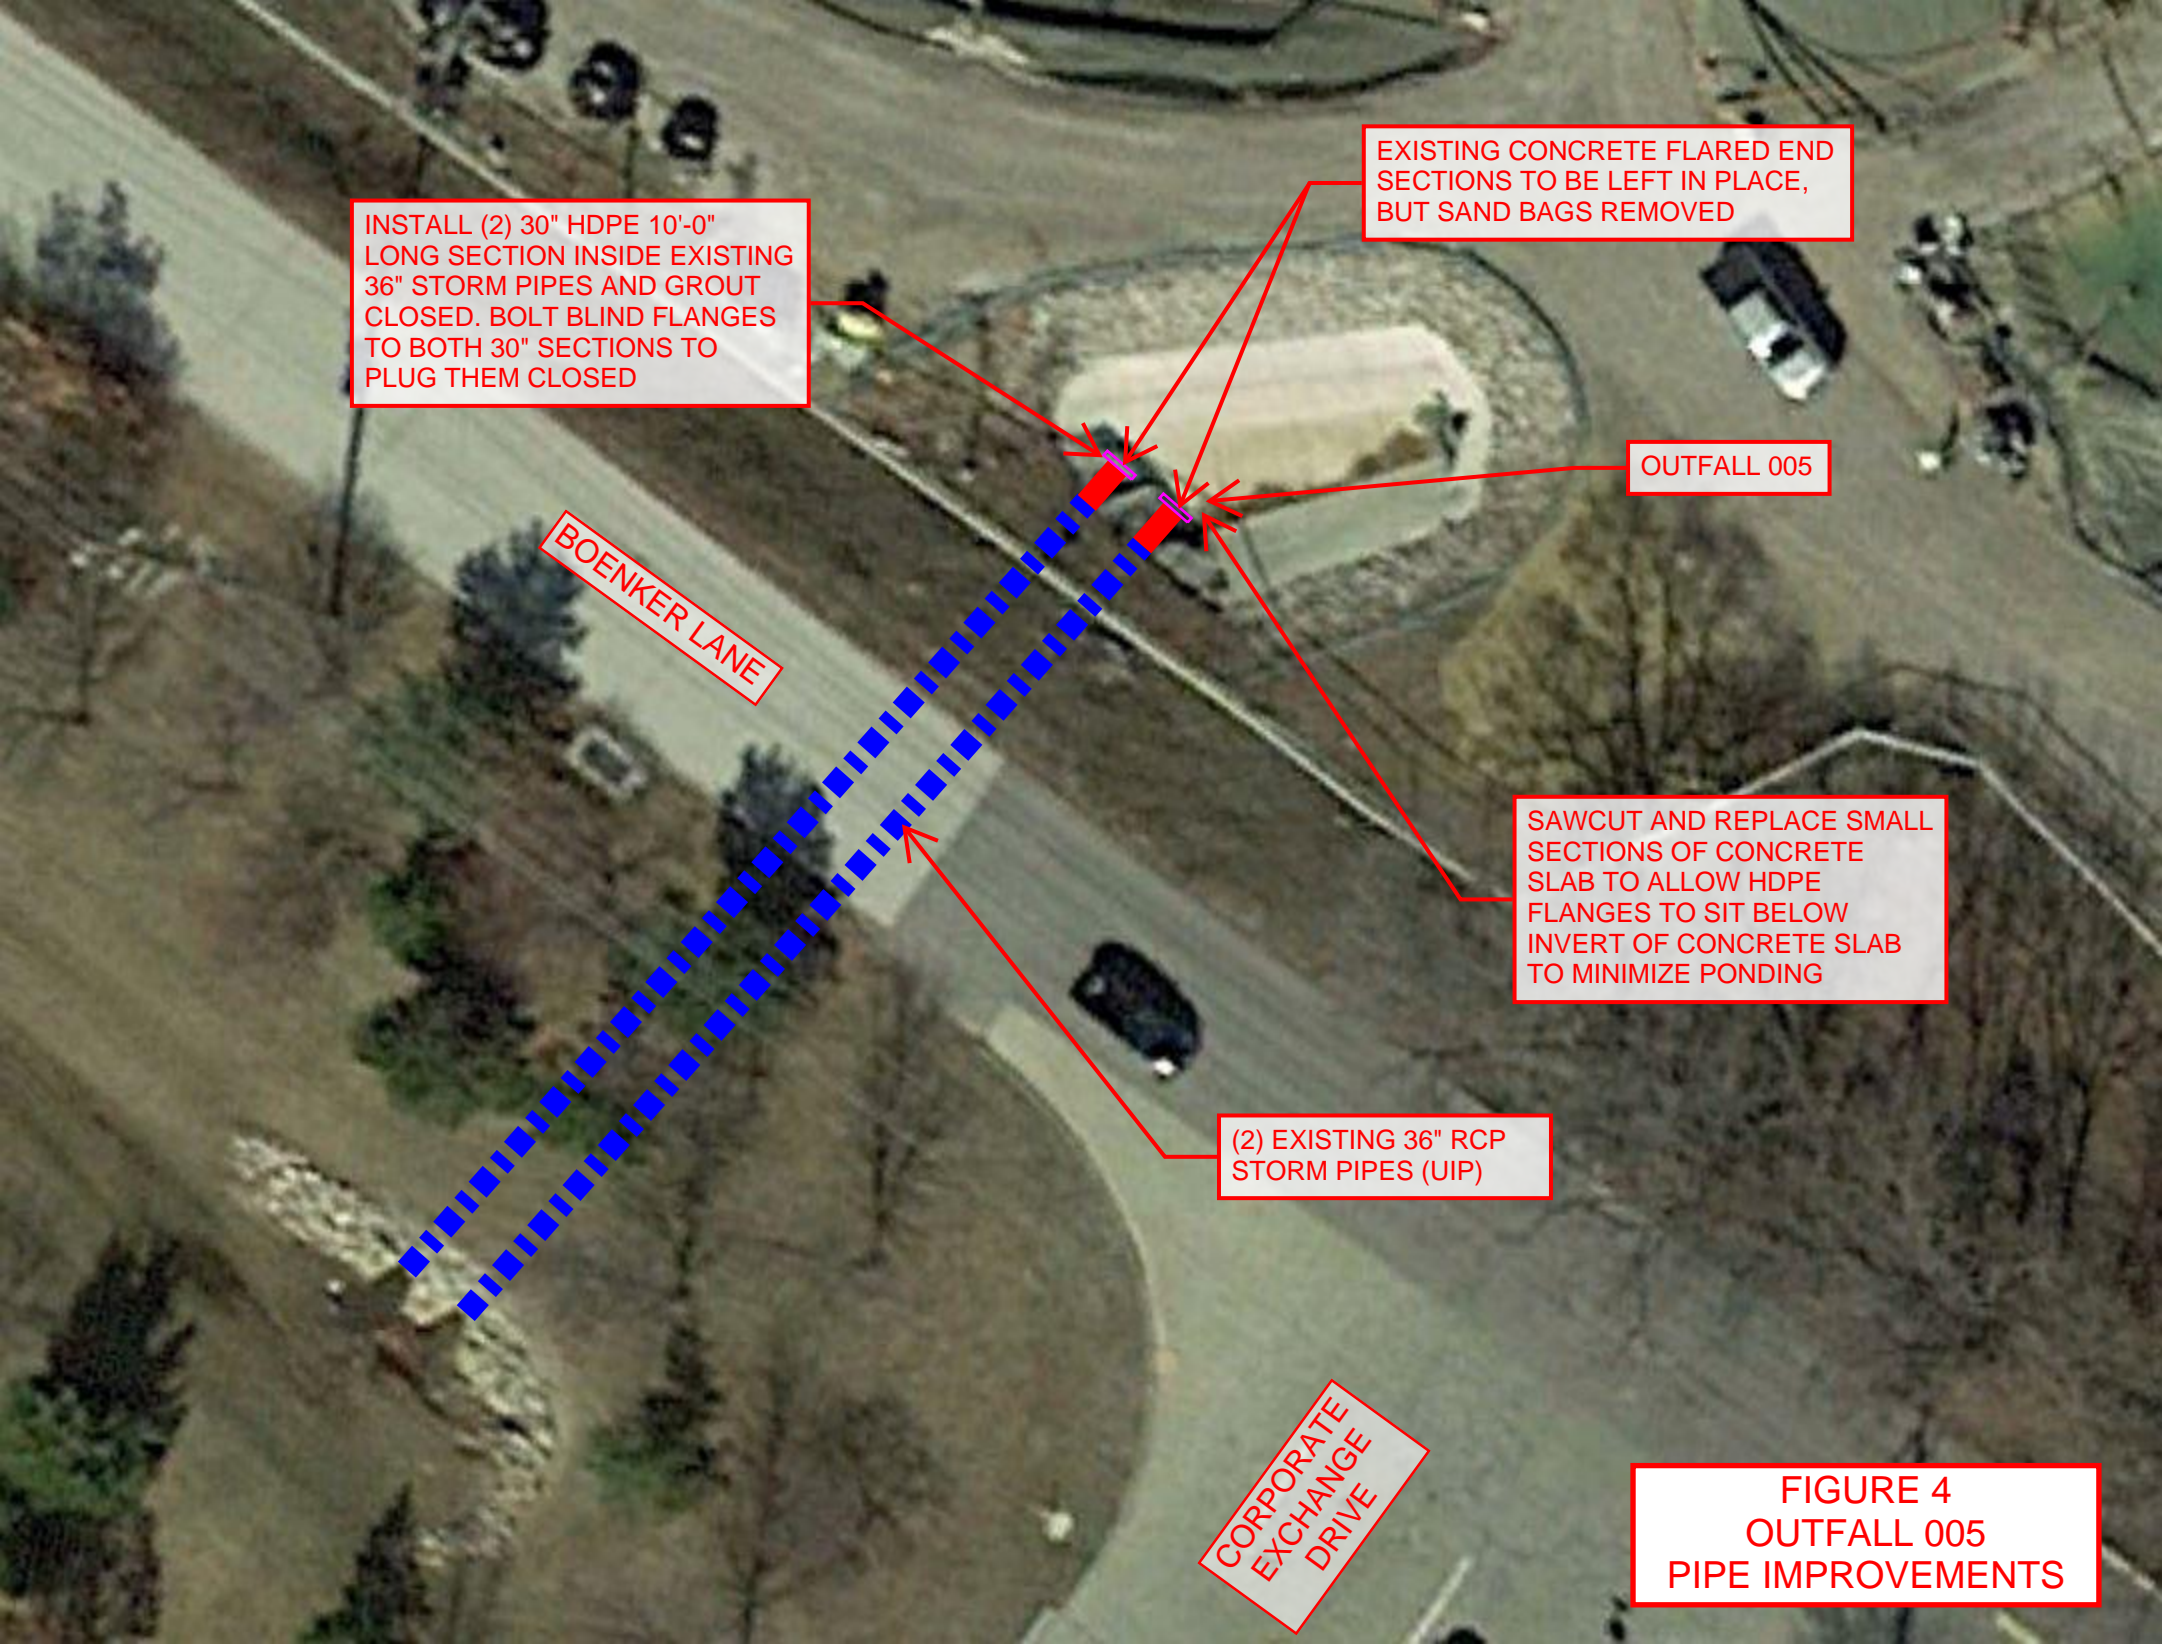
FIGURE 4
OUTFALL 005
PIPE IMPROVEMENTS

However, in 2020Q1 a heavy rain event caused the sand bags to become dislodged and allowed a discharge of stormwater that exceeded permitted limitations/benchmarks of TSS, iron and aluminum. To prevent this from occurring in the future, we recommend to more permanently secure the outfall by installing flanged pipe end sections on the upstream ends of the storm outlet pipes – see enclosed *Figure 4*. The Landfill's MDNR NPDES stormwater permit is also being modified to reflect this procedure.

INSTALL (2) 30" HDPE 10'-0" LONG SECTION INSIDE EXISTING 36" STORM PIPES AND GROUT CLOSED. BOLT BLIND FLANGES TO BOTH 30" SECTIONS TO PLUG THEM CLOSED

EXISTING CONCRETE FLARED END SECTIONS TO BE LEFT IN PLACE, BUT SAND BAGS REMOVED

SAWCUT AND REPLACE SMALL SECTIONS OF CONCRETE SLAB TO ALLOW HDPE FLANGES TO SIT BELOW INVERT OF CONCRETE SLAB TO MINIMIZE PONDING
