Bridgeton Landfill, LLC

Weekly Data Submittal

Week of June 07, 2020 – June 13, 2020

**Required by Section IX.33.g of Final Consent Judgment, Case No. 13SL-
CC01088-01
Effective June 29, 2018**

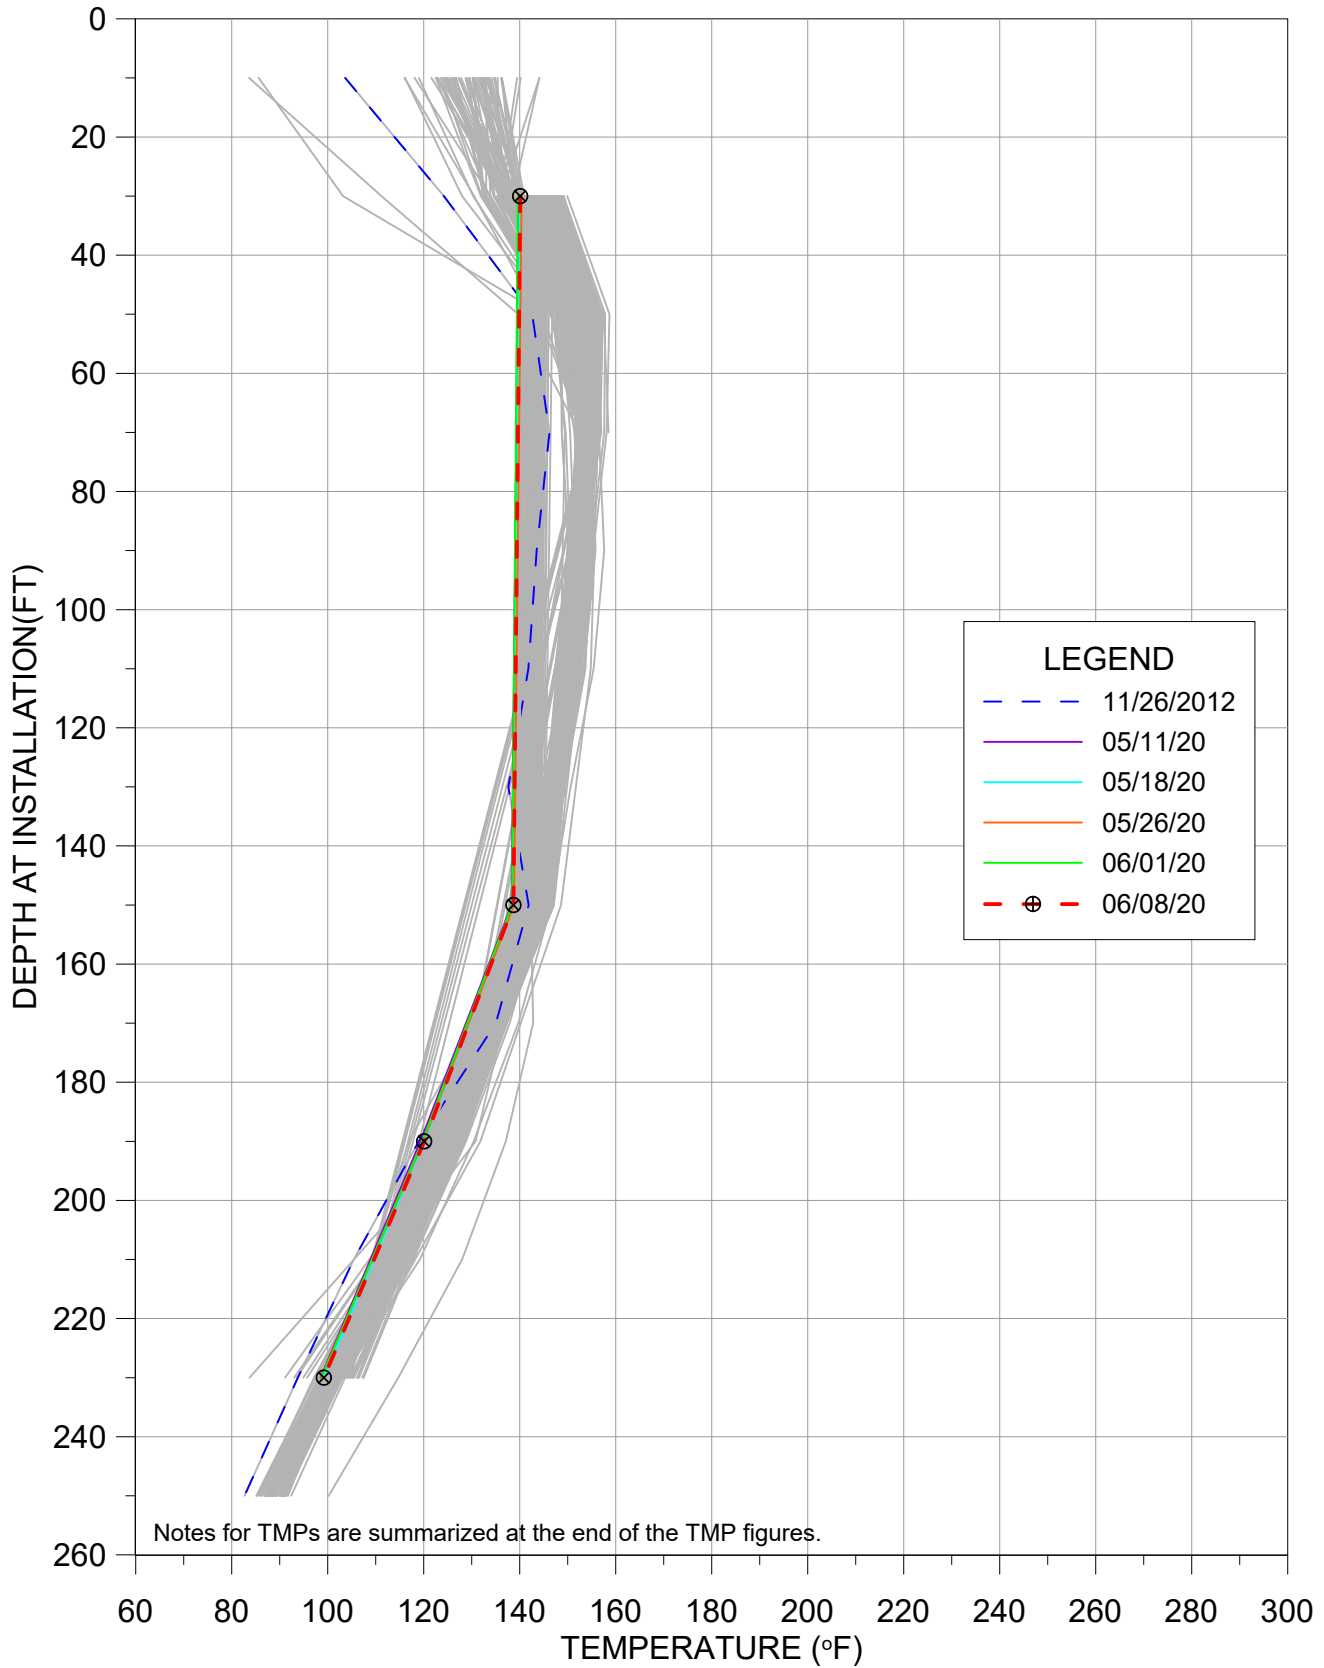
TMP-3

1. No reliable temperature readings have been obtained at 170 ft depth since 1/29/2014, except on 3/13/2014.
2. The connectivity tests on 4/11/2014 conducted by CEC showed that units at 10, 90, 130, 210 and 250 ft depths are no longer reliable.
3. The connectivity tests on 10/28/2014 conducted by Feezor Engineering showed that units at 10, 90, 110, 130, 210 and 250 ft depths are not reliable.
4. The unit at 50 ft depth was fluctuating resistance since 10/1/2018. Therefore the temperature is determined to be unreliable.
5. No temperature reading could be obtained at 70 ft depth since 10/22/2018.

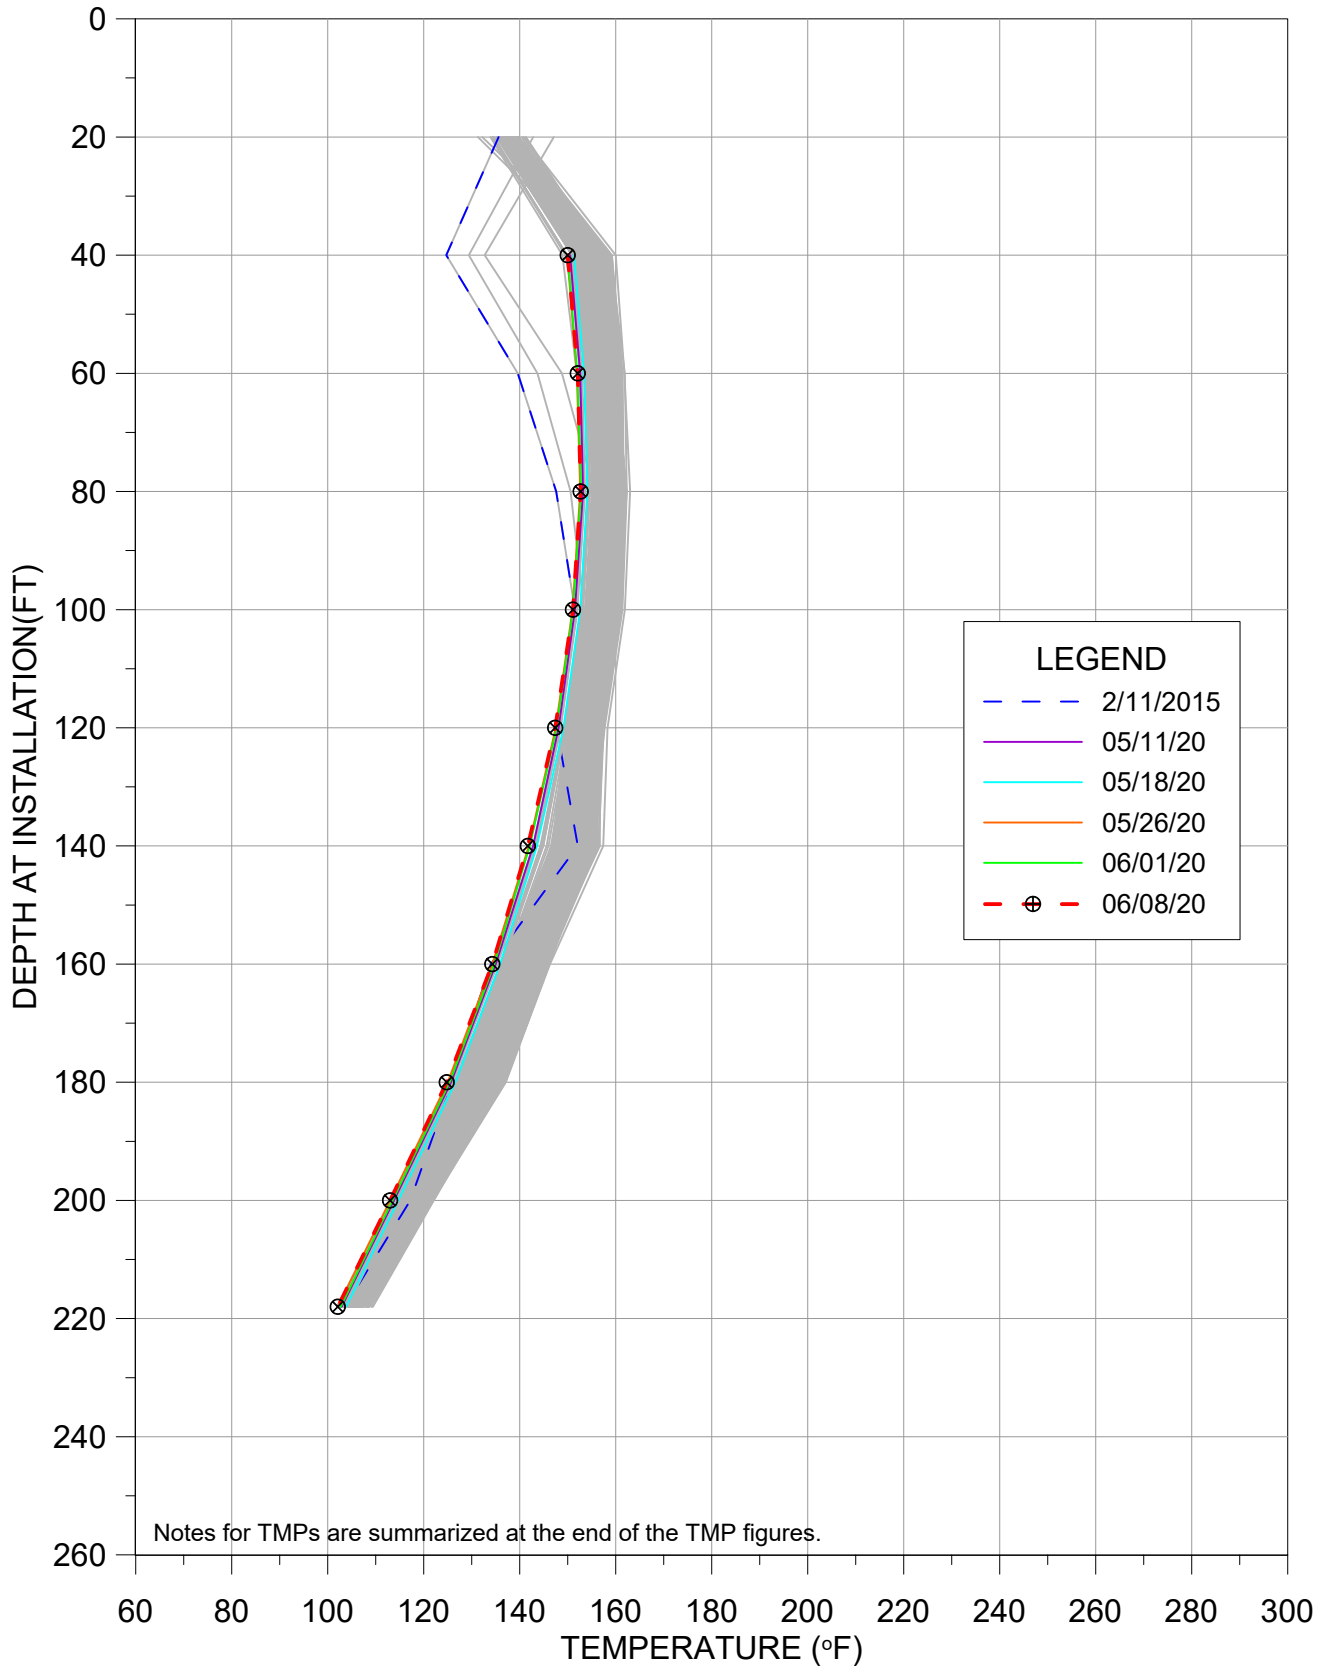
TMP-3R

1. The unit at 20 ft depth had a fluctuating resistance since 9/25/2017. Therefore the temperature is determined to be unreliable.

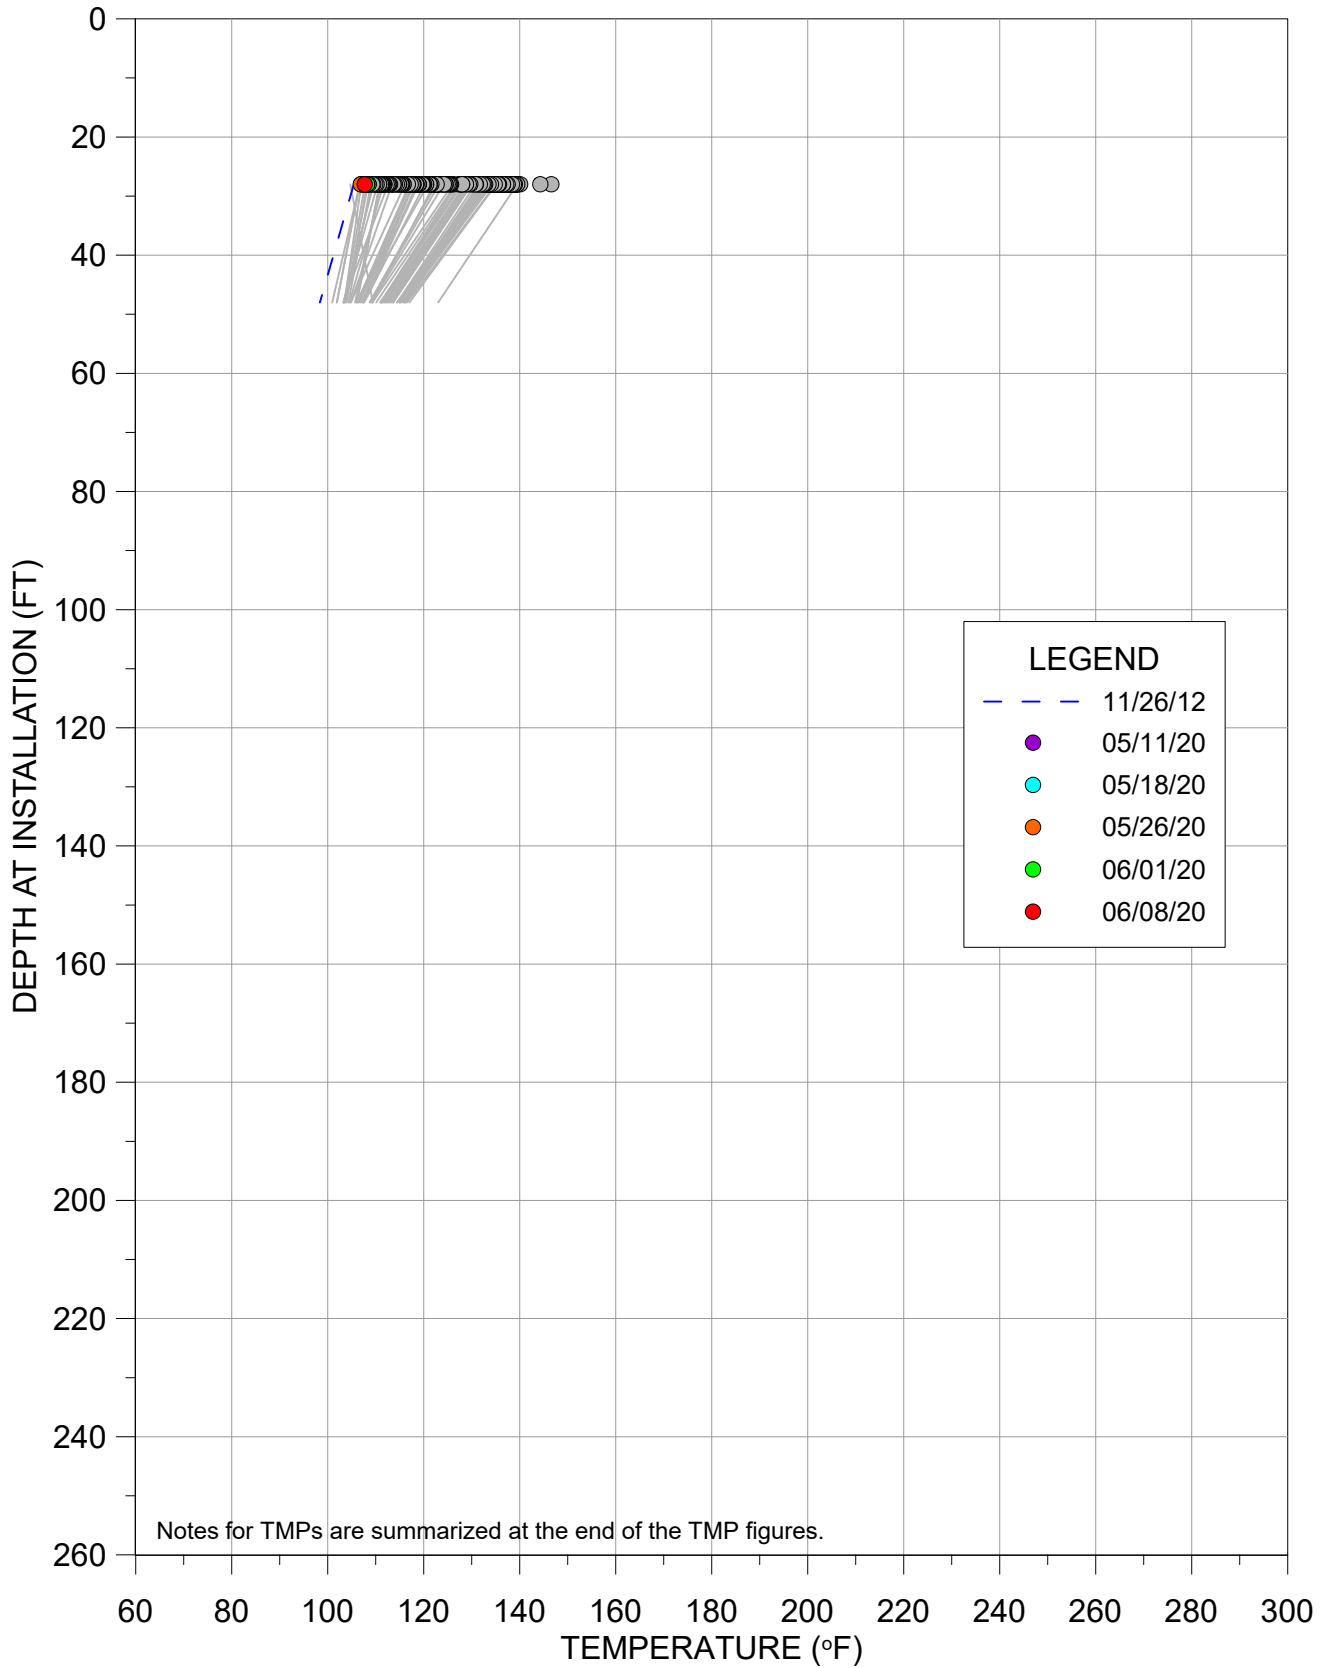
TMP-4

1. The connectivity tests on 4/11/2014 conducted by CEC showed that the unit at 48 ft depth is no longer reliable.

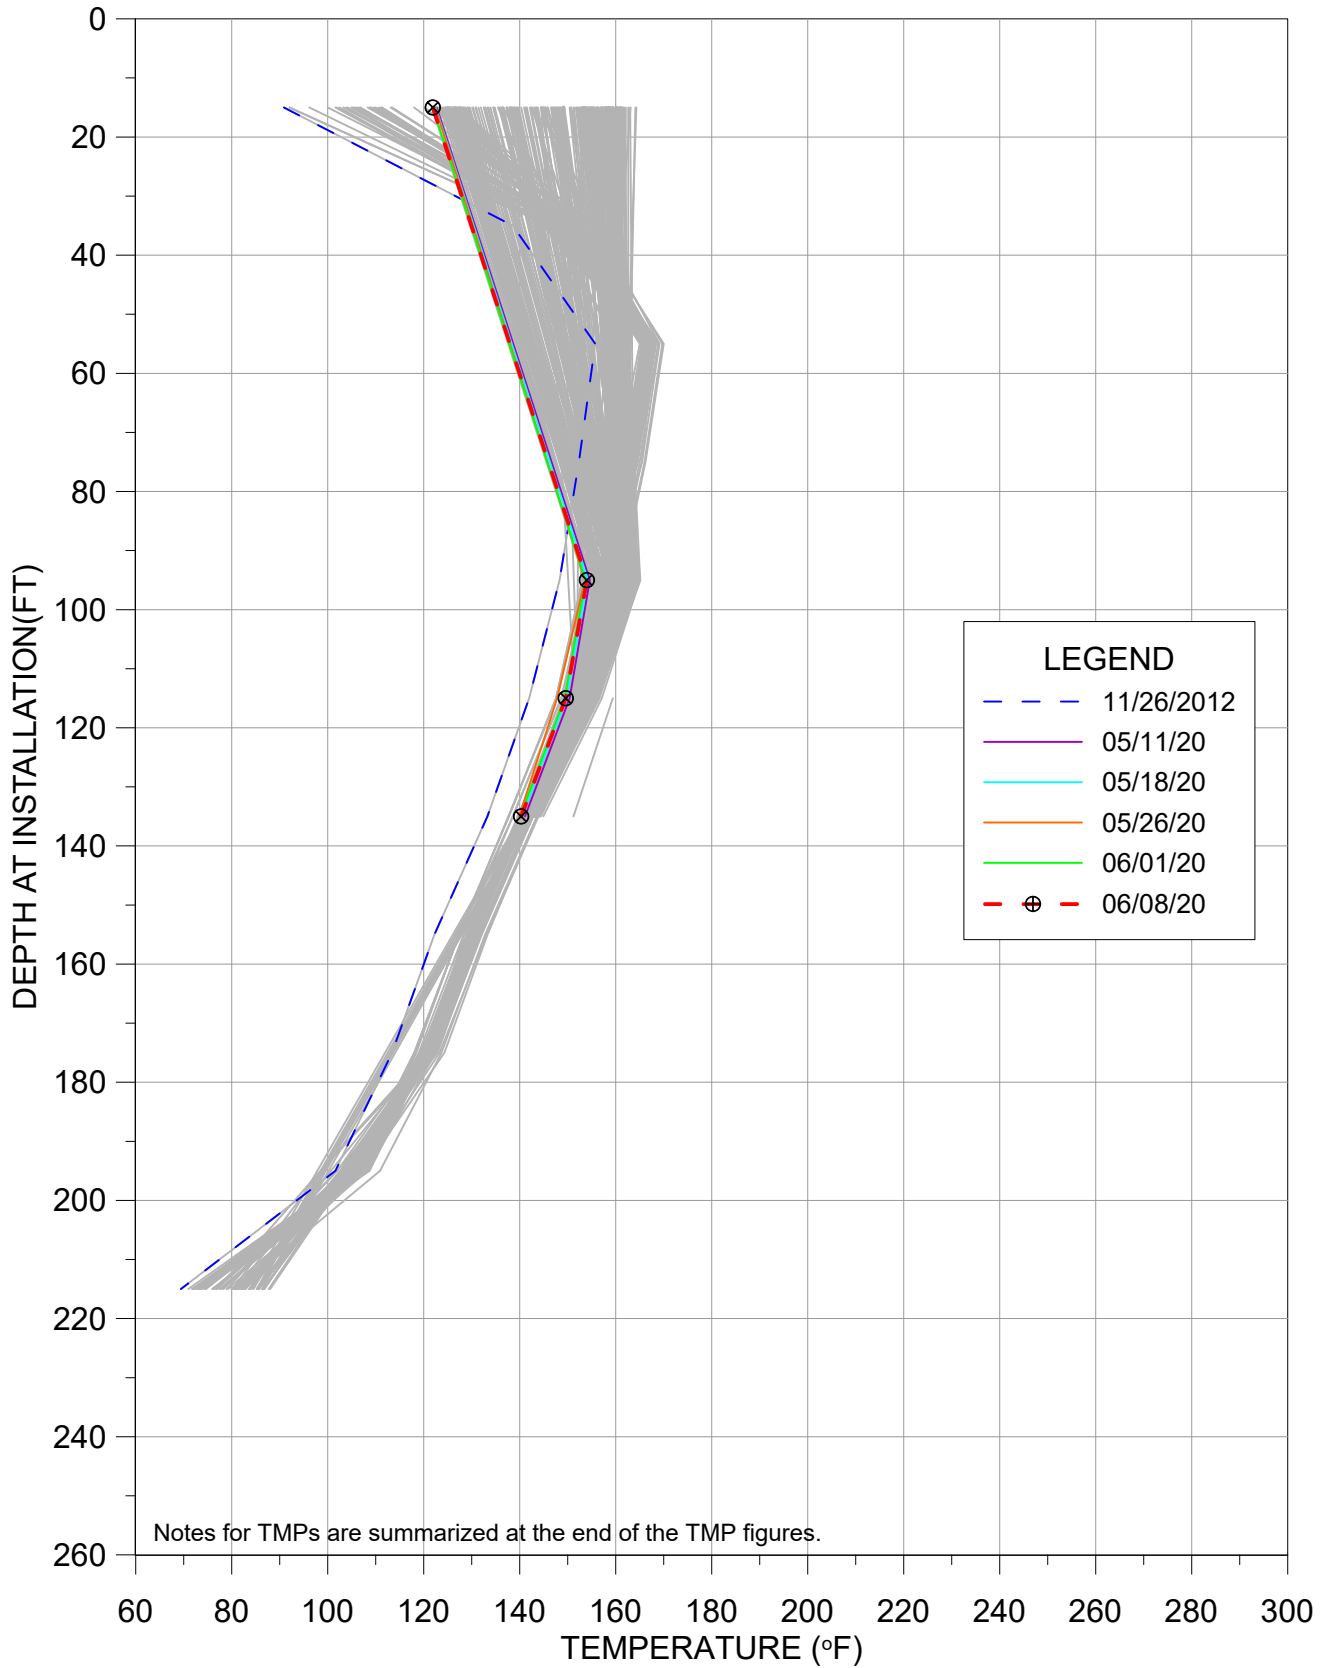
TMP-6

1. The connectivity tests on 4/11/2014 conducted by CEC showed that units at 35, 55, 75, 155, 175, and 195 ft depths are no longer reliable.
2. No reliable temperature readings have been obtained at the unit at 215 ft depth since 6/13/2014.

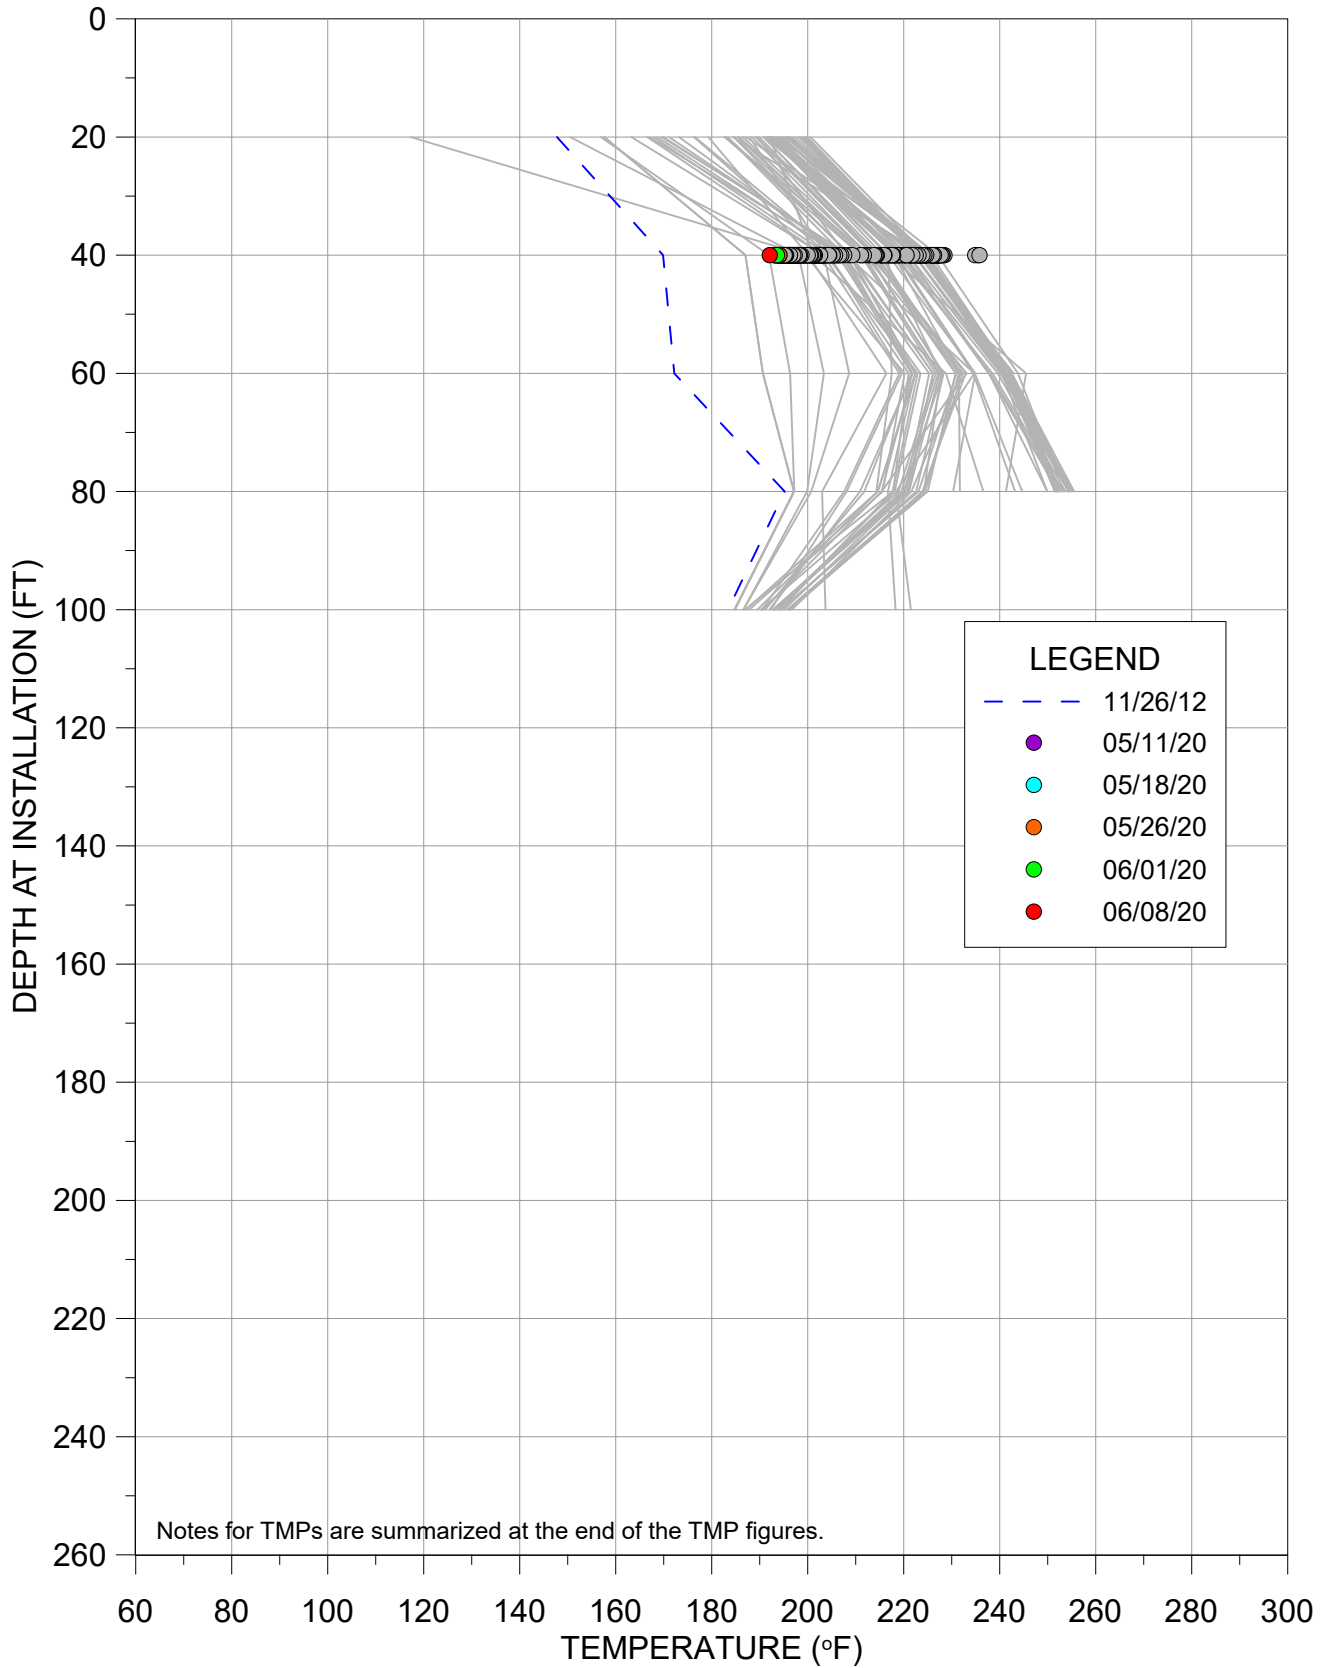
TMP-9

1. Unit at 100 ft depth had an inaccurate temperature reading on 8/1/2013 and no reading since 8/6/2013.
2. The connectivity tests on 4/11/2014 conducted by CEC showed that units at 20, 60, 80, and 100 ft depths are no longer reliable.

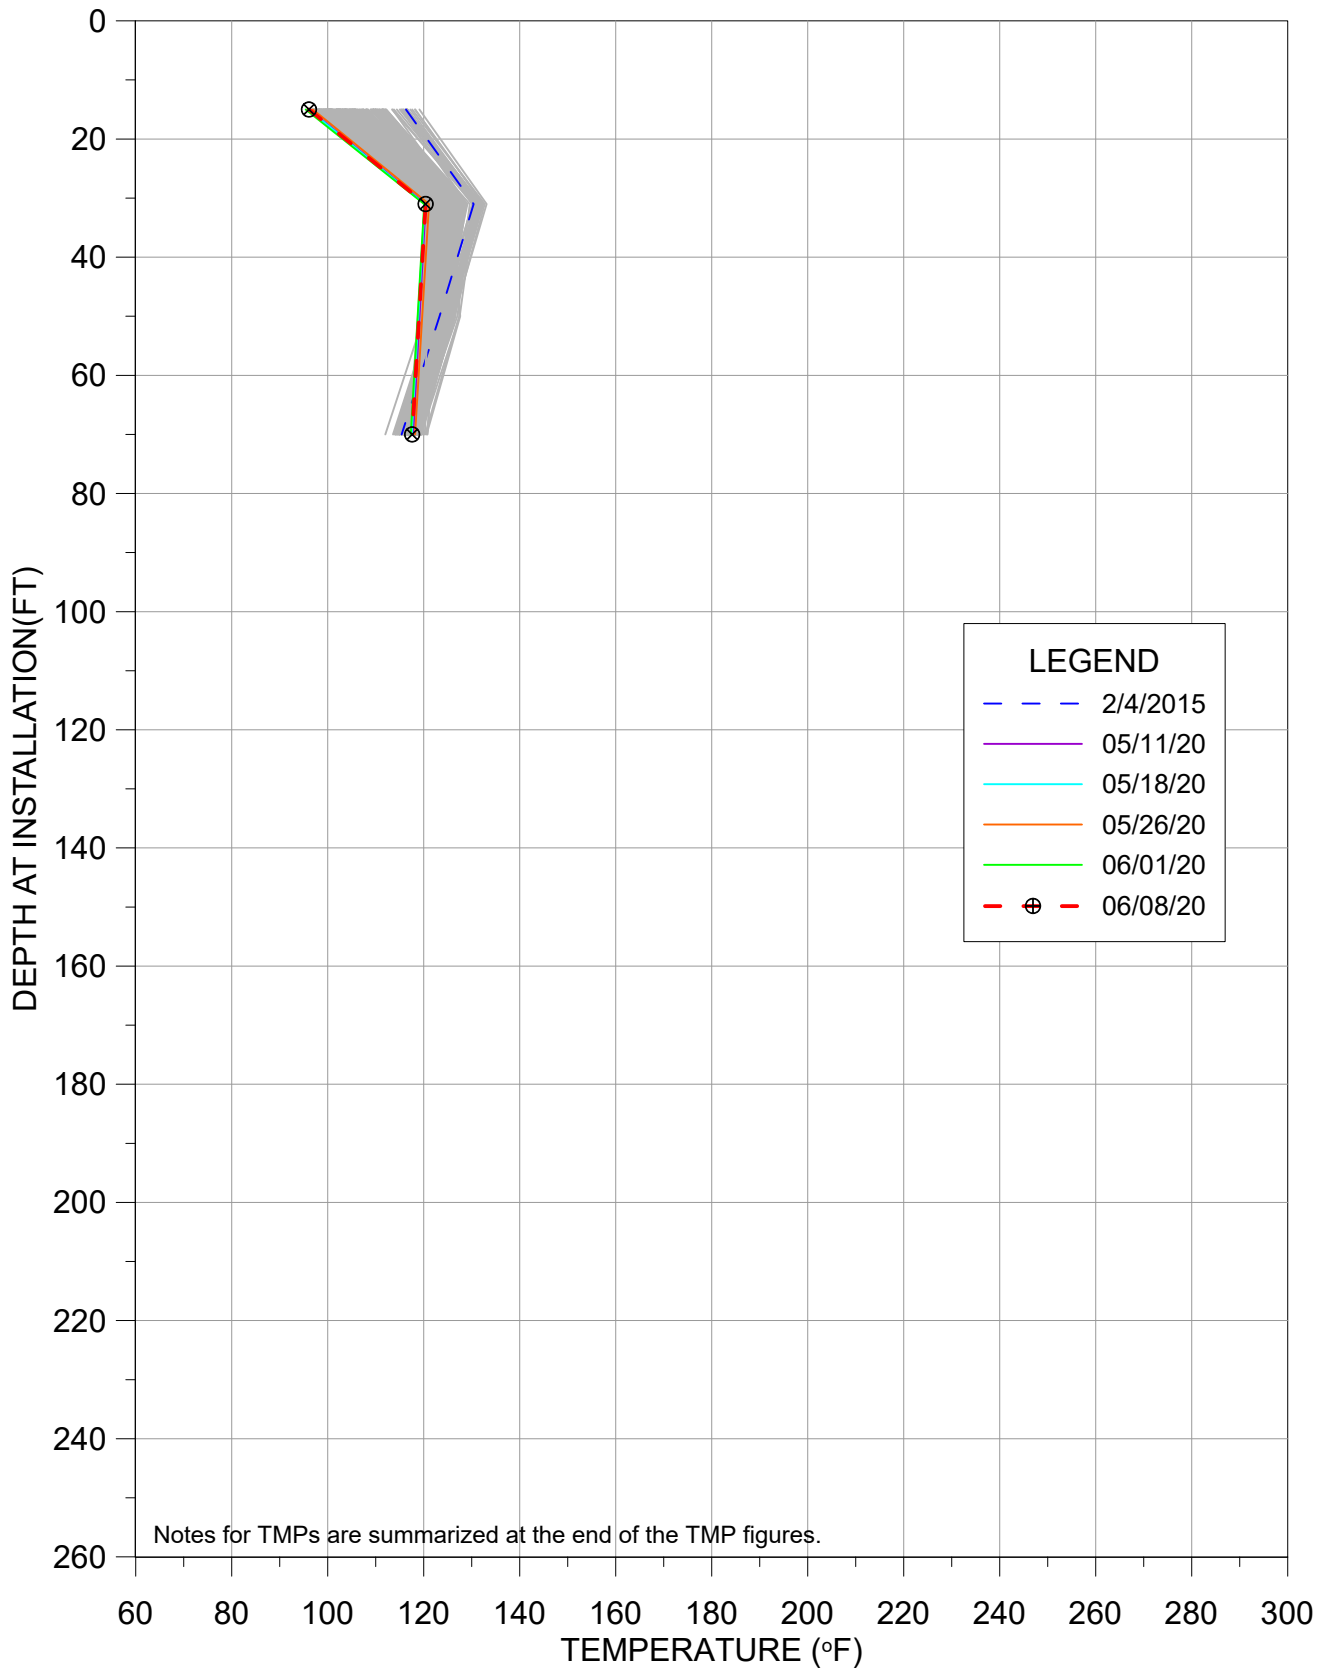
TMP-22

1. No temperature reading could be obtained and resistivity was fluctuating at the unit at 50 ft depth since 4/2/2018.

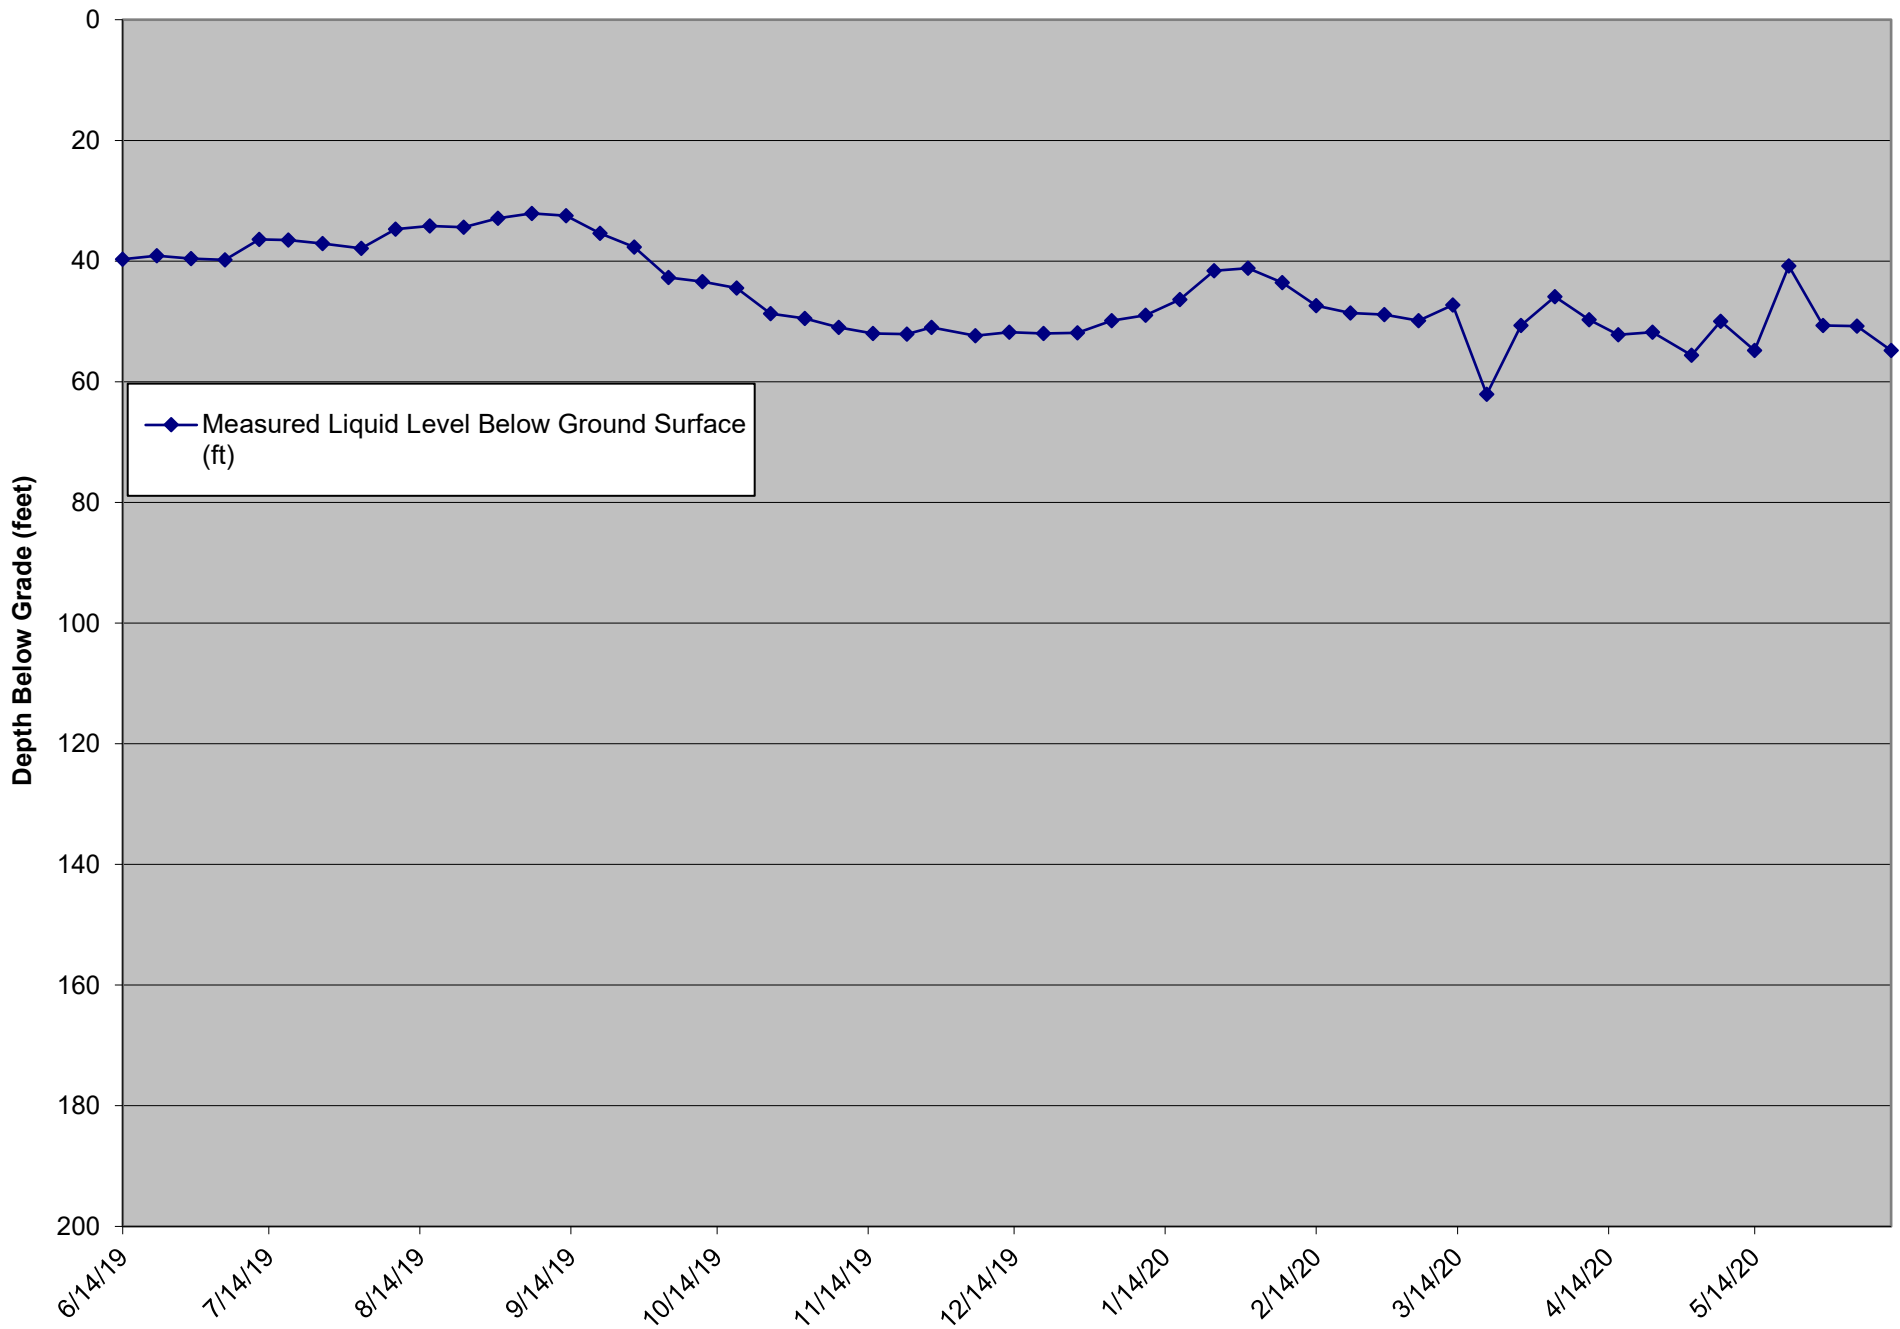
LCS-3D Liquid Level Below Ground Surface

A Blackhawk pneumatic pump was installed in LCS-3D on 2/14/19 and was fully operational during the weekly reporting period. Liquid level was measured manually.

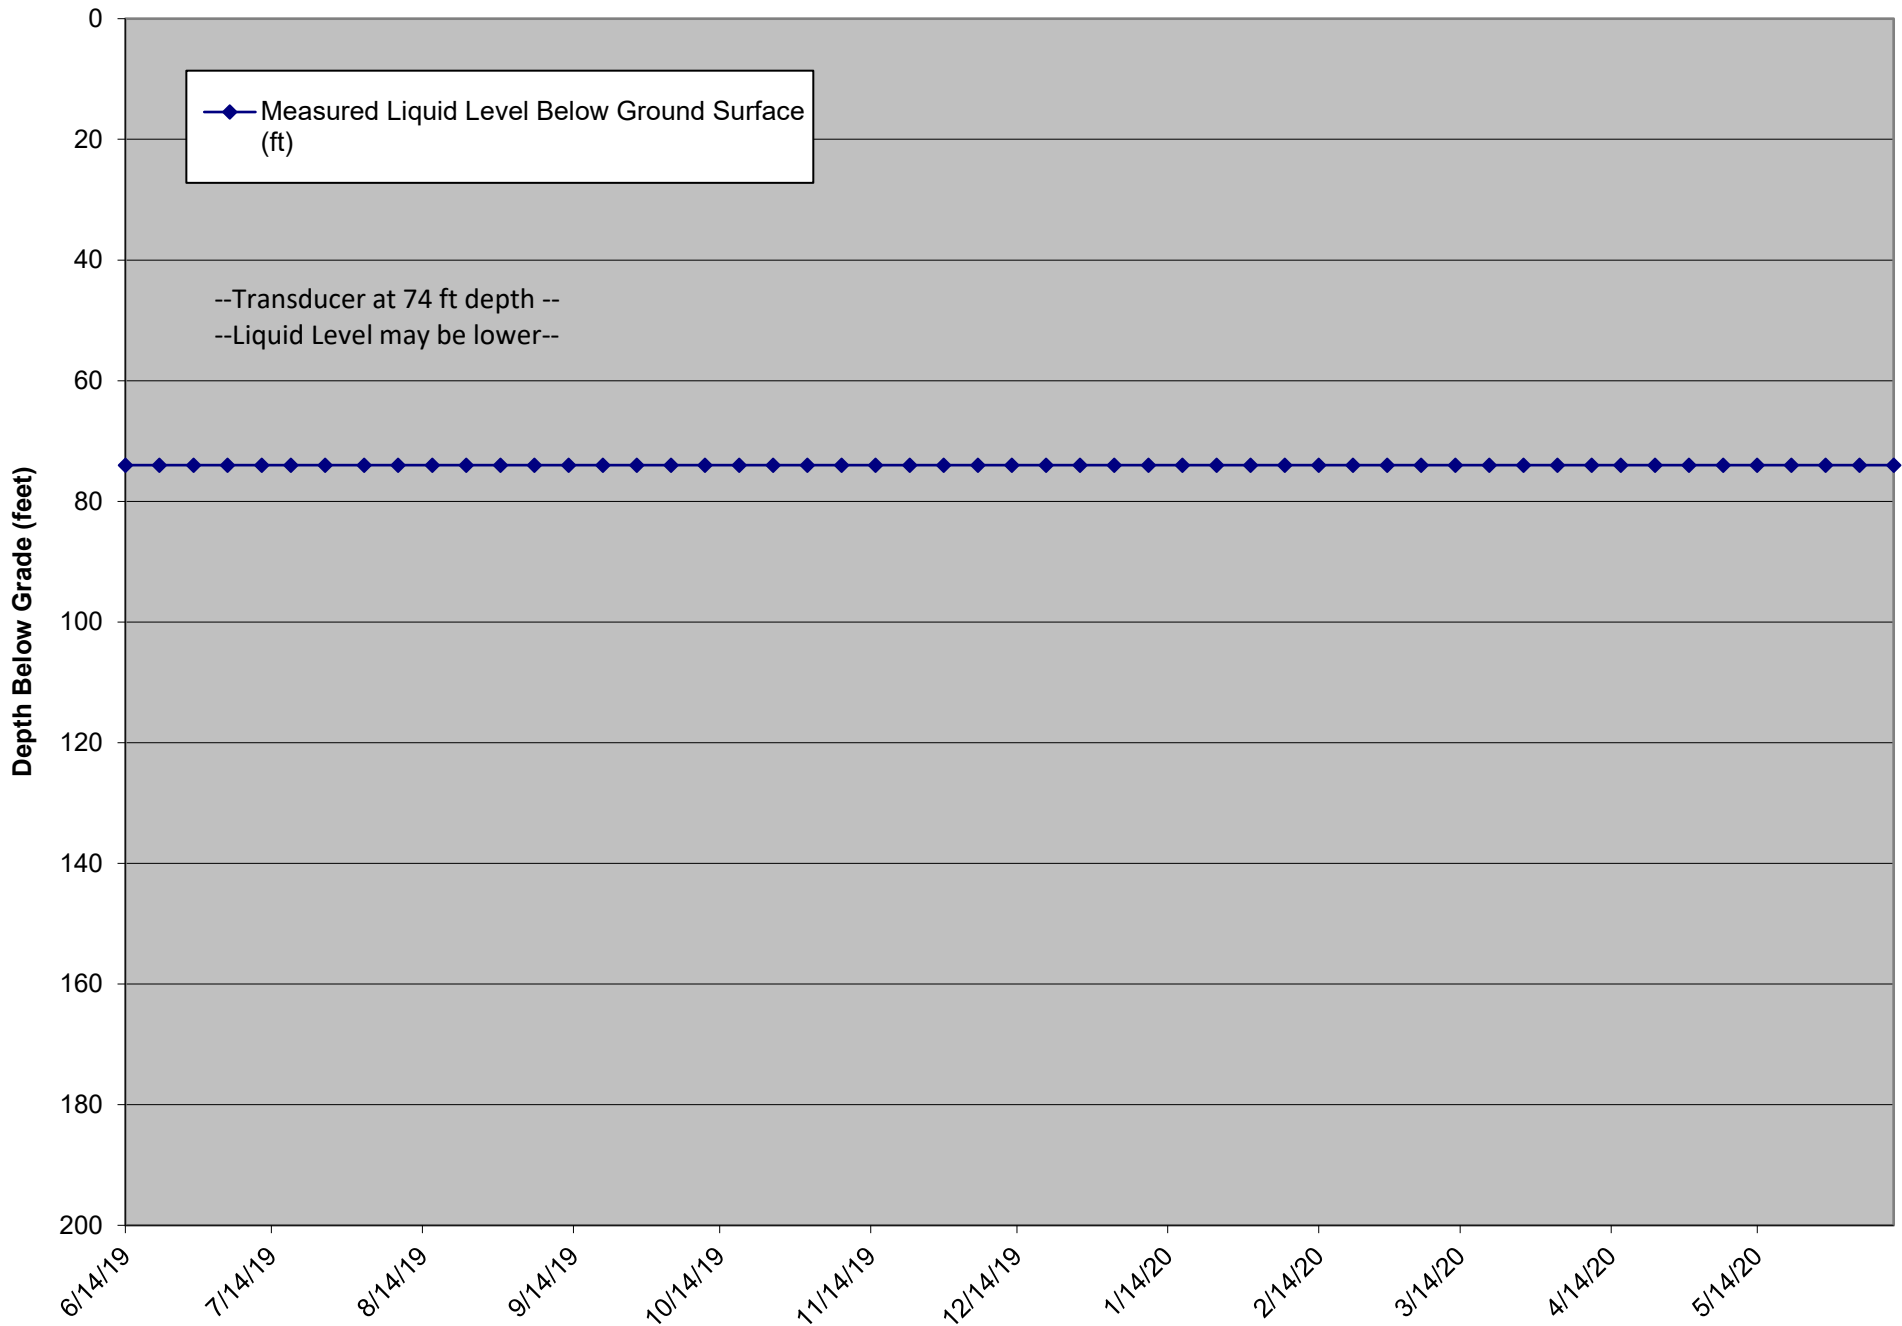
LCS-4B Liquid Level Below Ground Surface

The level sensor in LCS-4B is currently operational and responsive. Liquid level was not recorded by the level sensor during the weekly reporting period. LCS-4B is equipped with a flow meter that displayed no flow during the weekly reporting period. Therefore, it can be concluded that the liquid level was below the bottom of the pump and level sensor in LCS-4B.

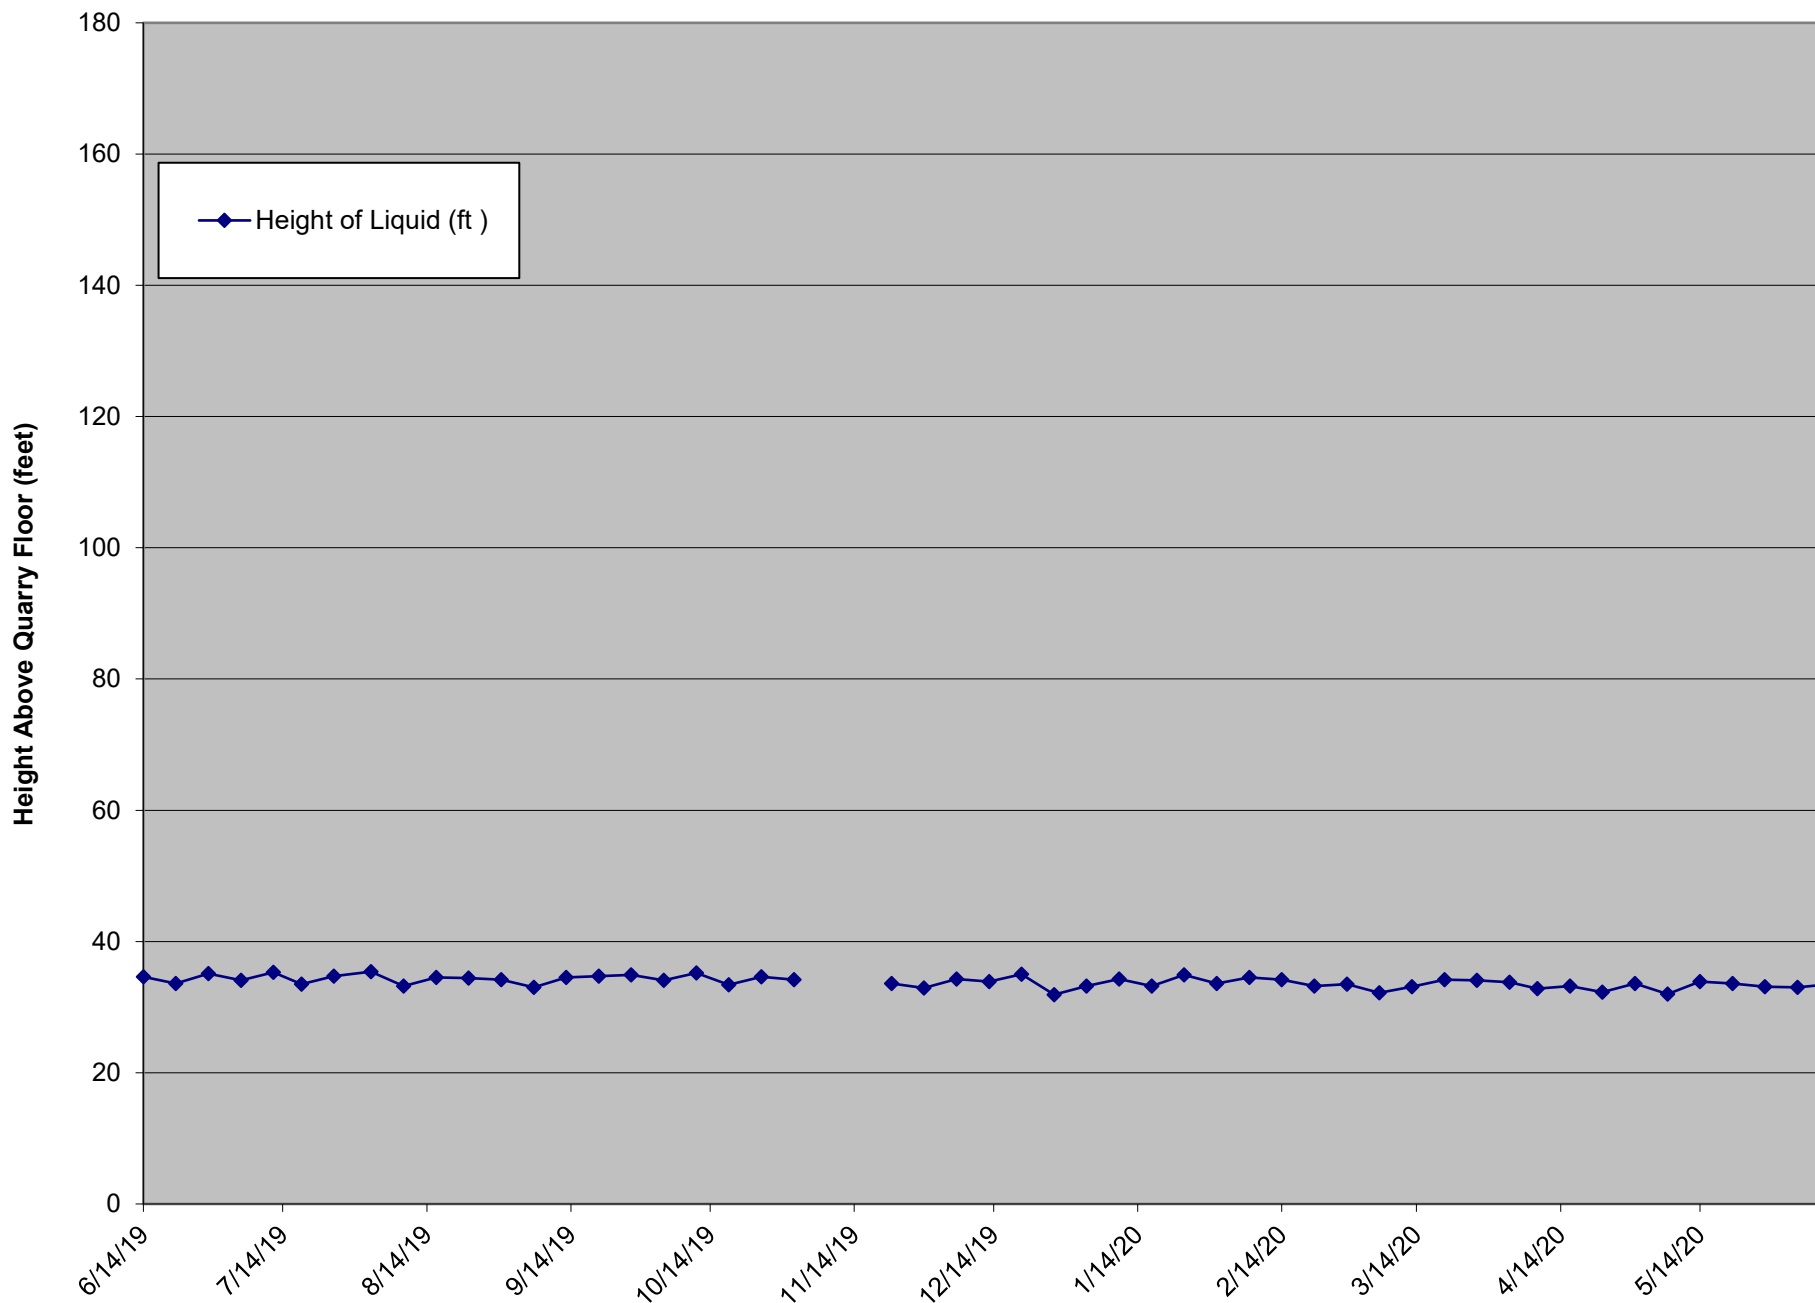
LCS-5B Liquid Level Above Quarry Floor

*The transducer in LCS-5B was down from 11/6/19 to 11/19/19.
