Bridgeton Landfill, LLC

Weekly Data Submittal

Week of June 07, 2020 – June 13, 2020

**Required by Section IX.33.g of Final Consent Judgment, Case No. 13SL-
CC01088-01
Effective June 29, 2018**

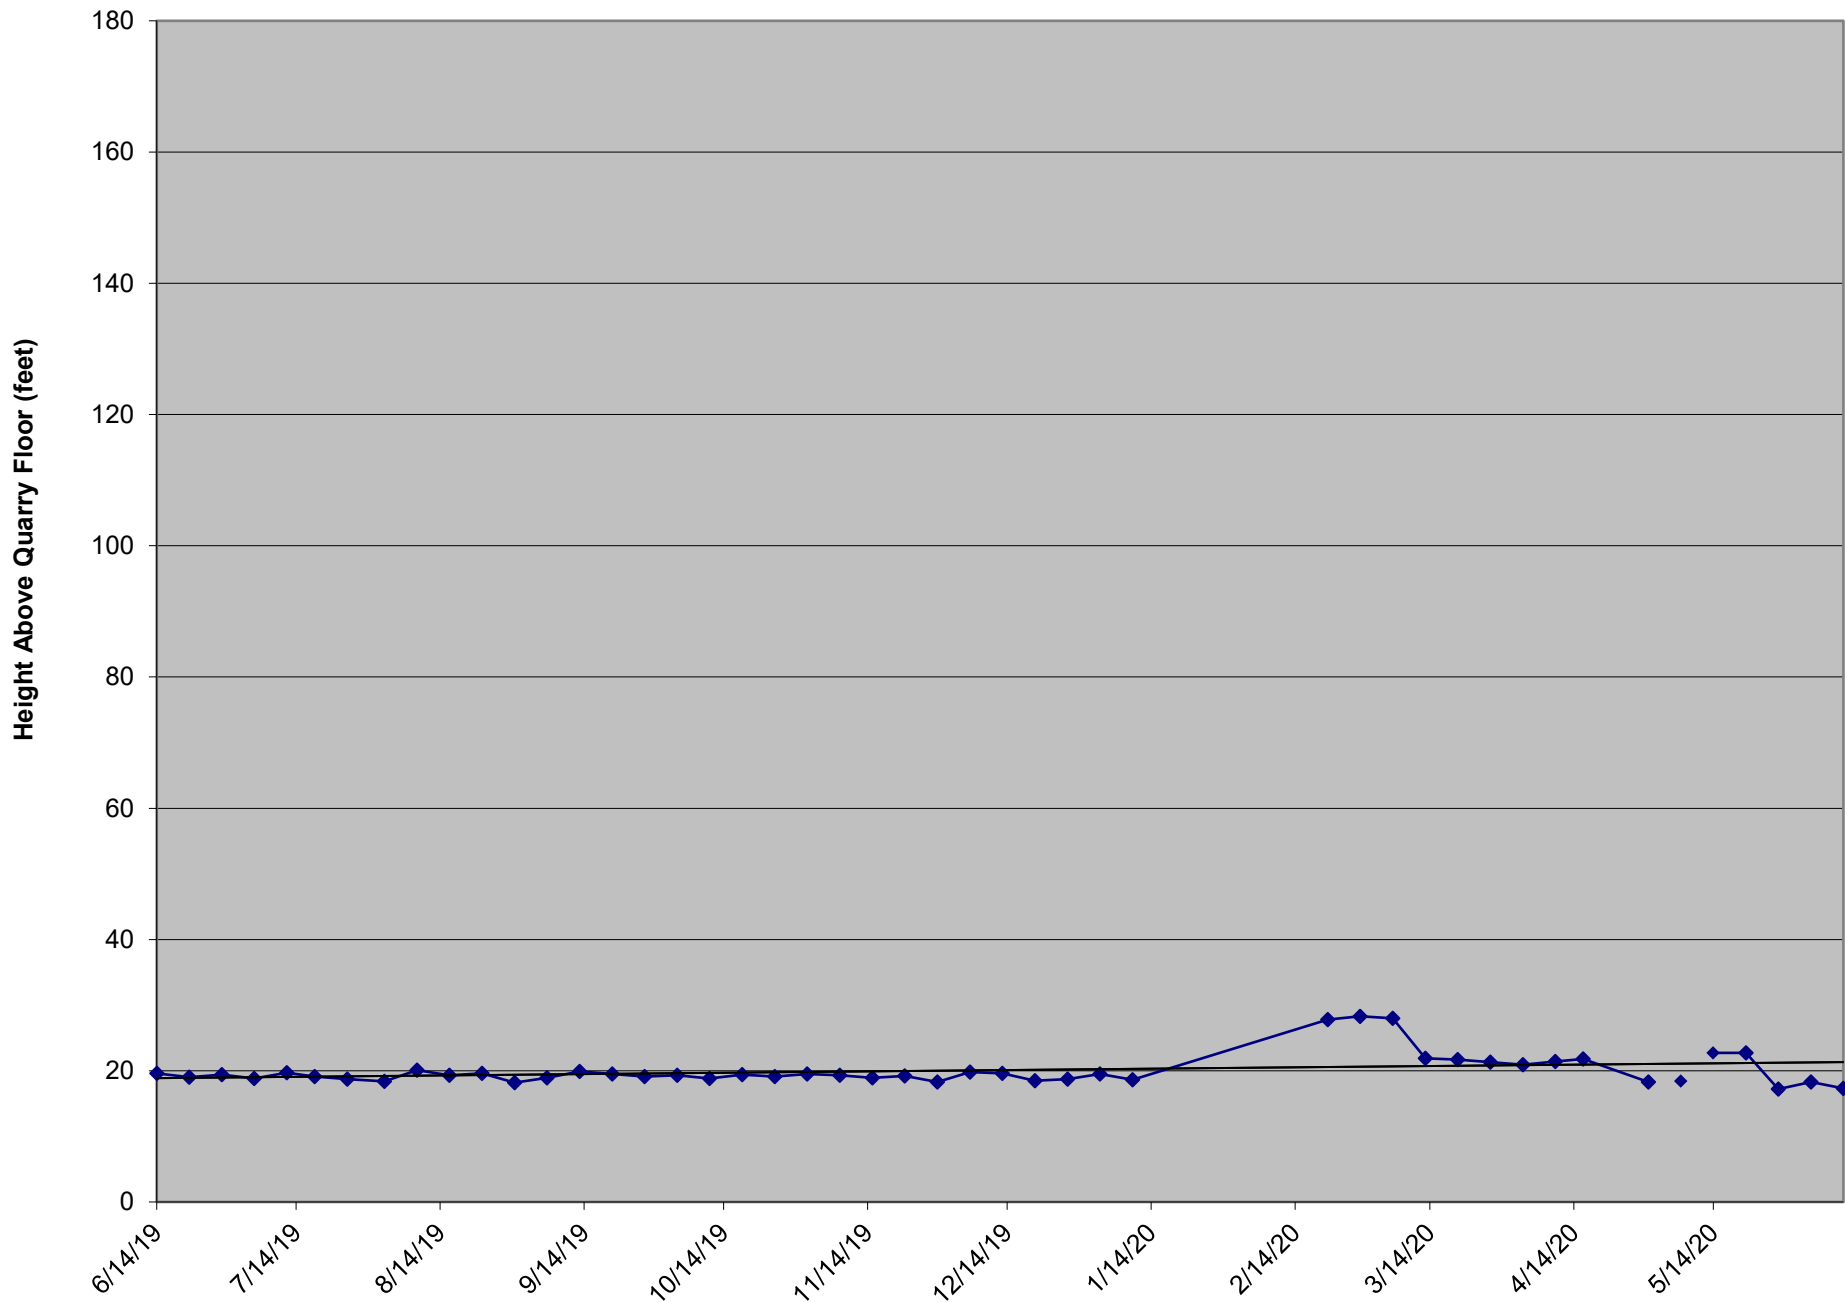
LCS-6B Liquid Level Above Quarry Floor

The transducer became non-operational on 1/13/20. Liquid level was measured manually on 2/21/20, 2/28/20 and 3/6/20. The transducer became operational on 3/13/20. The VFD was observed to be non-operational on 4/23/20, it was replaced on 4/23/20, however the level sensor reading was not taken due to VFD communication loss with SCADA.
