Bridgeton Landfill, LLC

Weekly Data Submittal

Week of February 21, 2021 – February 27, 2021

Required by Section IX.33.g of Final Consent Judgment, Case No. 13SL-CC01088-01 Effective June 29, 2018

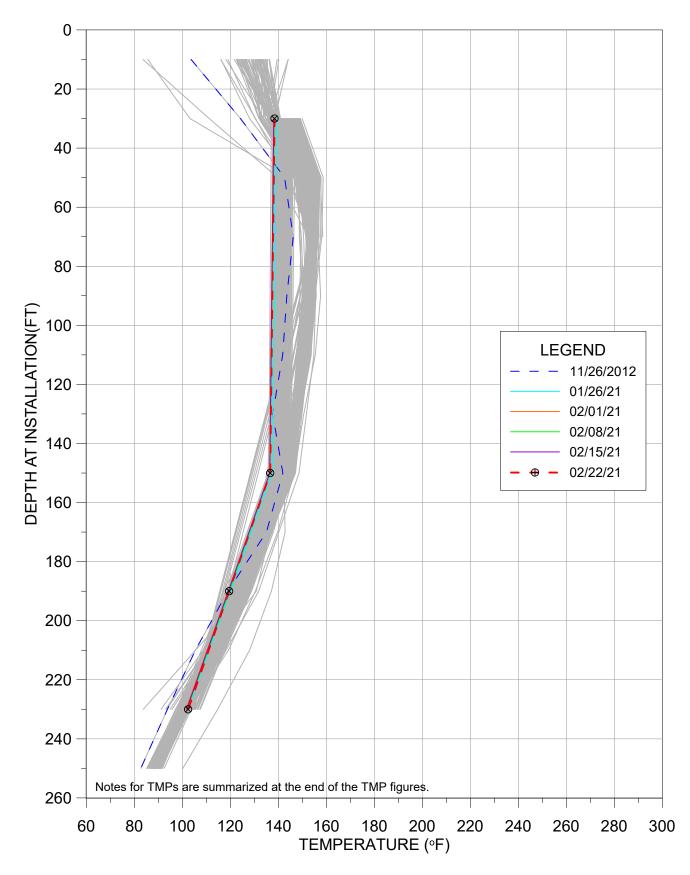
TMP-3R

1. The unit at 20 ft depth had a fluctuating resistance since 9/25/2017. Therefore the temperature is determined to be unreliable.

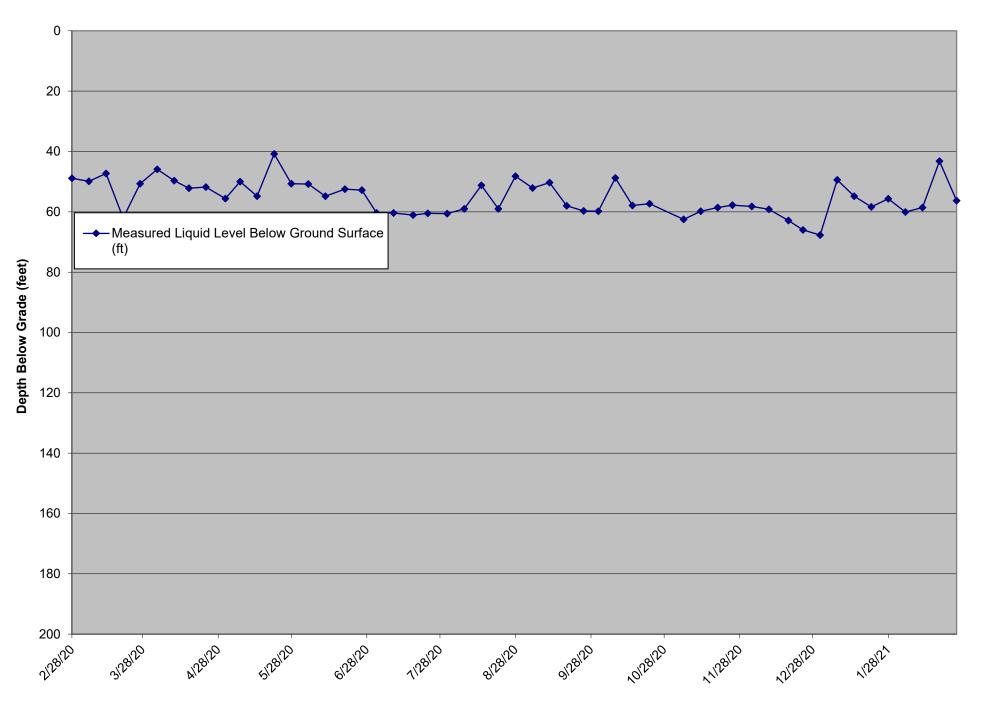
LCS-4B Liquid Level Below Ground Surface

The level sensor in LCS-4B is currently operational and responsive. Liquid level was not recorded by the level sensor during the weekly reporting period. LCS-4B is equipped with a flow meter that displayed no flow during the weekly reporting period. Therefore, it can be concluded that the liquid level was below the bottom of the pump and level sensor in LCS-4B.

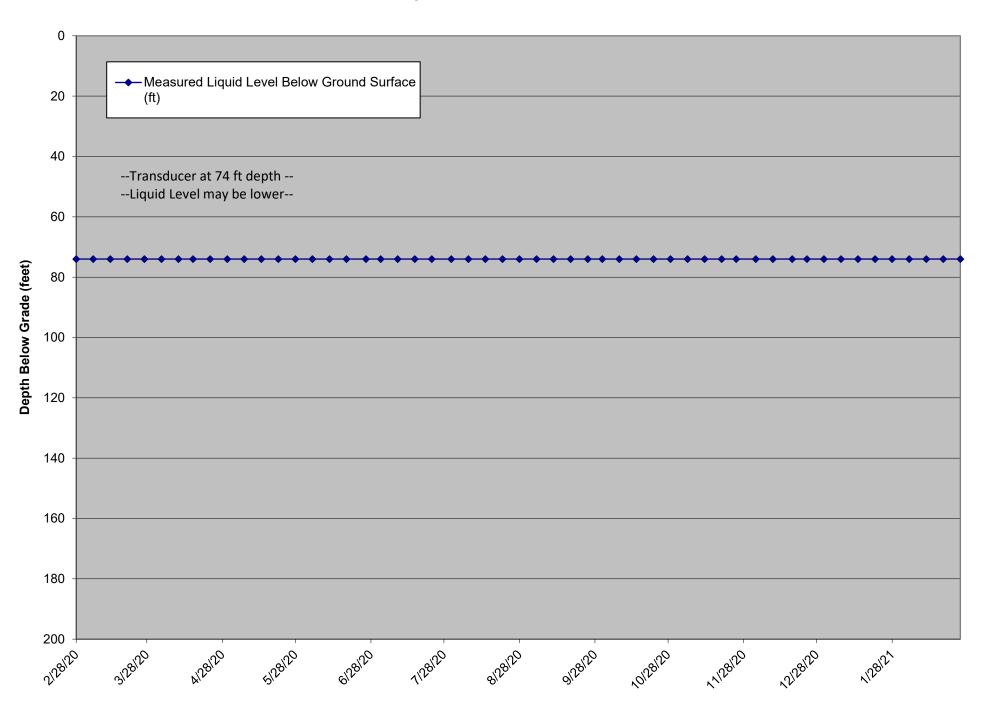
LCS-5B Liquid Level Above Quarry Floor

The pump in LCS-5B was non-operational on 2/15/21 due to a frozen forcemain. The pump became operational again on 2/25/21.

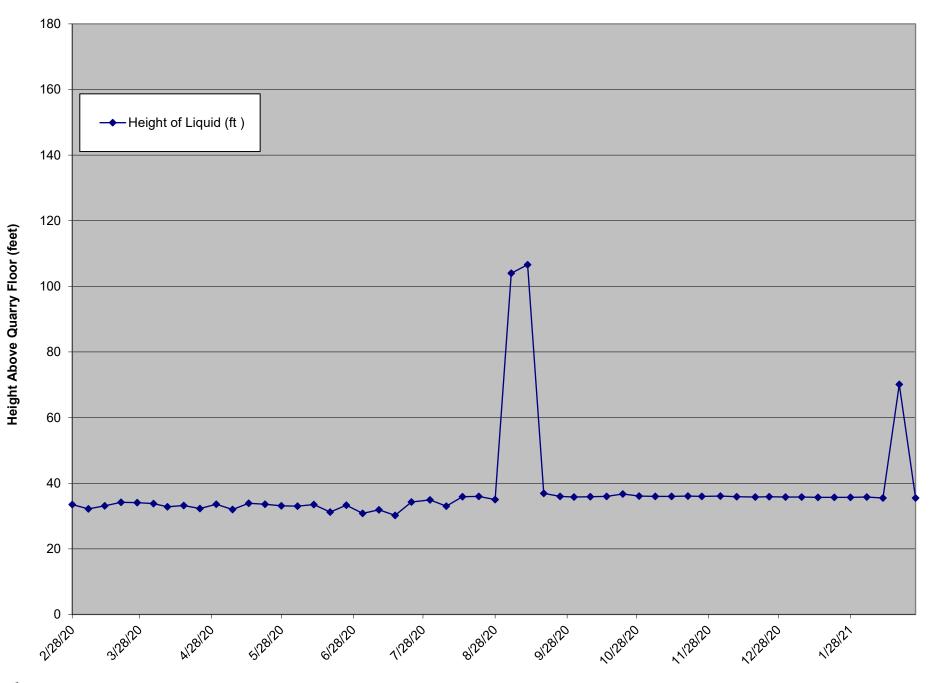
LCS-6B Liquid Level Above Quarry Floor

The pump in LCS-6B was non-operational on 2/9/21 due to a frozen forcemain. The pump became operational again on 2/22/21.

*The LCS-5B pump was turned off on 8/31/20 for forecmain repairs leading to an increase in liquid level. The pump was replaced on 9/17/20.
