Case Study: The Phantom MIL

By Randy Bernklau

Introduction

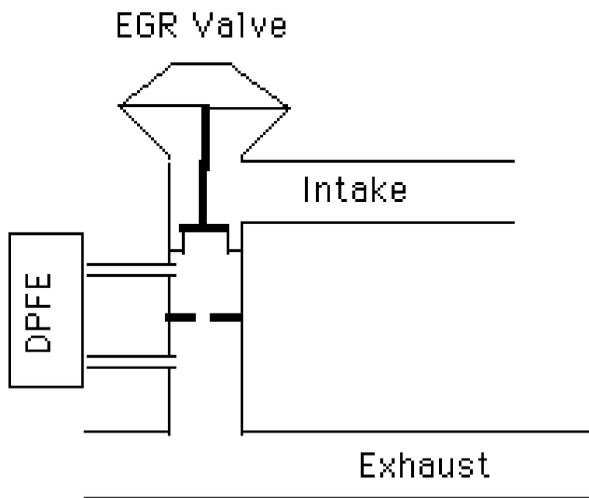
Freeze Frames Code P0402

Item	Value
RPM	673
Fuel System 1	Closed
Fuel System 2	NA
Coolant Temperature	198 Degrees F
Bank 1 Short Term Fuel Trim	- 1.6 %
Bank 1 Long Term Fuel Trim	- 5.5 %
Bank 2 Short Term Fuel Trim	- 1.6 %
Bank 2 Long Term Fuel Trim	- 5.5 %
Vehicle Speed	0 MPH
Engine Load	41.4 %

Analyzing this data tells me that the code was set at idle and since EGR flow should not occur at idle, I know that the PCM was told that there was EGR flow without an EGR command. Normally, the diagnosis would lead to checking the EGR system, but I decided to clear the code and see if it returned. This step is not always necessary, but I felt it would be interesting to see if the code would reset. It should be noted that some steps are taken for the sake of research and may not be necessary during a normal diagnosis. After clearing the code, all the monitors were reset to “Not Ready.”
