Bridgeton Landfill, LLC

Weekly Data Submittals

Required by Section 52.F of Agreed Order, Case No. 13SL-CC01088 Effective May 13, 2013

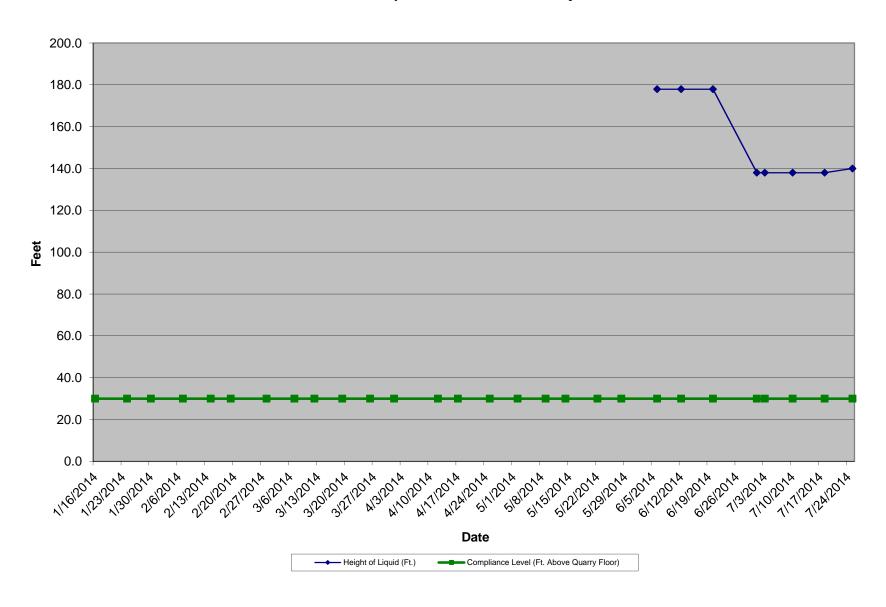
LCS-1D Liquid Level Above Quarry Floor

LCS-1D, -2D -5A, and -6B were partially or fully operational during the weekly reporting period.

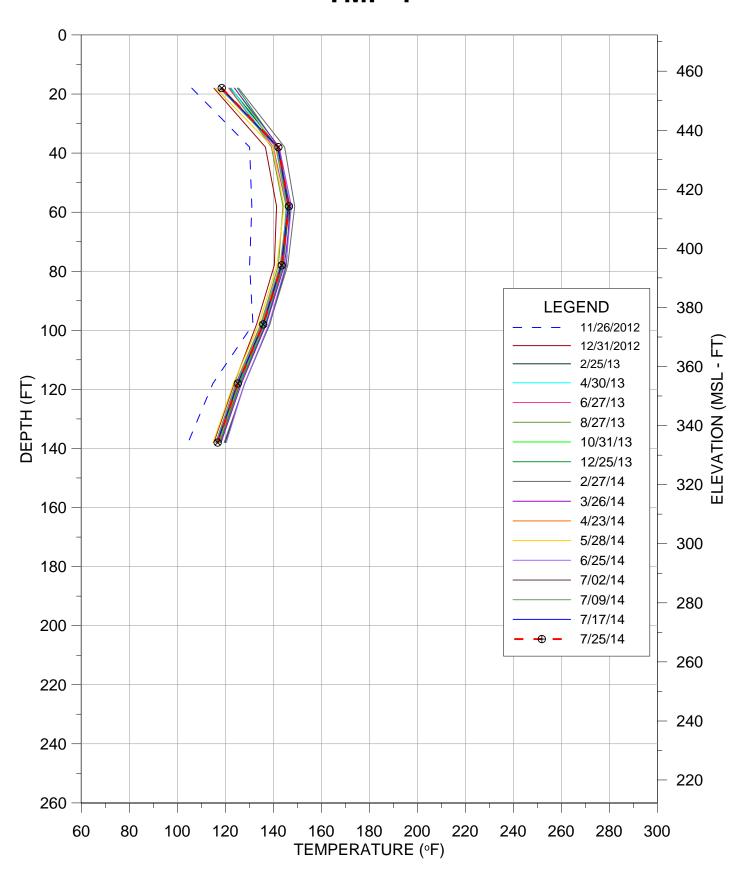
TMP-1

The following TMPs indicated consistent profiles to previous week(s): TMP-1, -2, -3, -4, -6, -8, -9, -10, -11, -12, and -14.

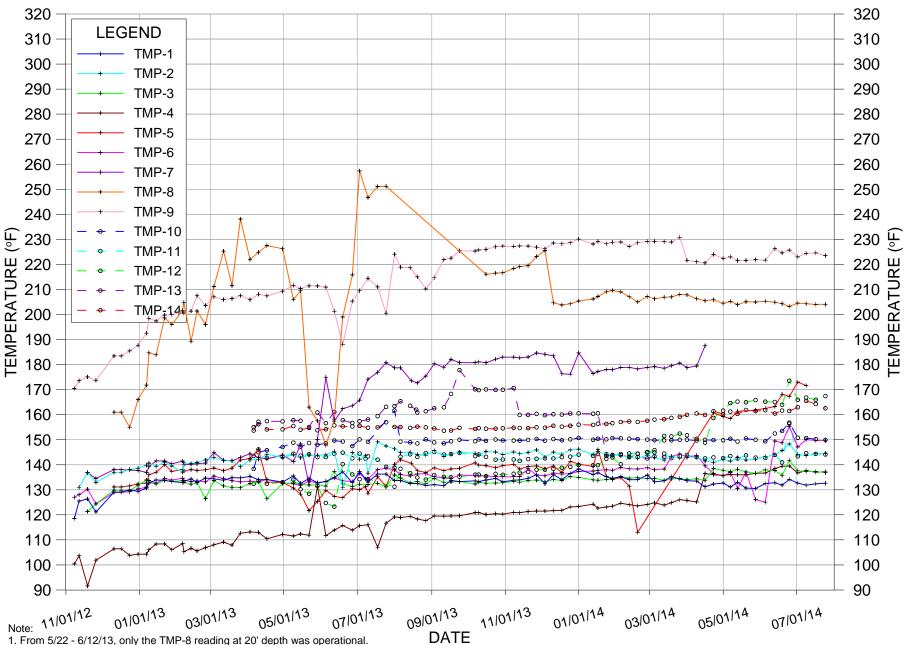
AVERAGE TEMPERATURES

From 5/22 - 6/12/13, only the TMP-8 reading at 20' depth was operational.
 No valid readings were obtained for TMP-8 from 8/1 to 10/10/2013. Valid readings from 20' to 40' resumed on 10/16/2013.

- 2. A new OMEGA dial was installed at TMP-7R on 6/12/2013 enabling more vaild readings.
- 3. No valid readings were obtained for TMP-10 and TMP-12 on 7/18/2013 or 7/25/2013.
- 4. End terminals were replaced just prior to the 8/6/2013 readings with type T Omega connectors (part # SMPW-CC-T-M) on all TMPs except for TMP-8.

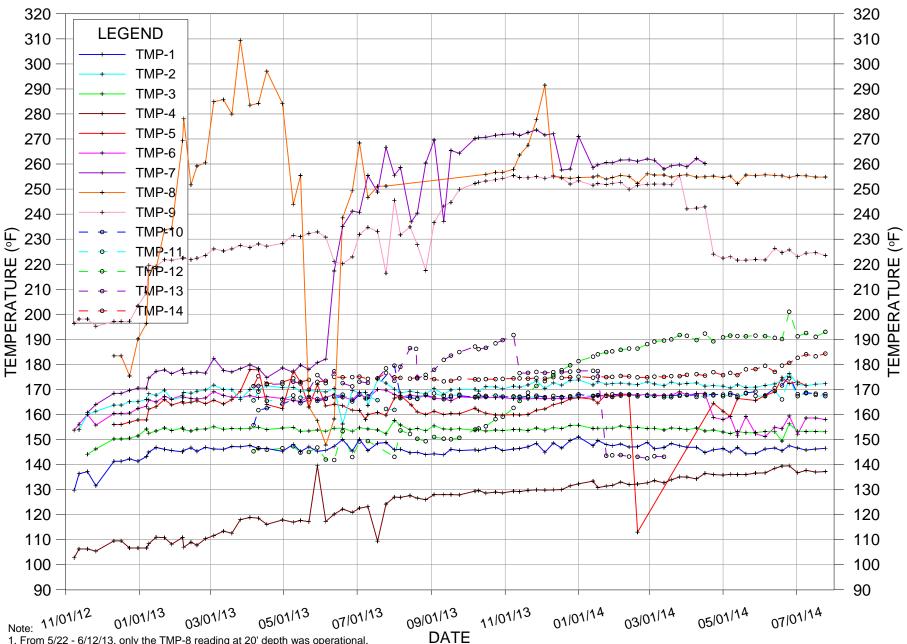
MAXIMUM TEMPERATURES

1. From 5/22 - 6/12/13, only the TMP-8 reading at 20' depth was operational.

No valid readings were obtained for TMP-8 from 8/1 to 10/10/2013. Valid readings from 20' to 40' resumed on 10/16/2013.

2. A new OMEGA dial was installed at TMP-7R on 6/12/2013 enabling more vaild readings.

3. No valid readings were obtained for TMP-10 and TMP-12 on 7/18/2013 or 7/25/2013.

4. End terminals were replaced just prior to the 8/6/2013 readings with type T Omega connectors (part # SMPW-CC-T-M) on all TMPs except for TMP-8.

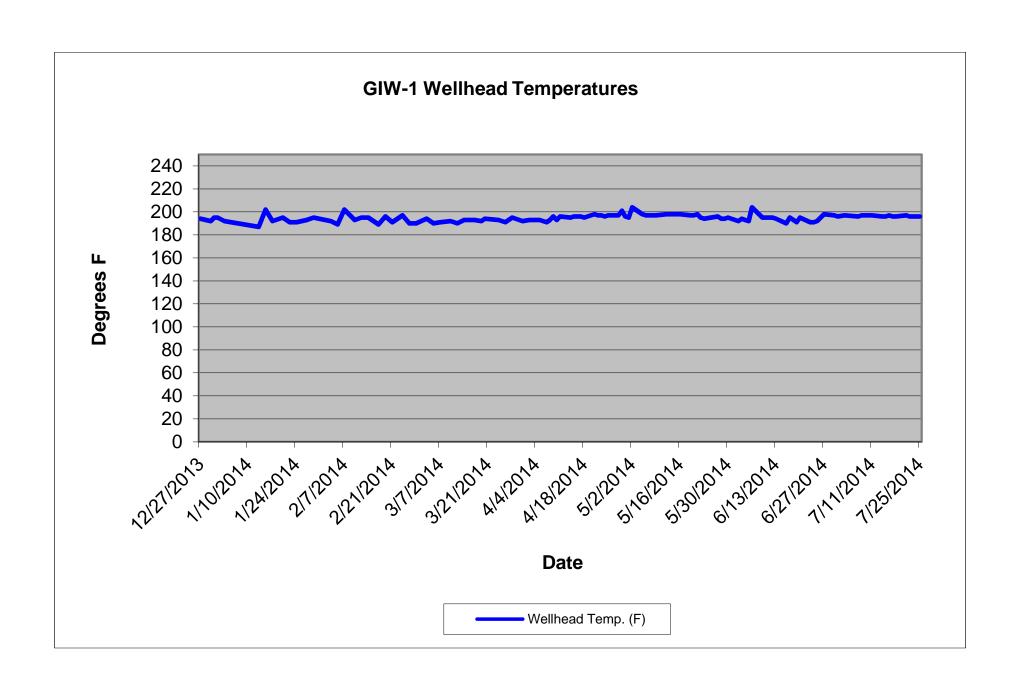
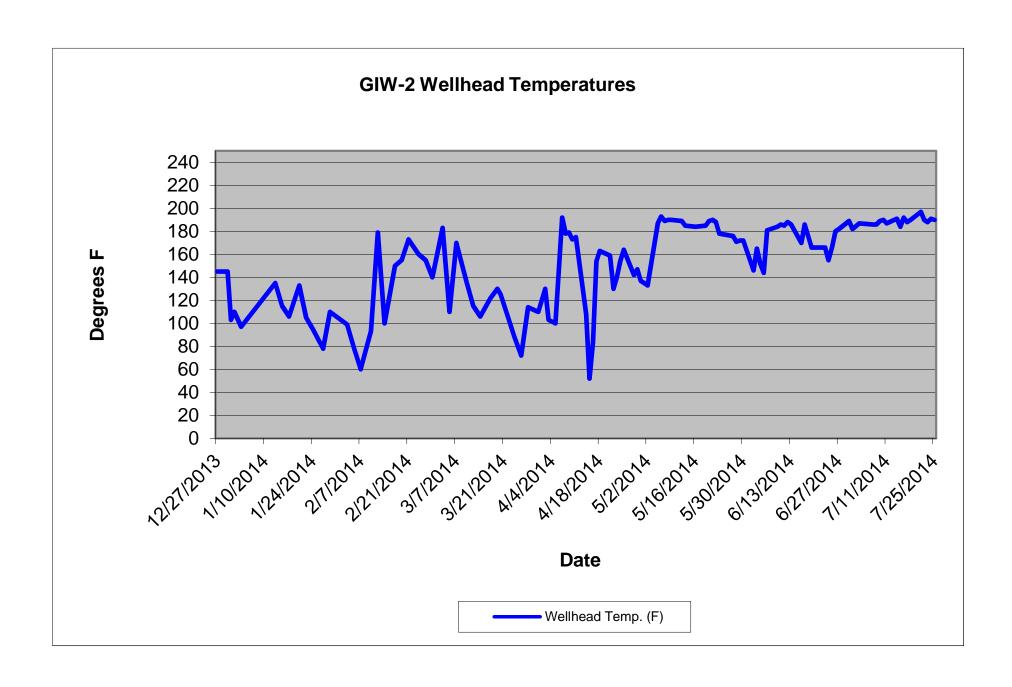
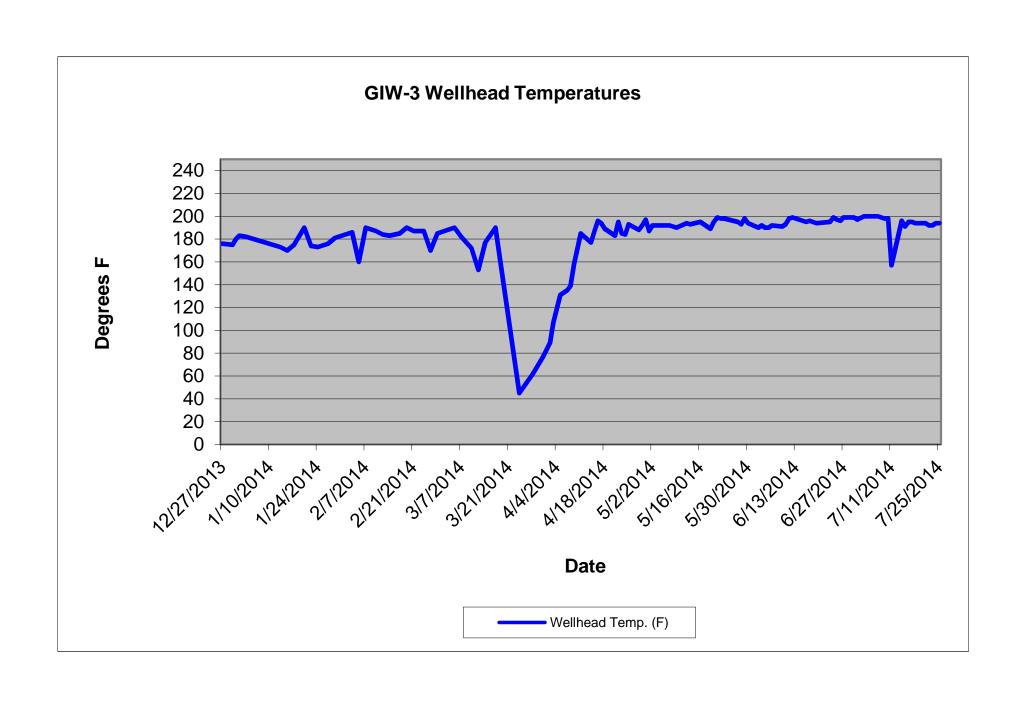
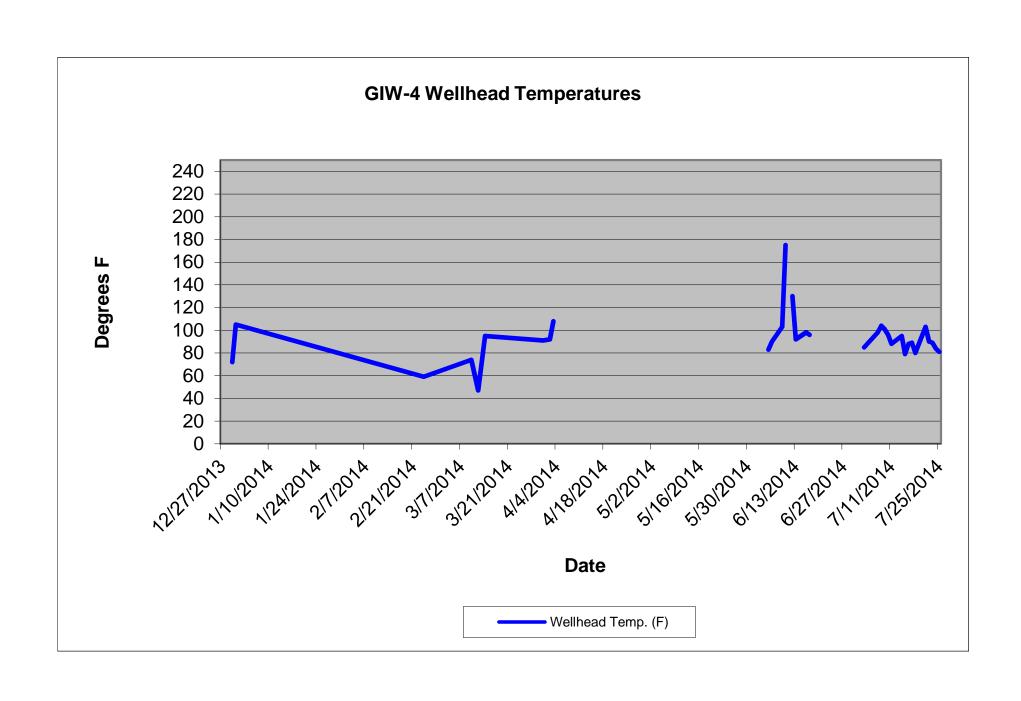
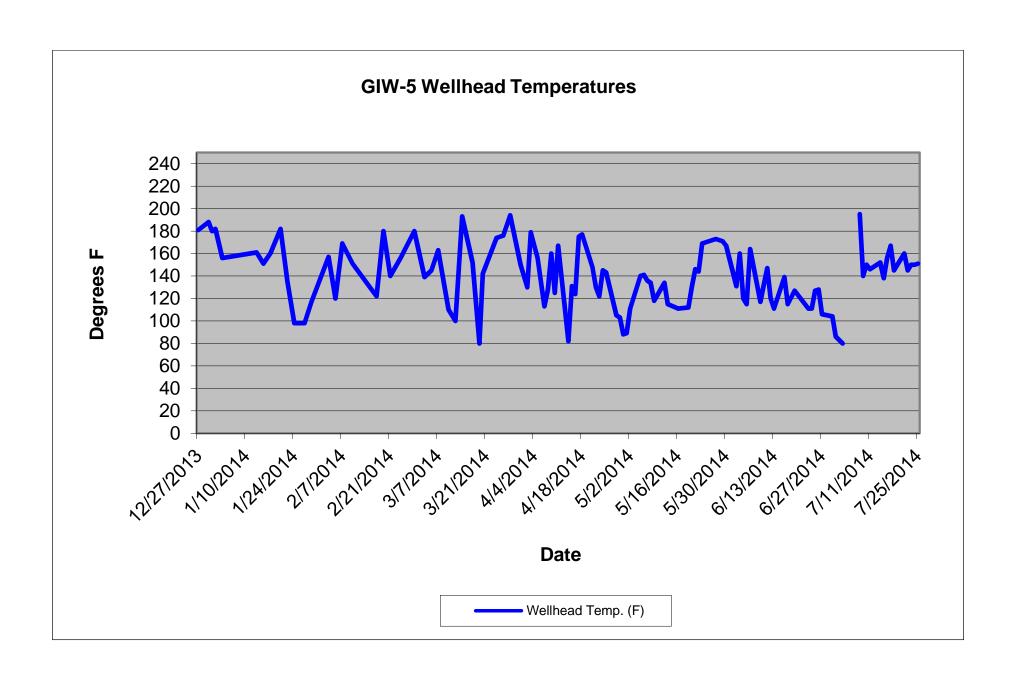
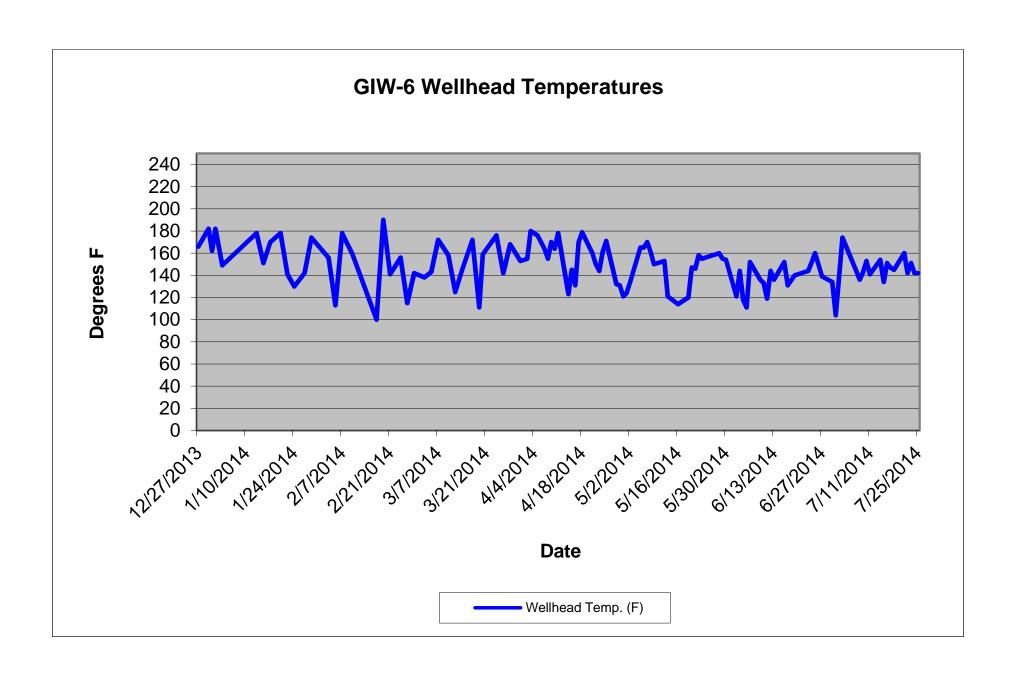
The fluctuation in wellhead gas temperatures can be attributed to variation in available vacuum, gas flow and ambient temperatures at the respective well.

Each gas interceptor well remained relatively consistent or lower with regards to gas wellhead temperatures previously measured at each location.

The water circulation cooling loop is currently installed in GIW-4.
