Bridgeton Landfill, LLC

Weekly Data Submittals

**Required by Section 52.F of Agreed Order, Case No. 13SL-CC01088
Effective May 13, 2013**

August 5, 2014

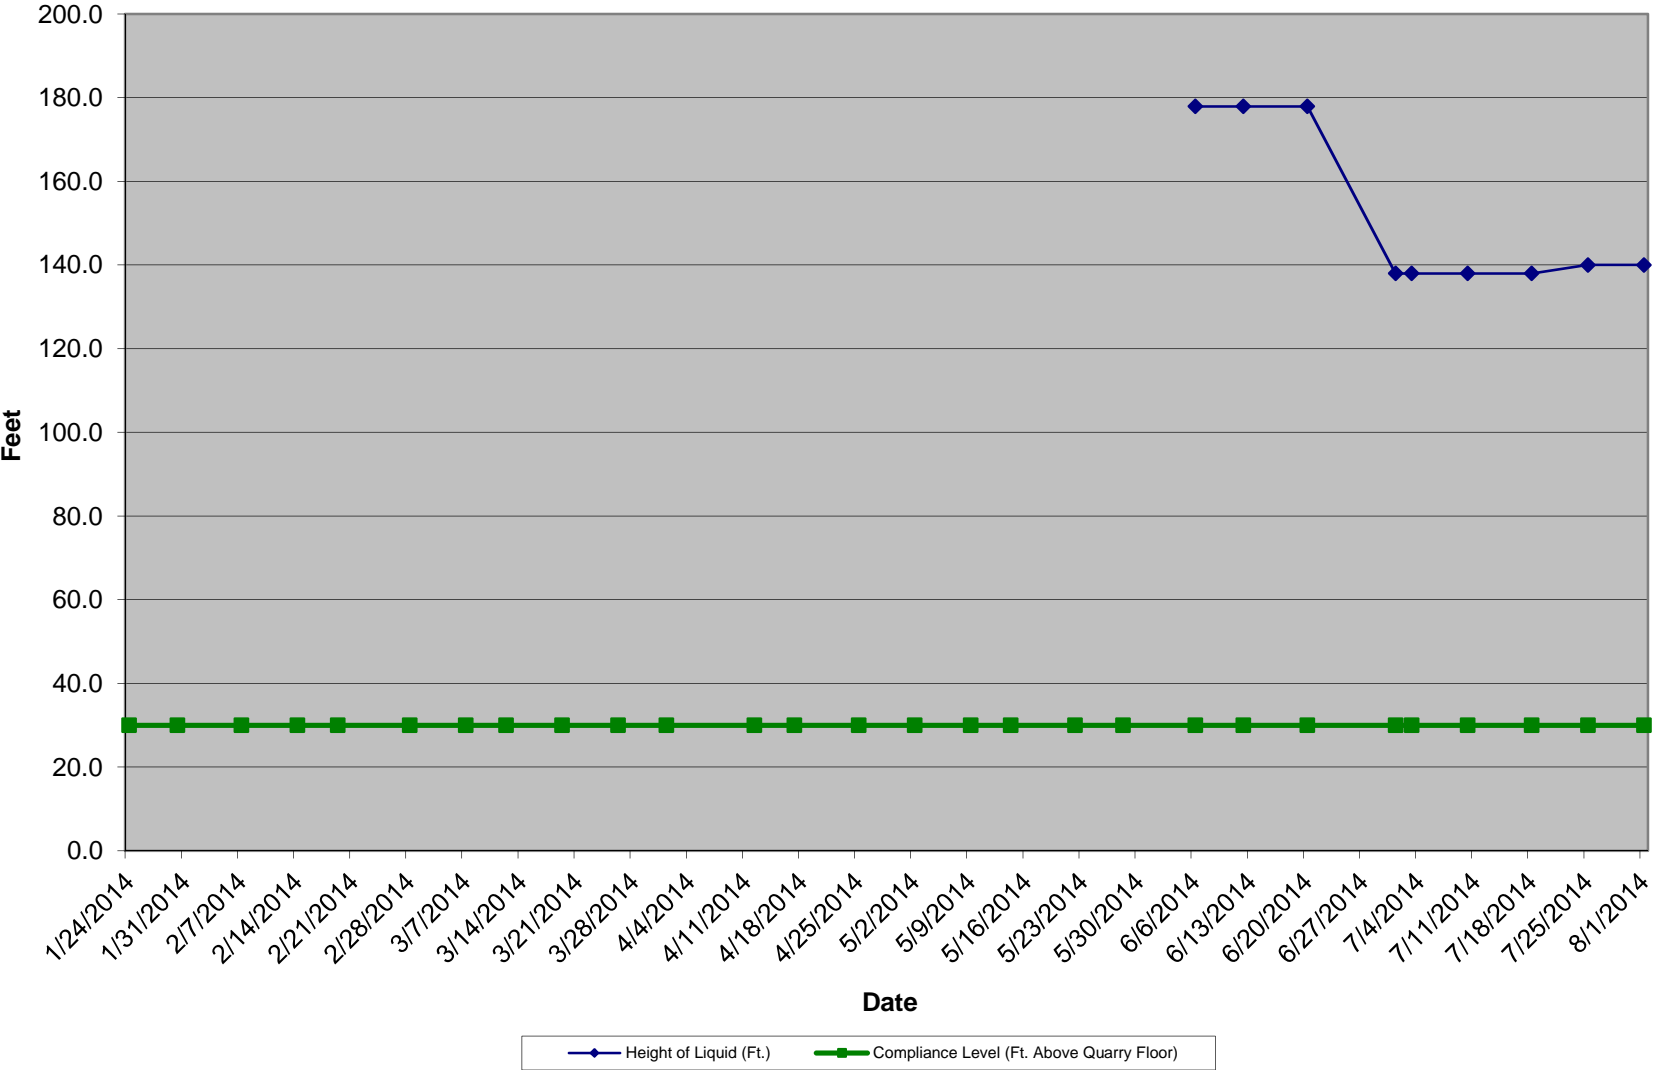
LCS-1D Liquid Level Above Quarry Floor

LCS-1D, -2D -5A, and -6B were partially or fully operational during the weekly reporting period.

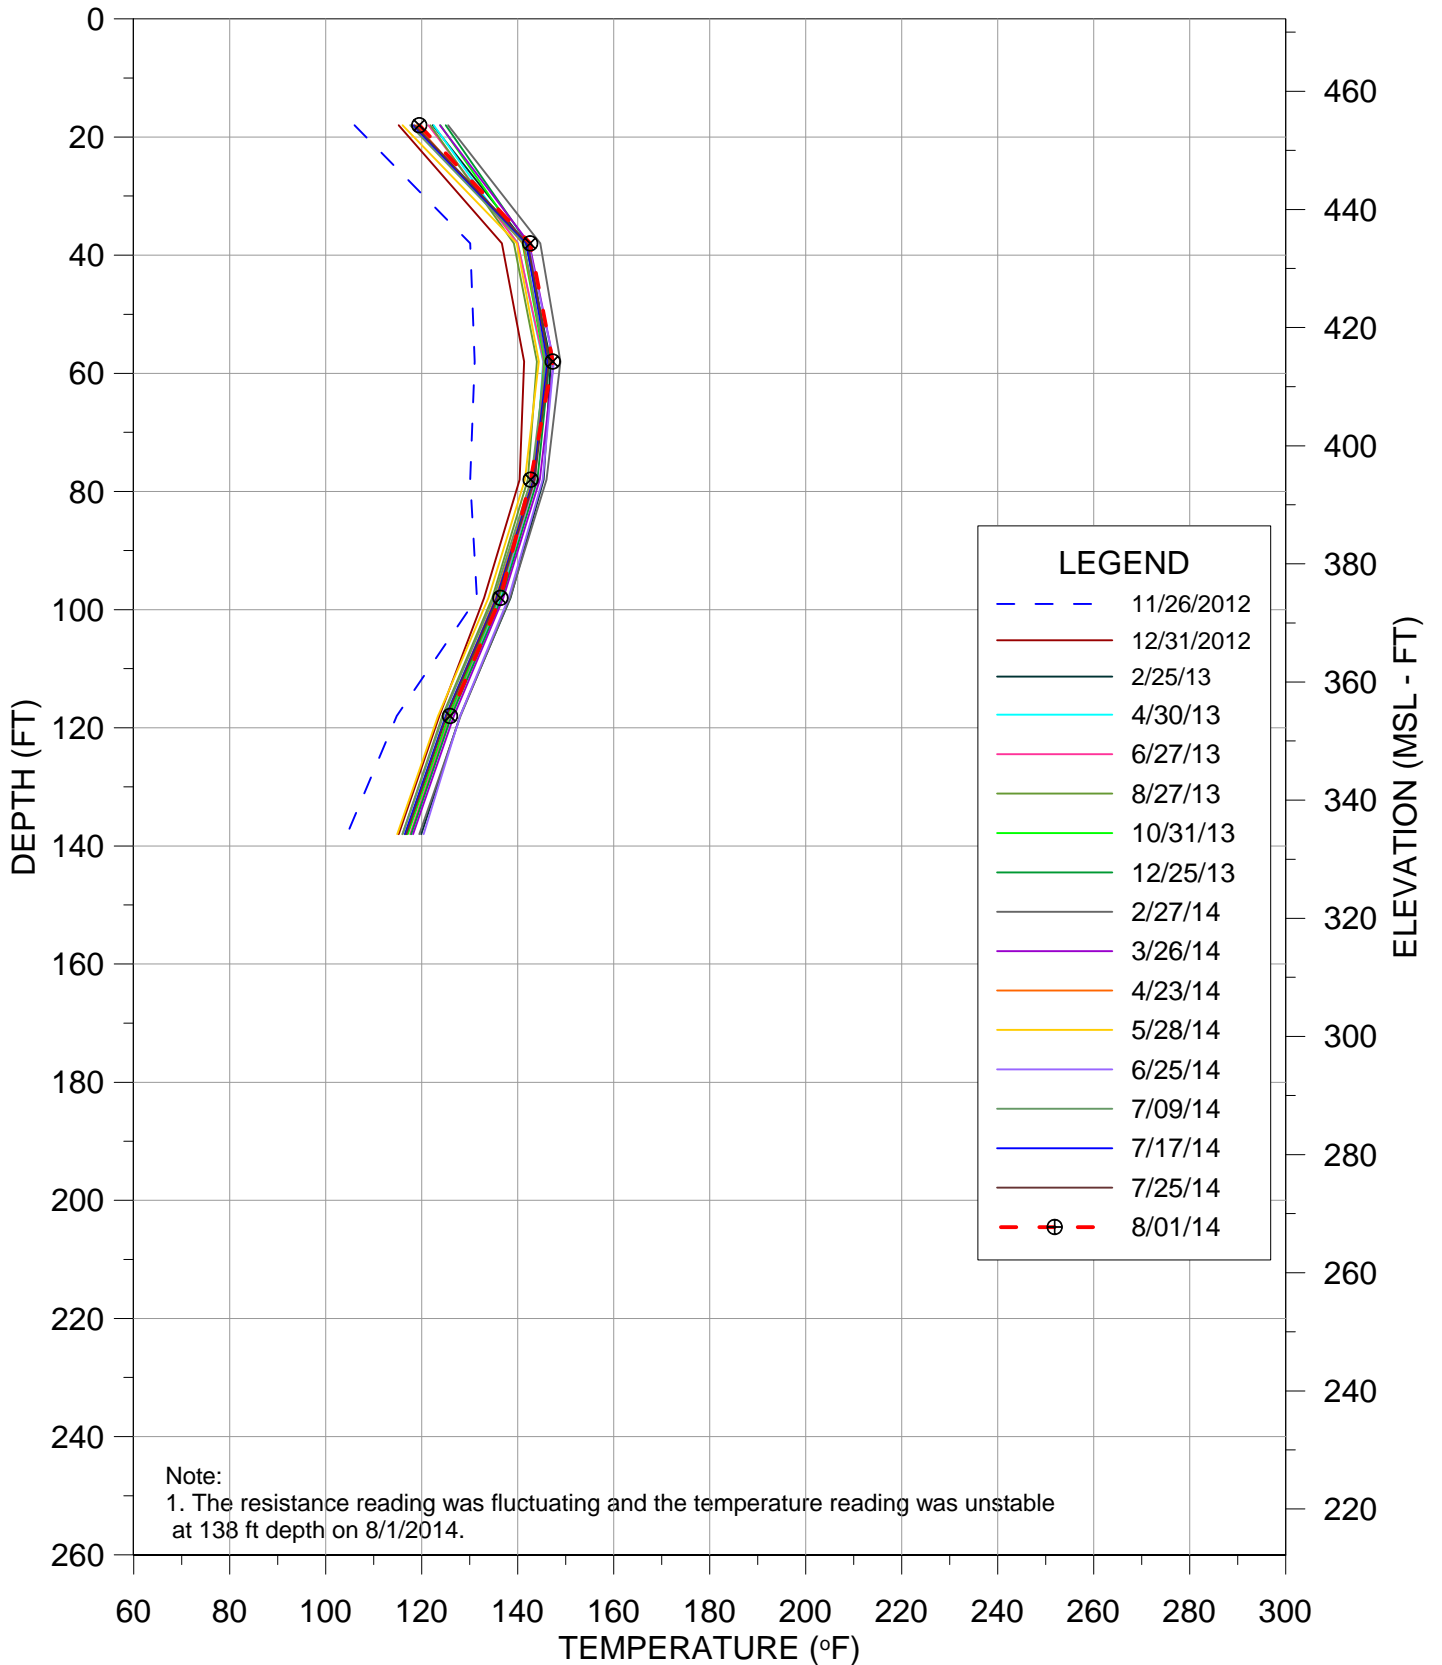
TMP-1

The following TMPs indicated consistent profiles to previous week(s): TMP-1, -2, -3, -4, -6, -8, -9, -10, -11, -12, and -14.

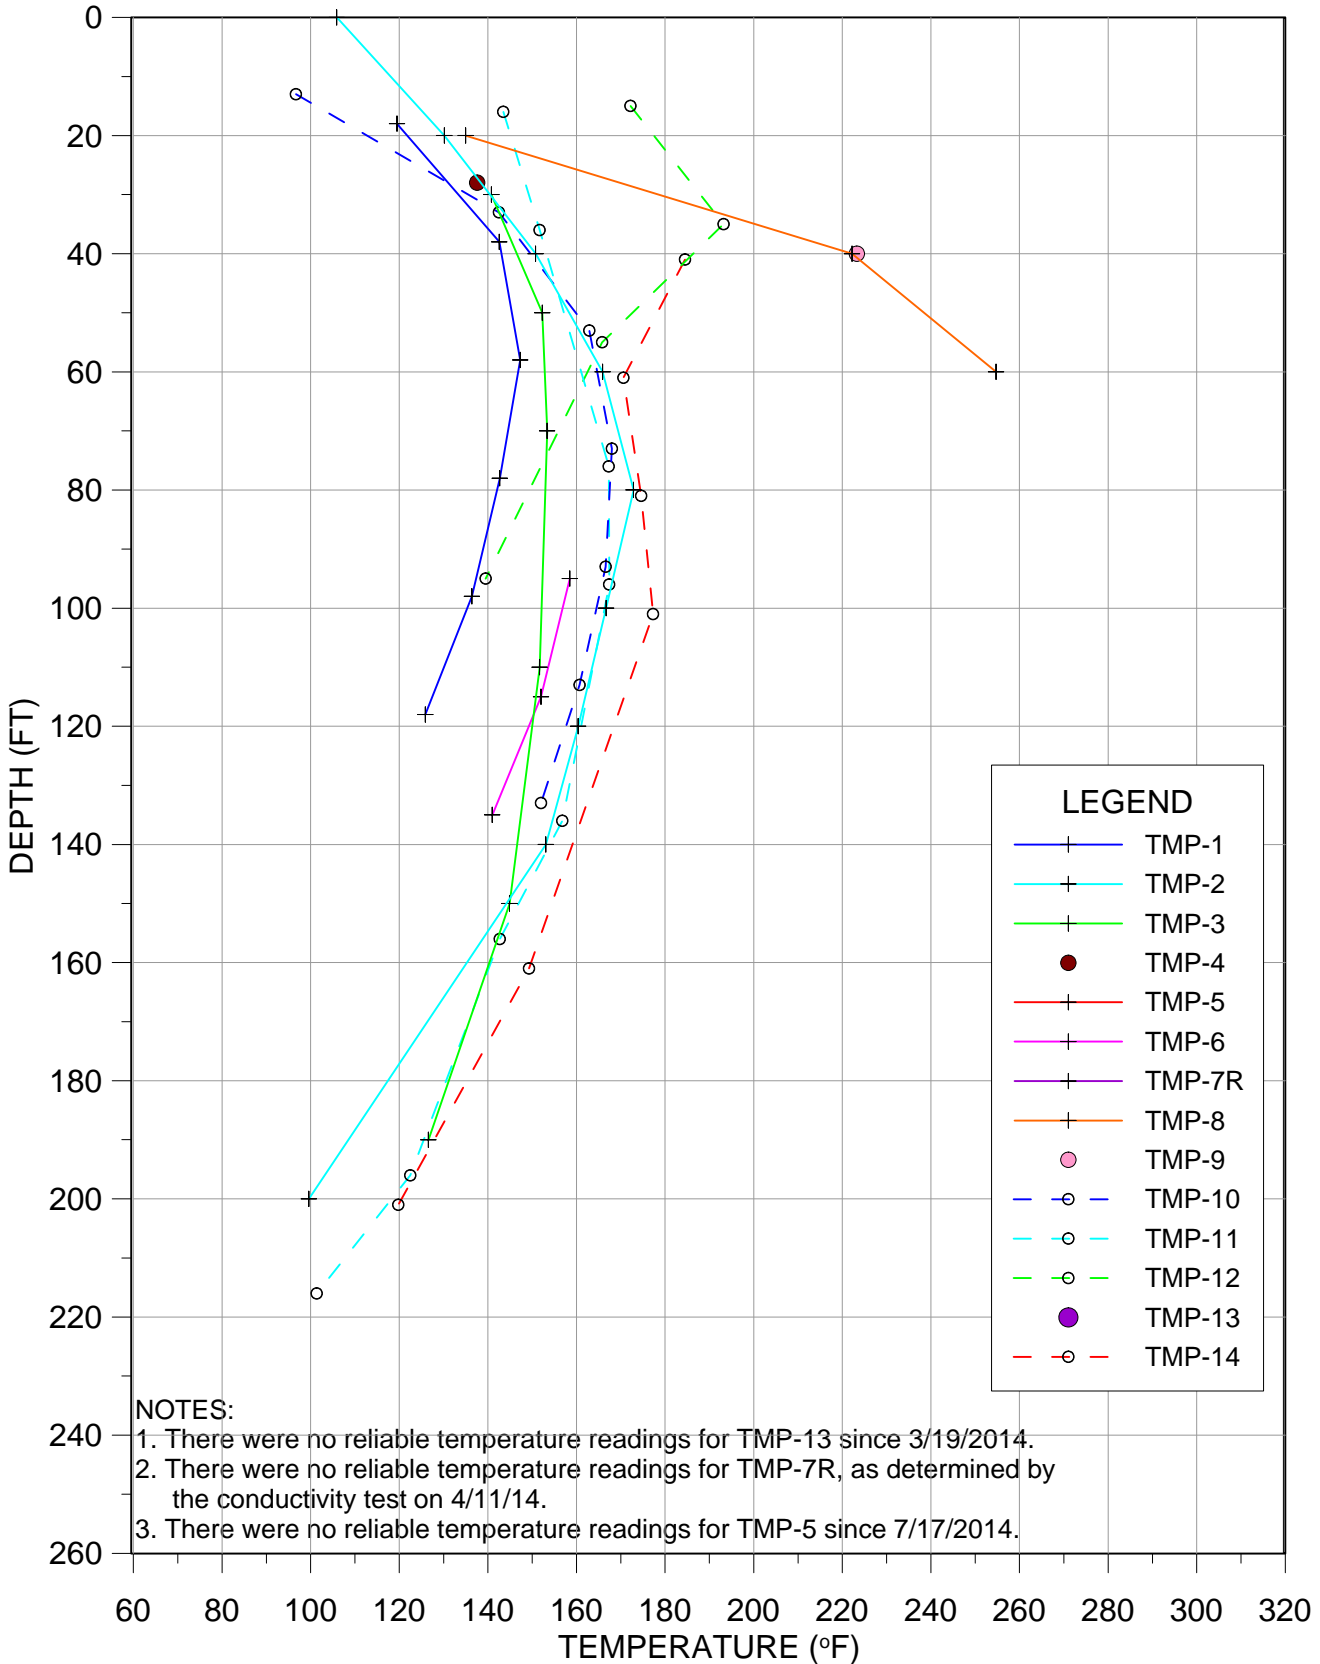
08/01/2014 -DEPTH

NOTES:
 1. There were no reliable temperature readings for TMP-13 since 3/19/2014.
 2. There were no reliable temperature readings for TMP-7R, as determined by the conductivity test on 4/11/14.
 3. There were no reliable temperature readings for TMP-5 since 7/17/2014.

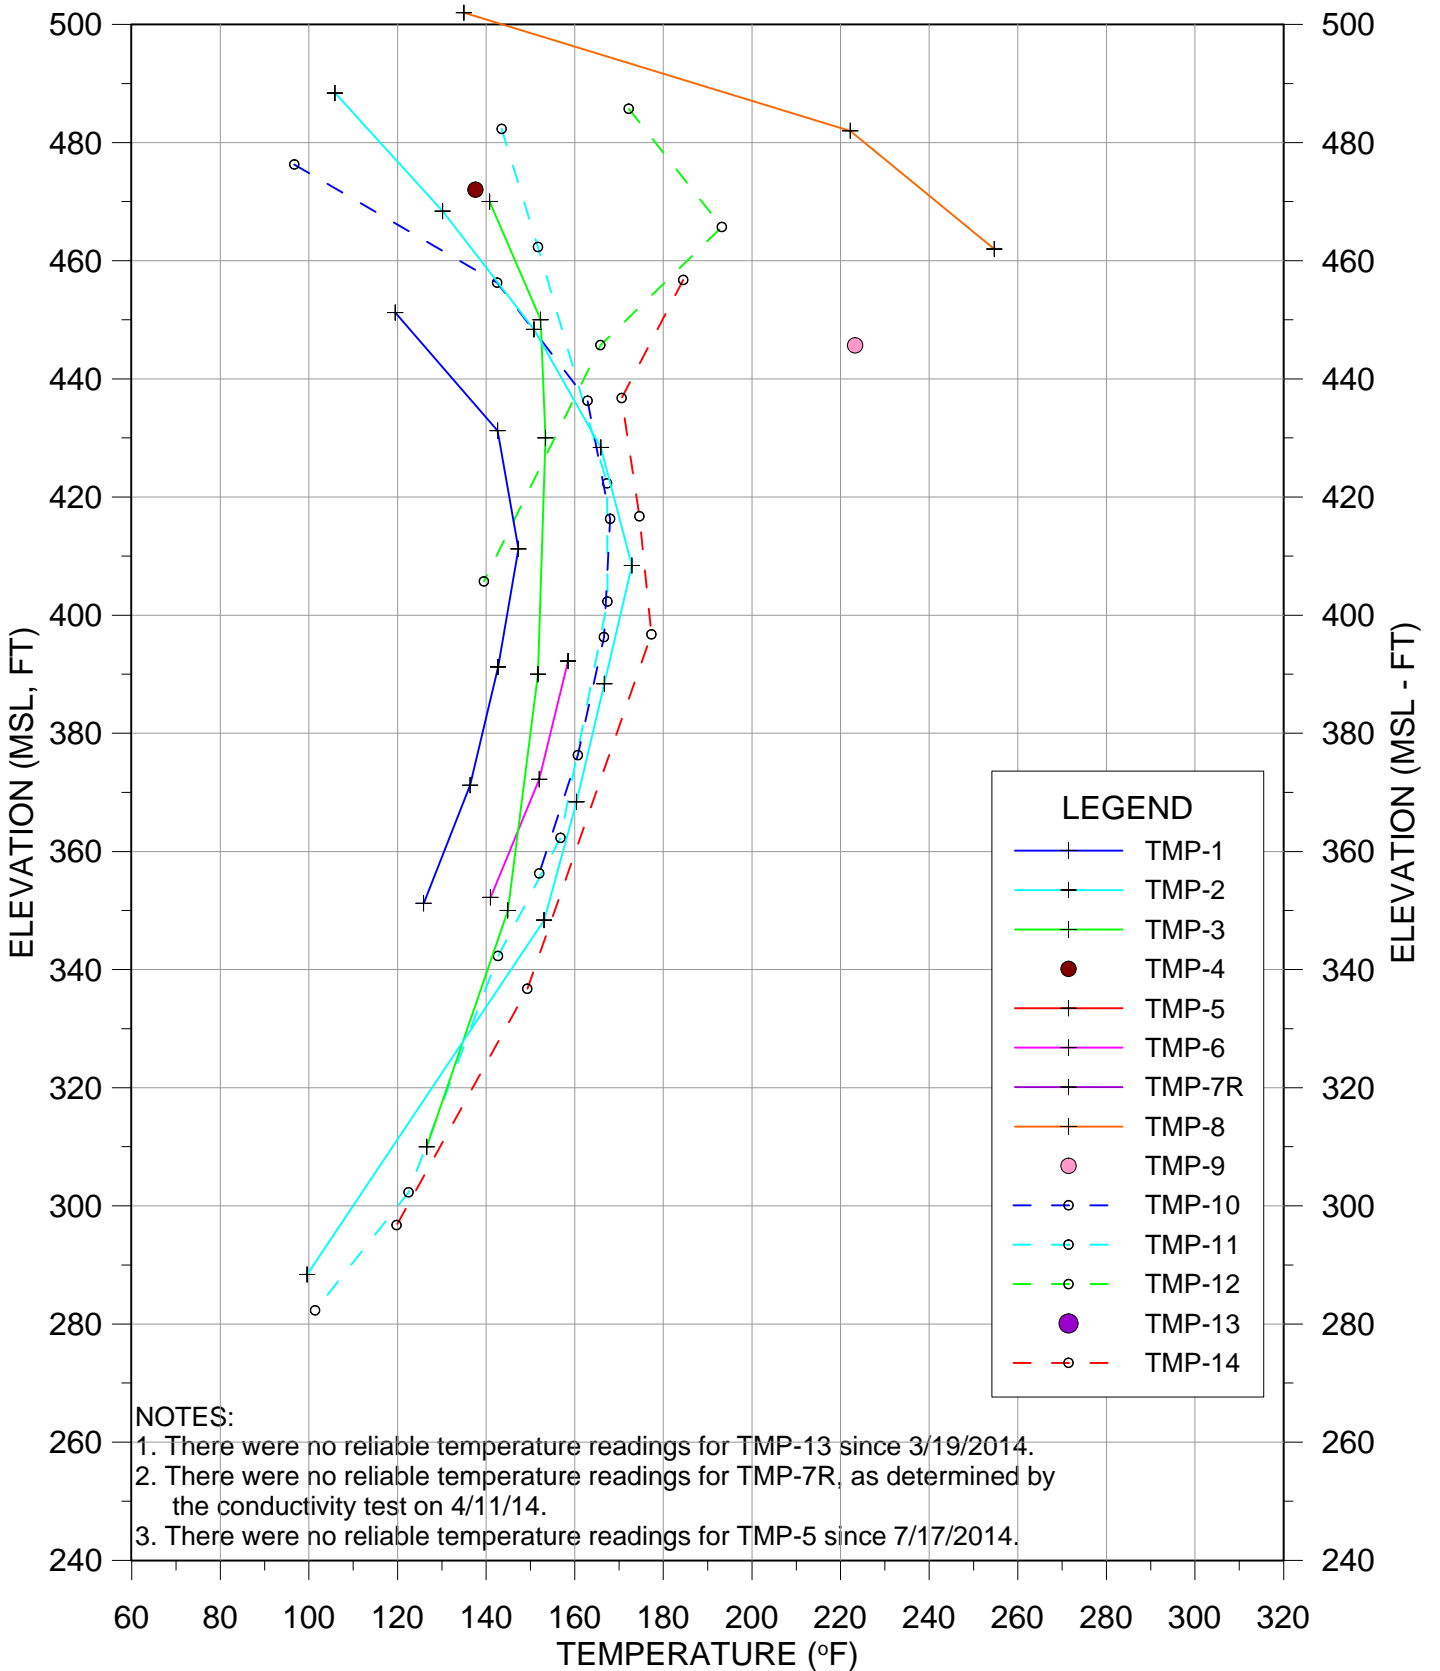
TEMPERATURE VS DEPTH
BRIDGETON LANDFILL

08/01/2014 - ELEVATION

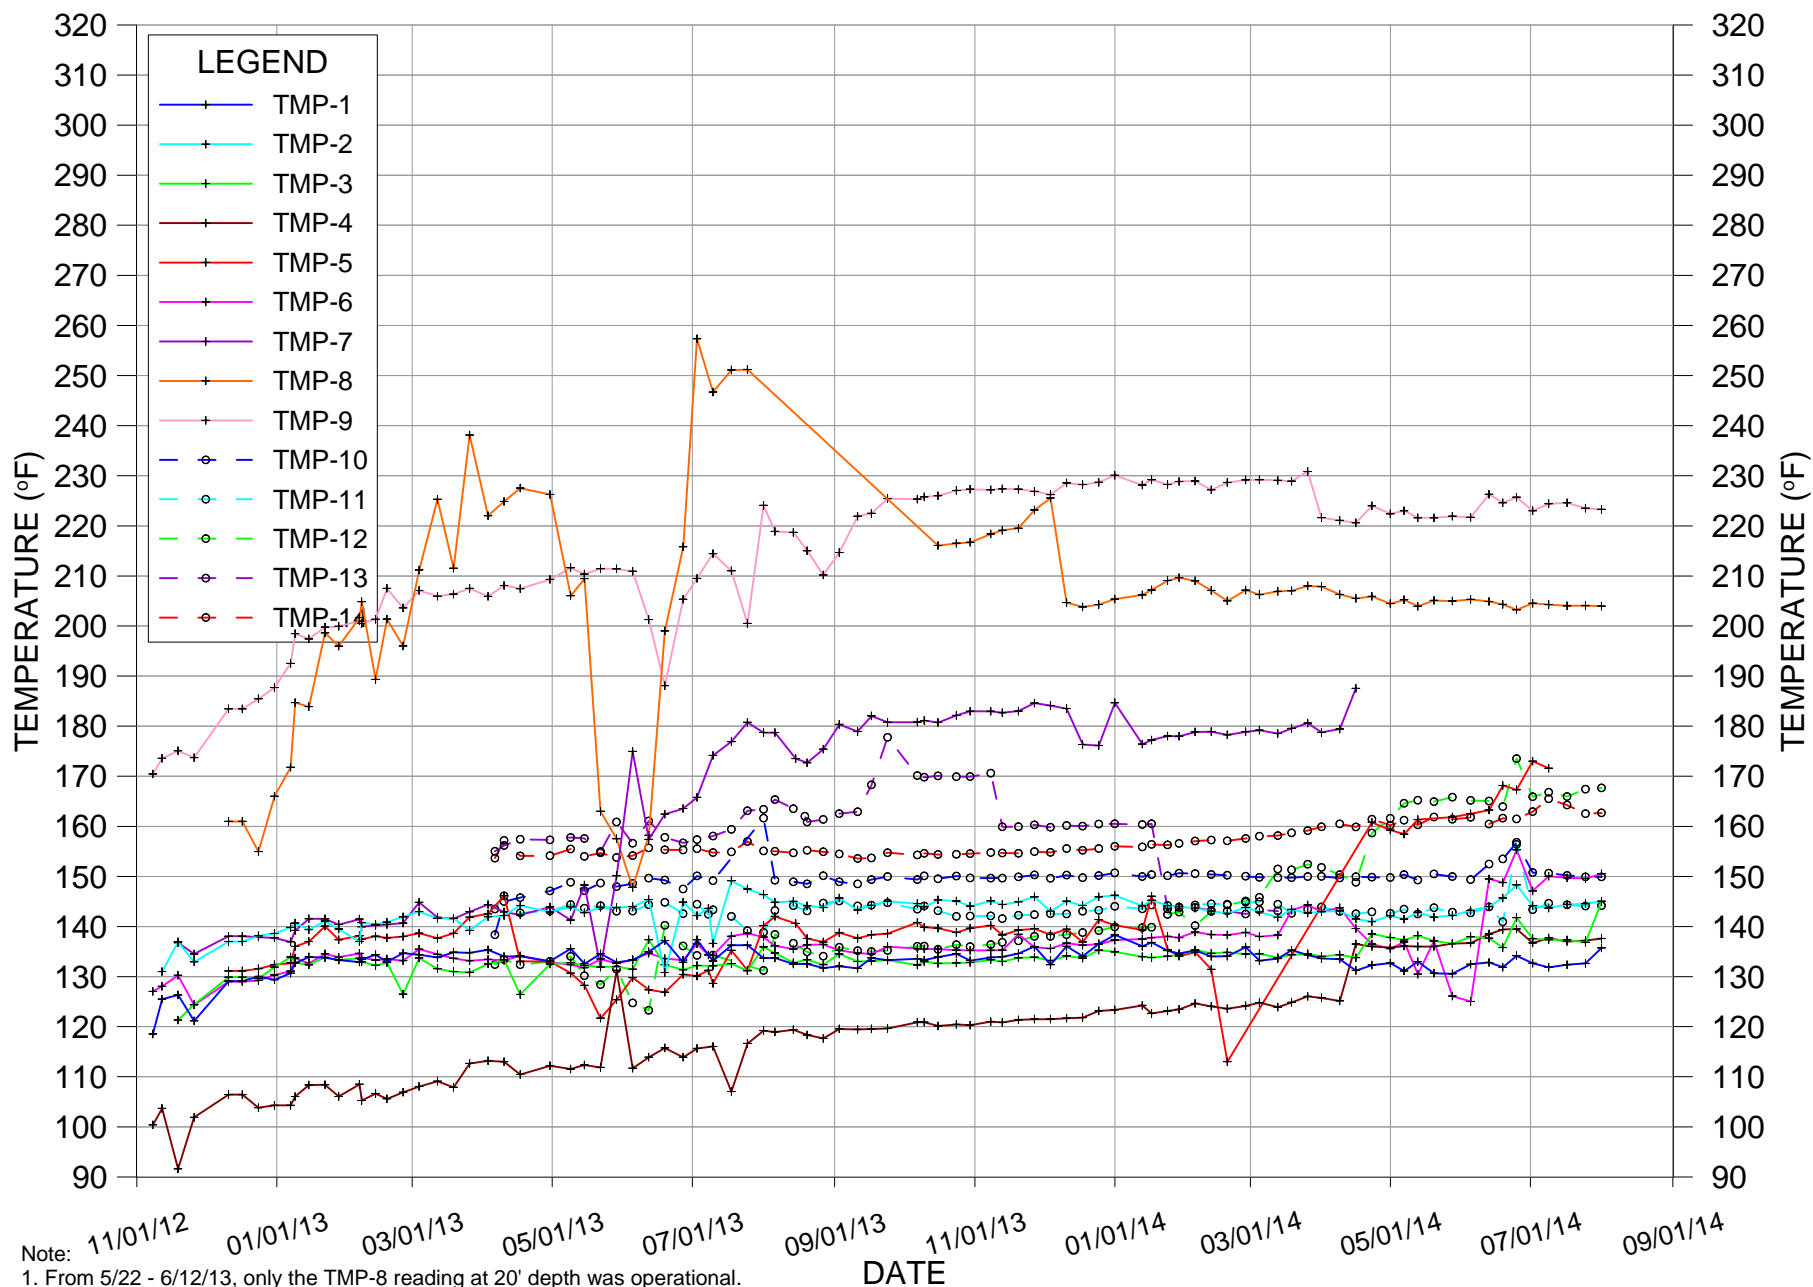
AVERAGE TEMPERATURES

1. From 5/22 - 6/12/13, only the TMP-8 reading at 20' depth was operational. No valid readings were obtained for TMP-8 from 8/1 to 10/10/2013. Valid readings from 20' to 40' resumed on 10/16/2013.
2. A new OMEGA dial was installed at TMP-7R on 6/12/2013 enabling more valid readings.
3. No valid readings were obtained for TMP-10 and TMP-12 on 7/18/2013 or 7/25/2013.
4. End terminals were replaced just prior to the 8/6/2013 readings with type T Omega connectors (part # SMPW-CC-T-M) on all TMPs except for TMP-8.

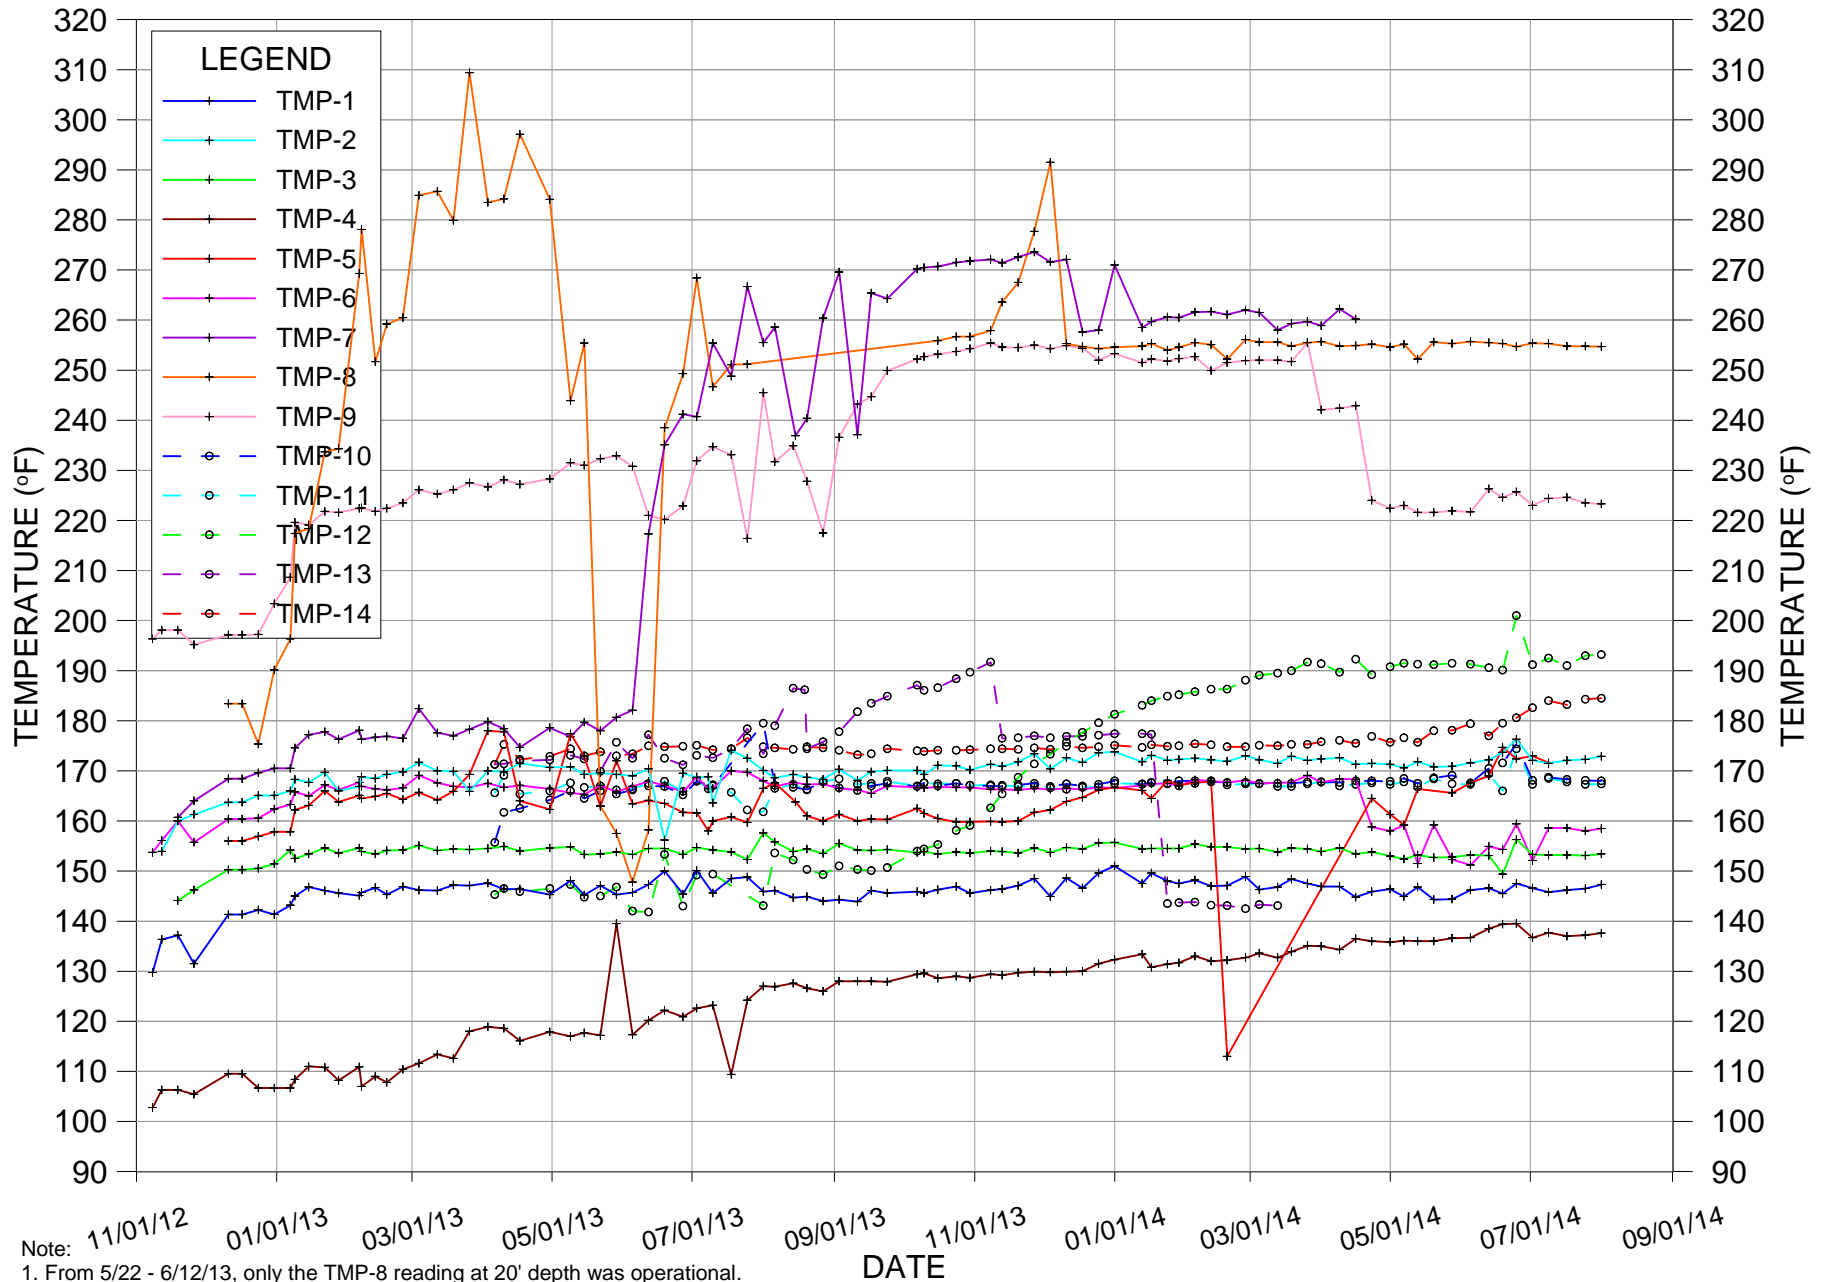
MAXIMUM TEMPERATURES

- Note: 11/01/12 01/01/13 03/01/13 05/01/13 07/01/13 09/01/13 11/01/13 01/01/14 03/01/14 05/01/14 07/01/14 09/01/14
1. From 5/22 - 6/12/13, only the TMP-8 reading at 20' depth was operational.
No valid readings were obtained for TMP-8 from 8/1 to 10/10/2013. Valid readings from 20' to 40' resumed on 10/16/2013.
 2. A new OMEGA dial was installed at TMP-7R on 6/12/2013 enabling more valid readings.
 3. No valid readings were obtained for TMP-10 and TMP-12 on 7/18/2013 or 7/25/2013.
 4. End terminals were replaced just prior to the 8/6/2013 readings with type T Omega connectors (part # SMPW-CC-T-M) on all TMPs except for TMP-8.

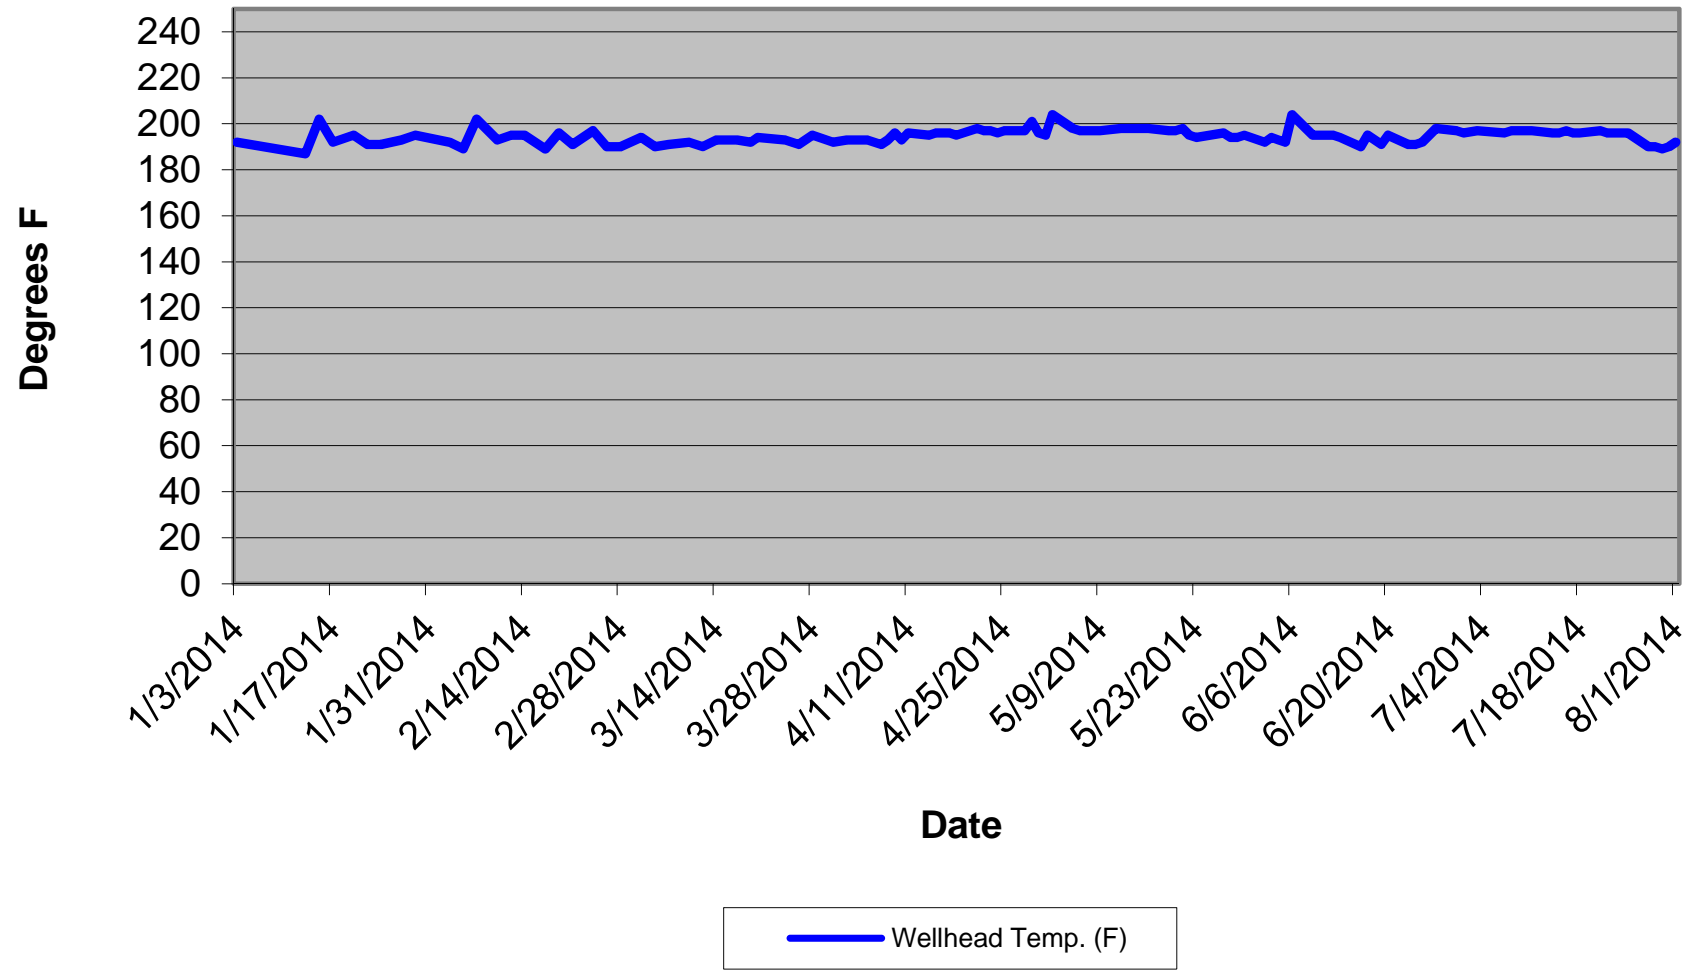
GIW-1 Wellhead Temperatures

The fluctuation in wellhead gas temperatures can be attributed to variation in available vacuum, gas flow and ambient temperatures at the respective well.

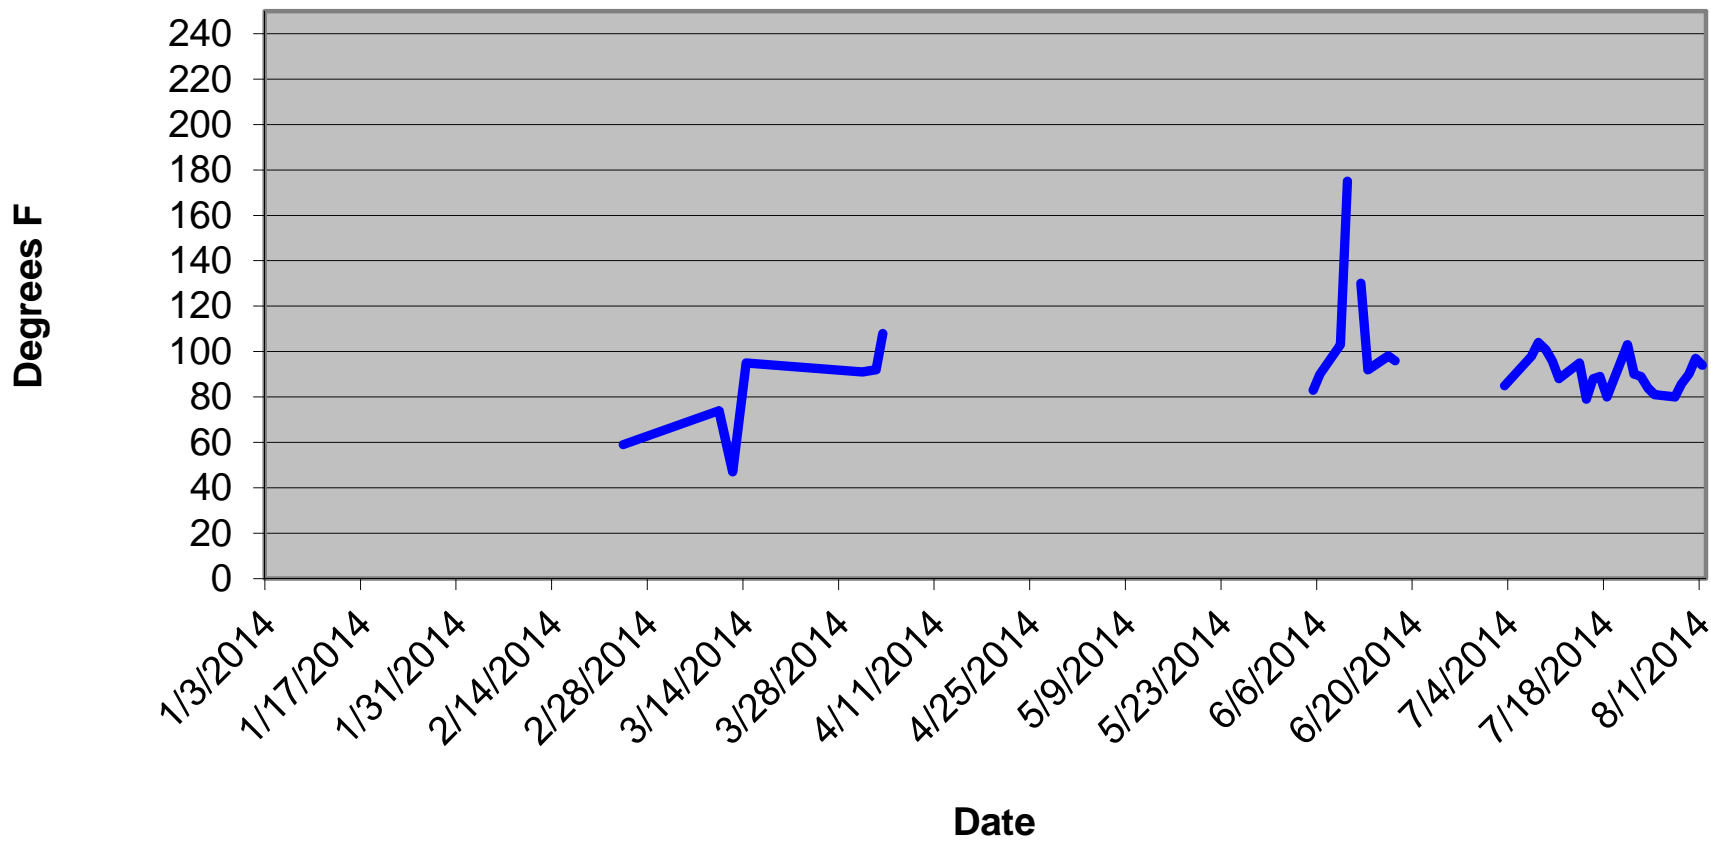
GIW-4 Wellhead Temperatures

Each gas interceptor well remained relatively consistent or lower with regards to gas wellhead temperatures previously measured at each location.

The water circulation cooling loop is currently installed in GIW-4.
