Bridgeton Landfill, LLC

Weekly Data Submittals

Required by Section 52.F of Agreed Order, Case No. 13SL-CC01088 Effective May 13, 2013

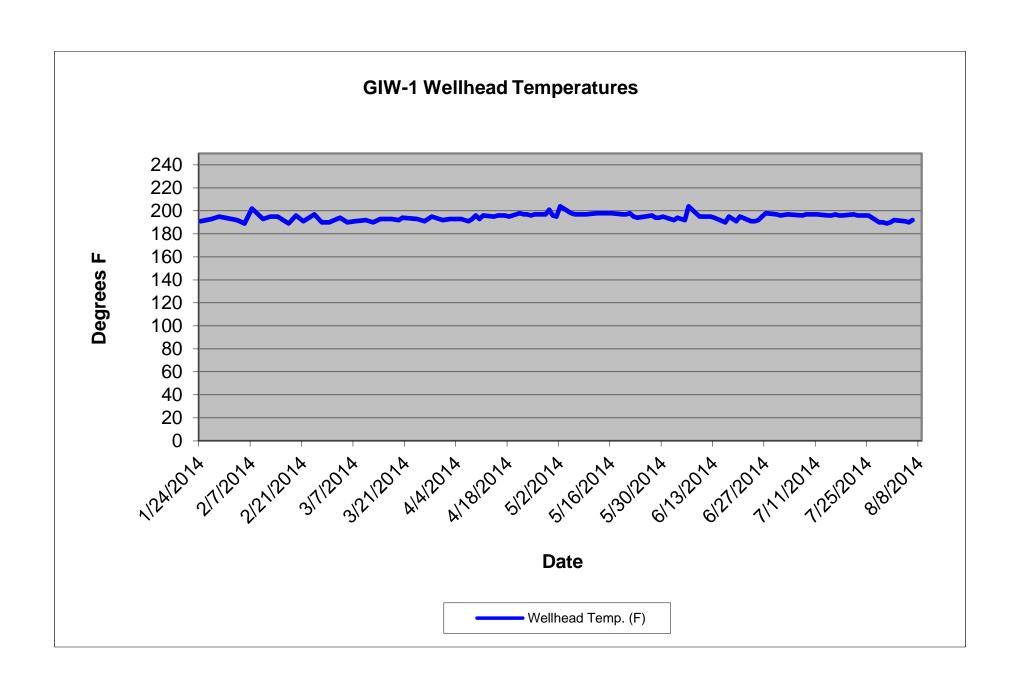
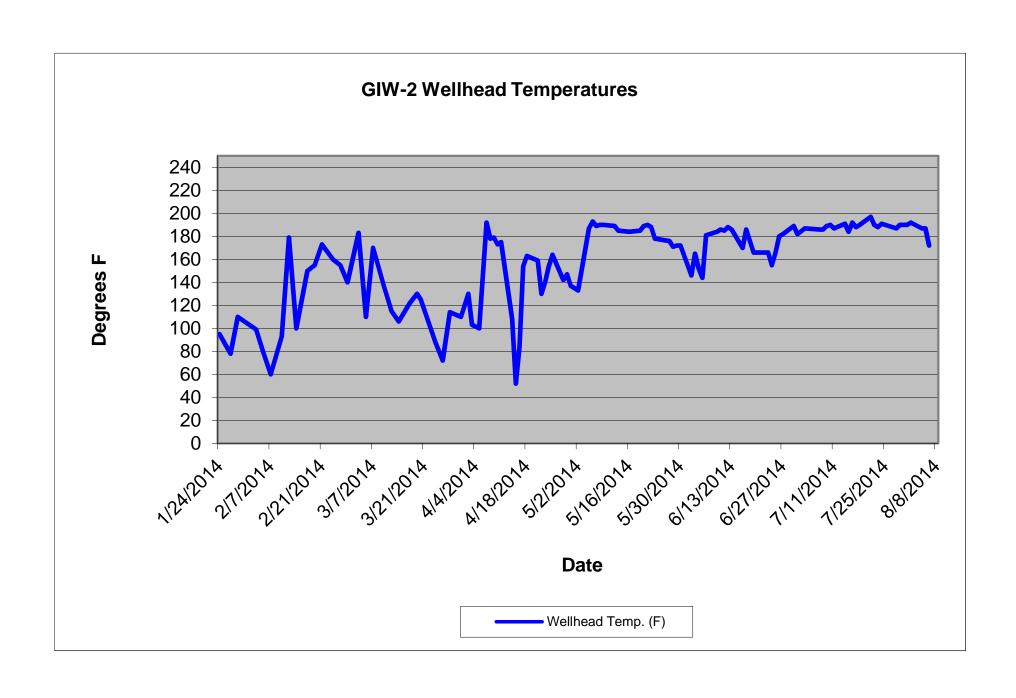
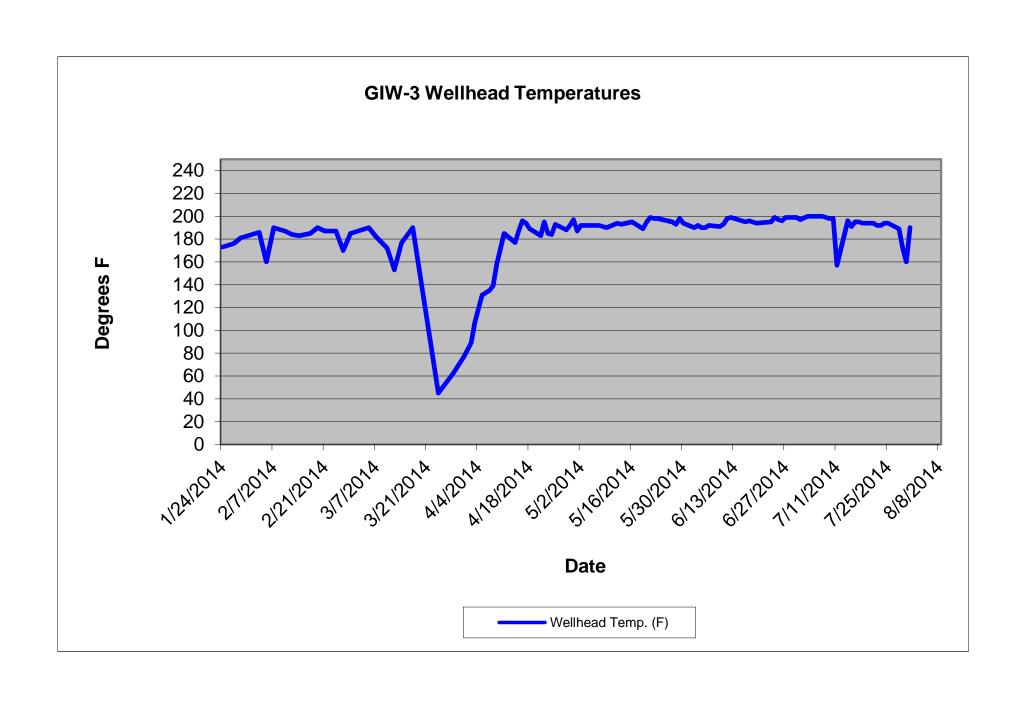
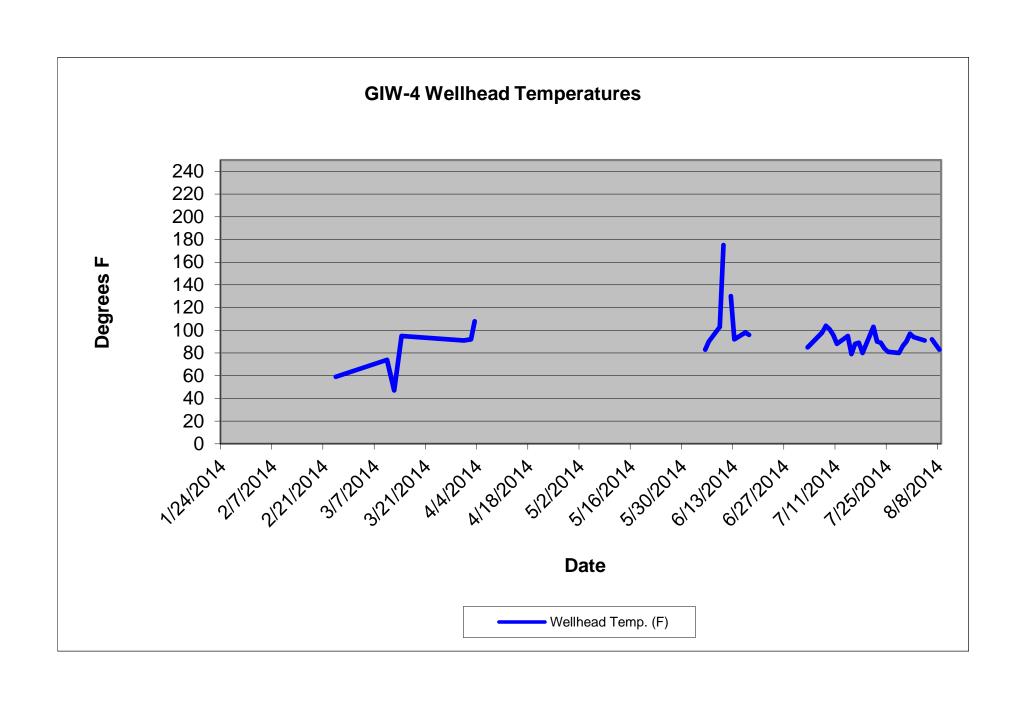
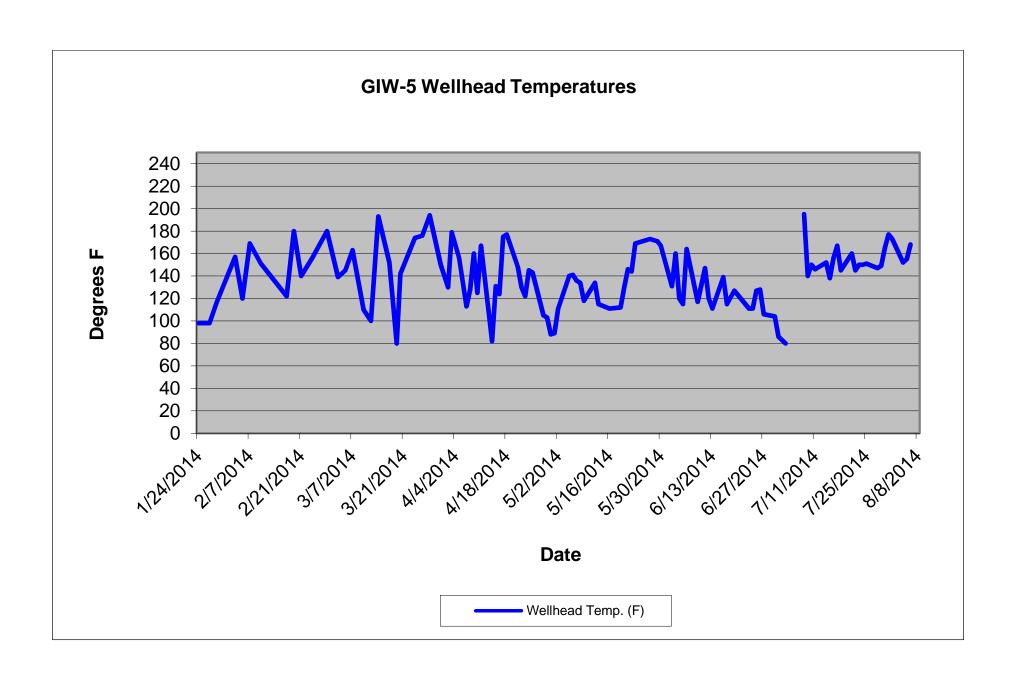
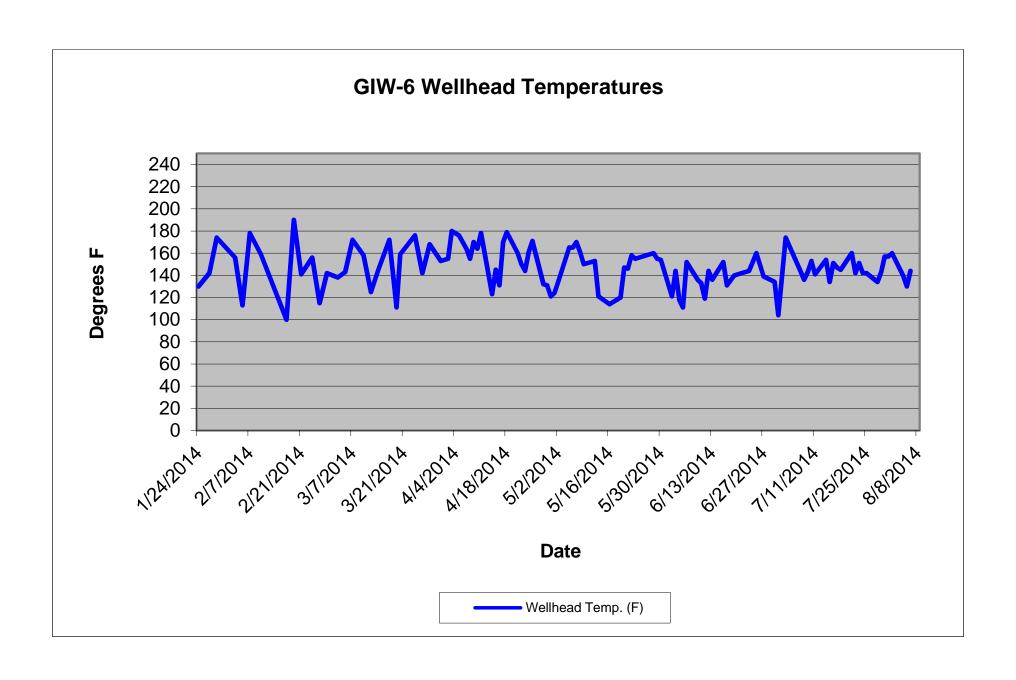
The fluctuation in wellhead gas temperatures can be attributed to variation in available vacuum, gas flow and ambient temperatures at the respective well.

Each gas interceptor well remained relatively consistent or lower with regards to gas wellhead temperatures previously measured at each location.
