# **Bridgeton Landfill, LLC**

## **Weekly Data Submittal**

**Week of February 5, 2017 – February 11, 2017**

**Required by Section 52.F of Agreed Order, Case No. 13SL-CC01088  
Effective May 13, 2013**

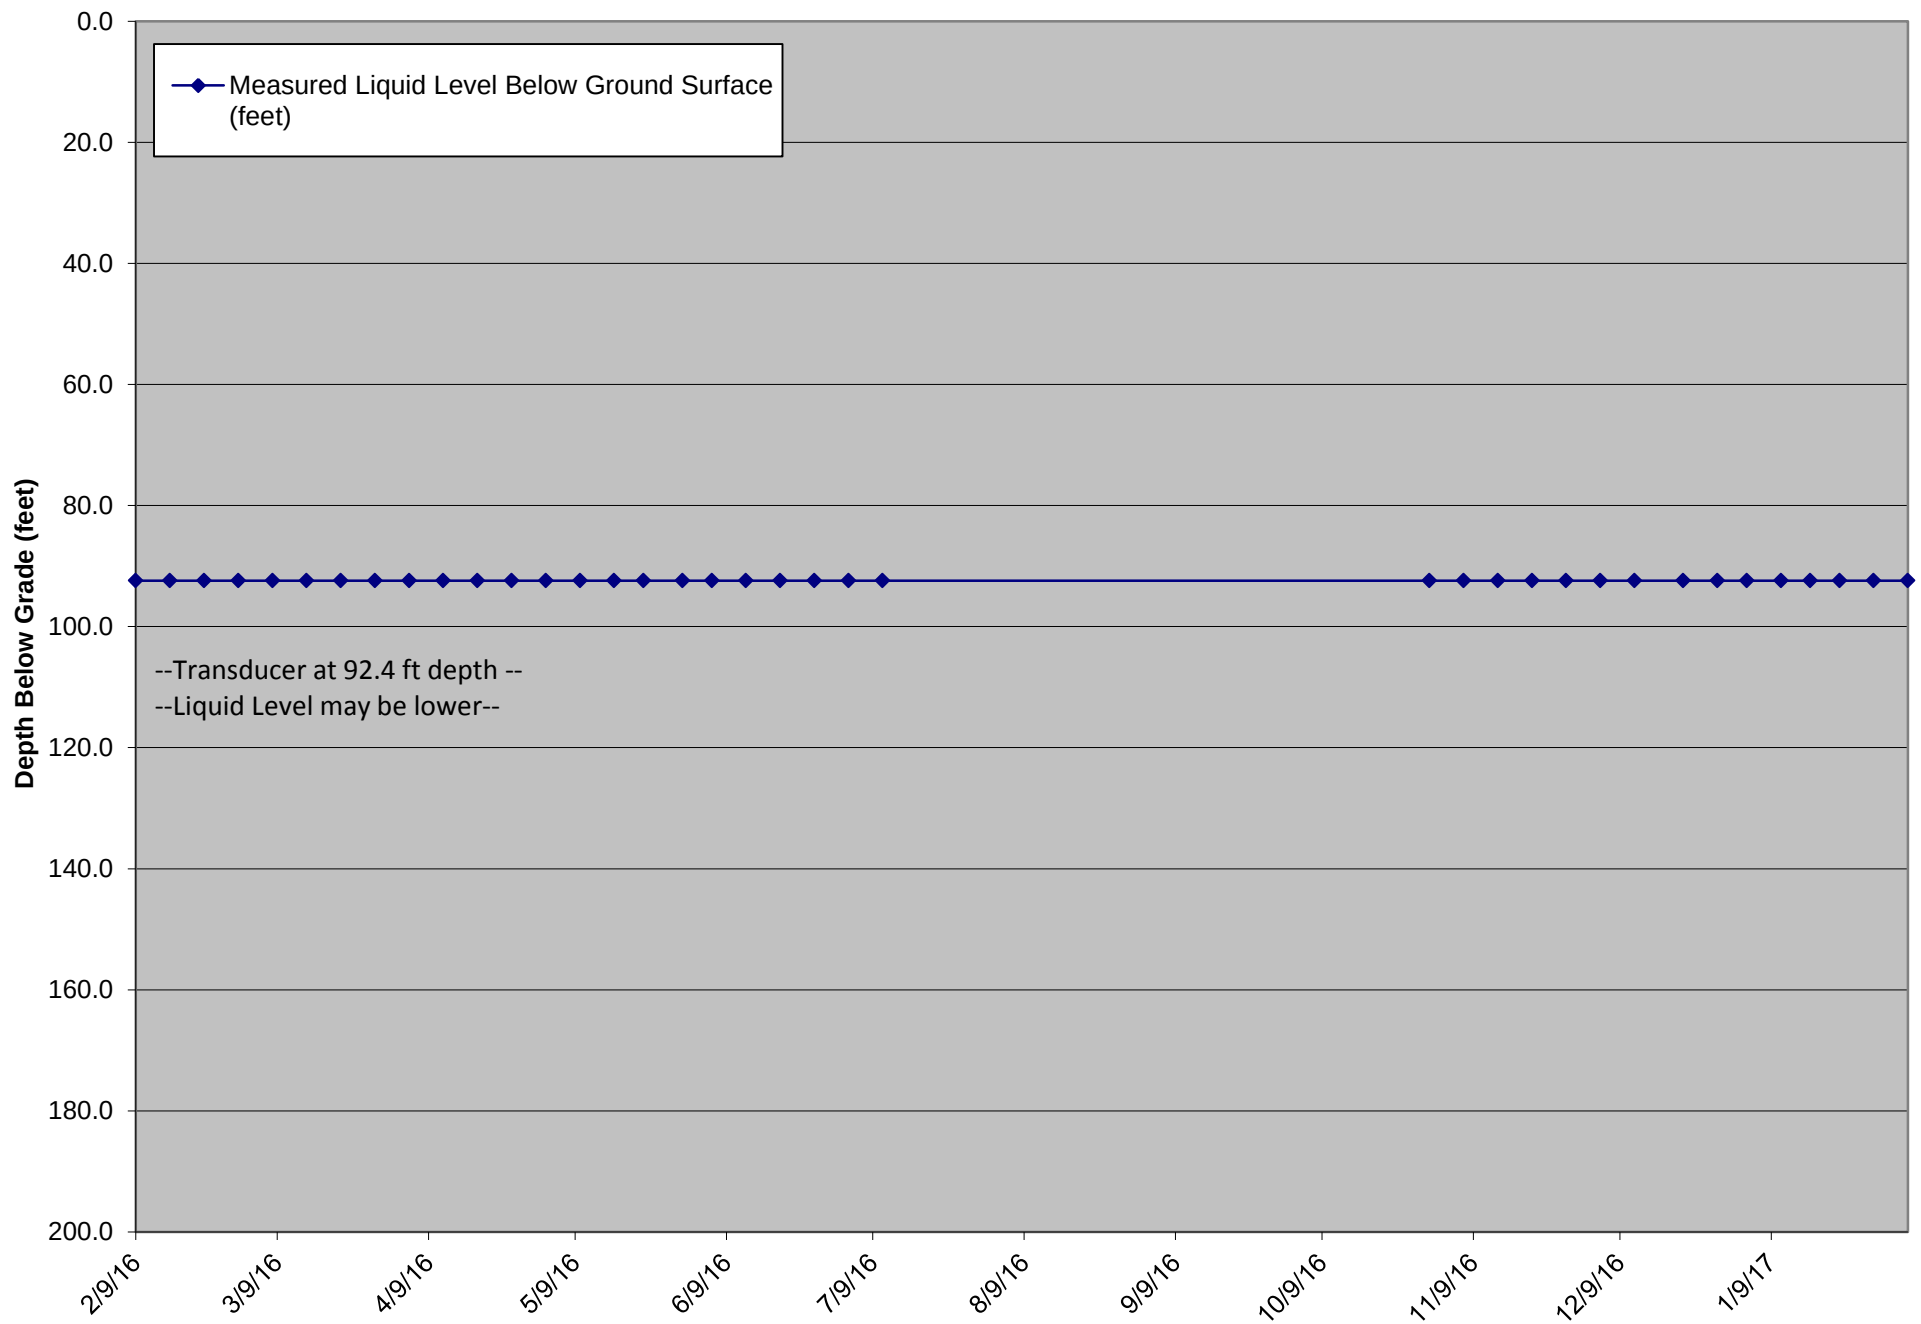
# LCS-1D Liquid Level Below Ground Surface

LCS-1D is equipped with a level sensor and a flow meter. Liquid level was not recorded by the level sensor during the weekly reporting period. The flow meter on LCS-1D displayed flow during the weekly reporting period. Bridgeton Landfill is currently evaluating the level sensor and flow meter to determine if both are currently operational.

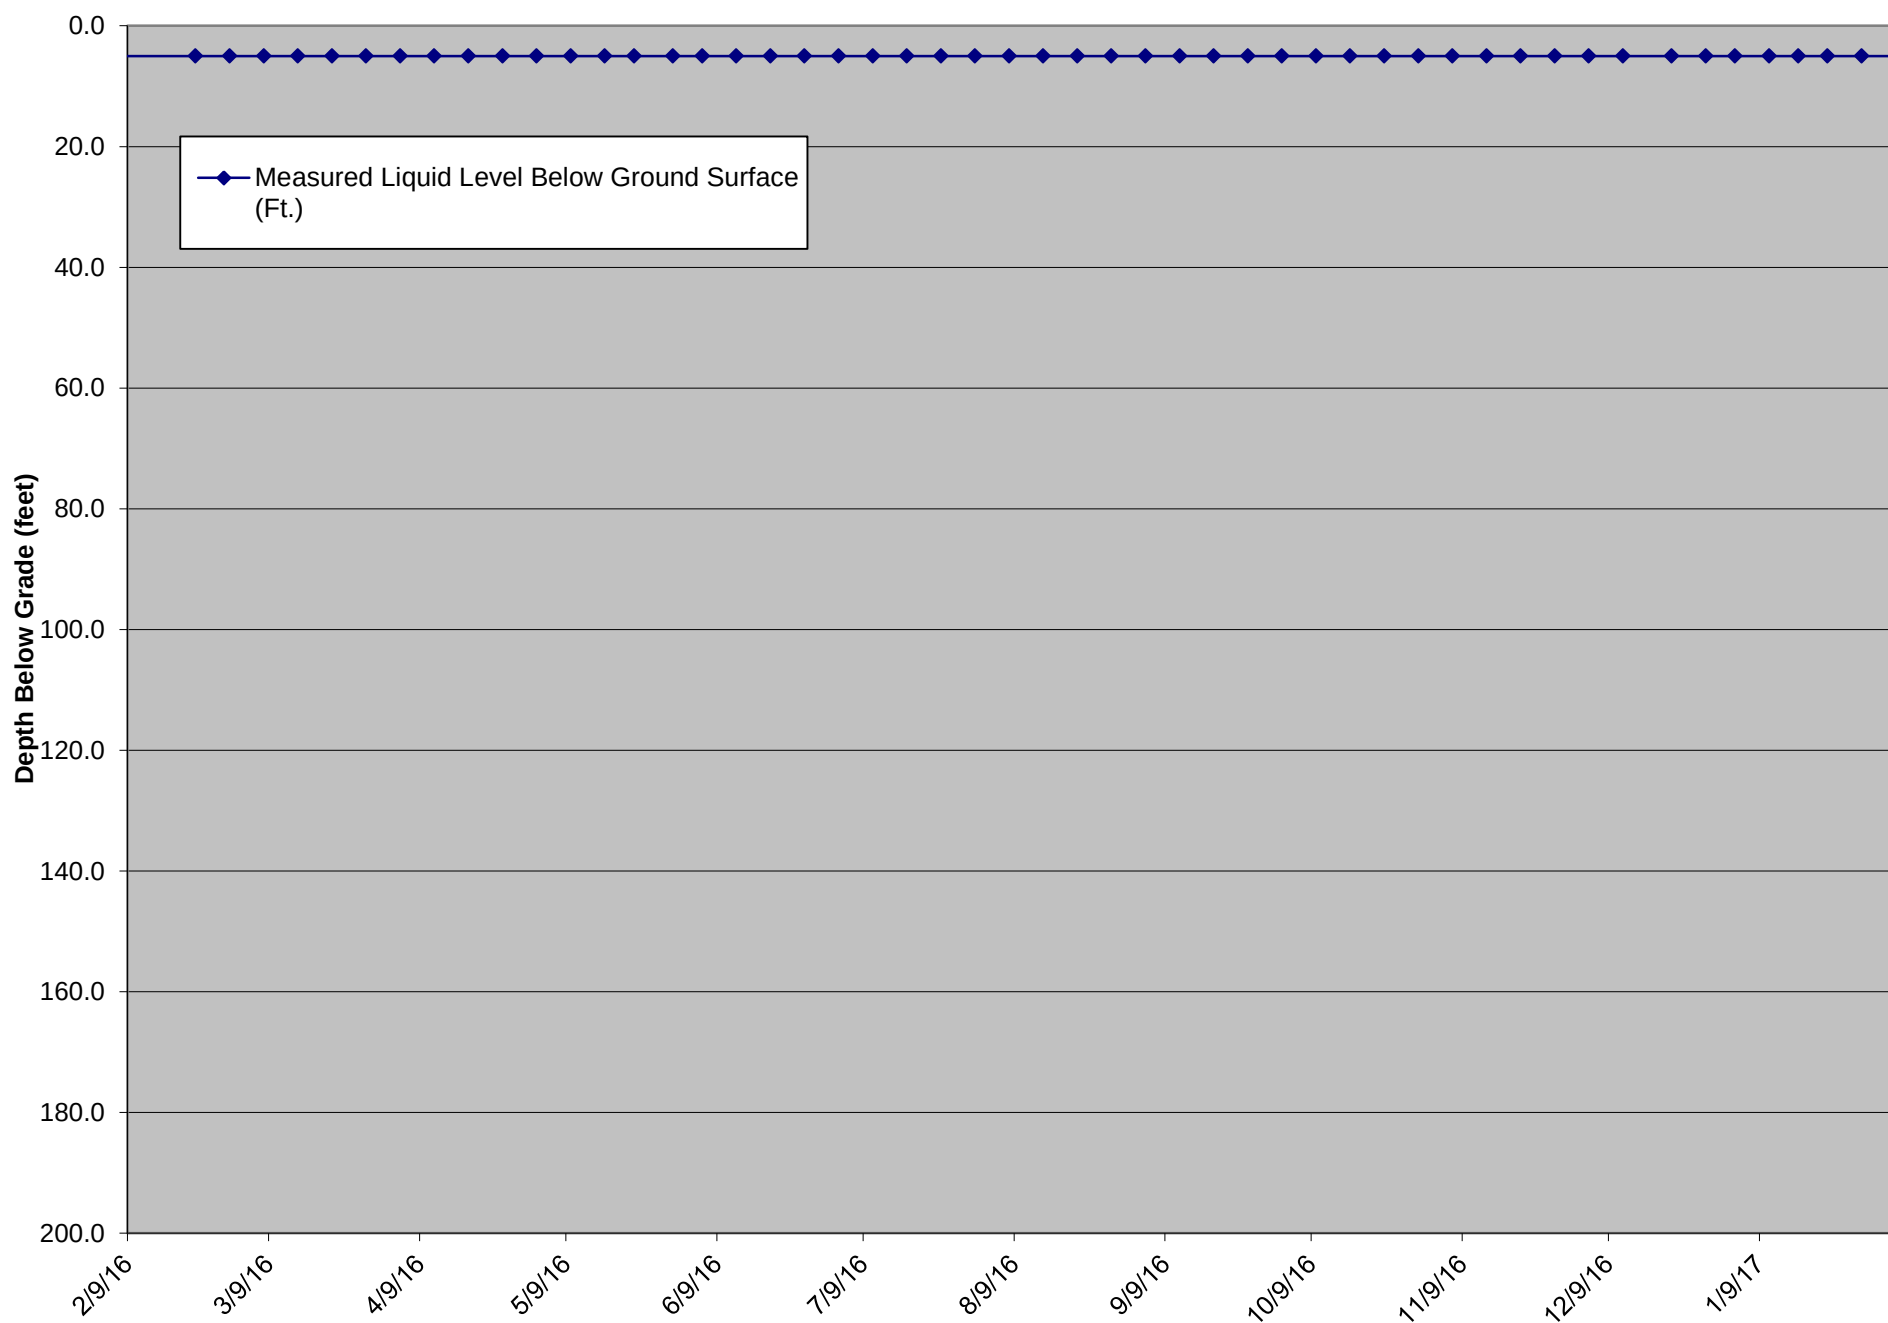
# LCS-3D Liquid Level Below Ground Surface

The pump in LCS-3D was non-operational during the weekly reporting period. The transducer in LCS-3D continued to report liquid levels.

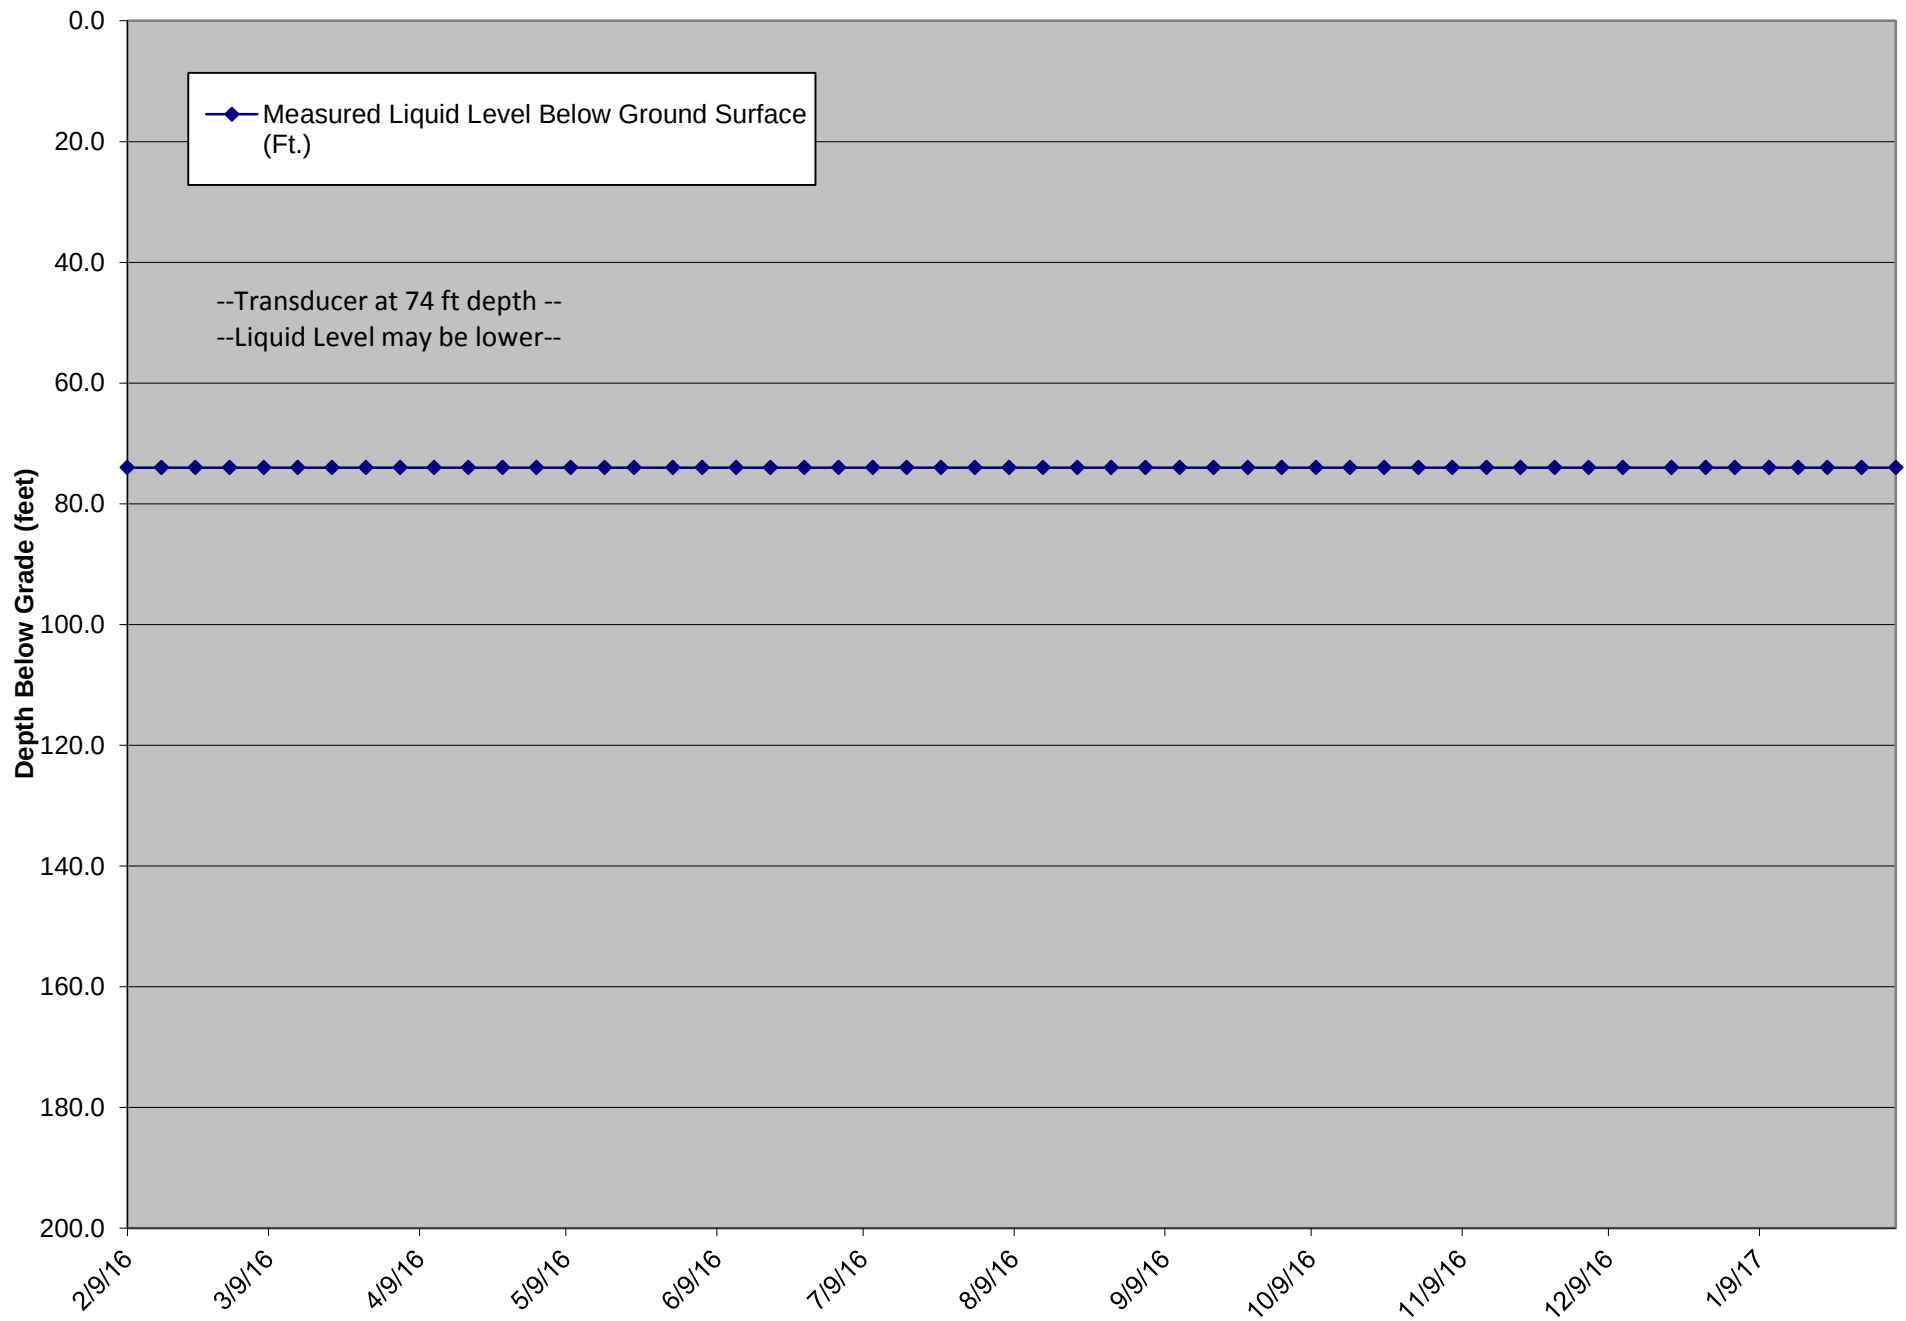
# LCS-4B Liquid Level Below Ground Surface

The level sensor in LCS-4B is currently operational and responsive. Liquid level was not recorded by the level sensor during the weekly reporting period. LCS-4B is equipped with a flow meter that displayed no flow during the weekly reporting period. Therefore, it can be concluded that the liquid level was below the bottom of the pump and level sensor in LCS-4B.

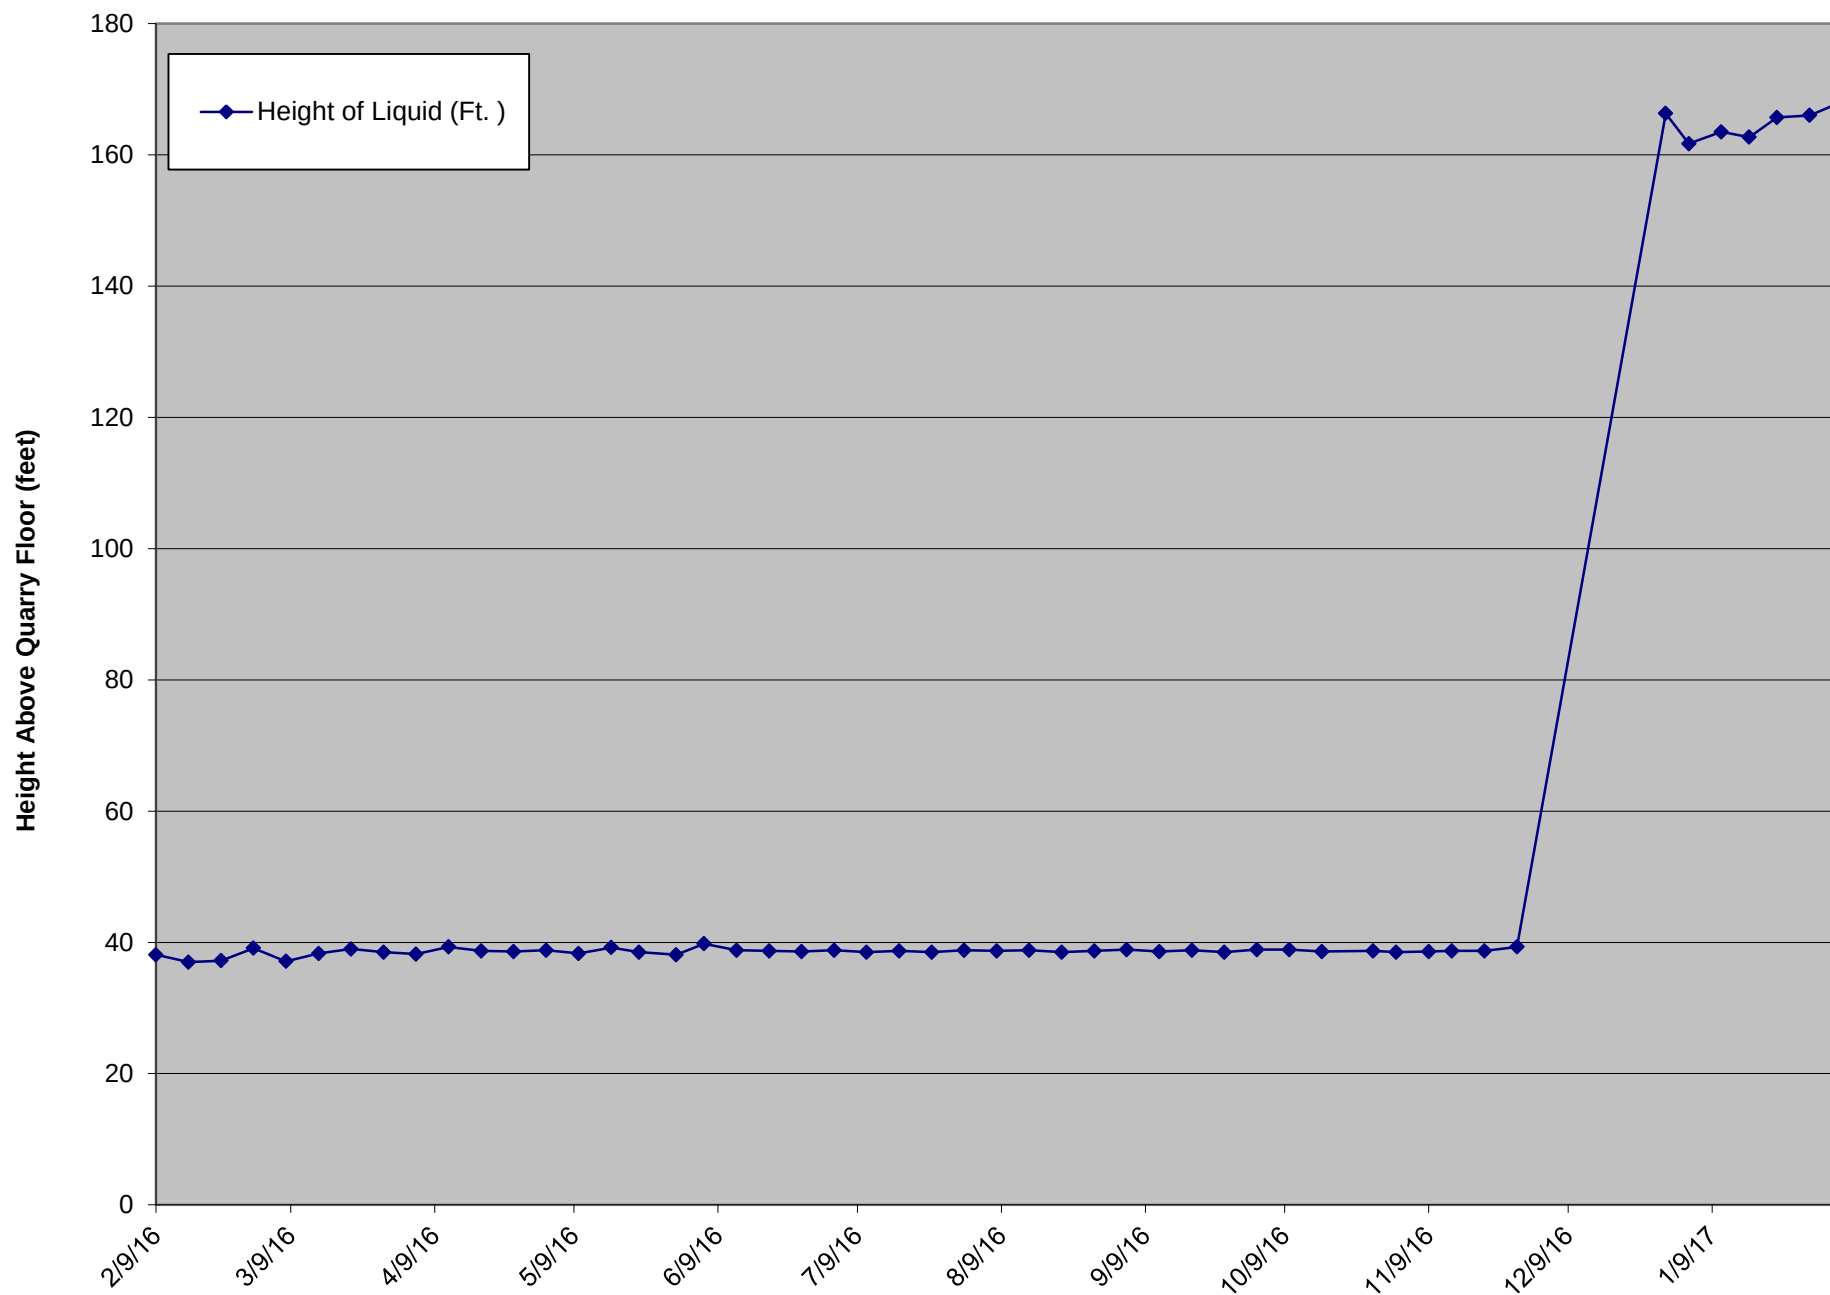
LCS-5A Liquid Level Above Quarry Floor

The pump and level sensor in LCS-5A was replaced and reinstalled the week of 12/26/16. A partial collapse of the sump casing prevented reinstallation of pump and level sensor to the bottom of the sump. The pump and level sensor were set above the partial collapse and are fully operational.

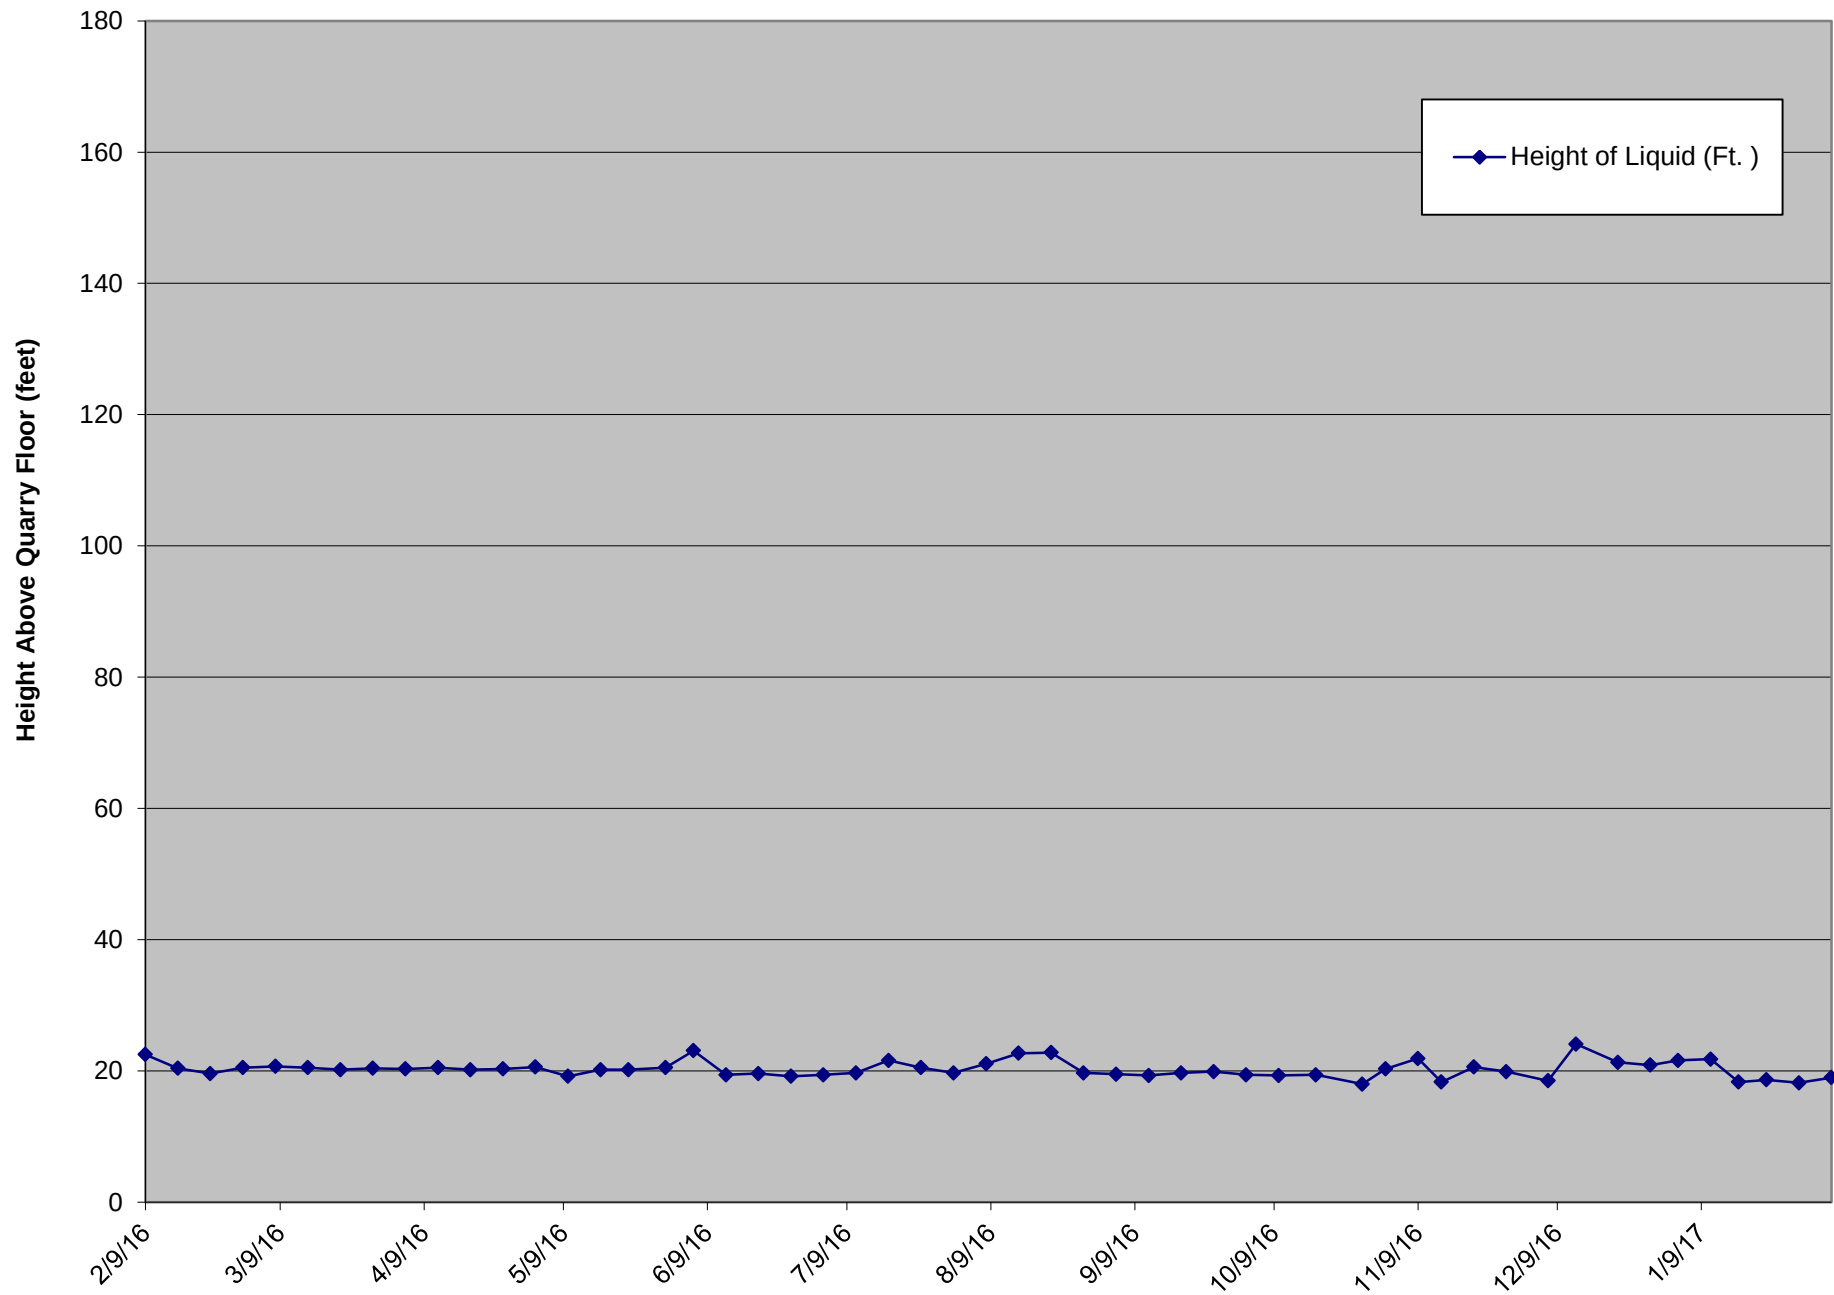
LCS-6B Liquid Level Above Quarry Floor

LCS-6B was fully operational during the weekly reporting period.

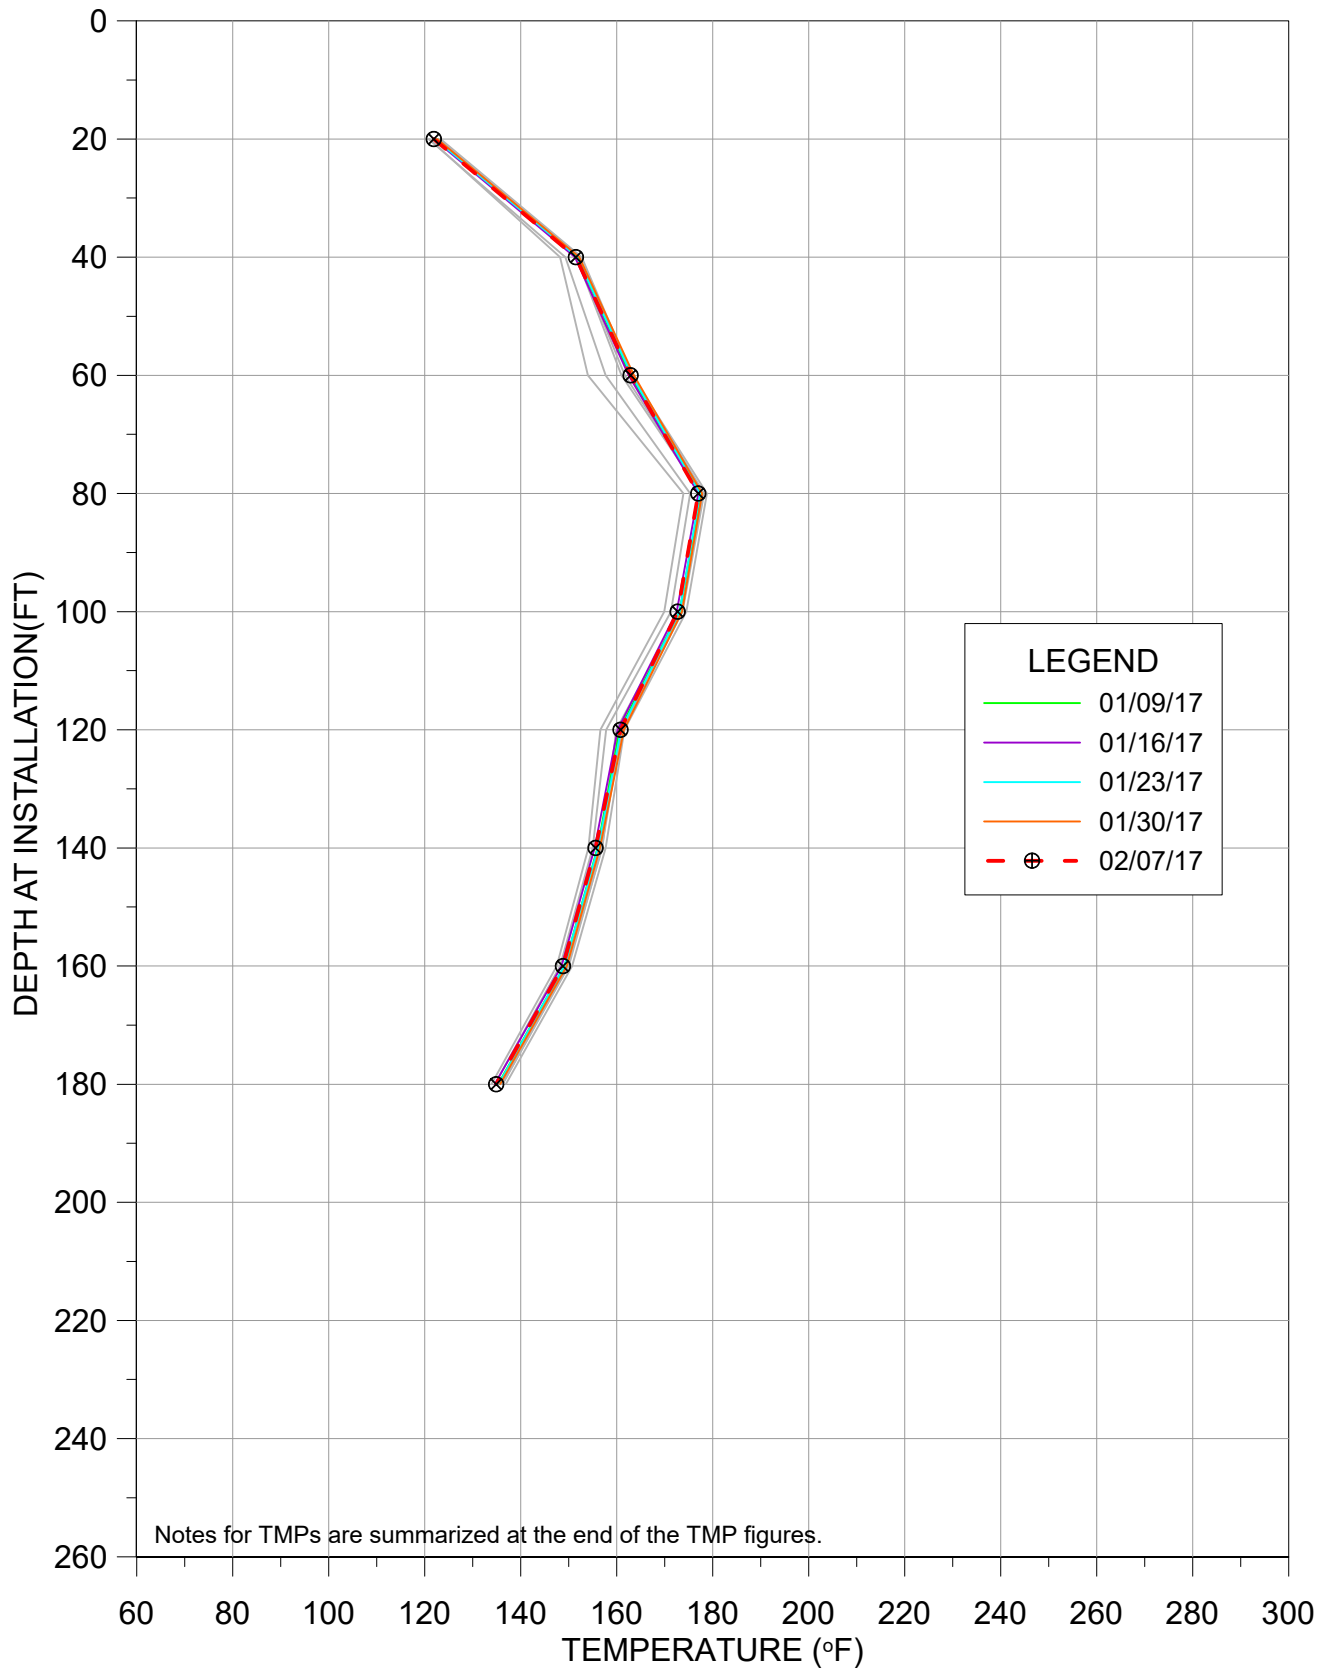
# TMP-2R

1. Data reported on 11/29/2016 was inadvertently left as the 11/22/2016 data. This was corrected on 12/5/2016 reading submittal.

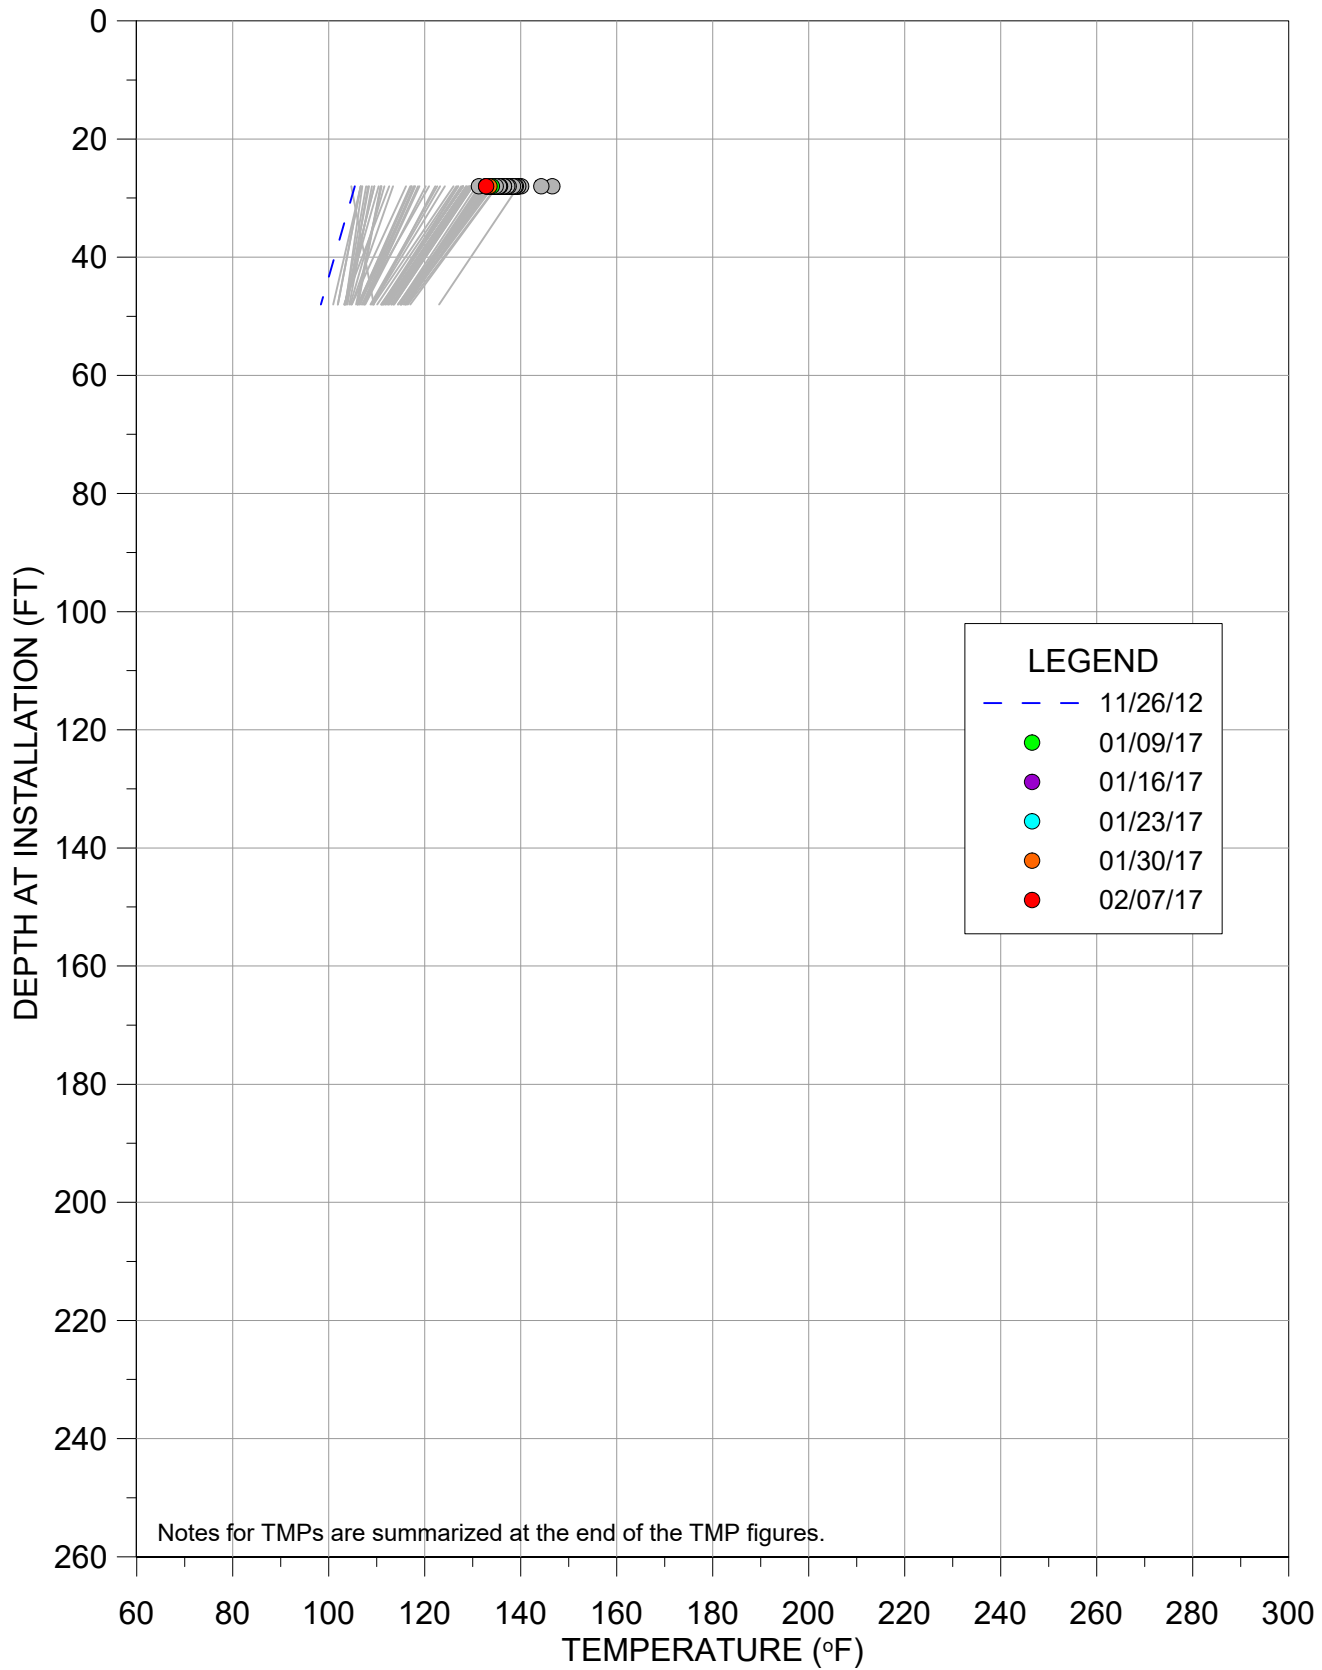
# TMP-4

1. The connectivity tests on 4/11/2014 conducted by CEC showed that the unit at 48 ft depth is no longer reliable.

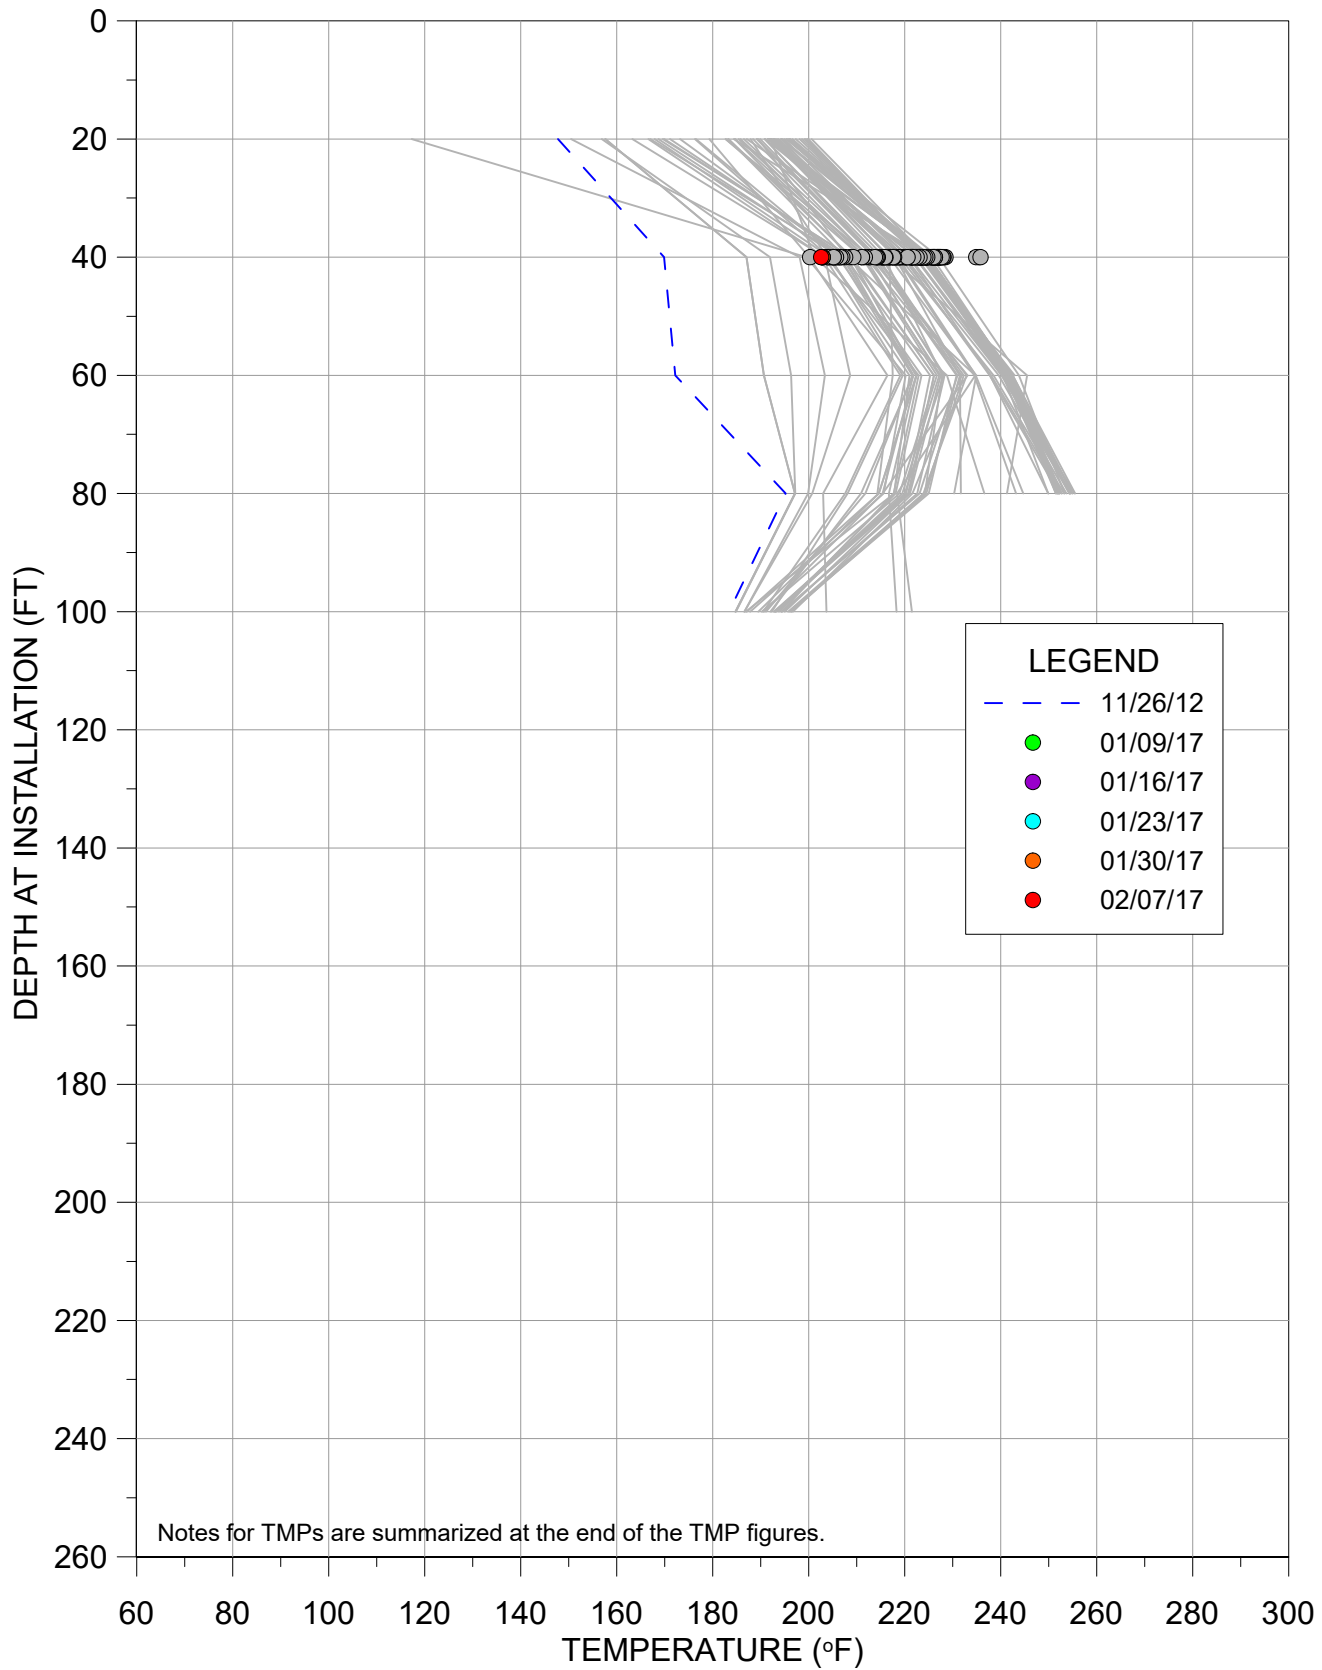
# TMP-9

1. Unit at 100 ft depth had an inaccurate temperature reading on 8/1/2013 and no reading since 8/6/2013.
2. The connectivity tests on 4/11/2014 conducted by CEC showed that units at 20, 60, 80, and 100 ft depths are no longer reliable.

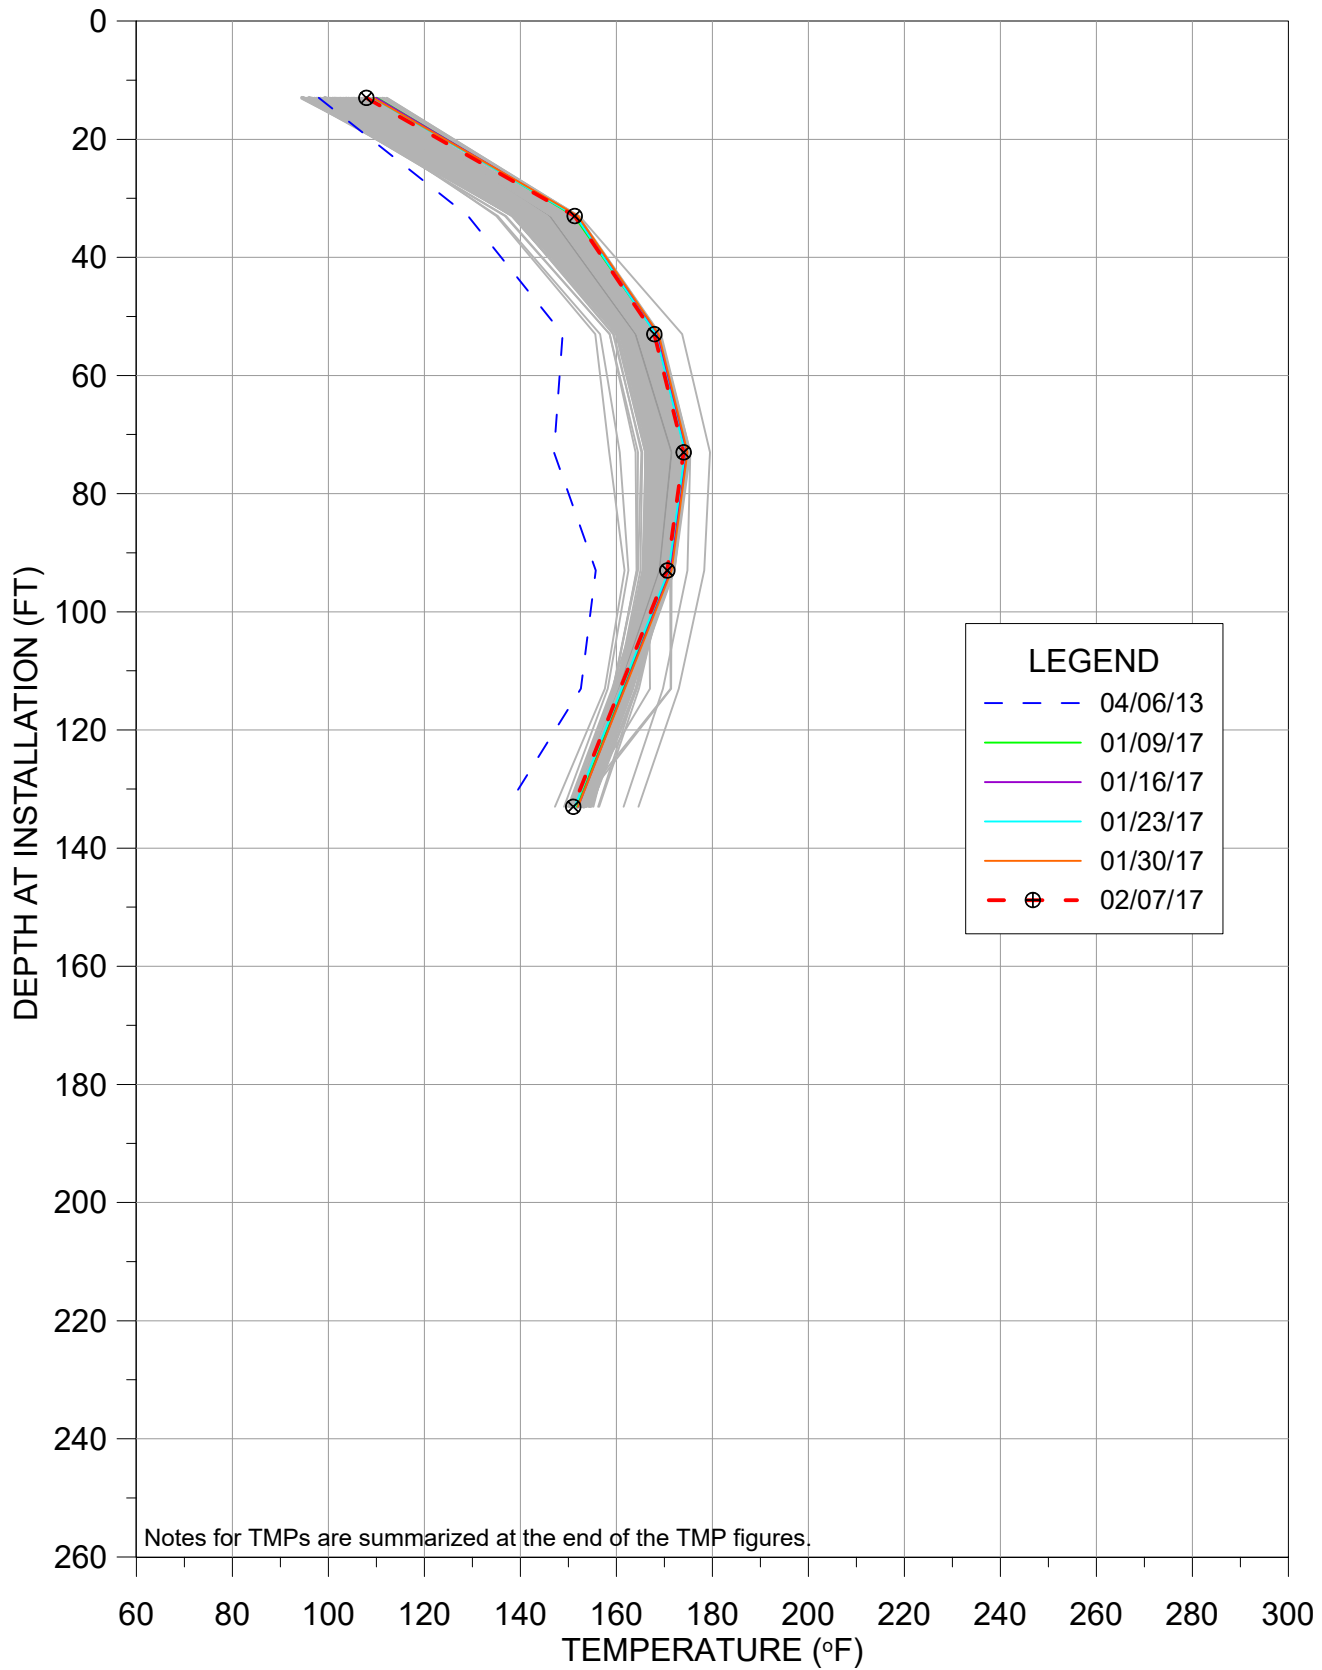
# TMP-10

1. Unit at 113 ft had resistance below the minimum level, change in resistance occurred as of 11/08/16 and has remained below acceptable level.
