# **Bridgeton Landfill, LLC**

## **Weekly Data Submittal**

**Week of February 5, 2017 – February 11, 2017**

**Required by Section 52.F of Agreed Order, Case No. 13SL-CC01088  
Effective May 13, 2013**

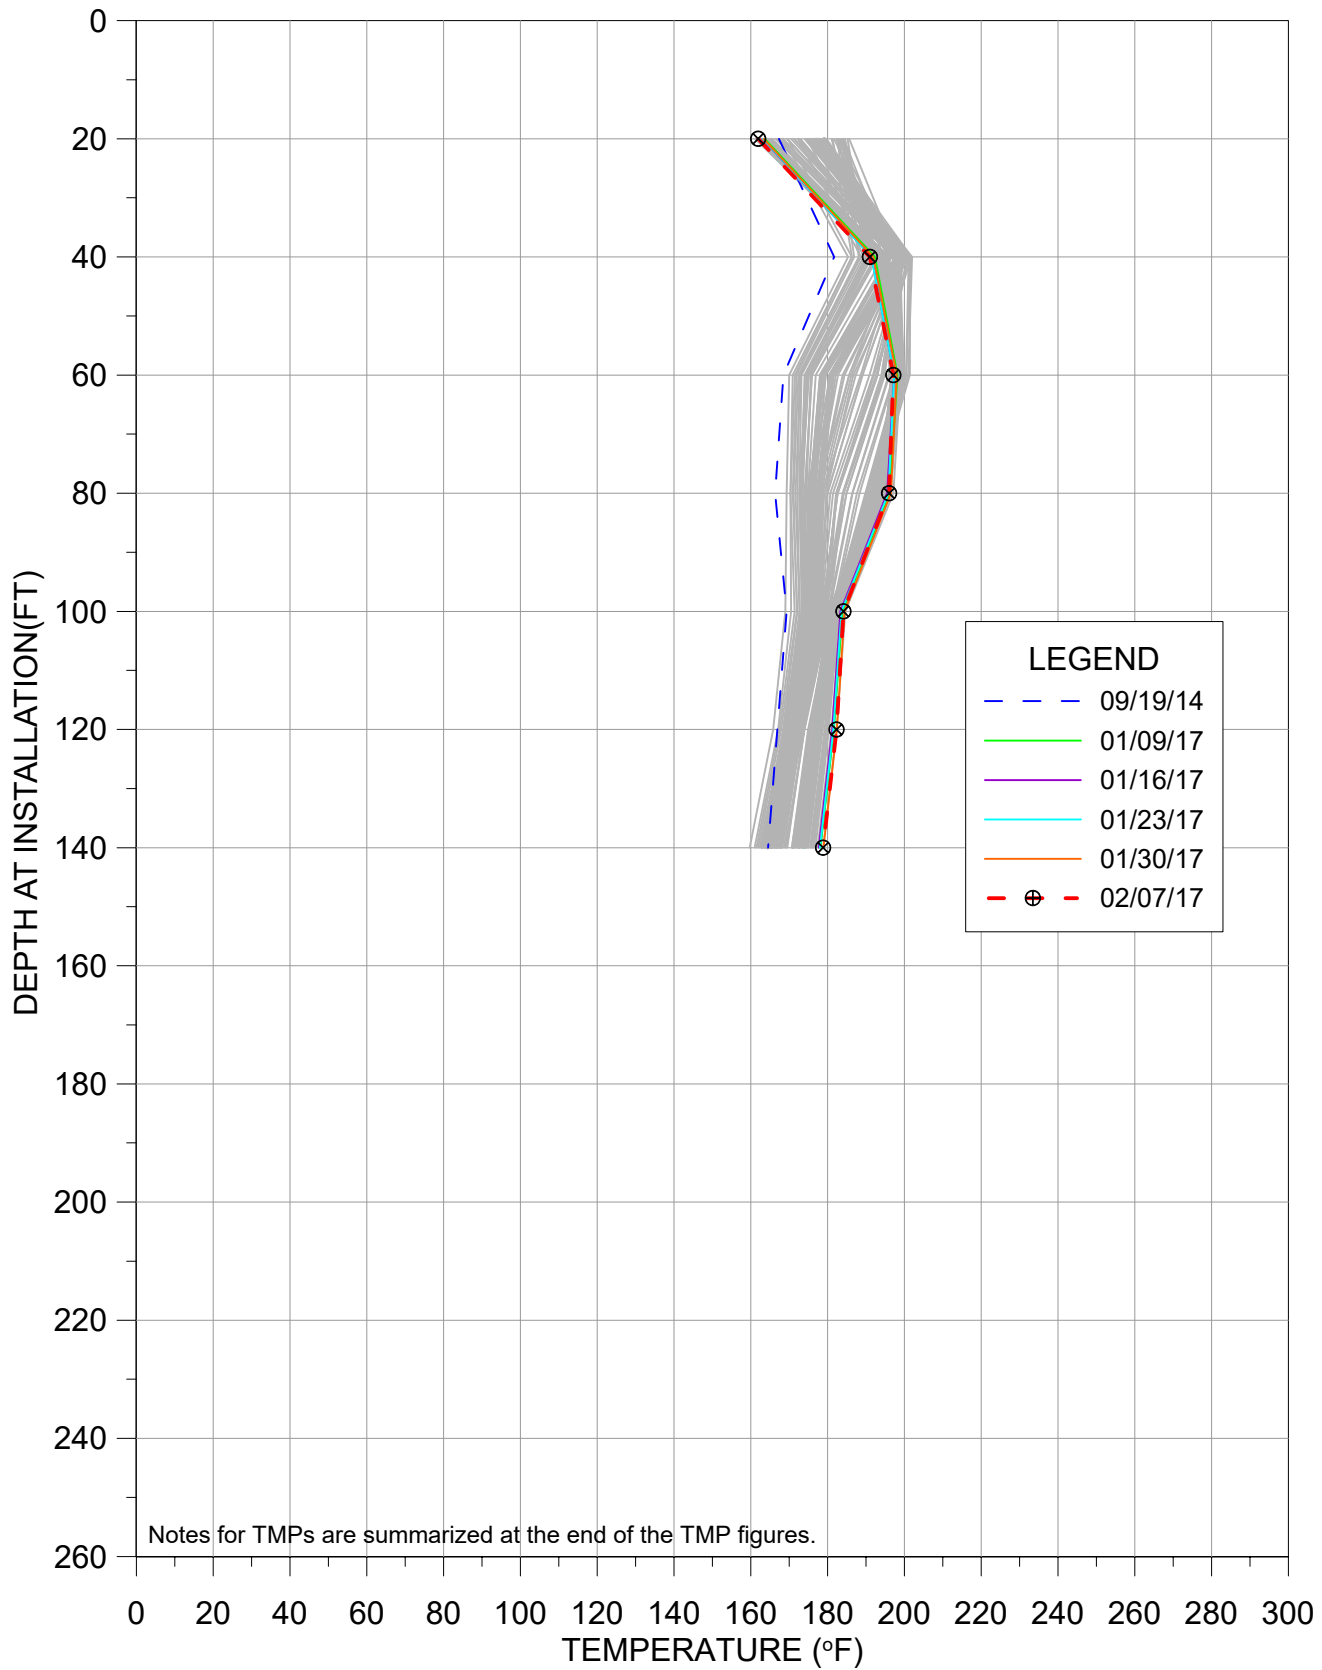
# TMP-14R

1. Due to the connectivity test results by Feezor Engineering on TMP-14 (see note above), TMP-14R is added to this reporting data set as of 3/7/2016.

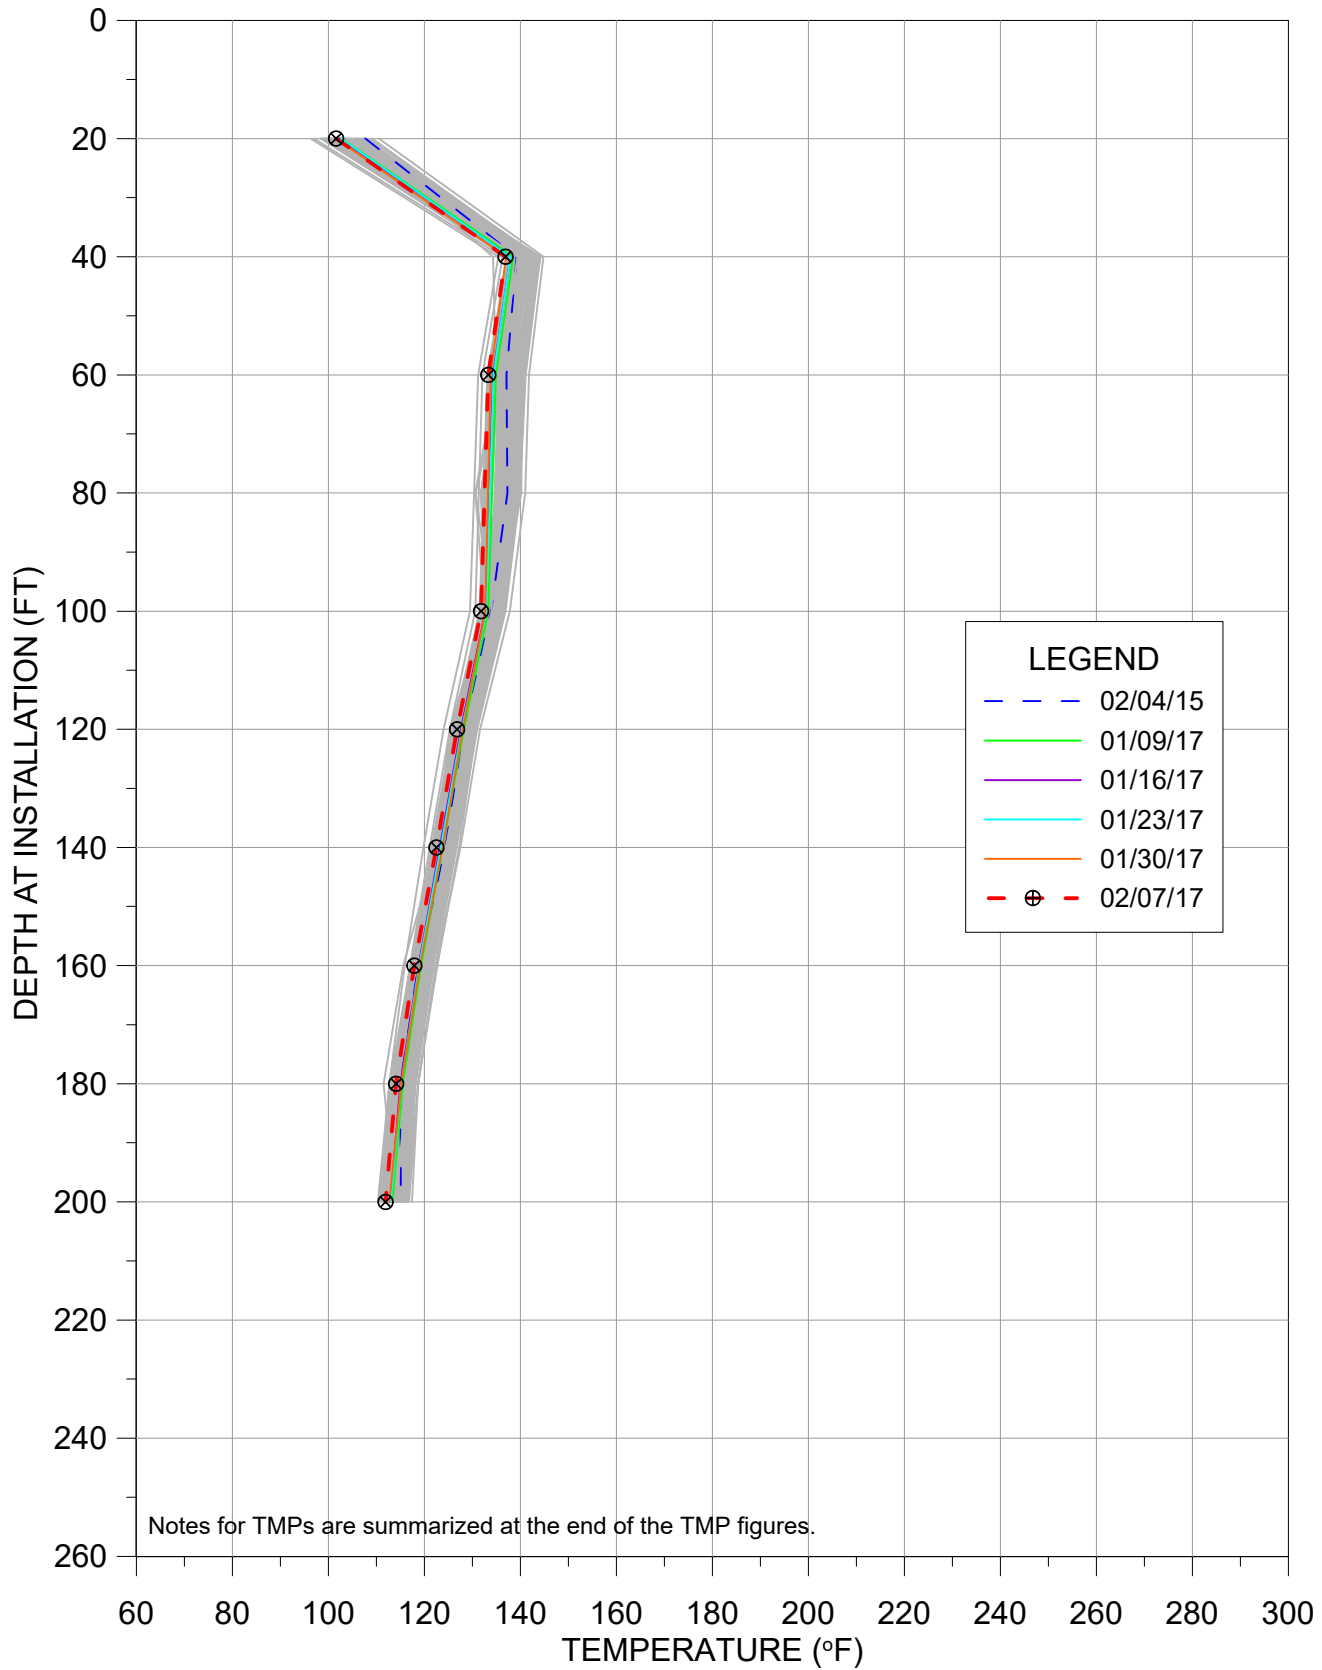
# TMP-28

1. The unit at 217 ft depth has had no resistance or temperature readings since installation.
2. The unit at 80 ft depth had a resistance drop and an unreasonable temperature decrease on 6/1/2016. The temperature has since fluctuated and is determined to be unreliable.

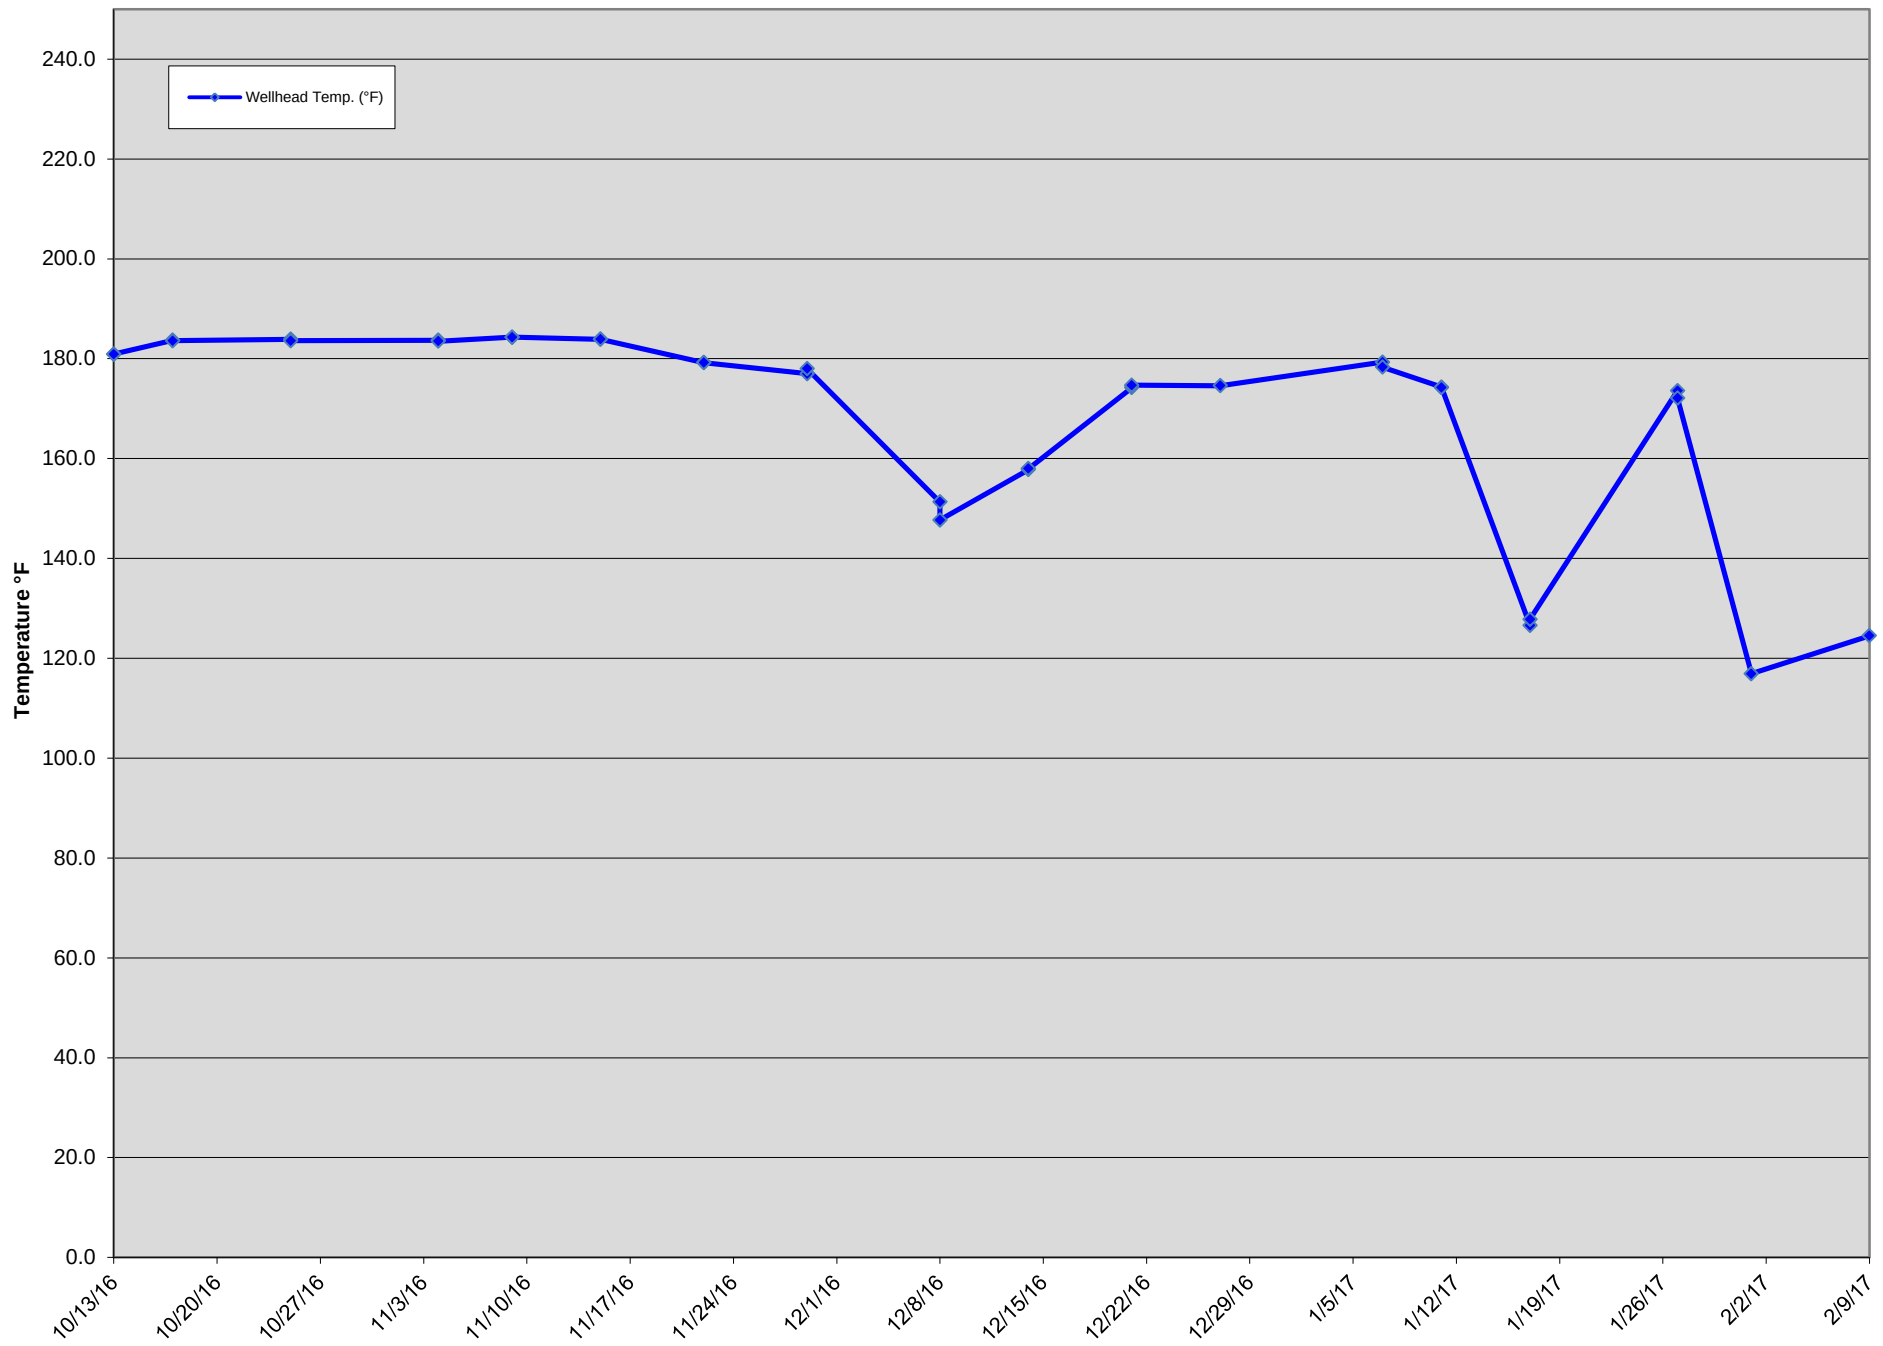
## GIW-1 Wellhead Temperatures

As part of the HES, there are currently cooling water circulation loops installed in twelve Gas Interceptor Wells (GIWs) (GIW-02 through GIW-13). The remaining well (GIW-01) had a measured gas temperature within its historical operating limits.
