# **Bridgeton Landfill, LLC**

## **Weekly Data Submittal**

**Week of March 12, 2017 – March 18, 2017**

**Required by Section 52.F of Agreed Order, Case No. 13SL-CC01088  
Effective May 13, 2013**

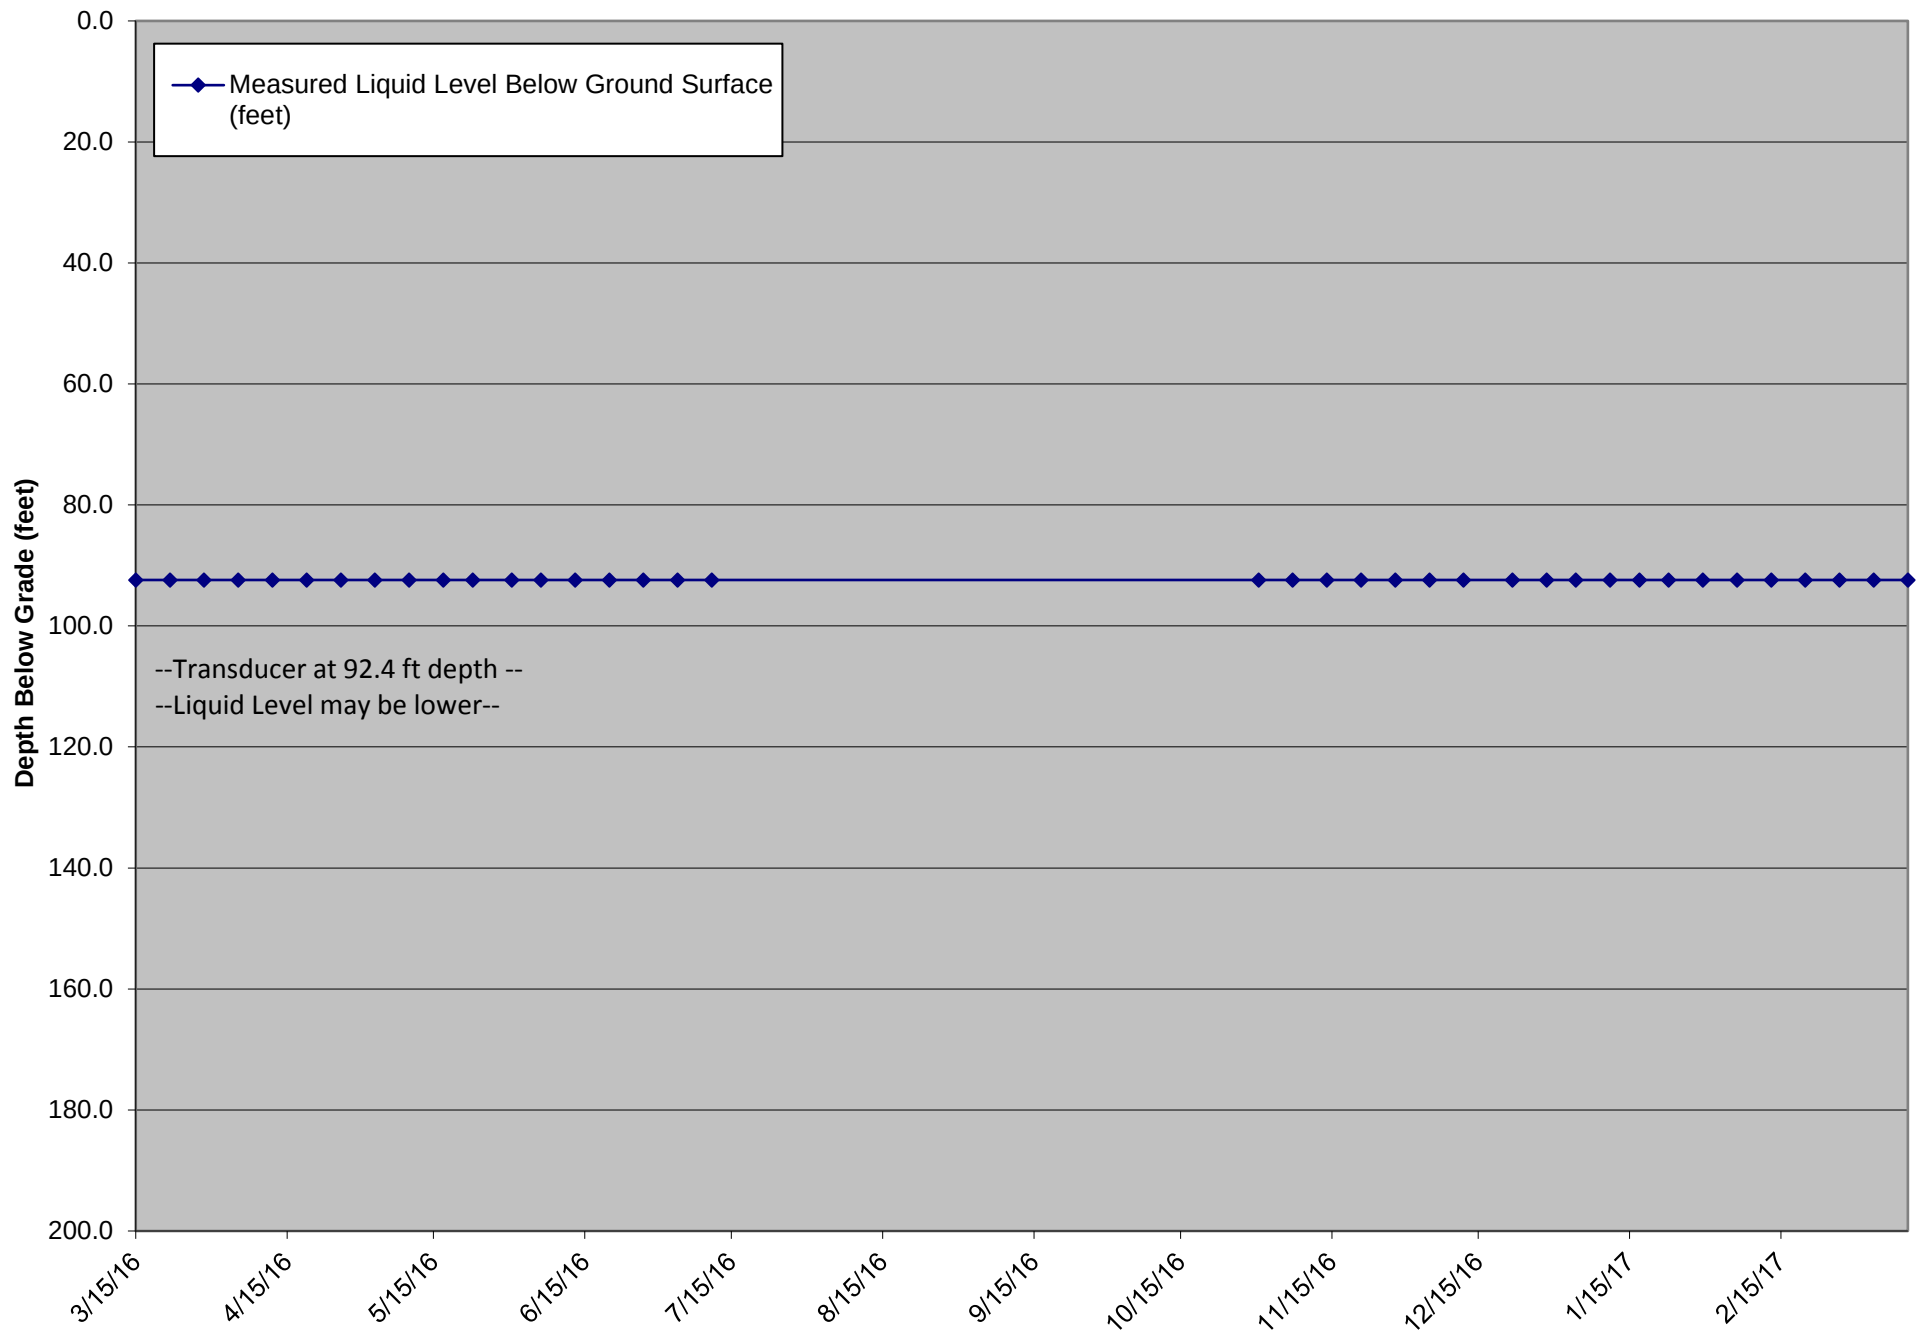
# LCS-1D Liquid Level Below Ground Surface

LCS-1D is equipped with a level sensor and a flow meter. Bridgeton Landfill confirmed that the flow meter on LCS-1D is operational and the flow was observed during the weekly reporting period. Liquid level was not recorded by the level sensor during the weekly reporting period. Bridgeton Landfill is currently looking into replacing the level sensor on LCS-1D.

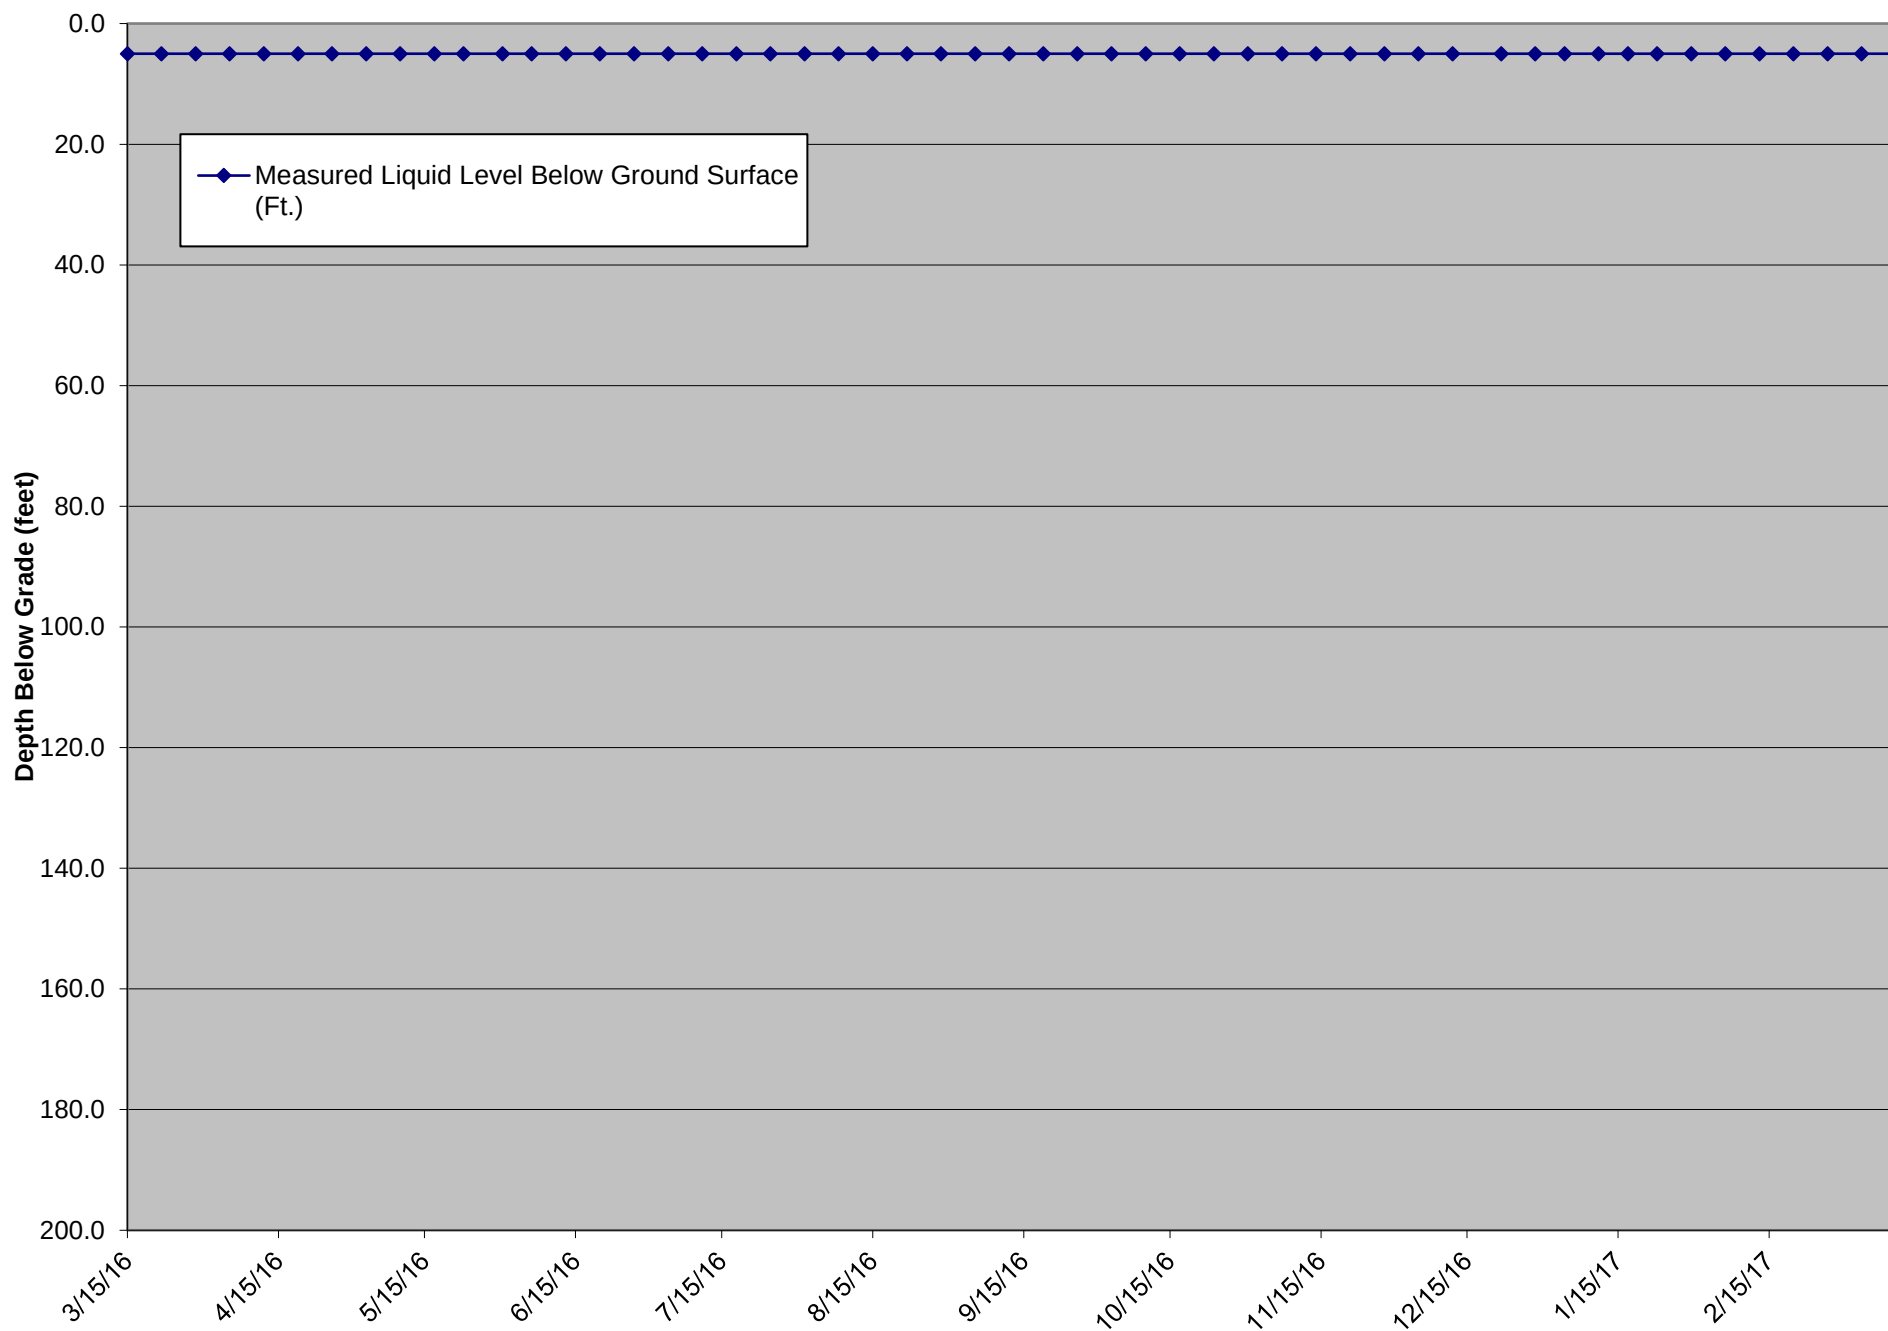
### LCS-3D Liquid Level Below Ground Surface

The pump in LCS-3D was non-operational during the weekly reporting period. The transducer in LCS-3D continued to report liquid levels.

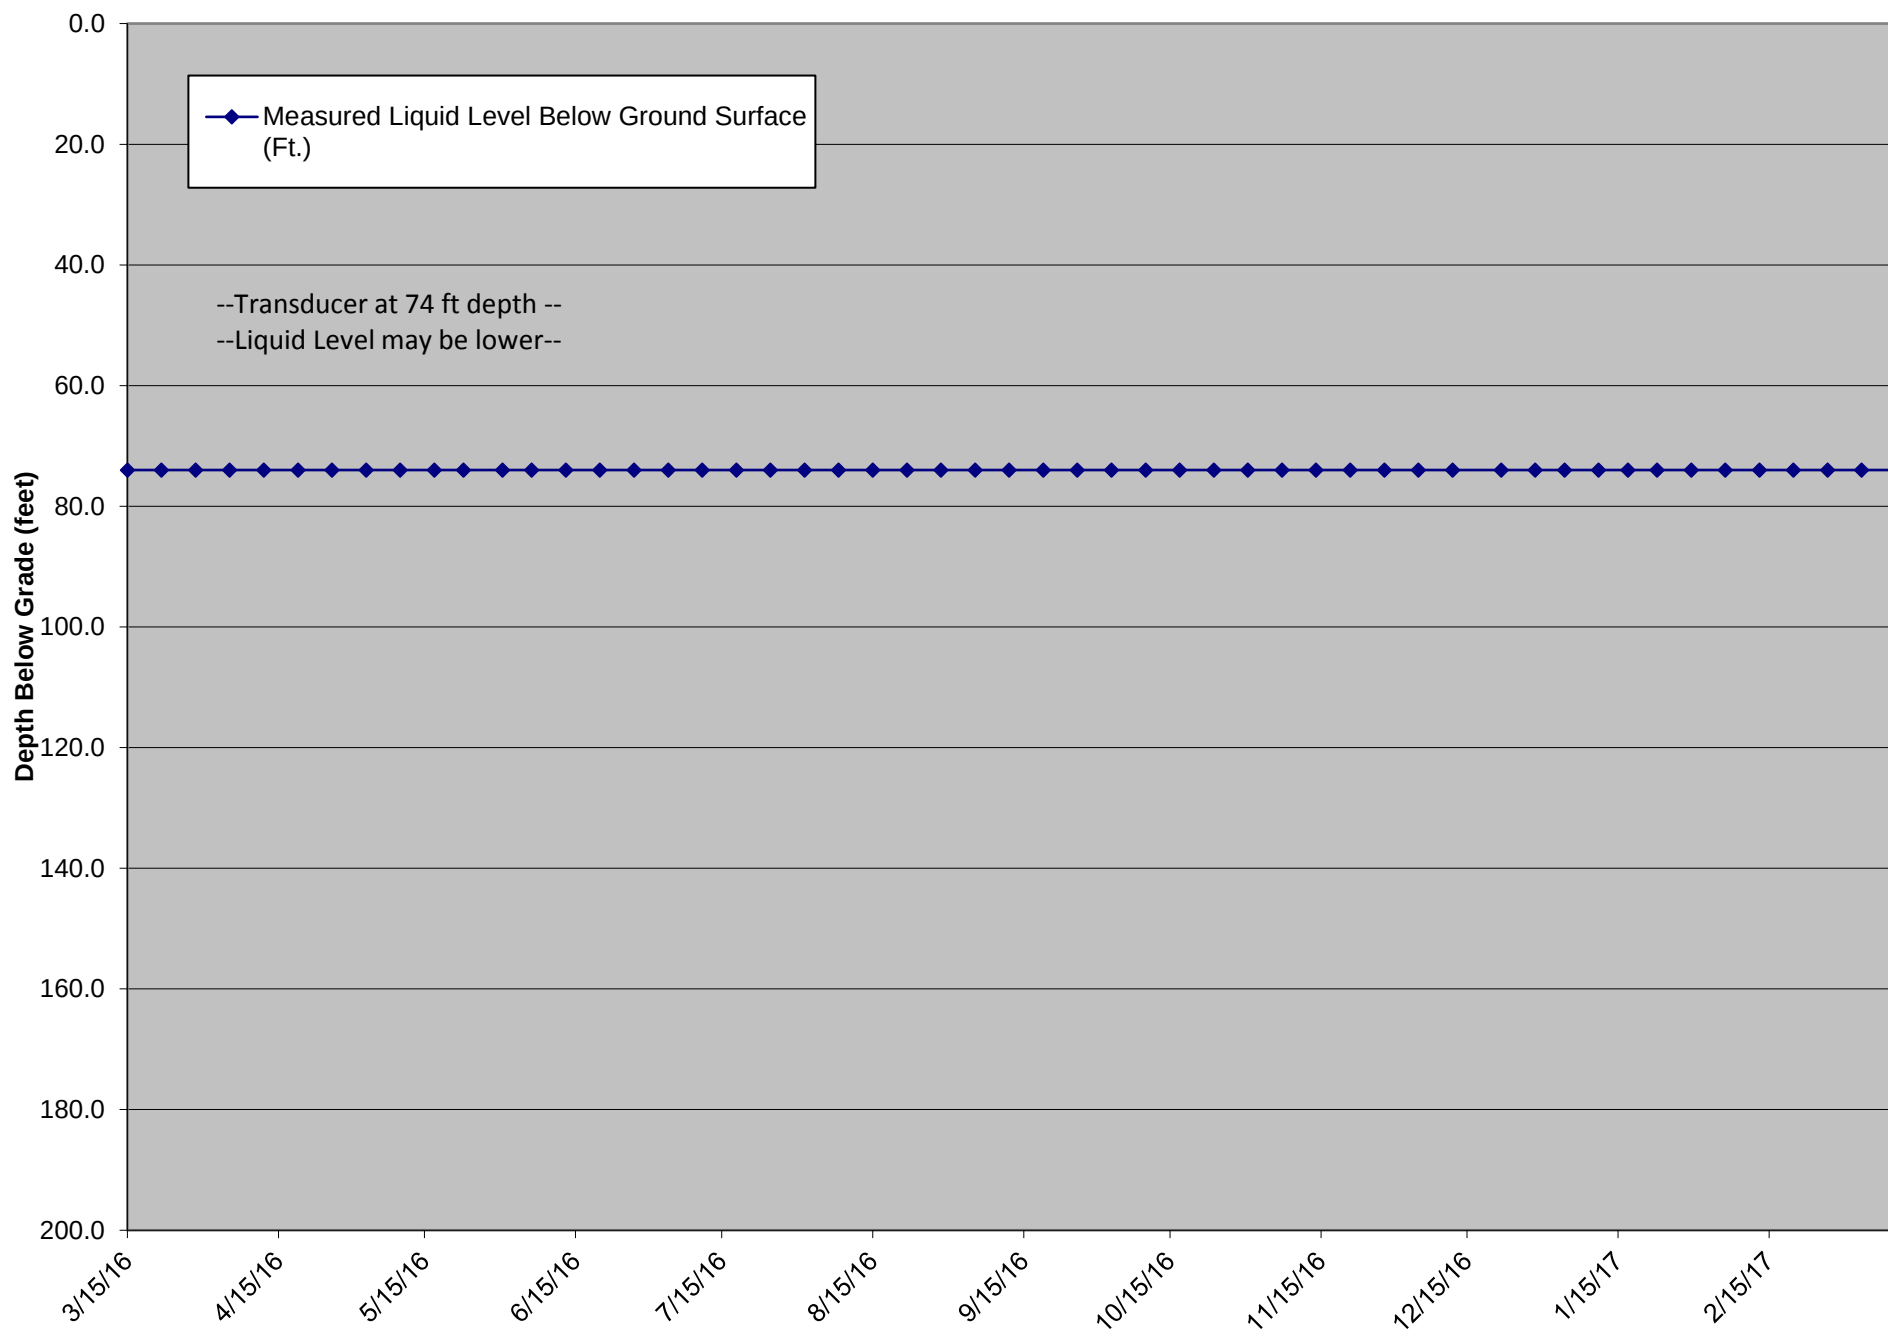
# LCS-4B Liquid Level Below Ground Surface

The level sensor in LCS-4B is currently operational and responsive. Liquid level was not recorded by the level sensor during the weekly reporting period. LCS-4B is equipped with a flow meter that displayed no flow during the weekly reporting period. Therefore, it can be concluded that the liquid level was below the bottom of the pump and level sensor in LCS-4B.

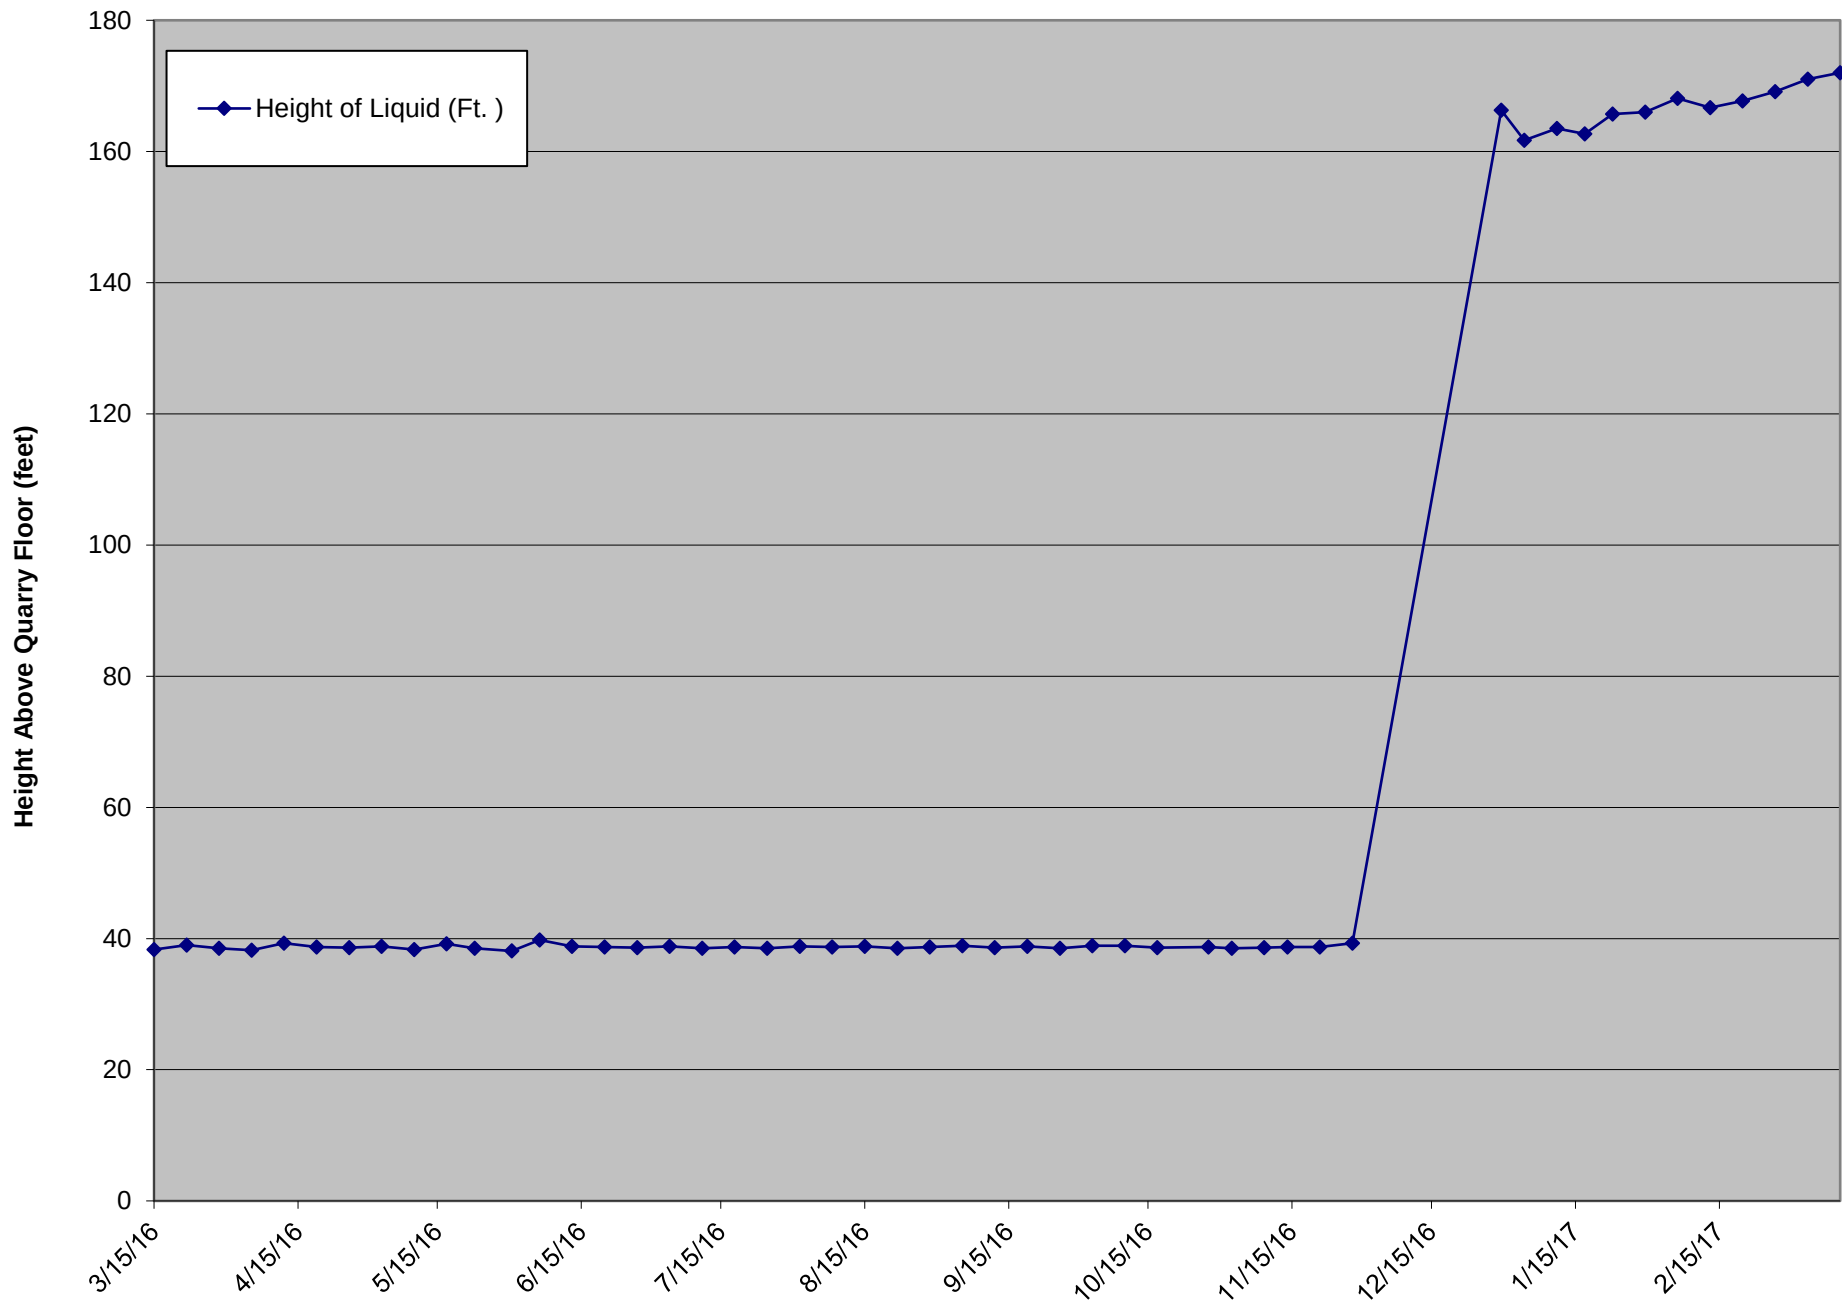
LCS-5A Liquid Level Above Quarry Floor

The pump and level sensor in LCS-5A was replaced and reinstalled the week of 12/26/16. A partial collapse of the sump casing prevented reinstallation of pump and level sensor to the bottom of the sump. The pump and level sensor were set above the partial collapse and are fully operational. LCS-5B has been drilled and installed. A pump and level sensor has been installed in LCS-5B and tuning of the pump and transducer is ongoing. Starting next week LCS-5B will replace LCS-5A as a compliance point.

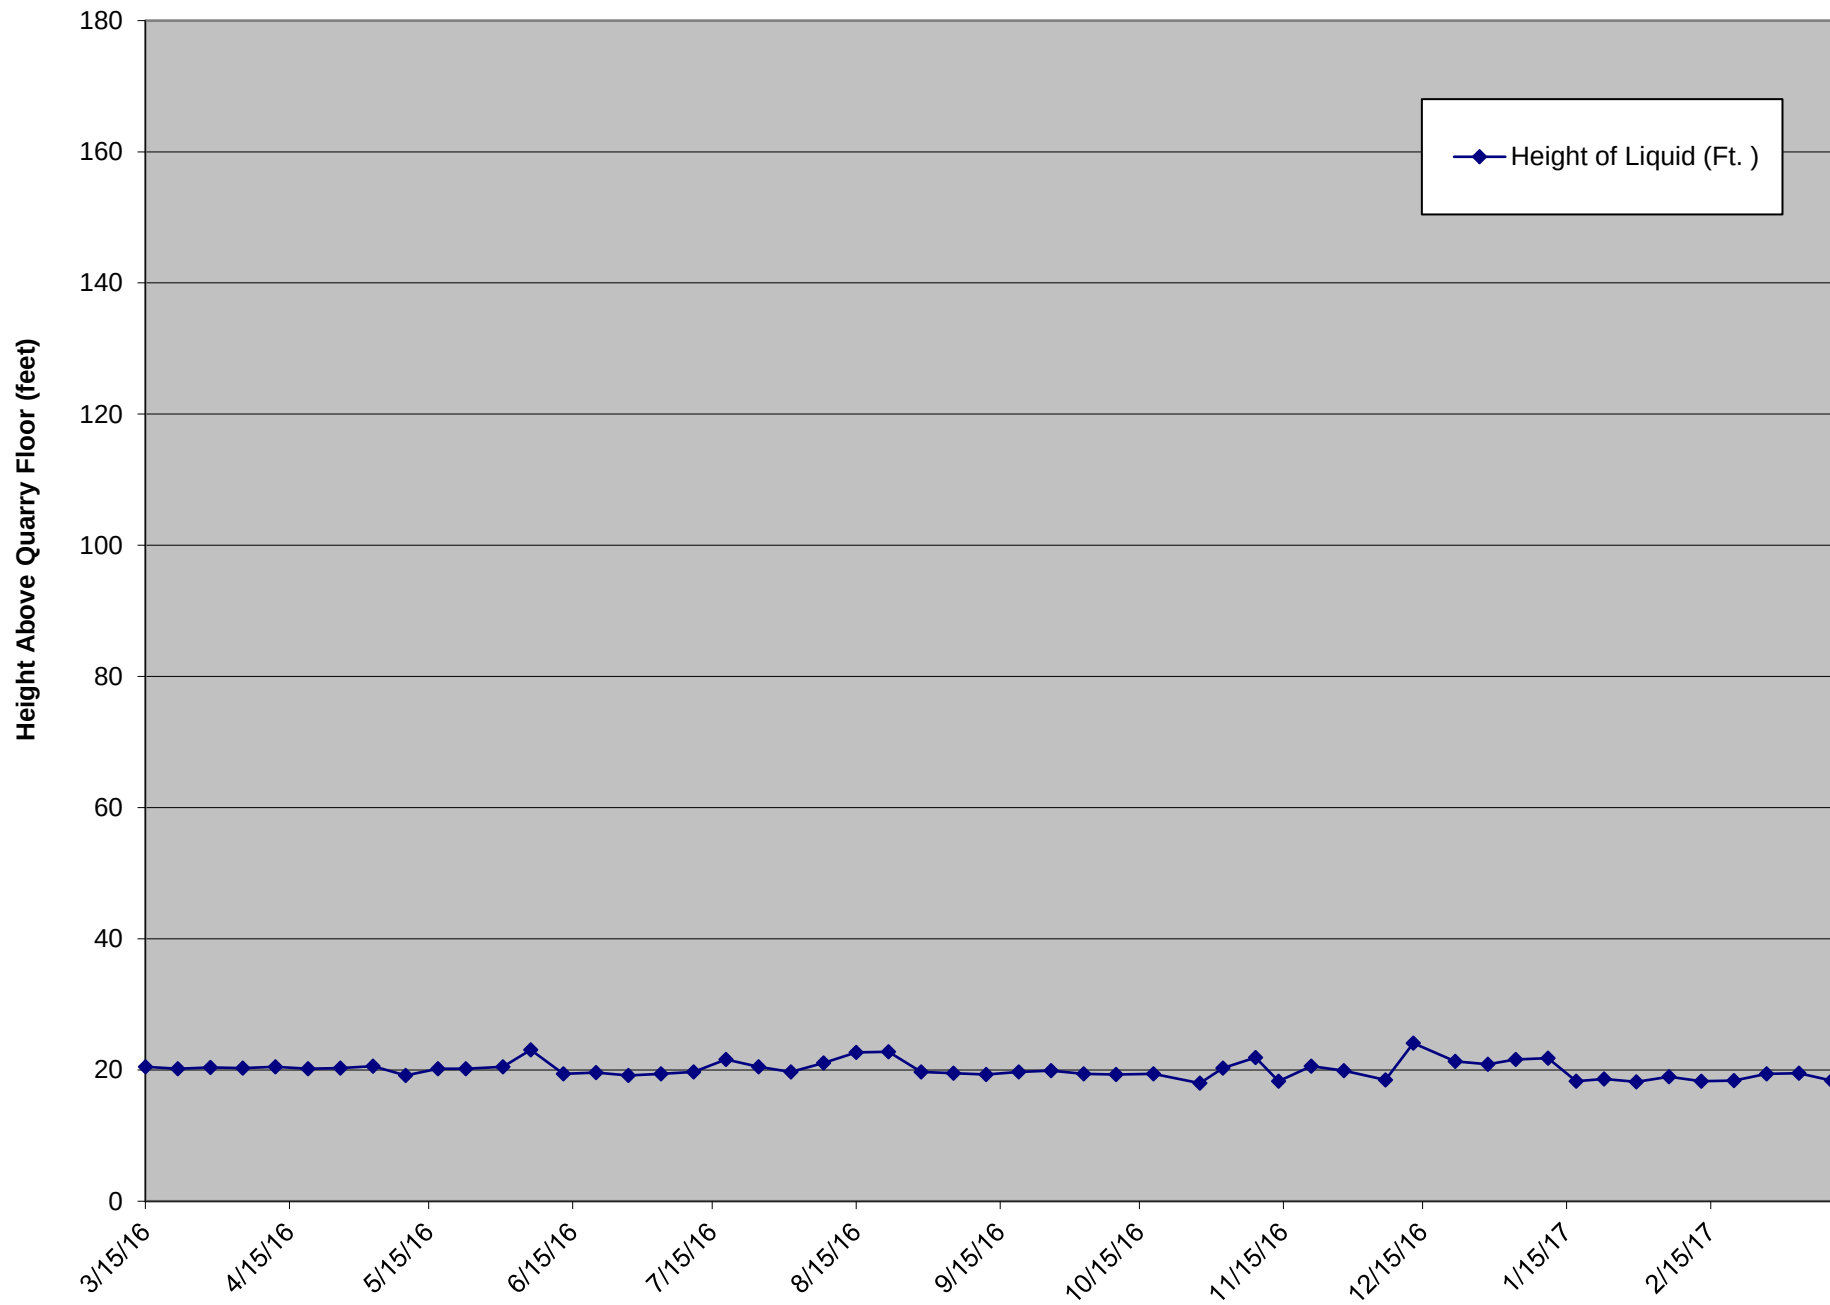
LCS-6B Liquid Level Above Quarry Floor

LCS-6B was fully operational during the weekly reporting period.

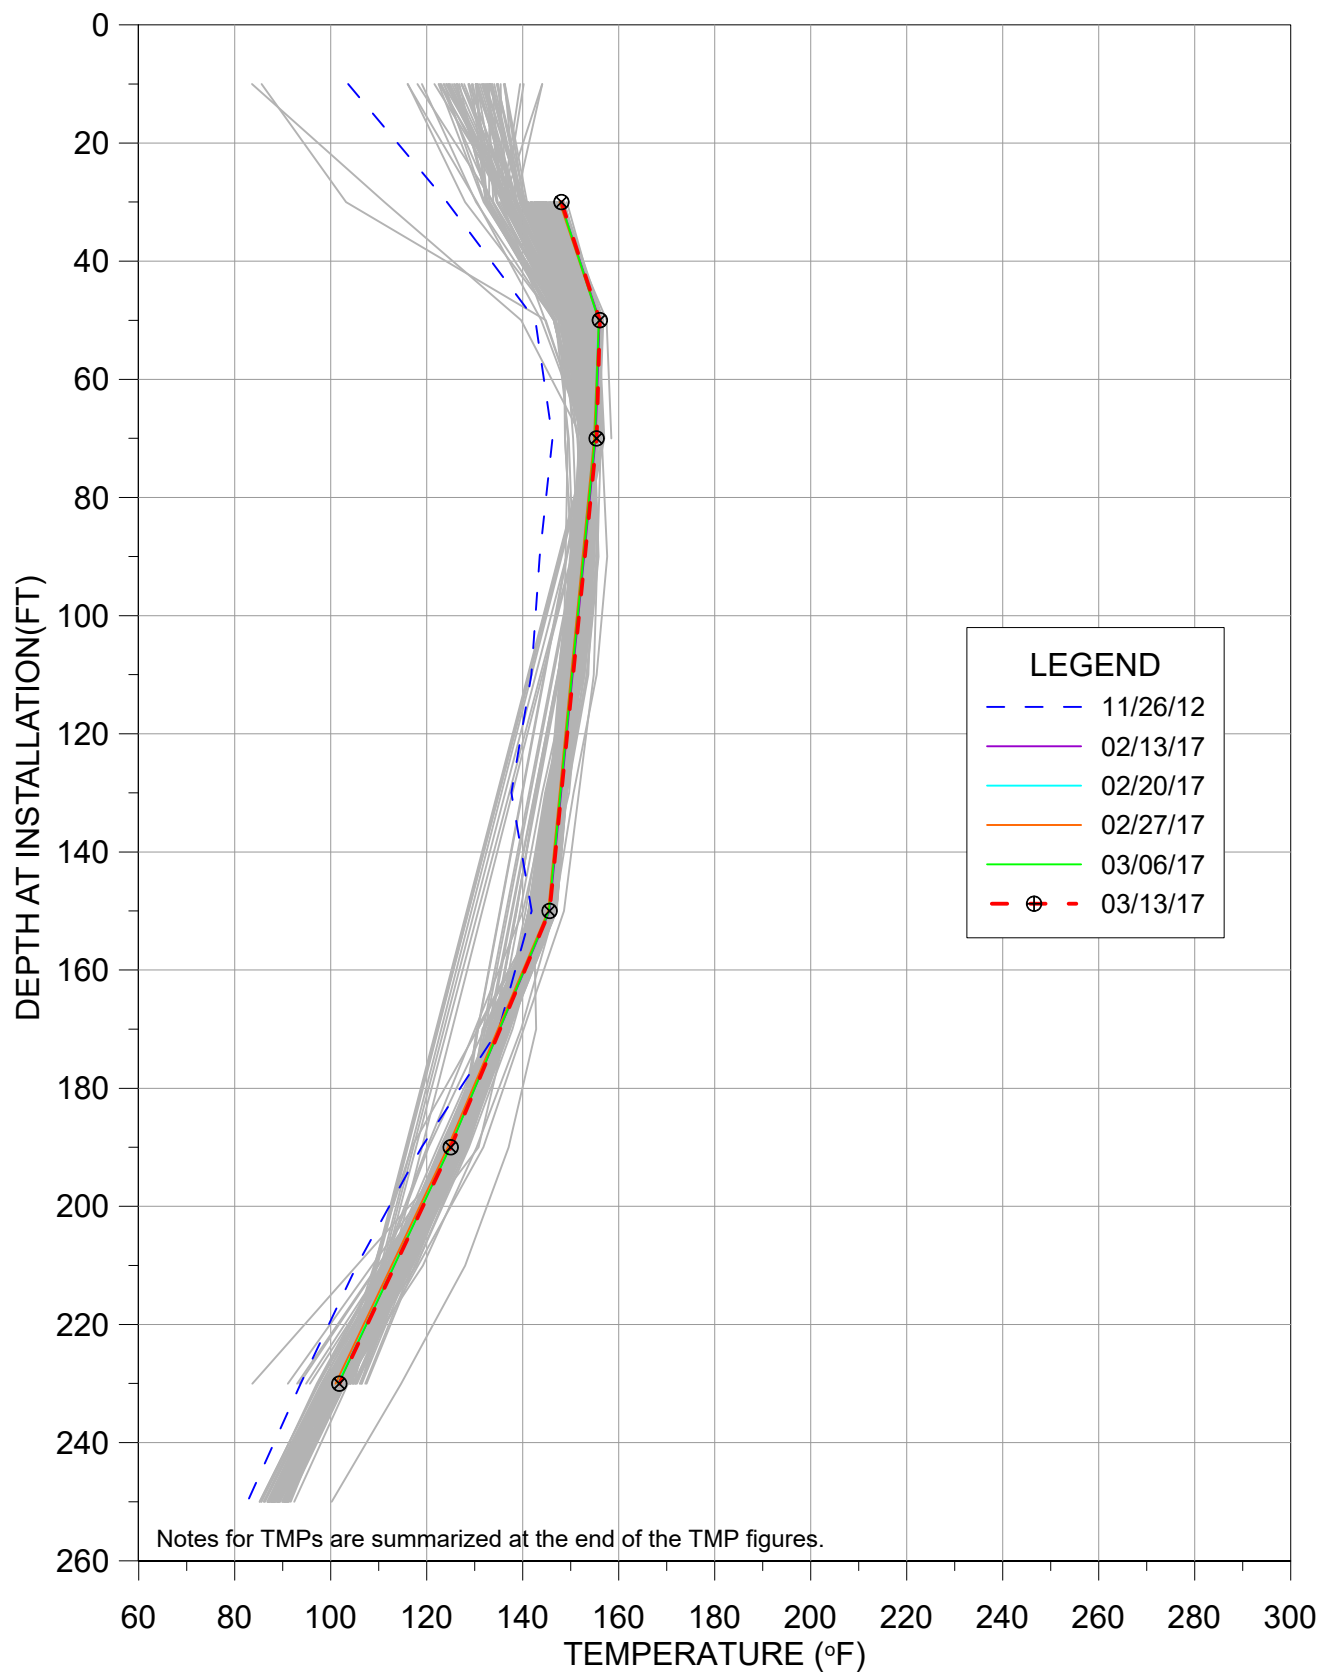
# TMP-3

1. No reliable temperature readings have been obtained at 170 ft depth since 1/29/2014, except on 3/13/2014.
2. The connectivity tests on 4/11/2014 conducted by CEC showed that units at 10, 90, 130, 210 and 250 ft depths are no longer reliable.
3. The connectivity tests on 10/28/2014 conducted by Feezor Engineering showed that units at 10, 90, 110, 130, 210 and 250 ft depths are not reliable.

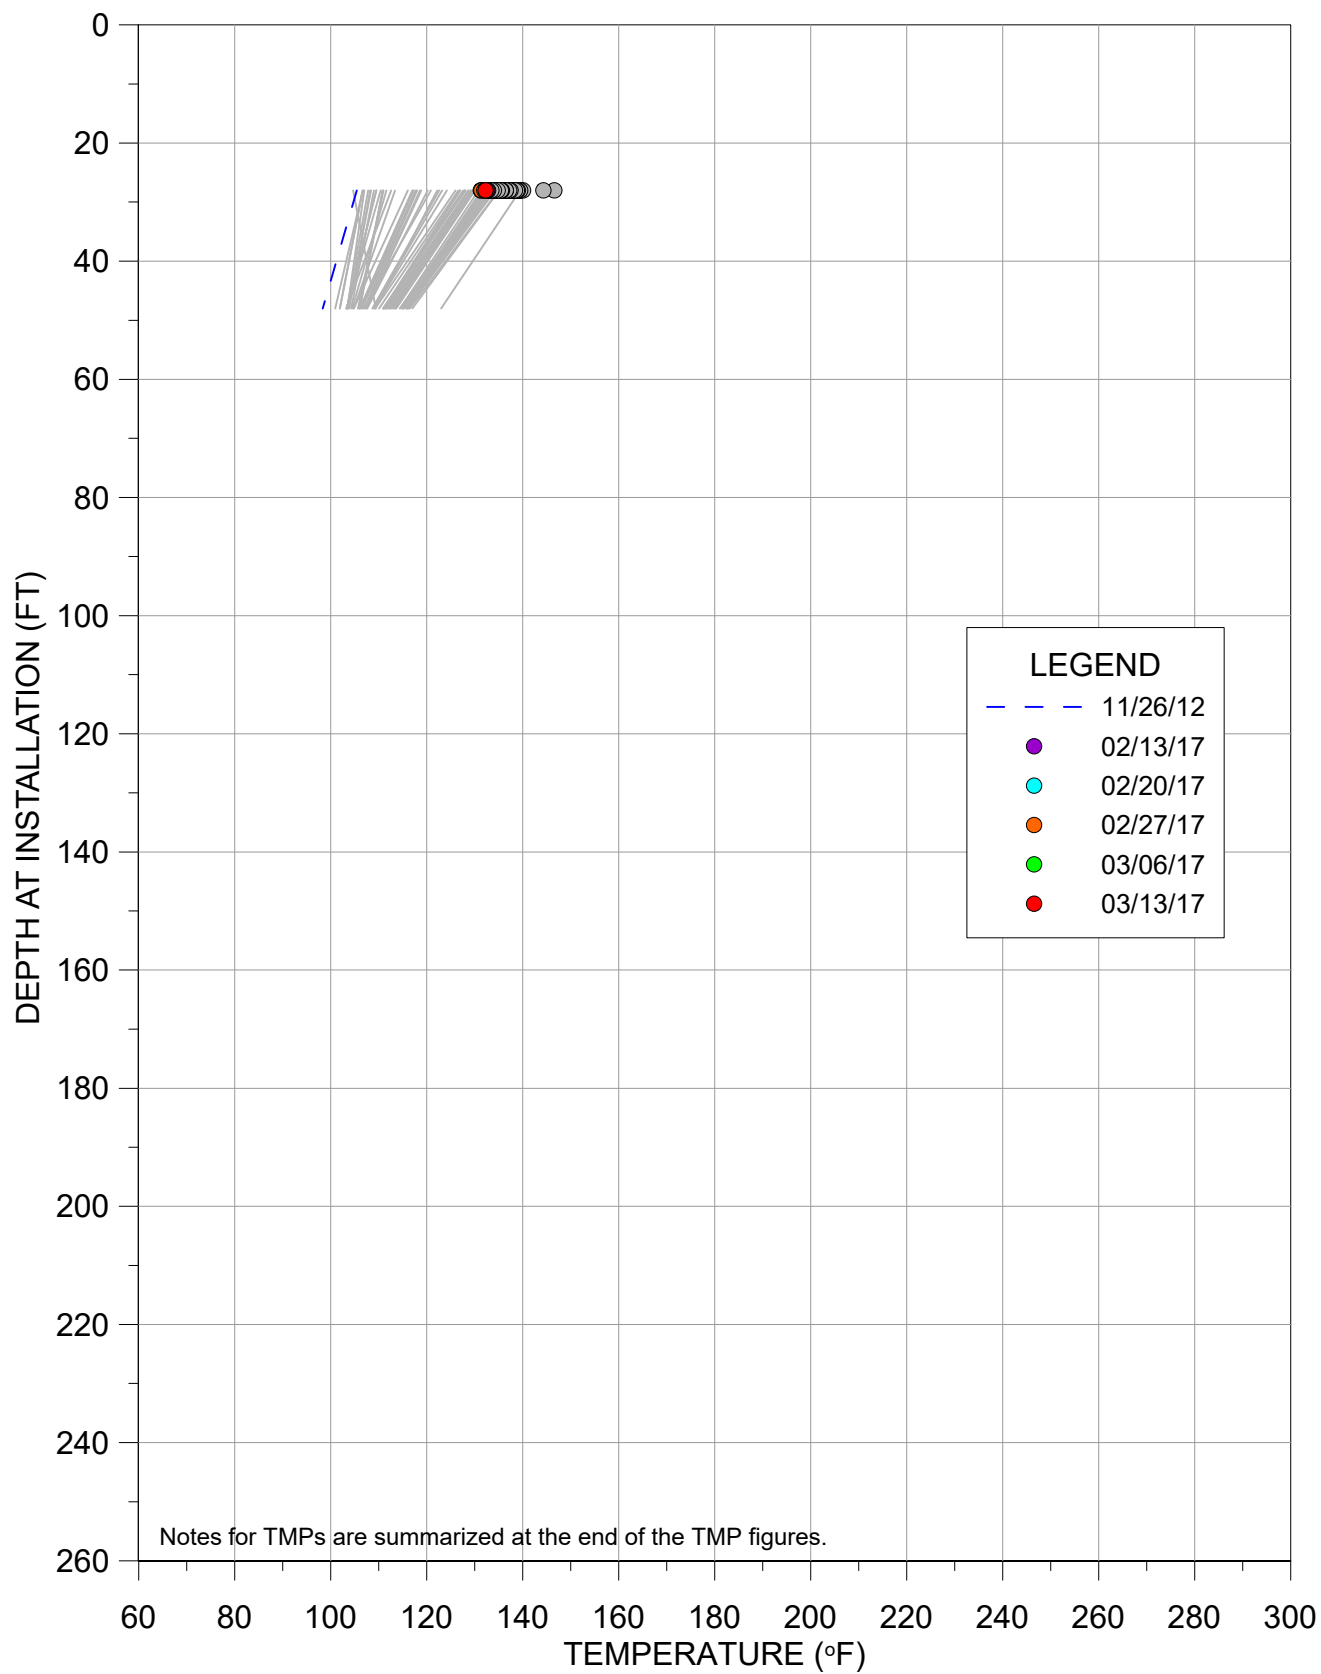
# TMP-4

1. The connectivity tests on 4/11/2014 conducted by CEC showed that the unit at 48 ft depth is no longer reliable.

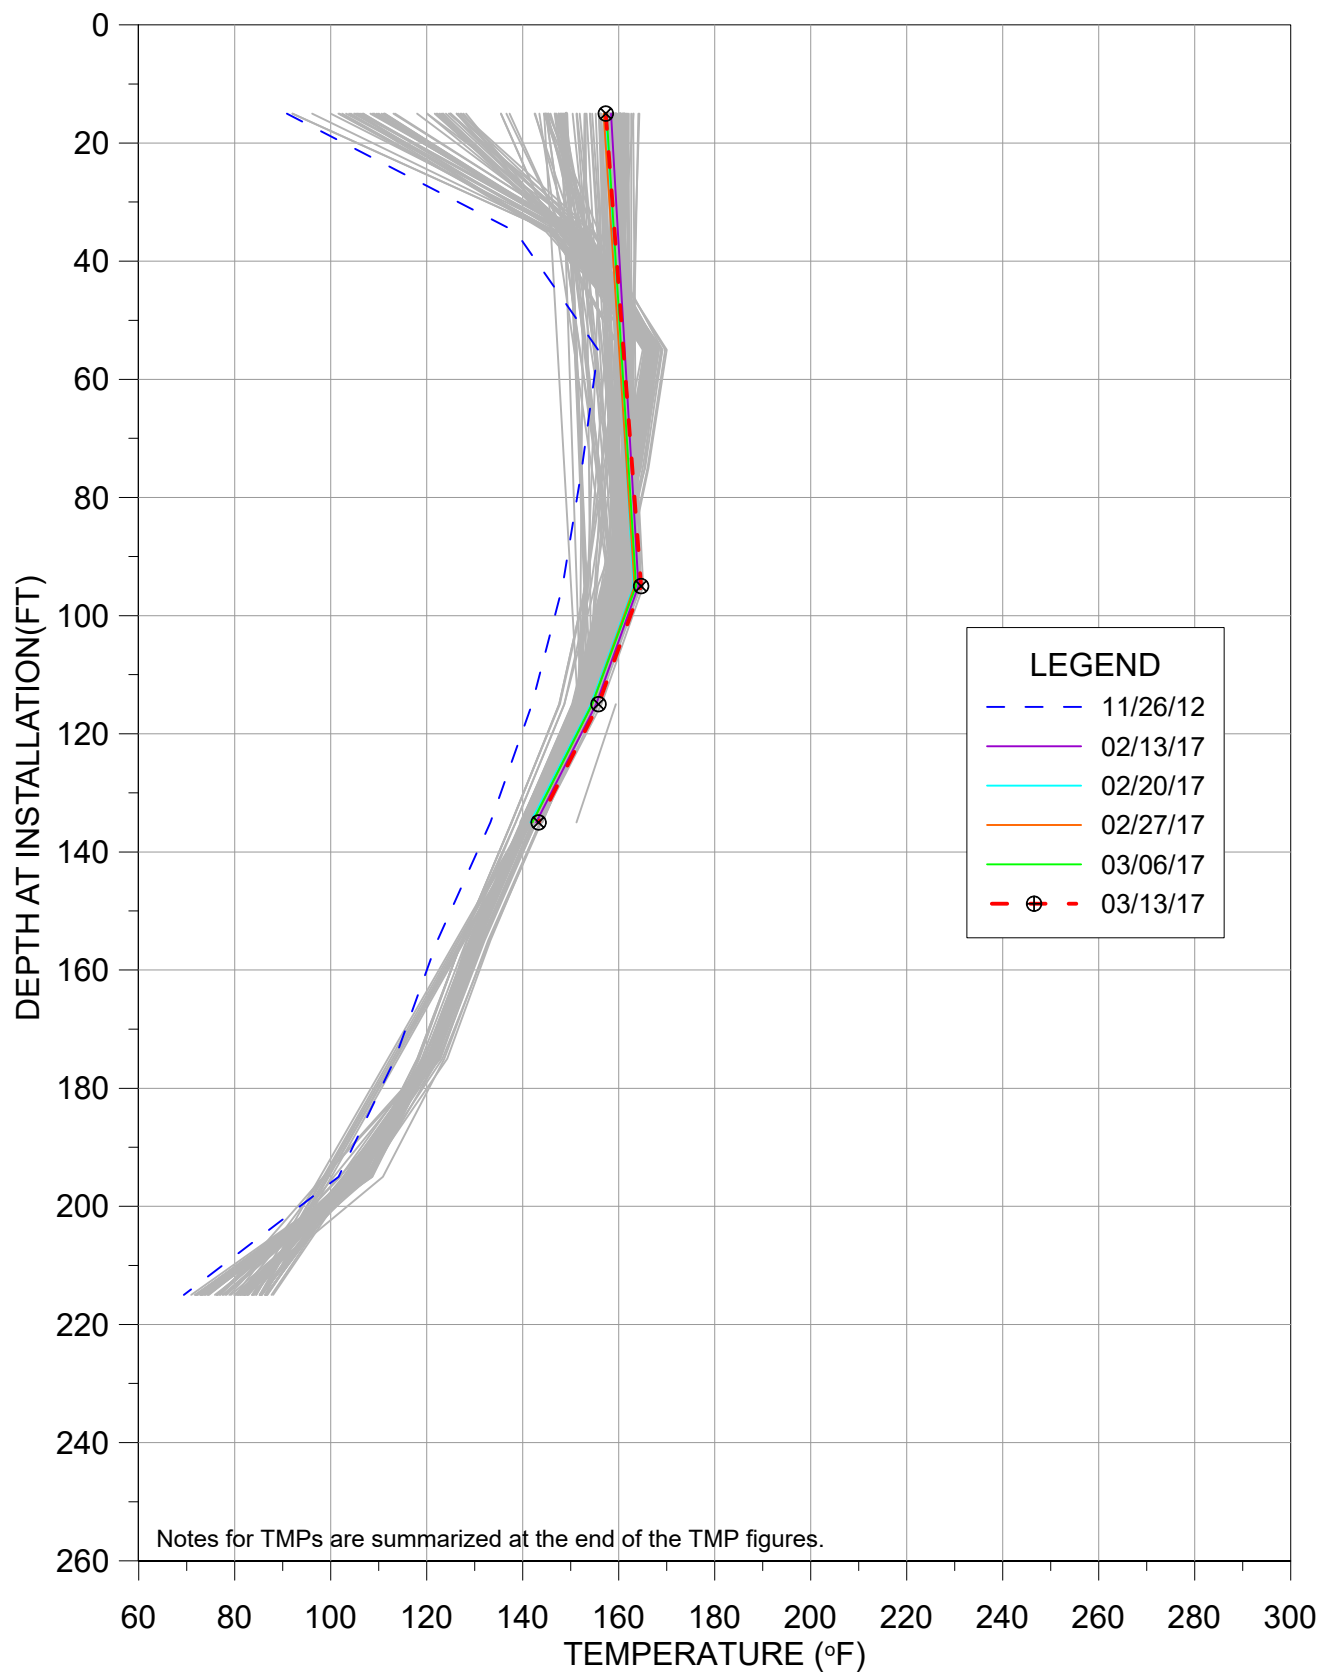
# TMP-6

1. The connectivity tests on 4/11/2014 conducted by CEC showed that units at 35, 55, 75, 155, 175, and 195 ft depths are no longer reliable.
2. No reliable temperature readings have been obtained at the unit at 215 ft depth since 6/13/2014.

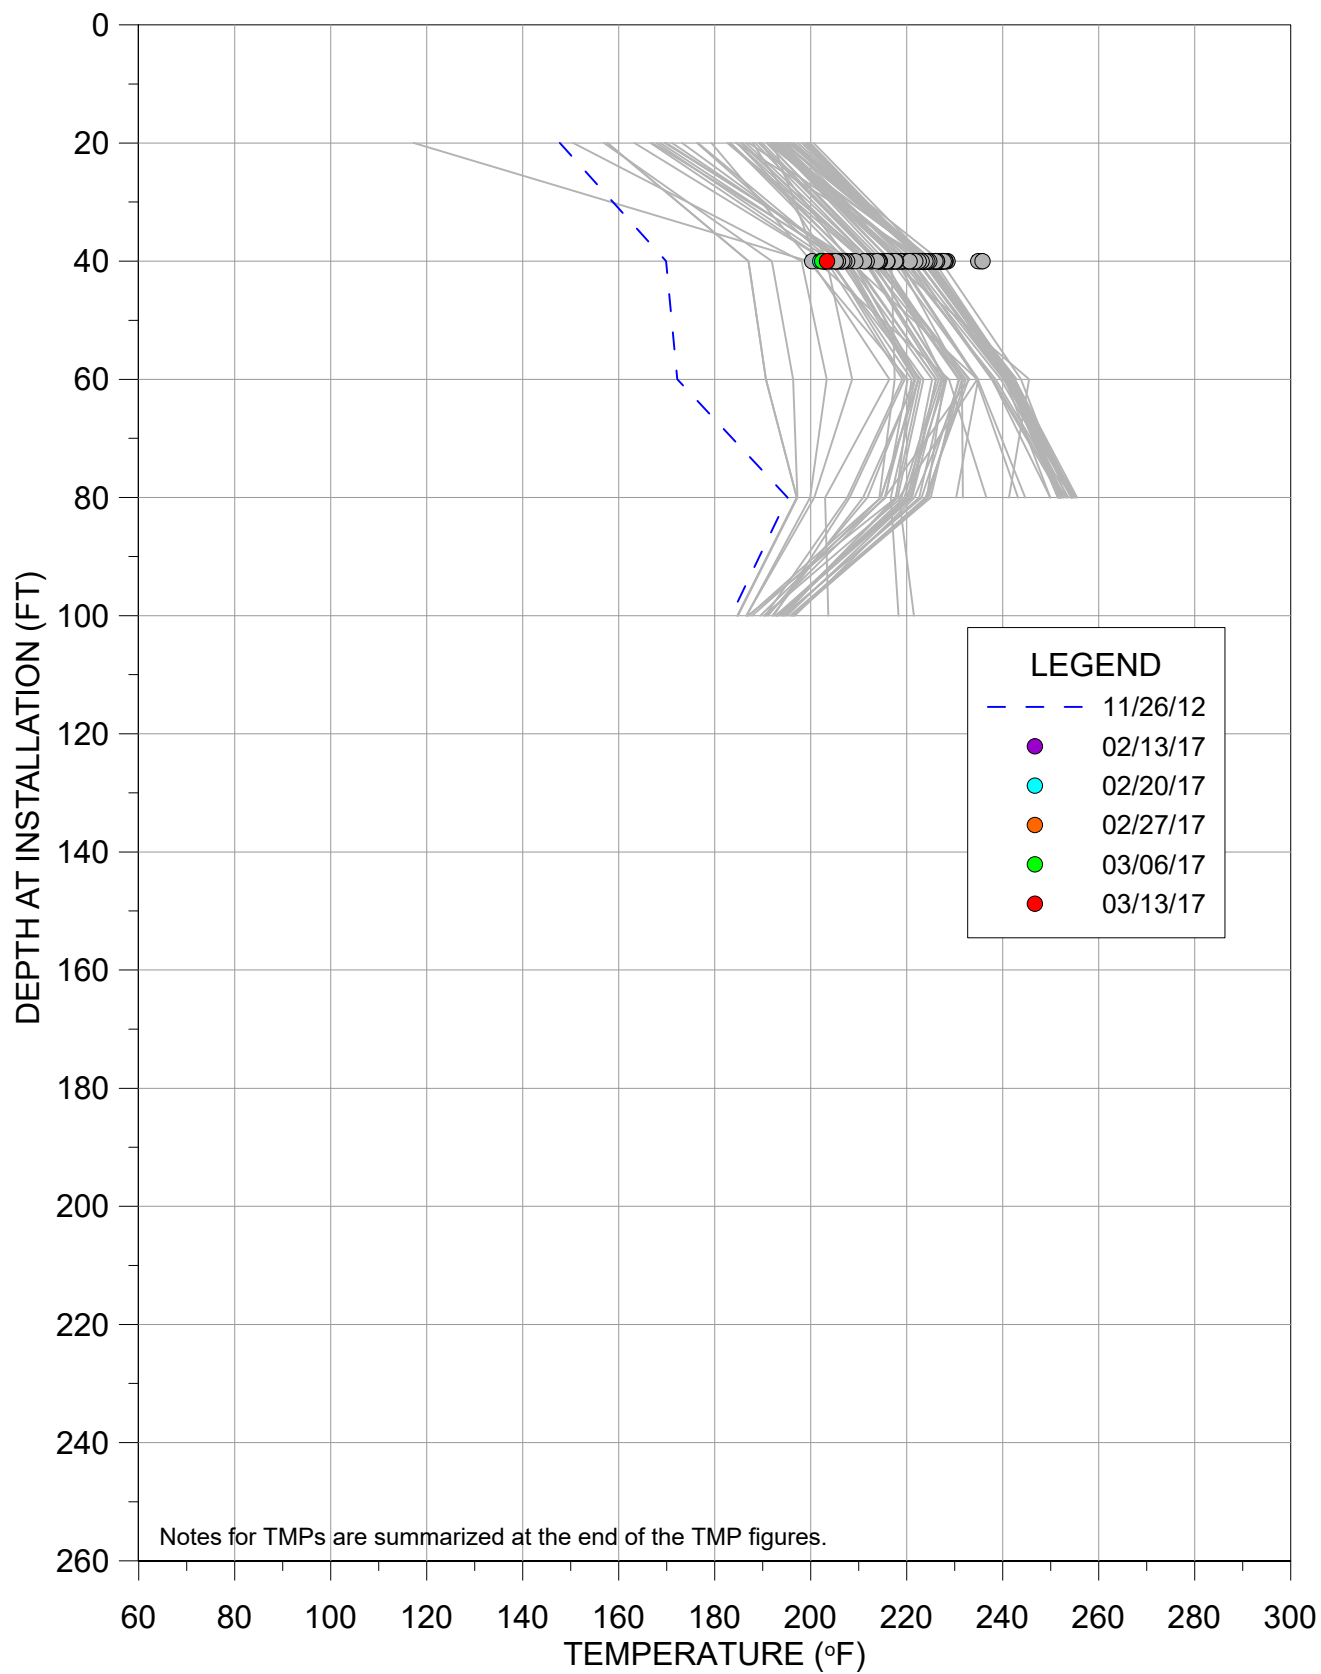
# TMP-9

1. Unit at 100 ft depth had an inaccurate temperature reading on 8/1/2013 and no reading since 8/6/2013.
2. The connectivity tests on 4/11/2014 conducted by CEC showed that units at 20, 60, 80, and 100 ft depths are no longer reliable.
