# **Bridgeton Landfill, LLC**

## **Weekly Data Submittal**

**Week of March 12, 2017 – March 18, 2017**

**Required by Section 52.F of Agreed Order, Case No. 13SL-CC01088  
Effective May 13, 2013**

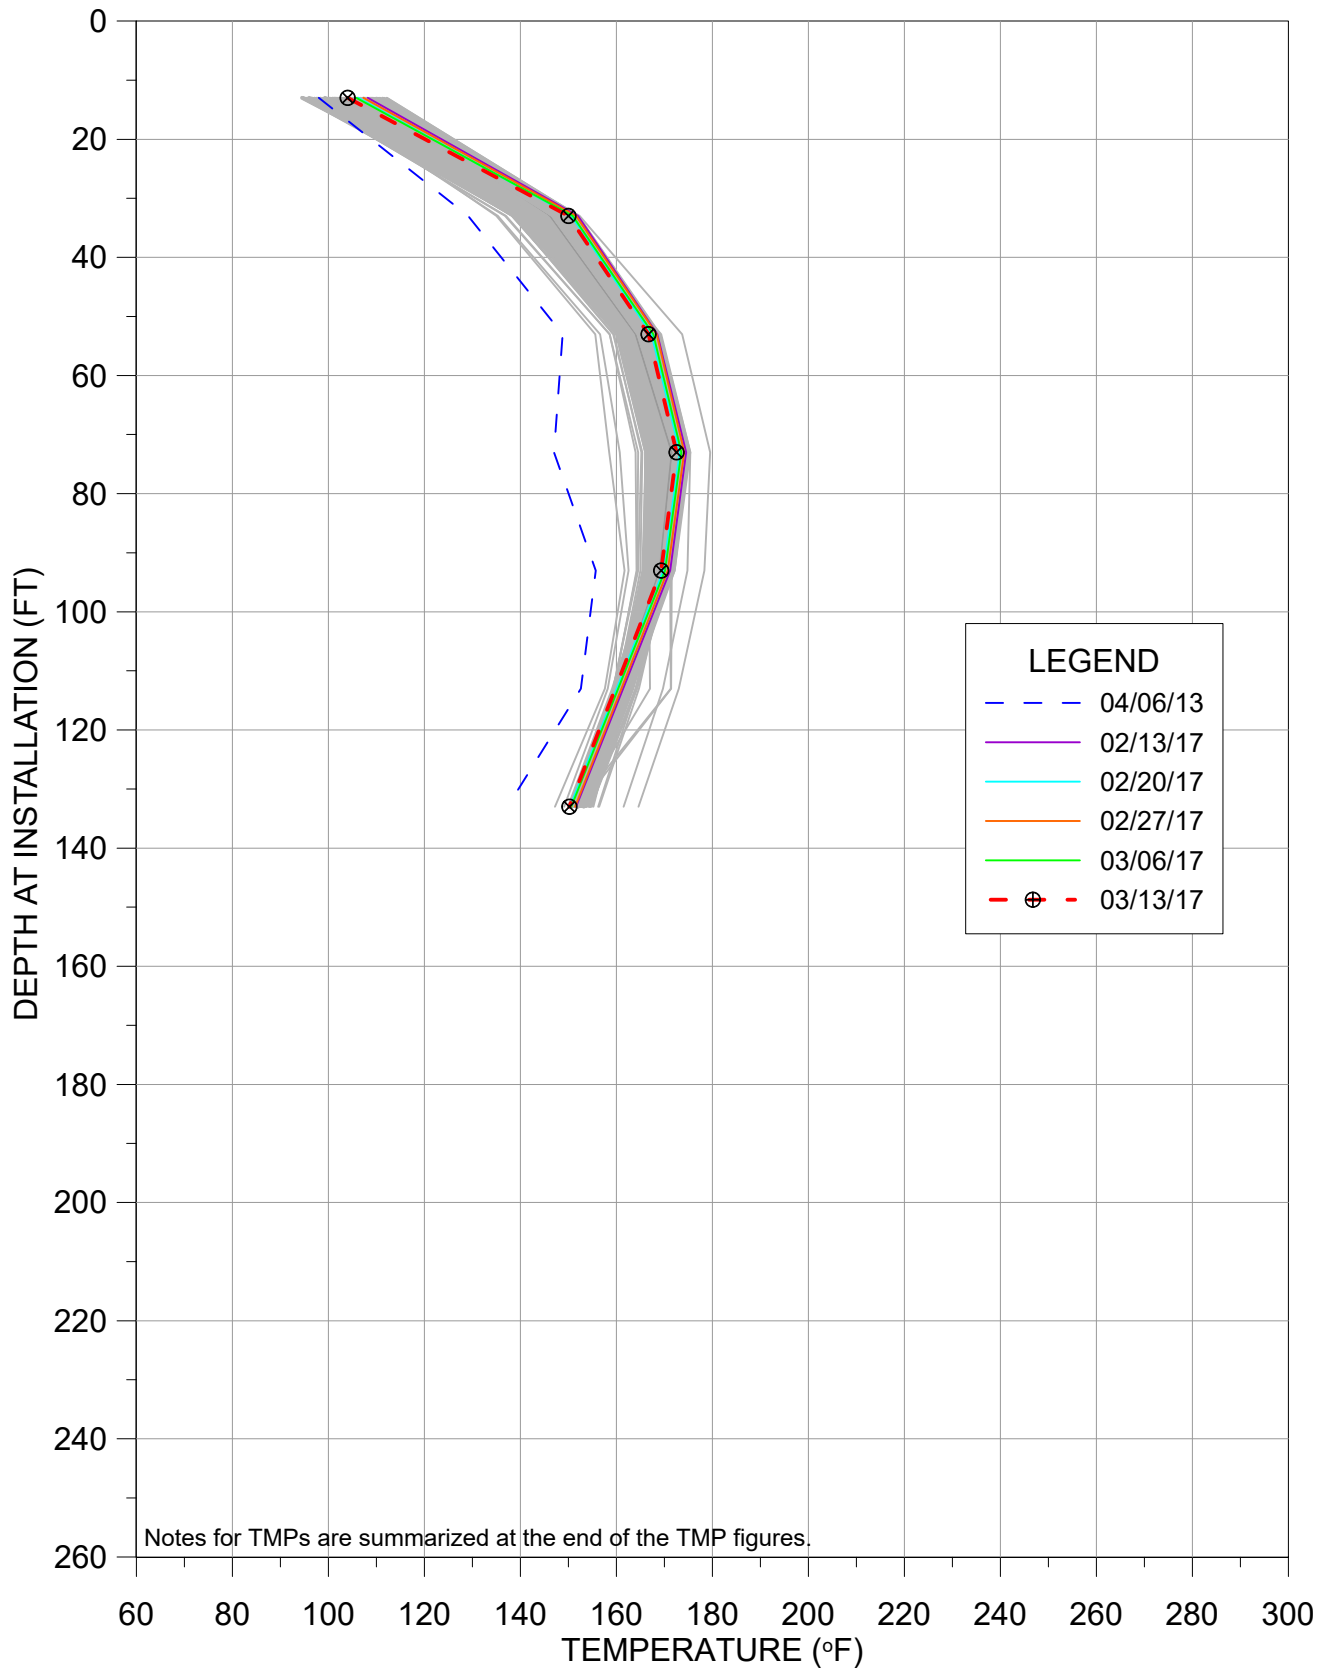
# TMP-10

1. Unit at 113 ft had resistance below the minimum level, change in resistance occurred as of 11/08/16 and has remained below acceptable level.

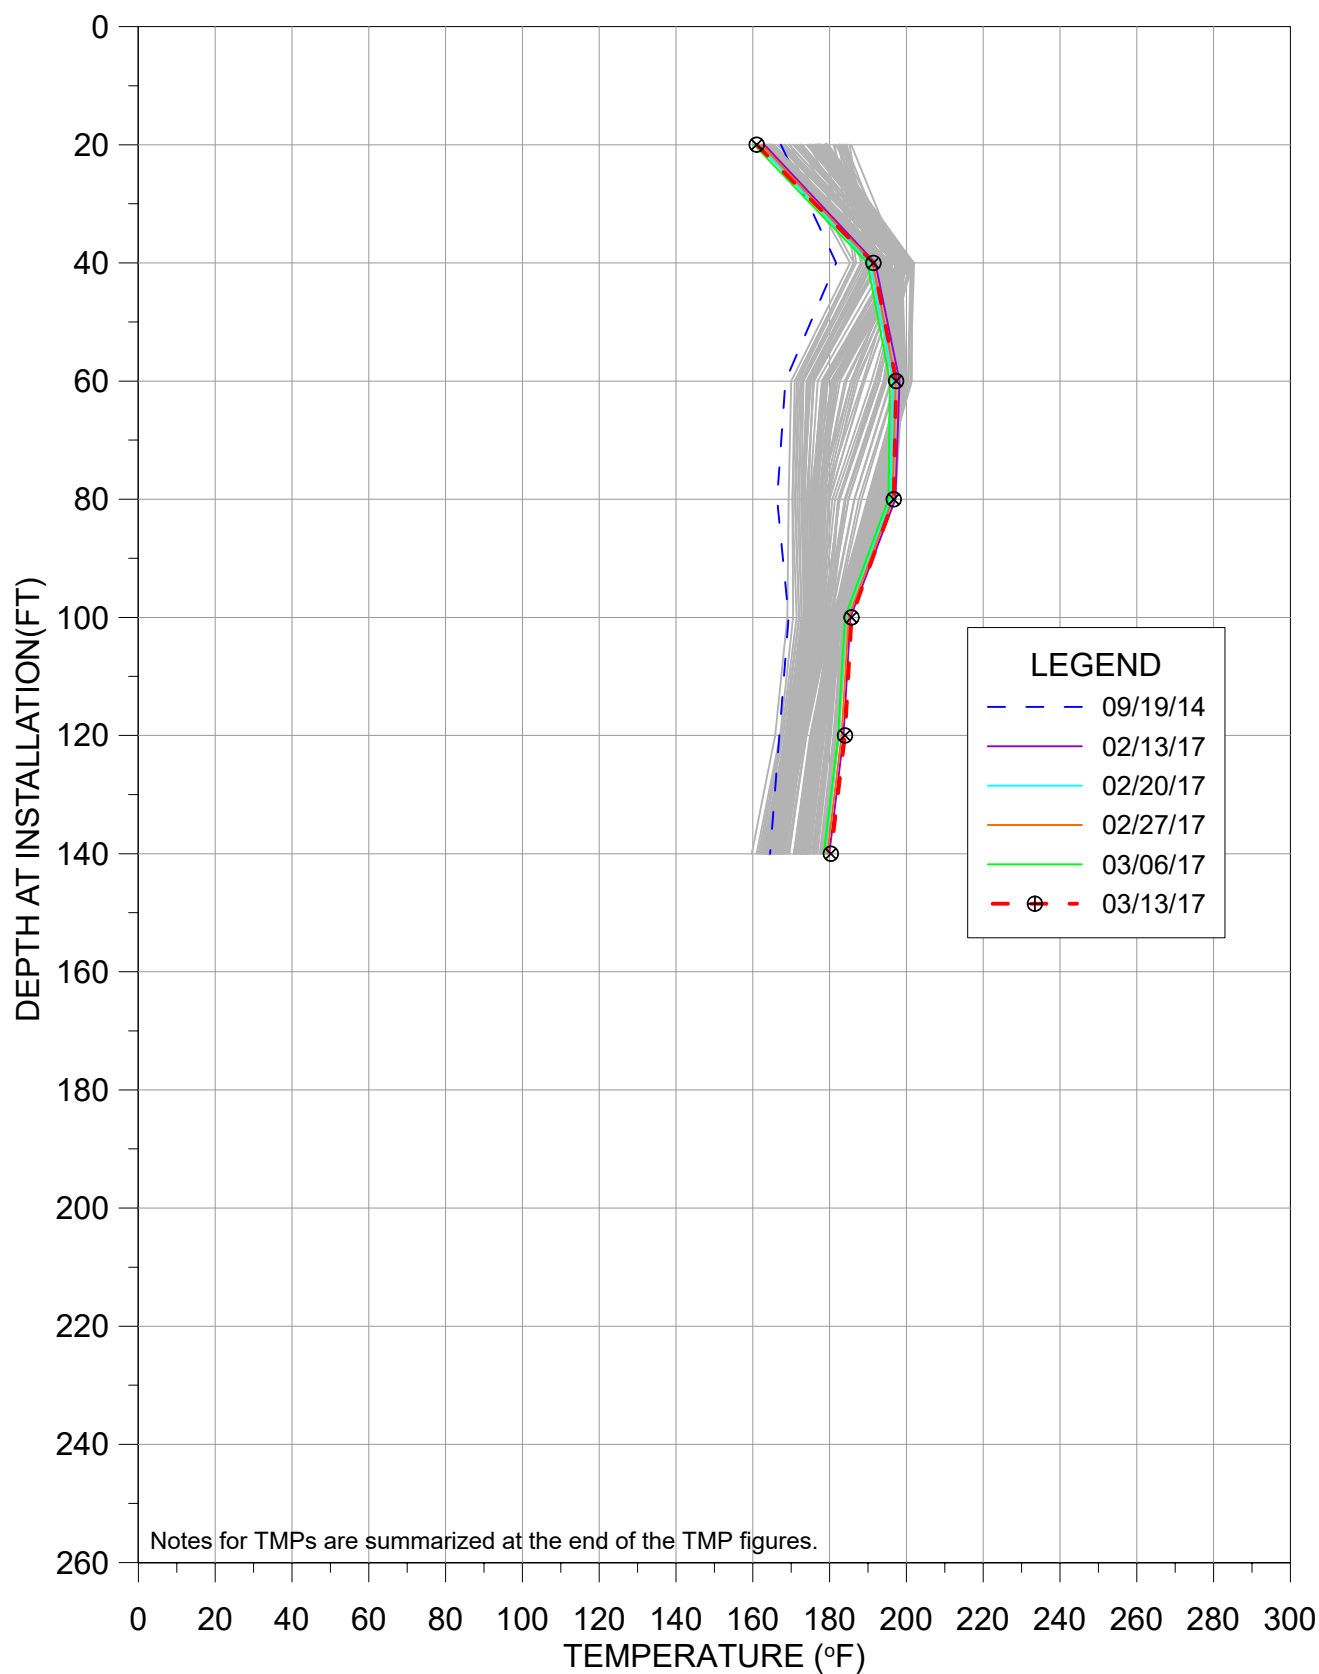
# TMP-14R

1. Due to the connectivity test results by Feezor Engineering on TMP-14 (see note above), TMP-14R is added to this reporting data set as of 3/7/2016.

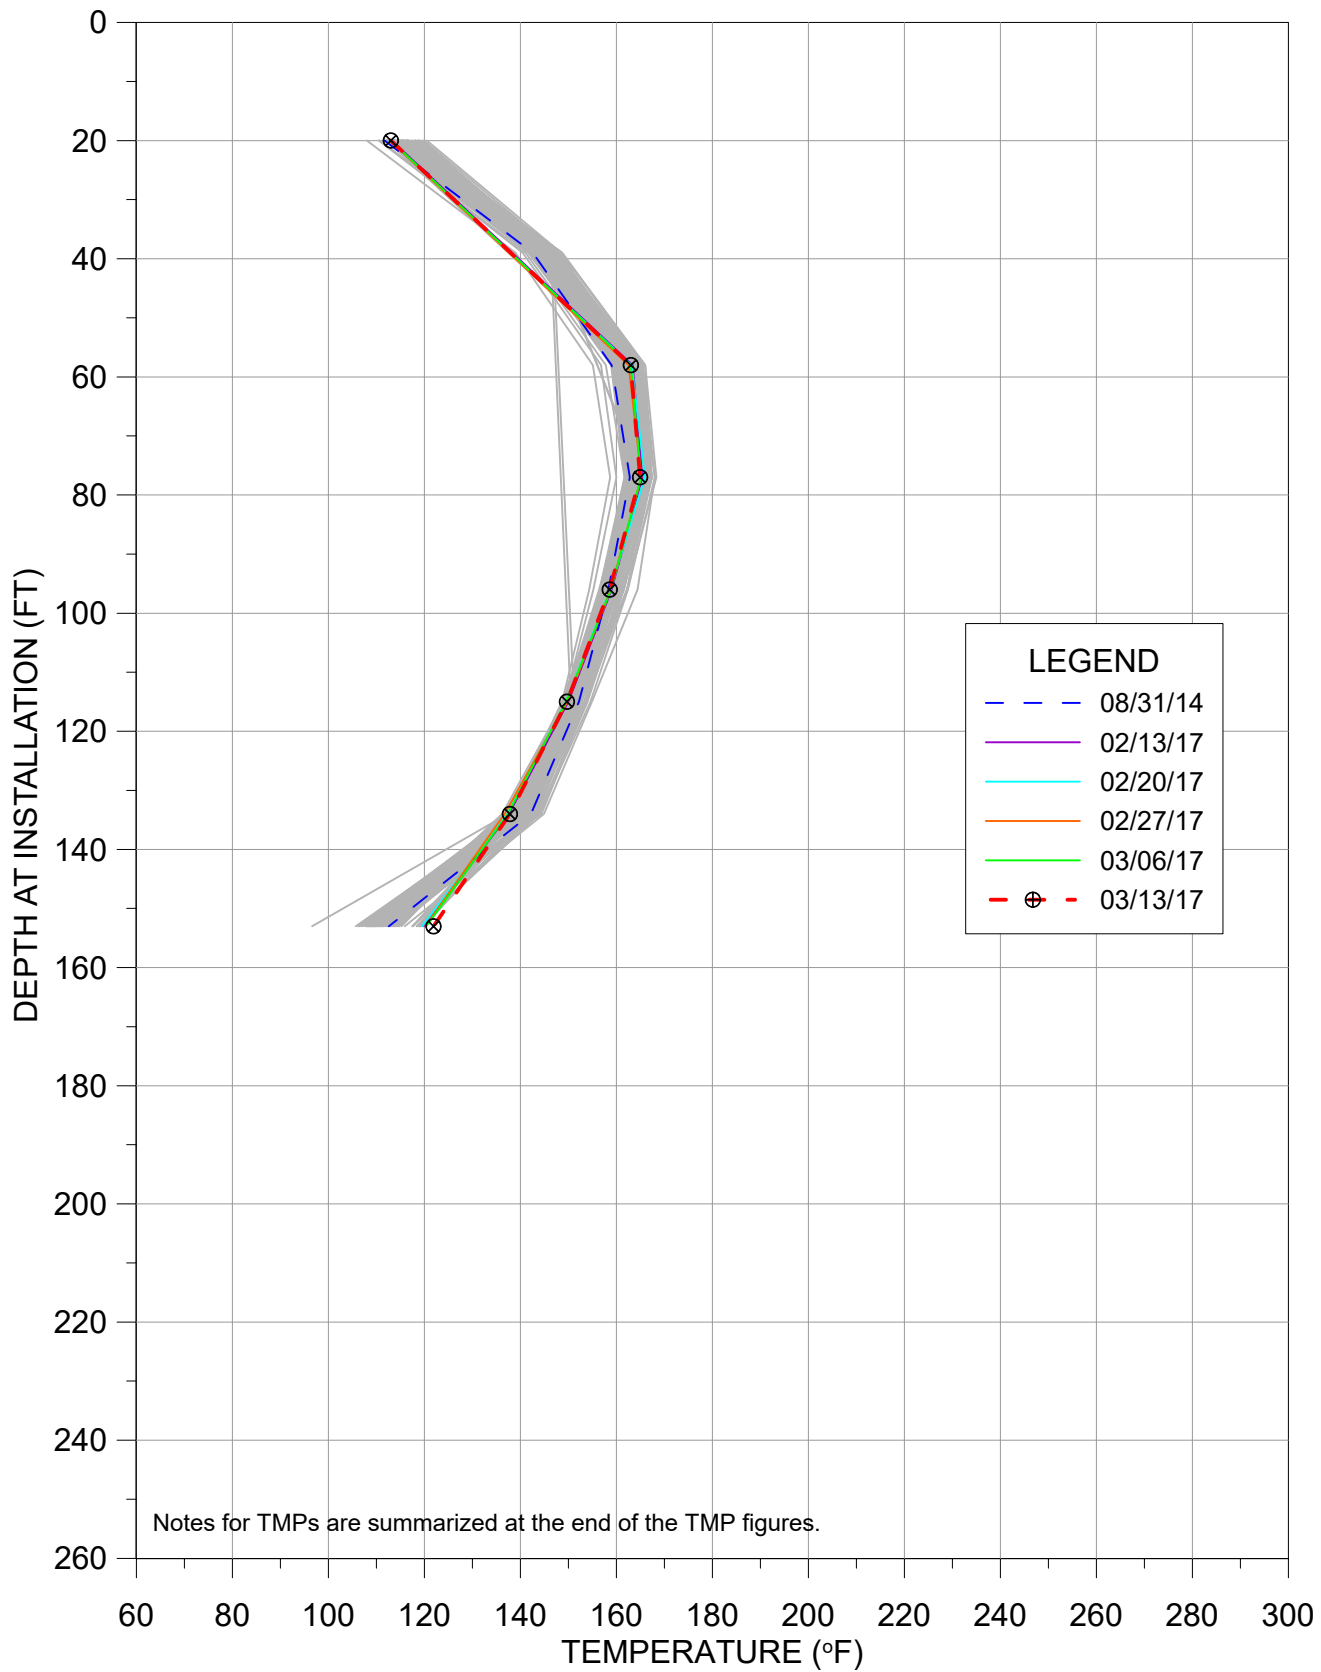
# TMP-16

1. A connectivity test conducted by Feezor Engineering showed that the units on TMP-16 may not be reliable since 9/9/2015. Further testing at the end of September 2015 showed possible connectivity on some of the units.
2. The unit at 153 ft depth had a low resistance reading and unreliable temperature since 12/21/2015.

3. The unit at 39 ft depth had a higher than acceptable resistance reading and unreliable temperature since 2/7/2017.

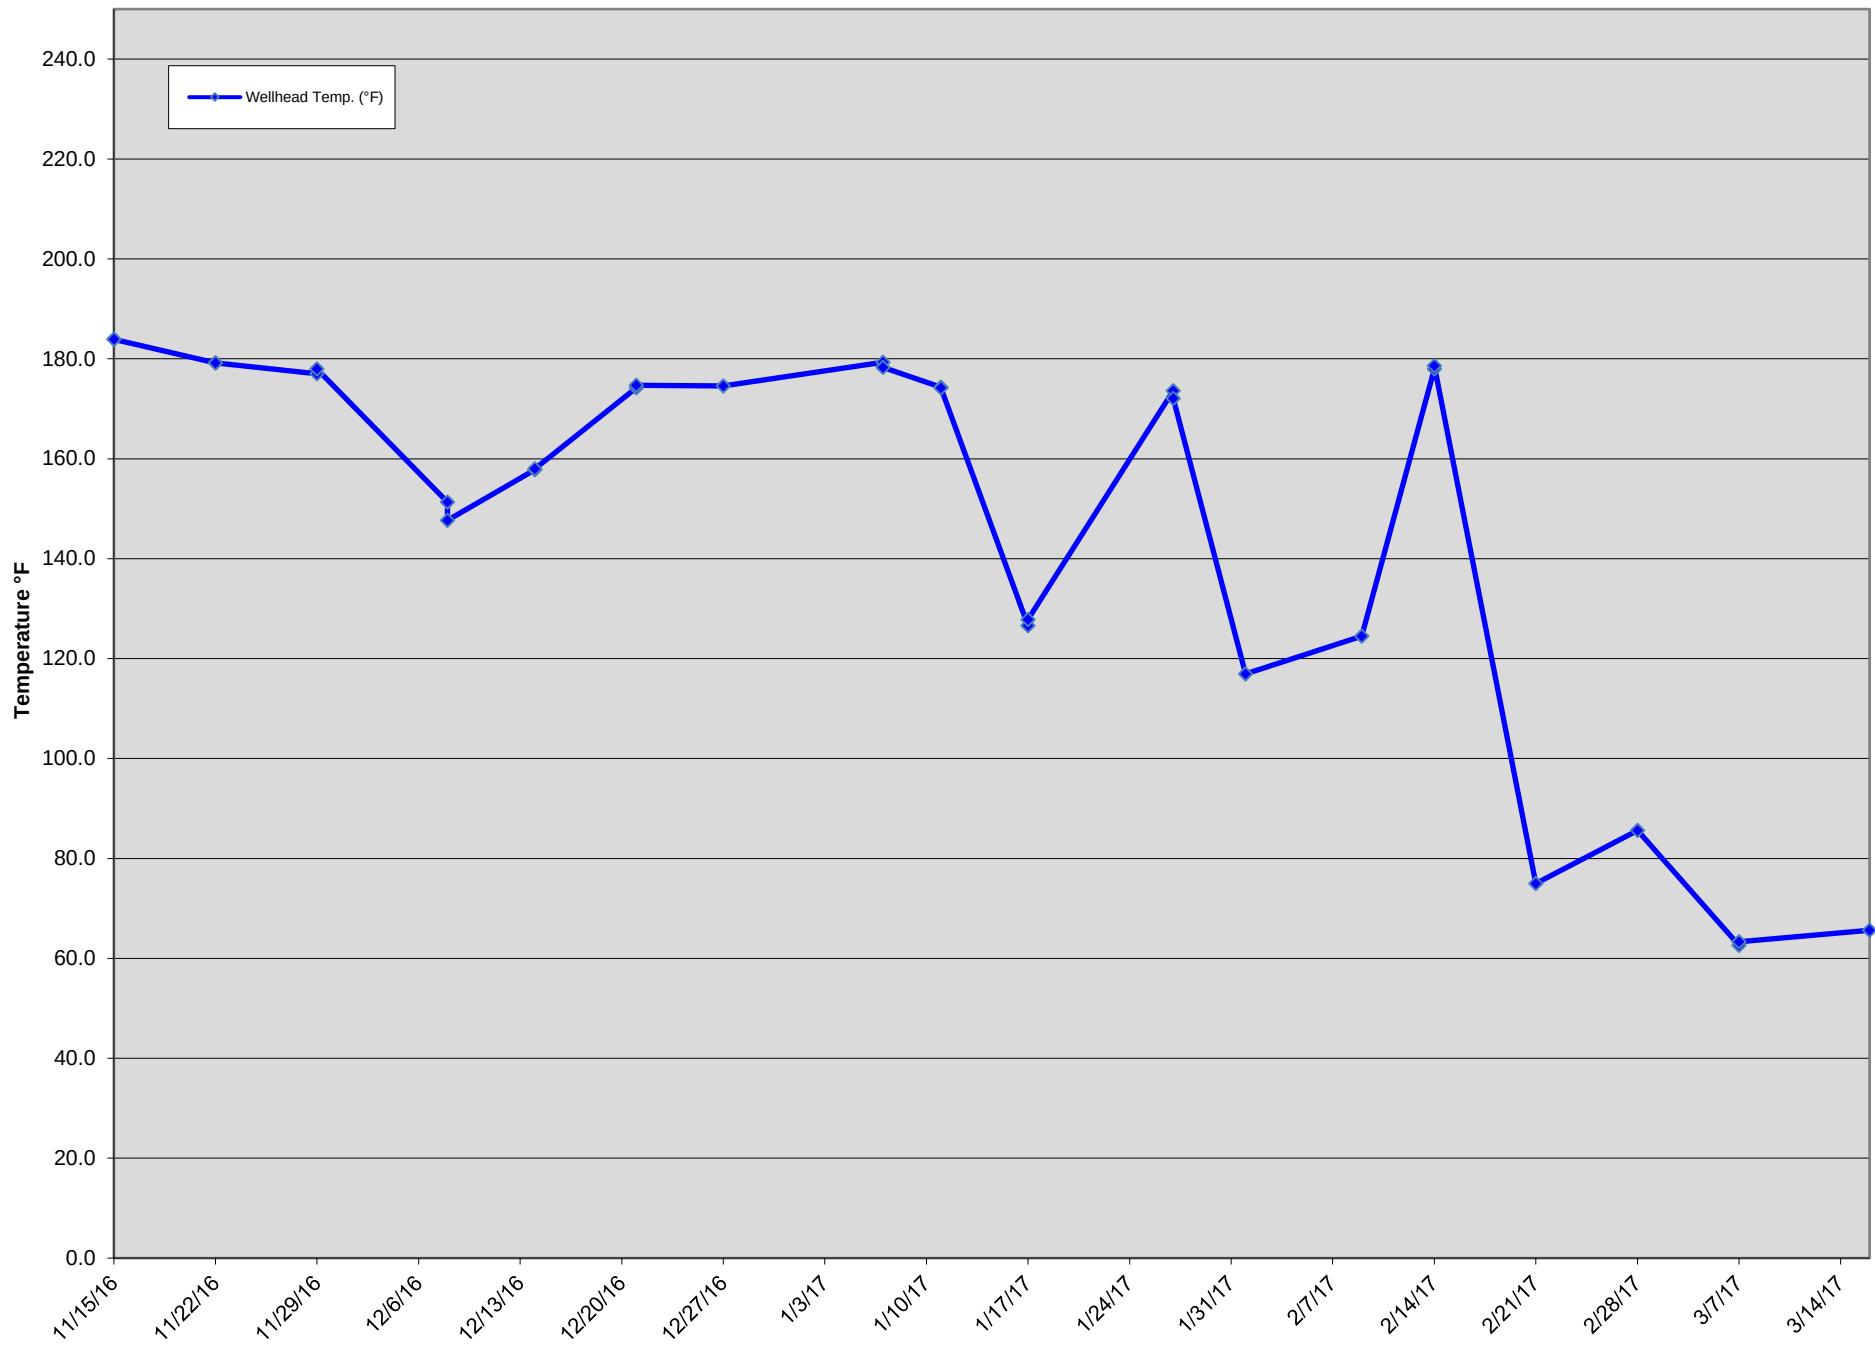
GIW-1 Wellhead Temperatures

As part of the HES, there are currently cooling water circulation loops installed in twelve Gas Interceptor Wells (GIWs) (GIW-02 through GIW-13). The remaining well (GIW-01) had a measured gas temperature within its historical operating limits.
