# **Bridgeton Landfill, LLC**

## **Weekly Data Submittal**

**Week of April 2, 2017 – April 8, 2017**

**Required by Section 52.F of Agreed Order, Case No. 13SL-CC01088  
Effective May 13, 2013**

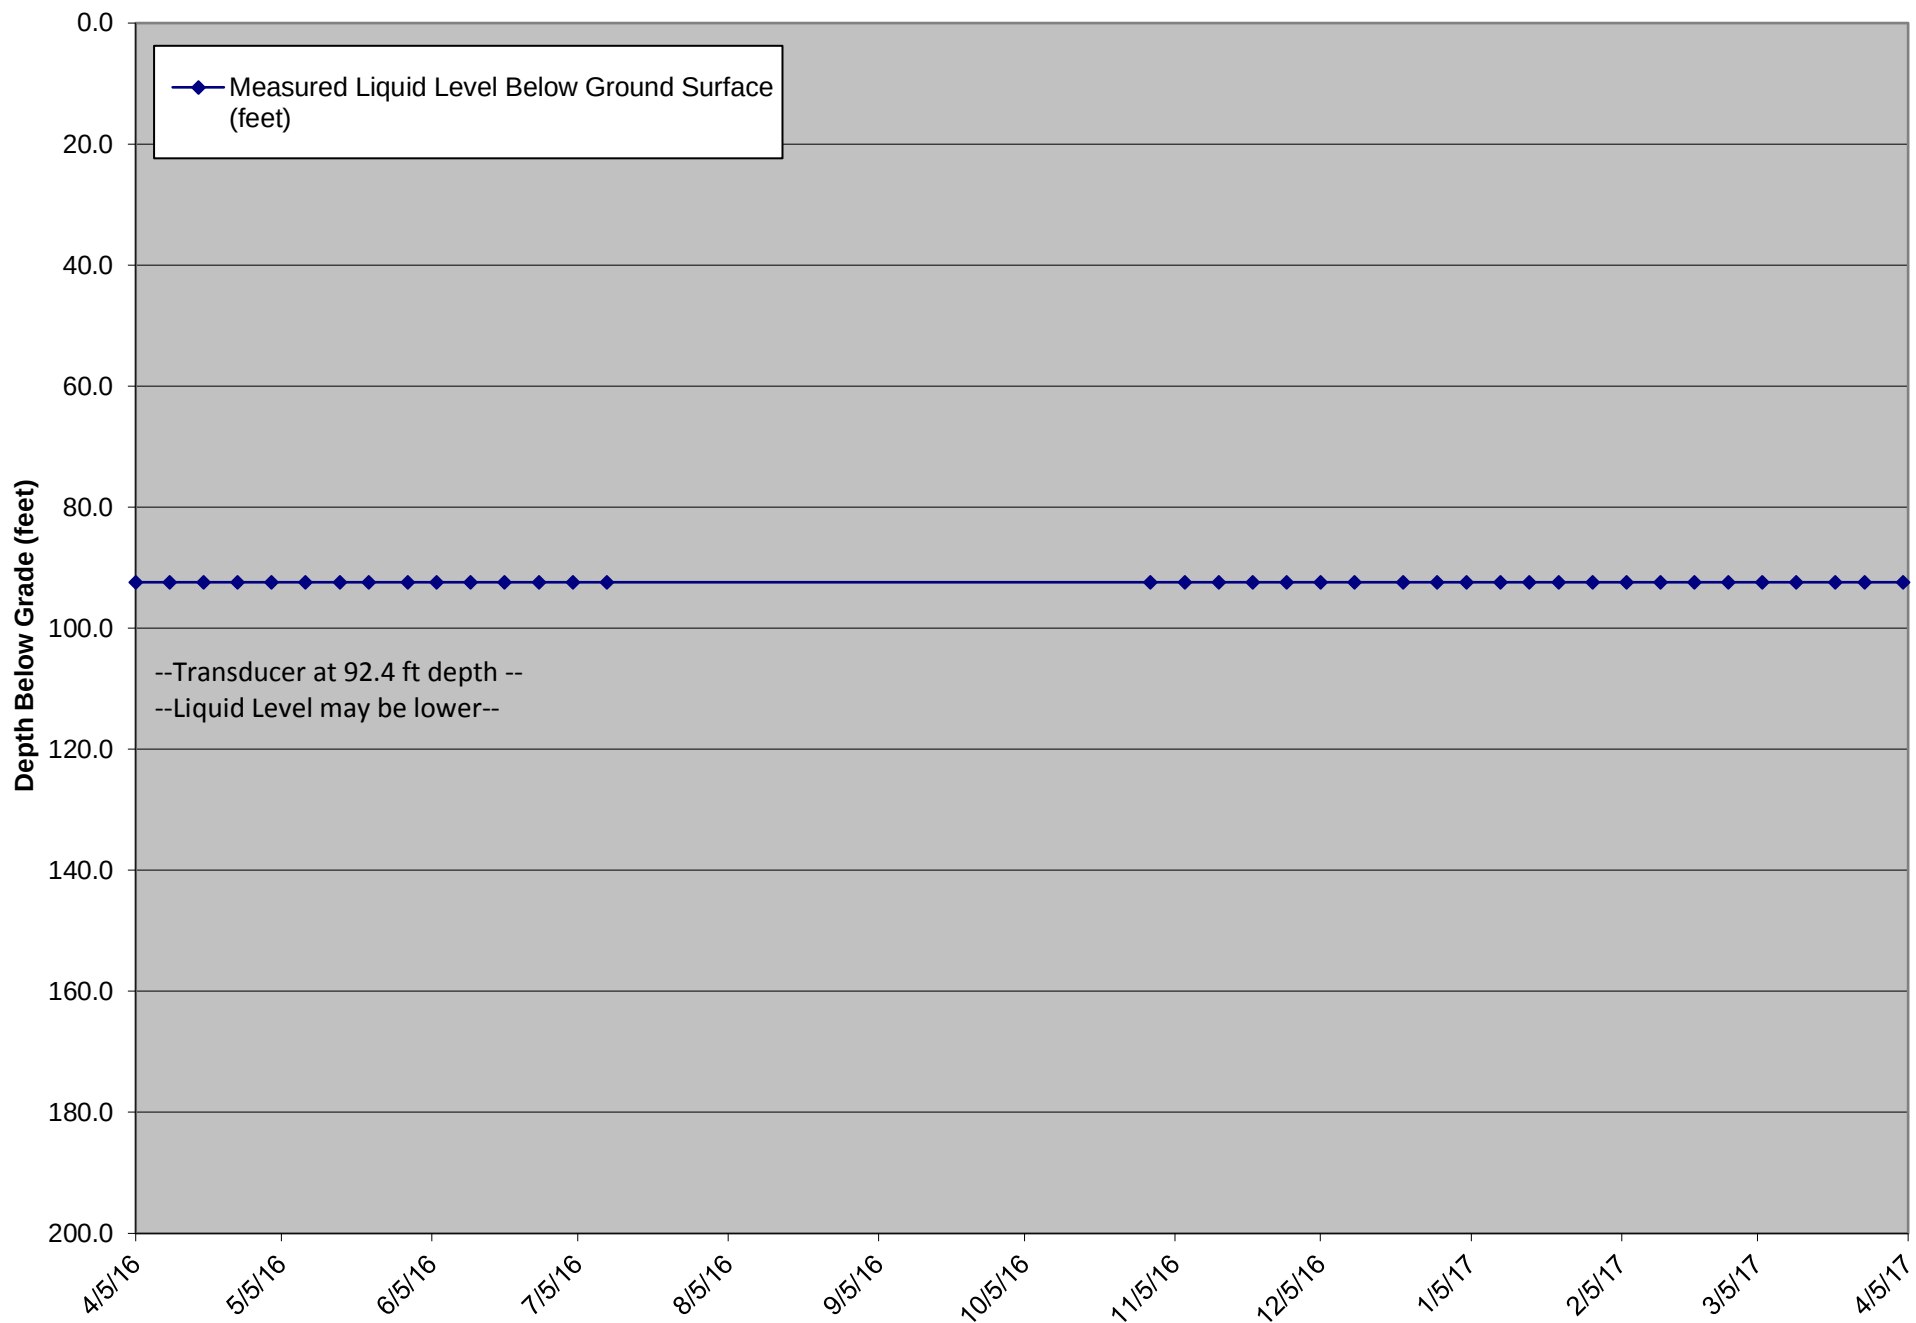
# LCS-1D Liquid Level Below Ground Surface

LCS-1D is equipped with a level sensor and a flow meter. Bridgeton Landfill confirmed that the flow meter on LCS-1D is operational and the flow was observed during the weekly reporting period. Liquid level was not recorded by the level sensor during the weekly reporting period. Bridgeton Landfill is currently looking into replacing the level sensor on LCS-1D.

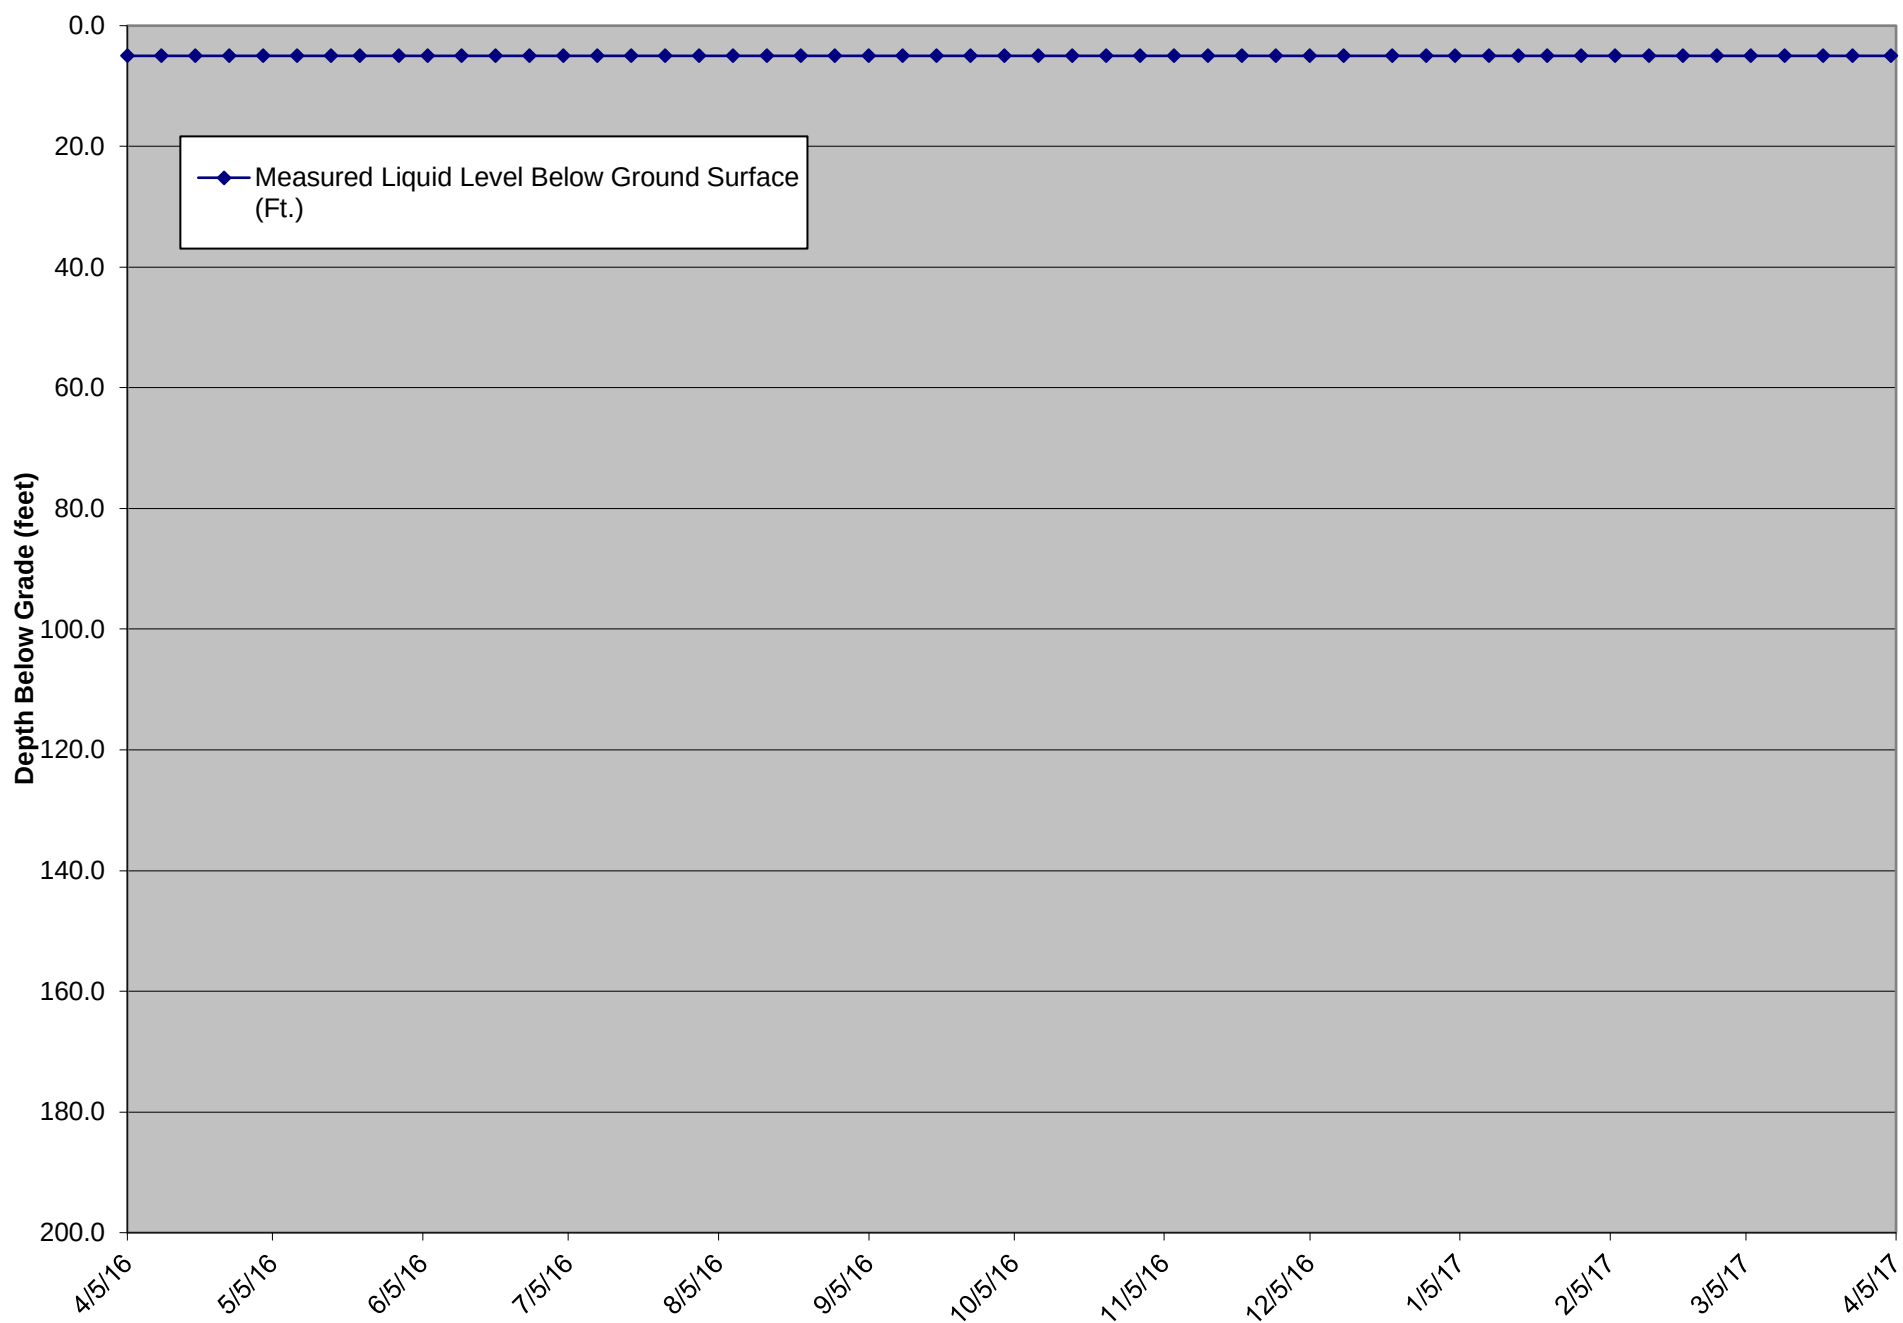
# LCS-3D Liquid Level Below Ground Surface

The pumps in LCS-2D and LCS-3D were non-operational during the weekly reporting period. The transducer in LCS-3D continued to report liquid levels.

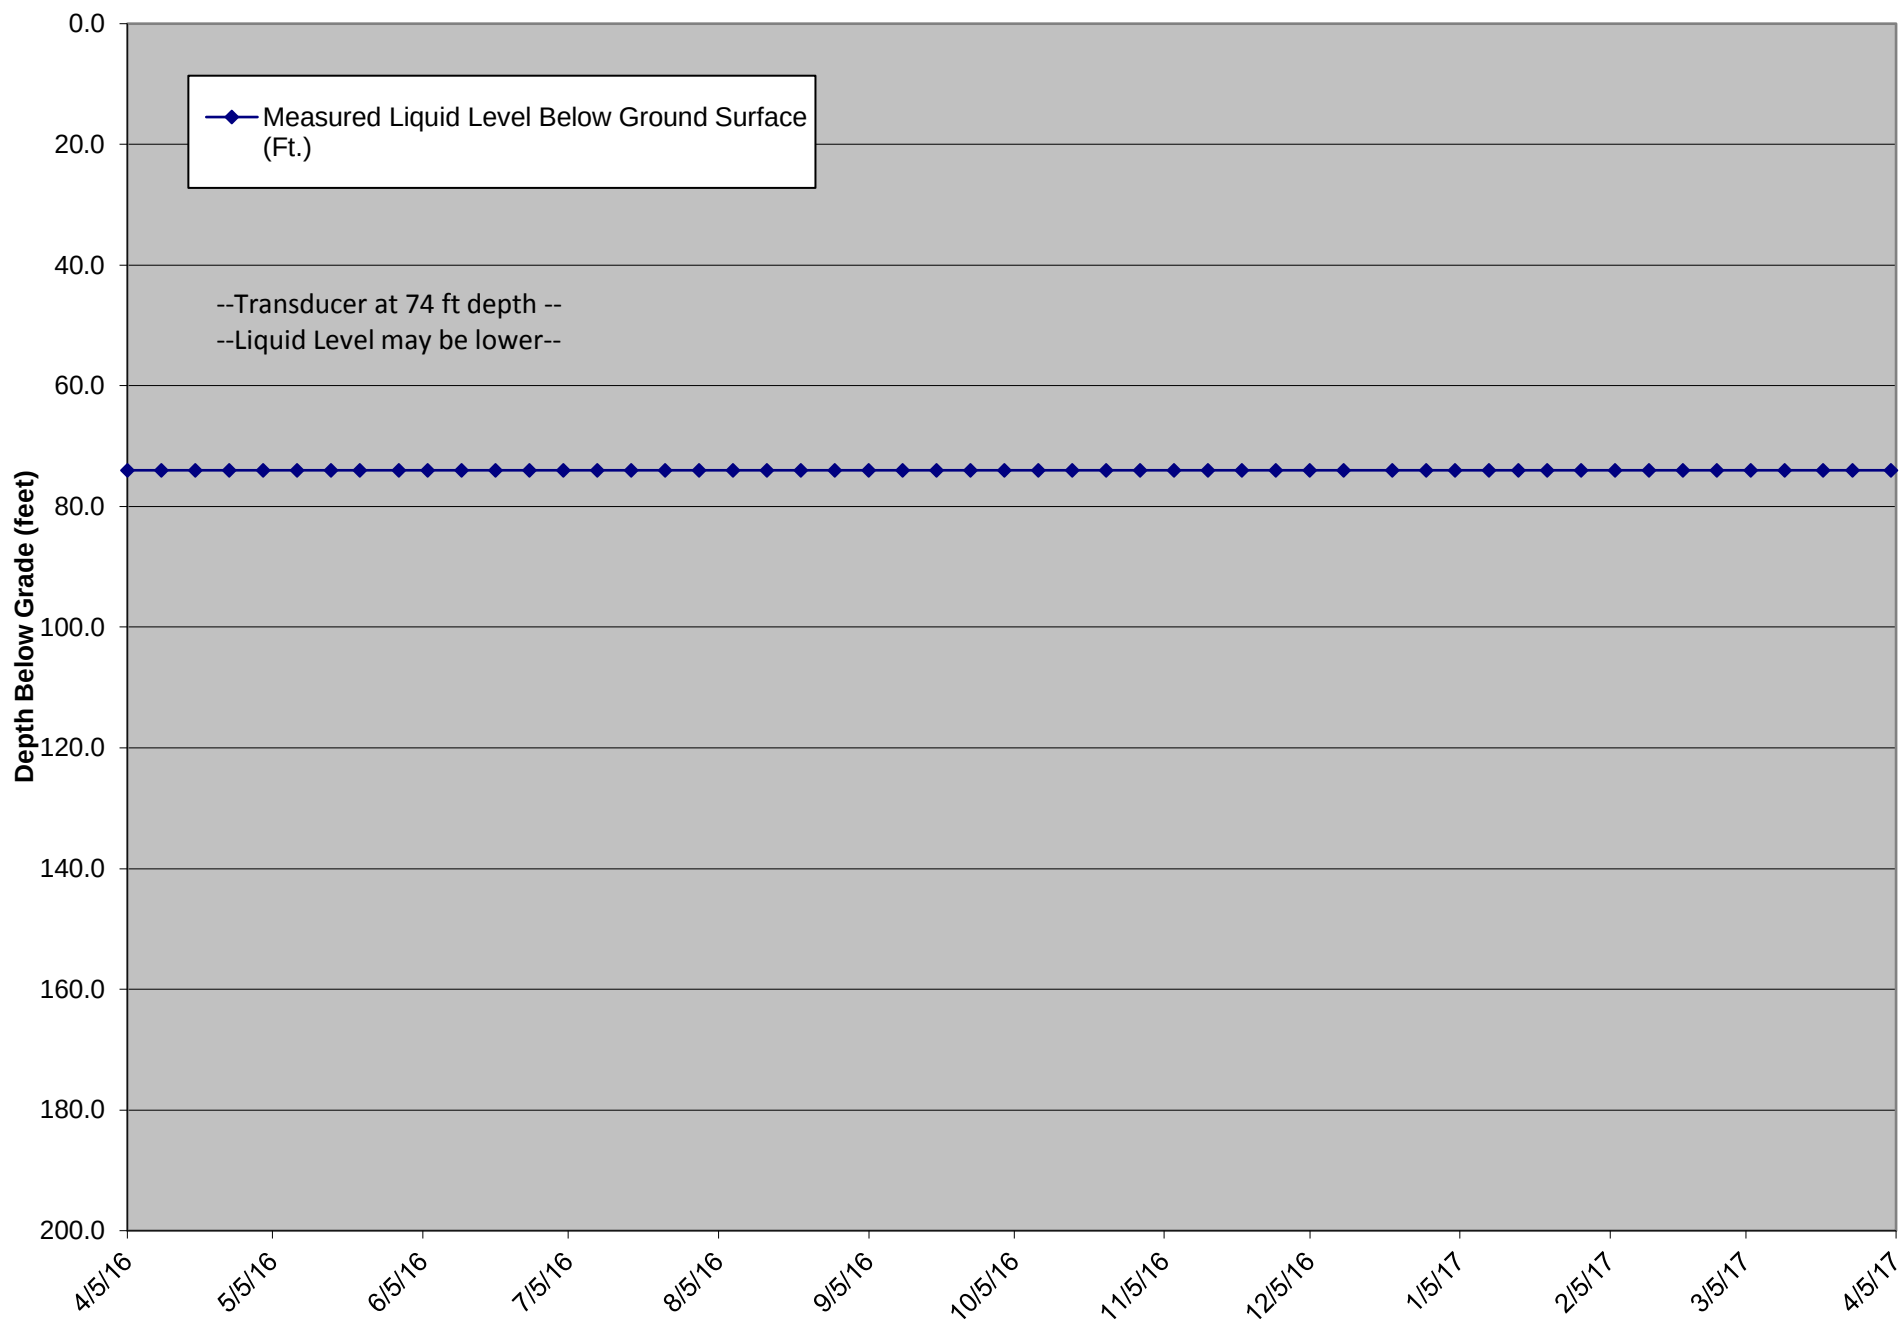
# LCS-4B Liquid Level Below Ground Surface

The level sensor in LCS-4B is currently operational and responsive. Liquid level was not recorded by the level sensor during the weekly reporting period. LCS-4B is equipped with a flow meter that displayed no flow during the weekly reporting period. Therefore, it can be concluded that the liquid level was below the bottom of the pump and level sensor in LCS-4B.

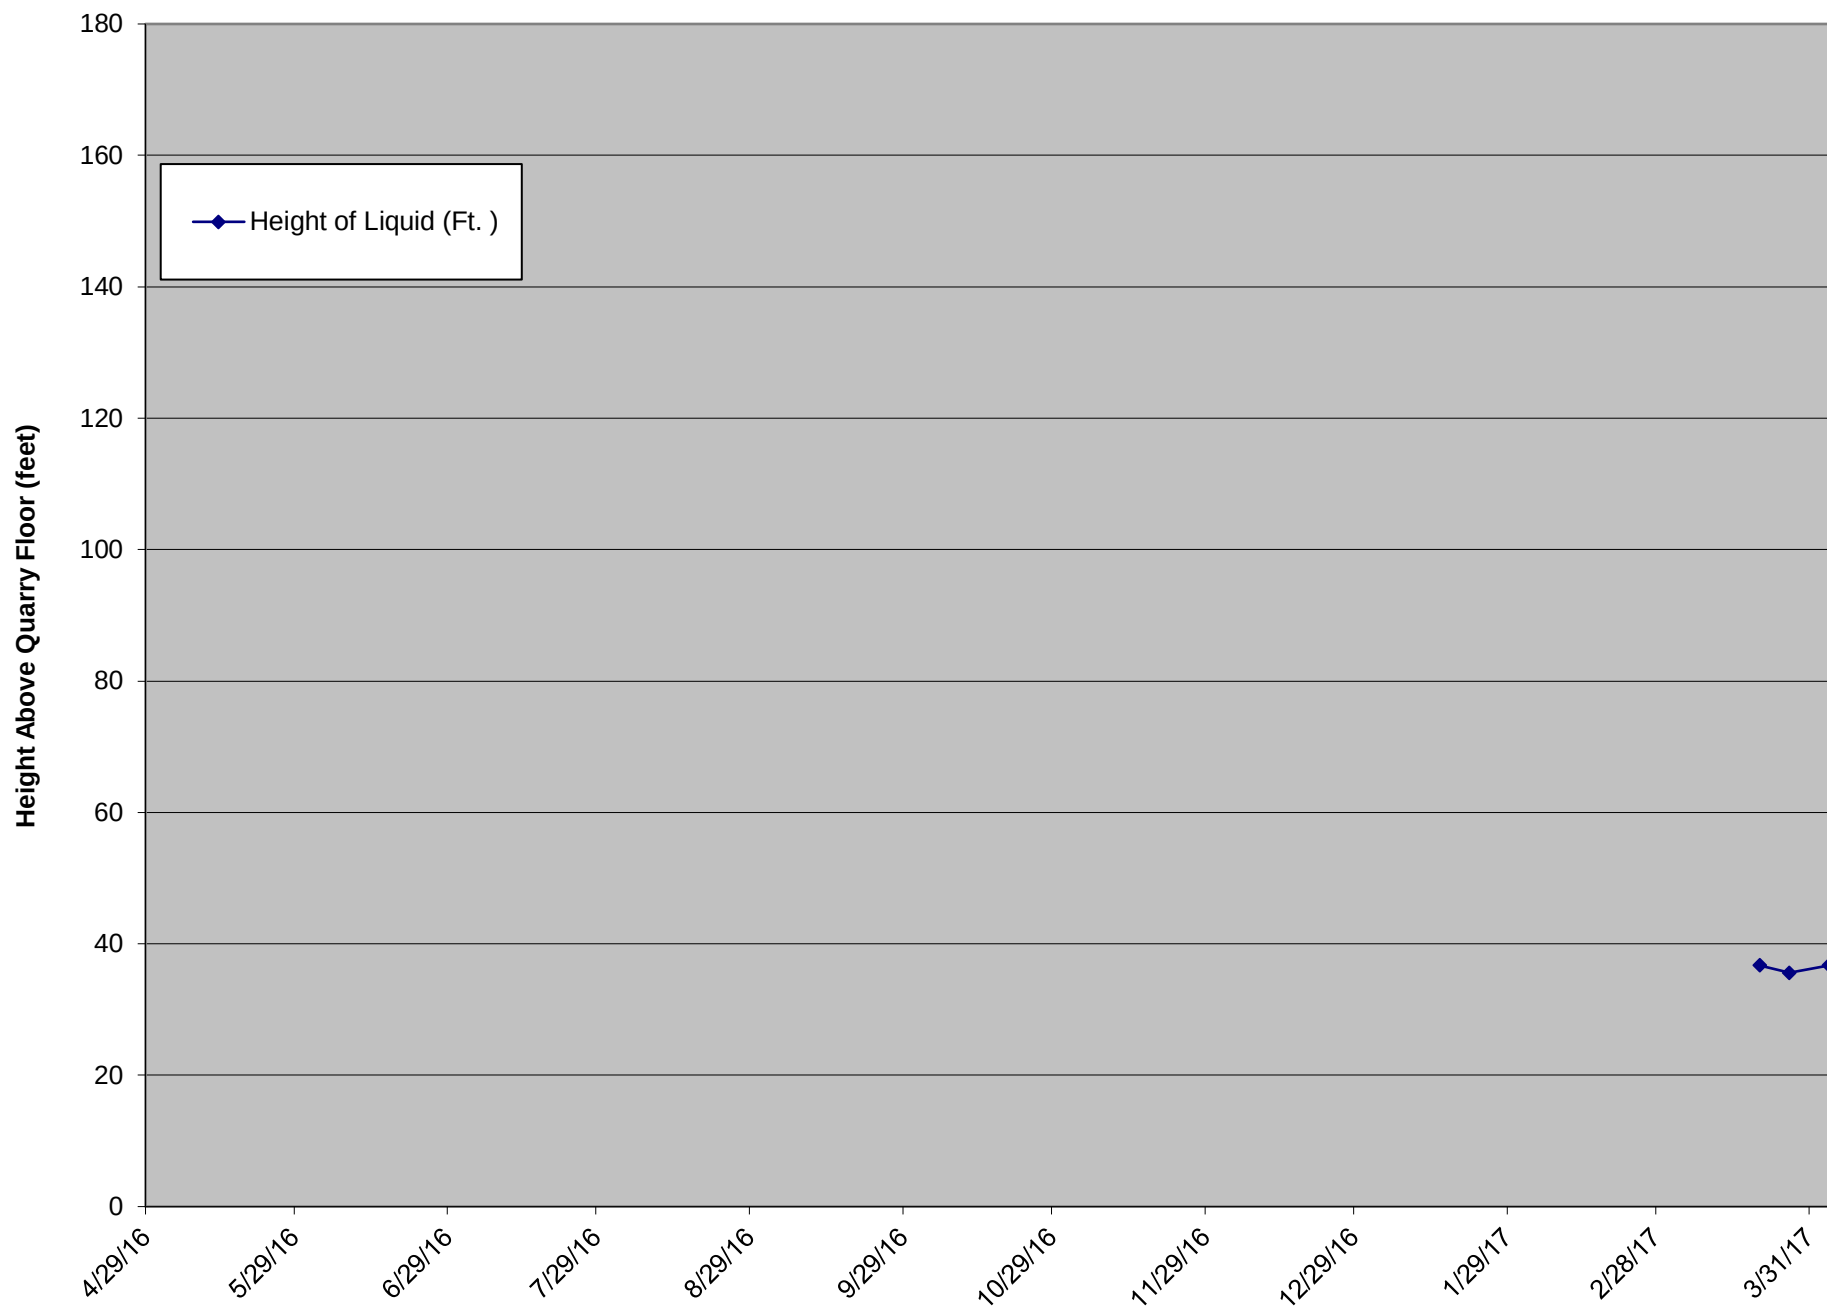
LCS-5B Liquid Level Above Quarry Floor

LCS-5B and LCS-6B were fully operational during the weekly reporting period.

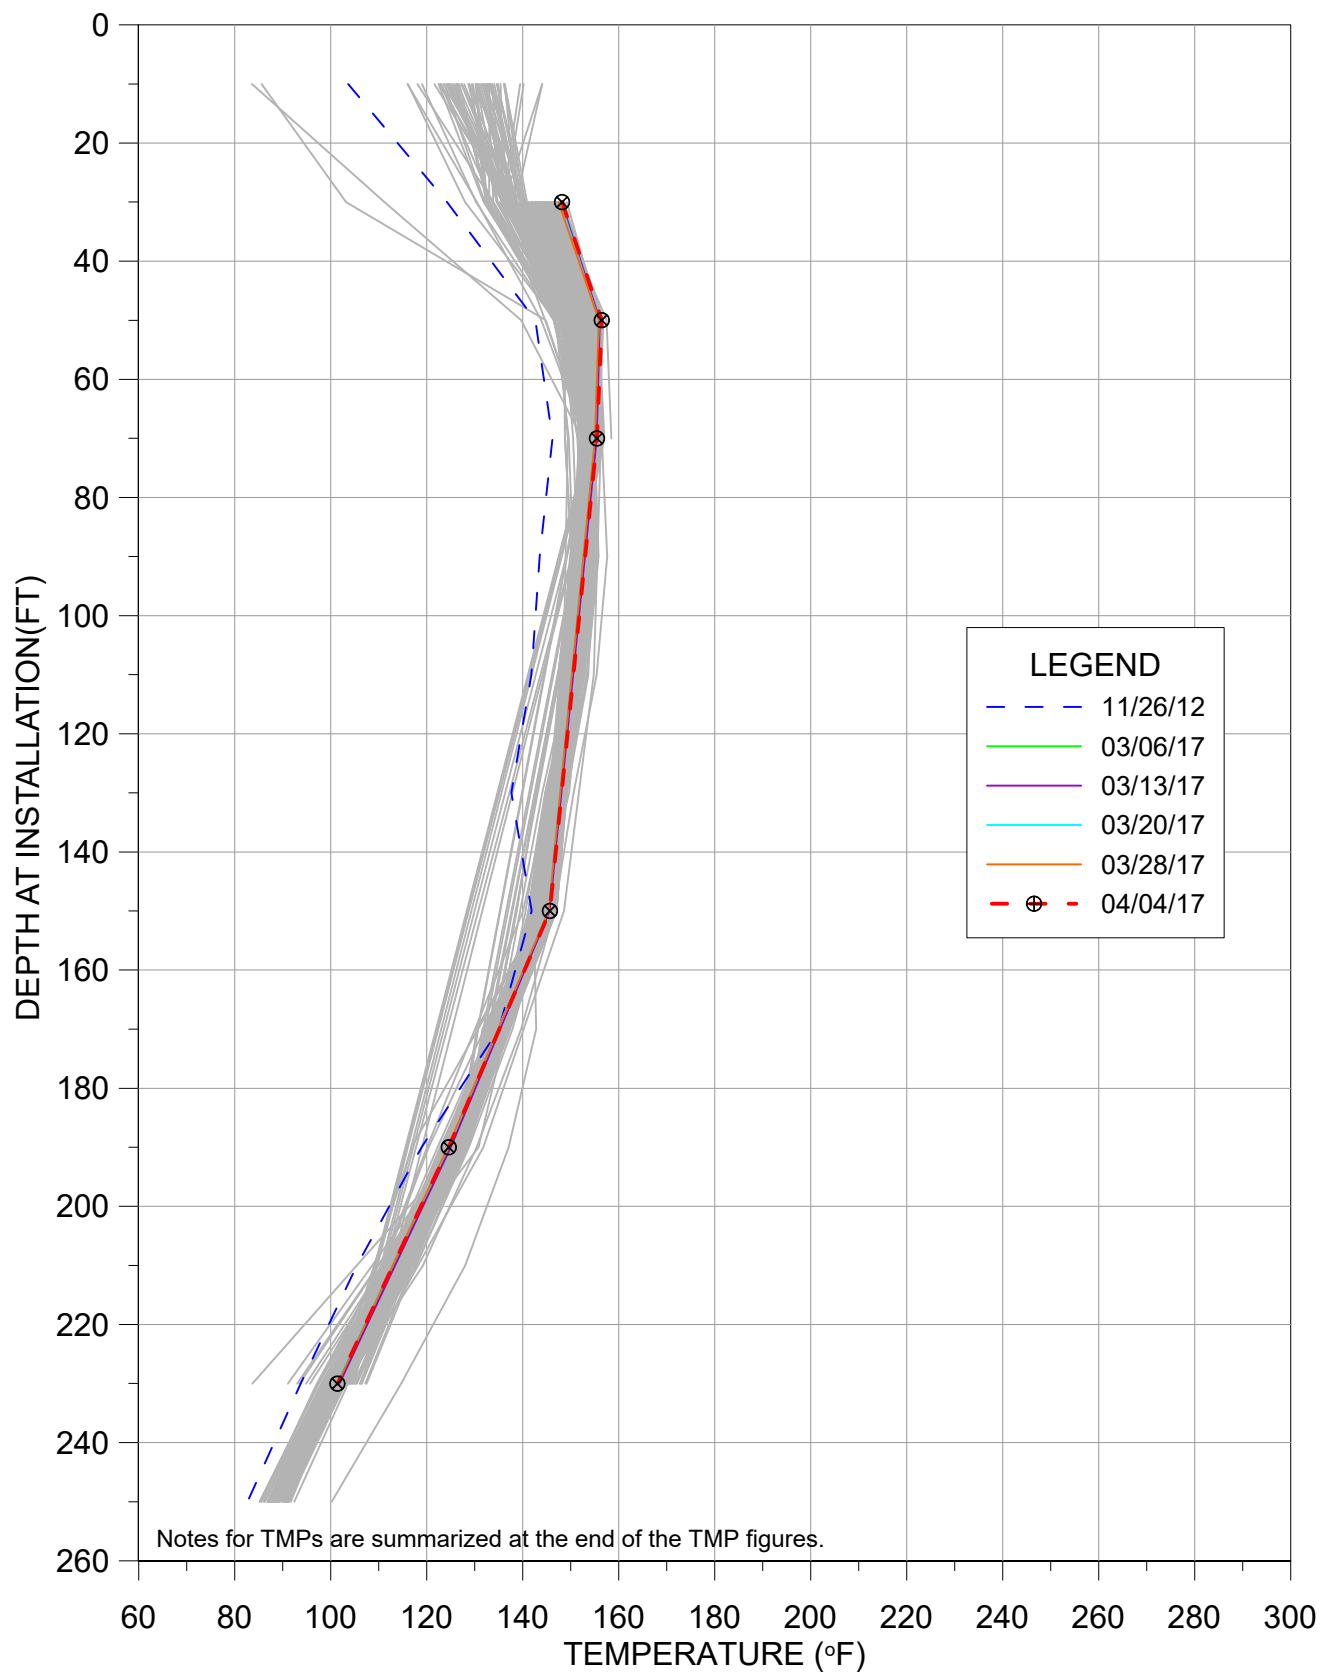
# TMP-3

1. No reliable temperature readings have been obtained at 170 ft depth since 1/29/2014, except on 3/13/2014.
2. The connectivity tests on 4/11/2014 conducted by CEC showed that units at 10, 90, 130, 210 and 250 ft depths are no longer reliable.
3. The connectivity tests on 10/28/2014 conducted by Feezor Engineering showed that units at 10, 90, 110, 130, 210 and 250 ft depths are not reliable.

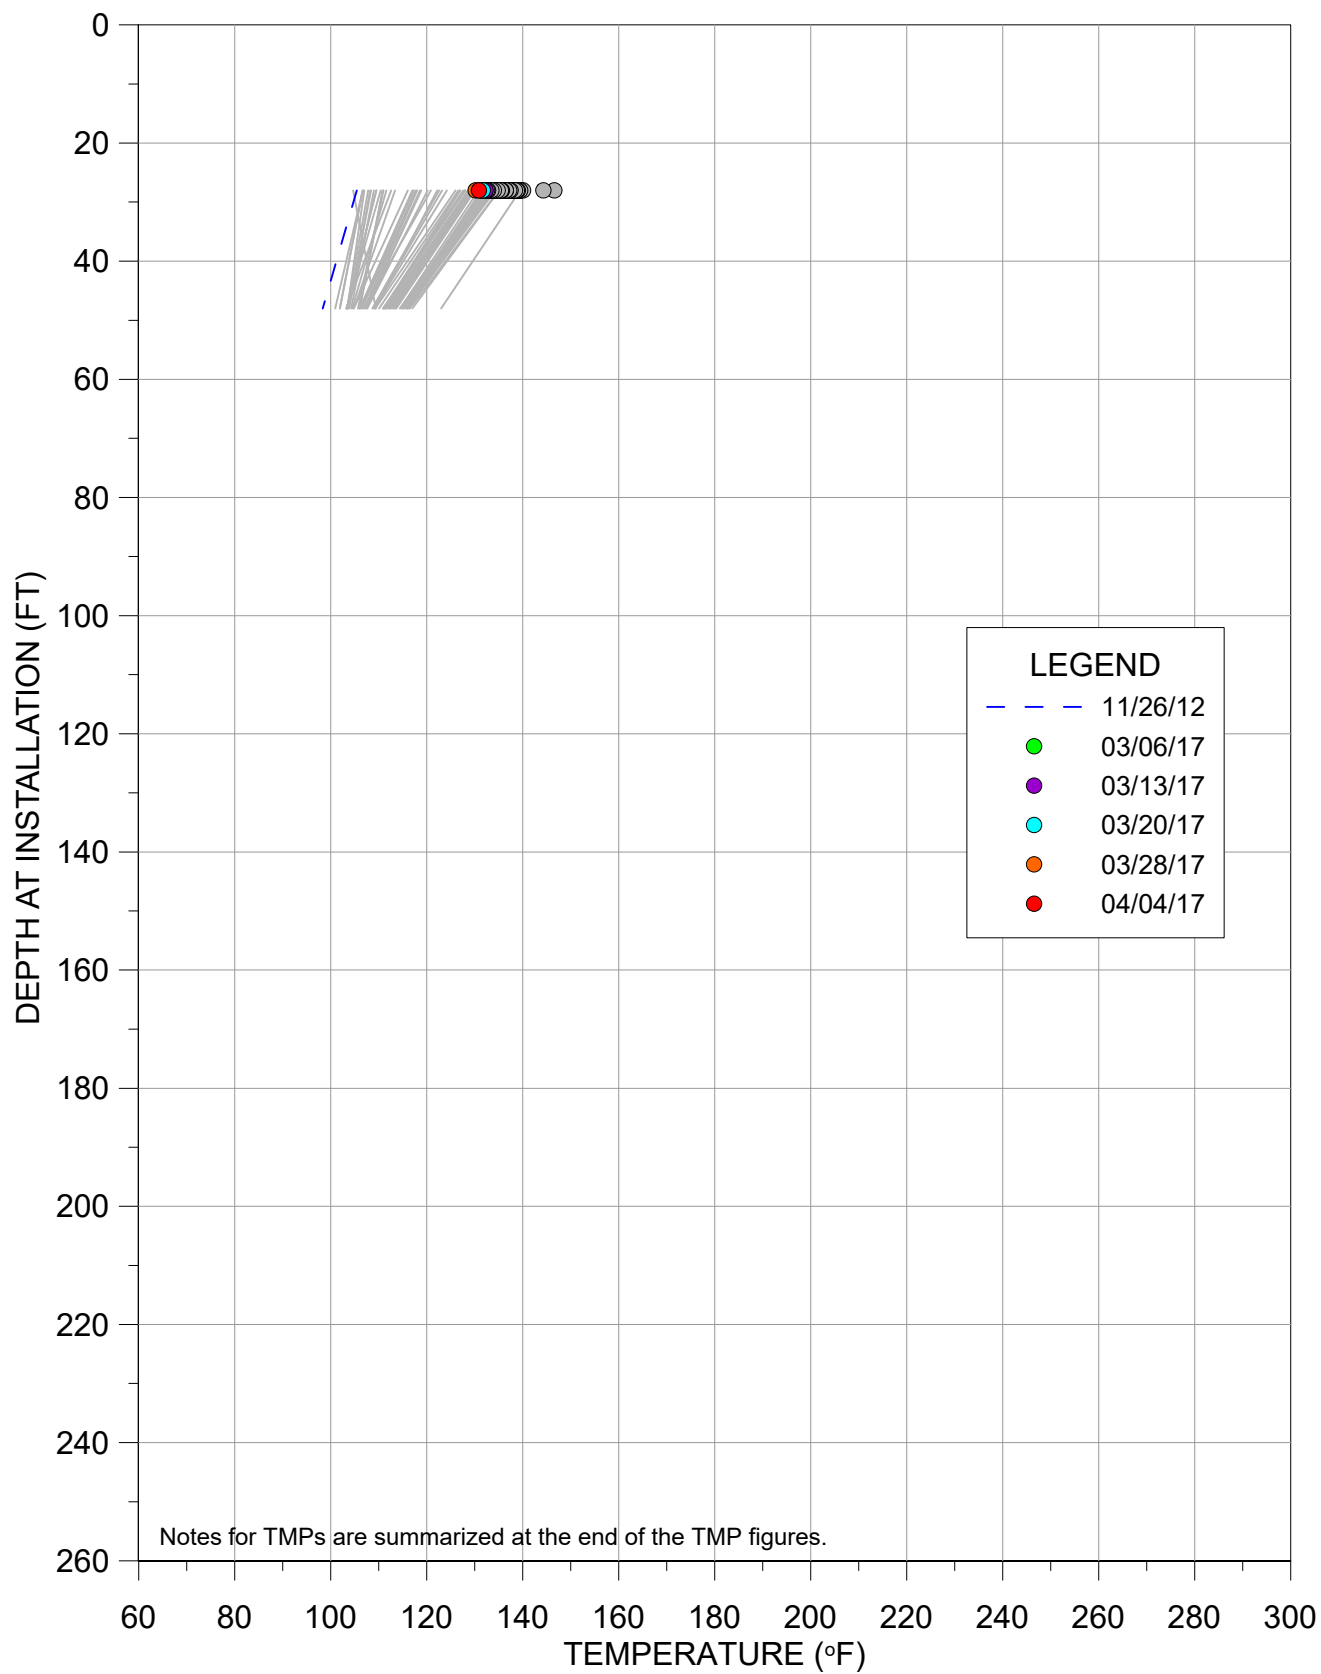
# TMP-4

1. The connectivity tests on 4/11/2014 conducted by CEC showed that the unit at 48 ft depth is no longer reliable.

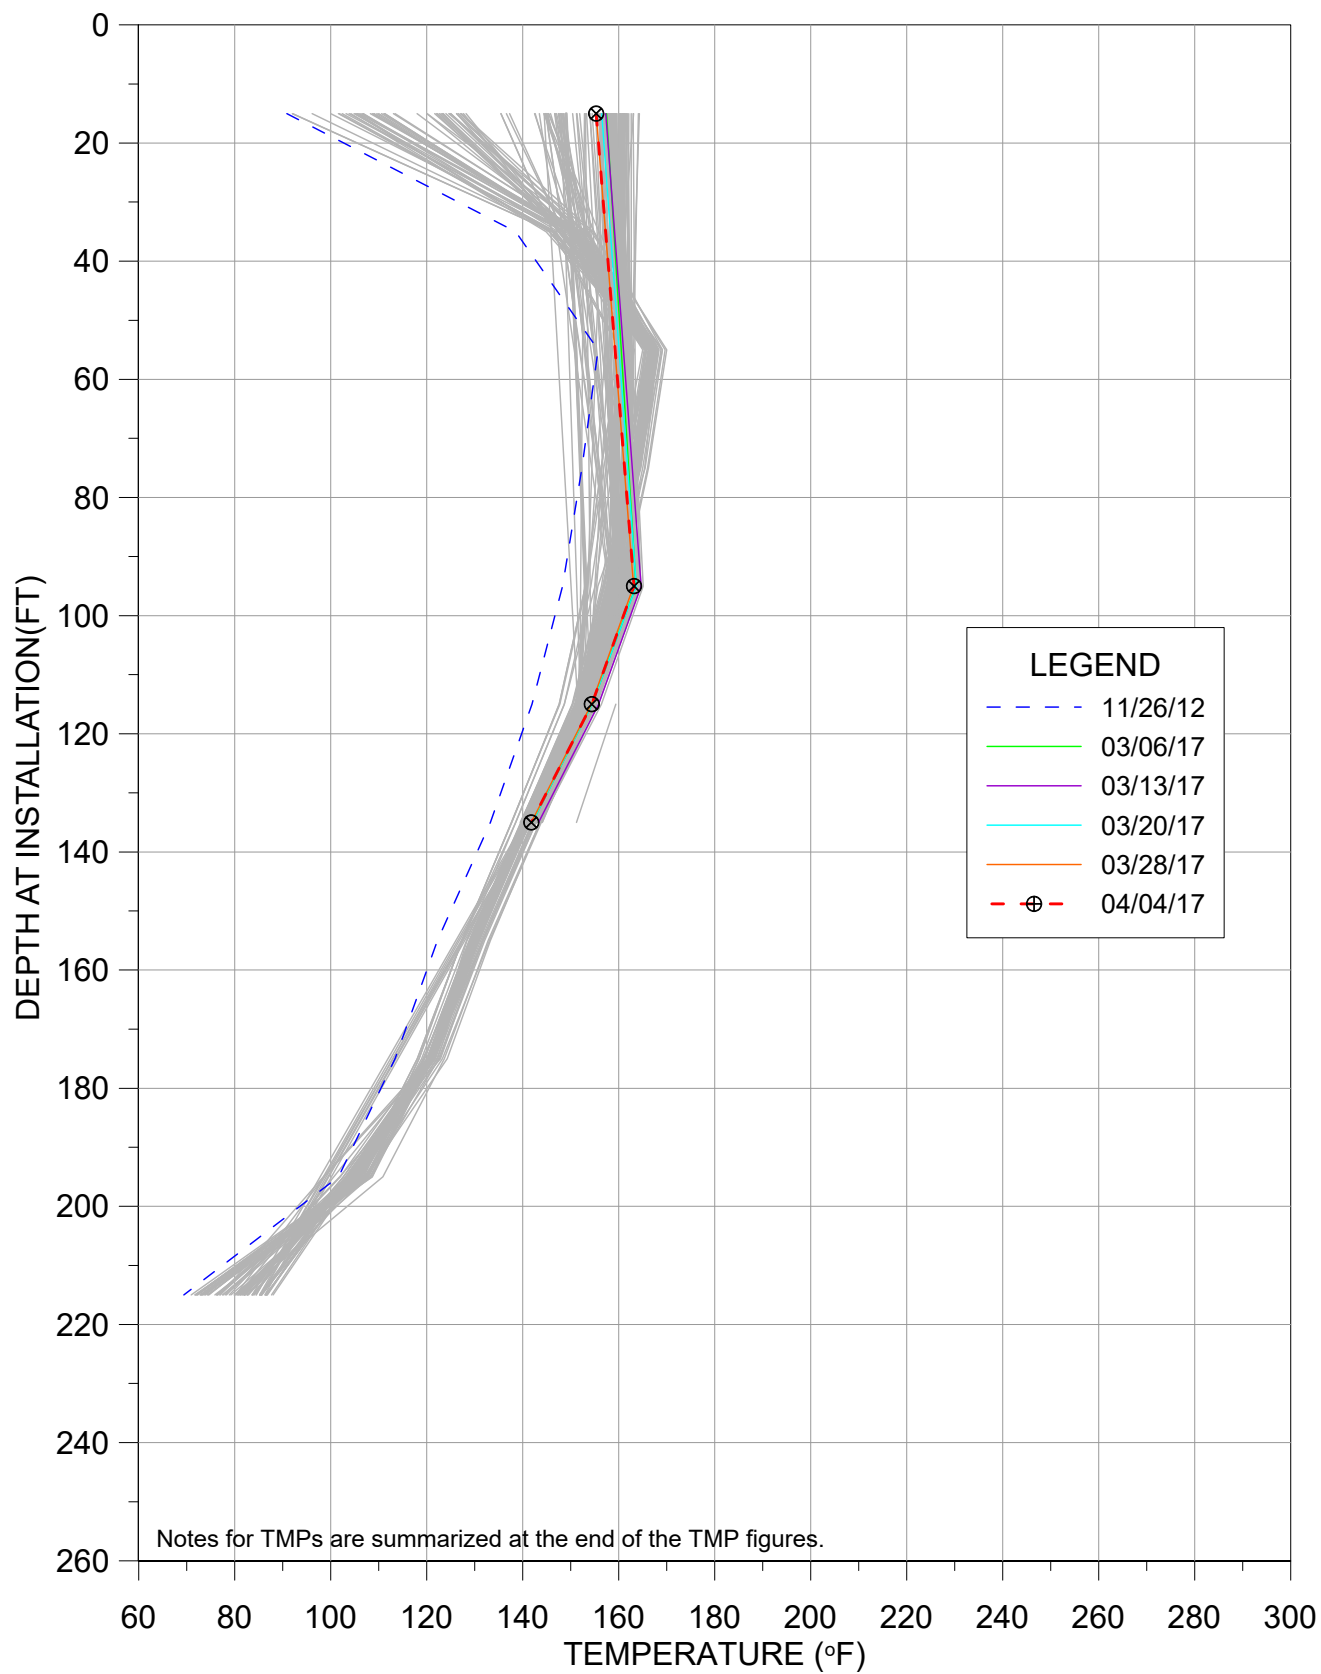
# TMP-6

1. The connectivity tests on 4/11/2014 conducted by CEC showed that units at 35, 55, 75, 155, 175, and 195 ft depths are no longer reliable.
2. No reliable temperature readings have been obtained at the unit at 215 ft depth since 6/13/2014.

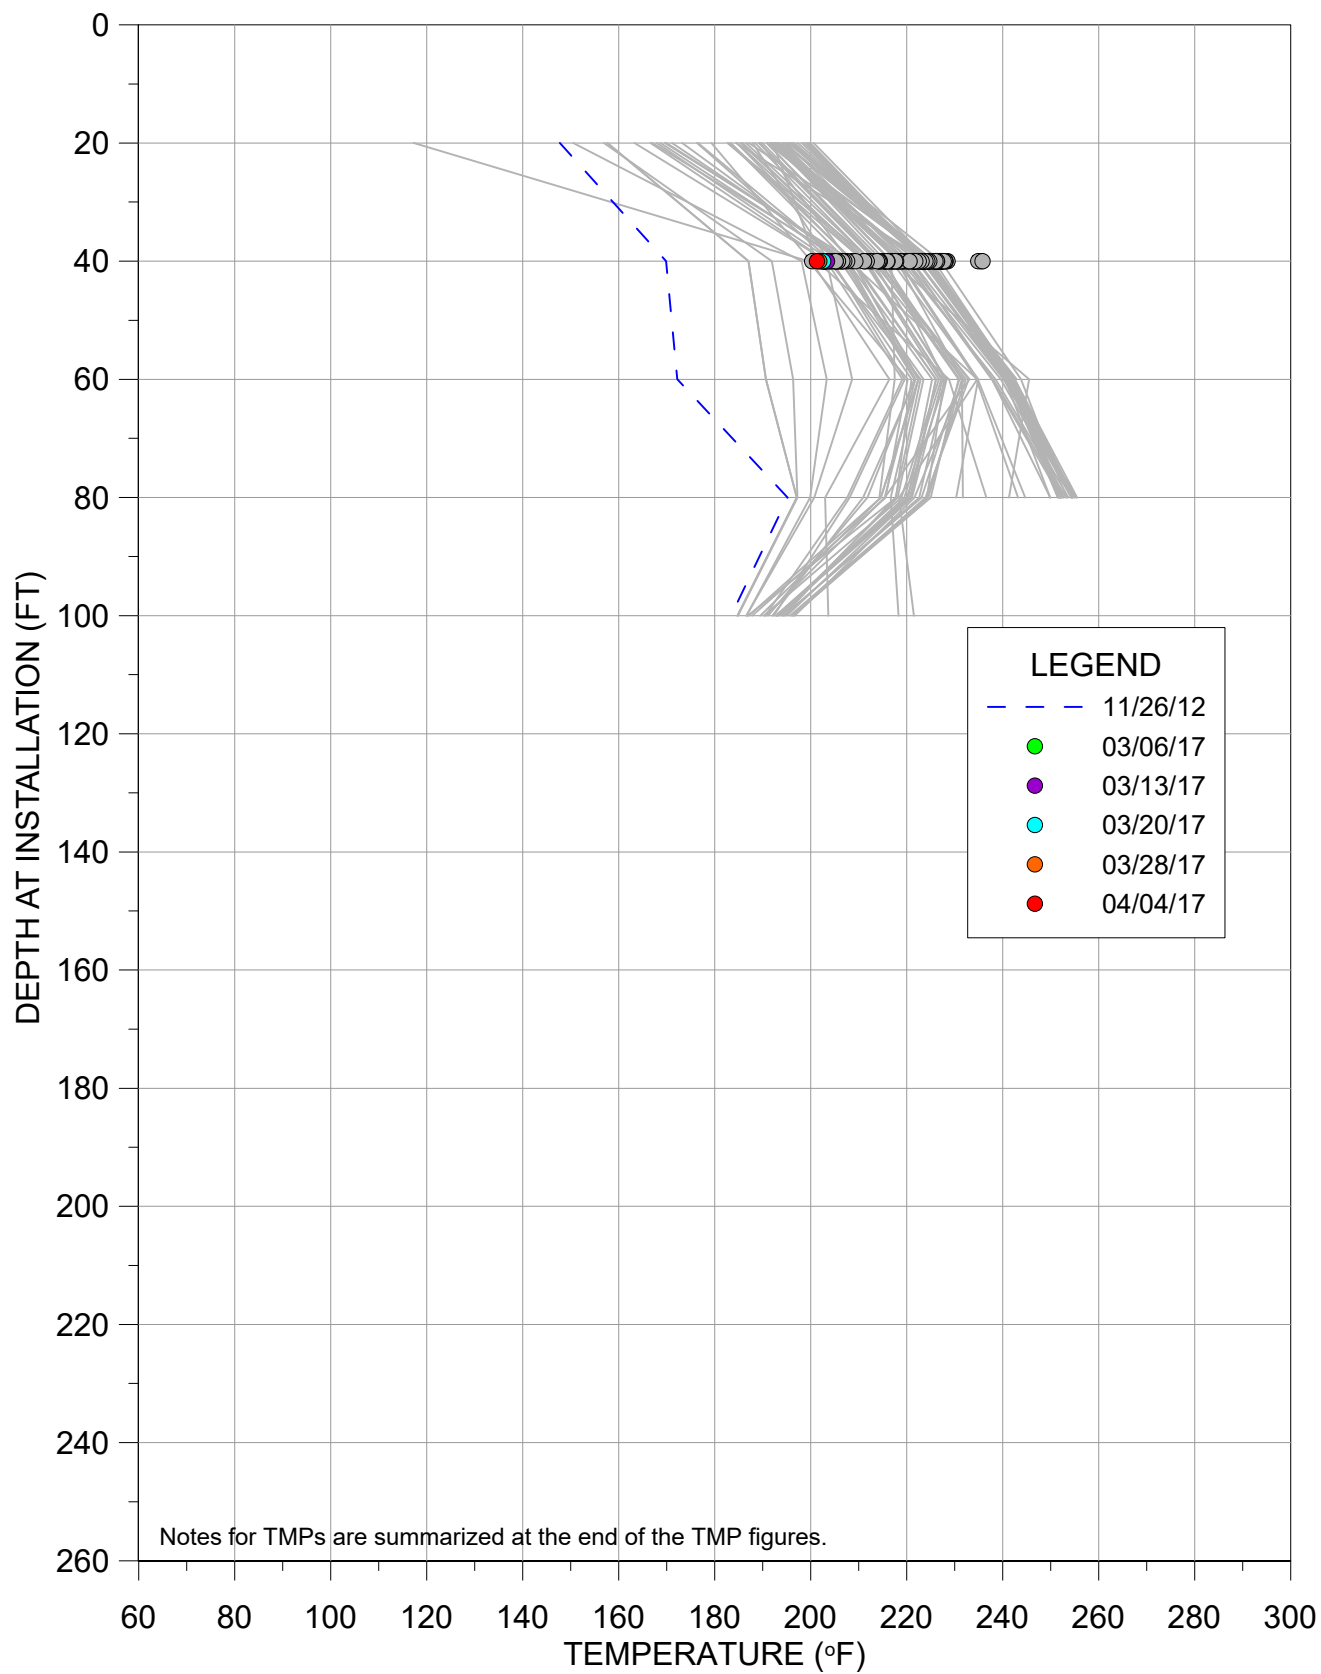
# TMP-9

1. Unit at 100 ft depth had an inaccurate temperature reading on 8/1/2013 and no reading since 8/6/2013.
2. The connectivity tests on 4/11/2014 conducted by CEC showed that units at 20, 60, 80, and 100 ft depths are no longer reliable.

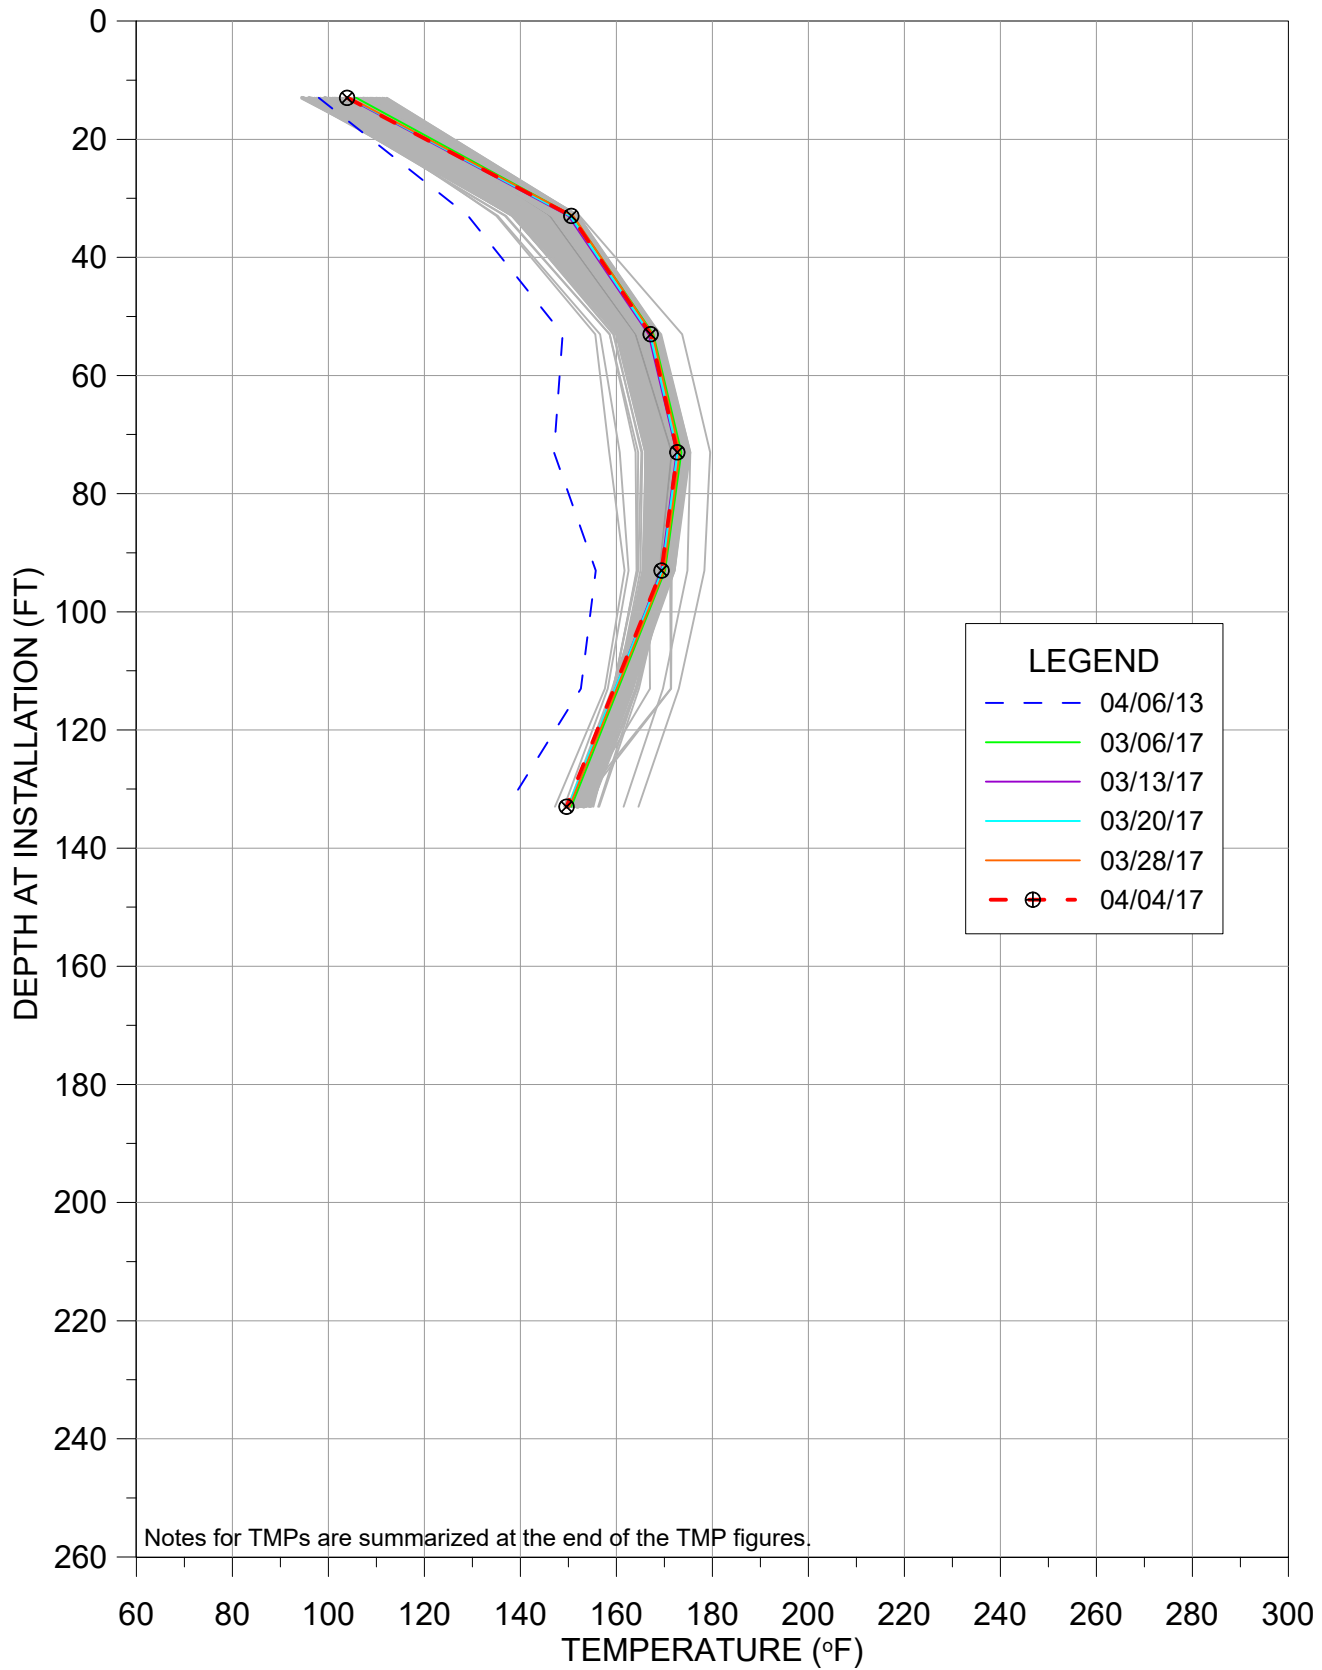
# TMP-10

1. Unit at 113 ft had resistance below the minimum level, change in resistance occurred as of 11/08/16 and has remained below acceptable level.
