# **Bridgeton Landfill, LLC**

## **Weekly Data Submittal**

**Week of April 2, 2017 – April 8, 2017**

**Required by Section 52.F of Agreed Order, Case No. 13SL-CC01088  
Effective May 13, 2013**

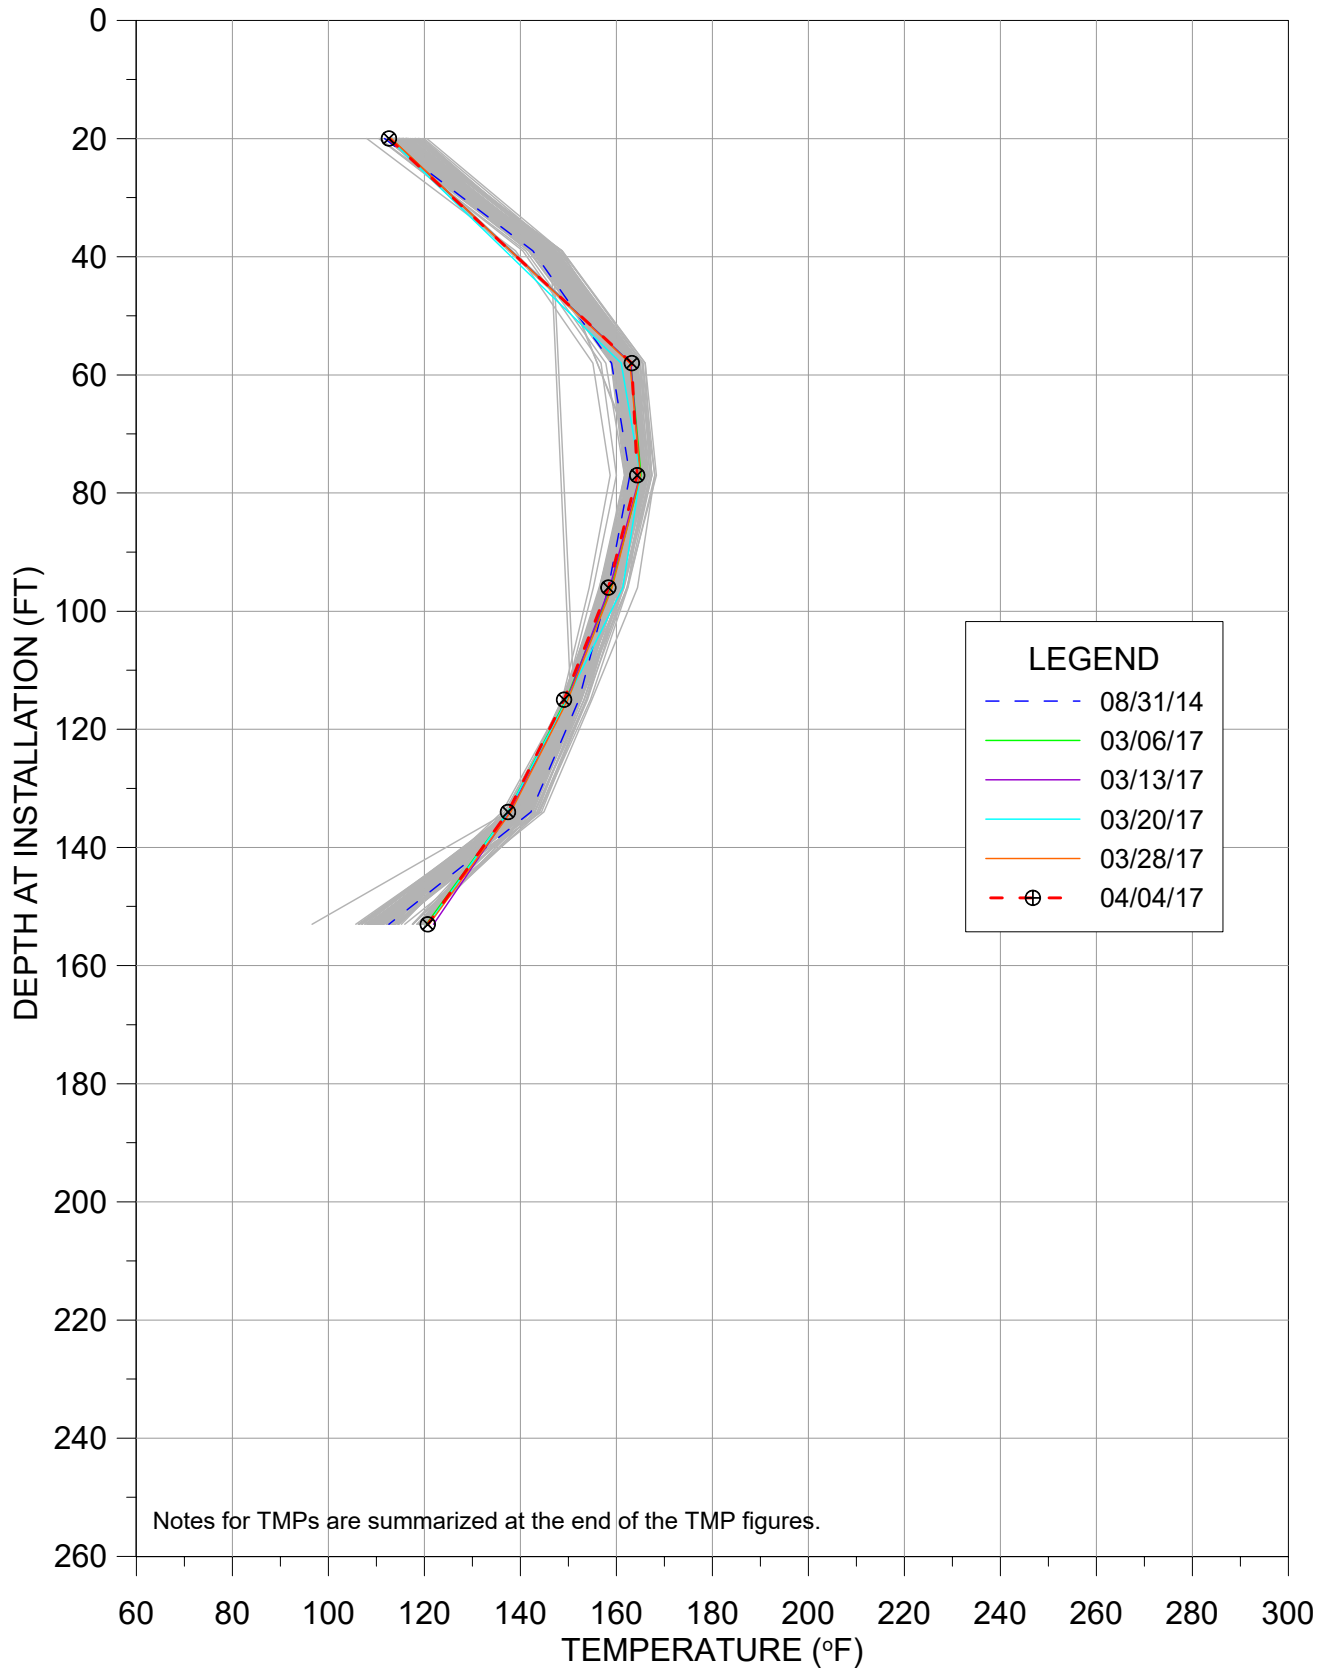
# TMP-16

1. A connectivity test conducted by Feezor Engineering showed that the units on TMP-16 may not be reliable since 9/9/2015. Further testing at the end of September 2015 showed possible connectivity on some of the units.
2. The unit at 153 ft depth had a low resistance reading and unreliable temperature since 12/21/2015.

3. The unit at 39 ft depth had a higher than acceptable resistance reading and unreliable temperature since 2/7/2017.

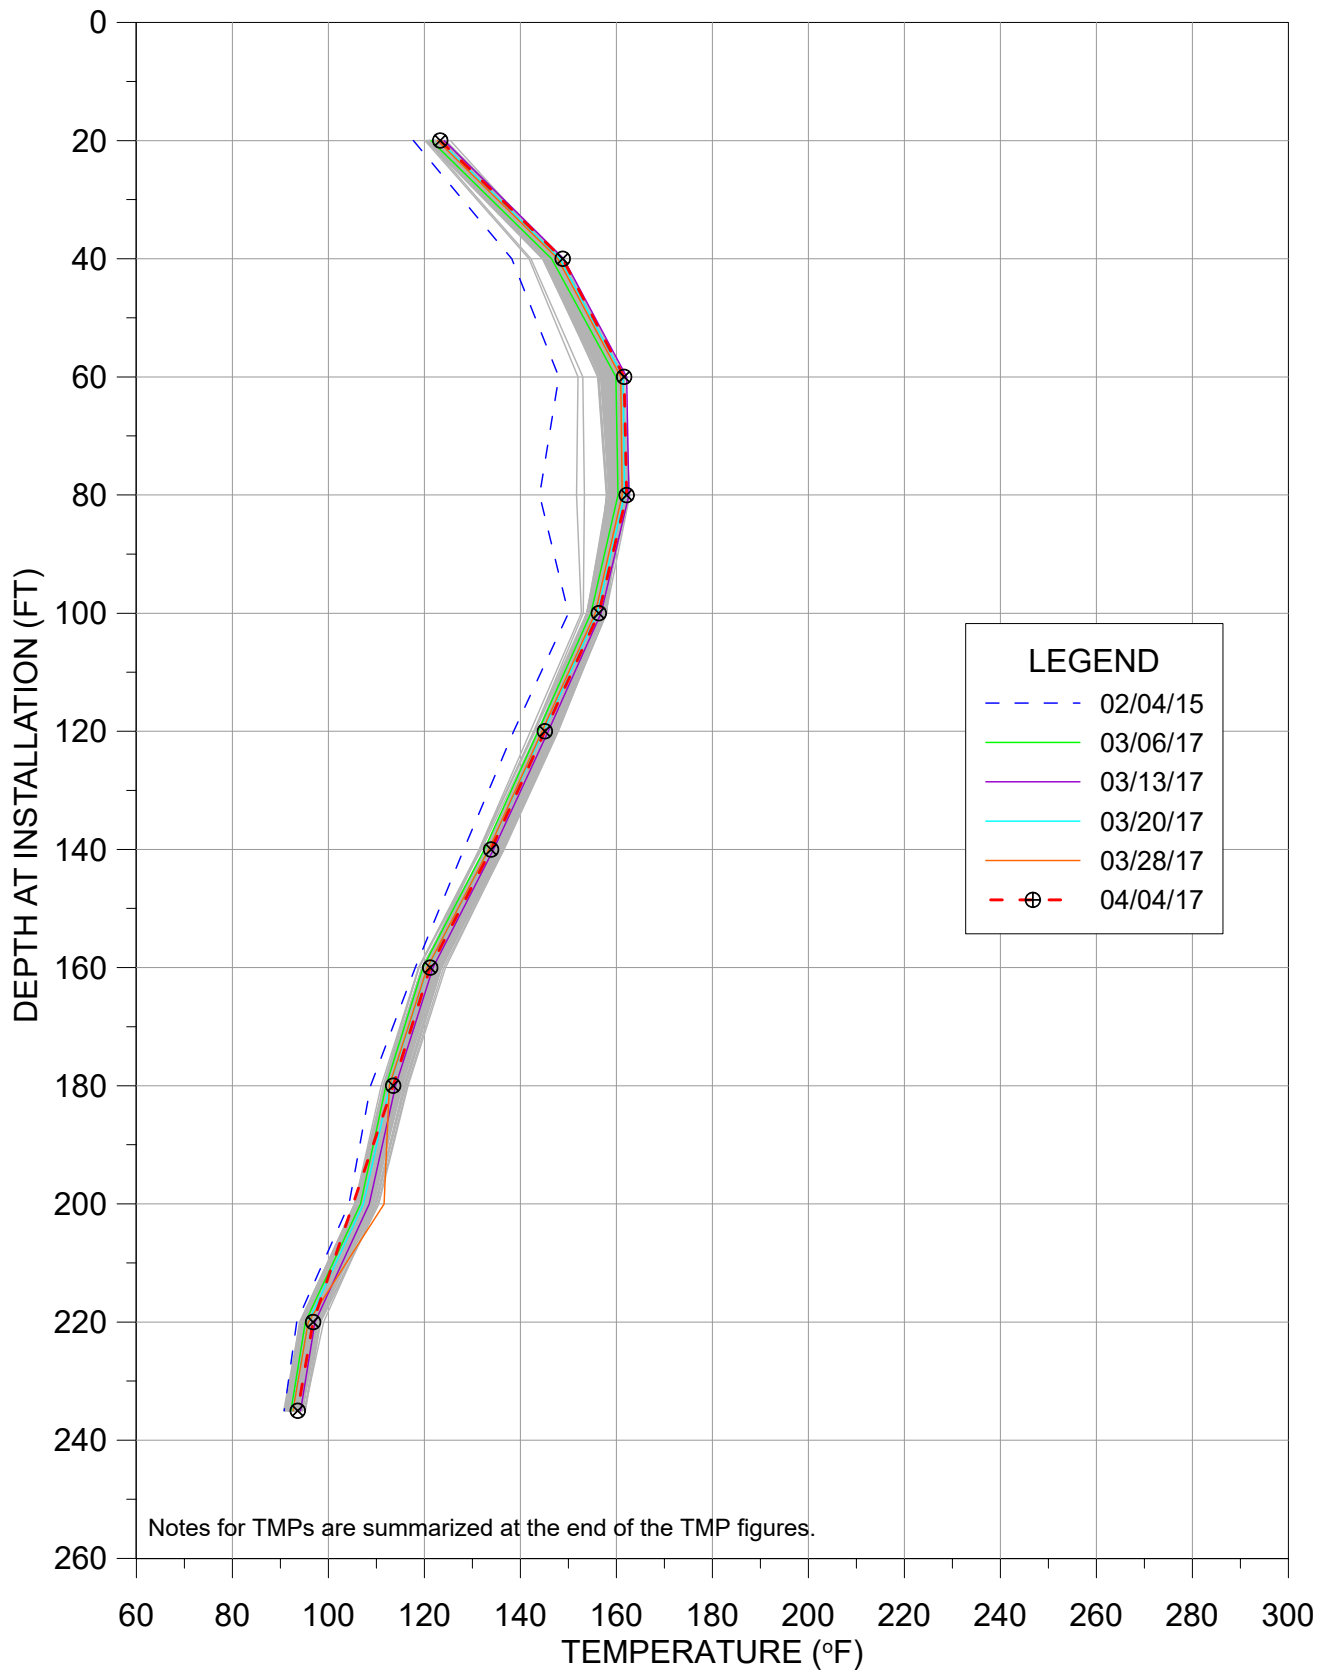
# TMP-25

1. The unit at 200 ft provided an apparent anomalous reading **on 3/28/2017**. Subsequent readings on 4/4/2017 showed the unit to have failed (**see below**). The unit is no longer working and the reading of **3/28/2017** was likely unreliable.
2. **The unit at 200 ft depth had a resistance reading greater 4000 ohms on 4/4/2017. A connectivity test conducted by Feezor Engineering on 4/7/2017 showed that this unit also had cross-connectivity. The unit is therefore determined to be no longer working as of the 4/4/2017 reading.**

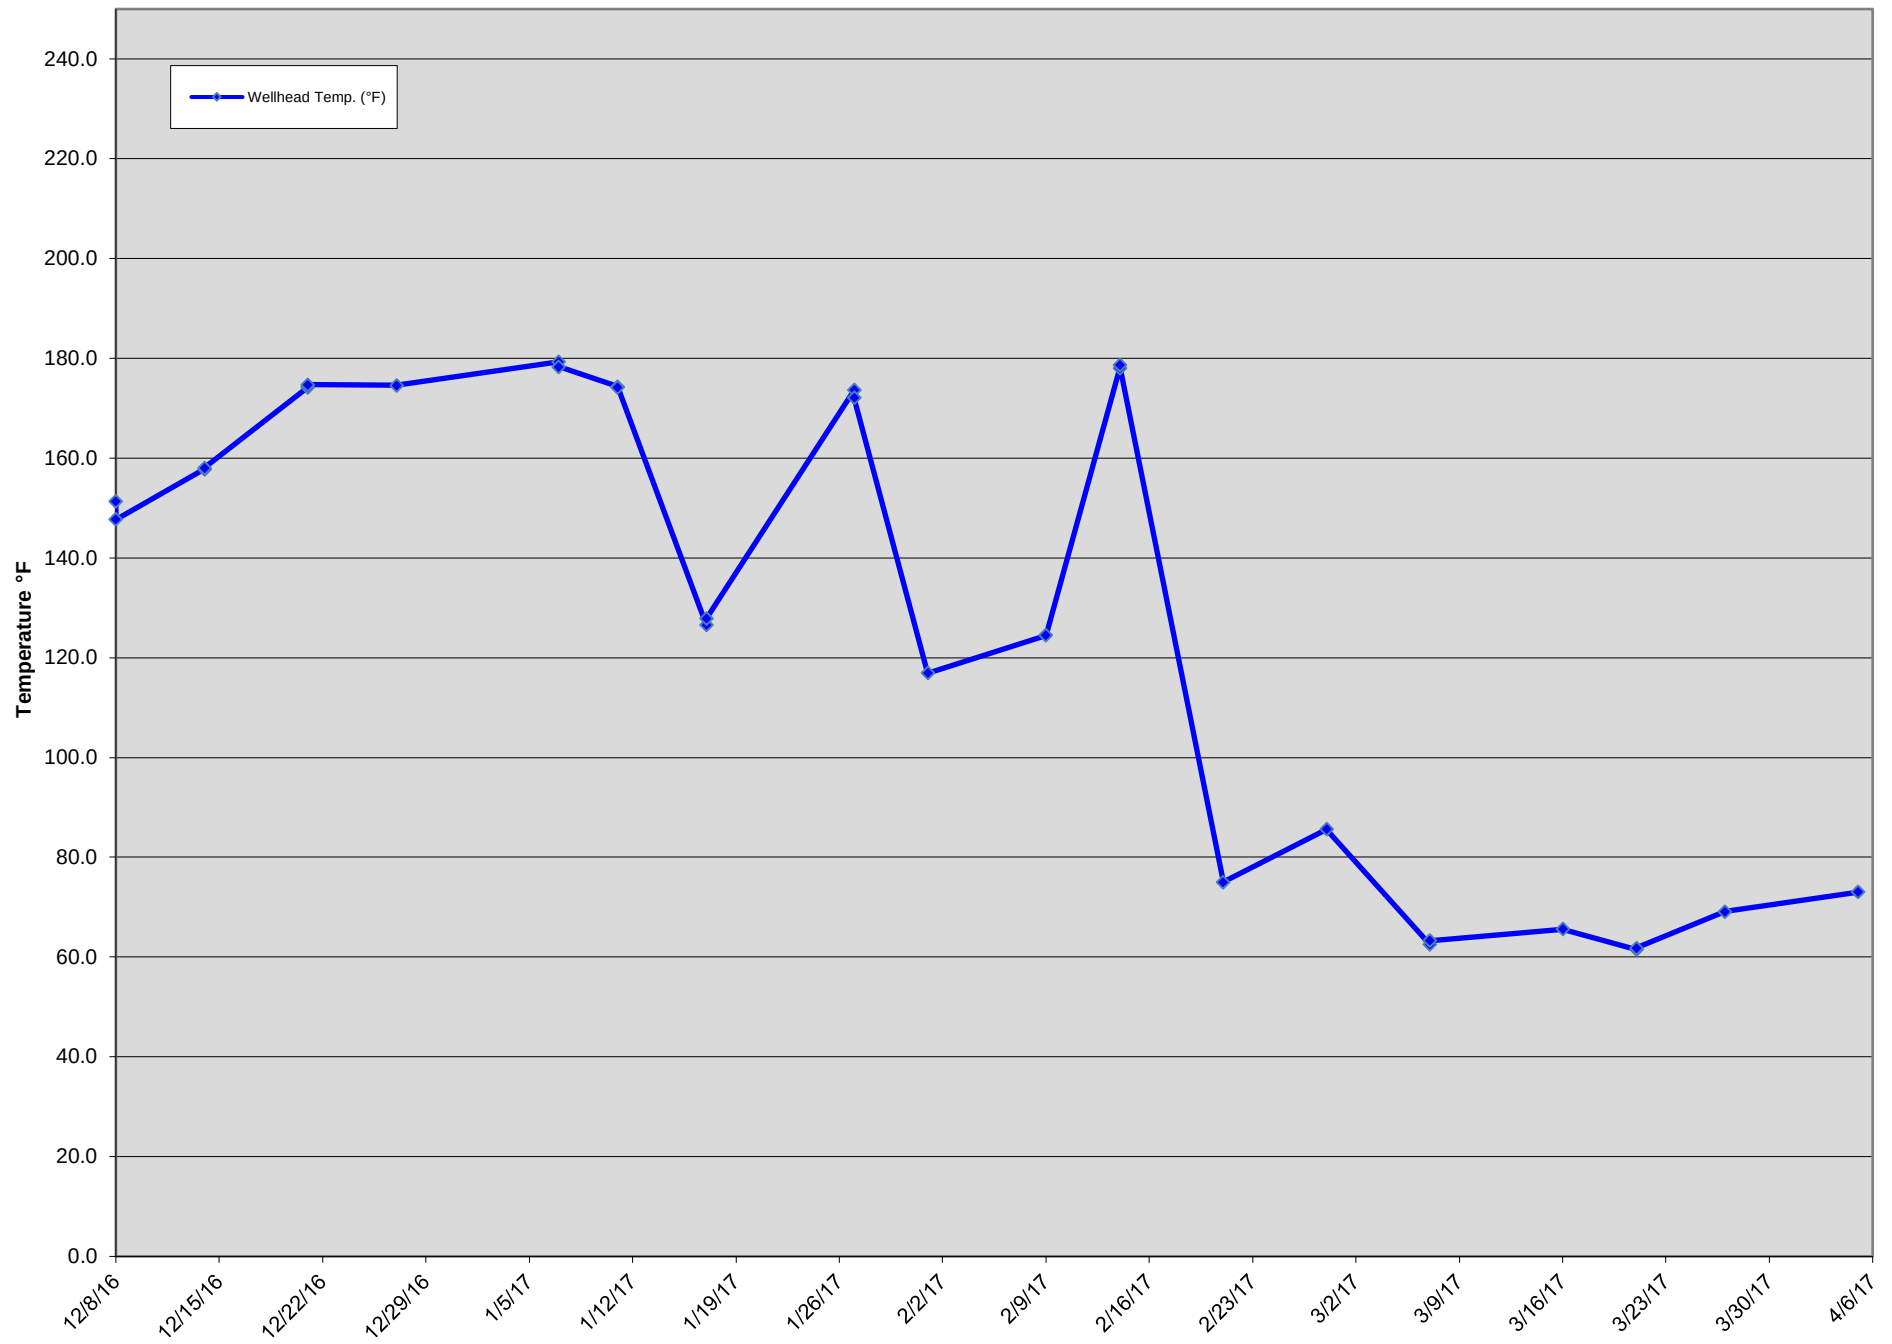
GIW-1 Wellhead Temperatures

As part of the HES, there are currently cooling water circulation loops installed in twelve Gas Interceptor Wells (GIWs) (GIW-02 through GIW-13). The remaining well (GIW-01) had a measured gas temperature within its historical operating limits.
