# **Bridgeton Landfill, LLC**

## **Weekly Data Submittal**

**Week of April 9, 2017 – April 15, 2017**

**Required by Section 52.F of Agreed Order, Case No. 13SL-CC01088  
Effective May 13, 2013**

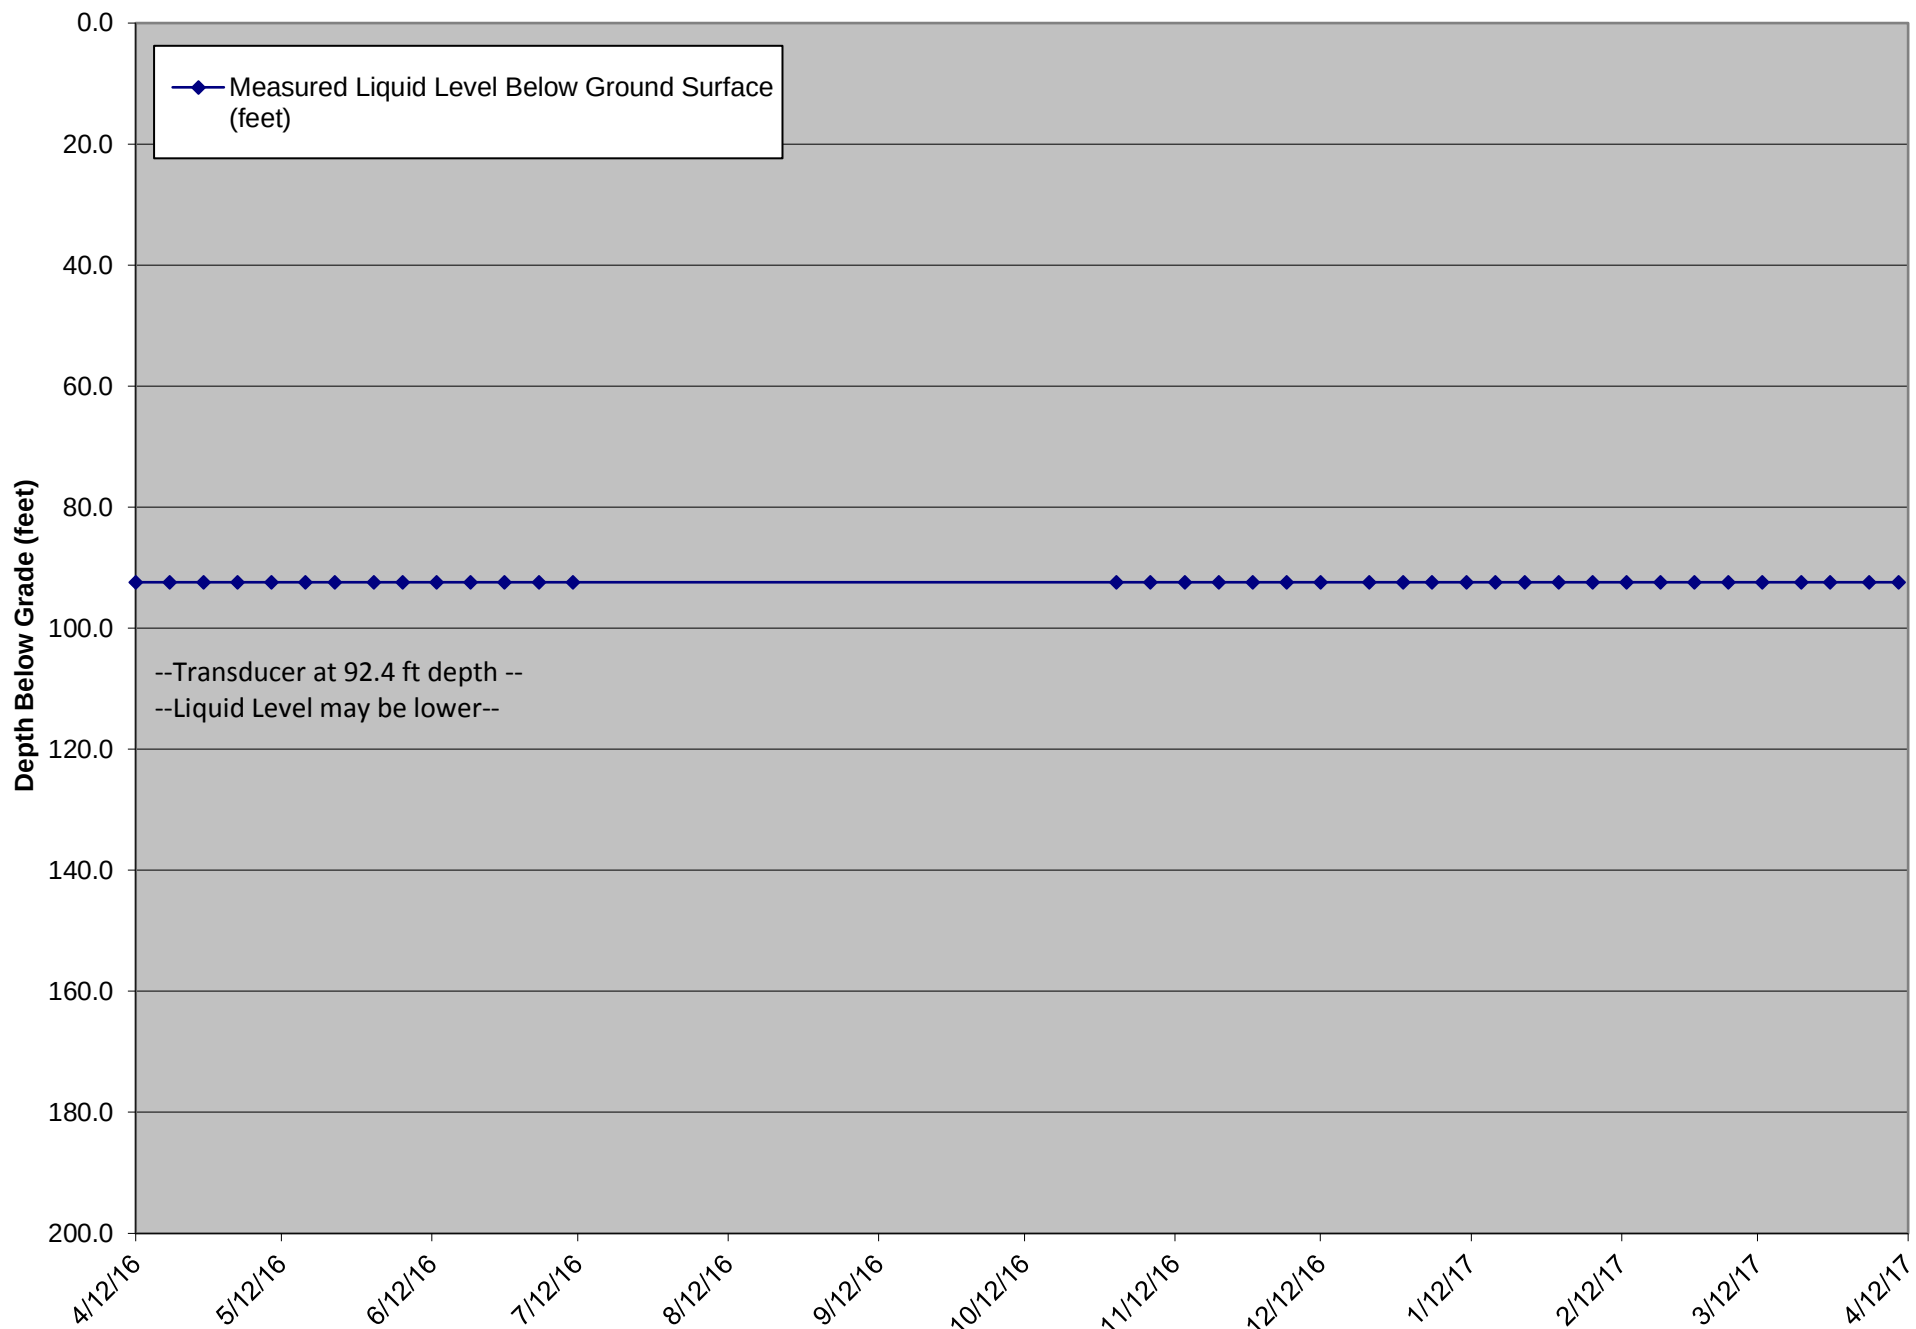
# LCS-1D Liquid Level Below Ground Surface

LCS-1D is equipped with a level sensor and a flow meter. Bridgeton Landfill confirmed that the flow meter on LCS-1D is operational and the flow was observed during the weekly reporting period. Liquid level was not recorded by the level sensor during the weekly reporting period. Bridgeton Landfill is currently looking into replacing the level sensor on LCS-1D.

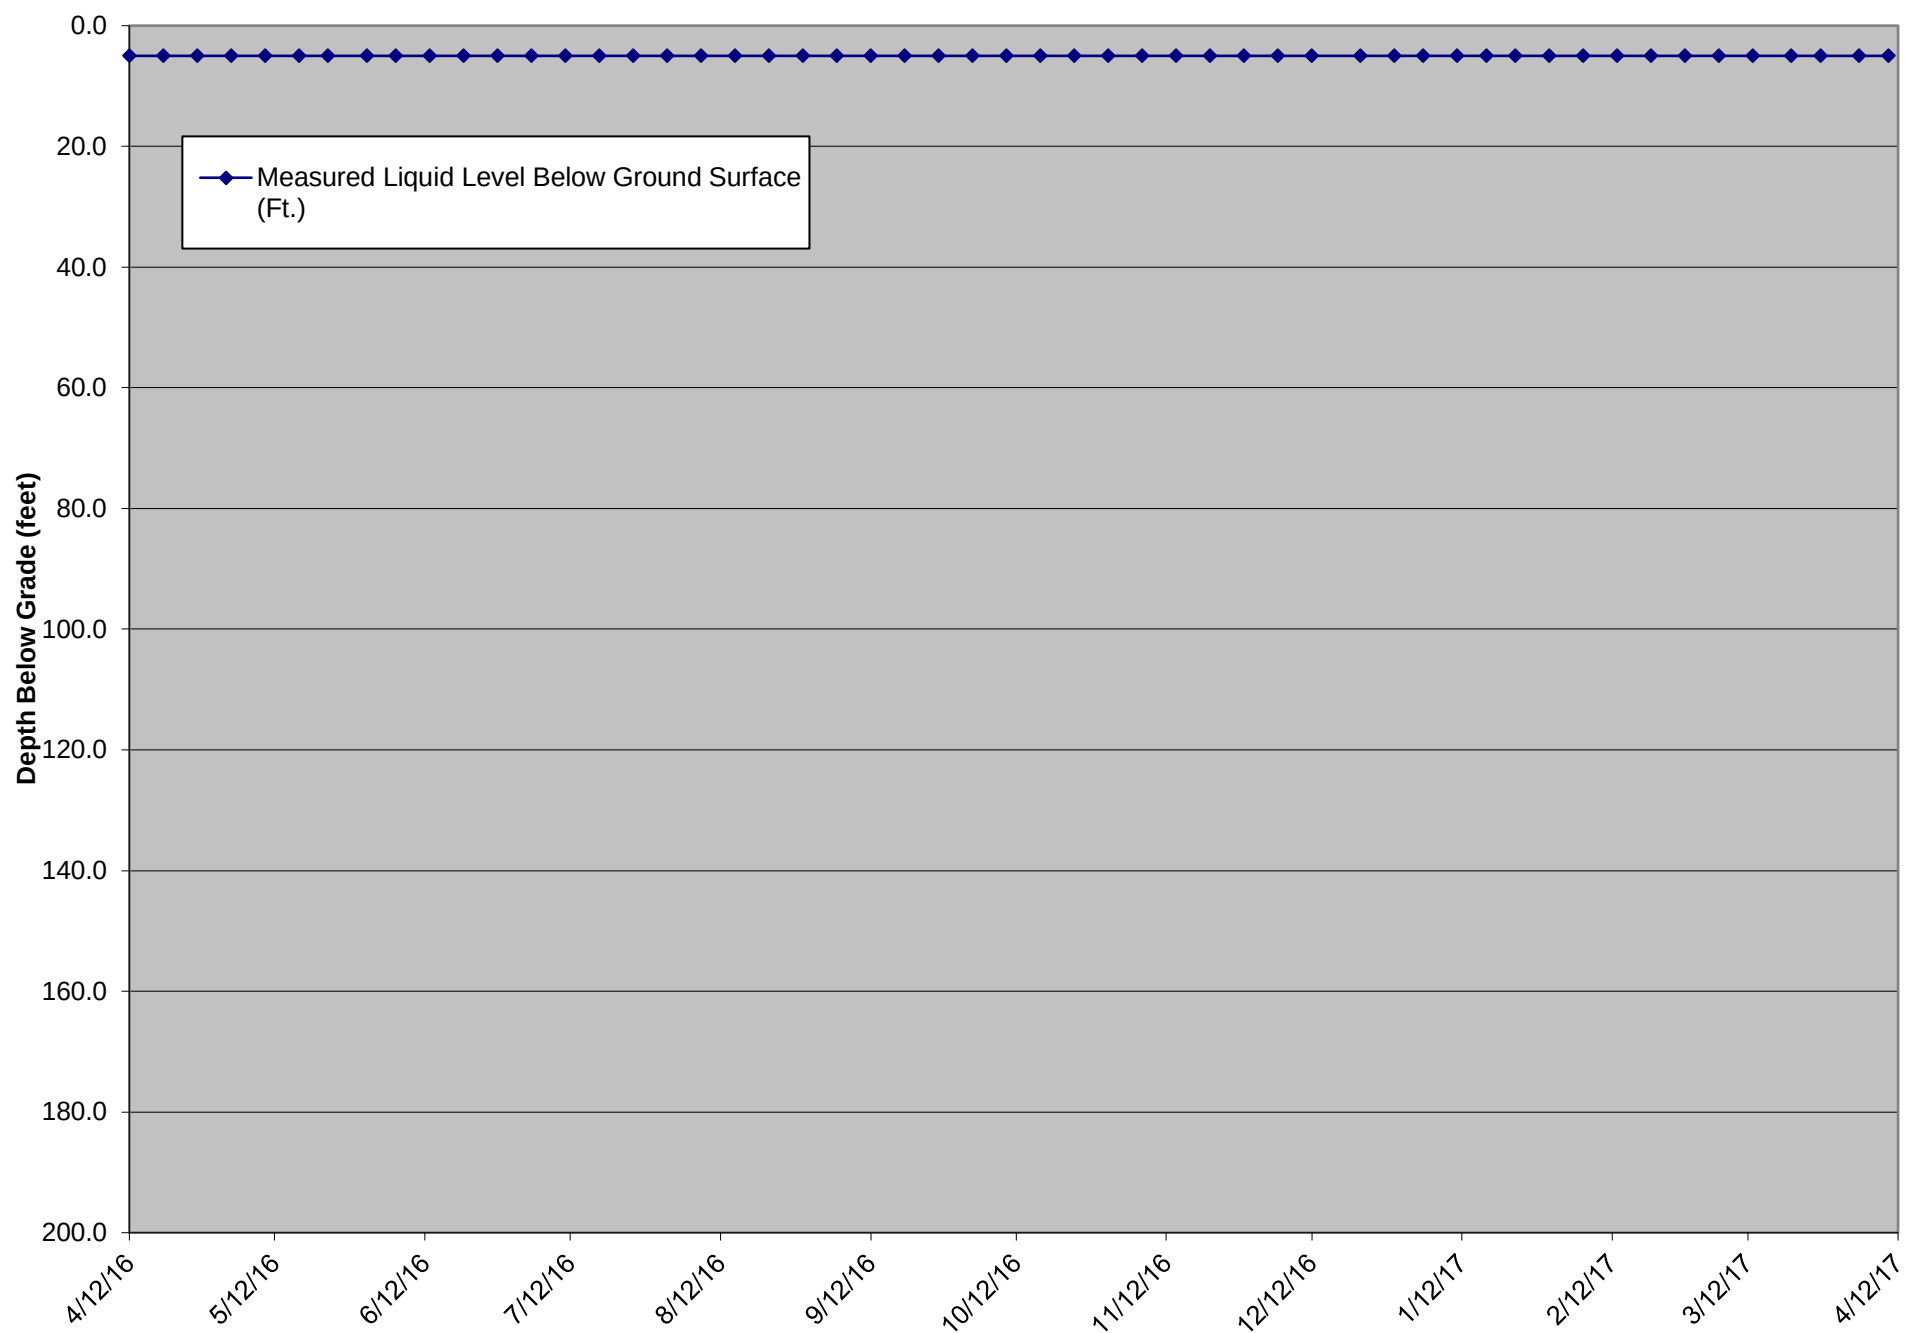
# LCS-3D Liquid Level Below Ground Surface

The pumps in LCS-2D and LCS-3D were non-operational during the weekly reporting period. The transducer in LCS-3D continued to report liquid levels.

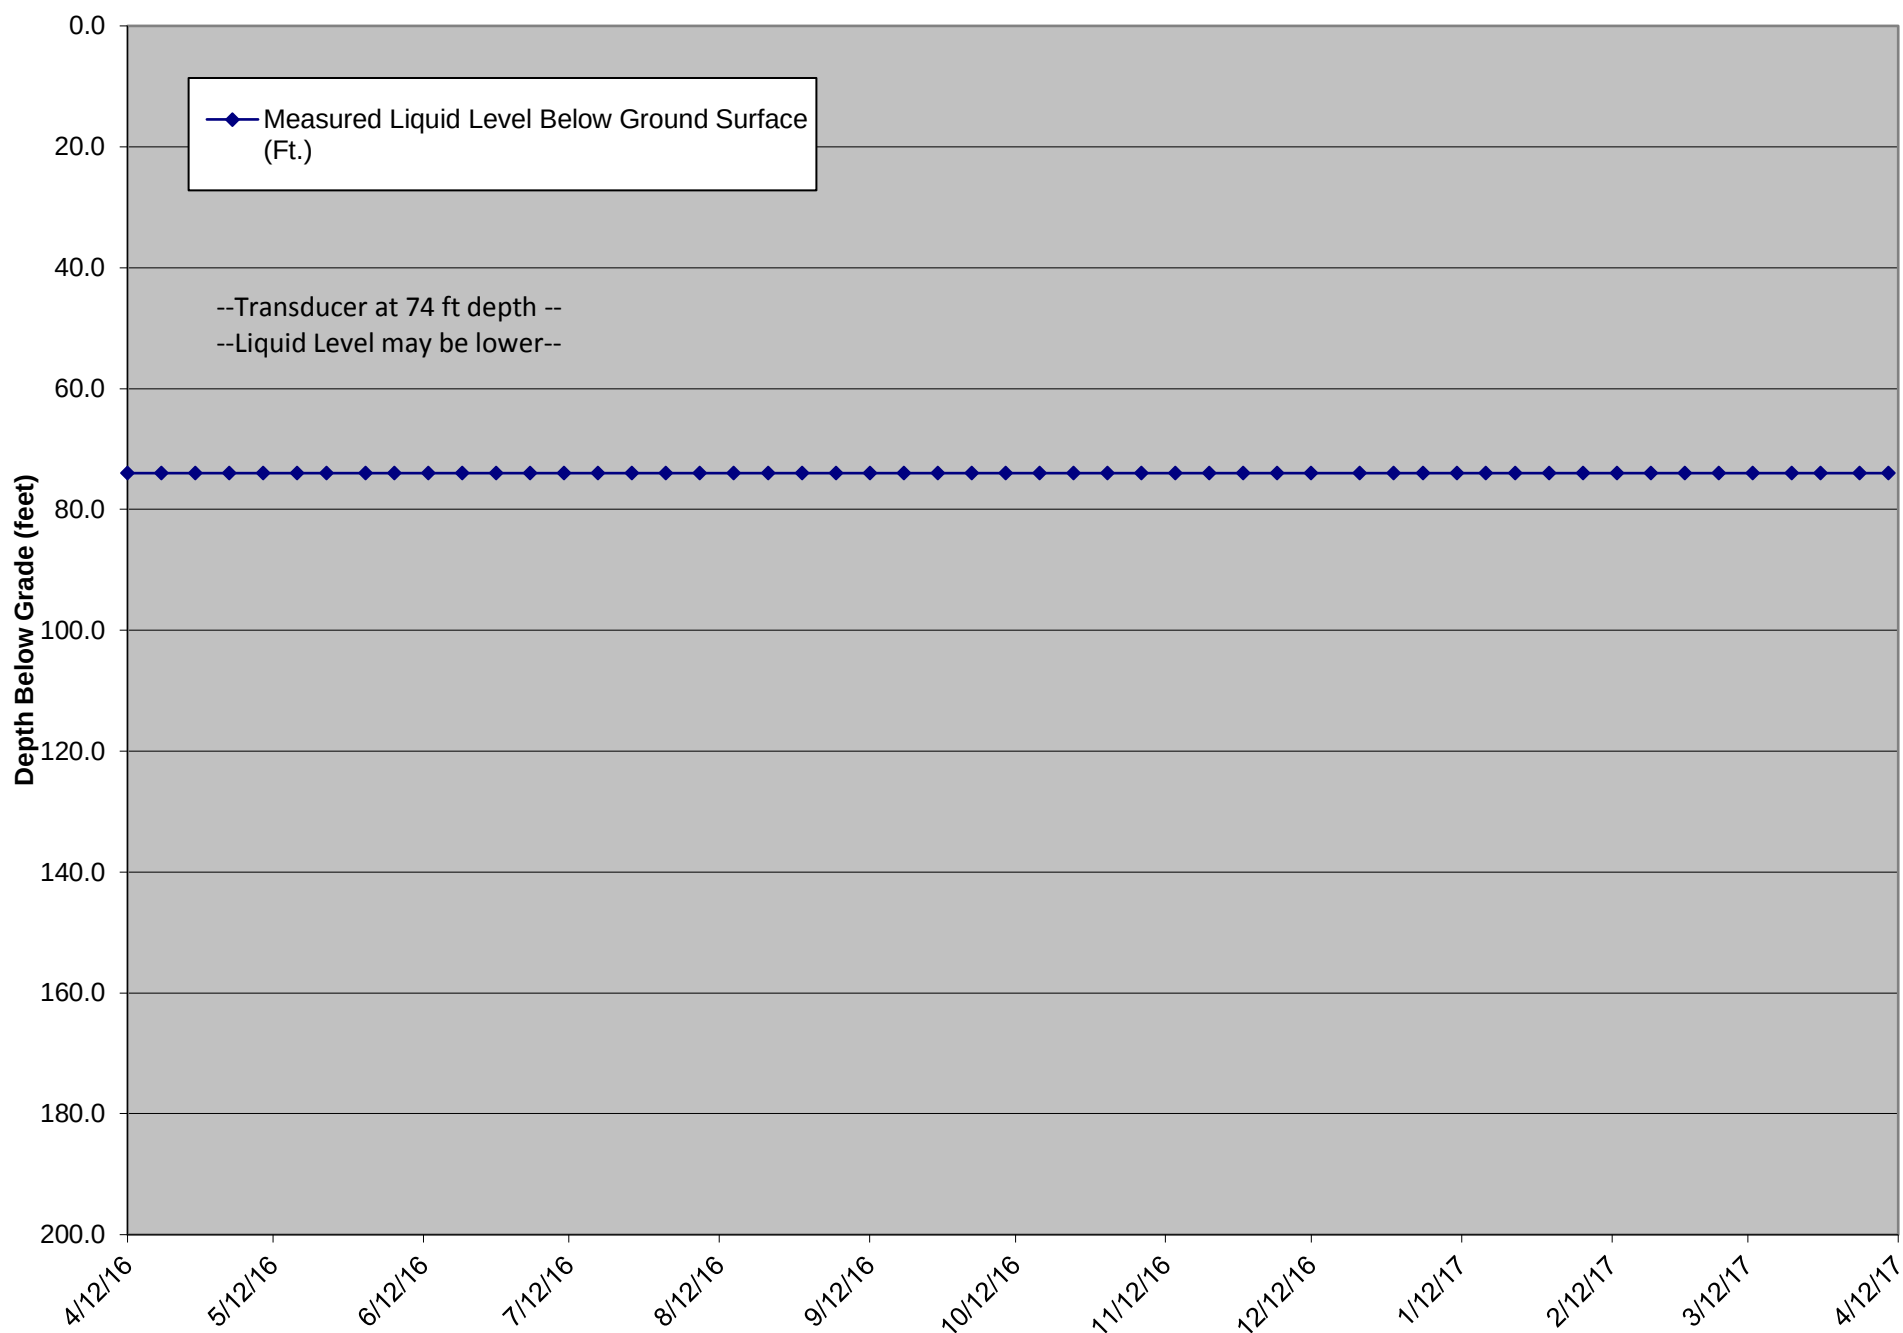
# LCS-4B Liquid Level Below Ground Surface

The level sensor in LCS-4B is currently operational and responsive. Liquid level was not recorded by the level sensor during the weekly reporting period. LCS-4B is equipped with a flow meter that displayed no flow during the weekly reporting period. Therefore, it can be concluded that the liquid level was below the bottom of the pump and level sensor in LCS-4B.

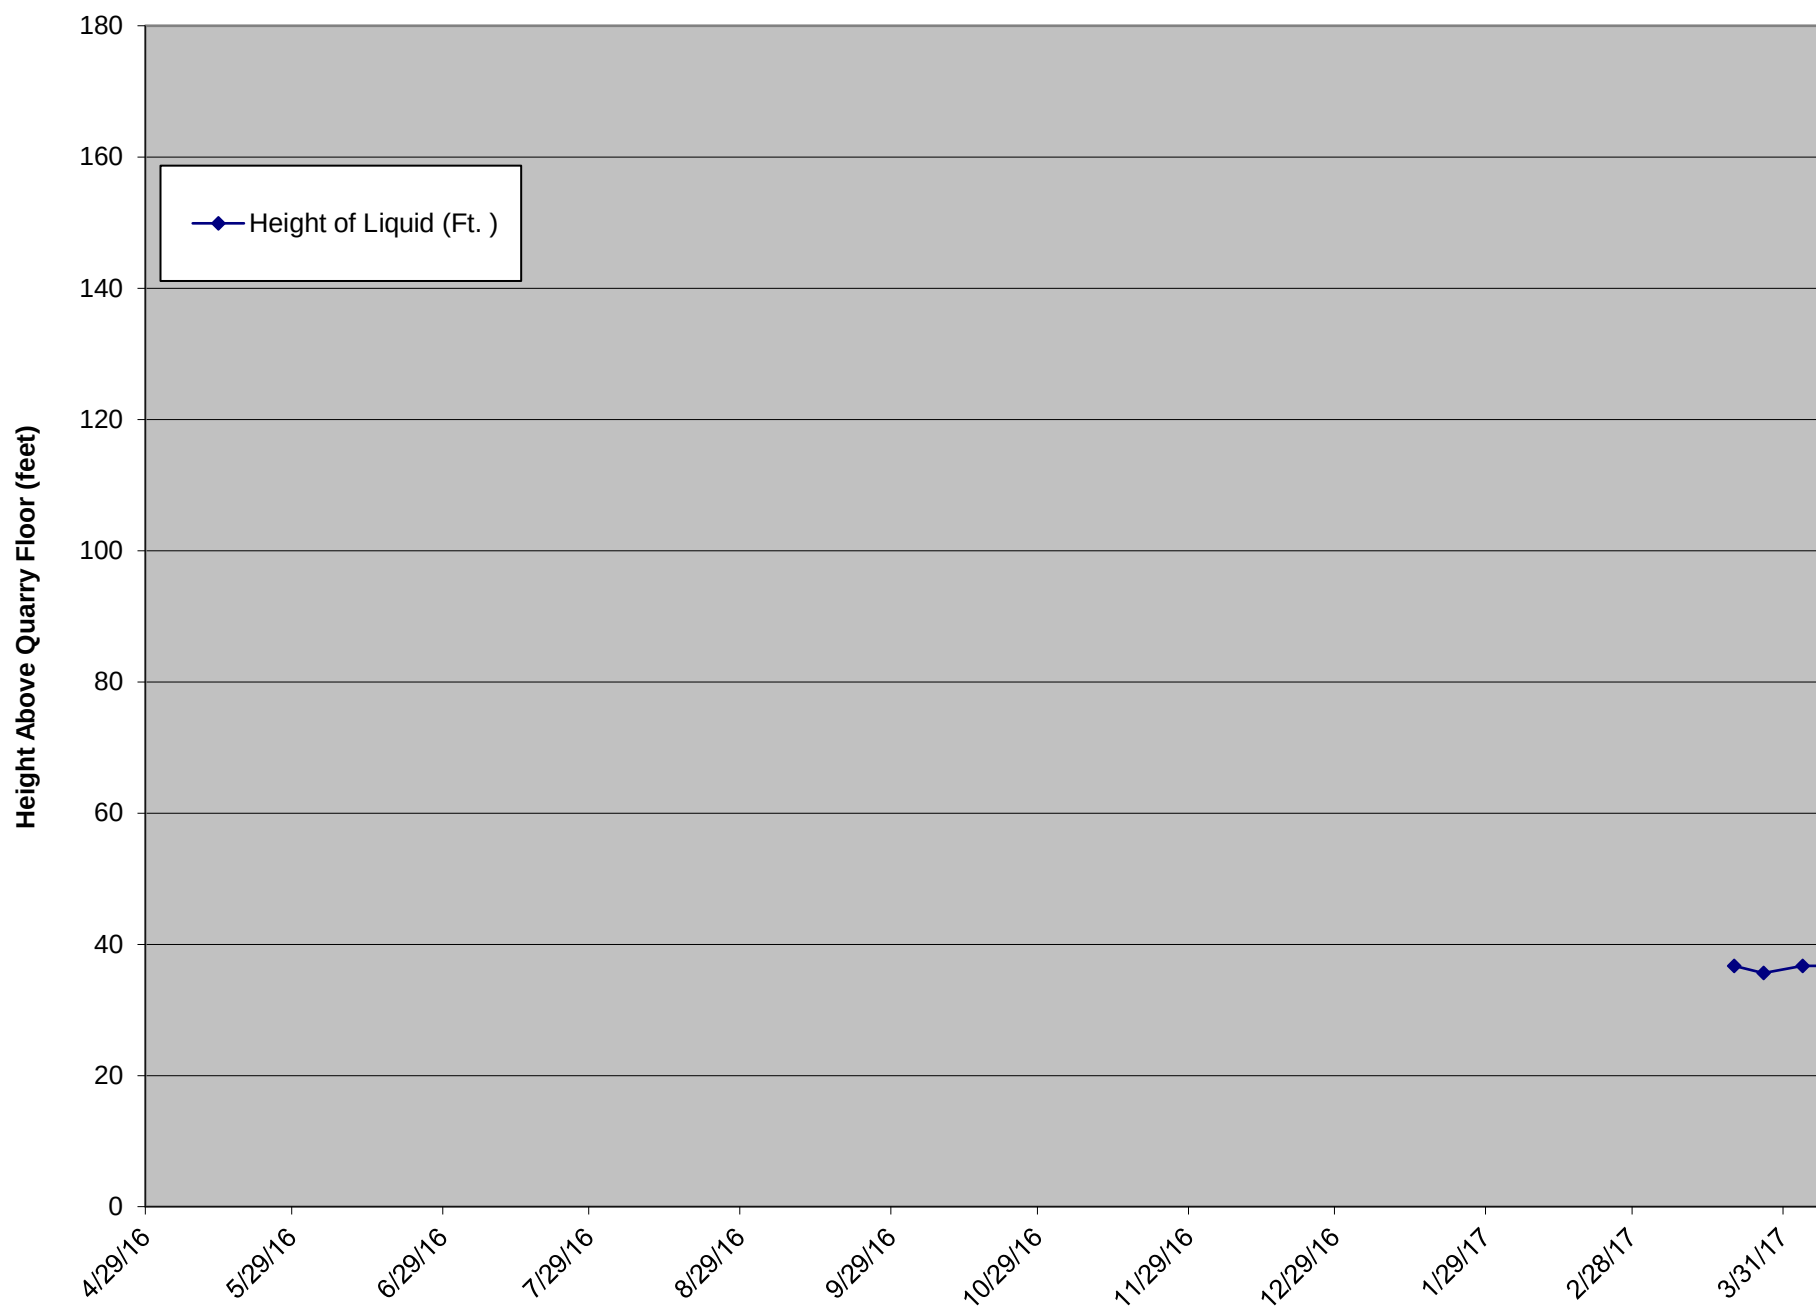
# LCS-5B Liquid Level Above Quarry Floor

LCS-5B and LCS-6B were fully operational during the weekly reporting period. LCS-6B was shut down for cap construction-related activities and was returned to operation the following week.

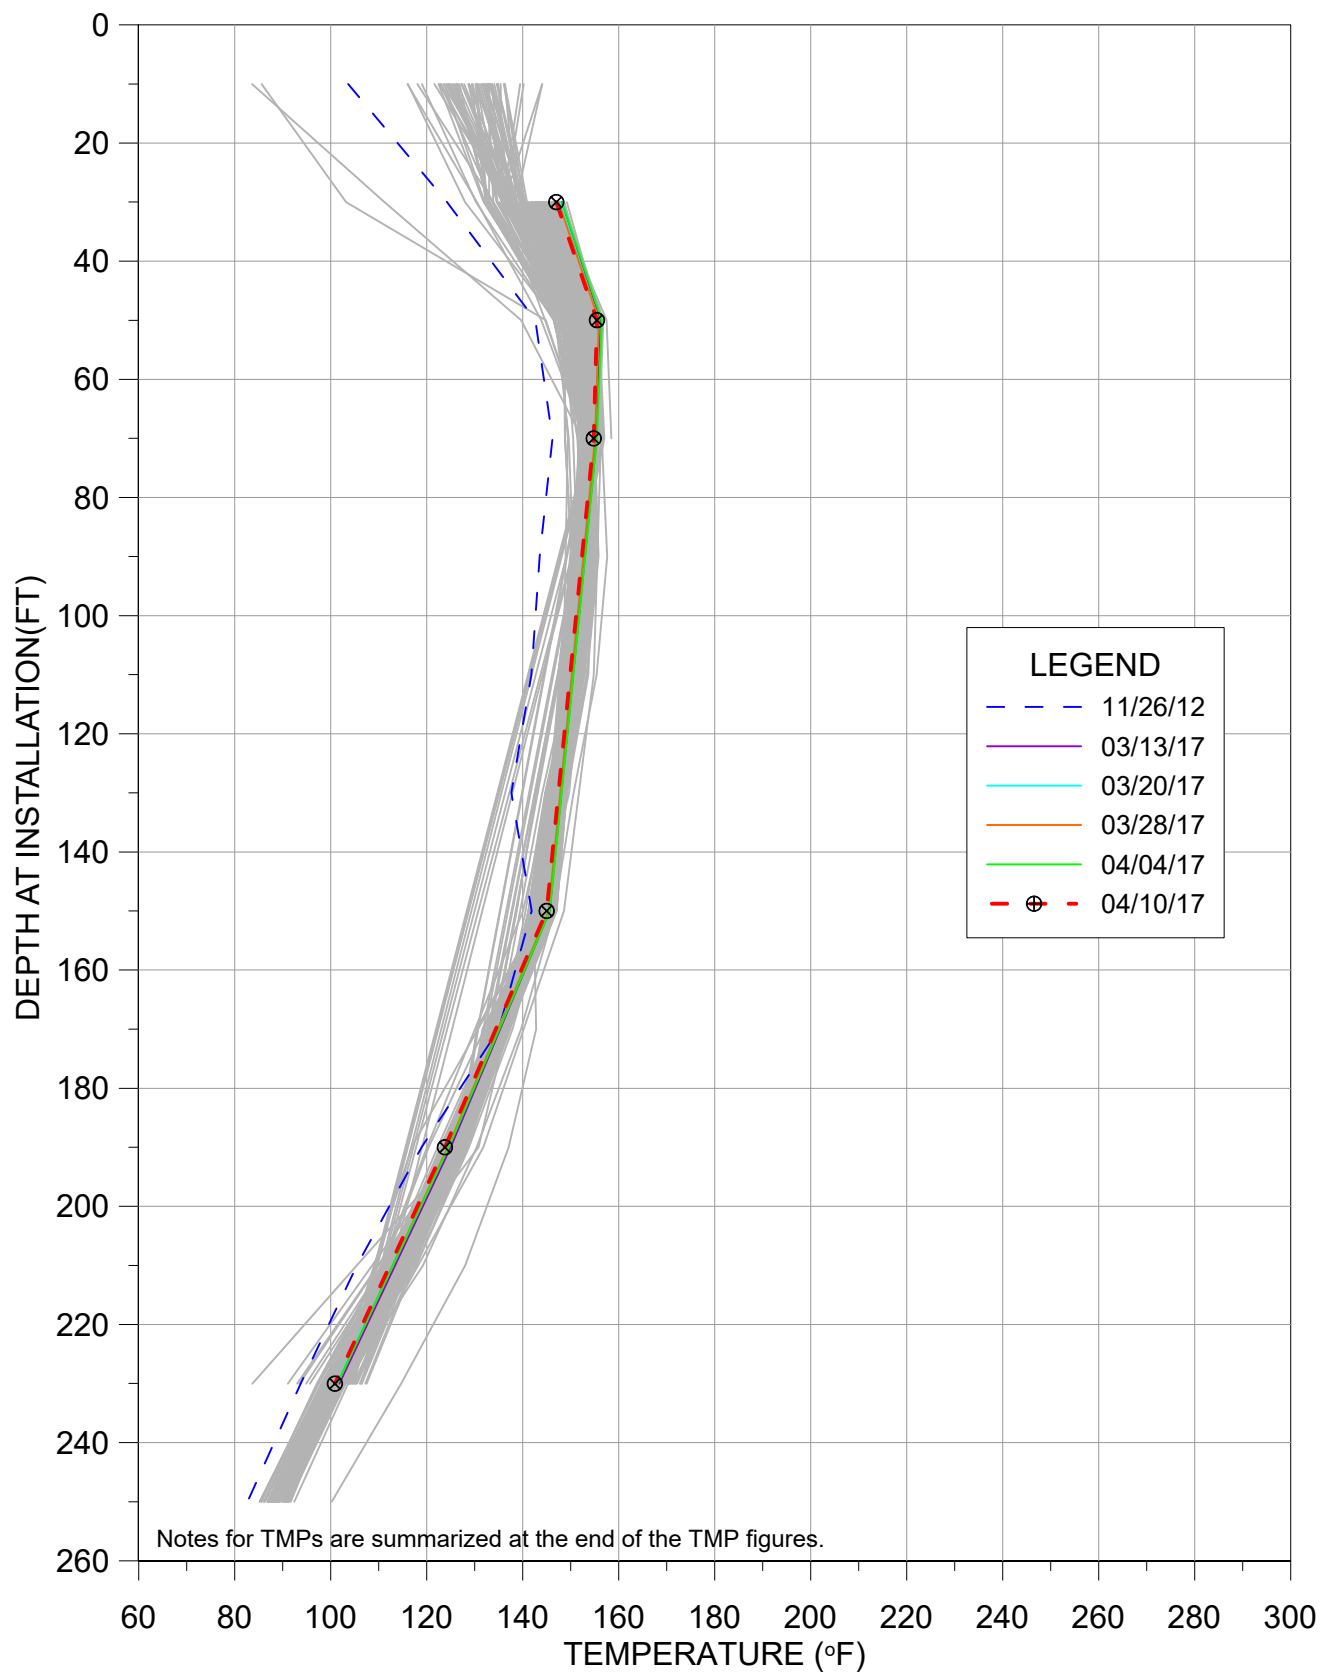
# TMP-3

1. No reliable temperature readings have been obtained at 170 ft depth since 1/29/2014, except on 3/13/2014.
2. The connectivity tests on 4/11/2014 conducted by CEC showed that units at 10, 90, 130, 210 and 250 ft depths are no longer reliable.
3. The connectivity tests on 10/28/2014 conducted by Feezor Engineering showed that units at 10, 90, 110, 130, 210 and 250 ft depths are not reliable.

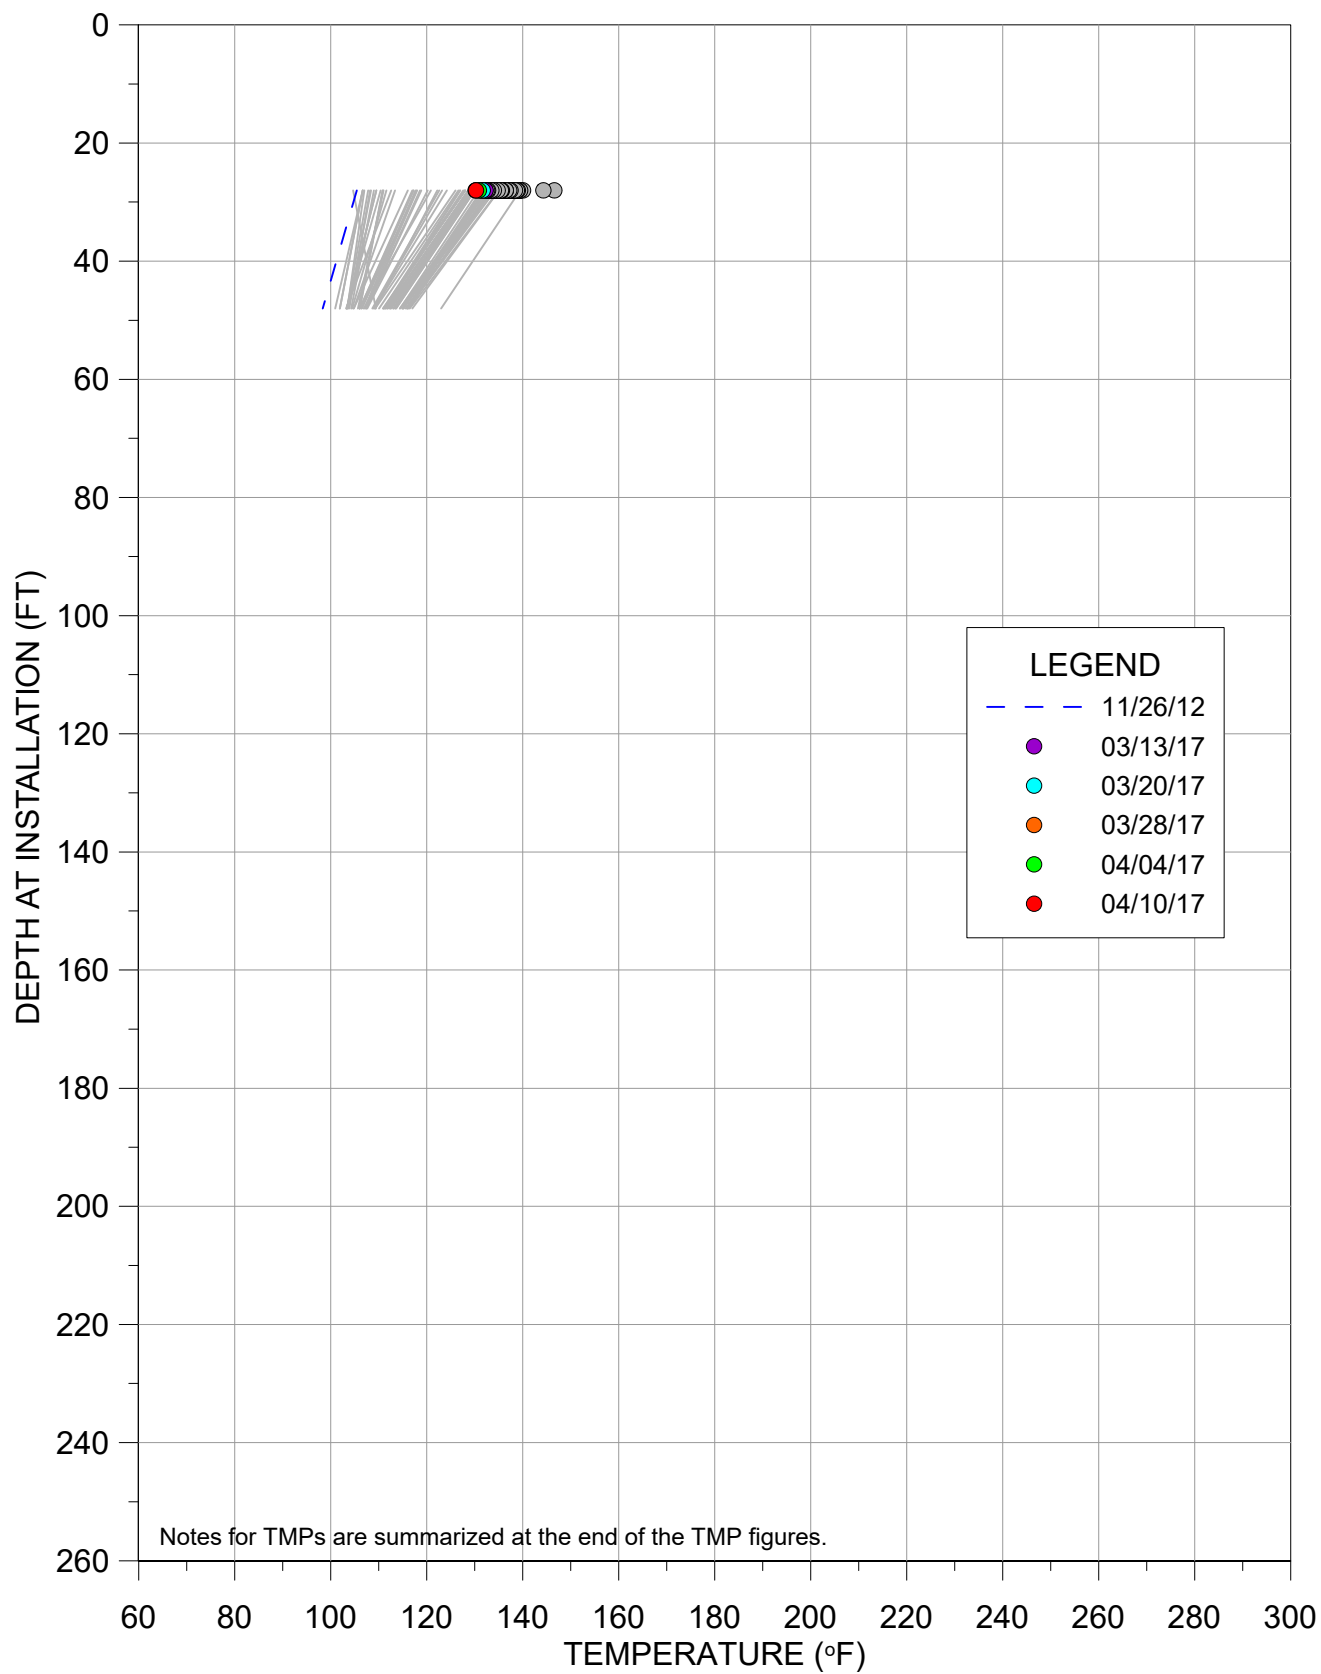
# TMP-4

1. The connectivity tests on 4/11/2014 conducted by CEC showed that the unit at 48 ft depth is no longer reliable.

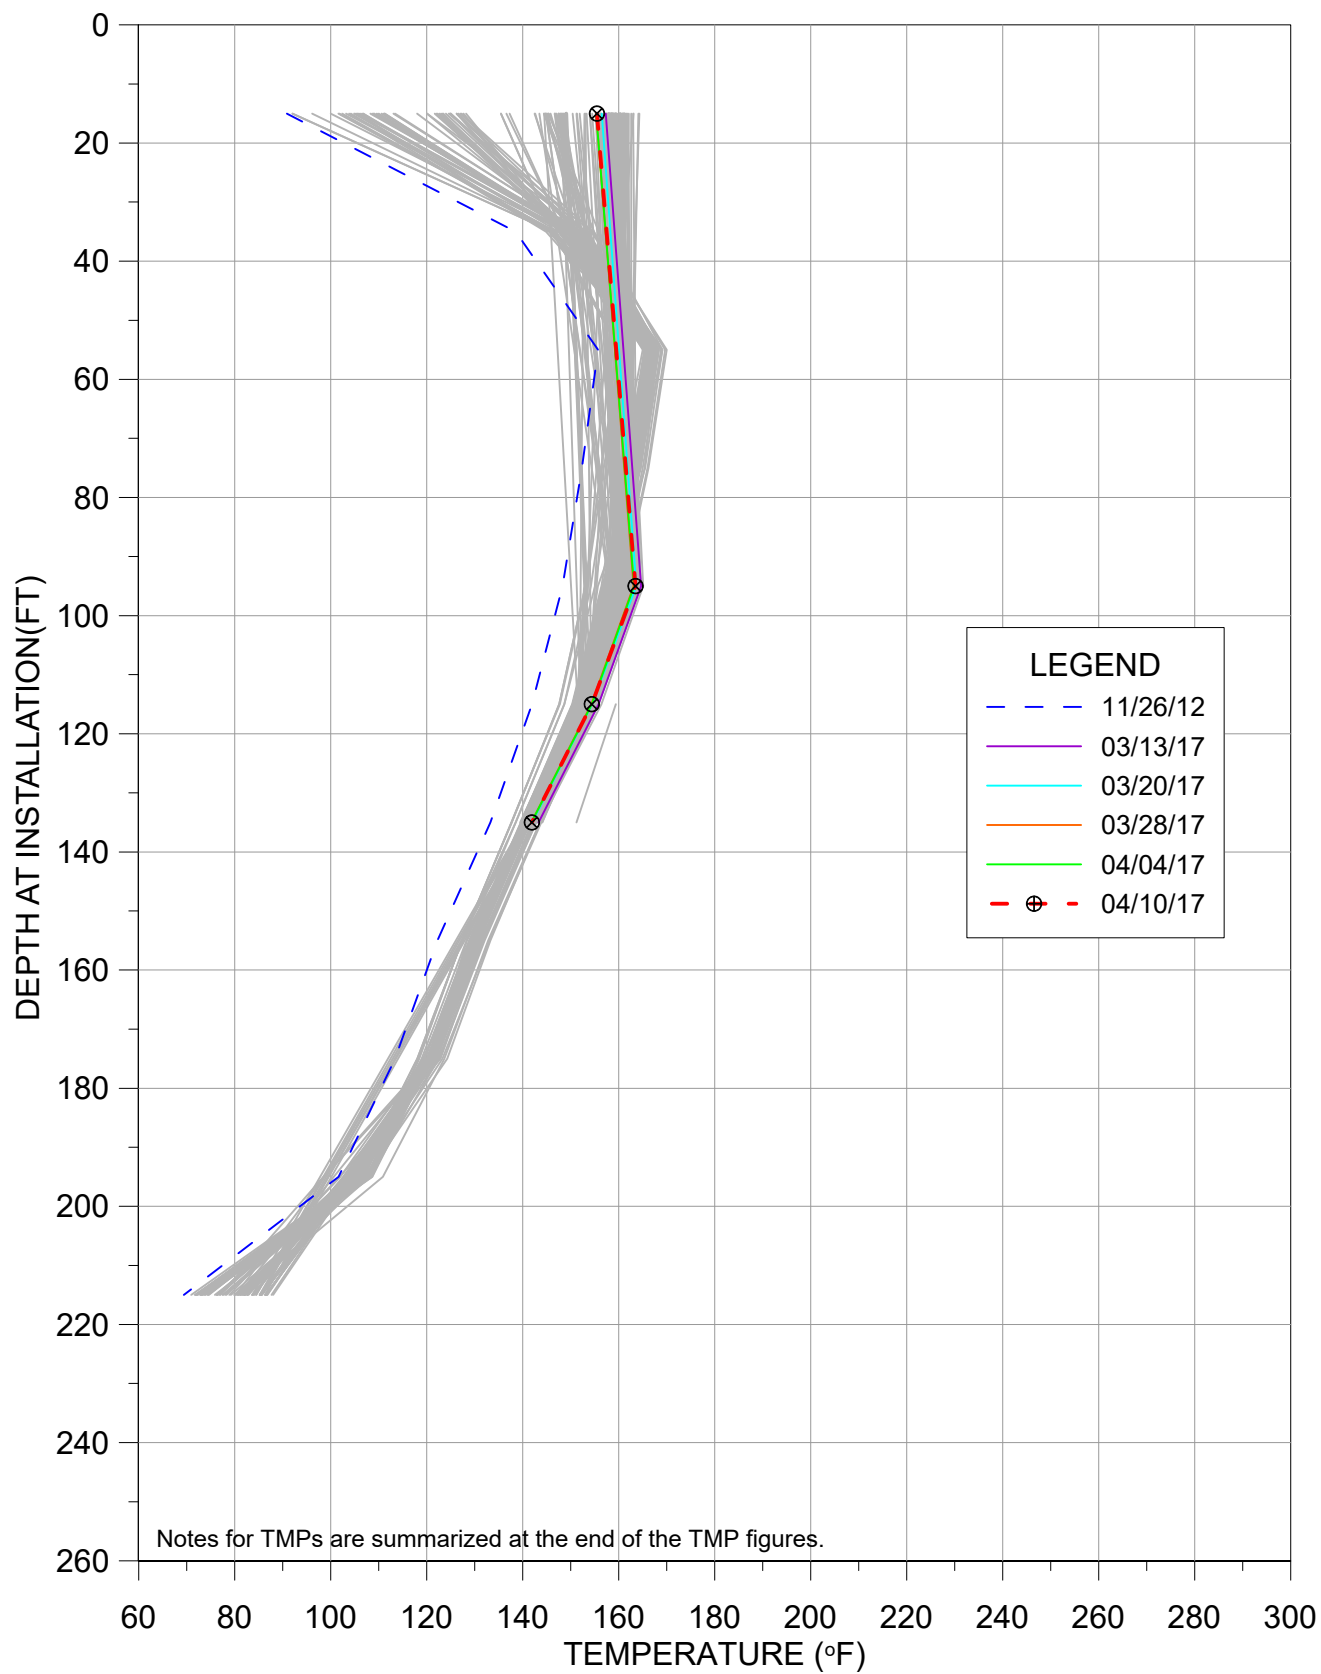
# TMP-6

1. The connectivity tests on 4/11/2014 conducted by CEC showed that units at 35, 55, 75, 155, 175, and 195 ft depths are no longer reliable.
2. No reliable temperature readings have been obtained at the unit at 215 ft depth since 6/13/2014.

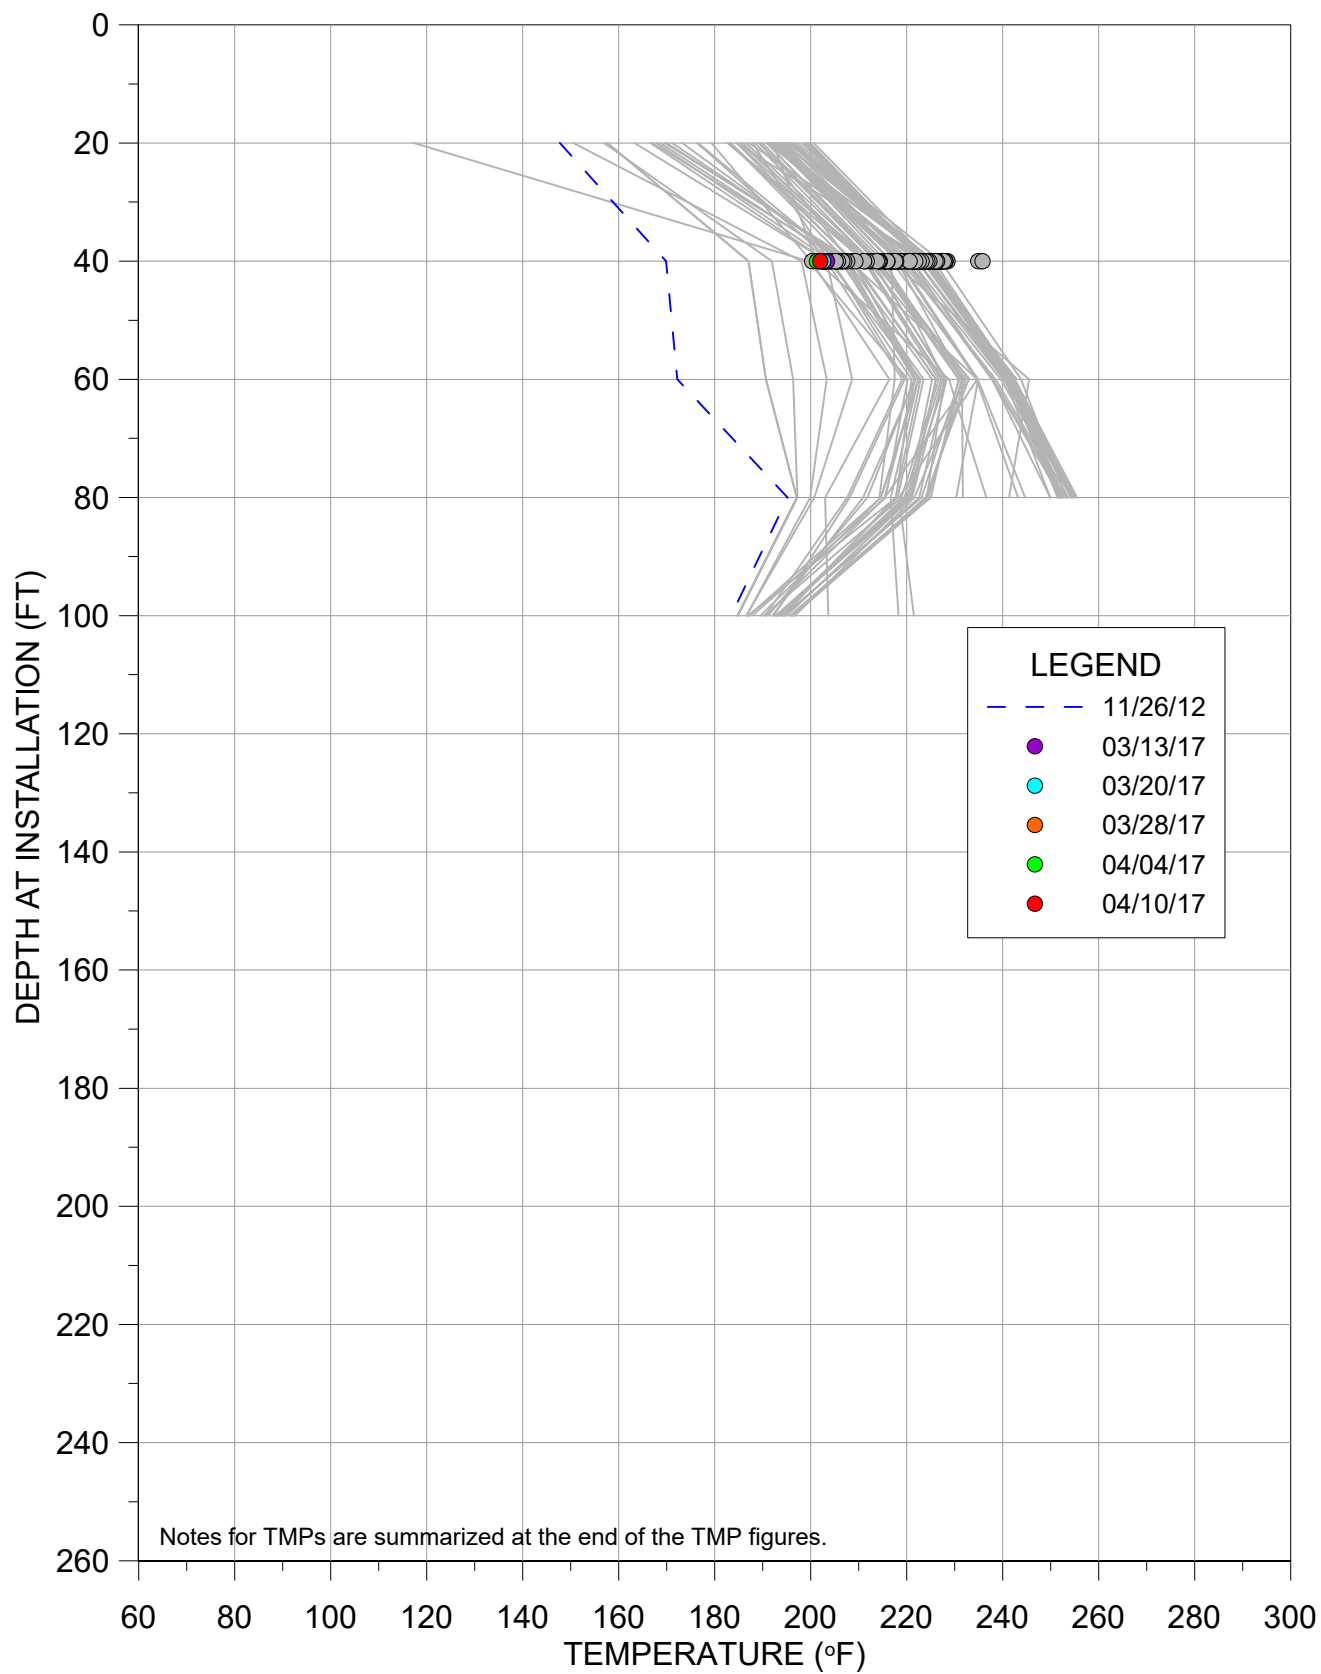
# TMP-9

1. Unit at 100 ft depth had an inaccurate temperature reading on 8/1/2013 and no reading since 8/6/2013.
2. The connectivity tests on 4/11/2014 conducted by CEC showed that units at 20, 60, 80, and 100 ft depths are no longer reliable.

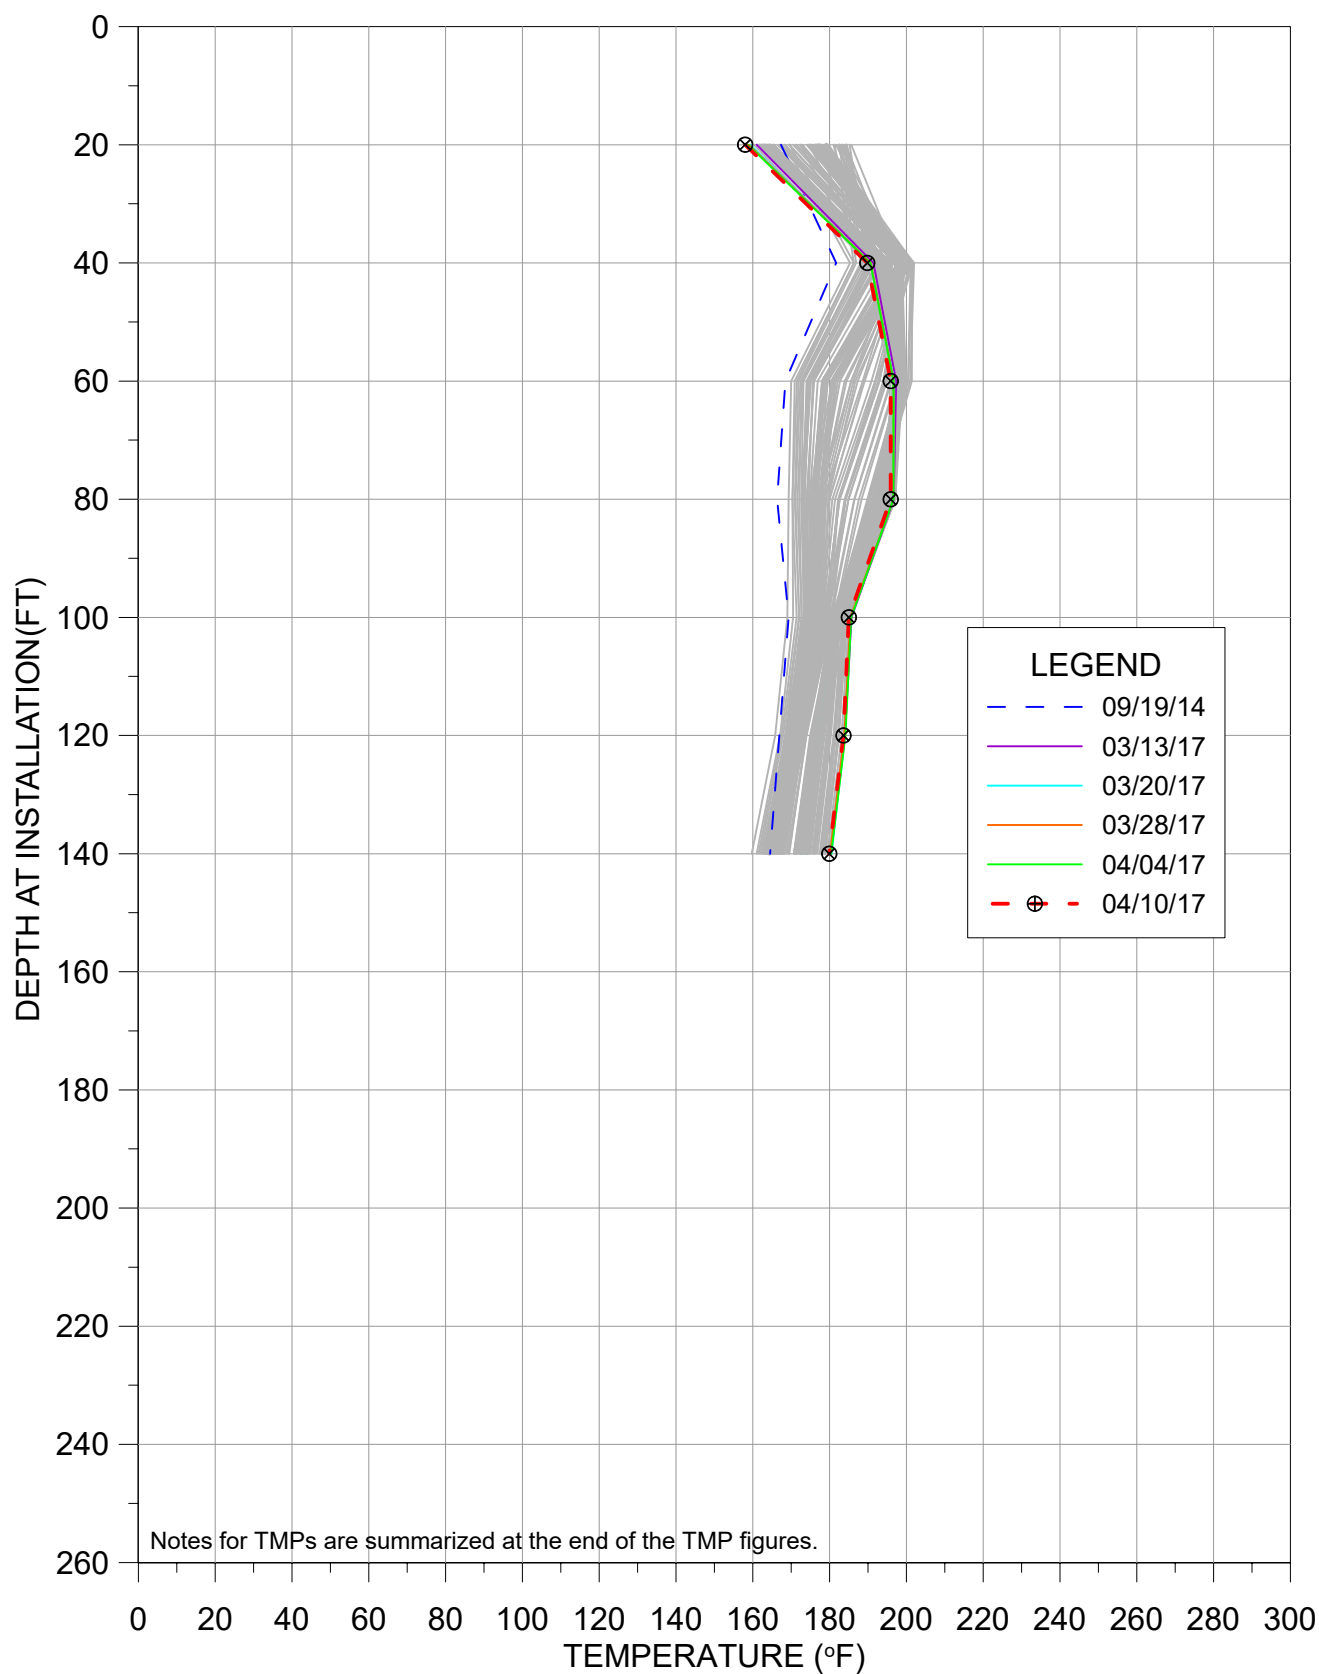
# TMP-14R

1. Due to the connectivity test results by Feezor Engineering on TMP-14 (see note above), TMP-14R is added to this reporting data set as of 3/7/2016.
