# **Bridgeton Landfill, LLC**

## **Weekly Data Submittal**

**Week of April 9, 2017 – April 15, 2017**

**Required by Section 52.F of Agreed Order, Case No. 13SL-CC01088  
Effective May 13, 2013**

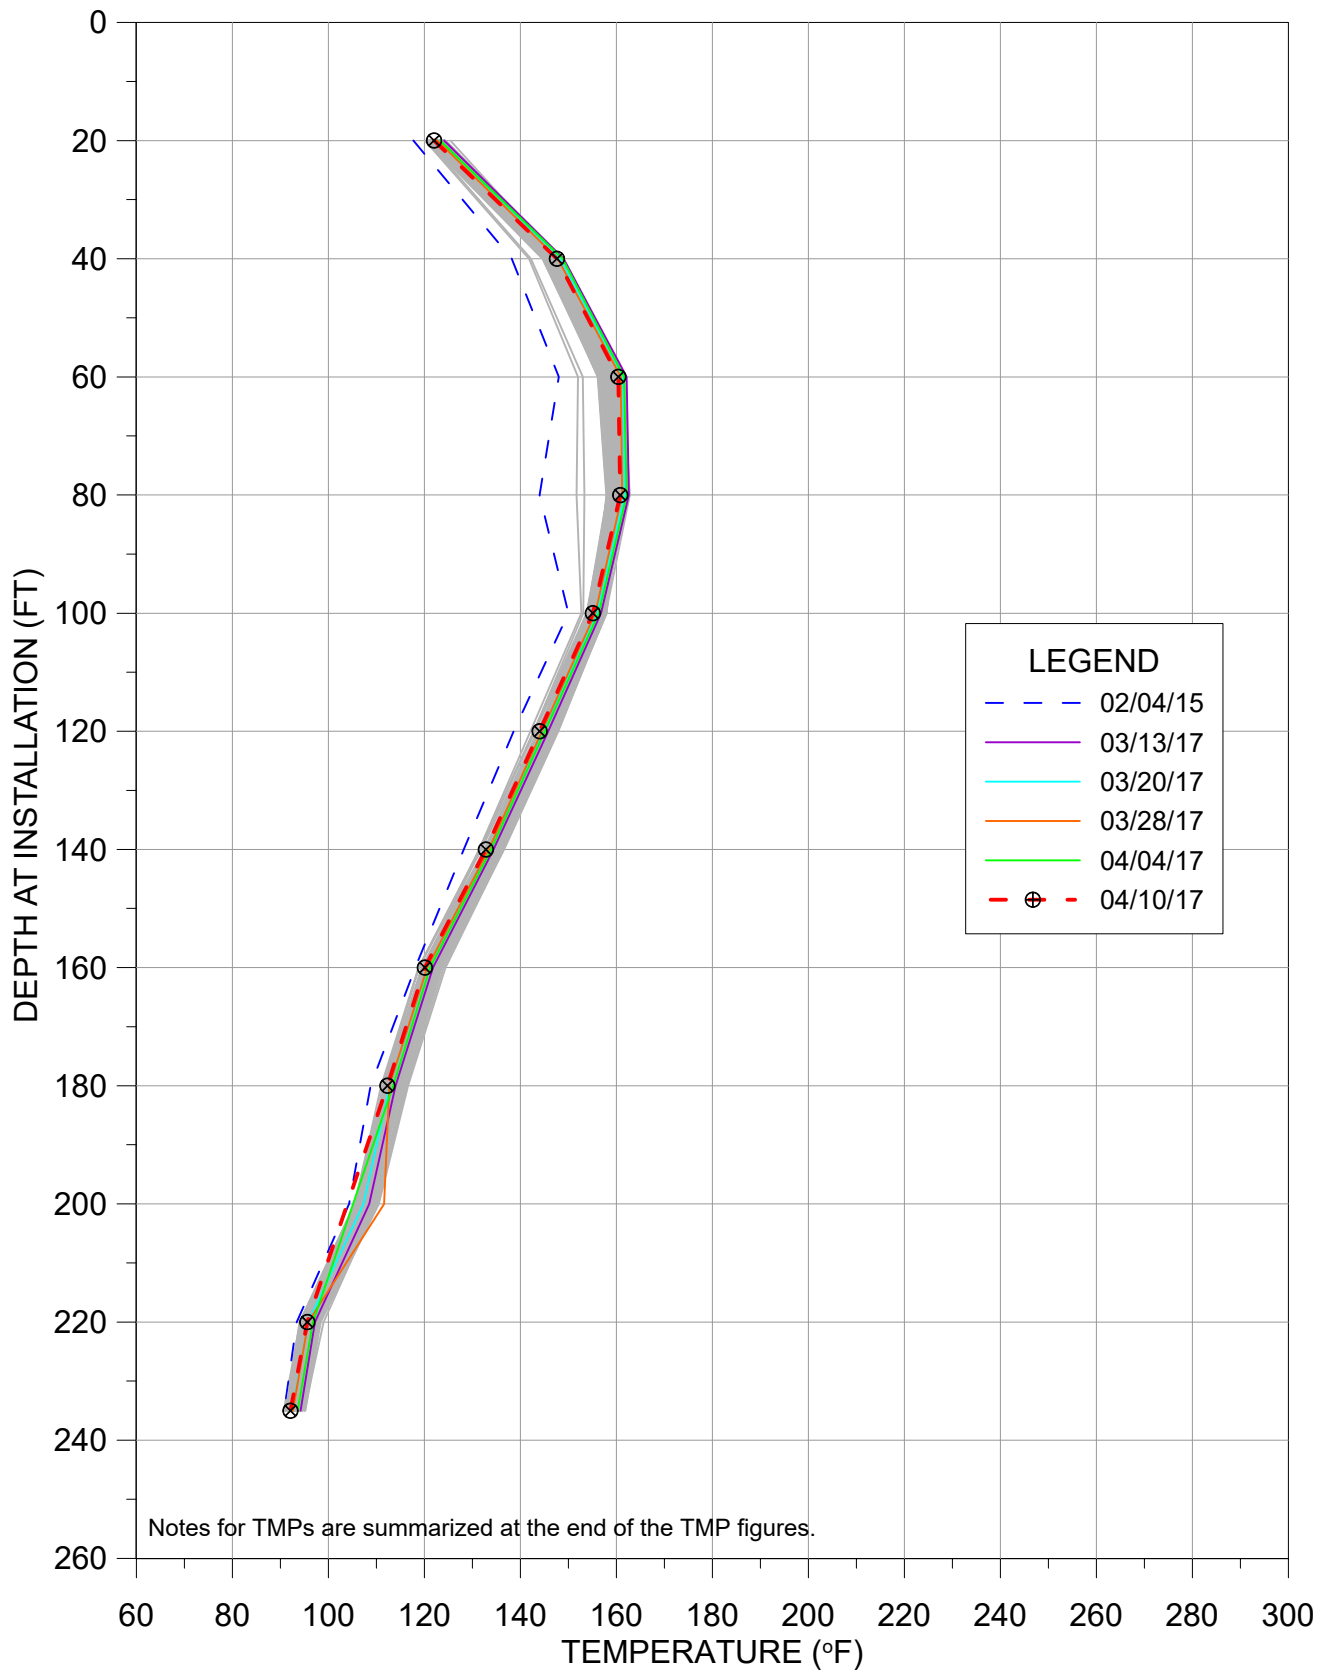
# TMP-25

1. The unit at 200 ft provided an apparent anomalous reading on 3/28/2017. Subsequent readings on 4/4/2017 showed the unit to have failed (see below). The unit is no longer working and the reading of 3/28/2017 was likely unreliable.
2. The unit at 200 ft depth had a resistance reading greater 4000 ohms on 4/4/2017. A connectivity test conducted by Feezor Engineering on 4/7/2017 showed that this unit also had cross-connectivity. The unit is therefore determined to be no longer working as of the 4/4/2017 reading.

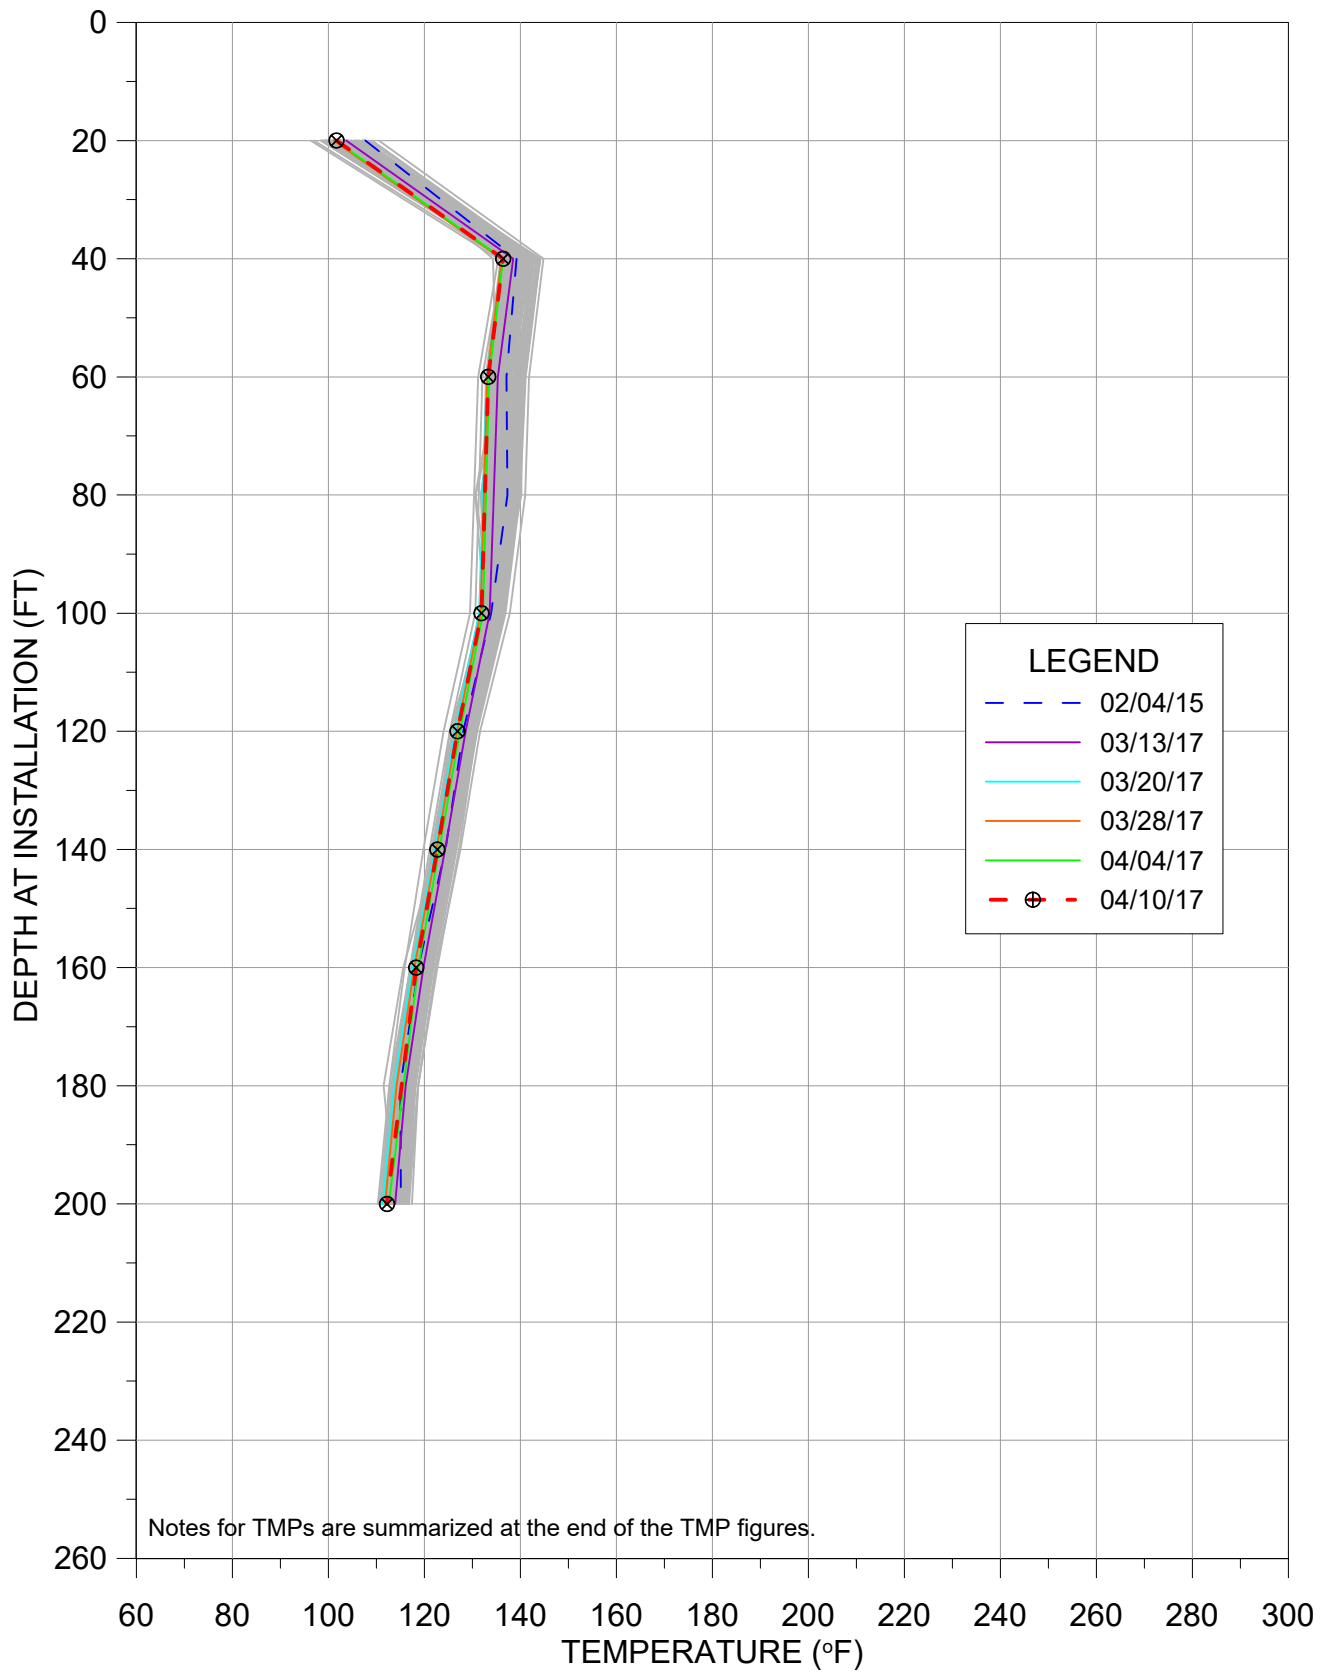
# TMP-28

1. The unit at 217 ft depth has had no resistance or temperature readings since installation.
2. The unit at 80 ft depth had a resistance drop and an unreasonable temperature decrease on 6/1/2016. The temperature has since fluctuated and is determined to be unreliable.
3. The unit at 180 feet has had a higher than acceptable limit since 3/28/2017 and is therefore determined to be unreliable as of the 4/4/2017 reading.

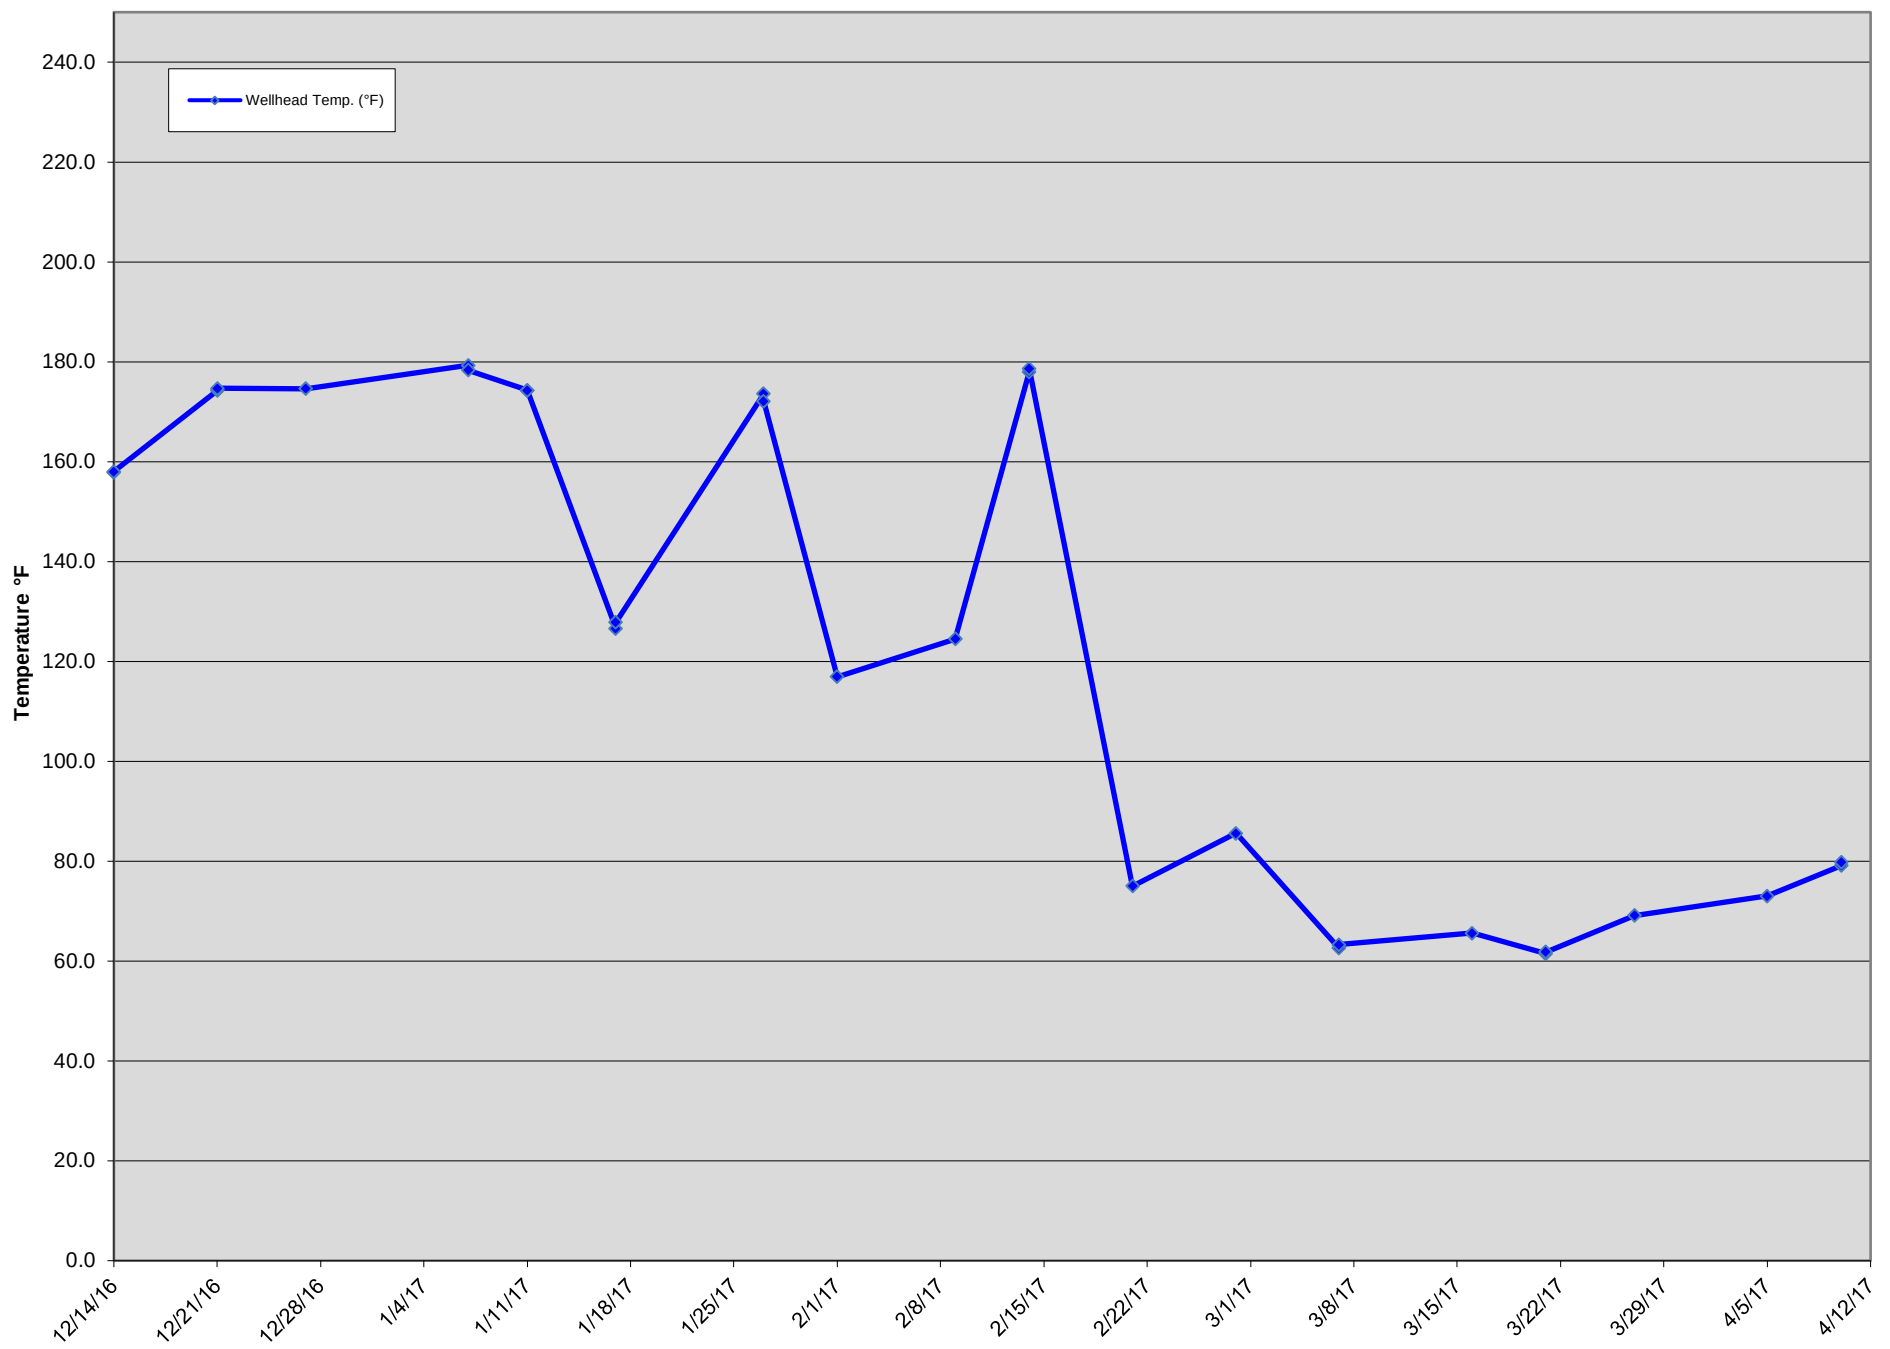
GIW-1 Wellhead Temperatures

As part of the HES, there are currently cooling water circulation loops installed in twelve Gas Interceptor Wells (GIWs) (GIW-02 through GIW-13). The remaining well (GIW-01) had a measured gas temperature within its historical operating limits.
