# **Bridgeton Landfill, LLC**

## **Weekly Data Submittal**

**Week of April 16, 2017 – April 22, 2017**

**Required by Section 52.F of Agreed Order, Case No. 13SL-CC01088  
Effective May 13, 2013**

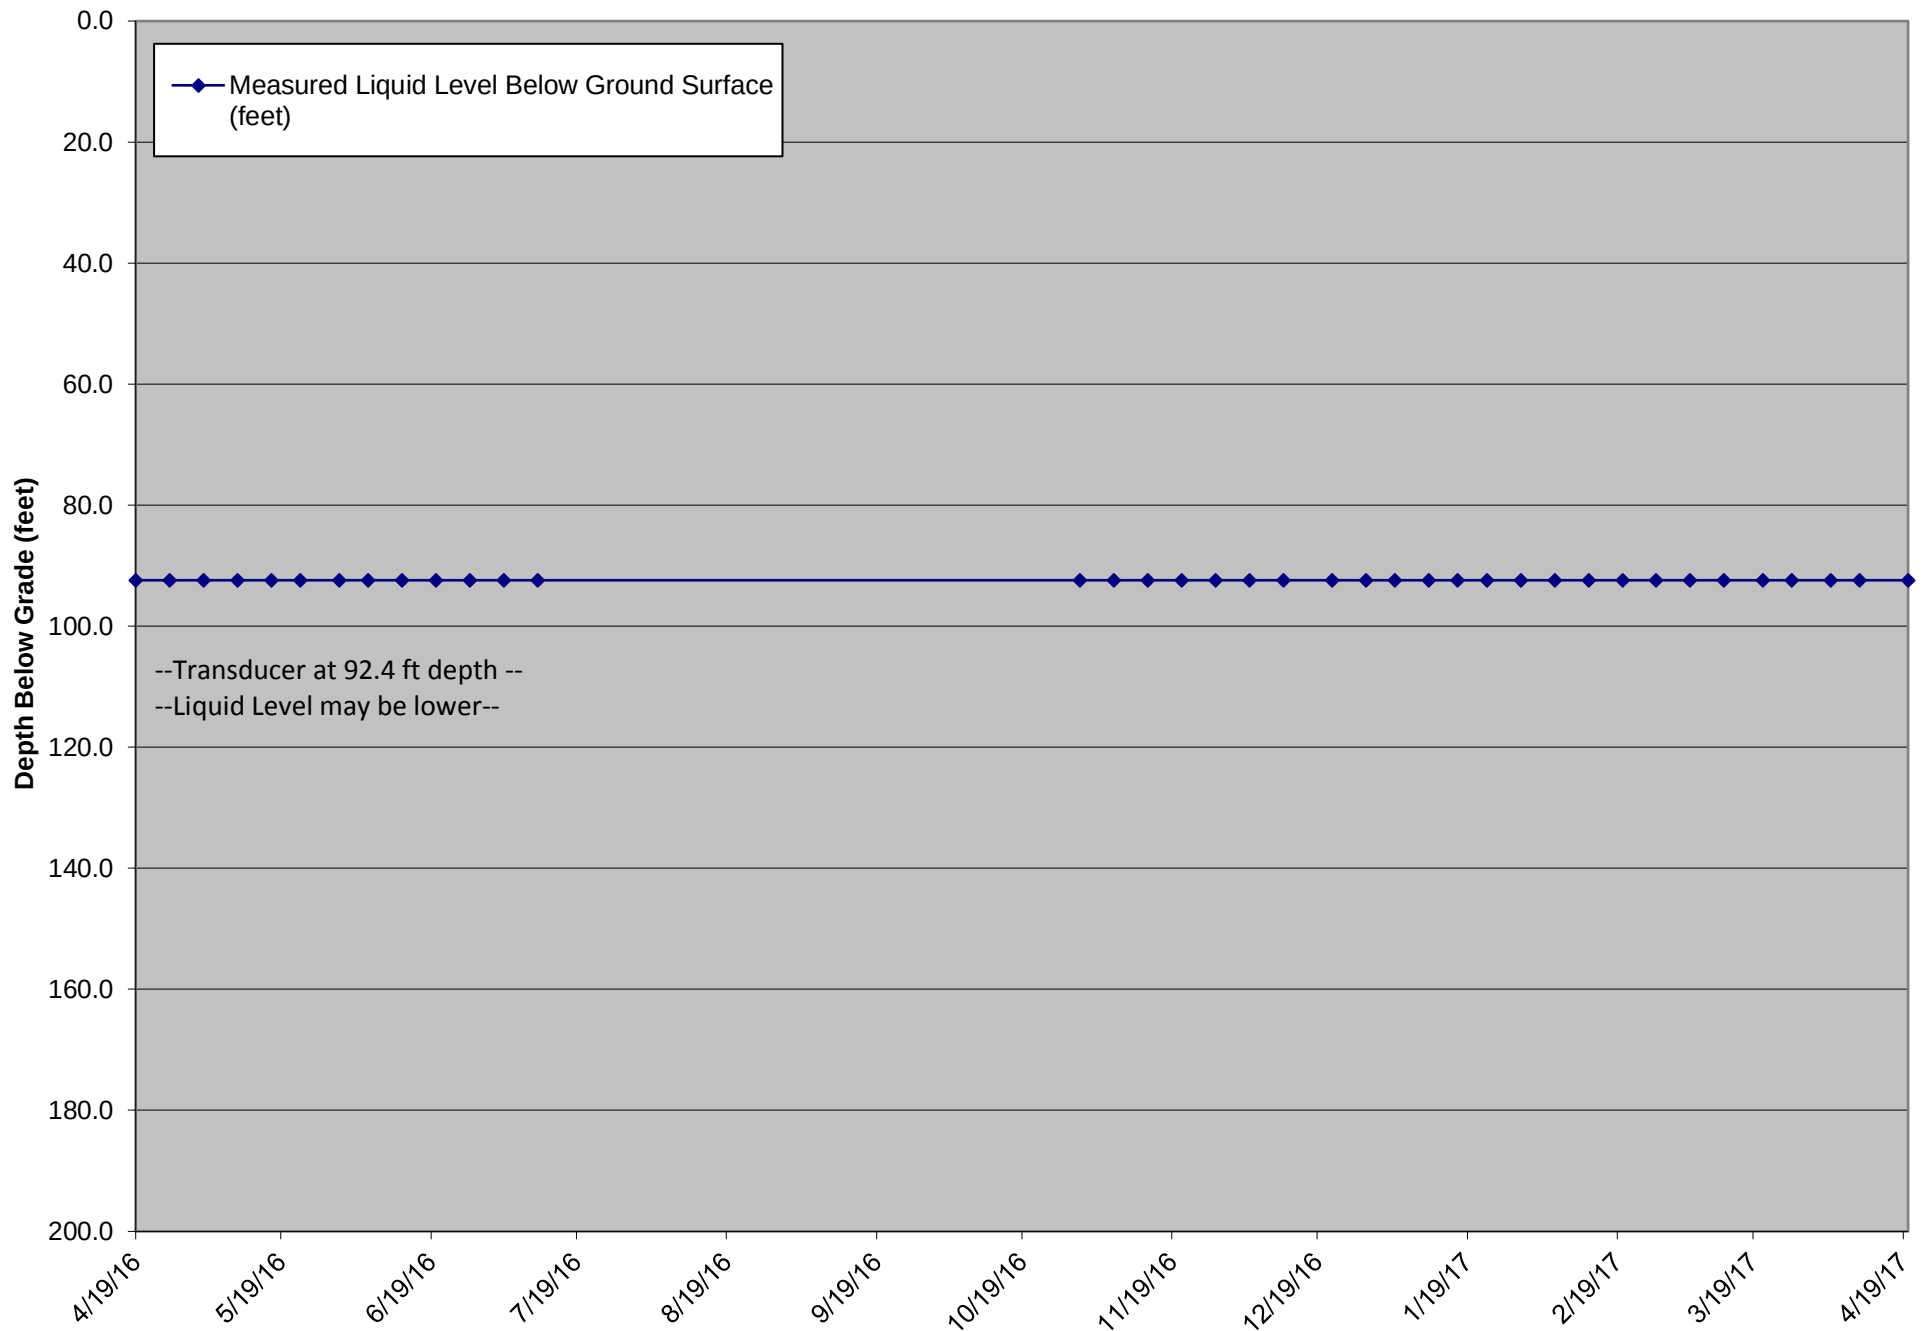
# LCS-1D Liquid Level Below Ground Surface

LCS-1D is equipped with a level sensor and a flow meter. Bridgeton Landfill confirmed that the flow meter on LCS-1D is operational and the flow was observed during the weekly reporting period. Liquid level was not recorded by the level sensor during the weekly reporting period. Bridgeton Landfill is currently looking into replacing the level sensor on LCS-1D.

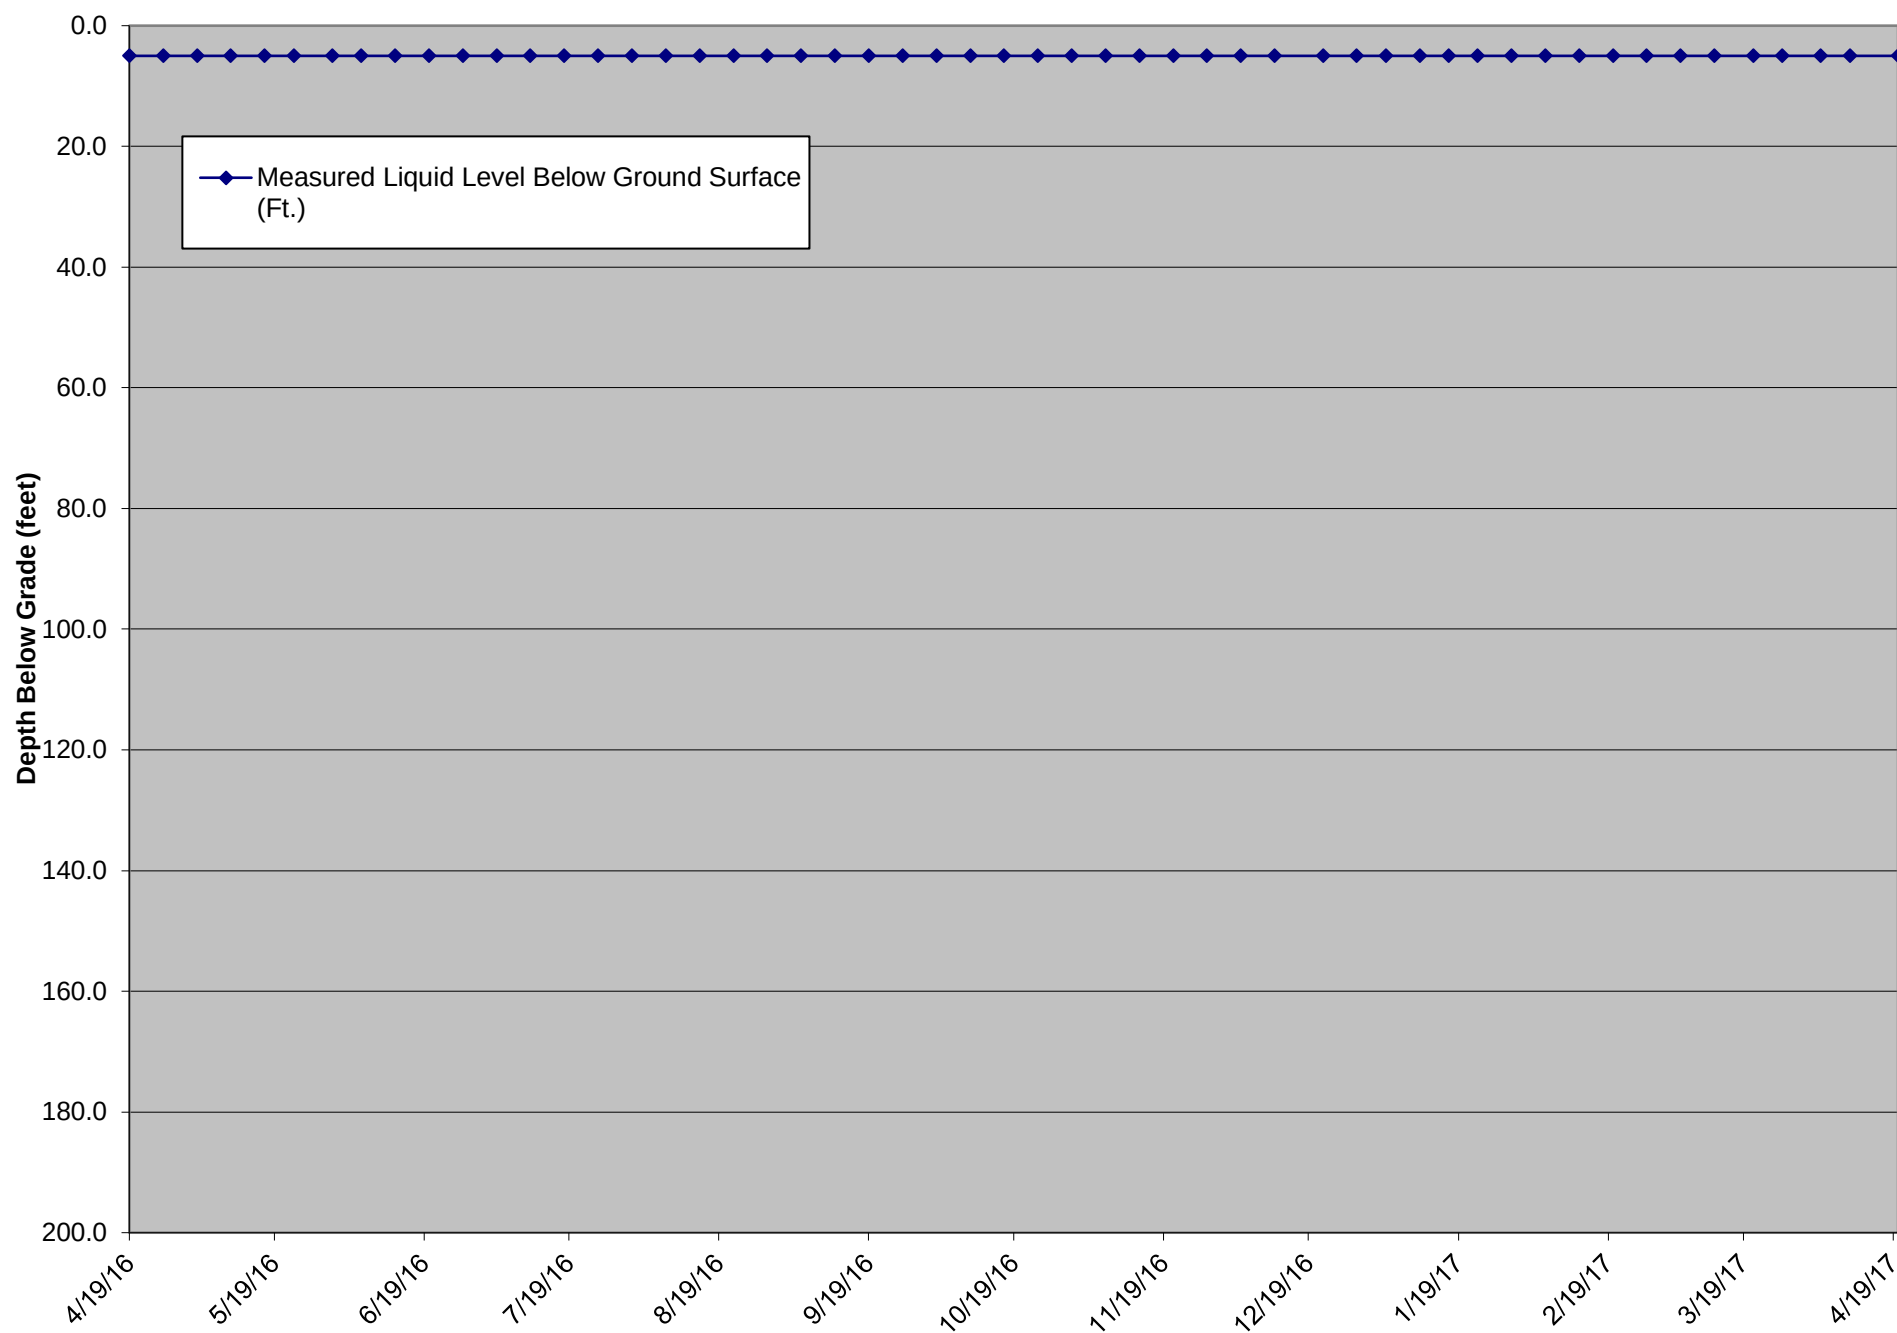
# LCS-3D Liquid Level Below Ground Surface

The pumps in LCS-2D and LCS-3D were non-operational during the weekly reporting period. The transducer in LCS-3D continued to report liquid levels.

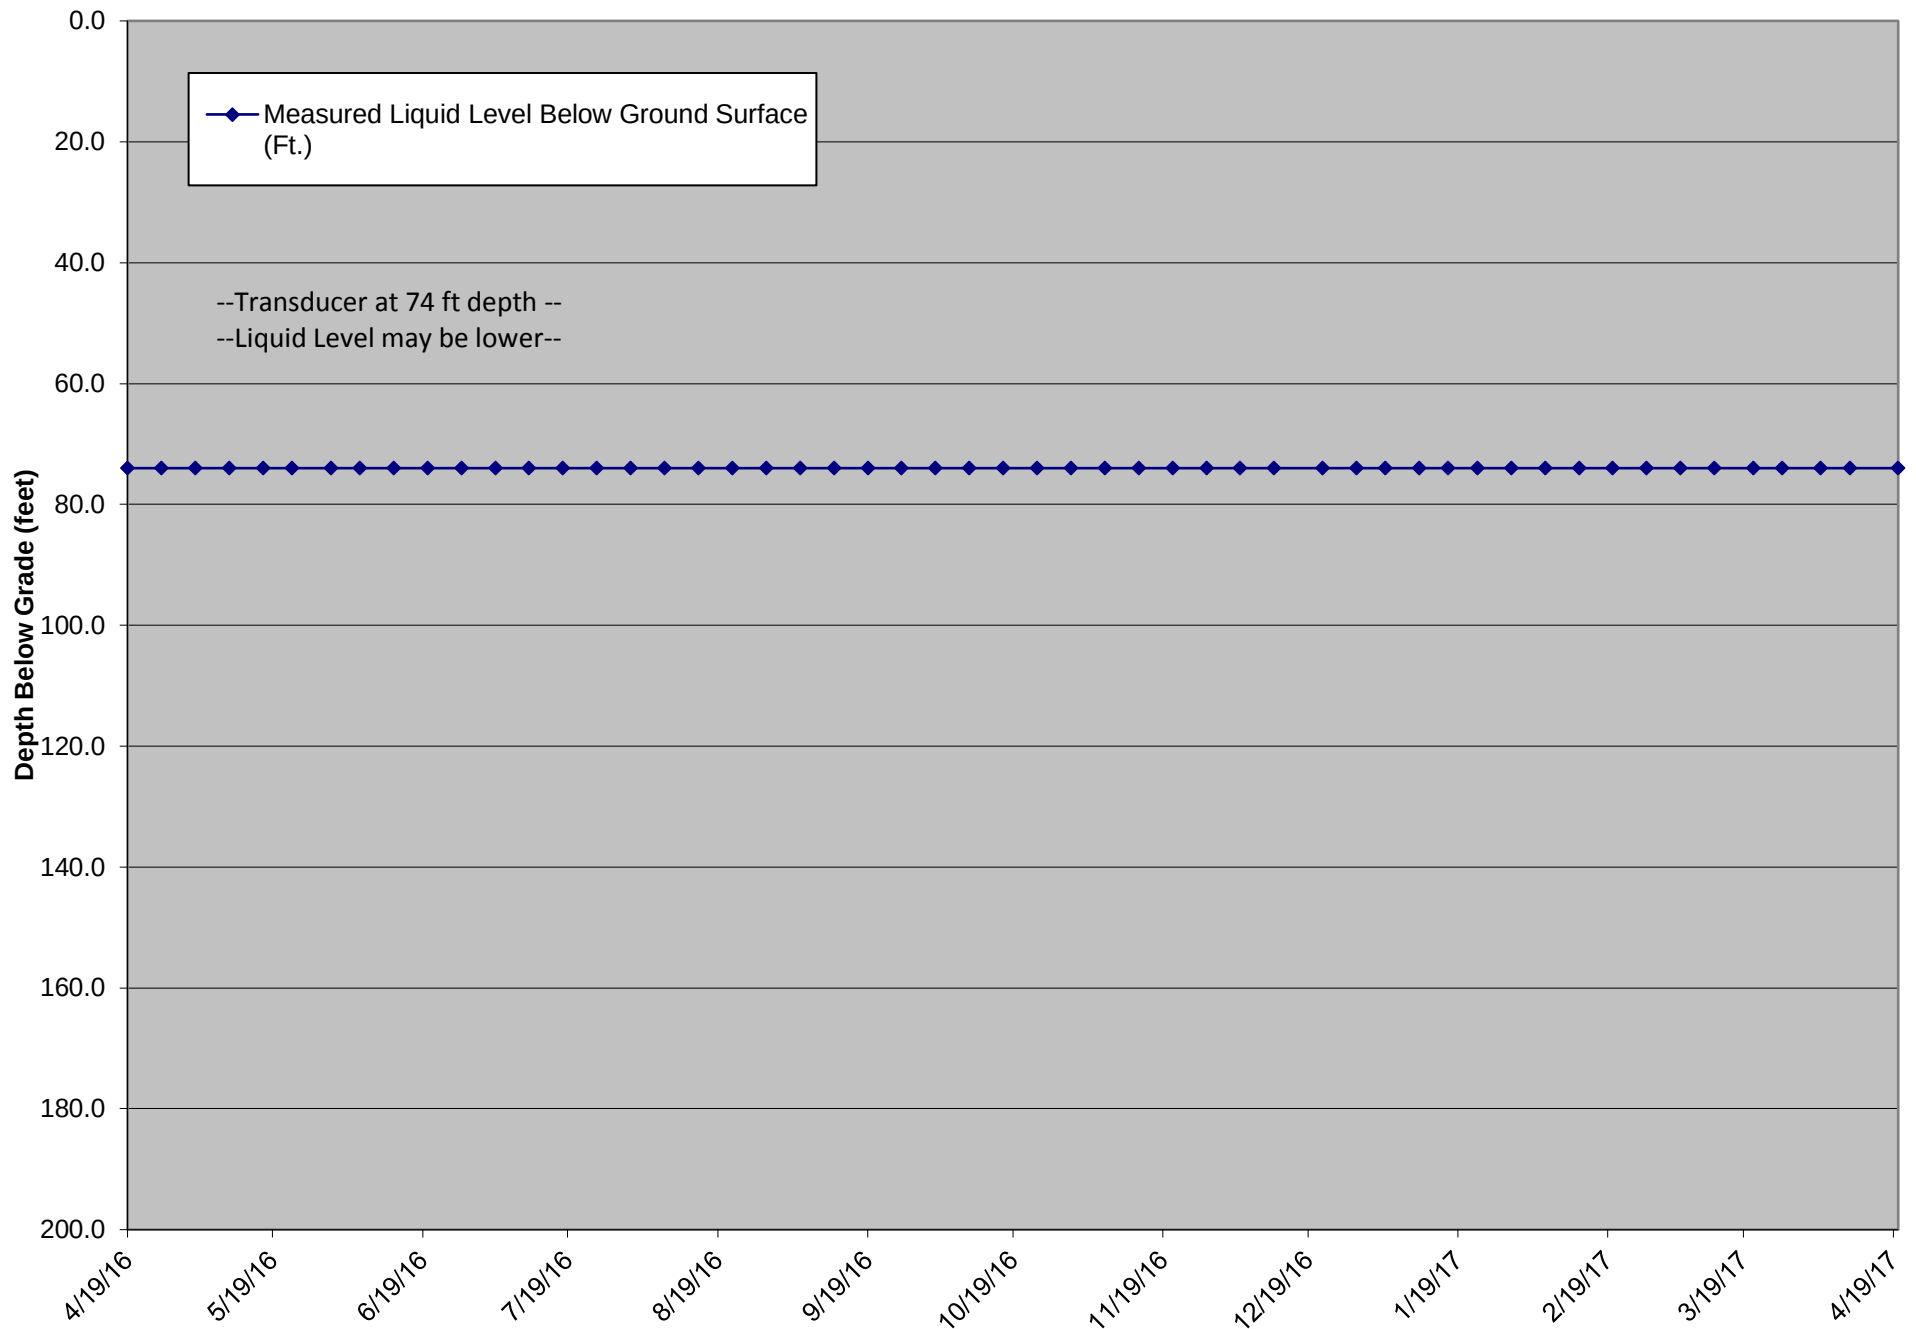
# LCS-4B Liquid Level Below Ground Surface

The level sensor in LCS-4B is currently operational and responsive. Liquid level was not recorded by the level sensor during the weekly reporting period. LCS-4B is equipped with a flow meter that displayed no flow during the weekly reporting period. Therefore, it can be concluded that the liquid level was below the bottom of the pump and level sensor in LCS-4B.

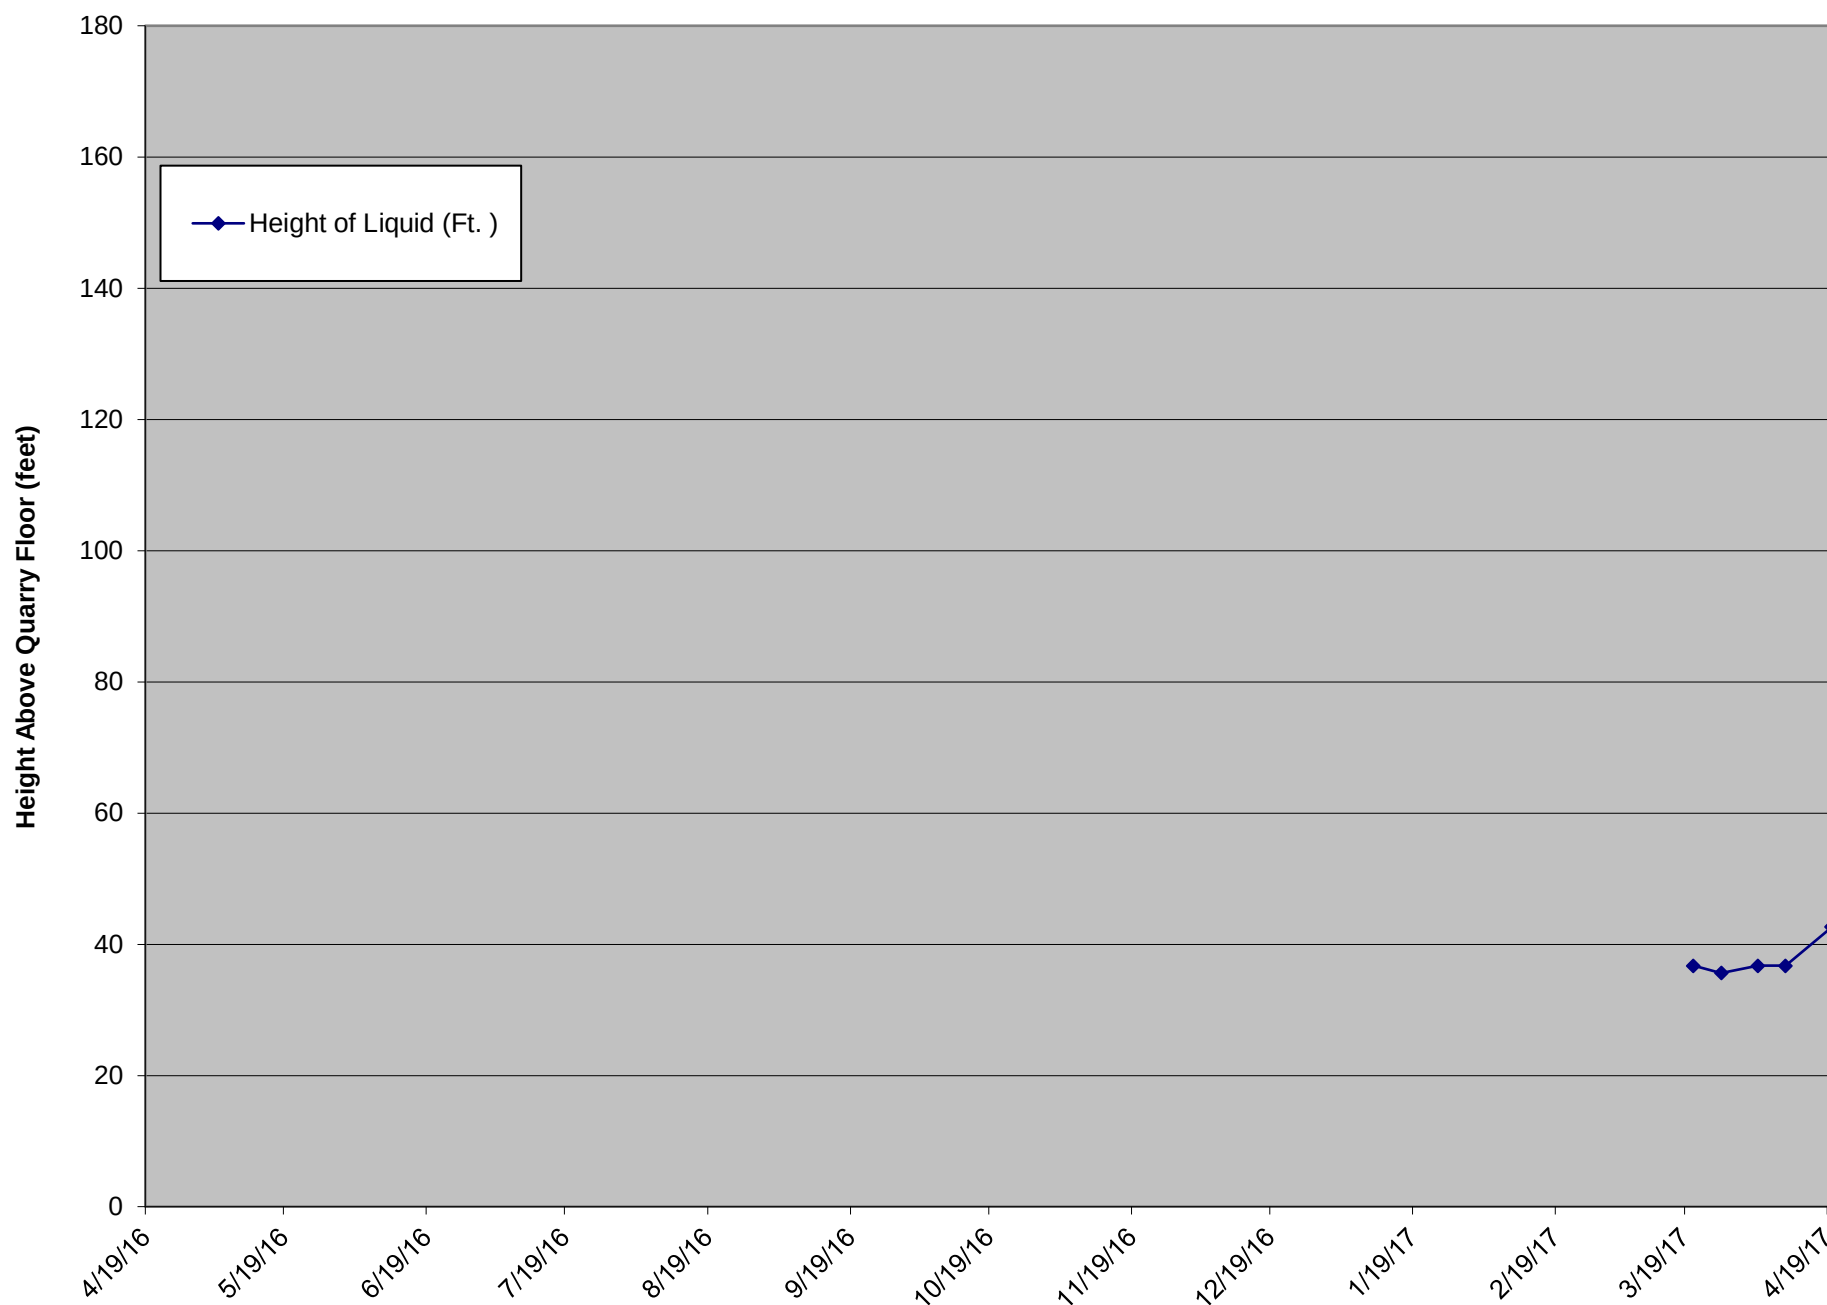
LCS-5B Liquid Level Above Quarry Floor

LCS-5B and LCS-6B were fully operational during the weekly reporting period. LCS-6B was shut down for cap construction-related activities and was returned to operation during the weekly reporting period.

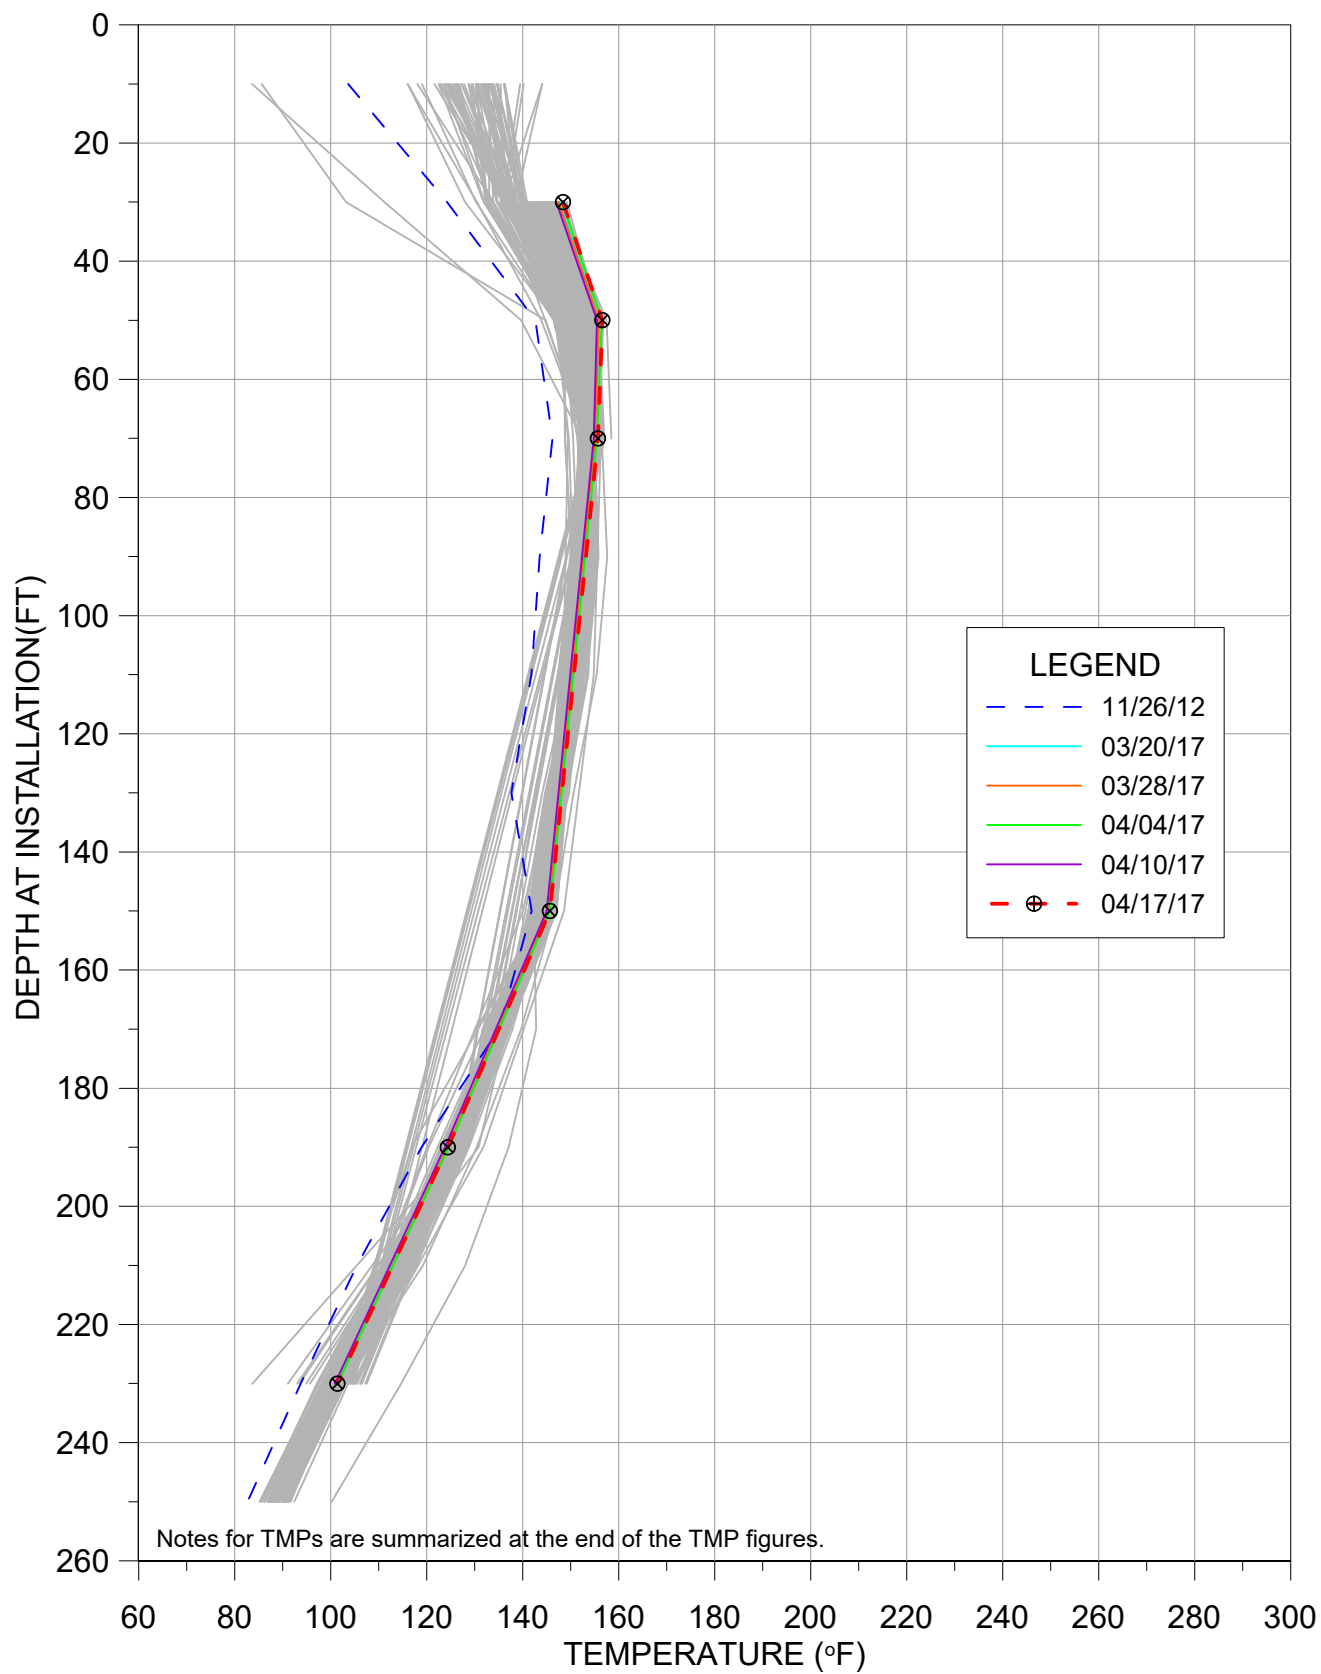
# TMP-3

1. No reliable temperature readings have been obtained at 170 ft depth since 1/29/2014, except on 3/13/2014.
2. The connectivity tests on 4/11/2014 conducted by CEC showed that units at 10, 90, 130, 210 and 250 ft depths are no longer reliable.
3. The connectivity tests on 10/28/2014 conducted by Feezor Engineering showed that units at 10, 90, 110, 130, 210 and 250 ft depths are not reliable.

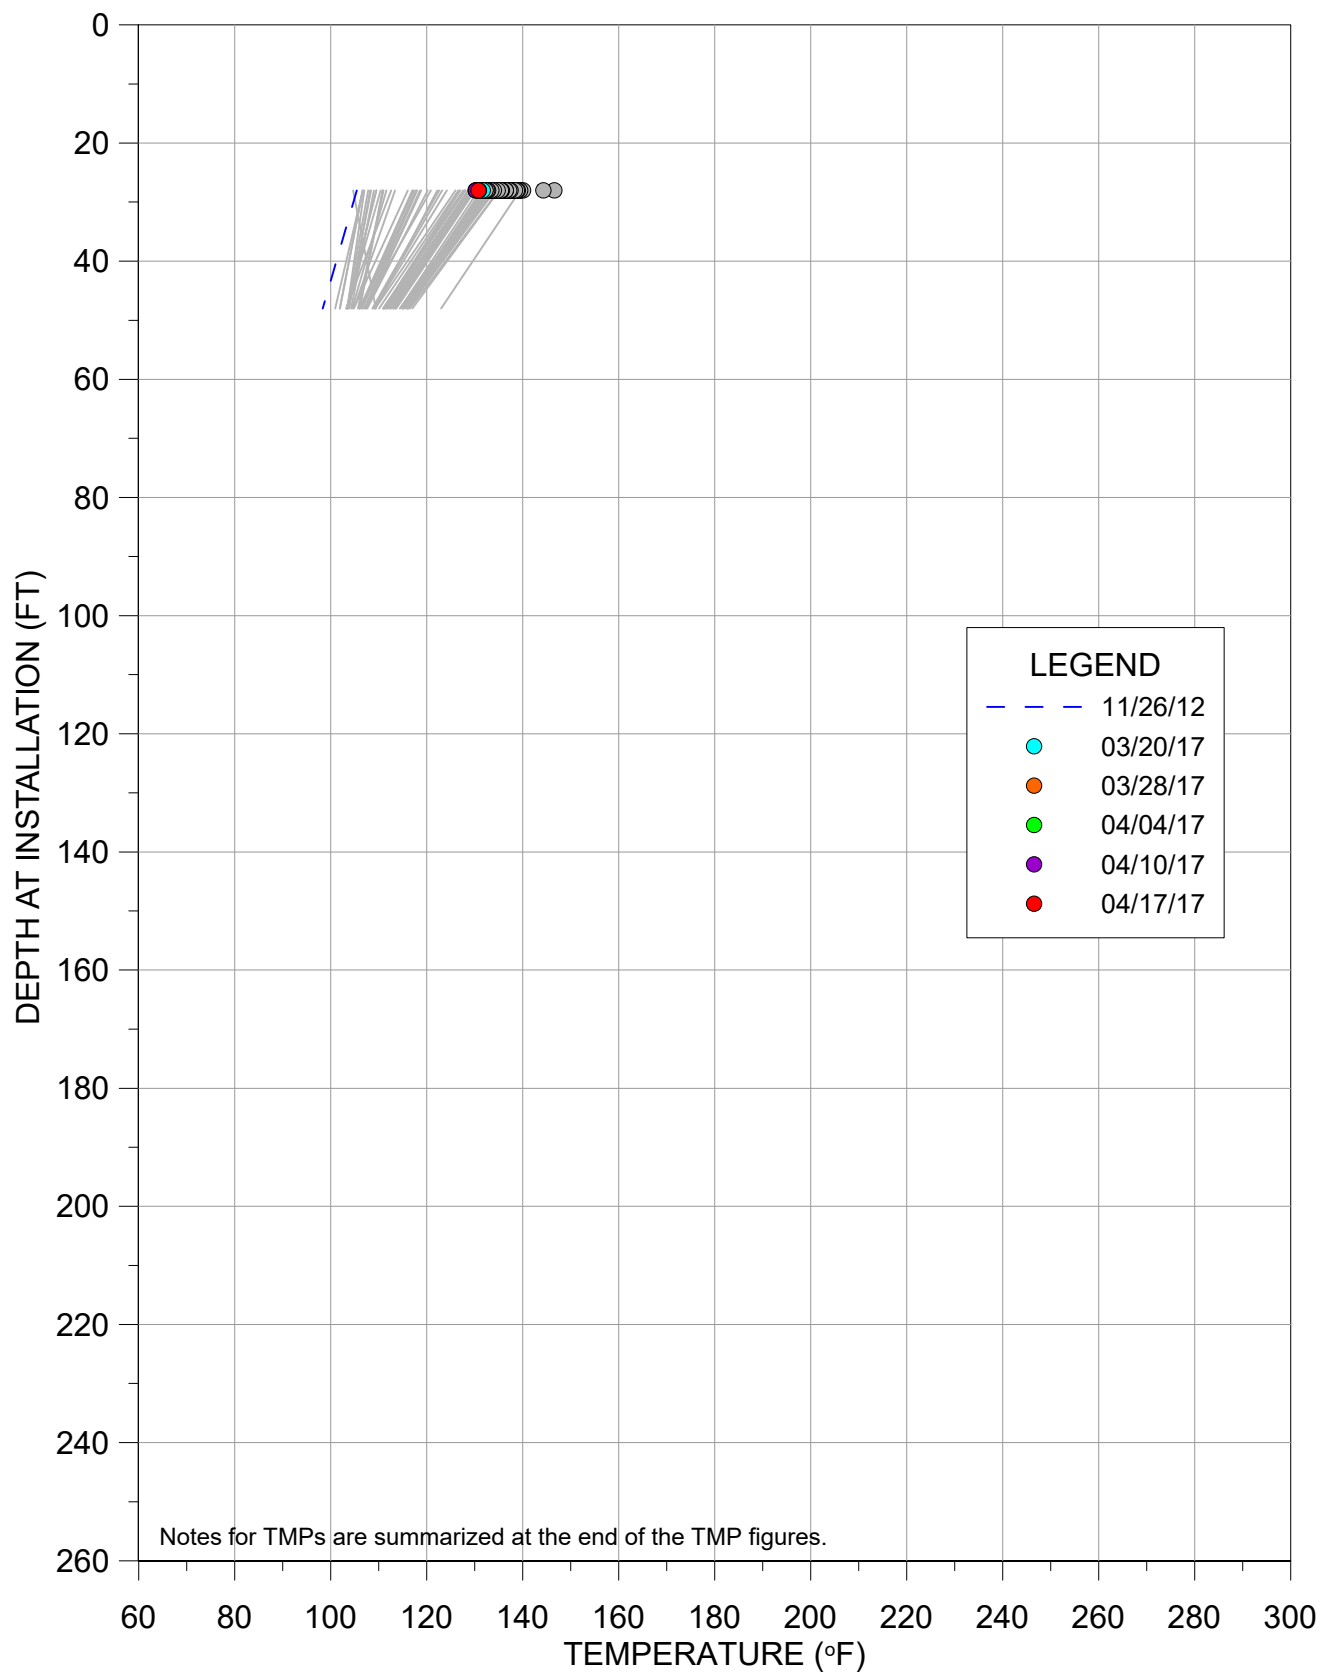
# TMP-4

1. The connectivity tests on 4/11/2014 conducted by CEC showed that the unit at 48 ft depth is no longer reliable.

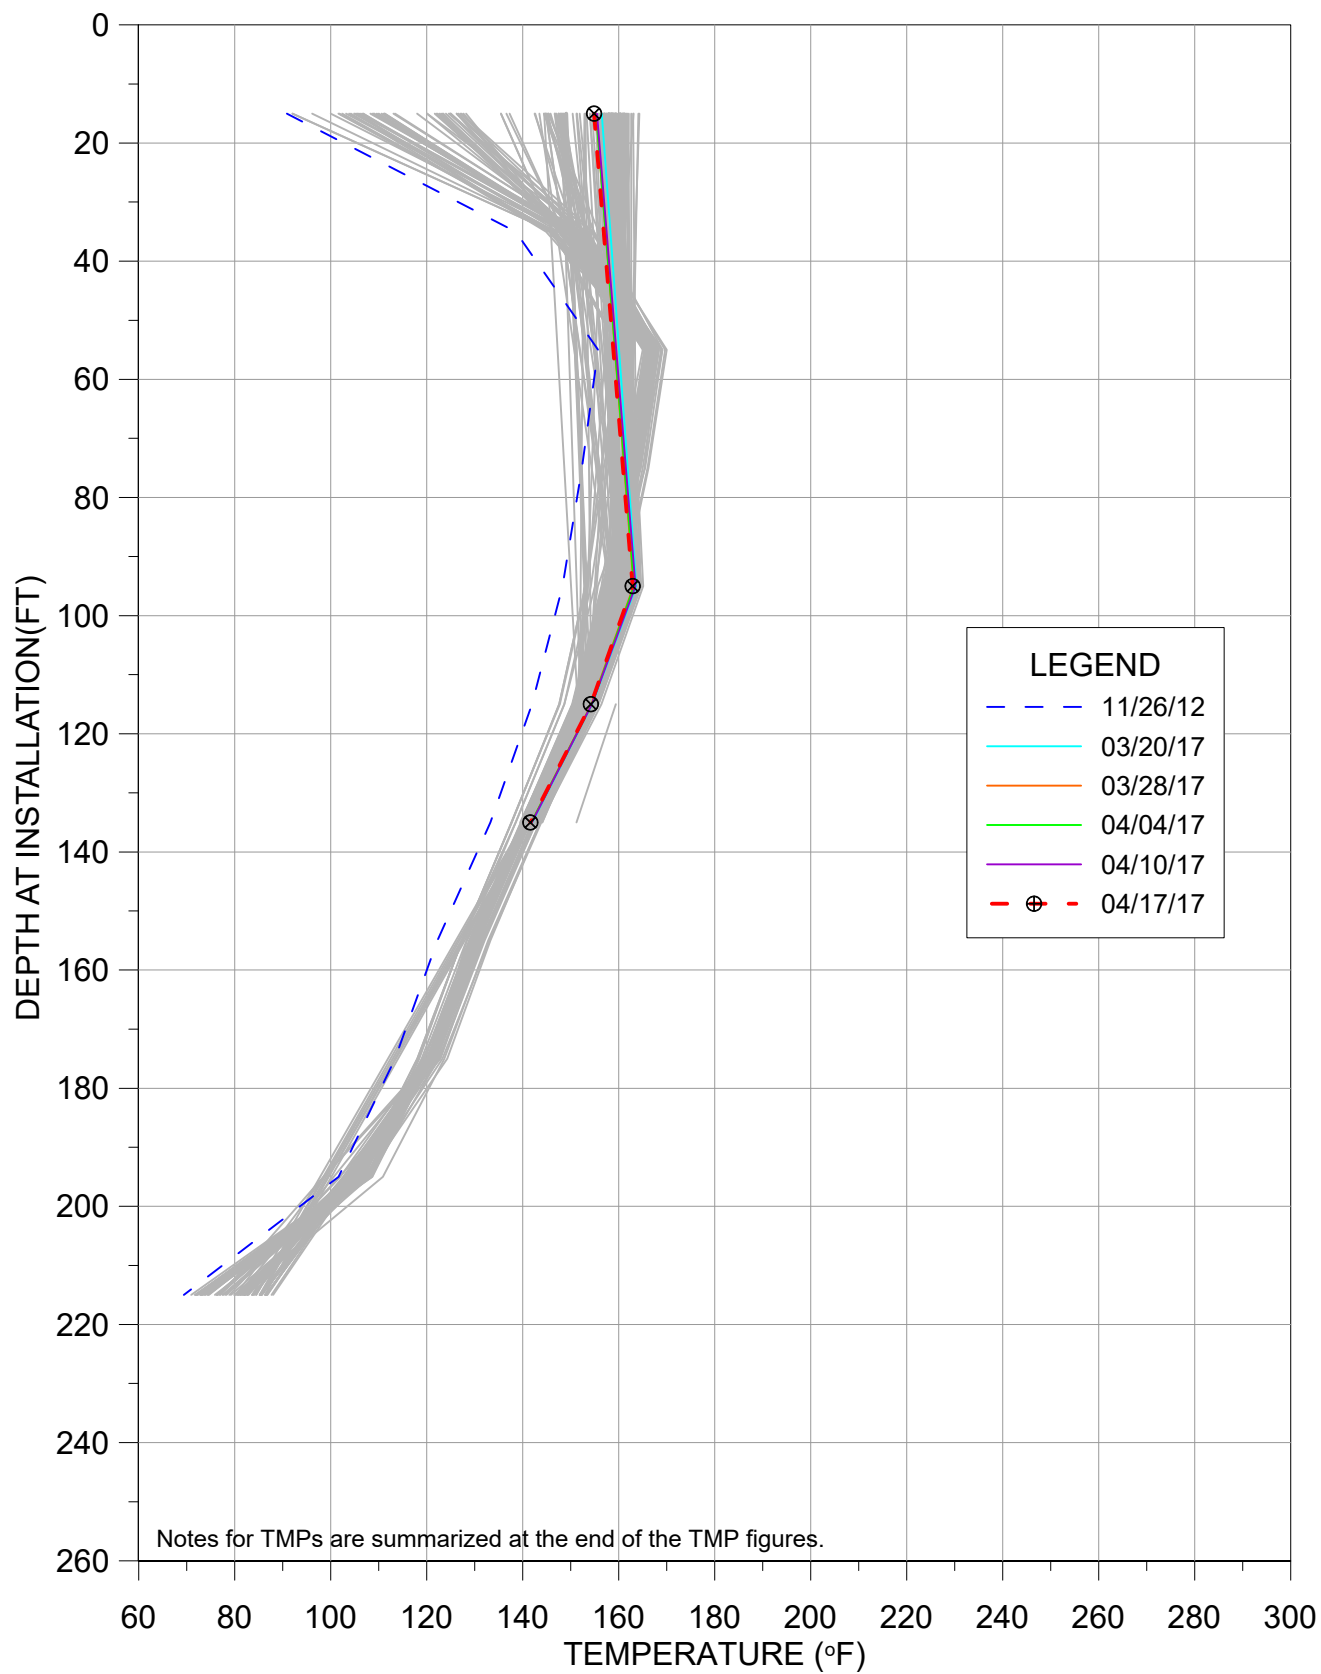
# TMP-6

1. The connectivity tests on 4/11/2014 conducted by CEC showed that units at 35, 55, 75, 155, 175, and 195 ft depths are no longer reliable.
2. No reliable temperature readings have been obtained at the unit at 215 ft depth since 6/13/2014.

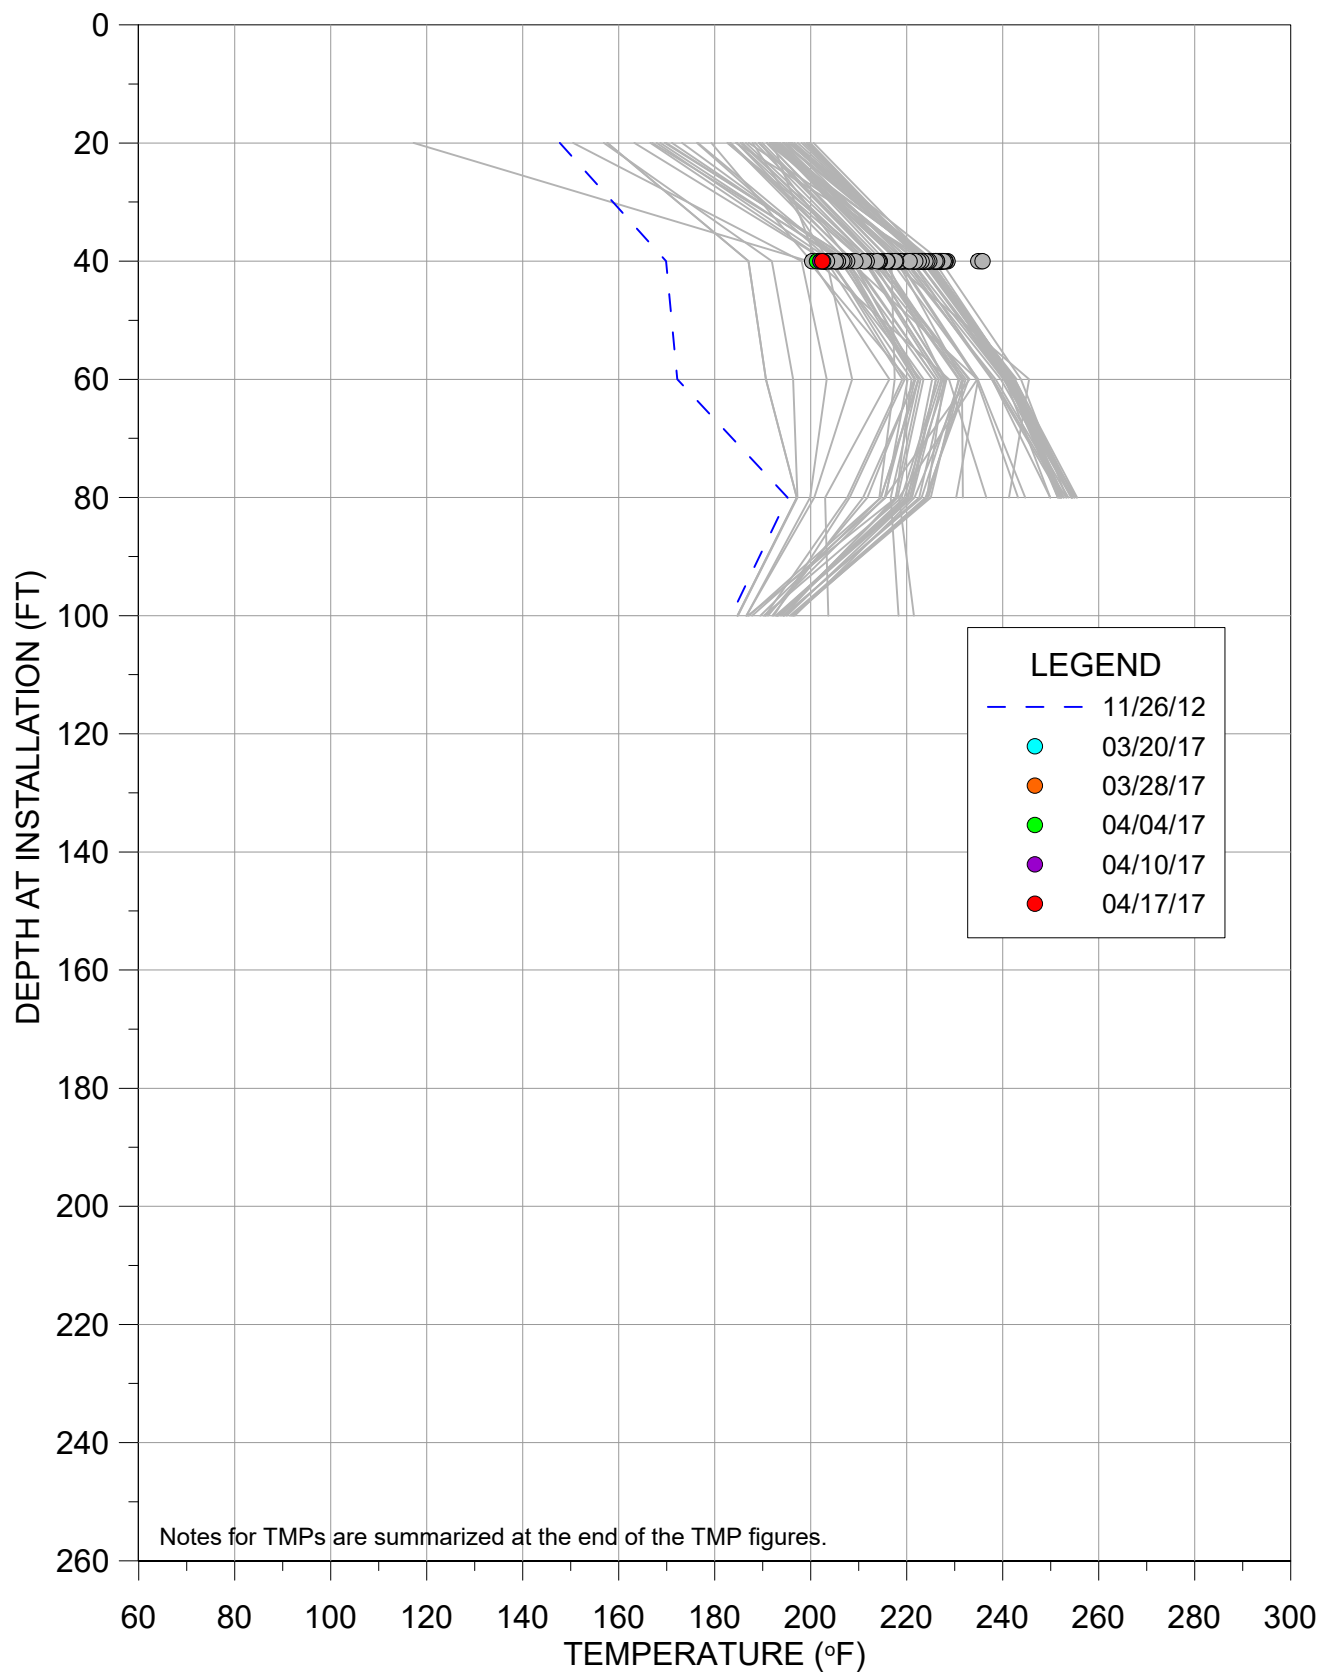
# TMP-9

1. Unit at 100 ft depth had an inaccurate temperature reading on 8/1/2013 and no reading since 8/6/2013.
2. The connectivity tests on 4/11/2014 conducted by CEC showed that units at 20, 60, 80, and 100 ft depths are no longer reliable.

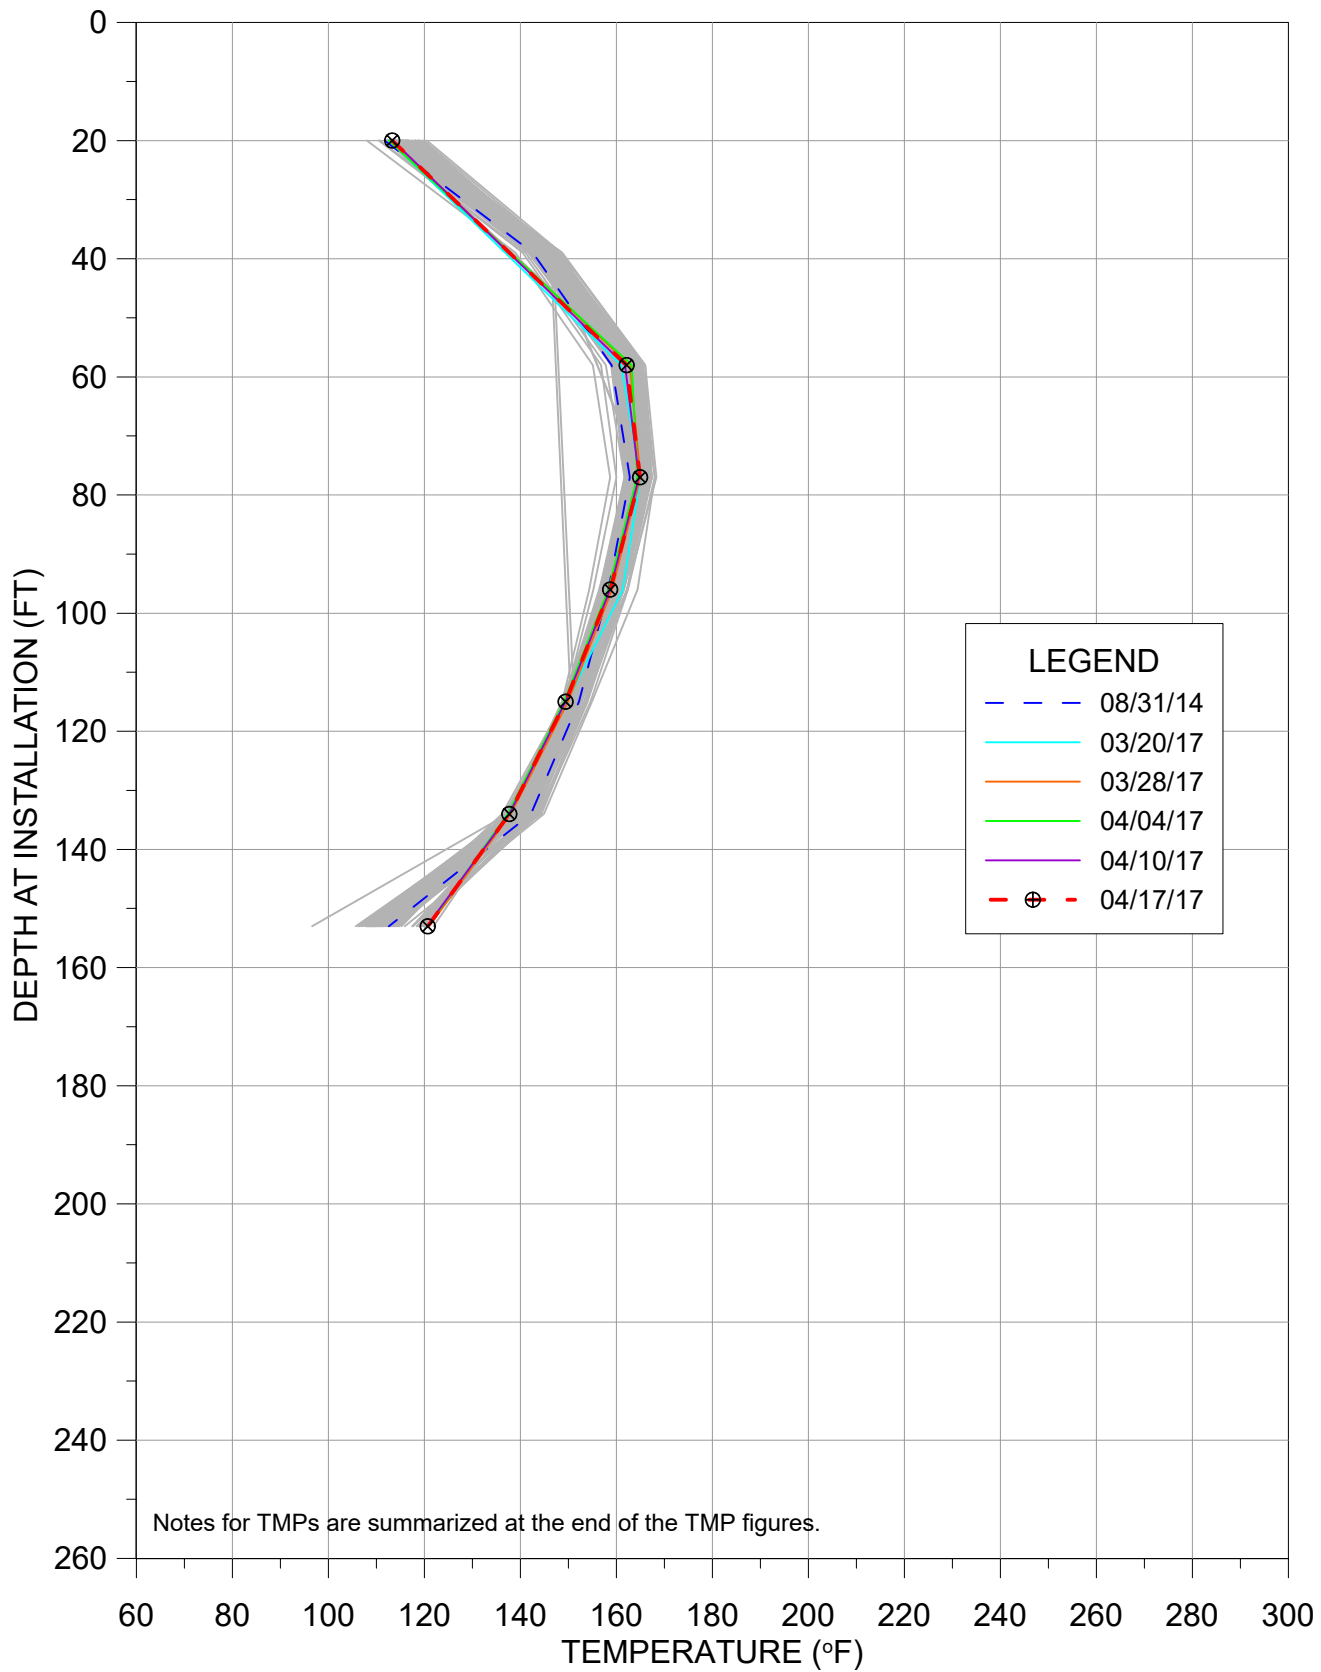
# TMP-16

1. A connectivity test conducted by Feezor Engineering showed that the units on TMP-16 may not be reliable since 9/9/2015. Further testing at the end of September 2015 showed possible connectivity on some of the units.
2. The unit at 153 ft depth had a low resistance reading and unreliable temperature since 12/21/2015.

3. The unit at 39 ft depth had a higher than acceptable resistance reading and unreliable temperature since 2/7/2017.
