# **Bridgeton Landfill, LLC**

## **Weekly Data Submittal**

**Week of April 16, 2017 – April 22, 2017**

**Required by Section 52.F of Agreed Order, Case No. 13SL-CC01088  
Effective May 13, 2013**

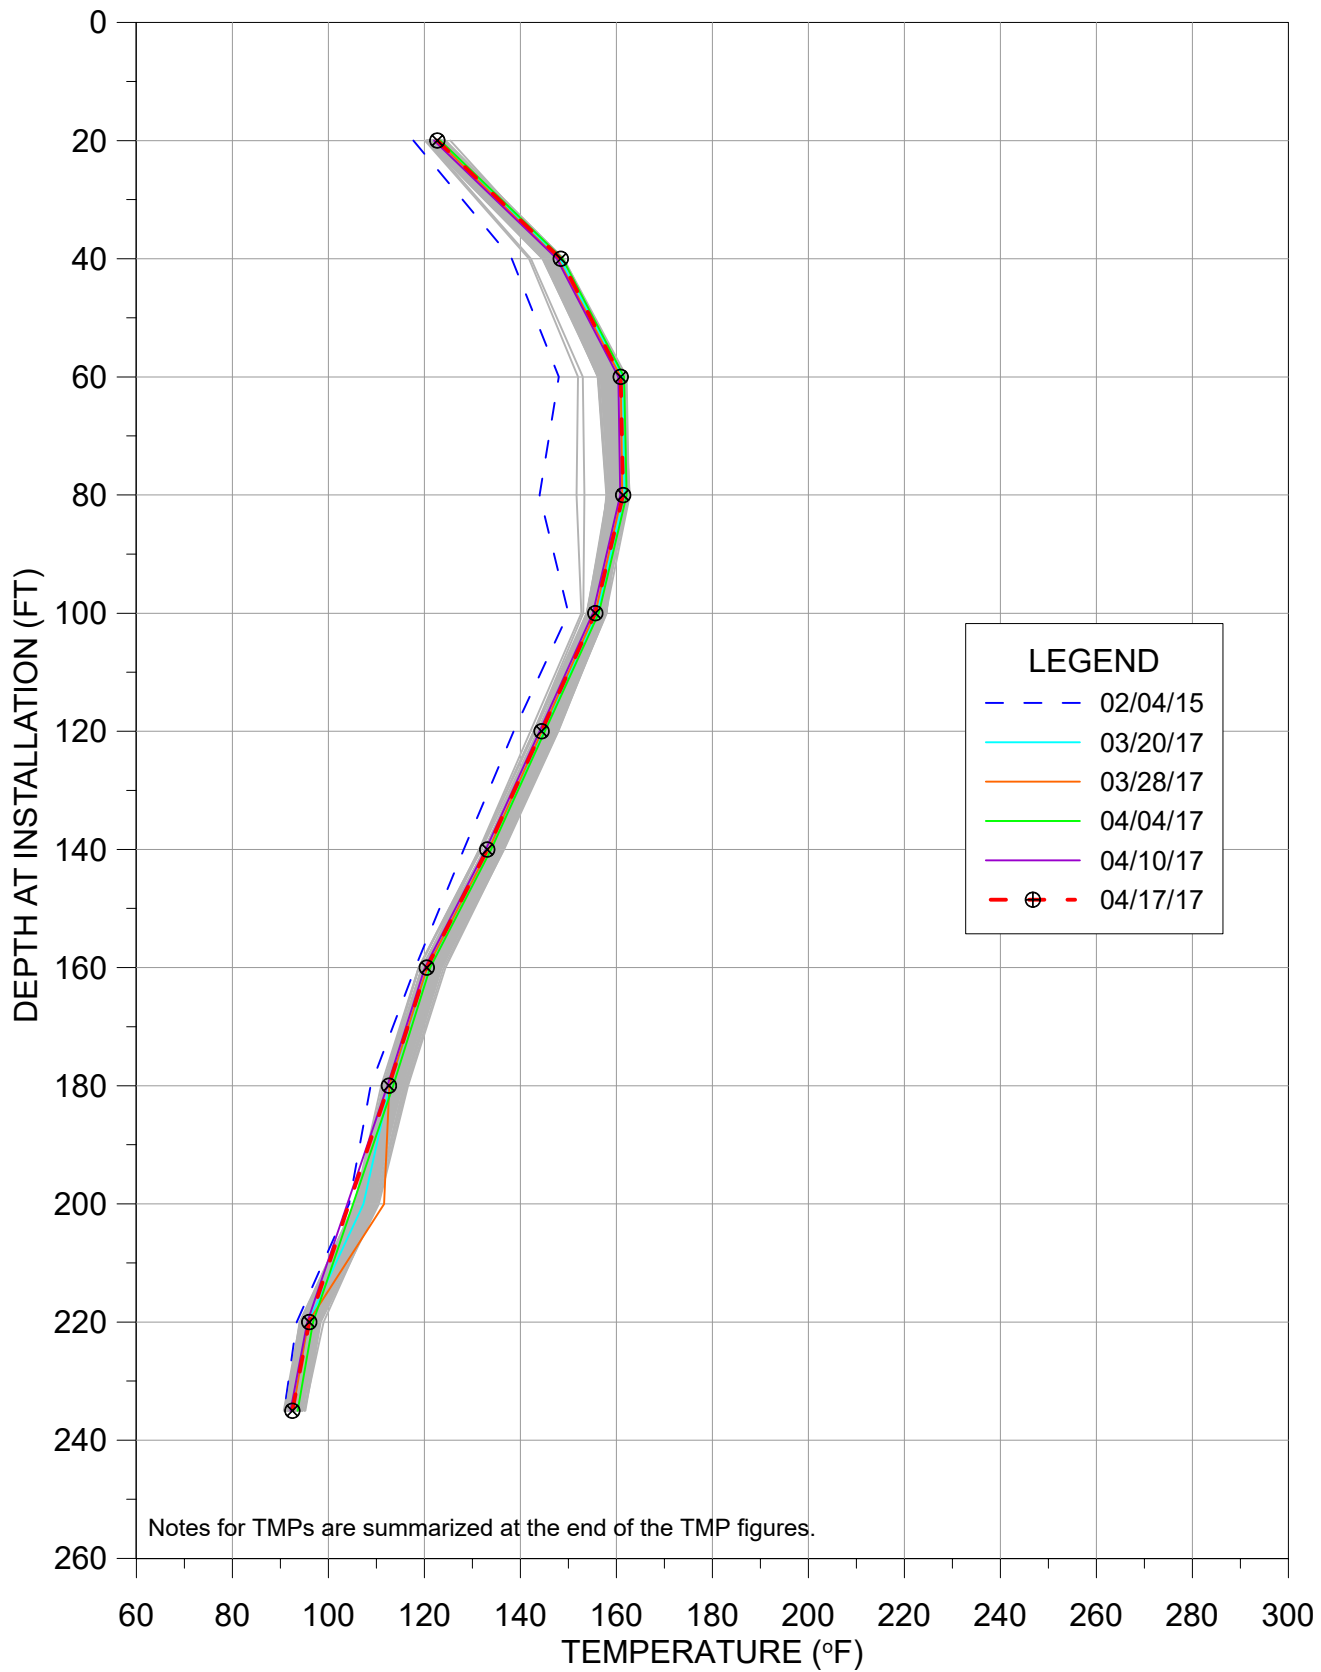
# TMP-25

1. The unit at 200 ft provided an apparent anomalous reading on 3/28/2017. Subsequent readings on 4/4/2017 showed the unit to have failed (see below). The unit is no longer working and the reading of 3/28/2017 was likely unreliable.
2. The unit at 200 ft depth had a resistance reading greater 4000 ohms on 4/4/2017. A connectivity test conducted by Feezor Engineering on 4/7/2017 showed that this unit also had cross-connectivity. The unit is therefore determined to be no longer working as of the 4/4/2017 reading.

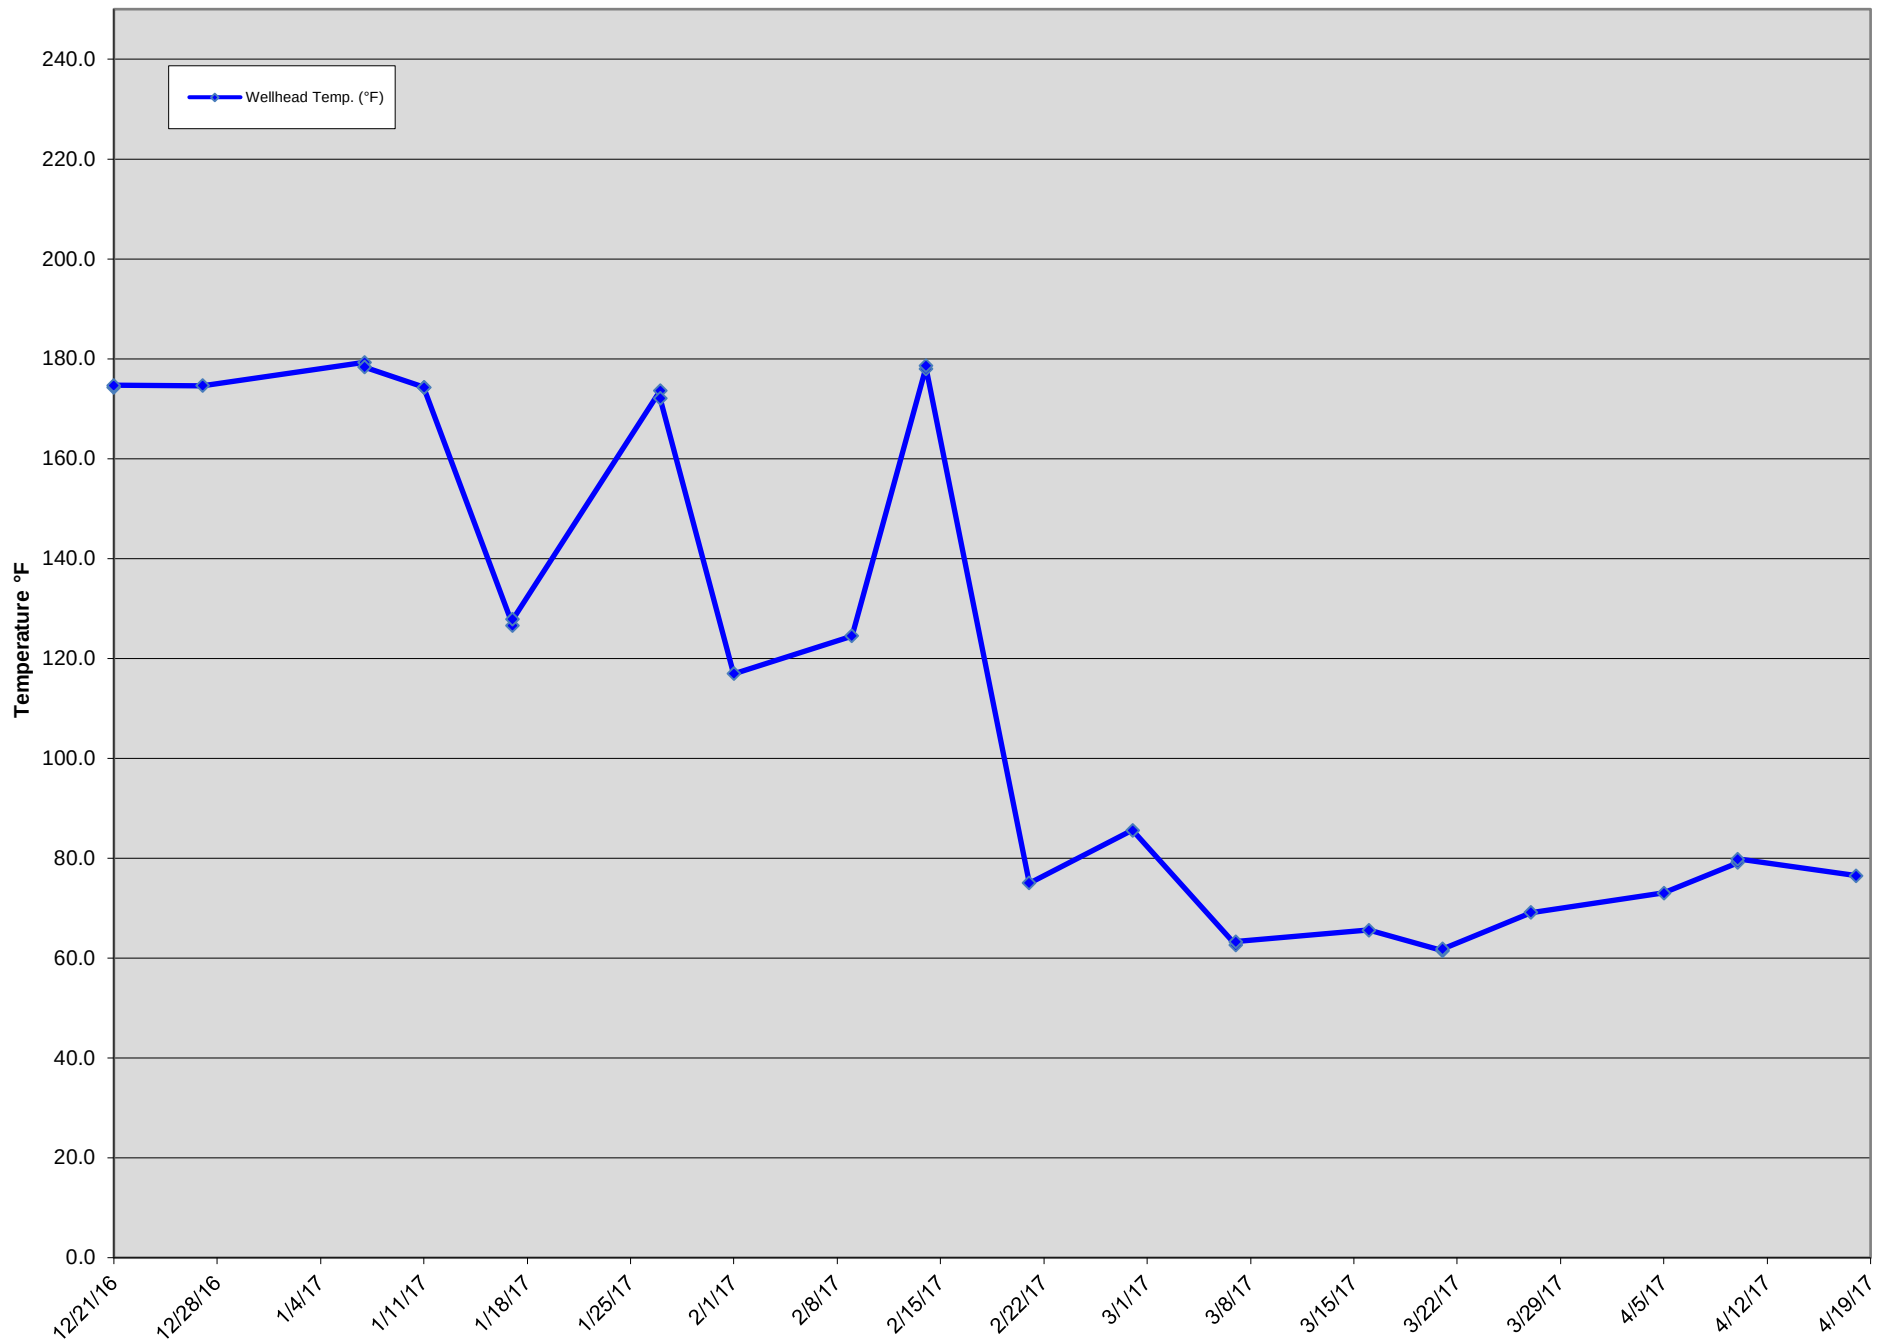
GIW-1 Wellhead Temperatures

As part of the HES, there are currently cooling water circulation loops installed in twelve Gas Interceptor Wells (GIWs) (GIW-02 through GIW-13). The remaining well (GIW-01) had a measured gas temperature within its historical operating limits.
