# **Bridgeton Landfill, LLC**

## **Weekly Data Submittal**

**Week of April 23, 2017 – April 29, 2017**

**Required by Section 52.F of Agreed Order, Case No. 13SL-CC01088  
Effective May 13, 2013**

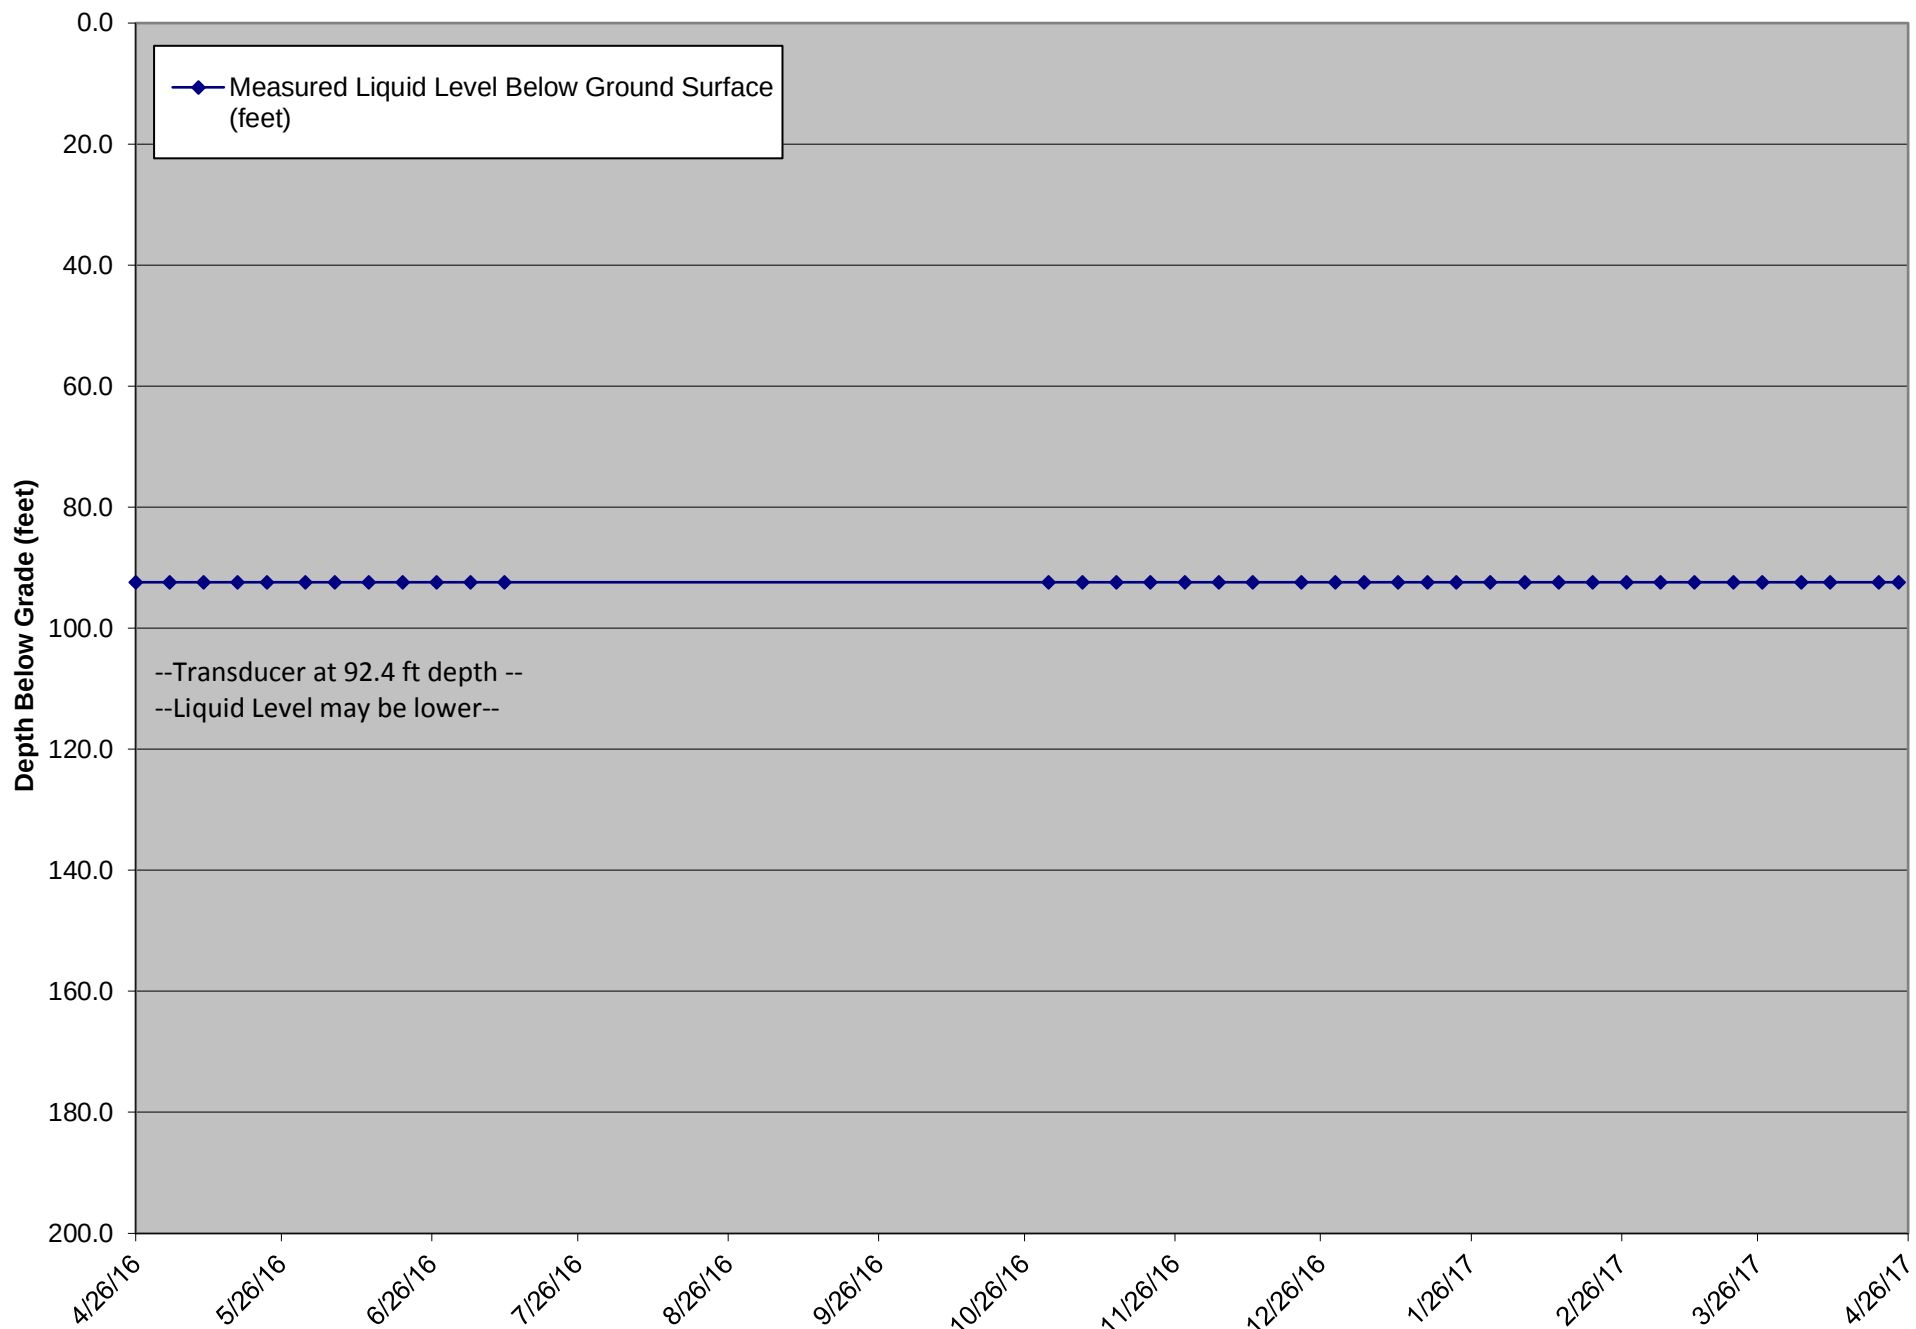
# LCS-1D Liquid Level Below Ground Surface

LCS-1D is equipped with a level sensor and a flow meter. Bridgeton Landfill confirmed that the flow meter on LCS-1D is operational and the flow was observed during the weekly reporting period. Liquid level was not recorded by the level sensor during the weekly reporting period. Bridgeton Landfill is tentatively scheduled to replace the level sensor on LCS-1D the week of 5/8/2017 pending parts arrival.

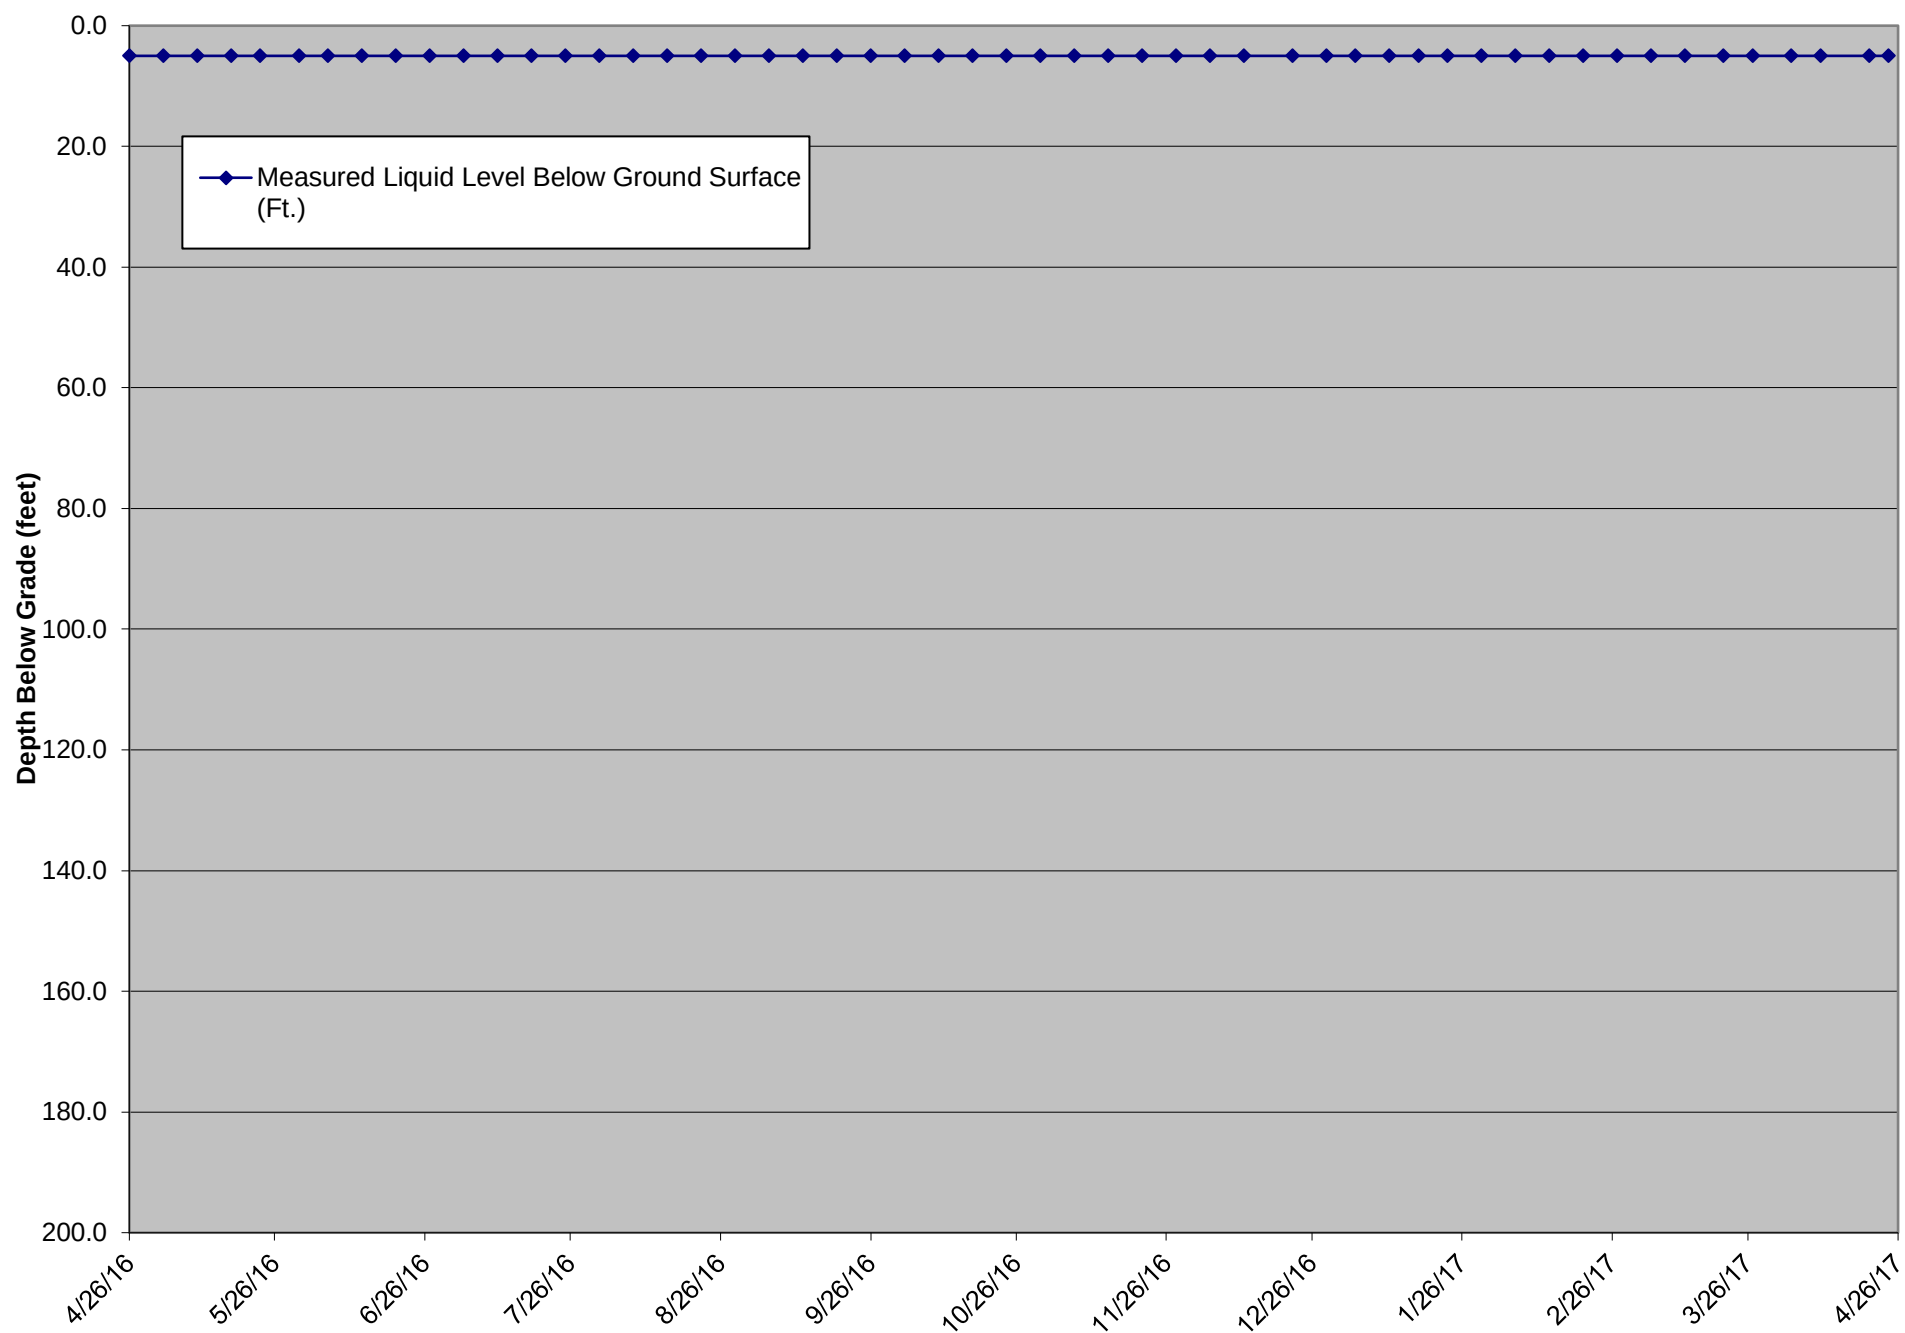
# LCS-3D Liquid Level Below Ground Surface

The pumps in LCS-2D and LCS-3D were non-operational during the weekly reporting period. The transducer in LCS-3D continued to report liquid levels. Flow was observed on the LCS-3D flow meter during the weekly reporting period. The pump and transducer in LCS-3D is tentatively scheduled to be replaced during the week of 5/8/2017 pending parts arrival.

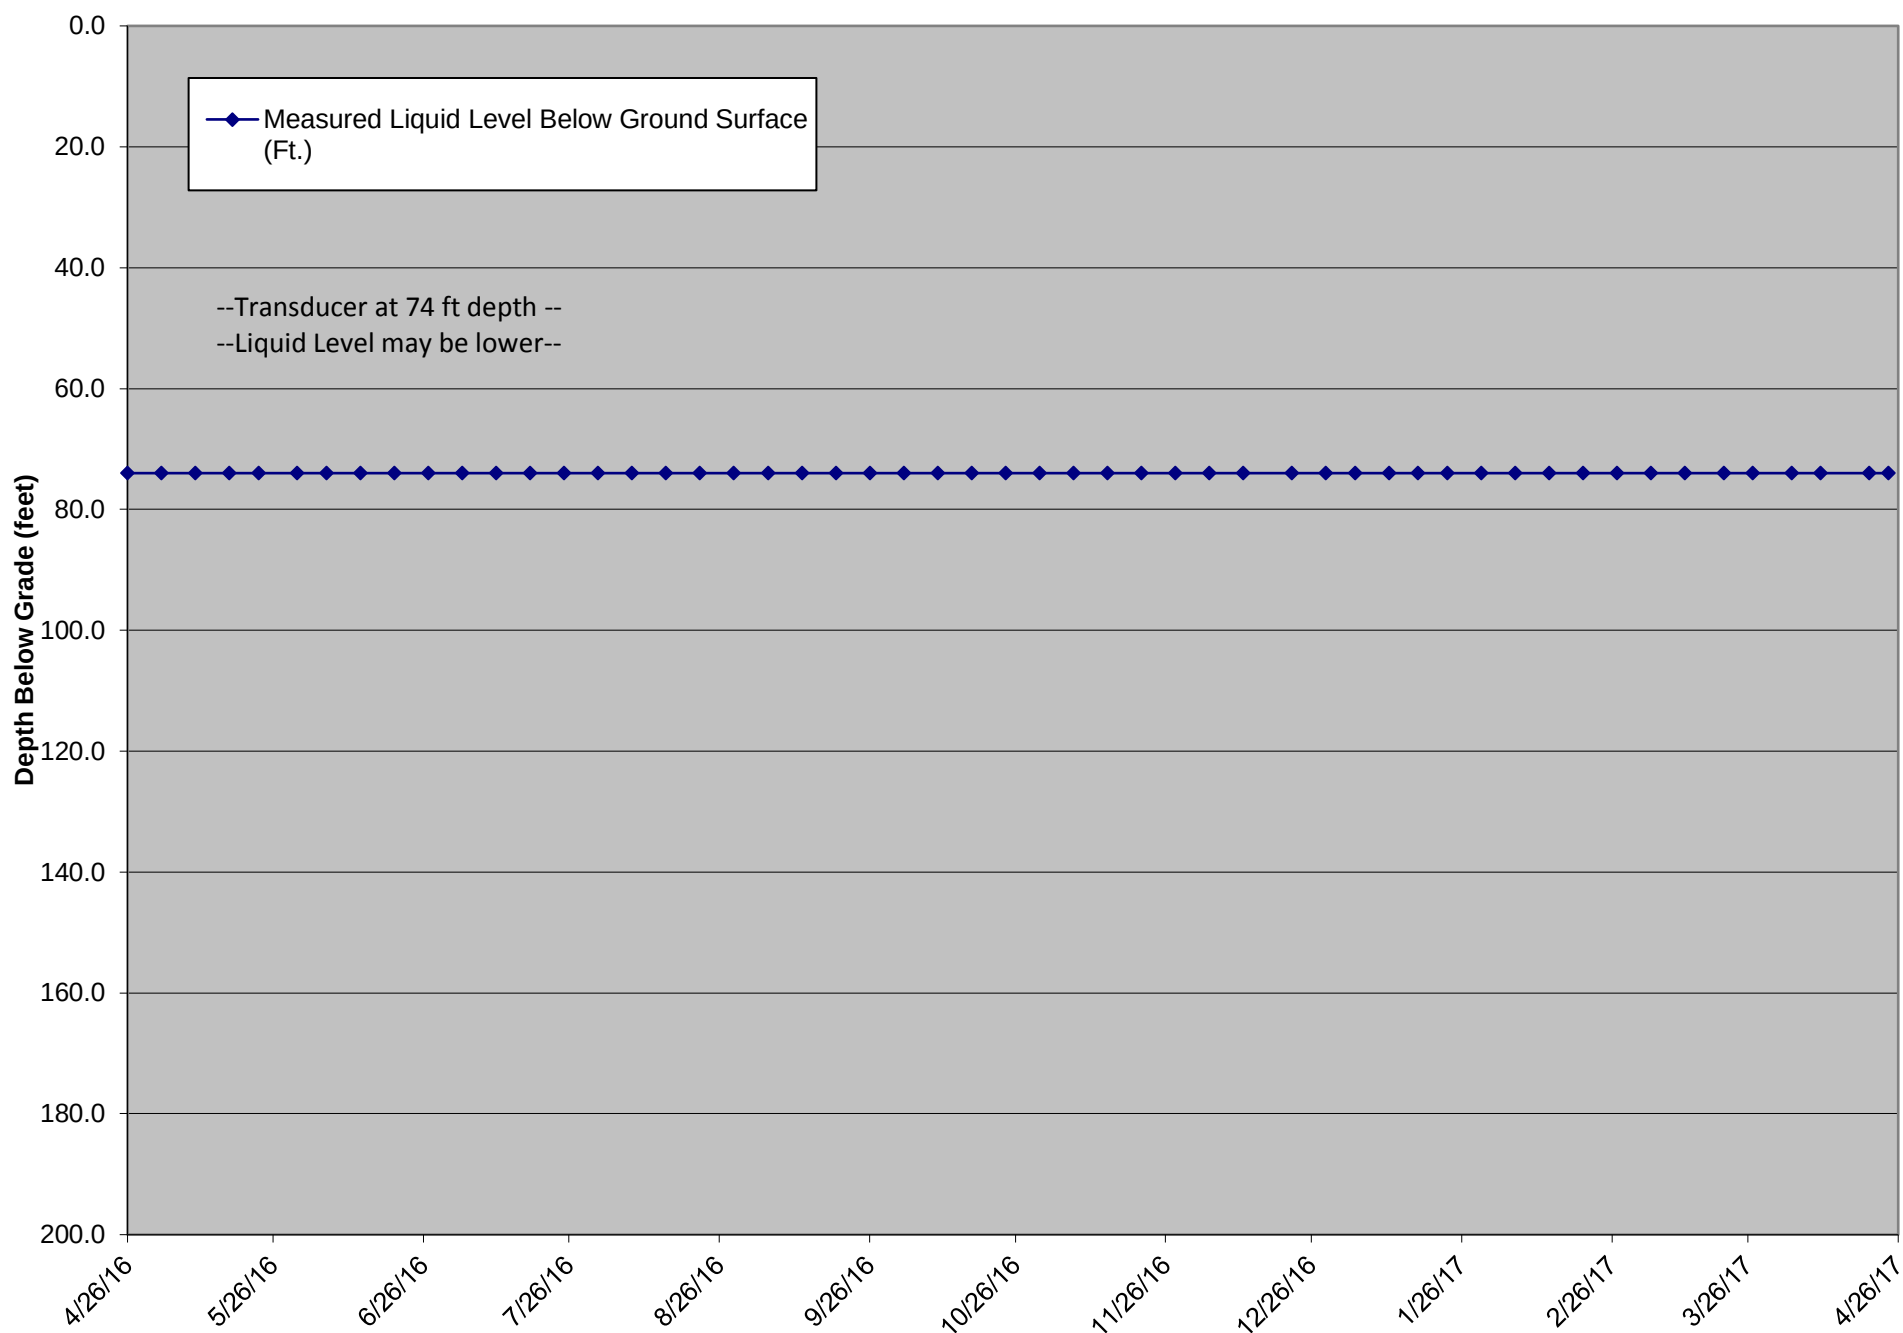
# LCS-4B Liquid Level Below Ground Surface

The level sensor in LCS-4B is currently operational and responsive. Liquid level was not recorded by the level sensor during the weekly reporting period. LCS-4B is equipped with a flow meter that displayed no flow during the weekly reporting period. Therefore, it can be concluded that the liquid level was below the bottom of the pump and level sensor in LCS-4B.

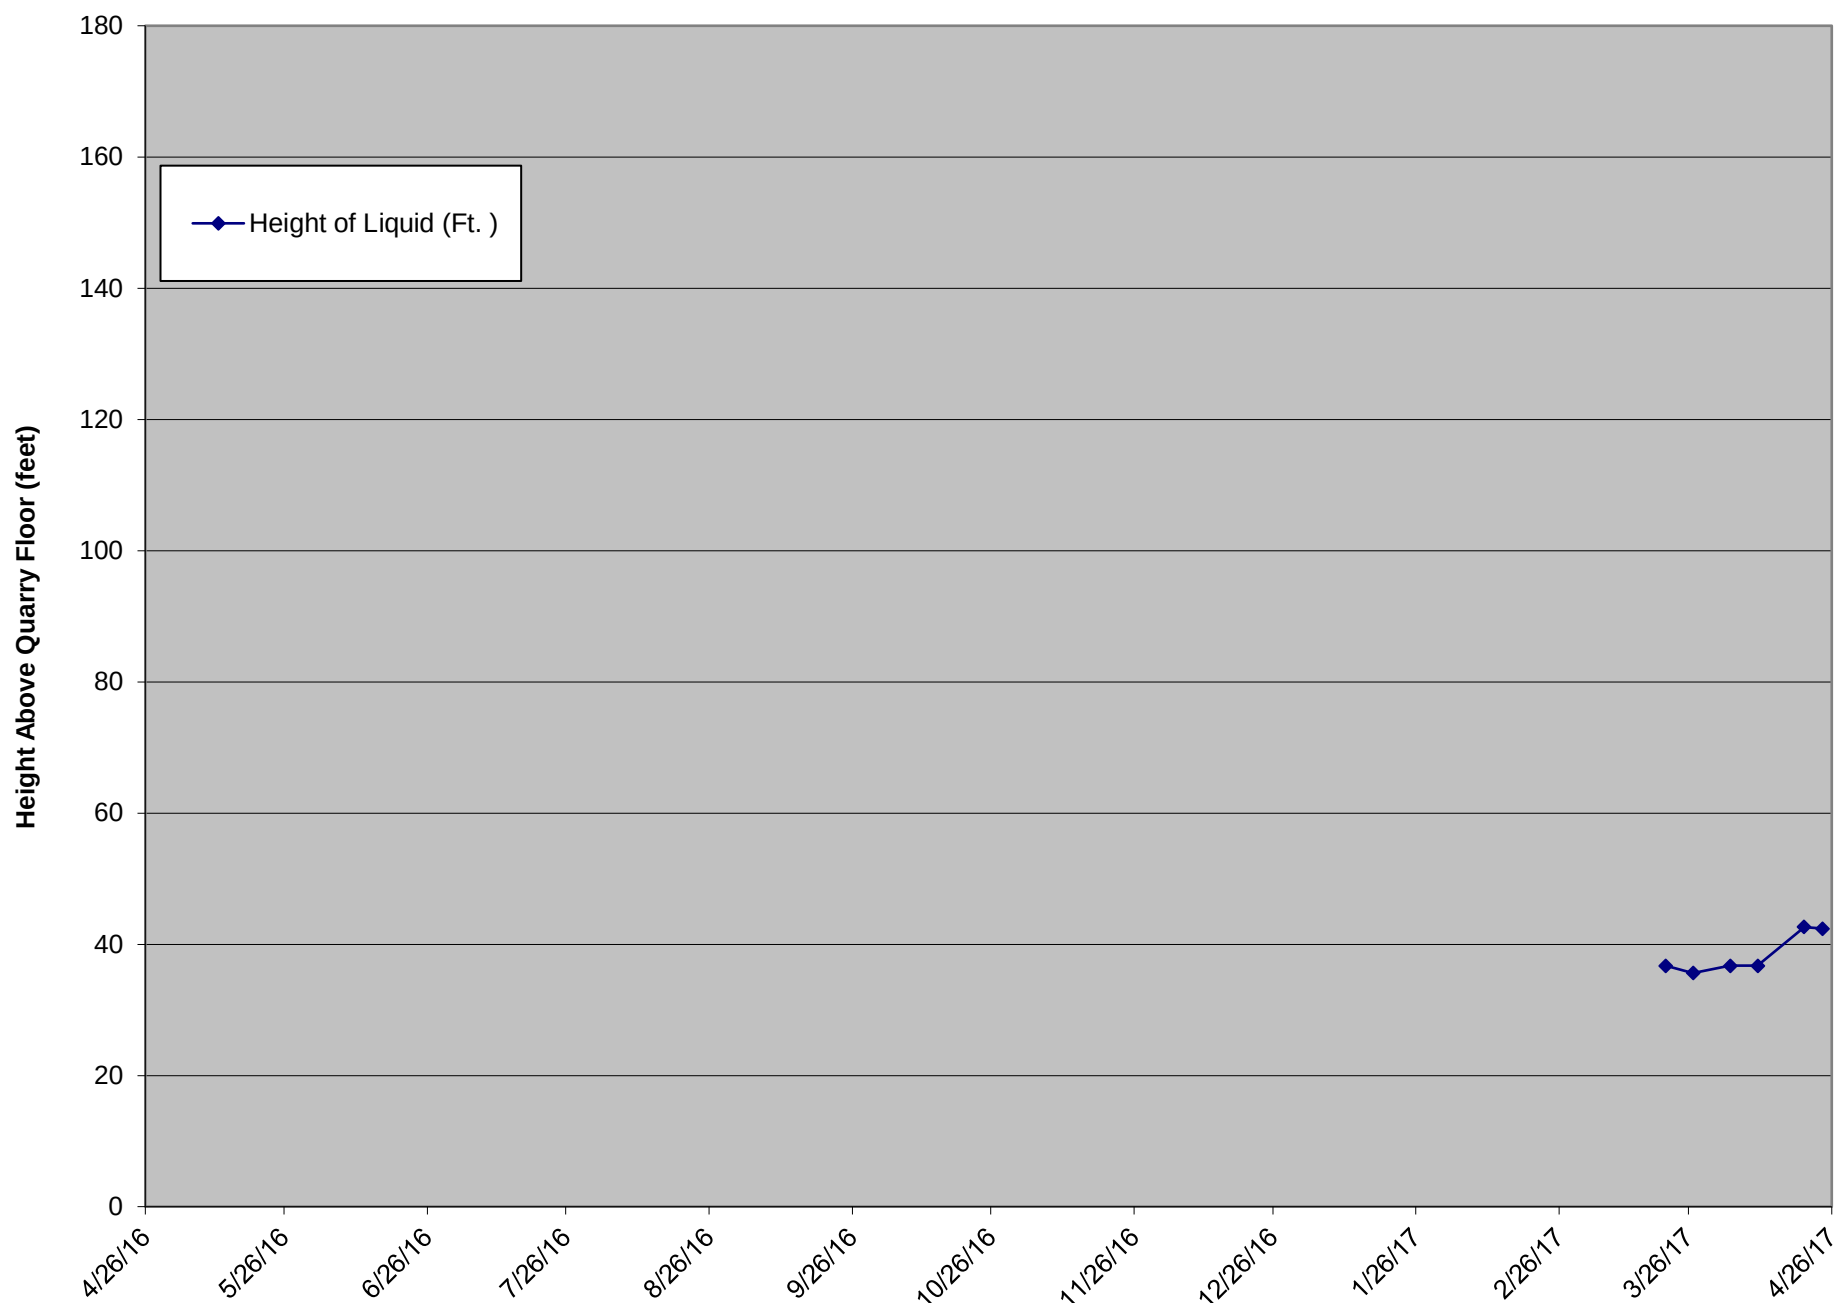
LCS-5B Liquid Level Above Quarry Floor

LCS-5B and LCS-6B were fully operational during the weekly reporting period.

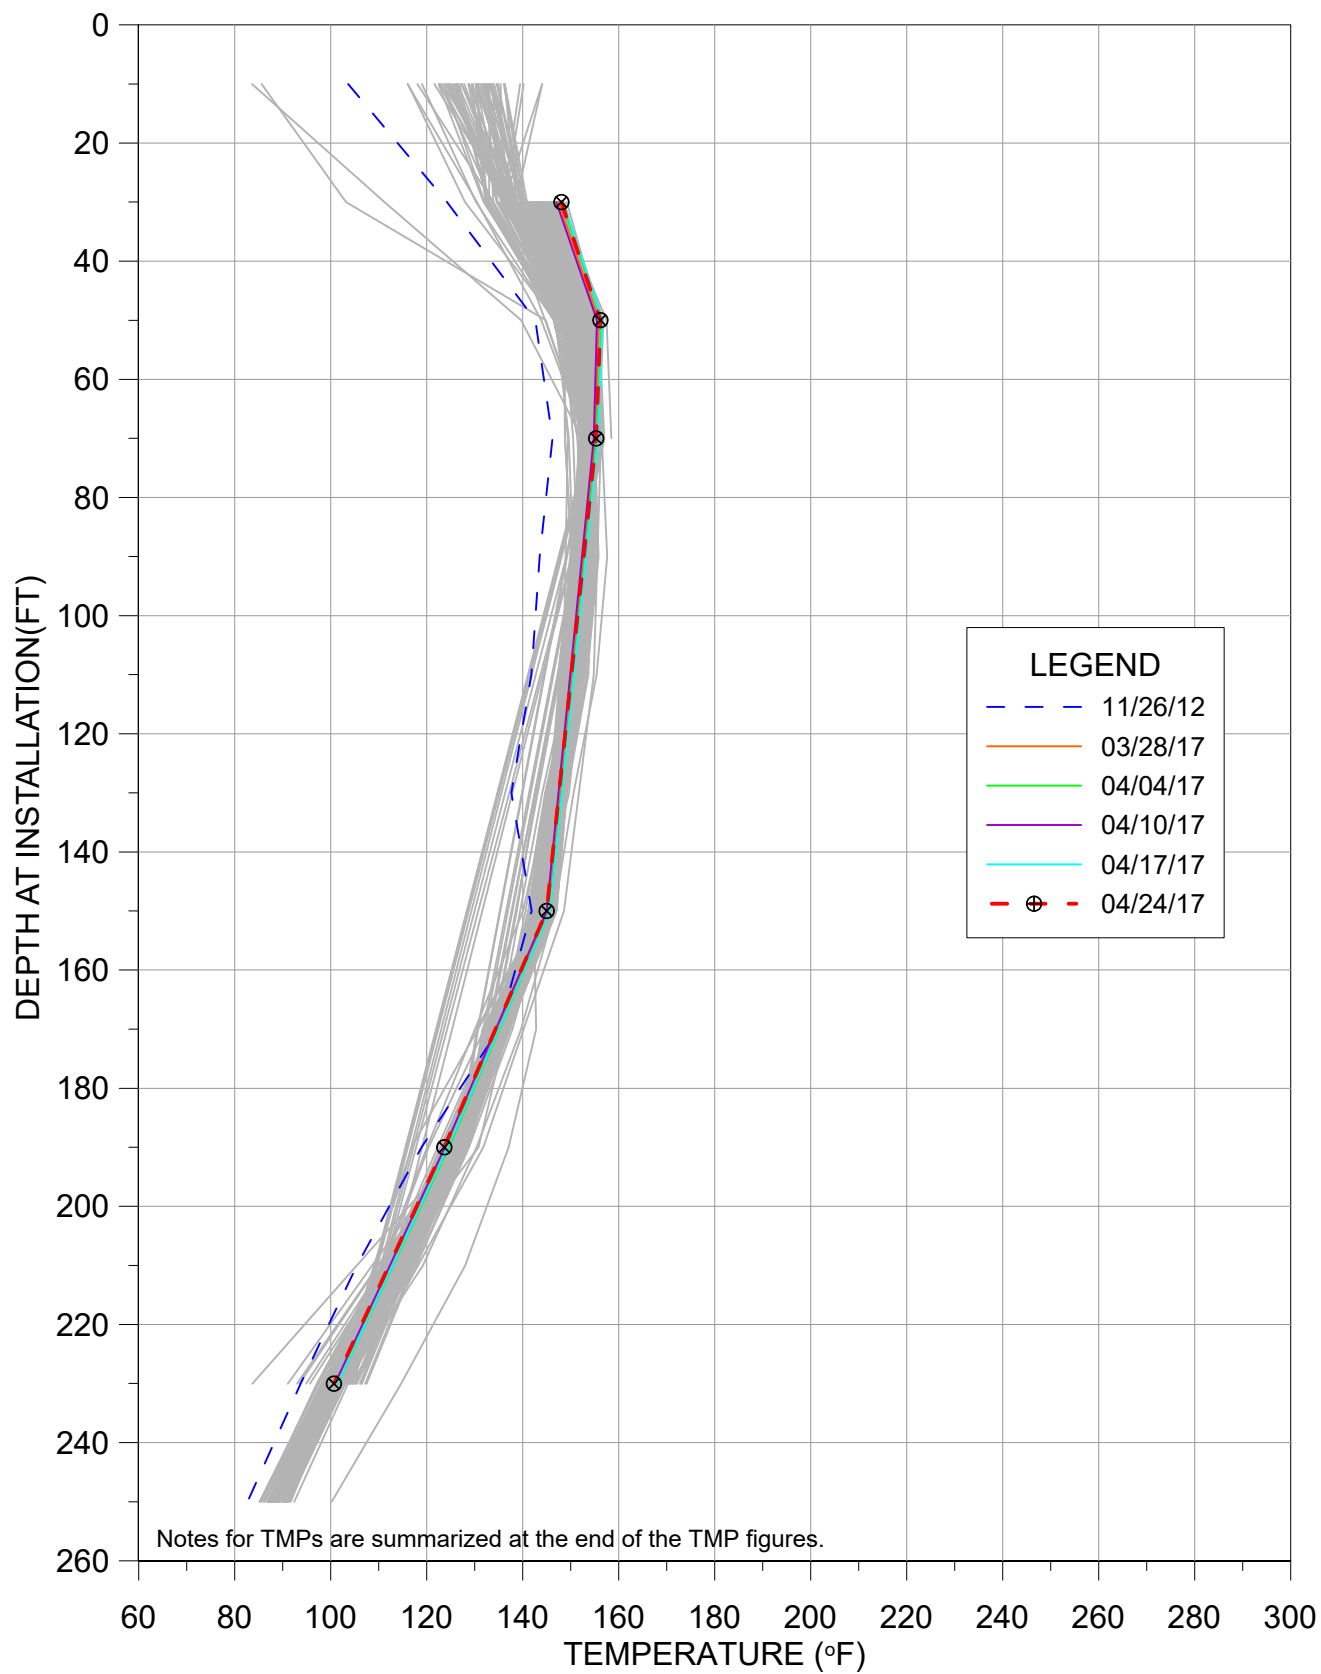
# TMP-3

1. No reliable temperature readings have been obtained at 170 ft depth since 1/29/2014, except on 3/13/2014.
2. The connectivity tests on 4/11/2014 conducted by CEC showed that units at 10, 90, 130, 210 and 250 ft depths are no longer reliable.
3. The connectivity tests on 10/28/2014 conducted by Feezor Engineering showed that units at 10, 90, 110, 130, 210 and 250 ft depths are not reliable.

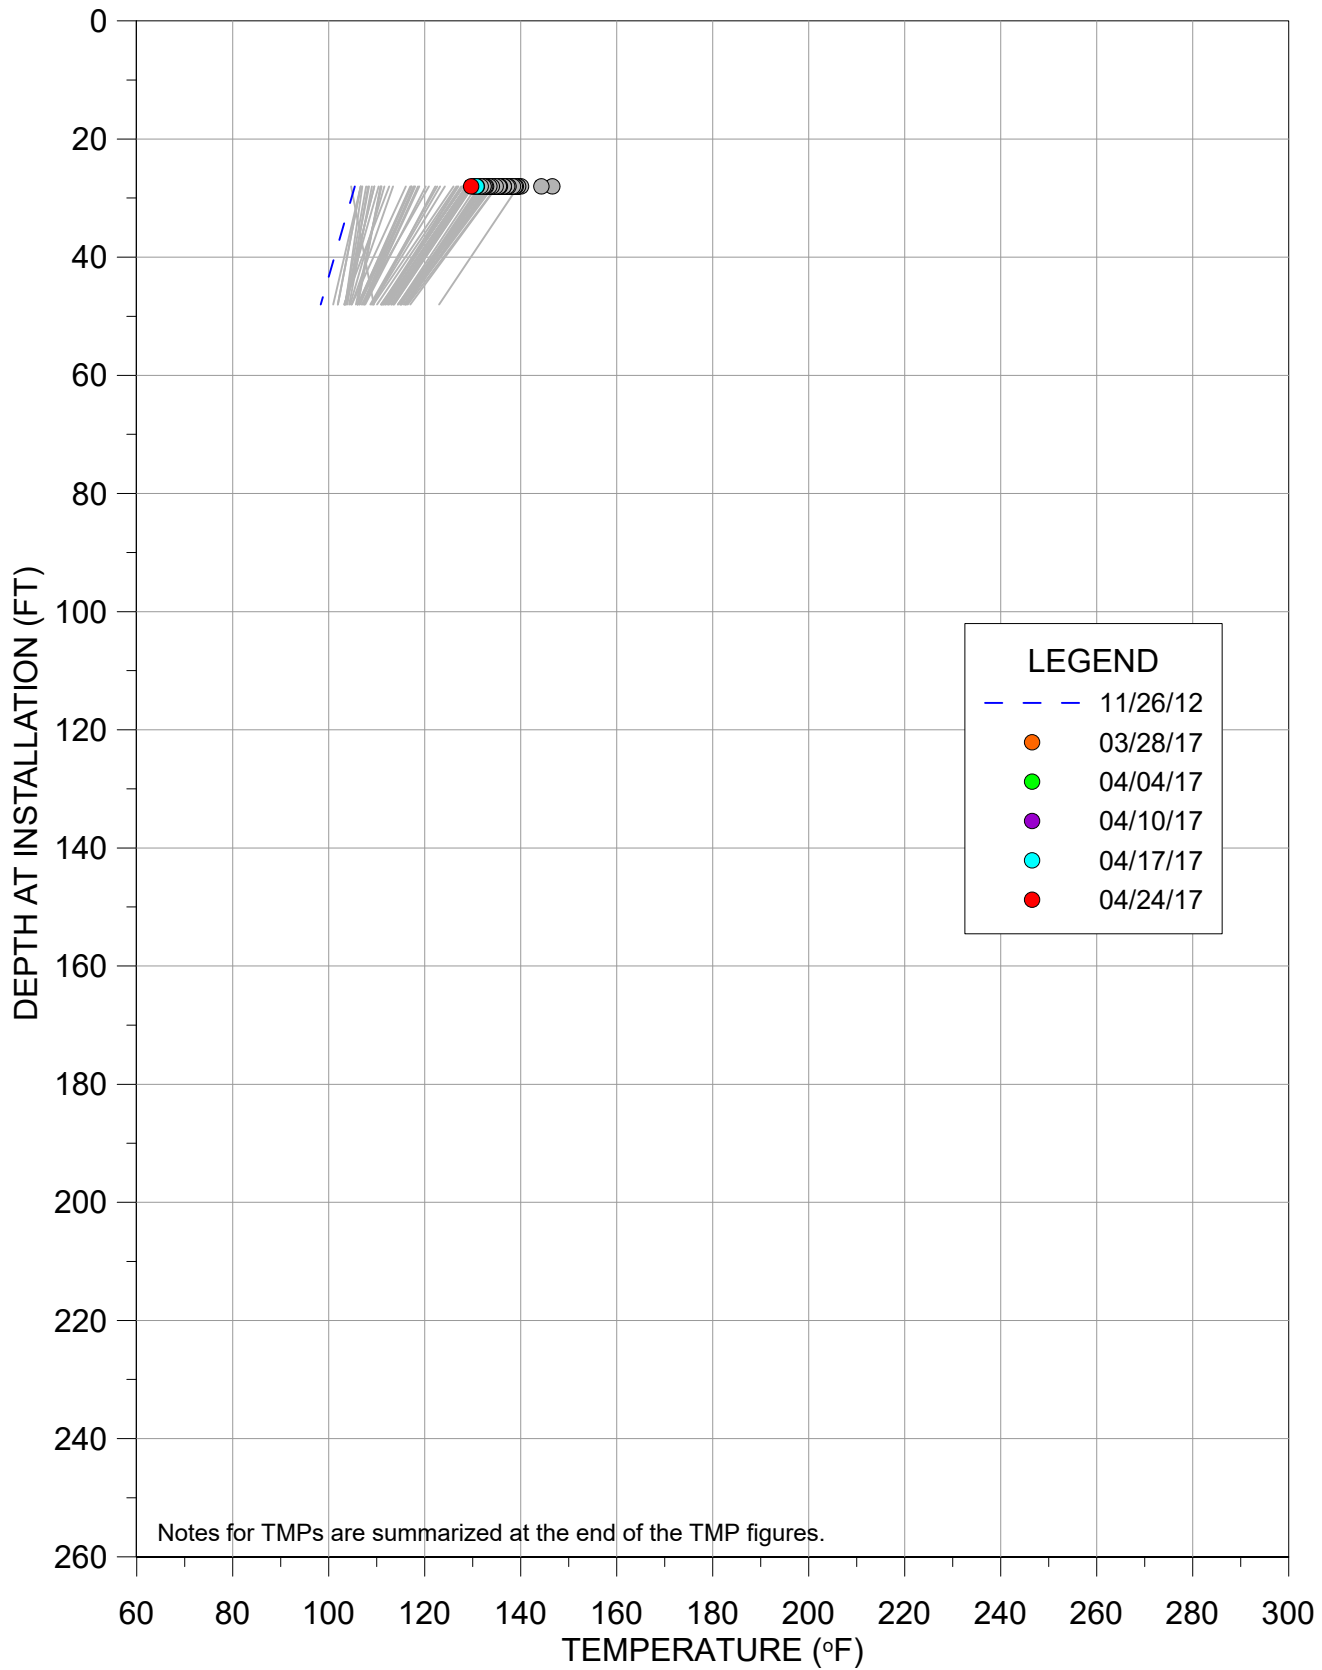
# TMP-4

1. The connectivity tests on 4/11/2014 conducted by CEC showed that the unit at 48 ft depth is no longer reliable.

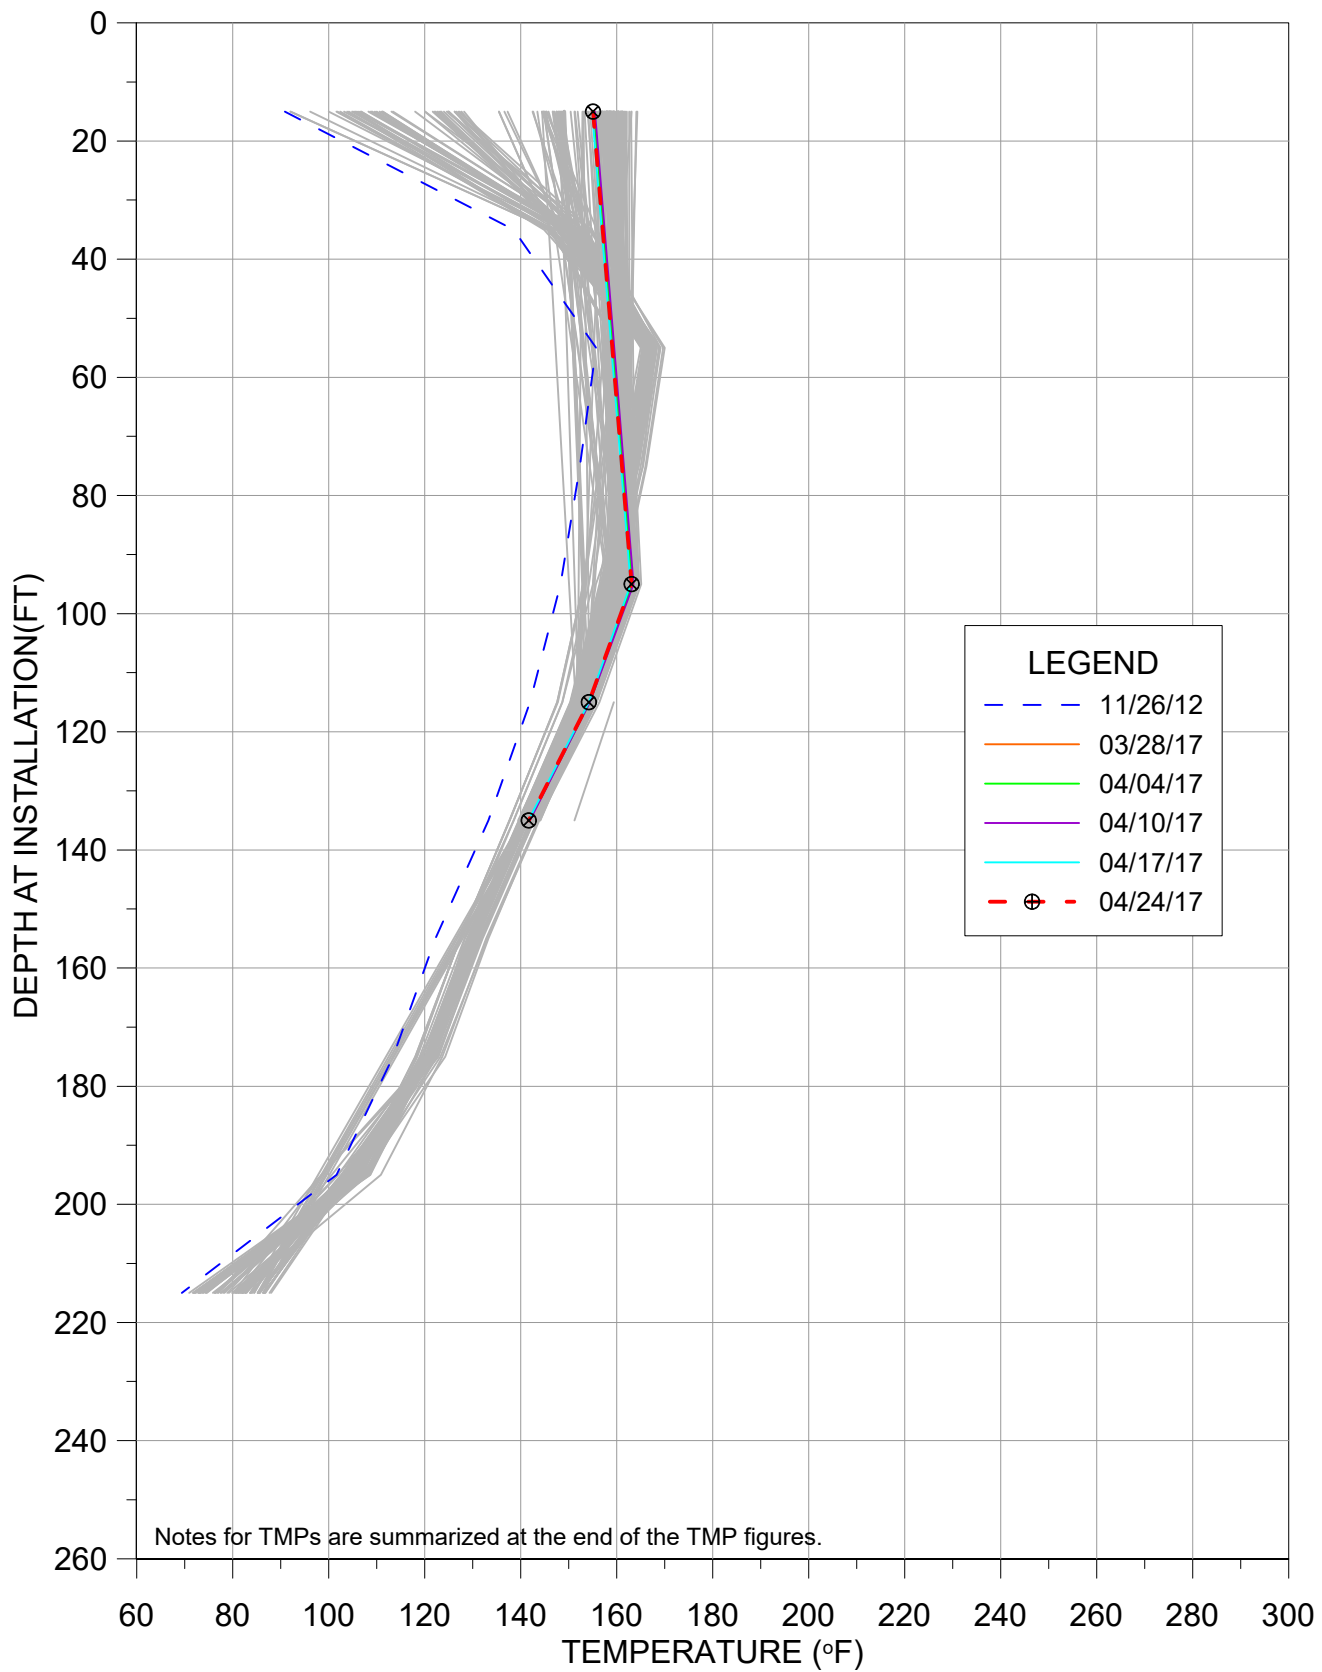
# TMP-6

1. The connectivity tests on 4/11/2014 conducted by CEC showed that units at 35, 55, 75, 155, 175, and 195 ft depths are no longer reliable.
2. No reliable temperature readings have been obtained at the unit at 215 ft depth since 6/13/2014.

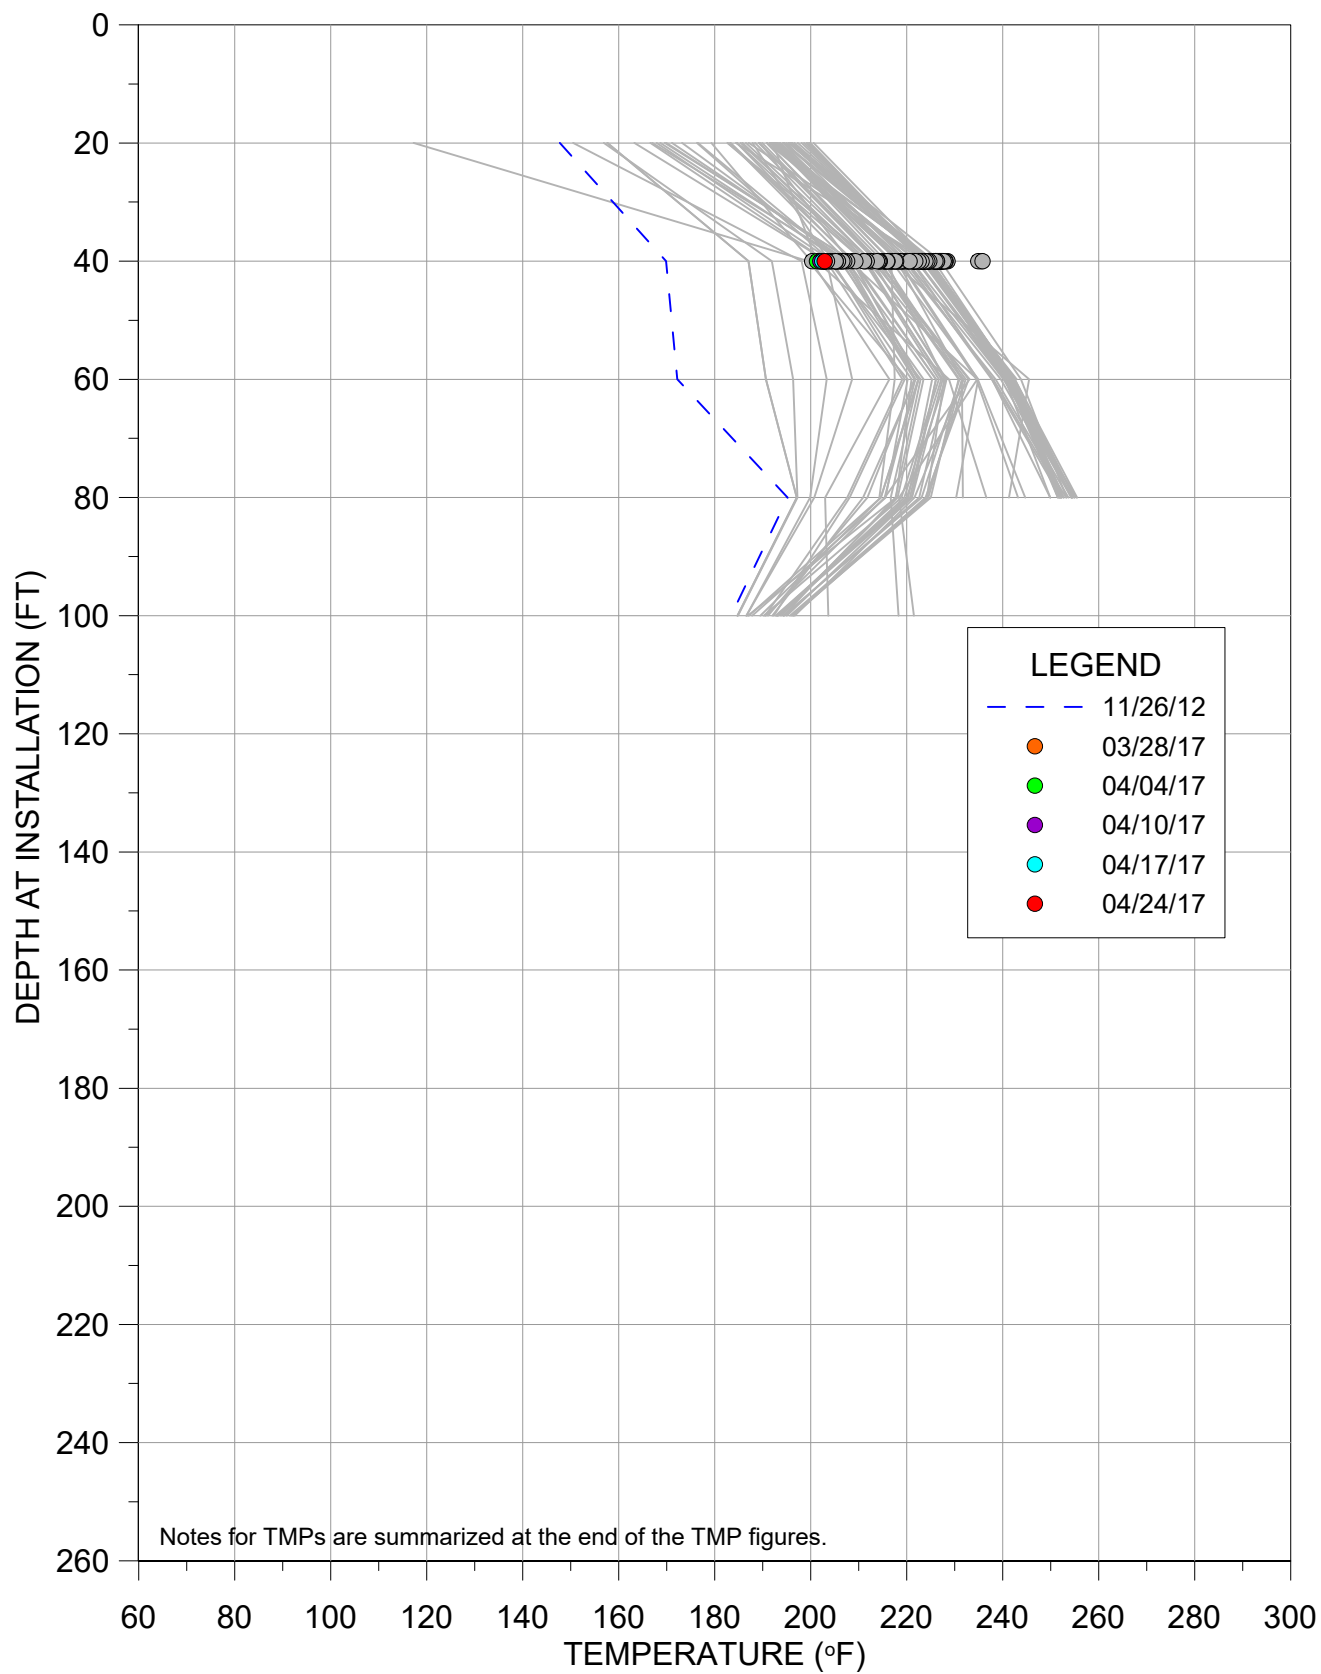
# TMP-9

1. Unit at 100 ft depth had an inaccurate temperature reading on 8/1/2013 and no reading since 8/6/2013.
2. The connectivity tests on 4/11/2014 conducted by CEC showed that units at 20, 60, 80, and 100 ft depths are no longer reliable.

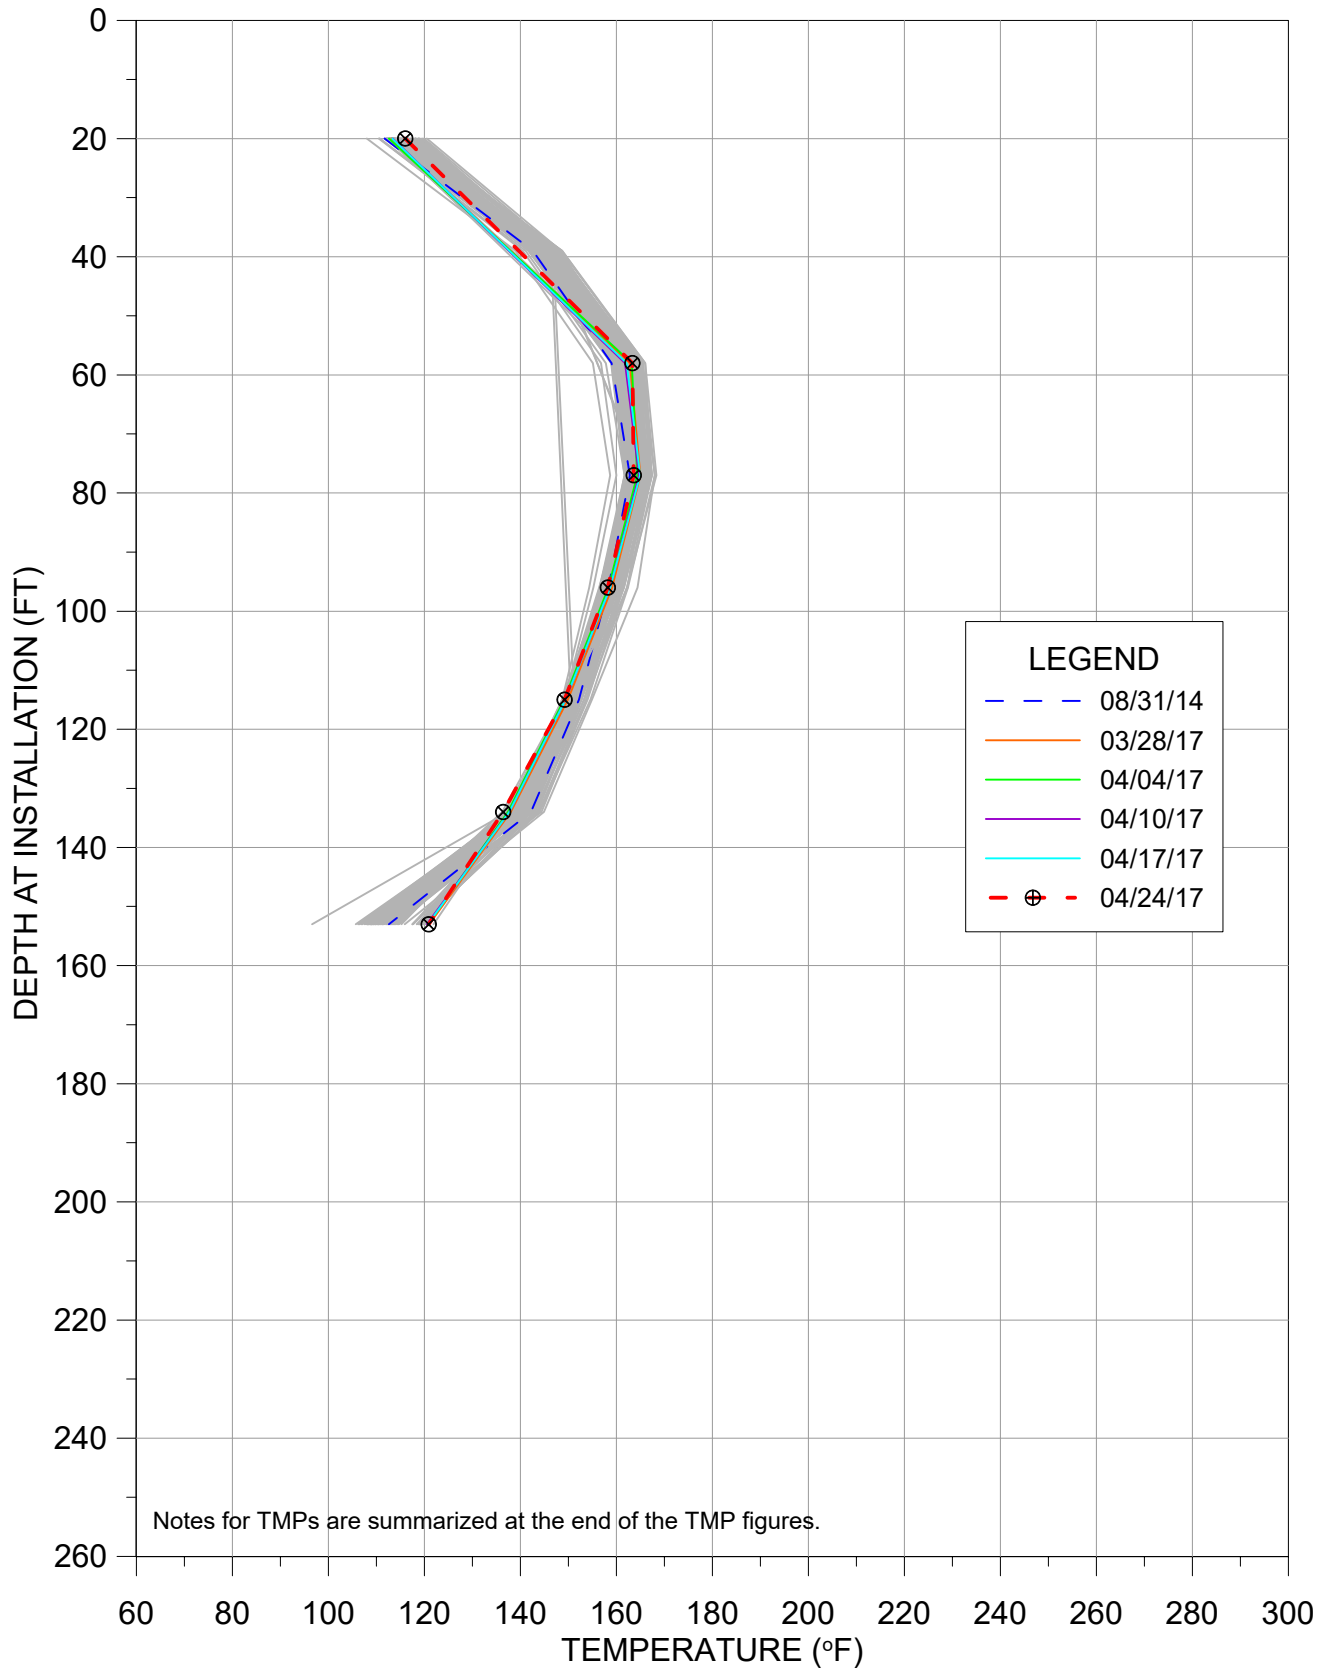
# TMP-16

1. A connectivity test conducted by Feezor Engineering showed that the units on TMP-16 may not be reliable since 9/9/2015. Further testing at the end of September 2015 showed possible connectivity on some of the units.
2. The unit at 153 ft depth had a low resistance reading and unreliable temperature since 12/21/2015.

3. The unit at 39 ft depth had a higher than acceptable resistance reading and unreliable temperature since 2/7/2017.
