# **Bridgeton Landfill, LLC**

## **Weekly Data Submittal**

**Week of April 23, 2017 – April 29, 2017**

**Required by Section 52.F of Agreed Order, Case No. 13SL-CC01088  
Effective May 13, 2013**

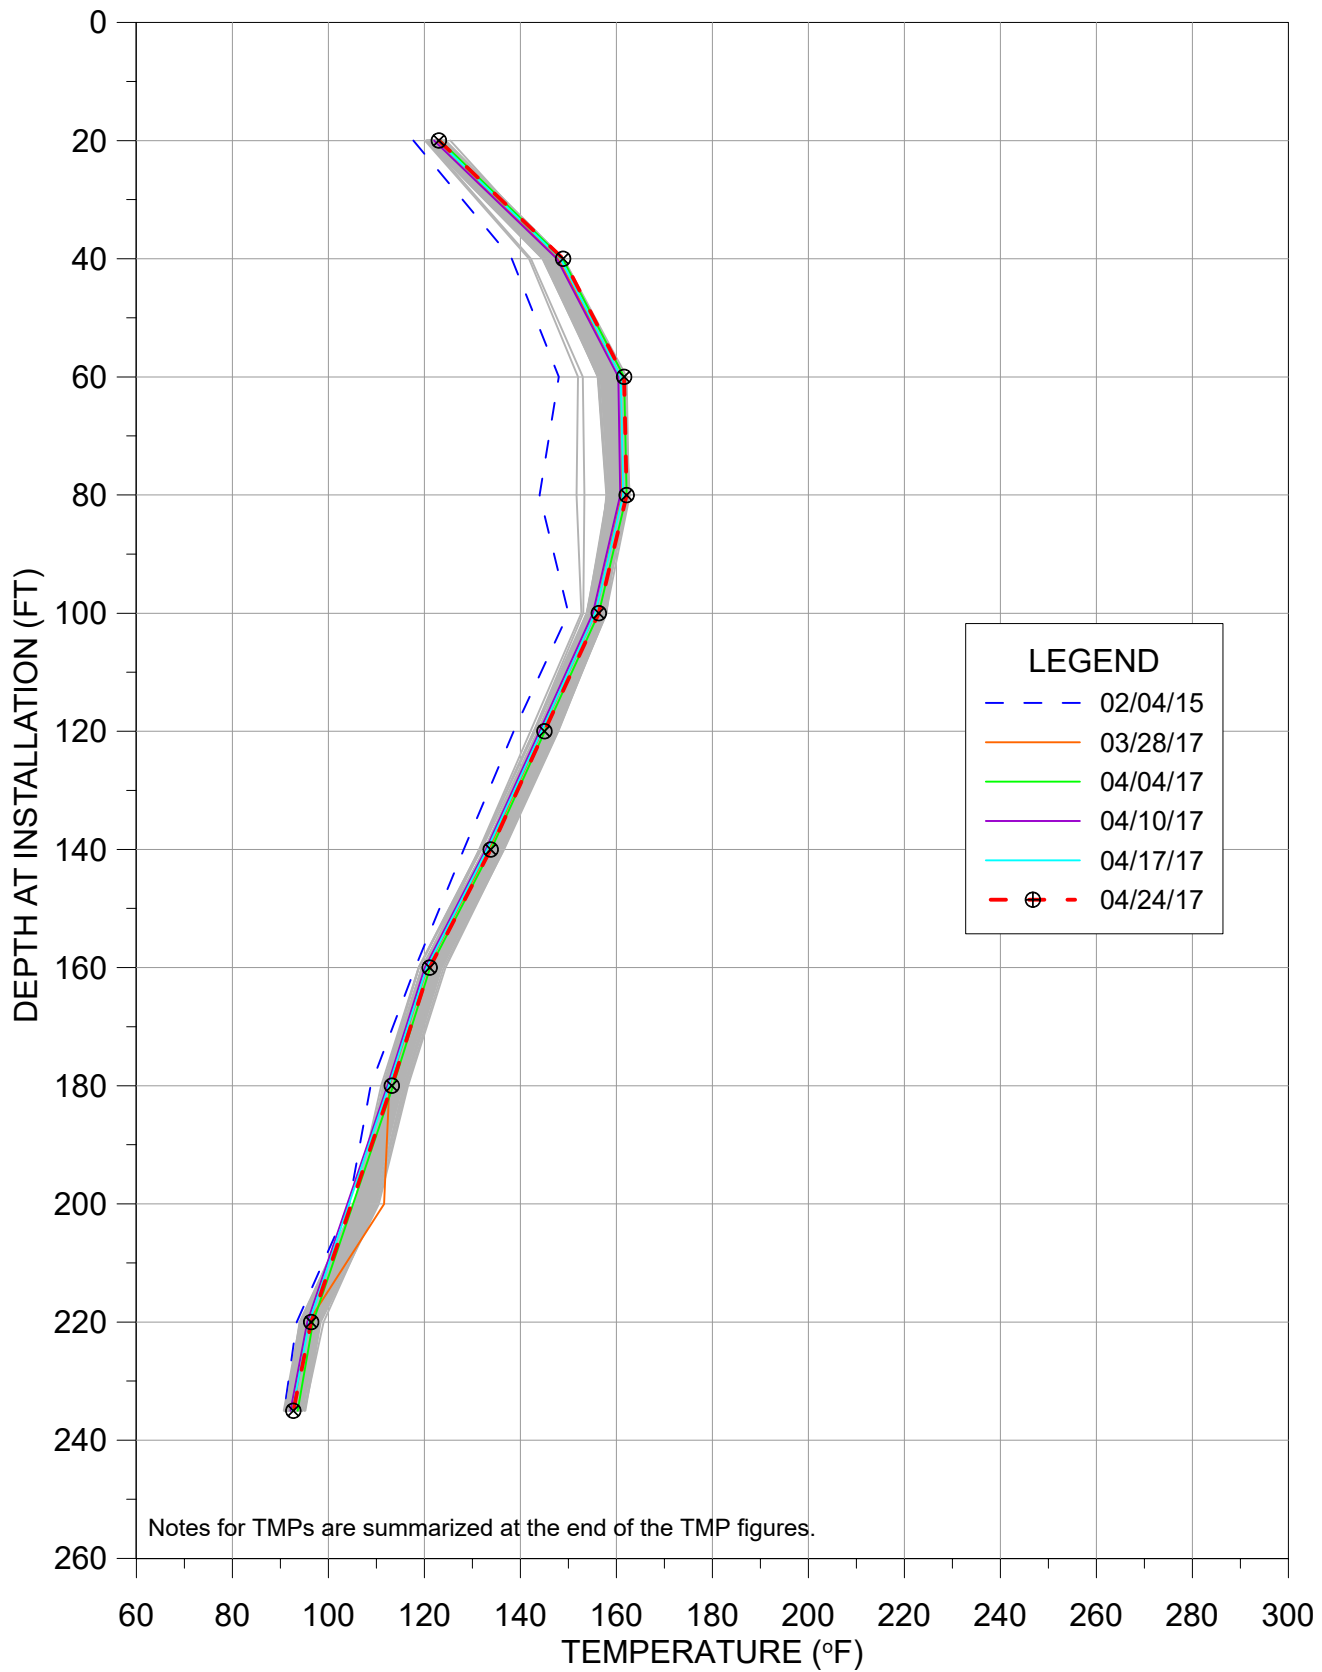
# TMP-25

1. The unit at 200 ft provided an apparent anomalous reading on 3/28/2017. Subsequent readings on 4/4/2017 showed the unit to have failed (see below). The unit is no longer working and the reading of 3/28/2017 was likely unreliable.
2. The unit at 200 ft depth had a resistance reading greater 4000 ohms on 4/4/2017. A connectivity test conducted by Feezor Engineering on 4/7/2017 showed that this unit also had cross-connectivity. The unit is therefore determined to be no longer working as of the 4/4/2017 reading.

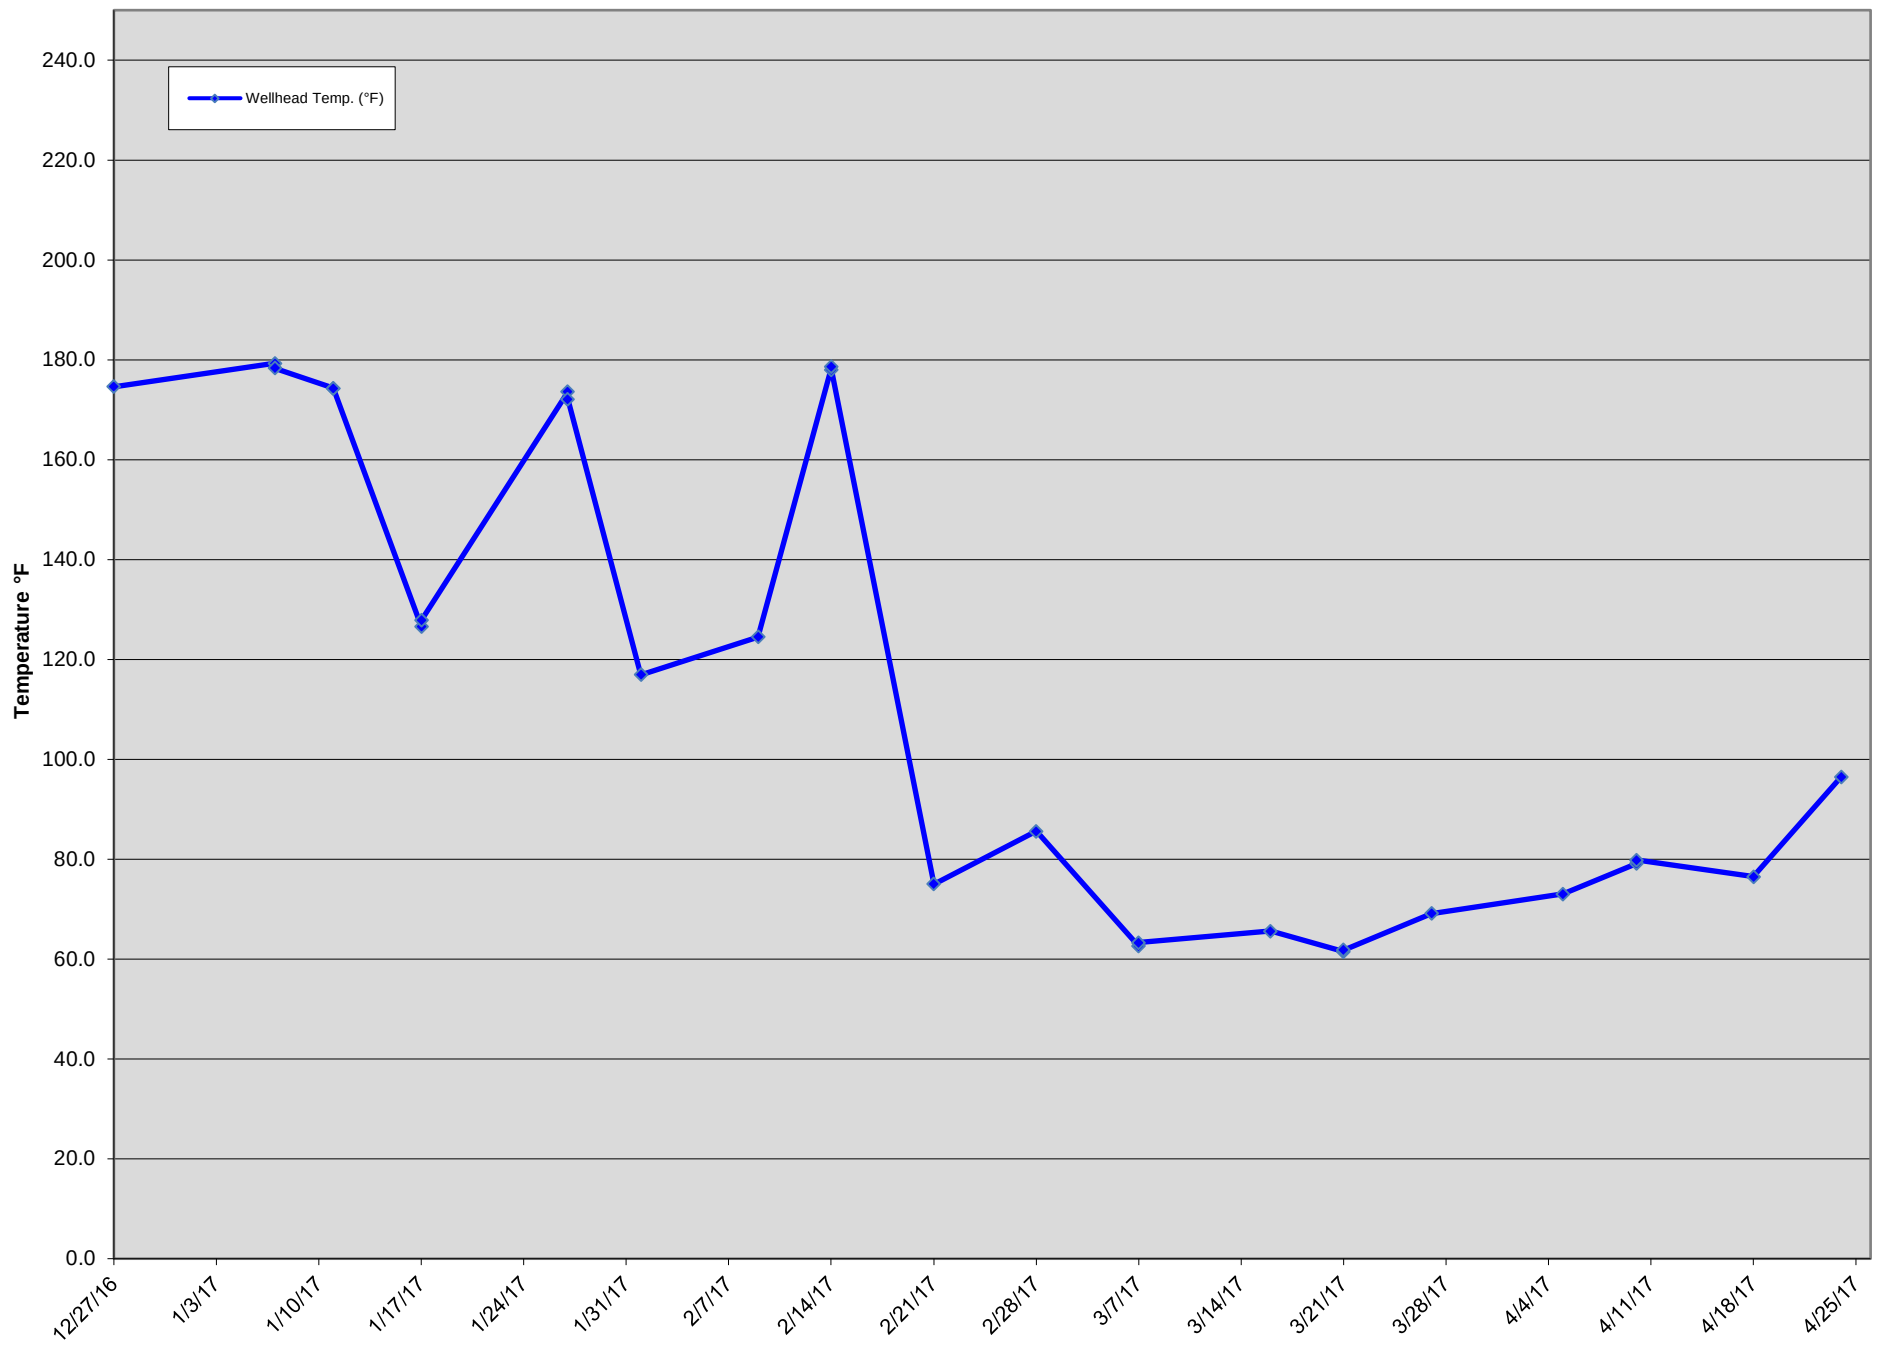
GIW-1 Wellhead Temperatures

As part of the HES, there are currently cooling water circulation loops installed in twelve Gas Interceptor Wells (GIWs) (GIW-02 through GIW-13). The remaining well (GIW-01) had a measured gas temperature within its historical operating limits.
