# **Bridgeton Landfill, LLC**

## **Weekly Data Submittal**

**Week of April 30, 2017 – May 6, 2017**

**Required by Section 52.F of Agreed Order, Case No. 13SL-CC01088  
Effective May 13, 2013**

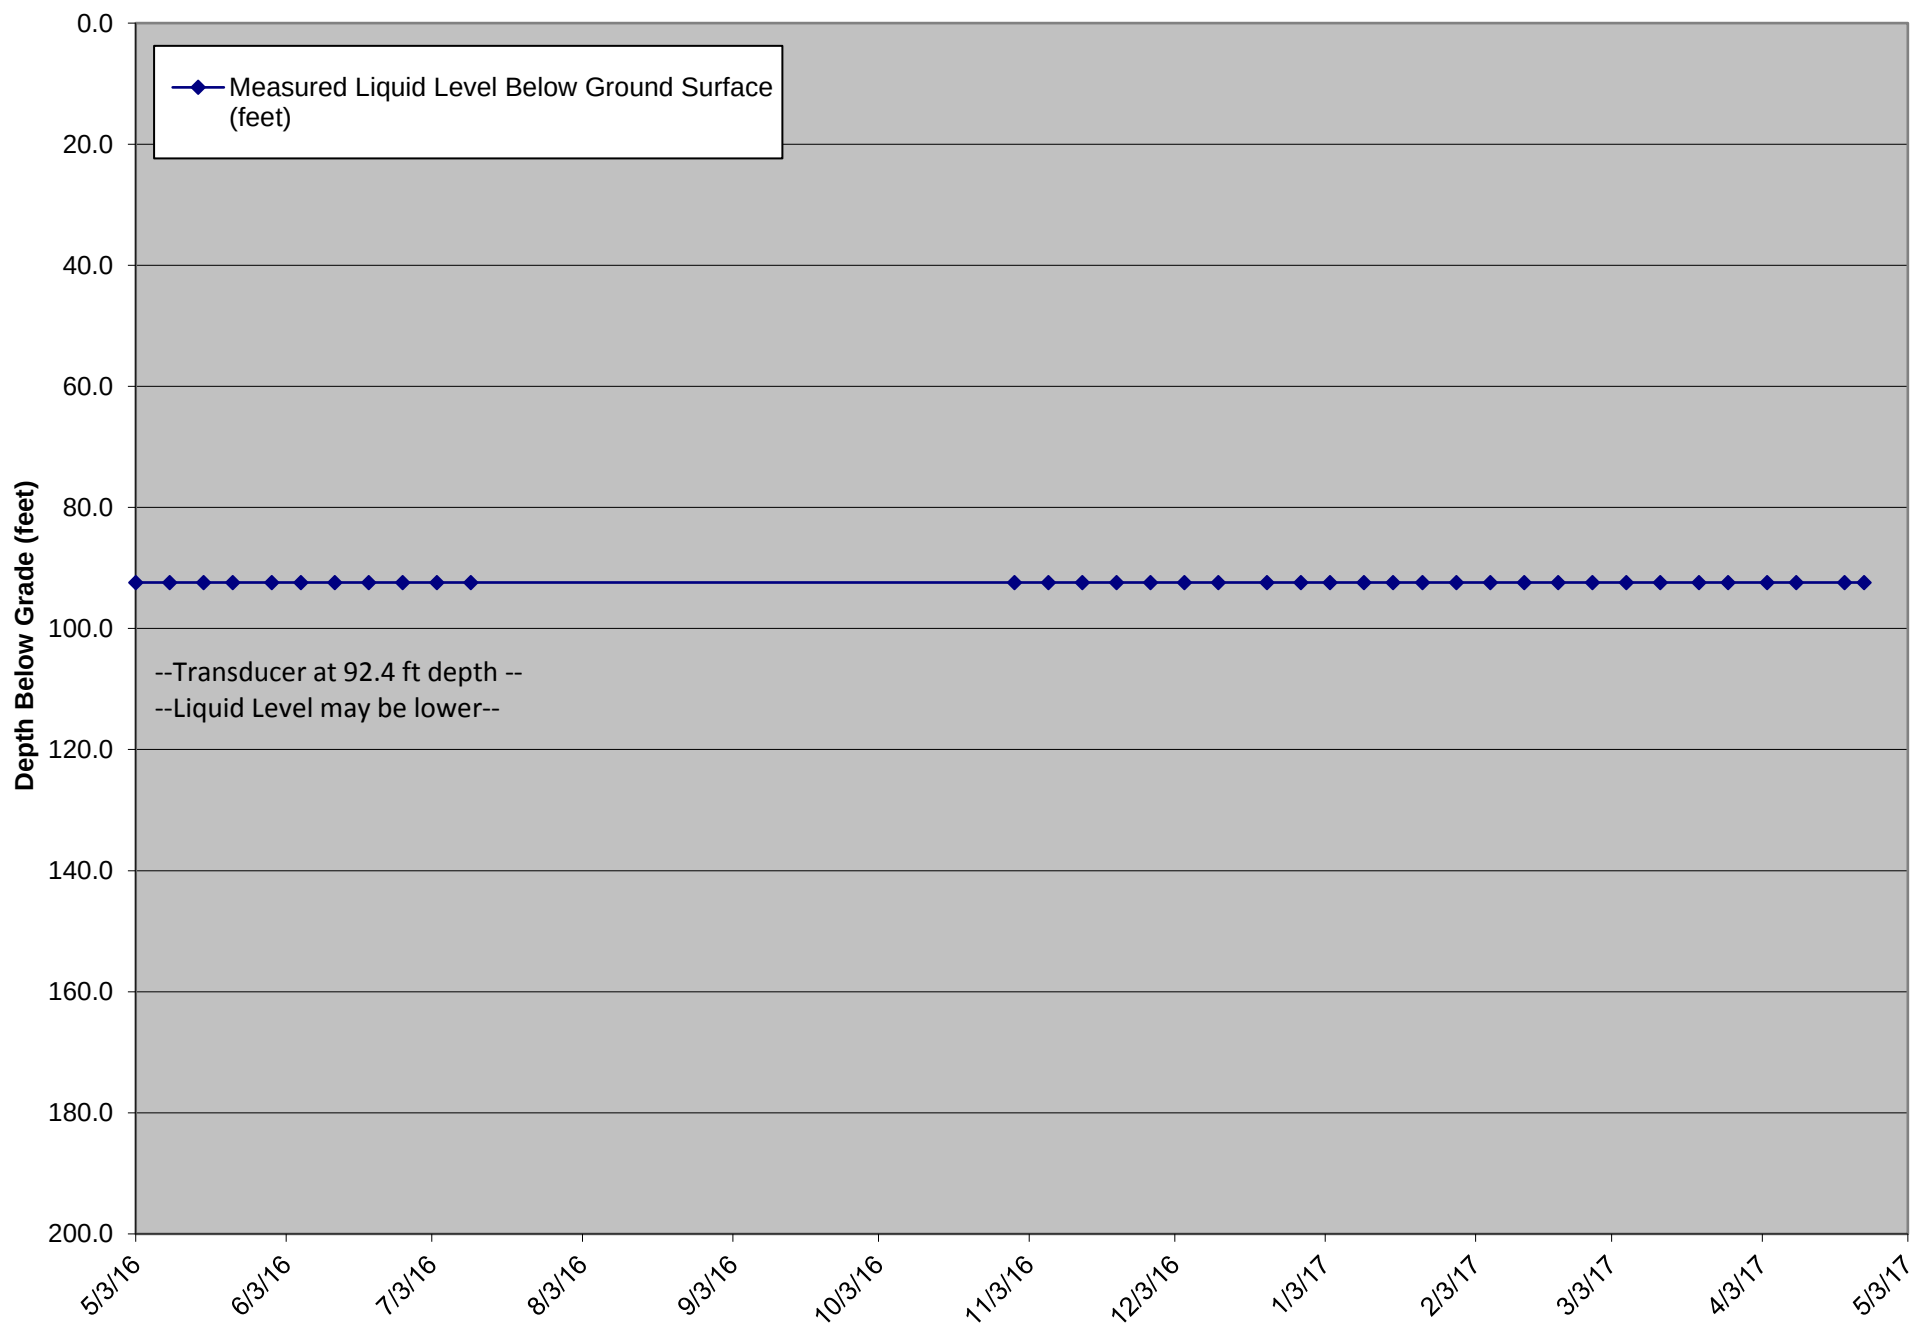
# LCS-1D Liquid Level Below Ground Surface

LCS-1D is equipped with a level sensor and a flow meter. The pump was non-operational during the weekly reporting period due to an electrical issue. Bridgeton Landfill confirmed that the flow meter on LCS-1D is operational and the flow was observed during the weekly reporting period. Liquid level was not recorded by the level sensor during the weekly reporting period. Bridgeton Landfill is tentatively scheduled to replace the level sensor on LCS-1D the week of 5/15/2017 pending contractor availability.

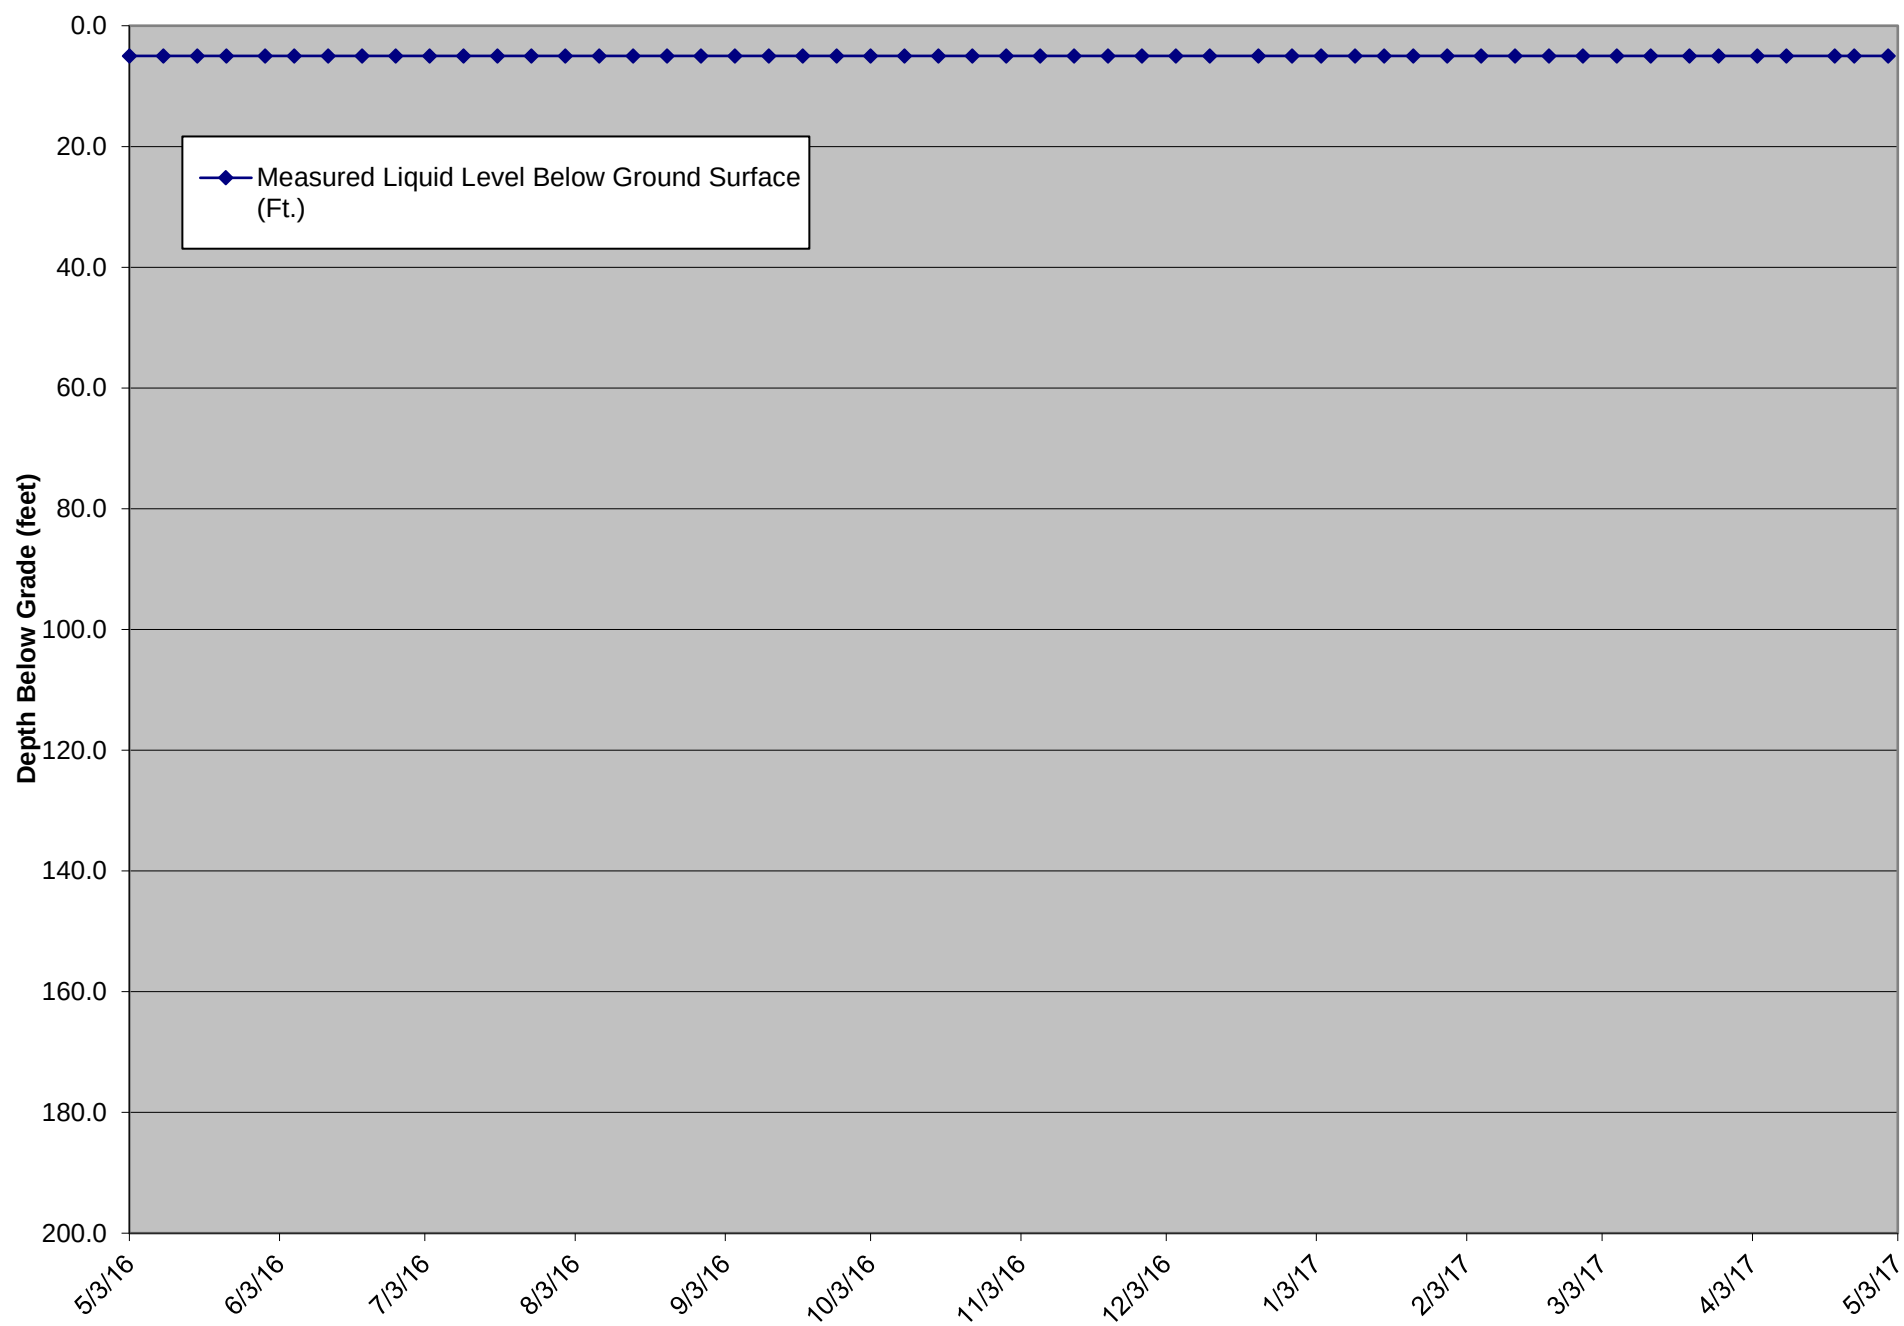
# LCS-3D Liquid Level Below Ground Surface

The pumps in LCS-2D and LCS-3D were non-operational during the weekly reporting period. The transducer in LCS-3D continued to report liquid levels. Flow was observed on the LCS-3D flow meter during the weekly reporting period. The pump and transducer in LCS-3D is tentatively scheduled to be replaced during the week of 5/15/2017 pending contractor availability.

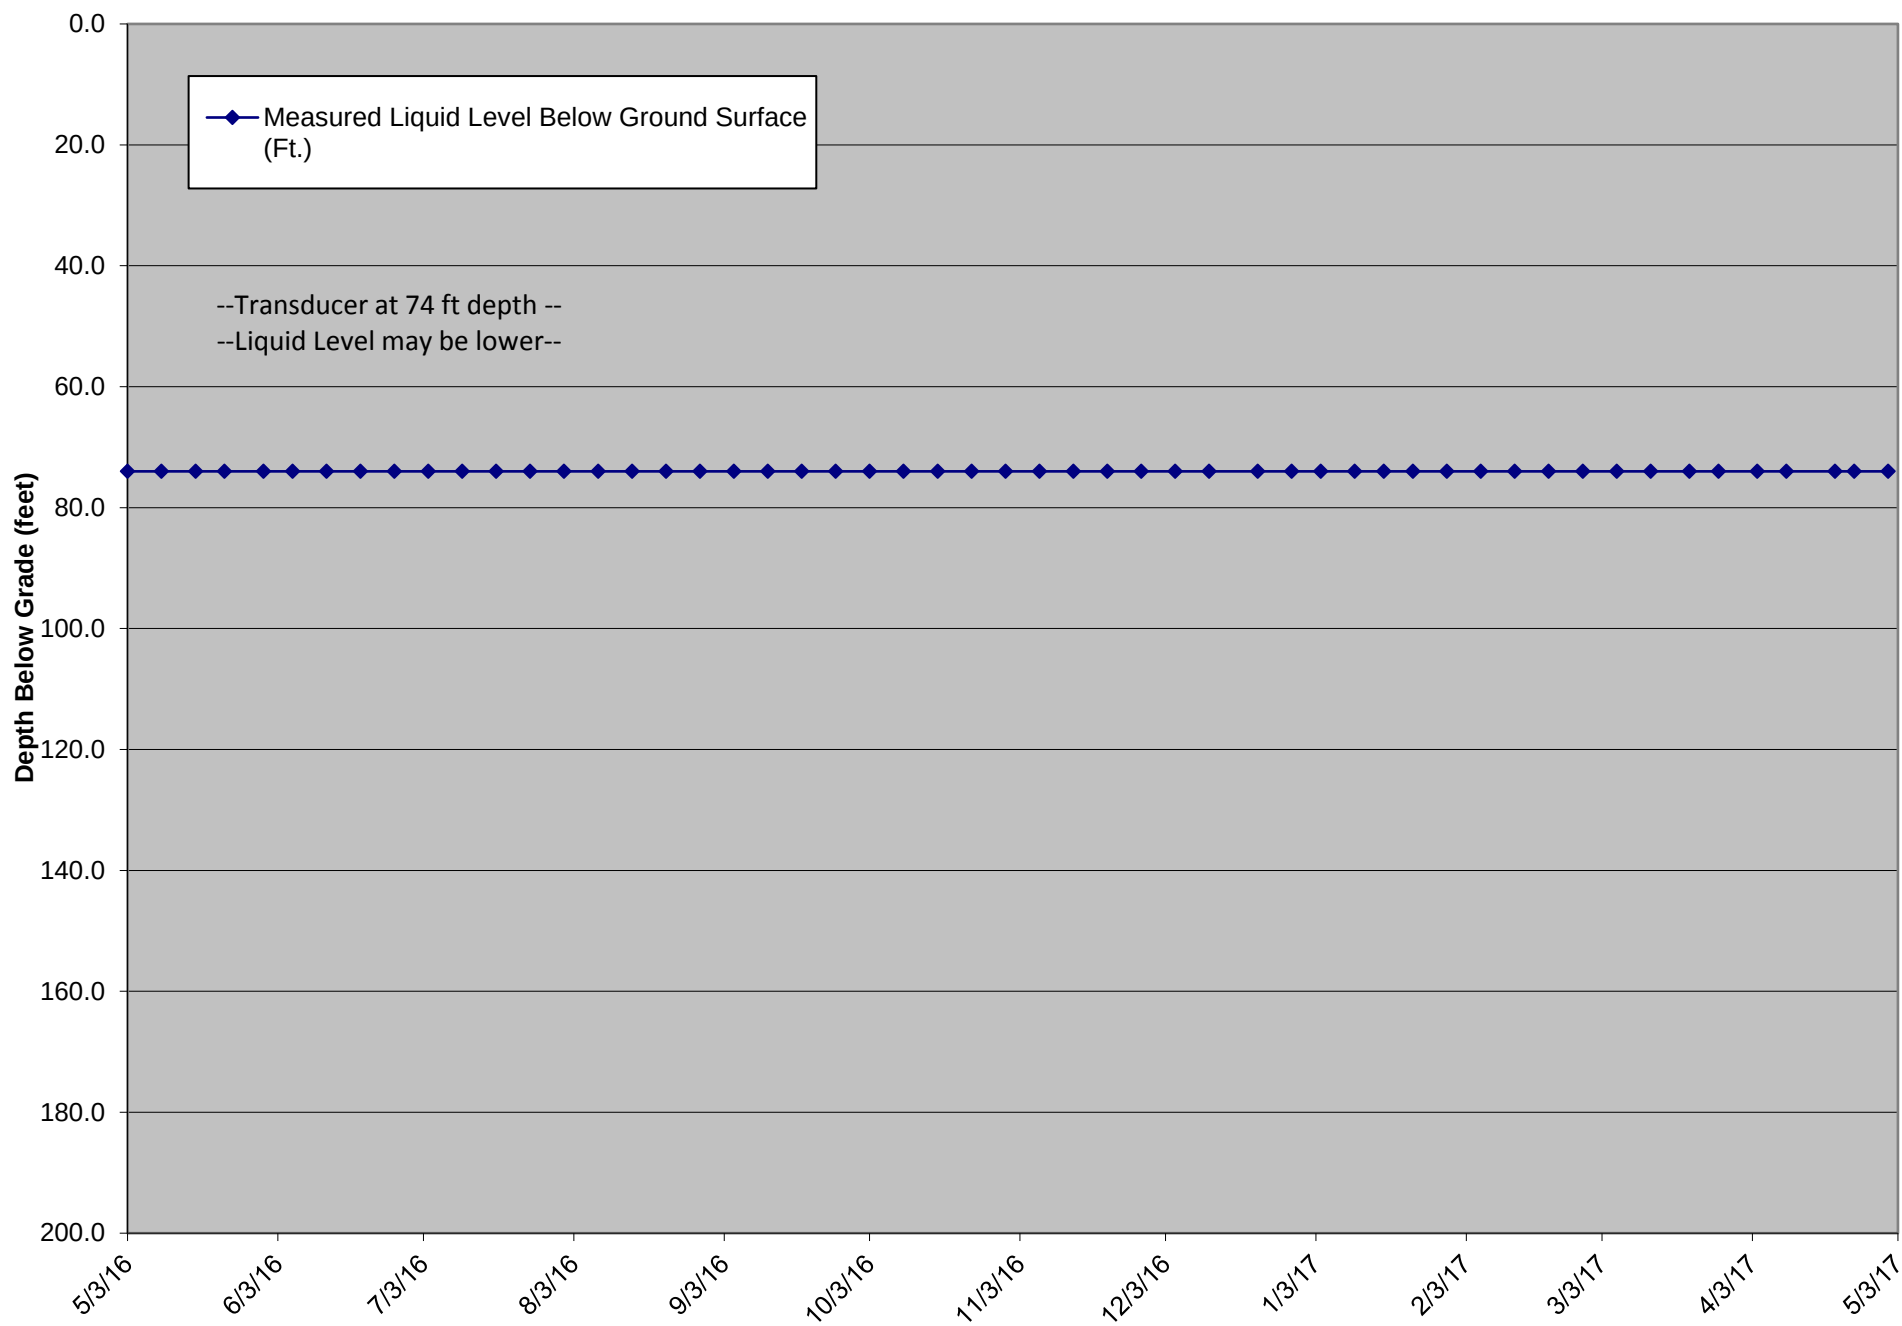
# LCS-4B Liquid Level Below Ground Surface

The level sensor in LCS-4B is currently operational and responsive. Liquid level was not recorded by the level sensor during the weekly reporting period. LCS-4B is equipped with a flow meter that displayed no flow during the weekly reporting period. Therefore, it can be concluded that the liquid level was below the bottom of the pump and level sensor in LCS-4B.

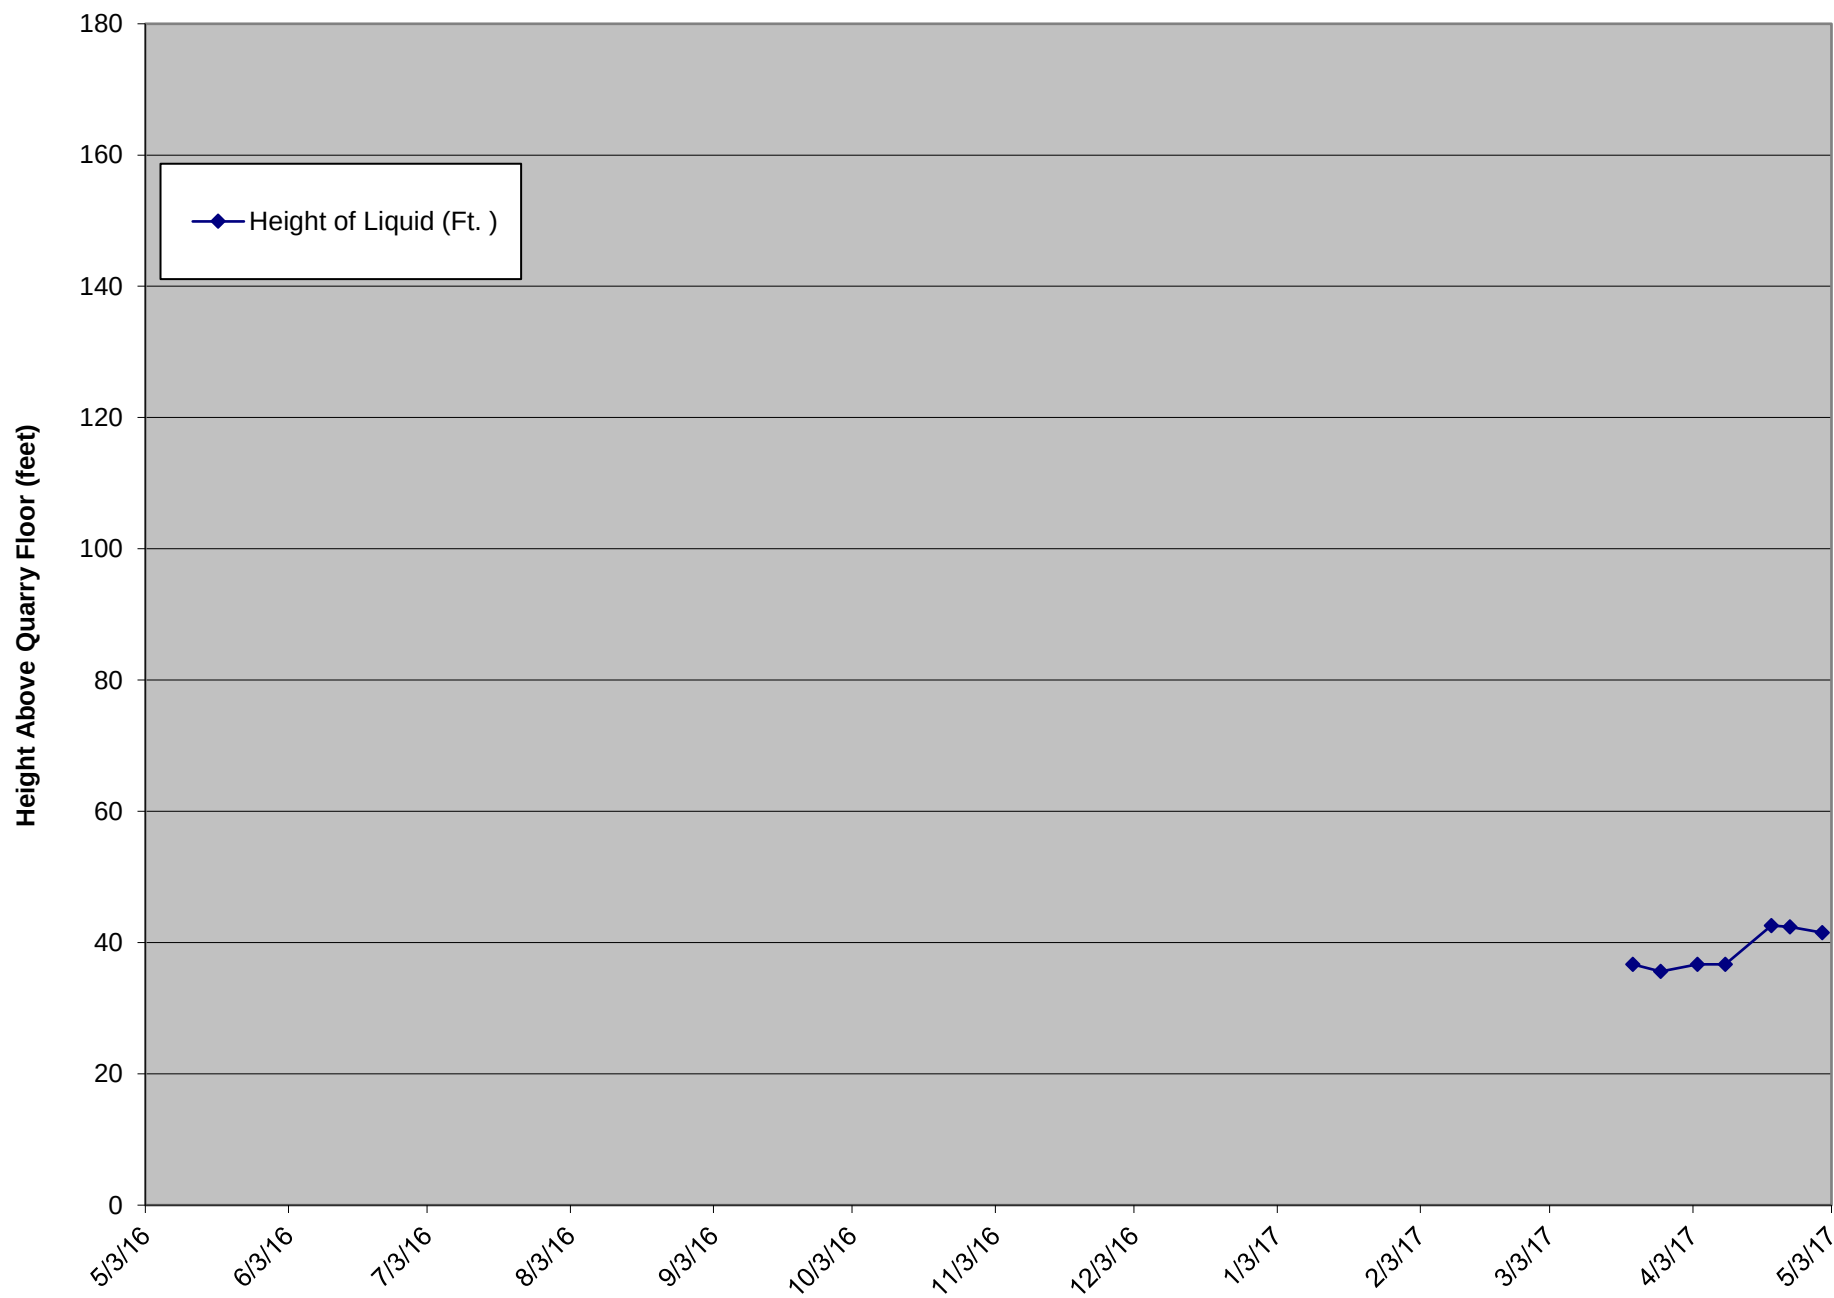
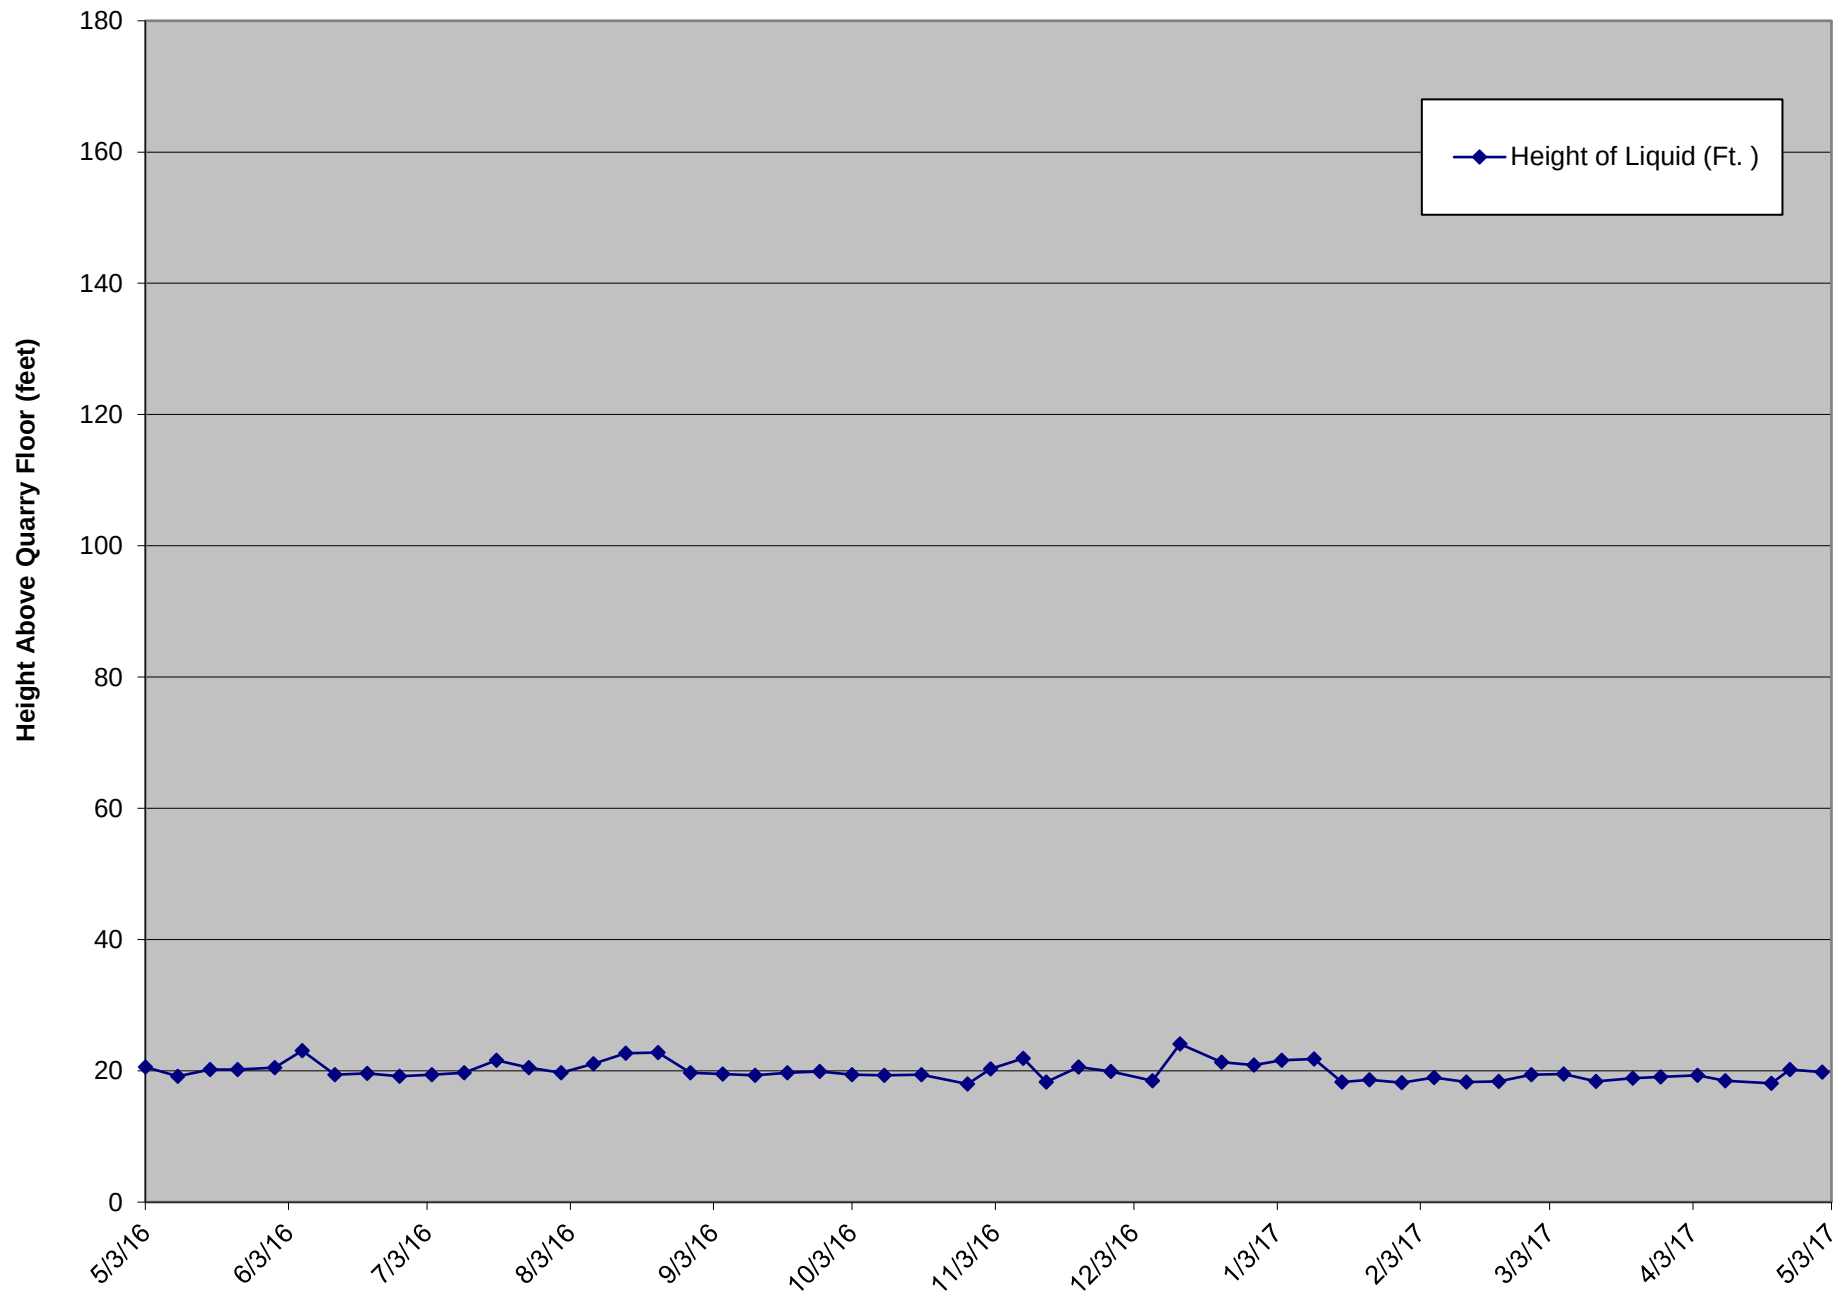
LCS-5B and LCS-6B were fully operational during the weekly reporting period.

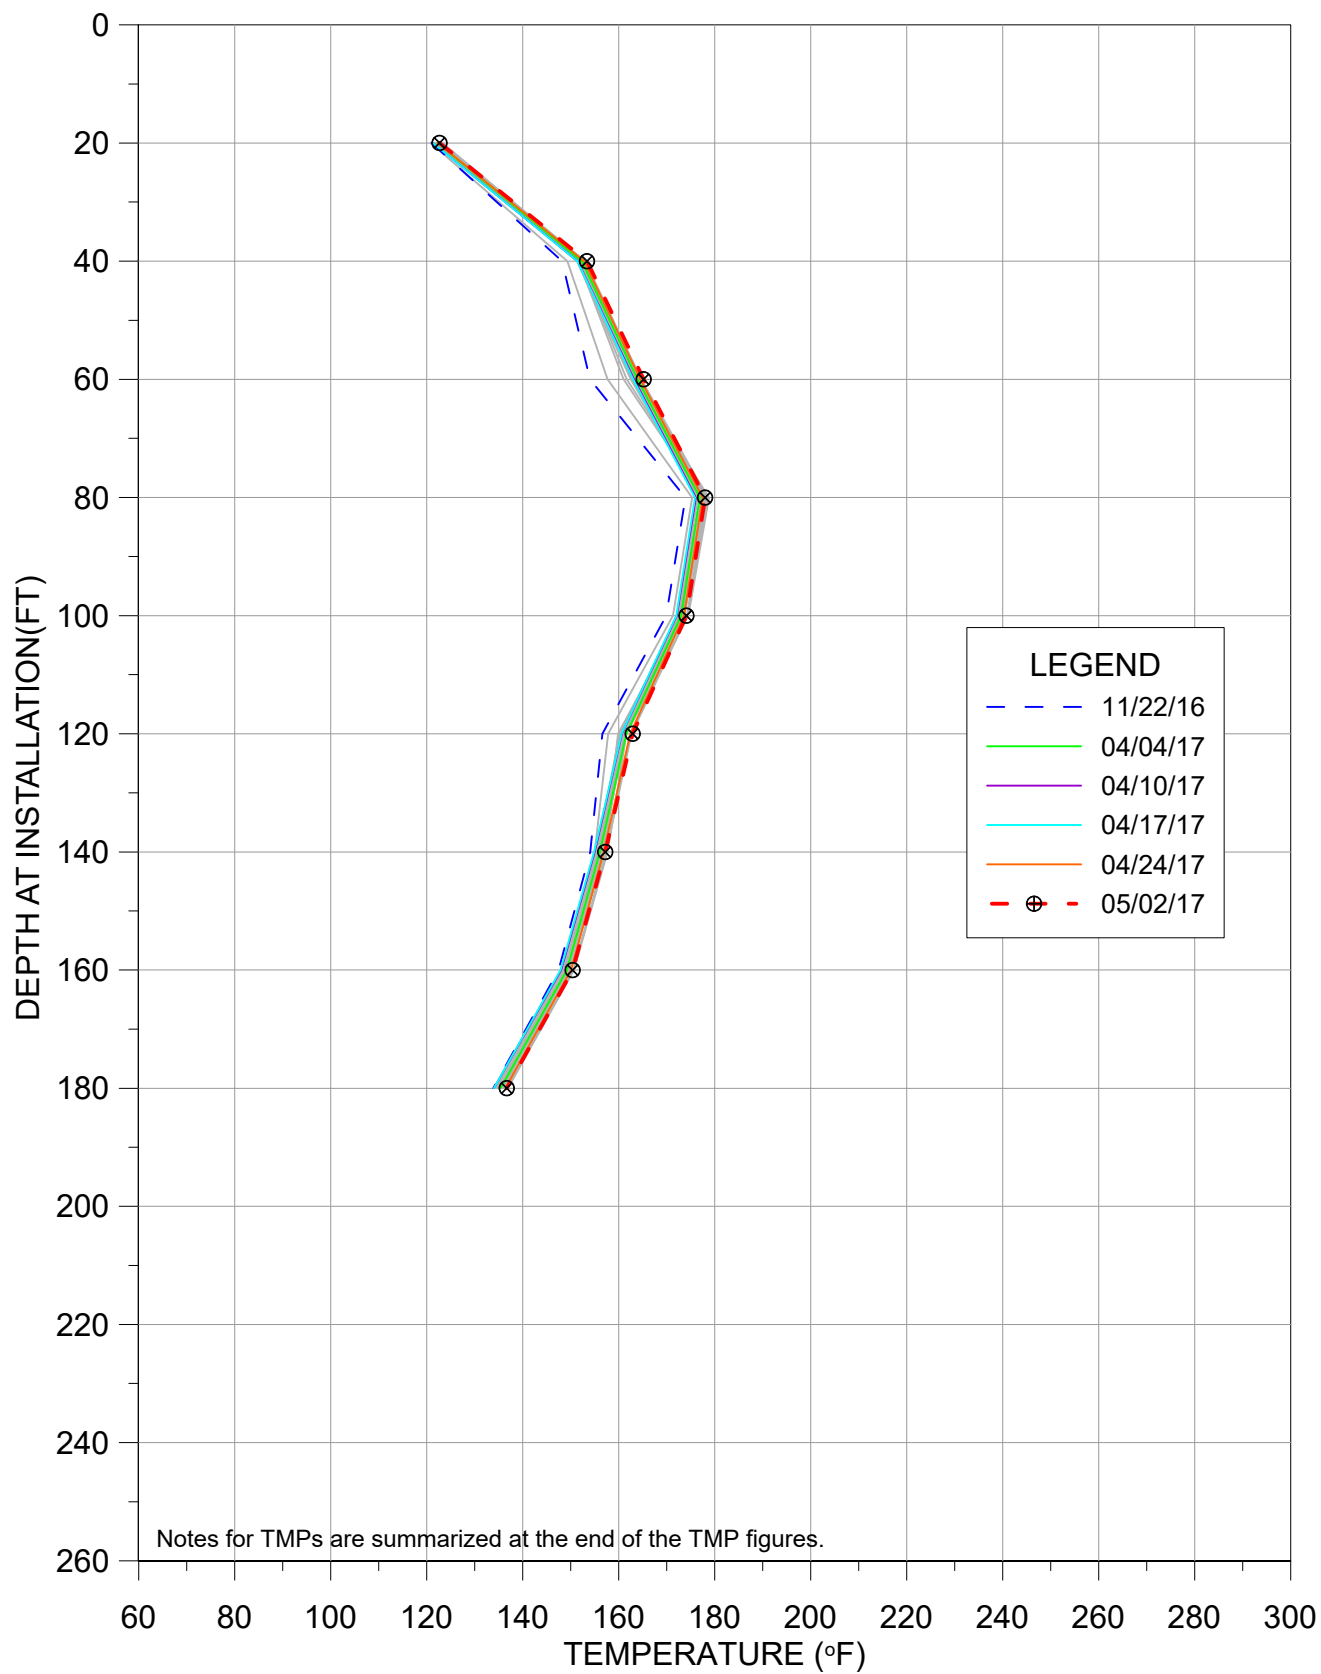
# TMP-2R

1. Data reported on 11/29/2016 was inadvertently left as the 11/22/2016 data. This was corrected on 12/5/2016 reading submittal.

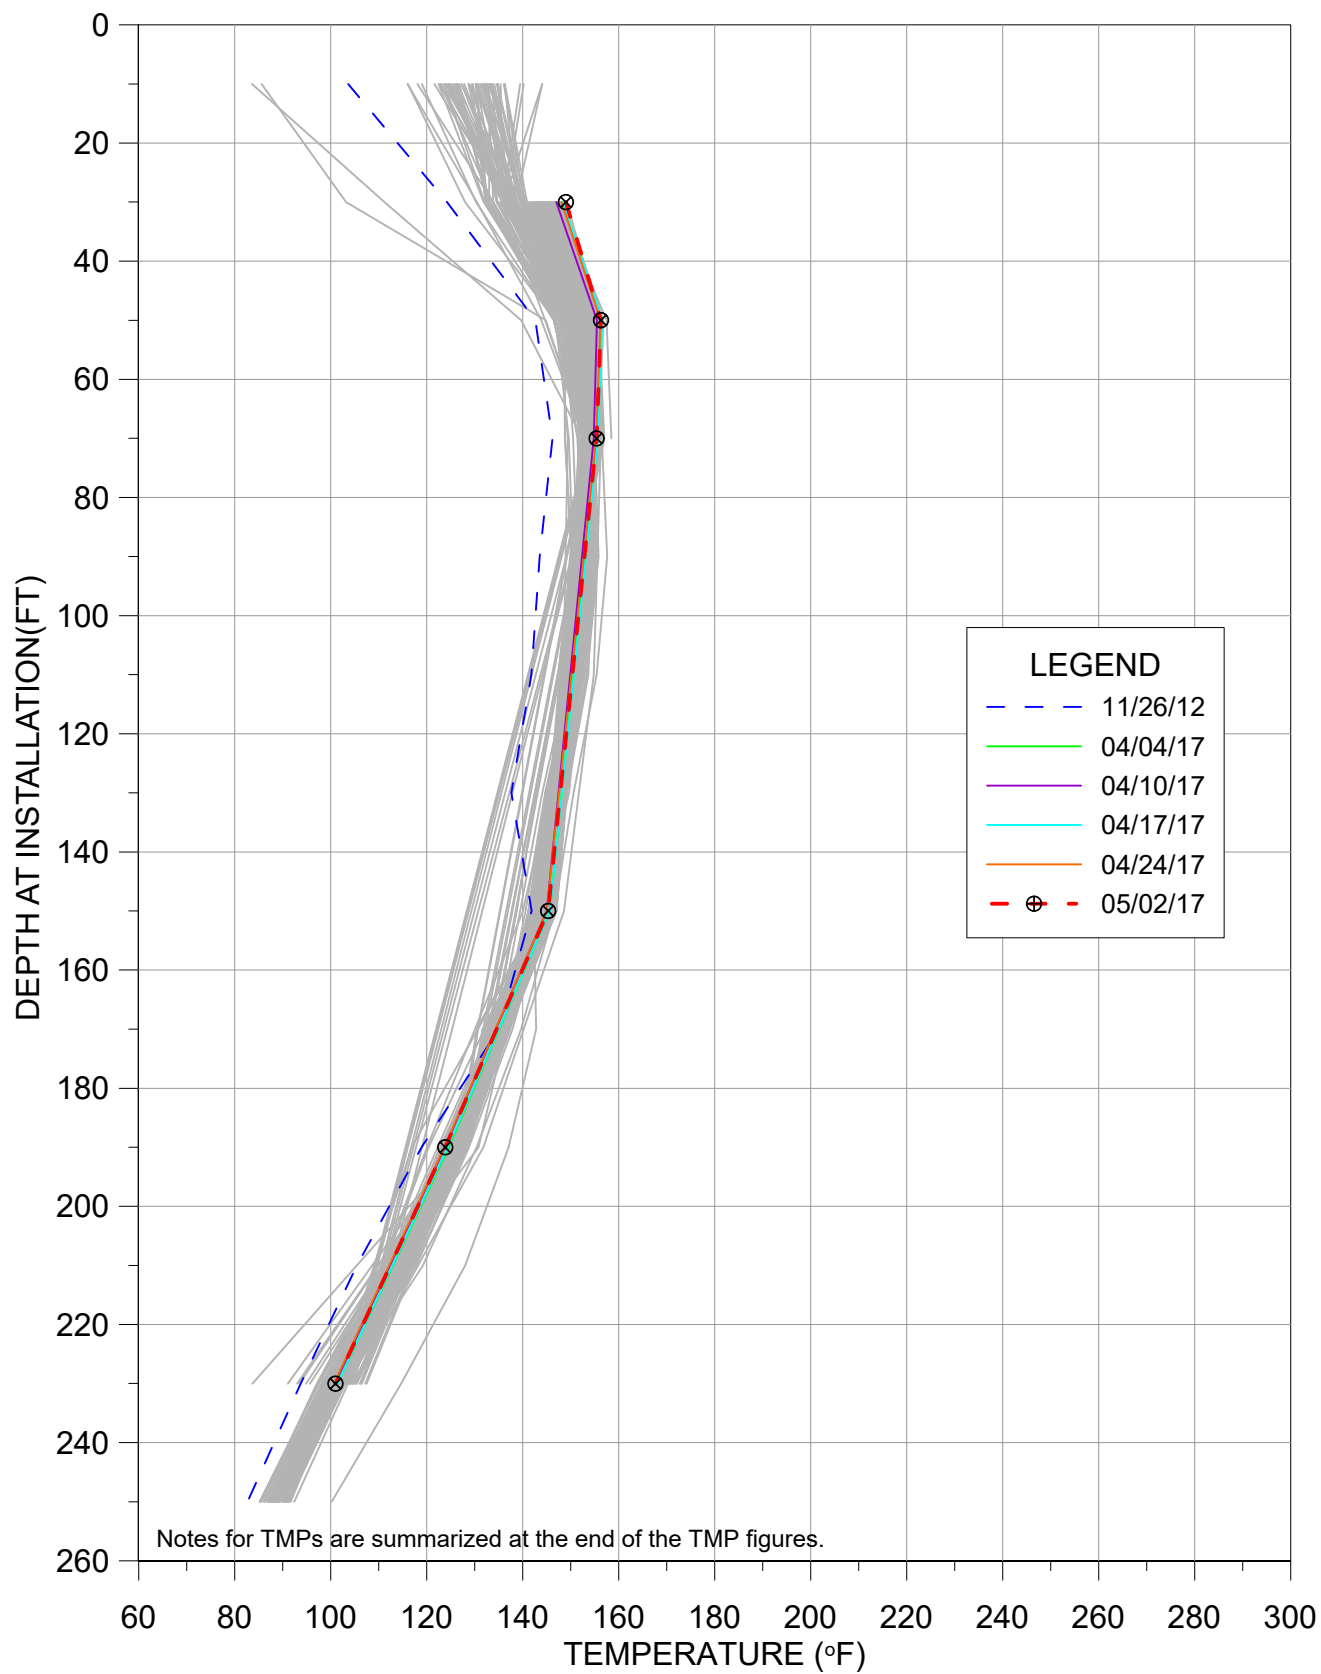
# TMP-3

1. No reliable temperature readings have been obtained at 170 ft depth since 1/29/2014, except on 3/13/2014.
2. The connectivity tests on 4/11/2014 conducted by CEC showed that units at 10, 90, 130, 210 and 250 ft depths are no longer reliable.
3. The connectivity tests on 10/28/2014 conducted by Feezor Engineering showed that units at 10, 90, 110, 130, 210 and 250 ft depths are not reliable.

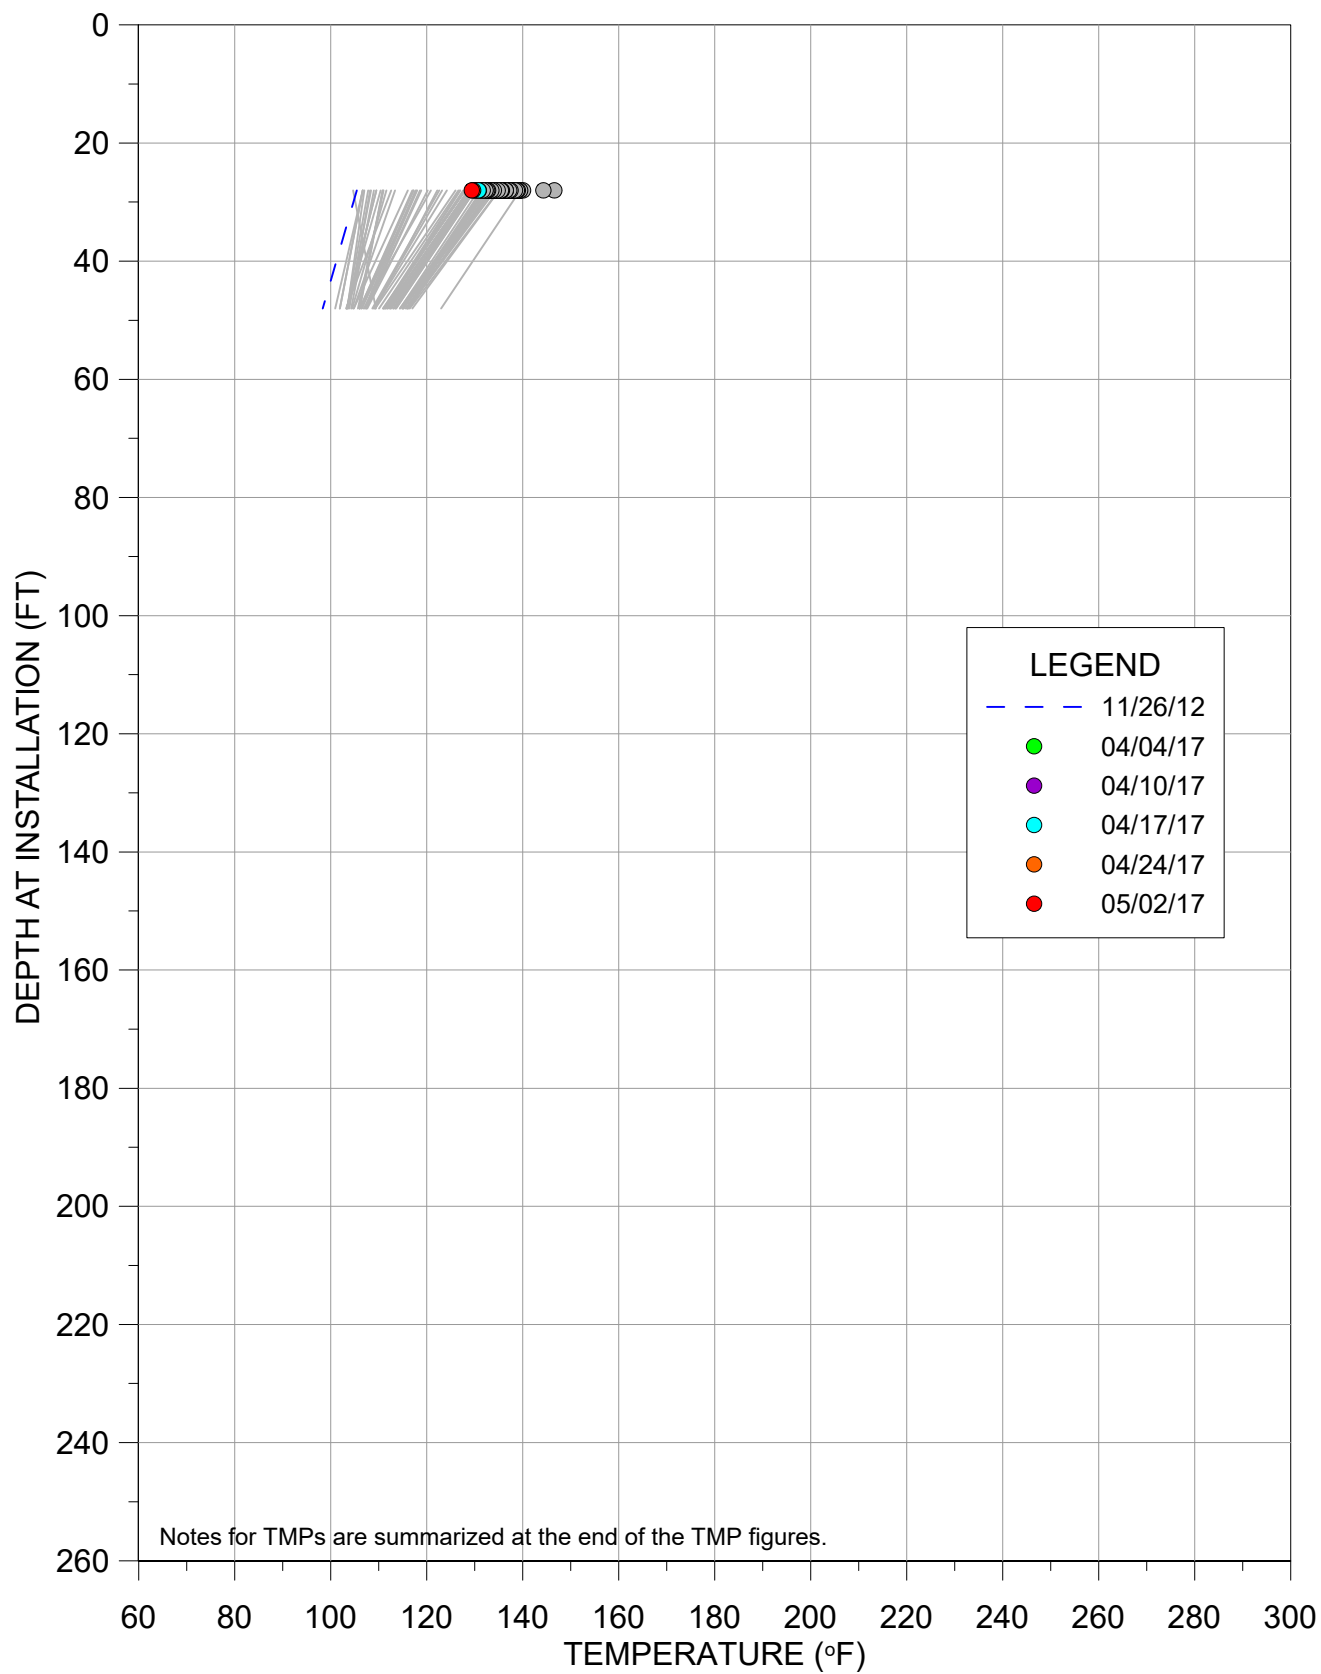
# TMP-4

1. The connectivity tests on 4/11/2014 conducted by CEC showed that the unit at 48 ft depth is no longer reliable.

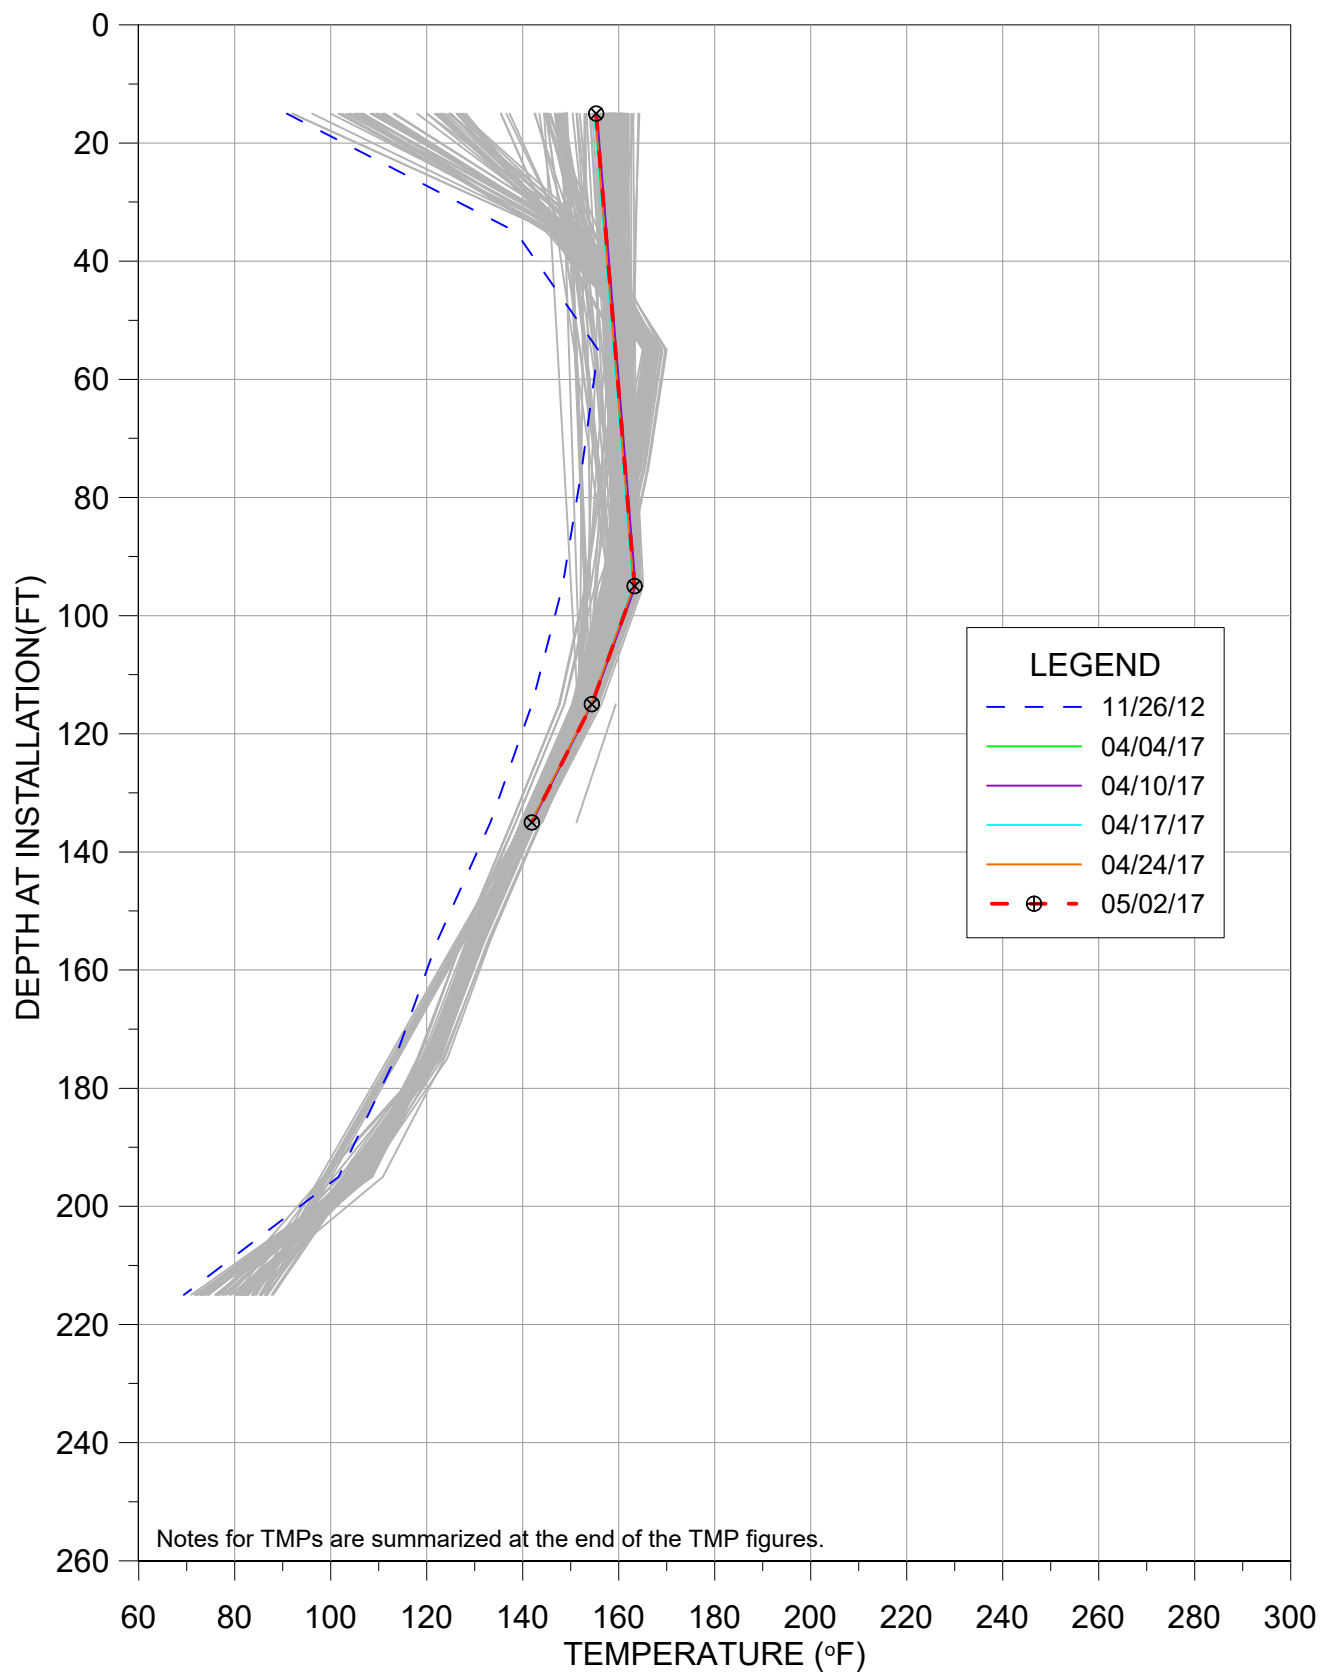
# TMP-6

1. The connectivity tests on 4/11/2014 conducted by CEC showed that units at 35, 55, 75, 155, 175, and 195 ft depths are no longer reliable.
2. No reliable temperature readings have been obtained at the unit at 215 ft depth since 6/13/2014.
