# **Bridgeton Landfill, LLC**

## **Weekly Data Submittal**

**Week of April 30, 2017 – May 6, 2017**

**Required by Section 52.F of Agreed Order, Case No. 13SL-CC01088  
Effective May 13, 2013**

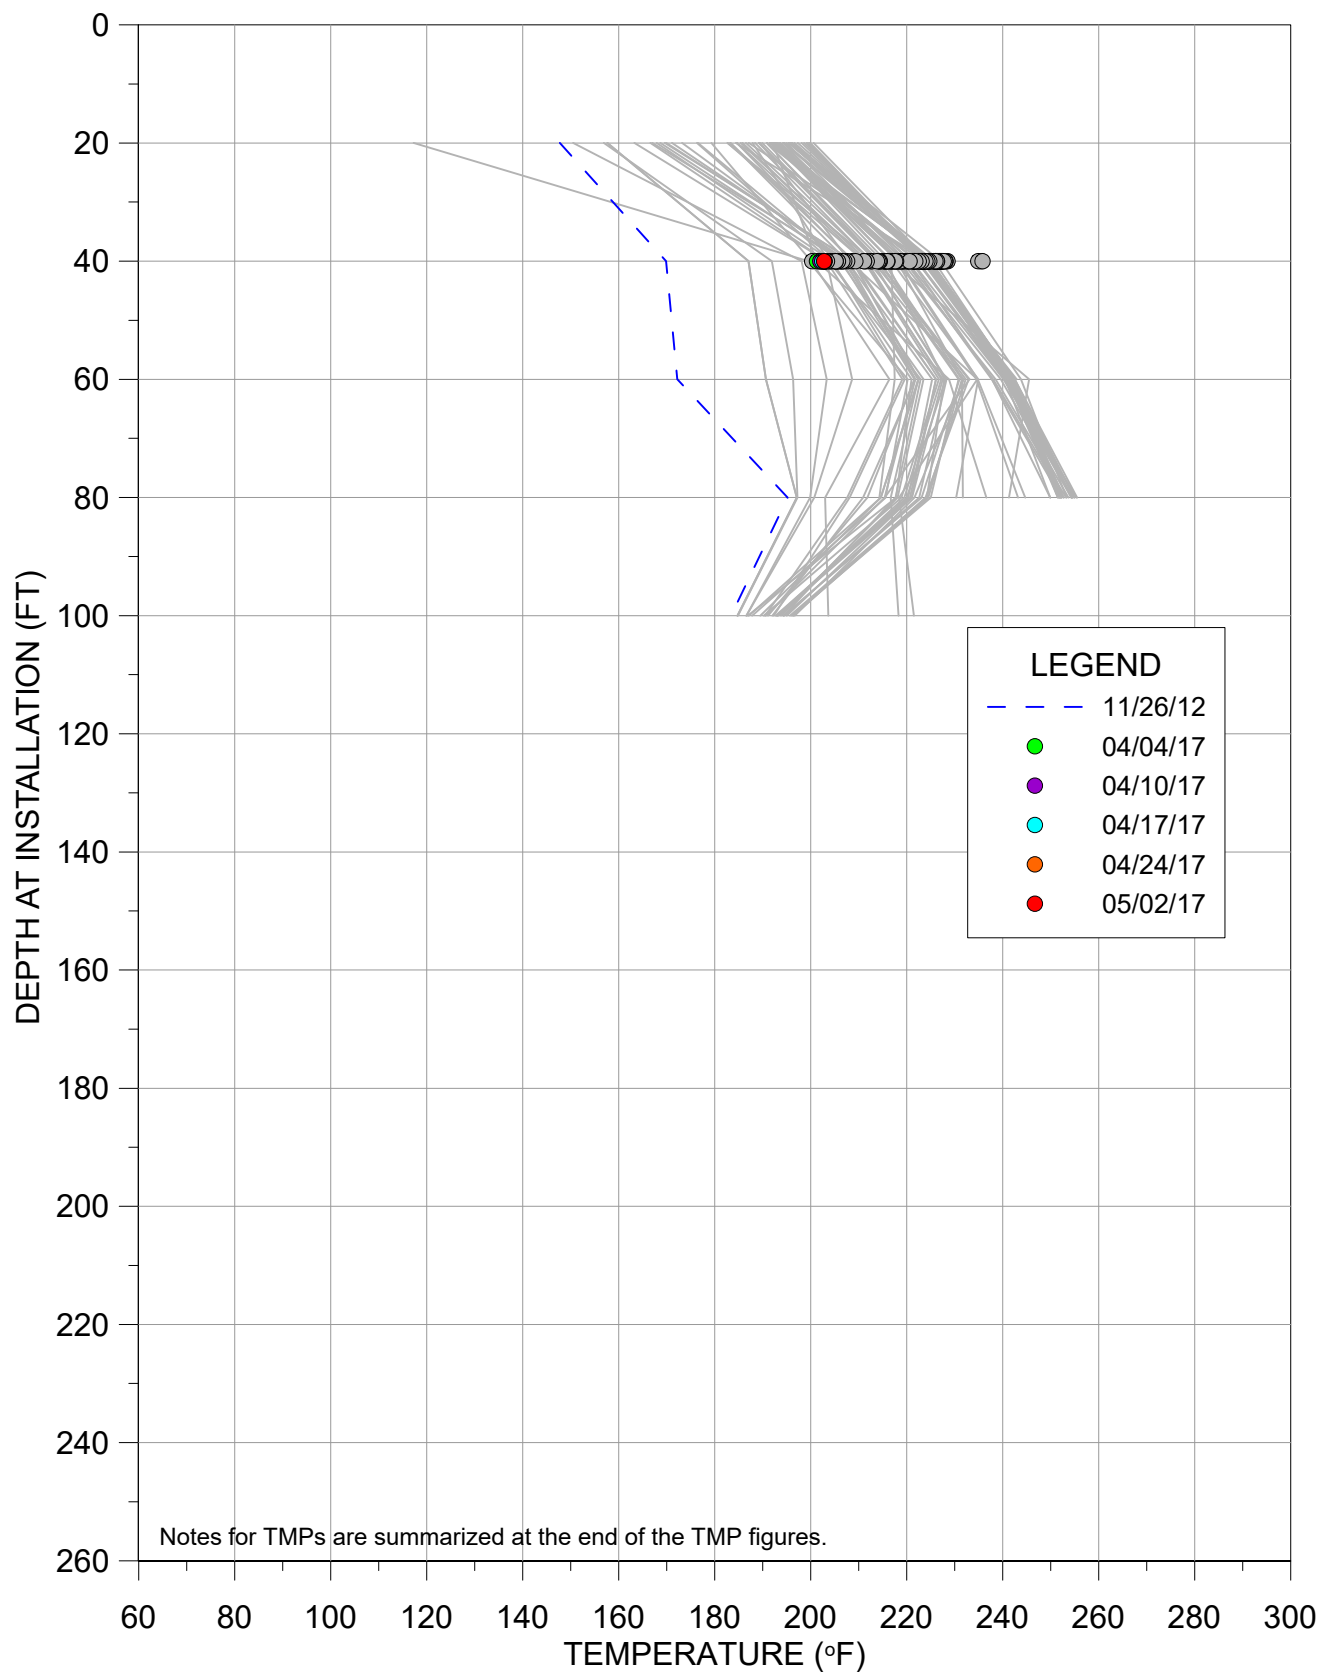
# TMP-9

1. Unit at 100 ft depth had an inaccurate temperature reading on 8/1/2013 and no reading since 8/6/2013.
2. The connectivity tests on 4/11/2014 conducted by CEC showed that units at 20, 60, 80, and 100 ft depths are no longer reliable.

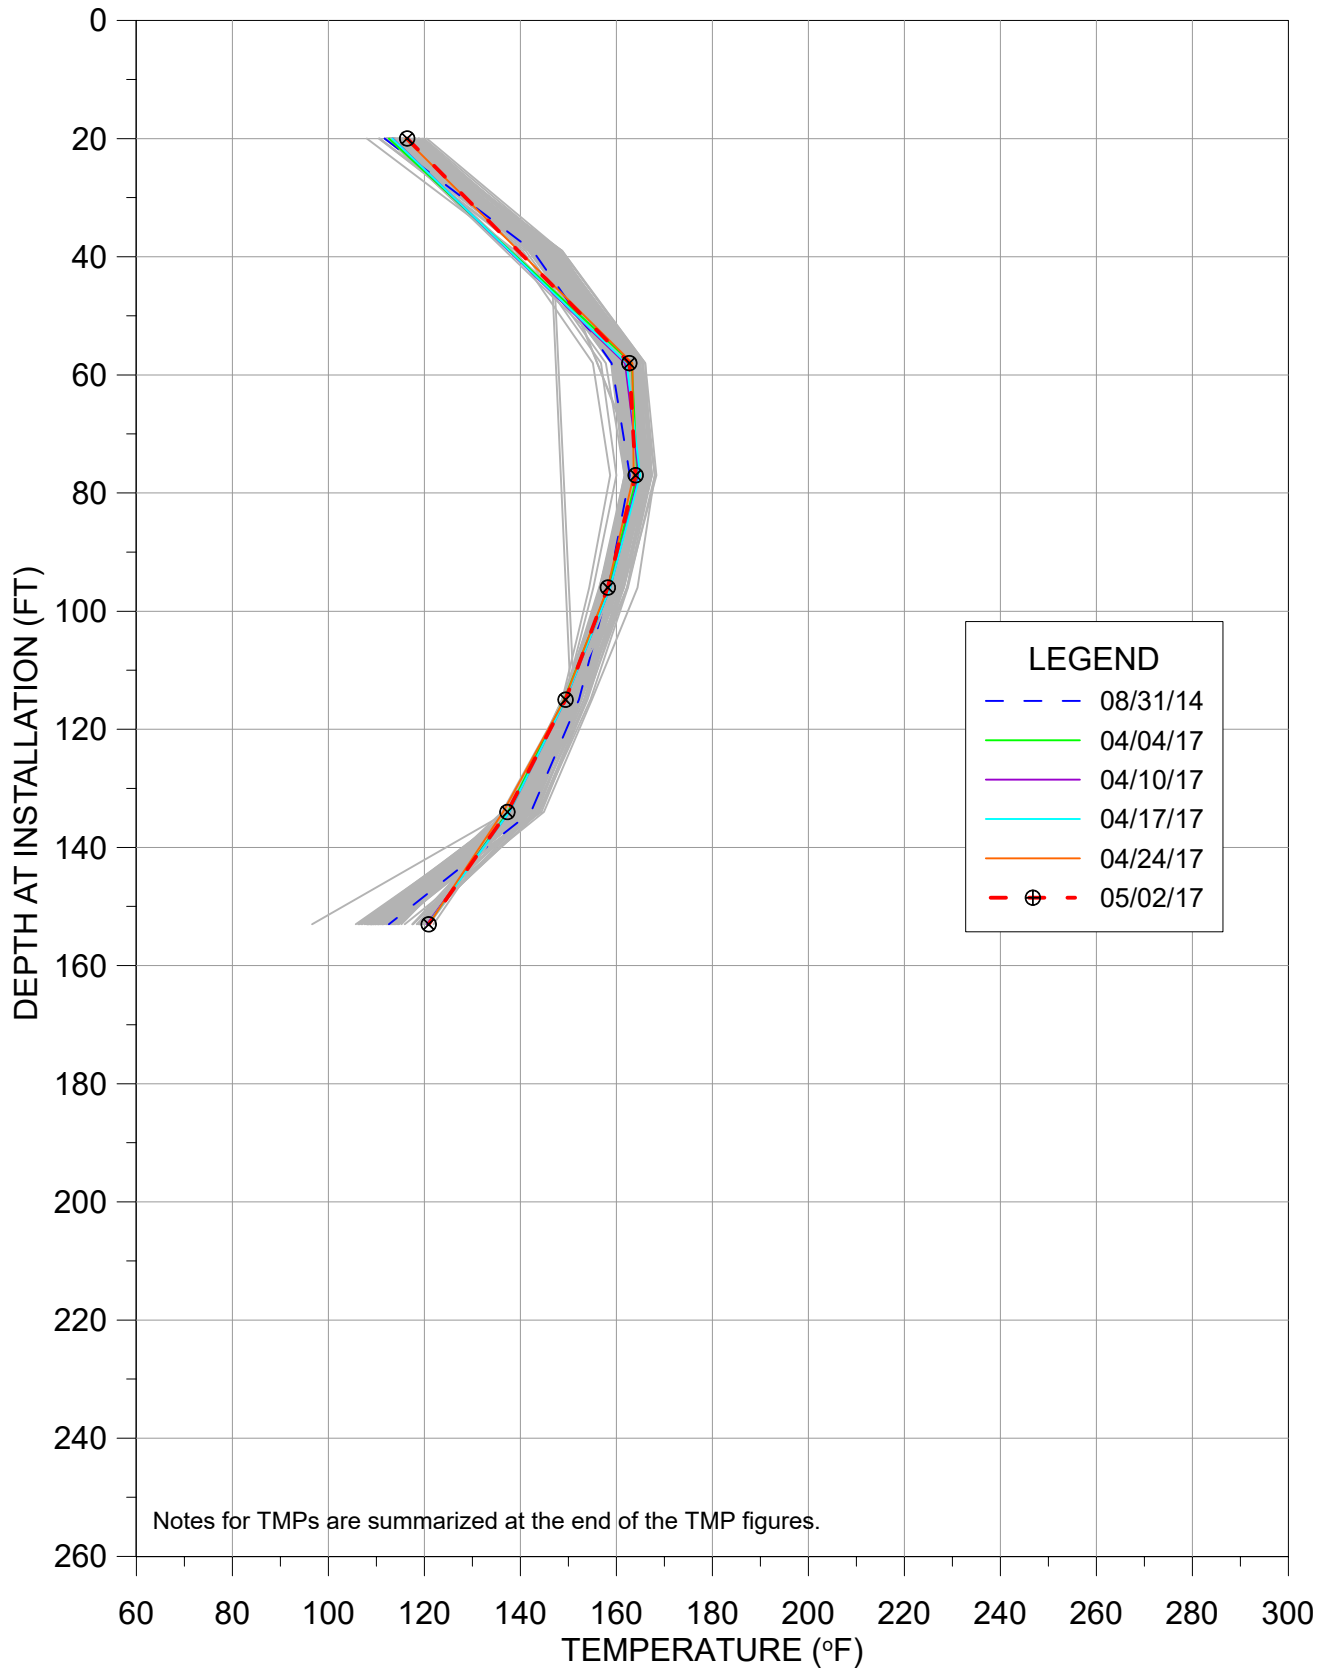
# TMP-16

1. A connectivity test conducted by Feezor Engineering showed that the units on TMP-16 may not be reliable since 9/9/2015. Further testing at the end of September 2015 showed possible connectivity on some of the units.
2. The unit at 153 ft depth had a low resistance reading and unreliable temperature since 12/21/2015.

3. The unit at 39 ft depth had a higher than acceptable resistance reading and unreliable temperature since 2/7/2017.

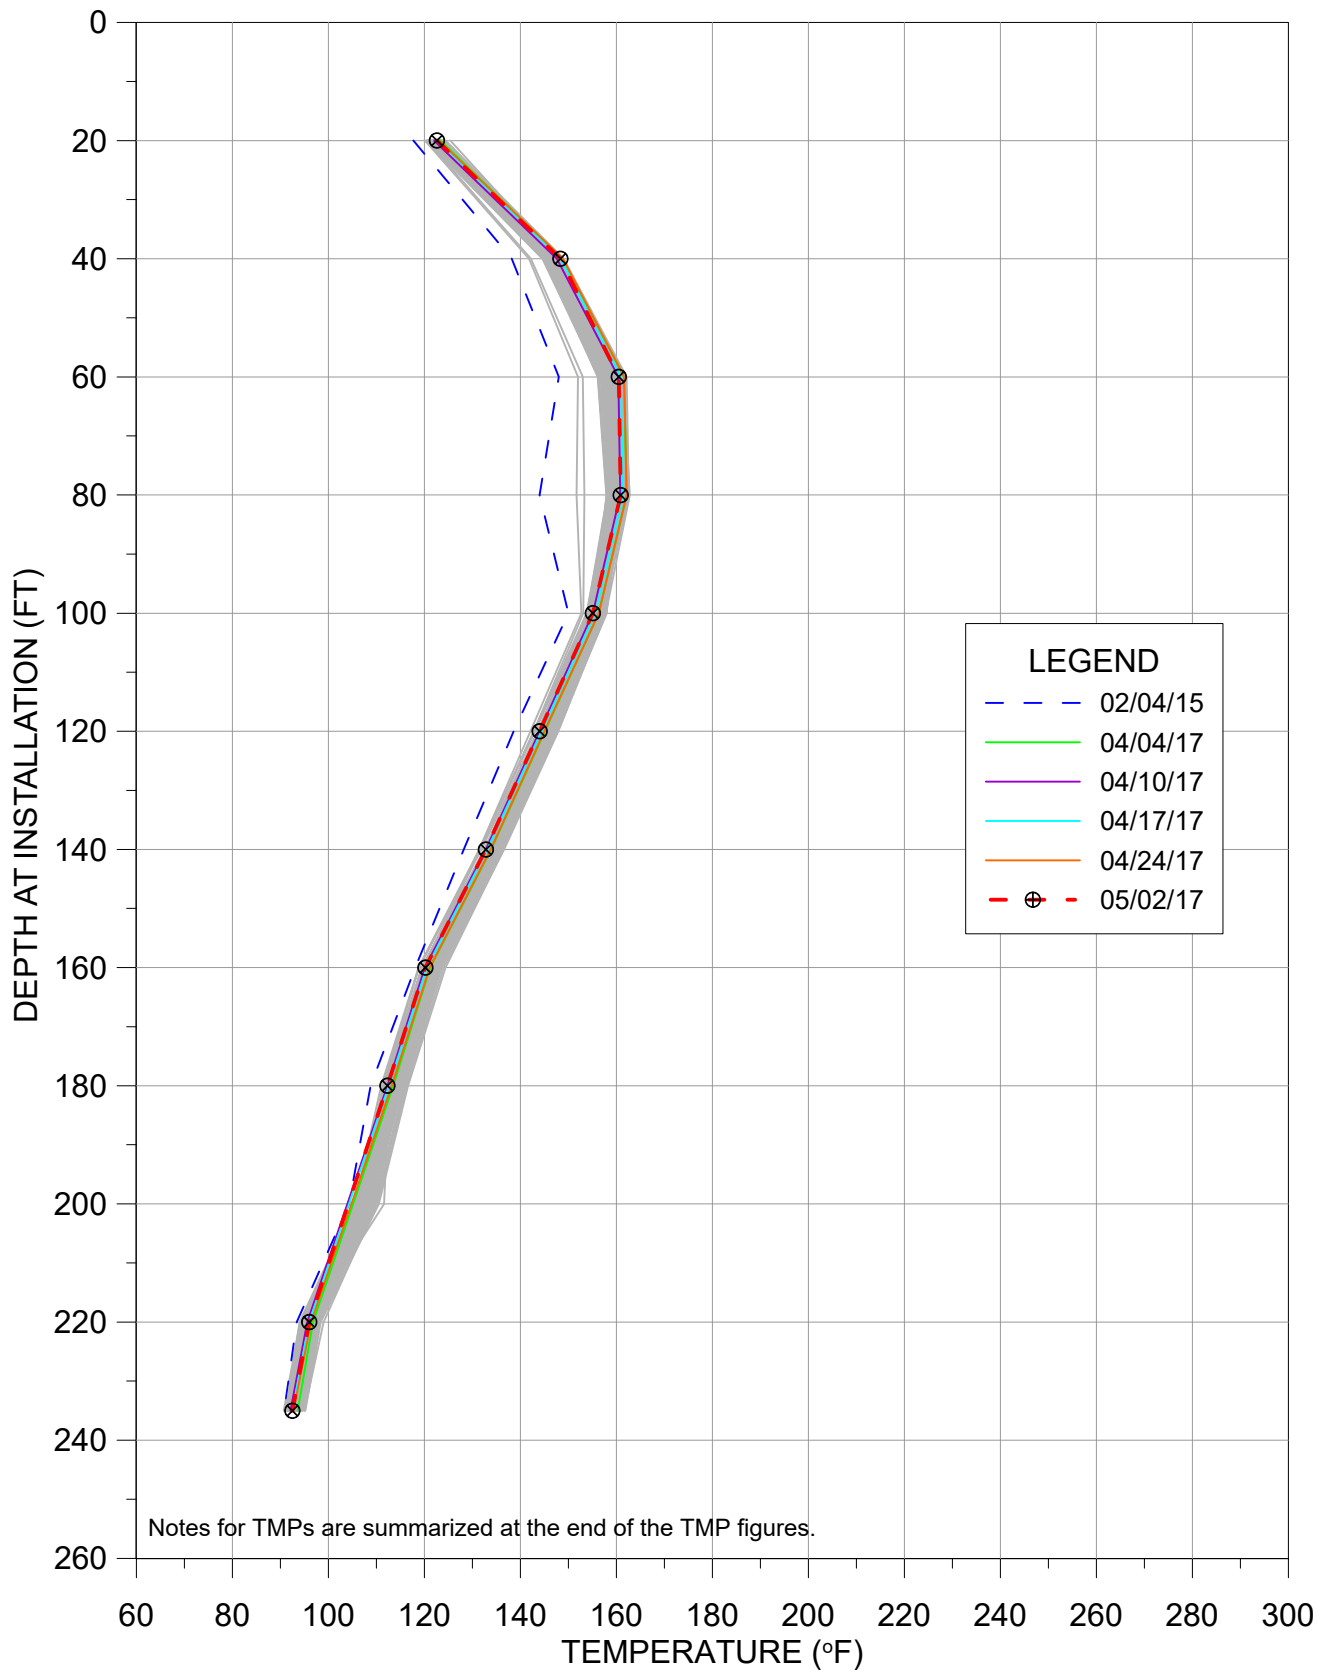
# TMP-25

1. The unit at 200 ft provided an apparent anomalous reading on 3/28/2017. Subsequent readings on 4/4/2017 showed the unit to have failed (see below). The unit is no longer working and the reading of 3/28/2017 was likely unreliable.
2. The unit at 200 ft depth had a resistance reading greater 4000 ohms on 4/4/2017. A connectivity test conducted by Feezor Engineering on 4/7/2017 showed that this unit also had cross-connectivity. The unit is therefore determined to be no longer working as of the 4/4/2017 reading.

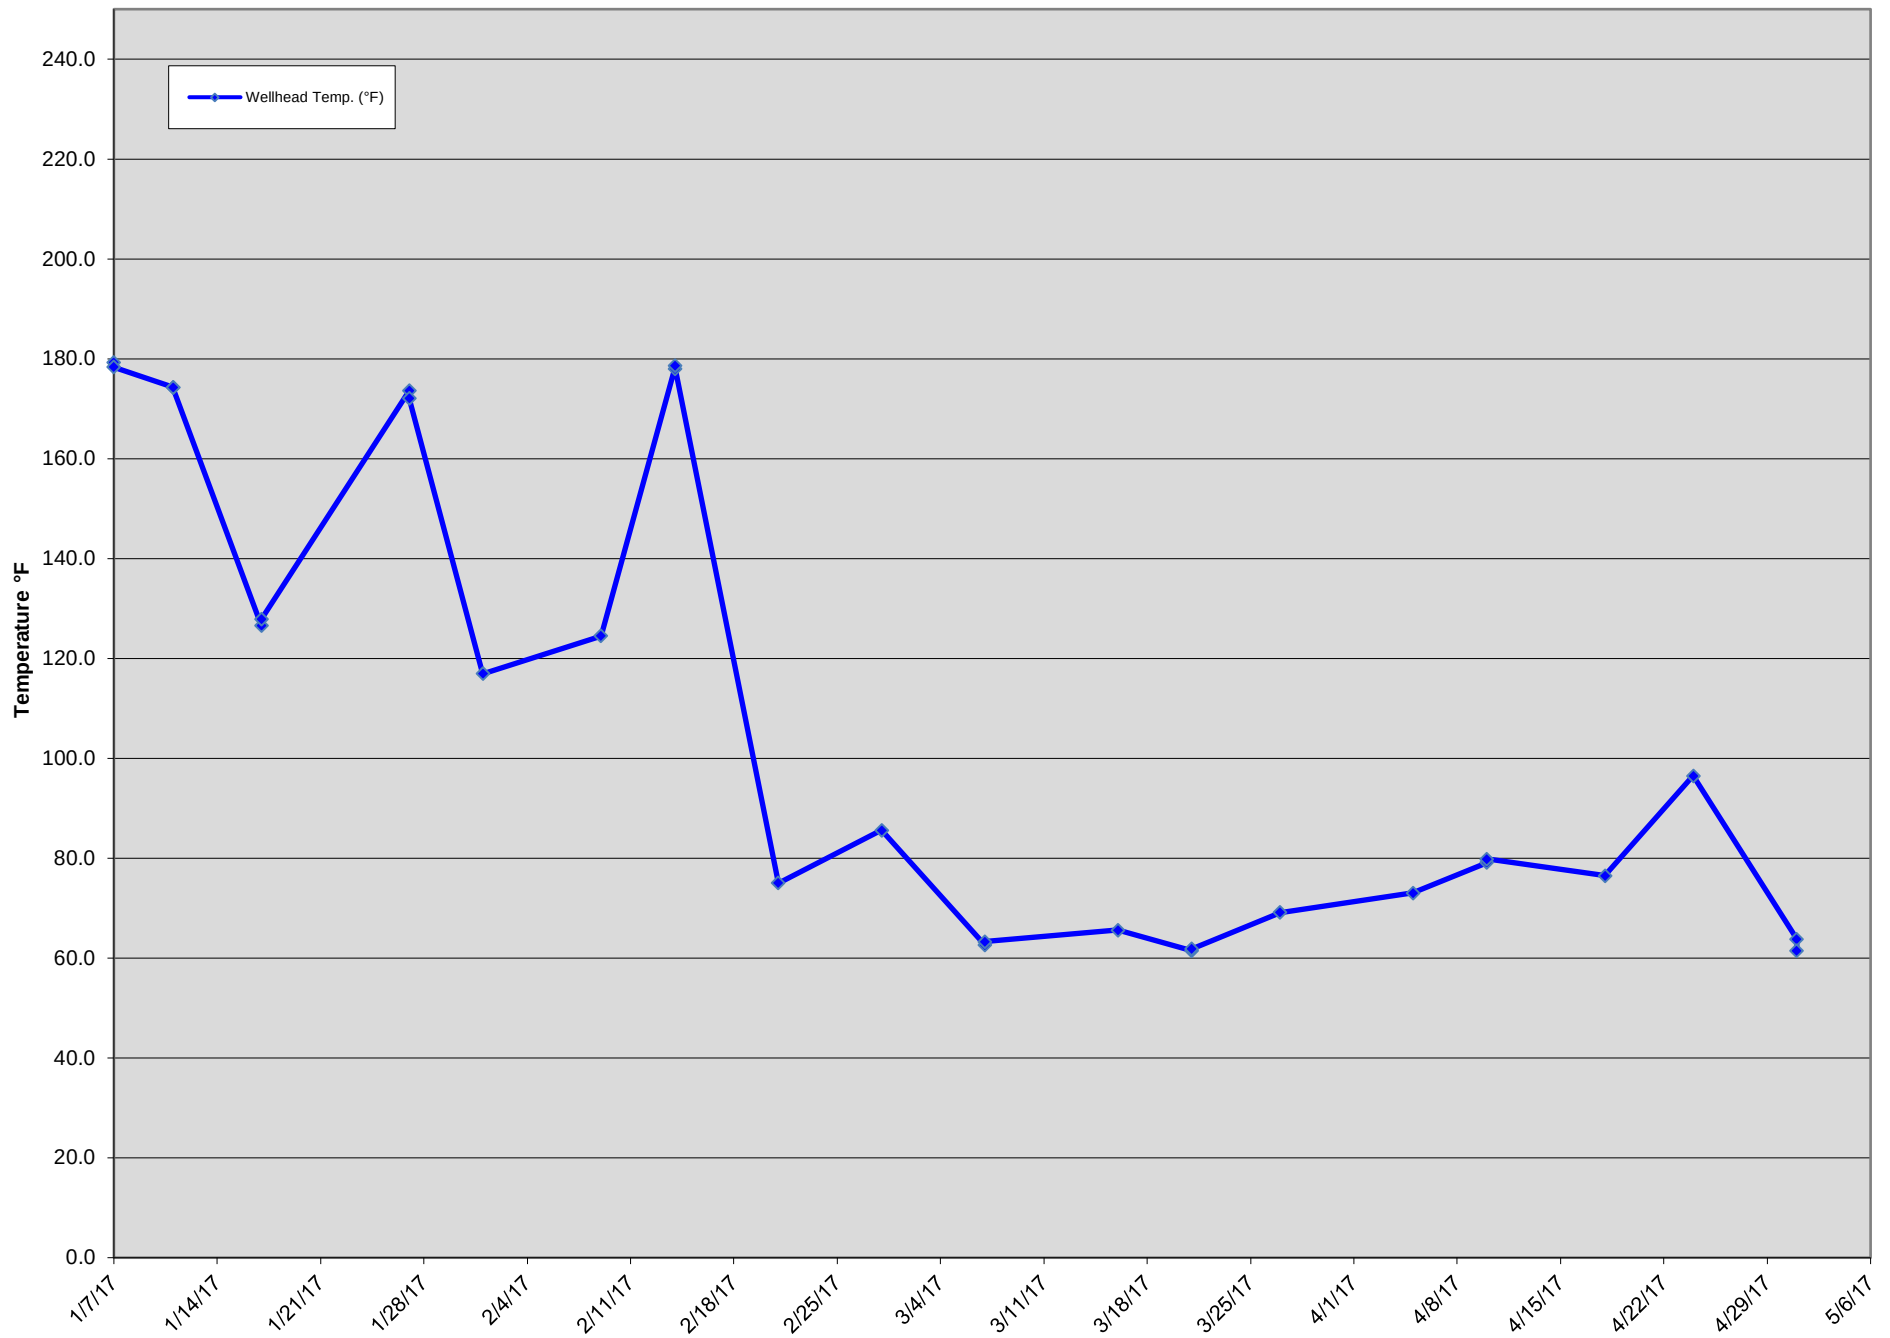
GIW-1 Wellhead Temperatures

As part of the HES, there are currently cooling water circulation loops installed in twelve Gas Interceptor Wells (GIWs) (GIW-02 through GIW-13). The remaining well (GIW-01) had a measured gas temperature within its historical operating limits.
