# **Bridgeton Landfill, LLC**

## **Weekly Data Submittal**

**Week of May 7, 2017 – May 13, 2017**

**Required by Section 52.F of Agreed Order, Case No. 13SL-CC01088  
Effective May 13, 2013**

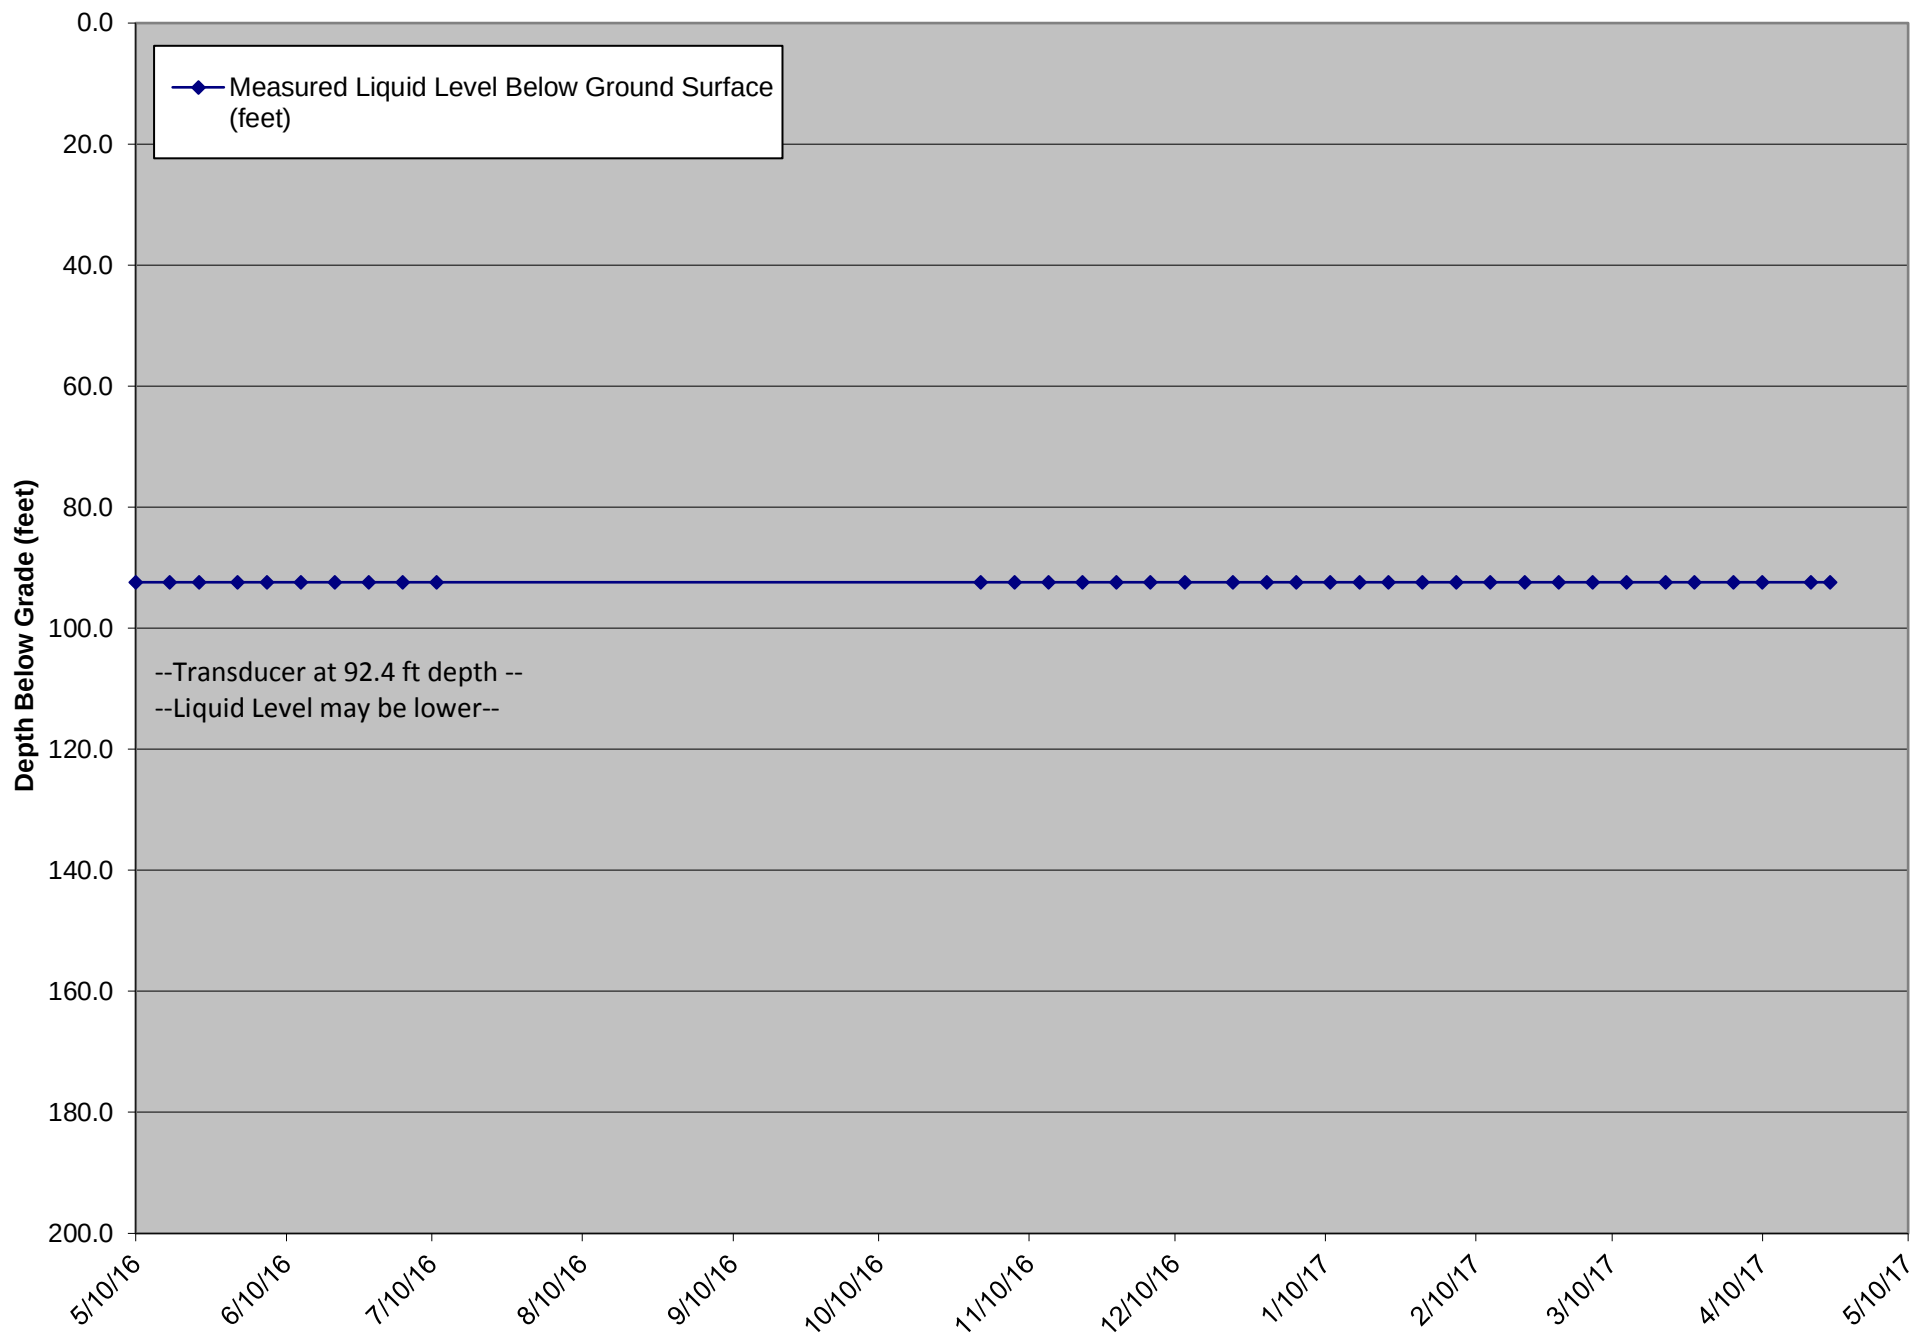
# LCS-1D Liquid Level Below Ground Surface

LCS-1D is equipped with a level sensor and a flow meter. The pump was non-operational during the weekly reporting period due to an electrical issue. Bridgeton Landfill confirmed that the flow meter on LCS-1D is operational and the flow was observed during the weekly reporting period. Liquid level was not recorded by the level sensor during the weekly reporting period. Bridgeton Landfill is tentatively scheduled to replace the level sensor on LCS-1D the week of 5/22/2017 pending contractor availability.

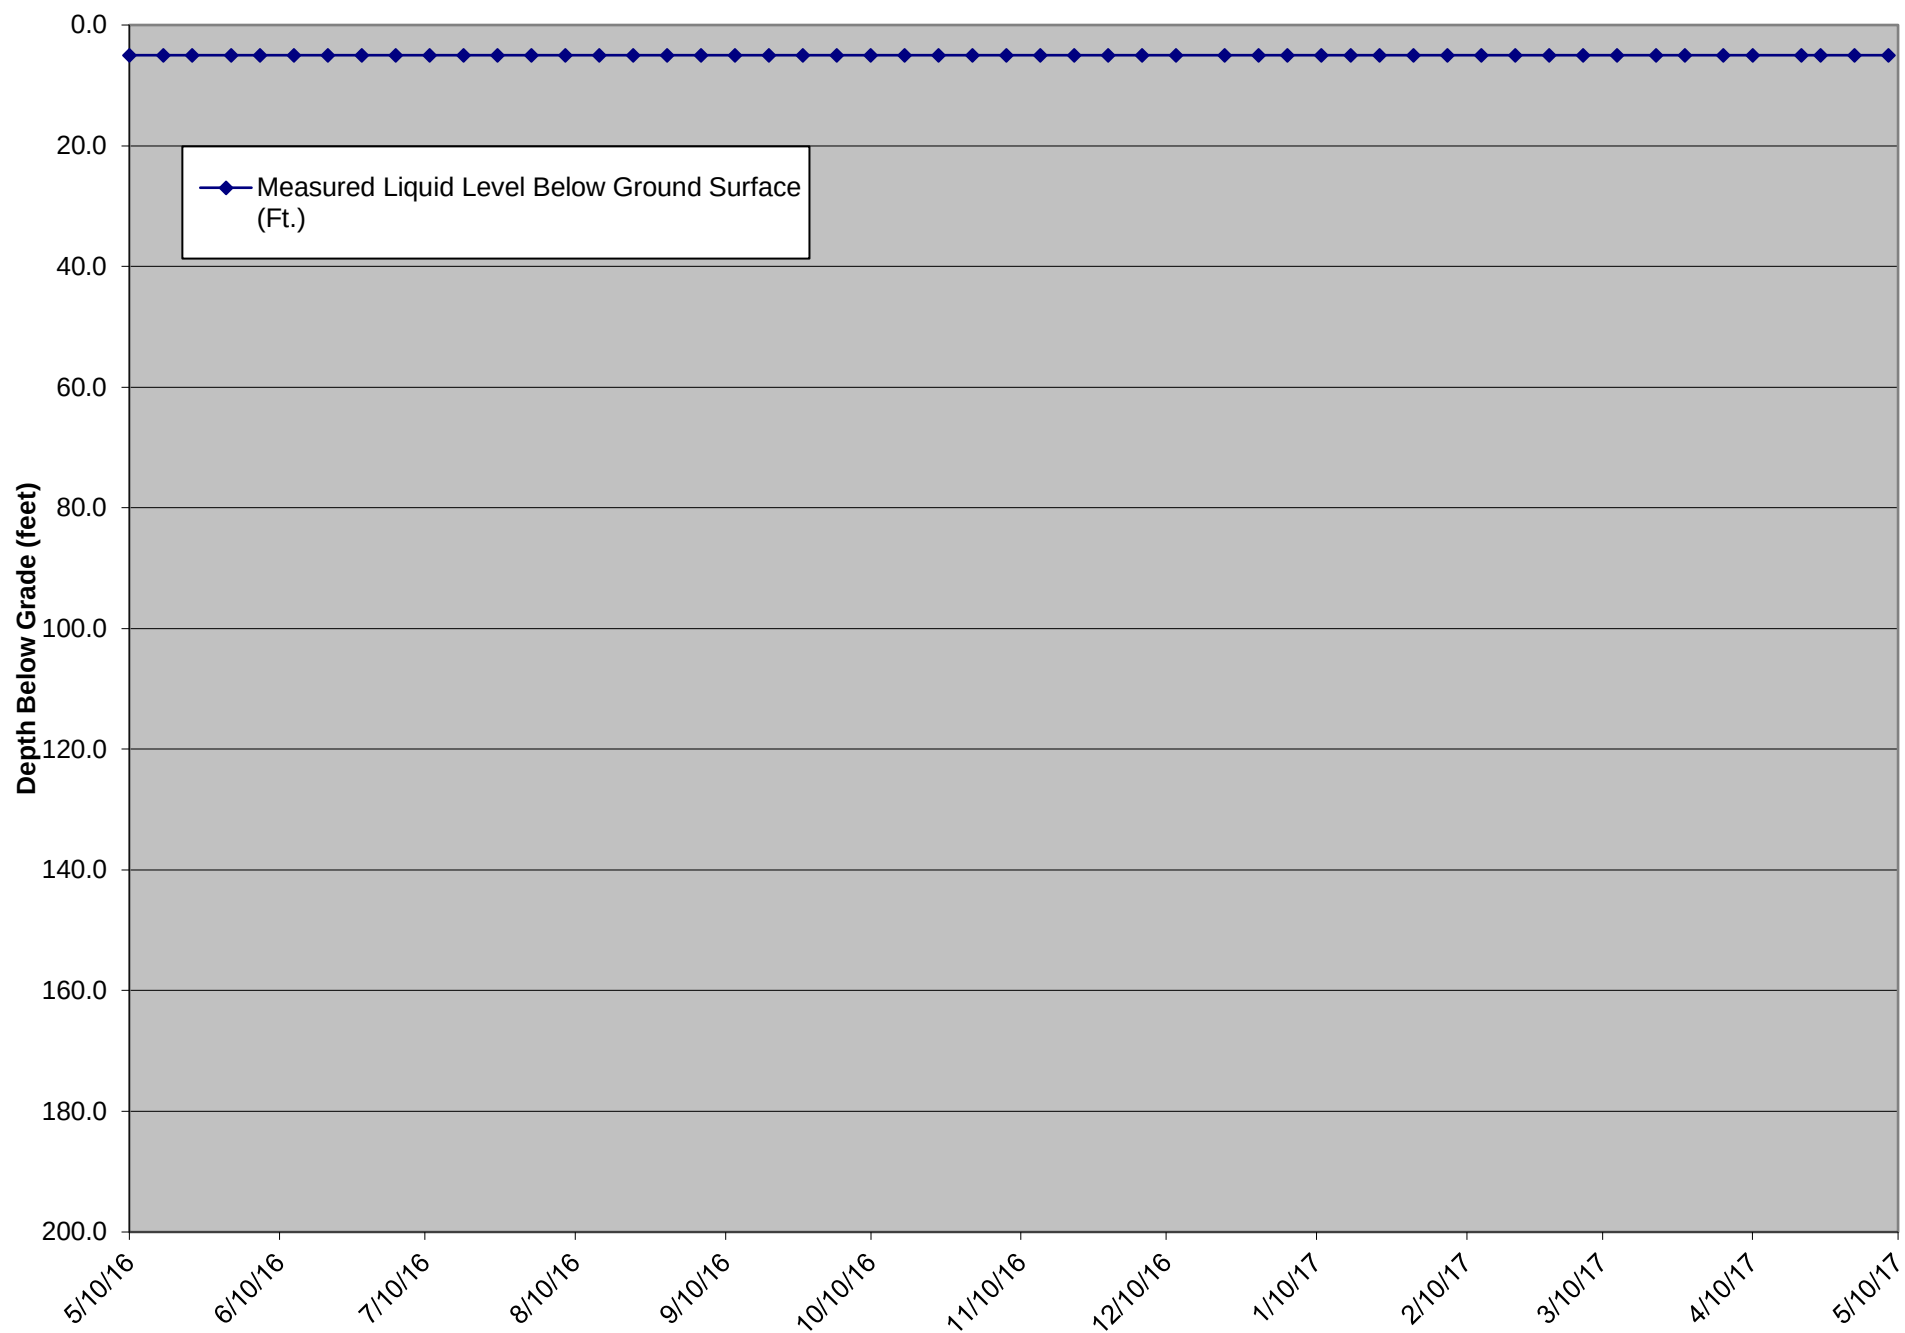
# LCS-3D Liquid Level Below Ground Surface

The pumps in LCS-2D and LCS-3D were non-operational during the weekly reporting period. The transducer in LCS-3D continued to report liquid levels. Flow was observed on the LCS-3D flow meter during the weekly reporting period. The pump and transducer in LCS-3D is tentatively scheduled to be replaced during the week of 5/22/2017 pending contractor availability.

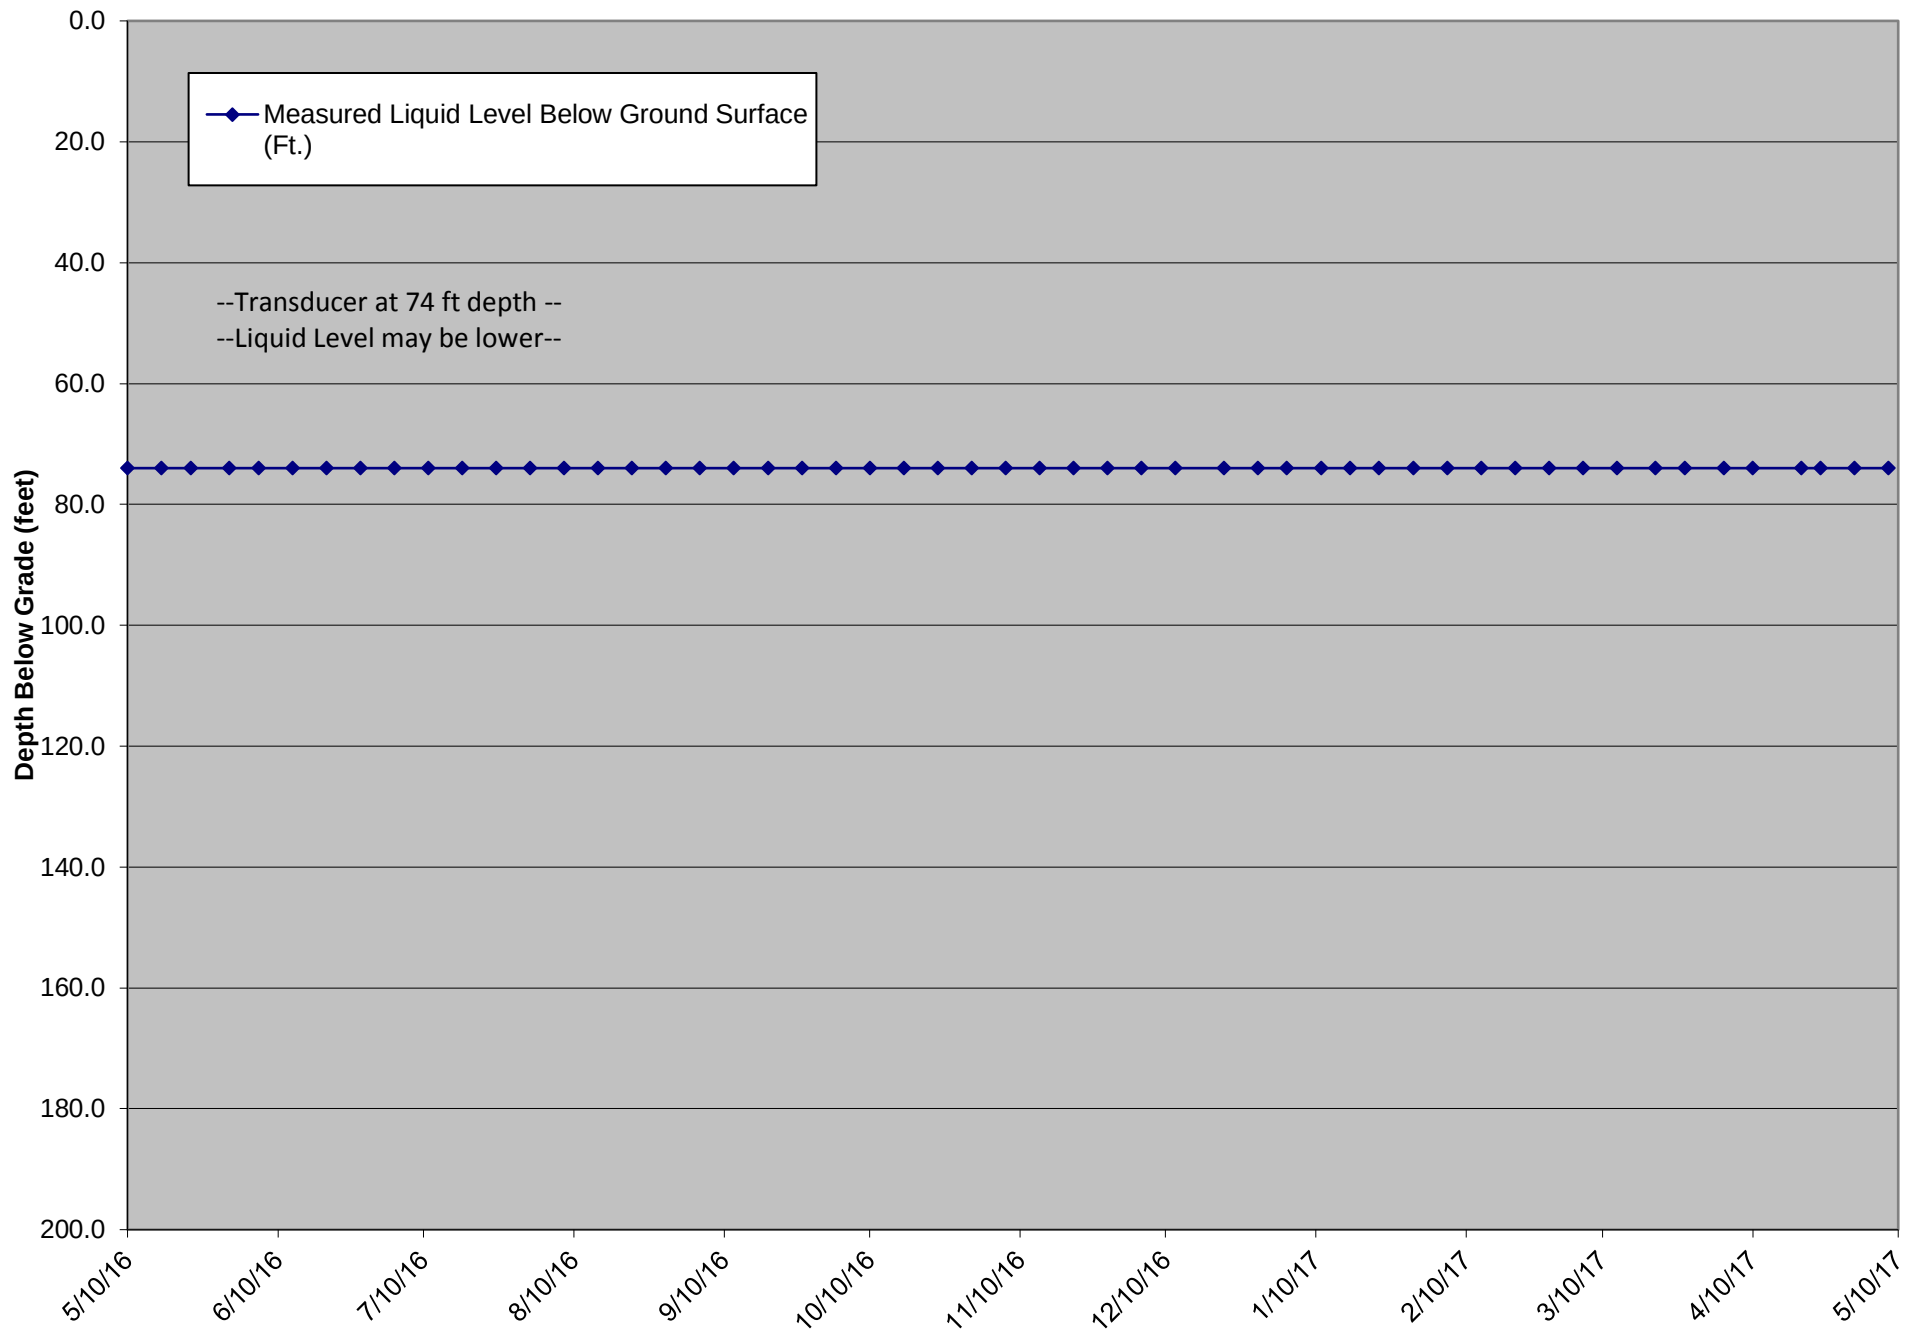
# LCS-4B Liquid Level Below Ground Surface

The level sensor in LCS-4B is currently operational and responsive. Liquid level was not recorded by the level sensor during the weekly reporting period. LCS-4B is equipped with a flow meter that displayed no flow during the weekly reporting period. Therefore, it can be concluded that the liquid level was below the bottom of the pump and level sensor in LCS-4B.

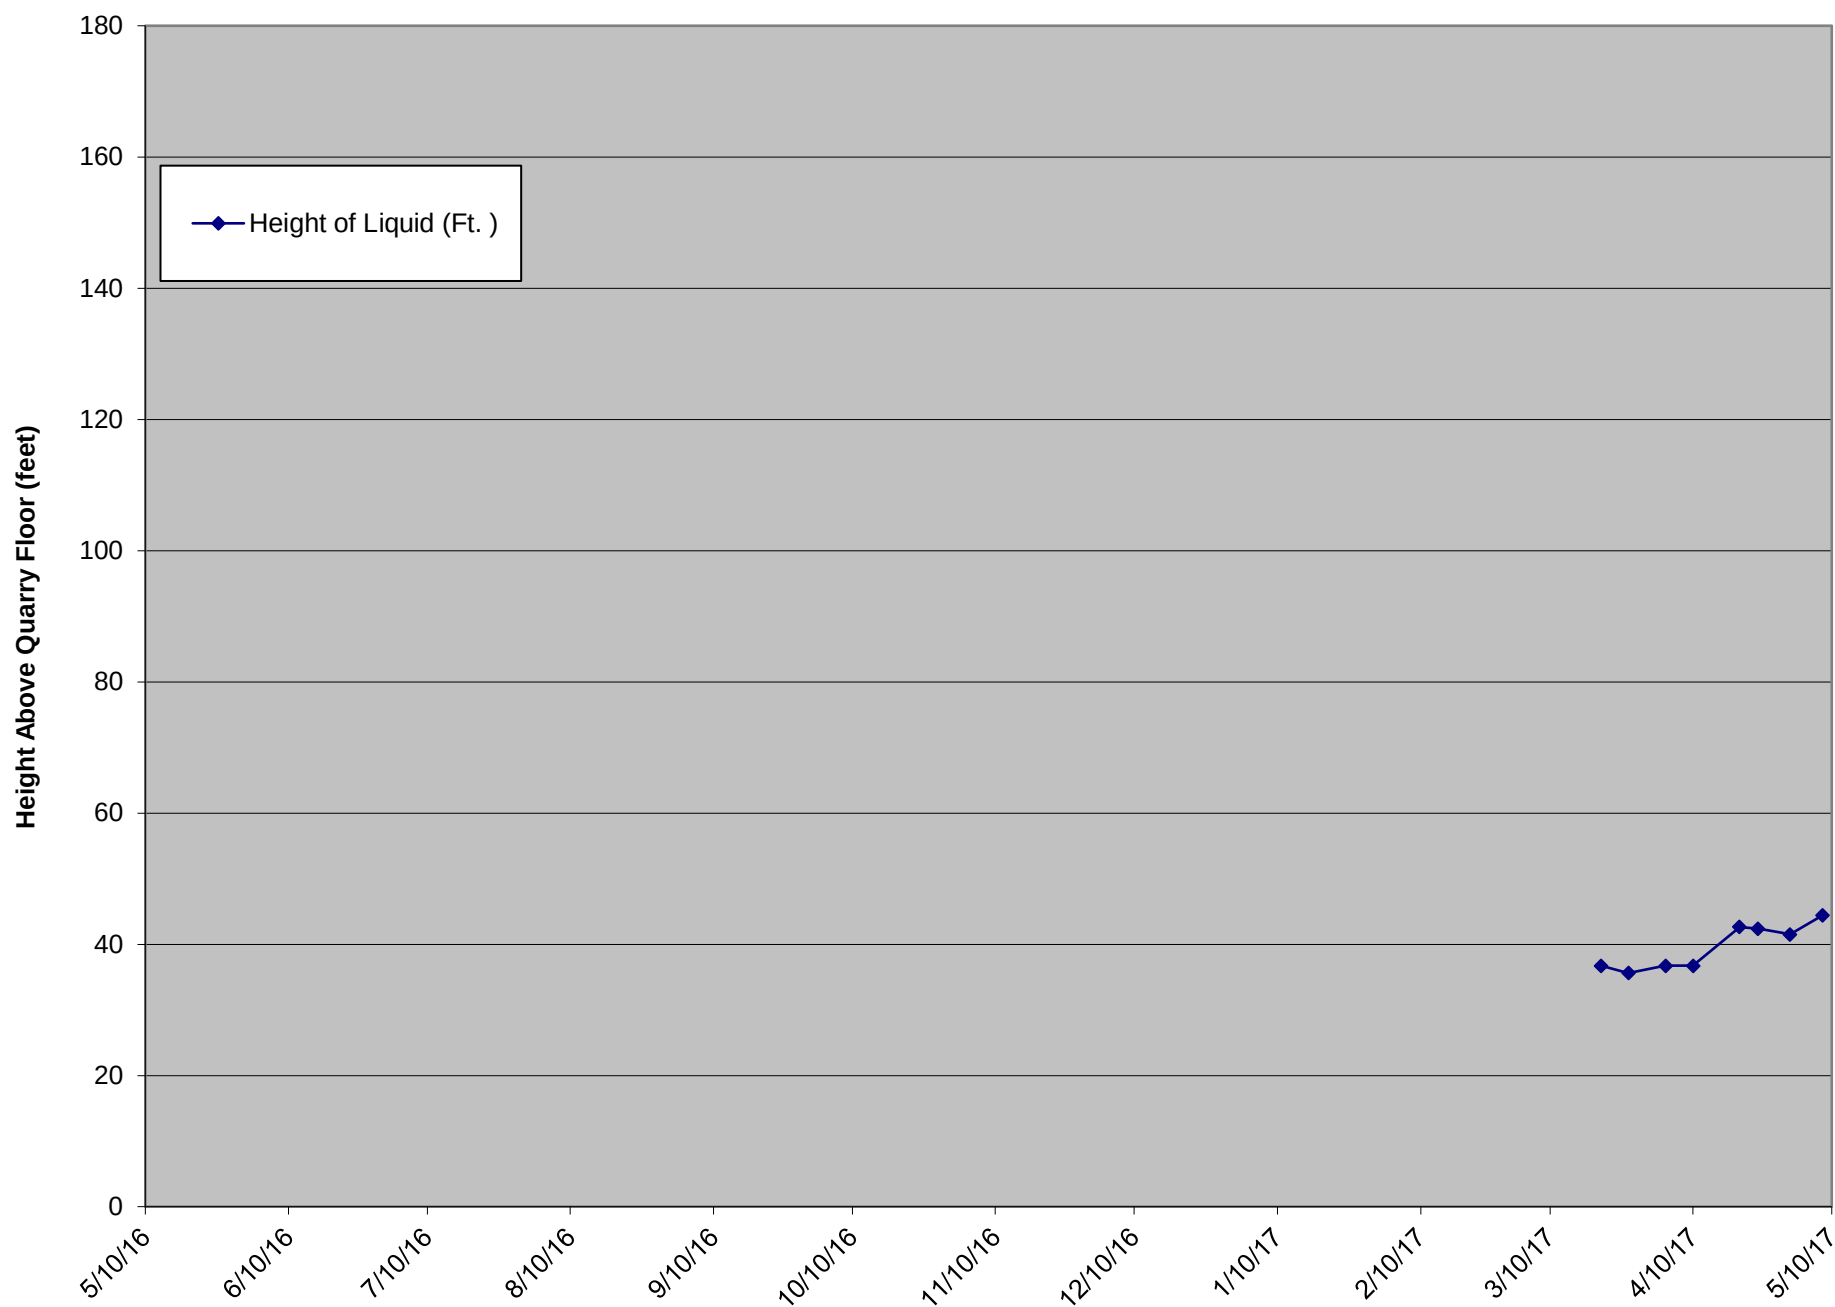
LCS-5B Liquid Level Above Quarry Floor

LCS-5B and LCS-6B were fully operational during the weekly reporting period.

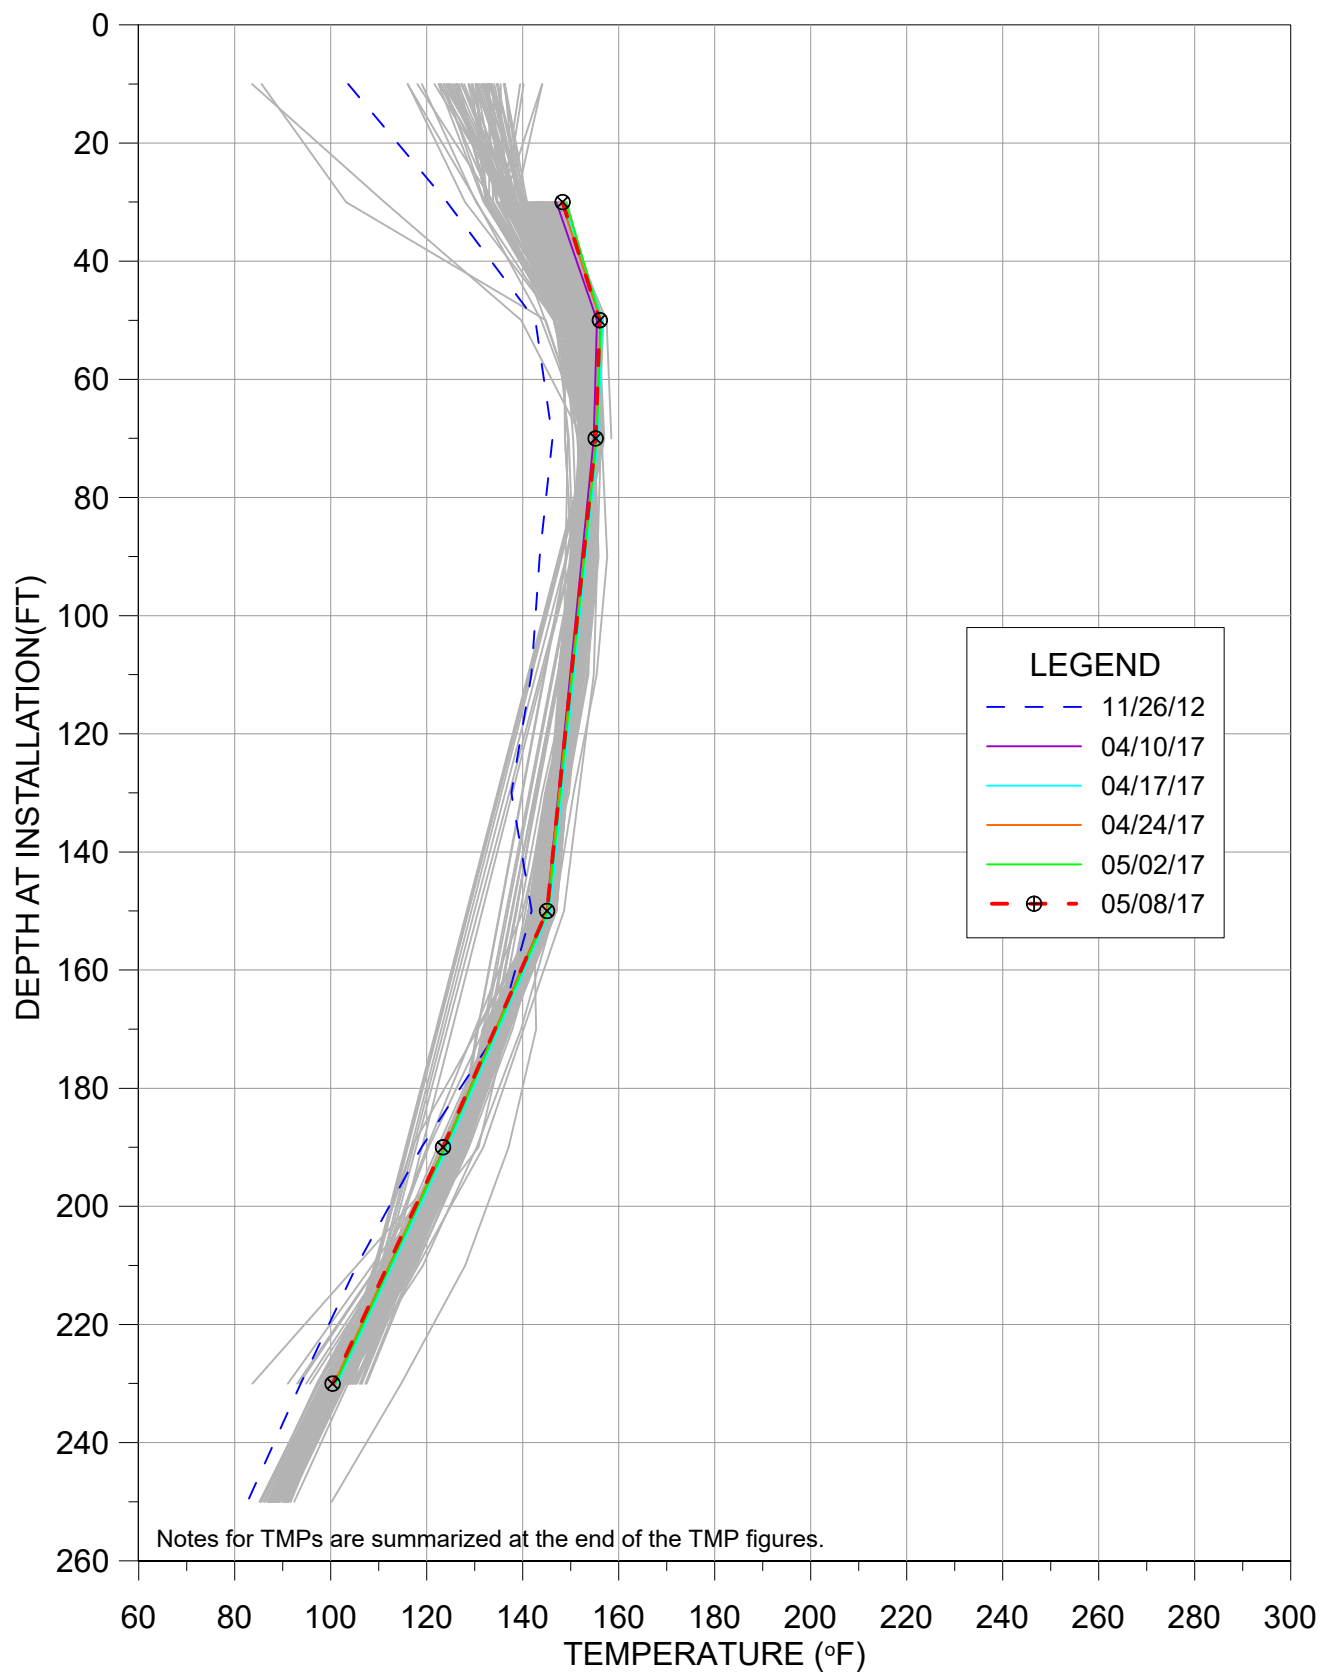
# TMP-3

1. No reliable temperature readings have been obtained at 170 ft depth since 1/29/2014, except on 3/13/2014.
2. The connectivity tests on 4/11/2014 conducted by CEC showed that units at 10, 90, 130, 210 and 250 ft depths are no longer reliable.
3. The connectivity tests on 10/28/2014 conducted by Feezor Engineering showed that units at 10, 90, 110, 130, 210 and 250 ft depths are not reliable.

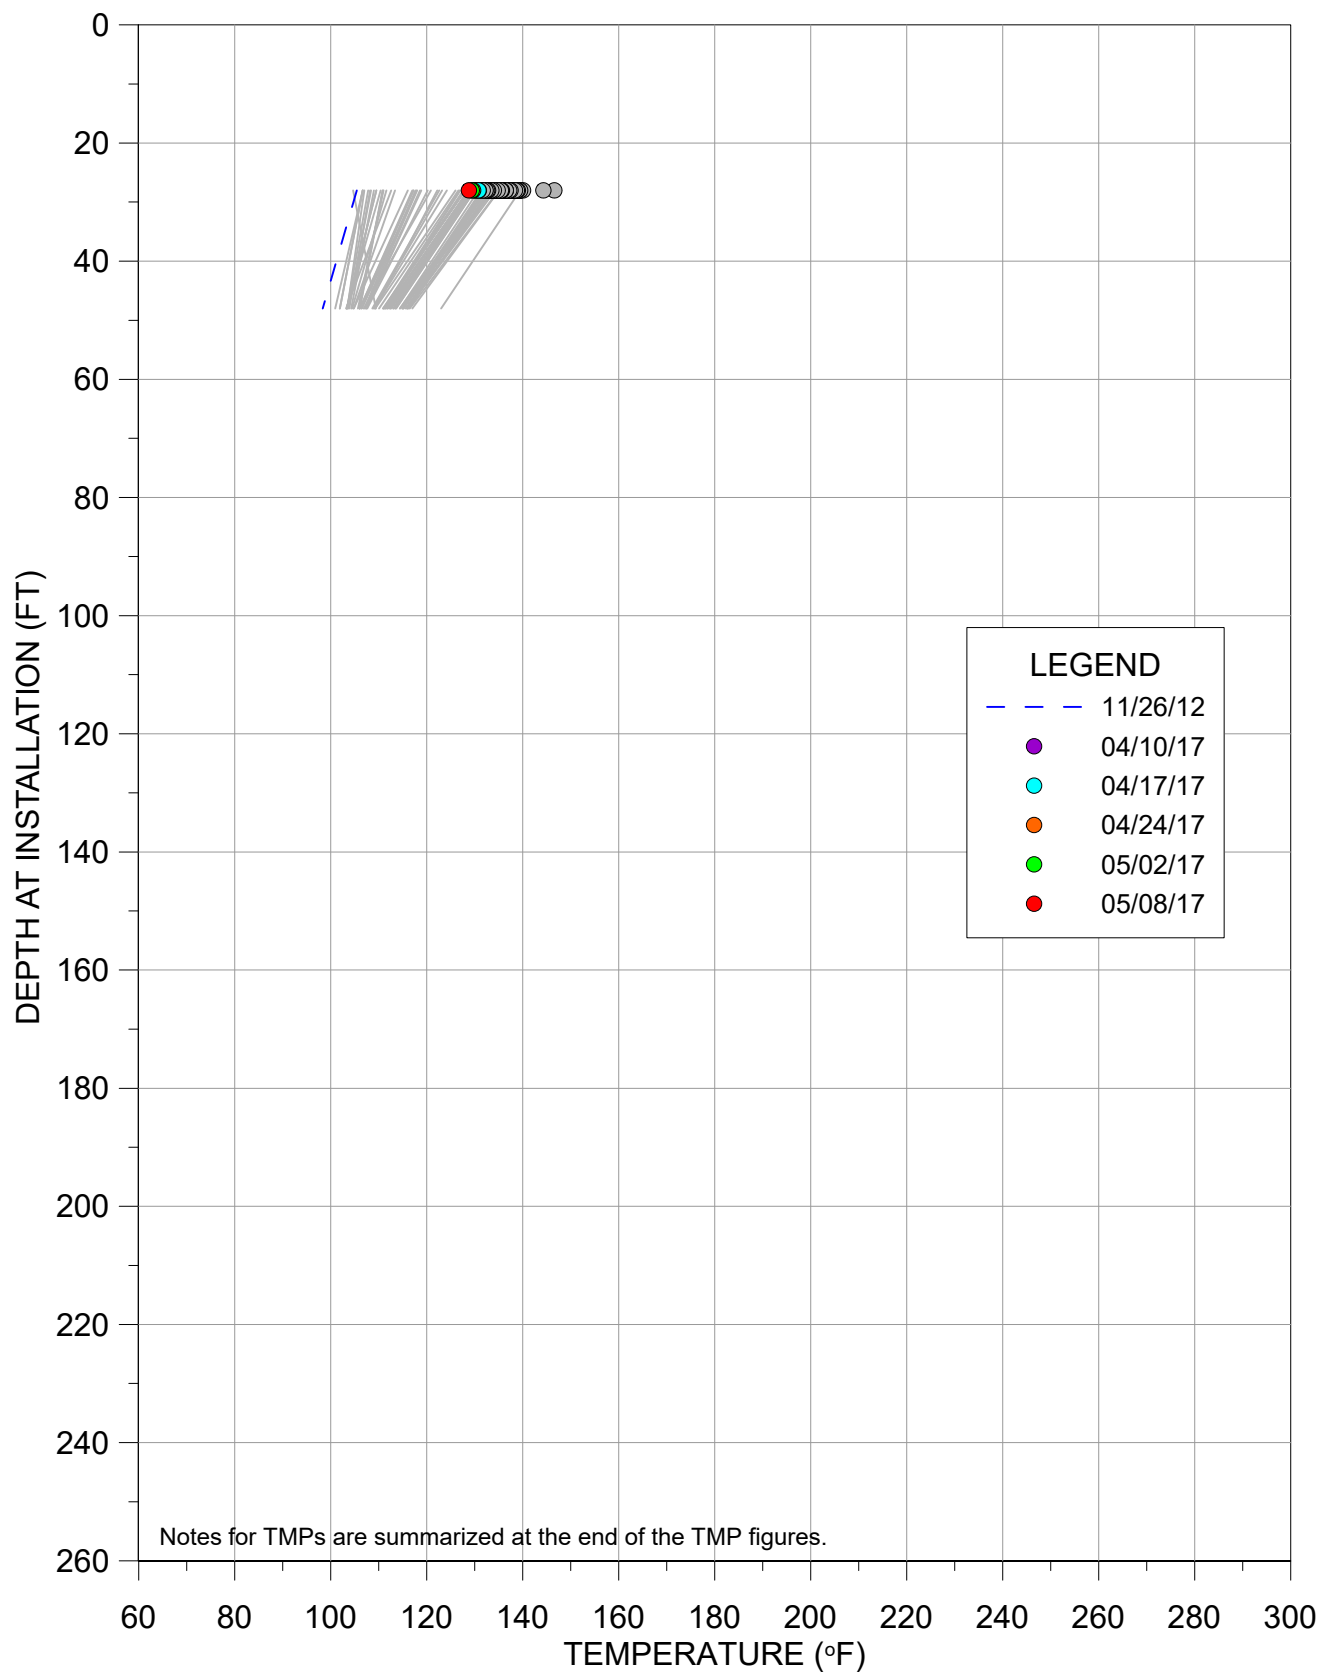
# TMP-4

1. The connectivity tests on 4/11/2014 conducted by CEC showed that the unit at 48 ft depth is no longer reliable.

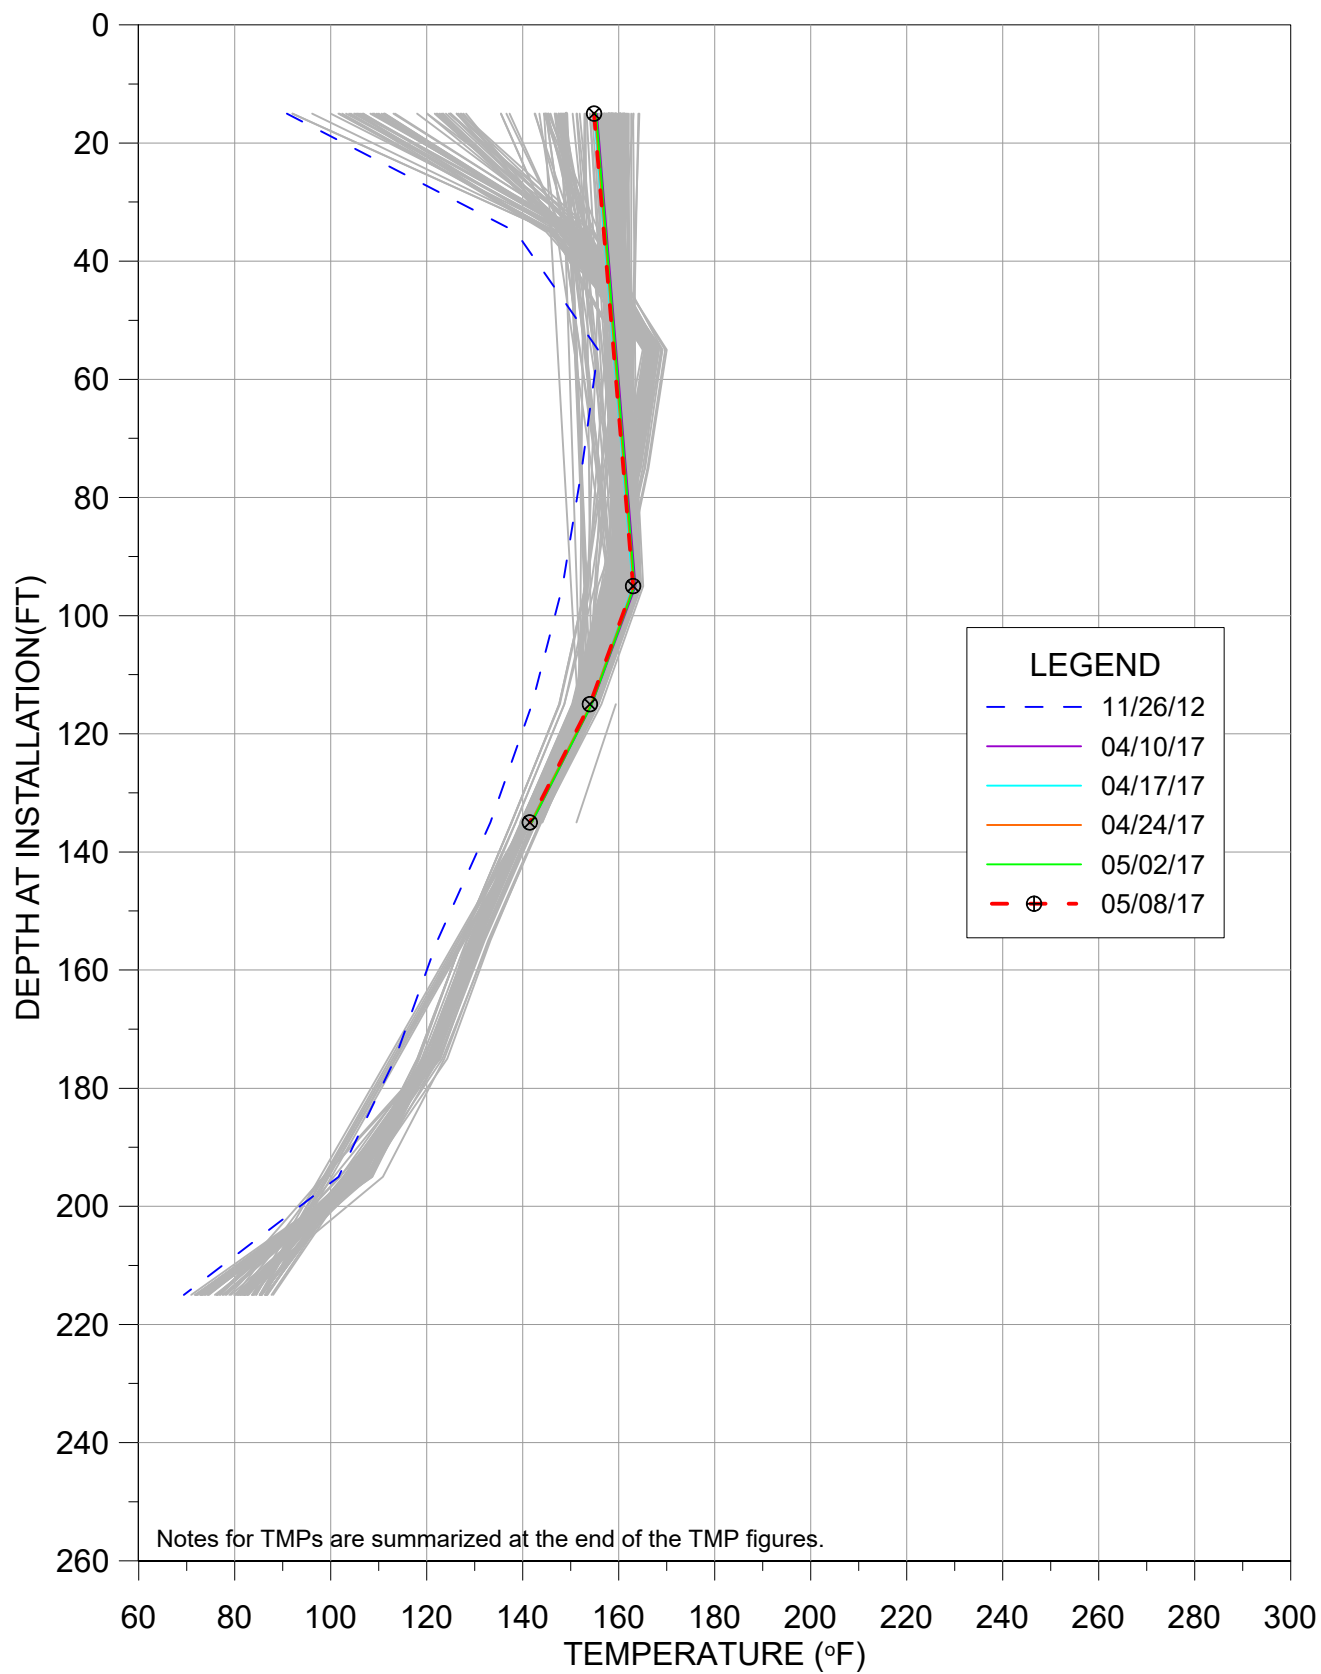
# TMP-6

1. The connectivity tests on 4/11/2014 conducted by CEC showed that units at 35, 55, 75, 155, 175, and 195 ft depths are no longer reliable.
2. No reliable temperature readings have been obtained at the unit at 215 ft depth since 6/13/2014.

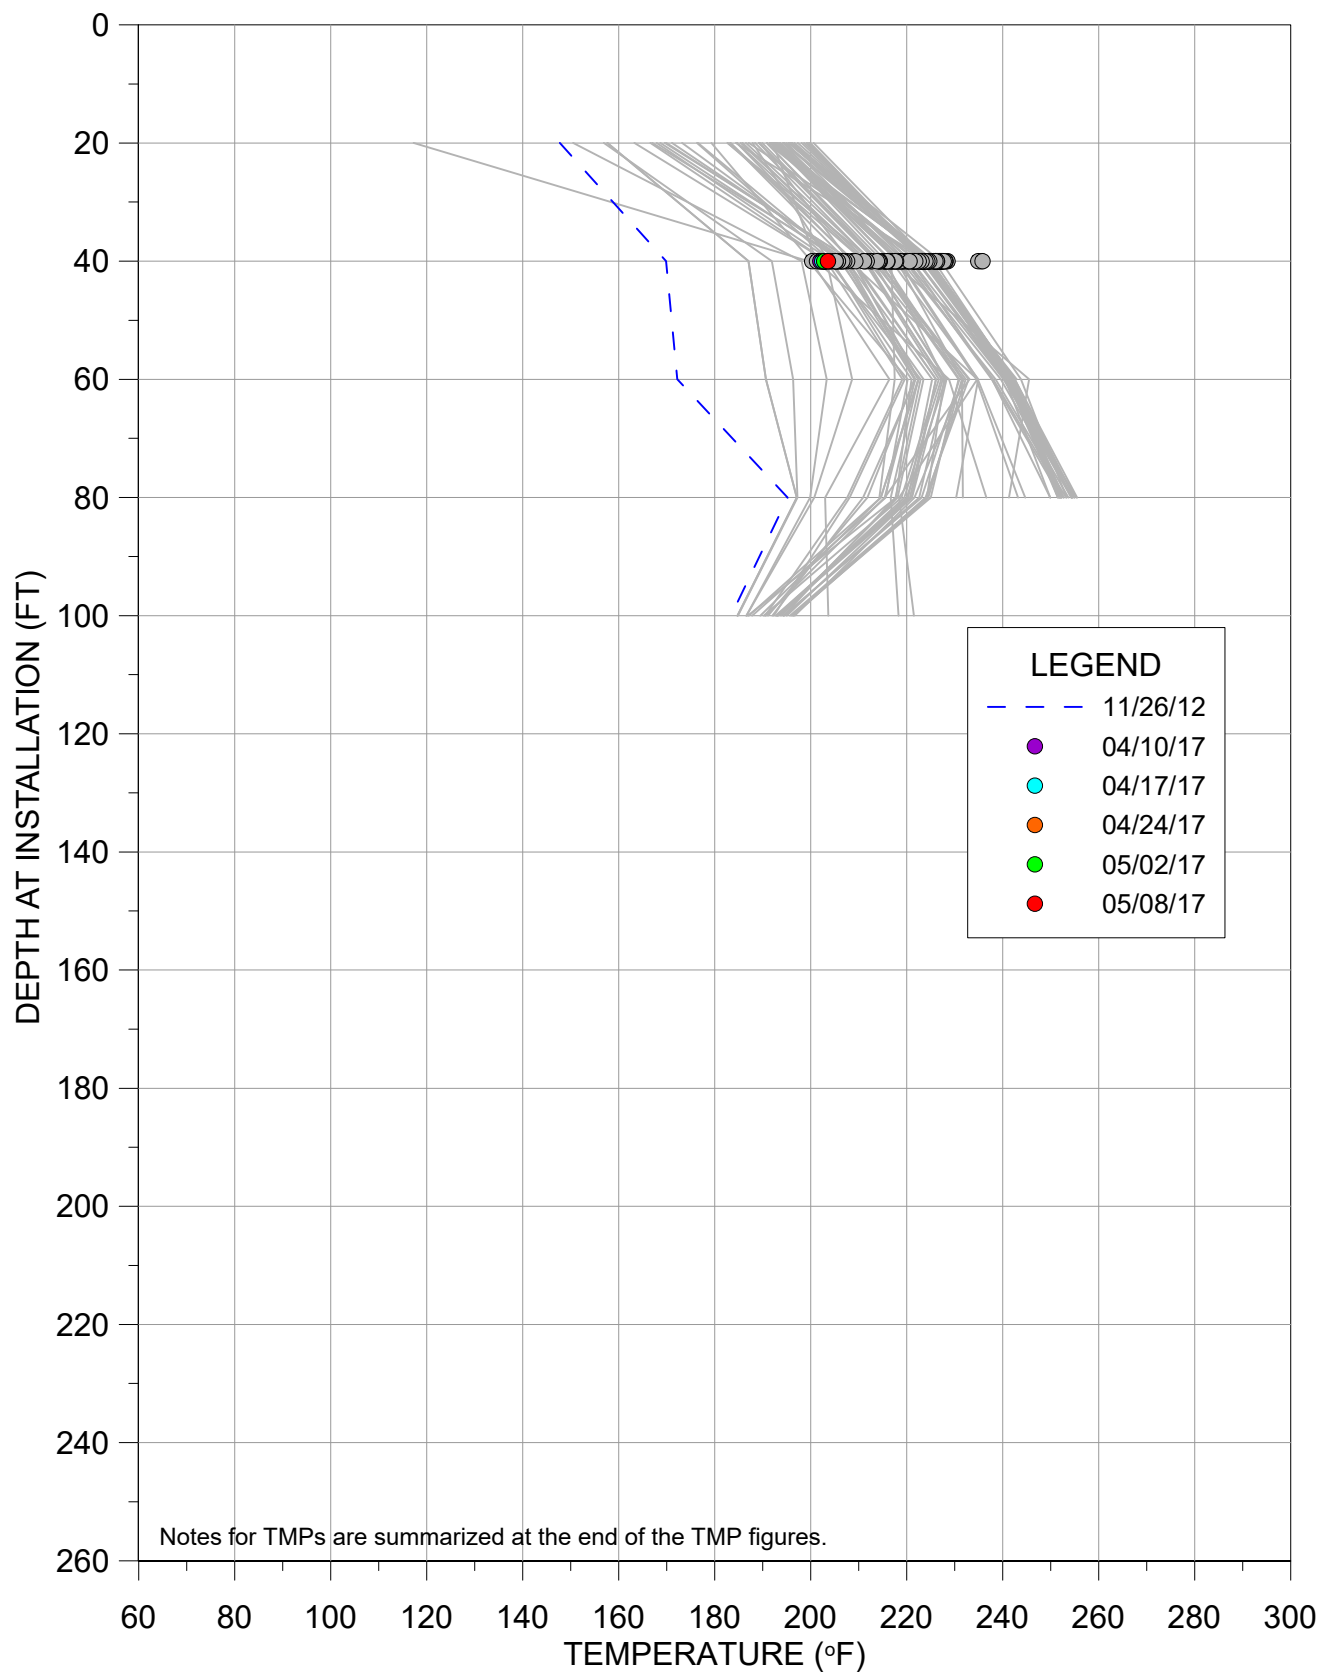
# TMP-9

1. Unit at 100 ft depth had an inaccurate temperature reading on 8/1/2013 and no reading since 8/6/2013.
2. The connectivity tests on 4/11/2014 conducted by CEC showed that units at 20, 60, 80, and 100 ft depths are no longer reliable.

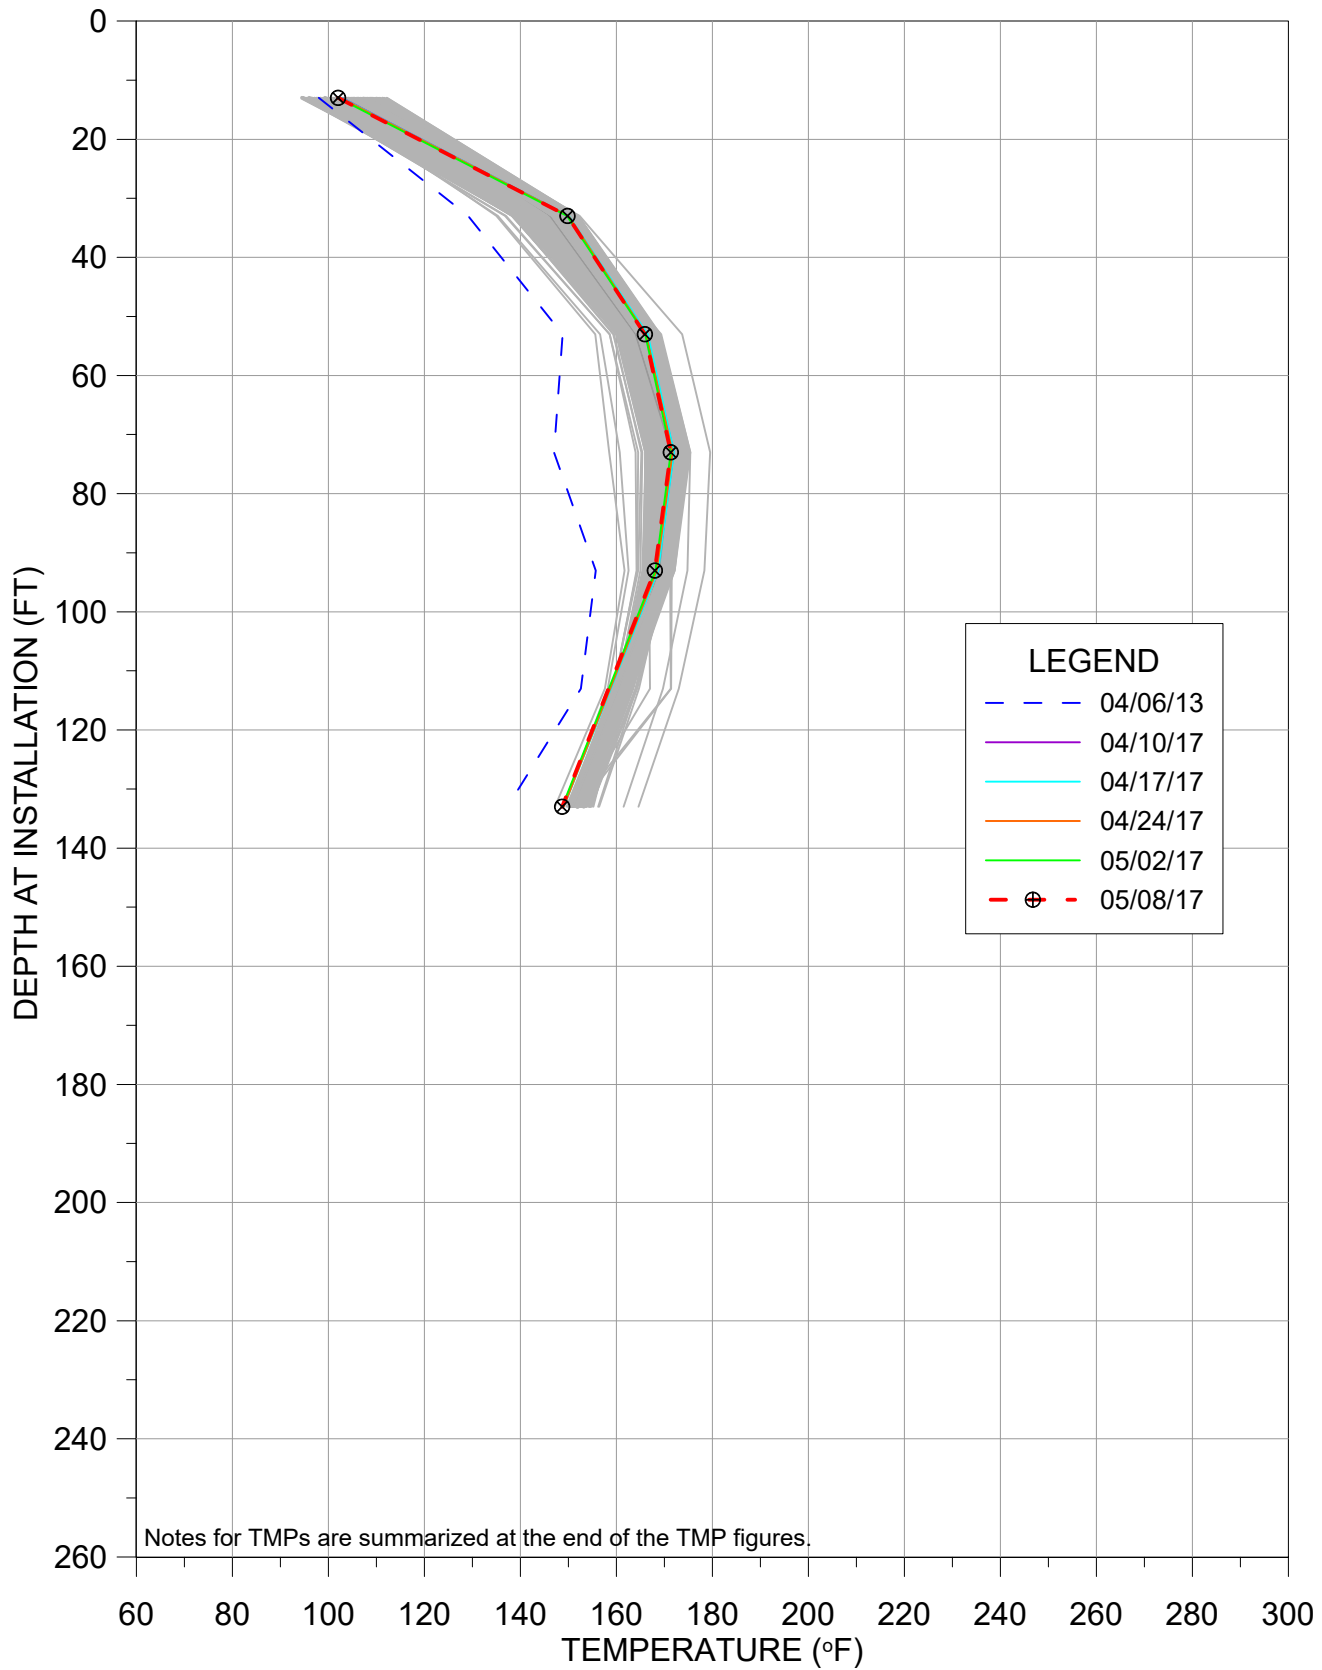
# TMP-10

1. Unit at 113 ft had resistance below the minimum level, change in resistance occurred as of 11/08/16 and has remained below acceptable level.
