# **Bridgeton Landfill, LLC**

## **Weekly Data Submittal**

**Week of May 7, 2017 – May 13, 2017**

**Required by Section 52.F of Agreed Order, Case No. 13SL-CC01088  
Effective May 13, 2013**

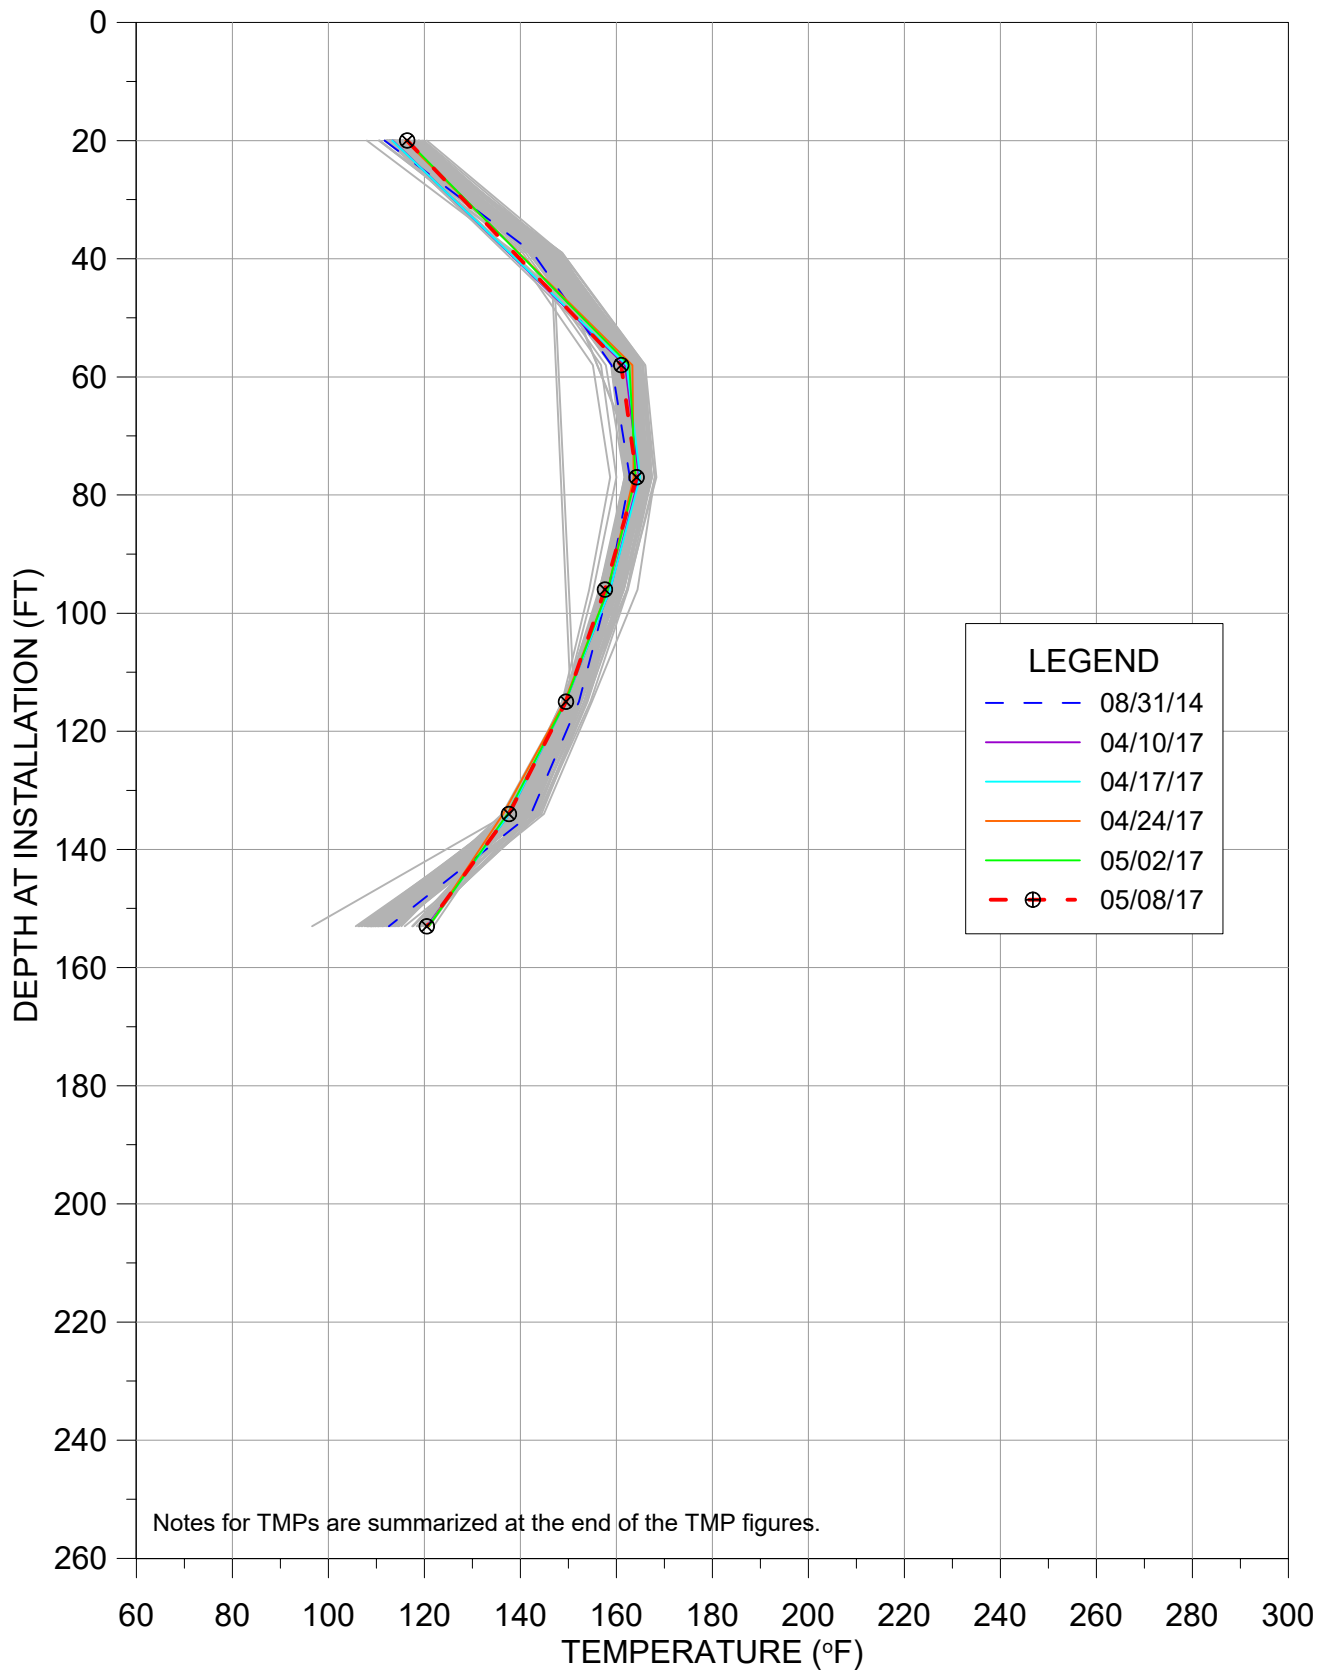
# TMP-16

1. A connectivity test conducted by Feezor Engineering showed that the units on TMP-16 may not be reliable since 9/9/2015. Further testing at the end of September 2015 showed possible connectivity on some of the units.
2. The unit at 153 ft depth had a low resistance reading and unreliable temperature since 12/21/2015.

3. The unit at 39 ft depth had a higher than acceptable resistance reading and unreliable temperature since 2/7/2017.

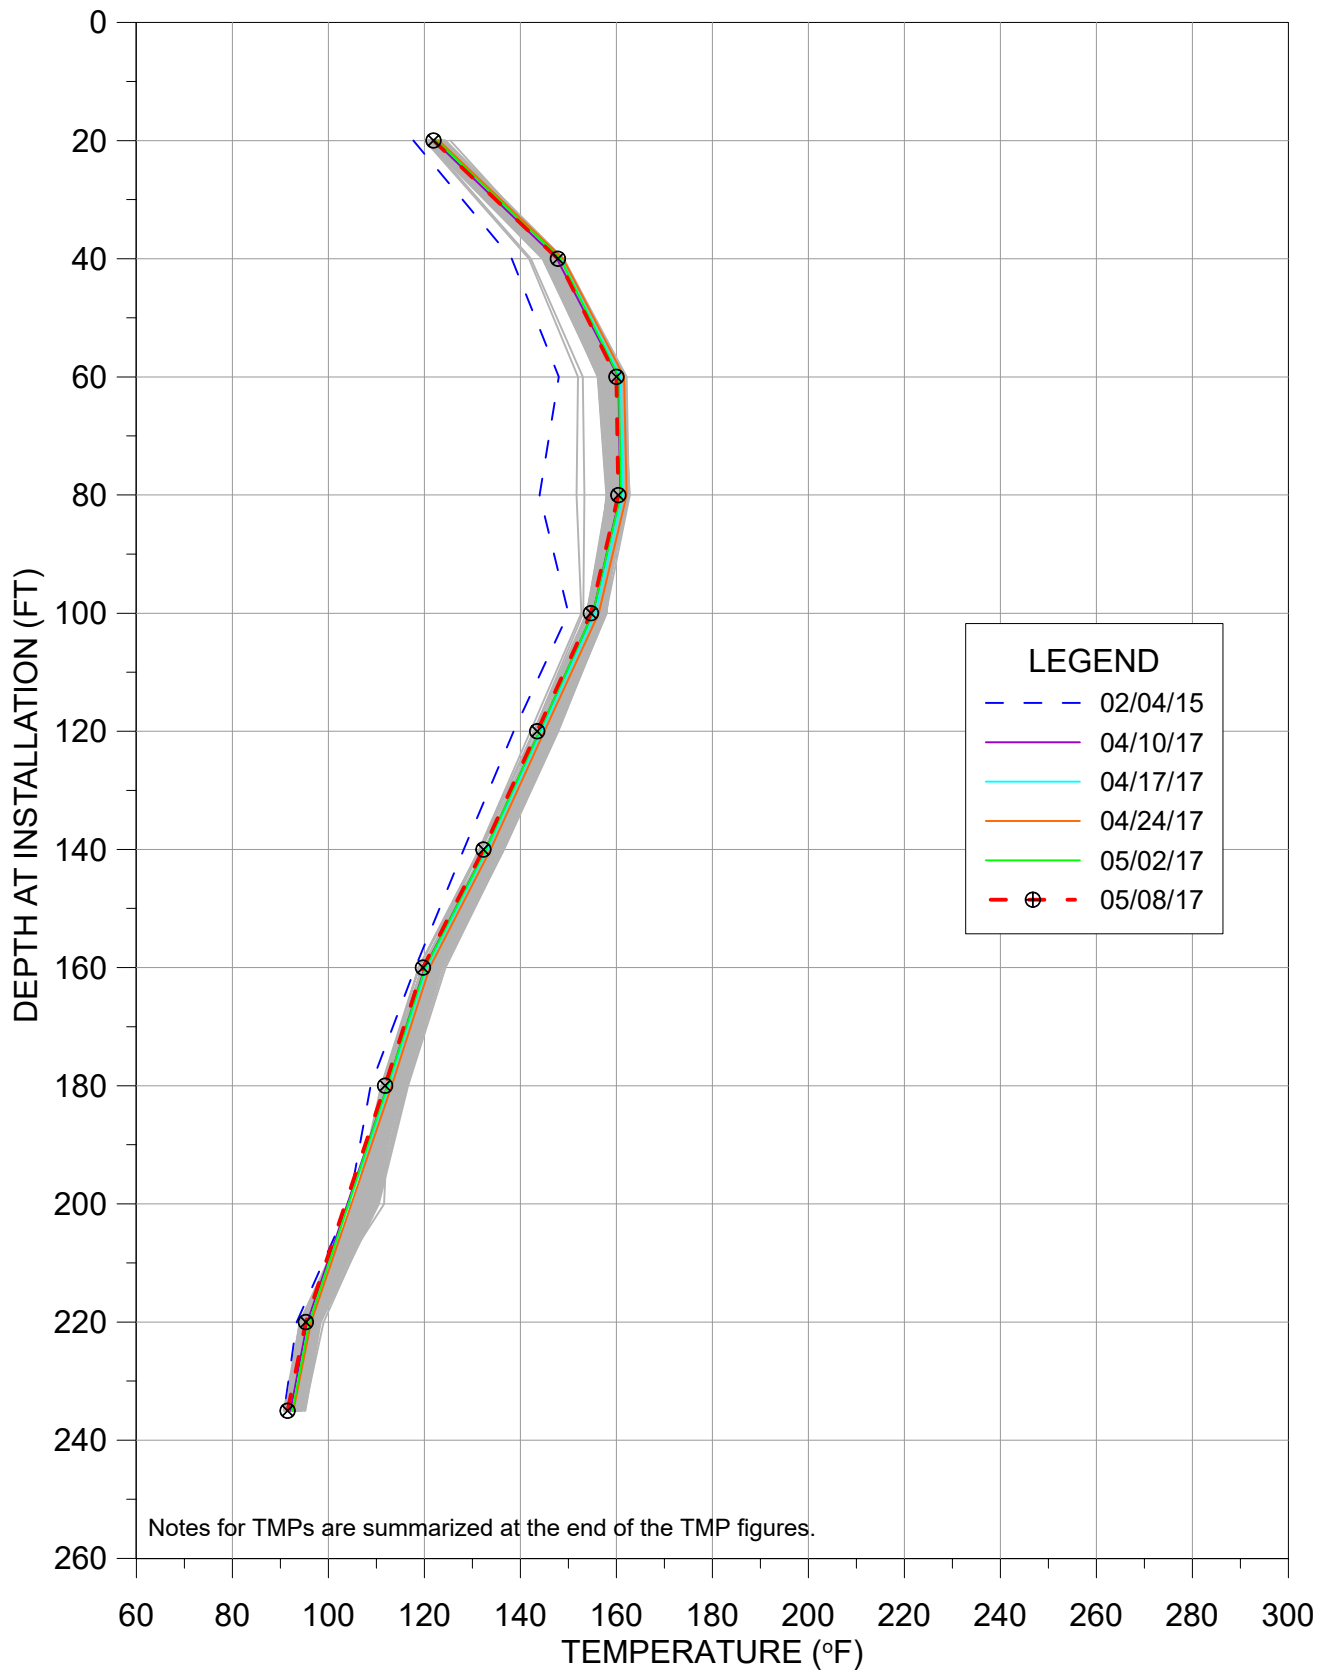
# TMP-25

1. The unit at 200 ft provided an apparent anomalous reading on 3/28/2017. Subsequent readings on 4/4/2017 showed the unit to have failed (see below). The unit is no longer working and the reading of 3/28/2017 was likely unreliable.
2. The unit at 200 ft depth had a resistance reading greater 4000 ohms on 4/4/2017. A connectivity test conducted by Feezor Engineering on 4/7/2017 showed that this unit also had cross-connectivity. The unit is therefore determined to be no longer working as of the 4/4/2017 reading.

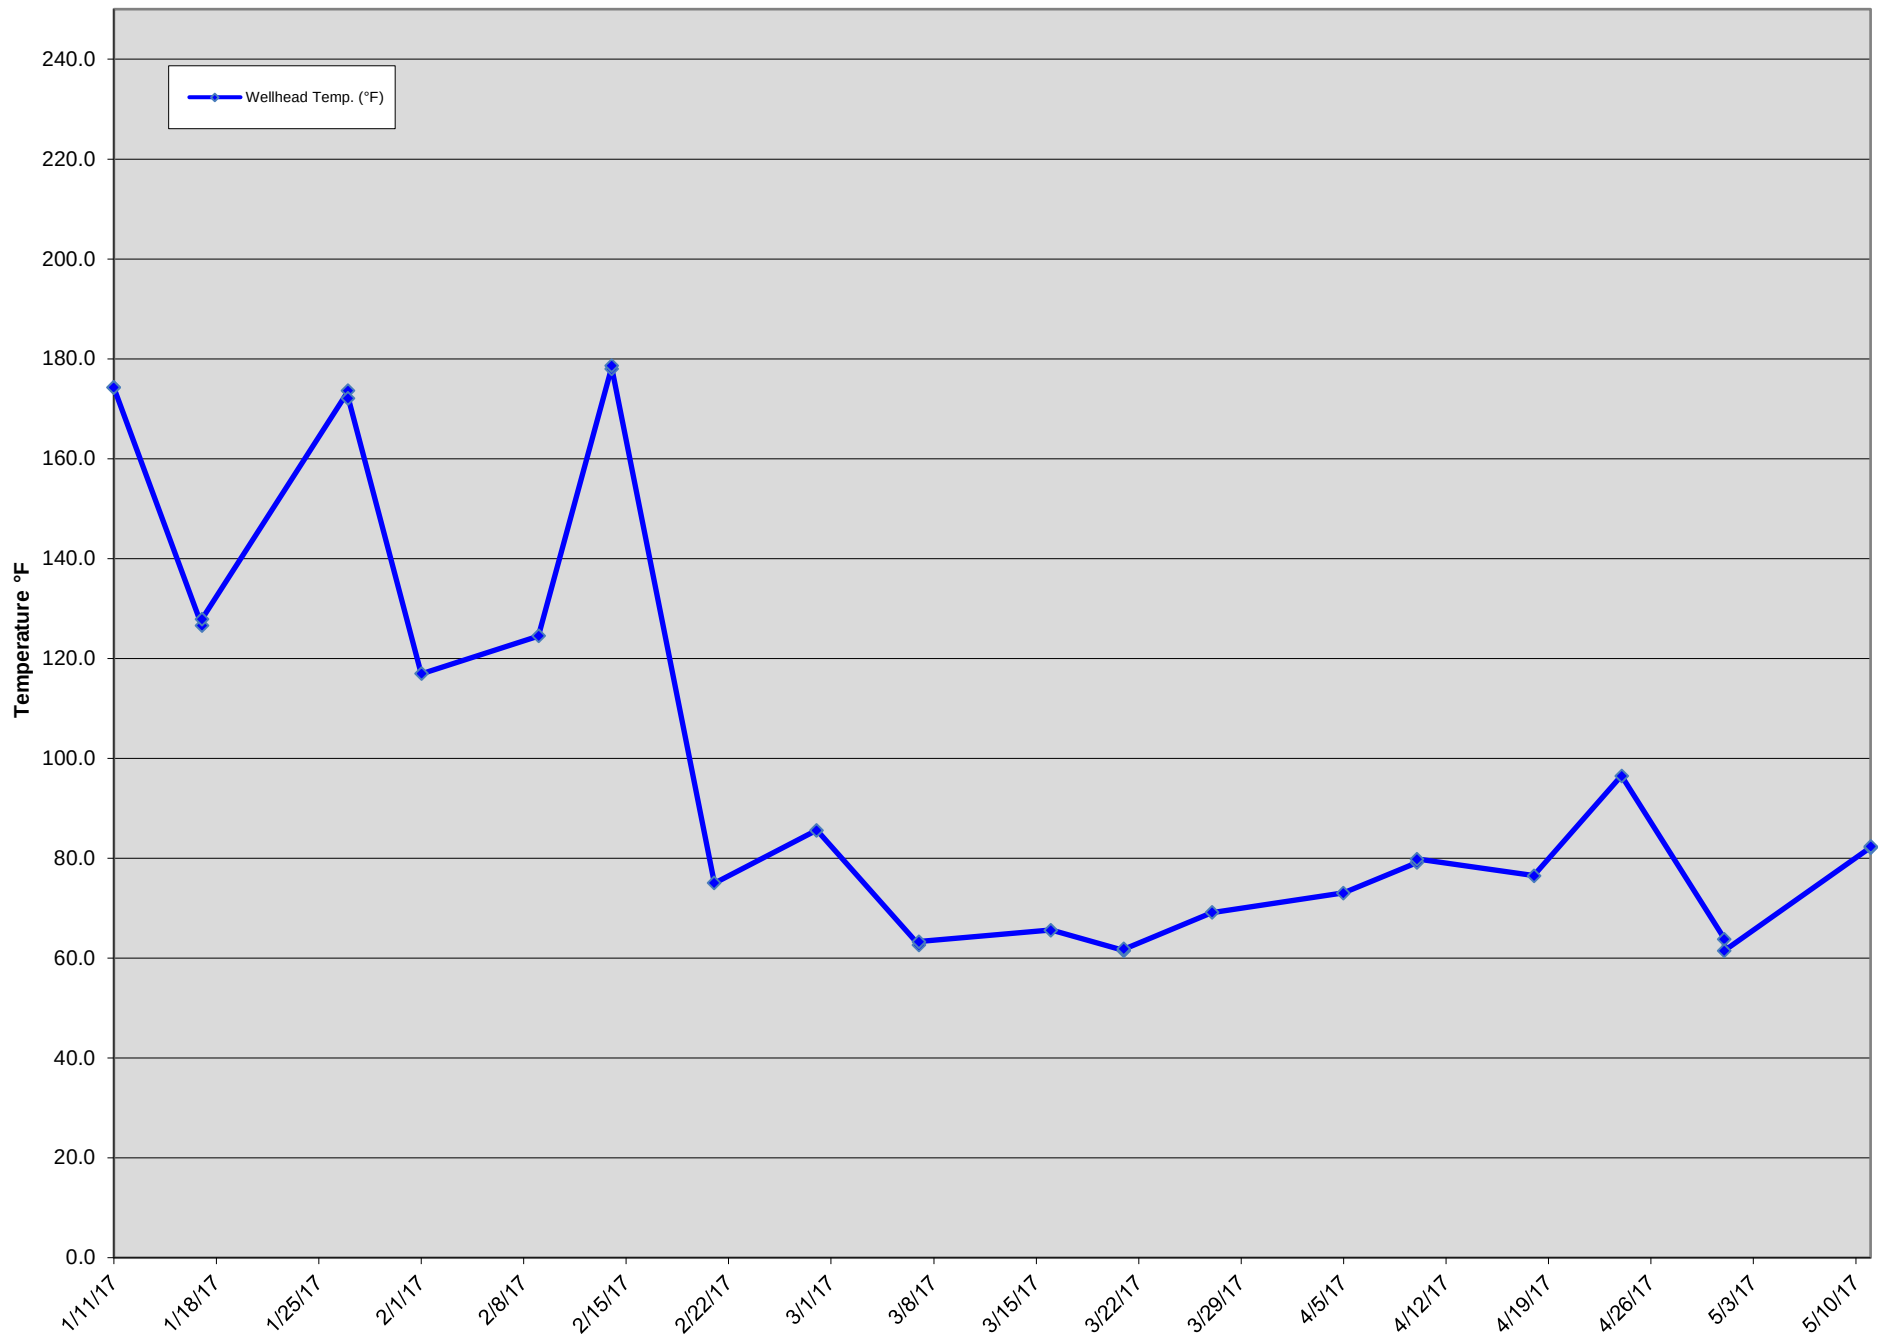
## GIW-1 Wellhead Temperatures

As part of the HES, there are currently cooling water circulation loops installed in twelve Gas Interceptor Wells (GIWs) (GIW-02 through GIW-13). The remaining well (GIW-01) had a measured gas temperature within its historical operating limits.
