# **Bridgeton Landfill, LLC**

## **Weekly Data Submittal**

**Week of May 14, 2017 – May 20, 2017**

**Required by Section 52.F of Agreed Order, Case No. 13SL-CC01088  
Effective May 13, 2013**

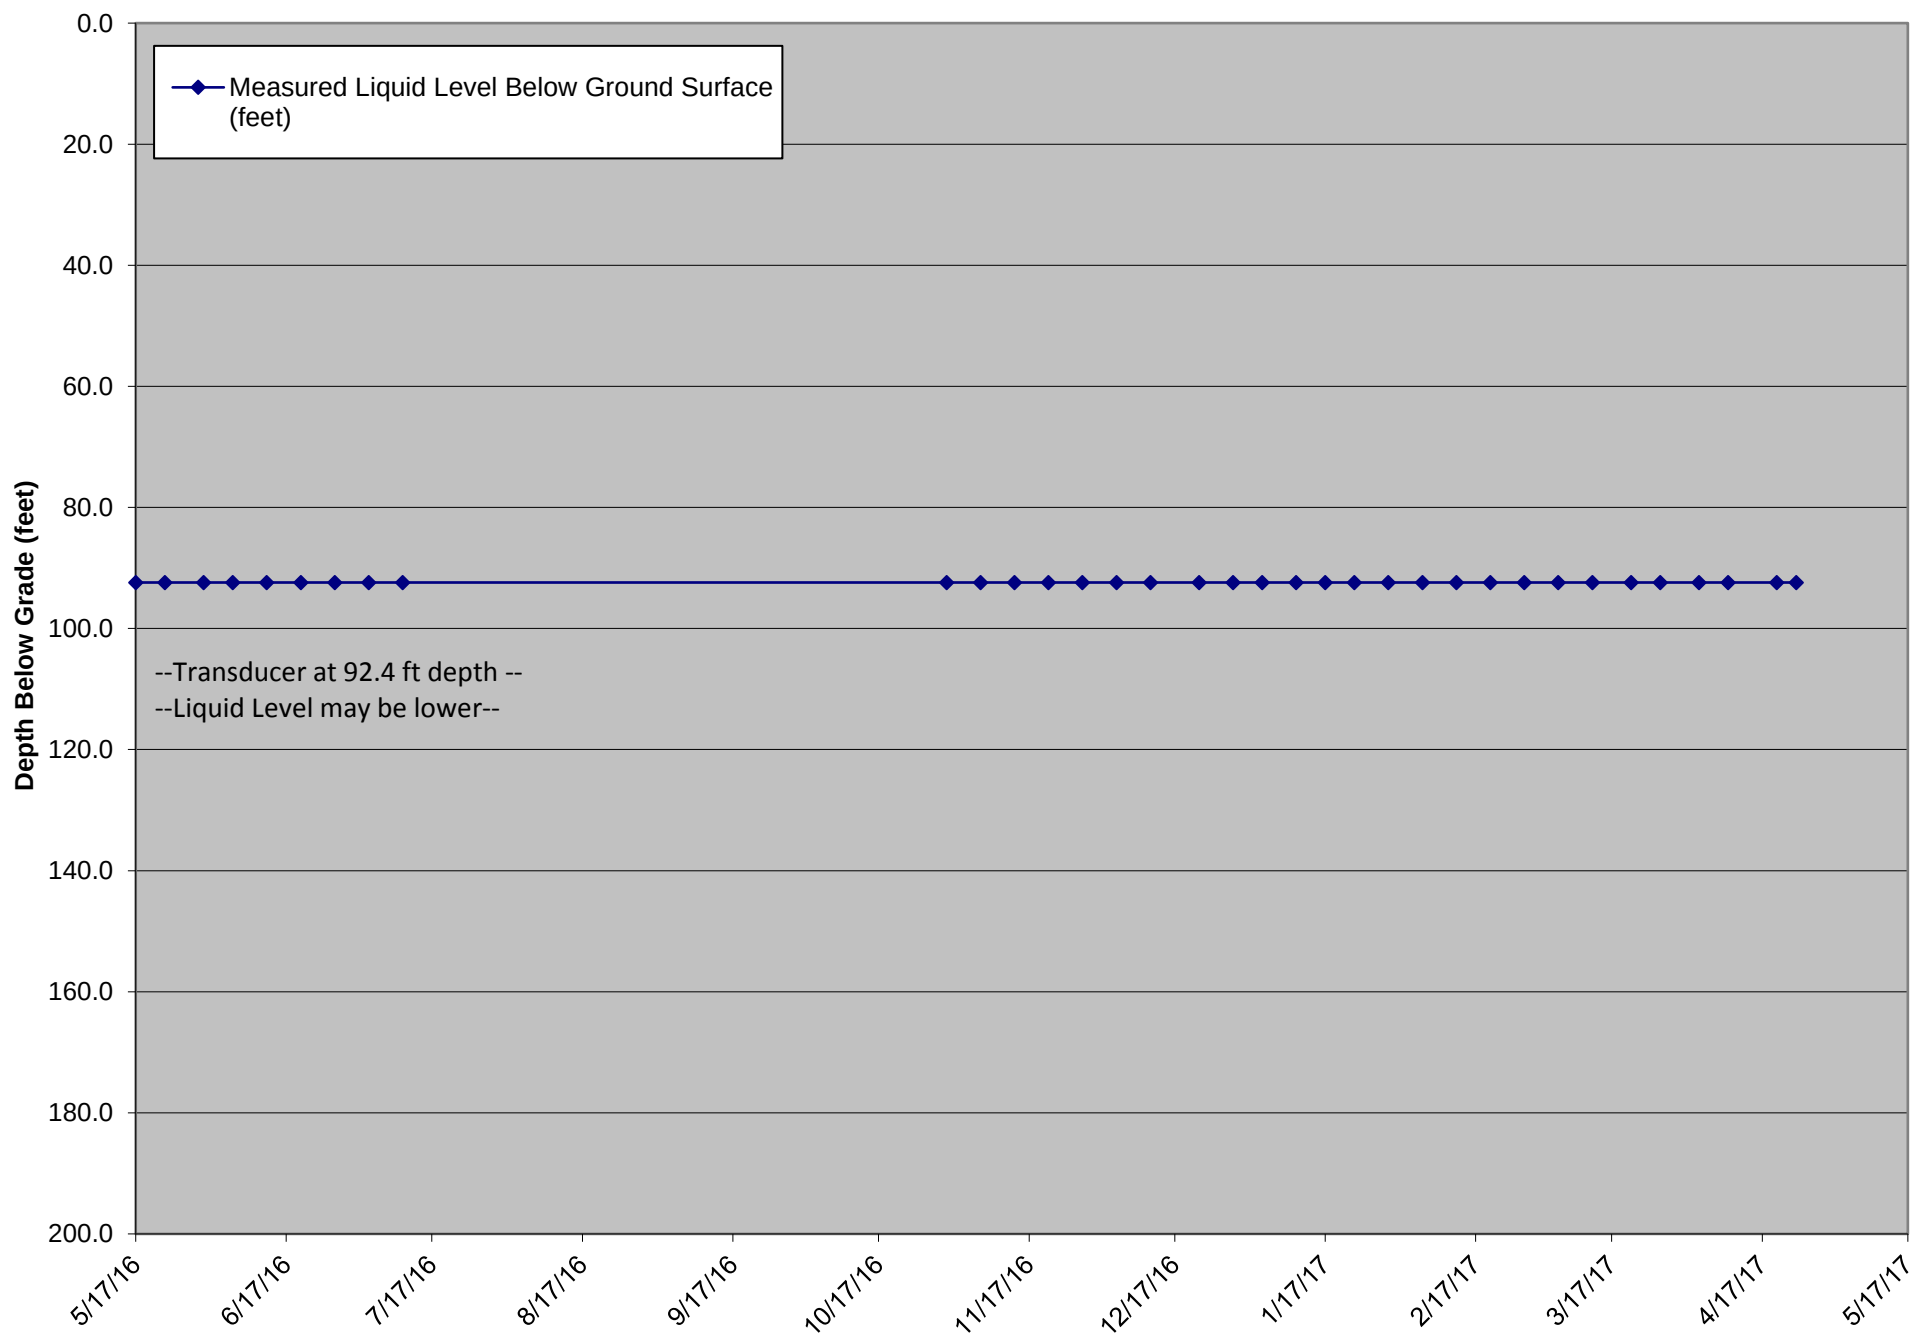
# LCS-1D Liquid Level Below Ground Surface

LCS-1D is equipped with a level sensor and a flow meter. The pump was non-operational during the weekly reporting period due to an electrical issue. Bridgeton Landfill confirmed that the flow meter on LCS-1D is operational and the flow was observed during the weekly reporting period. Liquid level was not recorded by the level sensor during the weekly reporting period. Bridgeton Landfill is tentatively scheduled to replace the level sensor on LCS-1D the week of 5/22/2017 pending contractor availability.

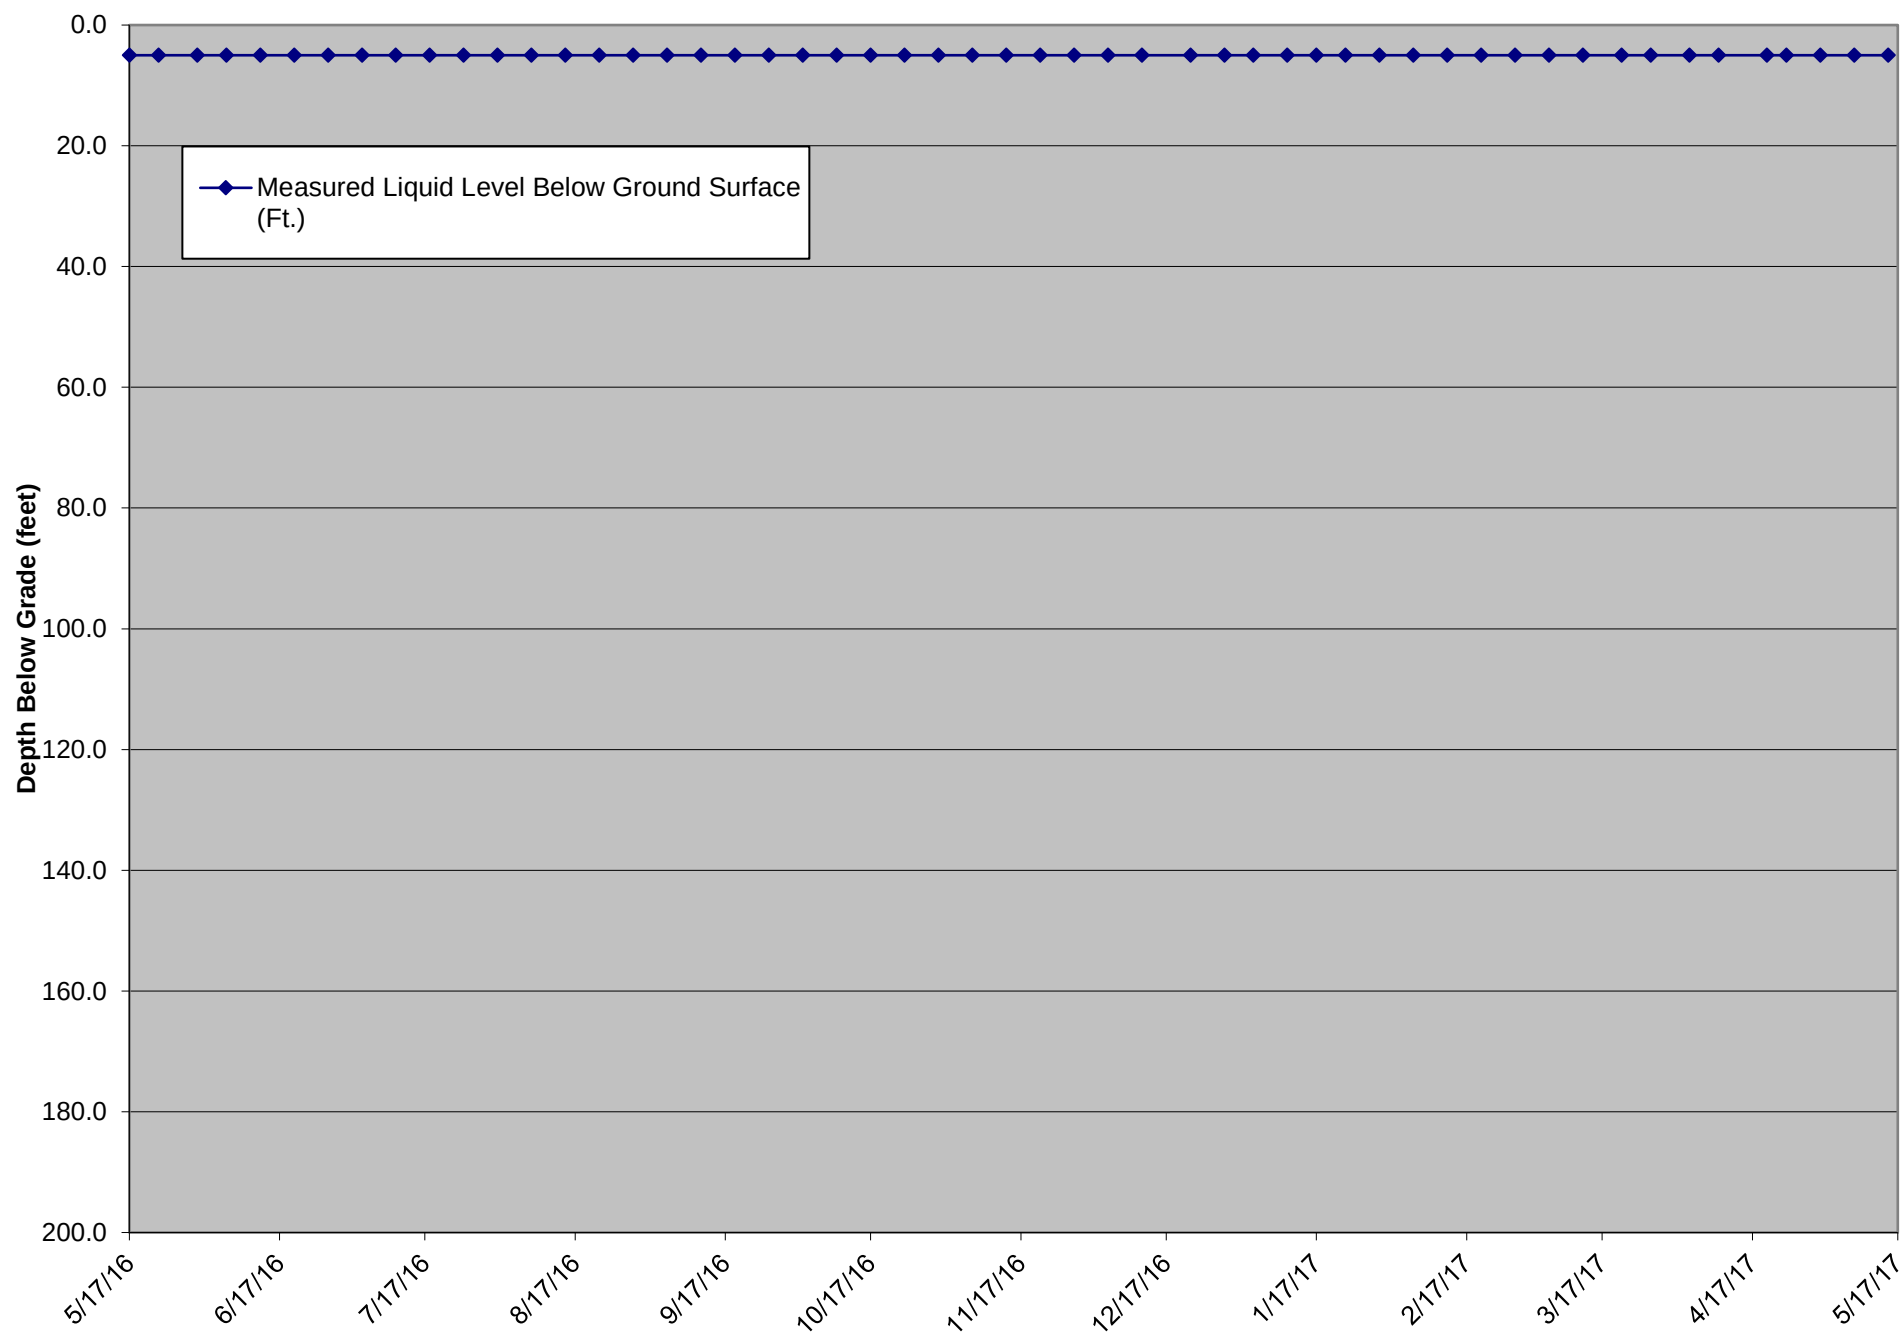
# LCS-3D Liquid Level Below Ground Surface

The pumps in LCS-2D and LCS-3D were non-operational during the weekly reporting period. The transducer in LCS-3D continued to report liquid levels. Flow was observed on the LCS-3D flow meter during the weekly reporting period. The pump and transducer in LCS-3D is tentatively scheduled to be replaced during the week of 5/22/2017 pending contractor availability.

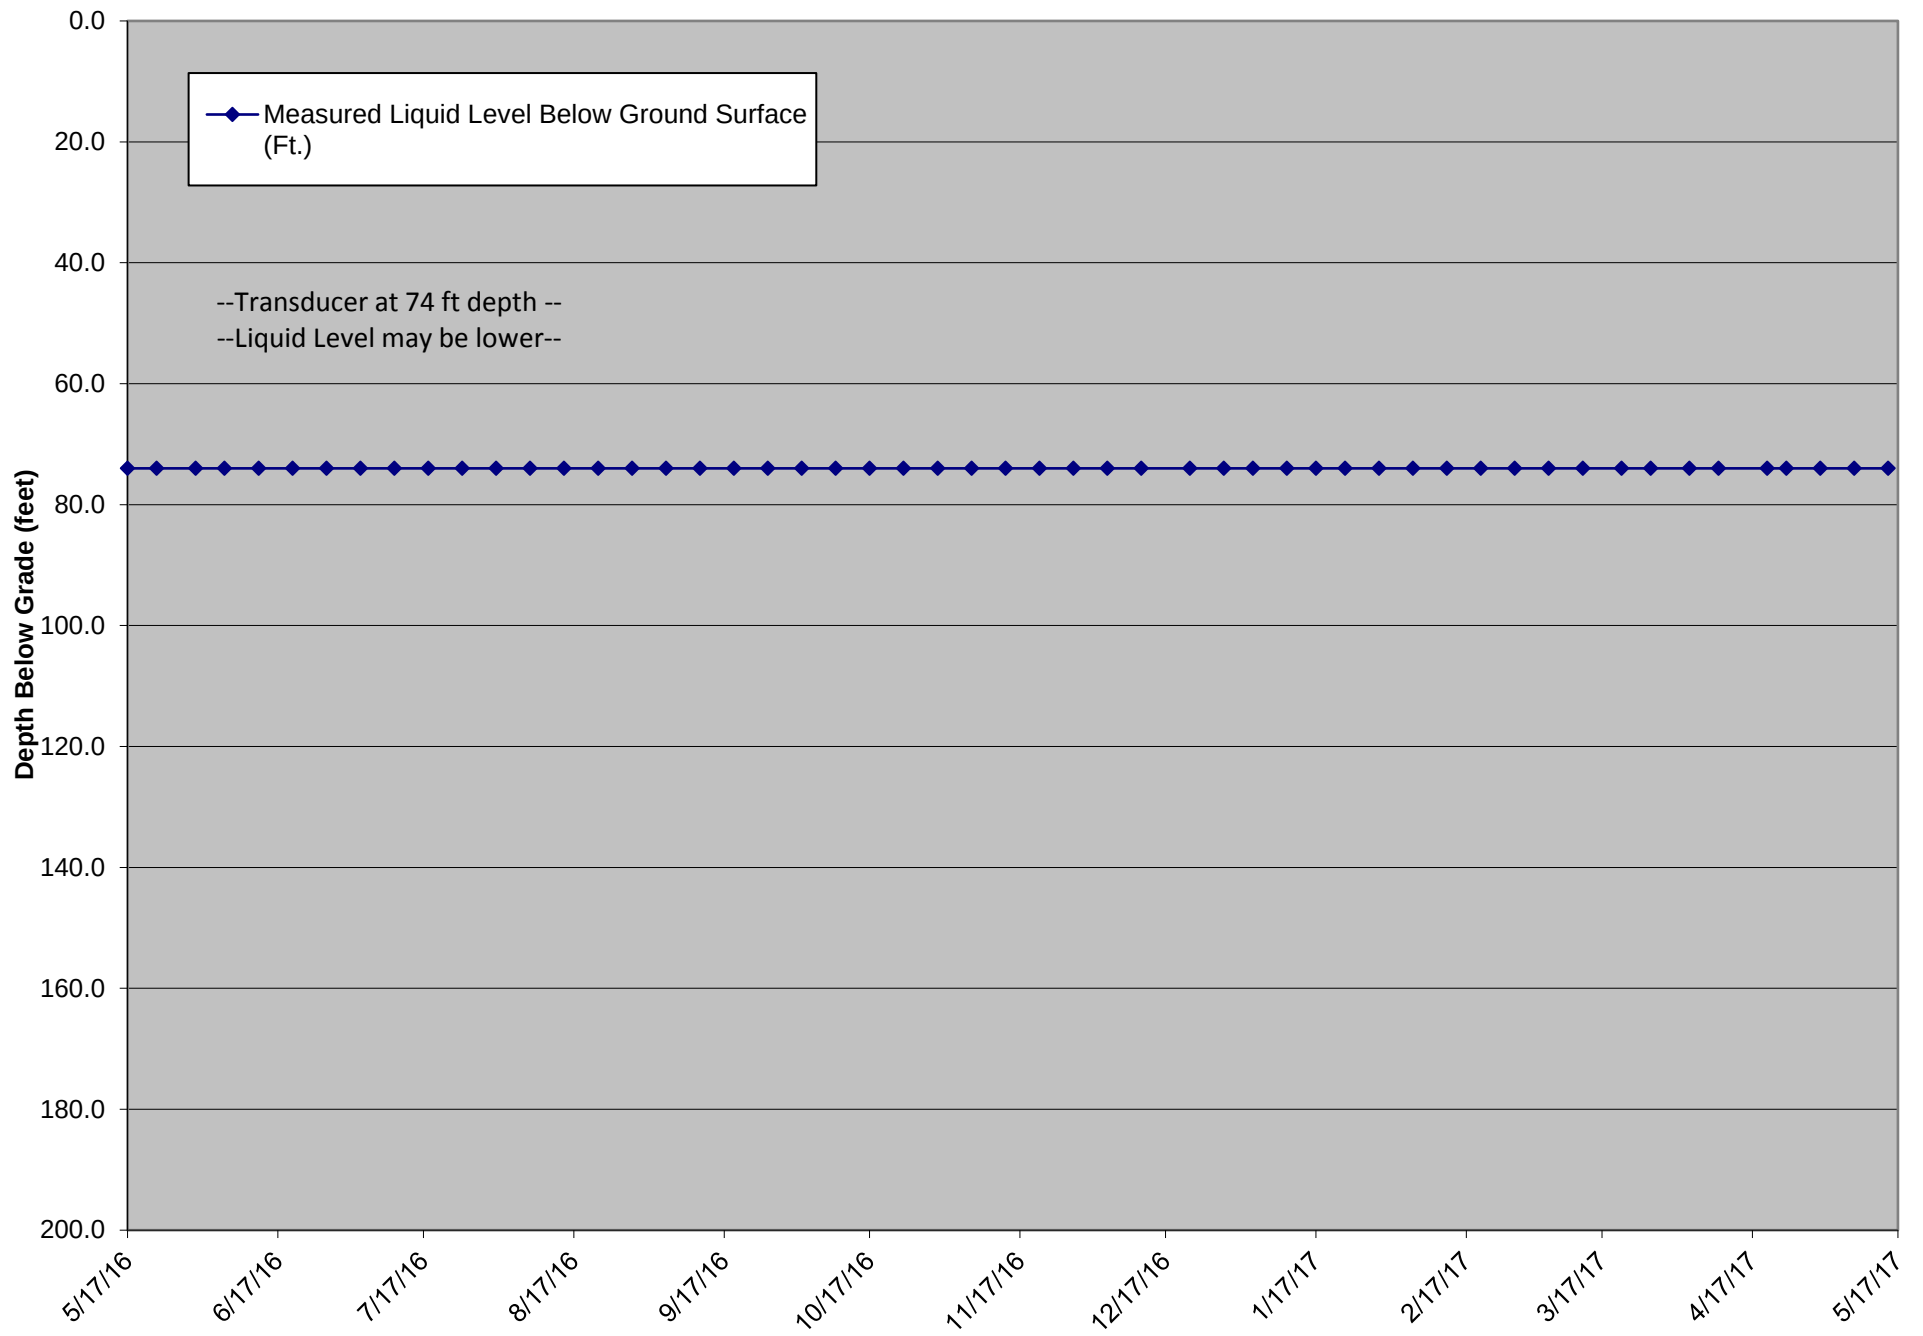
# LCS-4B Liquid Level Below Ground Surface

The level sensor in LCS-4B is currently operational and responsive. Liquid level was not recorded by the level sensor during the weekly reporting period. LCS-4B is equipped with a flow meter that displayed no flow during the weekly reporting period. Therefore, it can be concluded that the liquid level was below the bottom of the pump and level sensor in LCS-4B.

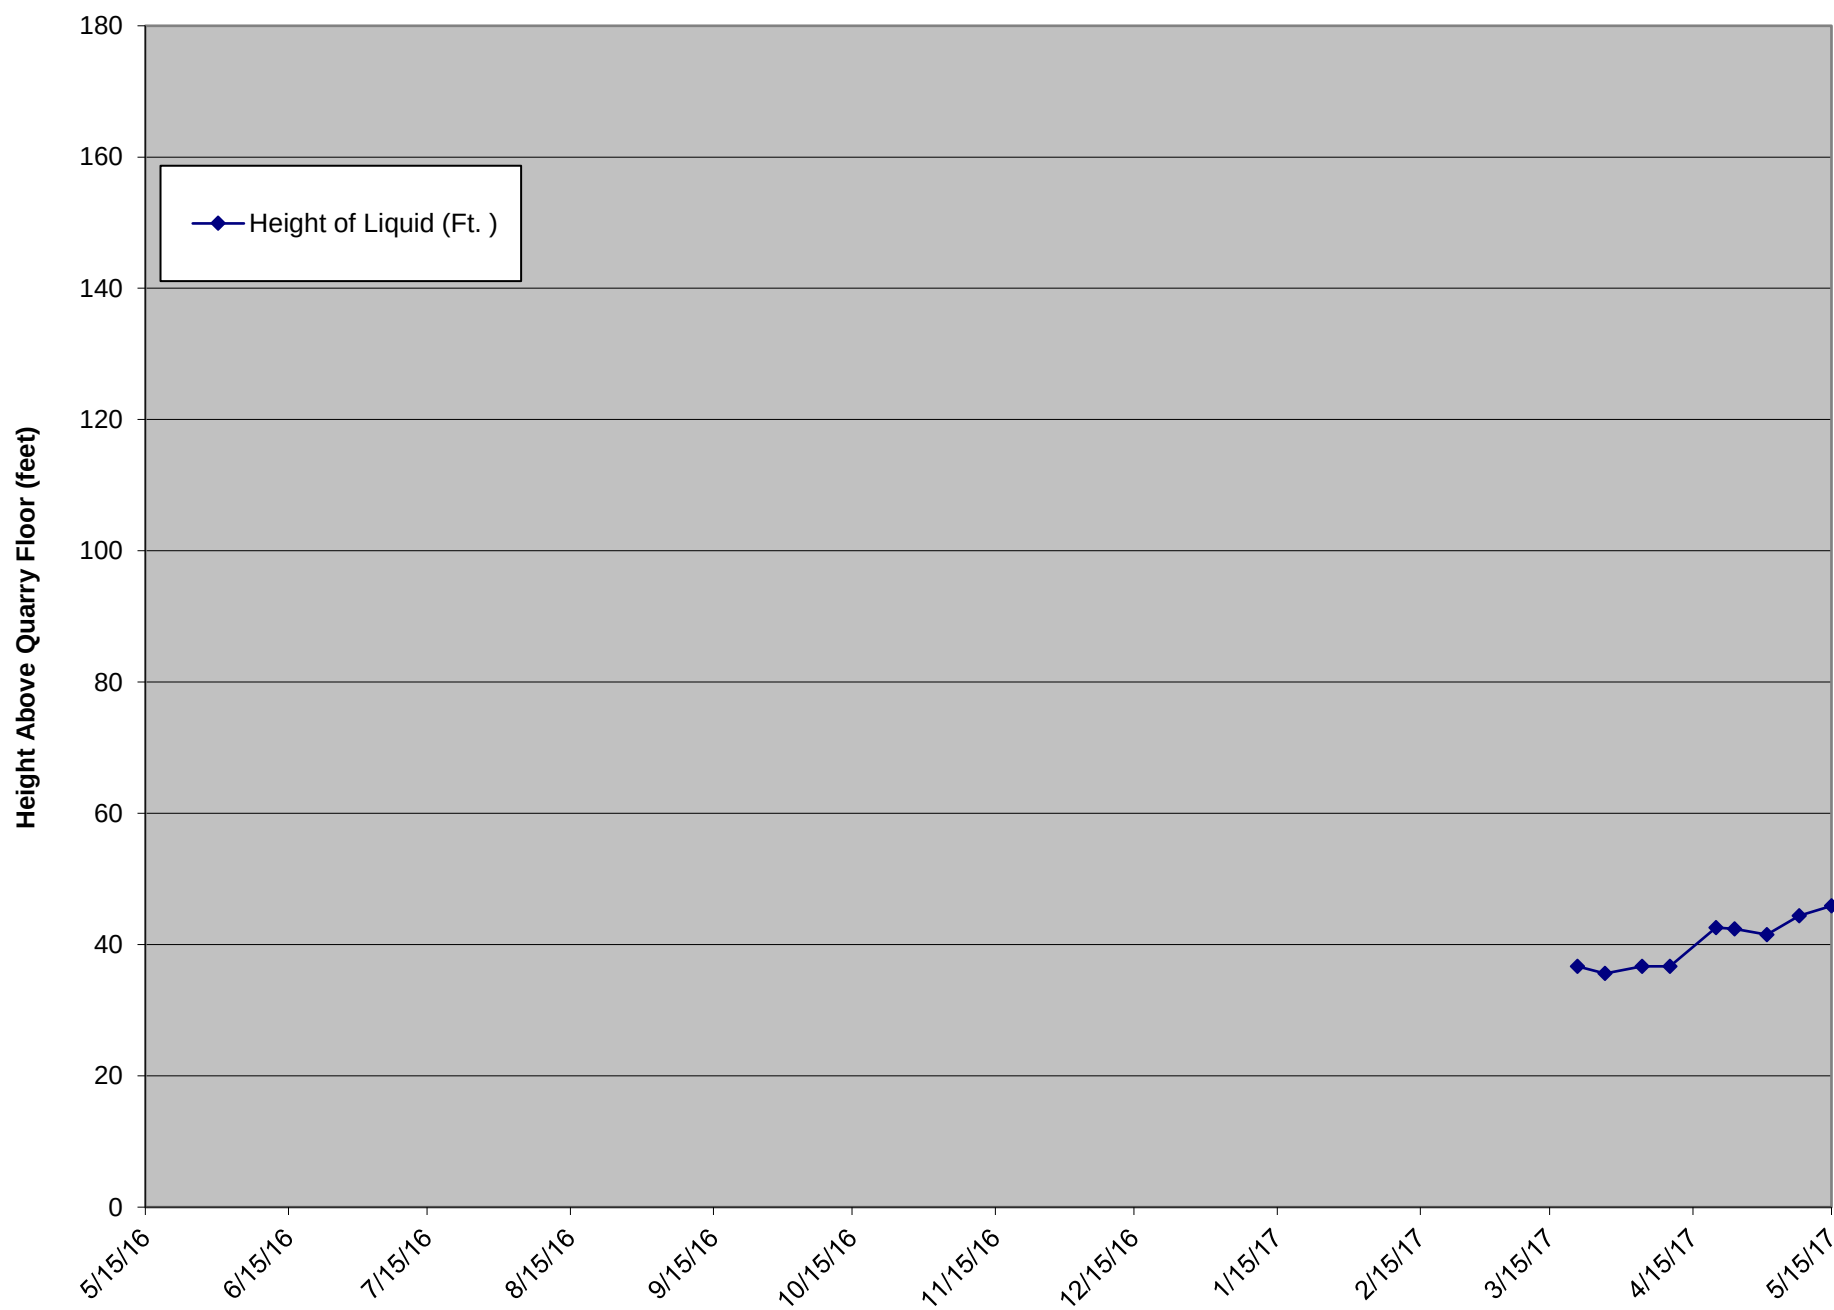
LCS-5B Liquid Level Above Quarry Floor

LCS-5B and LCS-6B were fully operational during the weekly reporting period.

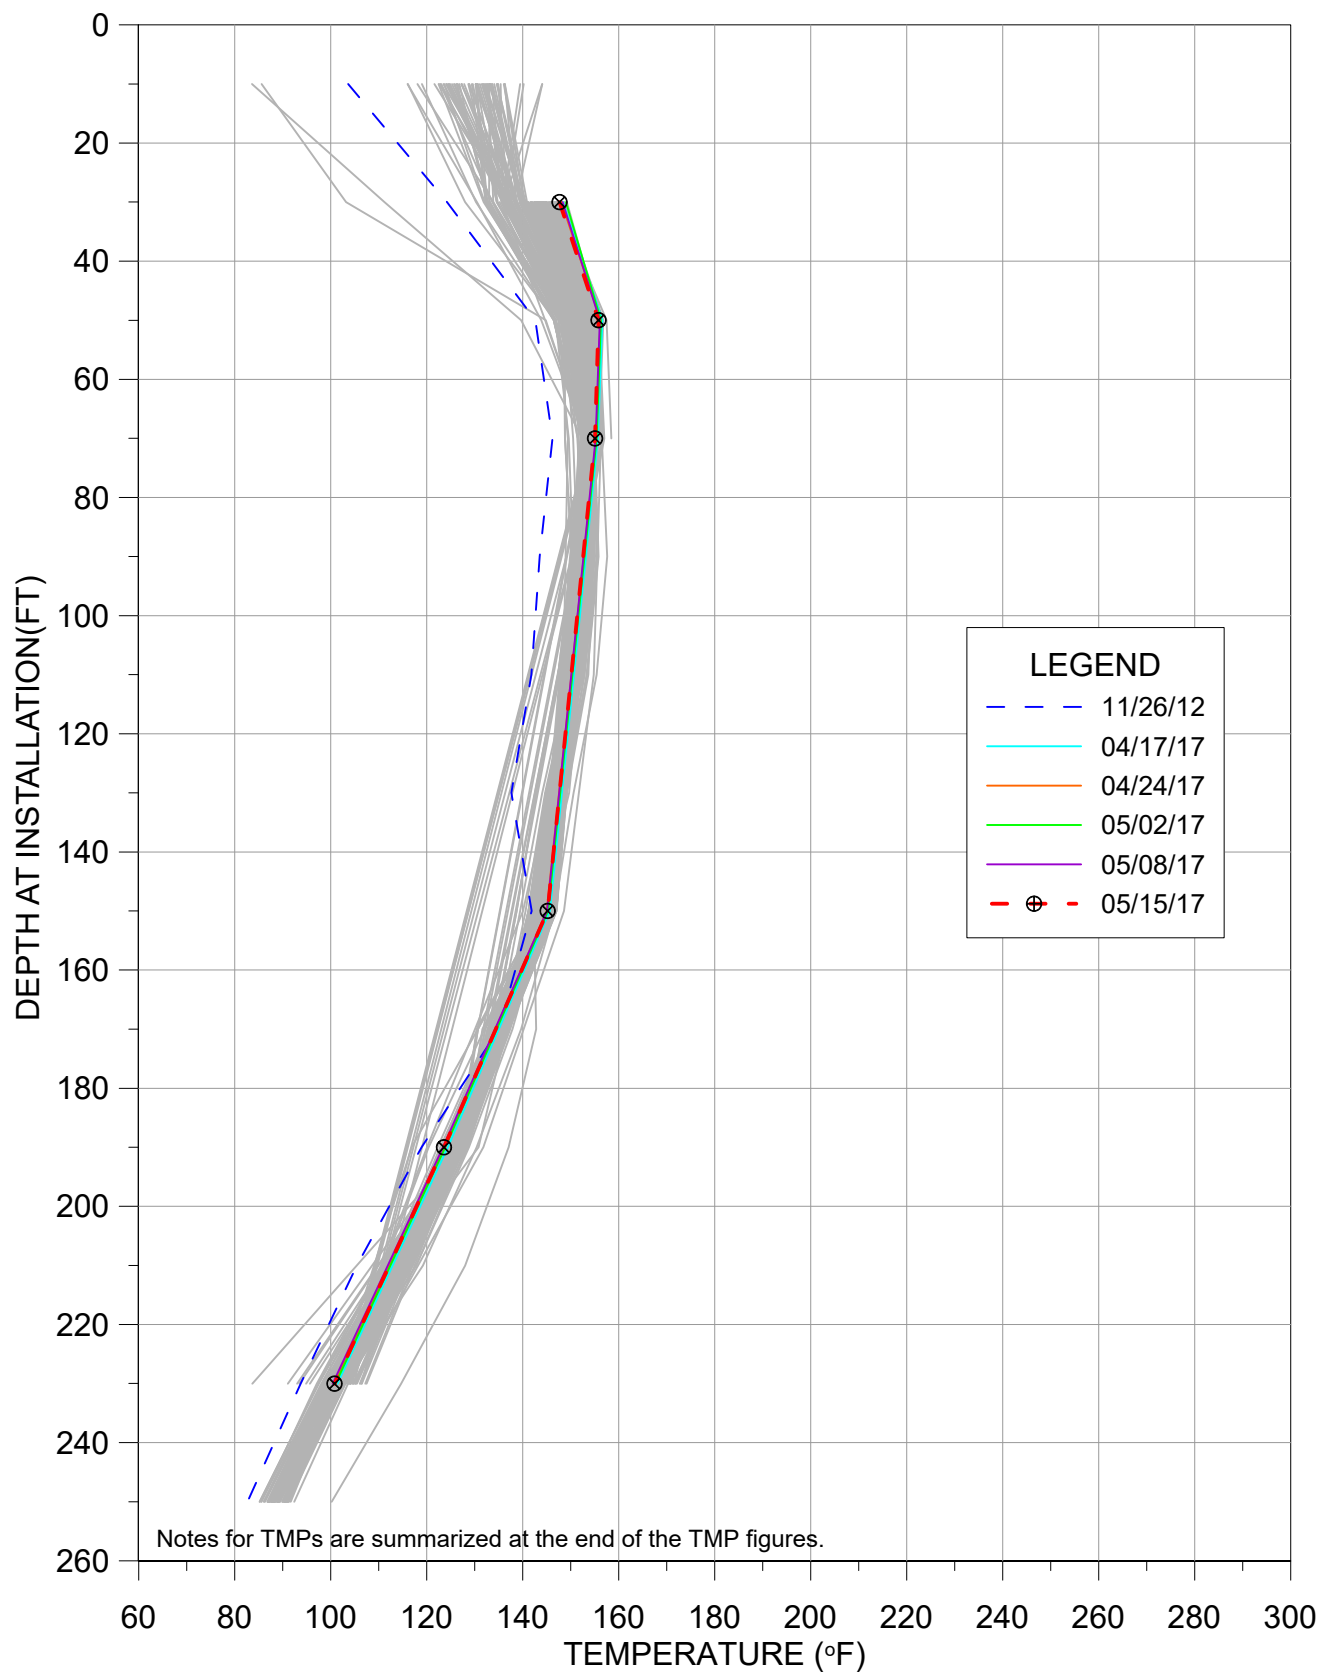
# TMP-3

1. No reliable temperature readings have been obtained at 170 ft depth since 1/29/2014, except on 3/13/2014.
2. The connectivity tests on 4/11/2014 conducted by CEC showed that units at 10, 90, 130, 210 and 250 ft depths are no longer reliable.
3. The connectivity tests on 10/28/2014 conducted by Feezor Engineering showed that units at 10, 90, 110, 130, 210 and 250 ft depths are not reliable.

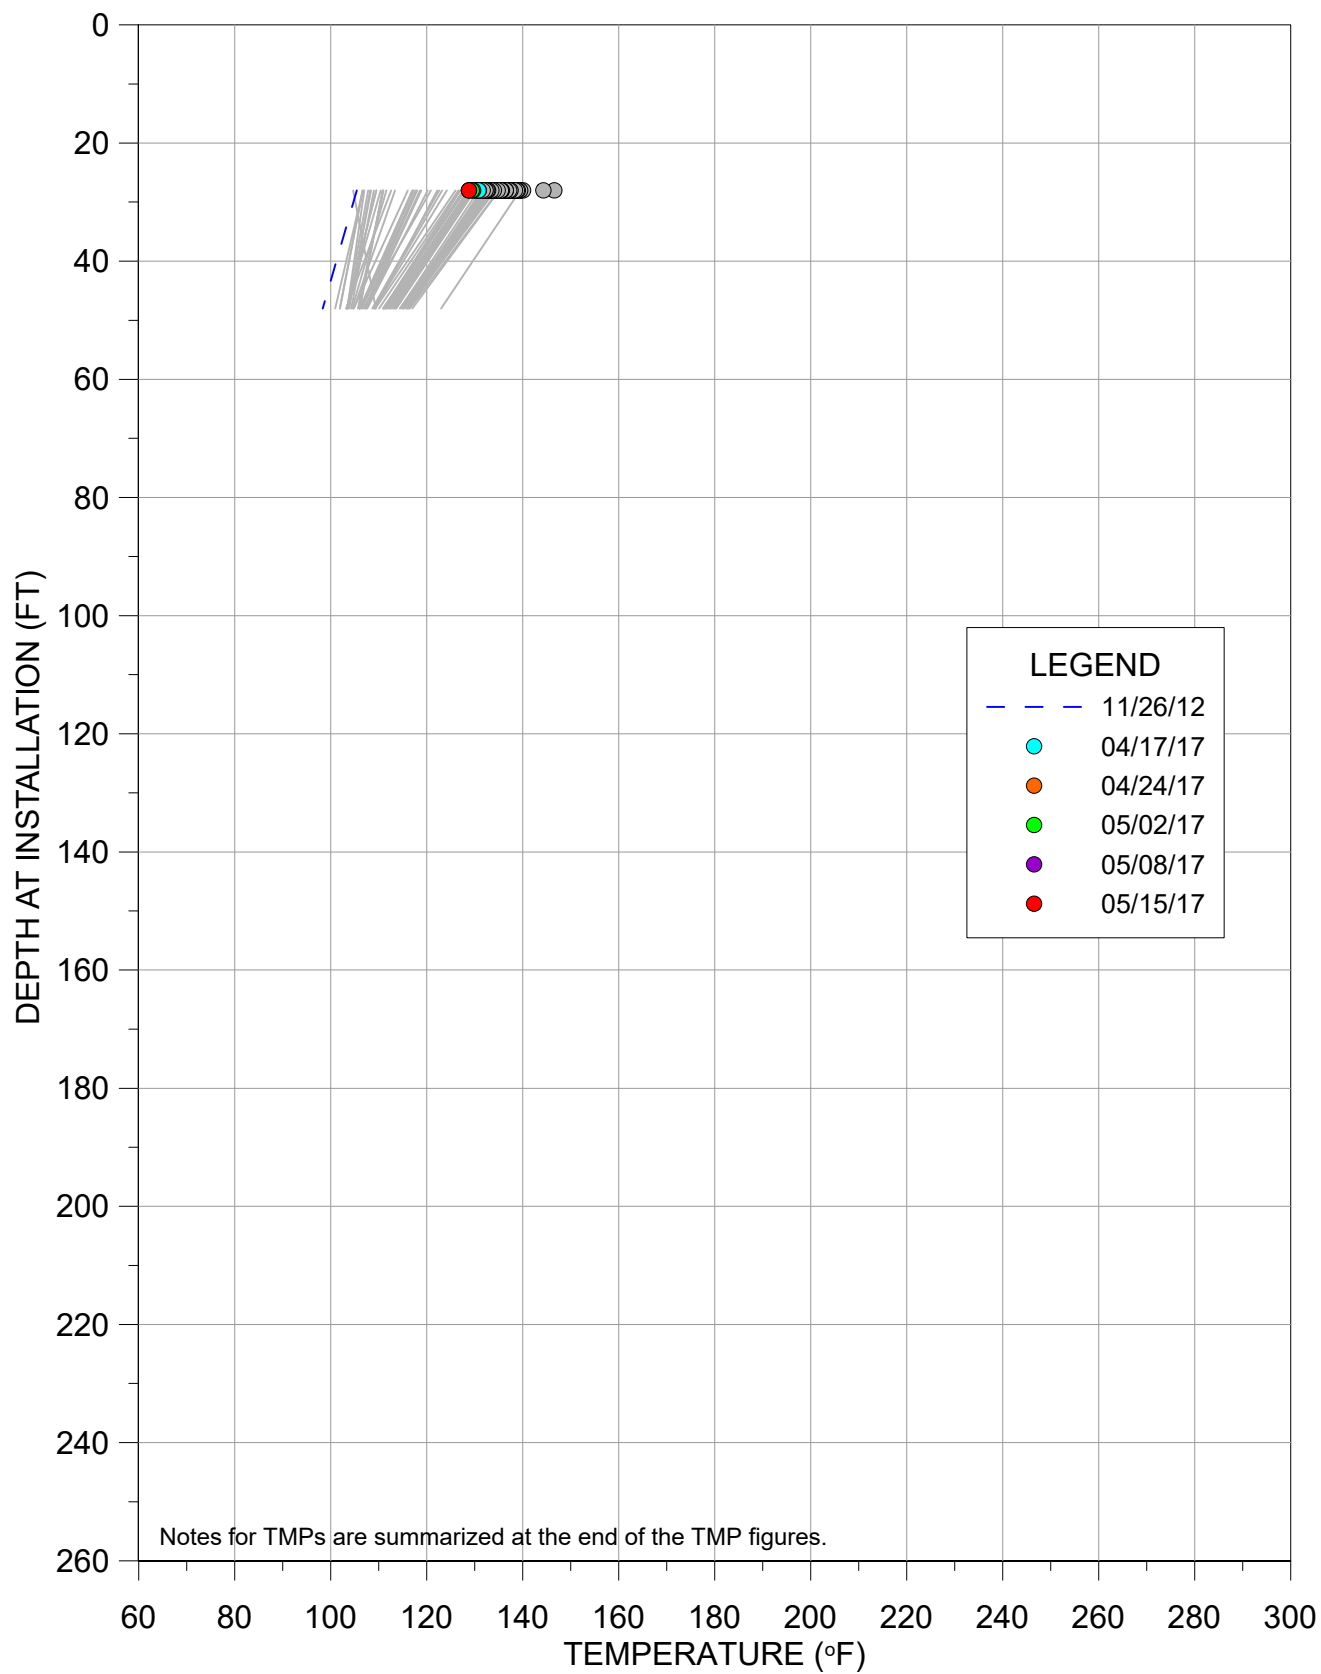
# TMP-4

1. The connectivity tests on 4/11/2014 conducted by CEC showed that the unit at 48 ft depth is no longer reliable.

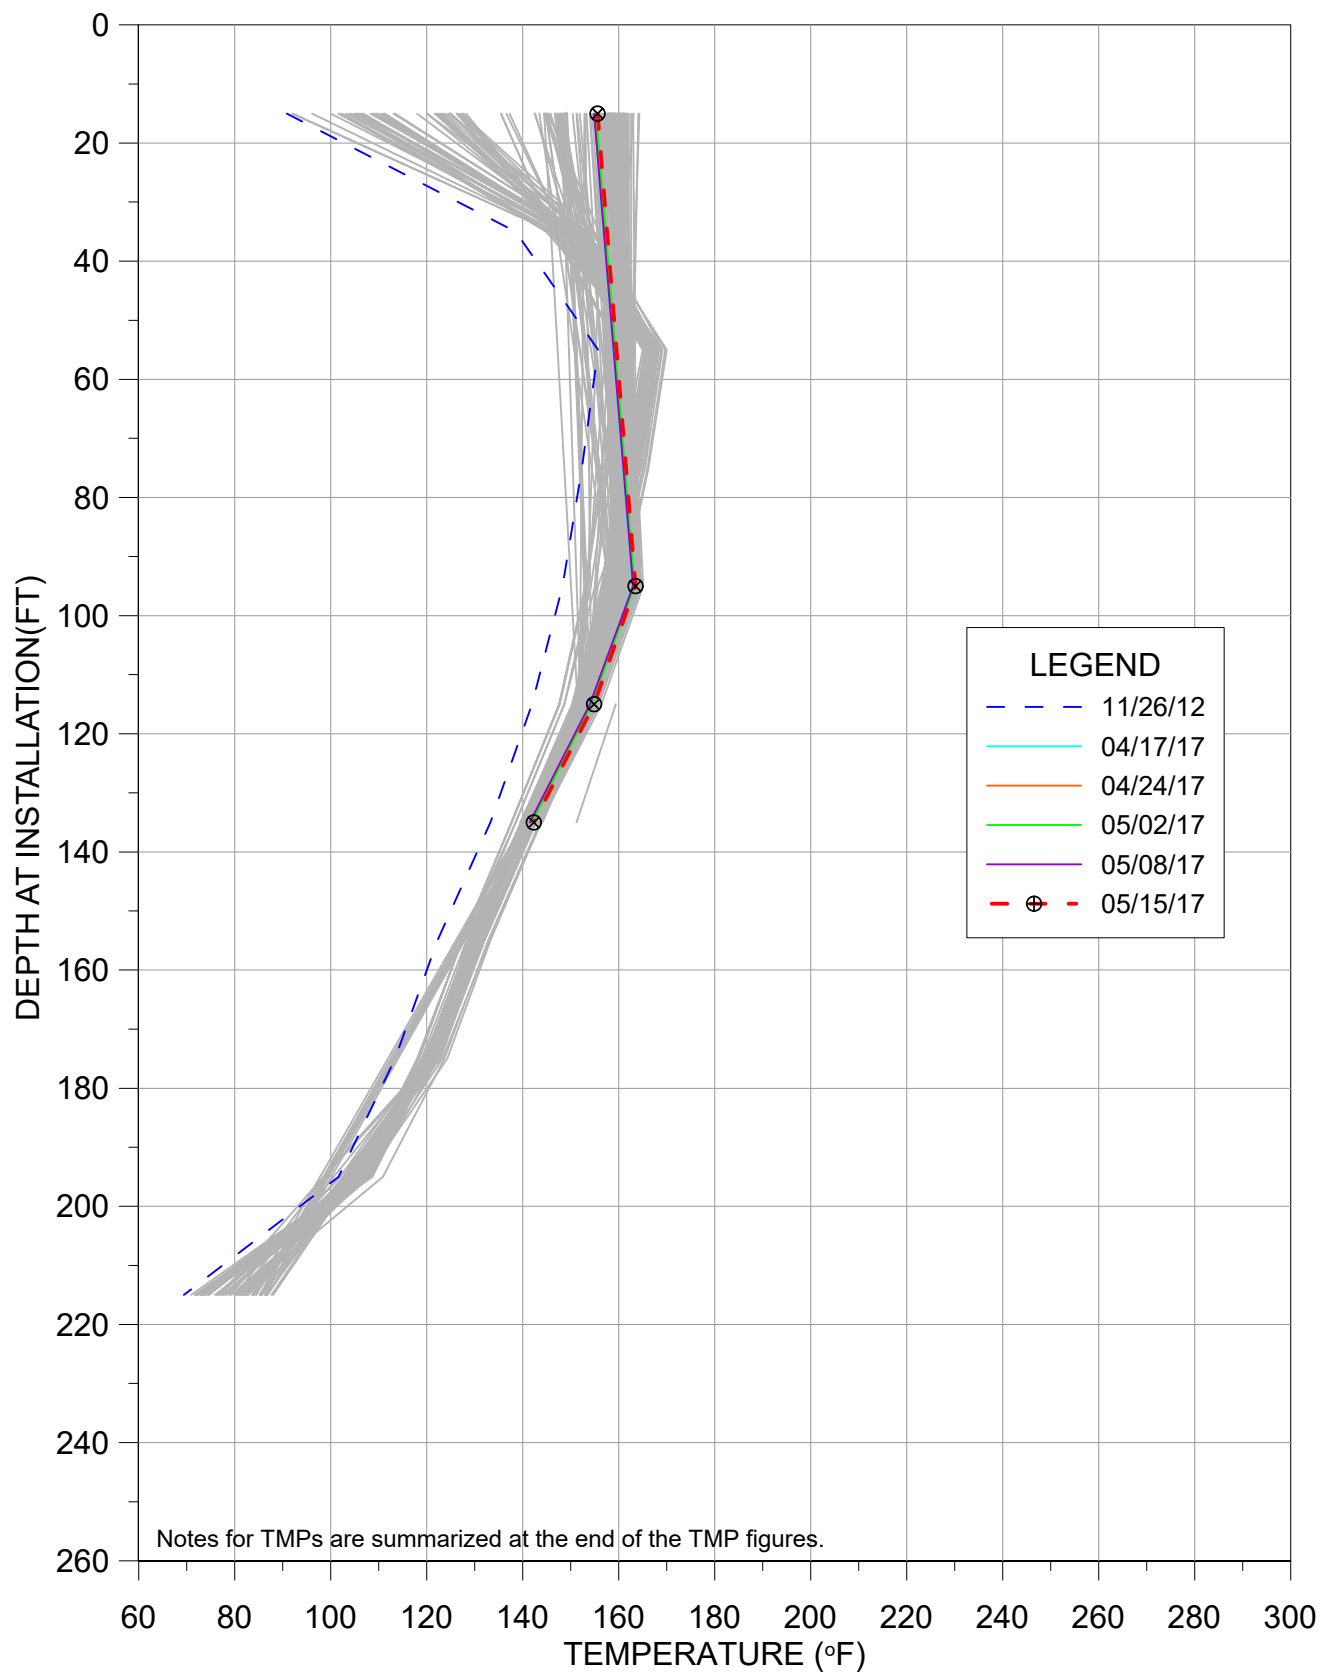
# TMP-6

1. The connectivity tests on 4/11/2014 conducted by CEC showed that units at 35, 55, 75, 155, 175, and 195 ft depths are no longer reliable.
2. No reliable temperature readings have been obtained at the unit at 215 ft depth since 6/13/2014.

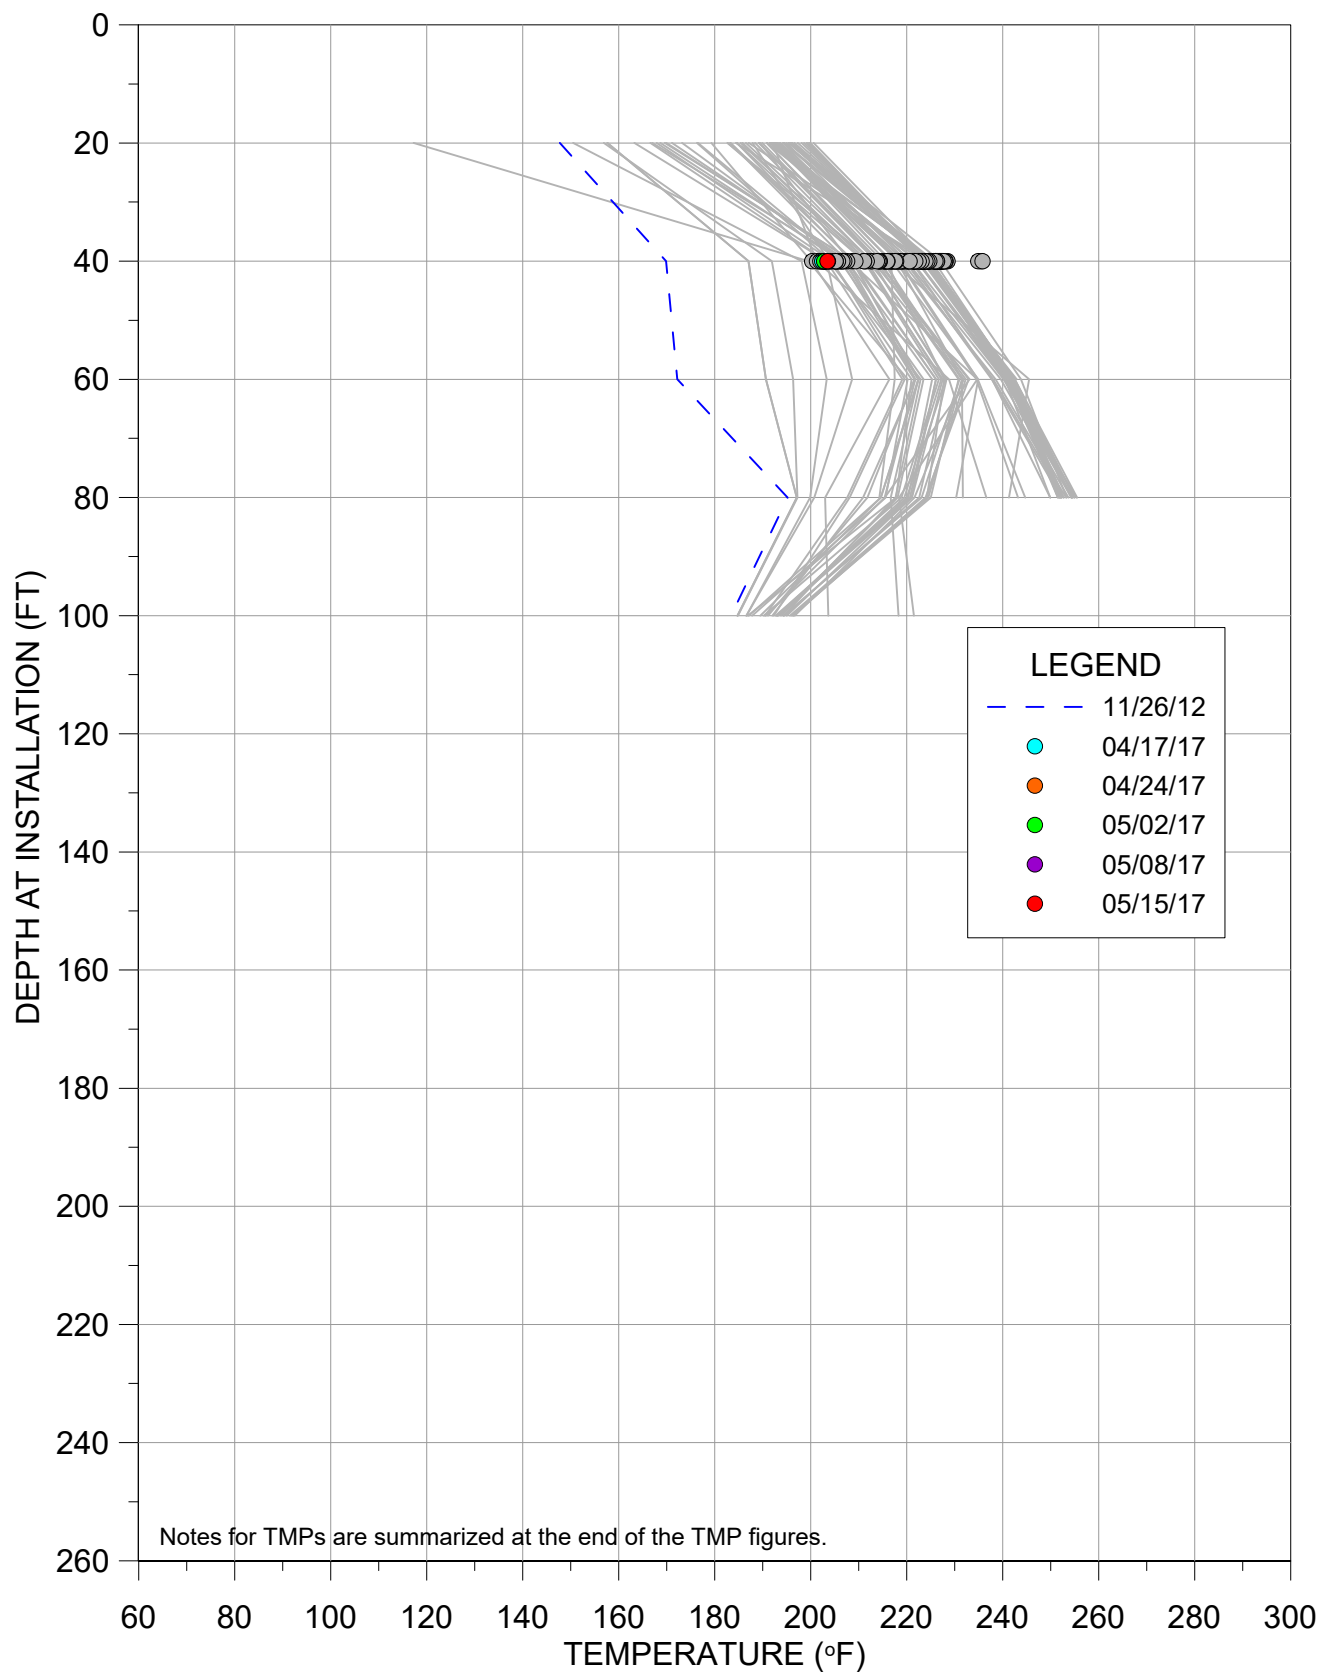
# TMP-9

1. Unit at 100 ft depth had an inaccurate temperature reading on 8/1/2013 and no reading since 8/6/2013.
2. The connectivity tests on 4/11/2014 conducted by CEC showed that units at 20, 60, 80, and 100 ft depths are no longer reliable.

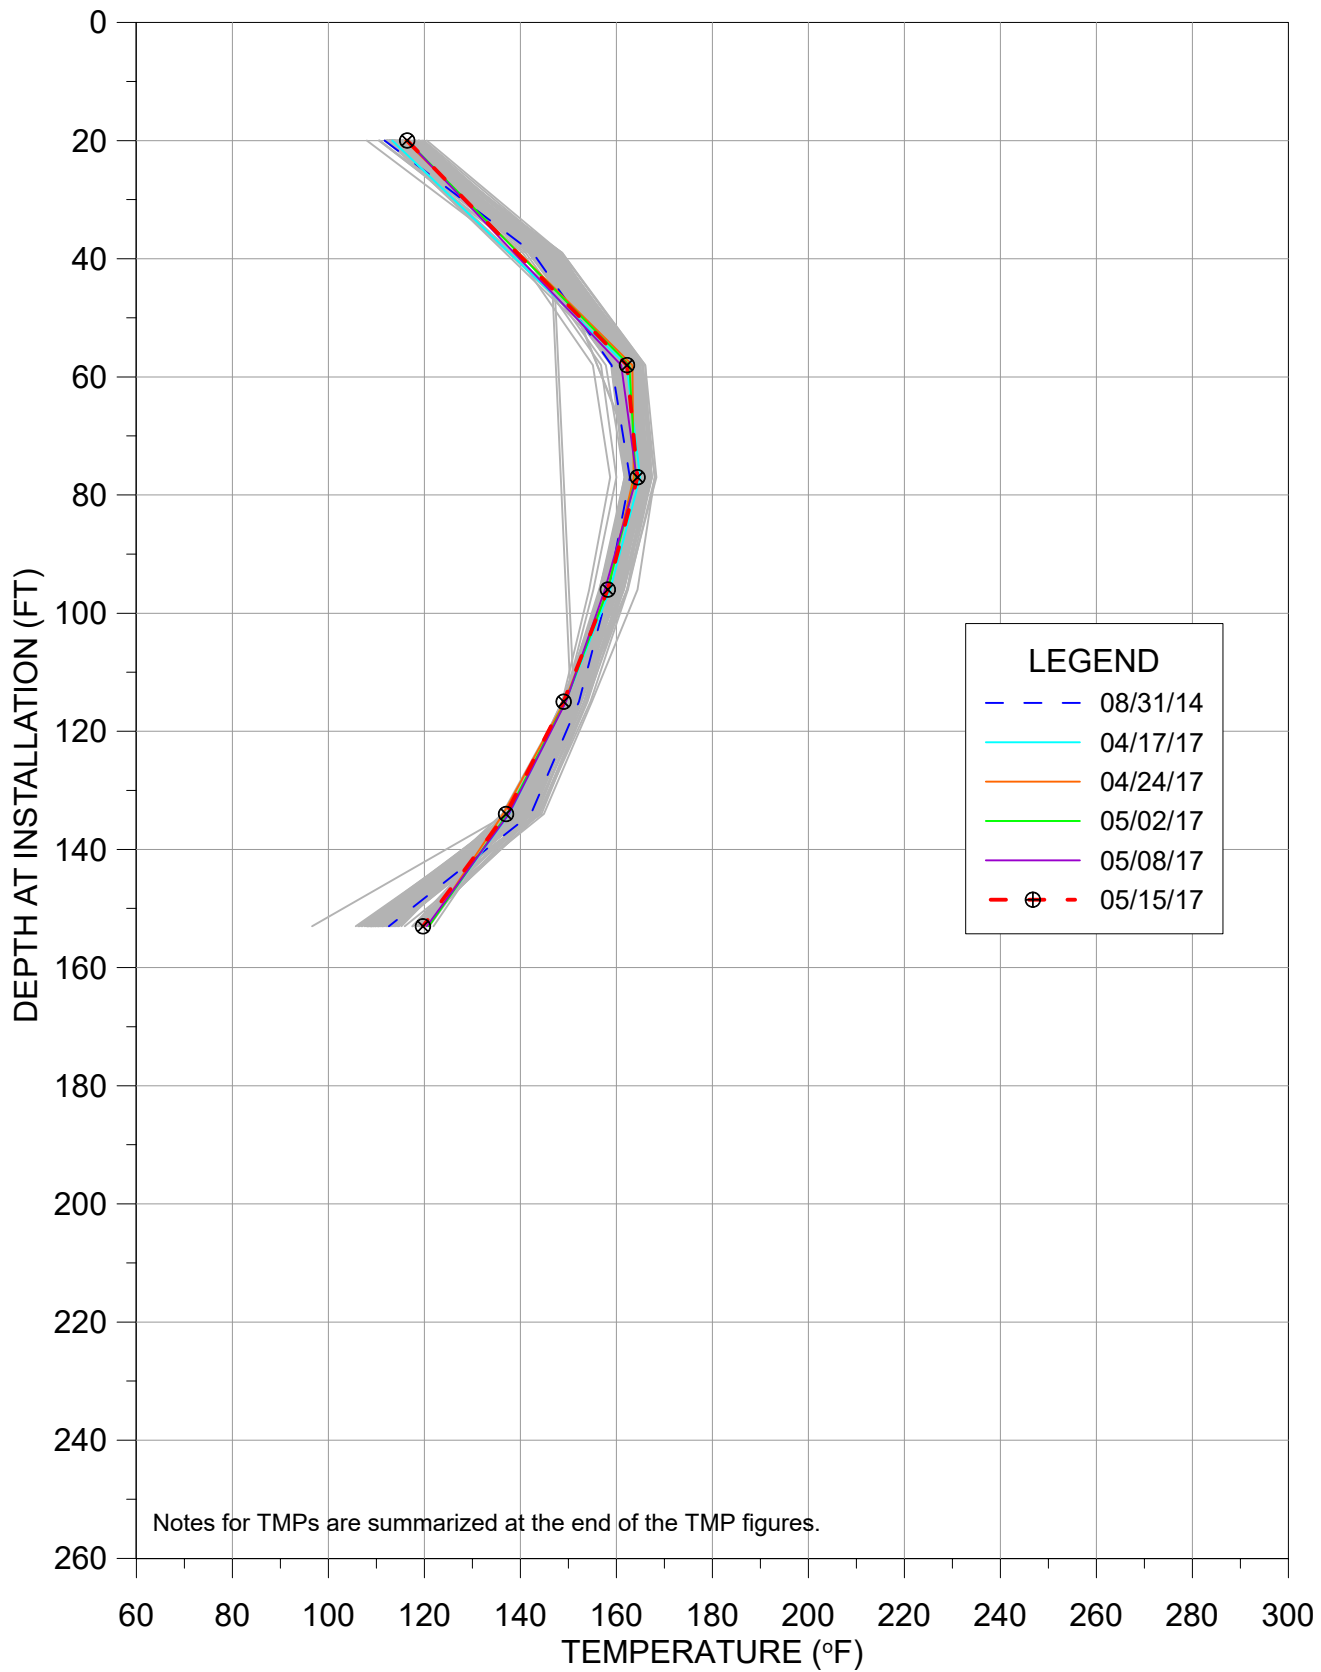
# TMP-16

1. A connectivity test conducted by Feezor Engineering showed that the units on TMP-16 may not be reliable since 9/9/2015. Further testing at the end of September 2015 showed possible connectivity on some of the units.
2. The unit at 153 ft depth had a low resistance reading and unreliable temperature since 12/21/2015.

3. The unit at 39 ft depth had a higher than acceptable resistance reading and unreliable temperature since 2/7/2017.
