# **Bridgeton Landfill, LLC**

## **Weekly Data Submittal**

**Week of May 14, 2017 – May 20, 2017**

**Required by Section 52.F of Agreed Order, Case No. 13SL-CC01088  
Effective May 13, 2013**

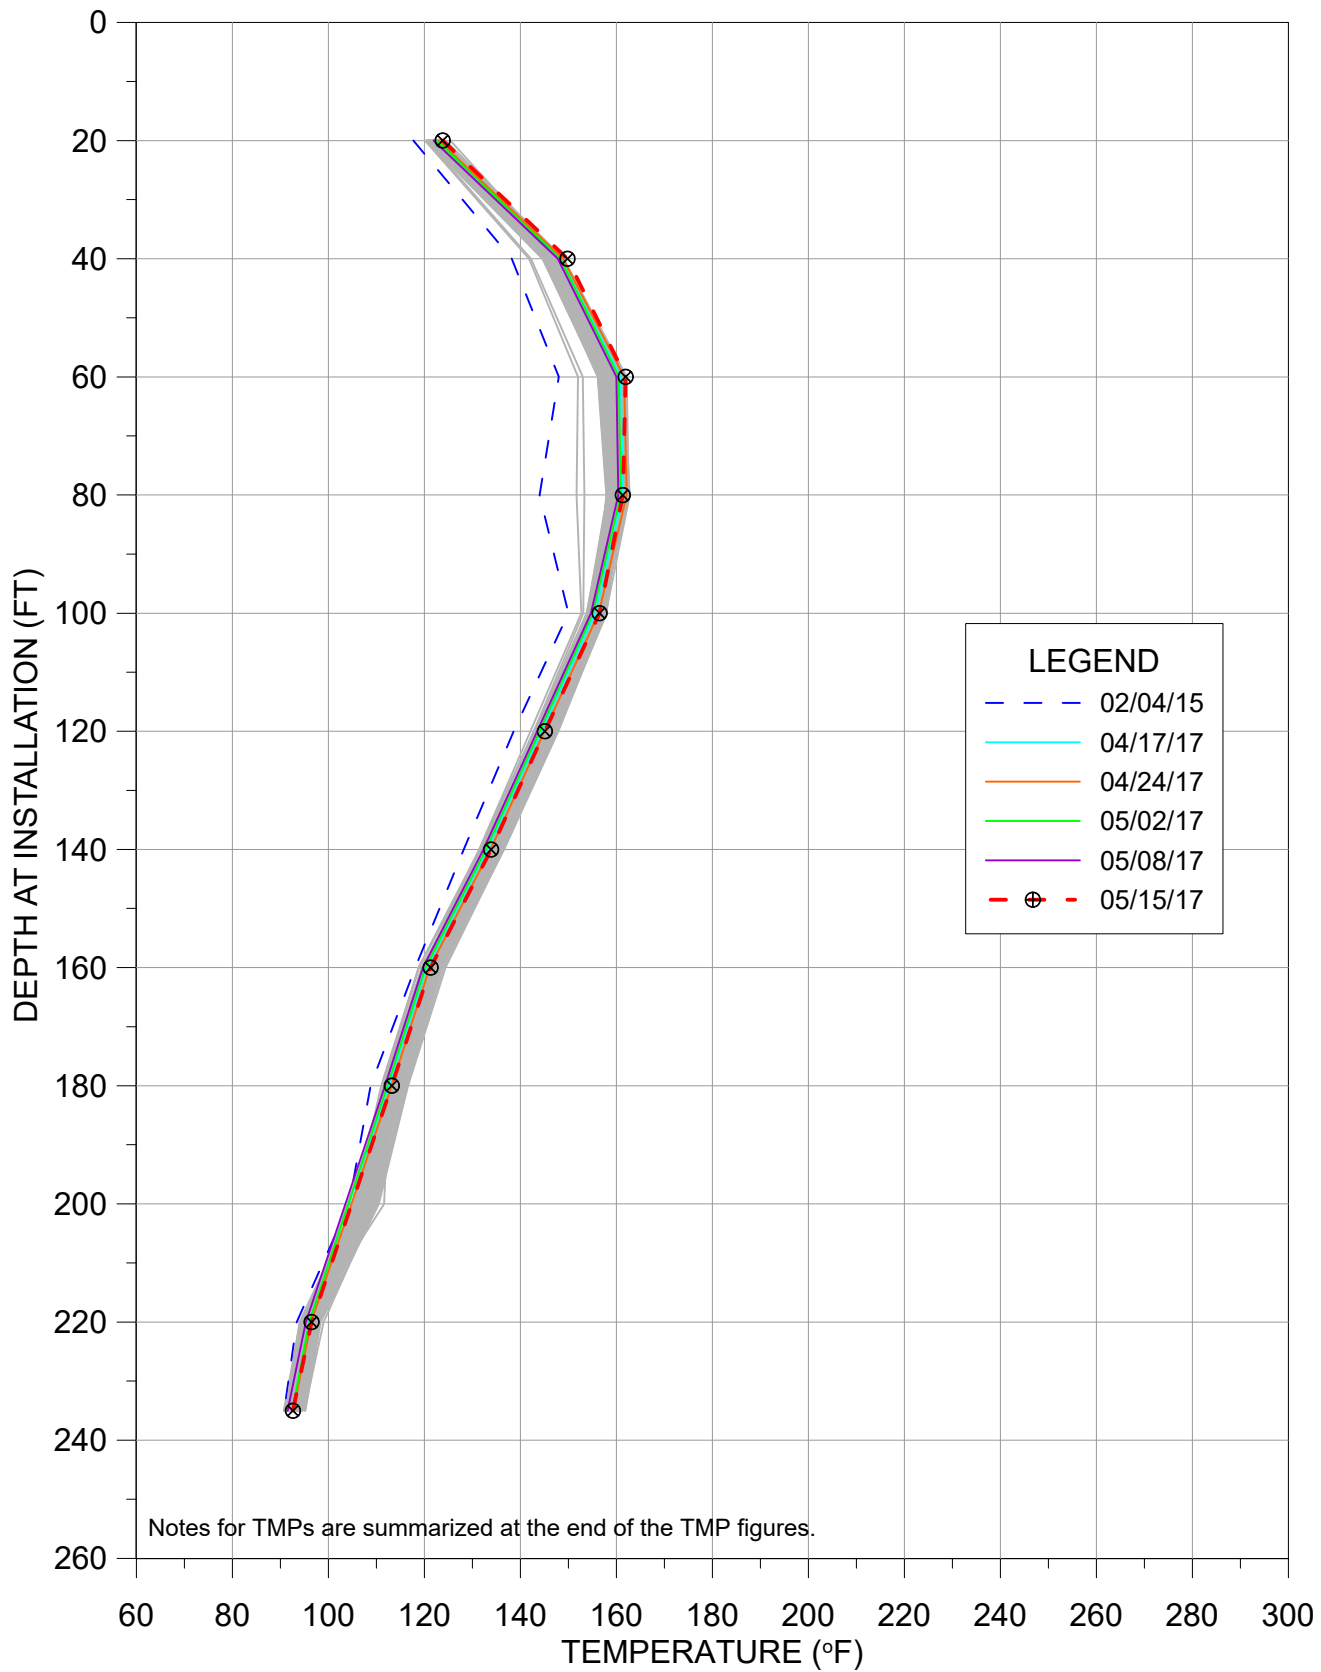
# TMP-25

1. The unit at 200 ft provided an apparent anomalous reading on 3/28/2017. Subsequent readings on 4/4/2017 showed the unit to have failed (see below). The unit is no longer working and the reading of 3/28/2017 was likely unreliable.
2. The unit at 200 ft depth had a resistance reading greater 4000 ohms on 4/4/2017. A connectivity test conducted by Feezor Engineering on 4/7/2017 showed that this unit also had cross-connectivity. The unit is therefore determined to be no longer working as of the 4/4/2017 reading.

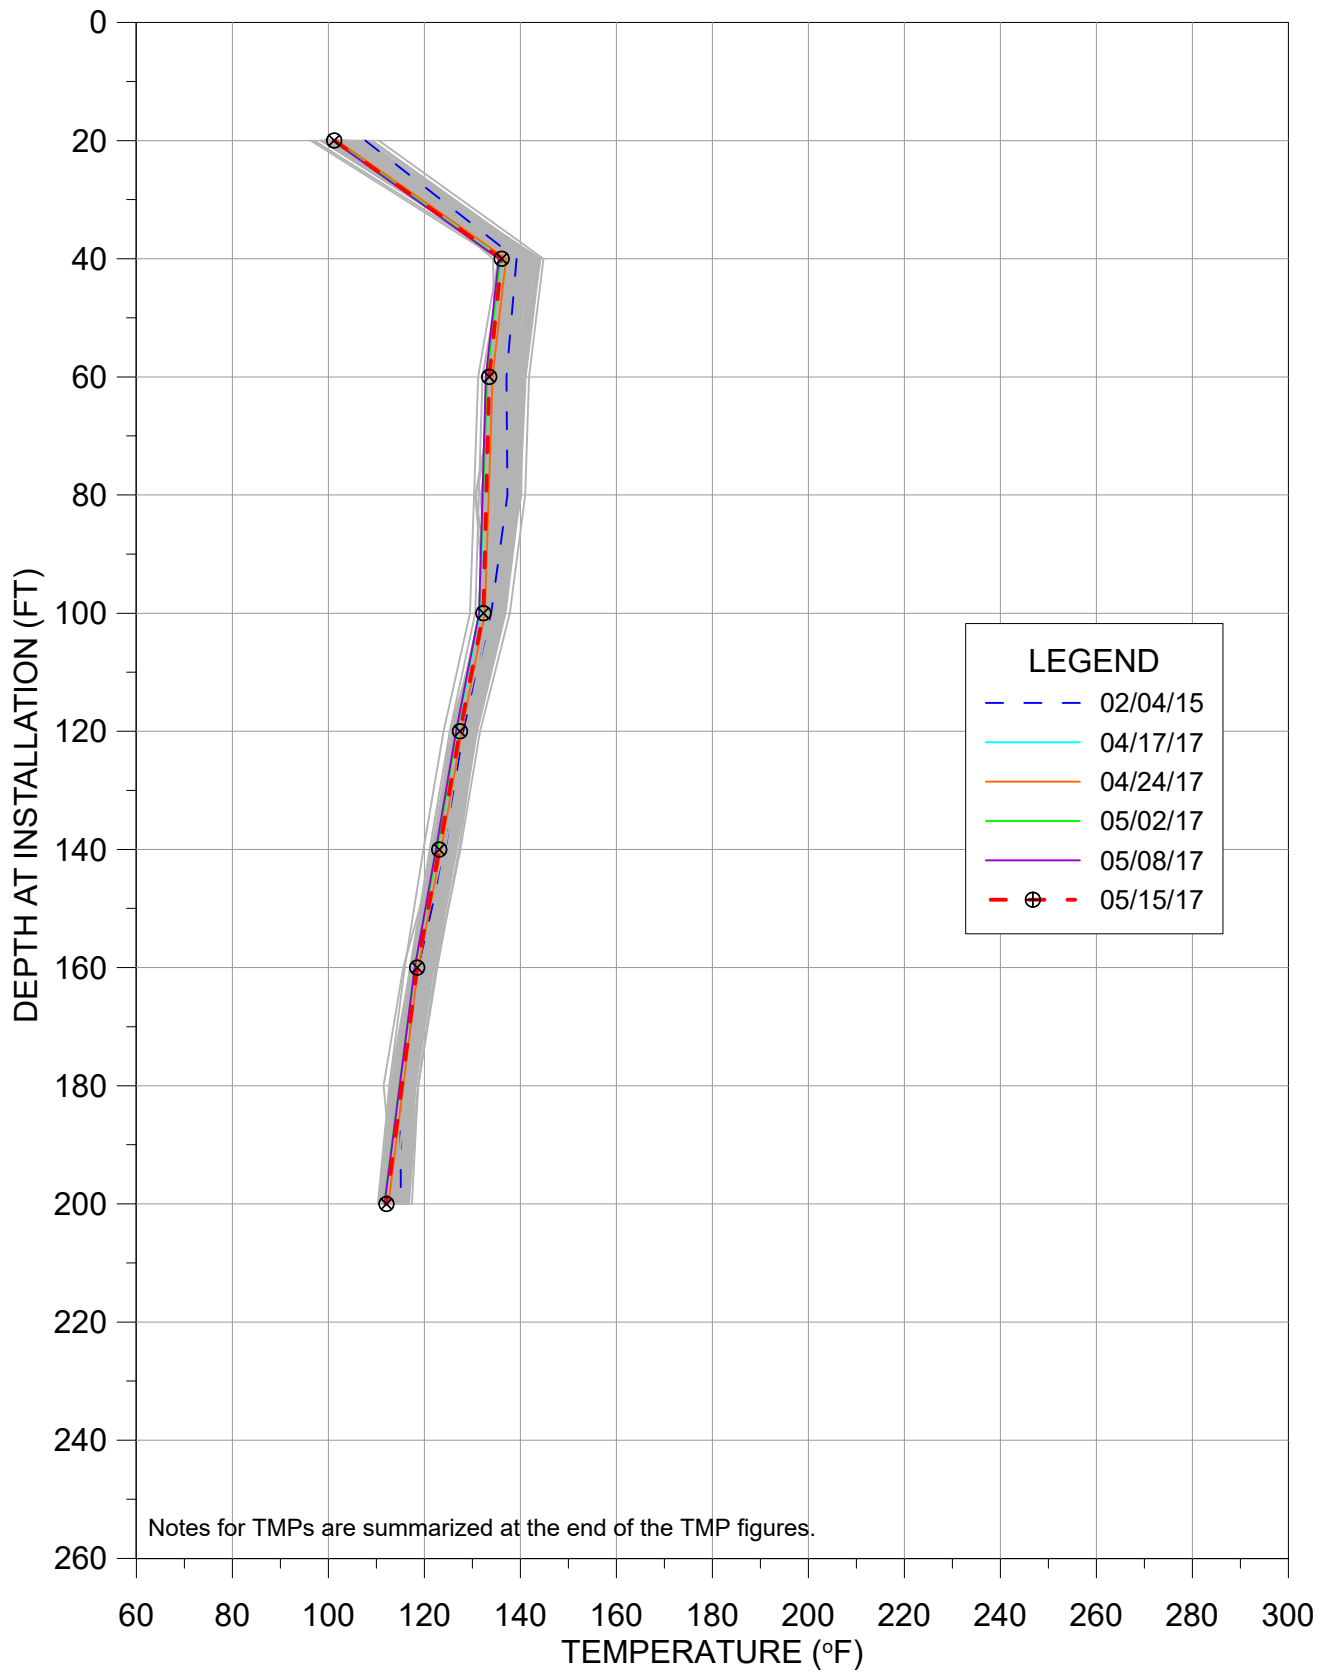
# TMP-28

1. The unit at 217 ft depth has had no resistance or temperature readings since installation.
2. The unit at 80 ft depth had a resistance drop and an unreasonable temperature decrease on 6/1/2016. The temperature has since fluctuated and is determined to be unreliable.
3. The unit at 180 feet has had a higher than acceptable limit since 3/28/2017 and is therefore determined to be unreliable as of the 4/4/2017 reading.

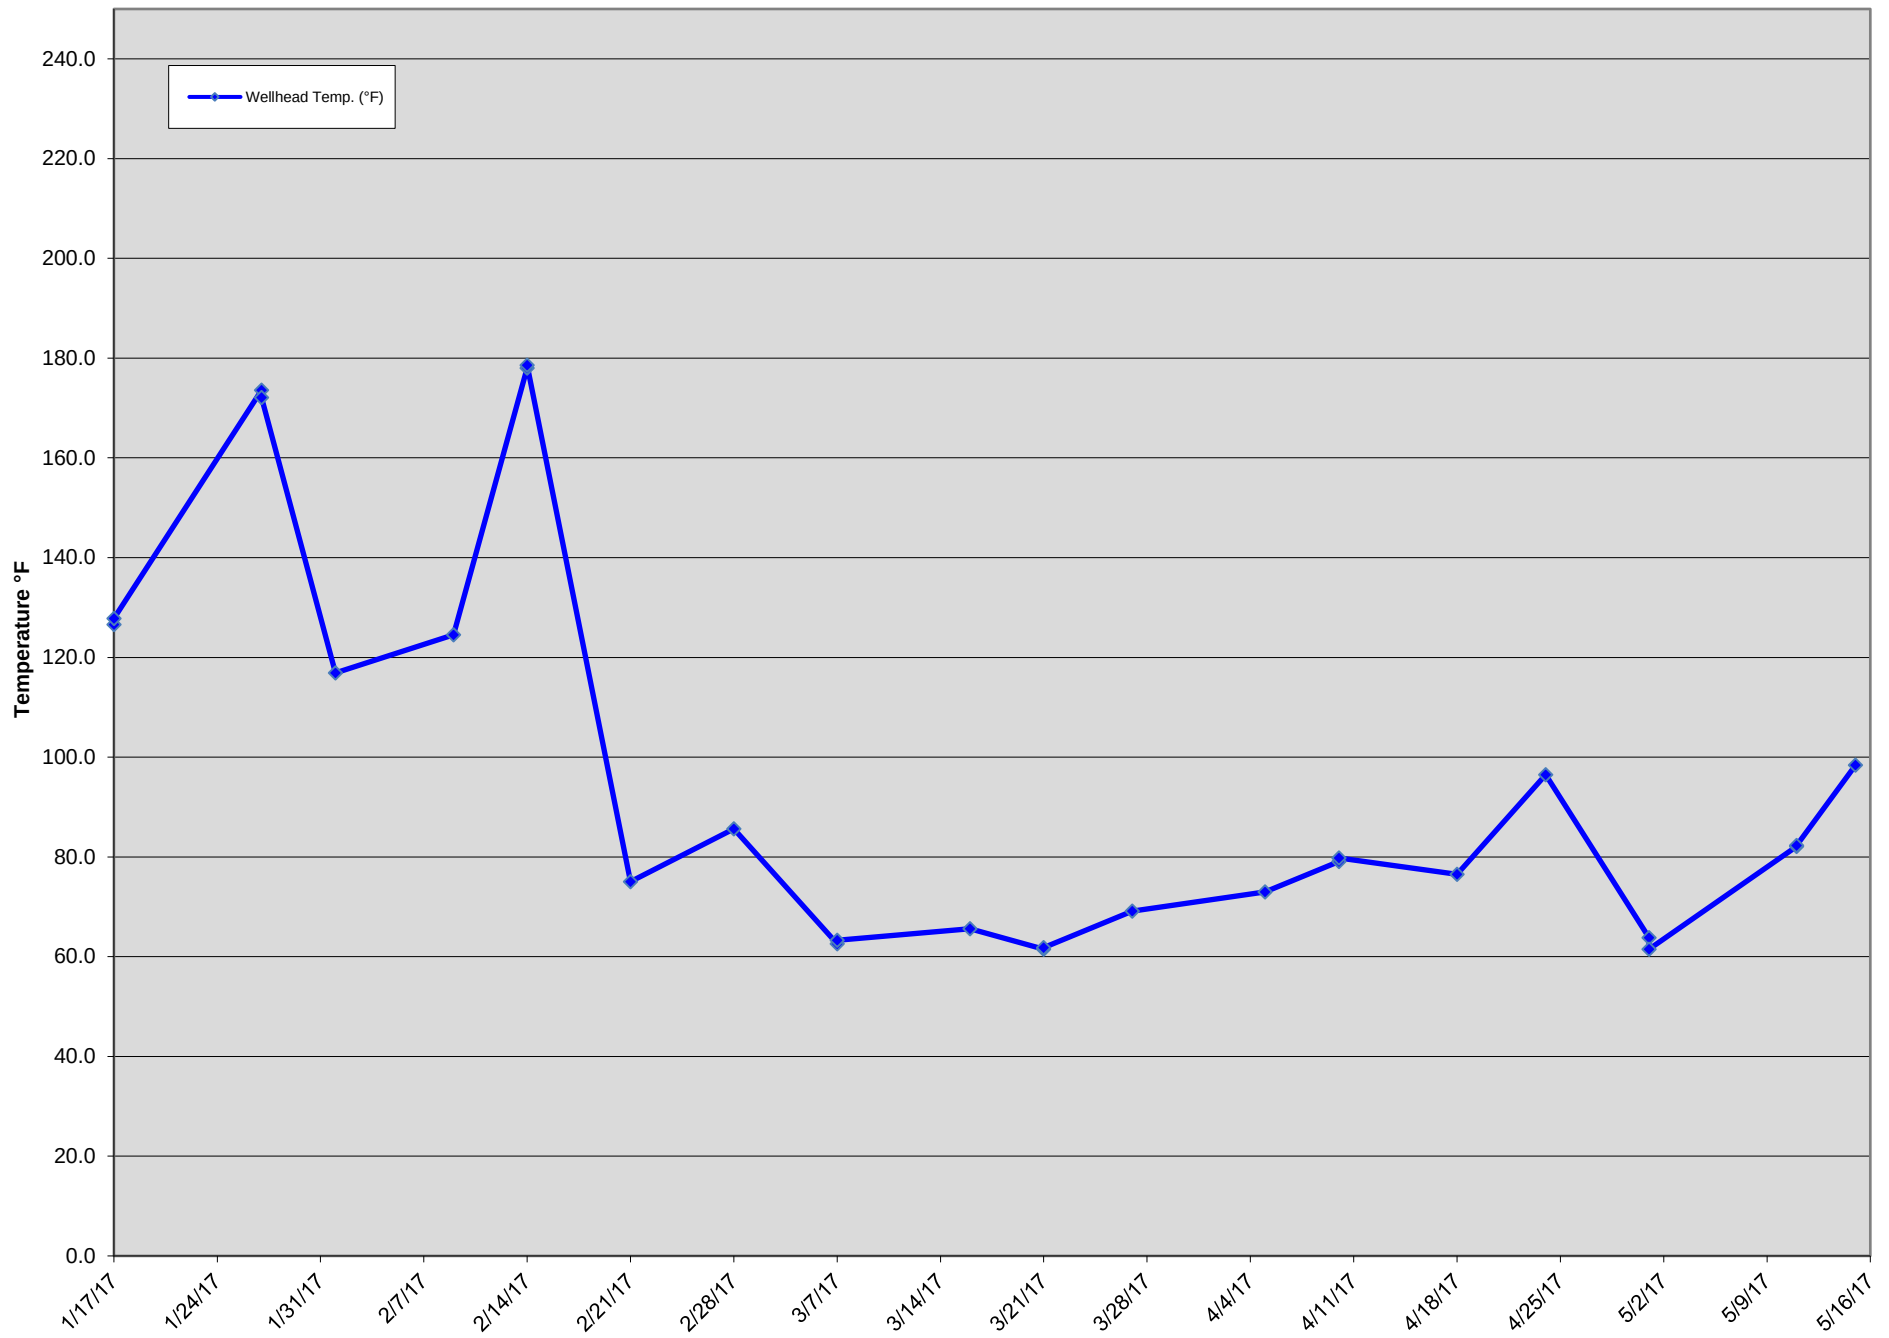
GIW-1 Wellhead Temperatures

As part of the HES, there are currently cooling water circulation loops installed in twelve Gas Interceptor Wells (GIWs) (GIW-02 through GIW-13). The remaining well (GIW-01) had a measured gas temperature within its historical operating limits.
