# **Bridgeton Landfill, LLC**

## **Weekly Data Submittal**

**Week of May 21, 2017 – May 27, 2017**

**Required by Section 52.F of Agreed Order, Case No. 13SL-CC01088  
Effective May 13, 2013**

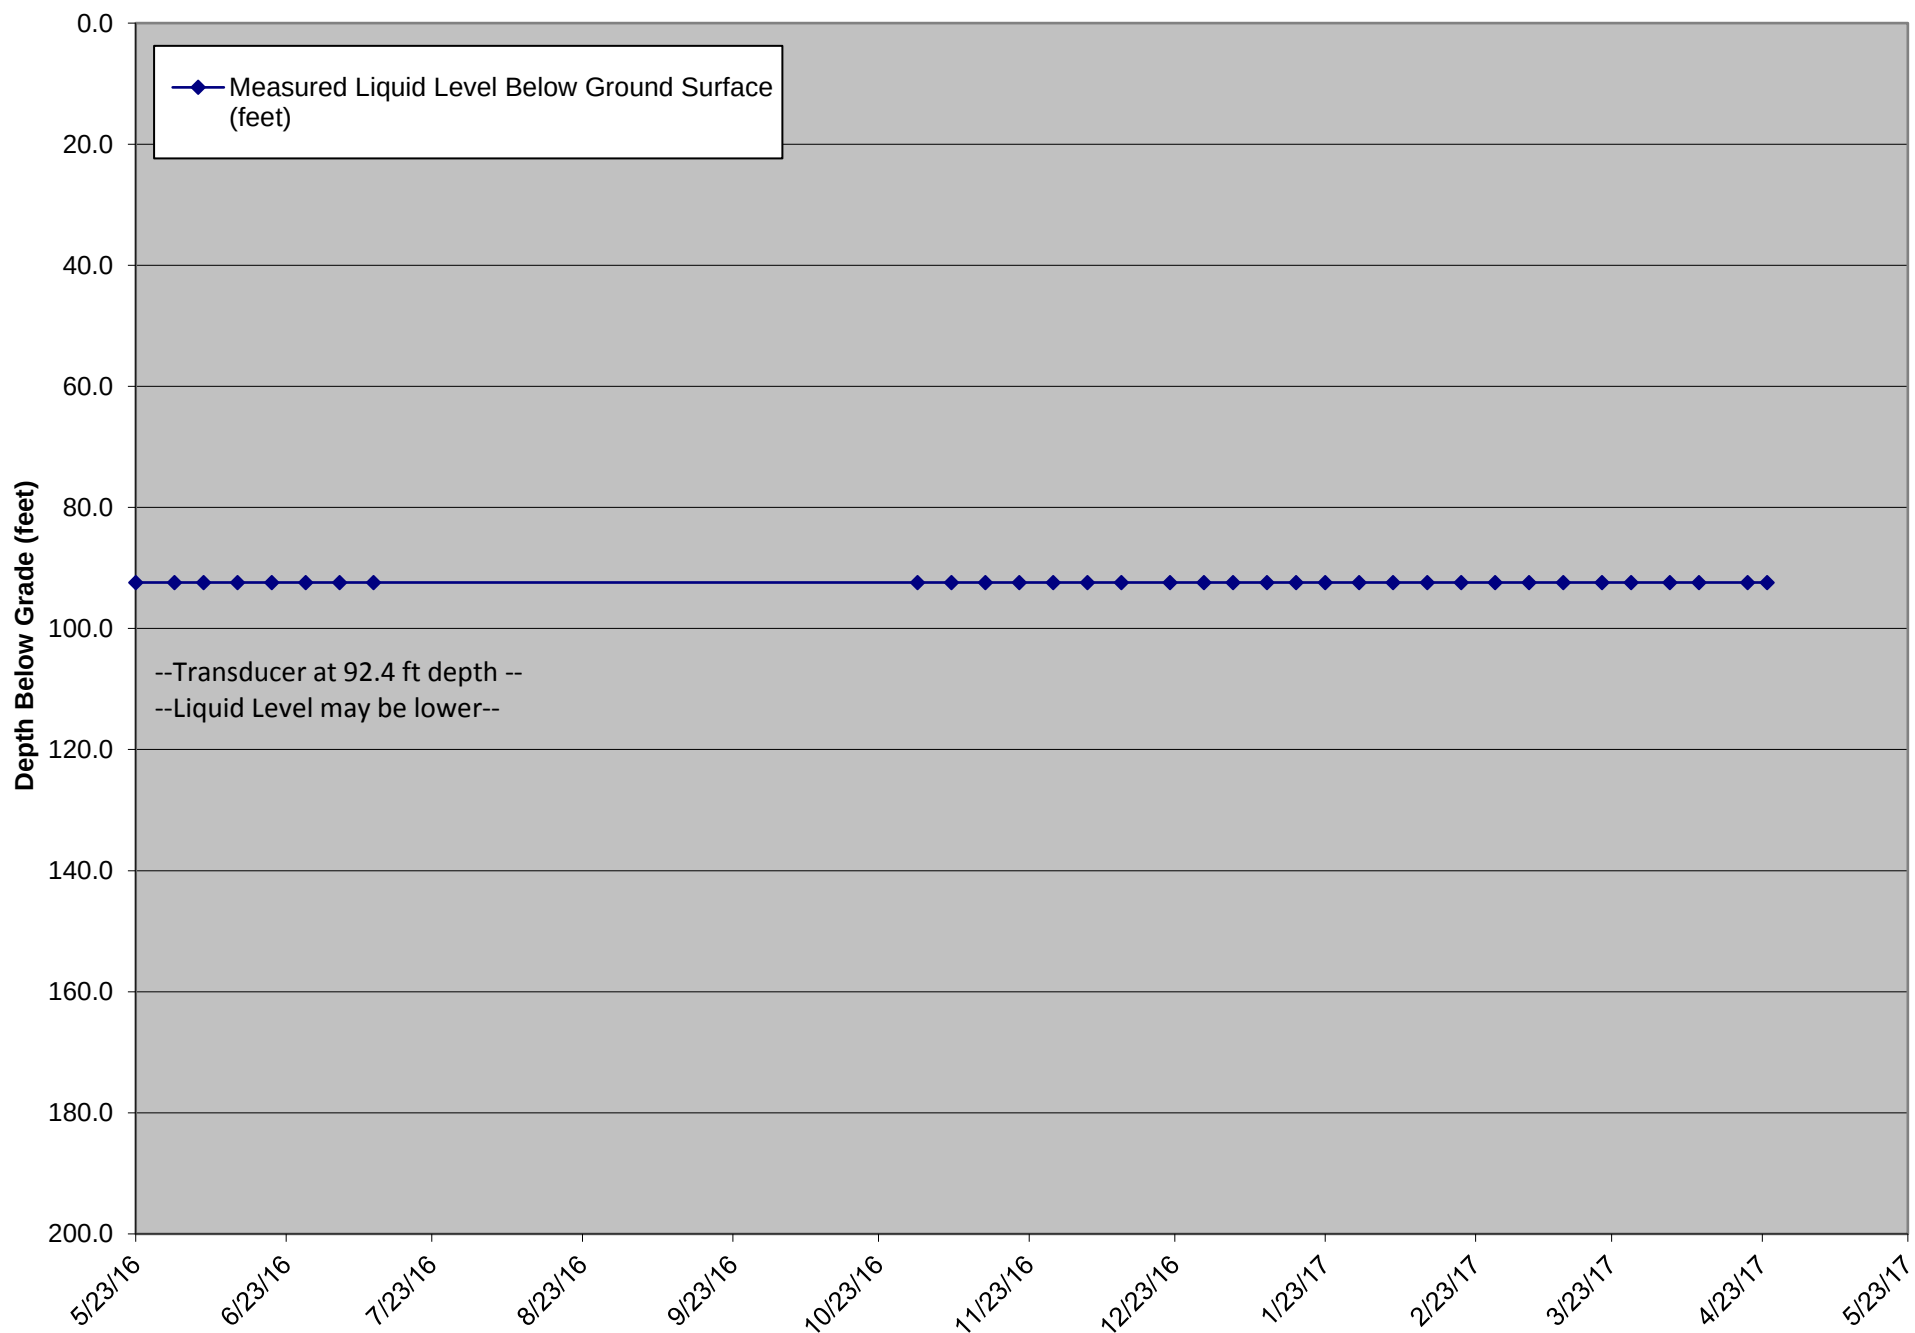
# LCS-1D Liquid Level Below Ground Surface

LCS-1D is equipped with a level sensor and a flow meter. The pump was non-operational during the weekly reporting period due to an electrical issue. Bridgeton Landfill confirmed that the flow meter on LCS-1D is operational and the flow was observed during the weekly reporting period. Liquid level was not recorded by the level sensor during the weekly reporting period. Bridgeton Landfill initiated pump repairs and replacement of the level sensor on LCS-1D during the week of 5/22/2017. Pump repairs and replacement of the level sensor on LCS-1D is tentatively scheduled to be completed the week of 5/29/2017 pending parts availability.

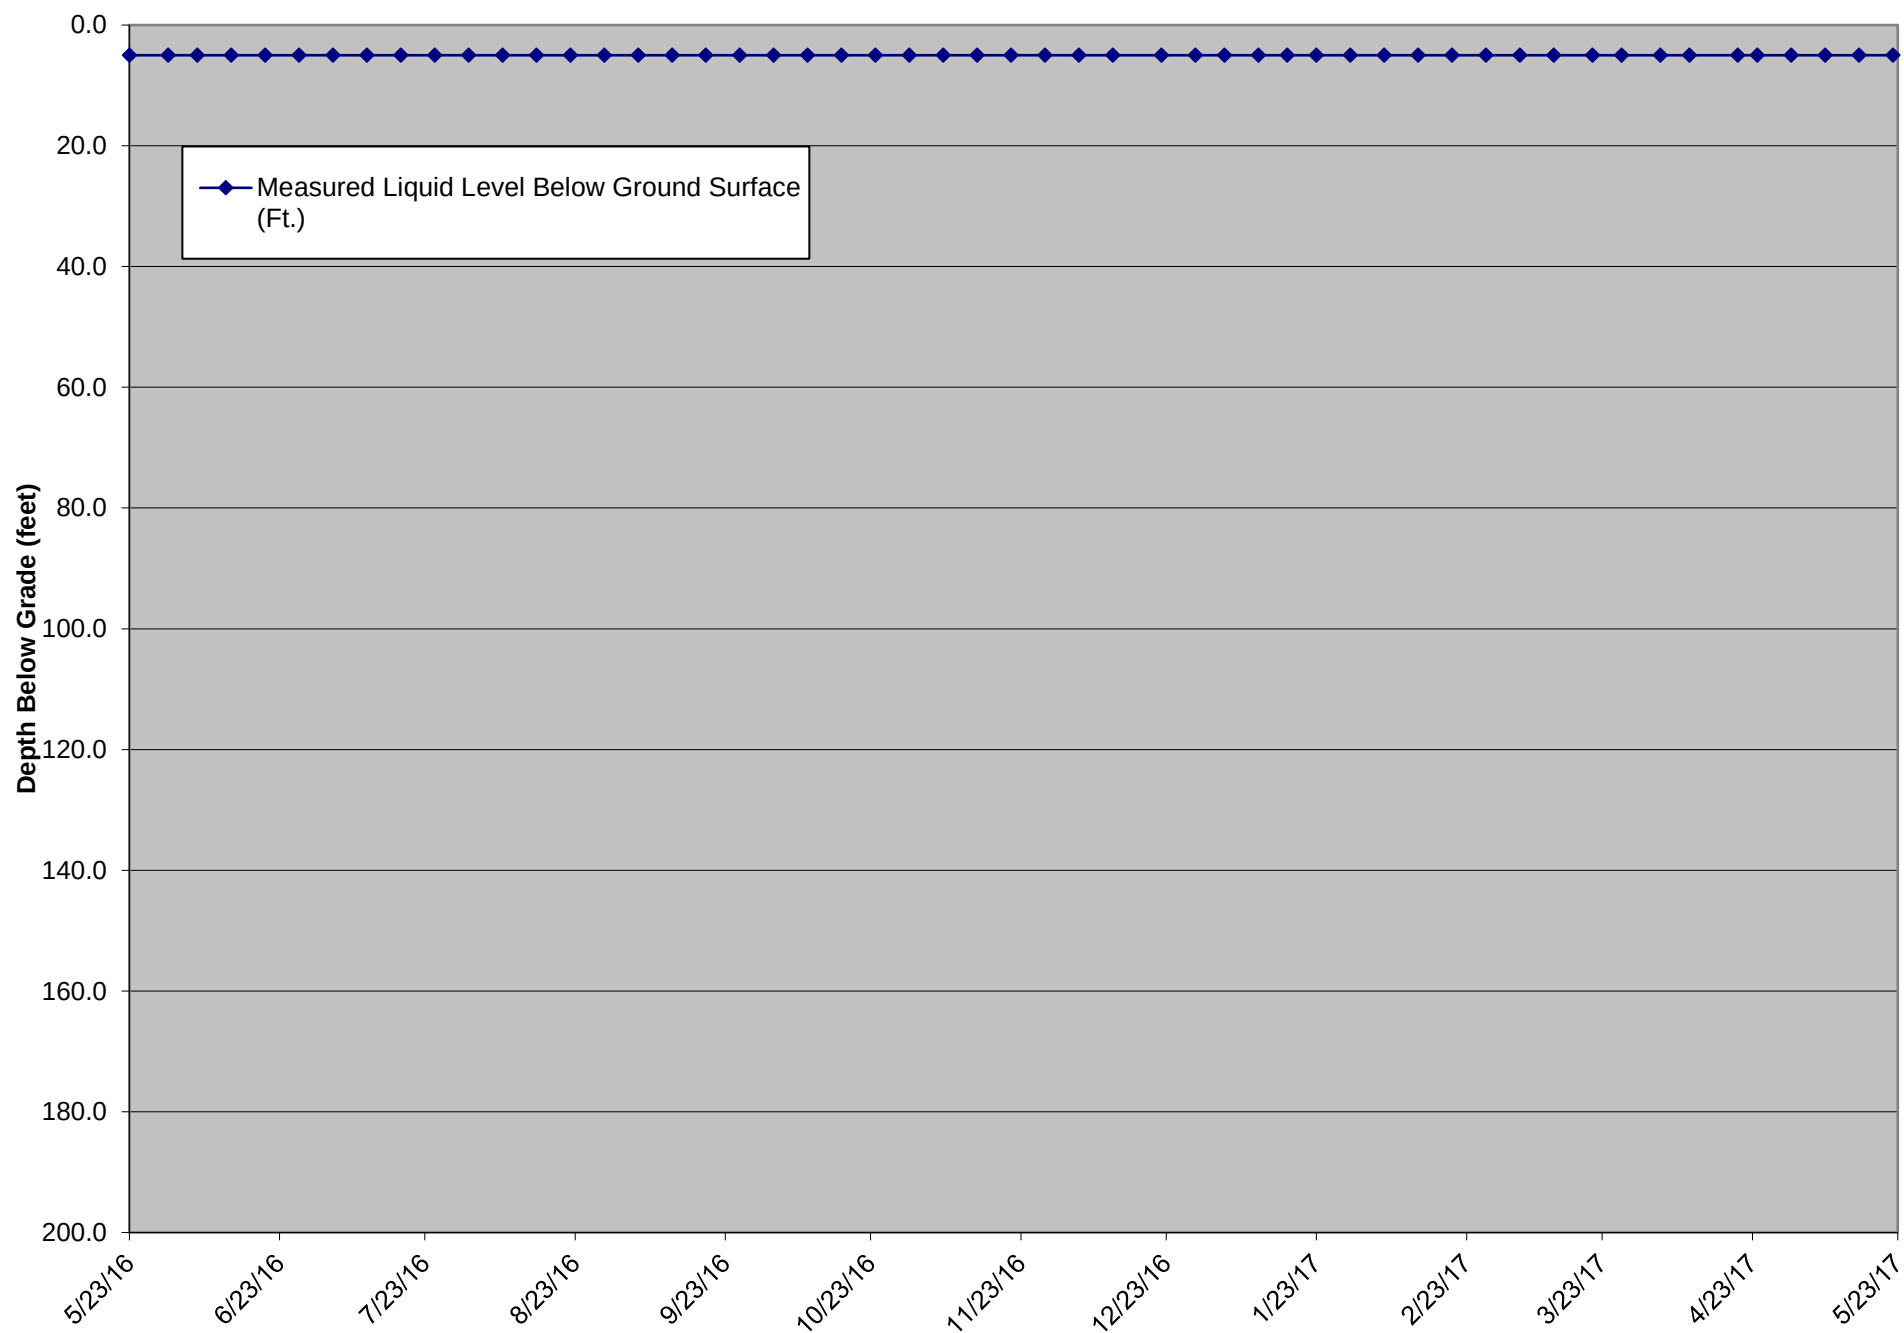
# LCS-3D Liquid Level Below Ground Surface

The pump in LCS-3D was non-operational during the weekly reporting period. The transducer in LCS-3D continued to report liquid levels. Flow was observed on the LCS-3D flow meter during the weekly reporting period. Pump repair and transducer maintenance was initiated on LCS-3D the week of 5/22/2017 and is tentatively scheduled to be completed the week of 5/29/2017 pending parts availability.

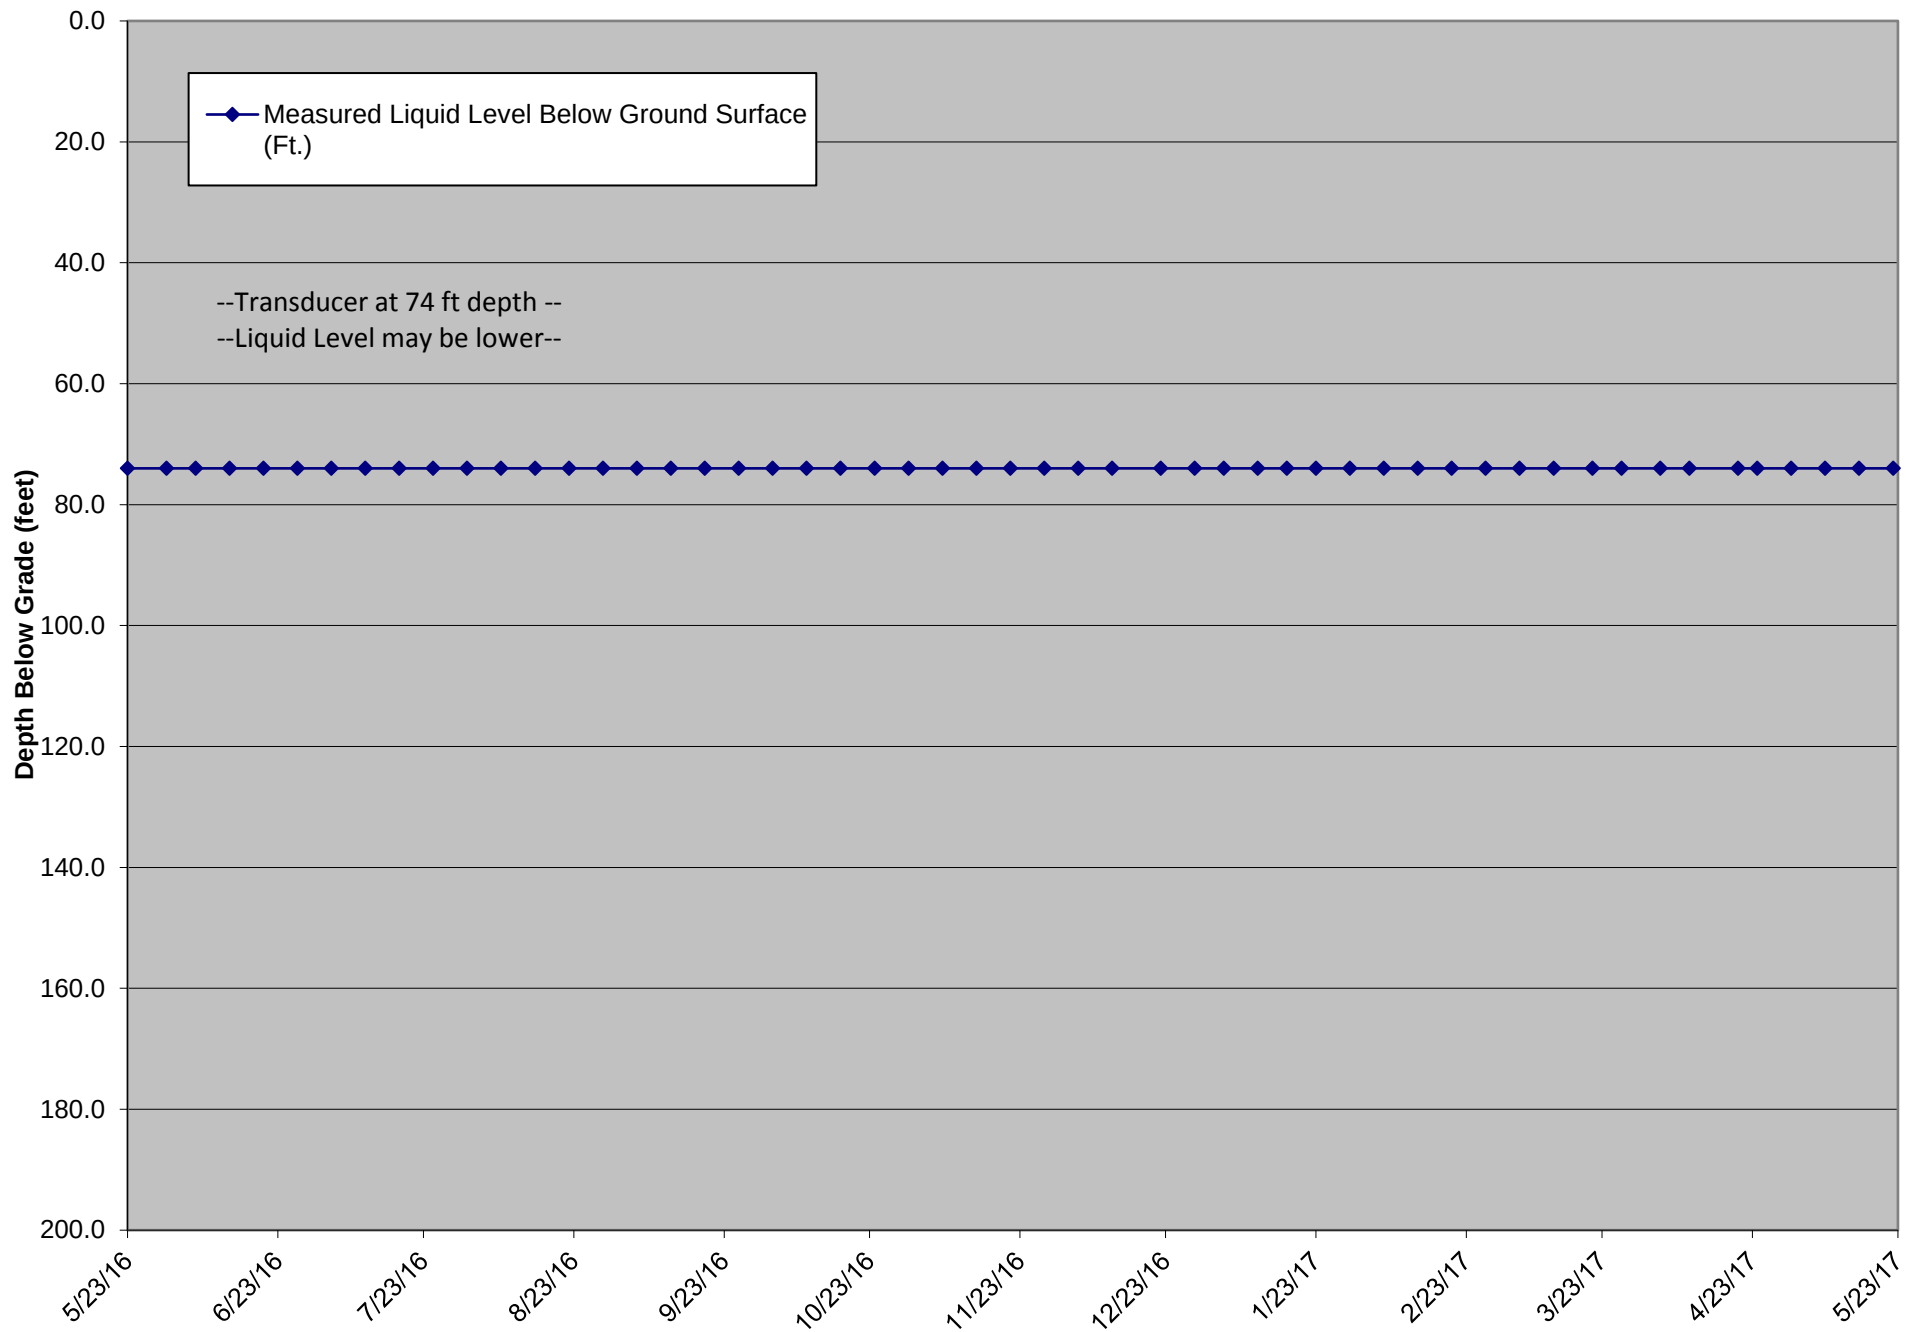
# LCS-4B Liquid Level Below Ground Surface

The level sensor in LCS-4B is currently operational and responsive. Liquid level was not recorded by the level sensor during the weekly reporting period. LCS-4B is equipped with a flow meter that displayed no flow during the weekly reporting period. Therefore, it can be concluded that the liquid level was below the bottom of the pump and level sensor in LCS-4B.

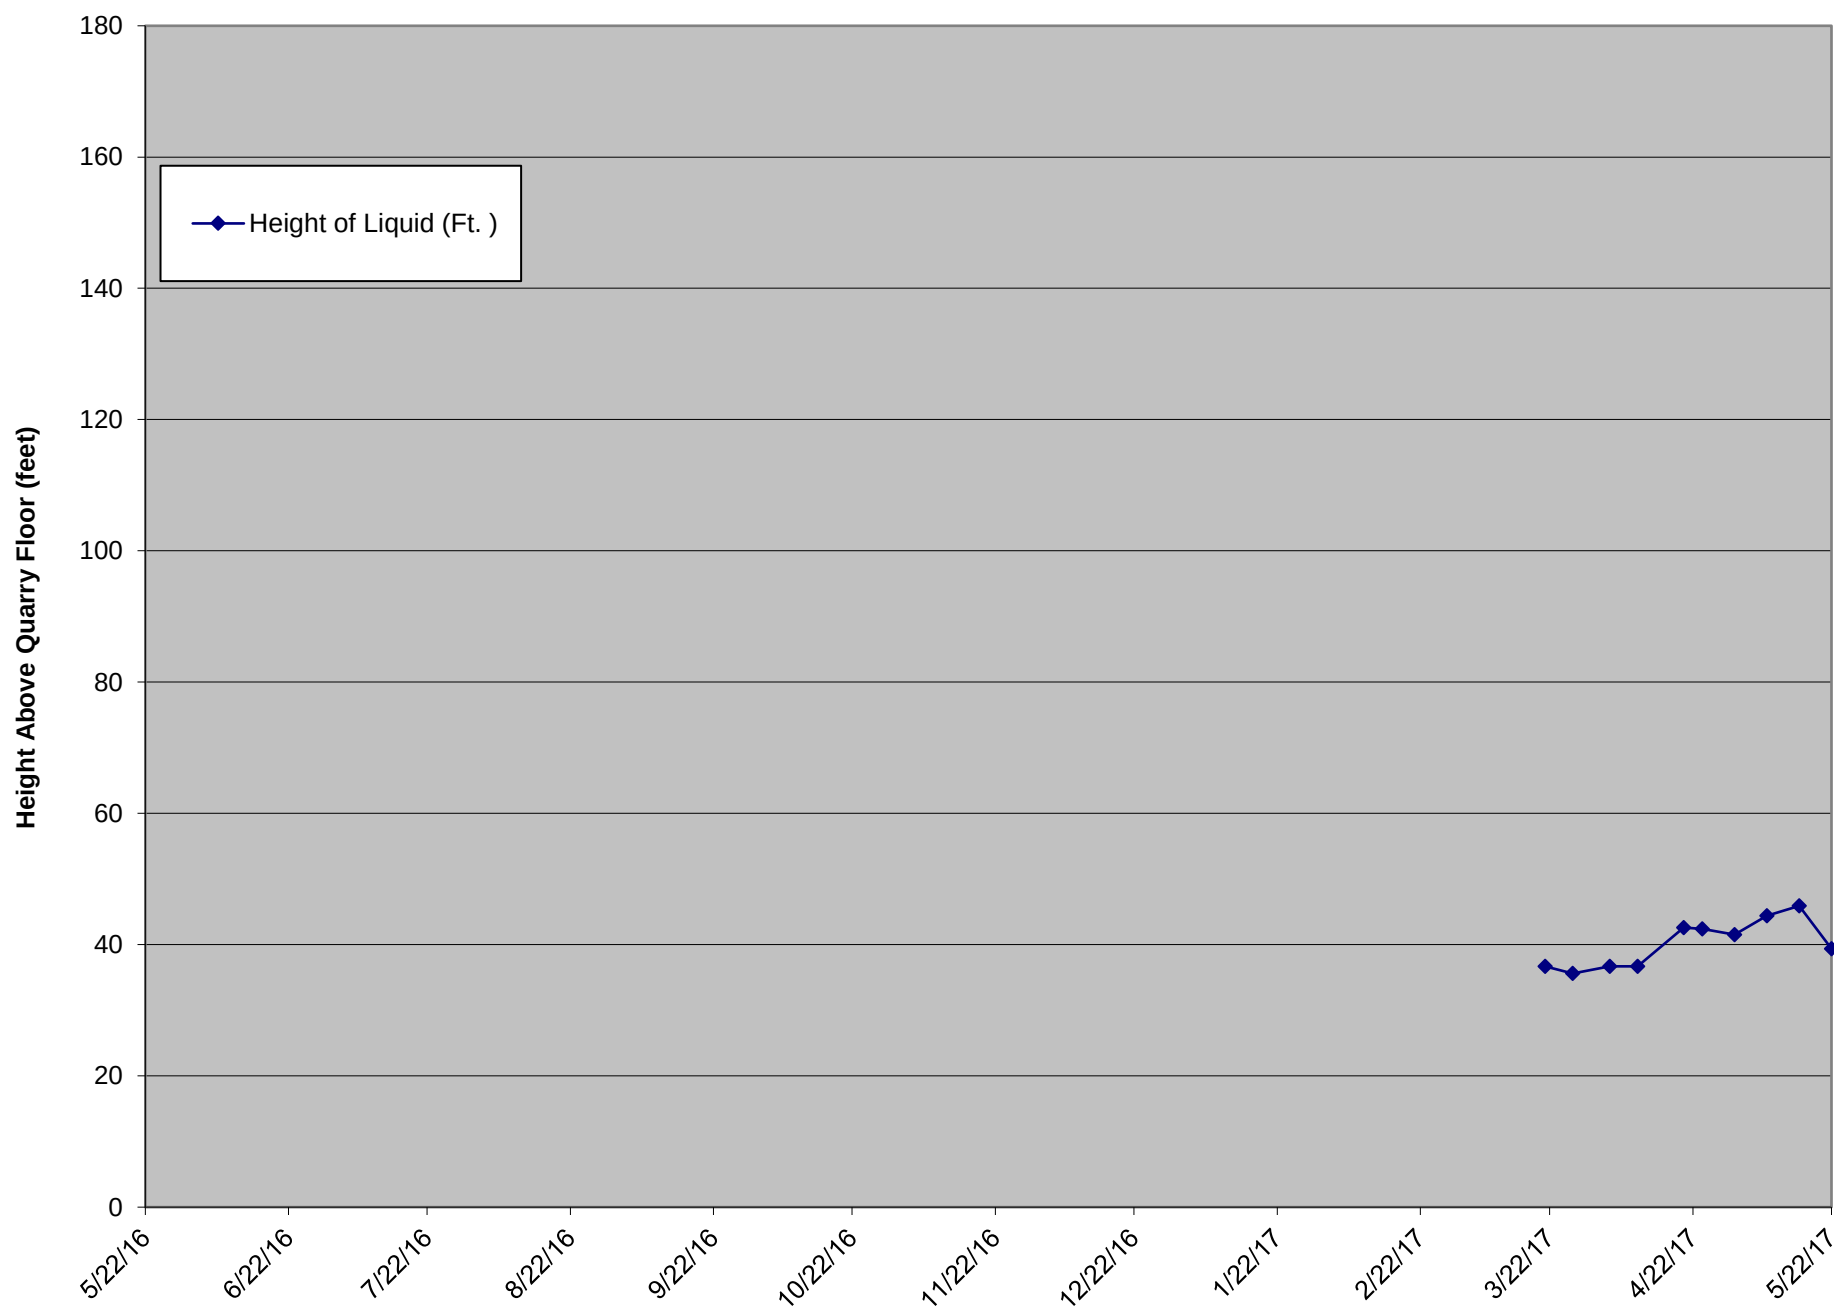
LCS-5B Liquid Level Above Quarry Floor

LCS-5B and LCS-6B were fully operational during the weekly reporting period.

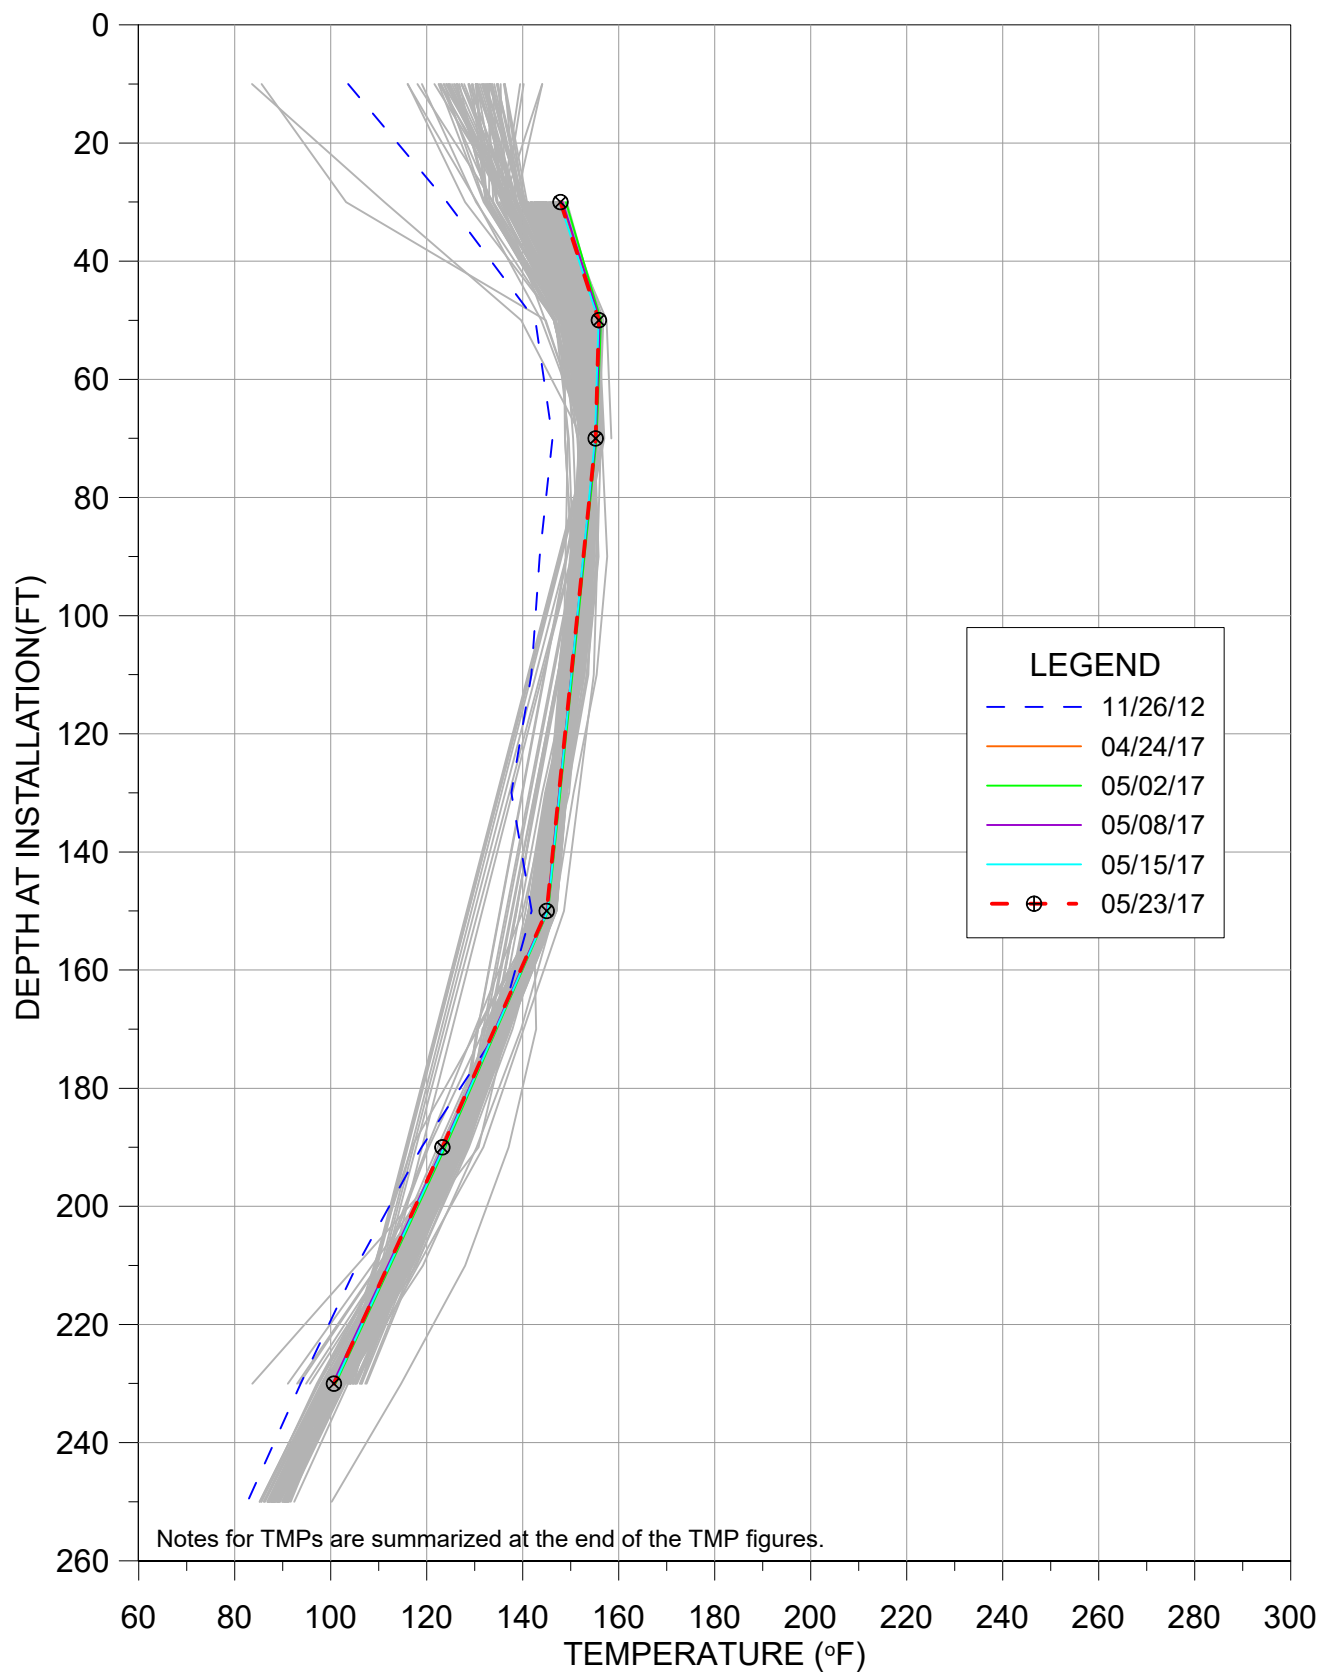
# TMP-3

1. No reliable temperature readings have been obtained at 170 ft depth since 1/29/2014, except on 3/13/2014.
2. The connectivity tests on 4/11/2014 conducted by CEC showed that units at 10, 90, 130, 210 and 250 ft depths are no longer reliable.
3. The connectivity tests on 10/28/2014 conducted by Feezor Engineering showed that units at 10, 90, 110, 130, 210 and 250 ft depths are not reliable.

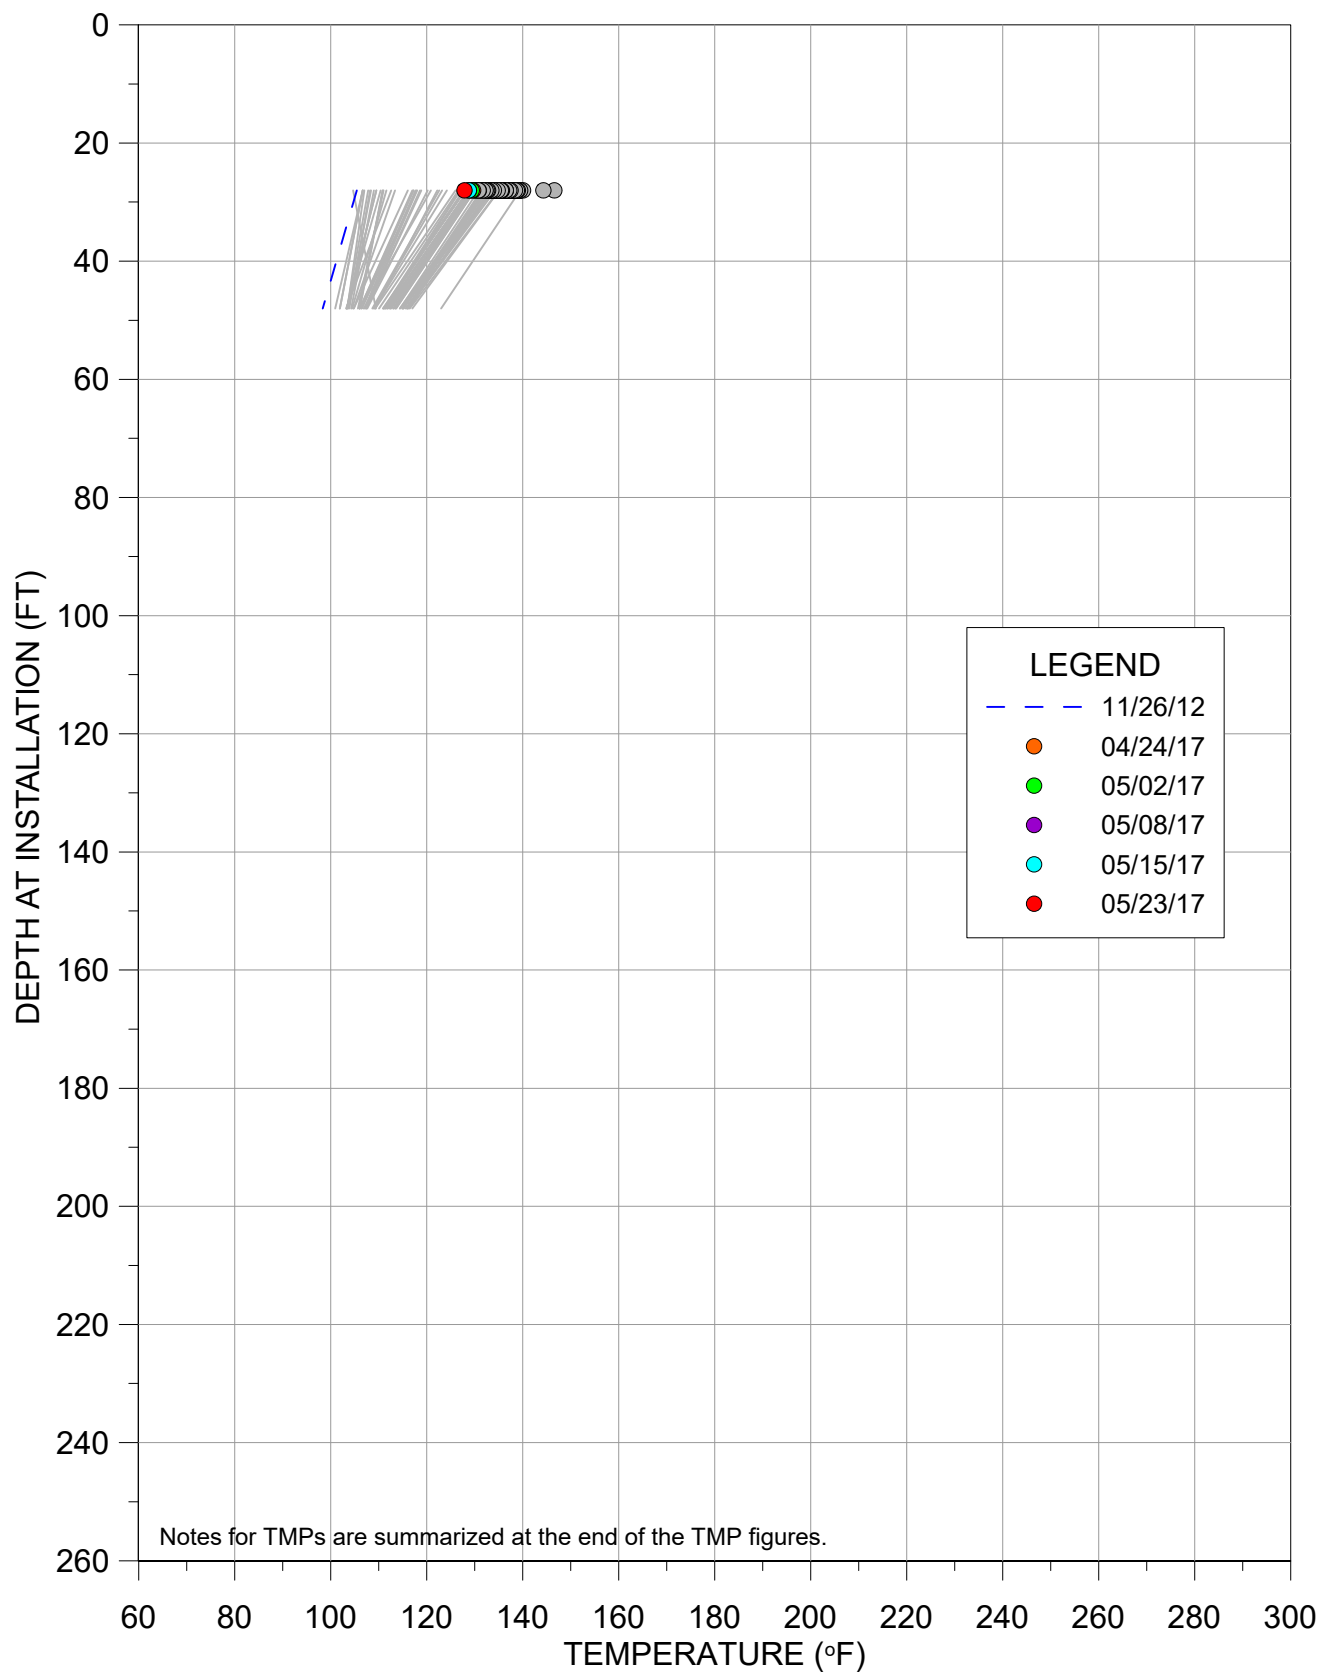
# TMP-4

1. The connectivity tests on 4/11/2014 conducted by CEC showed that the unit at 48 ft depth is no longer reliable.

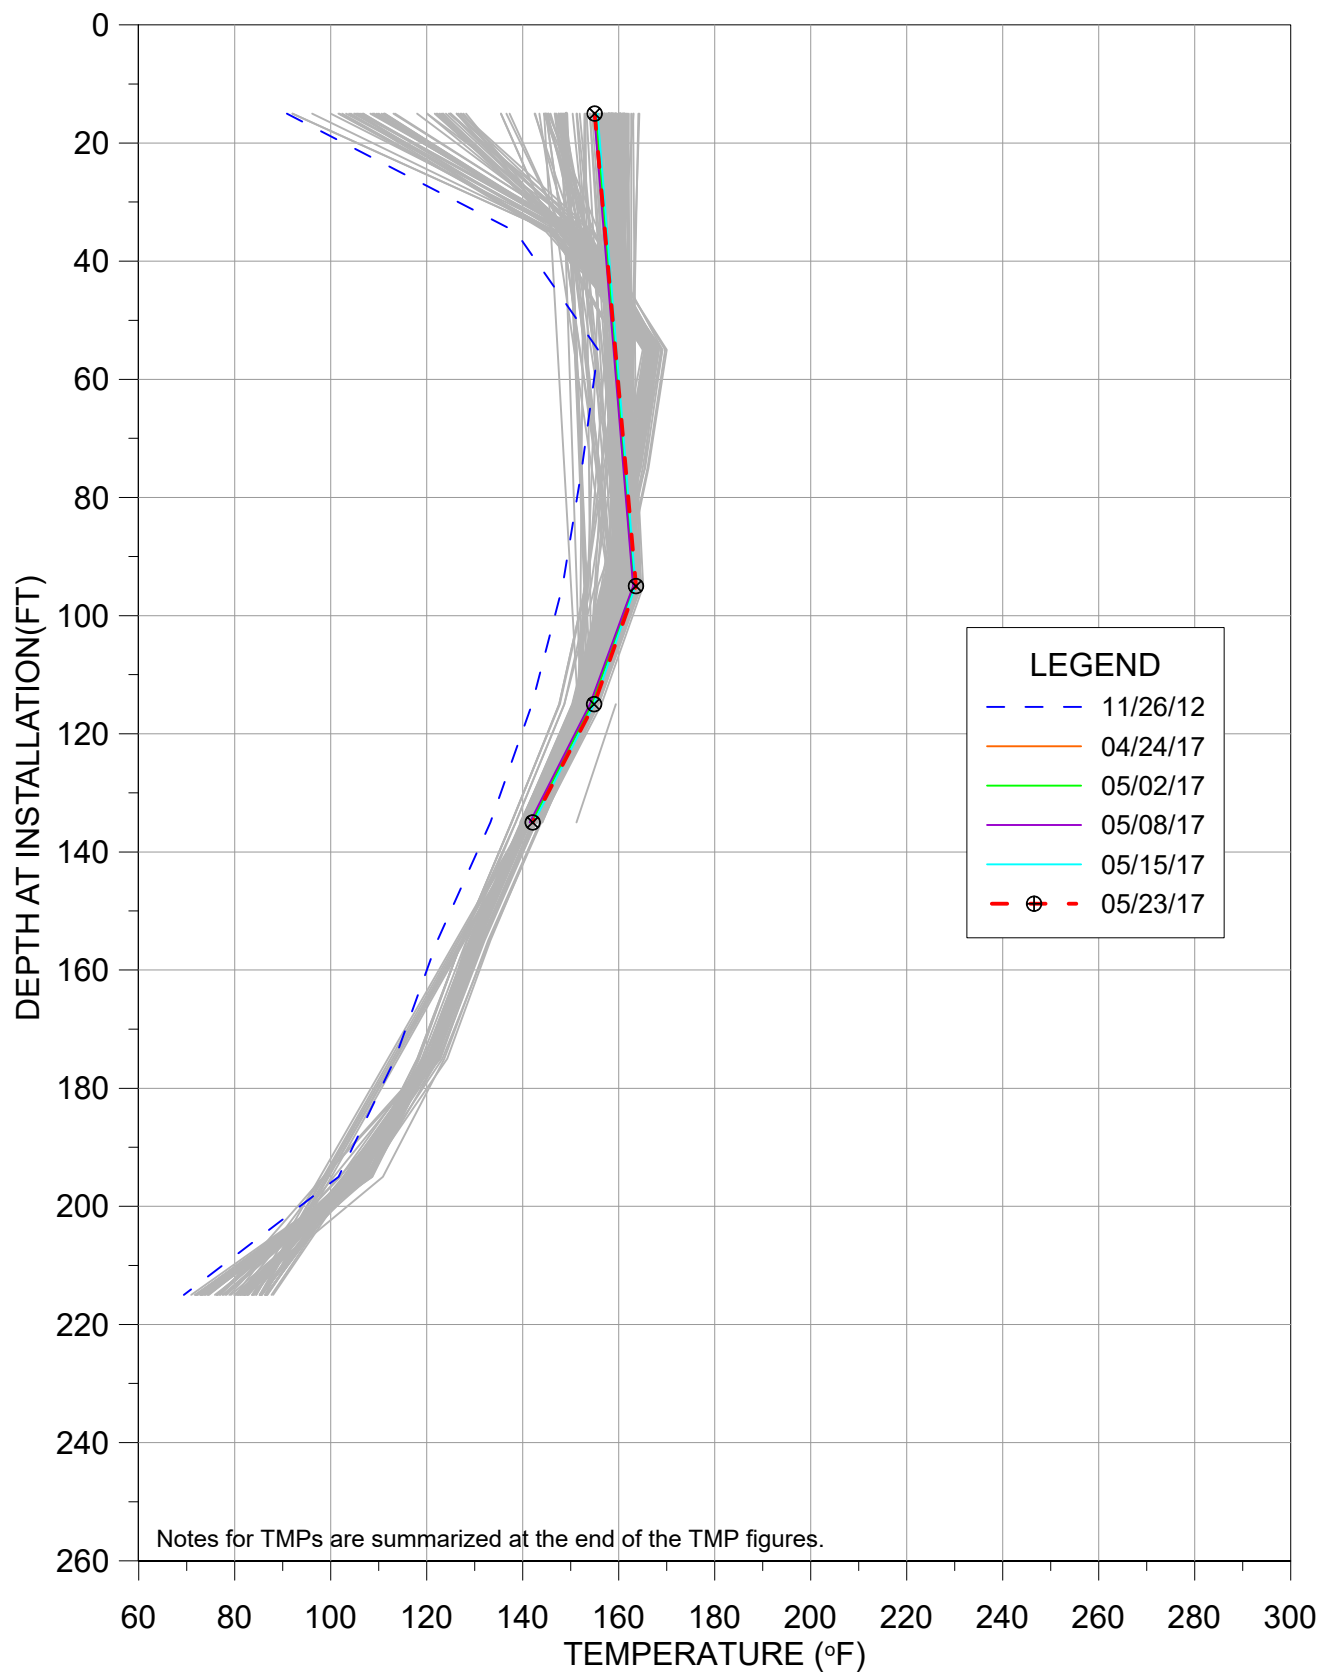
# TMP-6

1. The connectivity tests on 4/11/2014 conducted by CEC showed that units at 35, 55, 75, 155, 175, and 195 ft depths are no longer reliable.
2. No reliable temperature readings have been obtained at the unit at 215 ft depth since 6/13/2014.

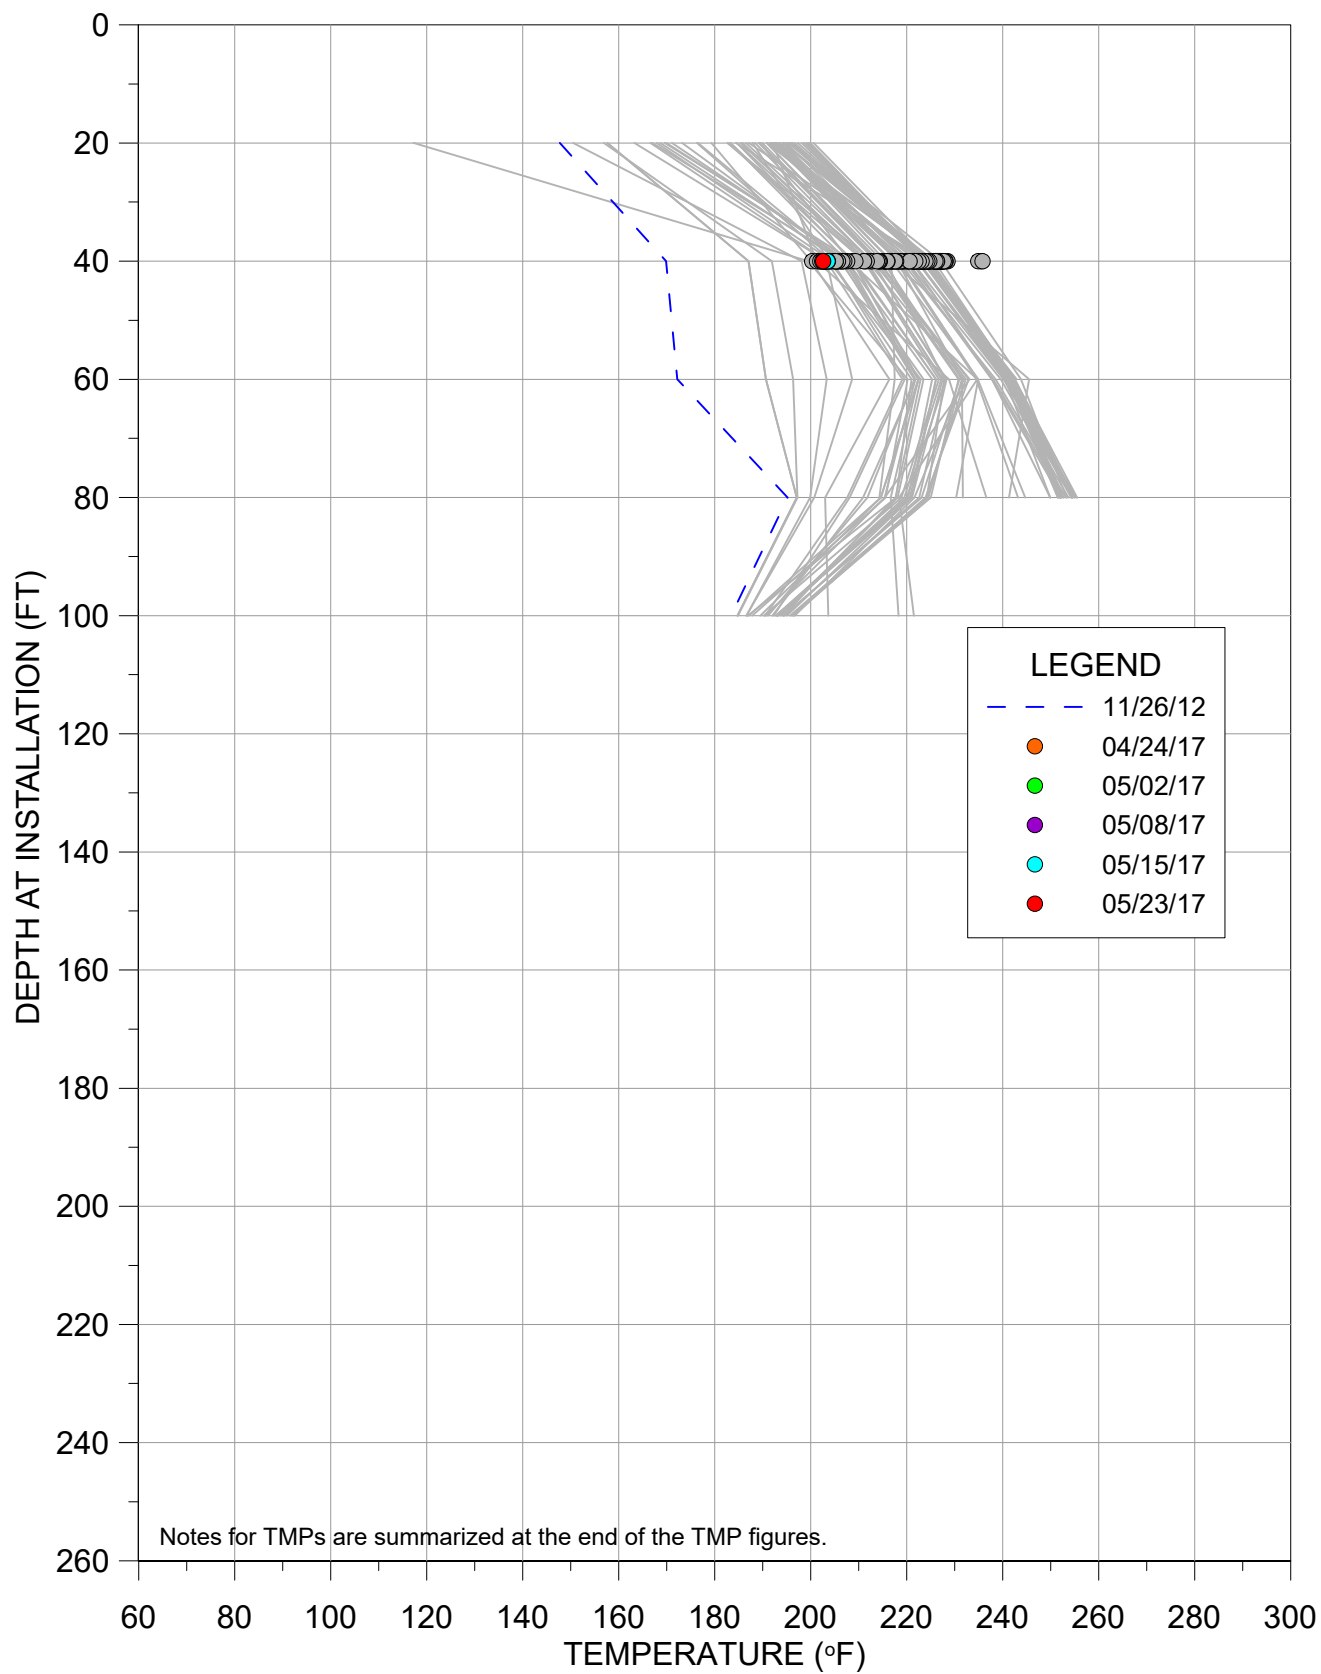
# TMP-9

1. Unit at 100 ft depth had an inaccurate temperature reading on 8/1/2013 and no reading since 8/6/2013.
2. The connectivity tests on 4/11/2014 conducted by CEC showed that units at 20, 60, 80, and 100 ft depths are no longer reliable.

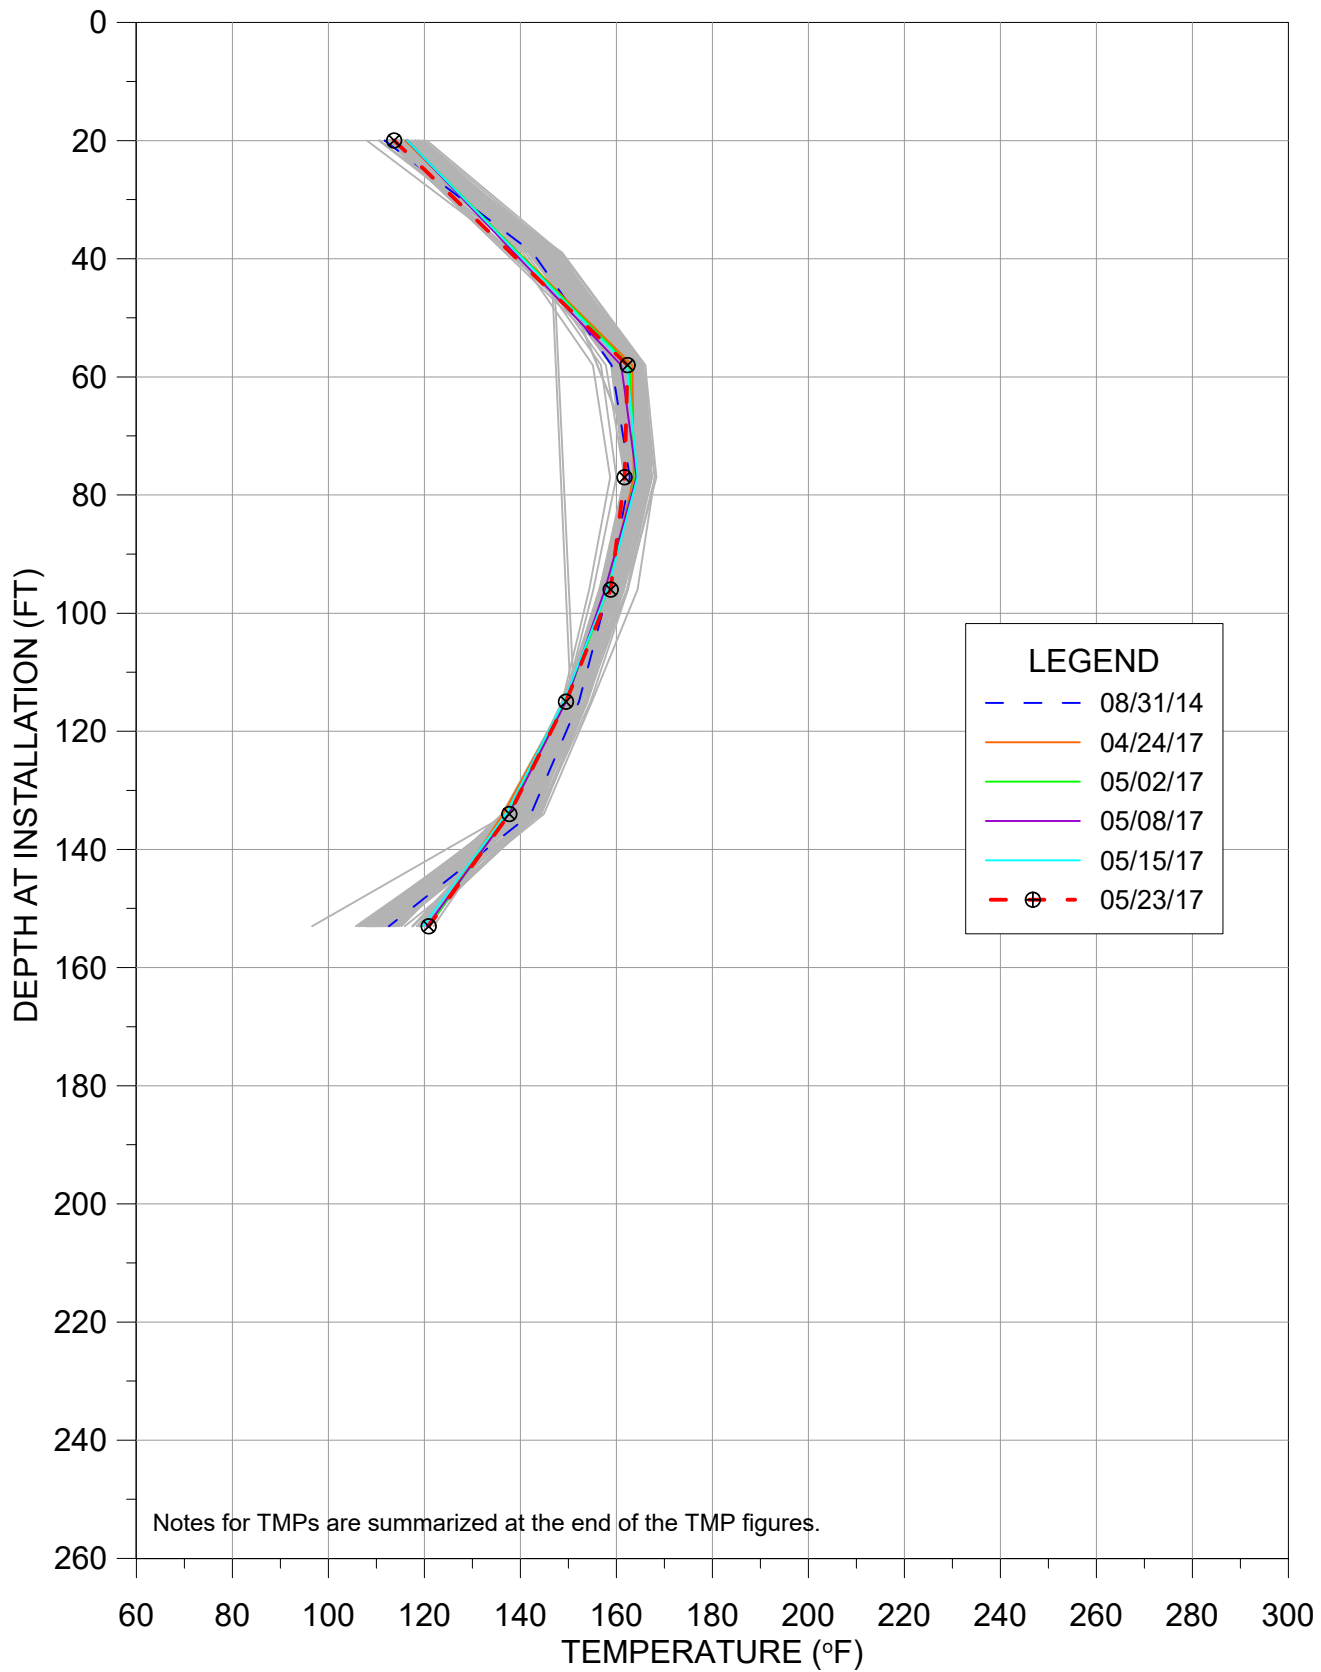
# TMP-16

1. A connectivity test conducted by Feezor Engineering showed that the units on TMP-16 may not be reliable since 9/9/2015. Further testing at the end of September 2015 showed possible connectivity on some of the units.
2. The unit at 153 ft depth had a low resistance reading and unreliable temperature since 12/21/2015.

3. The unit at 39 ft depth had a higher than acceptable resistance reading and unreliable temperature since 2/7/2017.
