# **Bridgeton Landfill, LLC**

## **Weekly Data Submittal**

**Week of May 21, 2017 – May 27, 2017**

**Required by Section 52.F of Agreed Order, Case No. 13SL-CC01088  
Effective May 13, 2013**

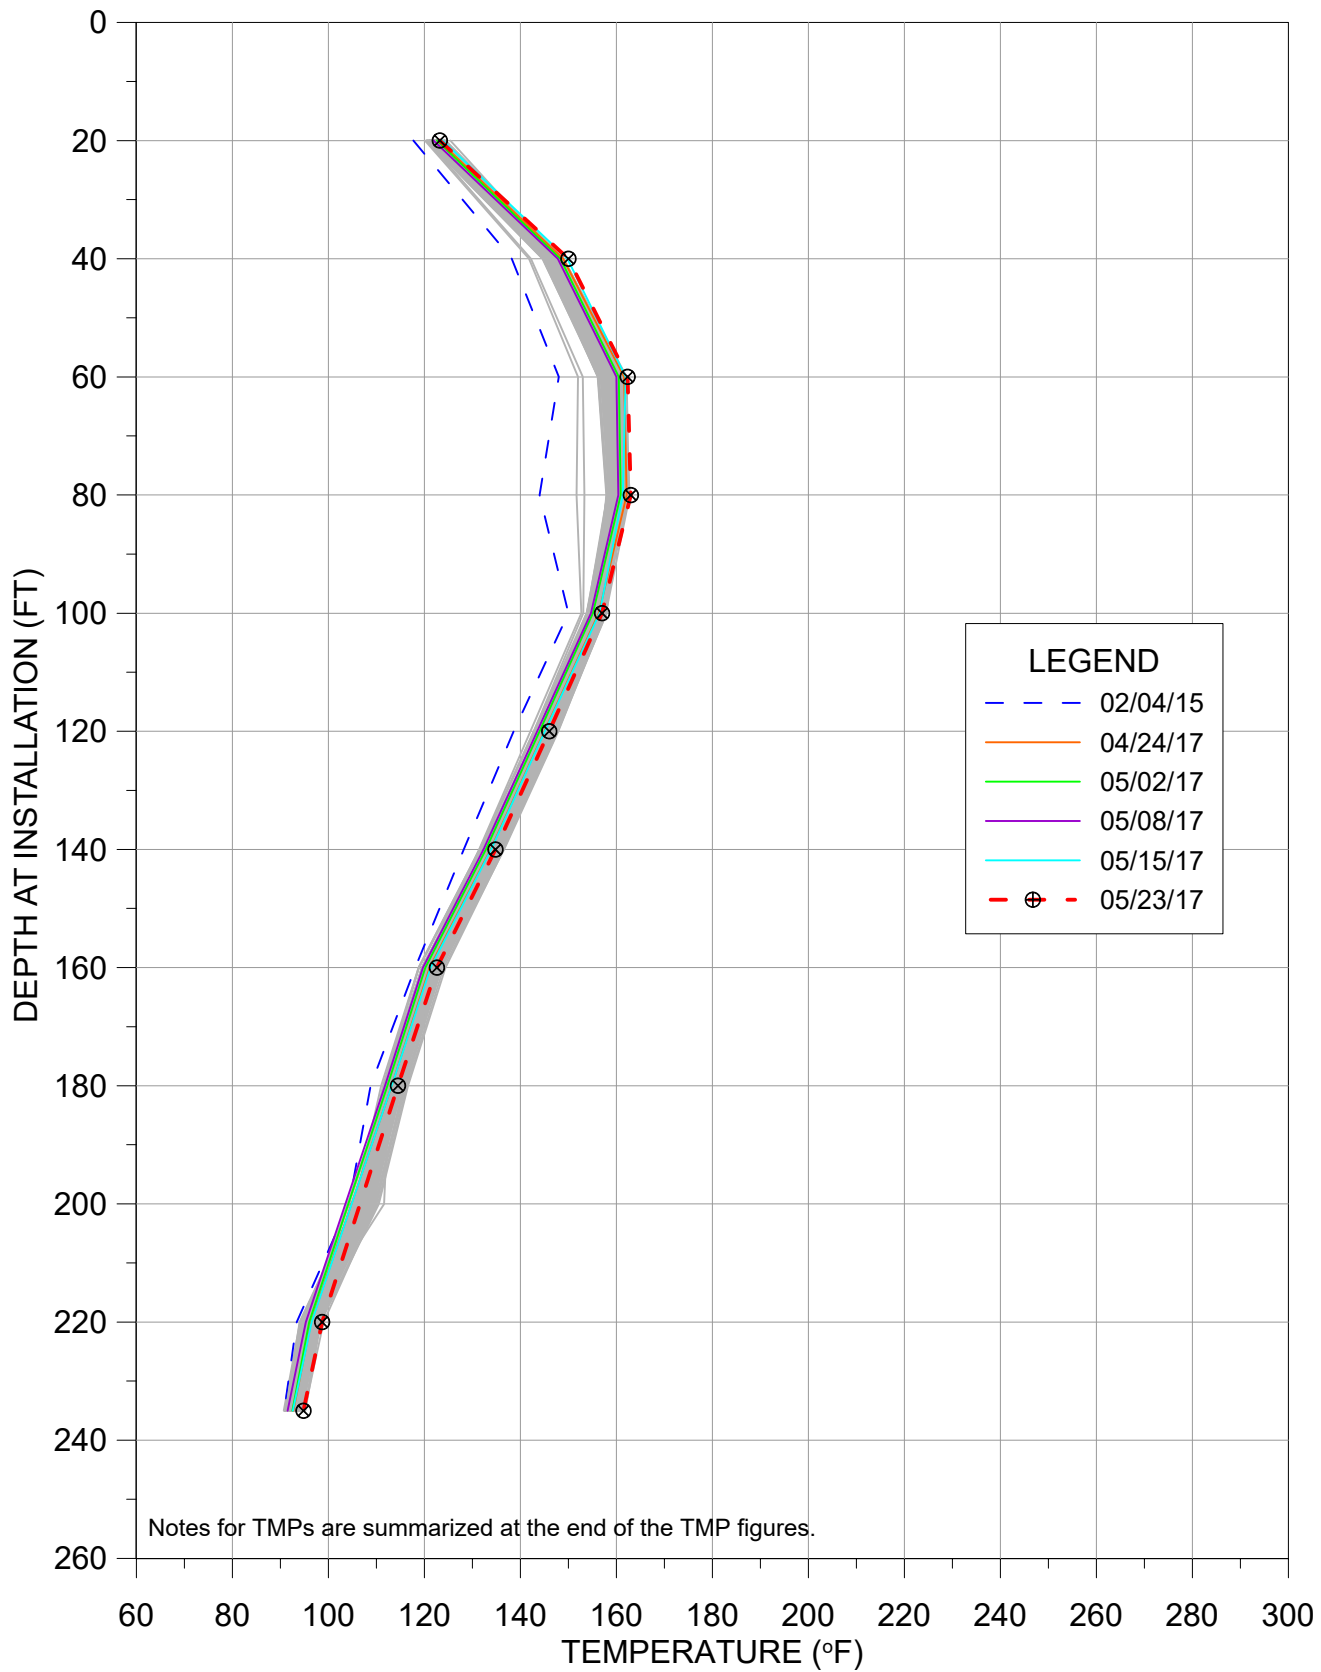
# TMP-25

1. The unit at 200 ft provided an apparent anomalous reading on 3/28/2017. Subsequent readings on 4/4/2017 showed the unit to have failed (see below). The unit is no longer working and the reading of 3/28/2017 was likely unreliable.
2. The unit at 200 ft depth had a resistance reading greater 4000 ohms on 4/4/2017. A connectivity test conducted by Feezor Engineering on 4/7/2017 showed that this unit also had cross-connectivity. The unit is therefore determined to be no longer working as of the 4/4/2017 reading.

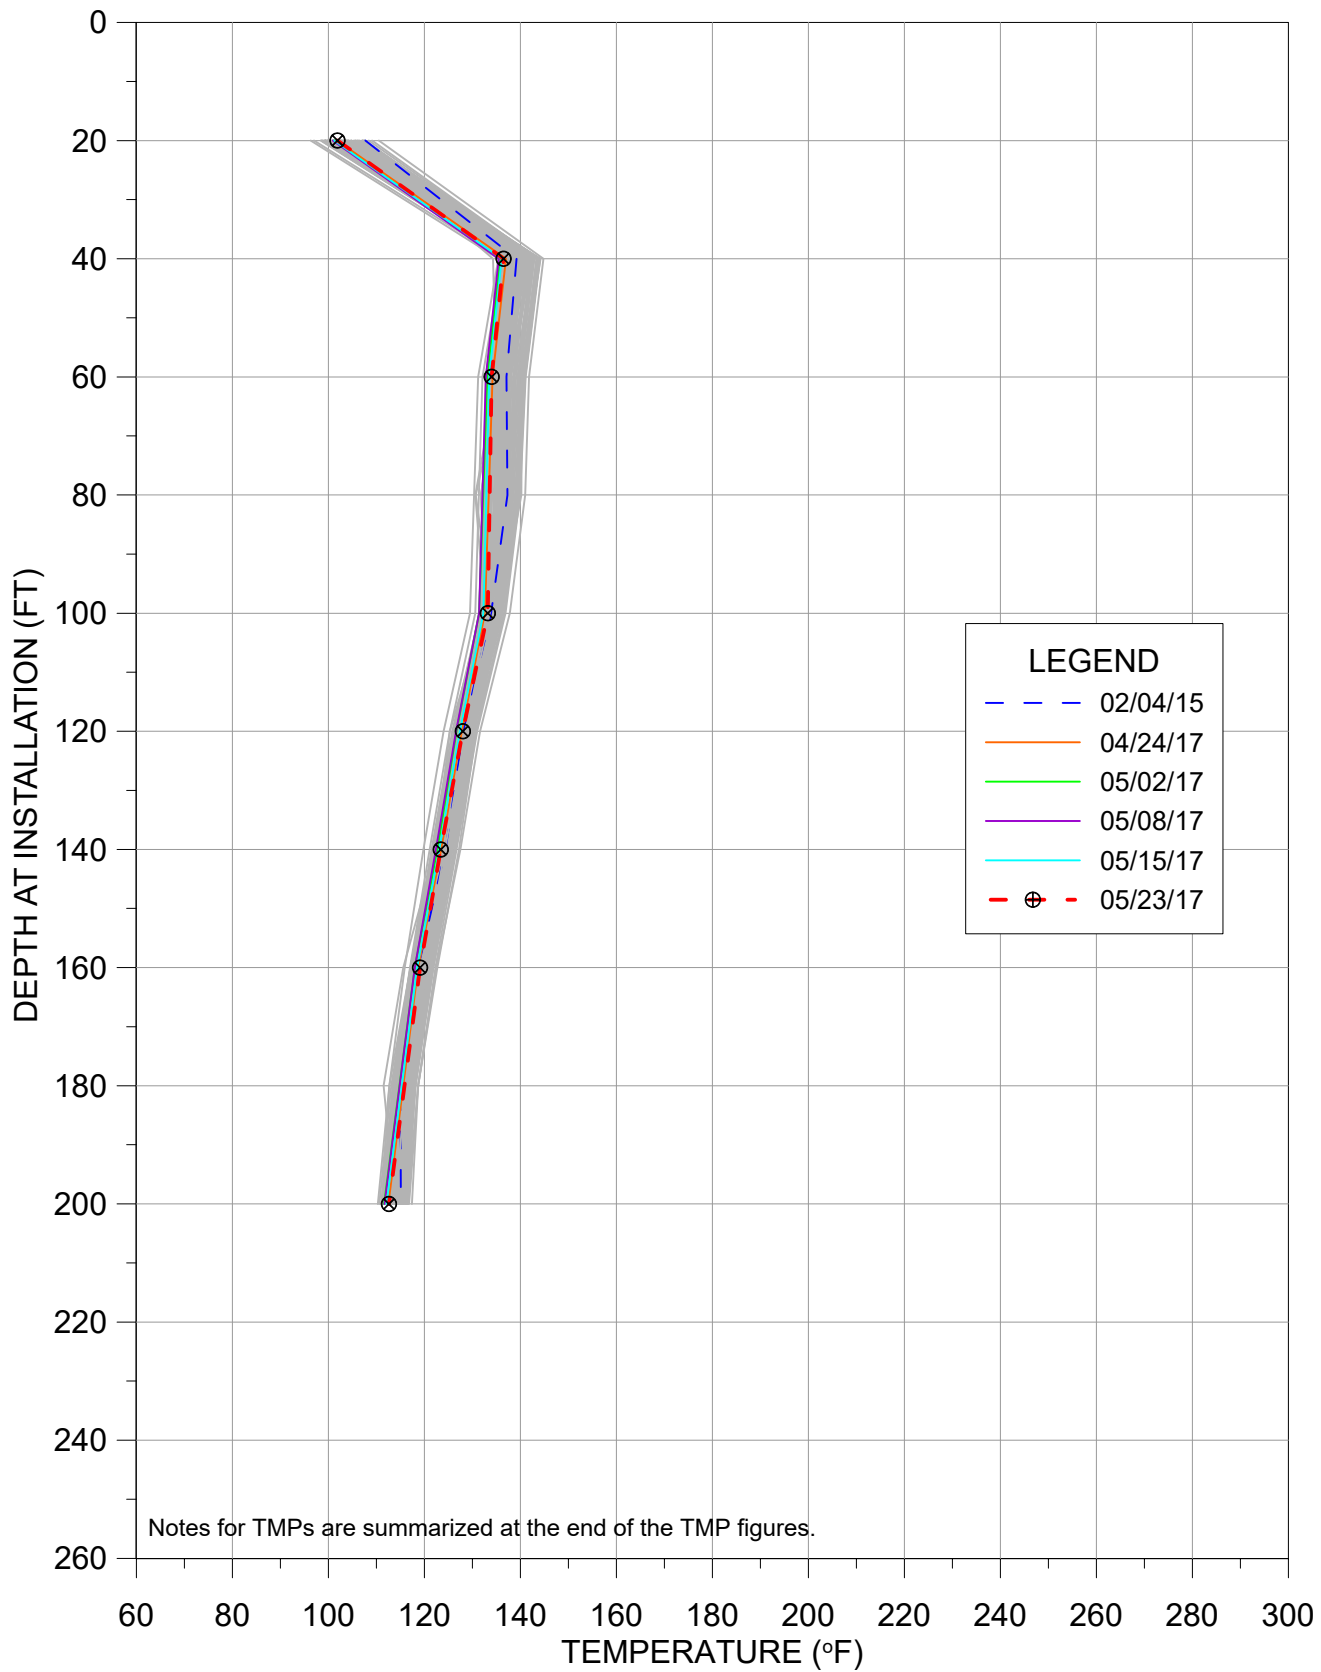
# TMP-28

1. The unit at 217 ft depth has had no resistance or temperature readings since installation.
2. The unit at 80 ft depth had a resistance drop and an unreasonable temperature decrease on 6/1/2016. The temperature has since fluctuated and is determined to be unreliable.
3. The unit at 180 feet has had a higher than acceptable limit since 3/28/2017 and is therefore determined to be unreliable as of the 4/4/2017 reading.

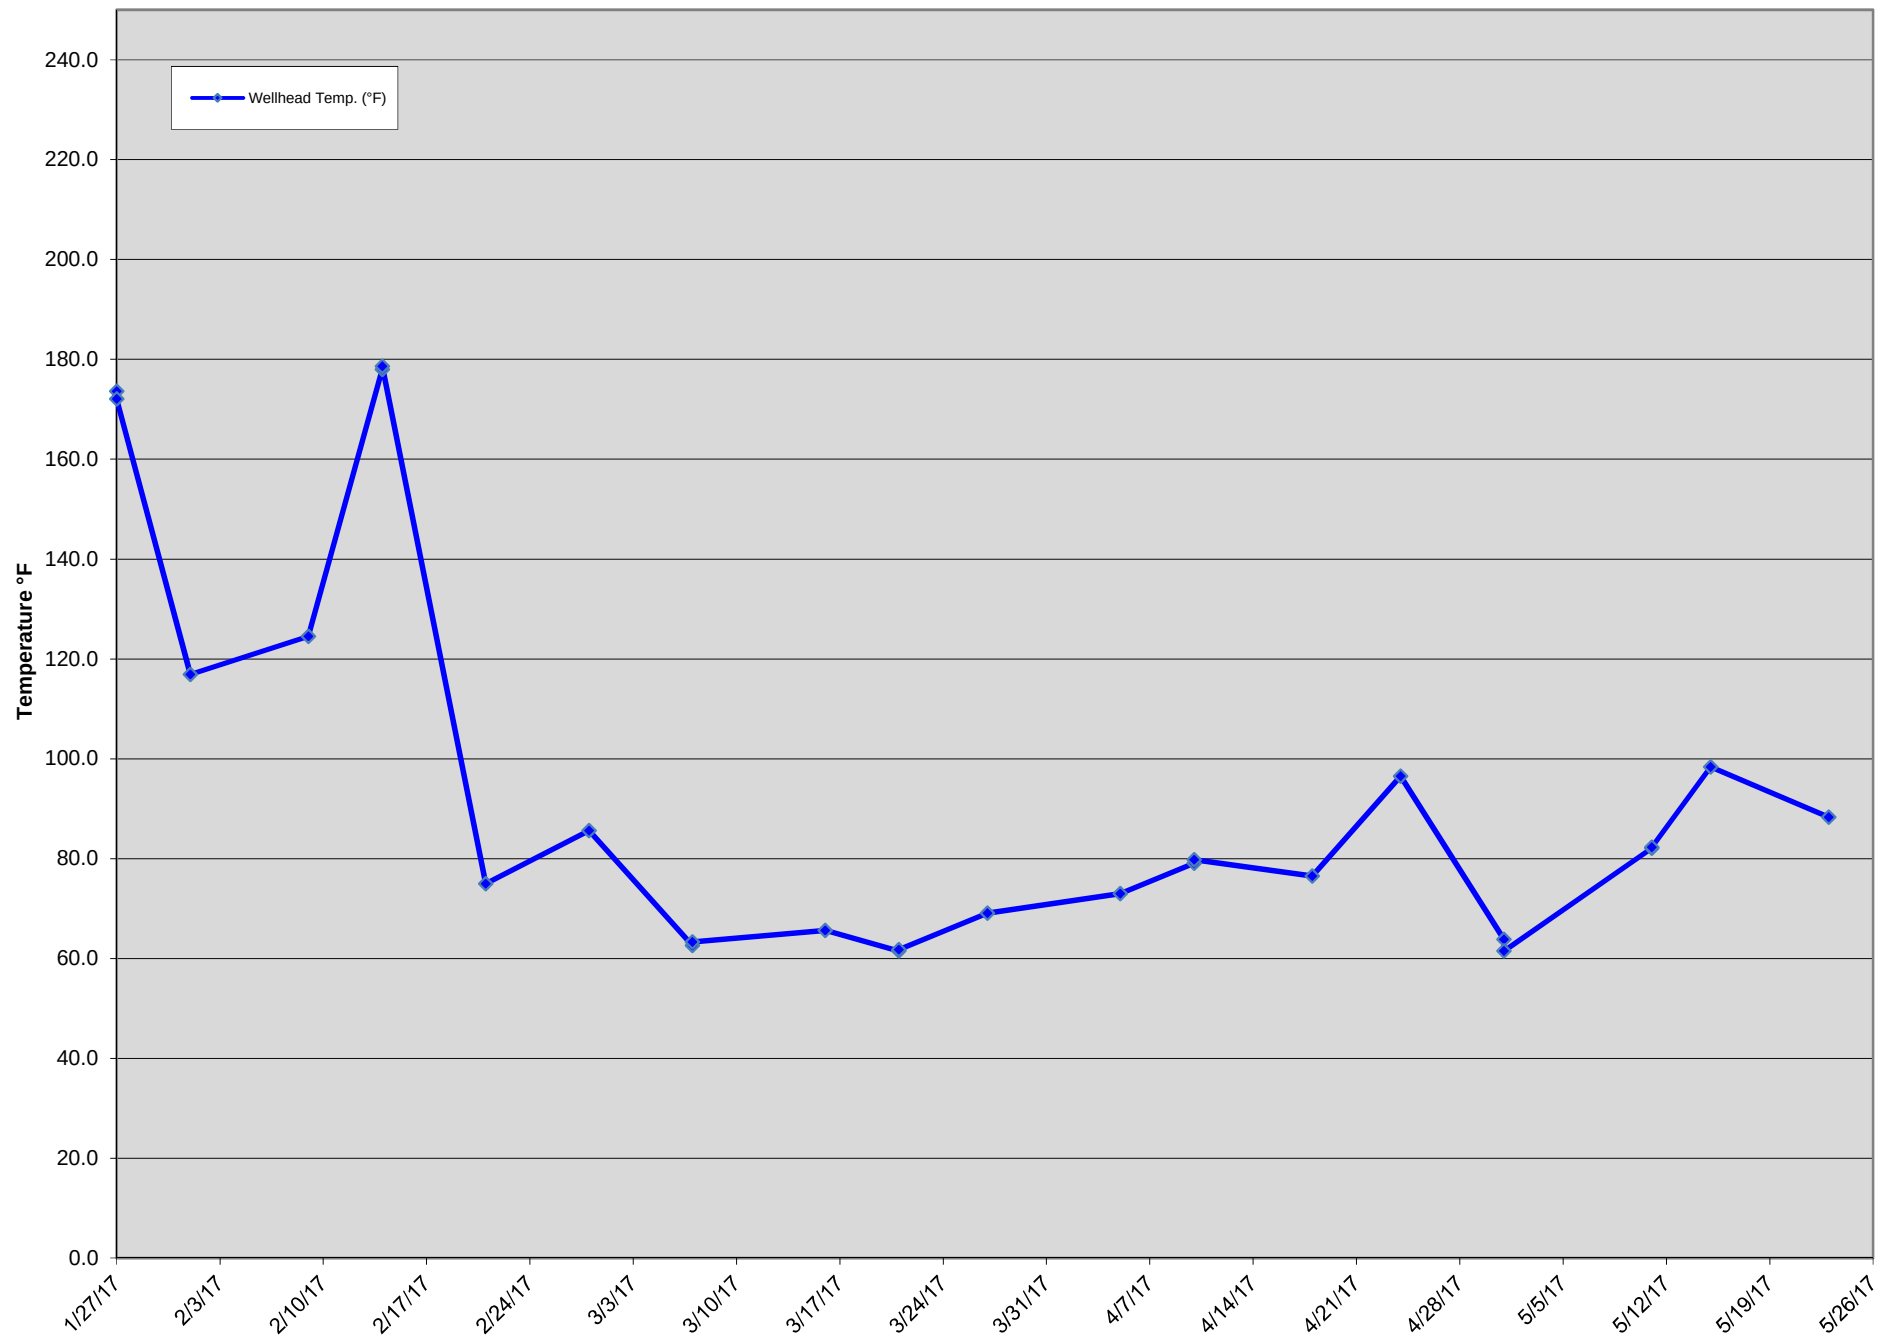
GIW-1 Wellhead Temperatures

As part of the HES, there are currently cooling water circulation loops installed in twelve Gas Interceptor Wells (GIWs) (GIW-02 through GIW-13). The remaining well (GIW-01) had a measured gas temperature within its historical operating limits.
