# **Bridgeton Landfill, LLC**

## **Weekly Data Submittal**

**Week of May 28, 2017 – June 3, 2017**

**Required by Section 52.F of Agreed Order, Case No. 13SL-CC01088  
Effective May 13, 2013**

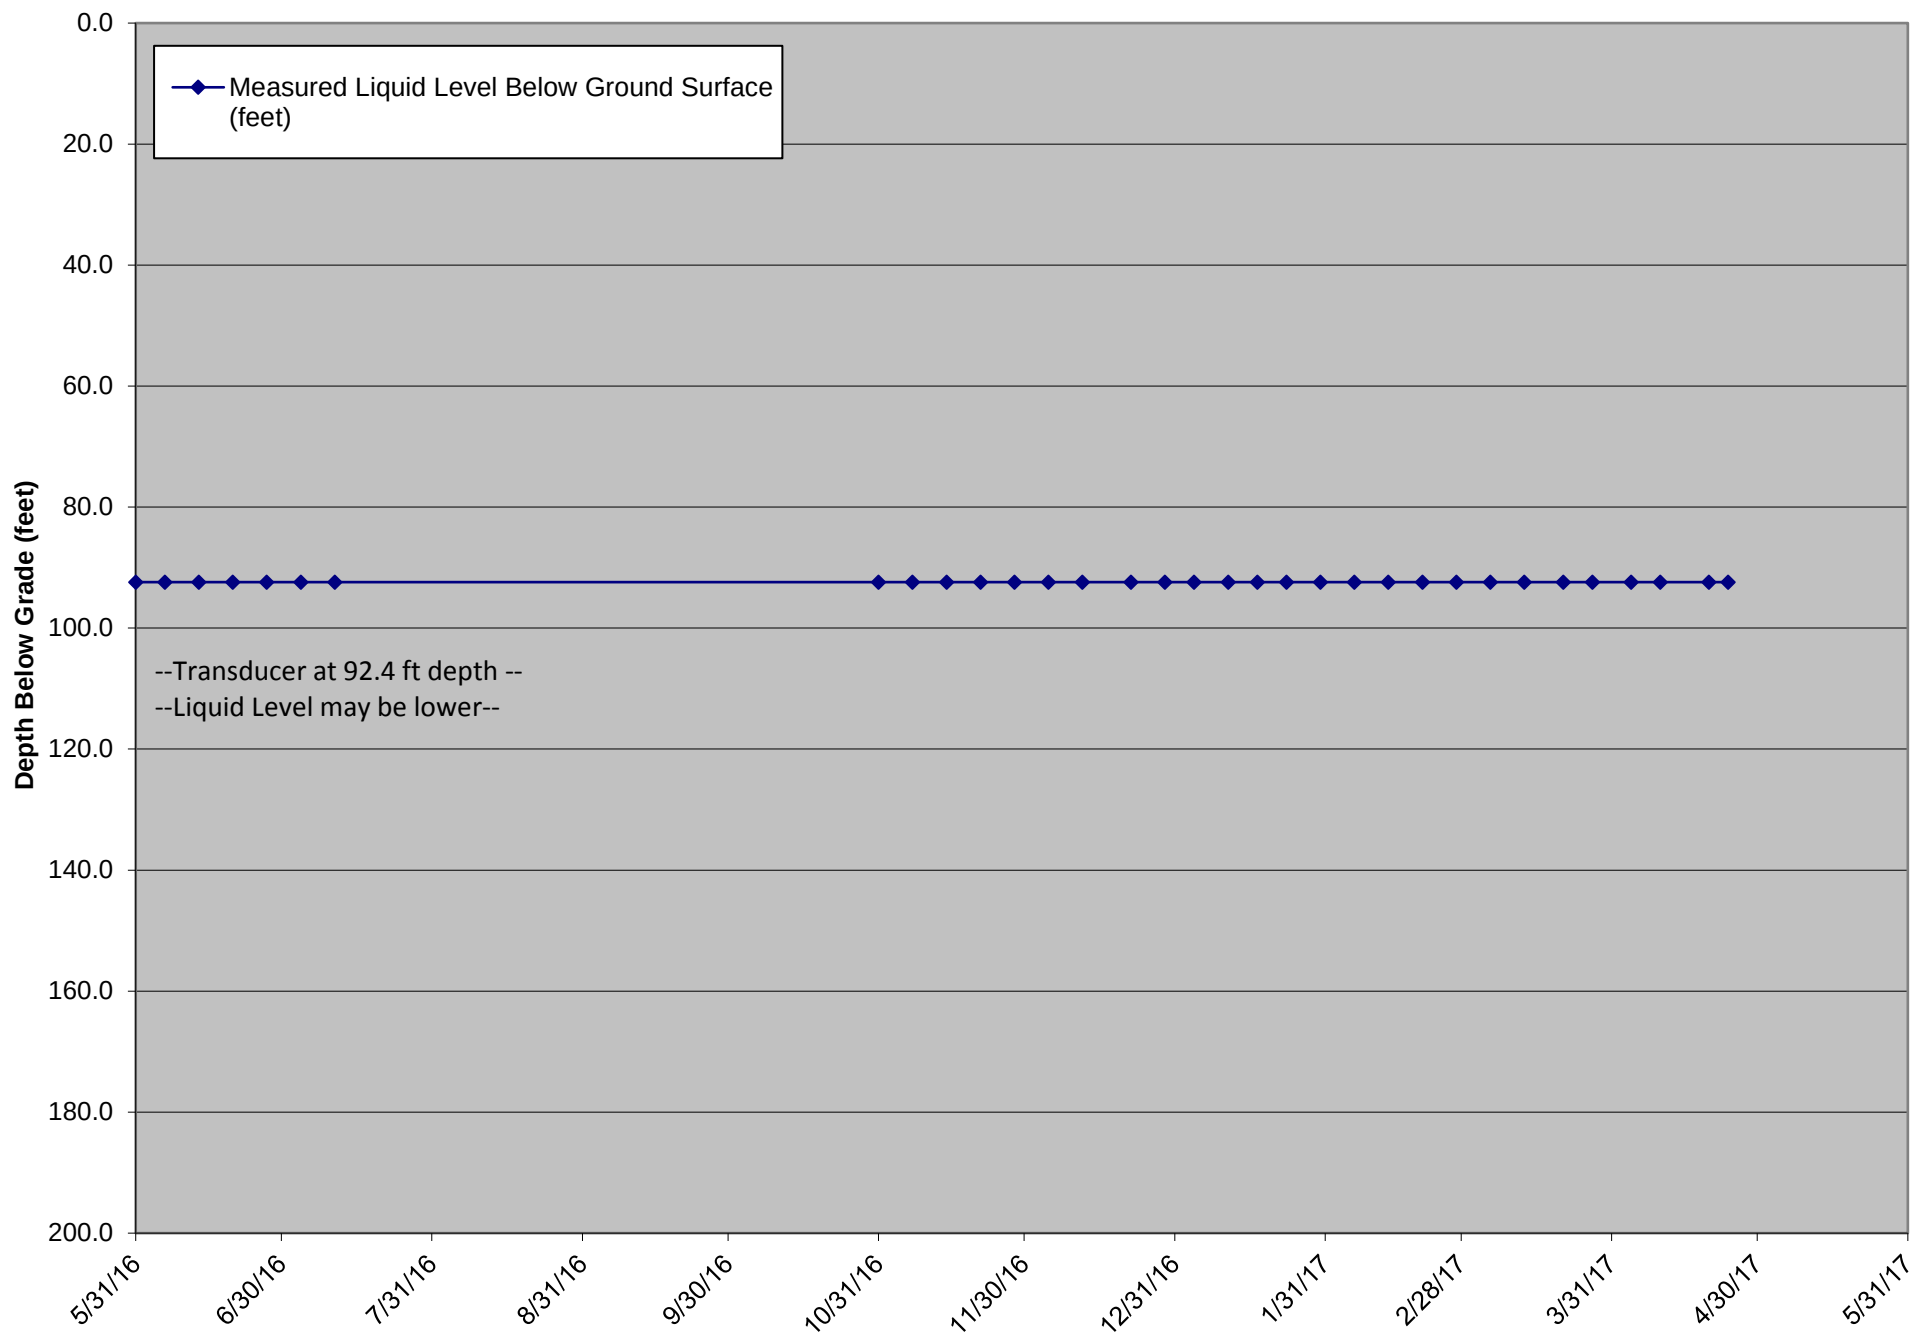
# LCS-1D Liquid Level Below Ground Surface

LCS-1D is equipped with a level sensor and a flow meter. Bridgeton Landfill confirmed that the flow meter on LCS-1D is operational and the flow was observed during the weekly reporting period. Liquid level was not recorded by the level sensor during the weekly reporting period. Bridgeton Landfill initiated pump repairs and replacement of the level sensor on LCS-1D during the week of 5/22/2017 and continued during the week of 5/29/2017. Level sensor replacement is pending while awaiting parts arrival.

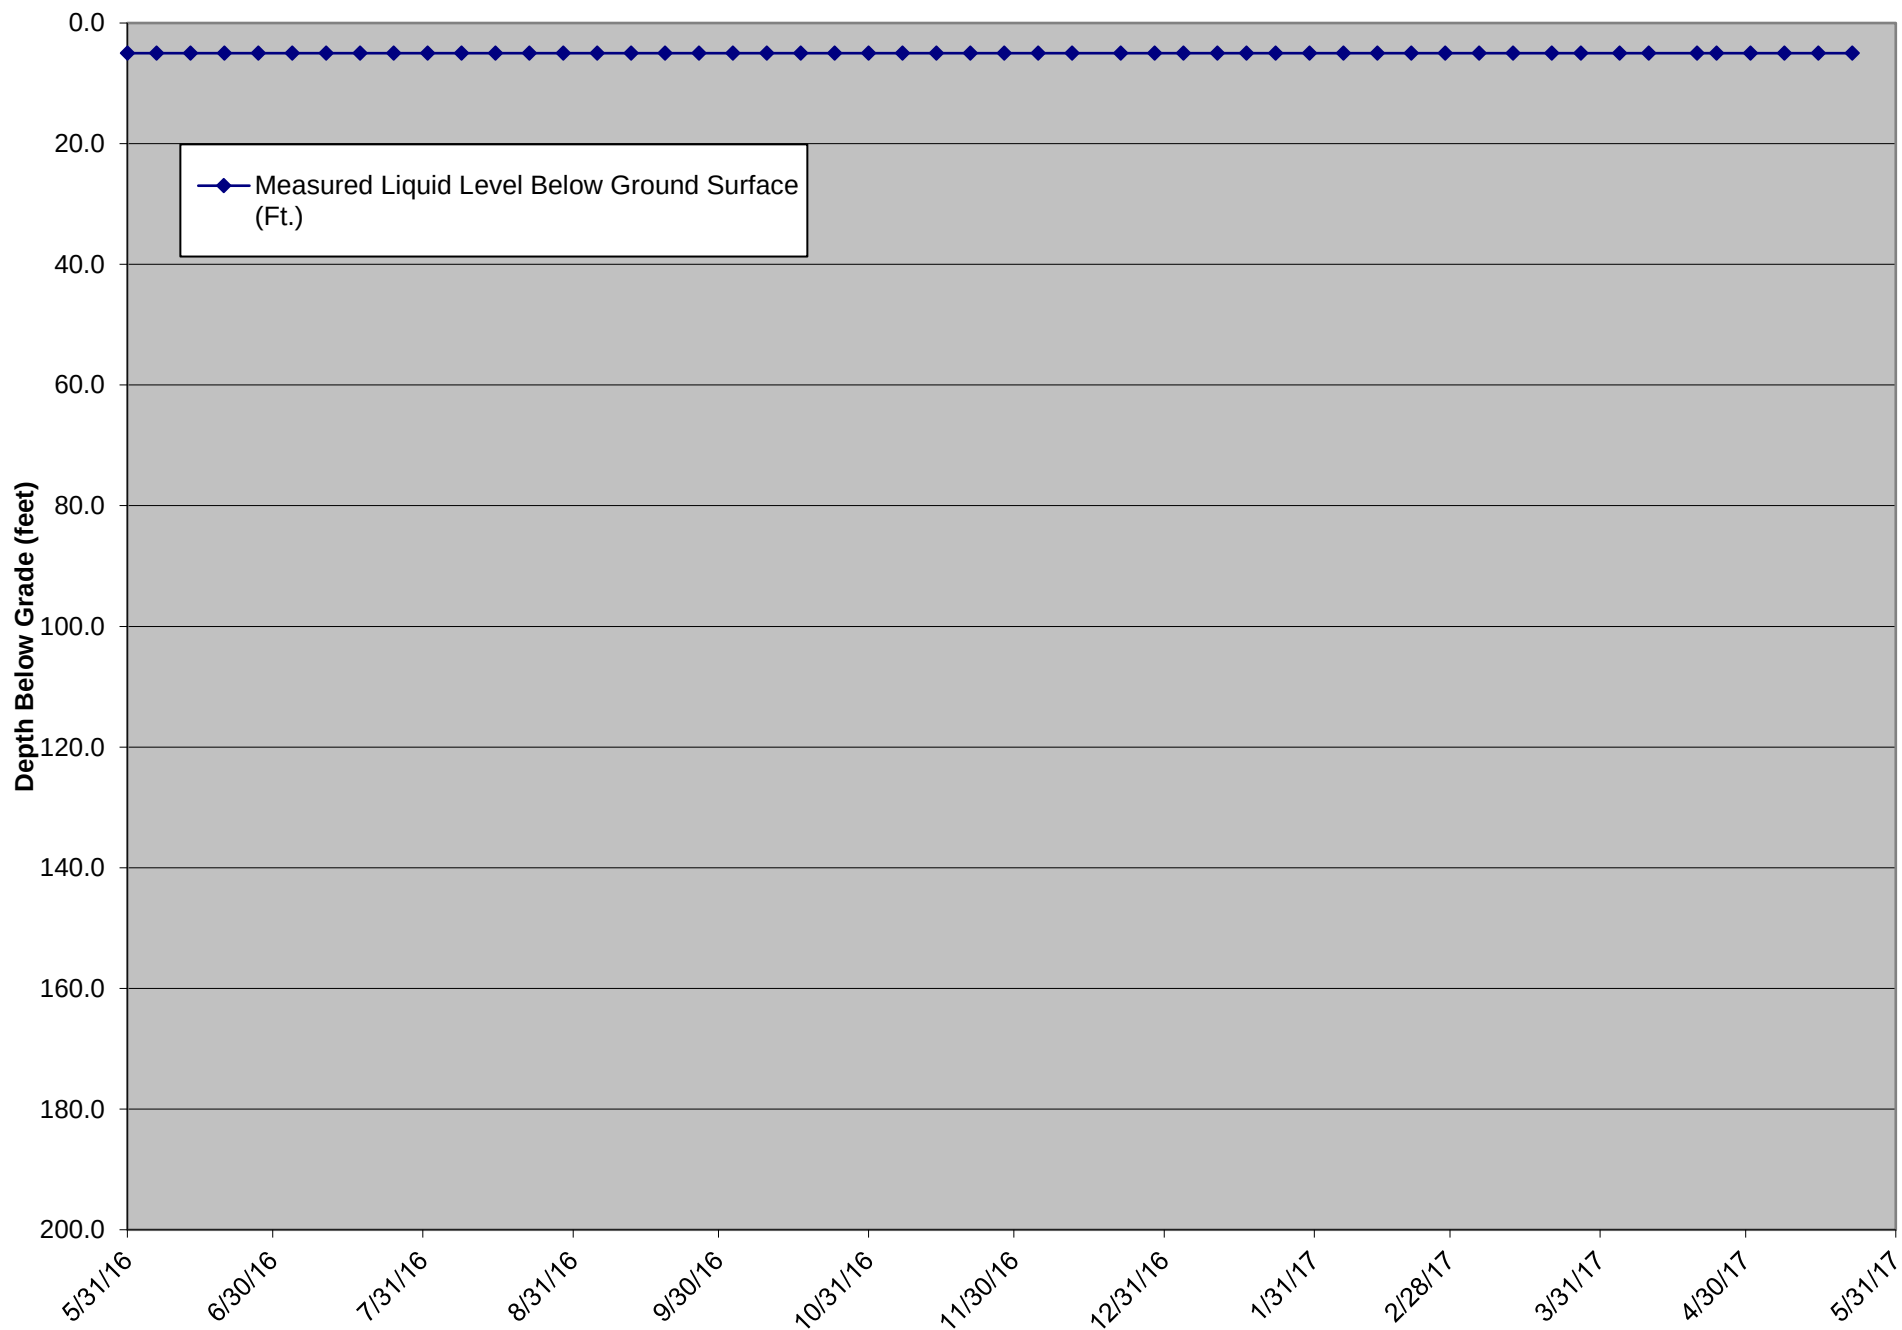
# LCS-3D Liquid Level Below Ground Surface

The pump in LCS-3D was non-operational during the weekly reporting period. Pump repair and transducer maintenance was initiated on LCD-3D the week of 5/22/2017 and continued the week of 5/29/2017.

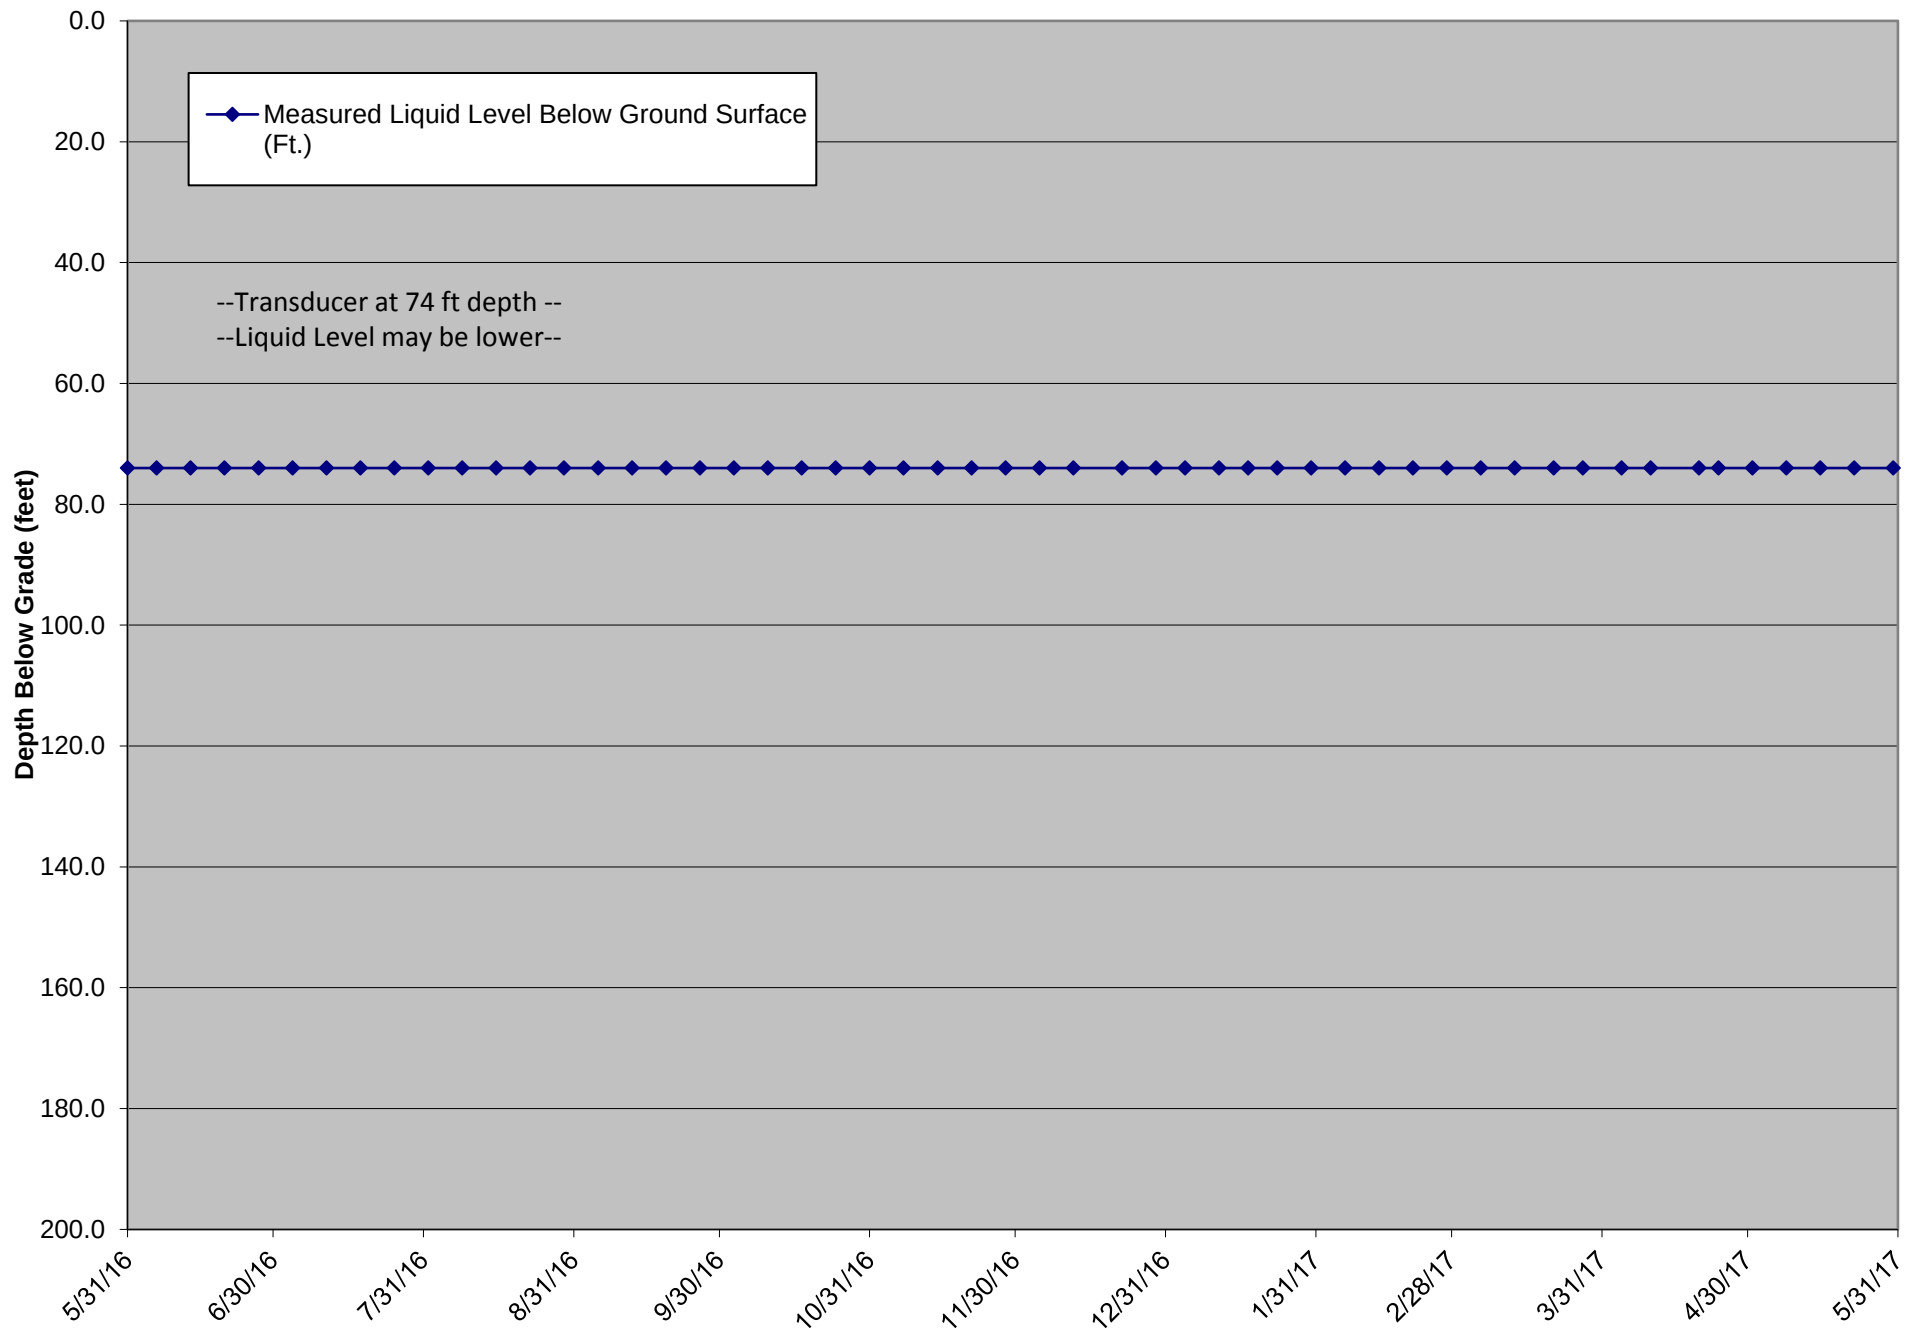
# LCS-4B Liquid Level Below Ground Surface

The level sensor in LCS-4B is currently operational and responsive. Liquid level was not recorded by the level sensor during the weekly reporting period. LCS-4B is equipped with a flow meter that displayed no flow during the weekly reporting period. Therefore, it can be concluded that the liquid level was below the bottom of the pump and level sensor in LCS-4B.

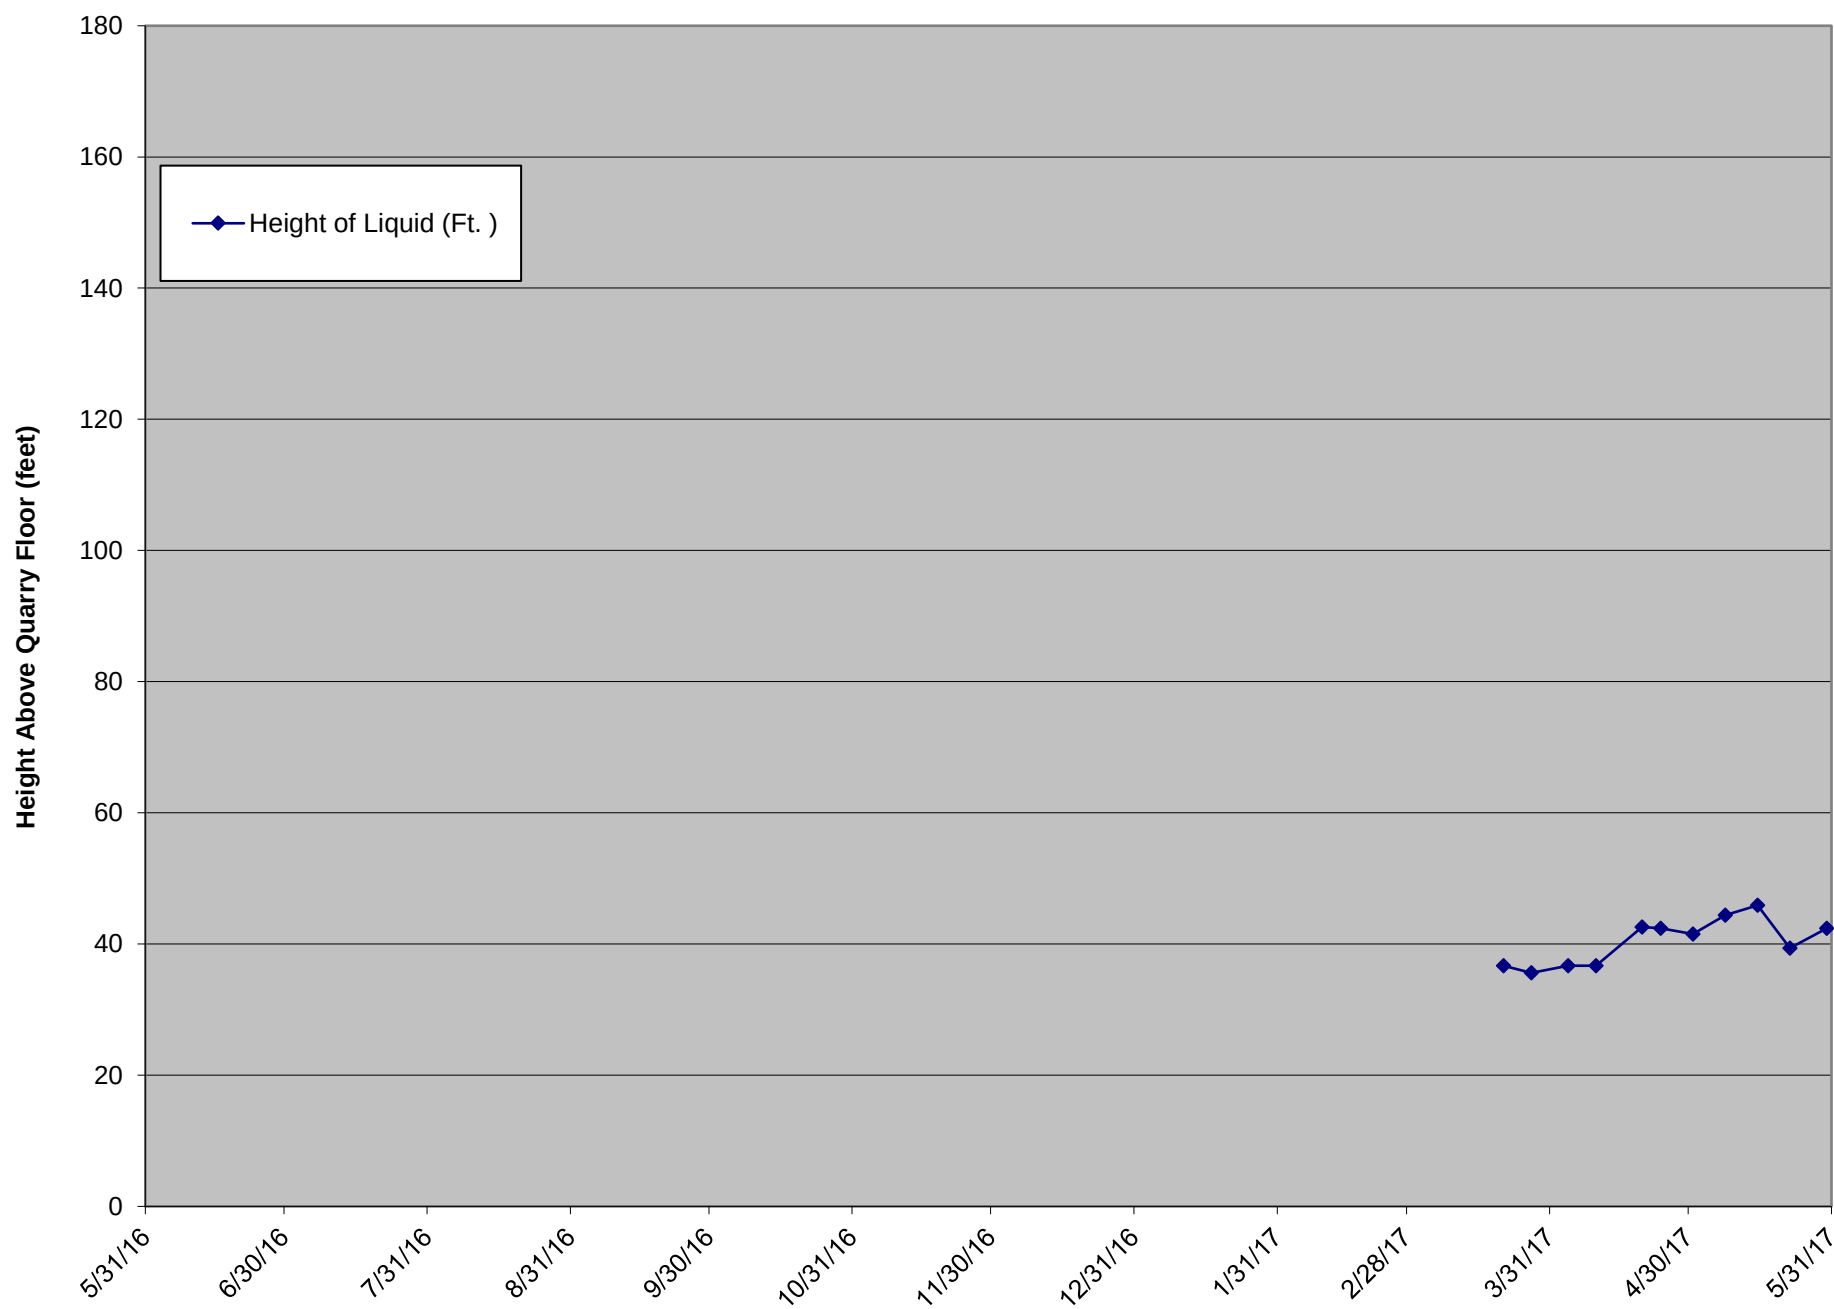
LCS-5B Liquid Level Above Quarry Floor

LCS-5B and LCS-6B were fully operational during the weekly reporting period. LCS-5B was shut off periodically during the weekly reporting period for North Quarry EVOH related work.

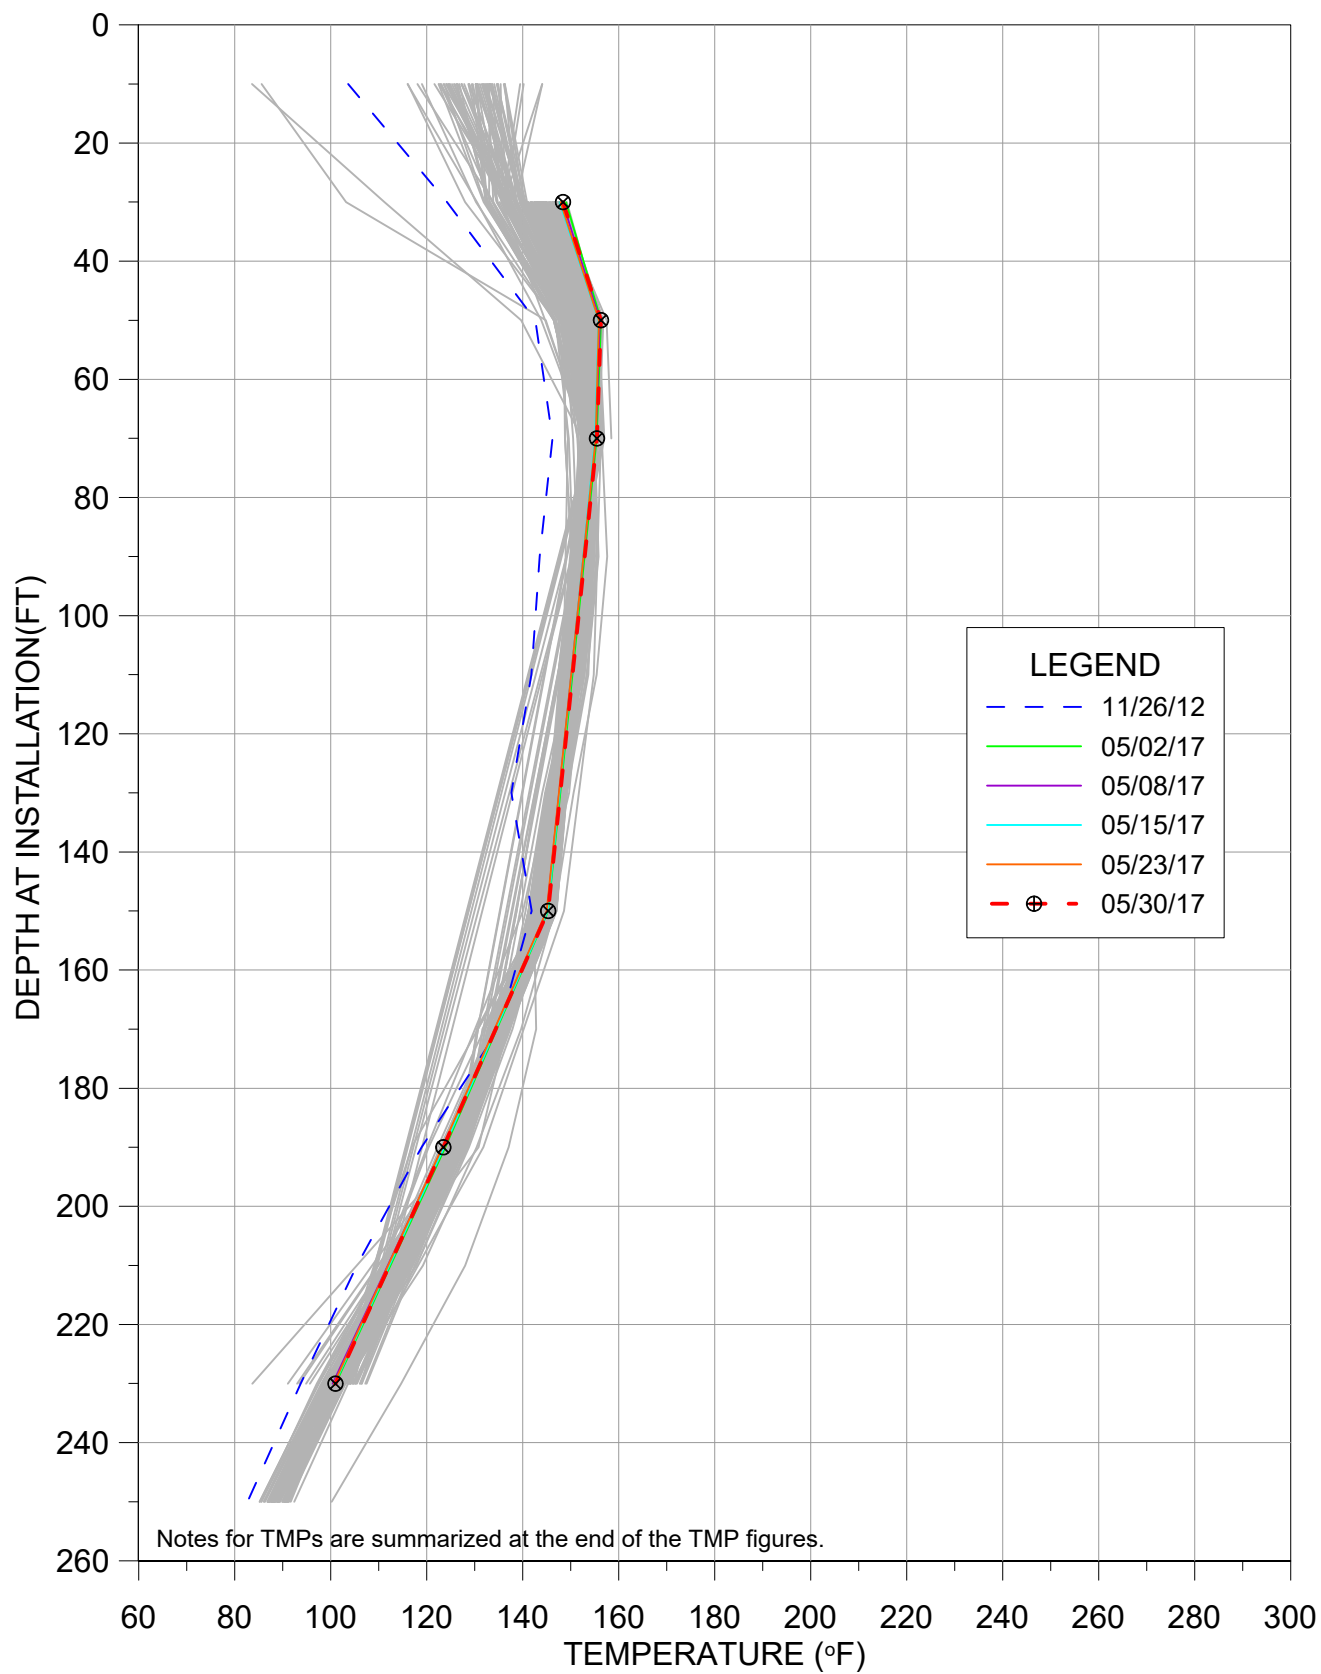
# TMP-3

1. No reliable temperature readings have been obtained at 170 ft depth since 1/29/2014, except on 3/13/2014.
2. The connectivity tests on 4/11/2014 conducted by CEC showed that units at 10, 90, 130, 210 and 250 ft depths are no longer reliable.
3. The connectivity tests on 10/28/2014 conducted by Feezor Engineering showed that units at 10, 90, 110, 130, 210 and 250 ft depths are not reliable.

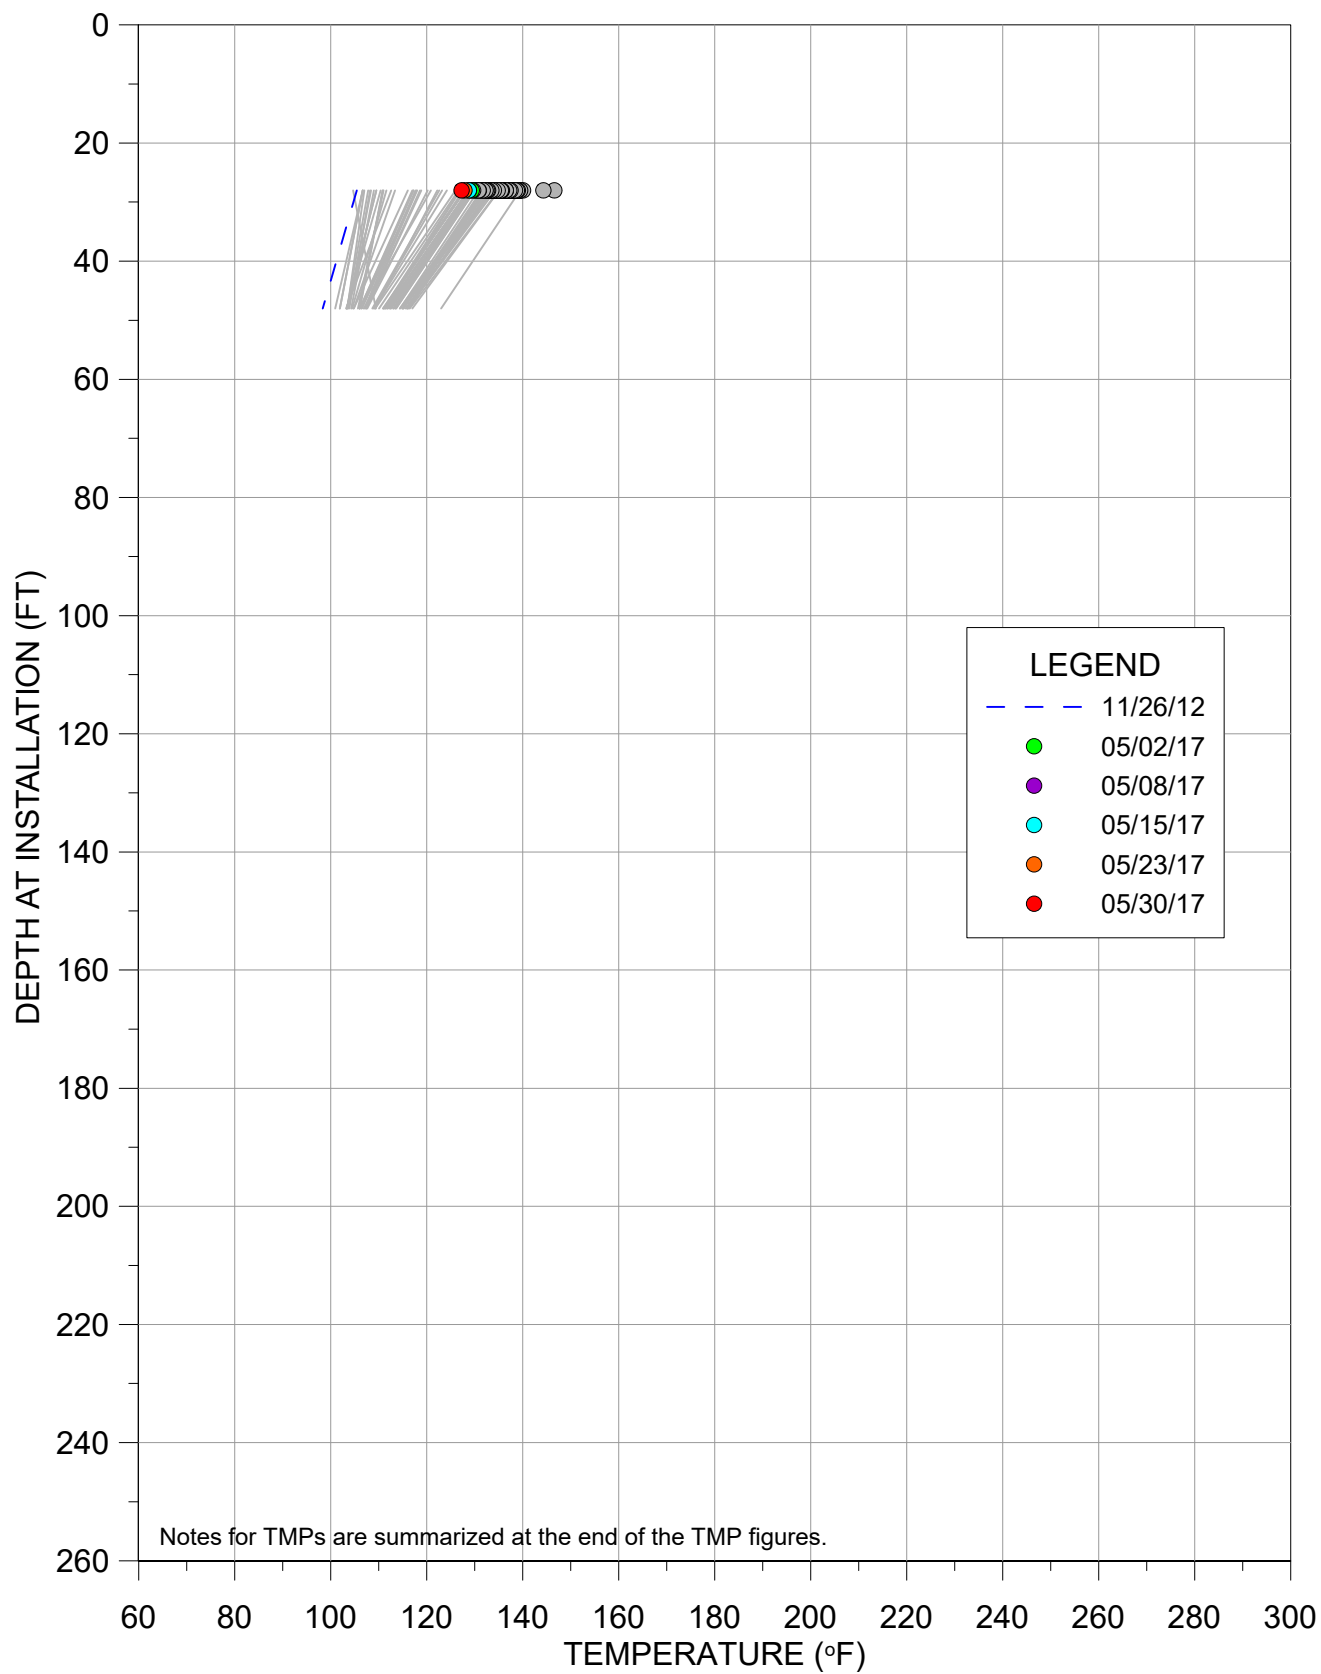
# TMP-4

1. The connectivity tests on 4/11/2014 conducted by CEC showed that the unit at 48 ft depth is no longer reliable.

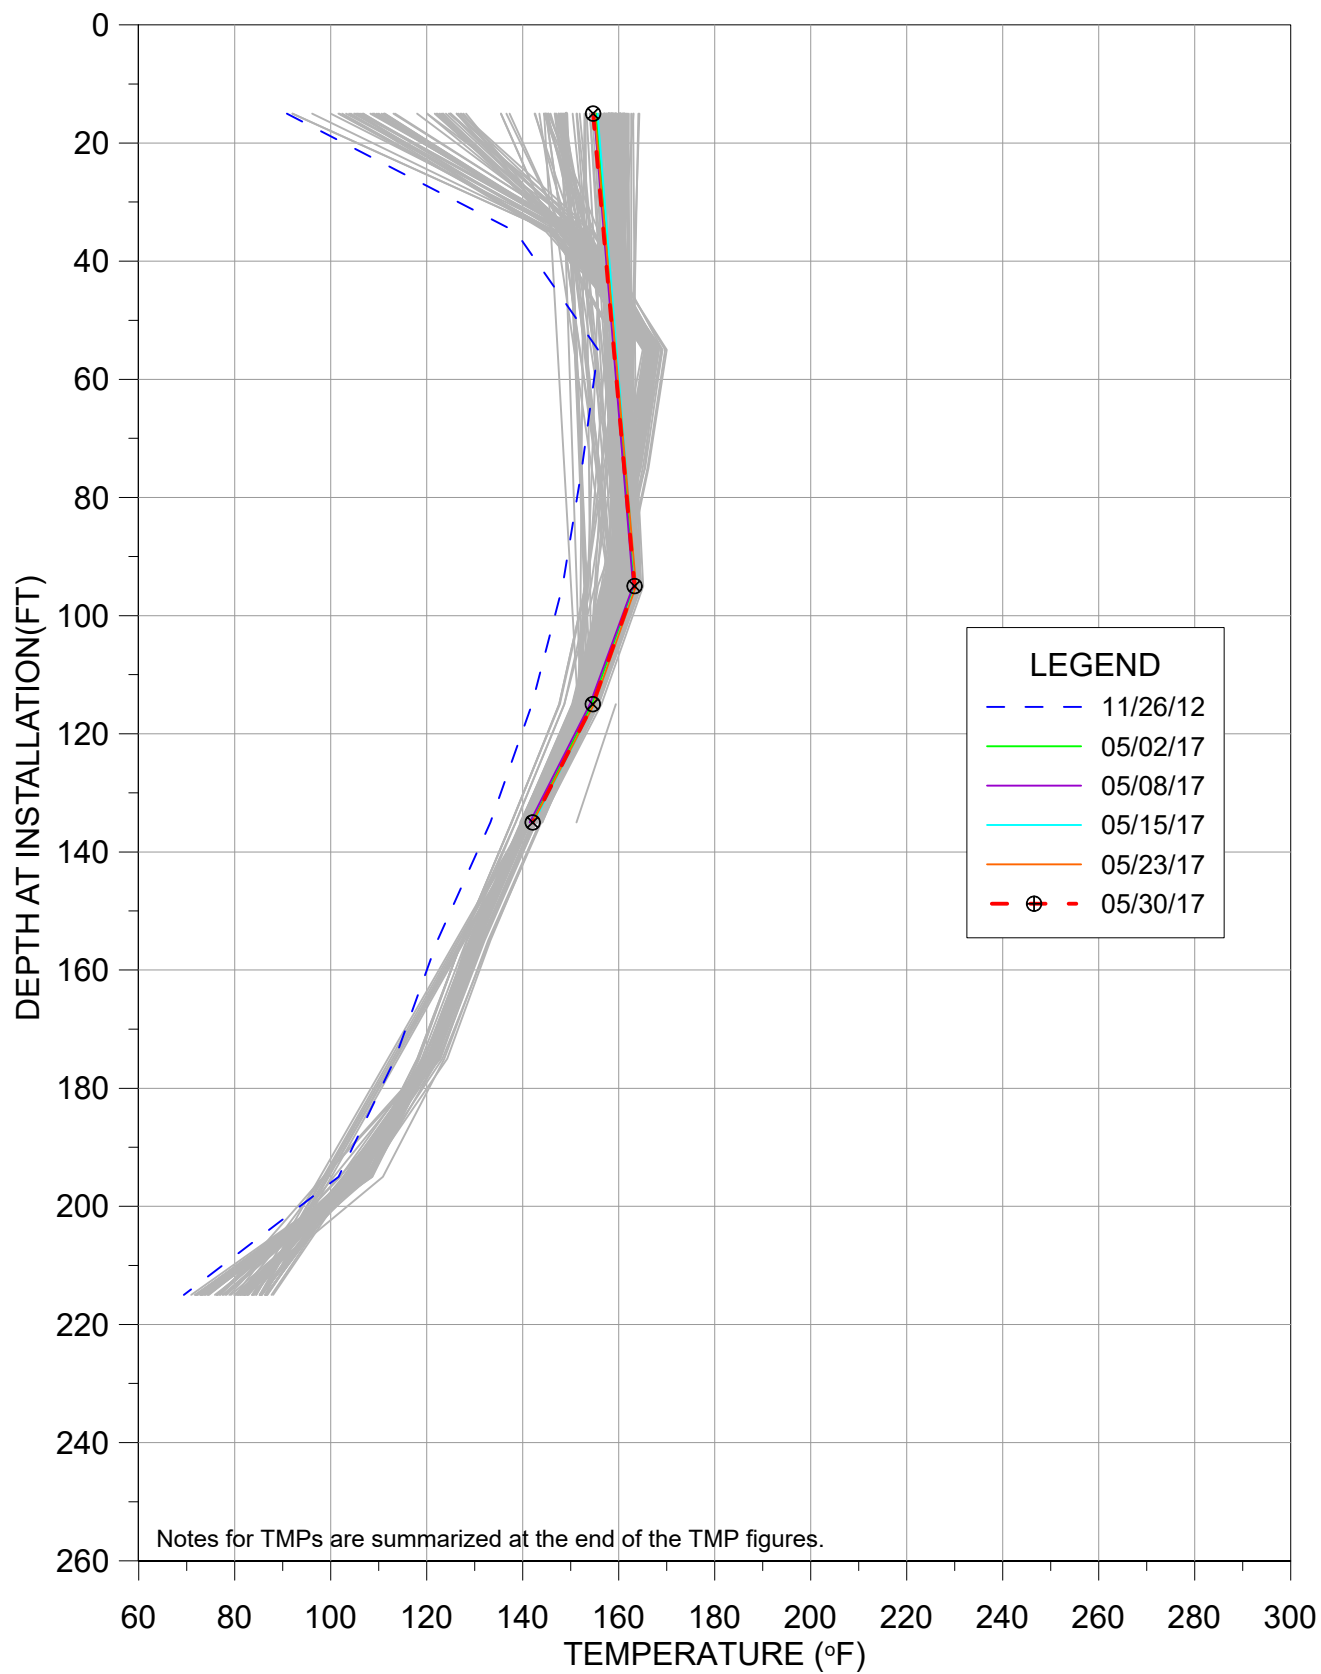
# TMP-6

1. The connectivity tests on 4/11/2014 conducted by CEC showed that units at 35, 55, 75, 155, 175, and 195 ft depths are no longer reliable.
2. No reliable temperature readings have been obtained at the unit at 215 ft depth since 6/13/2014.

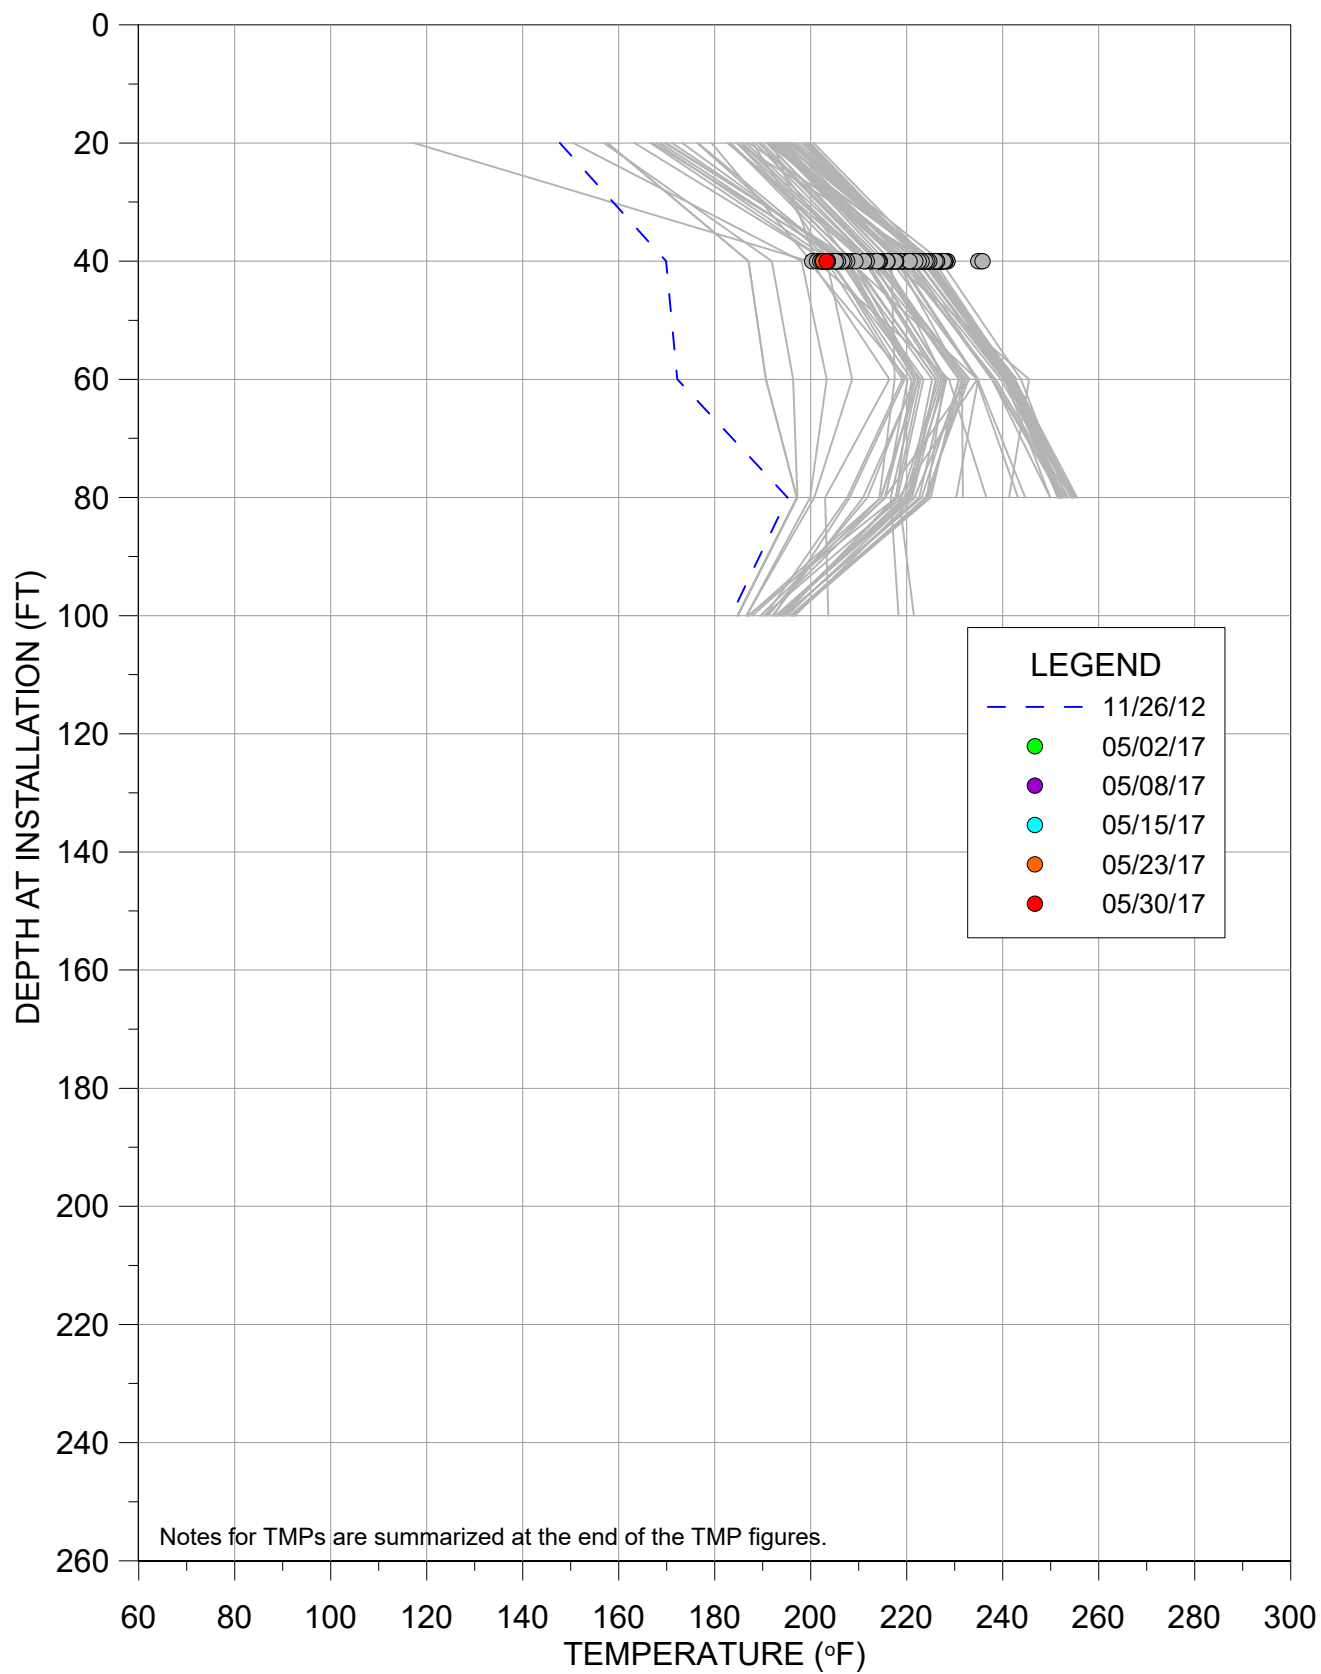
# TMP-9

1. Unit at 100 ft depth had an inaccurate temperature reading on 8/1/2013 and no reading since 8/6/2013.
2. The connectivity tests on 4/11/2014 conducted by CEC showed that units at 20, 60, 80, and 100 ft depths are no longer reliable.

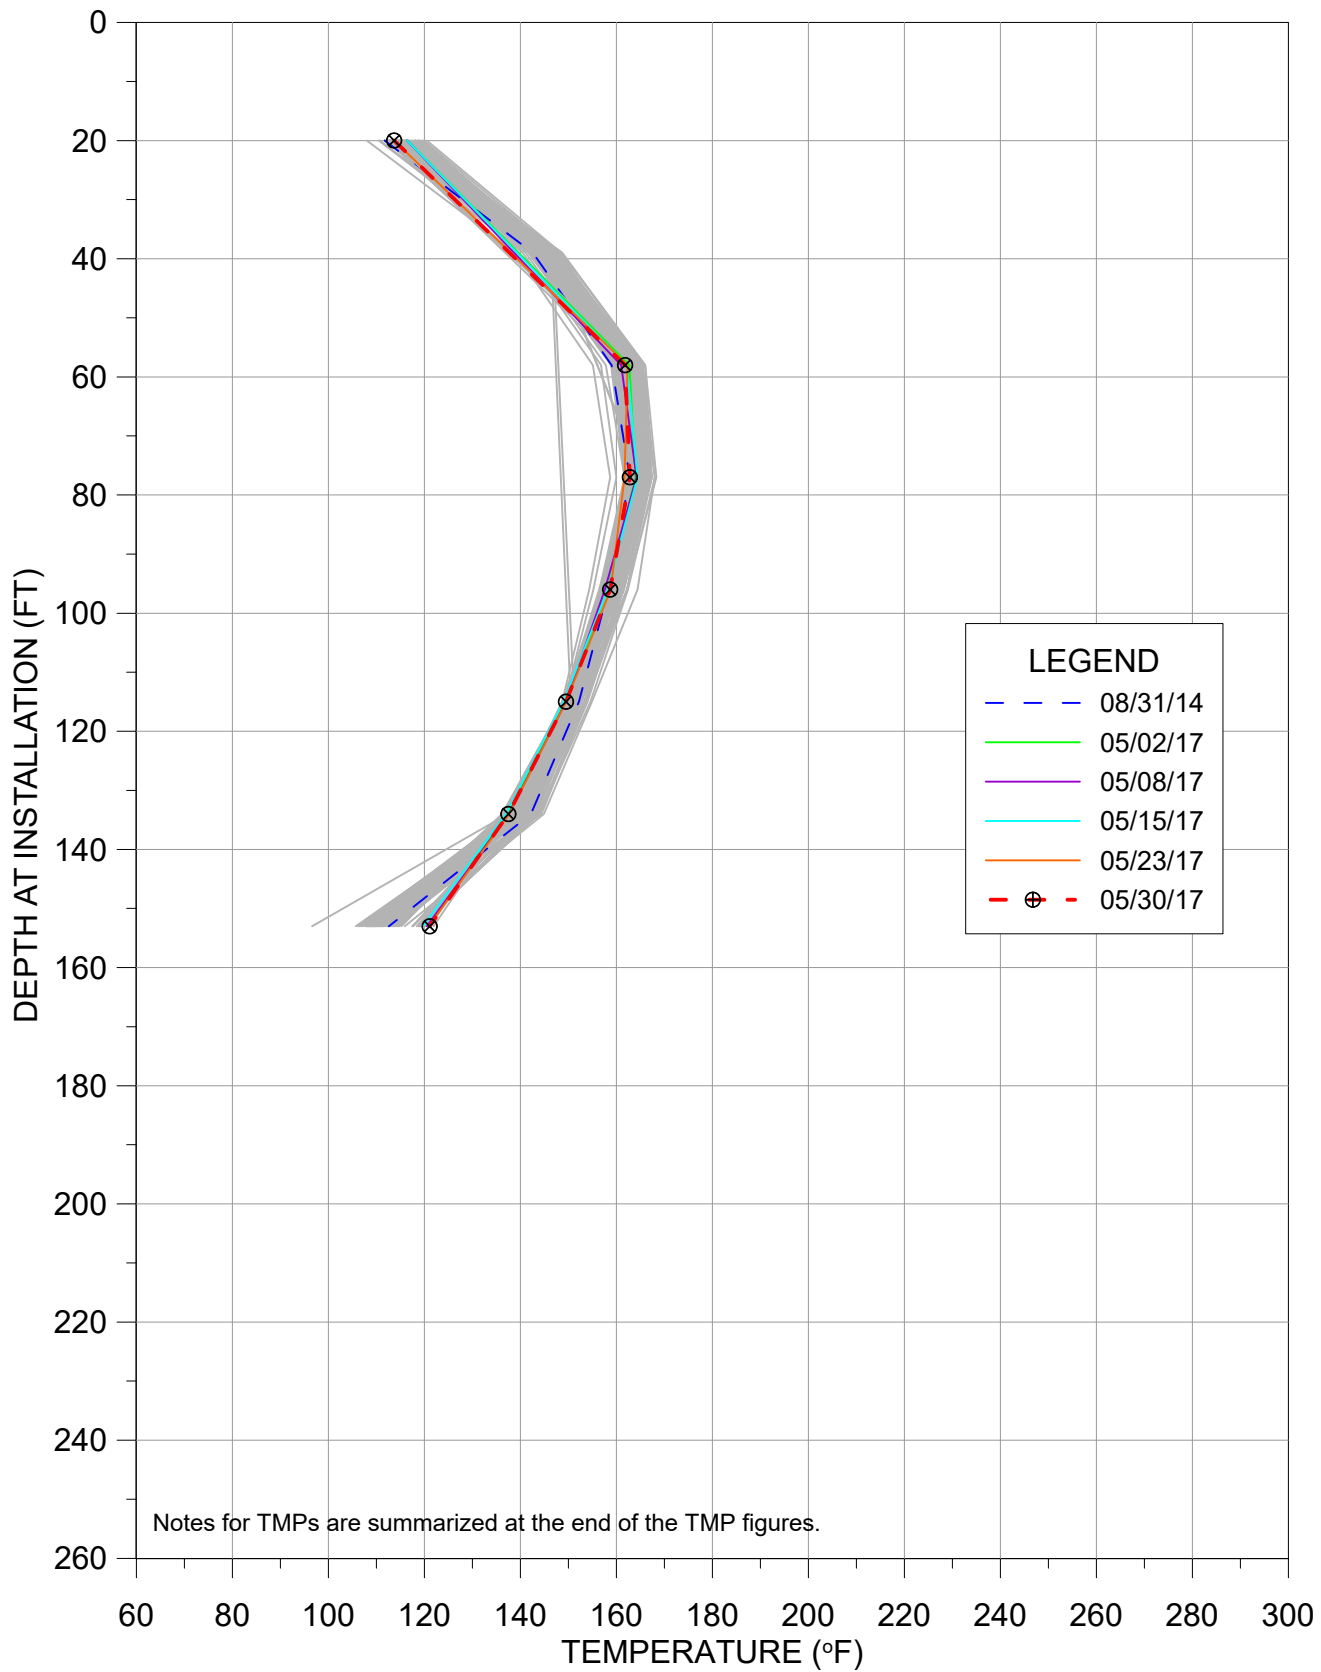
# TMP-16

1. A connectivity test conducted by Feezor Engineering showed that the units on TMP-16 may not be reliable since 9/9/2015. Further testing at the end of September 2015 showed possible connectivity on some of the units.
2. The unit at 153 ft depth had a low resistance reading and unreliable temperature since 12/21/2015.

3. The unit at 39 ft depth had a higher than acceptable resistance reading and unreliable temperature since 2/7/2017.
