# **Bridgeton Landfill, LLC**

## **Weekly Data Submittal**

**Week of May 28, 2017 – June 3, 2017**

**Required by Section 52.F of Agreed Order, Case No. 13SL-CC01088  
Effective May 13, 2013**

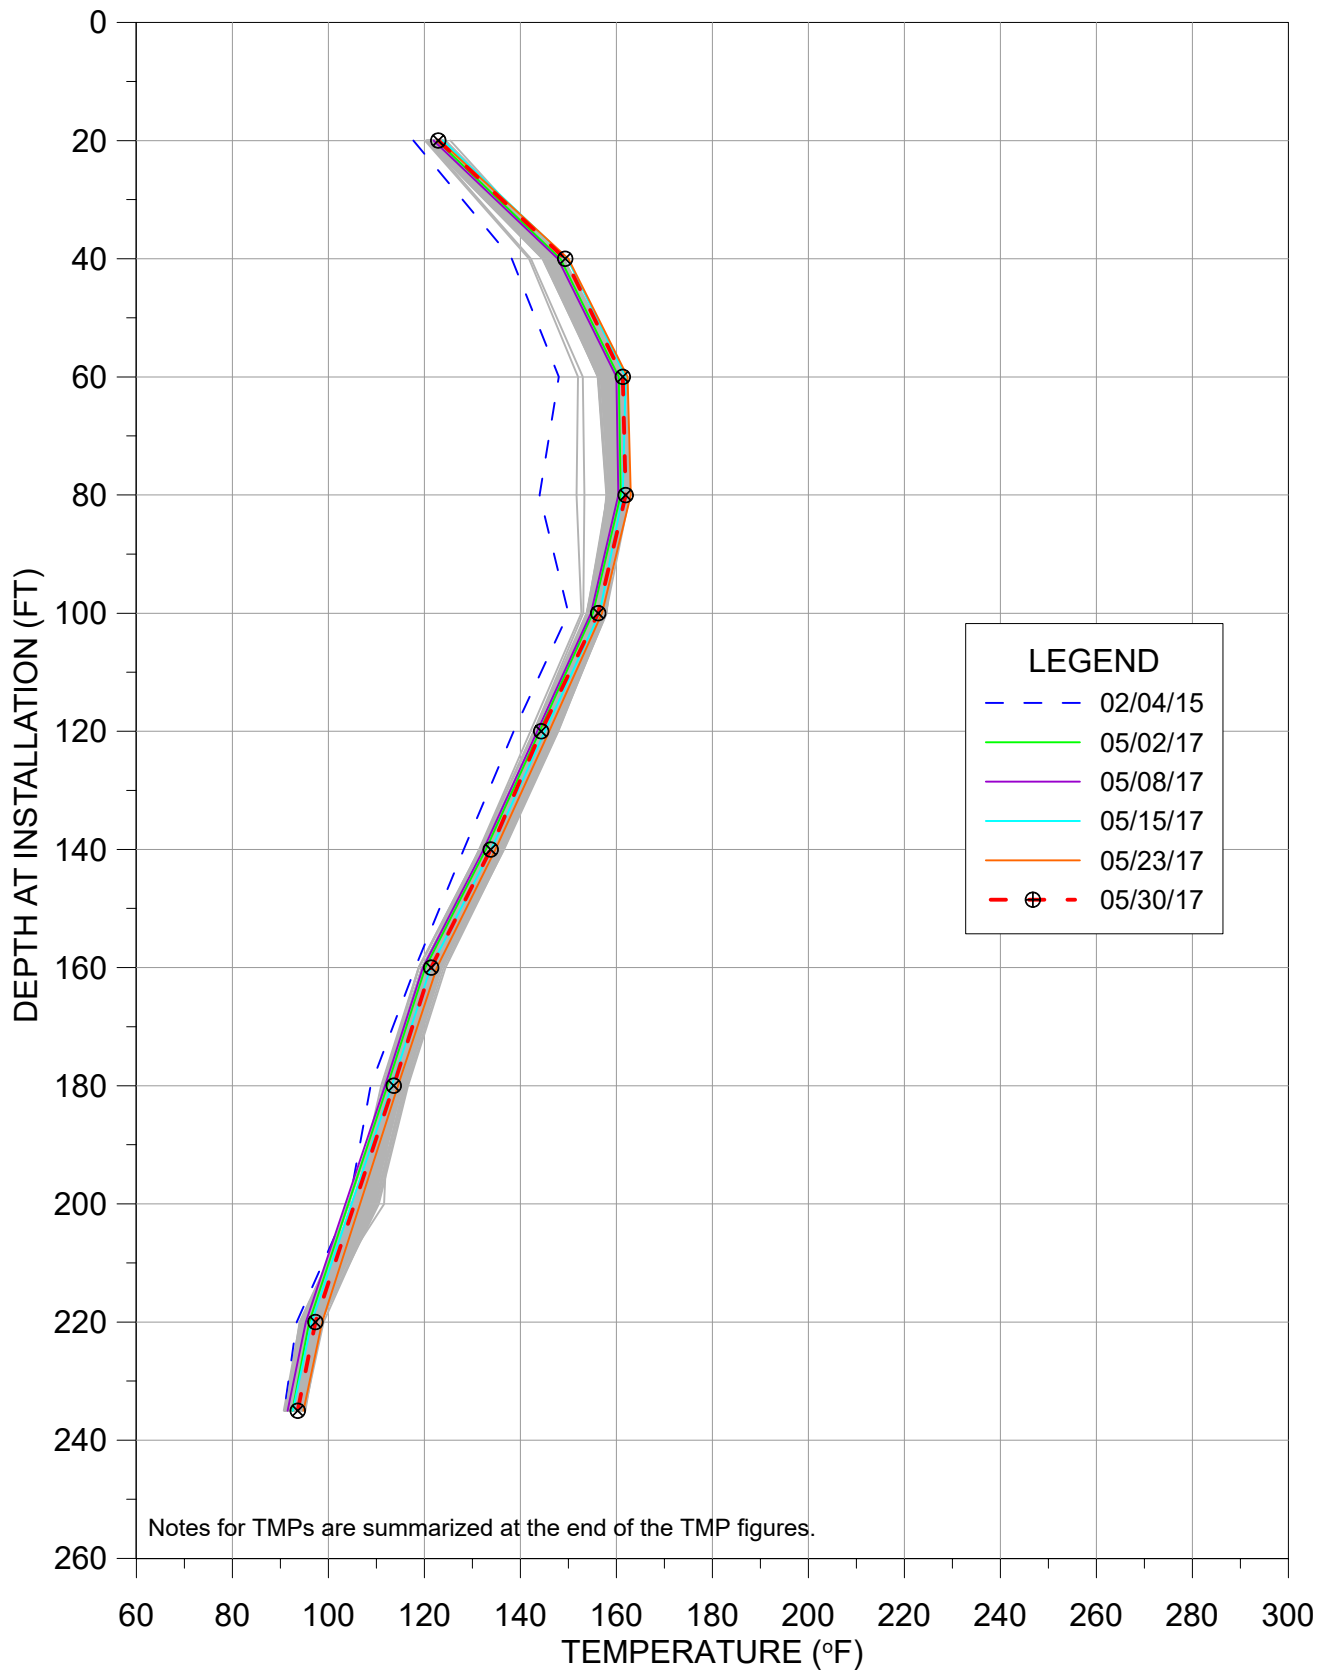
# TMP-25

1. The unit at 200 ft provided an apparent anomalous reading on 3/28/2017. Subsequent readings on 4/4/2017 showed the unit to have failed (see below). The unit is no longer working and the reading of 3/28/2017 was likely unreliable.
2. The unit at 200 ft depth had a resistance reading greater 4000 ohms on 4/4/2017. A connectivity test conducted by Feezor Engineering on 4/7/2017 showed that this unit also had cross-connectivity. The unit is therefore determined to be no longer working as of the 4/4/2017 reading.

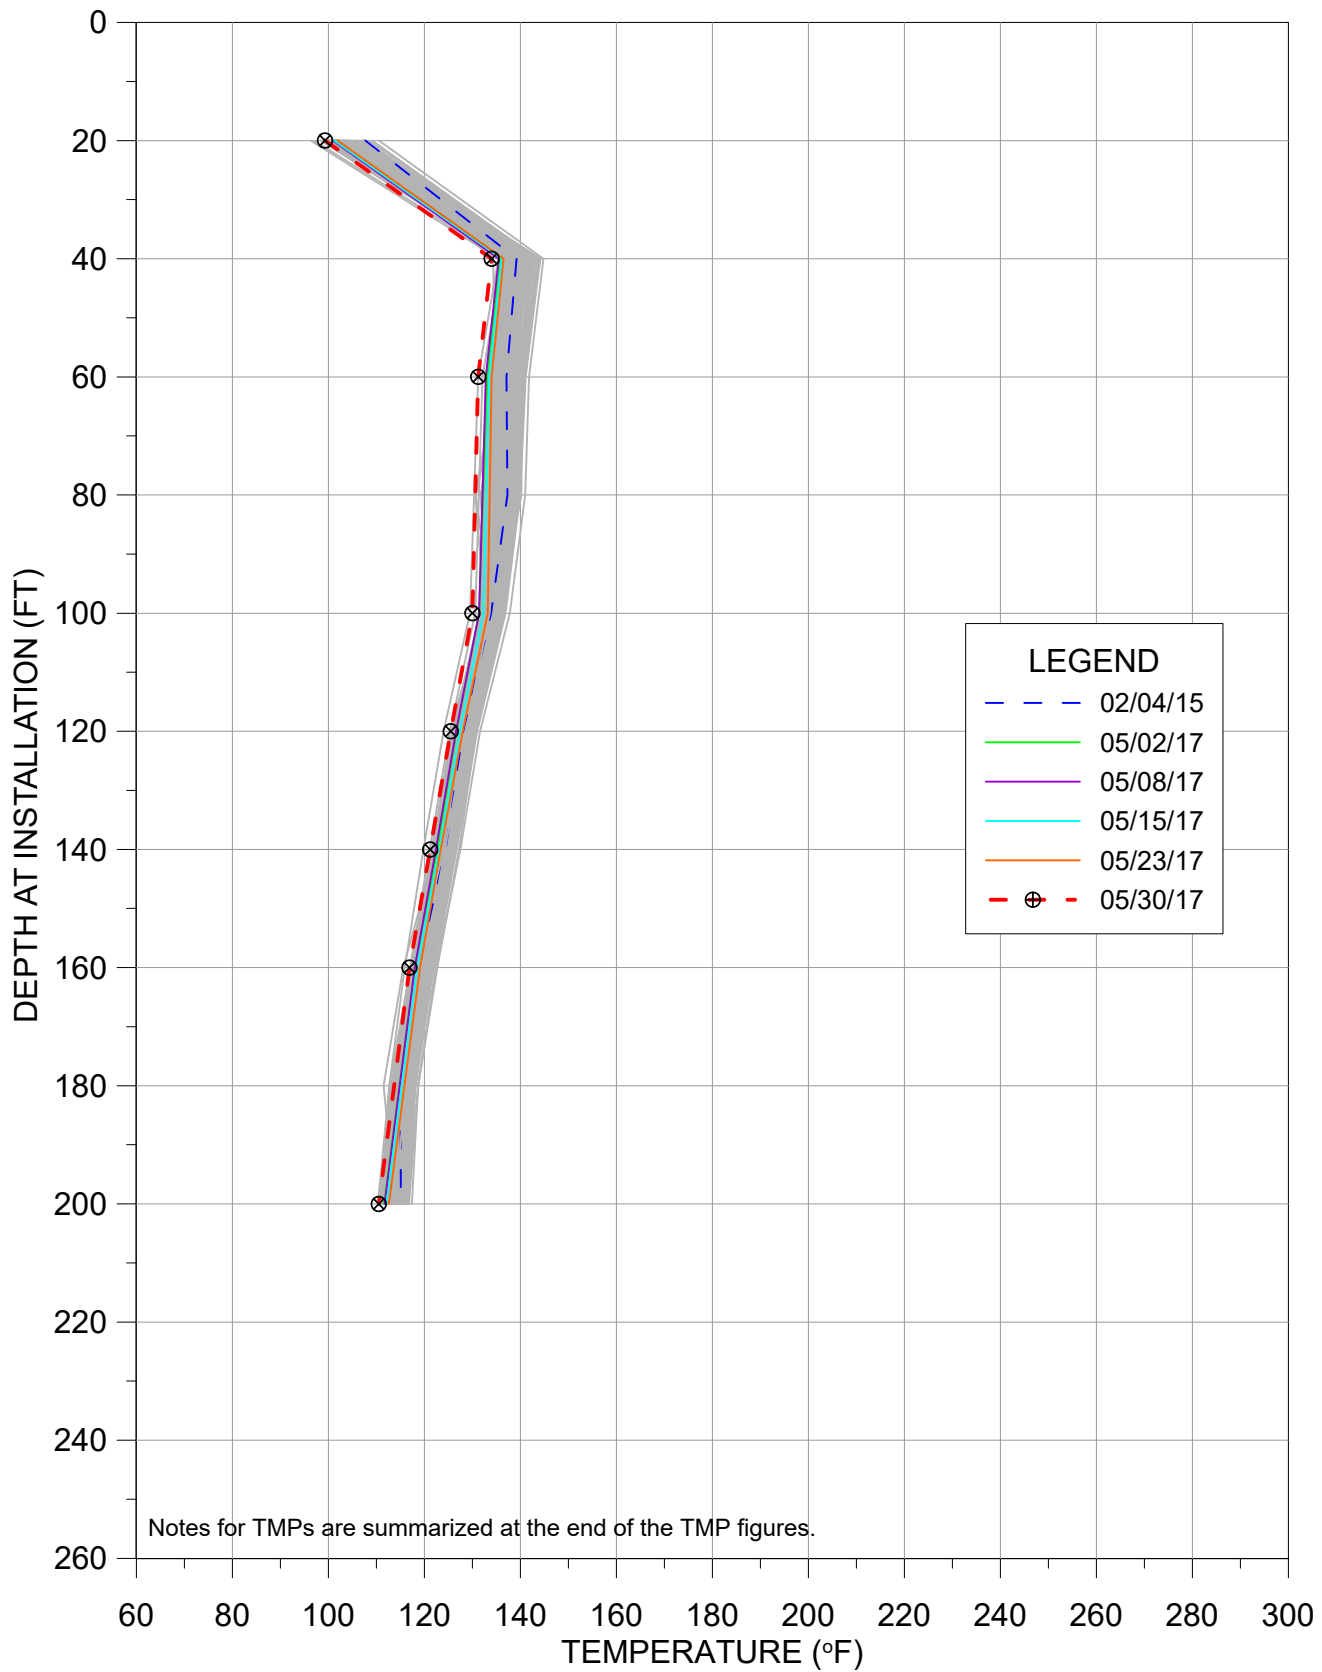
# TMP-28

1. The unit at 217 ft depth has had no resistance or temperature readings since installation.
2. The unit at 80 ft depth had a resistance drop and an unreasonable temperature decrease on 6/1/2016. The temperature has since fluctuated and is determined to be unreliable.
3. The unit at 180 feet has had a higher than acceptable limit since 3/28/2017 and is therefore determined to be unreliable as of the 4/4/2017 reading.

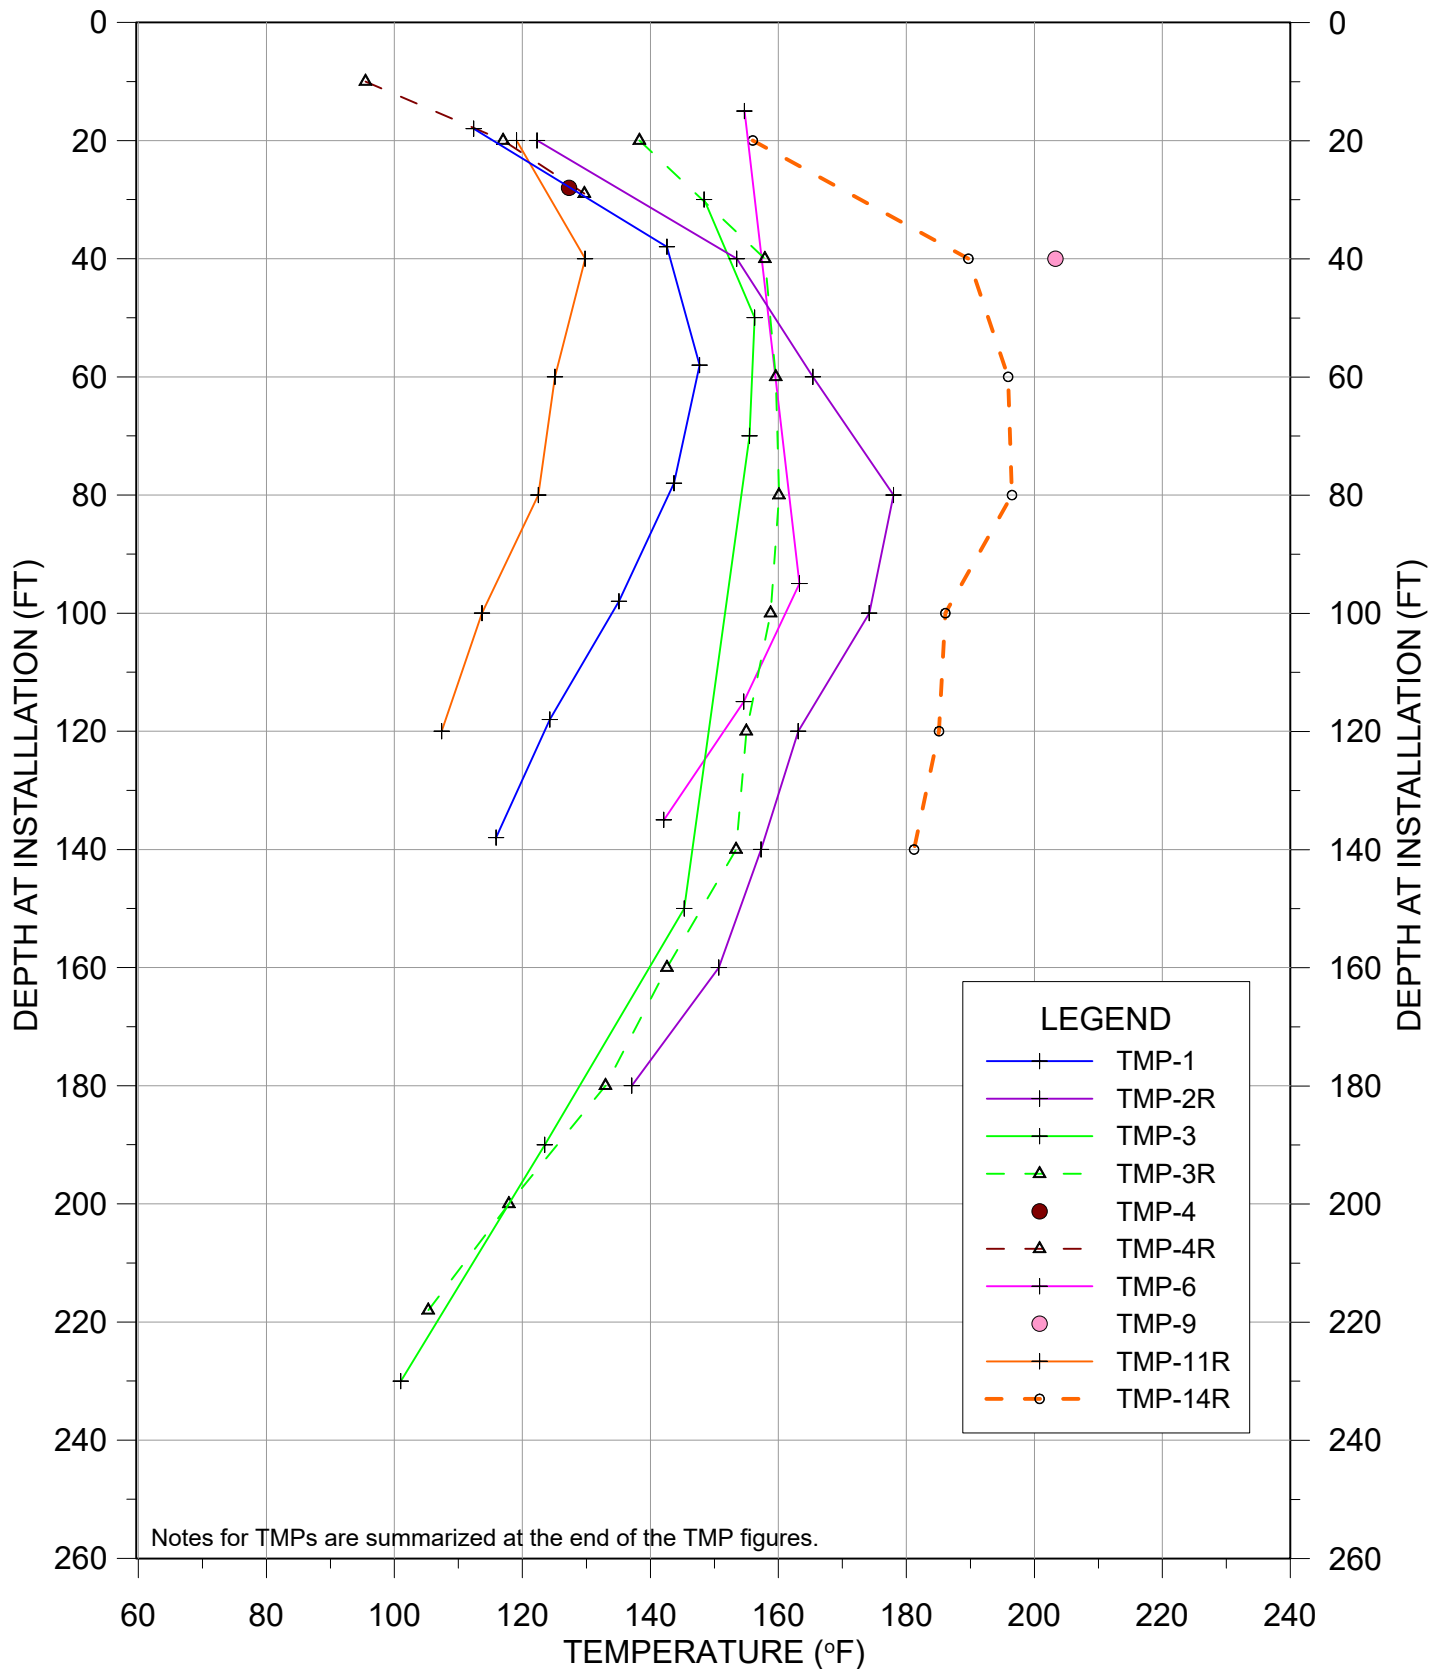
5/30/2017

TMP vs DEPTH and TMP vs ELEVATION (for **05/30/17**):

1. There were no reliable temperature readings for TMP-13 since 3/19/2014.
2. There were no reliable temperature readings for TMP-7R, as determined by the connectivity test on 4/11/2014.
3. There were no reliable temperature readings for TMP-5 since 11/5/2014.
4. There were no reliable temperature readings for TMP-12 since 9/28/2015.
5. There were no reliable temperature readings for TMP-8 since 9/9/2015.
6. There were no reliable temperature readings for TMP-14, confirmed since 3/7/2016.
7. There were no reliable temperature readings for TMP-11 as determined by the connectivity test on 11/23/2016.
8. TMP-2 has been replaced by TMP-2R and will no longer be monitored.
9. TMP-11 is no longer in service and will not be included in the presentation.
- 10. There were no reliable temperature readings for TMP-10 on 5/30/2017.**

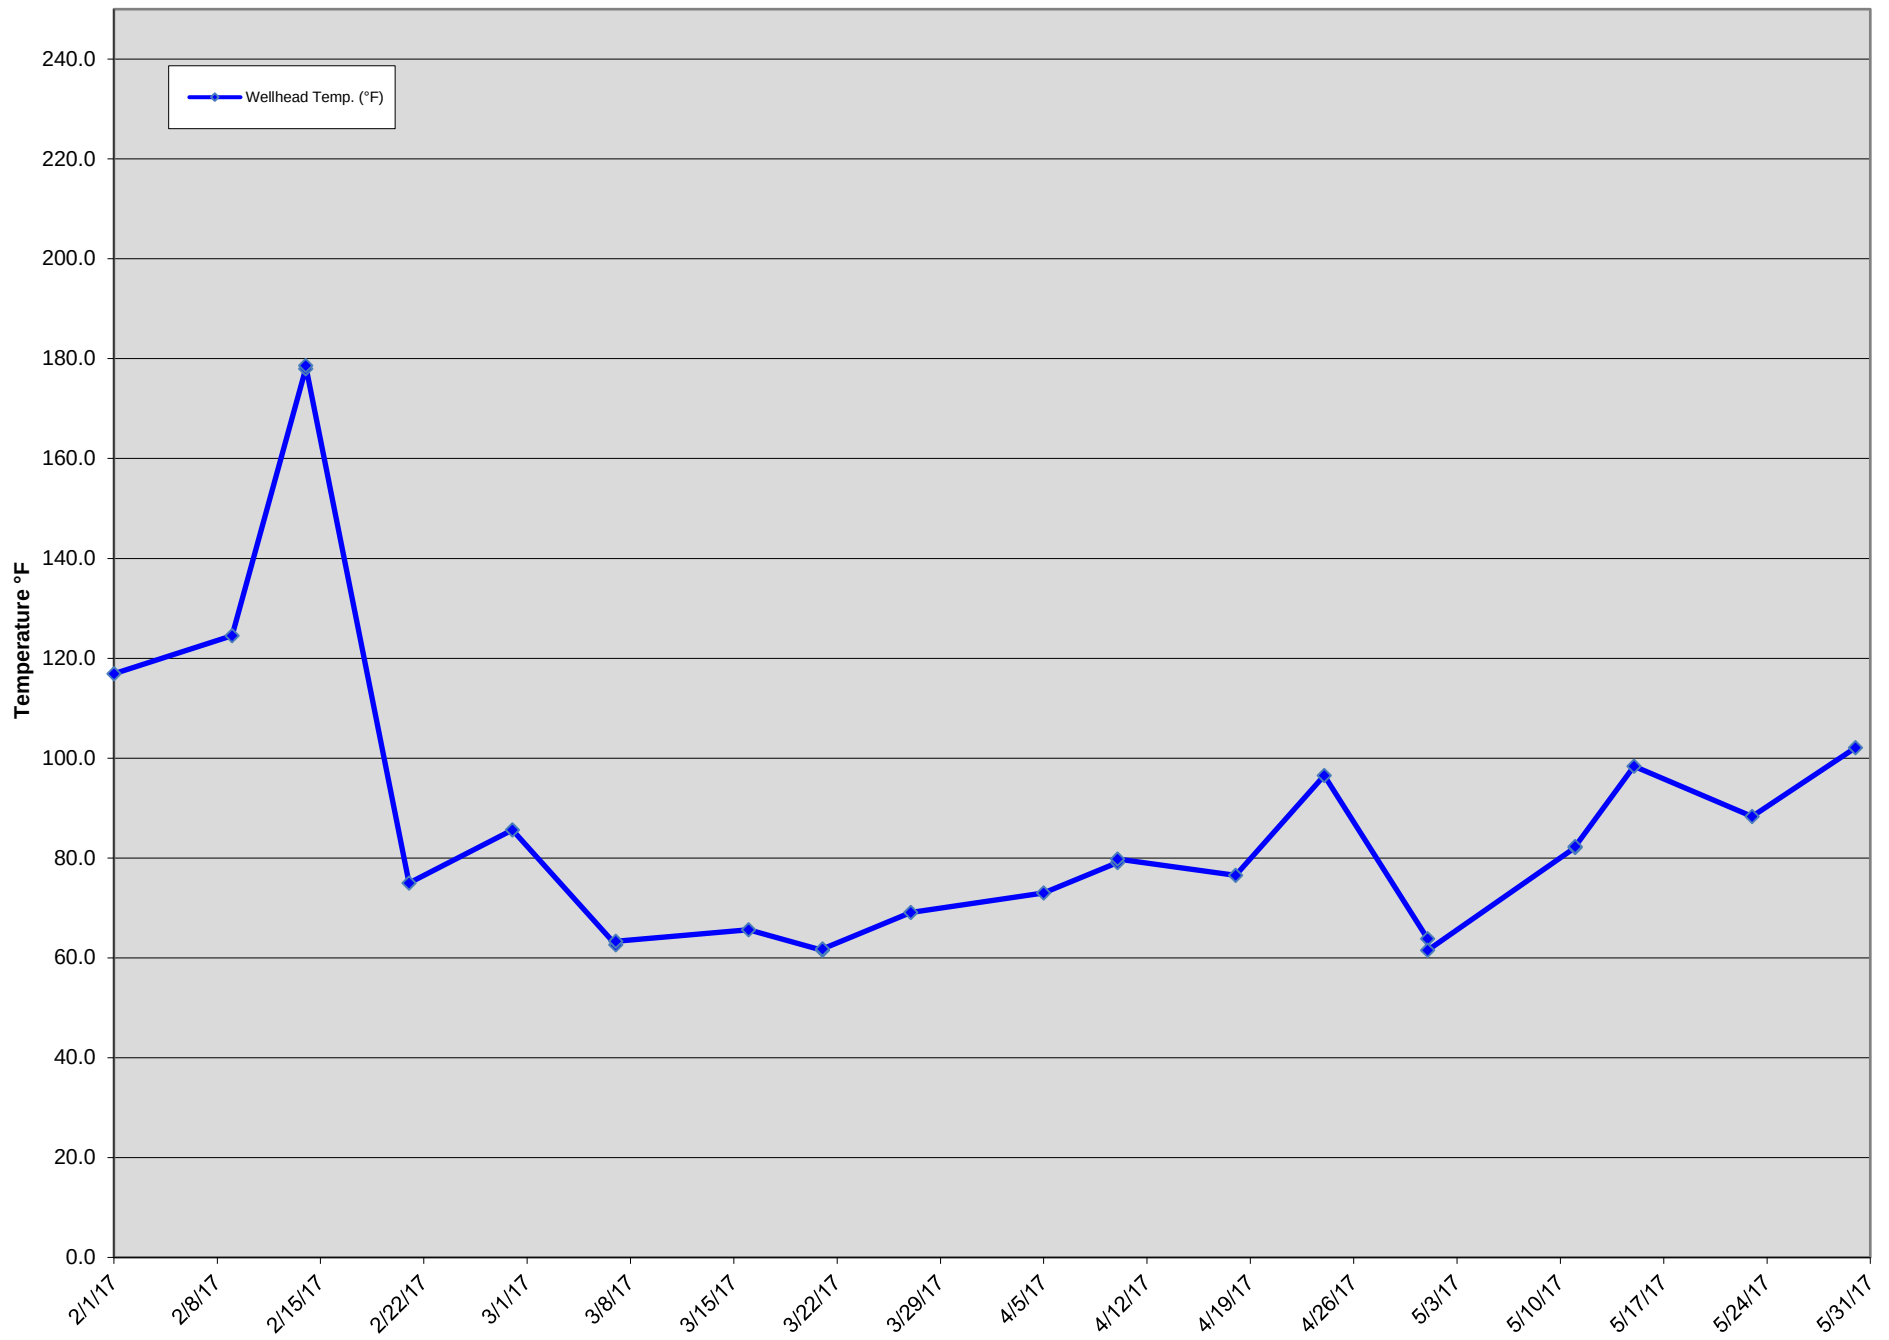
GIW-1 Wellhead Temperatures

As part of the HES, there are currently cooling water circulation loops installed in twelve Gas Interceptor Wells (GIWs) (GIW-02 through GIW-13). The remaining well (GIW-01) had a measured gas temperature within its historical operating limits.
