# **Bridgeton Landfill, LLC**

## **Weekly Data Submittal**

**Week of June 4, 2017 – June 10, 2017**

**Required by Section 52.F of Agreed Order, Case No. 13SL-CC01088  
Effective May 13, 2013**

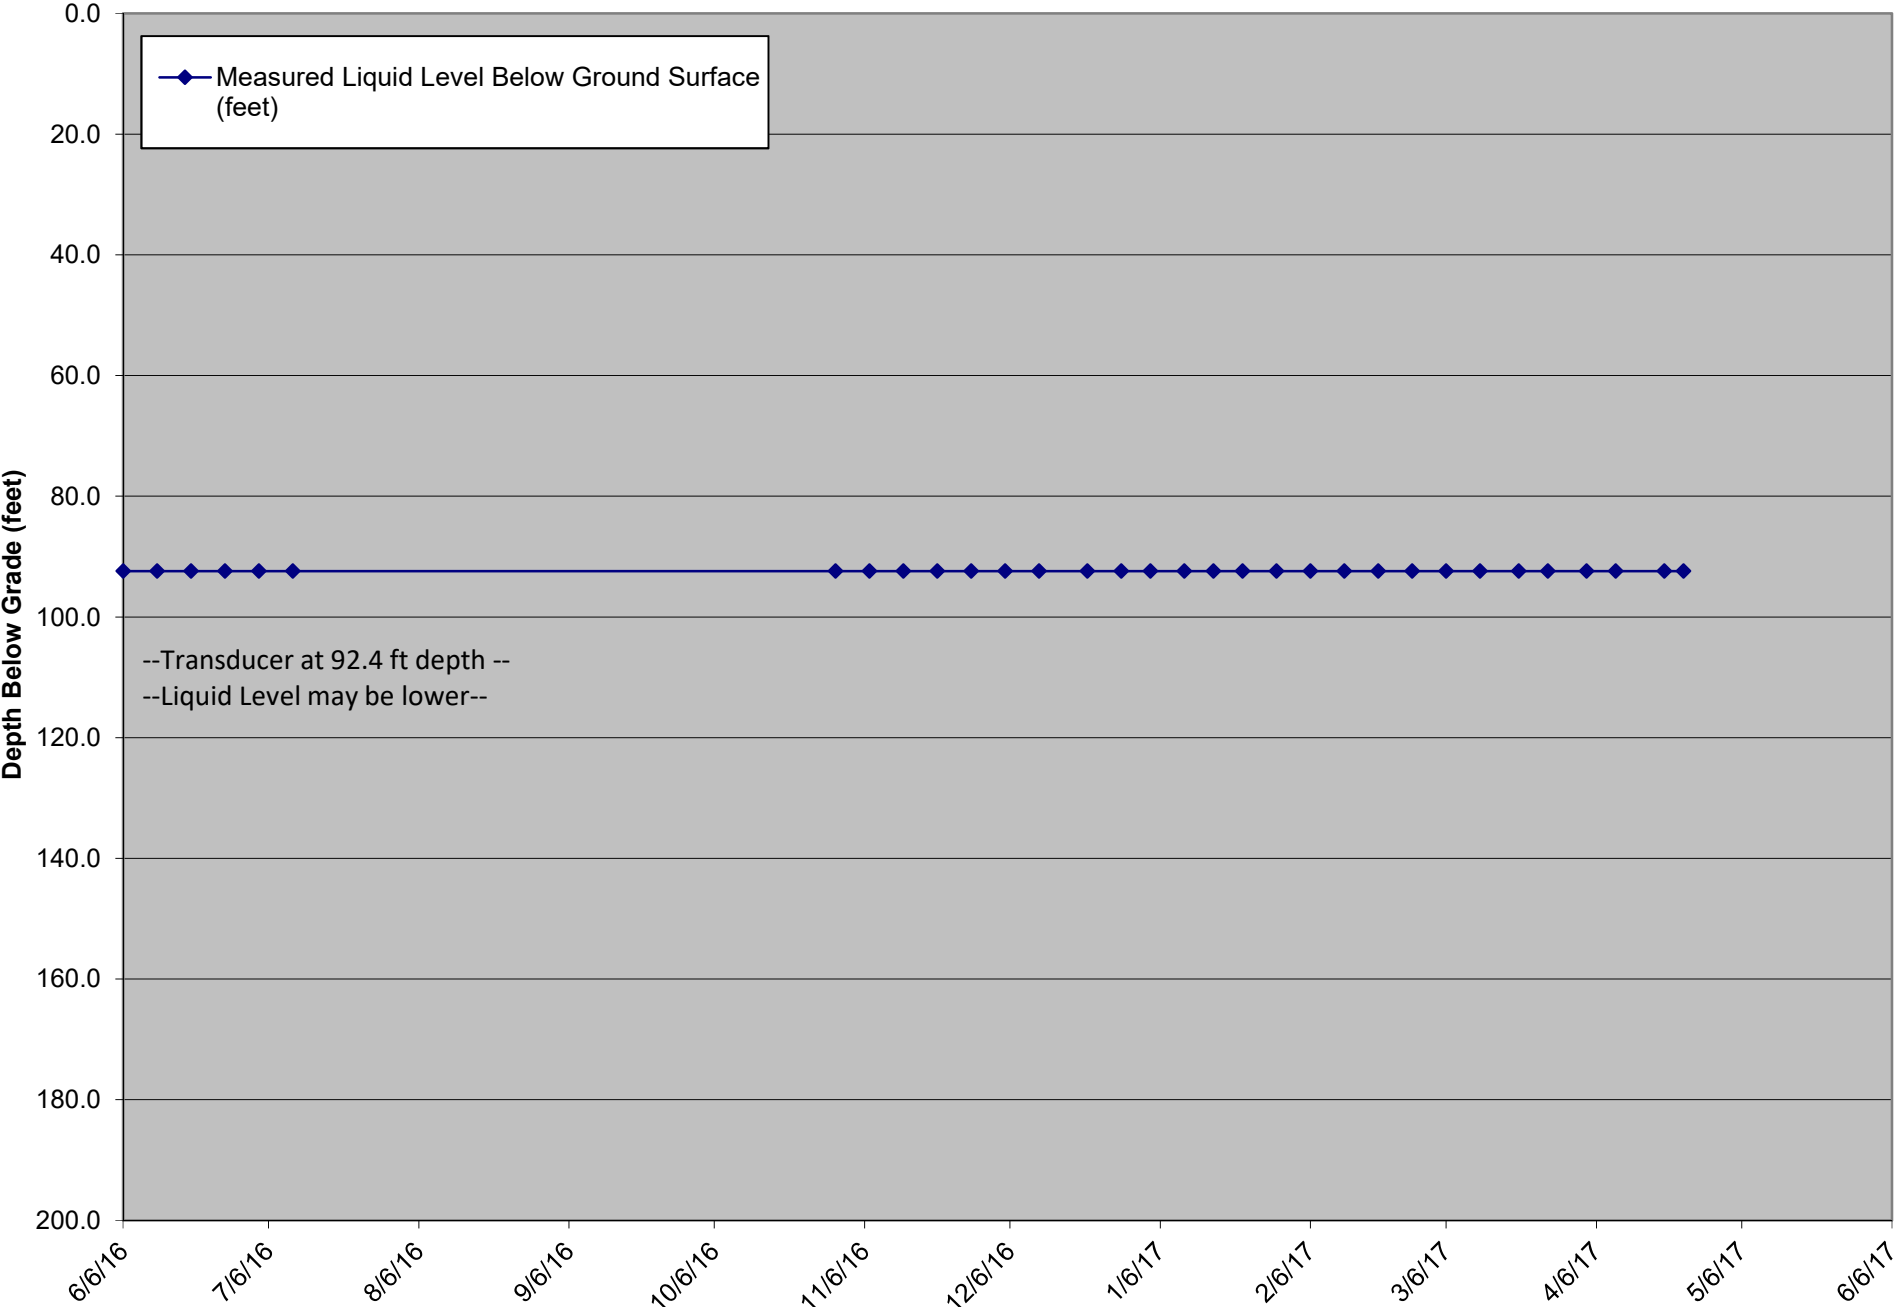
LCS-1D Liquid Level Below Ground Surface

Bridgeton Landfill initiated pump repairs and replacement of the level sensor on LCS-1D during the week of 5/22/2017 and continued during the week of 6/5/2017. Level sensor replacement is pending while awaiting parts arrival.

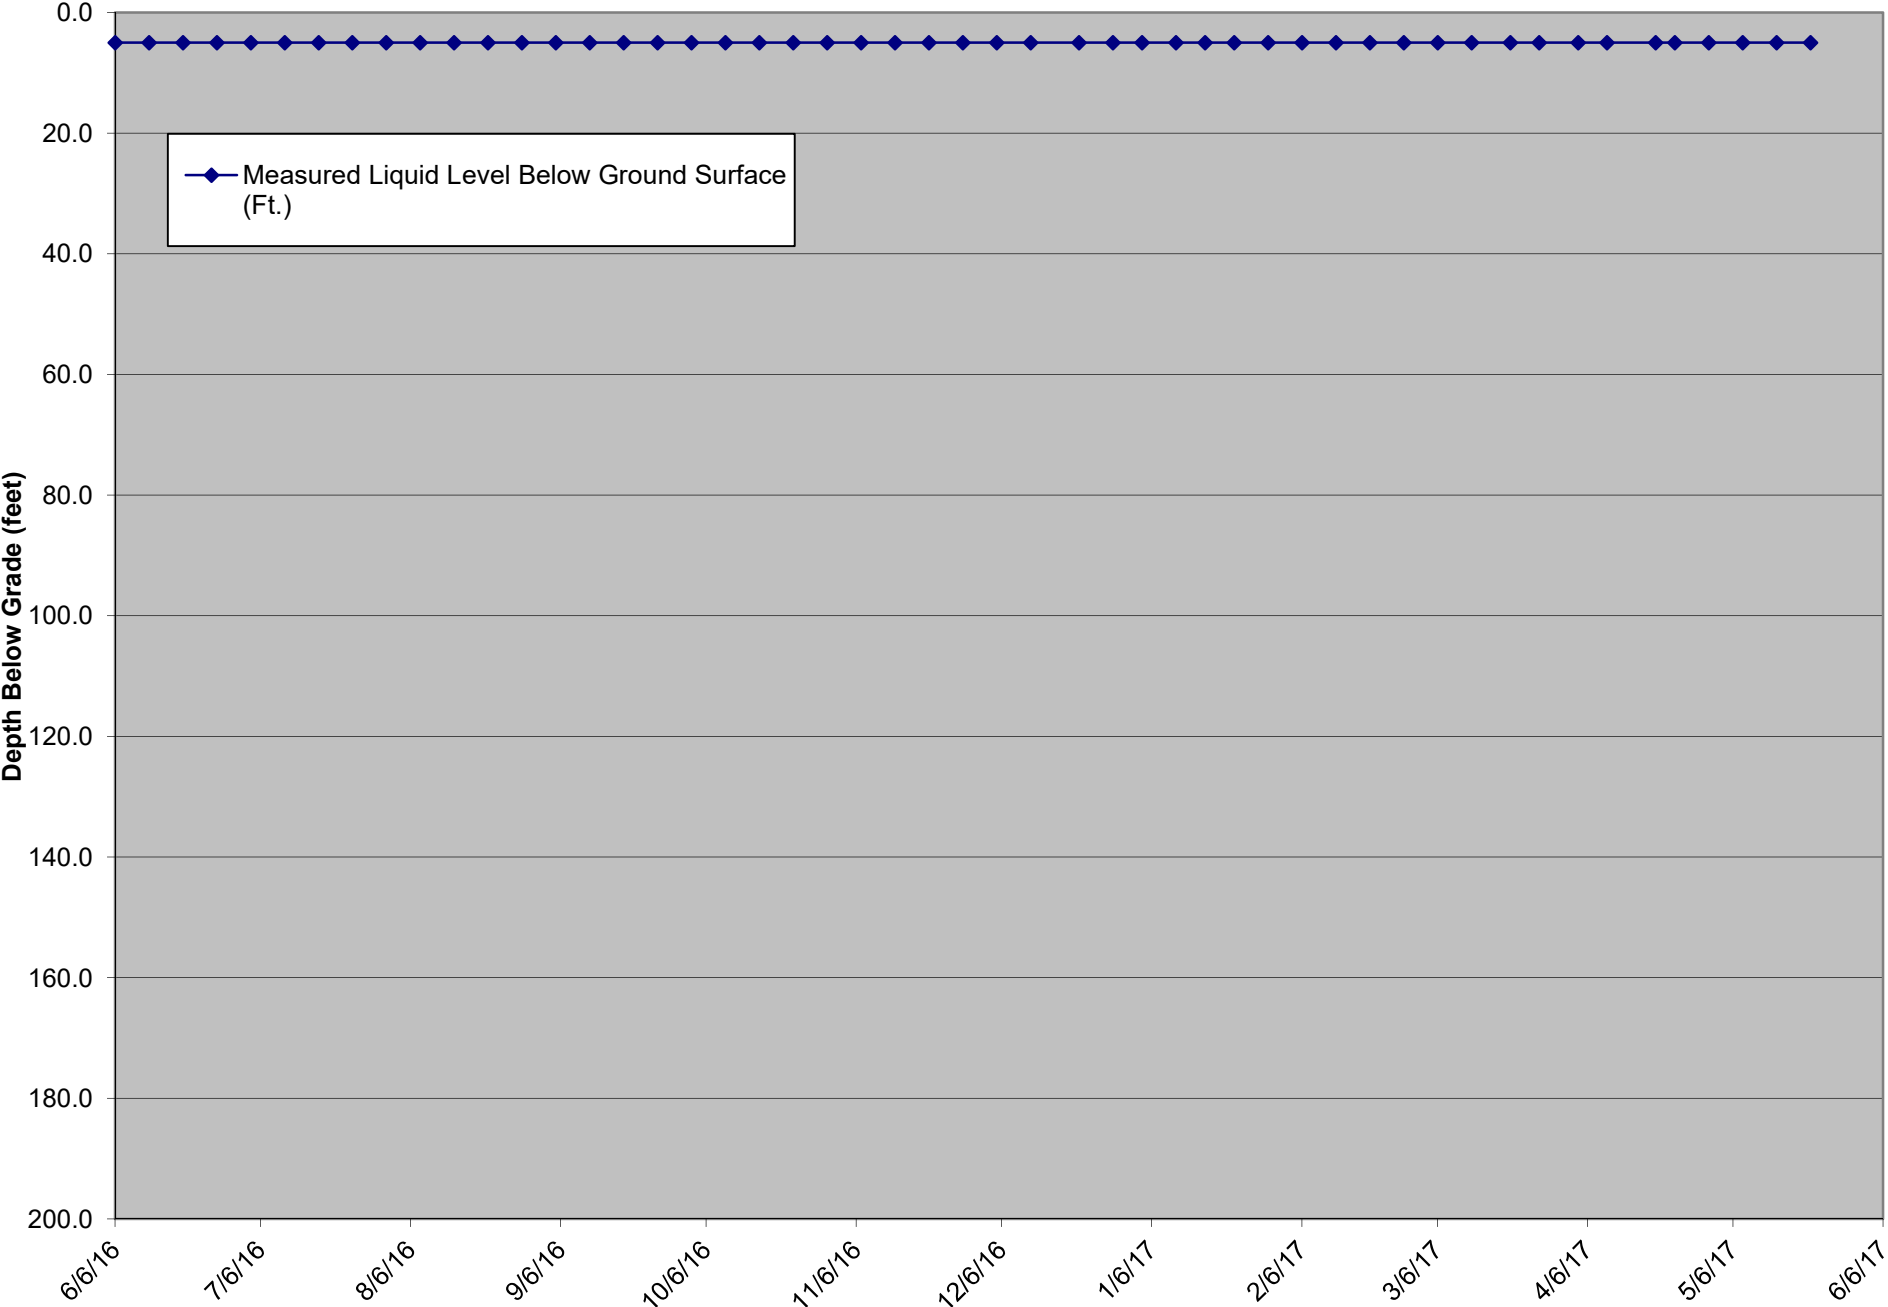
LCS-3D Liquid Level Below Ground Surface

The pump in LCS-3D was non-operational during the weekly reporting period. Pump repair and transducer maintenance was initiated on LCD-3D the week of 5/22/2017 and continued the week of 6/5/2017.

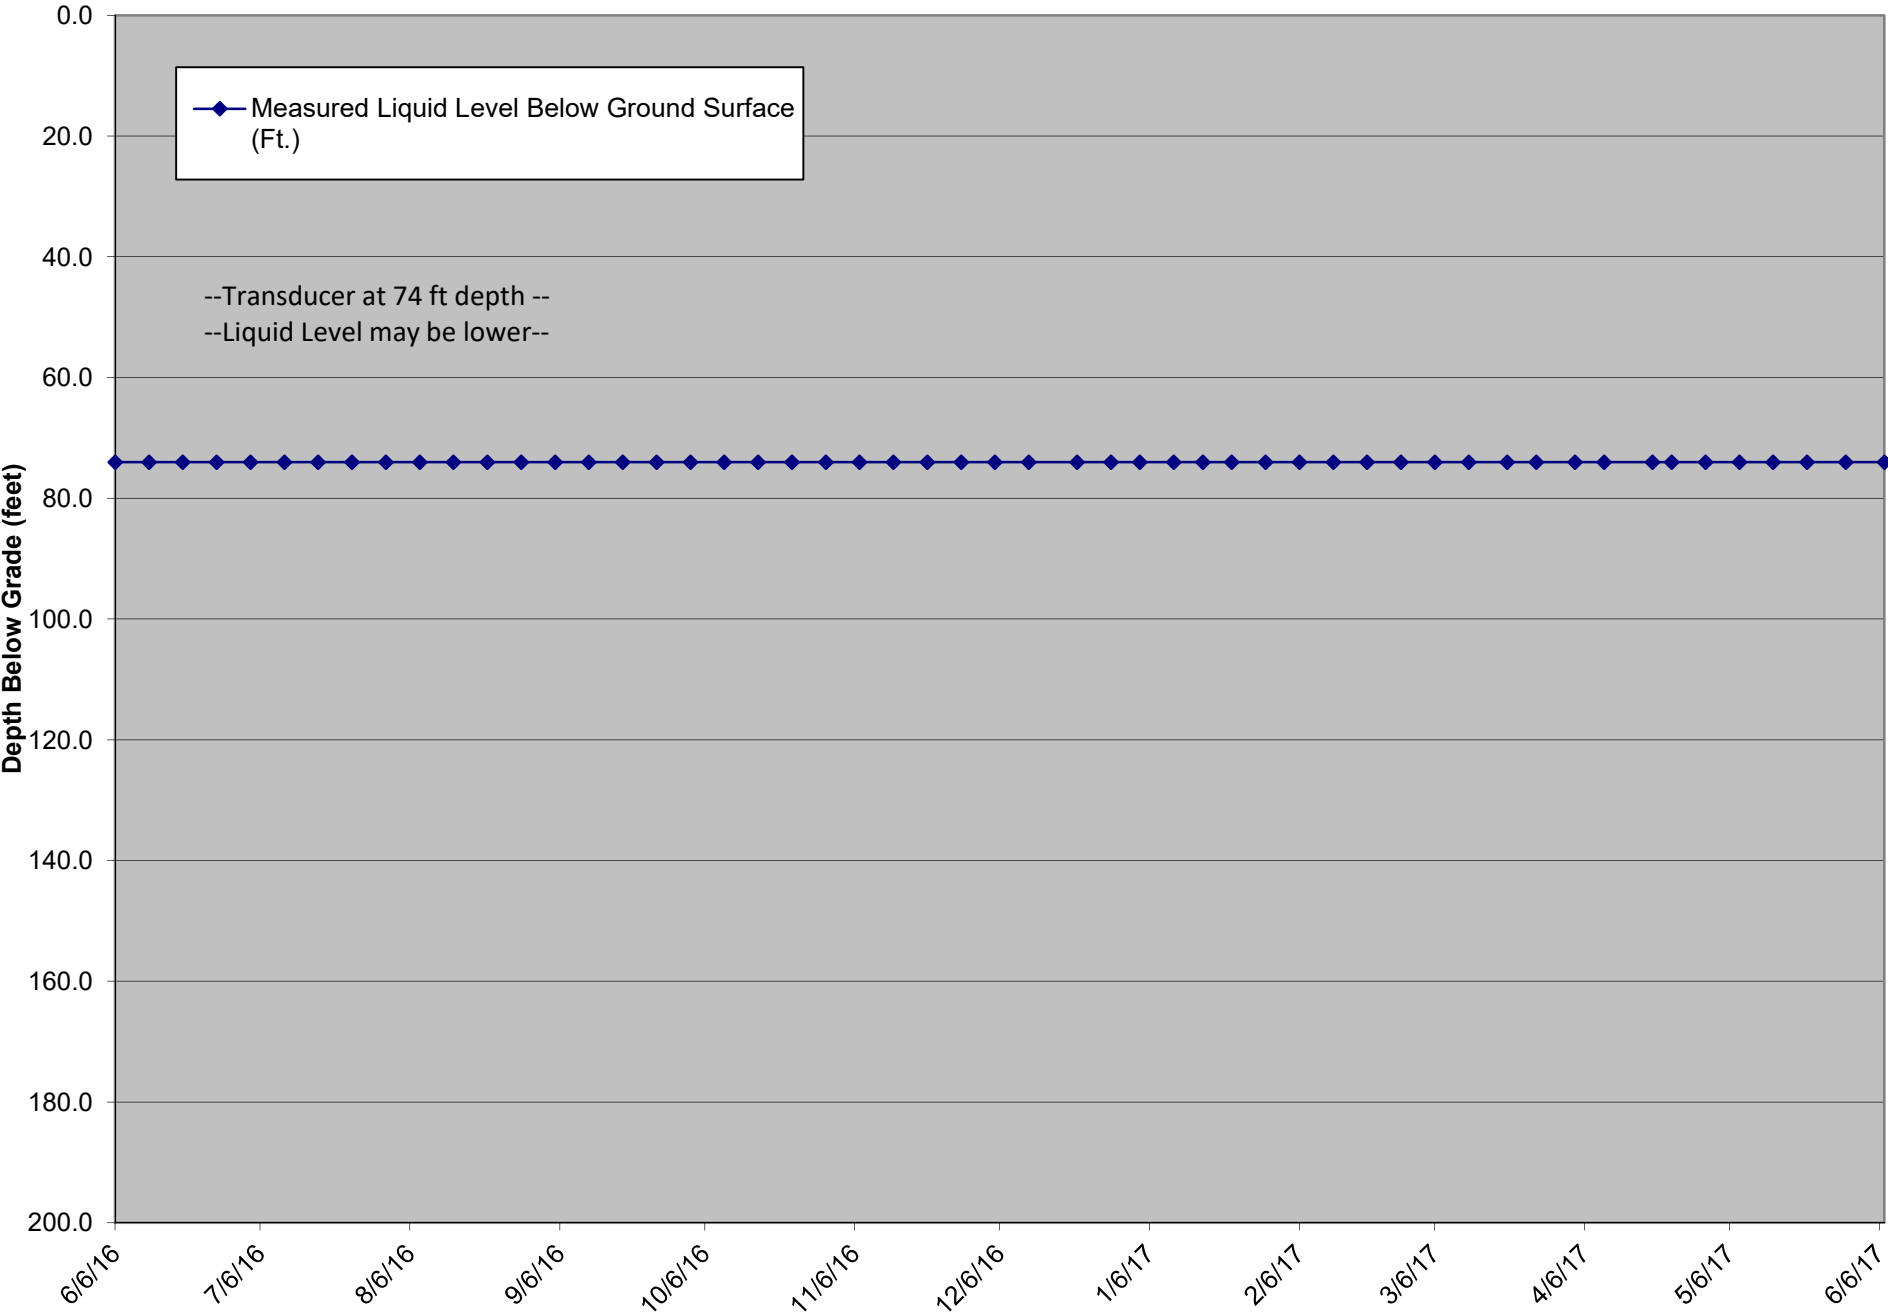
LCS-4B Liquid Level Below Ground Surface

The level sensor in LCS-4B is currently operational and responsive. Liquid level was not recorded by the level sensor during the weekly reporting period. LCS-4B is equipped with a flow meter that displayed no flow during the weekly reporting period. Therefore, it can be concluded that the liquid level was below the bottom of the pump and level sensor in LCS-4B.

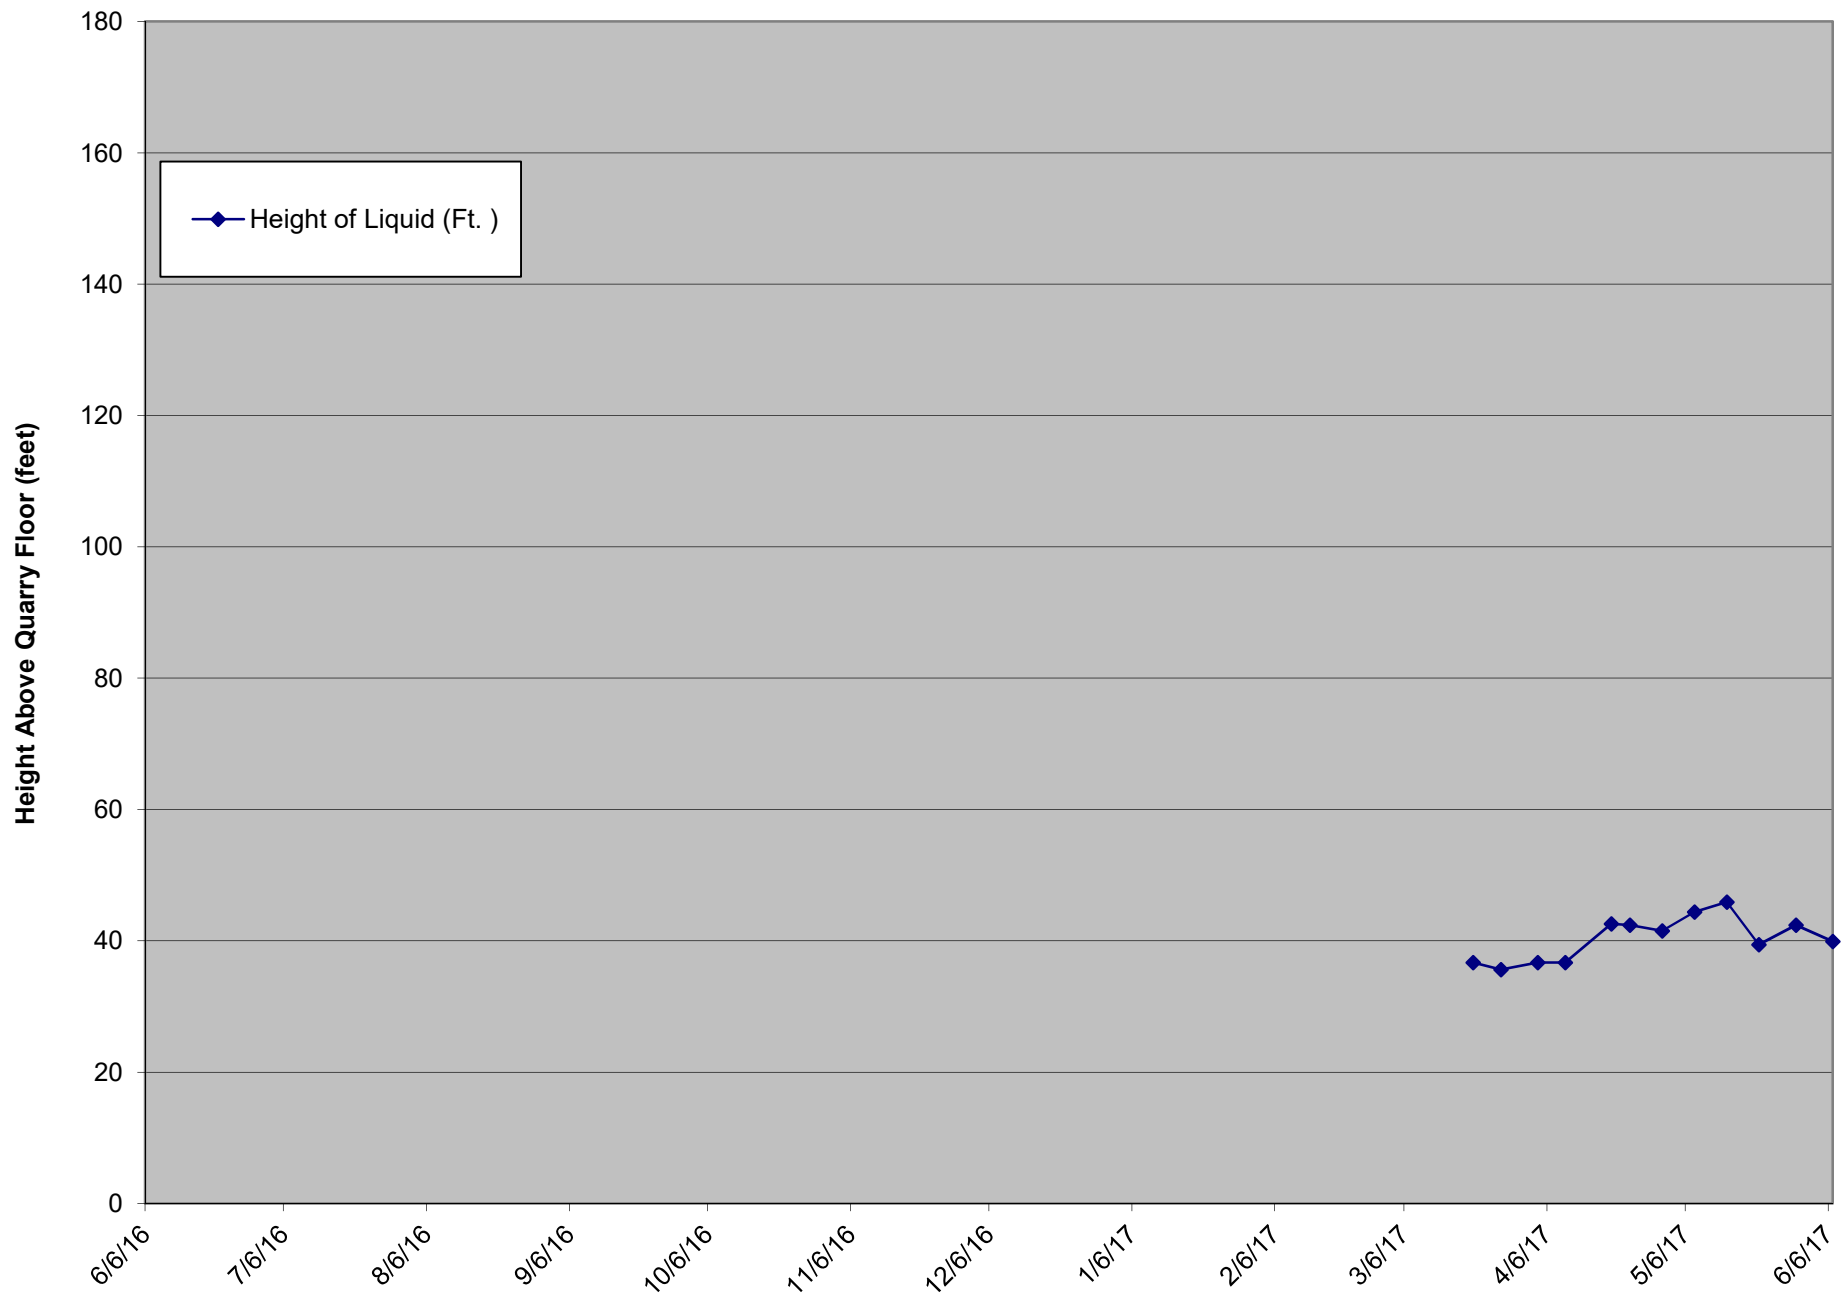
LCS-5B Liquid Level Above Quarry Floor

LCS-5B and LCS-6B were fully operational during the weekly reporting period. LCS-5B and LCS-6B were shut off periodically during the weekly reporting period for North Quarry EVOH related work.

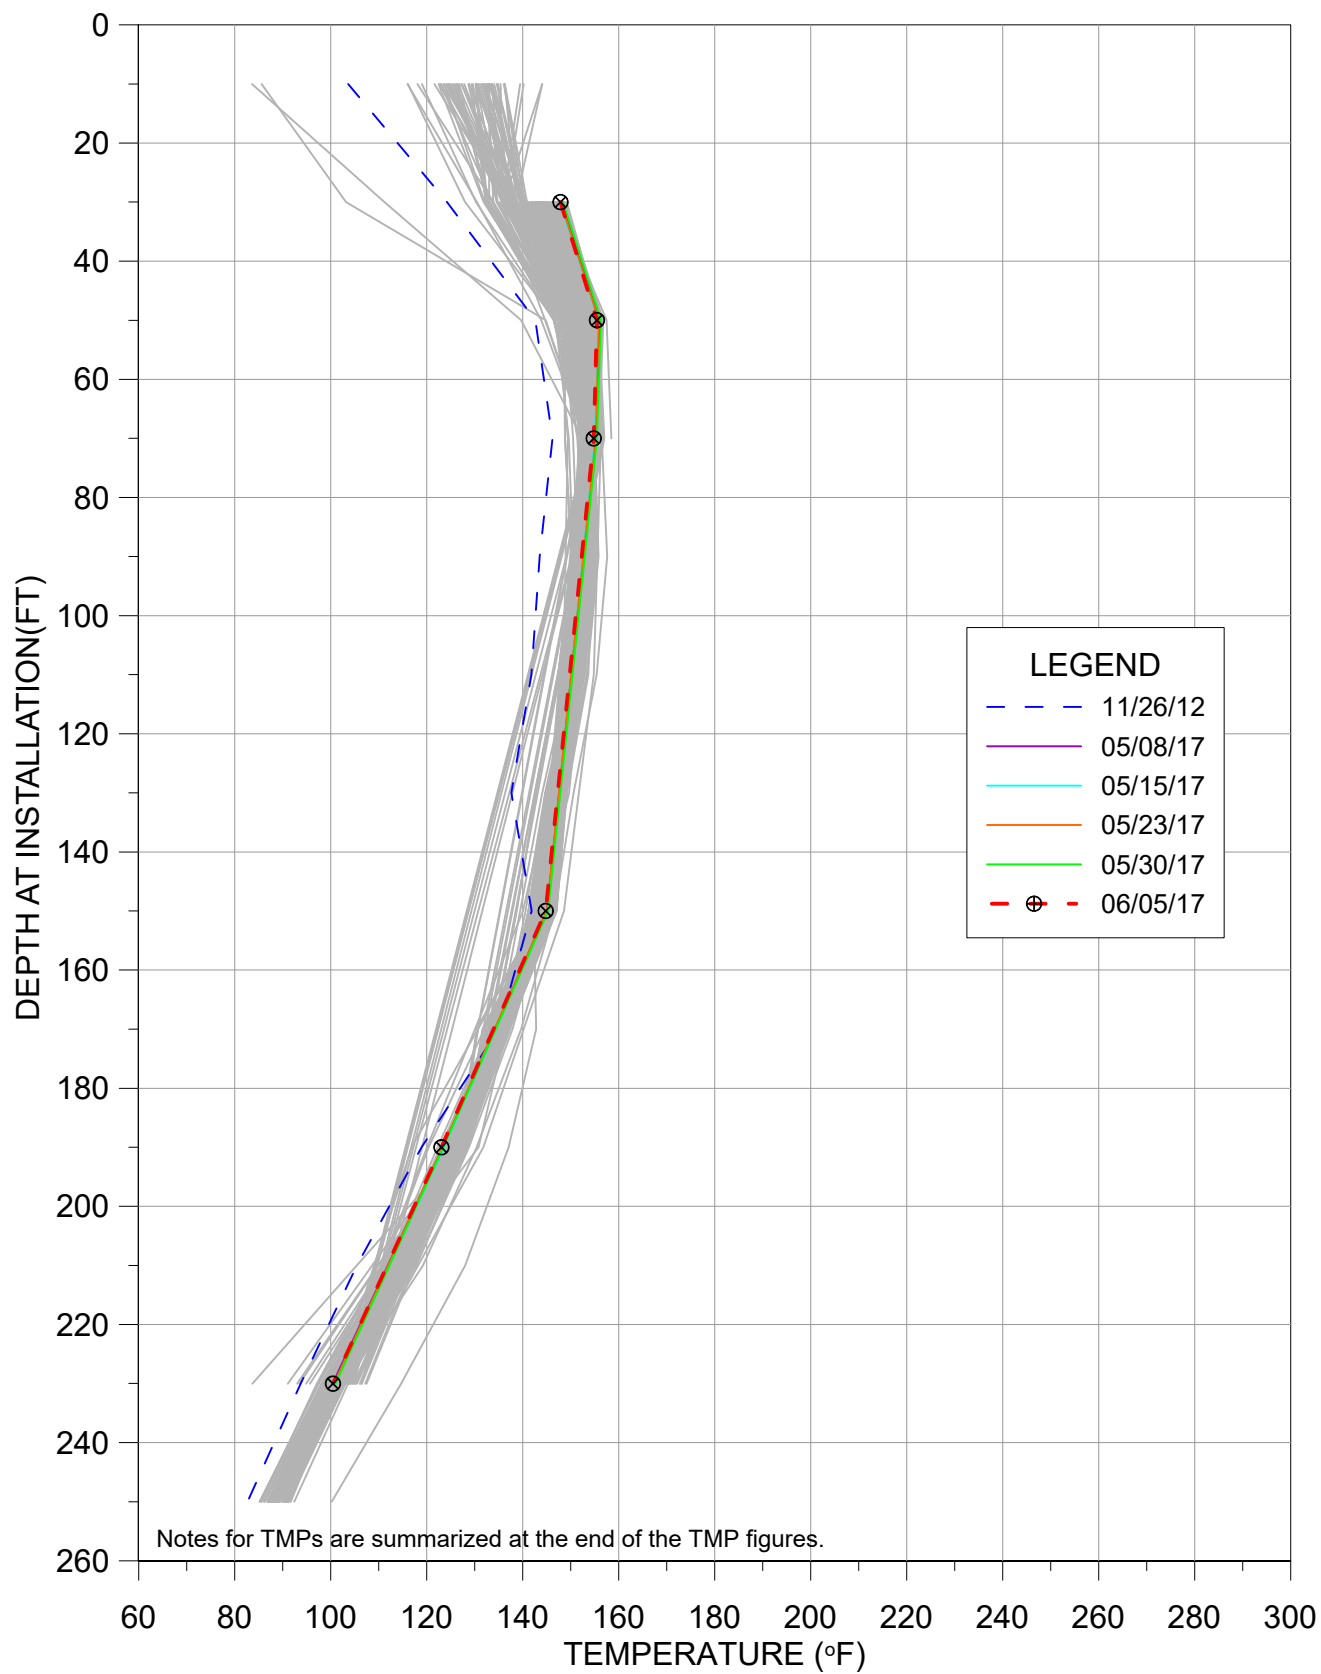
# TMP-3

1. No reliable temperature readings have been obtained at 170 ft depth since 1/29/2014, except on 3/13/2014.
2. The connectivity tests on 4/11/2014 conducted by CEC showed that units at 10, 90, 130, 210 and 250 ft depths are no longer reliable.
3. The connectivity tests on 10/28/2014 conducted by Feezor Engineering showed that units at 10, 90, 110, 130, 210 and 250 ft depths are not reliable.

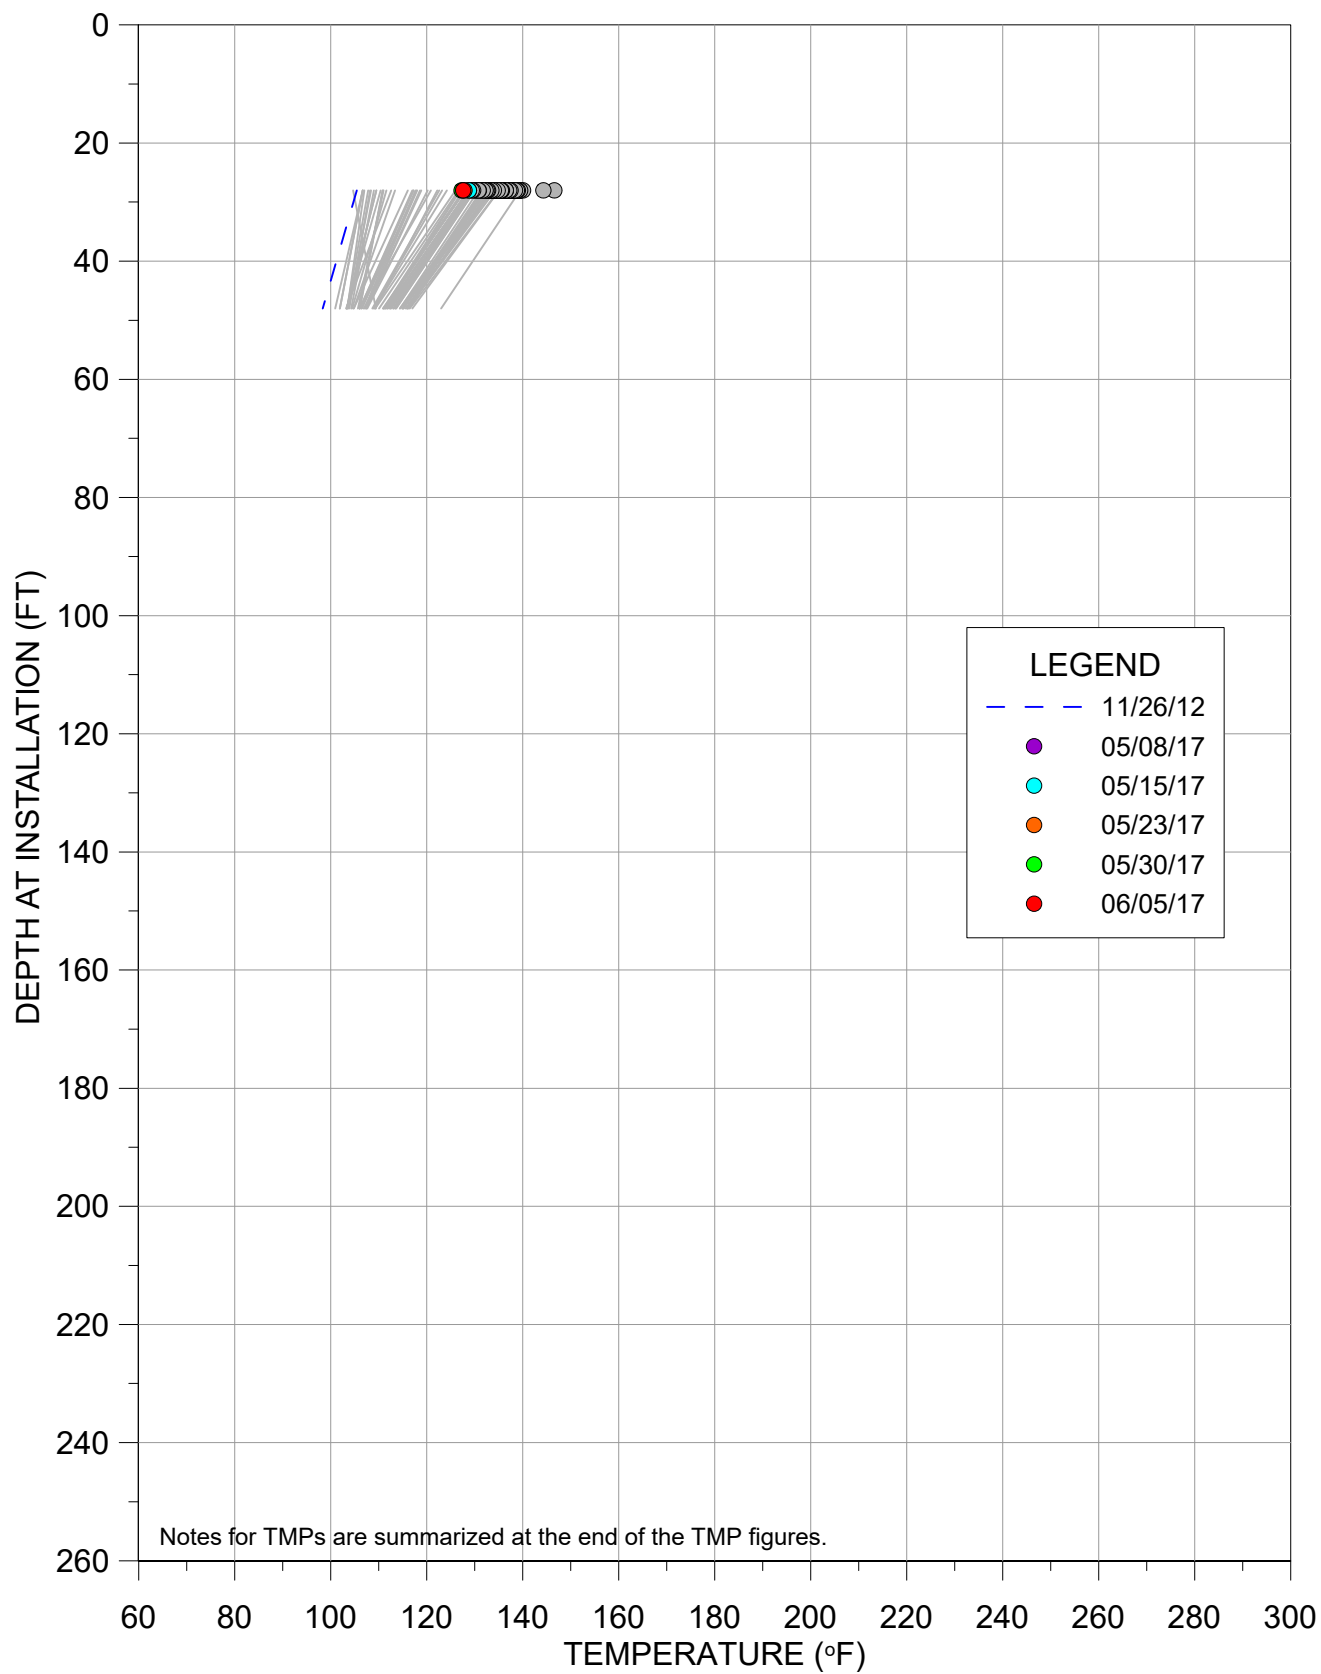
# TMP-4

1. The connectivity tests on 4/11/2014 conducted by CEC showed that the unit at 48 ft depth is no longer reliable.

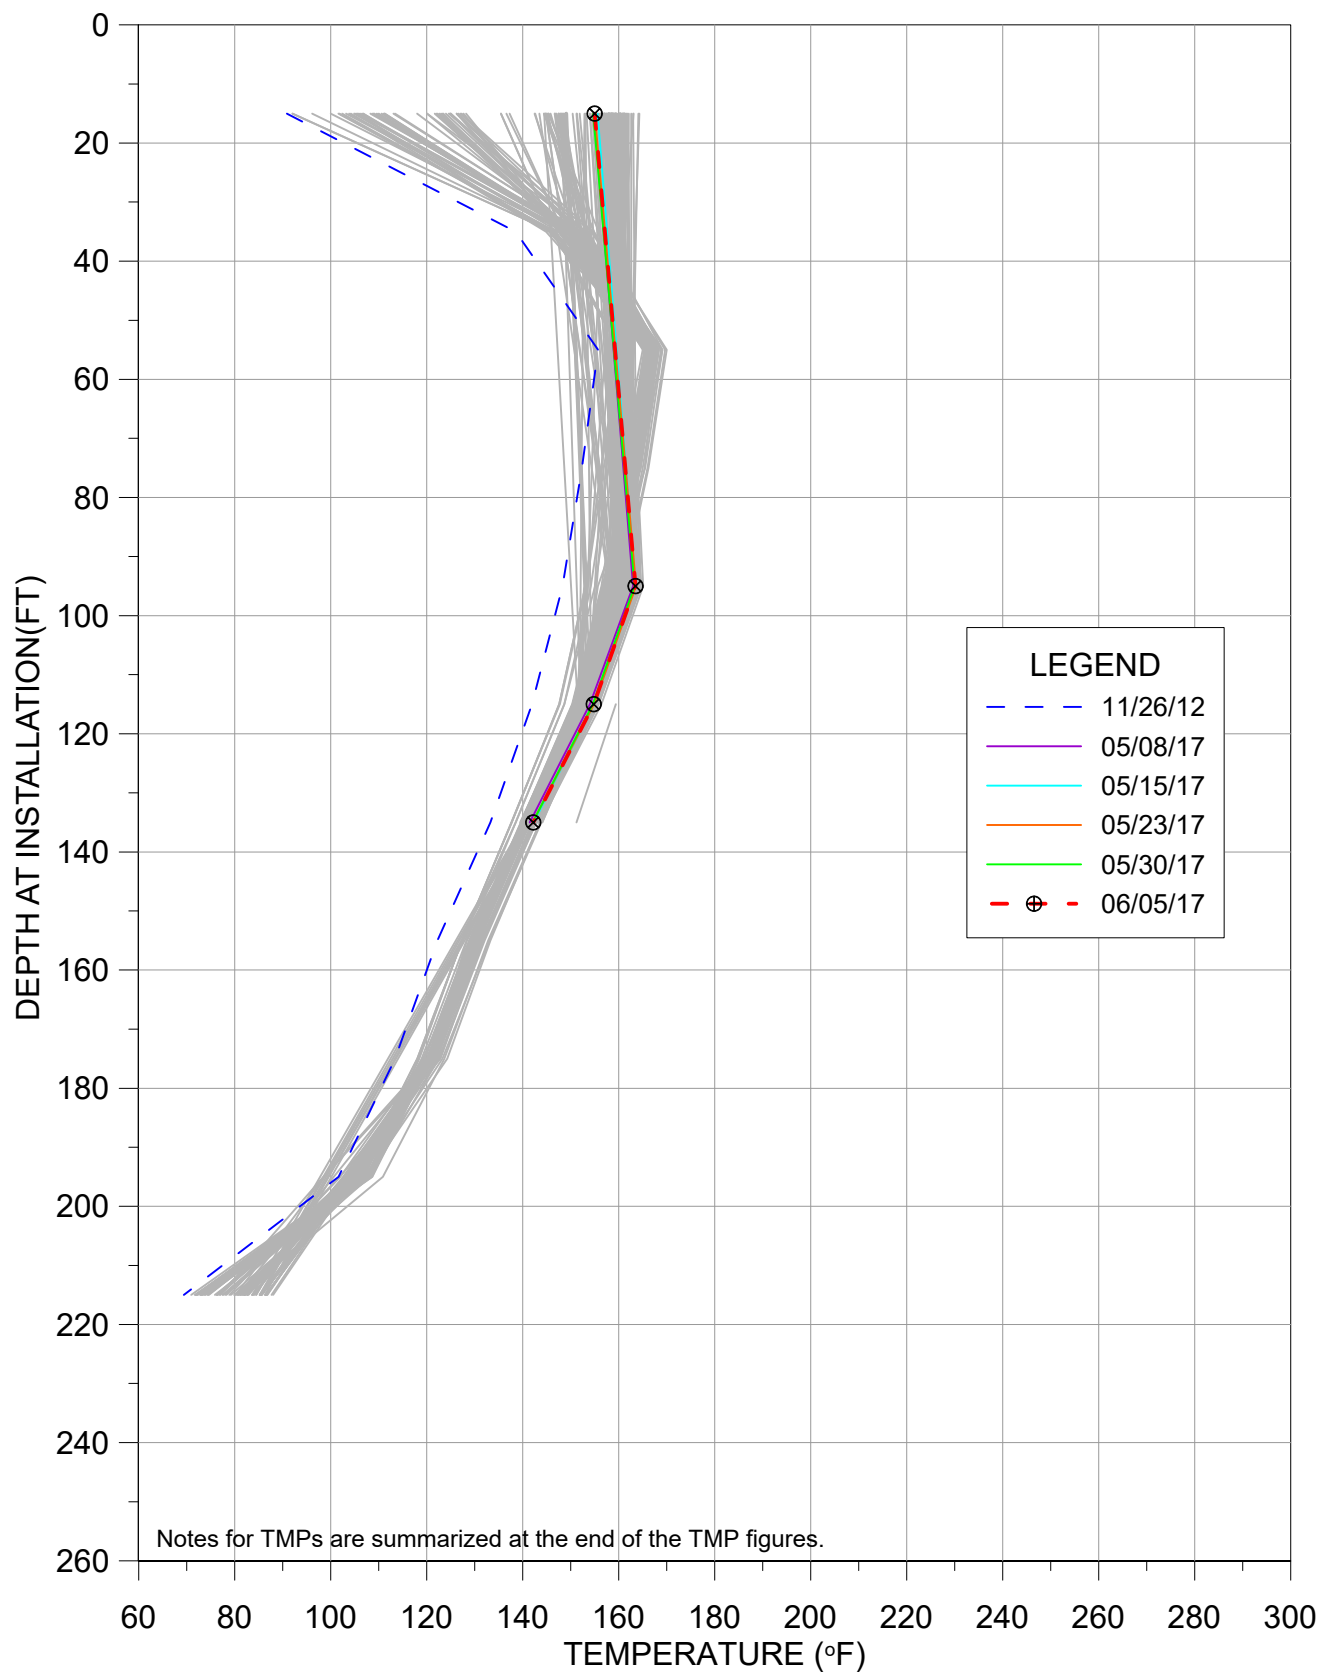
# TMP-6

1. The connectivity tests on 4/11/2014 conducted by CEC showed that units at 35, 55, 75, 155, 175, and 195 ft depths are no longer reliable.
2. No reliable temperature readings have been obtained at the unit at 215 ft depth since 6/13/2014.

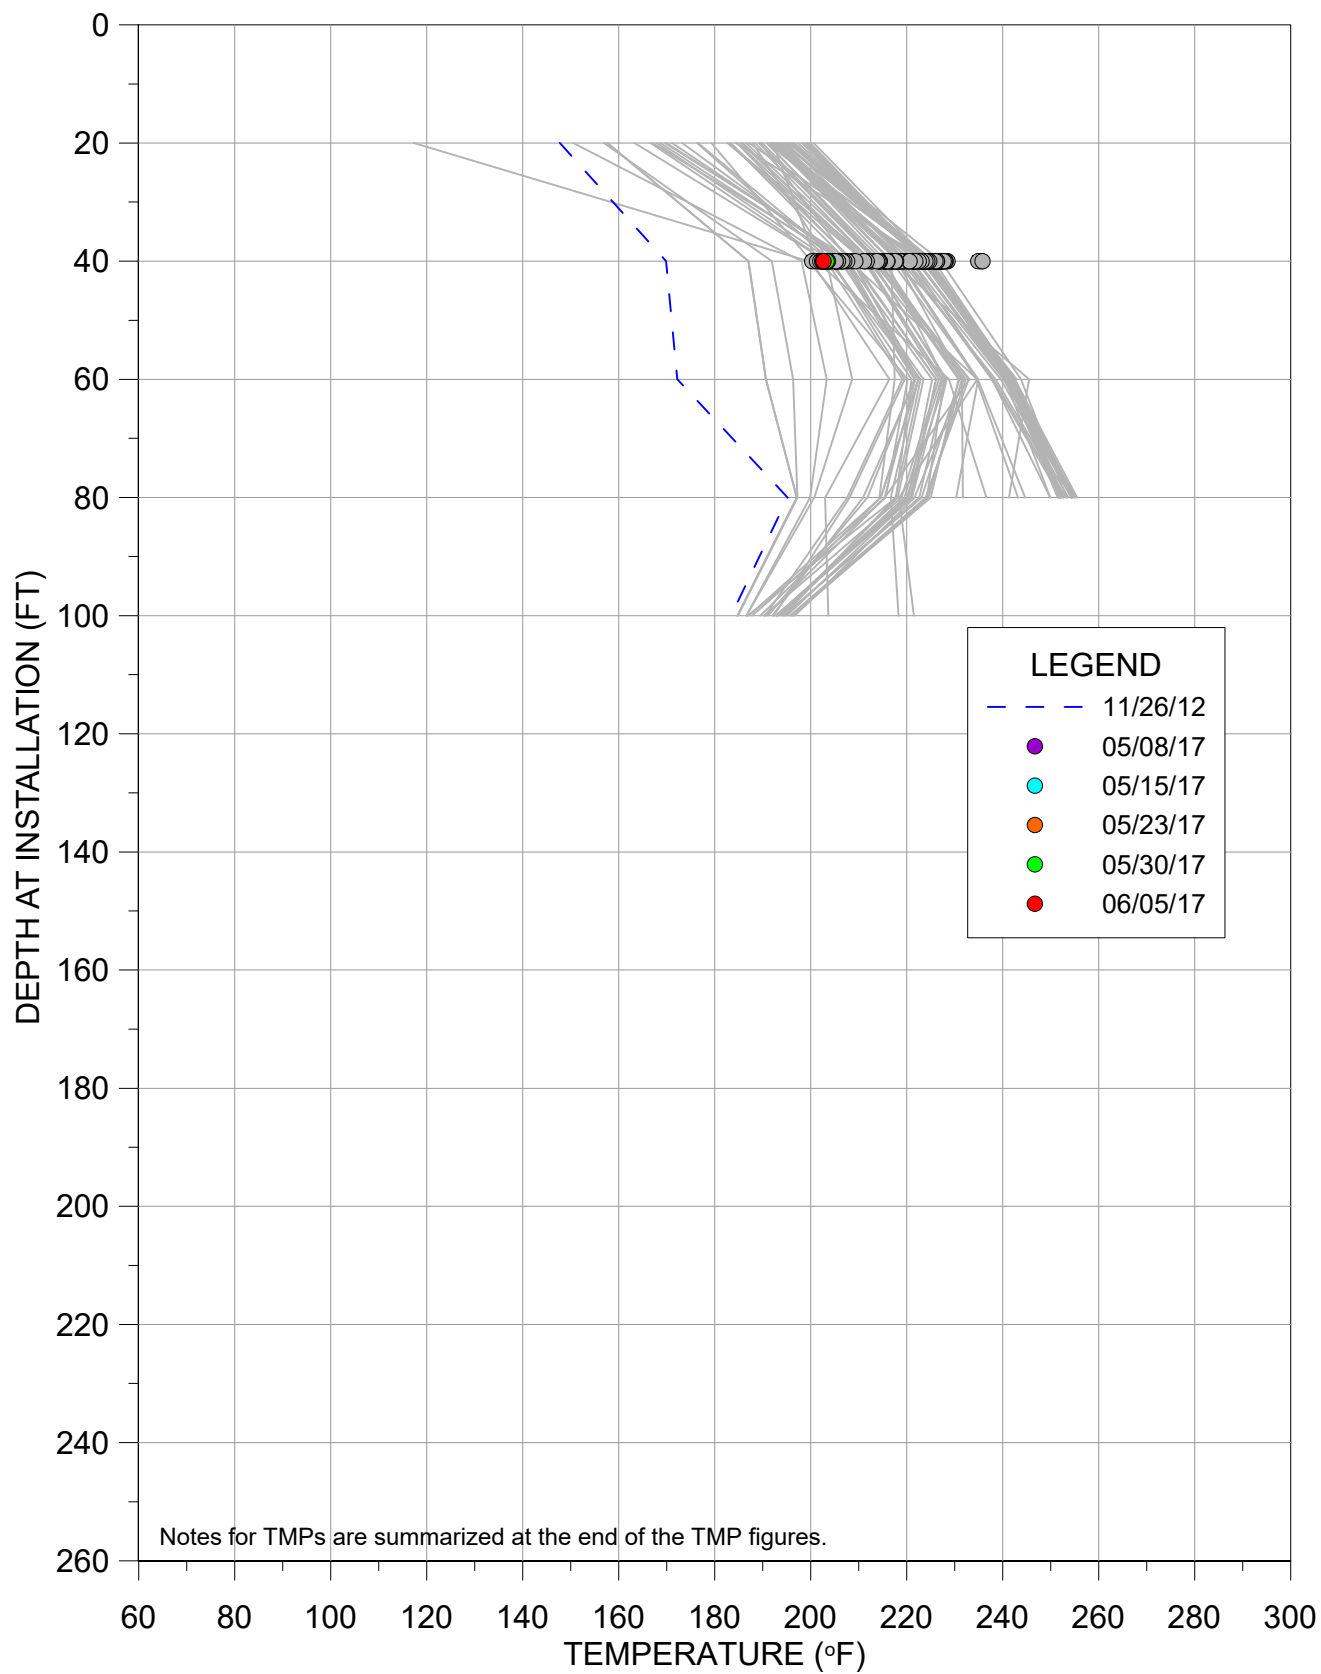
# TMP-9

1. Unit at 100 ft depth had an inaccurate temperature reading on 8/1/2013 and no reading since 8/6/2013.
2. The connectivity tests on 4/11/2014 conducted by CEC showed that units at 20, 60, 80, and 100 ft depths are no longer reliable.

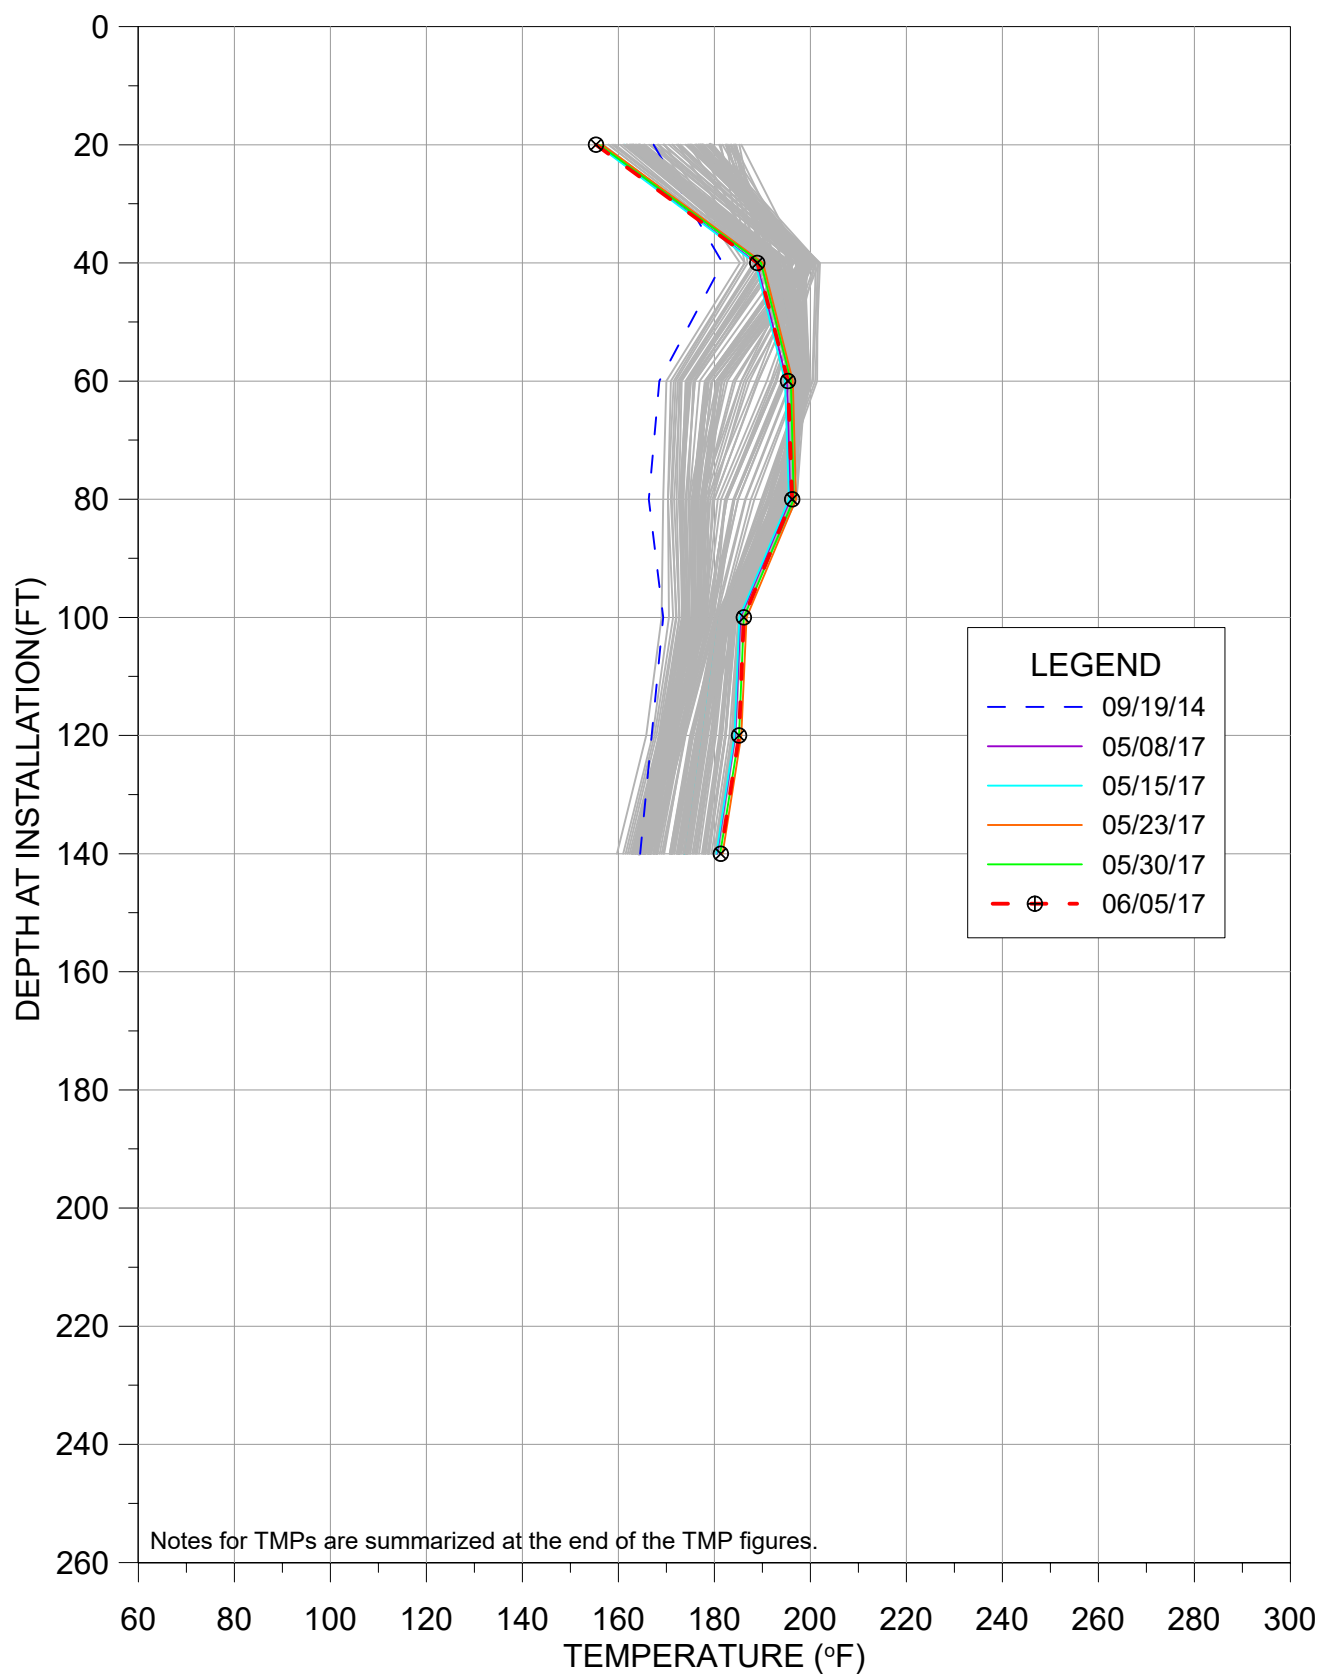
# TMP-14R

1. Due to the connectivity test results by Feezor Engineering on TMP-14 (see note above), TMP-14R is added to this reporting data set as of 3/7/2016.
