# **Bridgeton Landfill, LLC**

## **Weekly Data Submittal**

**Week of June 4, 2017 – June 10, 2017**

**Required by Section 52.F of Agreed Order, Case No. 13SL-CC01088  
Effective May 13, 2013**

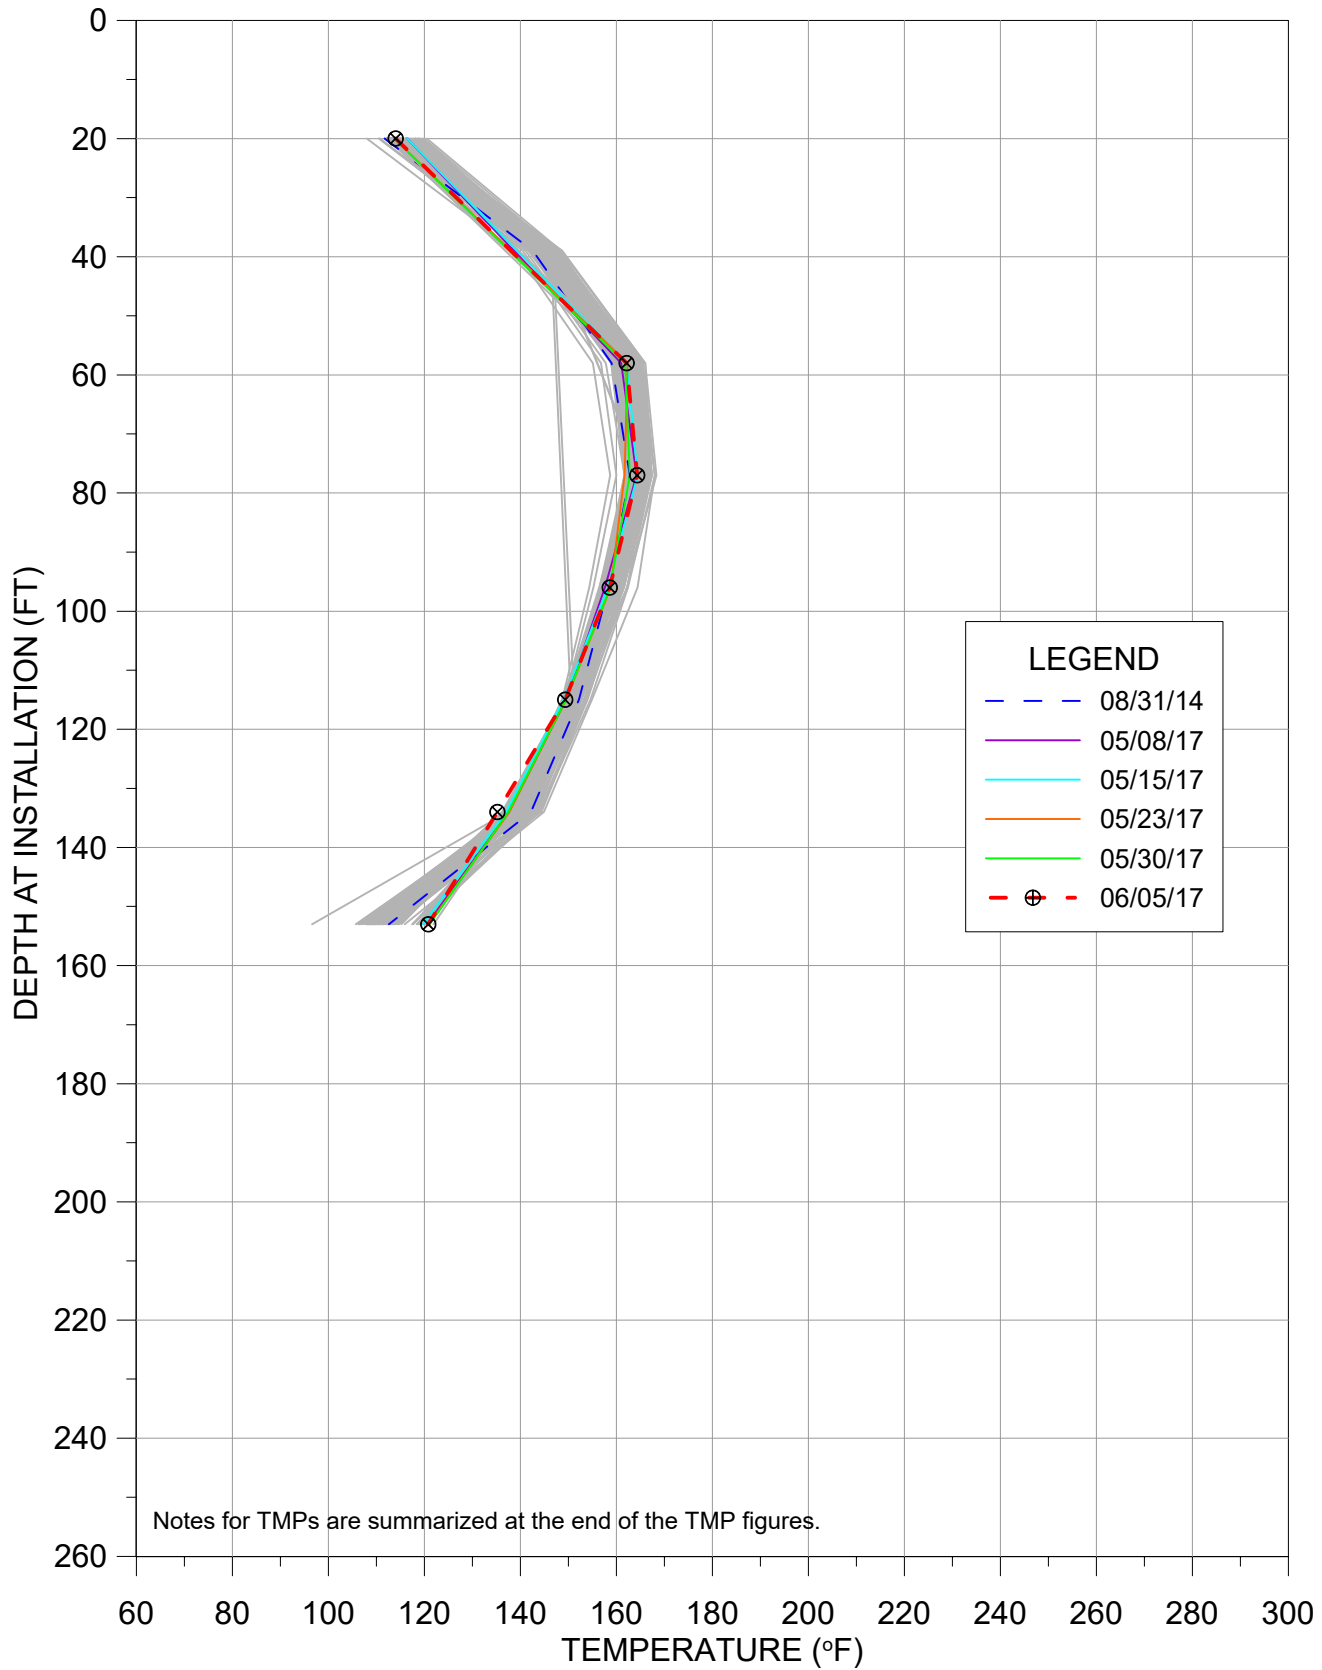
# TMP-16

1. A connectivity test conducted by Feezor Engineering showed that the units on TMP-16 may not be reliable since 9/9/2015. Further testing at the end of September 2015 showed possible connectivity on some of the units.
2. The unit at 153 ft depth had a low resistance reading and unreliable temperature since 12/21/2015.

3. The unit at 39 ft depth had a higher than acceptable resistance reading and unreliable temperature since 2/7/2017.

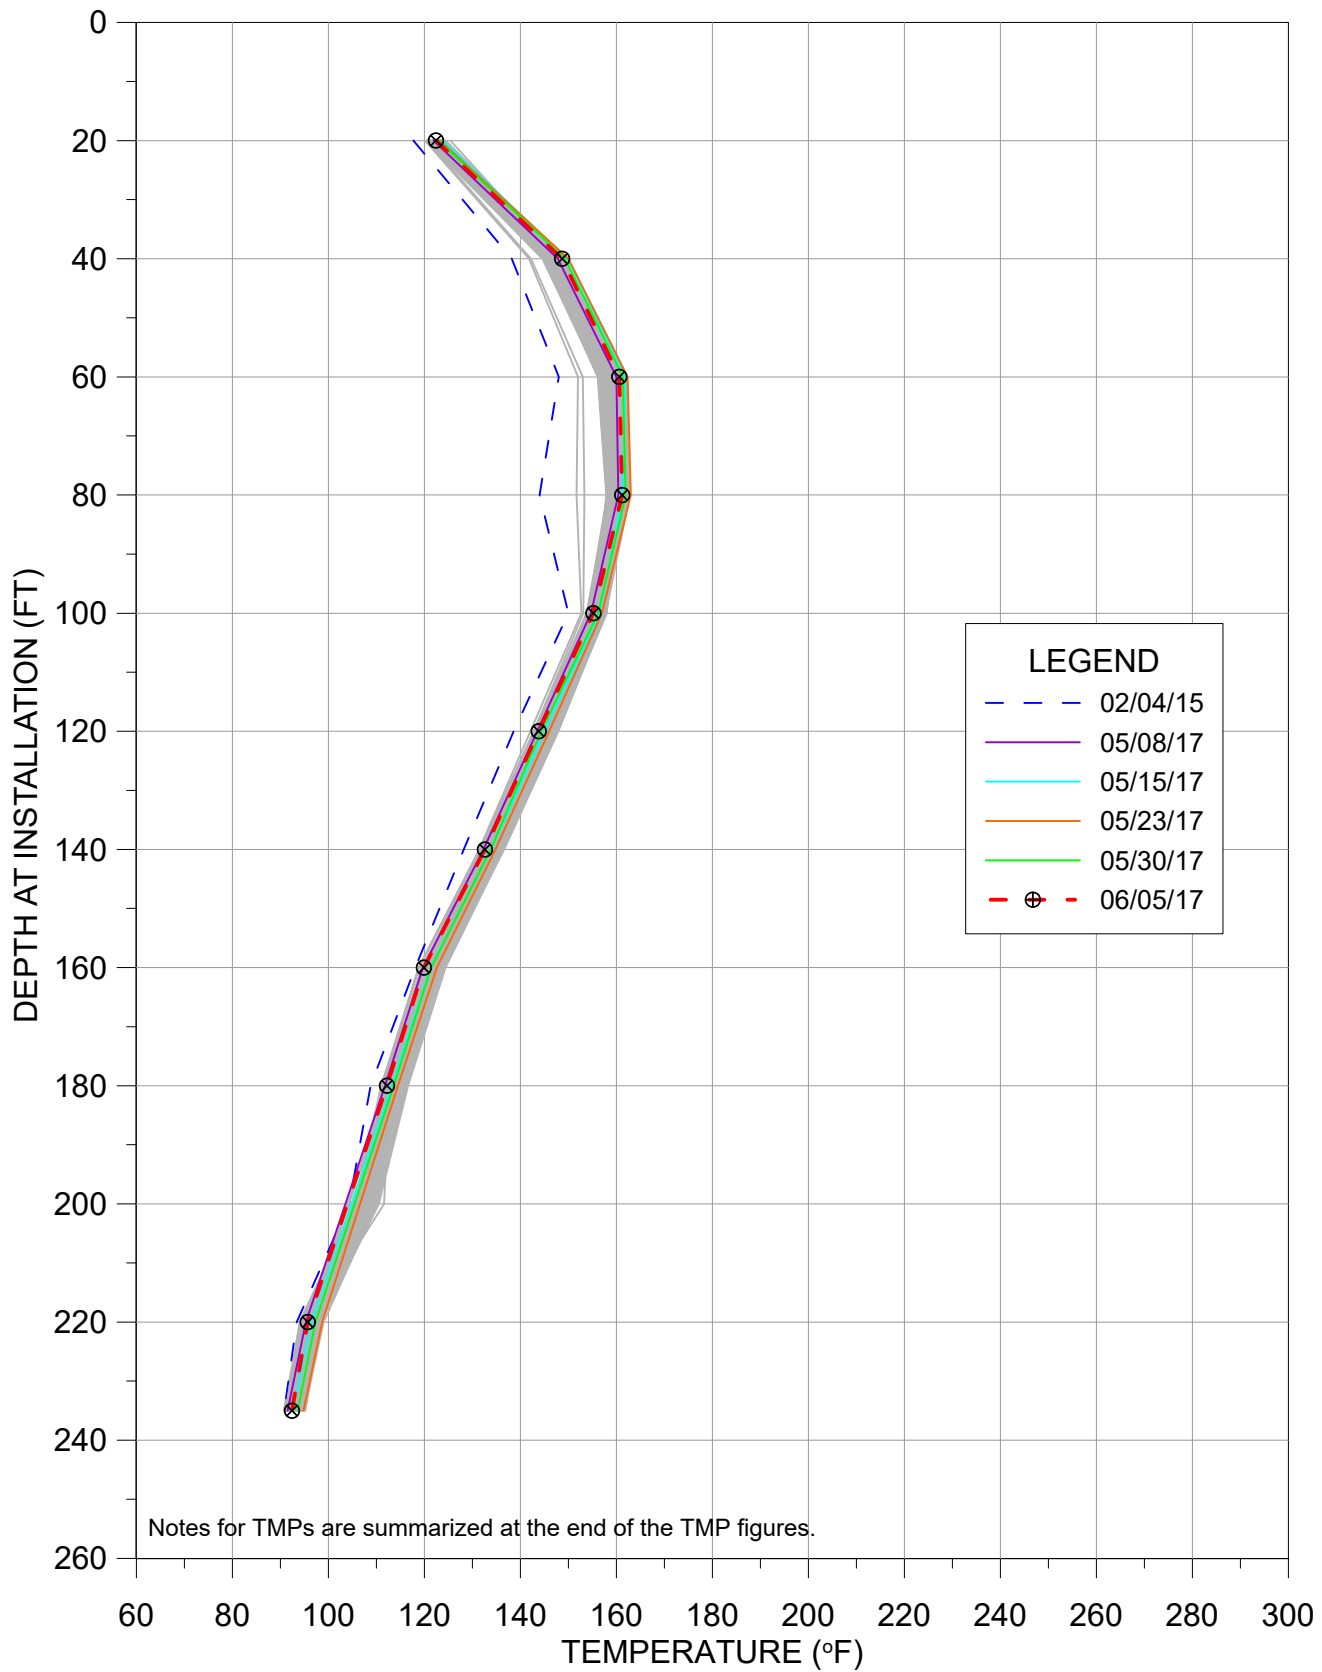
# TMP-25

1. The unit at 200 ft provided an apparent anomalous reading on 3/28/2017. Subsequent readings on 4/4/2017 showed the unit to have failed (see below). The unit is no longer working and the reading of 3/28/2017 was likely unreliable.
2. The unit at 200 ft depth had a resistance reading greater 4000 ohms on 4/4/2017. A connectivity test conducted by Feezor Engineering on 4/7/2017 showed that this unit also had cross-connectivity. The unit is therefore determined to be no longer working as of the 4/4/2017 reading.

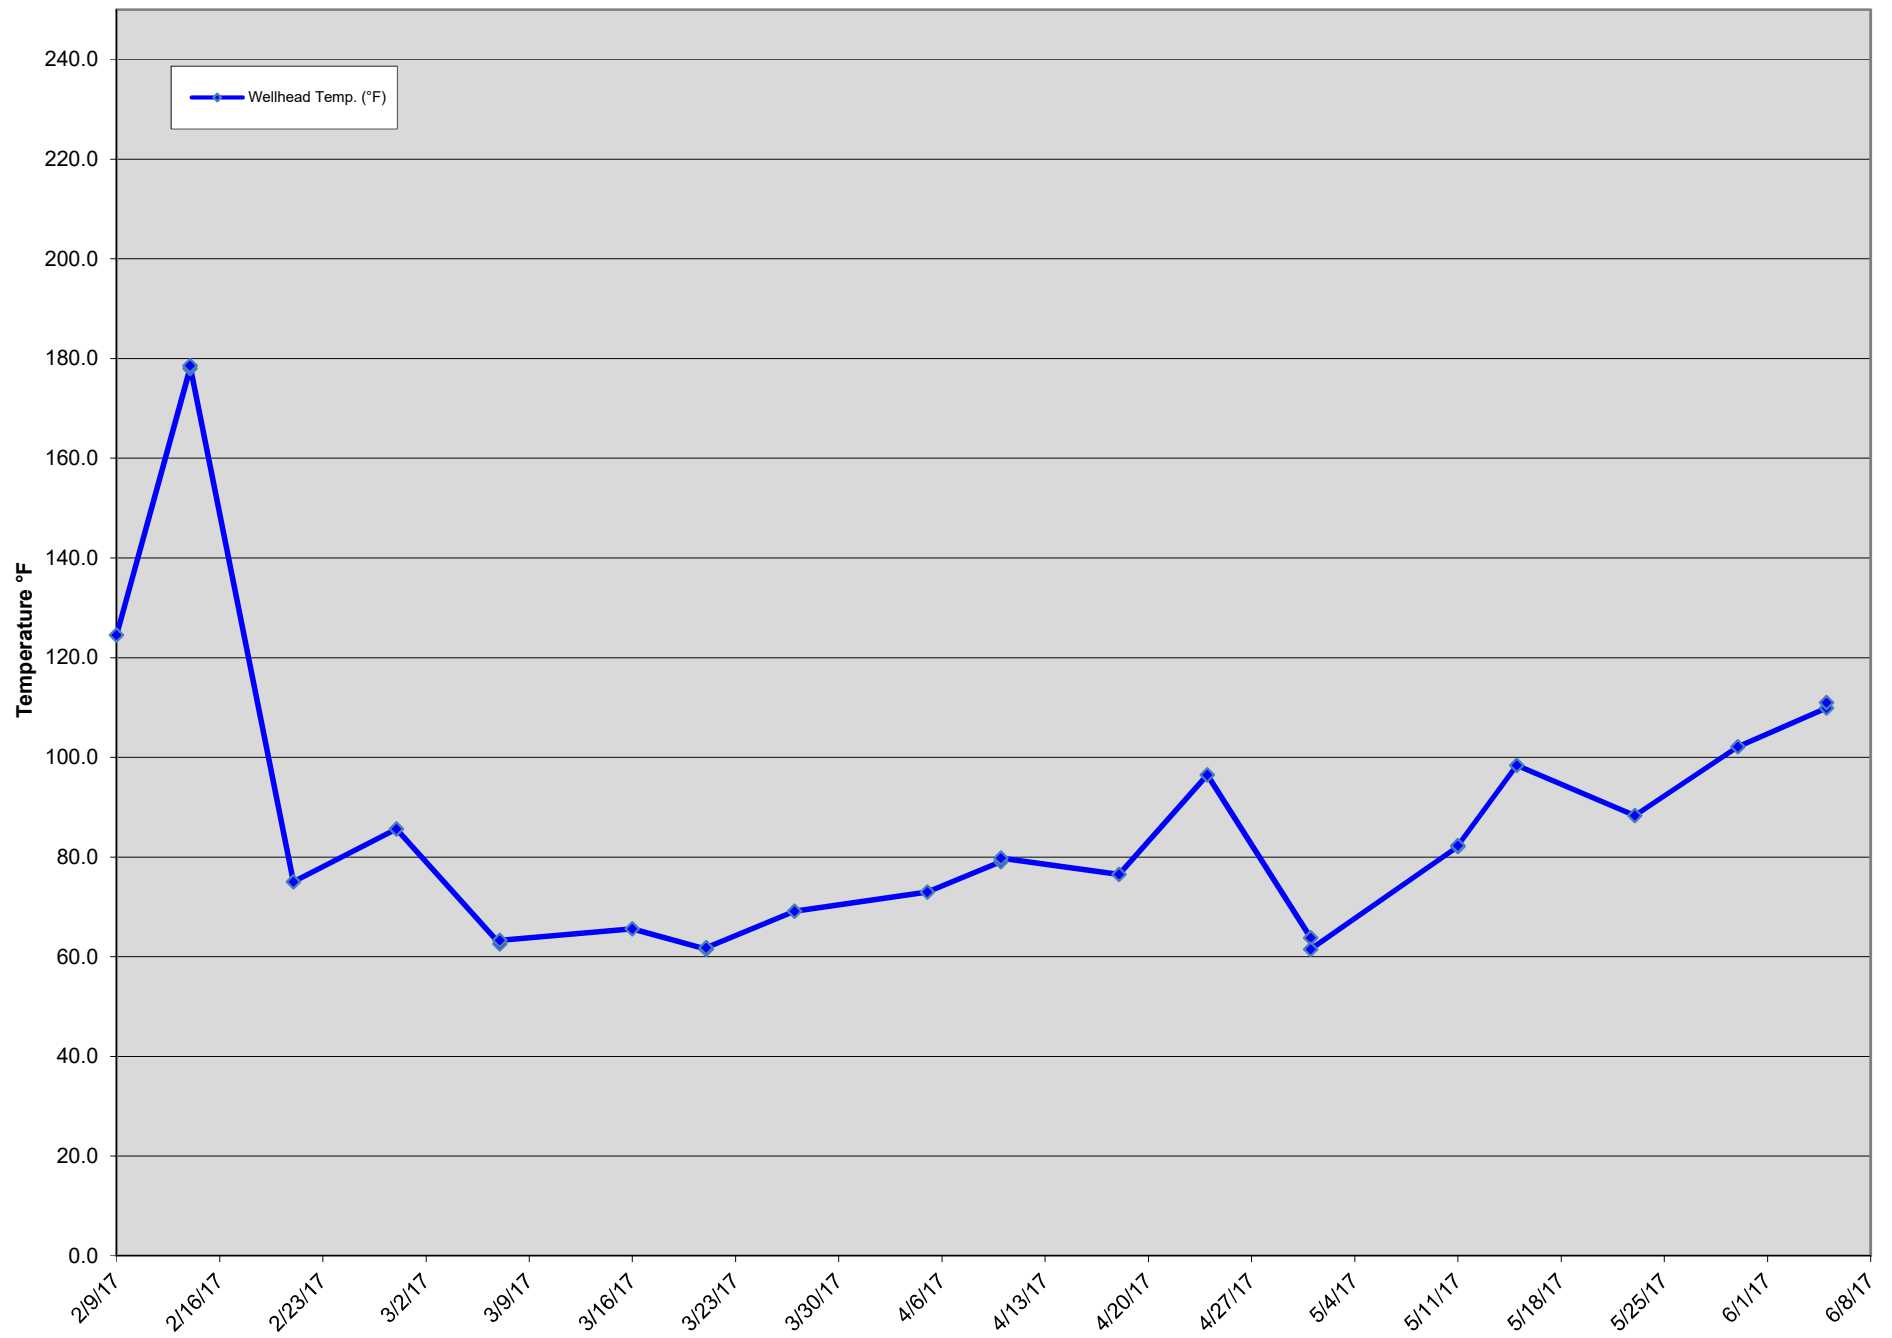
## GIW-1 Wellhead Temperatures

As part of the HES, there are currently cooling water circulation loops installed in twelve Gas Interceptor Wells (GIWs) (GIW-02 through GIW-13). The remaining well (GIW-01) had a measured gas temperature within its historical operating limits.
