# **Bridgeton Landfill, LLC**

## **Weekly Data Submittal**

**Week of June 11, 2017 – June 17, 2017**

**Required by Section 52.F of Agreed Order, Case No. 13SL-CC01088  
Effective May 13, 2013**

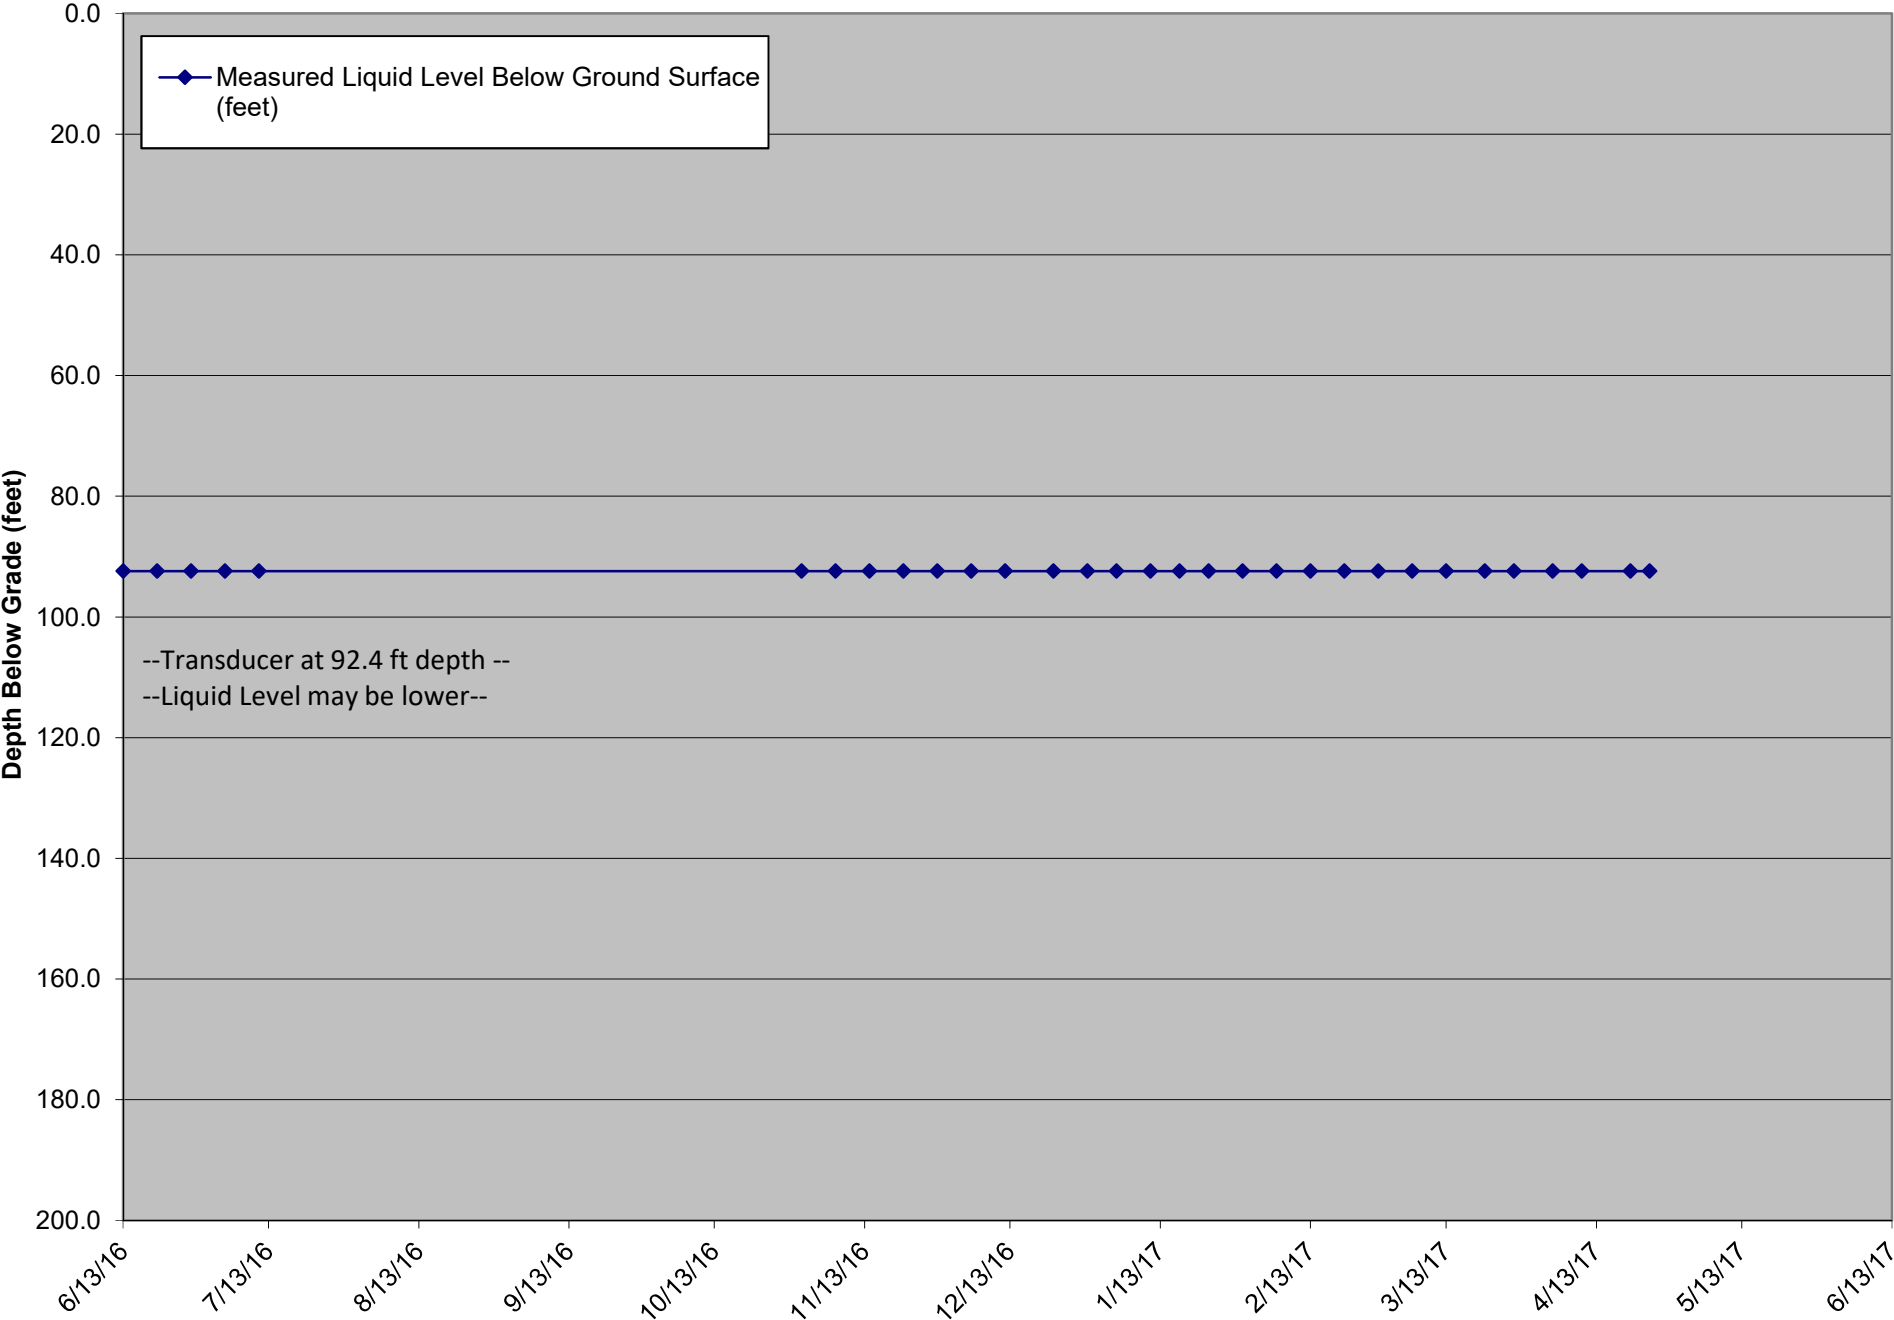
LCS-1D Liquid Level Below Ground Surface

Bridgeton Landfill is currently troubleshooting the pump in LCS-1D. Level sensor replacement is pending while awaiting parts arrival.

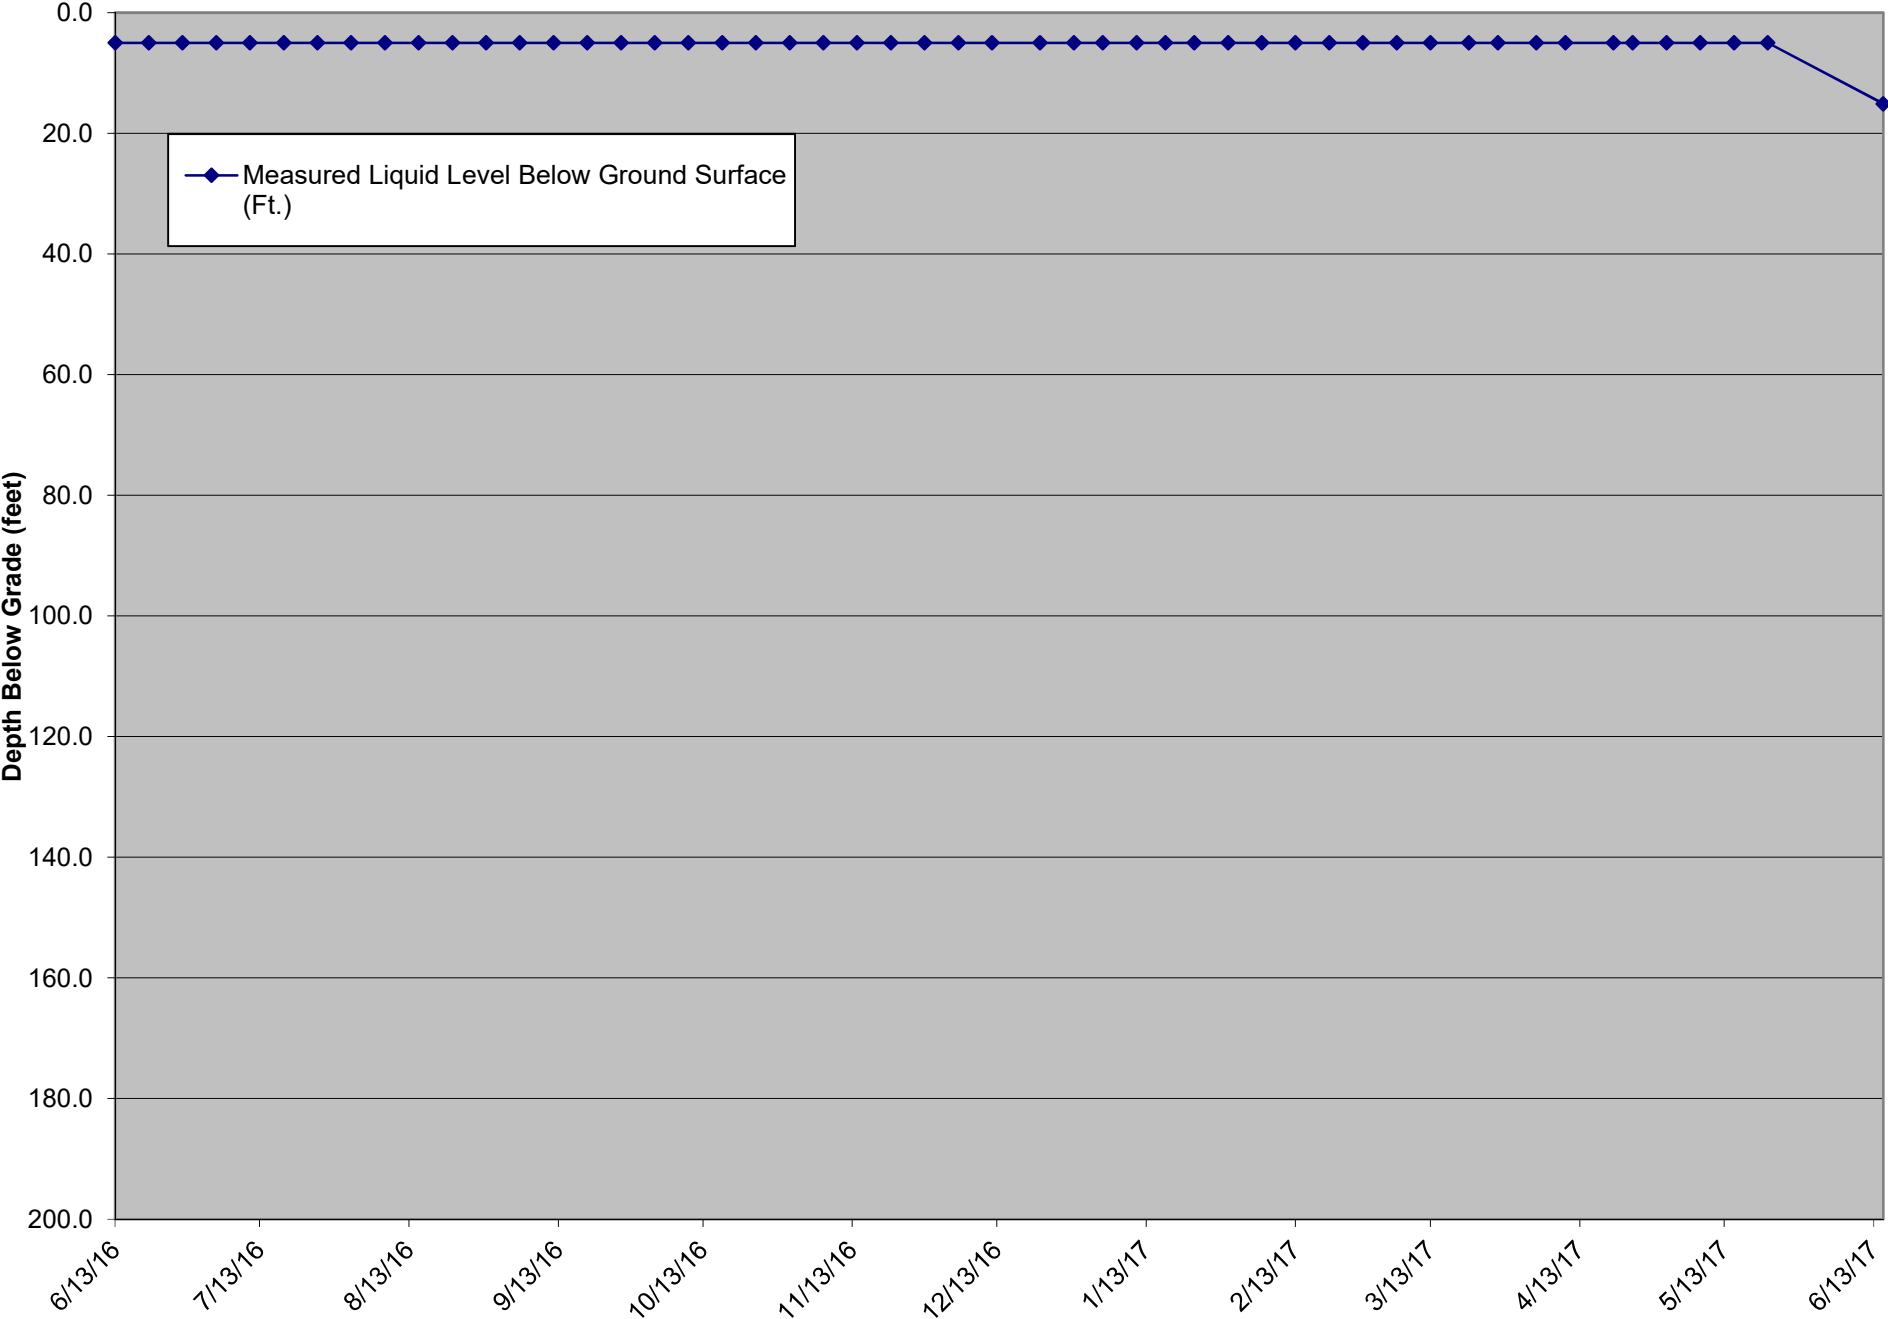
LCS-3D Liquid Level Below Ground Surface

Two Blackhawk pneumatic pumps were installed in LCS-3D on 6/13/2017. Blackhawk pumps do not require a level sensor. Liquid level was measured manually.

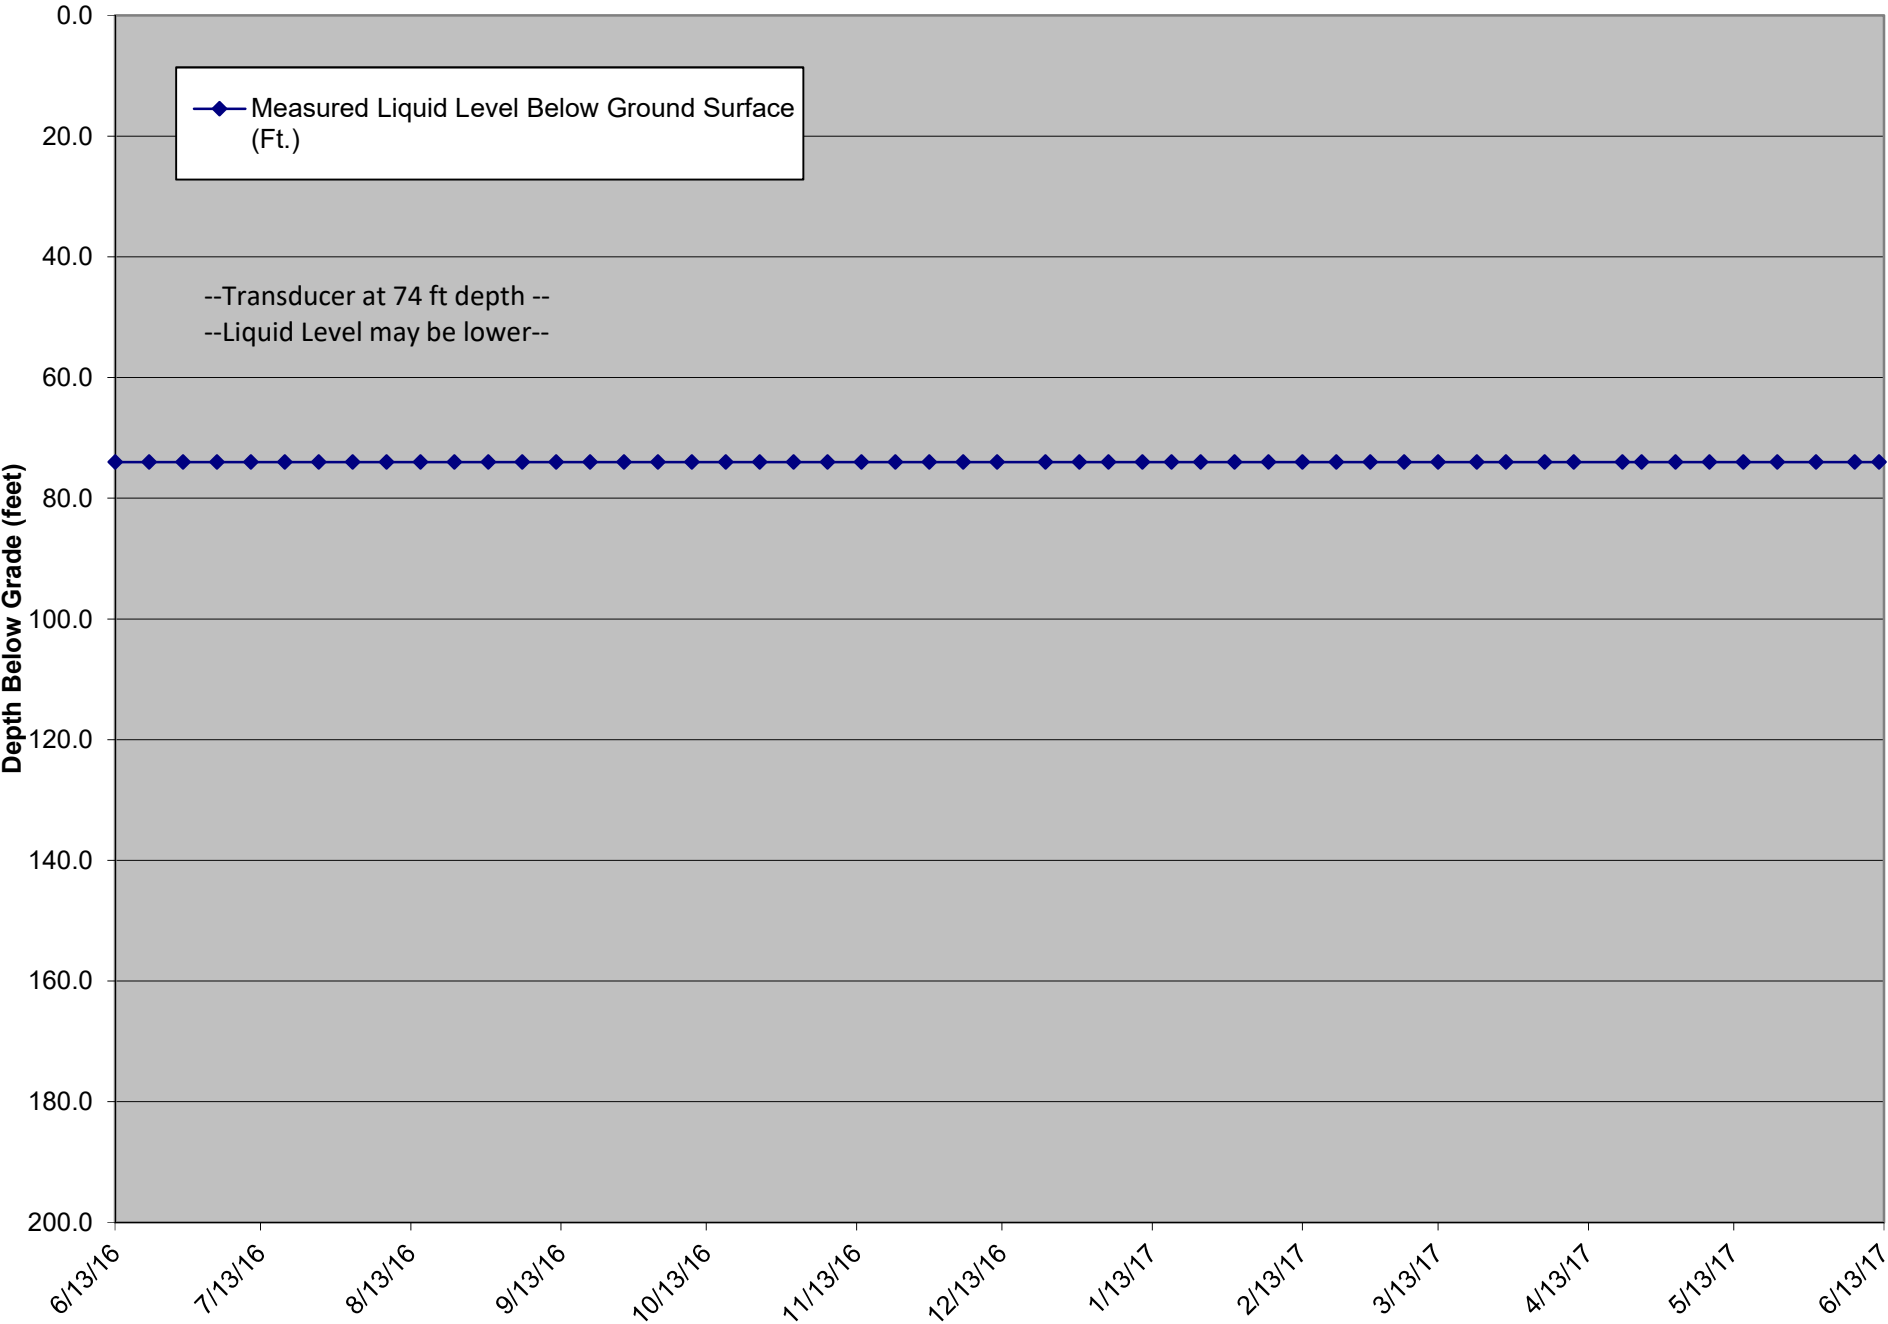
LCS-4B Liquid Level Below Ground Surface

The level sensor in LCS-4B is currently operational and responsive. Liquid level was not recorded by the level sensor during the weekly reporting period. LCS-4B is equipped with a flow meter that displayed no flow during the weekly reporting period. Therefore, it can be concluded that the liquid level was below the bottom of the pump and level sensor in LCS-4B.

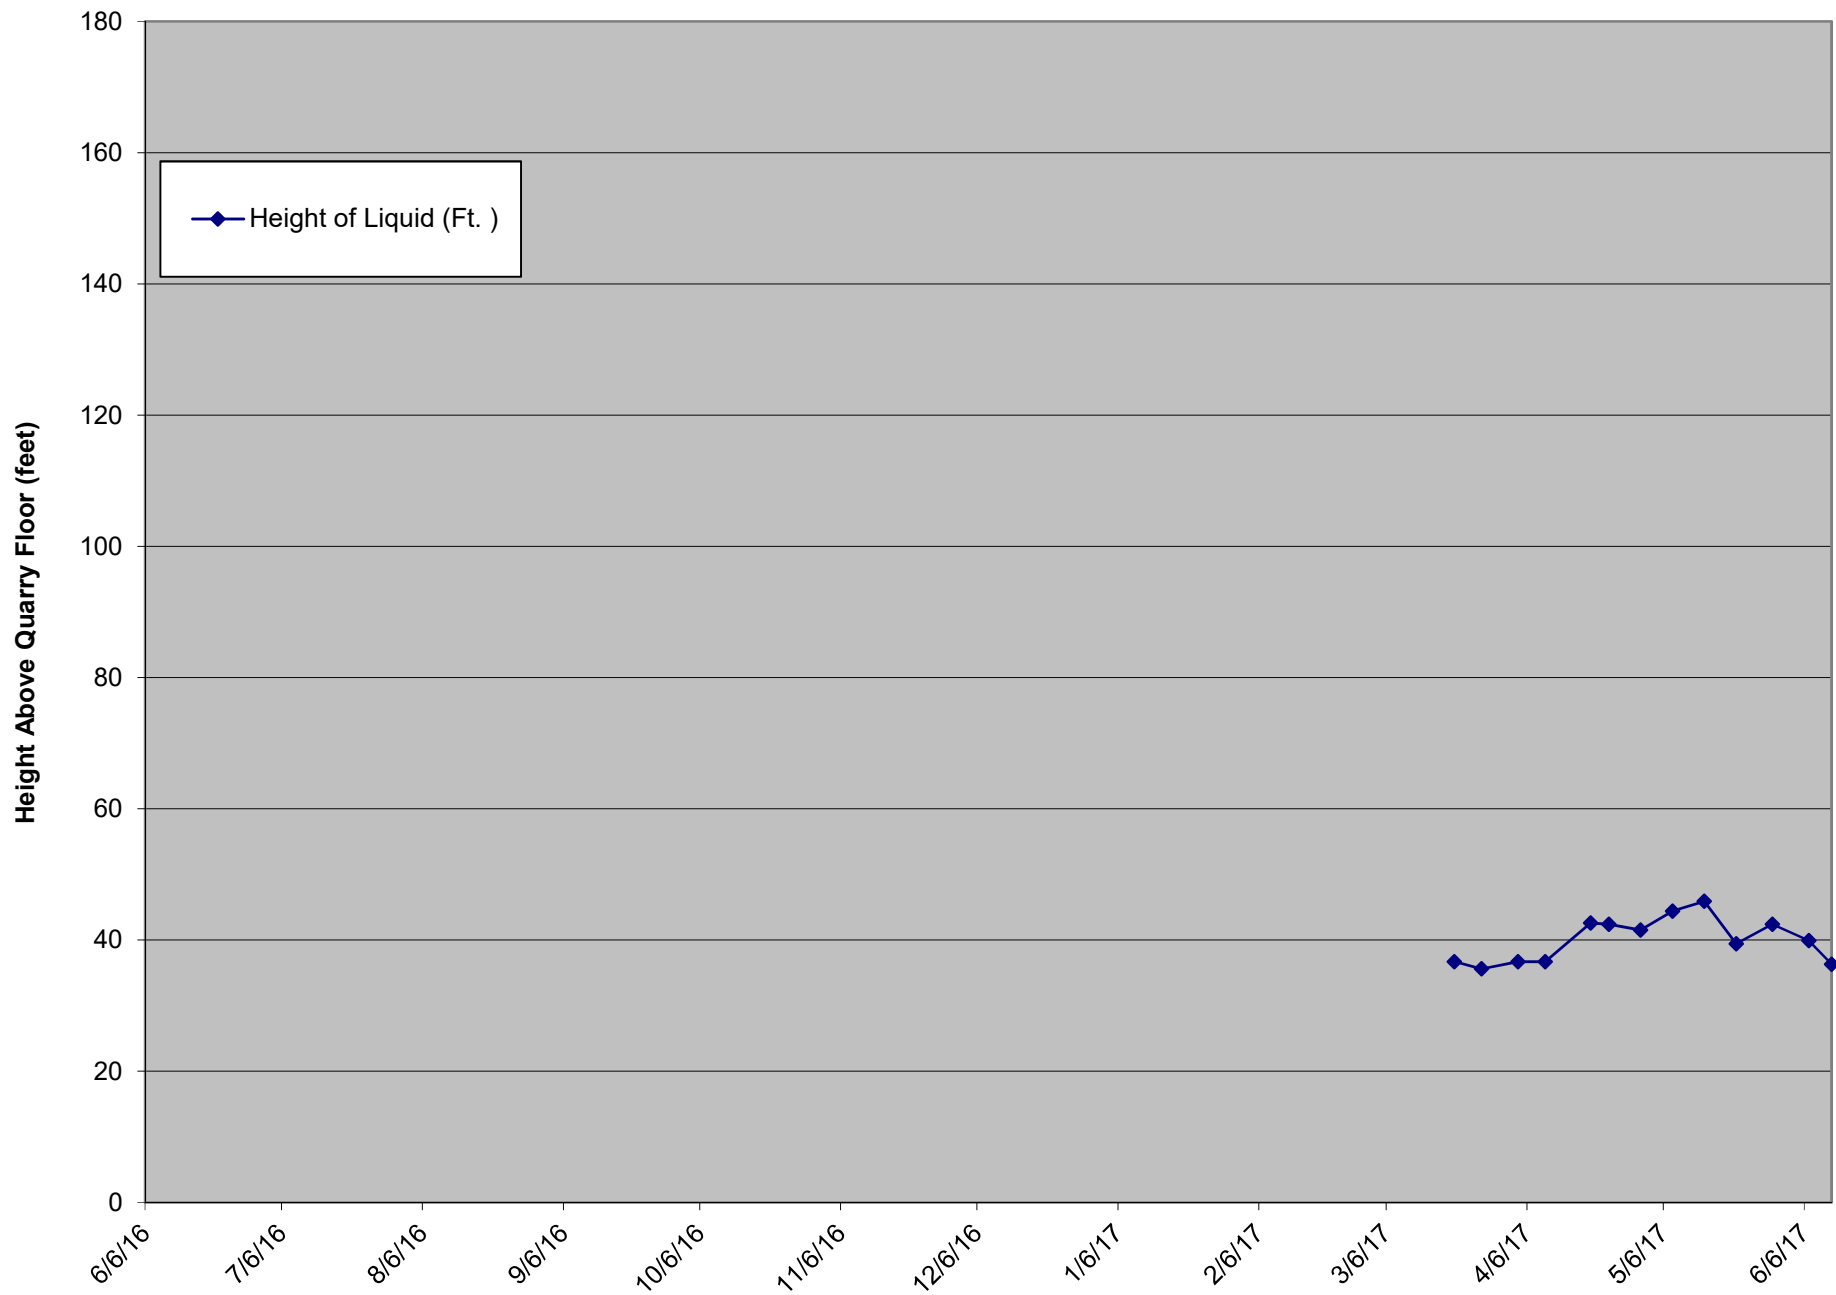
LCS-5B Liquid Level Above Quarry Floor

LCS-5B and LCS-6B were fully operational during the weekly reporting period. LCS-5B and LCS-6B were shut off periodically during the weekly reporting period for North Quarry EVOH related work.

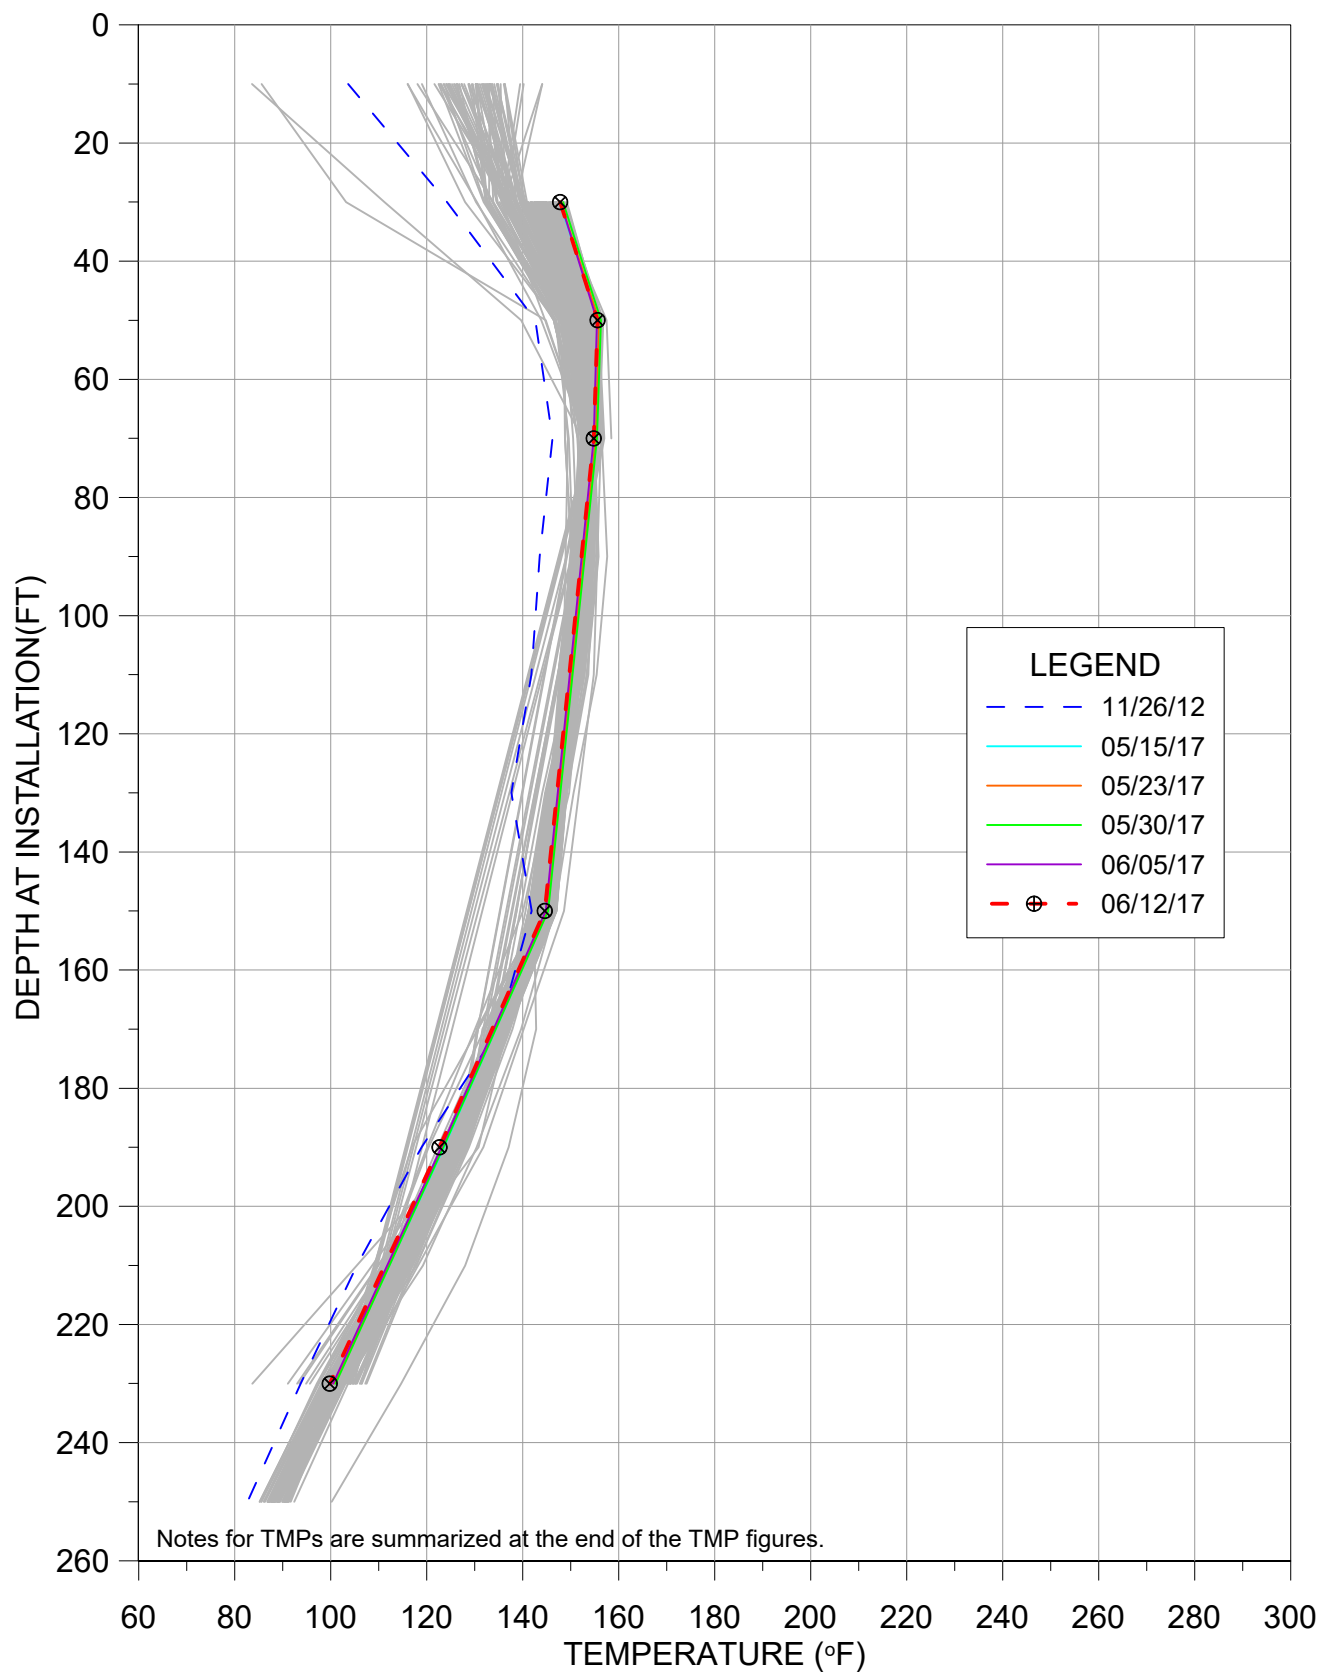
# TMP-3

1. No reliable temperature readings have been obtained at 170 ft depth since 1/29/2014, except on 3/13/2014.
2. The connectivity tests on 4/11/2014 conducted by CEC showed that units at 10, 90, 130, 210 and 250 ft depths are no longer reliable.
3. The connectivity tests on 10/28/2014 conducted by Feezor Engineering showed that units at 10, 90, 110, 130, 210 and 250 ft depths are not reliable.

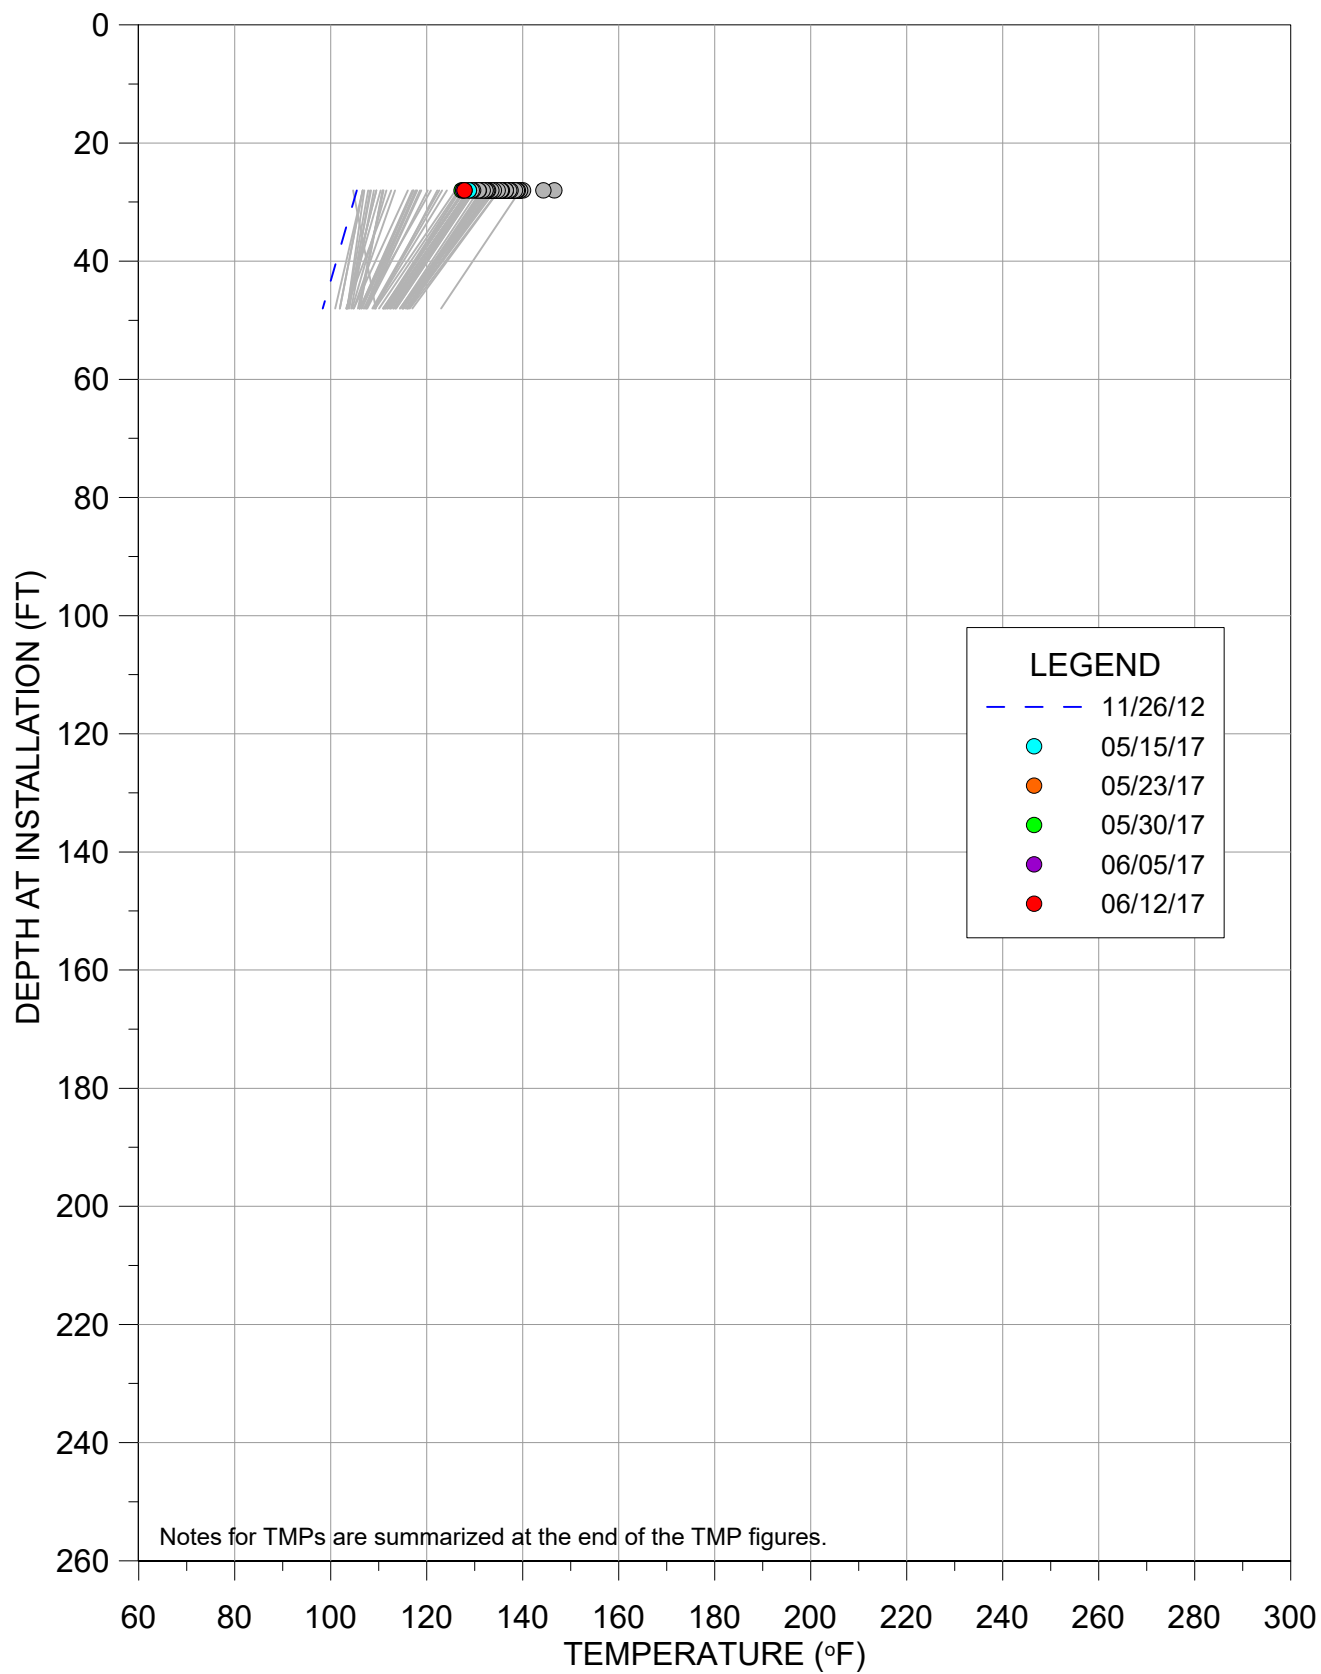
# TMP-4

1. The connectivity tests on 4/11/2014 conducted by CEC showed that the unit at 48 ft depth is no longer reliable.

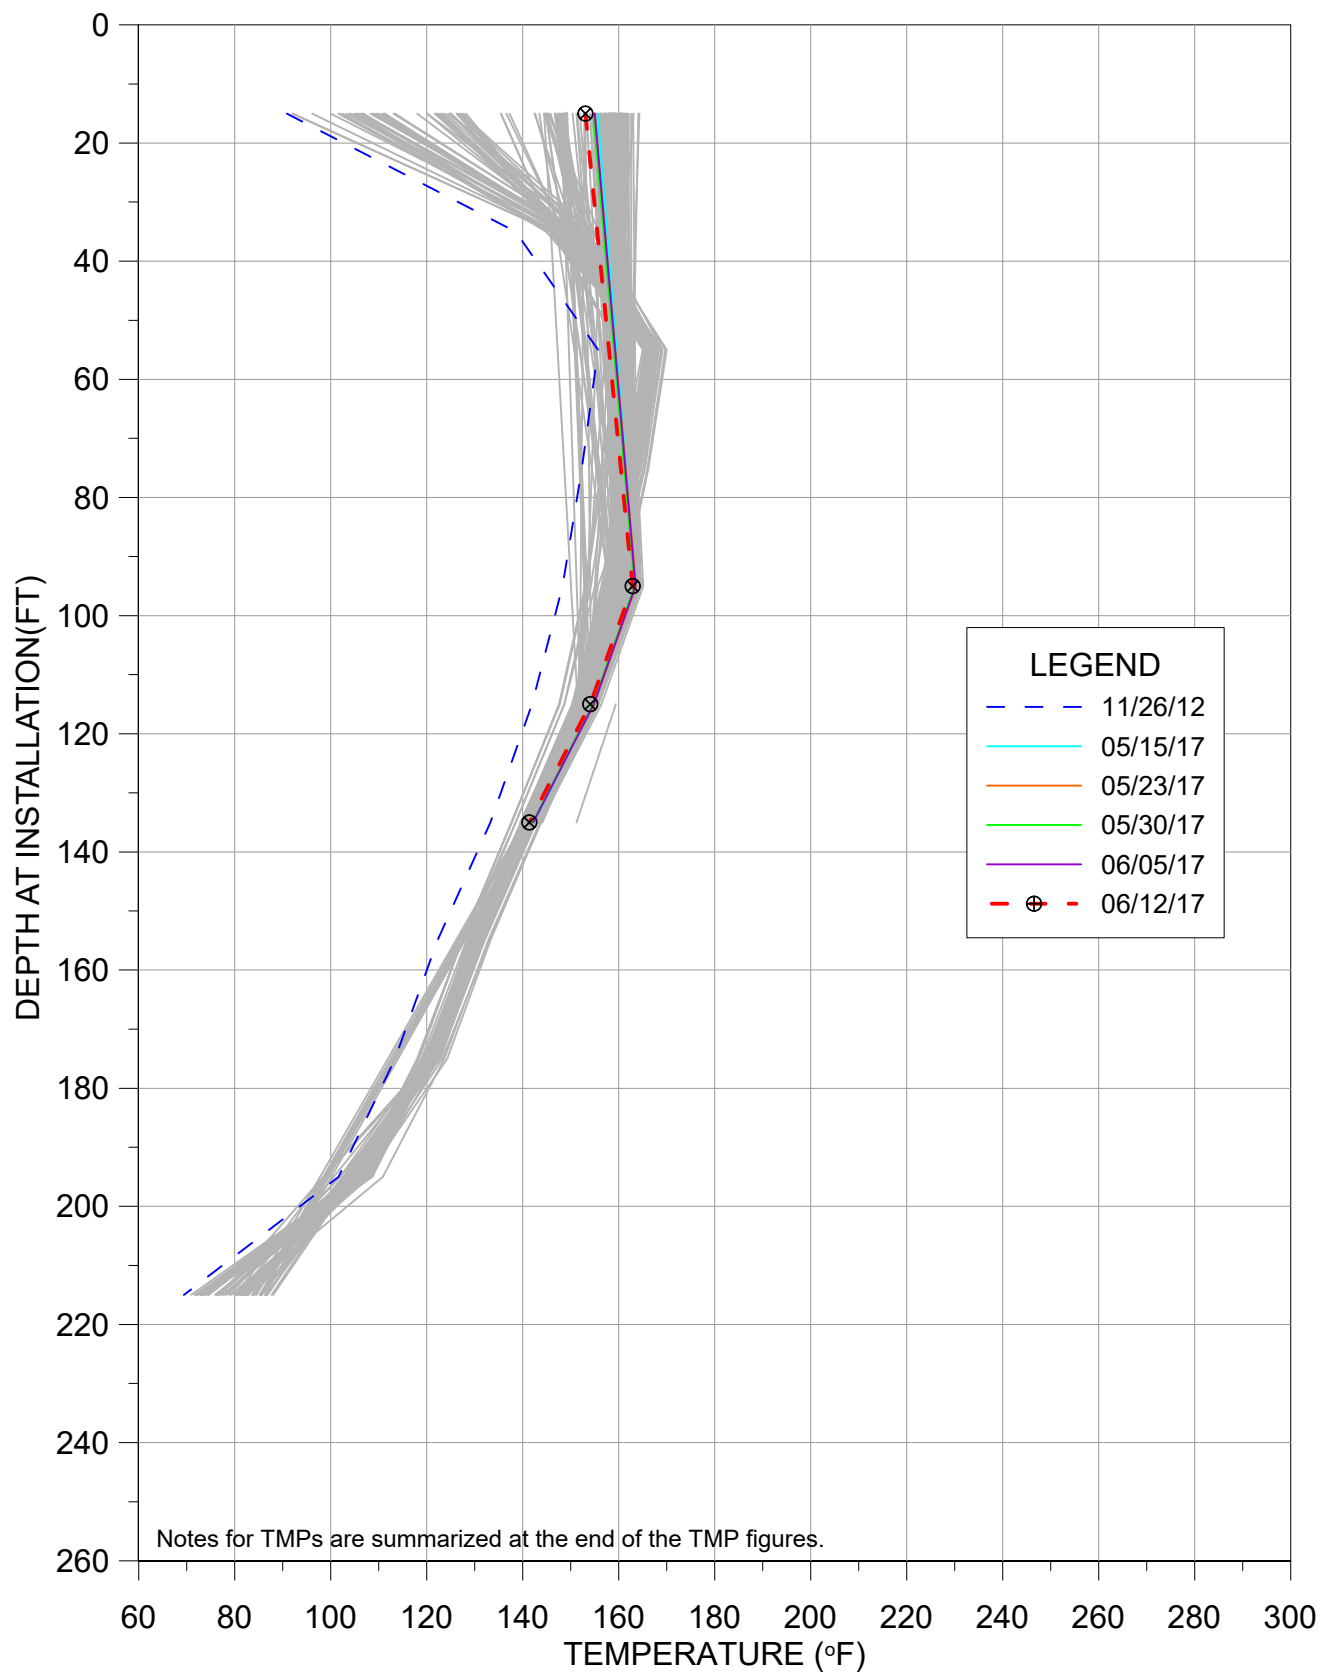
# TMP-6

1. The connectivity tests on 4/11/2014 conducted by CEC showed that units at 35, 55, 75, 155, 175, and 195 ft depths are no longer reliable.
2. No reliable temperature readings have been obtained at the unit at 215 ft depth since 6/13/2014.

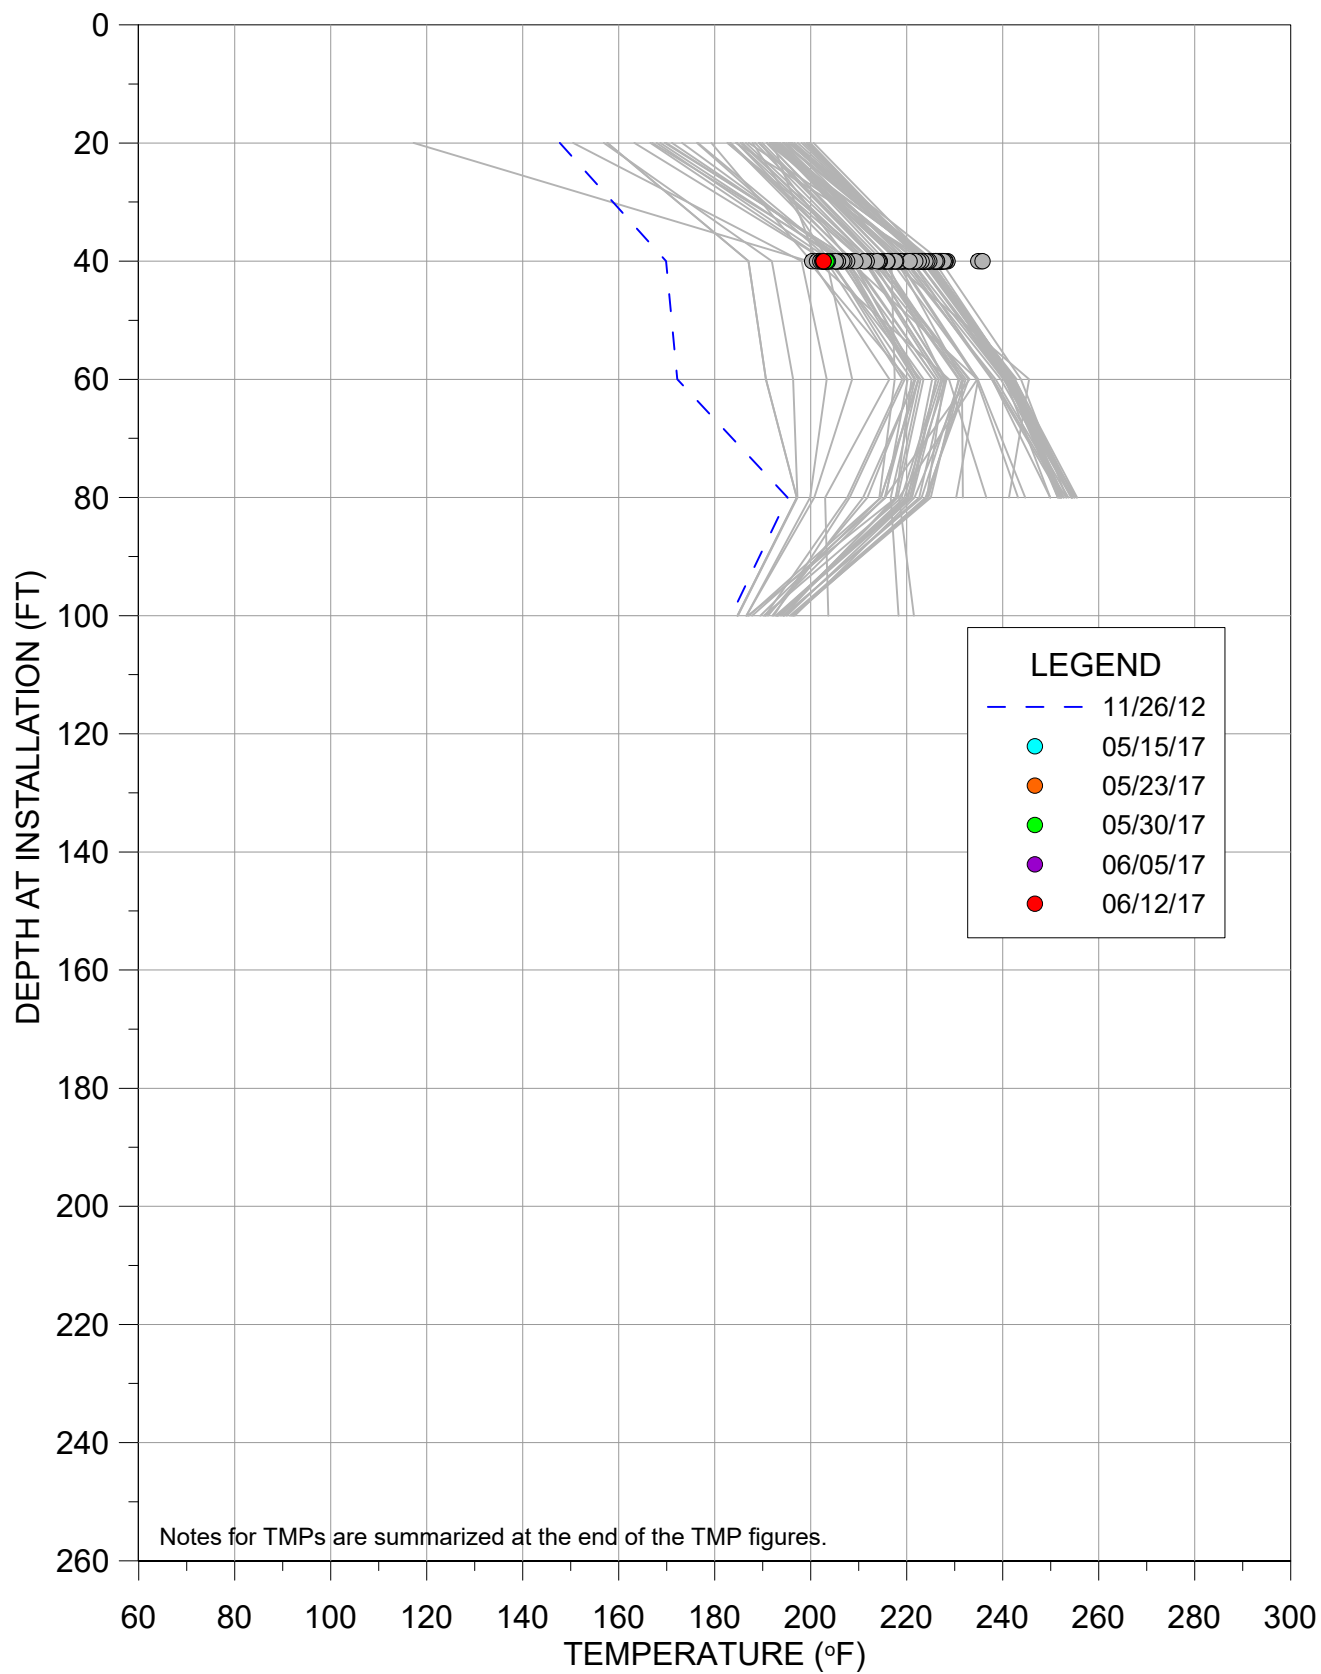
# TMP-9

1. Unit at 100 ft depth had an inaccurate temperature reading on 8/1/2013 and no reading since 8/6/2013.
2. The connectivity tests on 4/11/2014 conducted by CEC showed that units at 20, 60, 80, and 100 ft depths are no longer reliable.

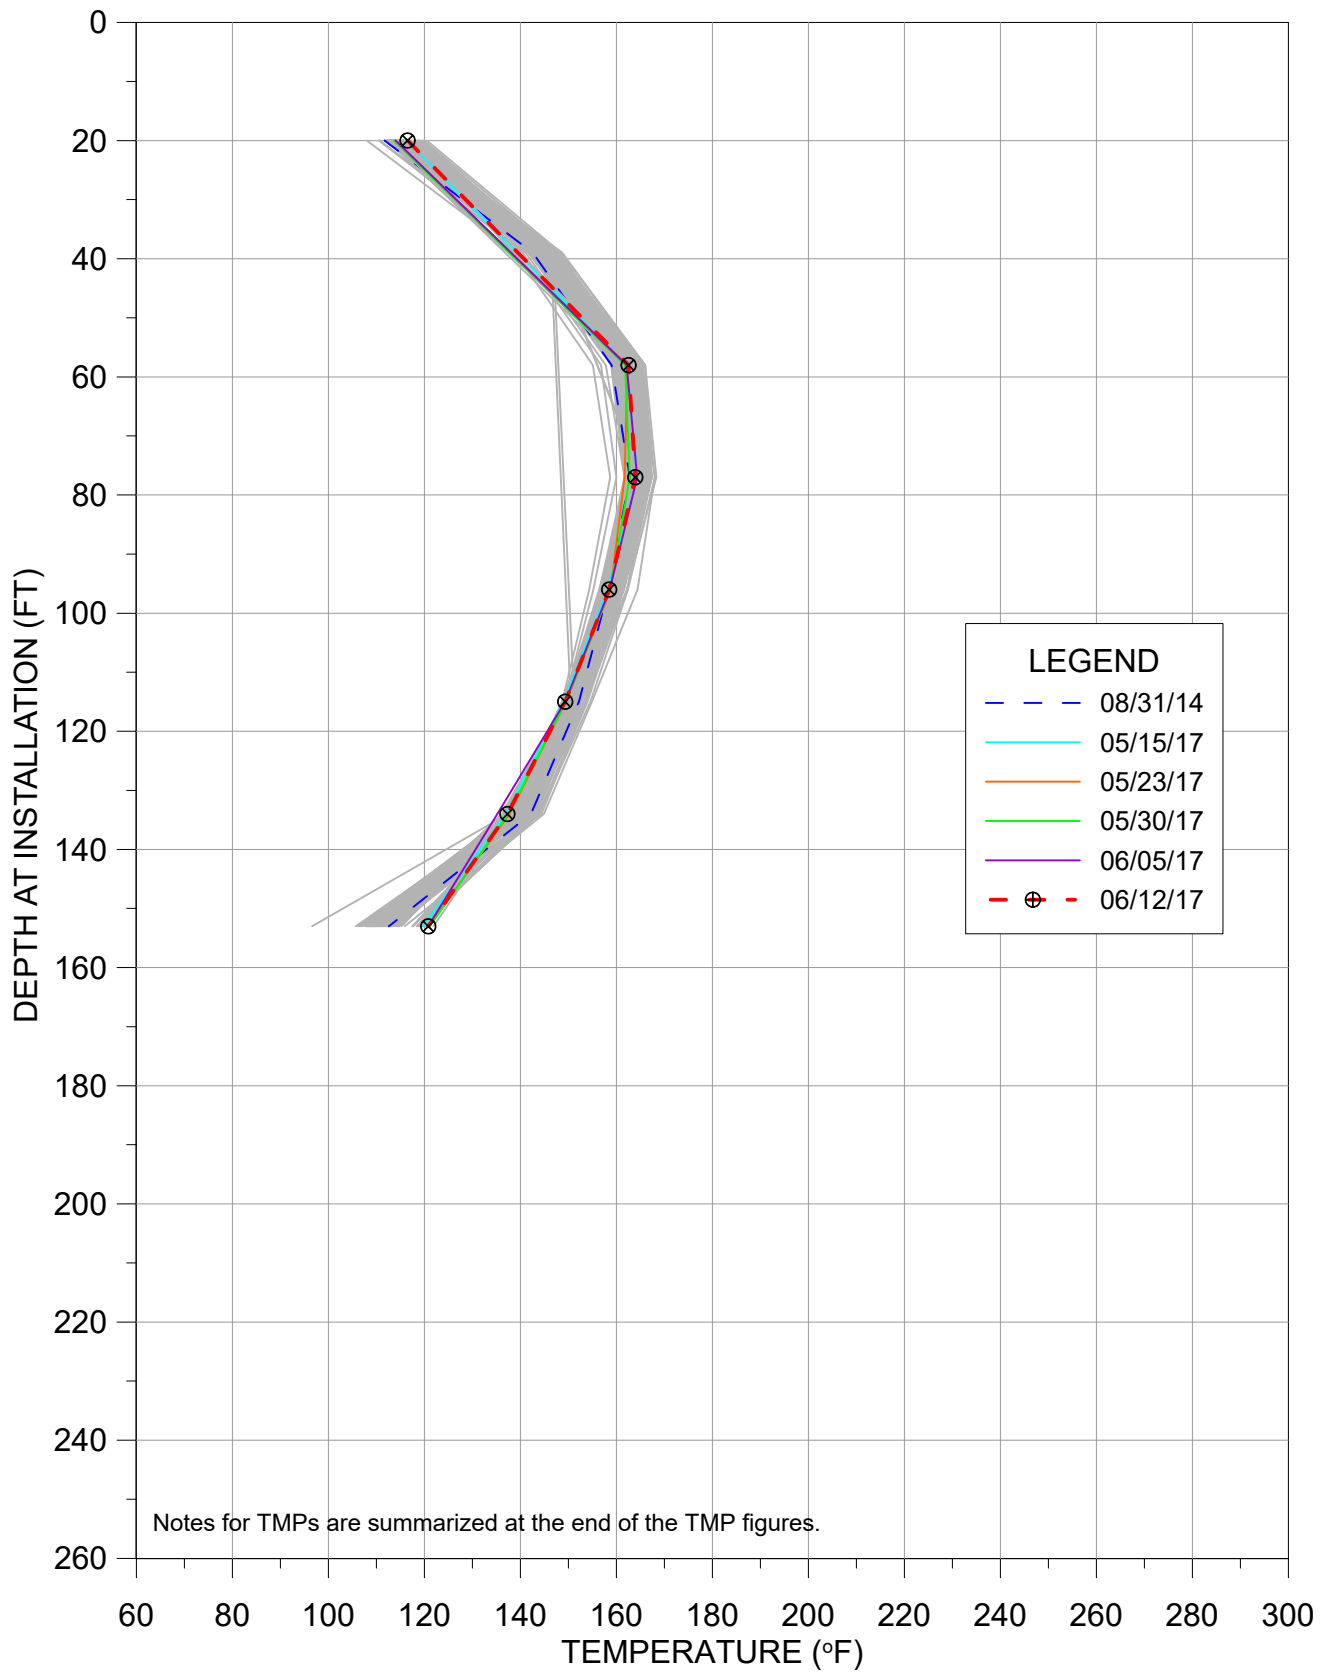
# TMP-16

1. A connectivity test conducted by Feezor Engineering showed that the units on TMP-16 may not be reliable since 9/9/2015. Further testing at the end of September 2015 showed possible connectivity on some of the units.
2. The unit at 153 ft depth had a low resistance reading and unreliable temperature since 12/21/2015.

3. The unit at 39 ft depth had a higher than acceptable resistance reading and unreliable temperature since 2/7/2017.
