# **Bridgeton Landfill, LLC**

## **Weekly Data Submittal**

**Week of June 11, 2017 – June 17, 2017**

**Required by Section 52.F of Agreed Order, Case No. 13SL-CC01088  
Effective May 13, 2013**

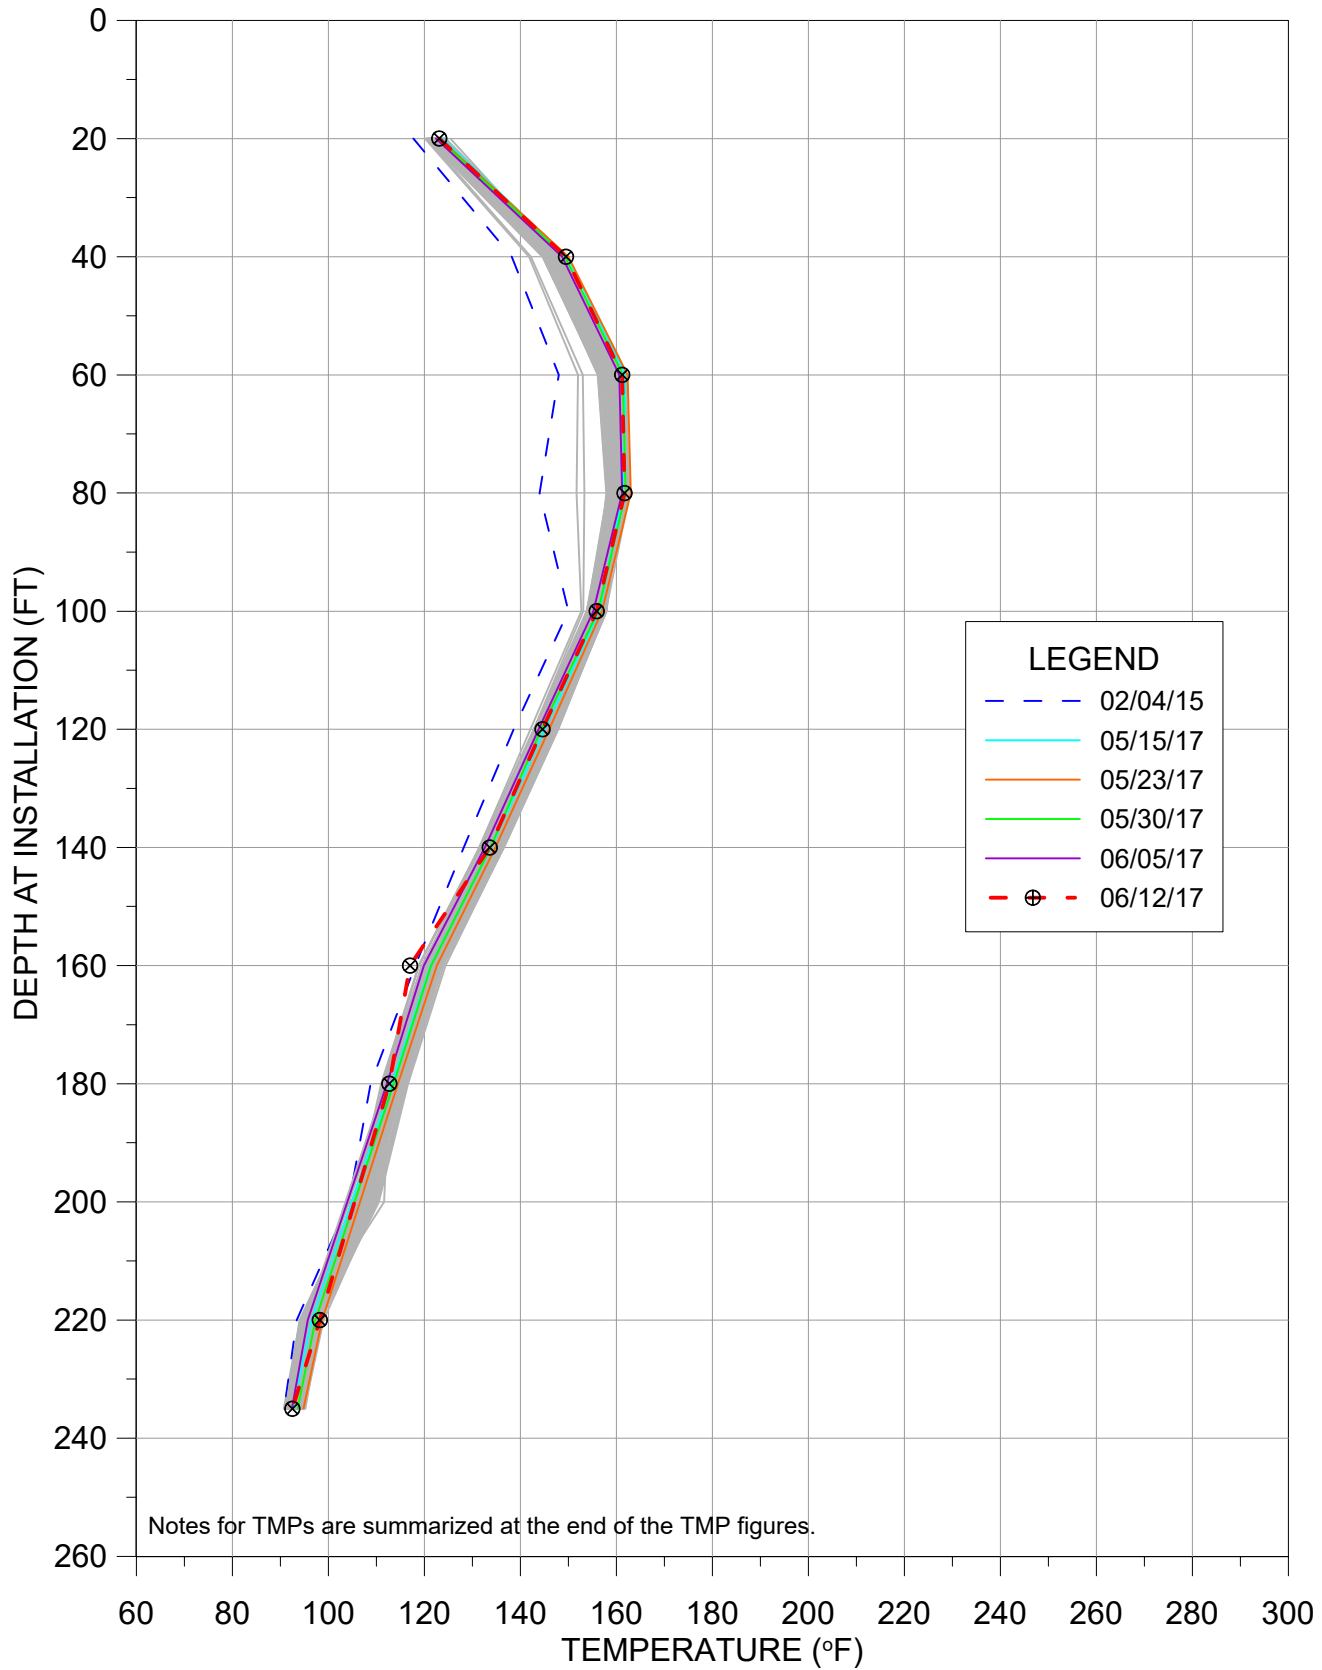
# TMP-25

1. The unit at 200 ft provided an apparent anomalous reading on 3/28/2017. Subsequent readings on 4/4/2017 showed the unit to have failed (see below). The unit is no longer working and the reading of 3/28/2017 was likely unreliable.
2. The unit at 200 ft depth had a resistance reading greater 4000 ohms on 4/4/2017. A connectivity test conducted by Feezor Engineering on 4/7/2017 showed that this unit also had cross-connectivity. The unit is therefore determined to be no longer working as of the 4/4/2017 reading.

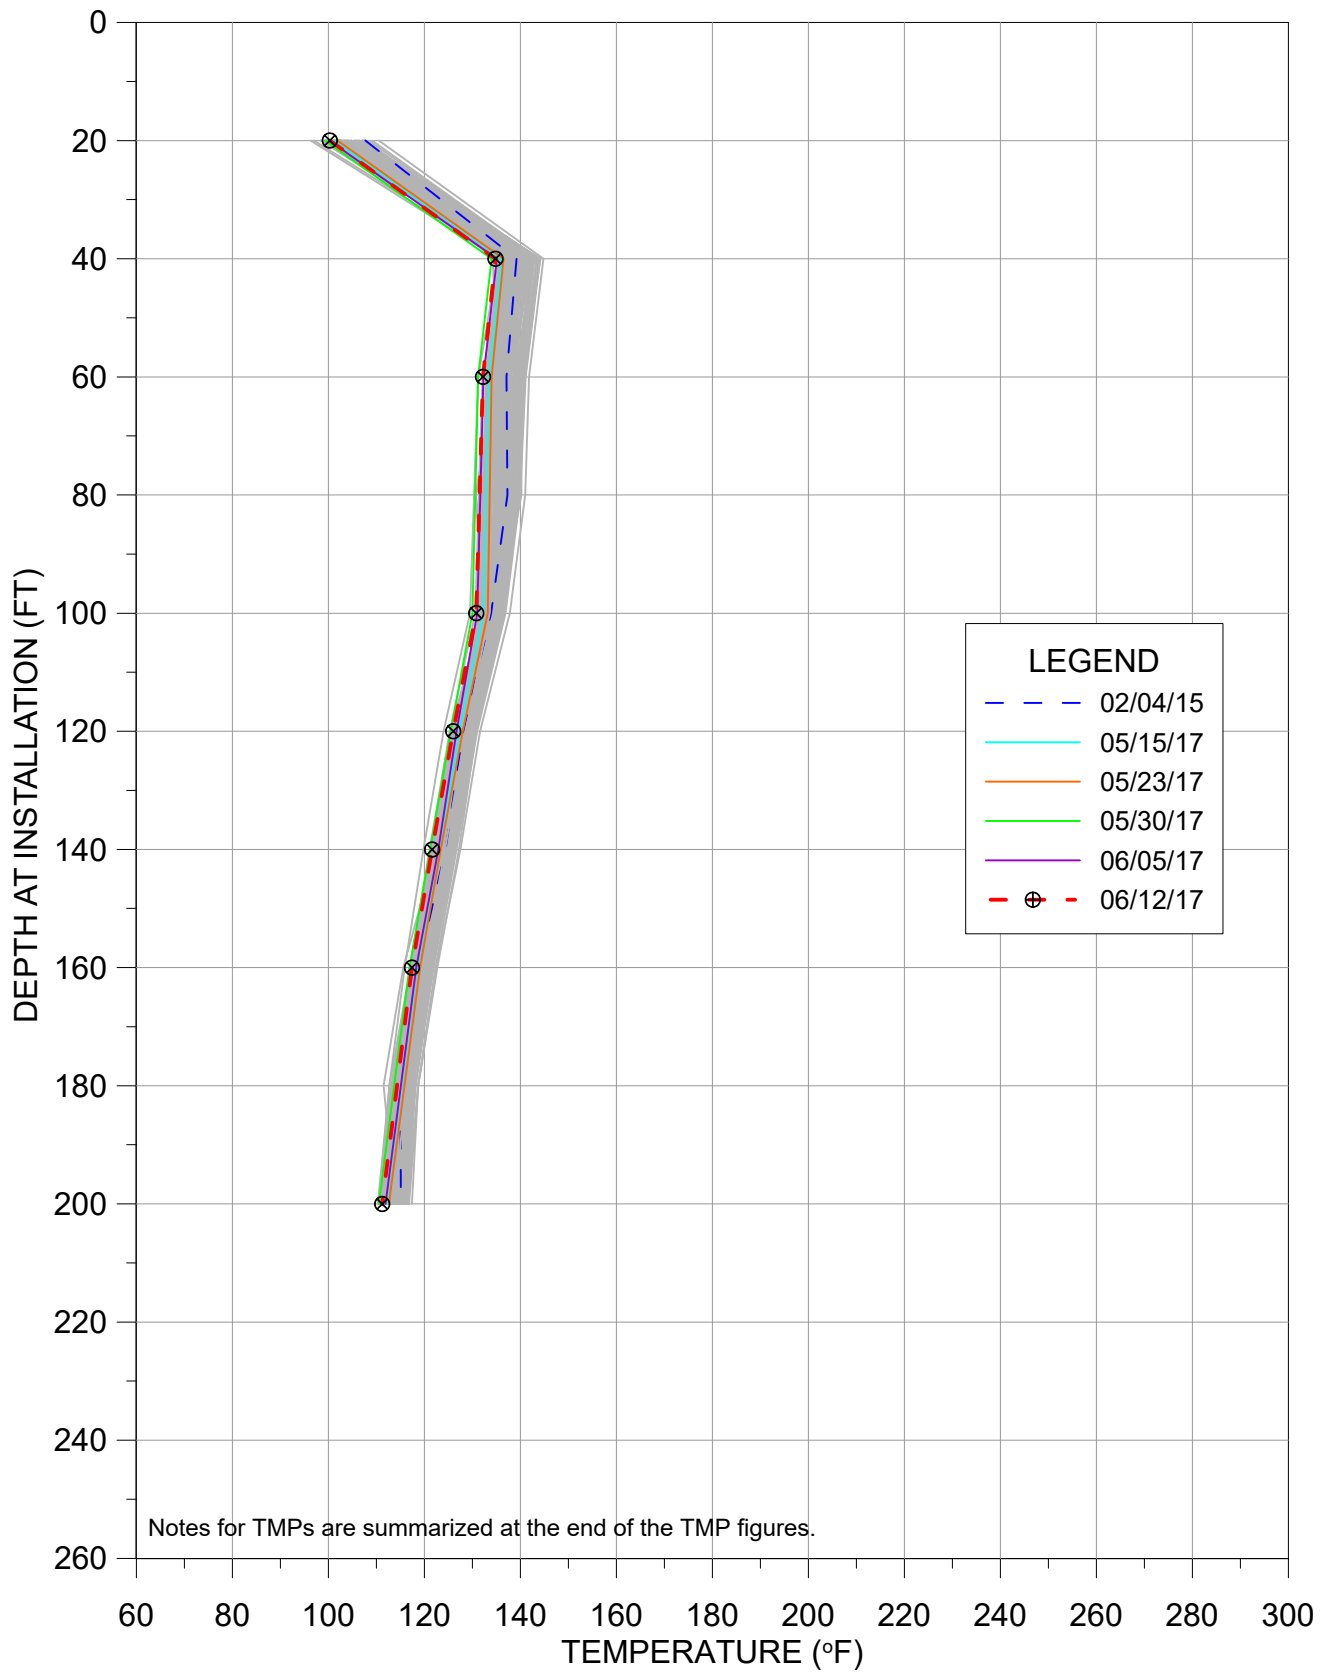
# TMP-28

1. The unit at 217 ft depth has had no resistance or temperature readings since installation.
2. The unit at 80 ft depth had a resistance drop and an unreasonable temperature decrease on 6/1/2016. The temperature has since fluctuated and is determined to be unreliable.
3. The unit at 180 feet has had a higher than acceptable limit since 3/28/2017 and is therefore determined to be unreliable as of the 4/4/2017 reading.

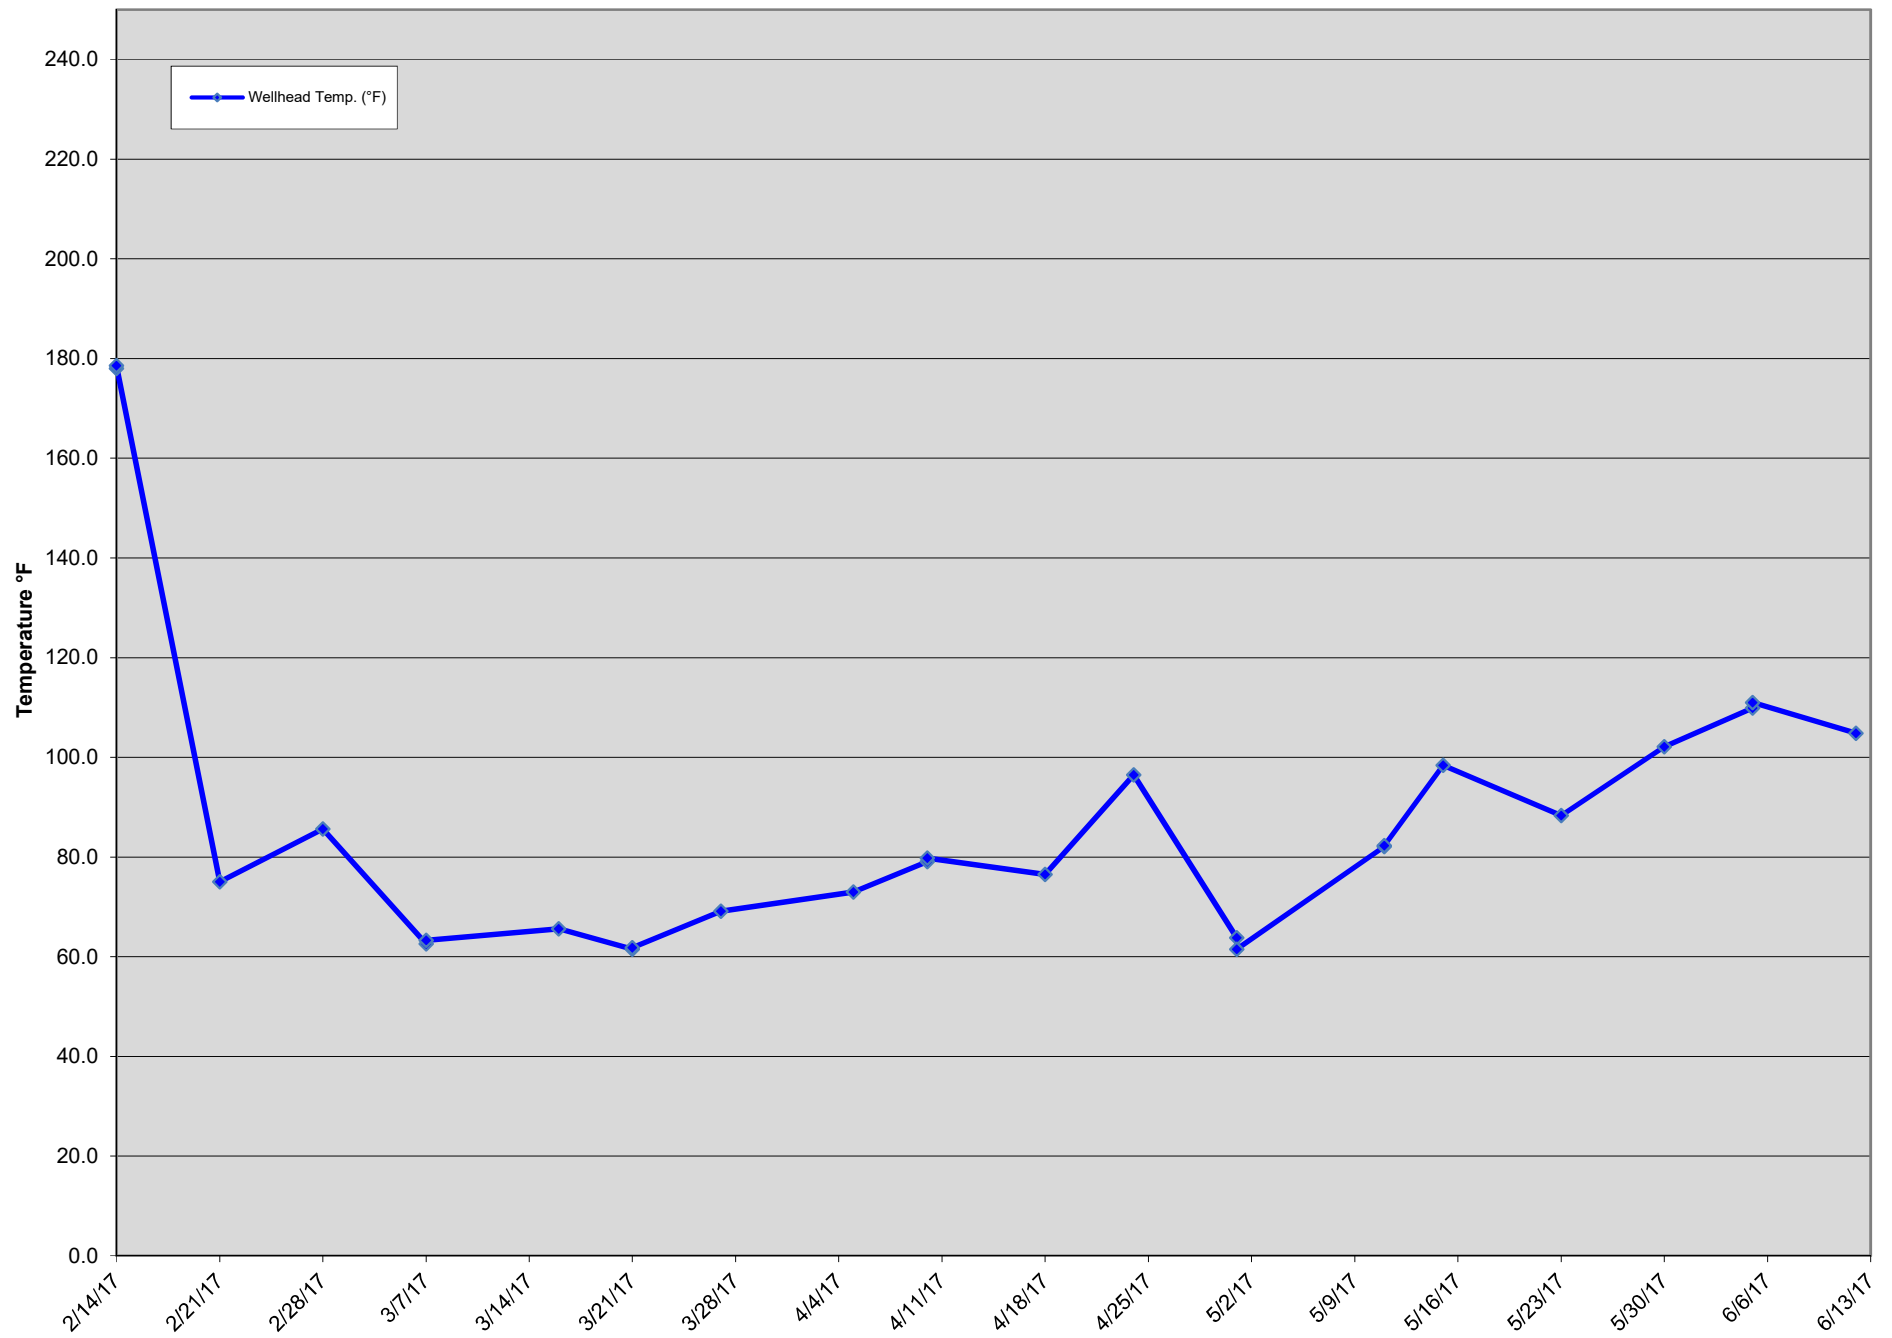
## GIW-1 Wellhead Temperatures

As part of the HES, there are currently cooling water circulation loops installed in twelve Gas Interceptor Wells (GIWs) (GIW-02 through GIW-13). The remaining well (GIW-01) had a measured gas temperature within its historical operating limits.
