# **Bridgeton Landfill, LLC**

## **Weekly Data Submittal**

**Week of August 13, 2017 – August 19, 2017**

**Required by Section 52.F of Agreed Order, Case No. 13SL-CC01088  
Effective May 13, 2013**

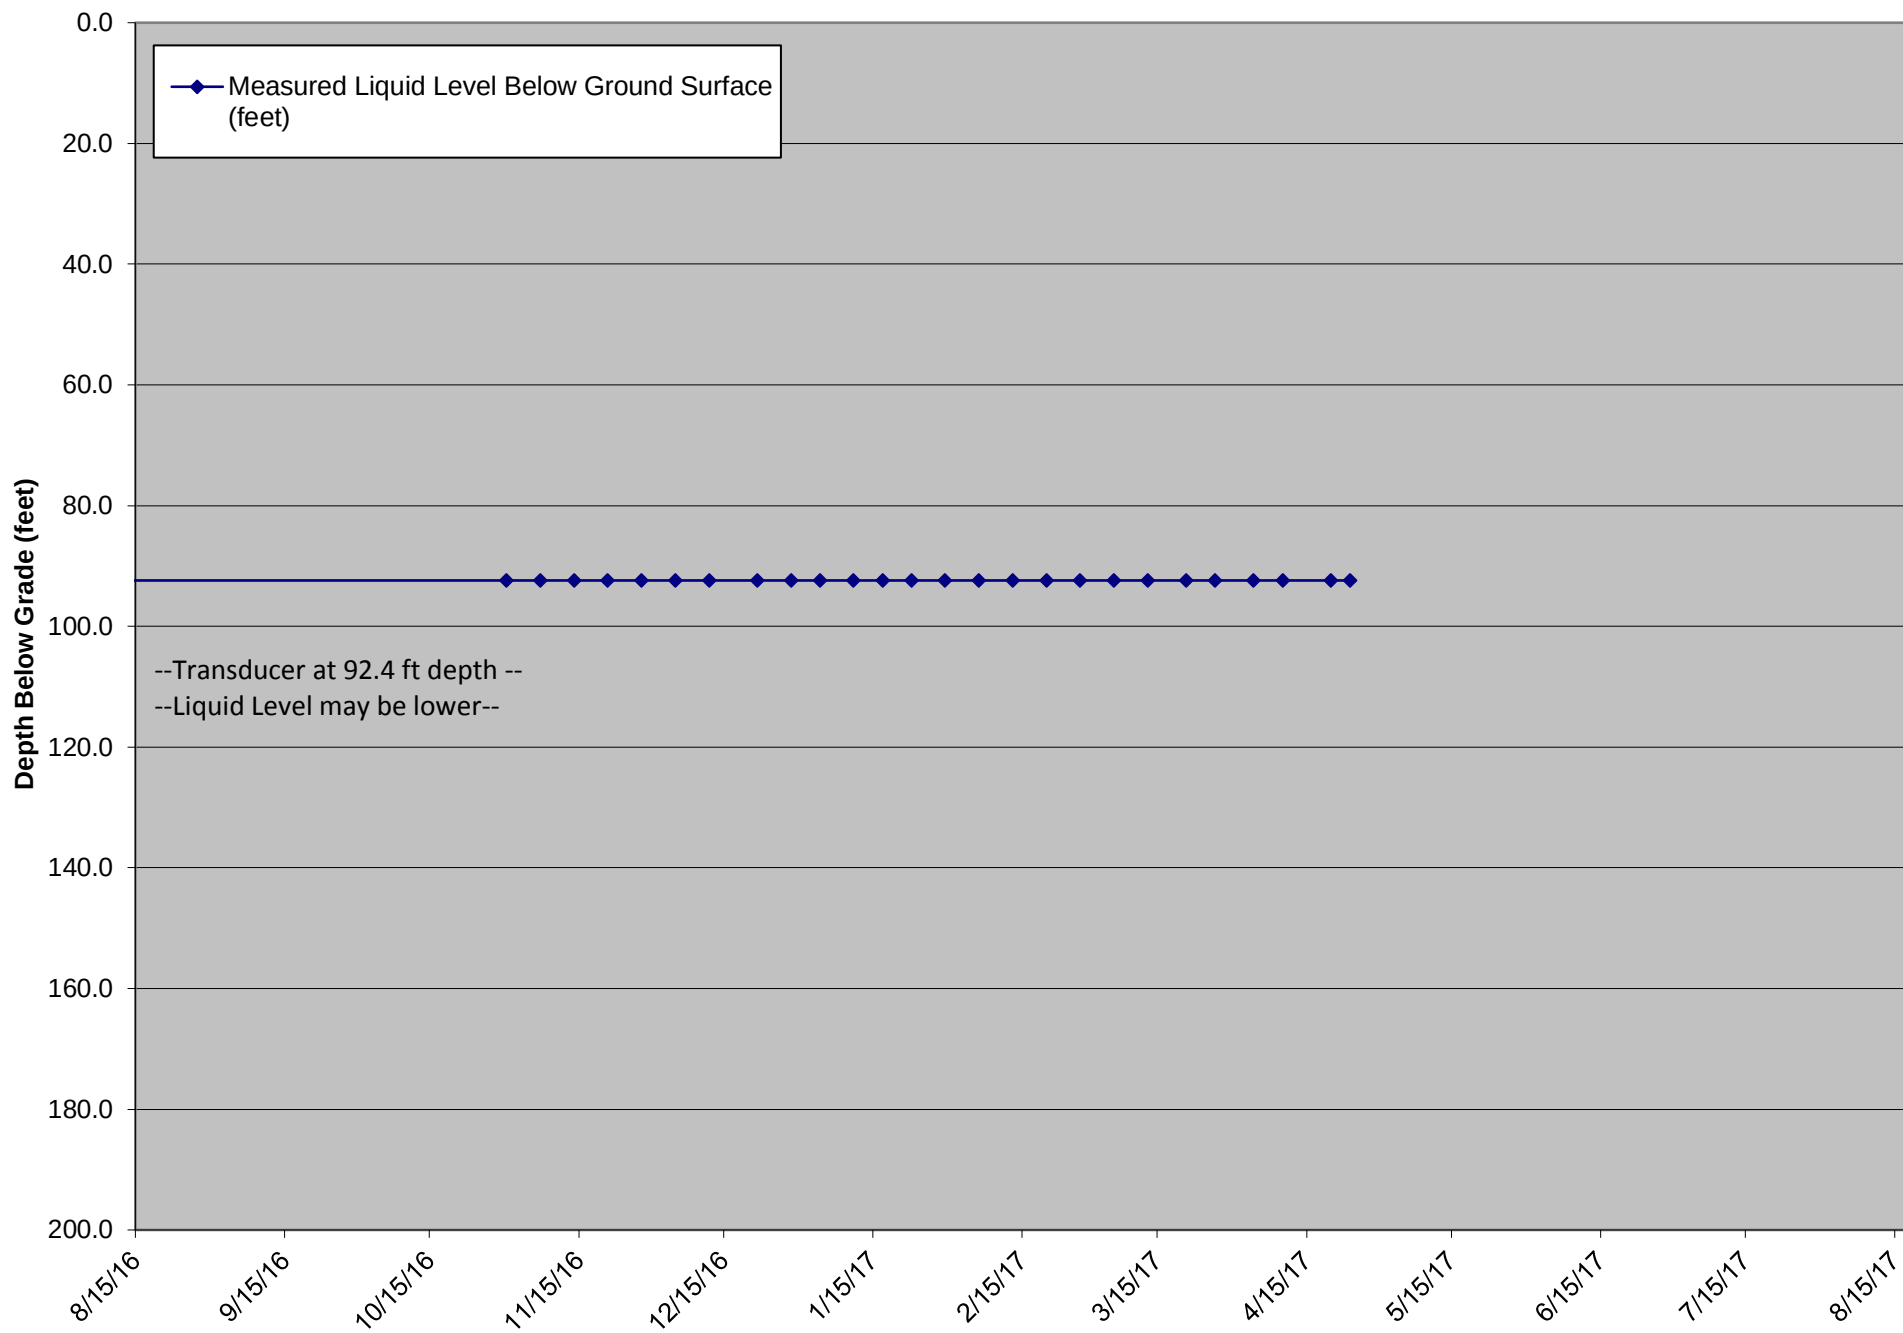
# LCS-1D Liquid Level Below Ground Surface

Bridgeton Landfill is currently troubleshooting the pump in LCS-1D. Level sensor replacement is pending while awaiting parts arrival.

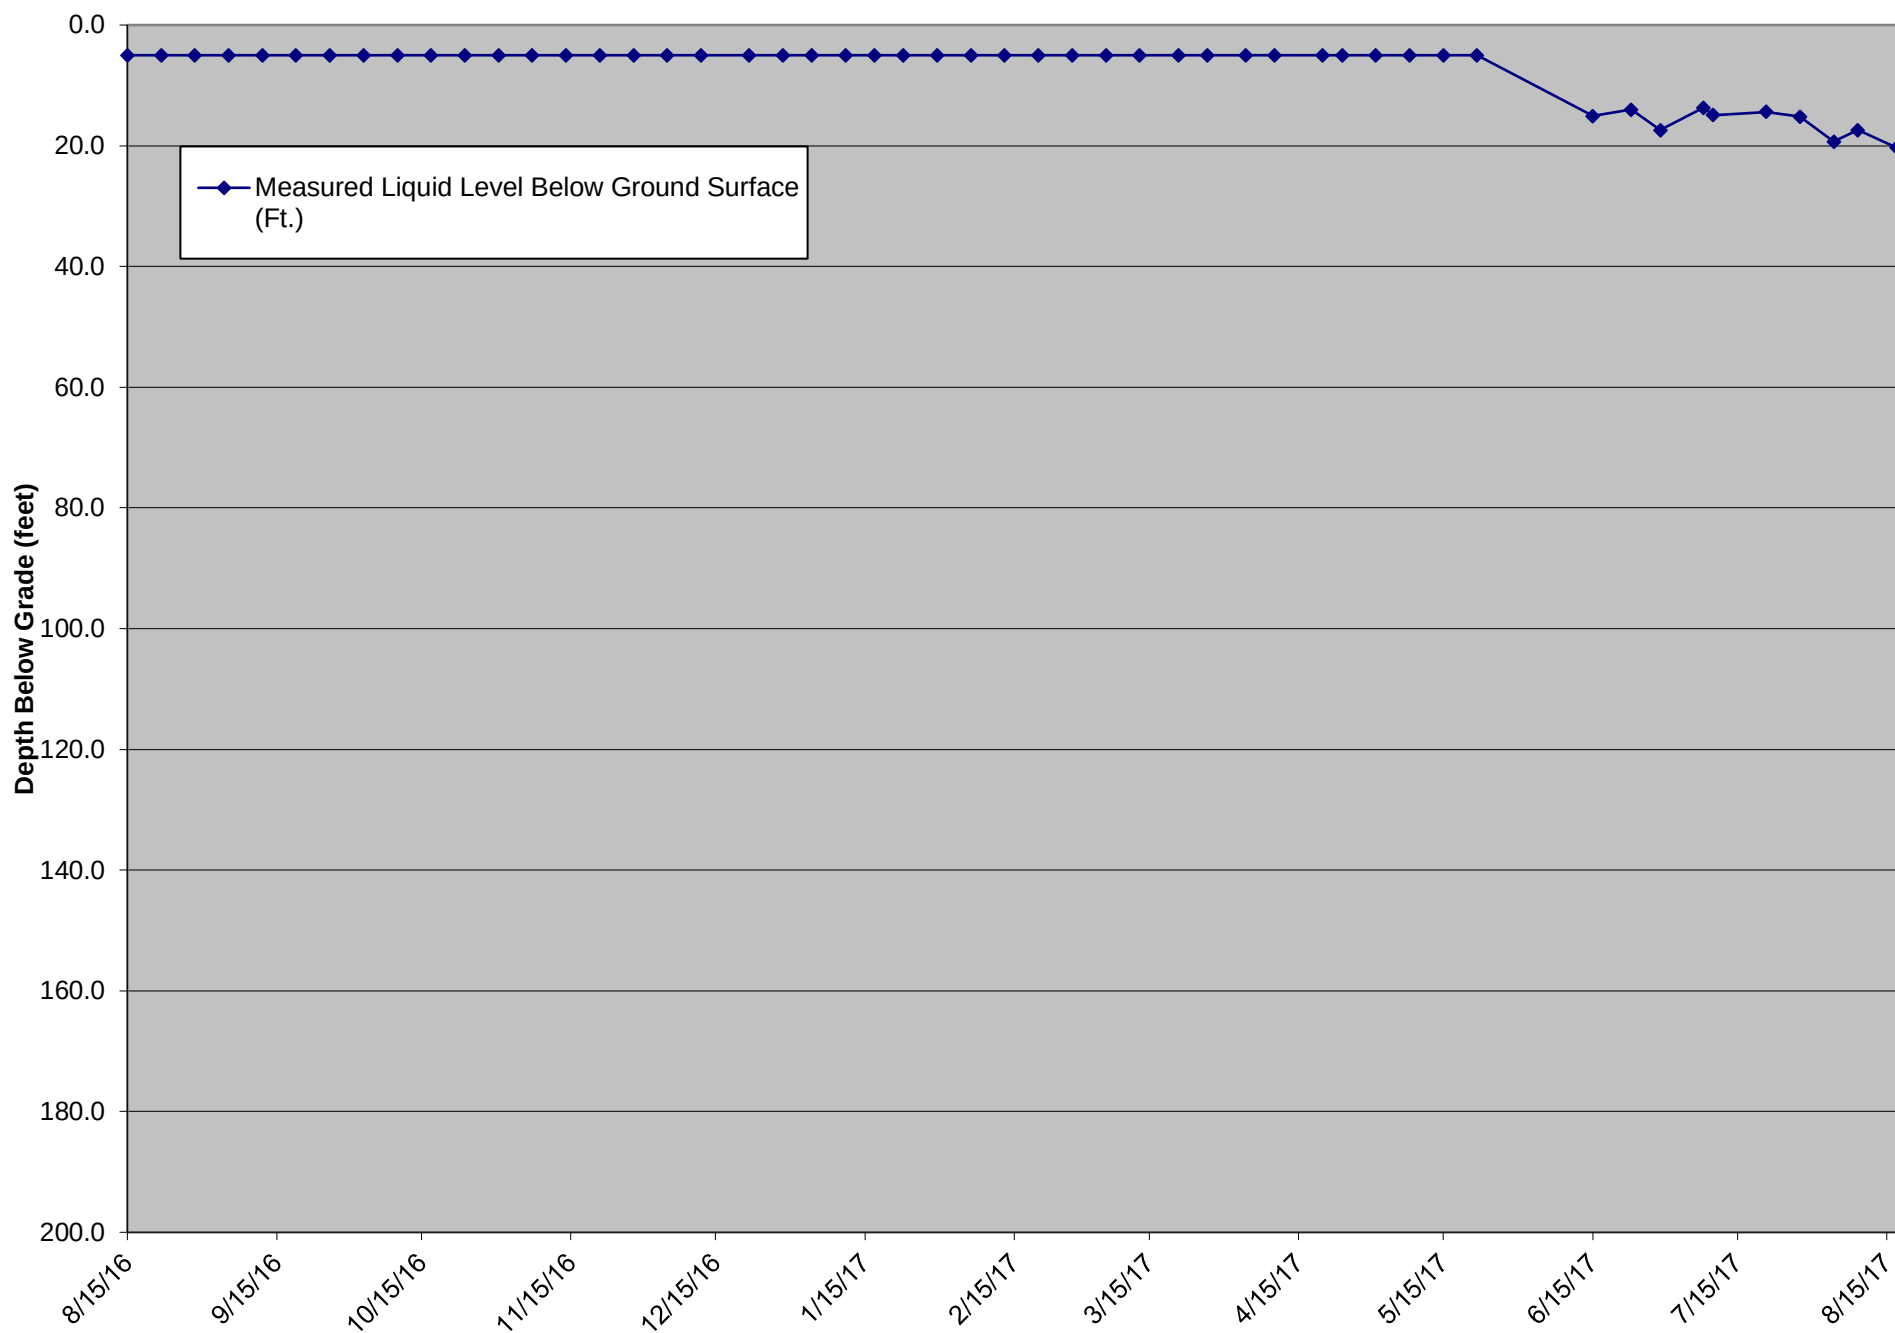
LCS-3D Liquid Level Below Ground Surface

Two Blackhawk pneumatic pumps were installed in LCS-3D on 6/13/2017. Blackhawk pumps do not require a level sensor. Liquid level was measured manually.

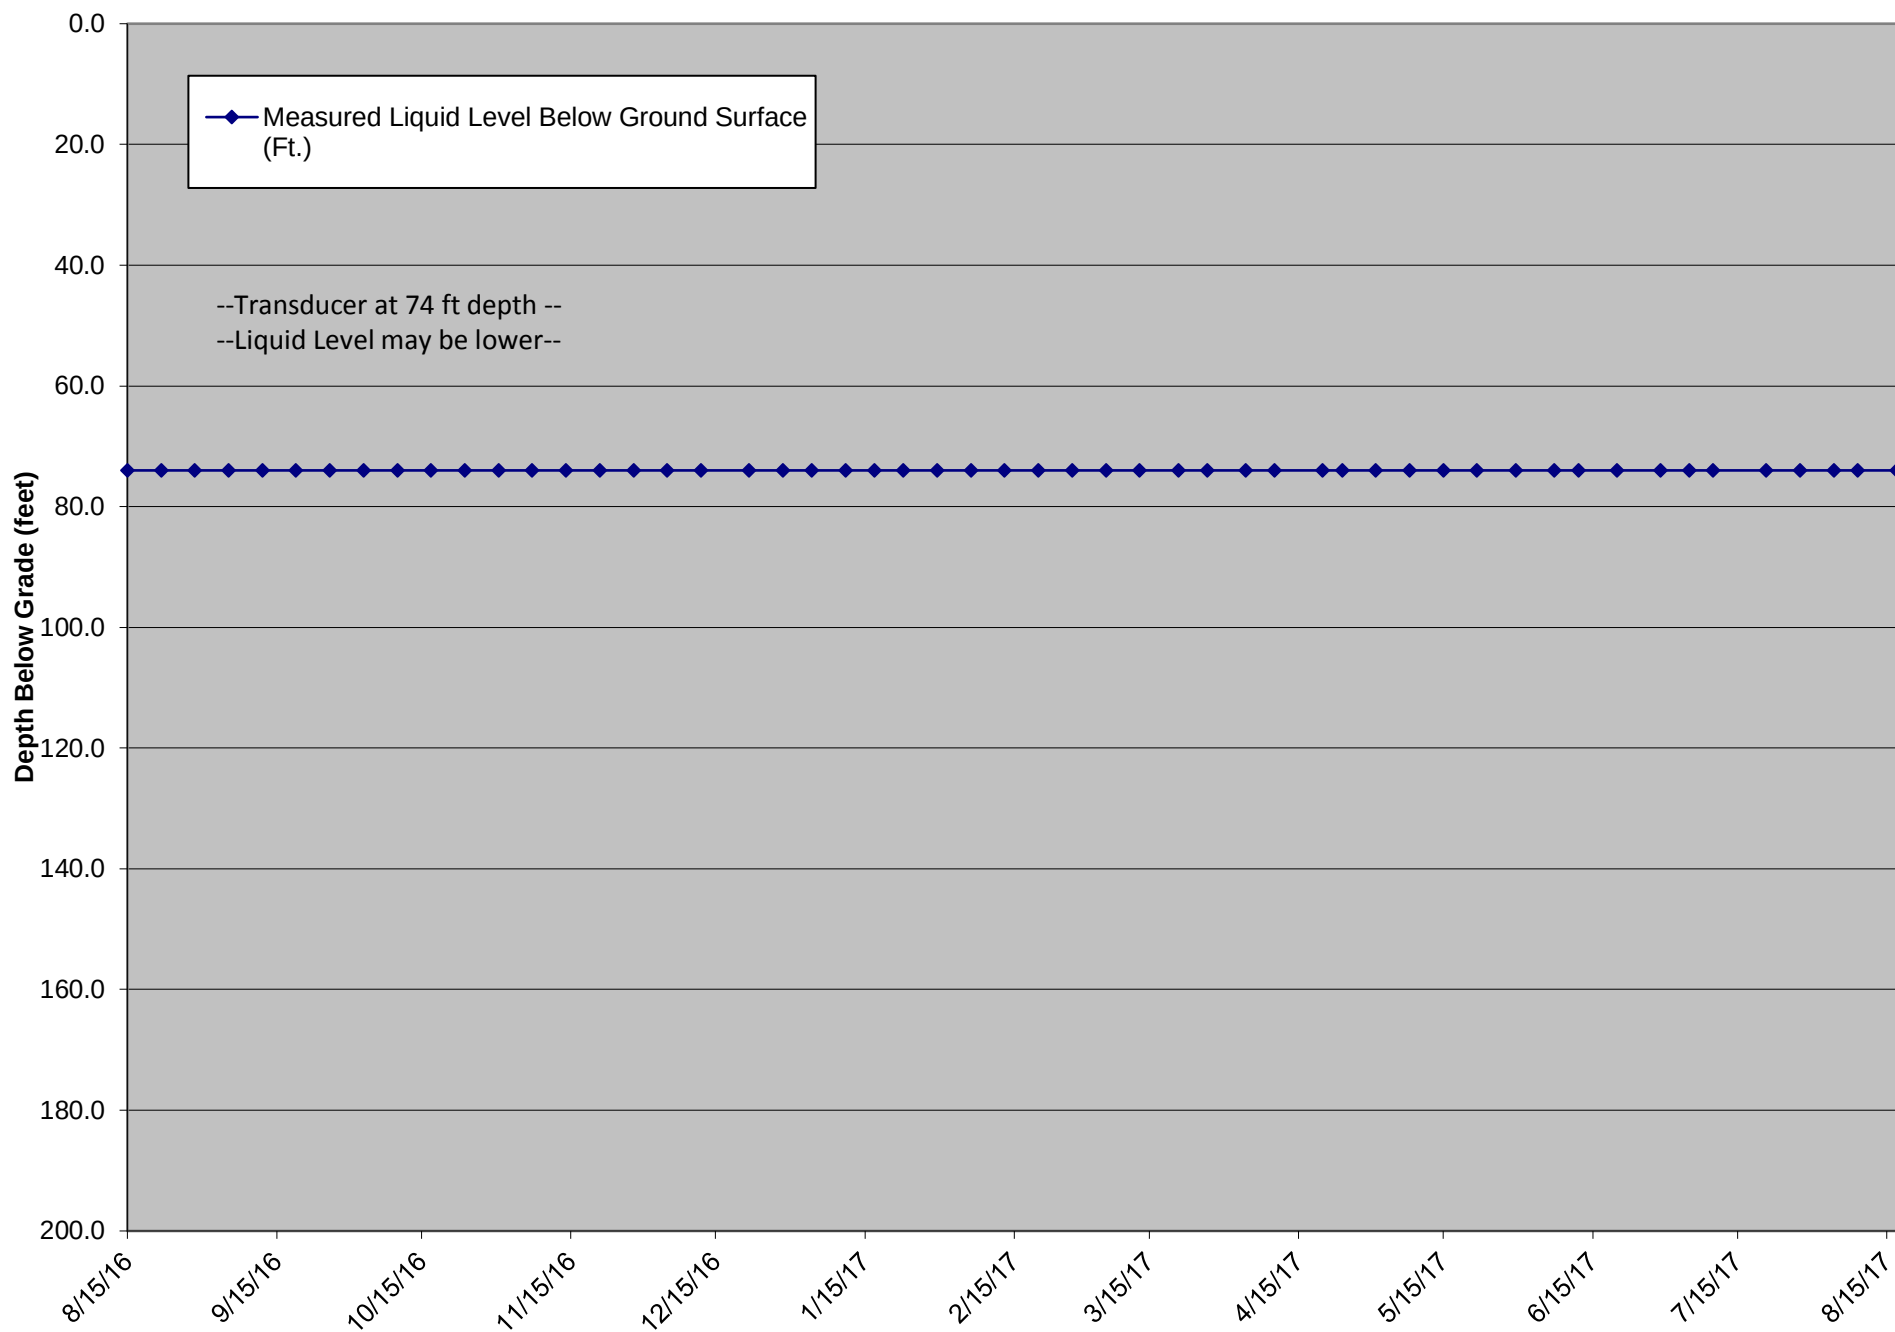
# LCS-4B Liquid Level Below Ground Surface

The level sensor in LCS-4B is currently operational and responsive. Liquid level was not recorded by the level sensor during the weekly reporting period. LCS-4B is equipped with a flow meter that displayed no flow during the weekly reporting period. Therefore, it can be concluded that the liquid level was below the bottom of the pump and level sensor in LCS-4B.

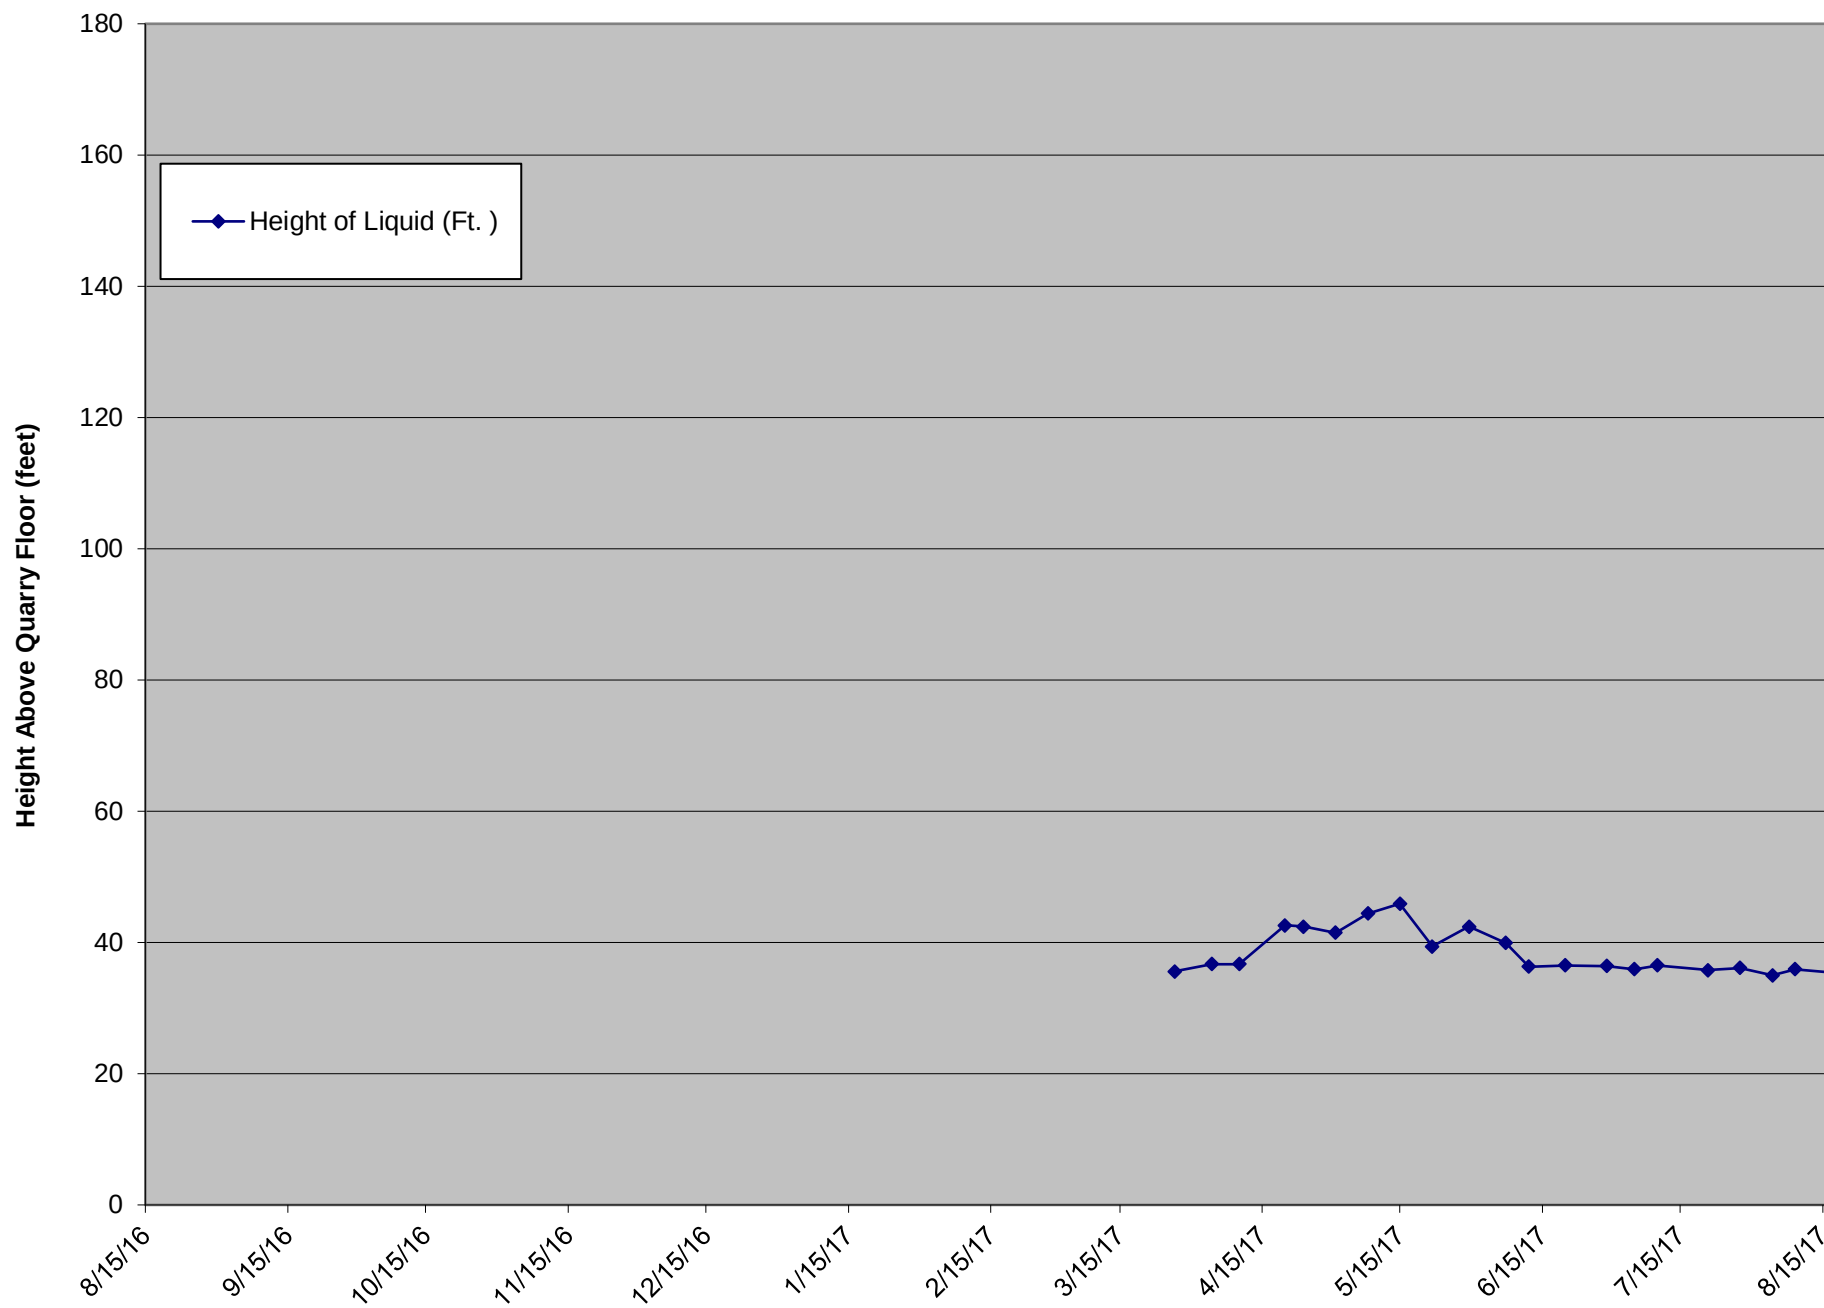
LCS-5B Liquid Level Above Quarry Floor

LCS-5B and LCS-6B were fully operational during the weekly reporting period.

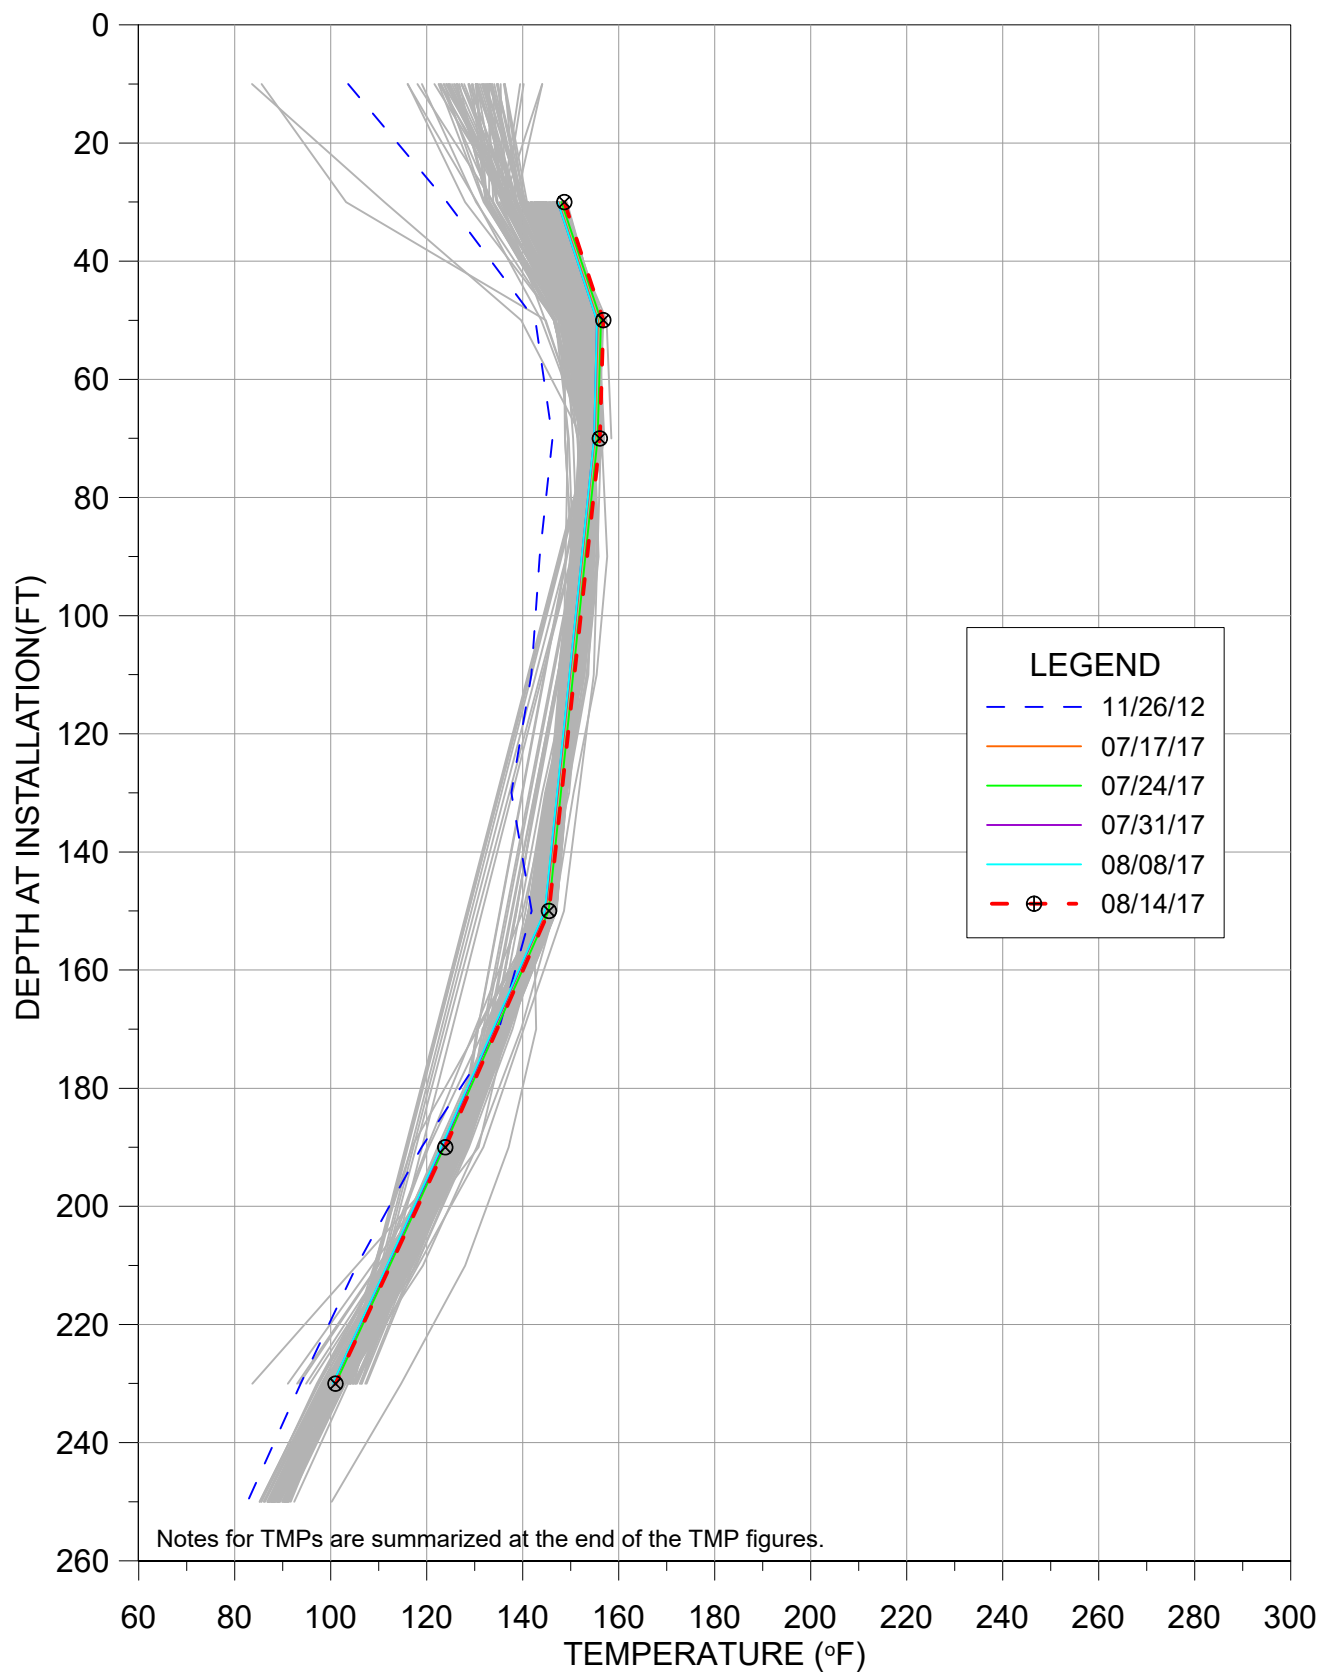
# TMP-3

1. No reliable temperature readings have been obtained at 170 ft depth since 1/29/2014, except on 3/13/2014.
2. The connectivity tests on 4/11/2014 conducted by CEC showed that units at 10, 90, 130, 210 and 250 ft depths are no longer reliable.
3. The connectivity tests on 10/28/2014 conducted by Feezor Engineering showed that units at 10, 90, 110, 130, 210 and 250 ft depths are not reliable.

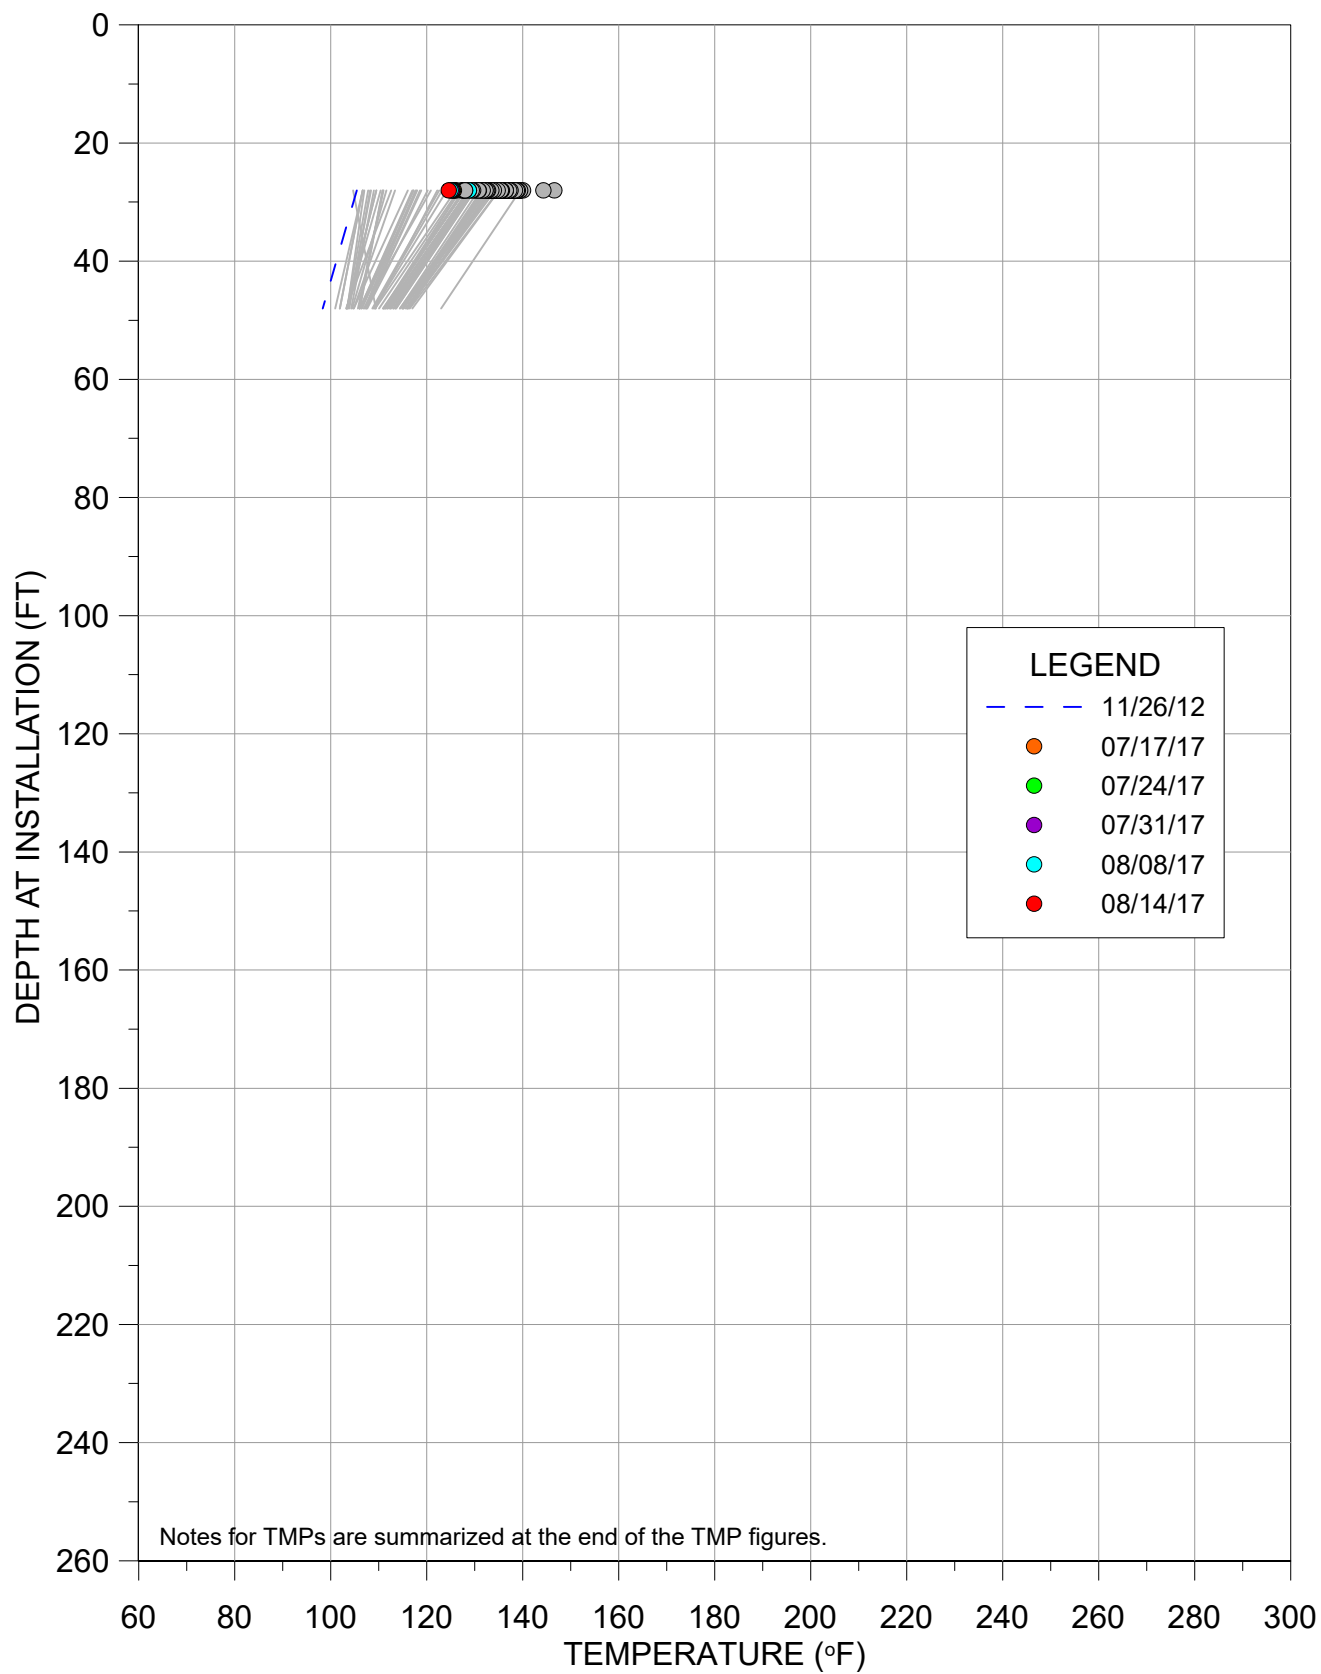
# TMP-4

1. The connectivity tests on 4/11/2014 conducted by CEC showed that the unit at 48 ft depth is no longer reliable.

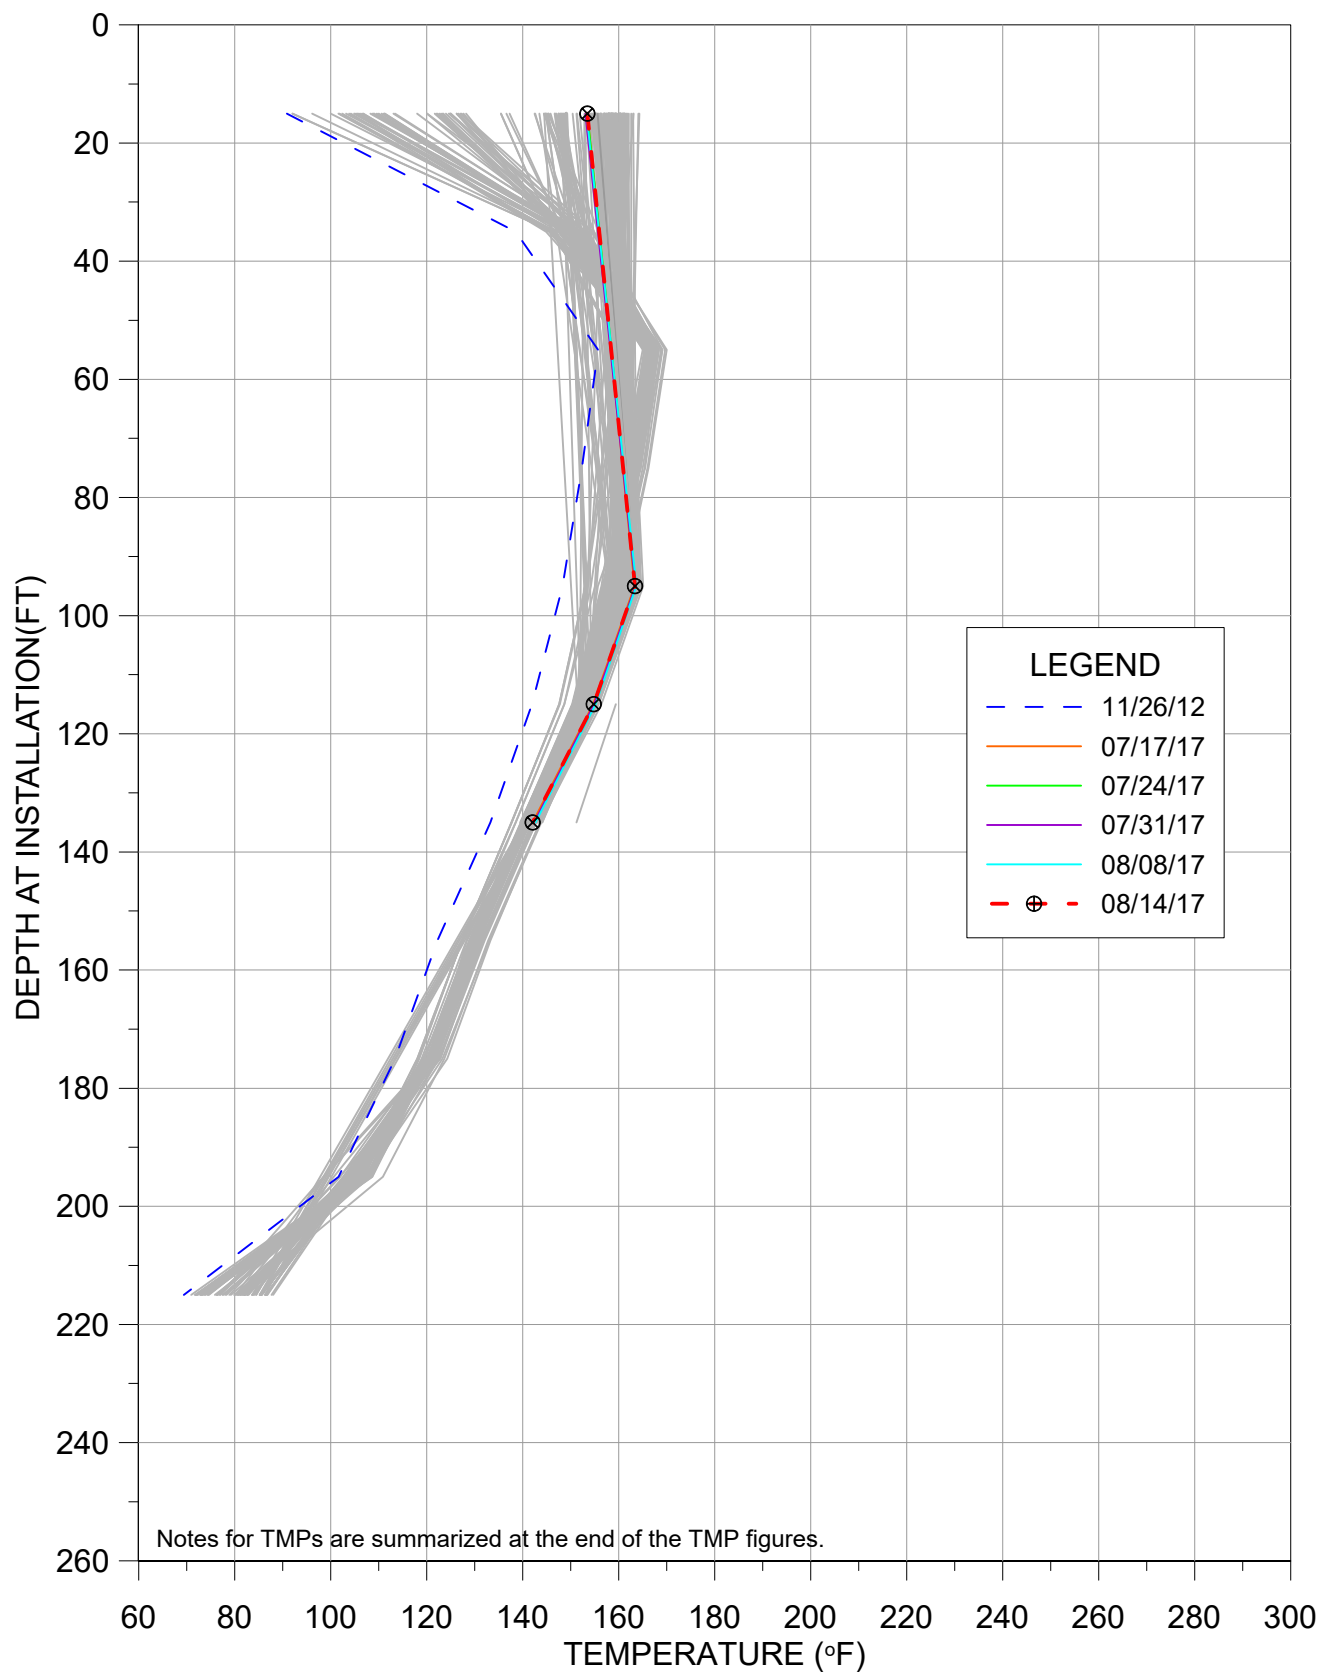
# TMP-6

1. The connectivity tests on 4/11/2014 conducted by CEC showed that units at 35, 55, 75, 155, 175, and 195 ft depths are no longer reliable.
2. No reliable temperature readings have been obtained at the unit at 215 ft depth since 6/13/2014.

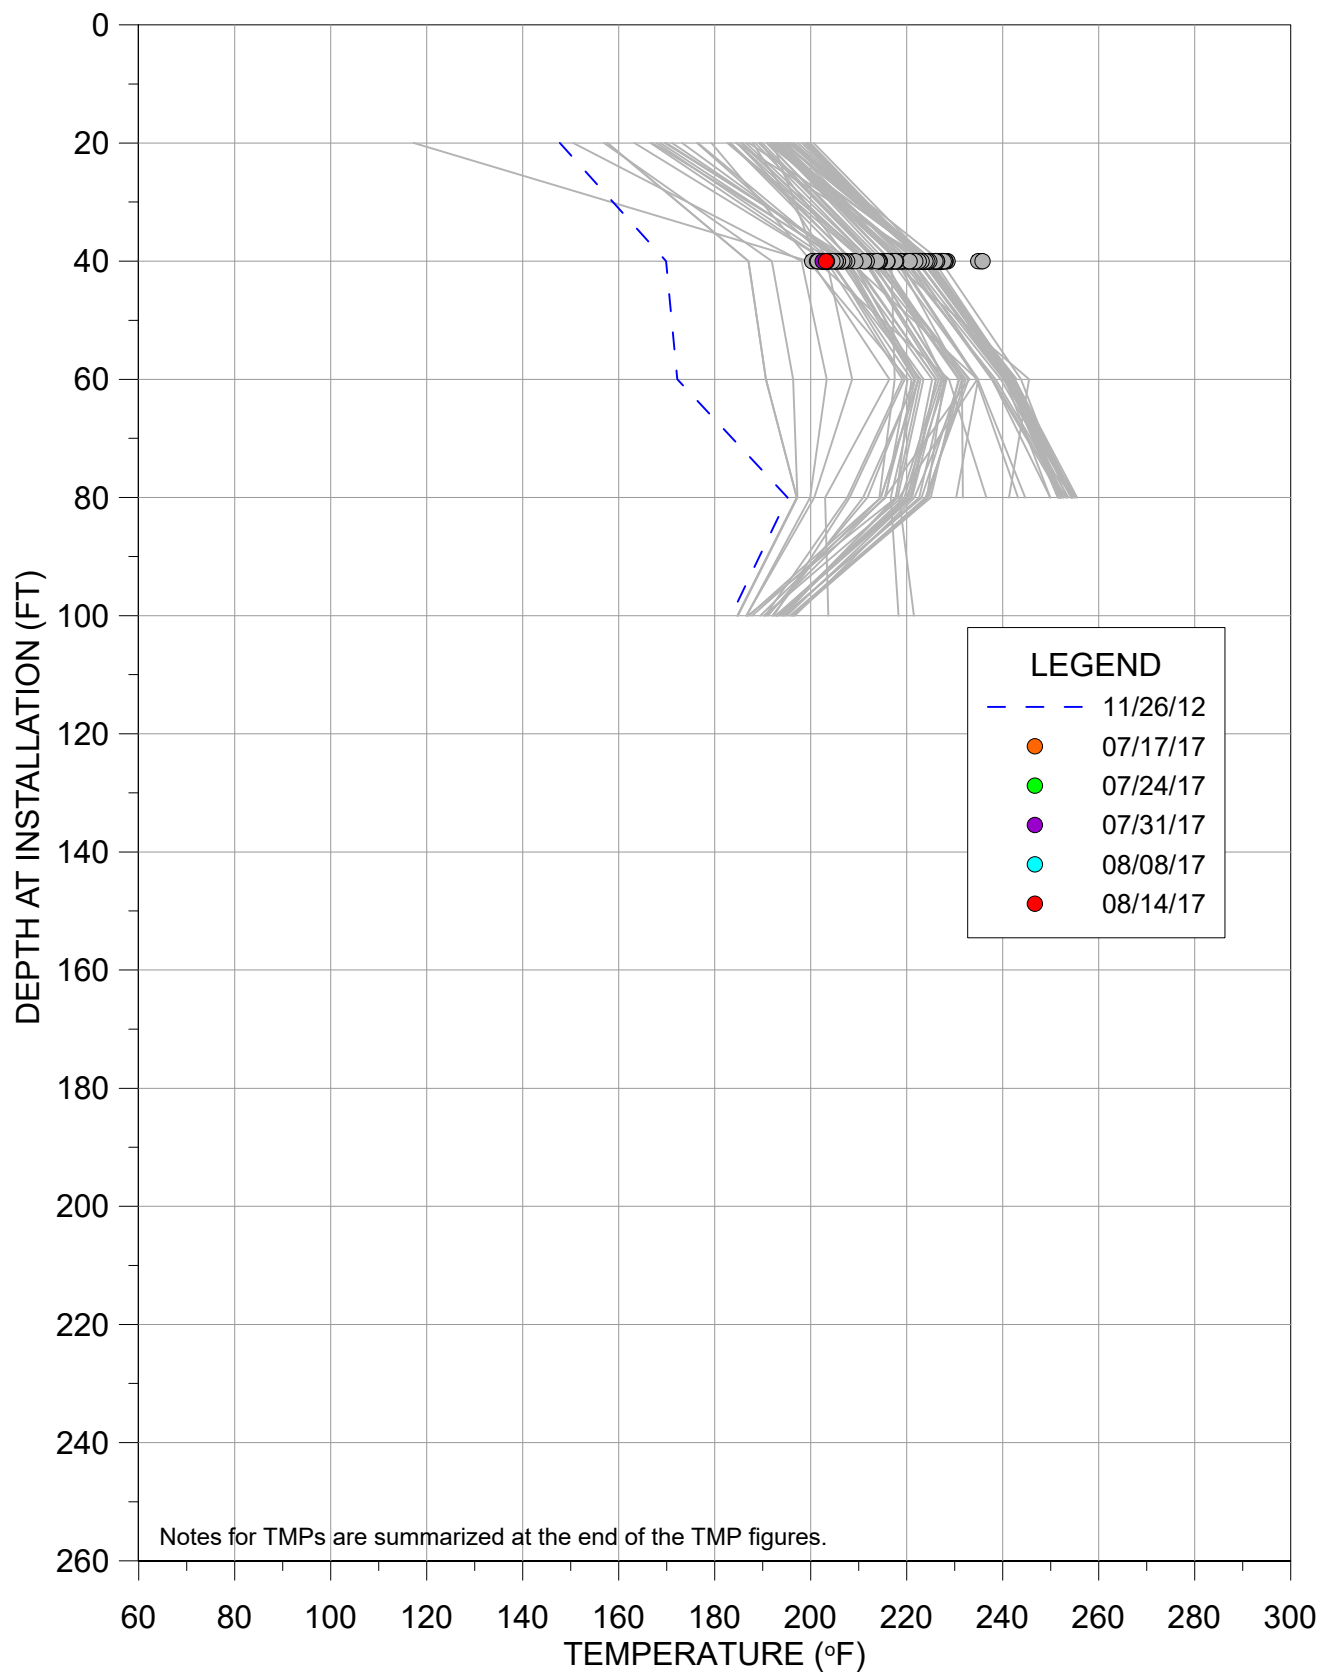
# TMP-9

1. Unit at 100 ft depth had an inaccurate temperature reading on 8/1/2013 and no reading since 8/6/2013.
2. The connectivity tests on 4/11/2014 conducted by CEC showed that units at 20, 60, 80, and 100 ft depths are no longer reliable.

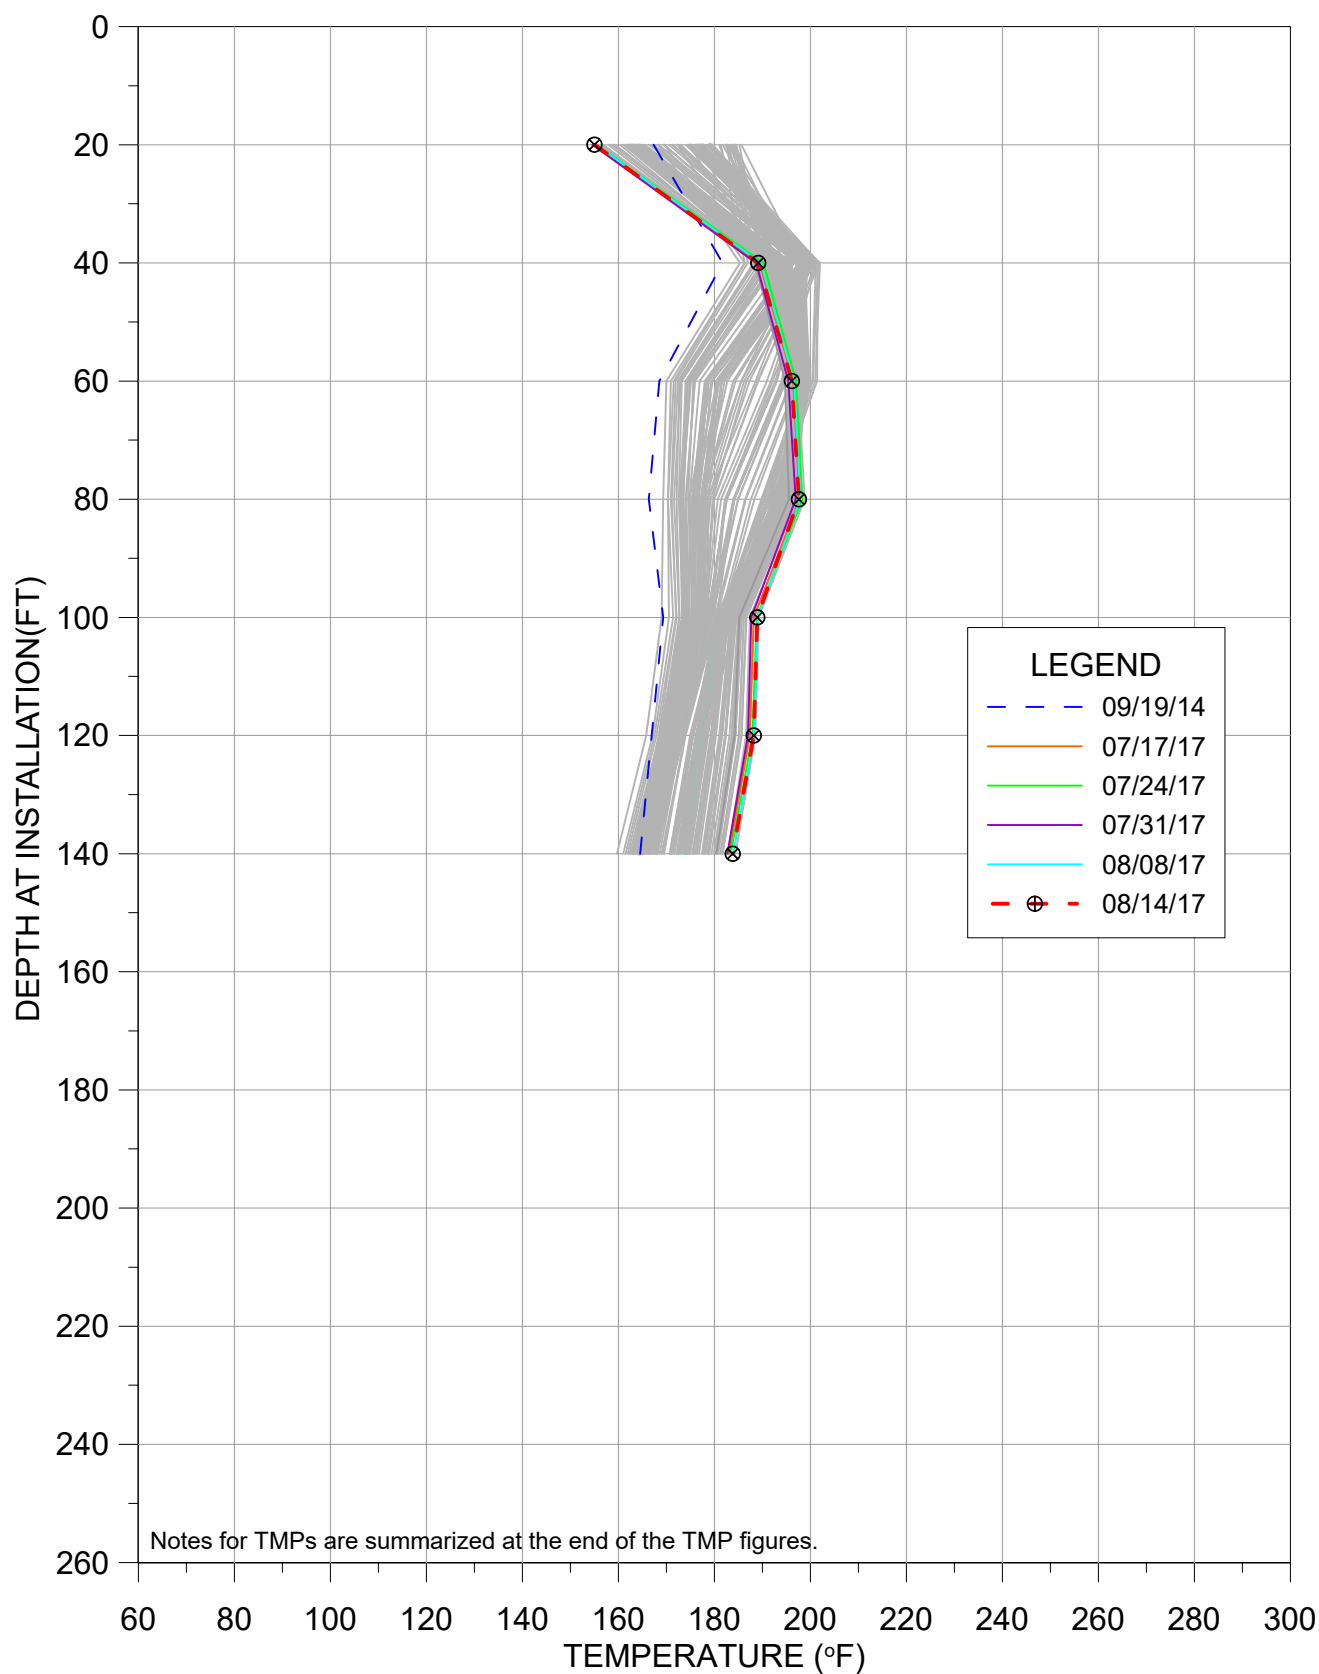
# TMP-14R

1. Due to the connectivity test results by Feezor Engineering on TMP-14 (see note above), TMP-14R is added to this reporting data set as of 3/7/2016.
