# **Bridgeton Landfill, LLC**

## **Weekly Data Submittal**

**Week of August 13, 2017 – August 19, 2017**

**Required by Section 52.F of Agreed Order, Case No. 13SL-CC01088  
Effective May 13, 2013**

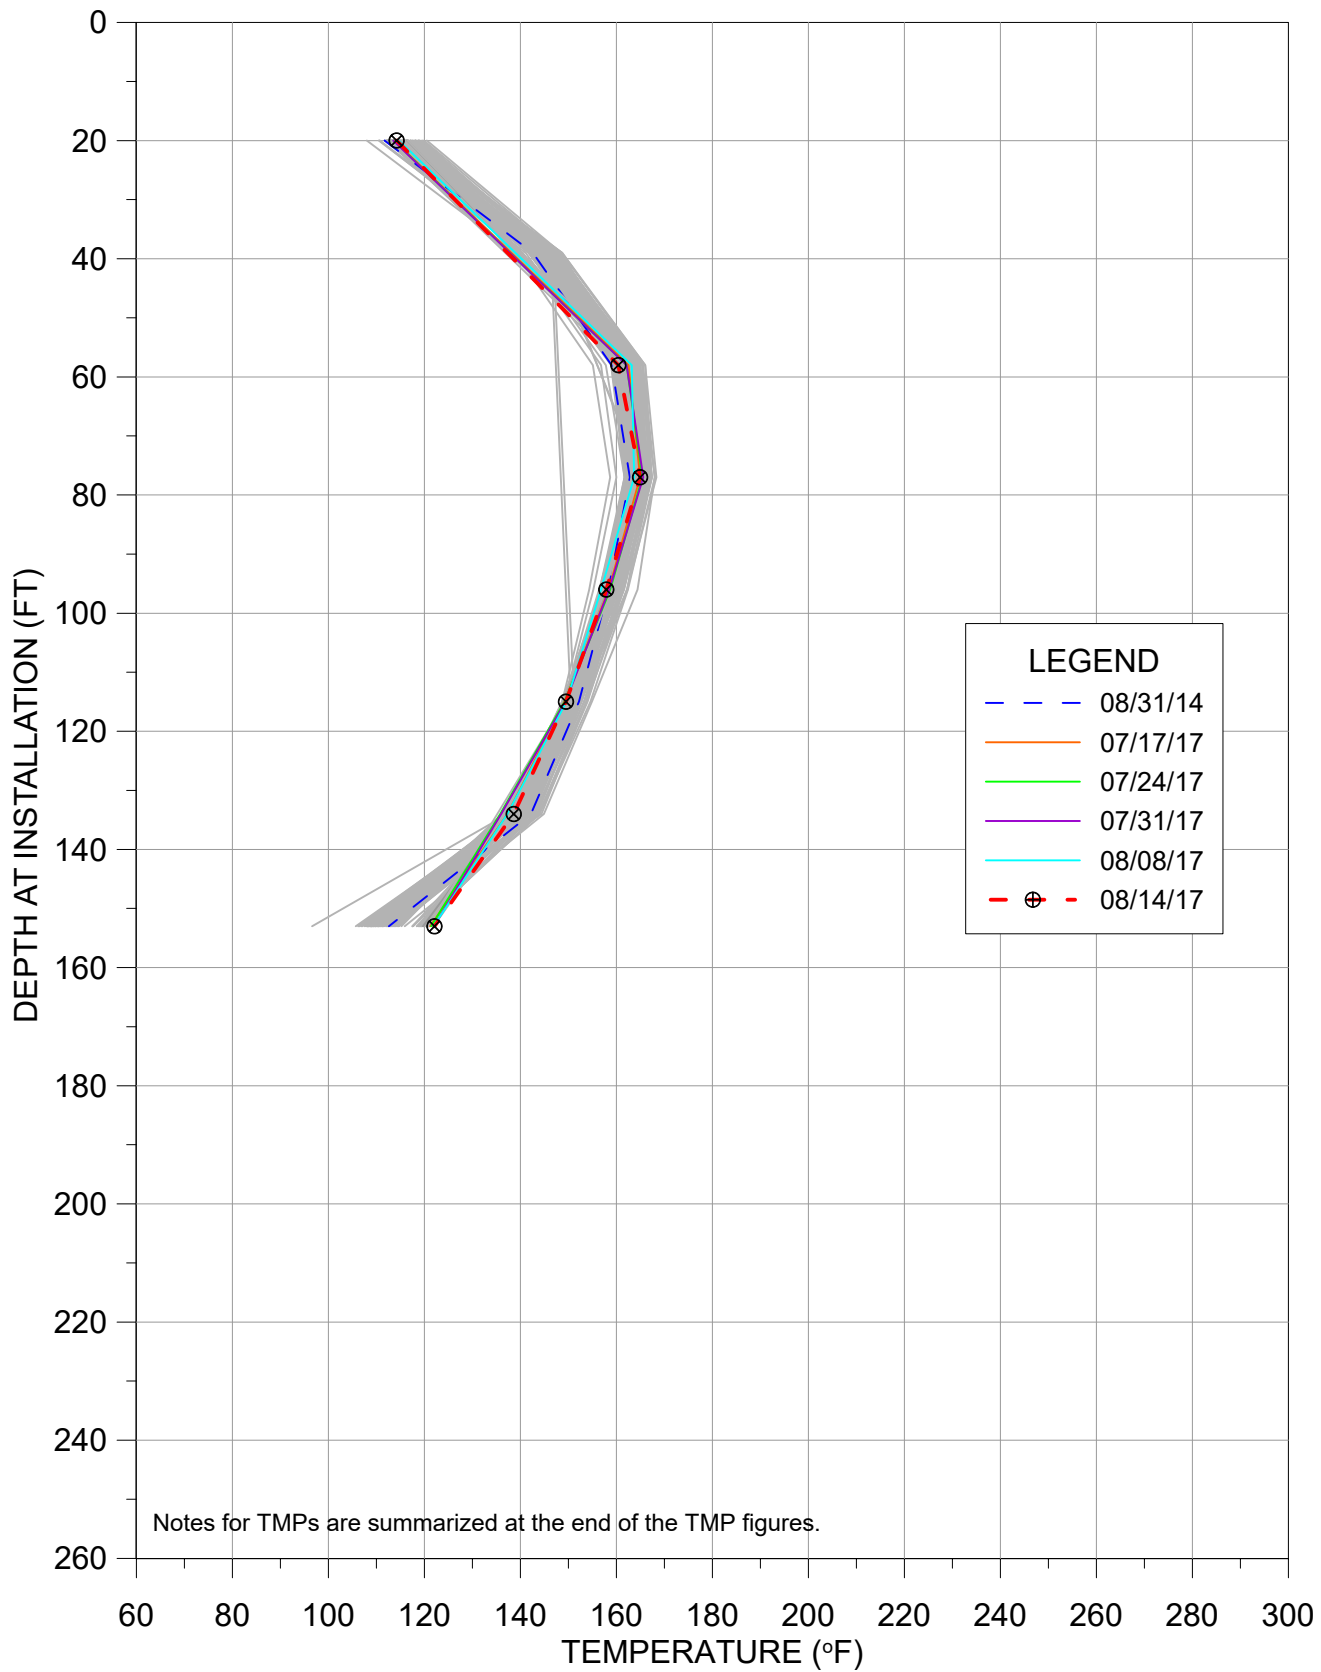
# TMP-16

1. A connectivity test conducted by Feezor Engineering showed that the units on TMP-16 may not be reliable since 9/9/2015. Further testing at the end of September 2015 showed possible connectivity on some of the units.
2. The unit at 153 ft depth had a low resistance reading and unreliable temperature since 12/21/2015.

3. The unit at 39 ft depth had a higher than acceptable resistance reading and unreliable temperature since 2/7/2017.

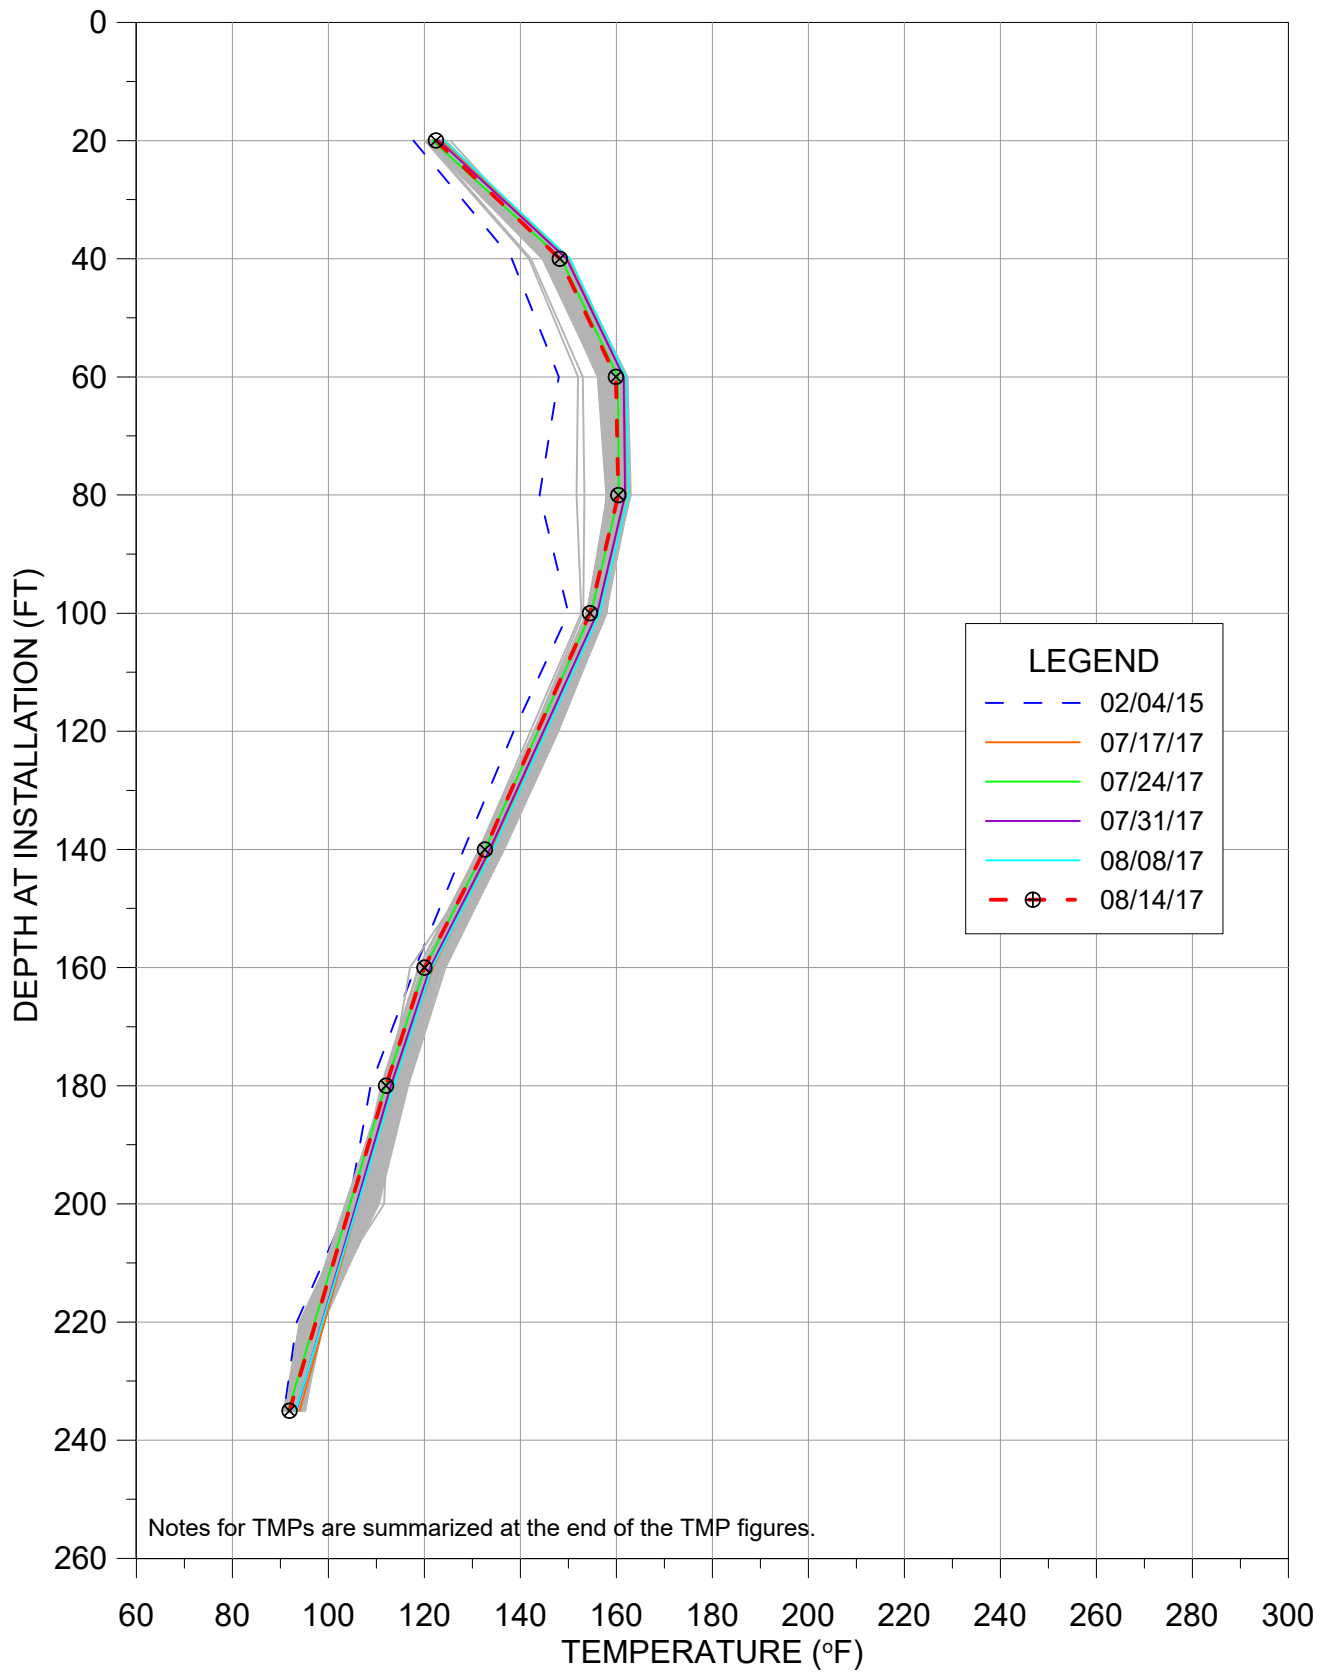
# TMP-25

1. The unit at 200 ft provided an apparent anomalous reading on 3/28/2017. Subsequent readings on 4/4/2017 showed the unit to have failed (see below). The unit is no longer working and the reading of 3/28/2017 was likely unreliable.

2. The unit at 200 ft depth had a resistance reading greater 4000 ohms on 4/4/2017. A connectivity test conducted by Feezor Engineering on 4/7/2017 showed that this unit also had cross-connectivity. The unit is therefore determined to be no longer working as of the 4/4/2017 reading.

3. The unit at 120 feet had a higher than acceptable limit on 7/10/2017. Also, a connectivity test conducted by Feezor Engineering on 4/7/2017 showed that this unit may be unreliable. Therefore, this unit is determined to be unreliable.

4. The unit at 220 ft has been reported as unable to attain a reading of any kind since June 19, 2017. The unit is considered to be on no longer working as of that date.

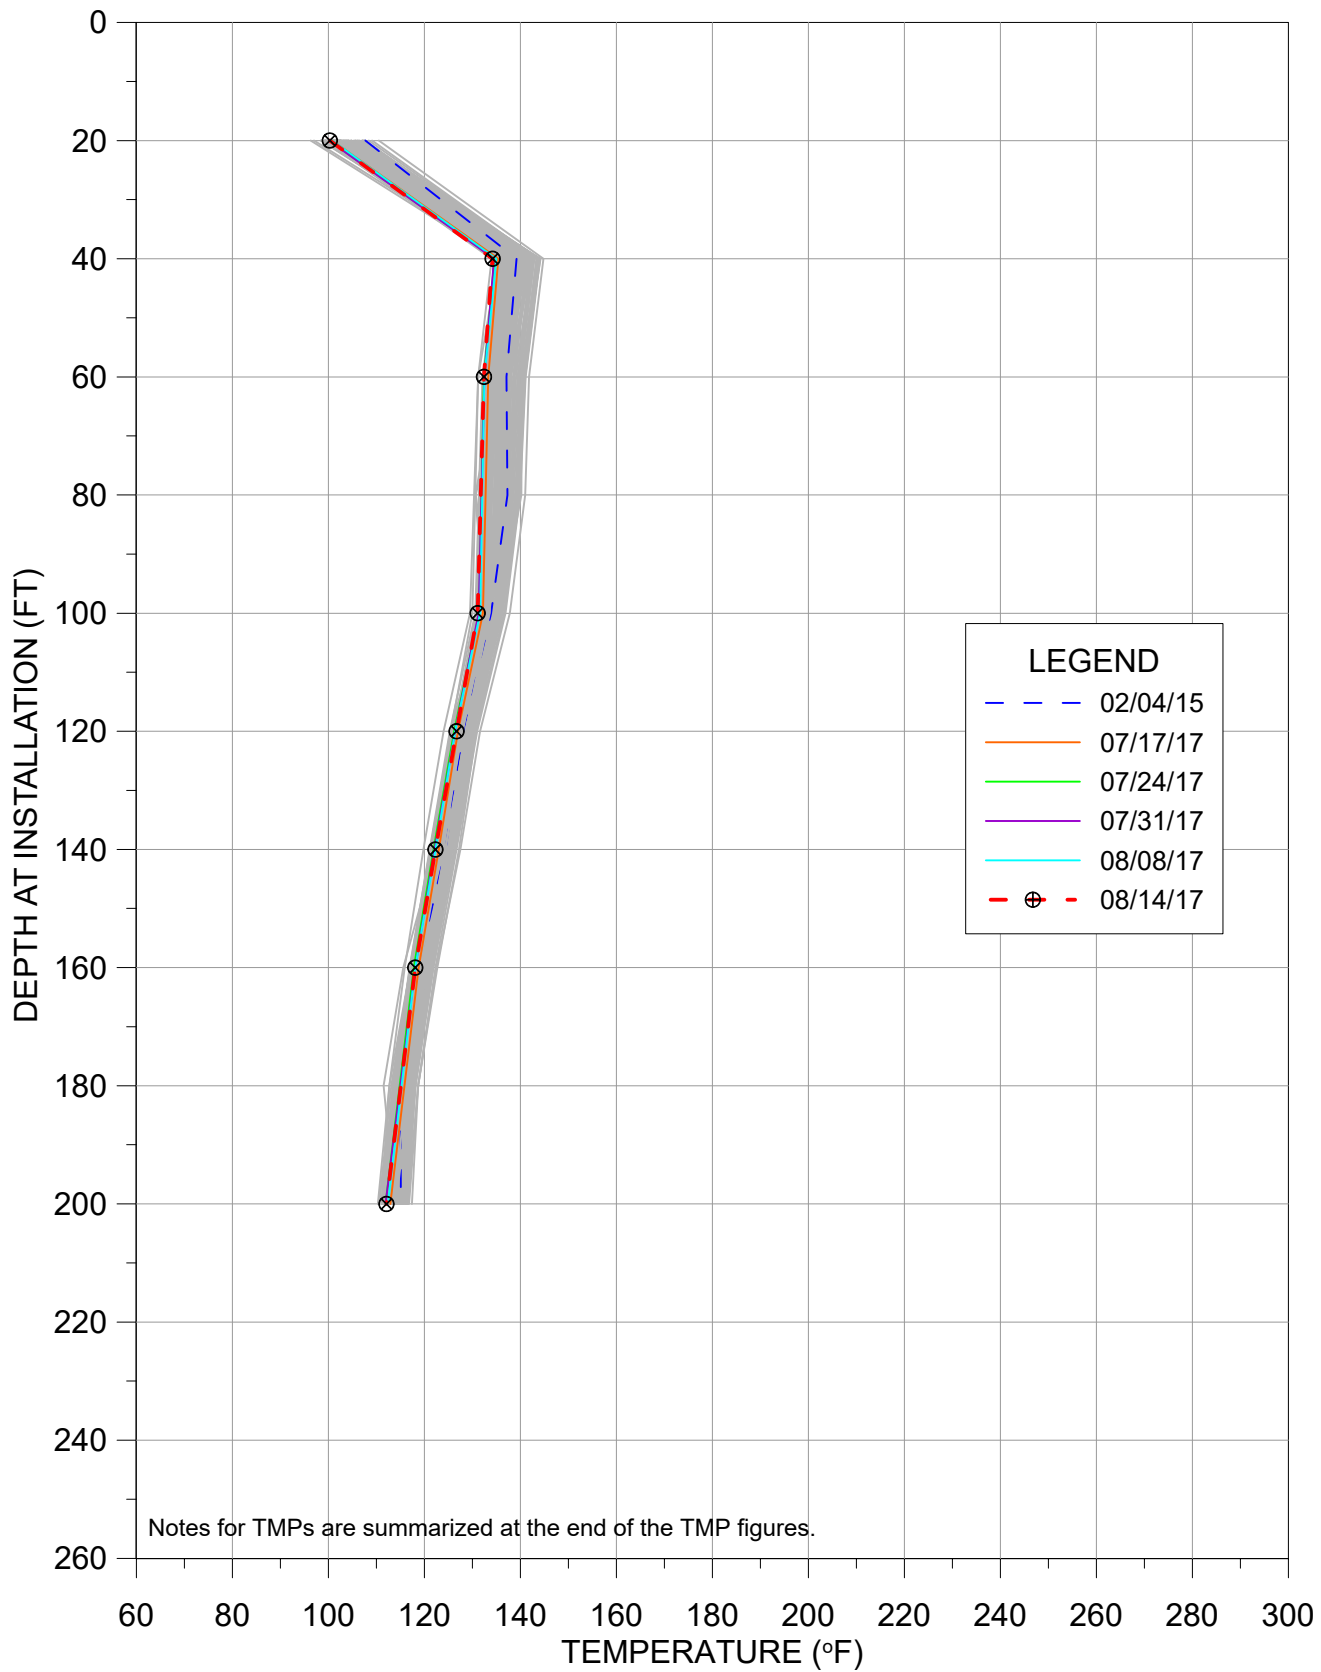
# TMP-28

1. The unit at 217 ft depth has had no resistance or temperature readings since installation.
2. The unit at 80 ft depth had a resistance drop and an unreasonable temperature decrease on 6/1/2016. The temperature has since fluctuated and is determined to be unreliable.
3. The unit at 180 feet has had a higher than acceptable limit since 3/28/2017 and is therefore determined to be unreliable as of the 4/4/2017 reading.

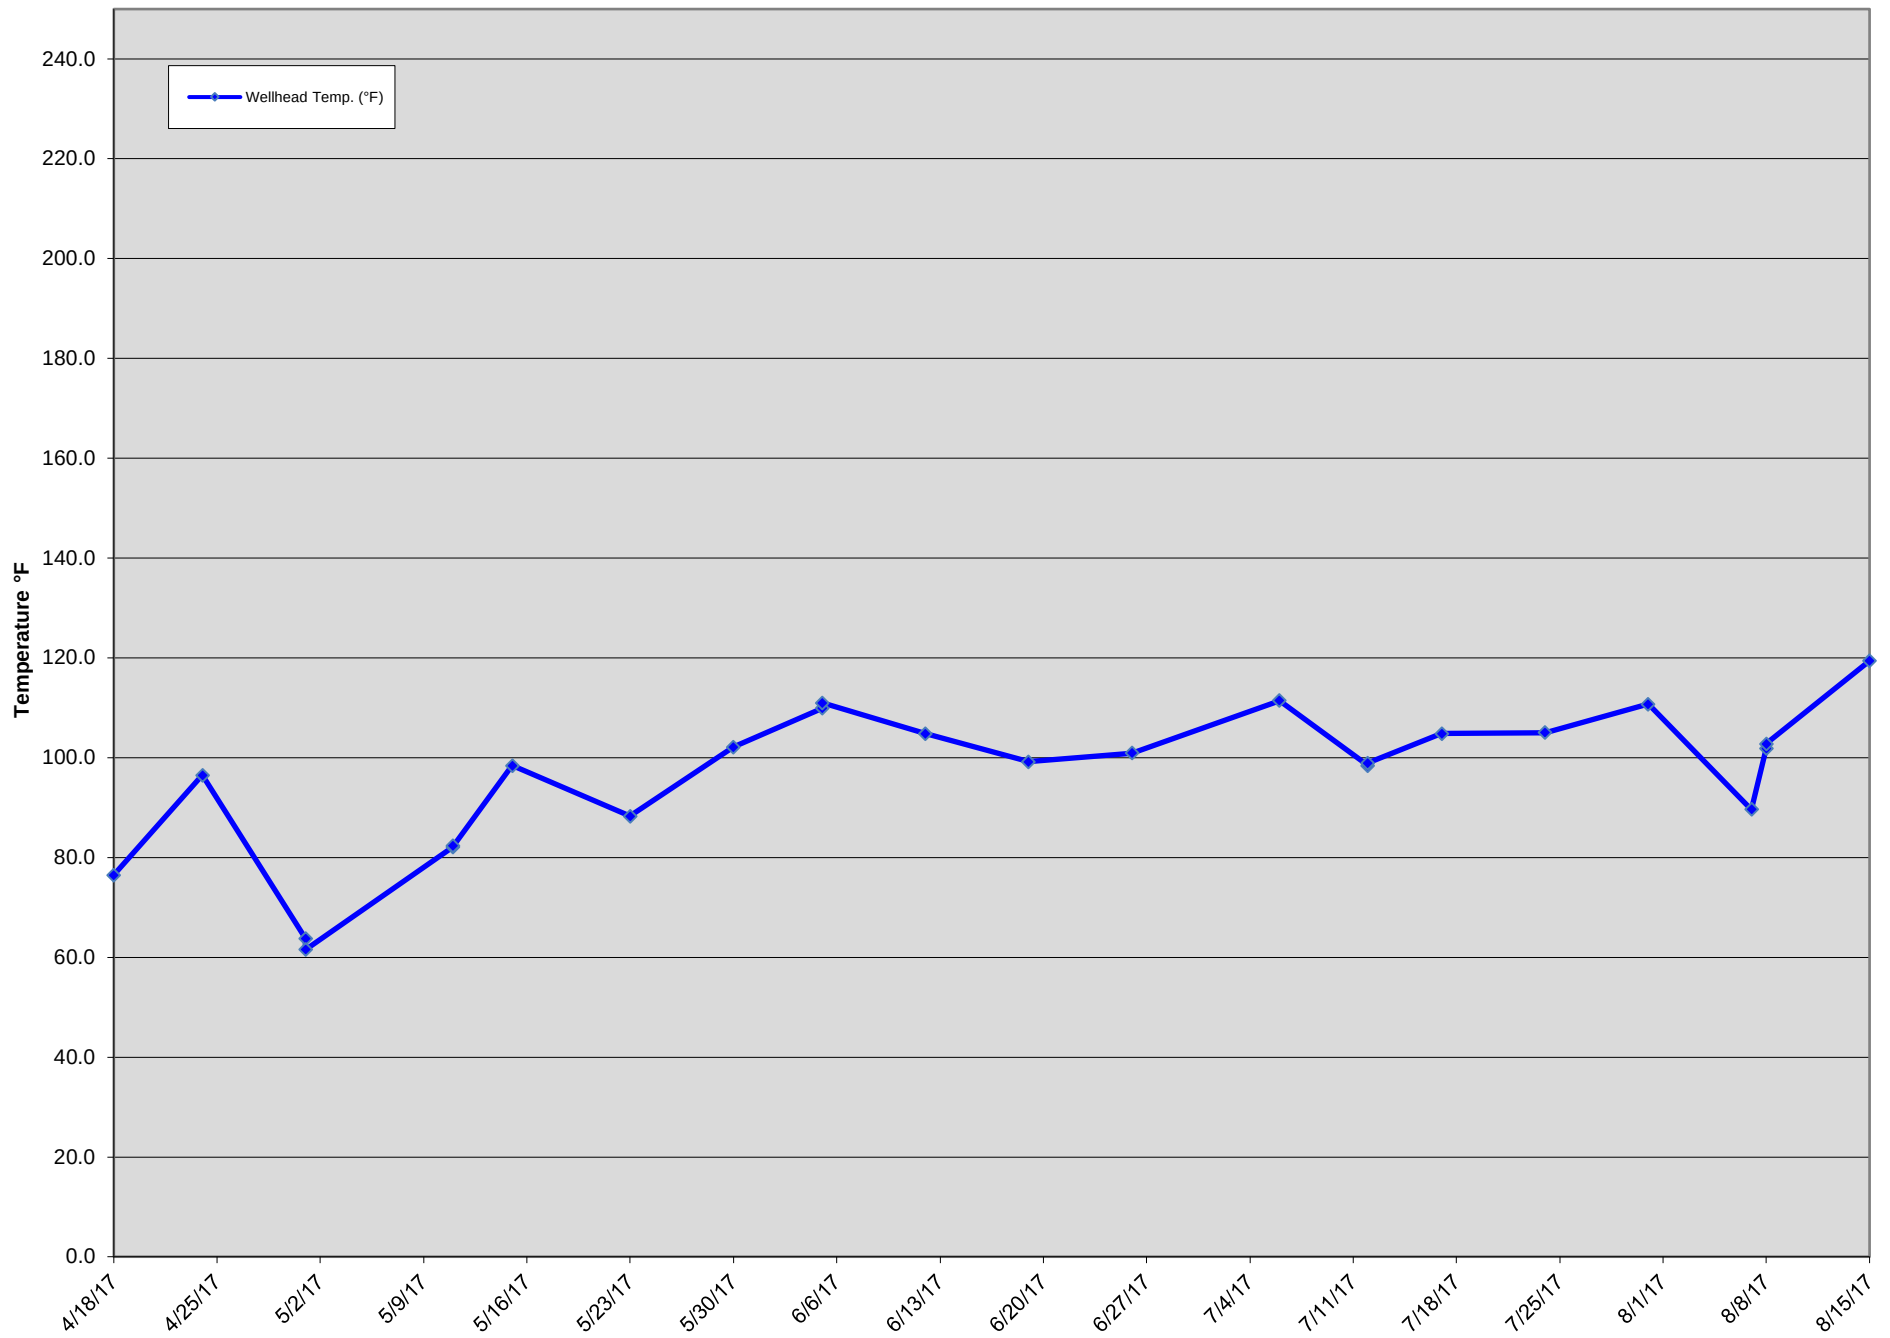
## GIW-1 Wellhead Temperatures

As part of the HES, there are currently cooling water circulation loops installed in twelve Gas Interceptor Wells (GIWs) (GIW-02 through GIW-13). The remaining well (GIW-01) had a measured gas temperature within its historical operating limits.
