# **Bridgeton Landfill, LLC**

## **Weekly Data Submittal**

**Week of August 20, 2017 – August 26, 2017**

**Required by Section 52.F of Agreed Order, Case No. 13SL-CC01088  
Effective May 13, 2013**

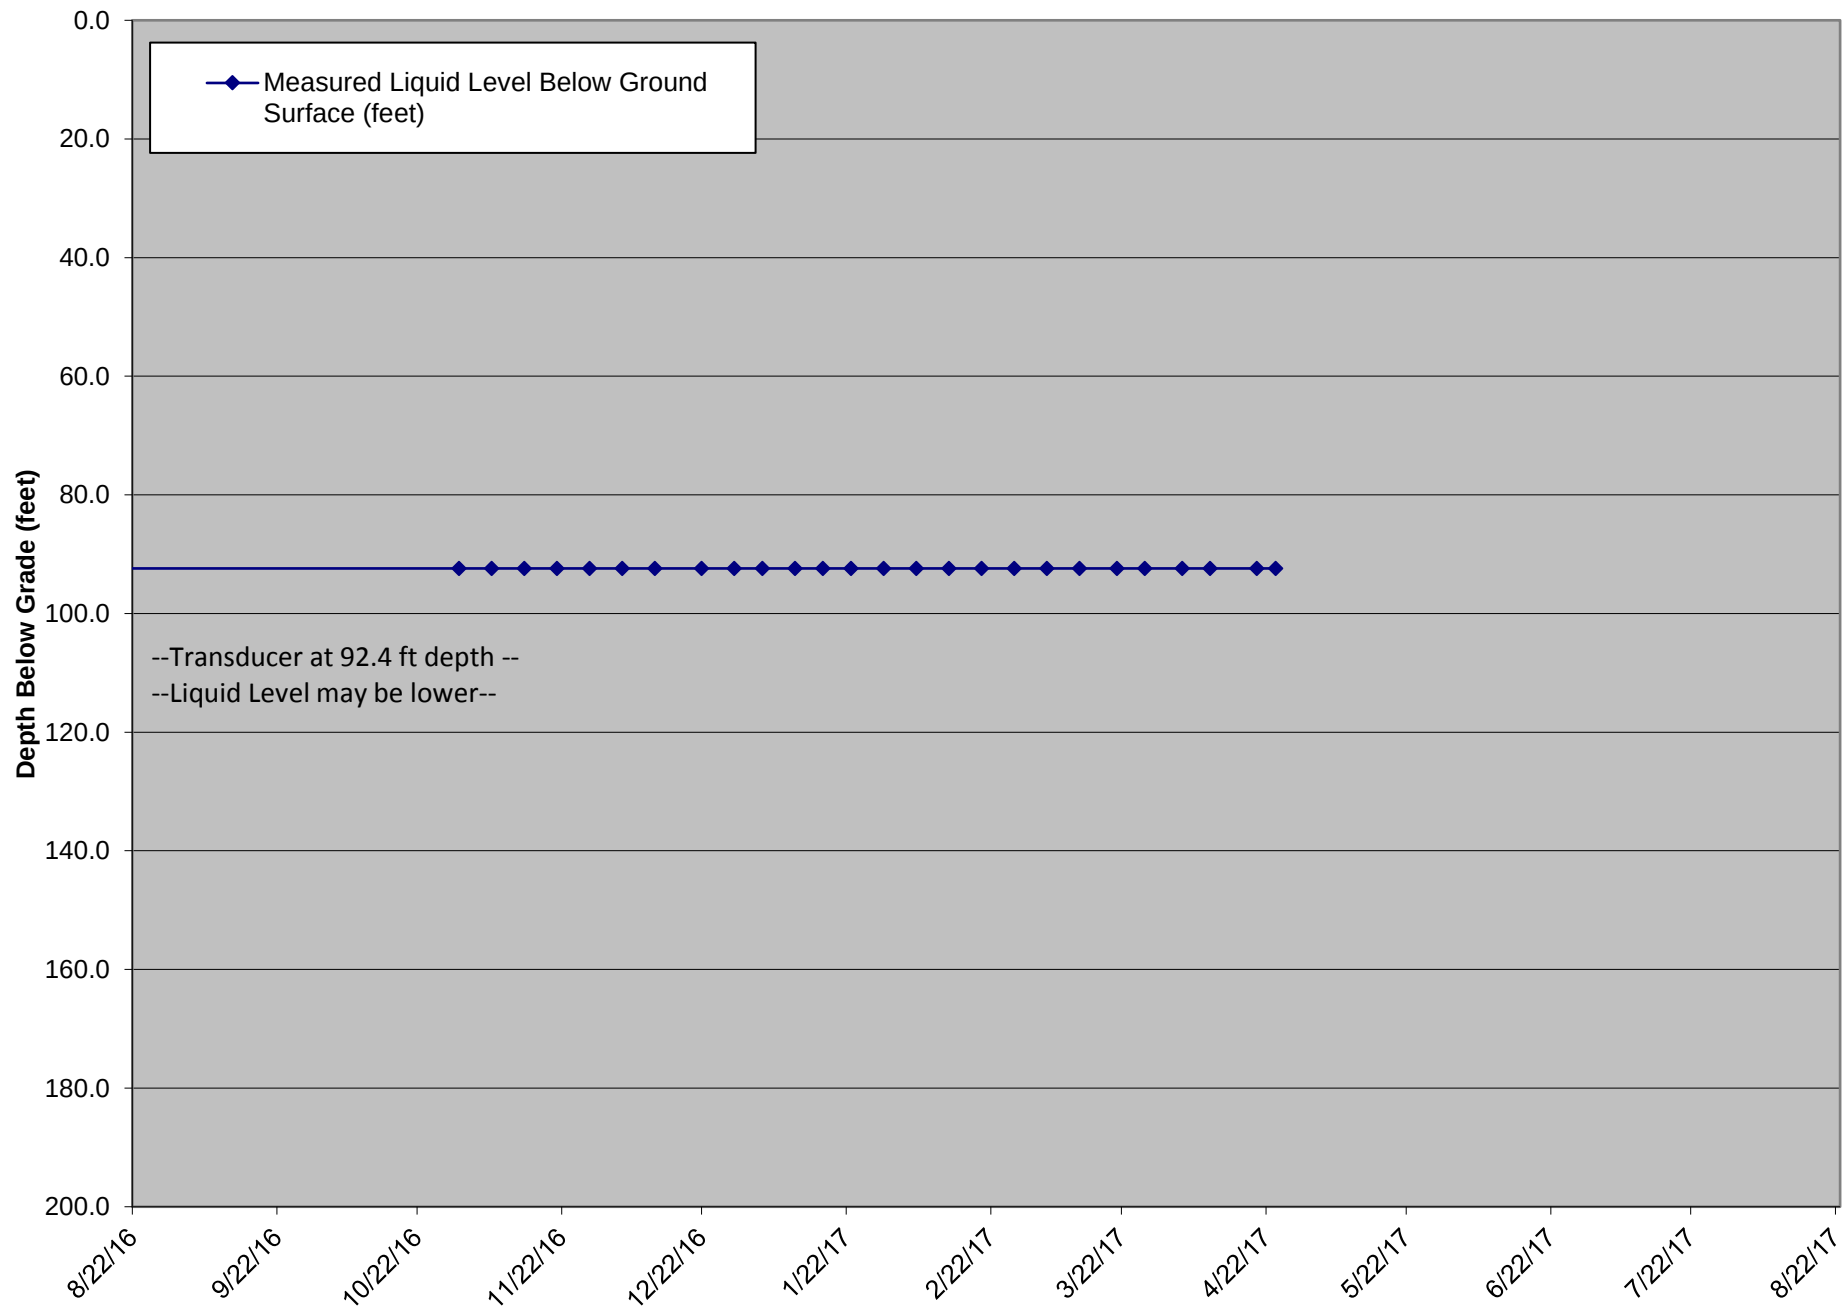
# LCS-1D Liquid Level Below Ground Surface

Bridgeton Landfill is currently troubleshooting the pump in LCS-1D. Level sensor replacement is pending while awaiting parts arrival.

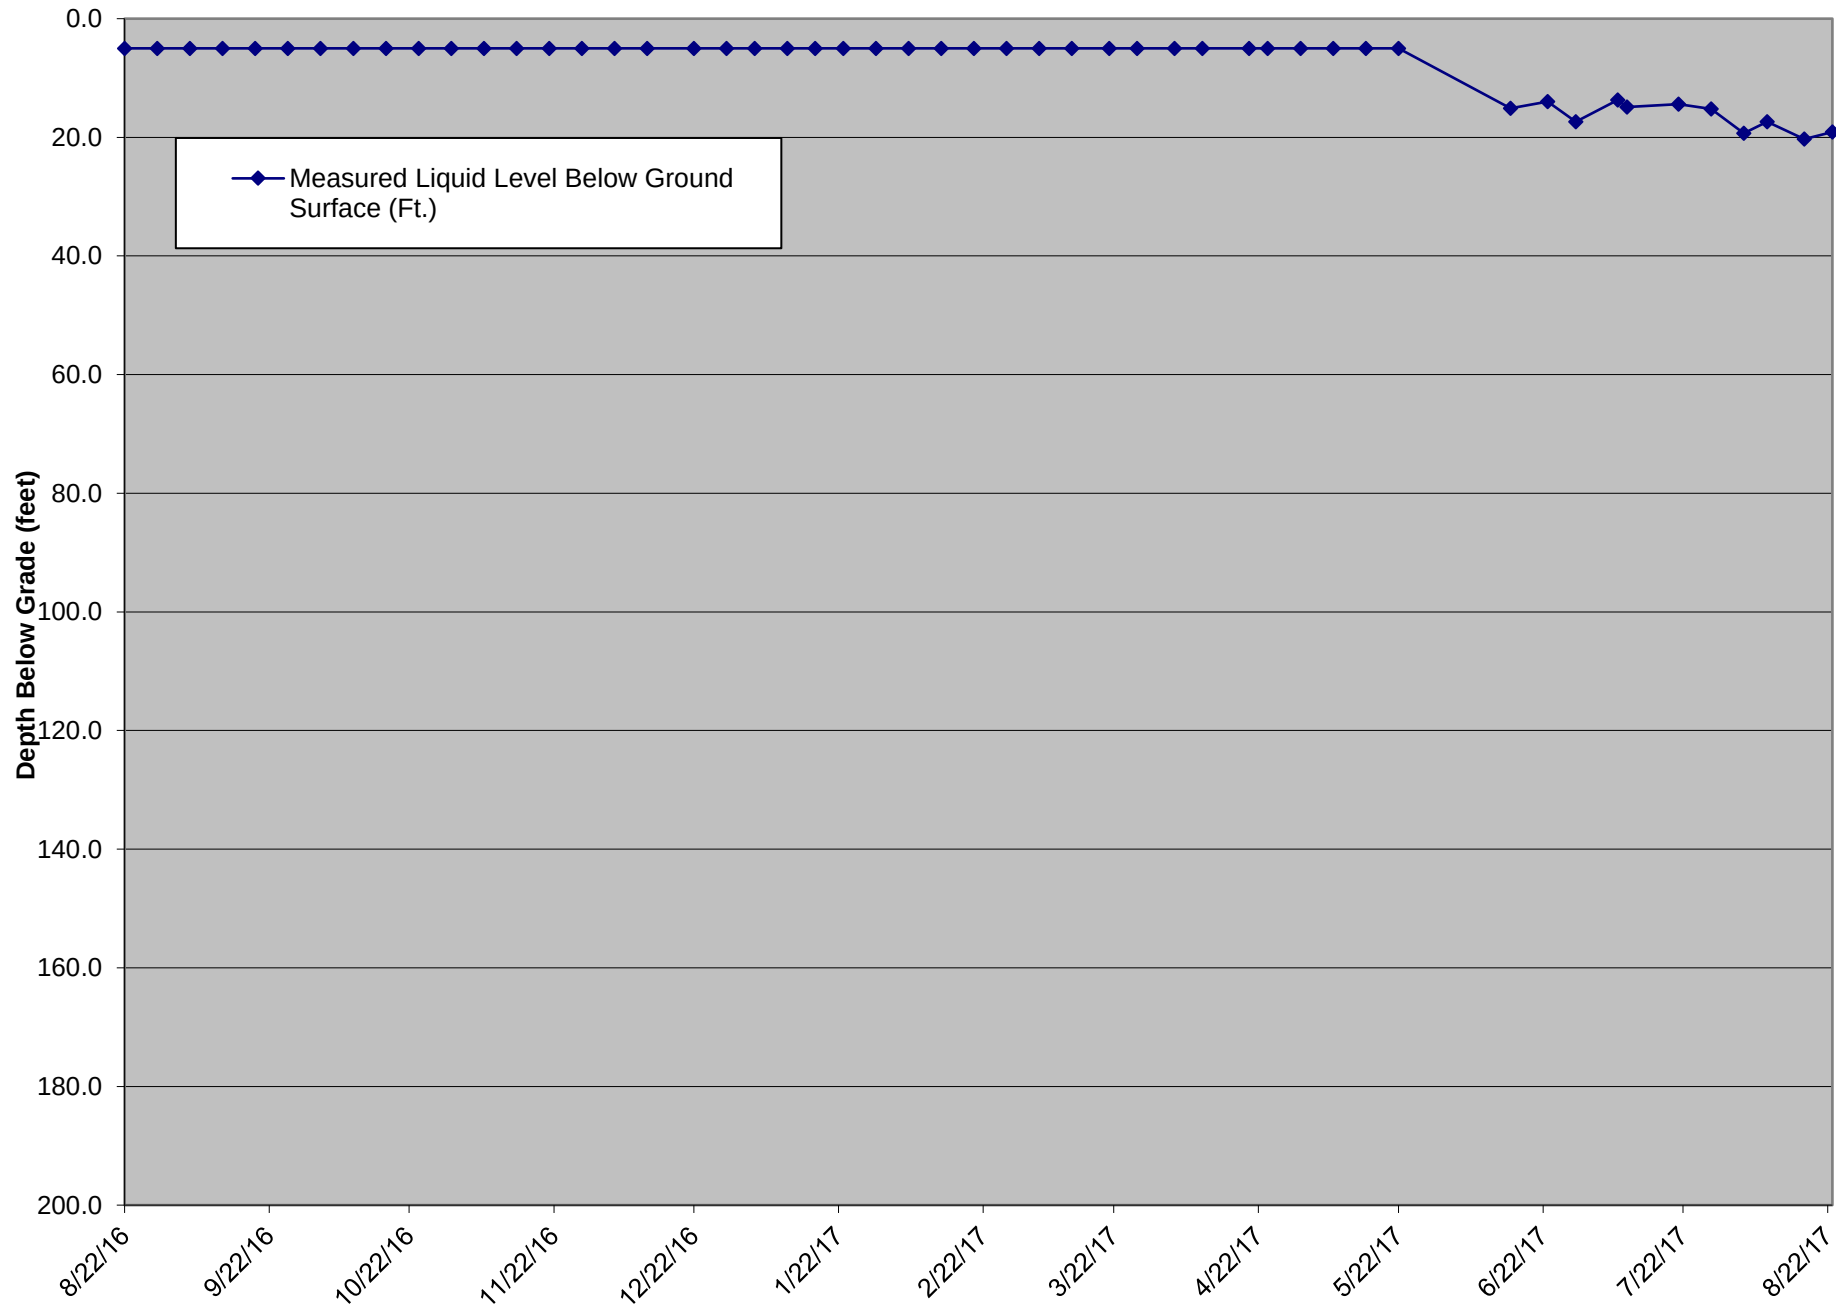
### LCS-3D Liquid Level Below Ground Surface

Two Blackhawk pneumatic pumps were installed in LCS-3D on 6/13/2017. Blackhawk pumps do not require a level sensor. Liquid level was measured manually.

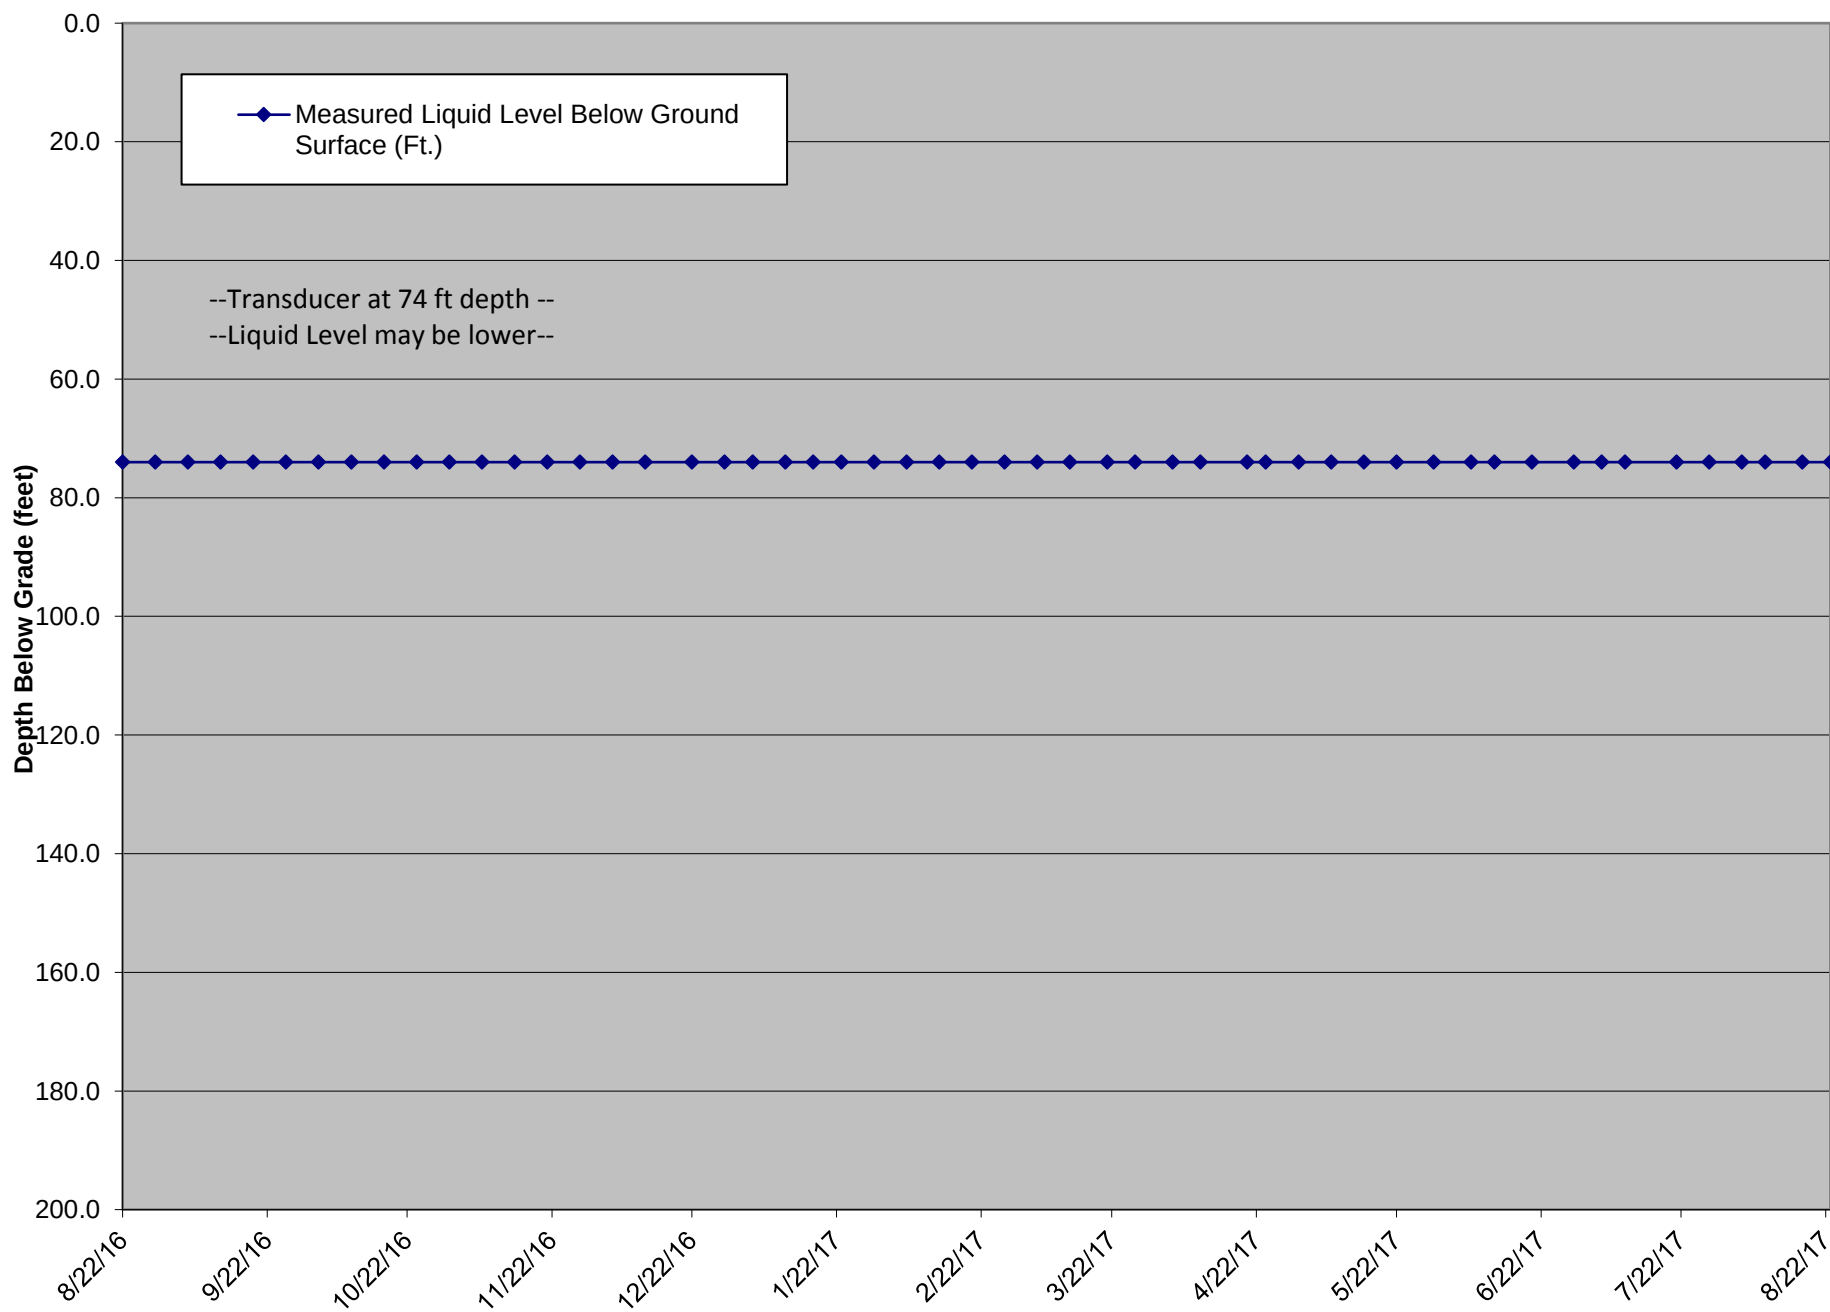
# LCS-4B Liquid Level Below Ground Surface

The level sensor in LCS-4B is currently operational and responsive. Liquid level was not recorded by the level sensor during the weekly reporting period. LCS-4B is equipped with a flow meter that displayed no flow during the weekly reporting period. Therefore, it can be concluded that the liquid level was below the bottom of the pump and level sensor in LCS-4B.

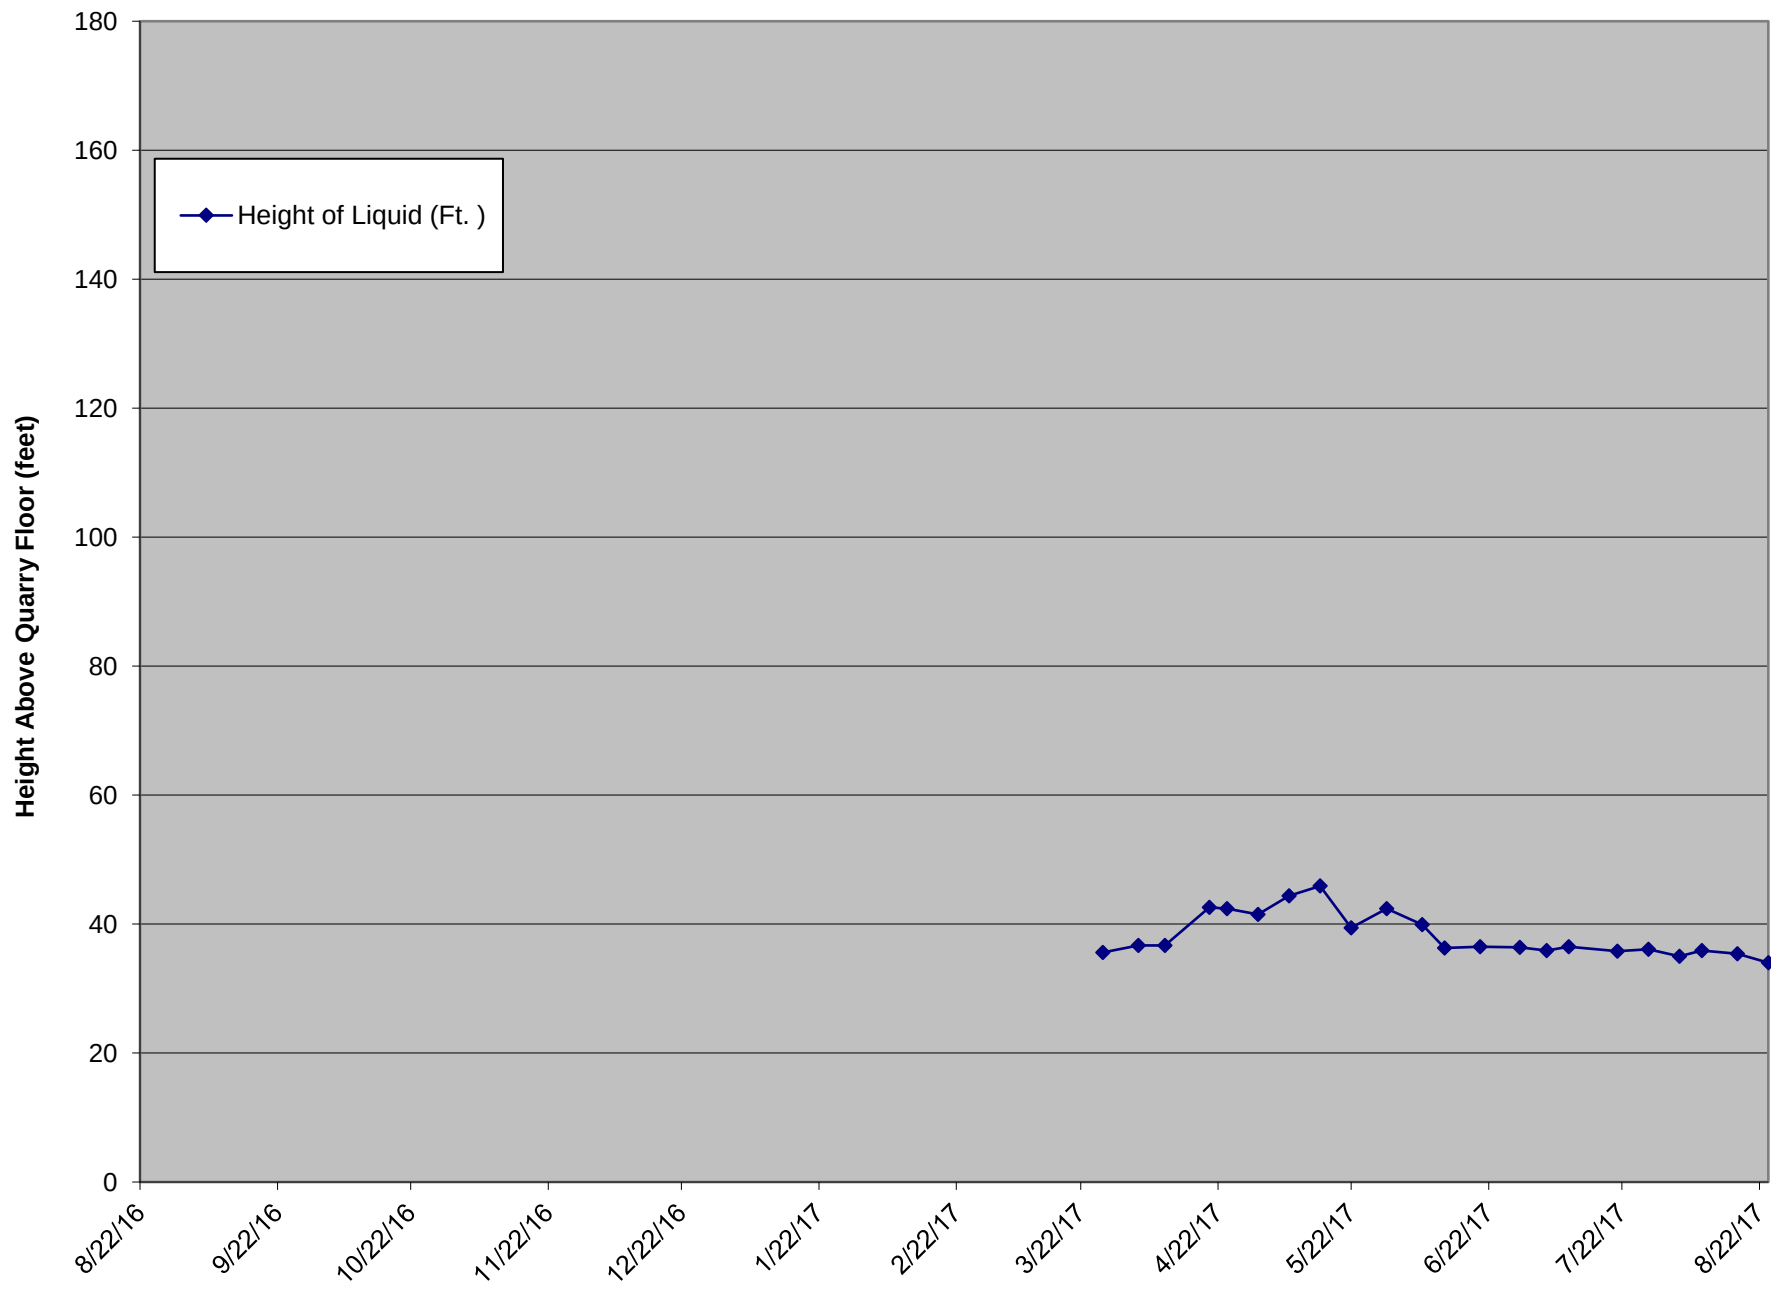
LCS-5B Liquid Level Above Quarry Floor

LCS-5B and LCS-6B were fully operational during the weekly reporting period.

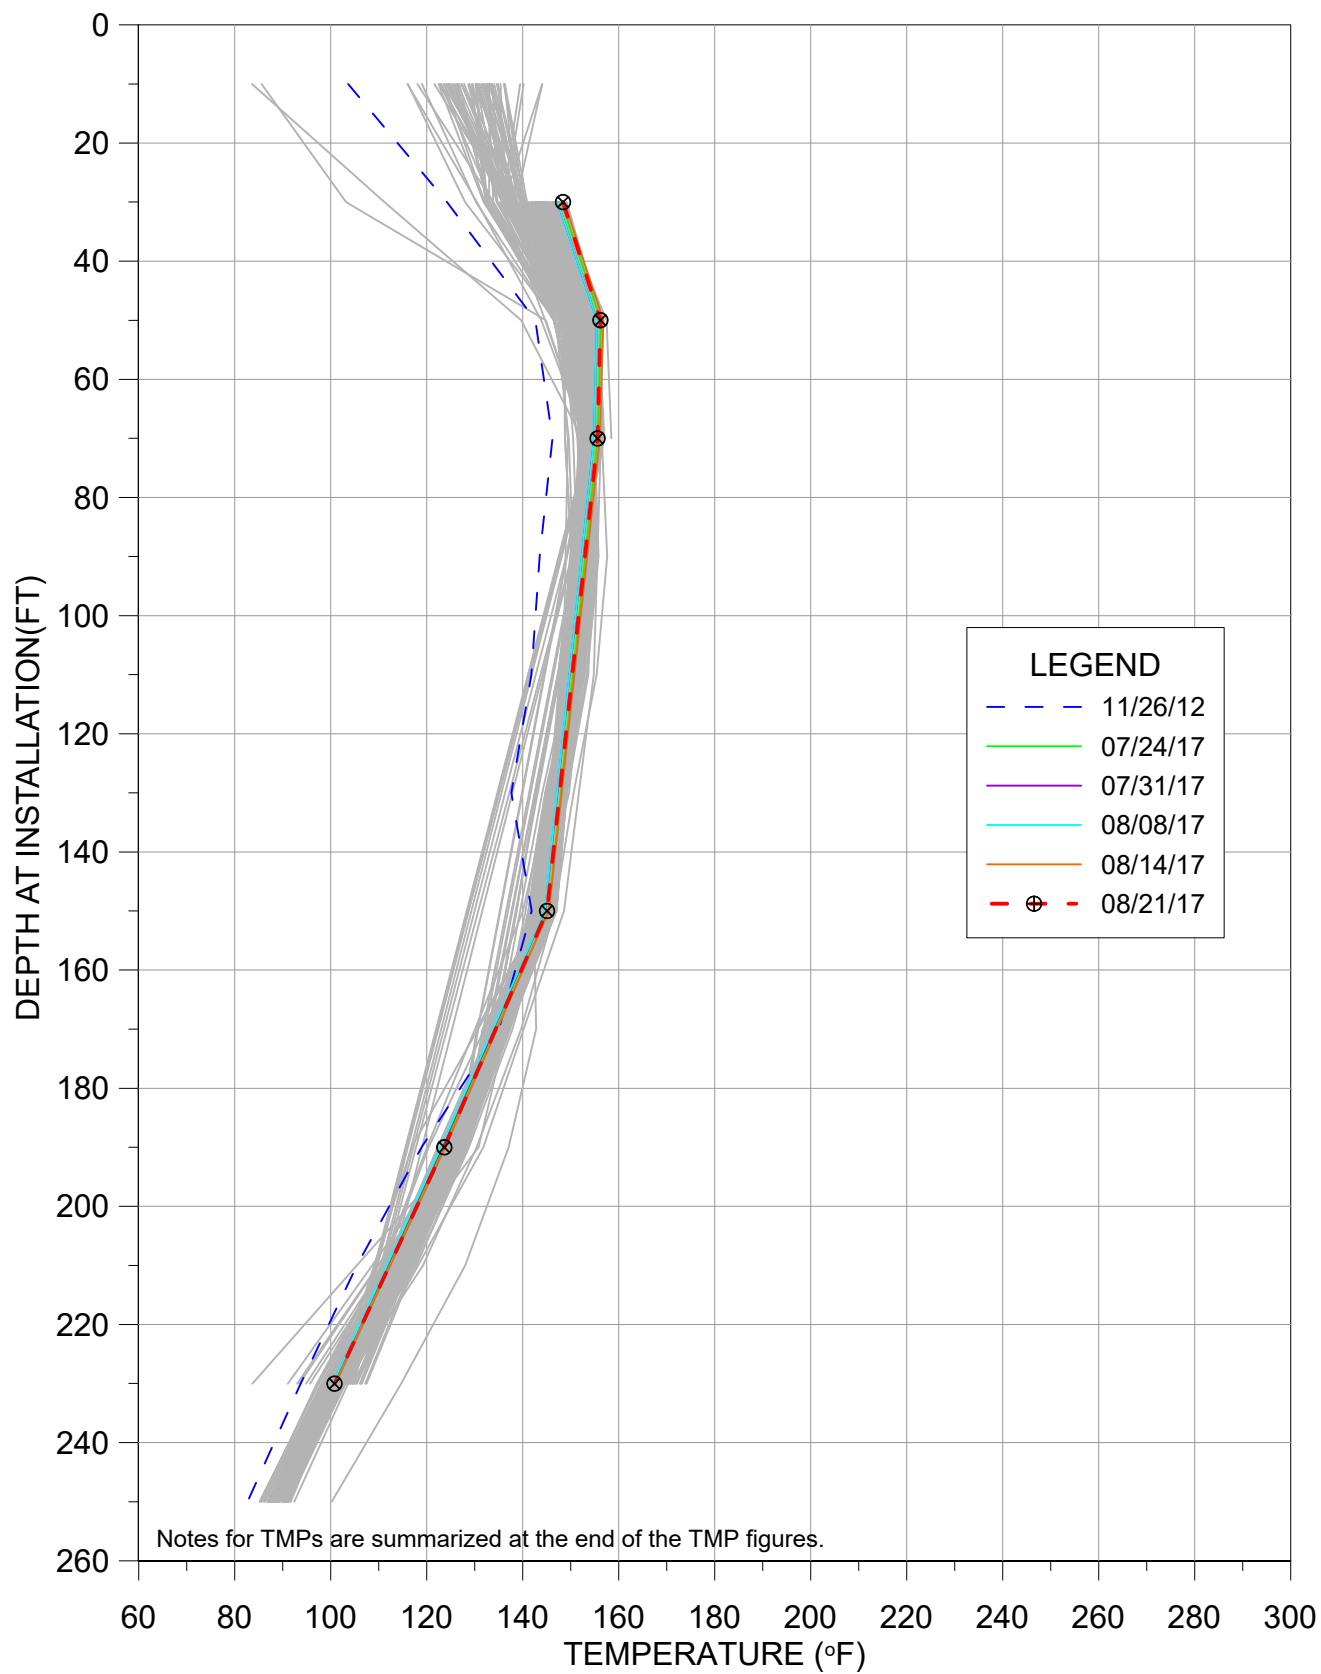
# TMP-3

1. No reliable temperature readings have been obtained at 170 ft depth since 1/29/2014, except on 3/13/2014.
2. The connectivity tests on 4/11/2014 conducted by CEC showed that units at 10, 90, 130, 210 and 250 ft depths are no longer reliable.
3. The connectivity tests on 10/28/2014 conducted by Feezor Engineering showed that units at 10, 90, 110, 130, 210 and 250 ft depths are not reliable.

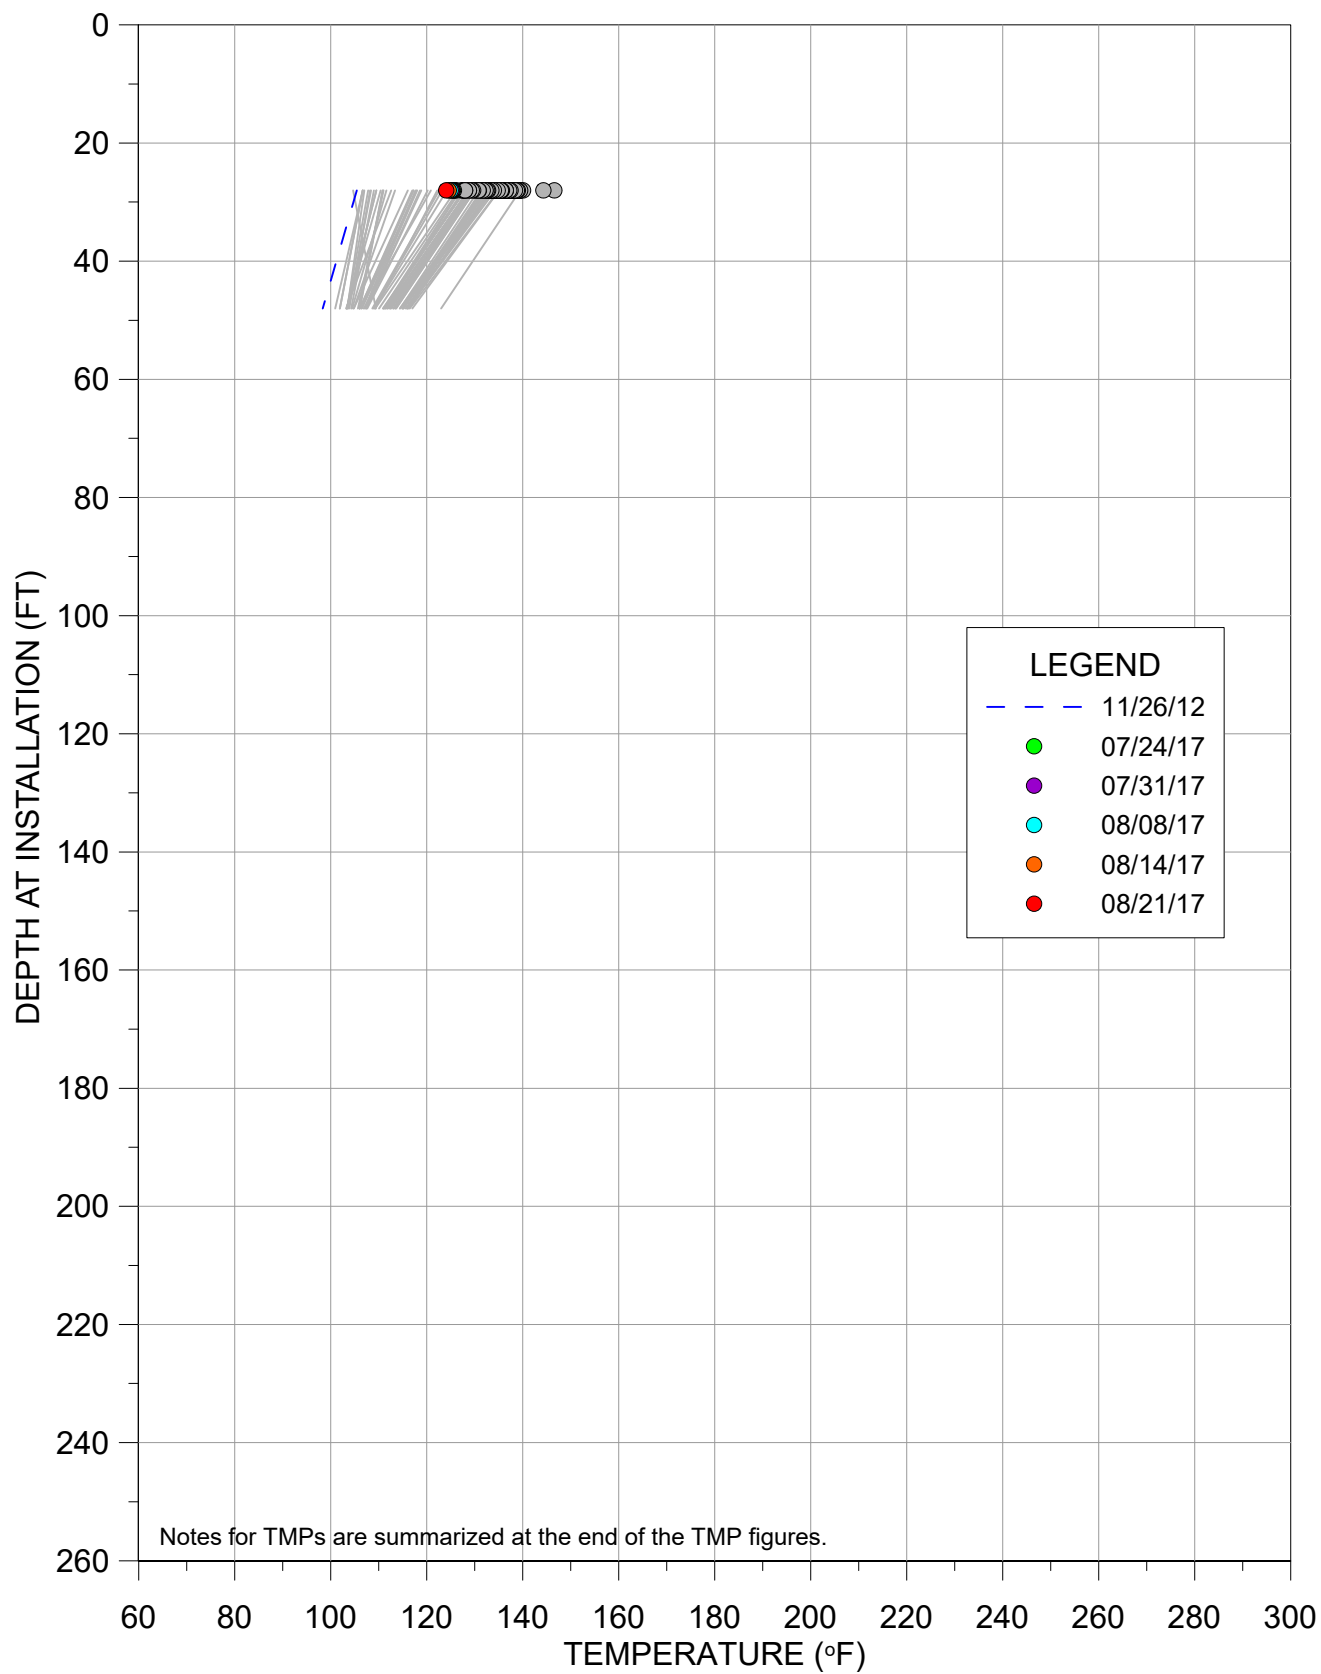
# TMP-4

1. The connectivity tests on 4/11/2014 conducted by CEC showed that the unit at 48 ft depth is no longer reliable.

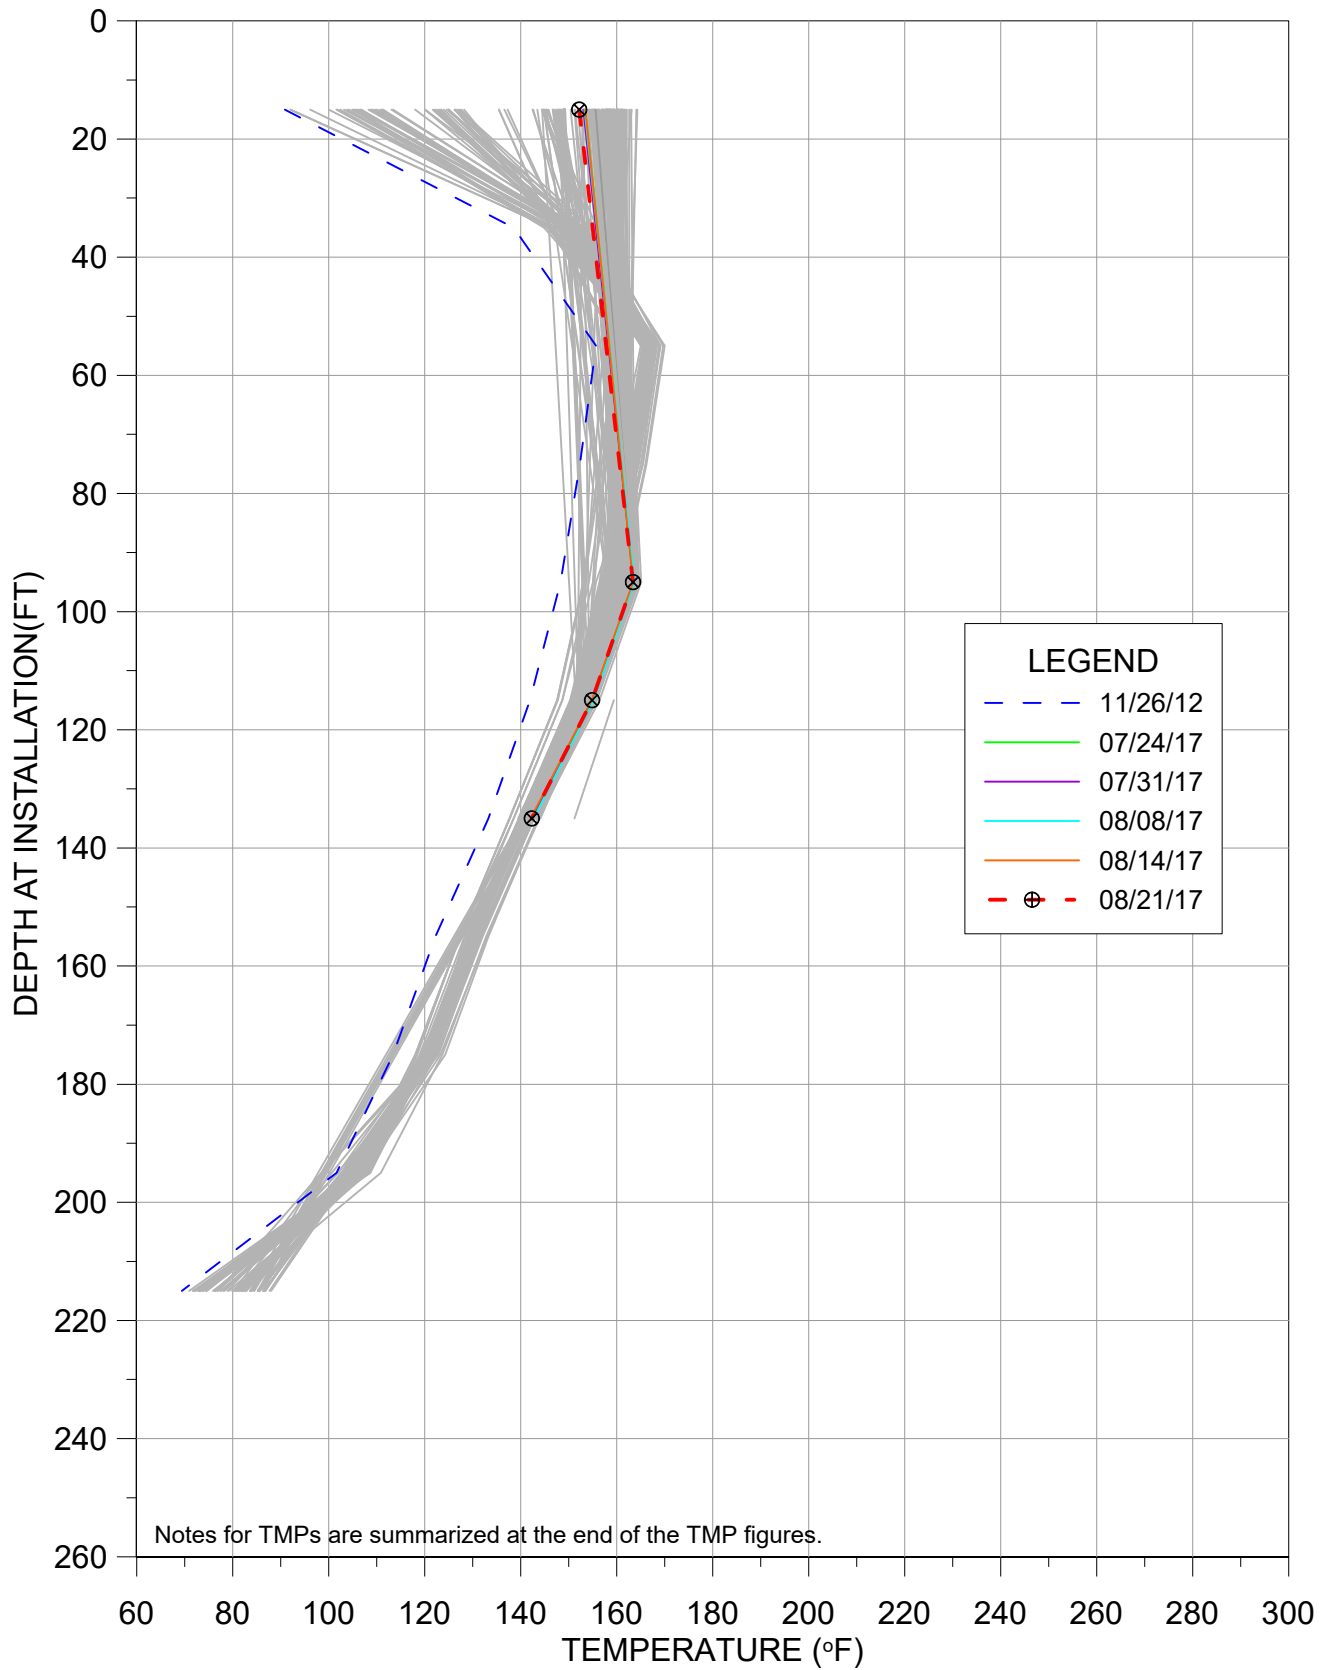
# TMP-6

1. The connectivity tests on 4/11/2014 conducted by CEC showed that units at 35, 55, 75, 155, 175, and 195 ft depths are no longer reliable.
2. No reliable temperature readings have been obtained at the unit at 215 ft depth since 6/13/2014.

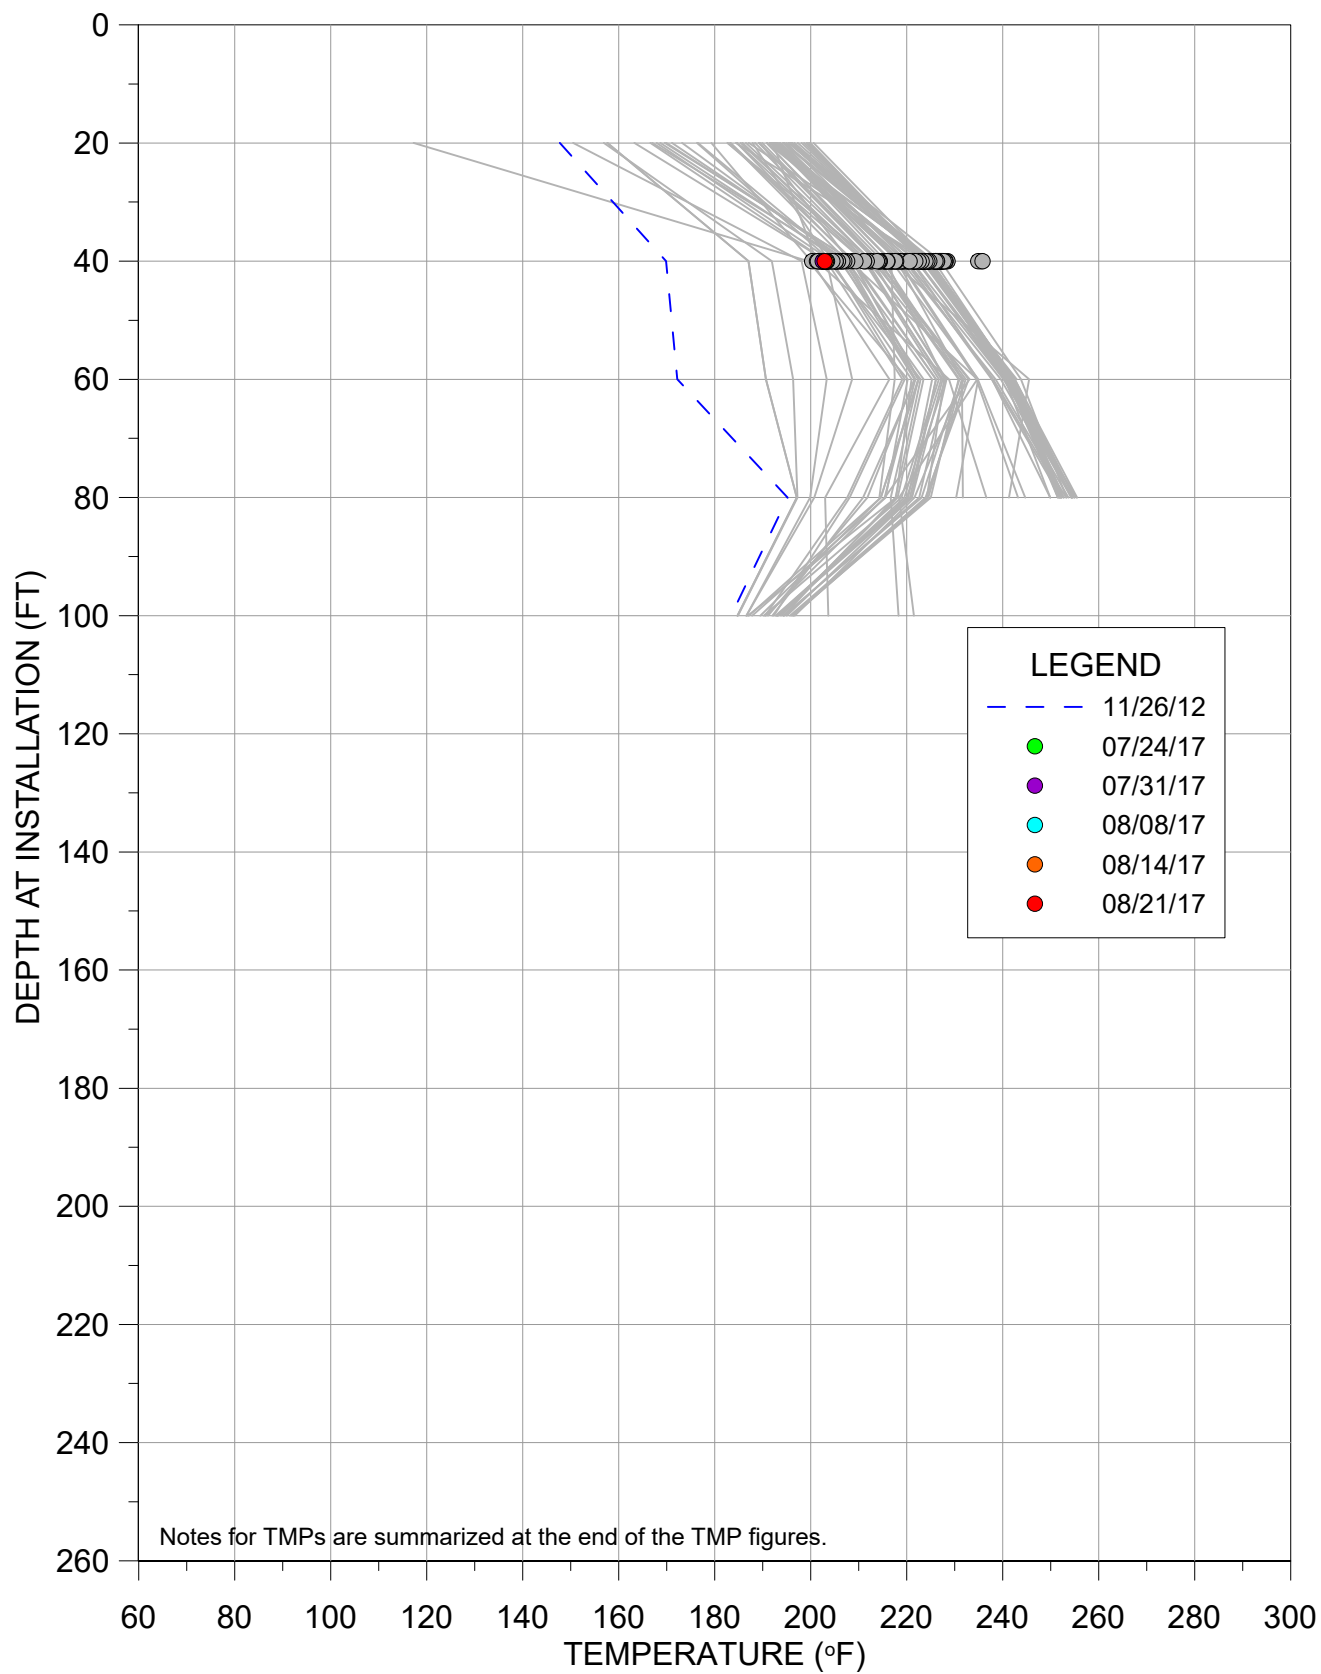
# TMP-9

1. Unit at 100 ft depth had an inaccurate temperature reading on 8/1/2013 and no reading since 8/6/2013.
2. The connectivity tests on 4/11/2014 conducted by CEC showed that units at 20, 60, 80, and 100 ft depths are no longer reliable.

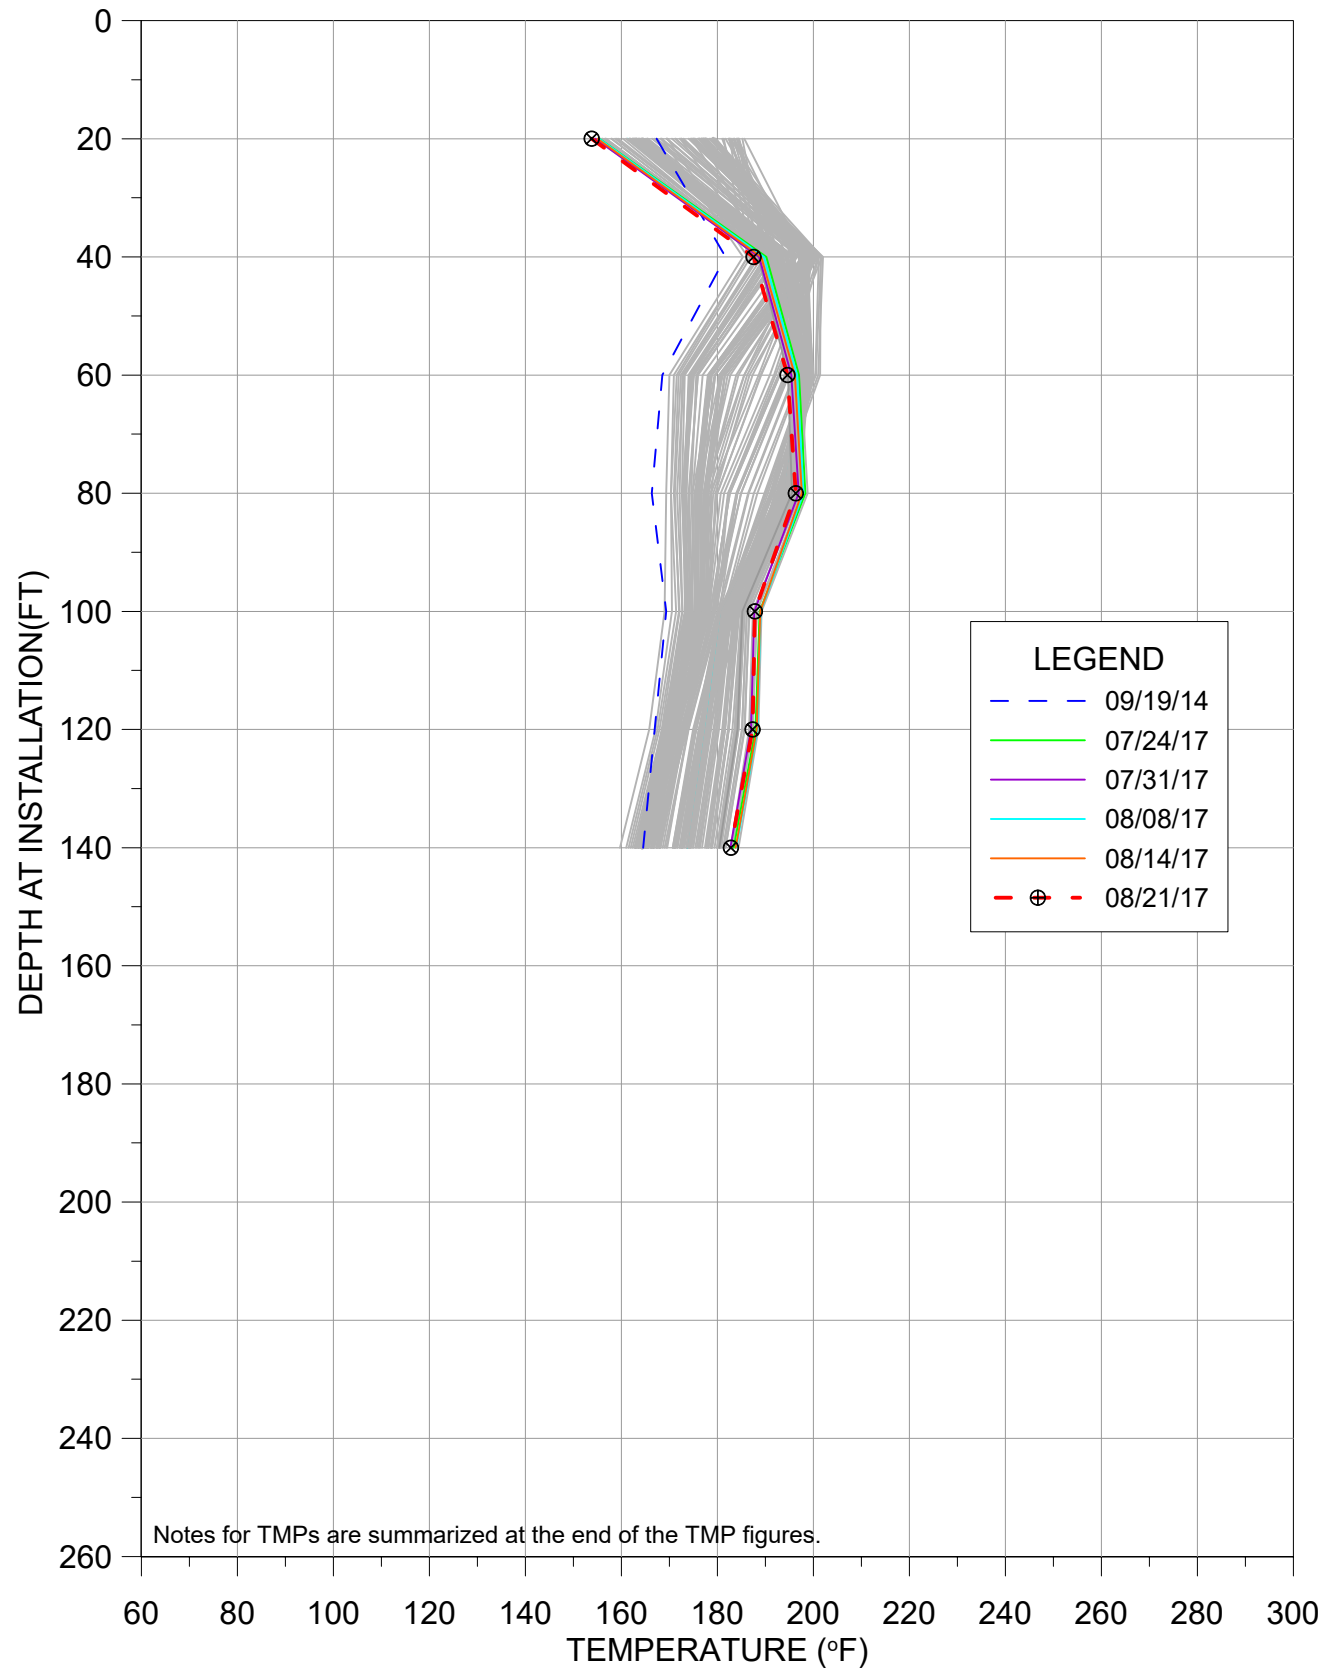
# TMP-14R

1. Due to the connectivity test results by Feezor Engineering on TMP-14 (see note above), TMP-14R is added to this reporting data set as of 3/7/2016.
