# **Bridgeton Landfill, LLC**

## **Weekly Data Submittal**

**Week of August 20, 2017 – August 26, 2017**

**Required by Section 52.F of Agreed Order, Case No. 13SL-CC01088  
Effective May 13, 2013**

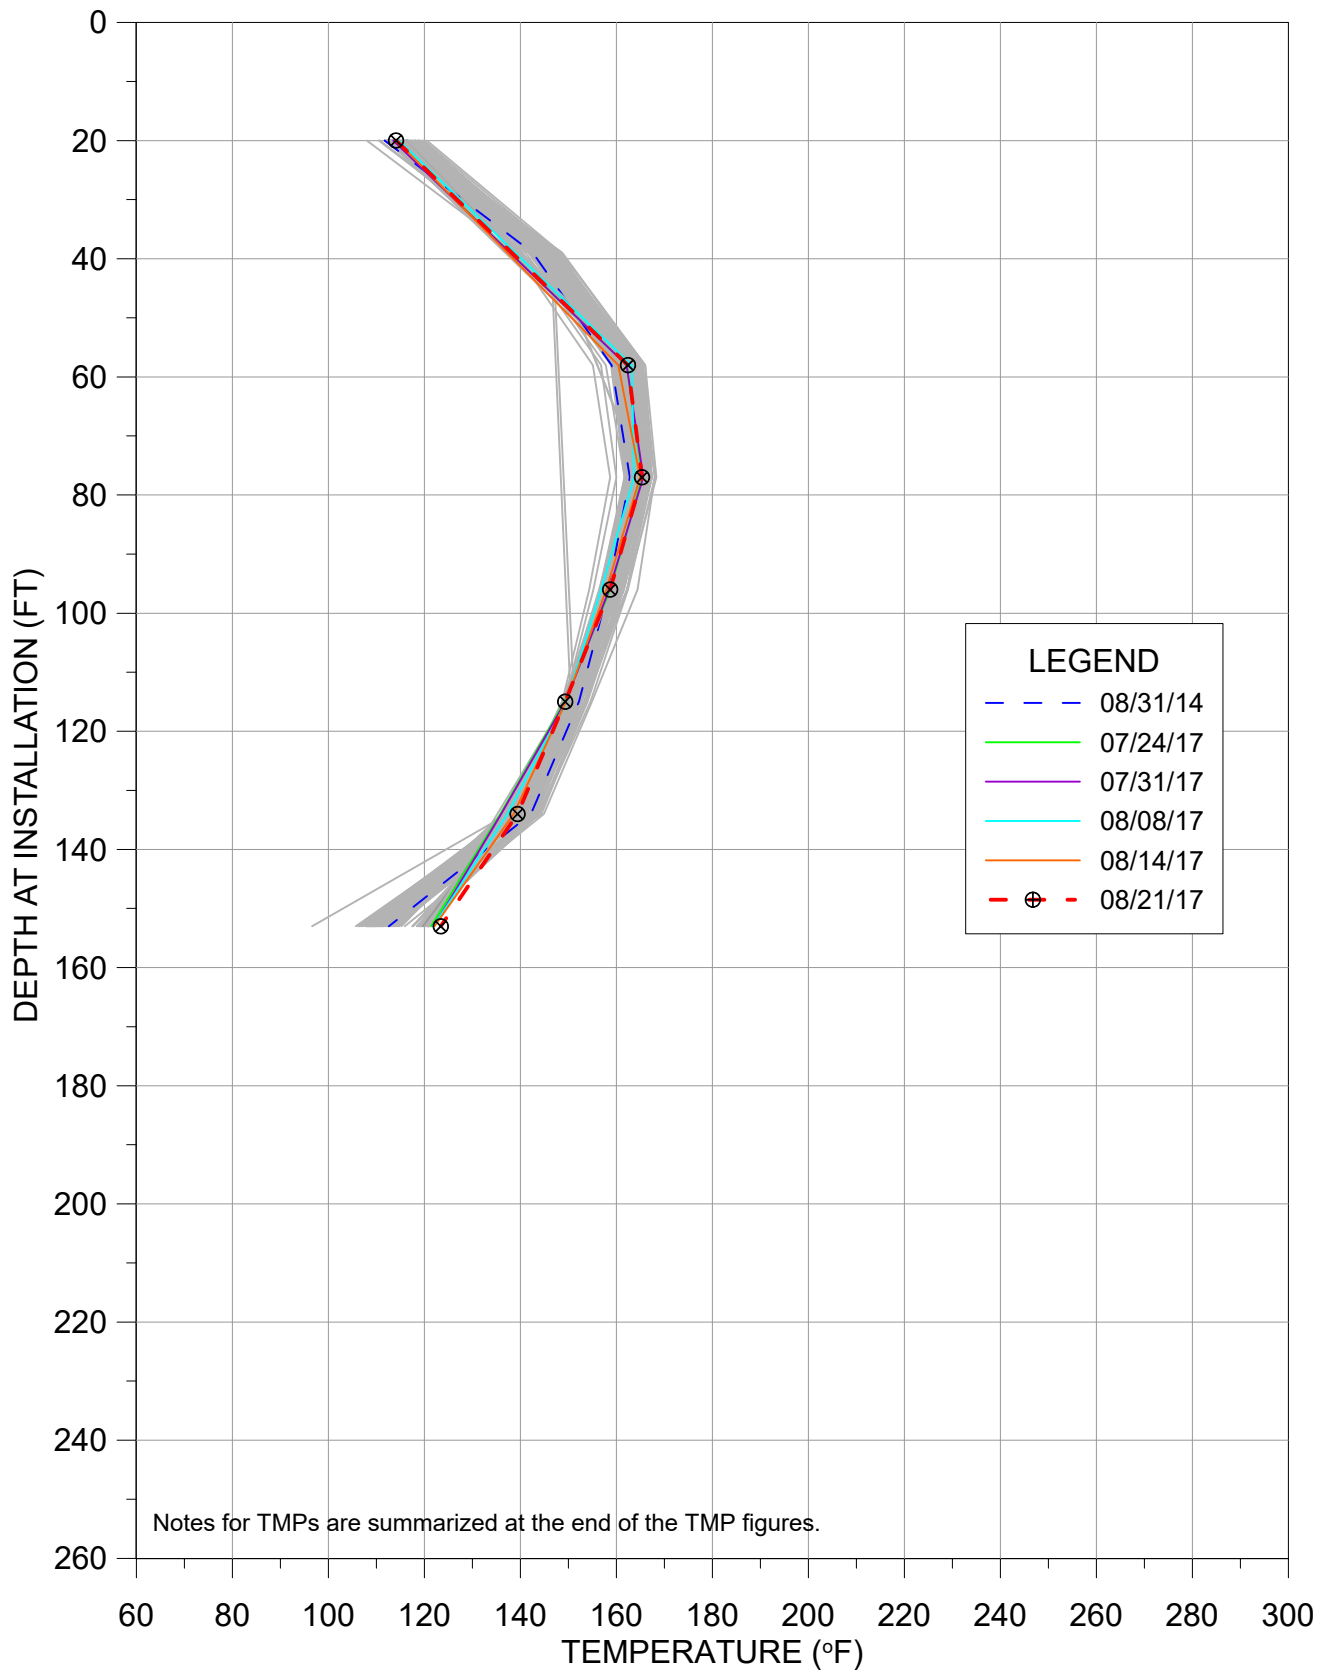
# TMP-16

1. A connectivity test conducted by Feezor Engineering showed that the units on TMP-16 may not be reliable since 9/9/2015. Further testing at the end of September 2015 showed possible connectivity on some of the units.
2. The unit at 153 ft depth had a low resistance reading and unreliable temperature since 12/21/2015.

3. The unit at 39 ft depth had a higher than acceptable resistance reading and unreliable temperature since 2/7/2017.

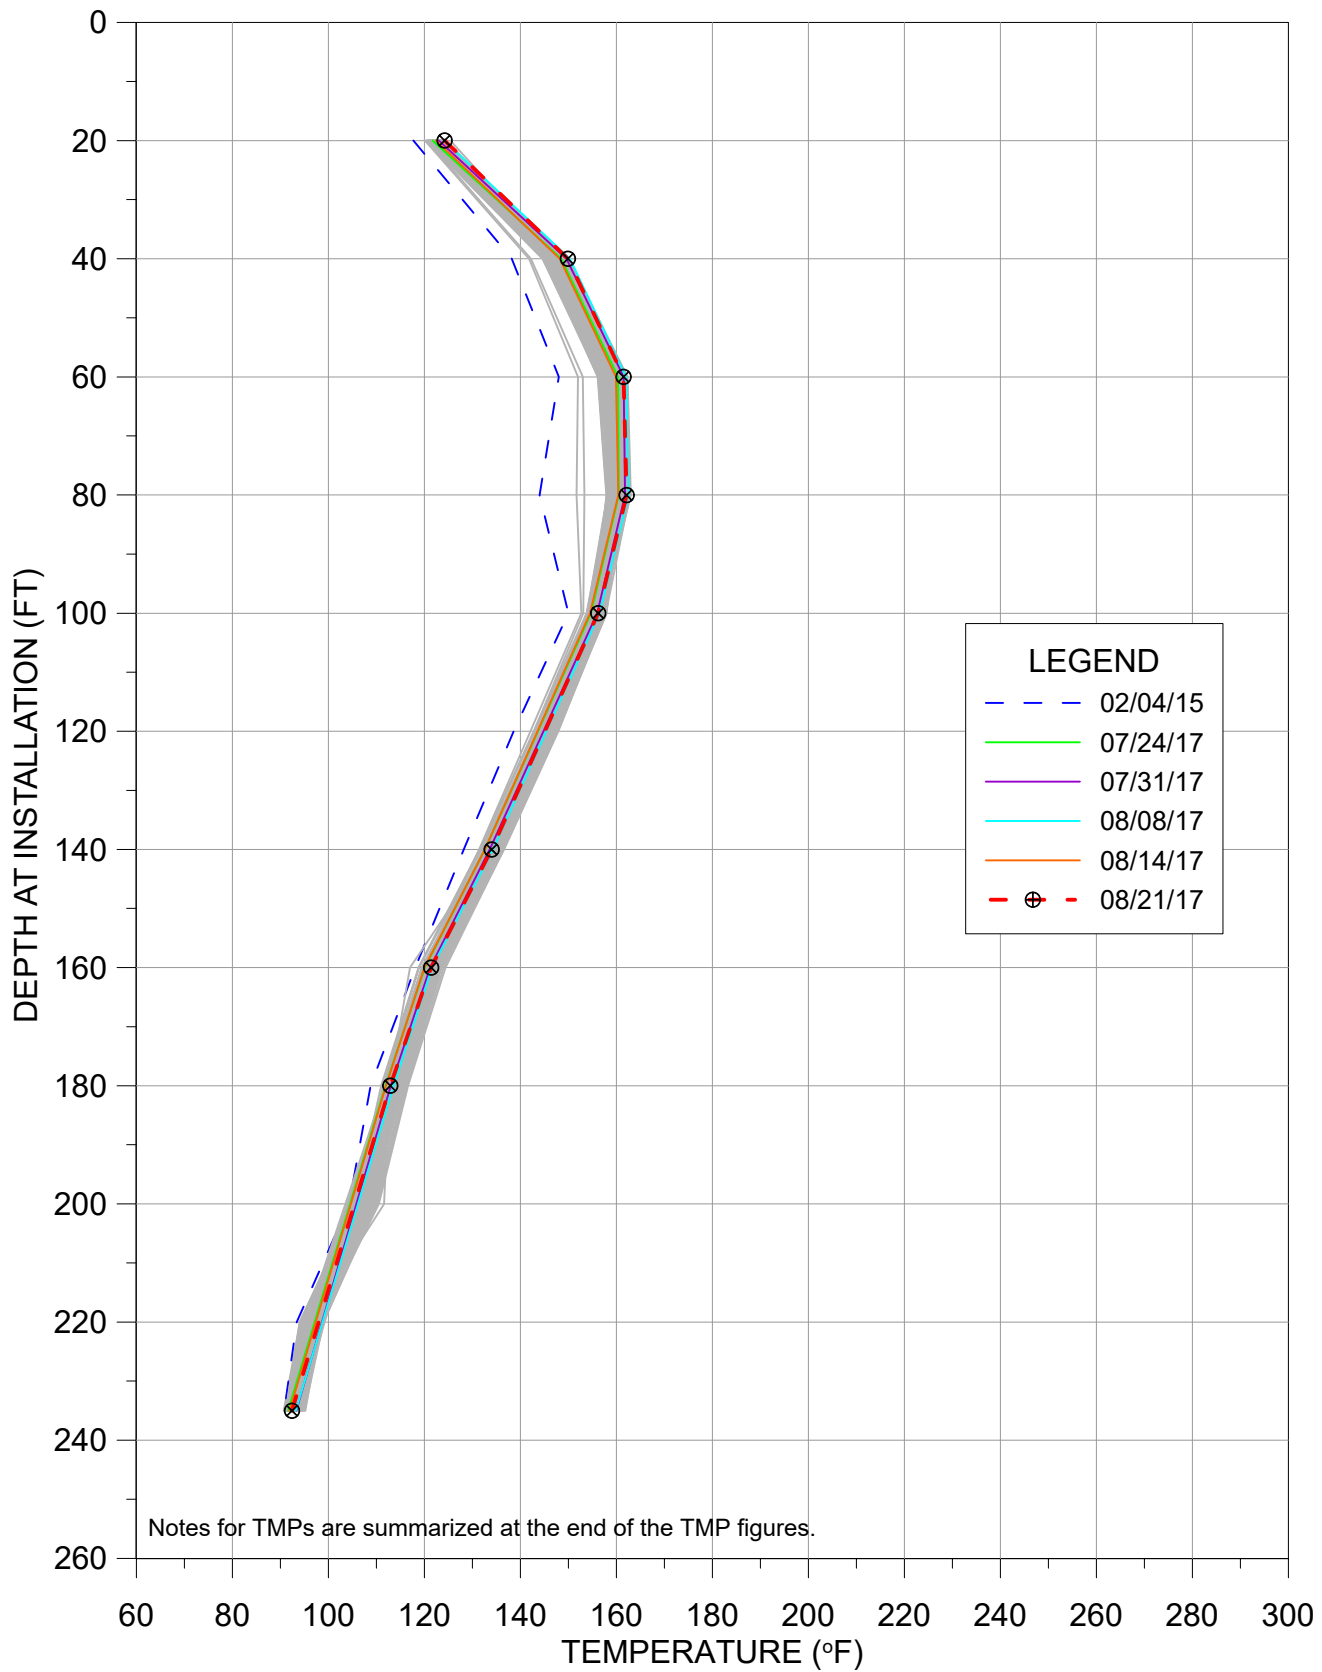
# TMP-25

1. The unit at 200 ft provided an apparent anomalous reading on 3/28/2017. Subsequent readings on 4/4/2017 showed the unit to have failed (see below). The unit is no longer working and the reading of 3/28/2017 was likely unreliable.

2. The unit at 200 ft depth had a resistance reading greater 4000 ohms on 4/4/2017. A connectivity test conducted by Feezor Engineering on 4/7/2017 showed that this unit also had cross-connectivity. The unit is therefore determined to be no longer working as of the 4/4/2017 reading.

3. The unit at 120 feet had a higher than acceptable limit on 7/10/2017. Also, a connectivity test conducted by Feezor Engineering on 4/7/2017 showed that this unit may be unreliable. Therefore, this unit is determined to be unreliable.

4. The unit at 220 ft has been reported as unable to attain a reading of any kind since June 19, 2017. The unit is considered to be on no longer working as of that date.

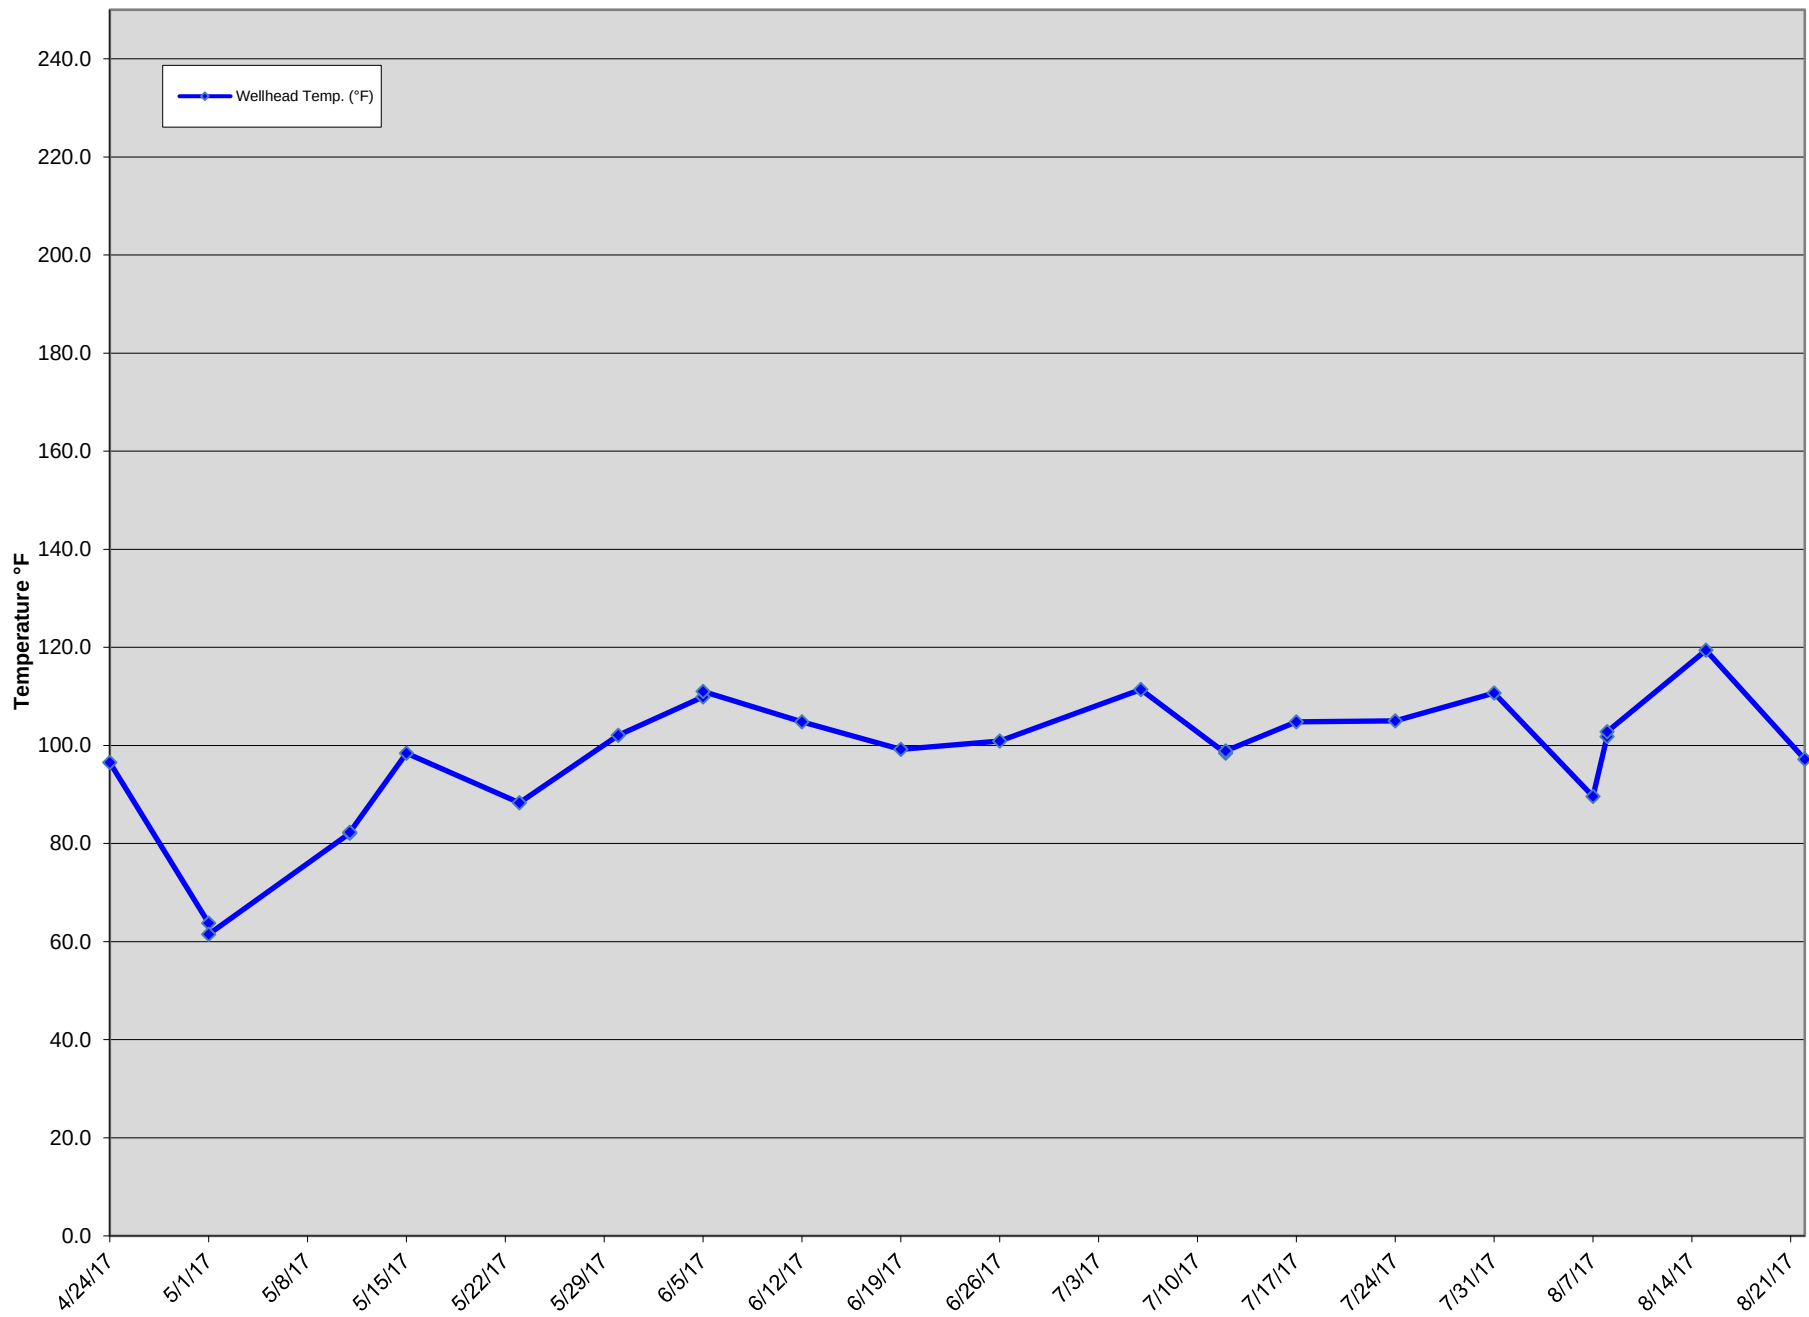
## GIW-1 Wellhead Temperatures

As part of the HES, there are currently cooling water circulation loops installed in twelve Gas Interceptor Wells (GIWs) (GIW-02 through GIW-13). The remaining well (GIW-01) had a measured gas temperature within its historical operating limits.
