# **Bridgeton Landfill, LLC**

## **Weekly Data Submittal**

**Week of September 3, 2017 – September 9, 2017**

**Required by Section 52.F of Agreed Order, Case No. 13SL-CC01088  
Effective May 13, 2013**

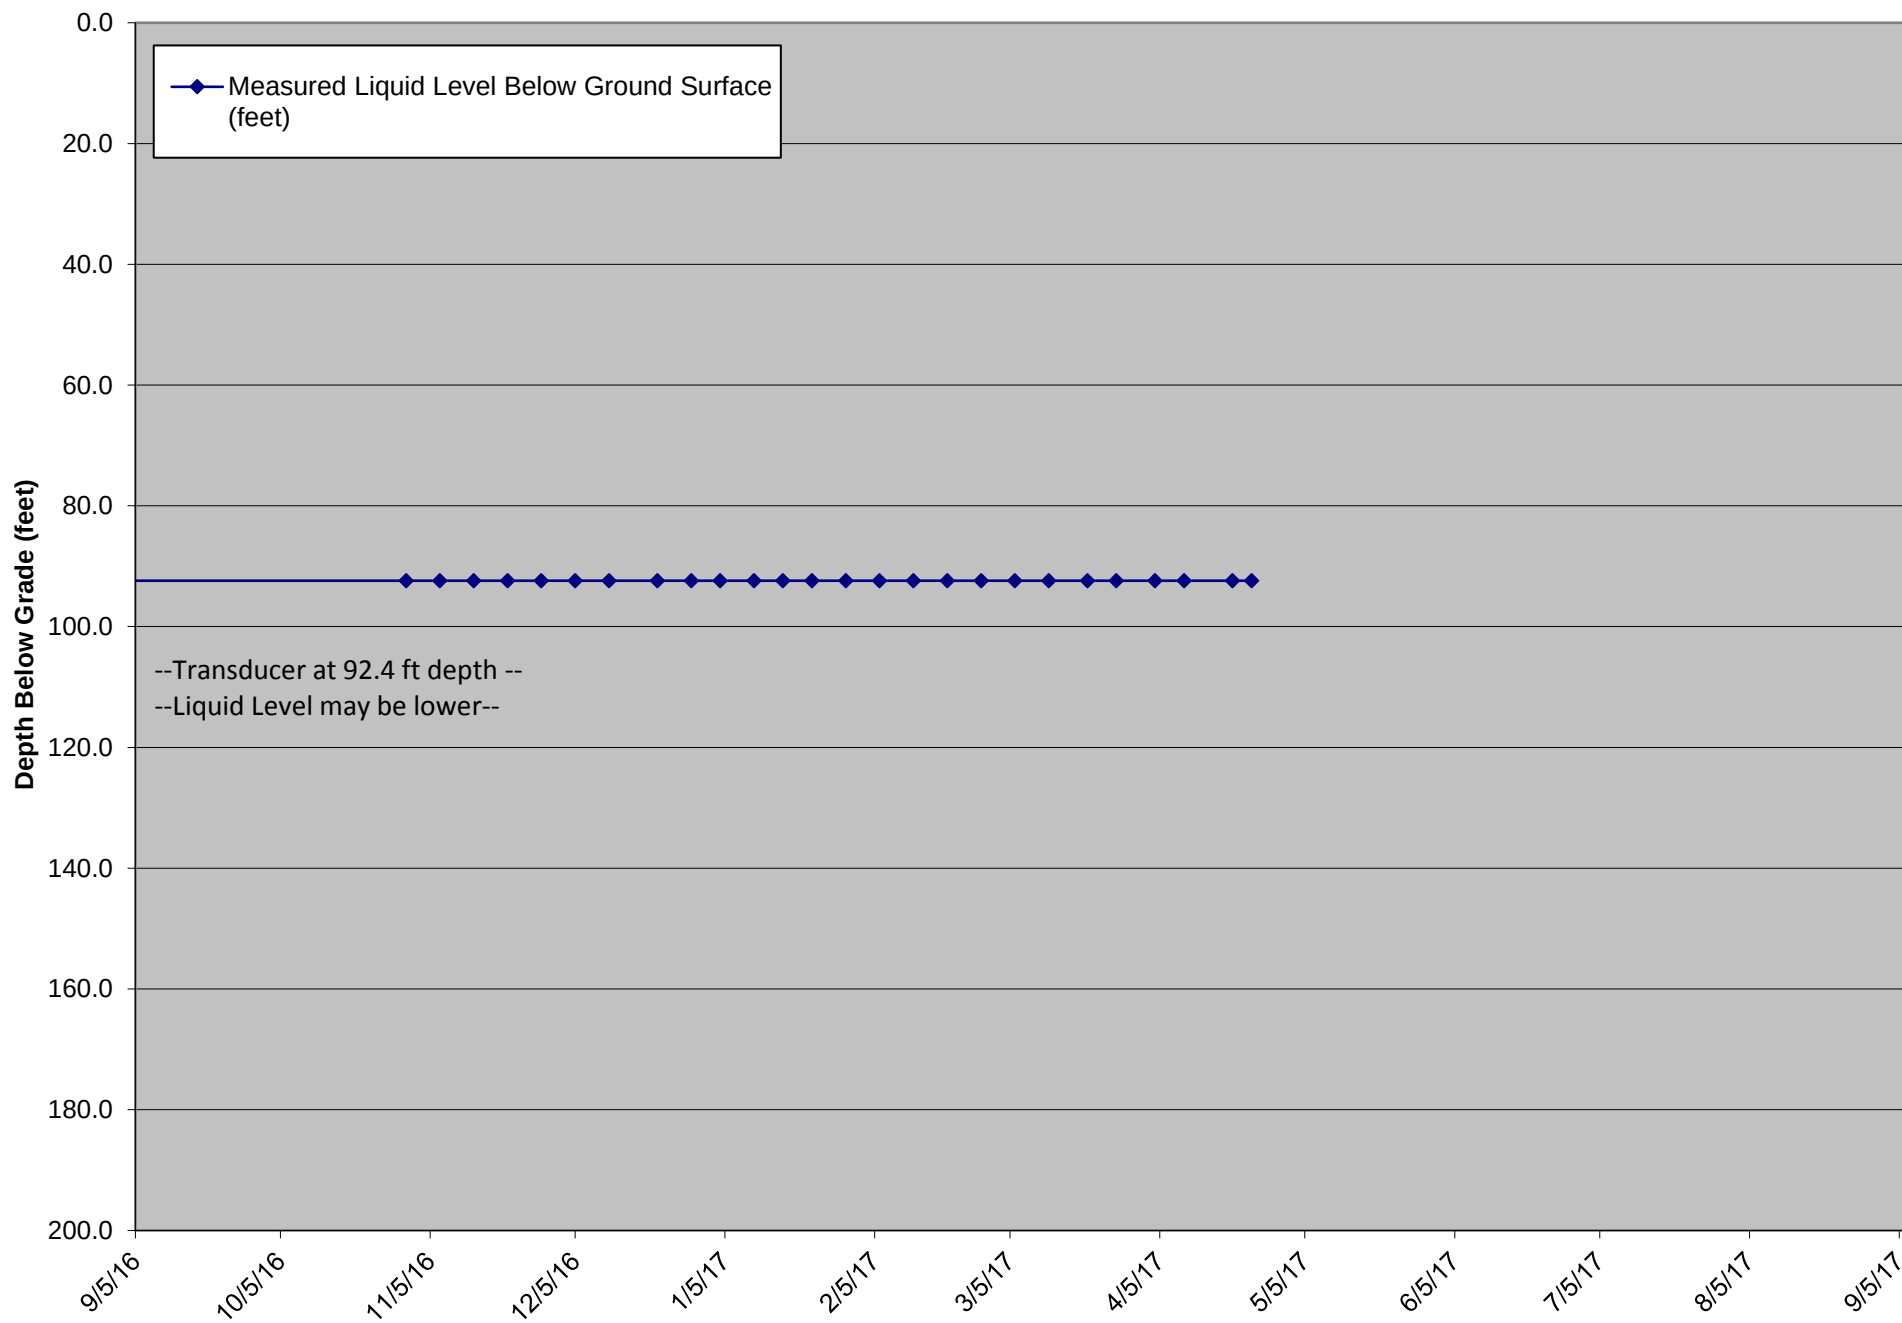
# LCS-1D Liquid Level Below Ground Surface

Bridgeton Landfill is currently troubleshooting the pump in LCS-1D. Level sensor replacement is pending while awaiting parts arrival.

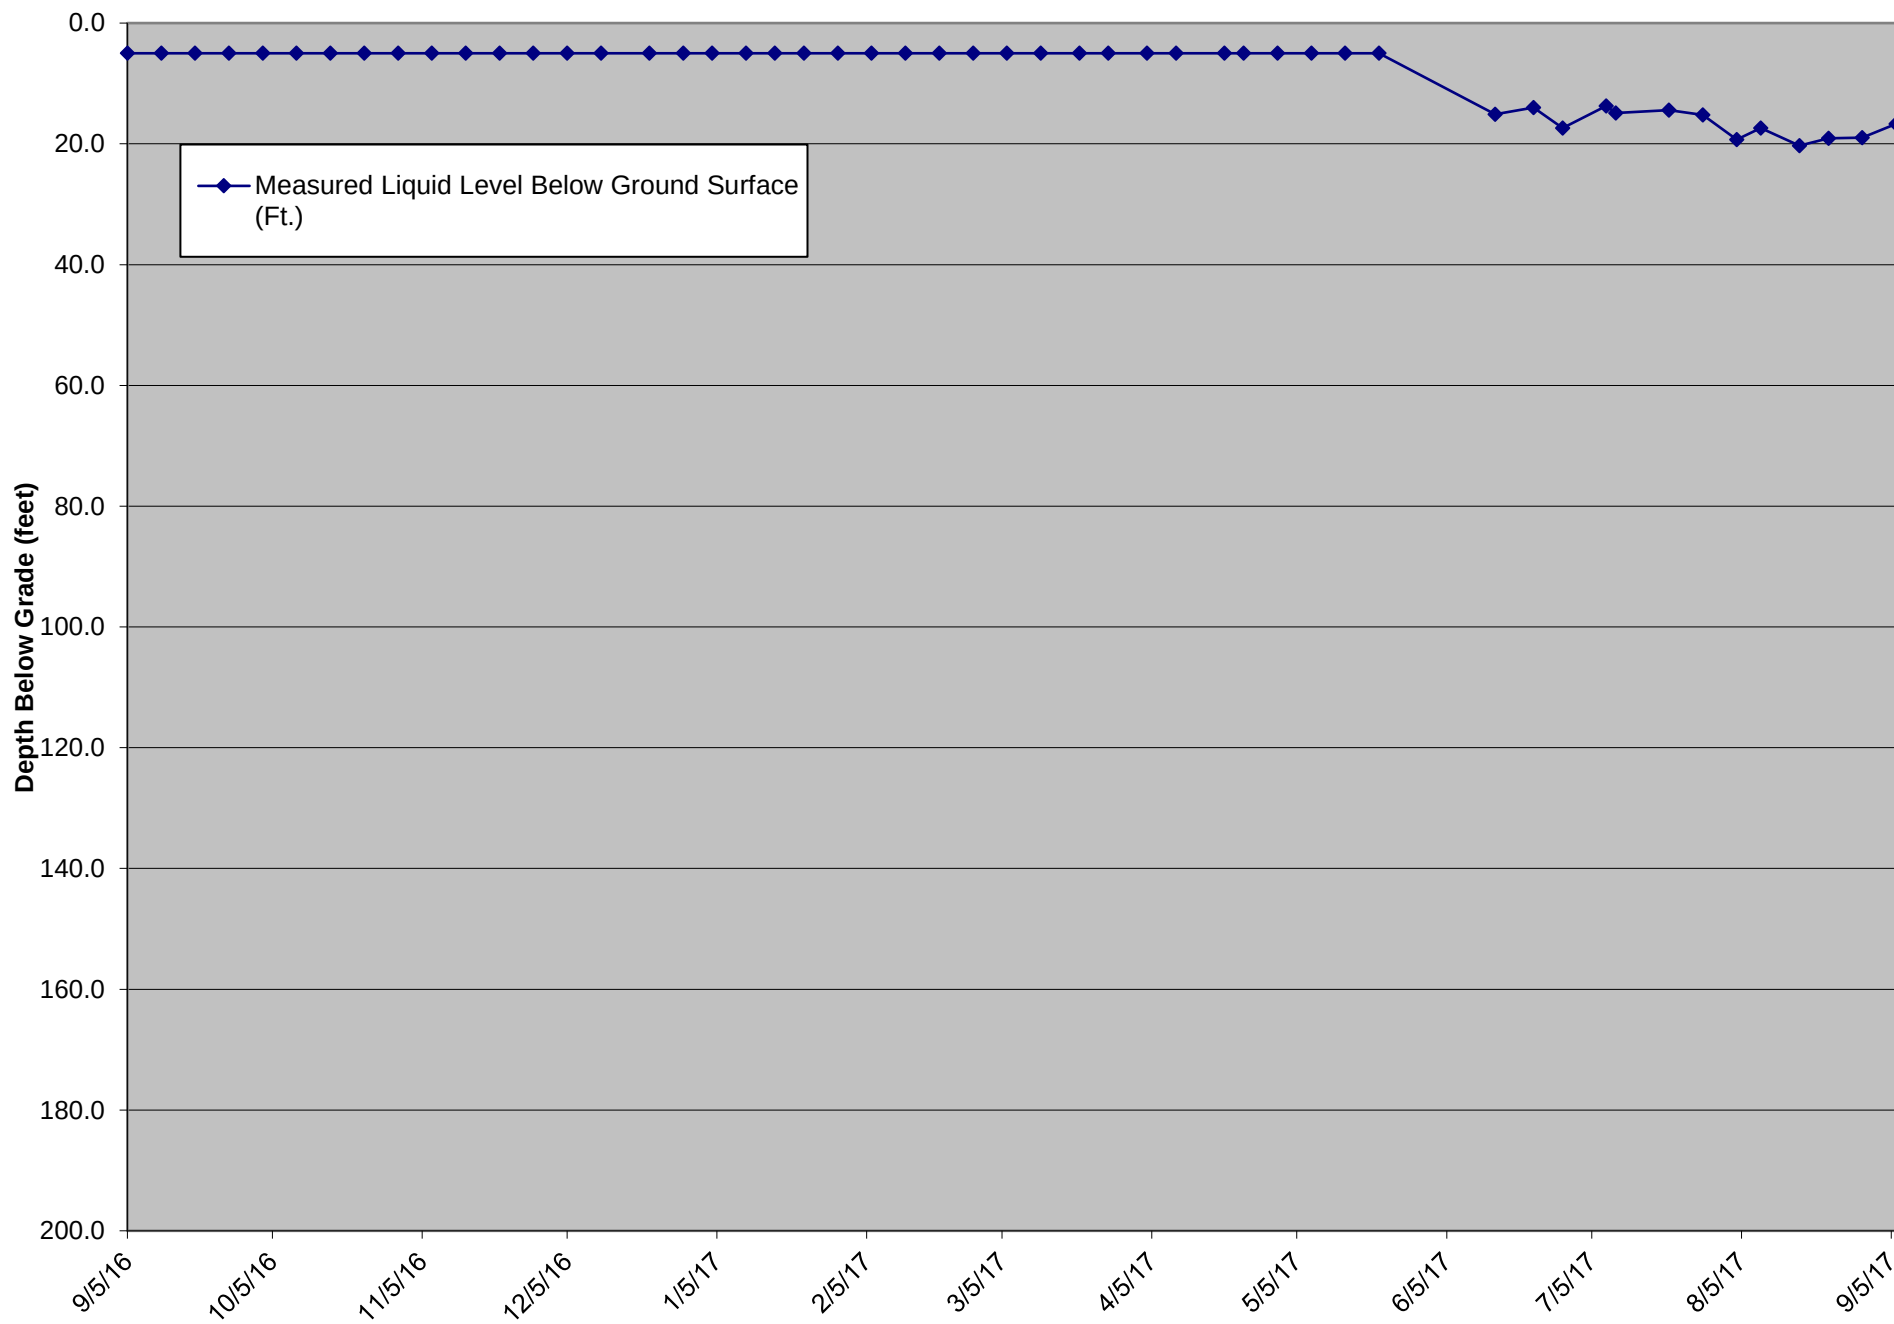
LCS-3D Liquid Level Below Ground Surface

Two Blackhawk pneumatic pumps were installed in LCS-3D on 6/13/2017. Blackhawk pumps do not require a level sensor. Liquid level was measured manually.

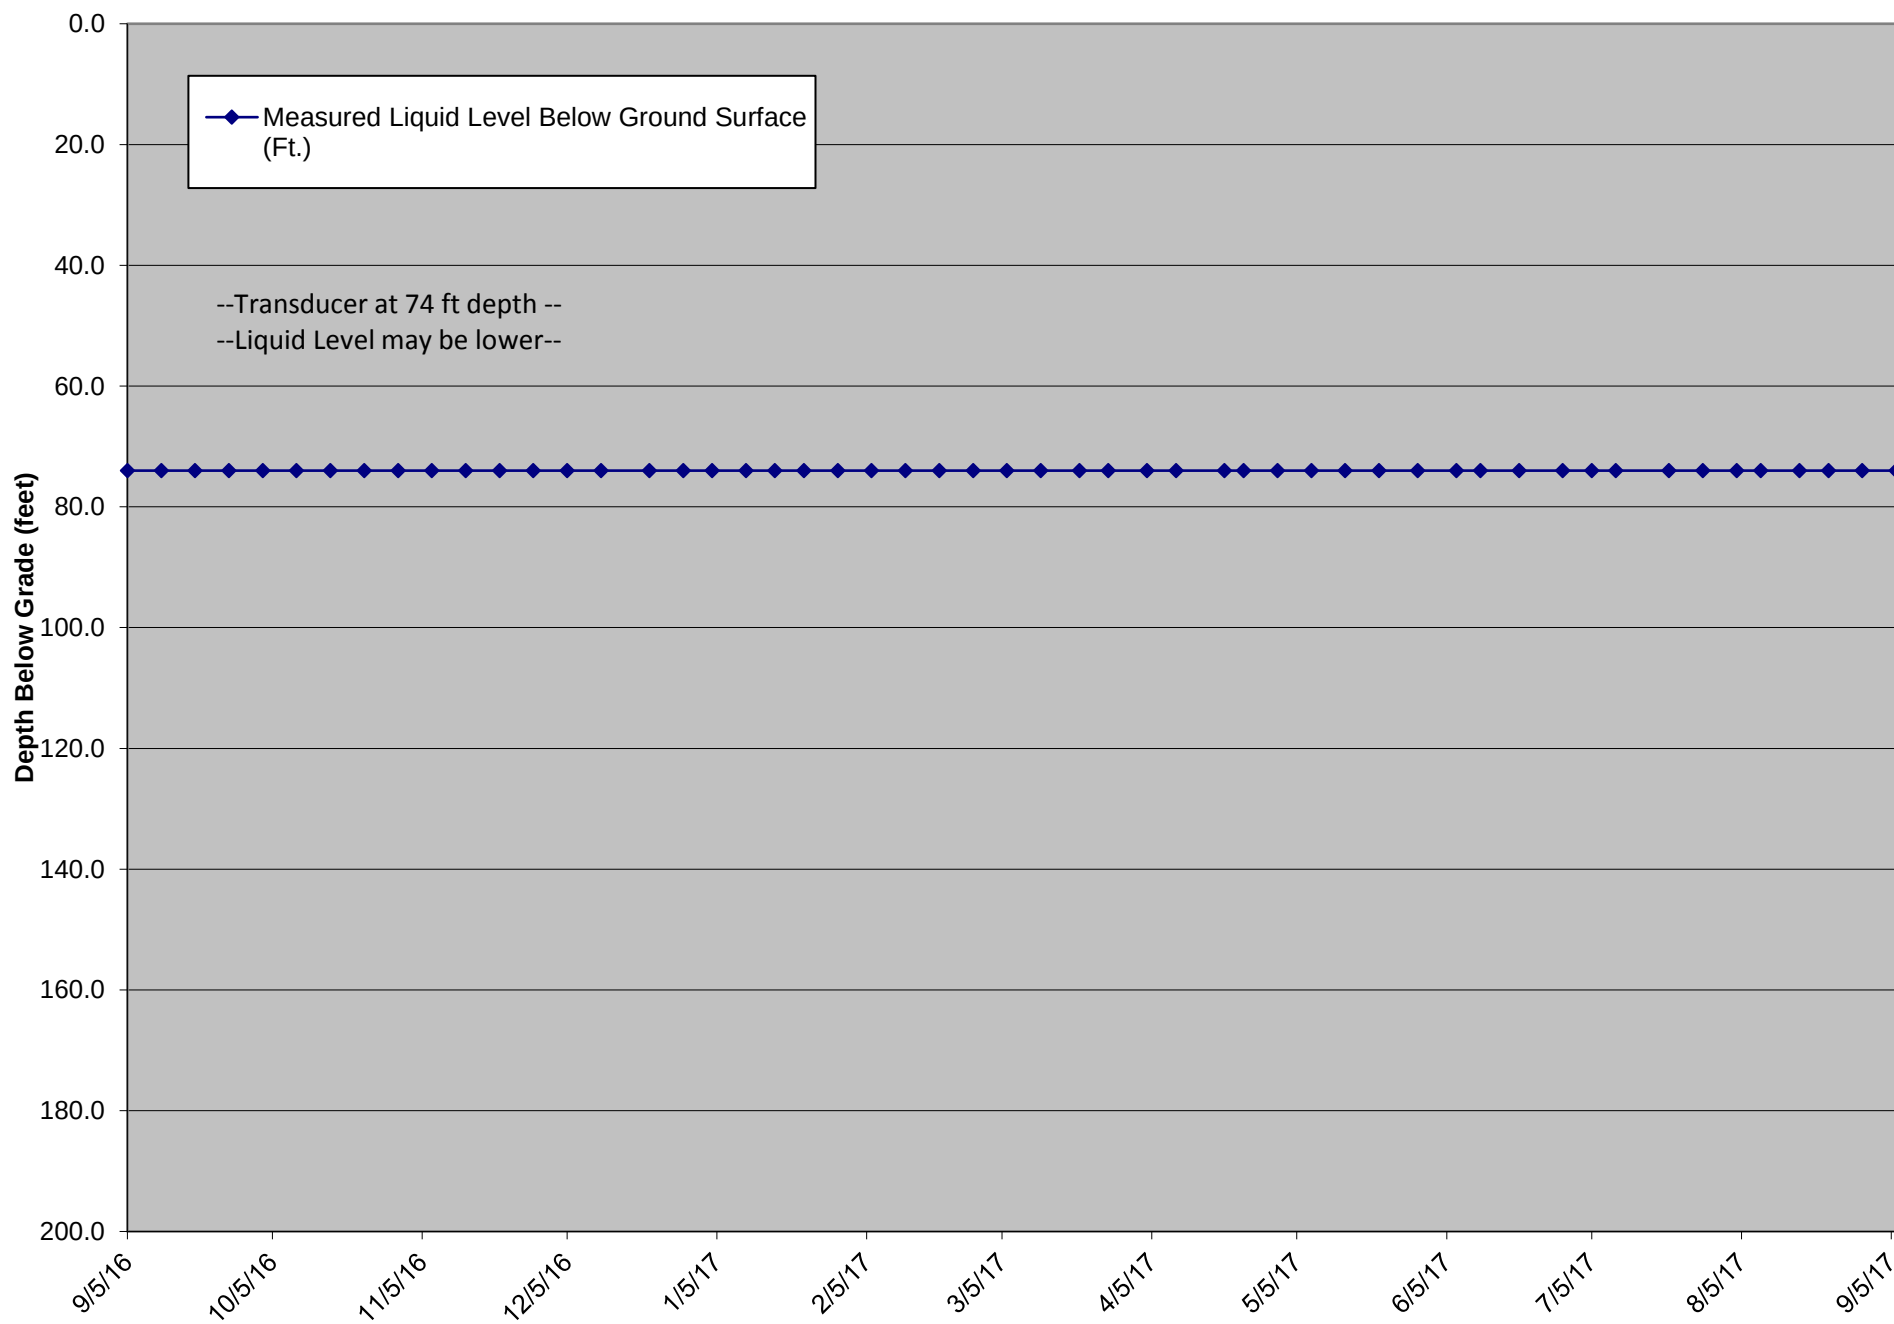
# LCS-4B Liquid Level Below Ground Surface

The level sensor in LCS-4B is currently operational and responsive. Liquid level was not recorded by the level sensor during the weekly reporting period. LCS-4B is equipped with a flow meter that displayed no flow during the weekly reporting period. Therefore, it can be concluded that the liquid level was below the bottom of the pump and level sensor in LCS-4B.

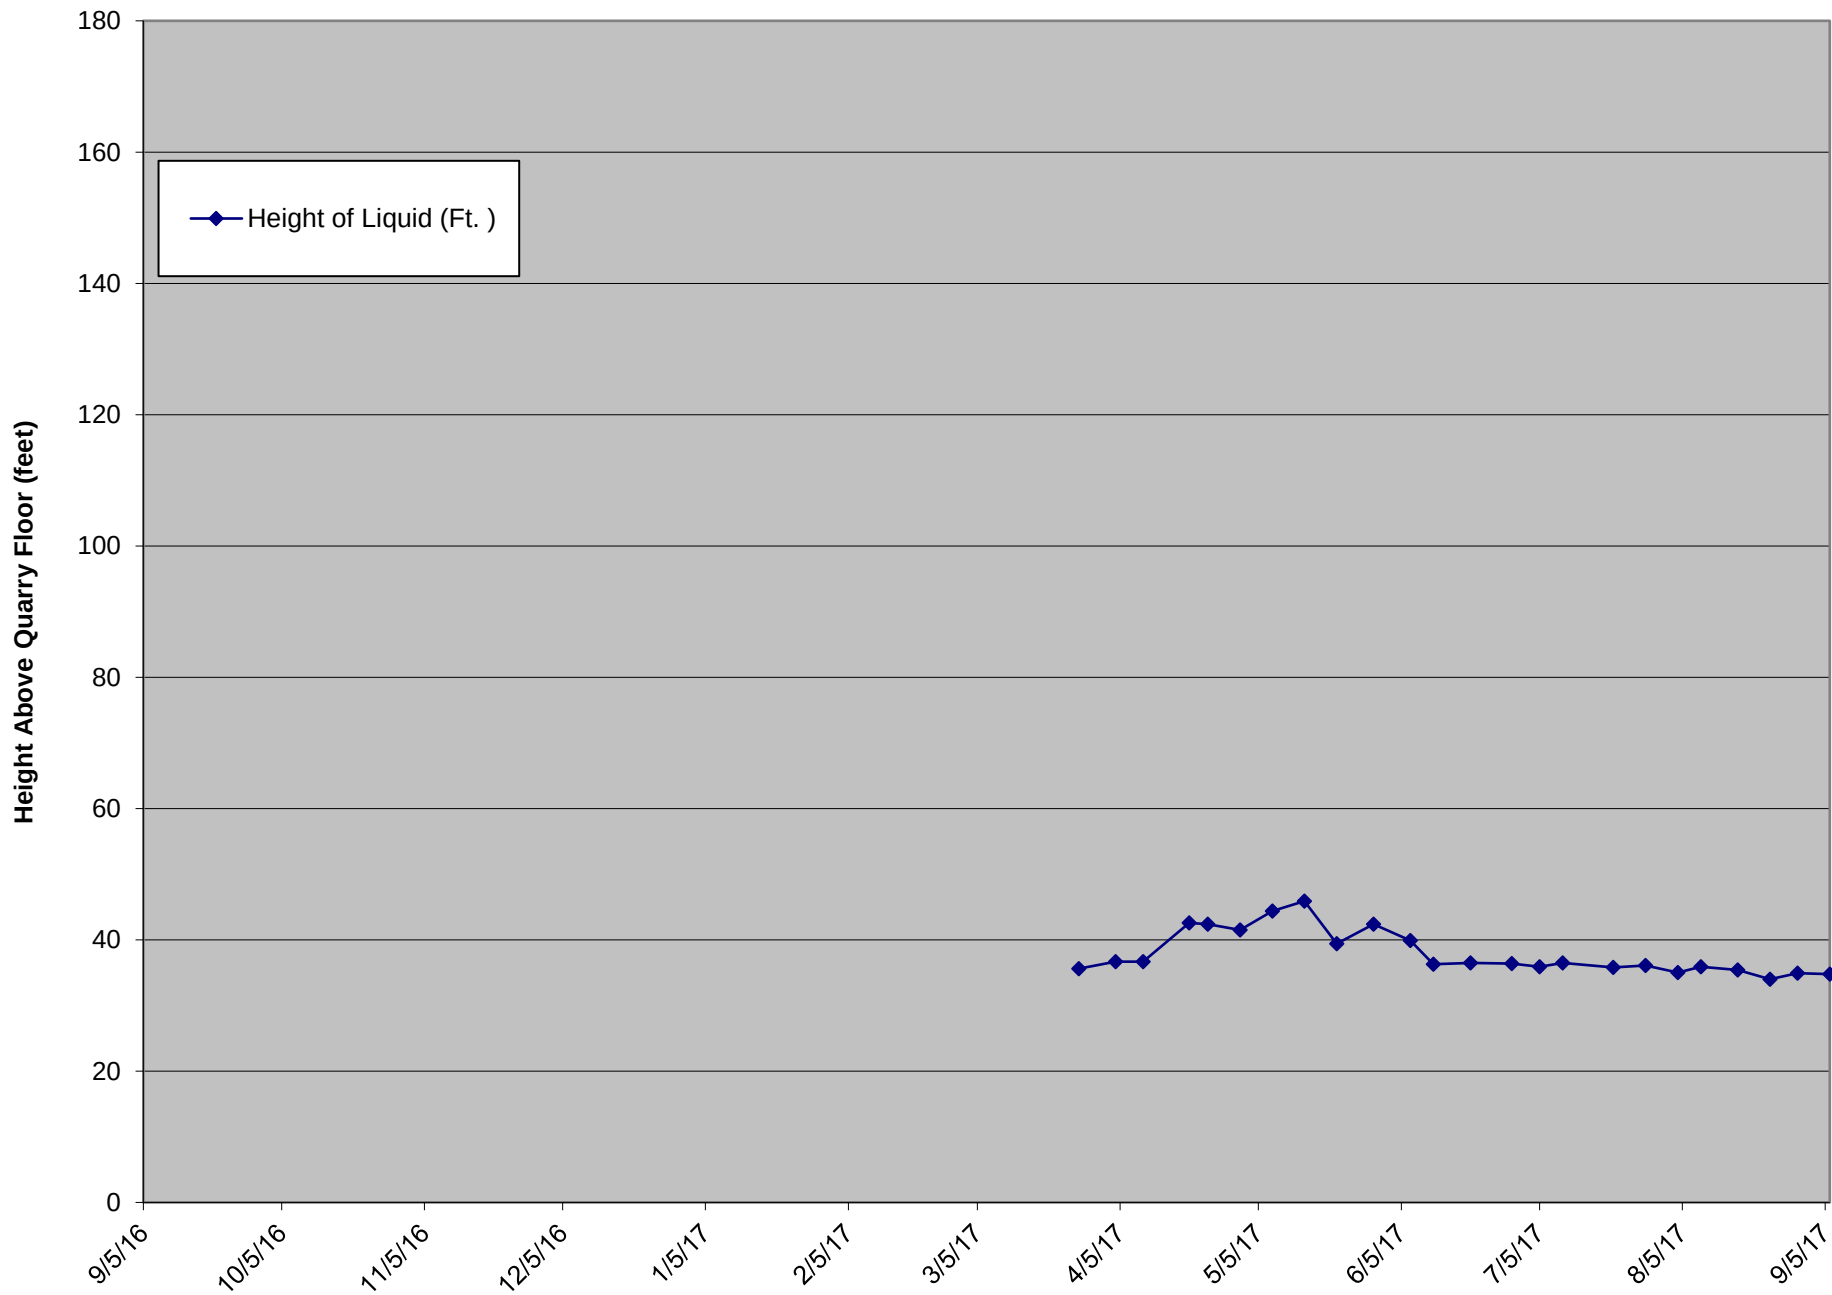
LCS-5B Liquid Level Above Quarry Floor

LCS-5B and LCS-6B were fully operational during the weekly reporting period.

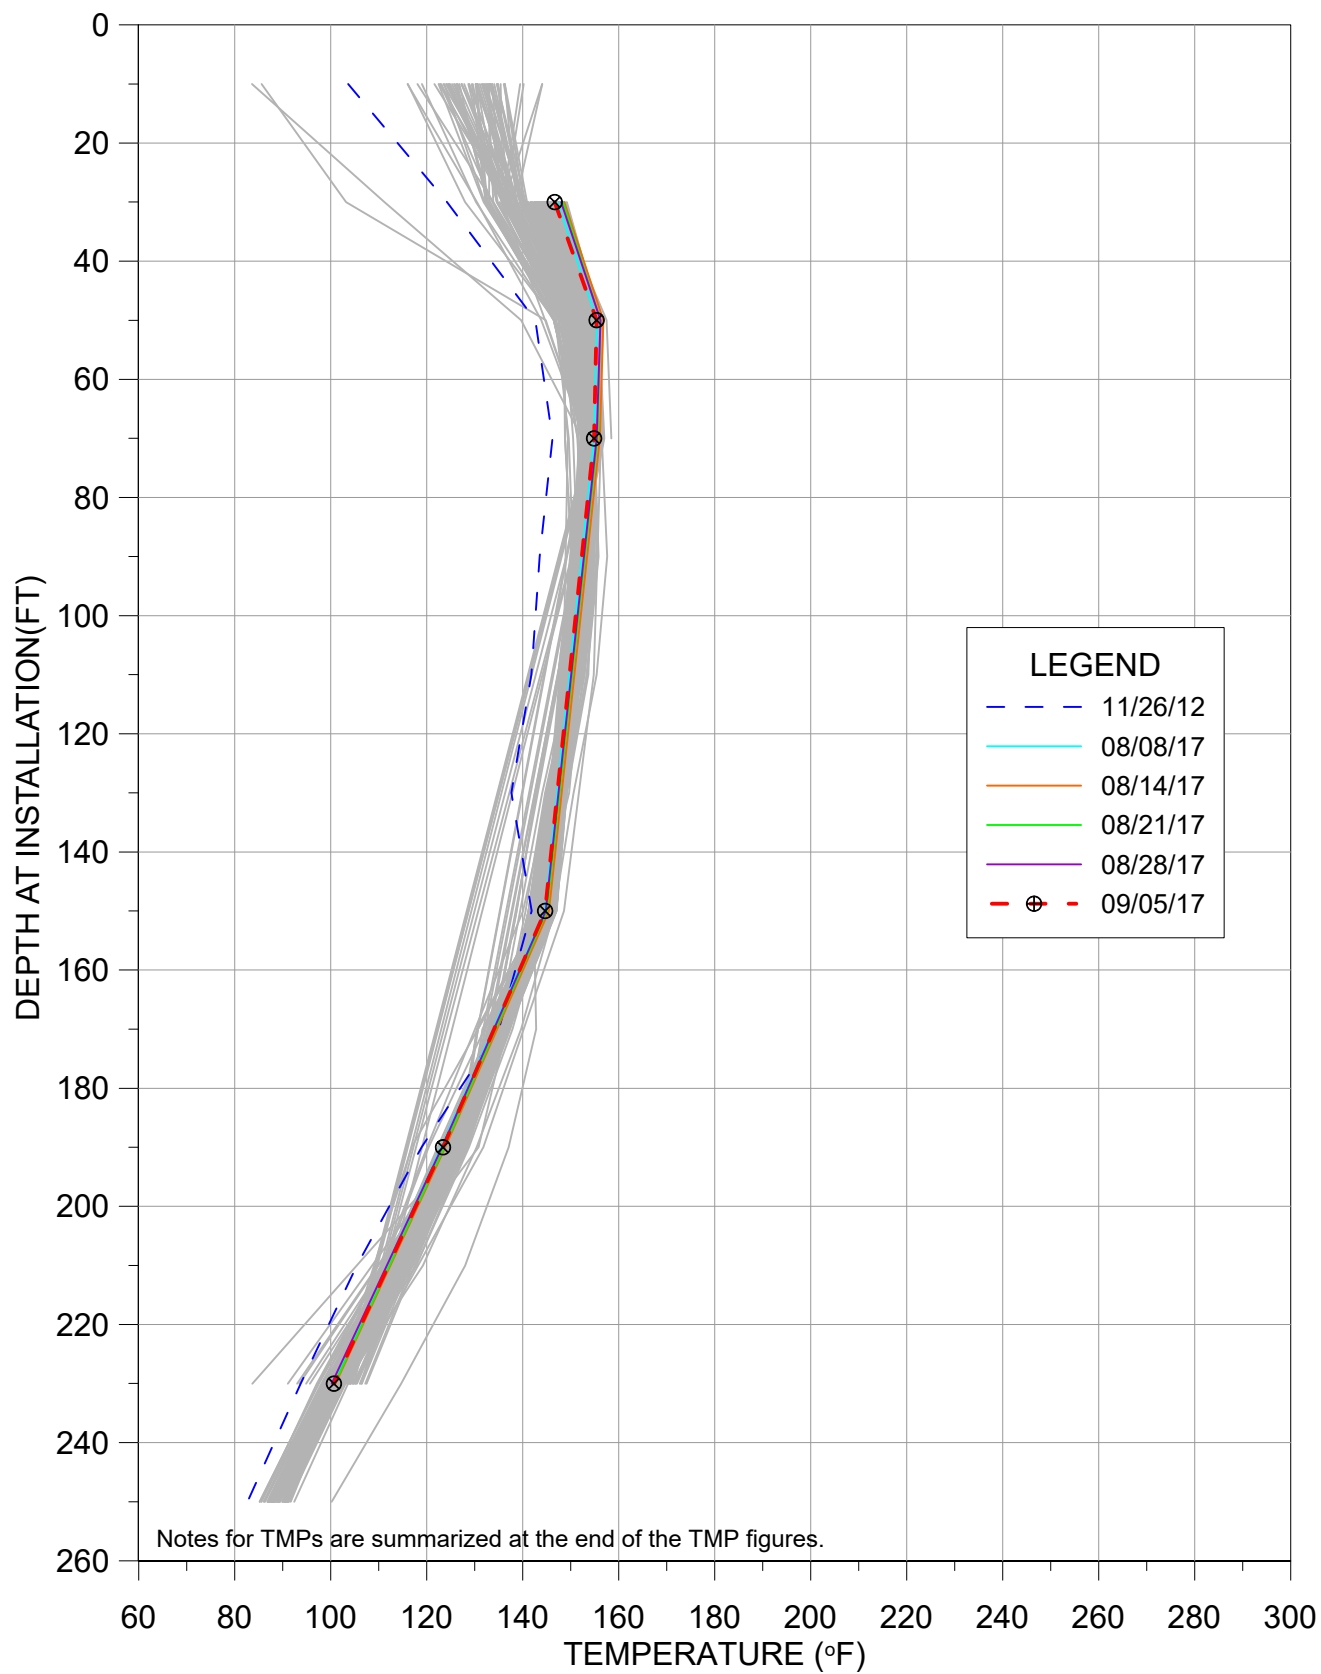
# TMP-3

1. No reliable temperature readings have been obtained at 170 ft depth since 1/29/2014, except on 3/13/2014.
2. The connectivity tests on 4/11/2014 conducted by CEC showed that units at 10, 90, 130, 210 and 250 ft depths are no longer reliable.
3. The connectivity tests on 10/28/2014 conducted by Feezor Engineering showed that units at 10, 90, 110, 130, 210 and 250 ft depths are not reliable.

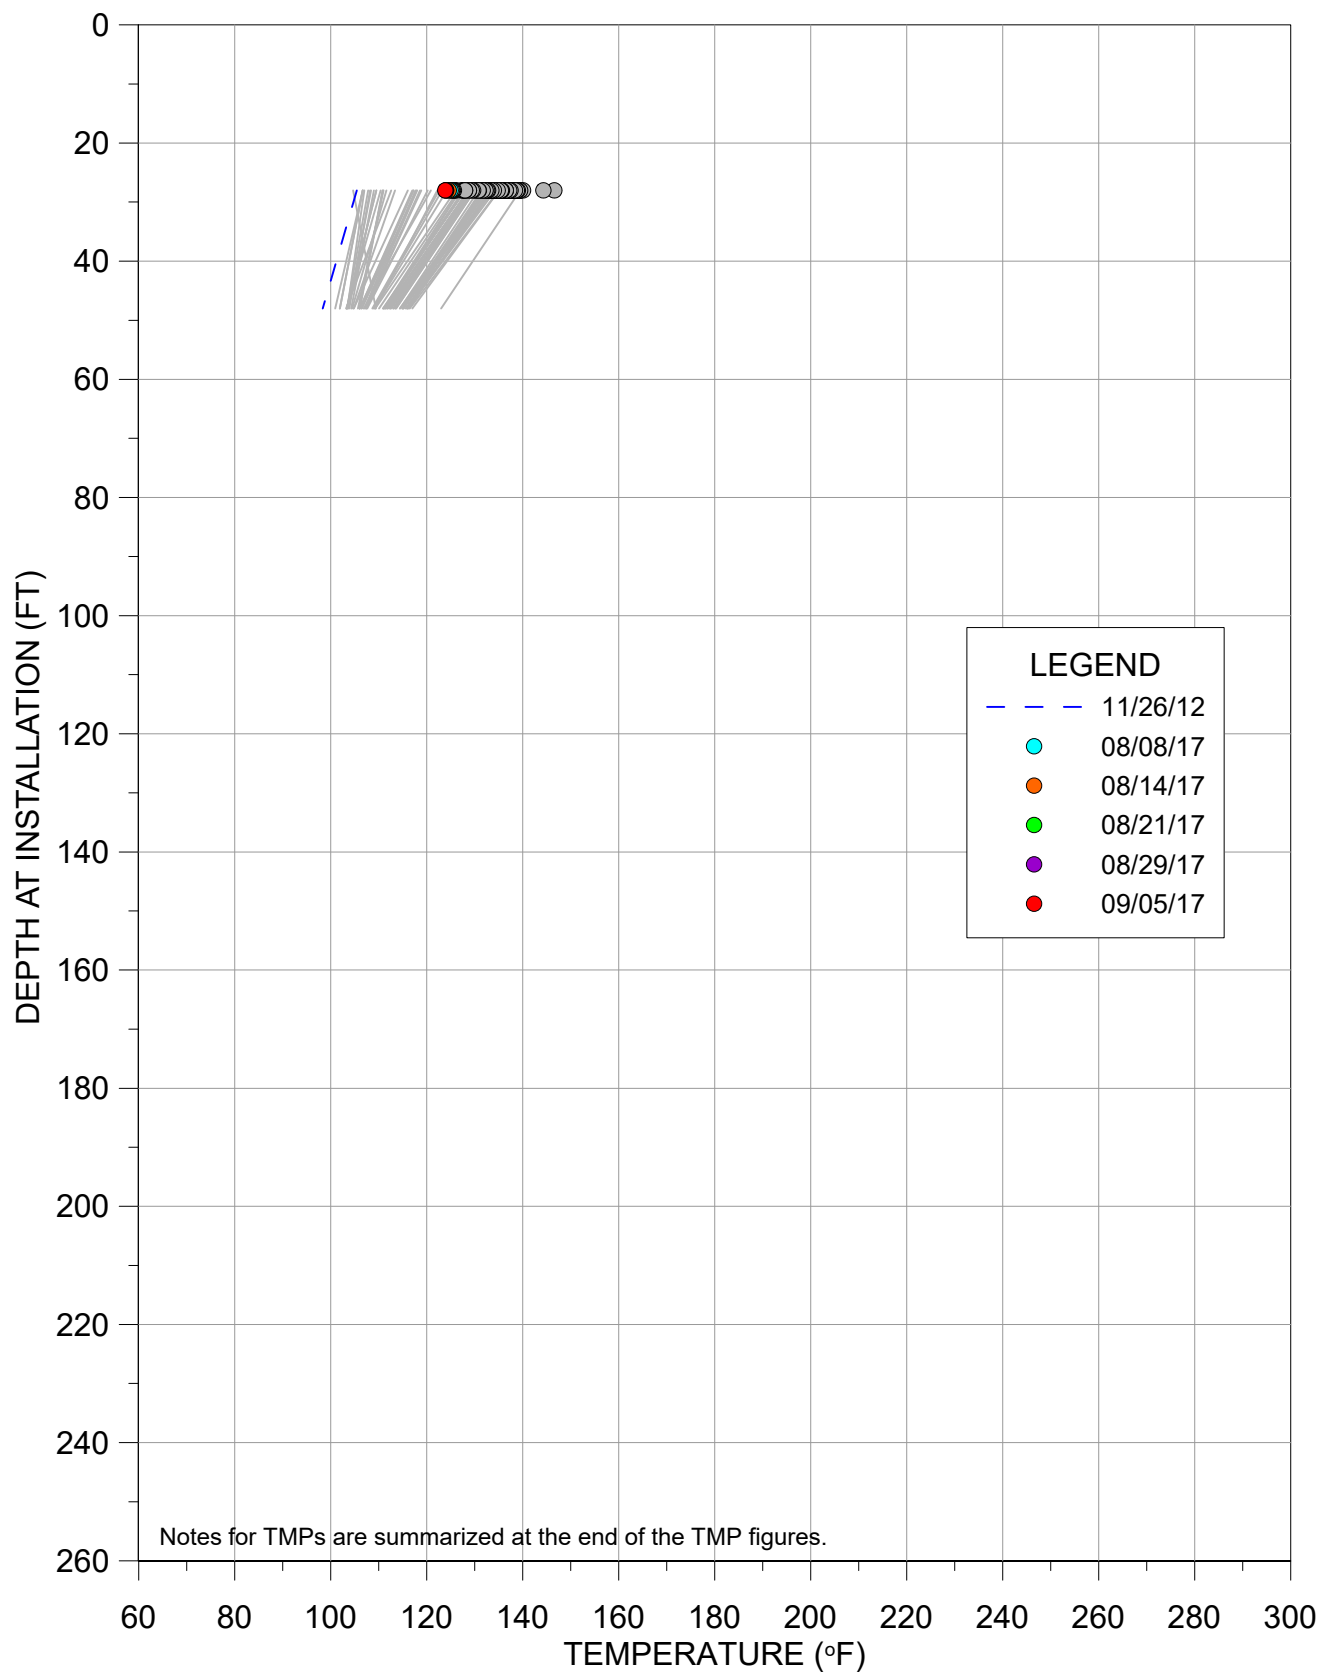
# TMP-4

1. The connectivity tests on 4/11/2014 conducted by CEC showed that the unit at 48 ft depth is no longer reliable.

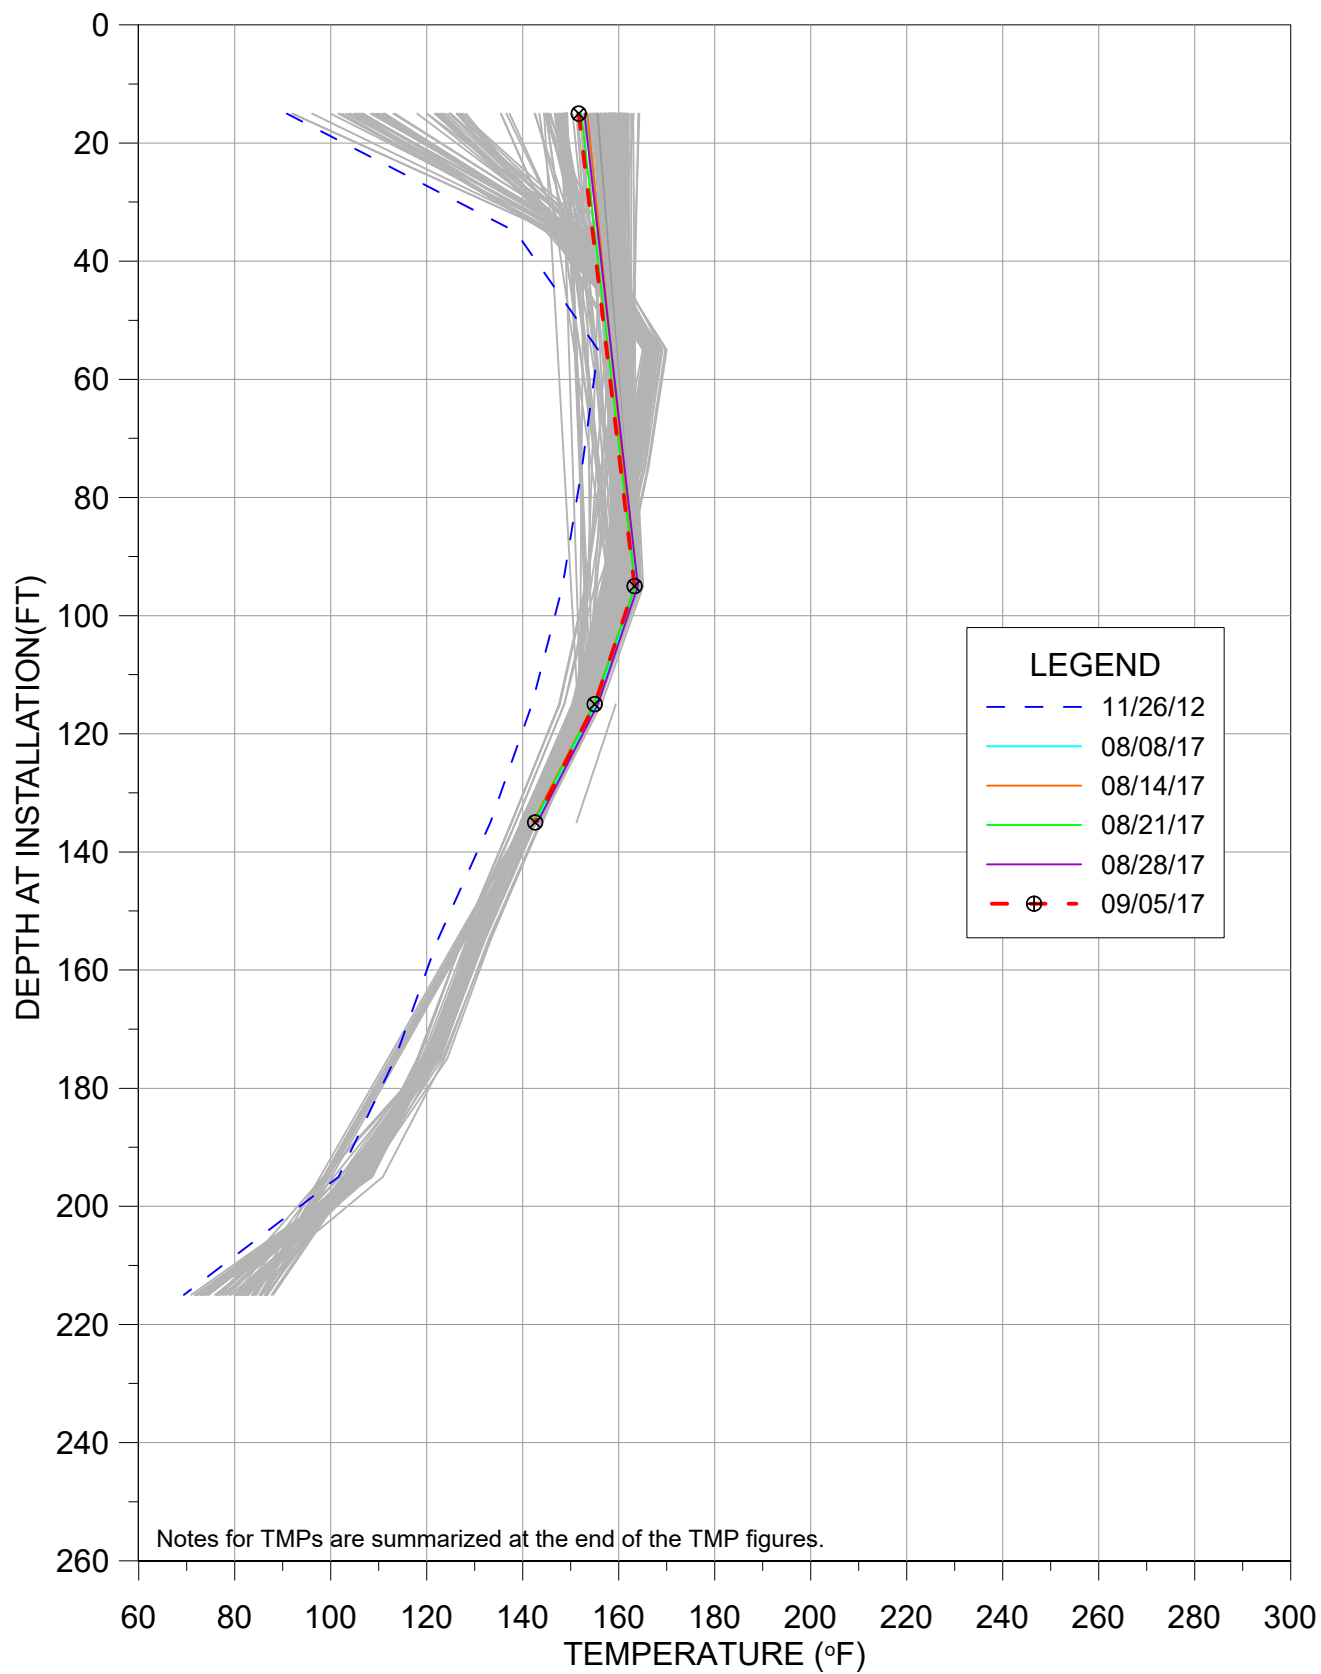
# TMP-6

1. The connectivity tests on 4/11/2014 conducted by CEC showed that units at 35, 55, 75, 155, 175, and 195 ft depths are no longer reliable.
2. No reliable temperature readings have been obtained at the unit at 215 ft depth since 6/13/2014.

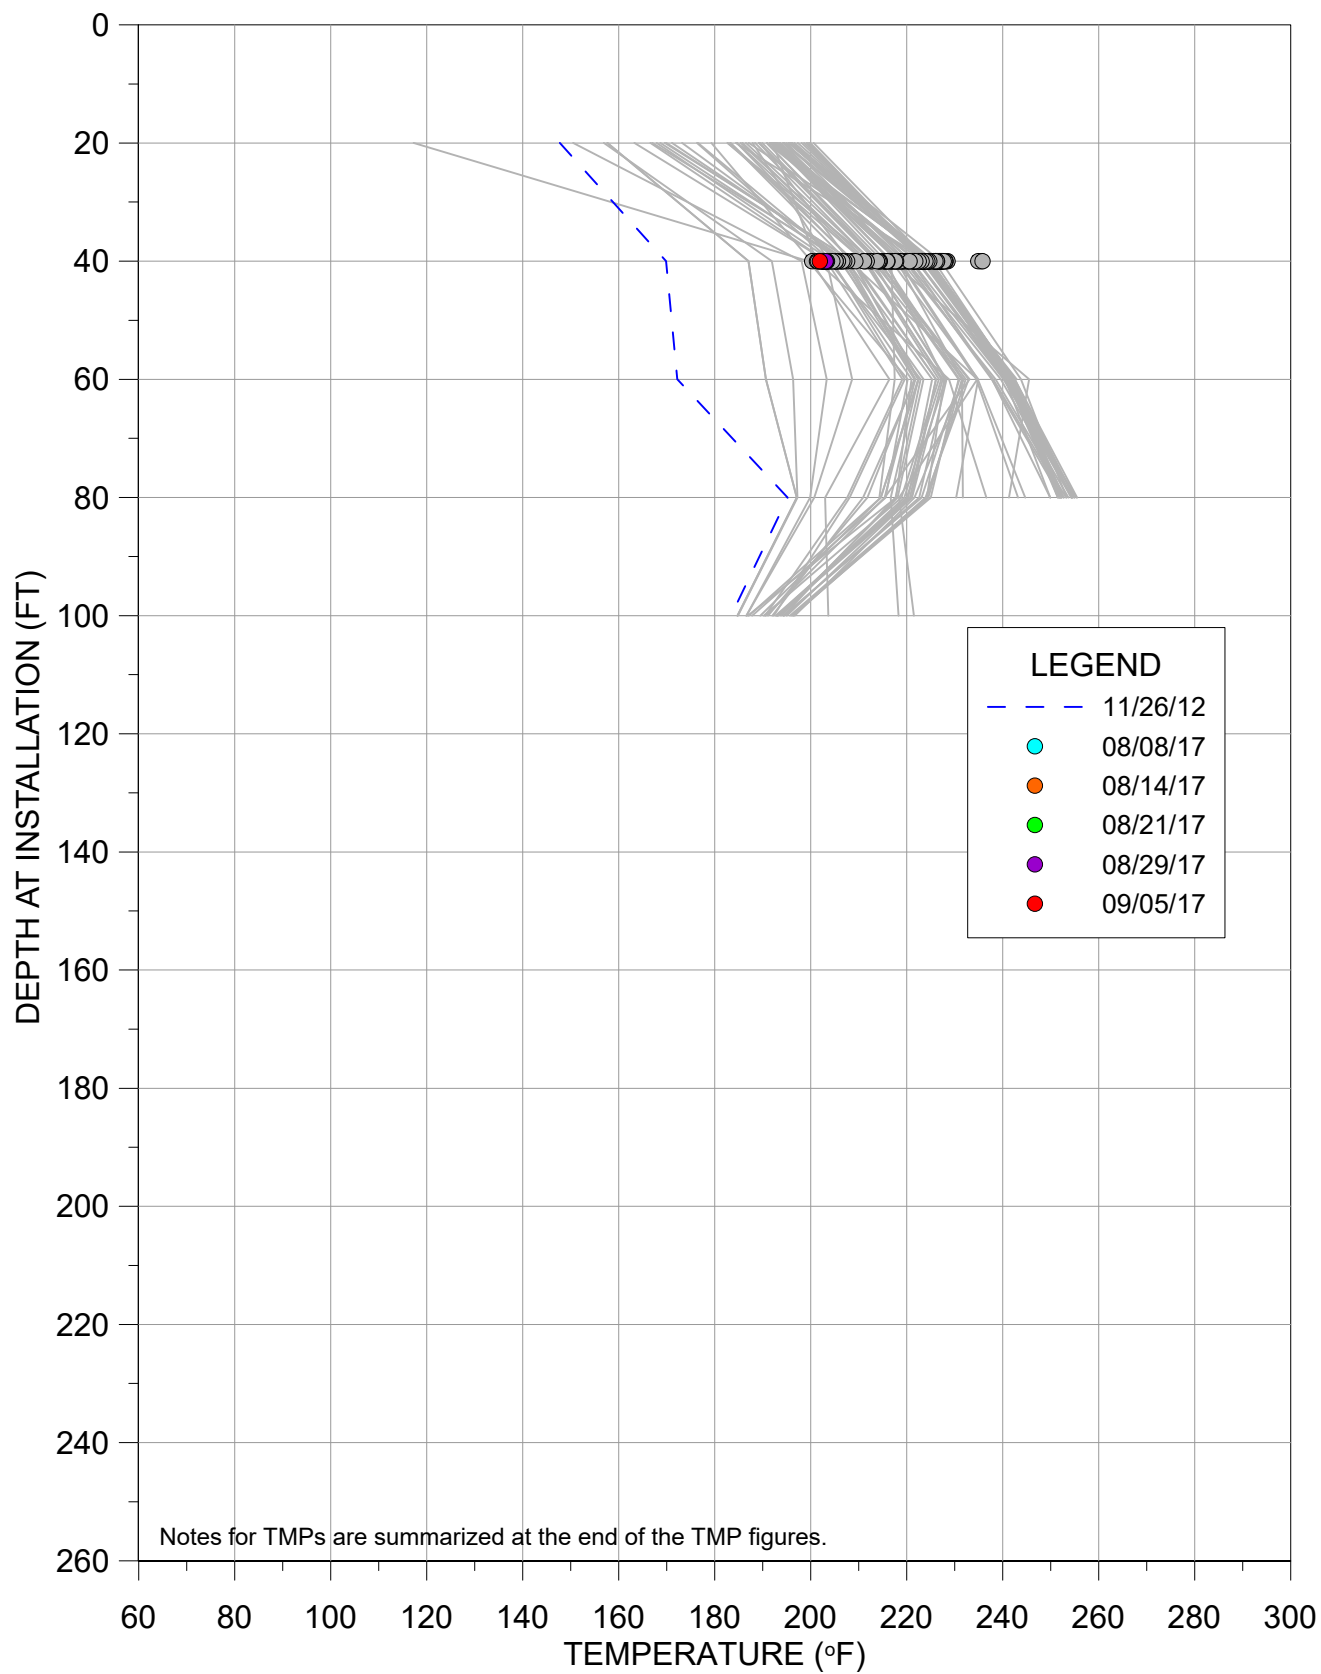
# TMP-9

1. Unit at 100 ft depth had an inaccurate temperature reading on 8/1/2013 and no reading since 8/6/2013.
2. The connectivity tests on 4/11/2014 conducted by CEC showed that units at 20, 60, 80, and 100 ft depths are no longer reliable.

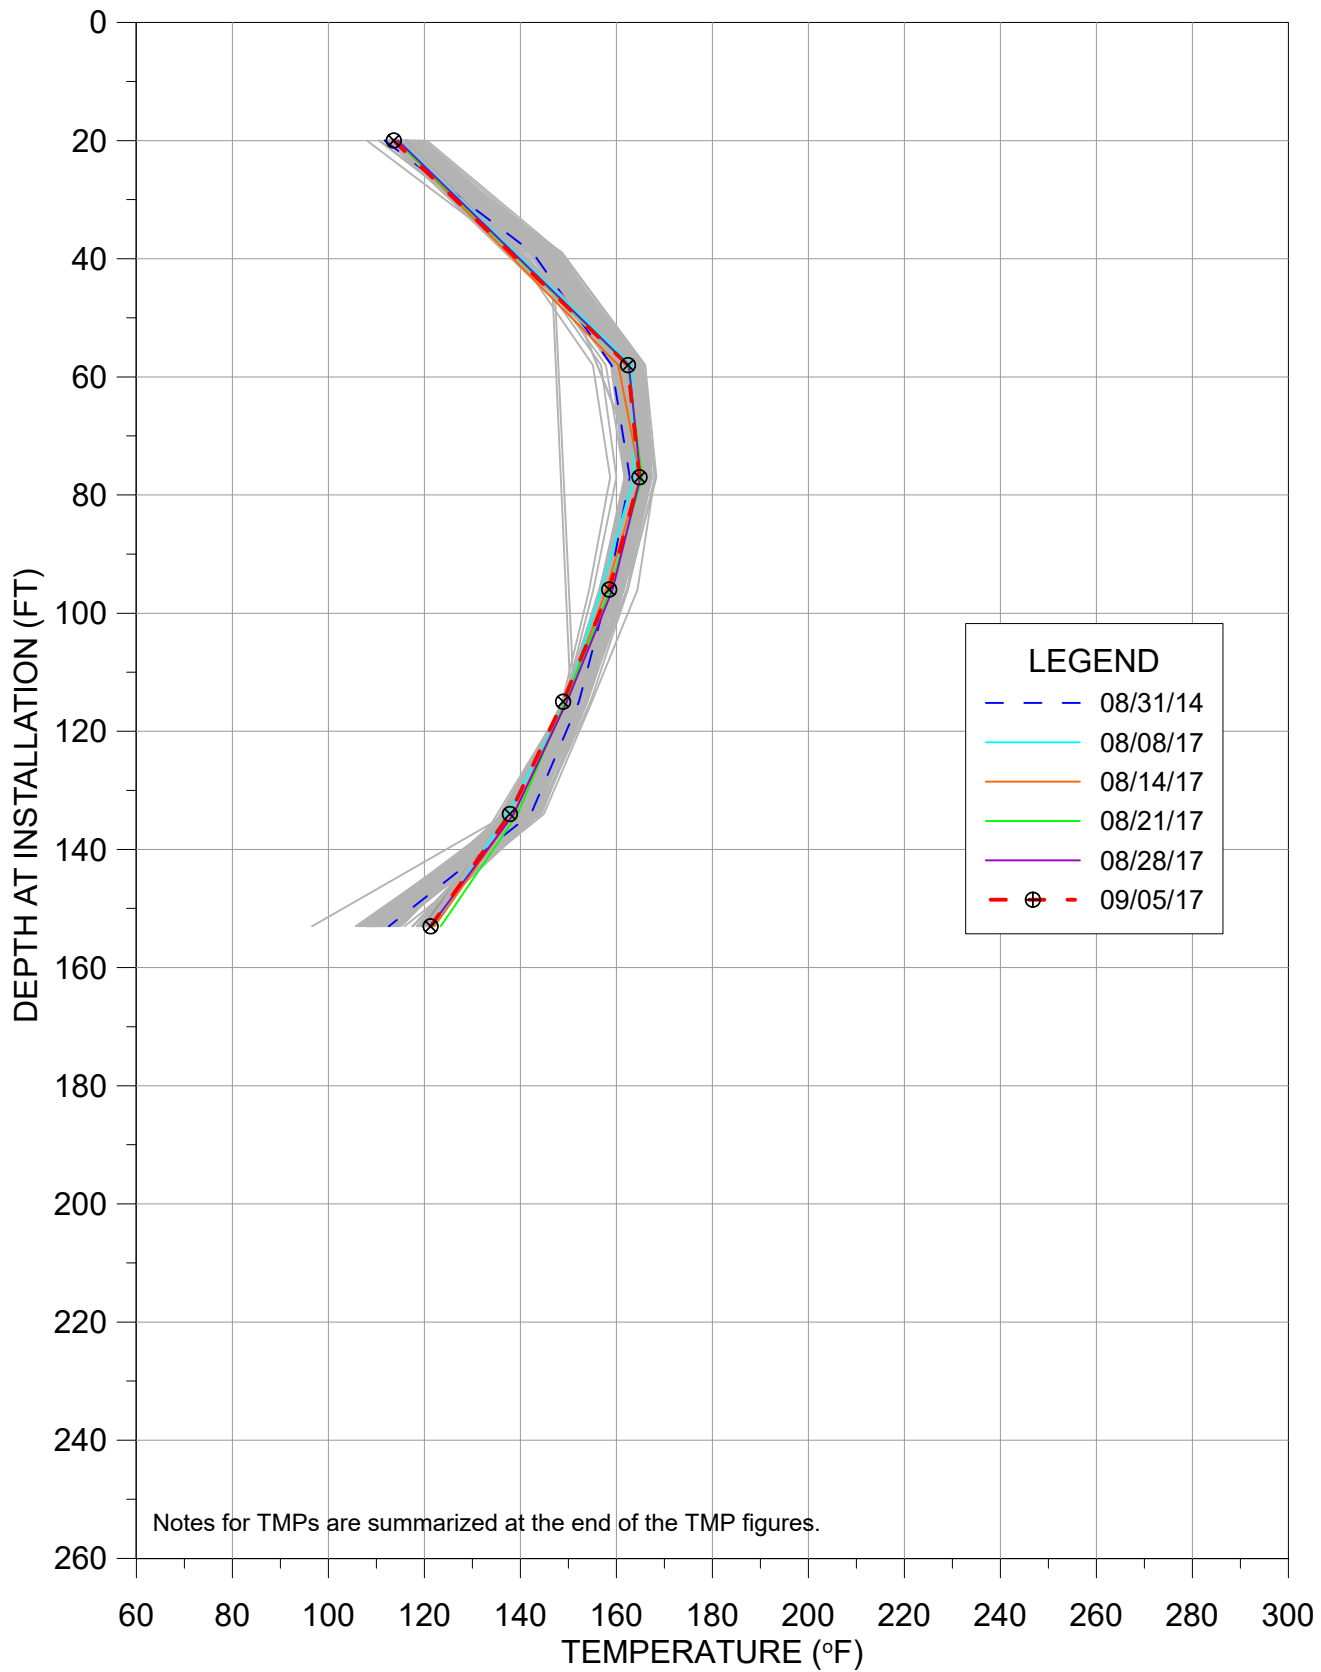
# TMP-16

1. A connectivity test conducted by Feezor Engineering showed that the units on TMP-16 may not be reliable since 9/9/2015. Further testing at the end of September 2015 showed possible connectivity on some of the units.
2. The unit at 153 ft depth had a low resistance reading and unreliable temperature since 12/21/2015.

3. The unit at 39 ft depth had a higher than acceptable resistance reading and unreliable temperature since 2/7/2017.
