# **Bridgeton Landfill, LLC**

## **Weekly Data Submittal**

**Week of September 3, 2017 – September 9, 2017**

**Required by Section 52.F of Agreed Order, Case No. 13SL-CC01088  
Effective May 13, 2013**

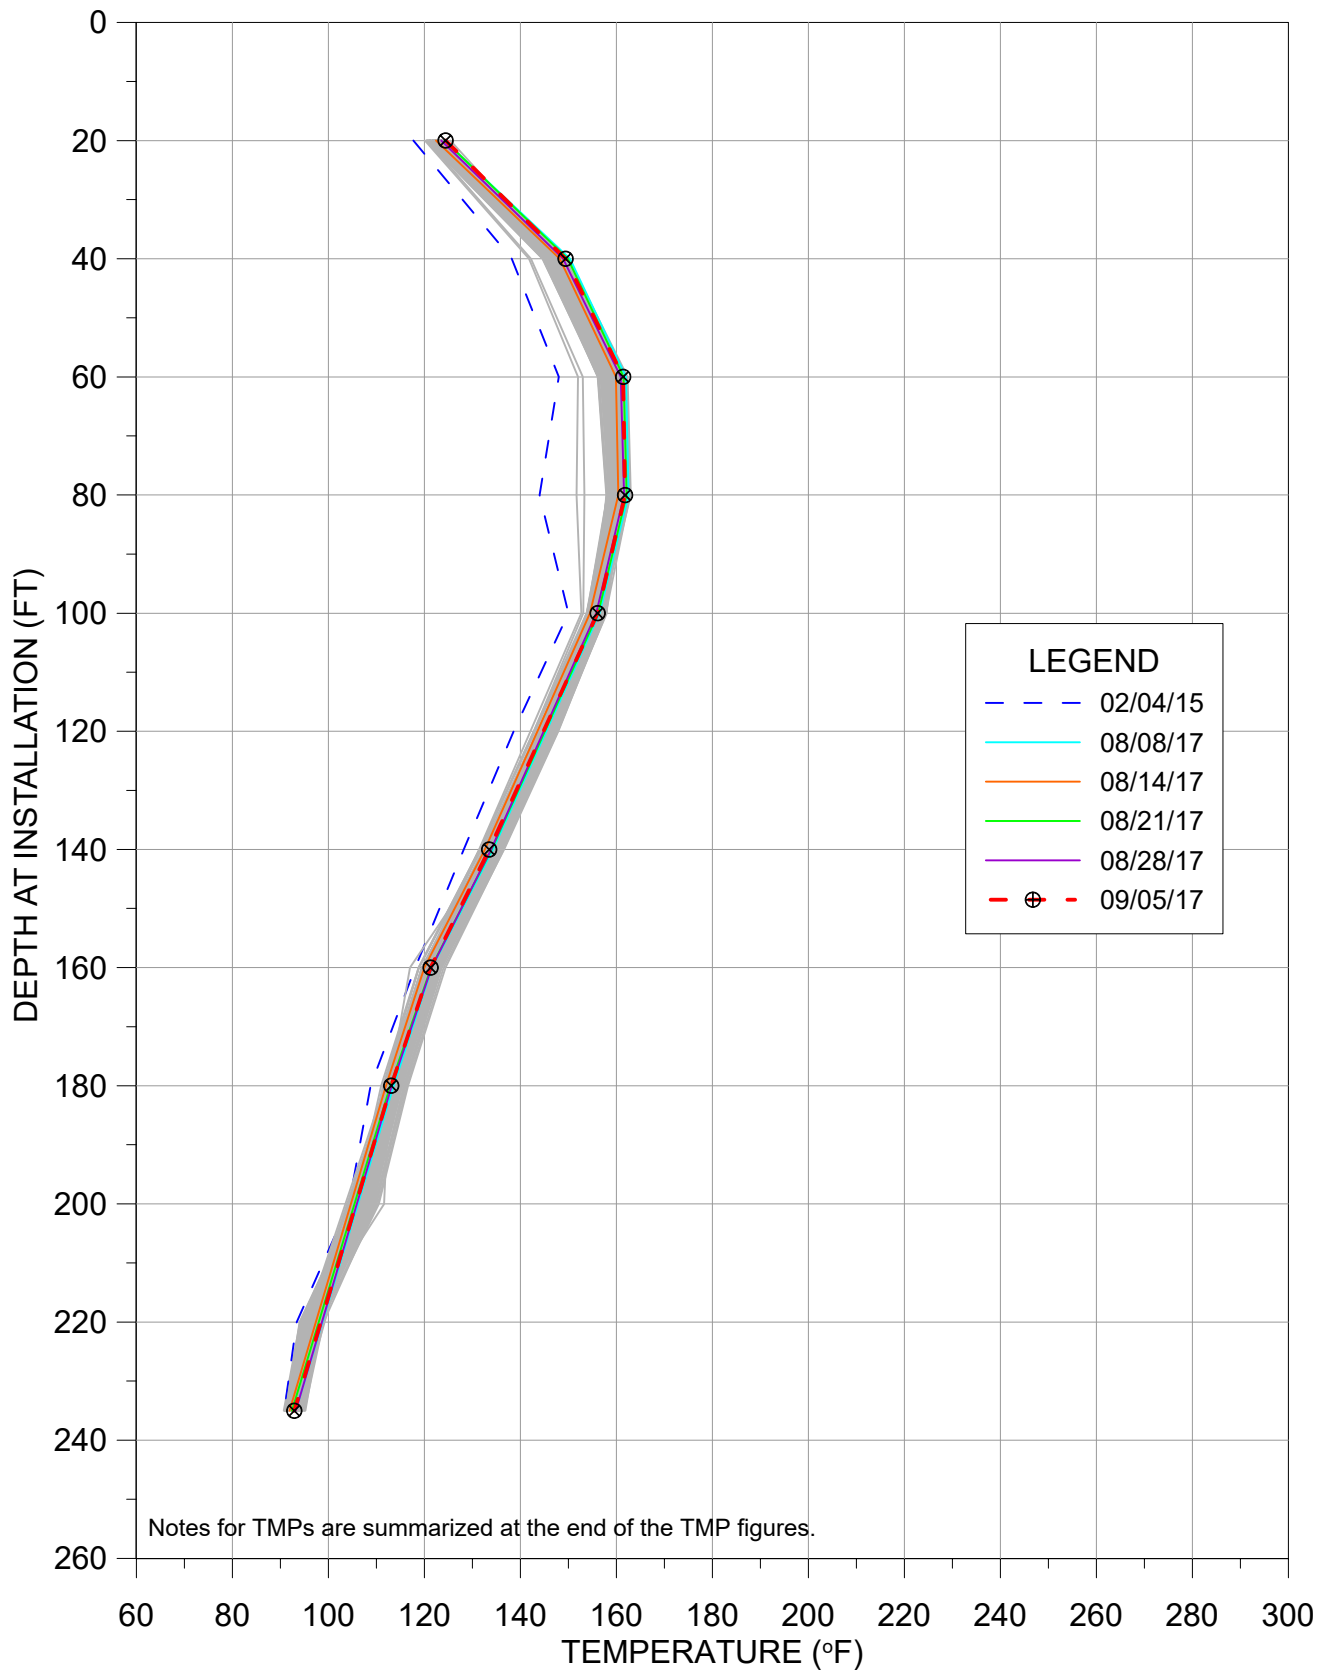
# TMP-25

1. The unit at 200 ft provided an apparent anomalous reading on 3/28/2017. Subsequent readings on 4/4/2017 showed the unit to have failed (see below). The unit is no longer working and the reading of 3/28/2017 was likely unreliable.

2. The unit at 200 ft depth had a resistance reading greater 4000 ohms on 4/4/2017. A connectivity test conducted by Feezor Engineering on 4/7/2017 showed that this unit also had cross-connectivity. The unit is therefore determined to be no longer working as of the 4/4/2017 reading.

3. The unit at 120 feet had a higher than acceptable limit on 7/10/2017. Also, a connectivity test conducted by Feezor Engineering on 4/7/2017 showed that this unit may be unreliable. Therefore, this unit is determined to be unreliable.

4. The unit at 220 ft has been reported as unable to attain a reading of any kind since June 19, 2017. The unit is considered to be no longer working as of that date.

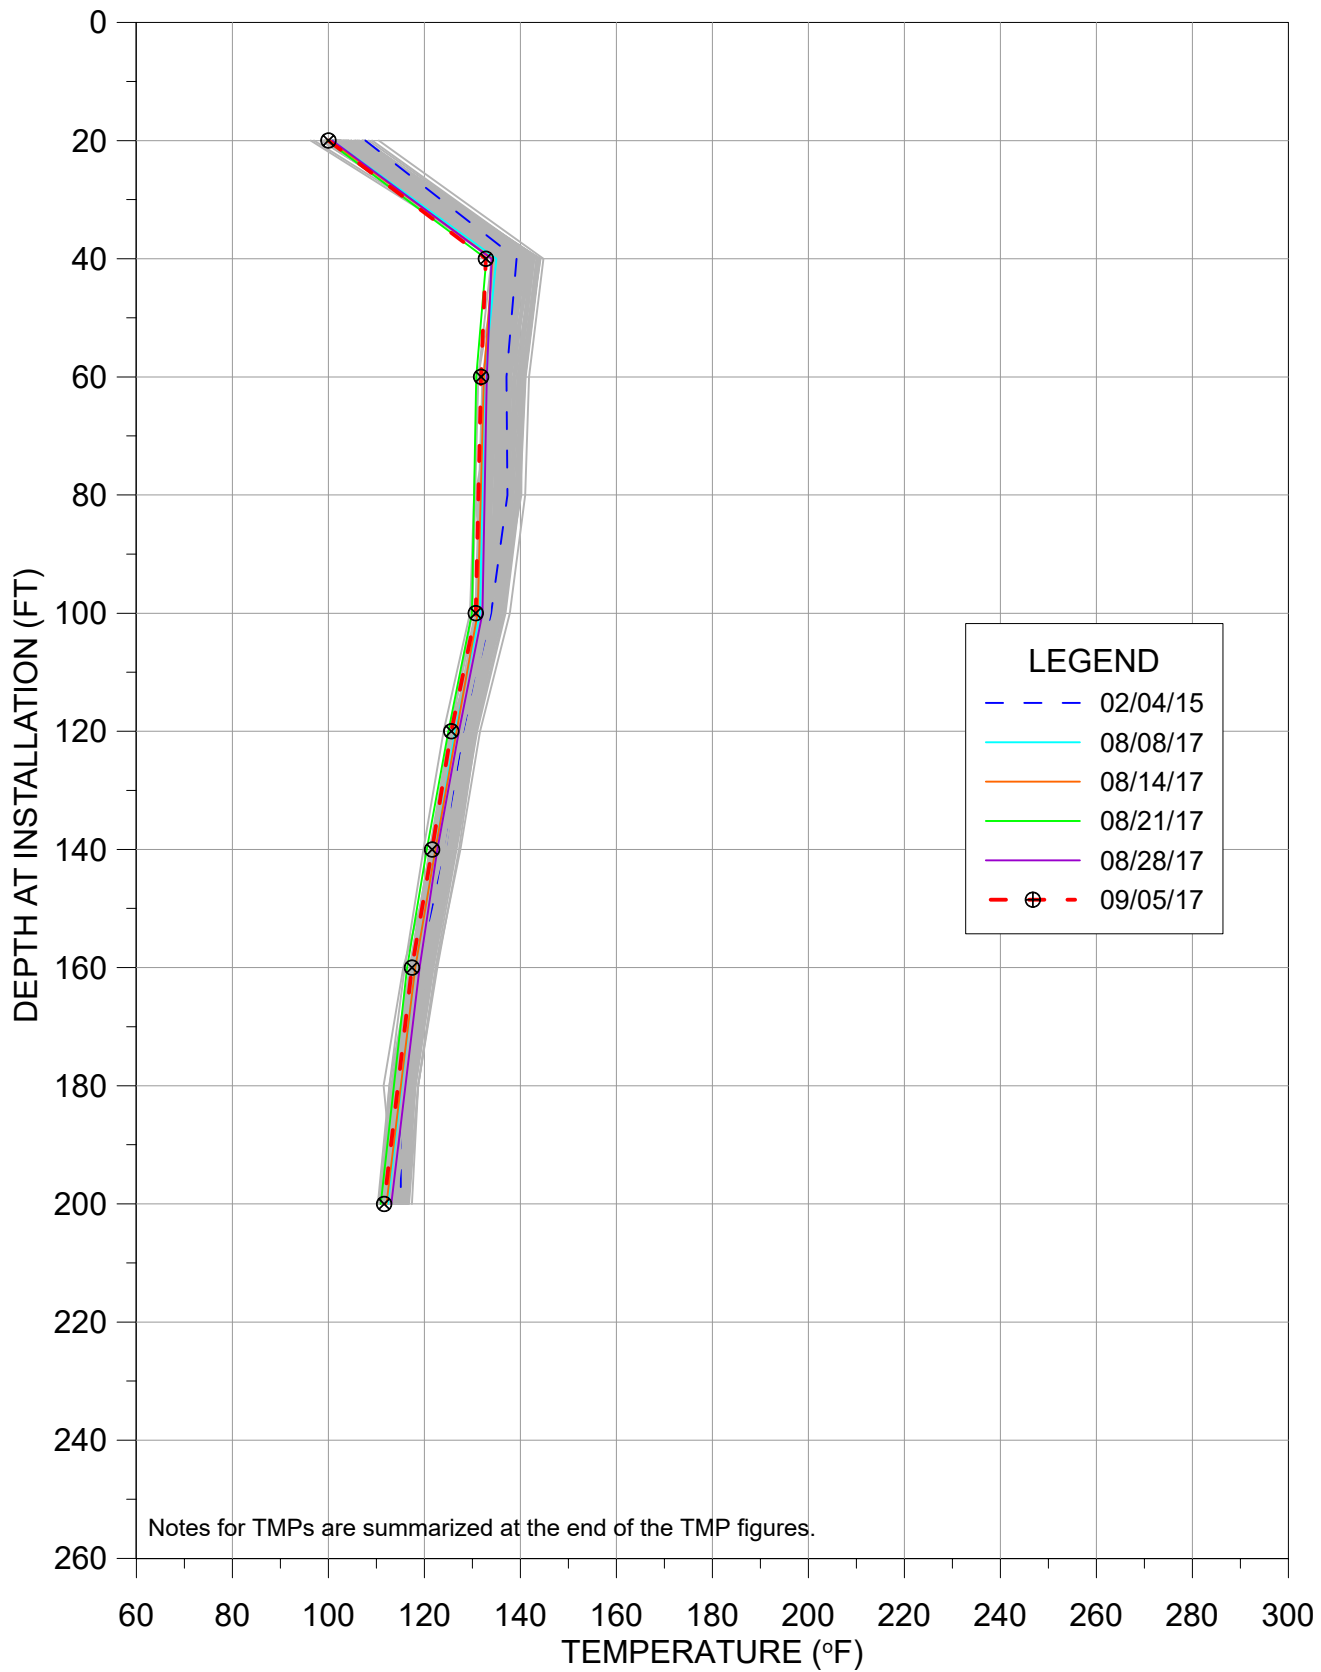
# TMP-28

1. The unit at 217 ft depth has had no resistance or temperature readings since installation.
2. The unit at 80 ft depth had a resistance drop and an unreasonable temperature decrease on 6/1/2016. The temperature has since fluctuated and is determined to be unreliable.
3. The unit at 180 feet has had a higher than acceptable limit since 3/28/2017 and is therefore determined to be unreliable as of the 4/4/2017 reading.

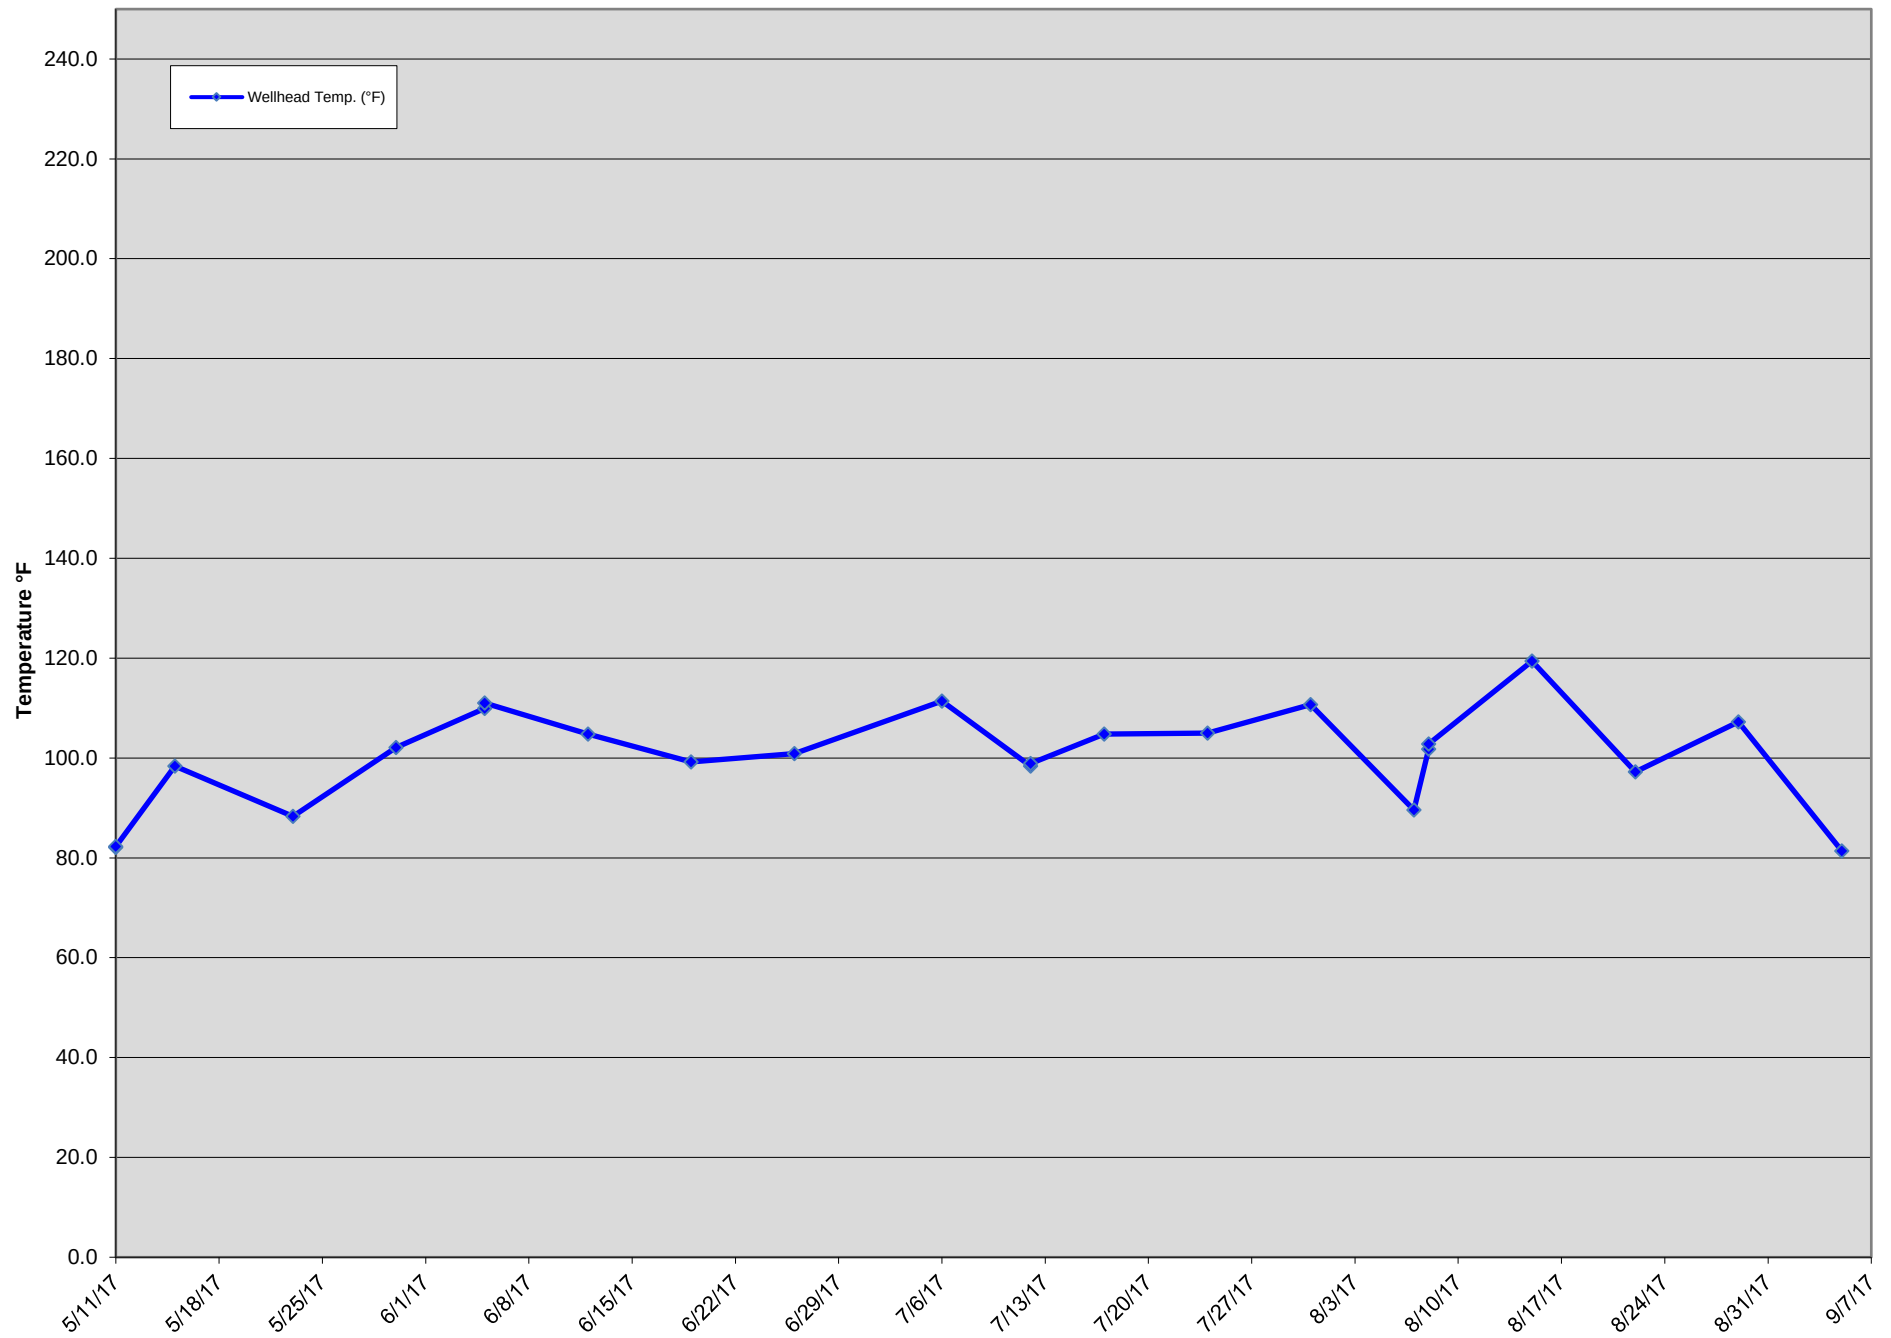
## GIW-1 Wellhead Temperatures

As part of the HES, there are currently cooling water circulation loops installed in twelve Gas Interceptor Wells (GIWs) (GIW-02 through GIW-13). The remaining well (GIW-01) had a measured gas temperature within its historical operating limits.
