# **Bridgeton Landfill, LLC**

## **Weekly Data Submittal**

**Week of September 10, 2017 – September 16, 2017**

**Required by Section 52.F of Agreed Order, Case No. 13SL-CC01088  
Effective May 13, 2013**

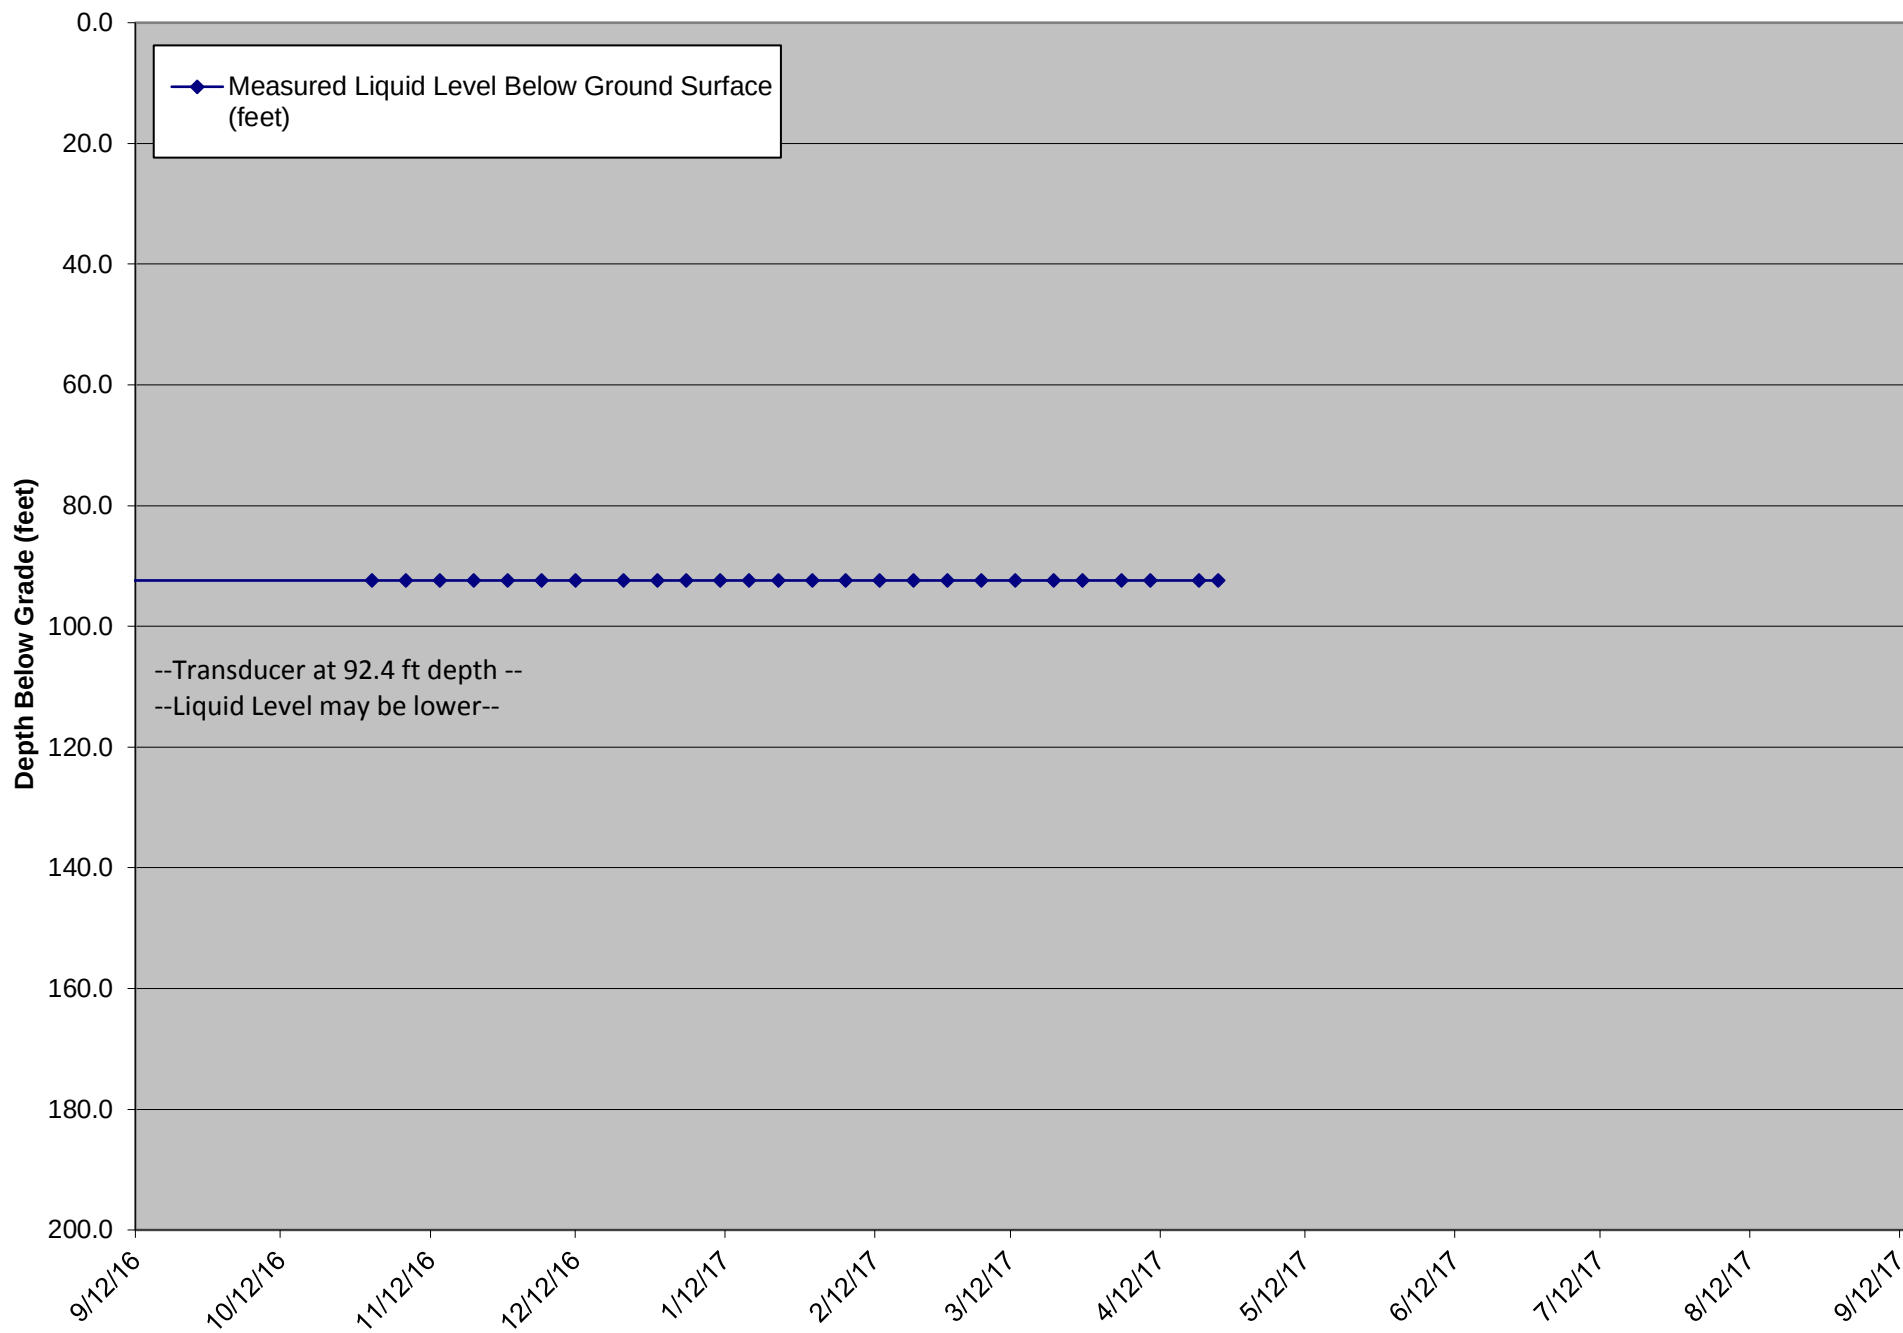
# LCS-1D Liquid Level Below Ground Surface

Bridgeton Landfill is currently troubleshooting the pump in LCS-1D. Level sensor replacement is pending while awaiting parts arrival.

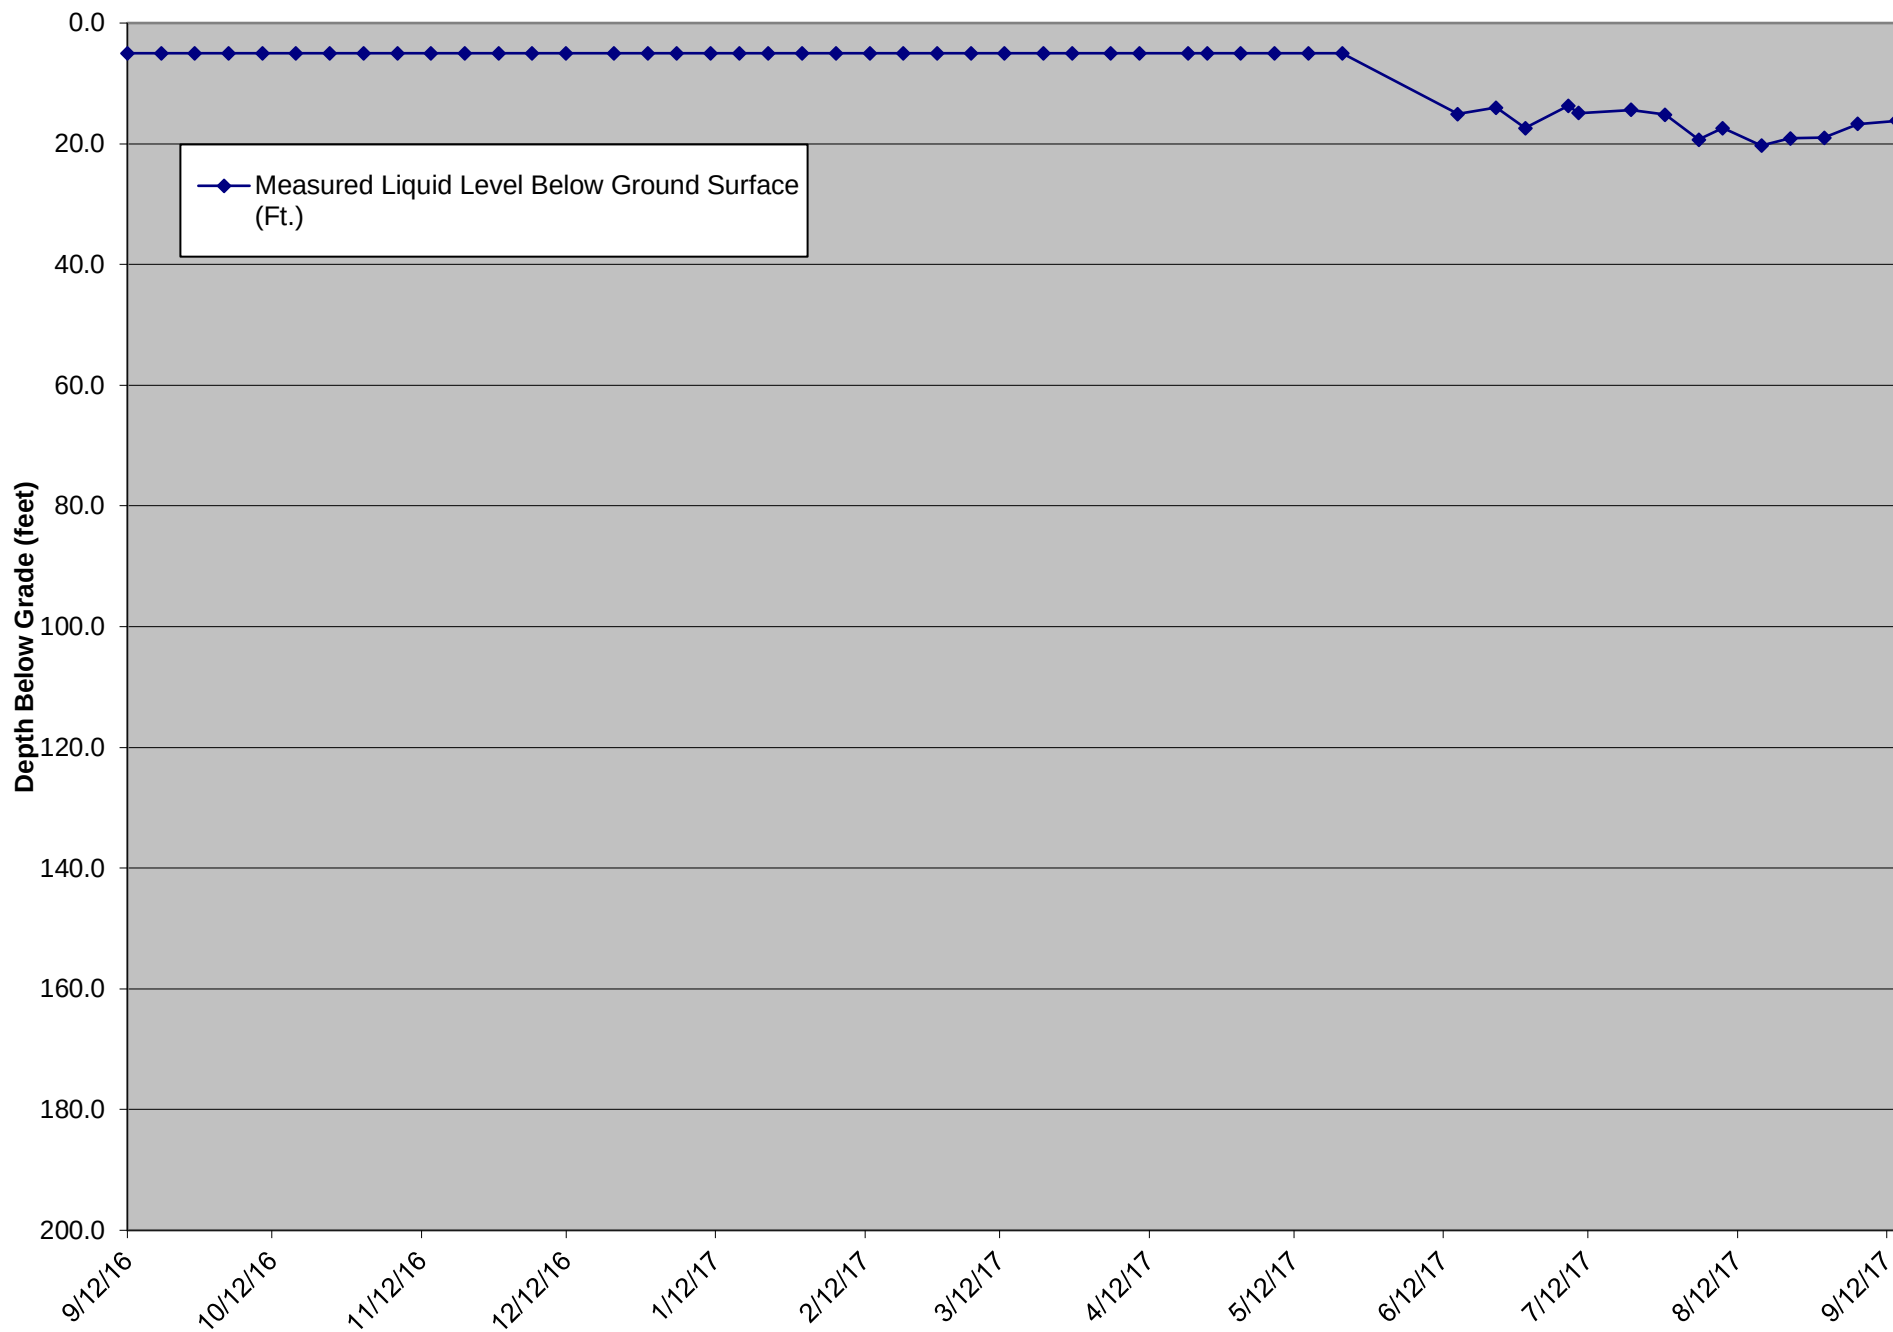
LCS-3D Liquid Level Below Ground Surface

Two Blackhawk pneumatic pumps were installed in LCS-3D on 6/13/2017. Blackhawk pumps do not require a level sensor. Liquid level was measured manually.

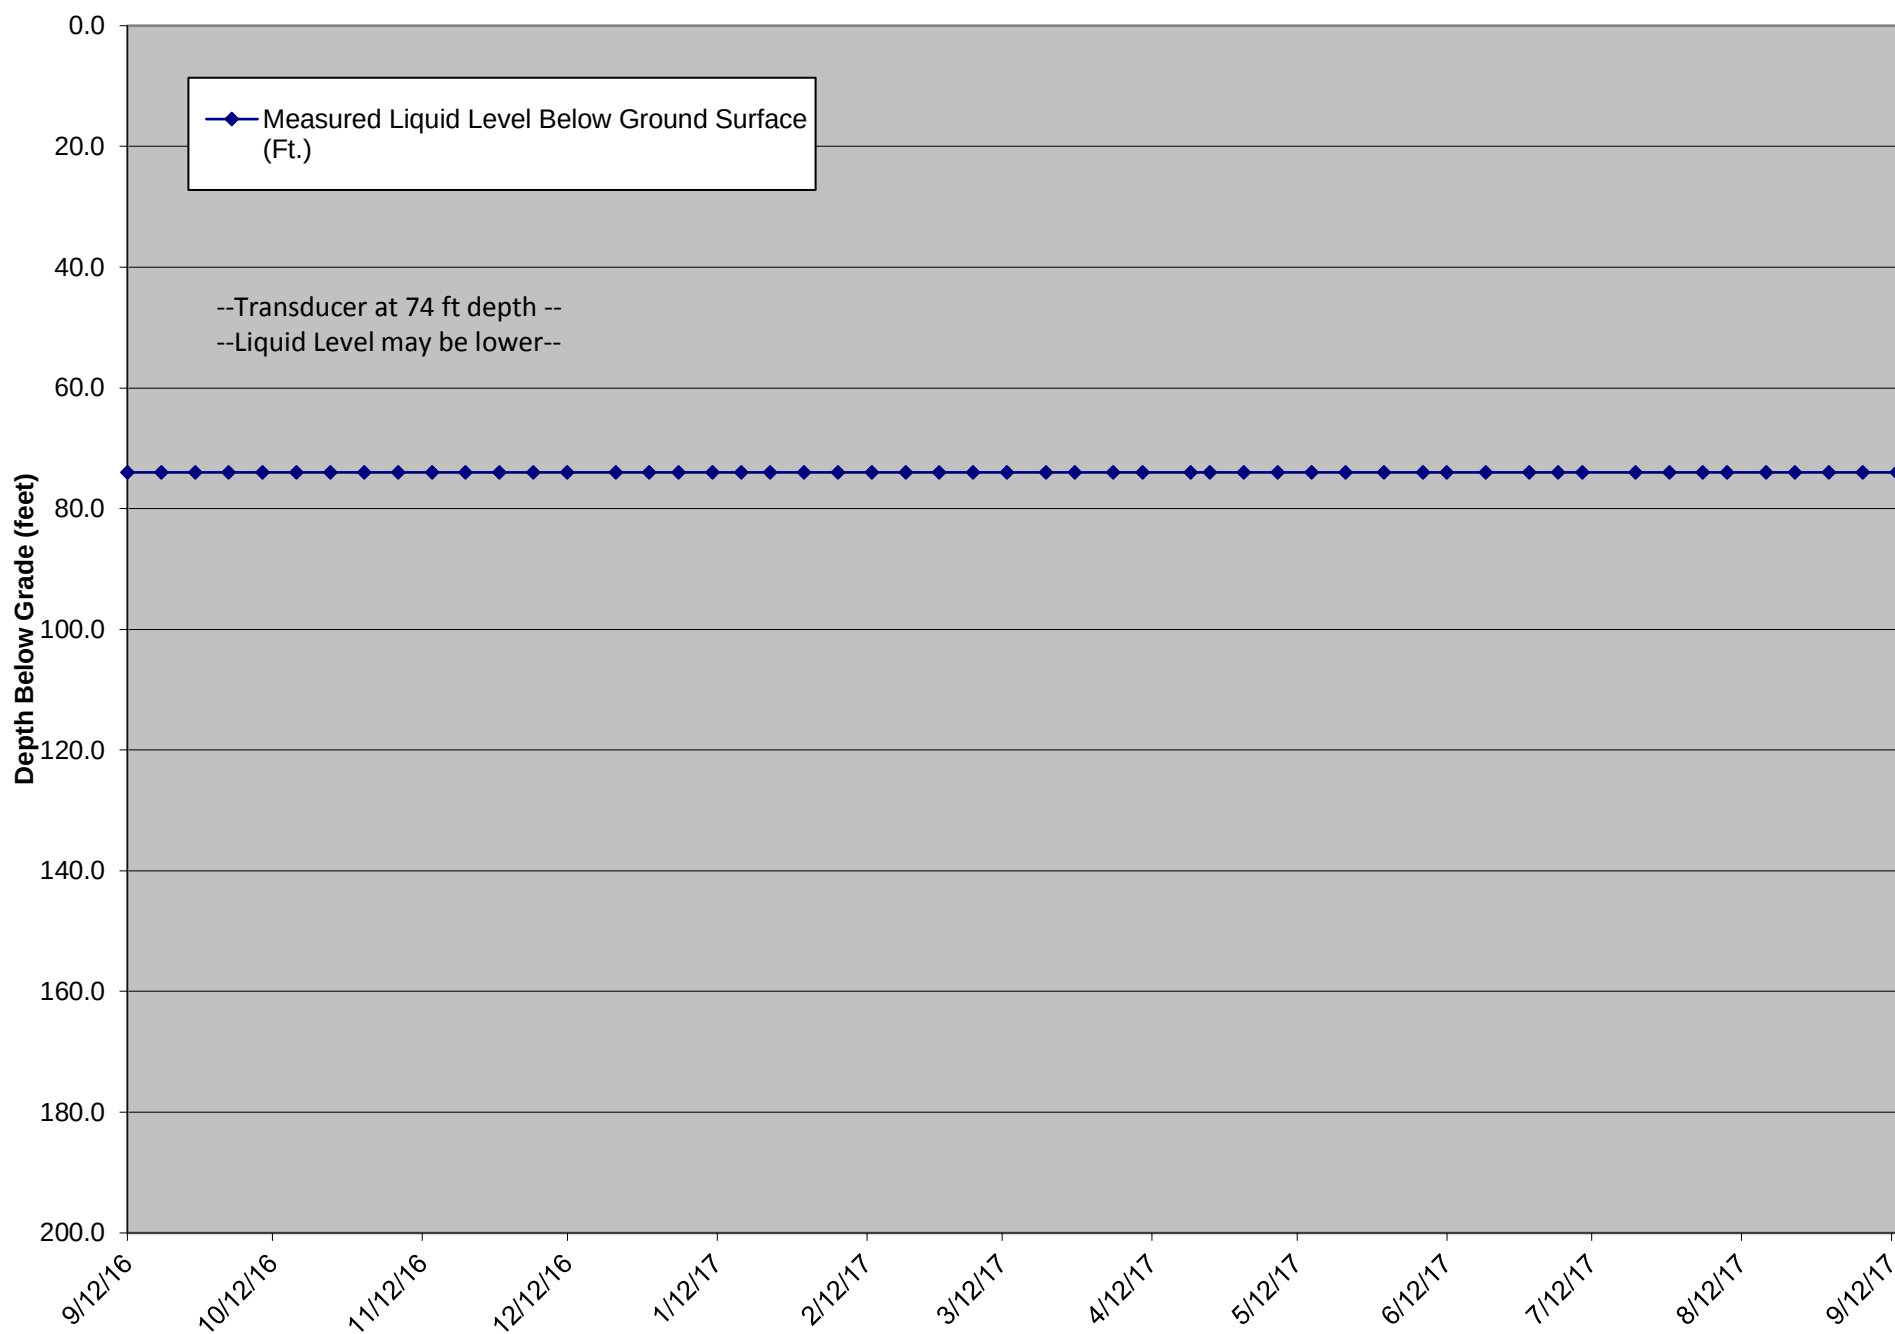
# LCS-4B Liquid Level Below Ground Surface

The level sensor in LCS-4B is currently operational and responsive. Liquid level was not recorded by the level sensor during the weekly reporting period. LCS-4B is equipped with a flow meter that displayed no flow during the weekly reporting period. Therefore, it can be concluded that the liquid level was below the bottom of the pump and level sensor in LCS-4B.

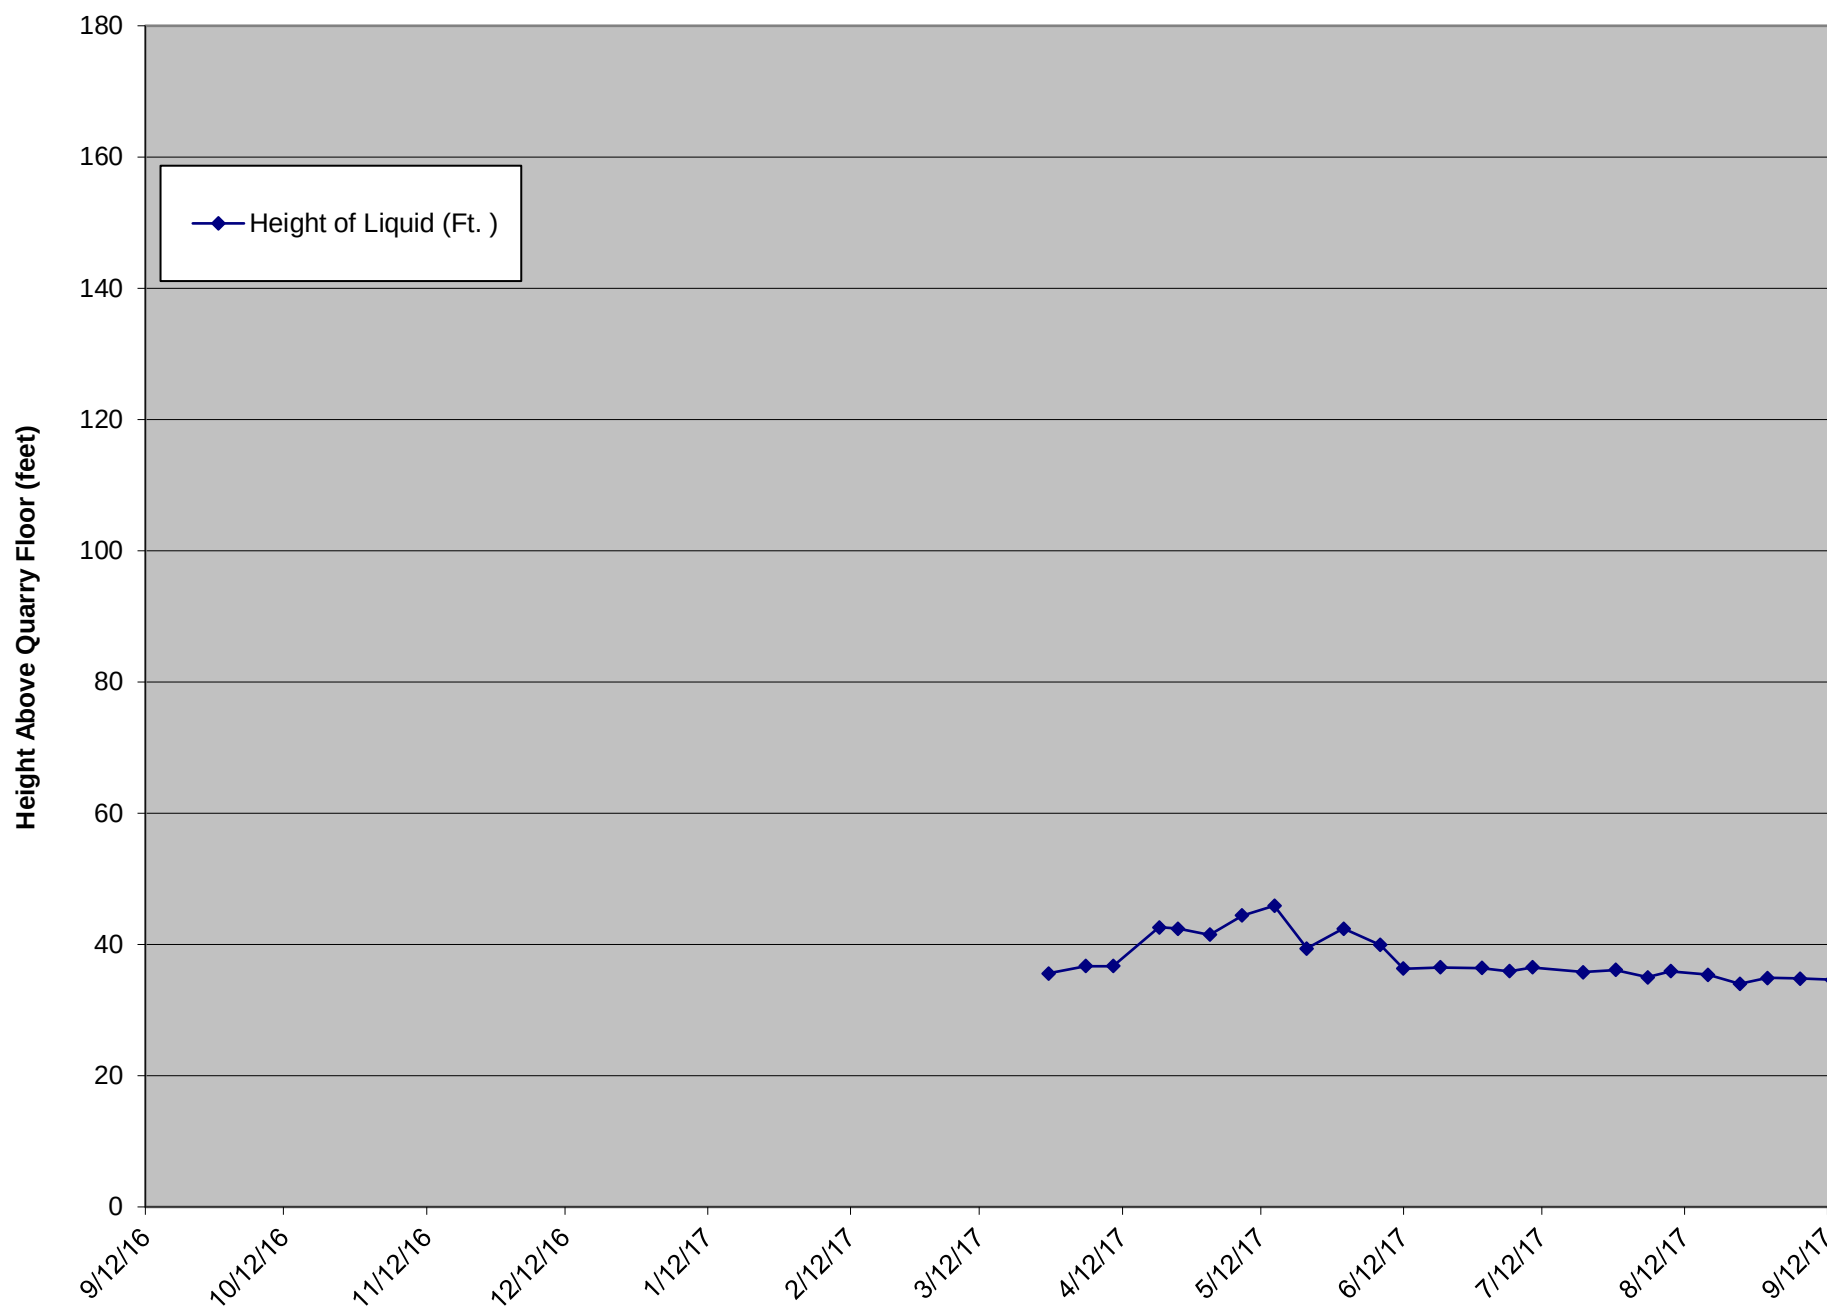
LCS-5B Liquid Level Above Quarry Floor

LCS-5B and LCS-6B were fully operational during the weekly reporting period.

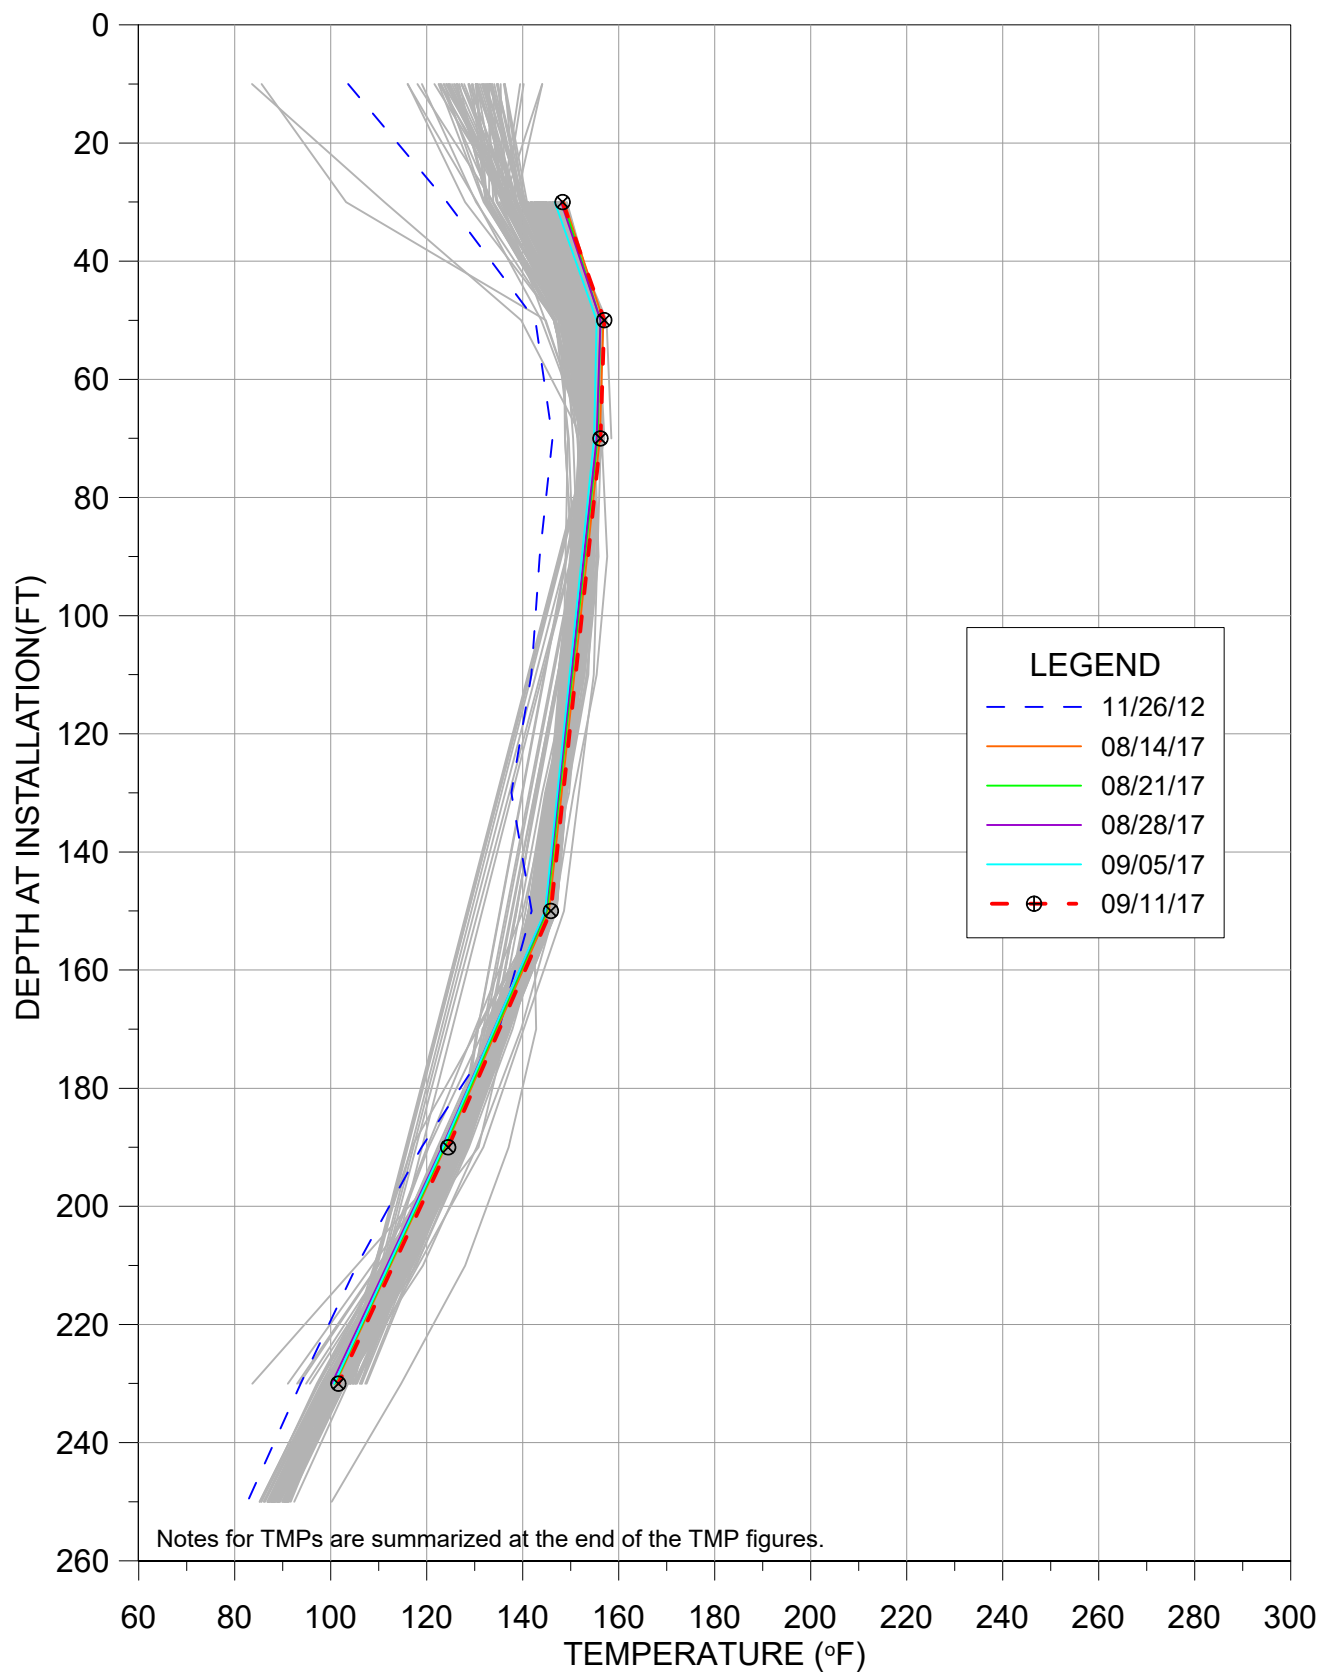
# TMP-3

1. No reliable temperature readings have been obtained at 170 ft depth since 1/29/2014, except on 3/13/2014.
2. The connectivity tests on 4/11/2014 conducted by CEC showed that units at 10, 90, 130, 210 and 250 ft depths are no longer reliable.
3. The connectivity tests on 10/28/2014 conducted by Feezor Engineering showed that units at 10, 90, 110, 130, 210 and 250 ft depths are not reliable.

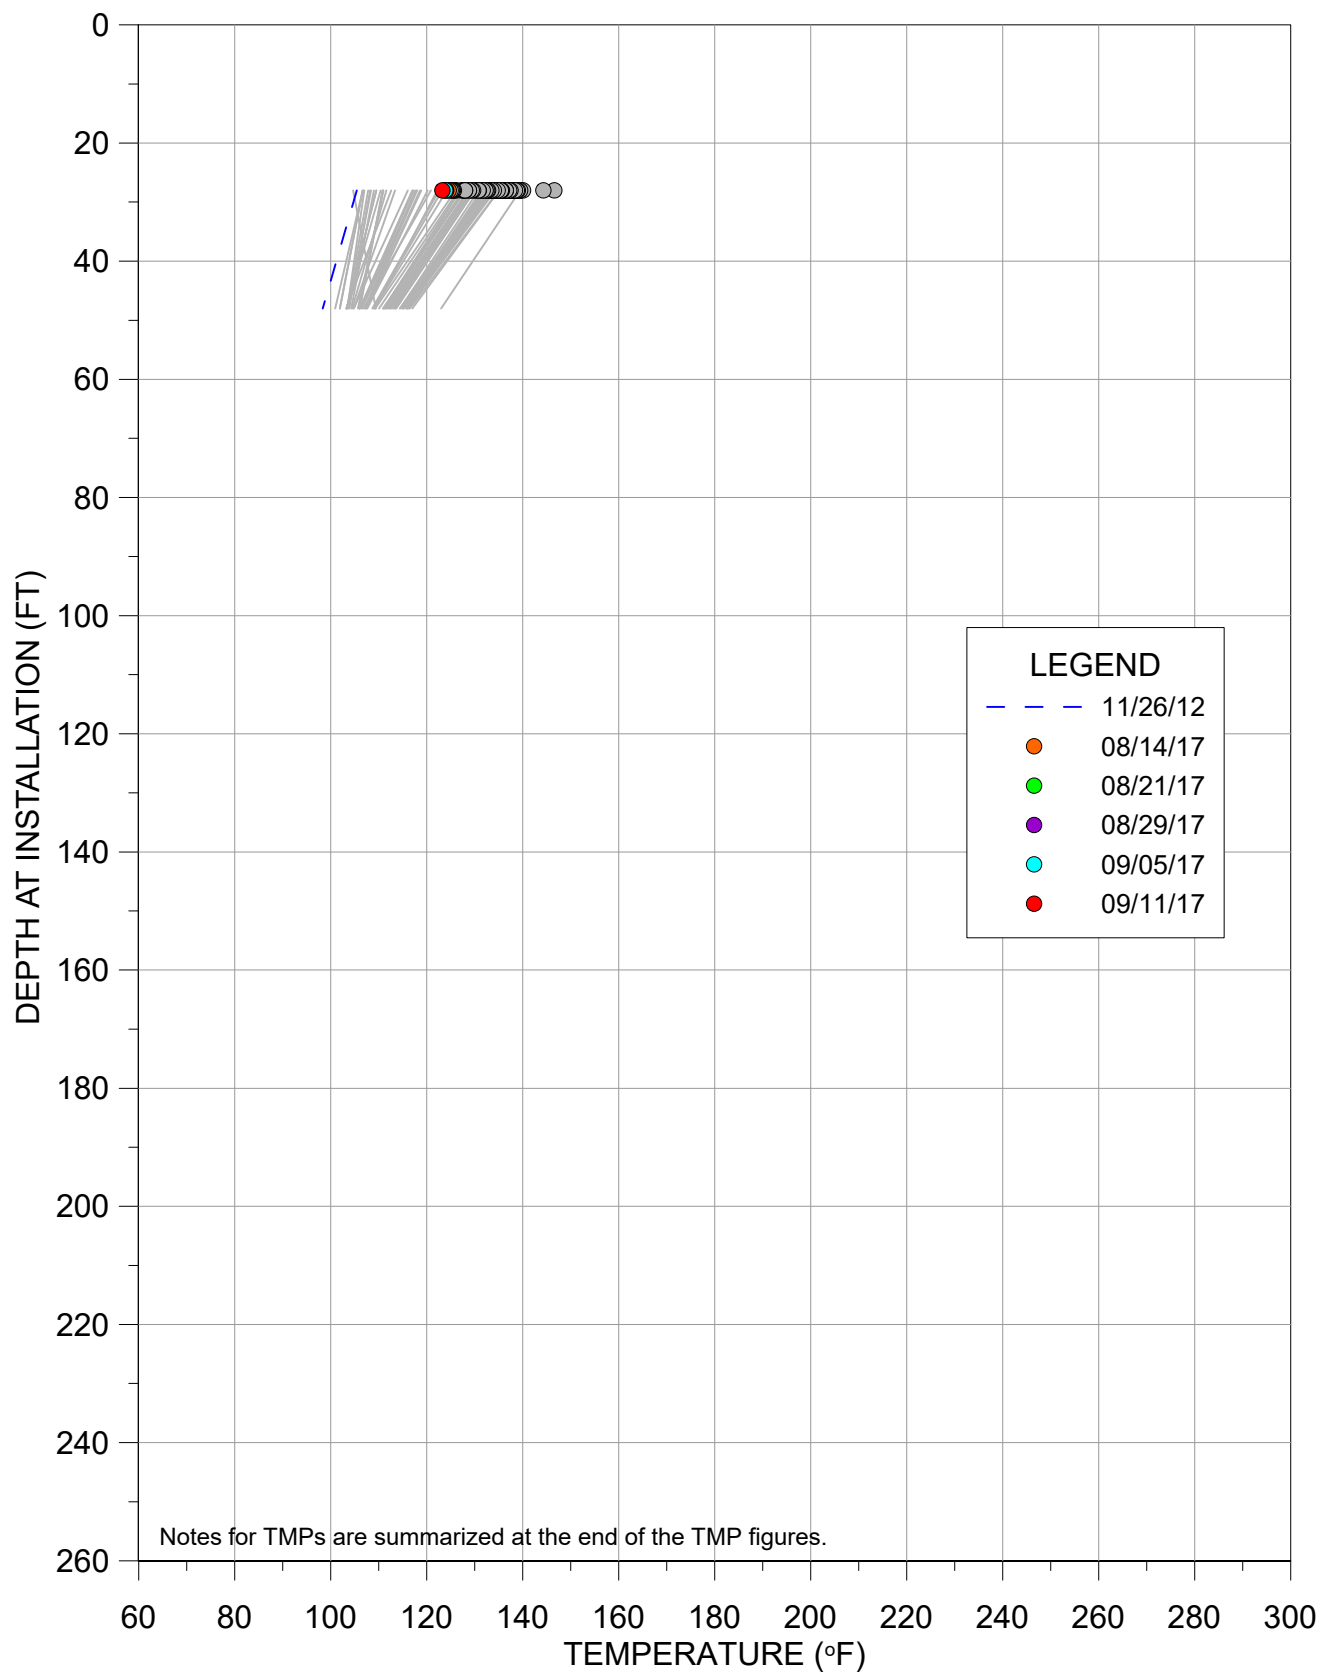
# TMP-4

1. The connectivity tests on 4/11/2014 conducted by CEC showed that the unit at 48 ft depth is no longer reliable.

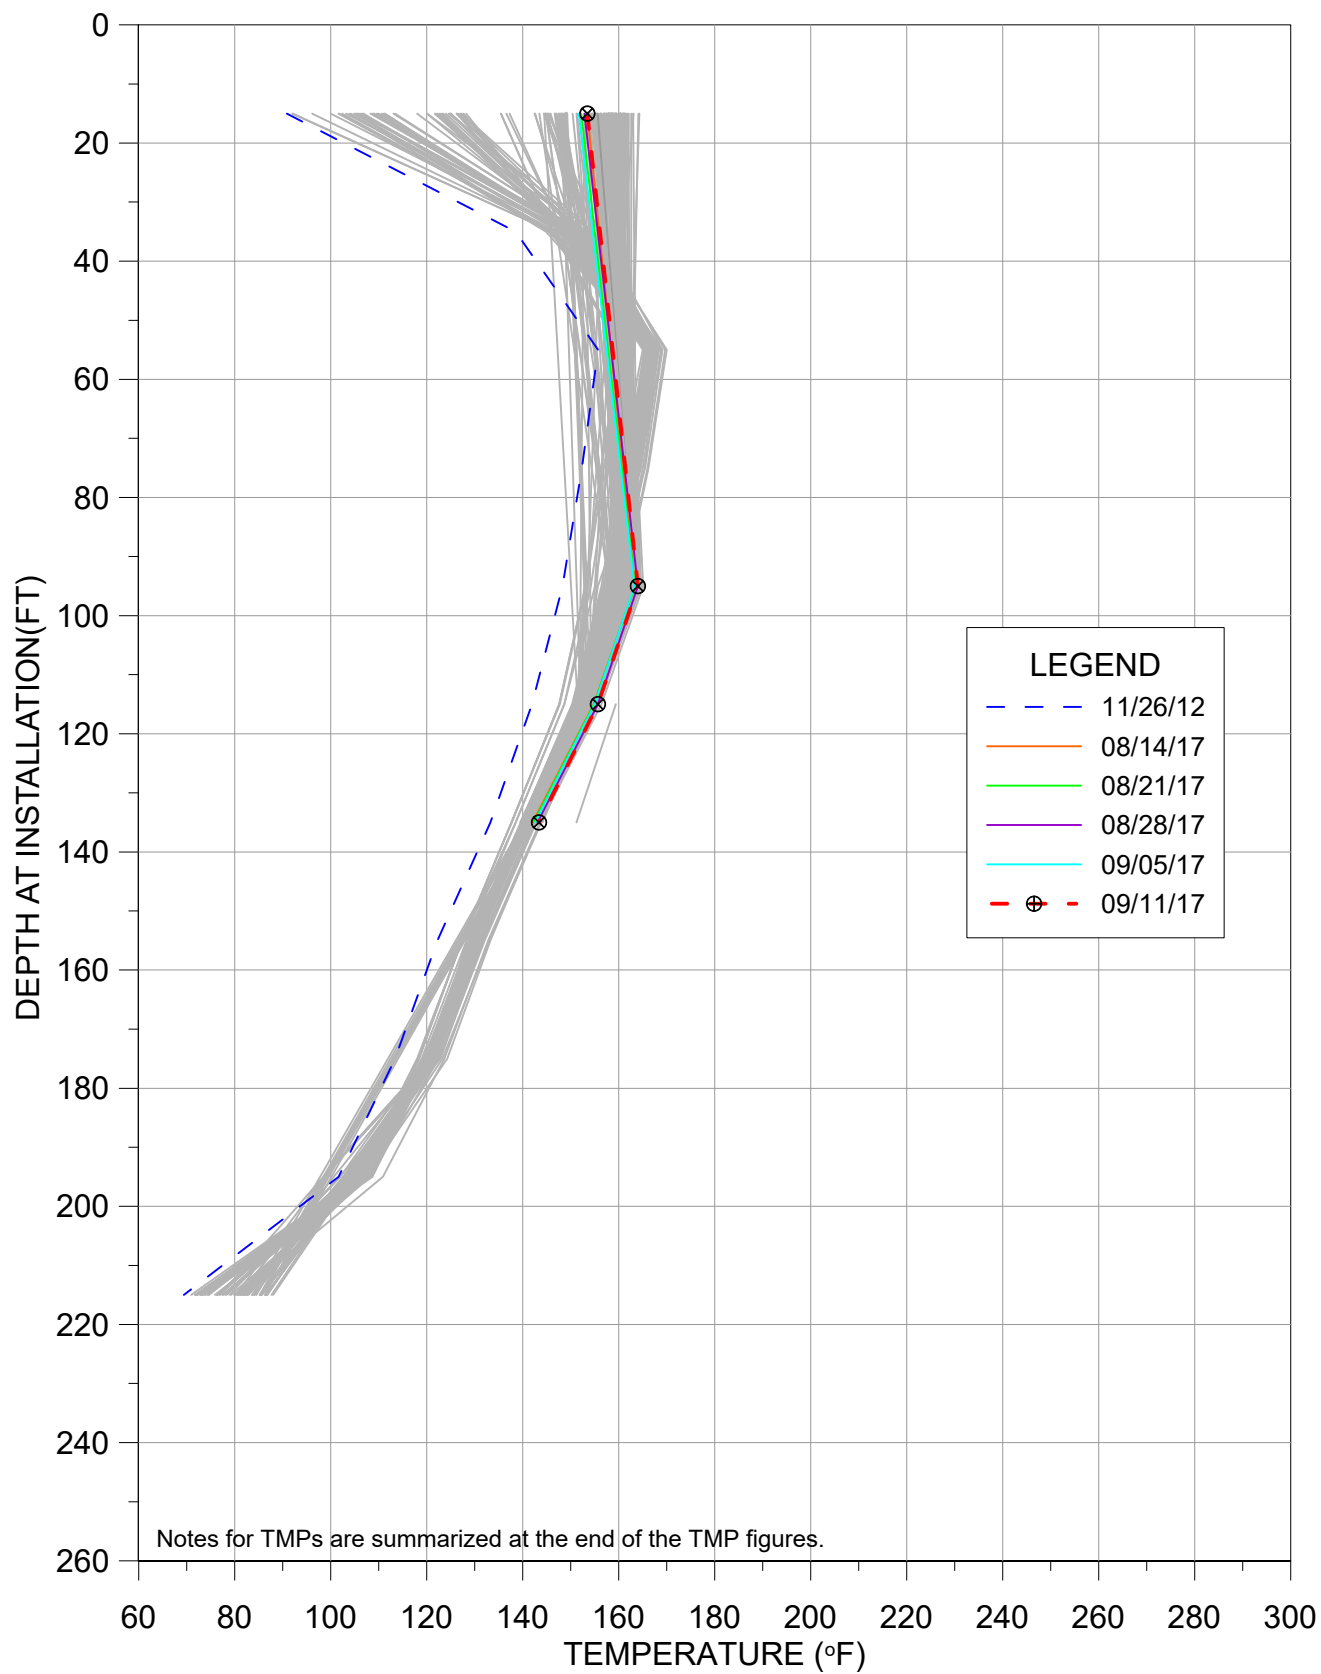
# TMP-6

1. The connectivity tests on 4/11/2014 conducted by CEC showed that units at 35, 55, 75, 155, 175, and 195 ft depths are no longer reliable.
2. No reliable temperature readings have been obtained at the unit at 215 ft depth since 6/13/2014.

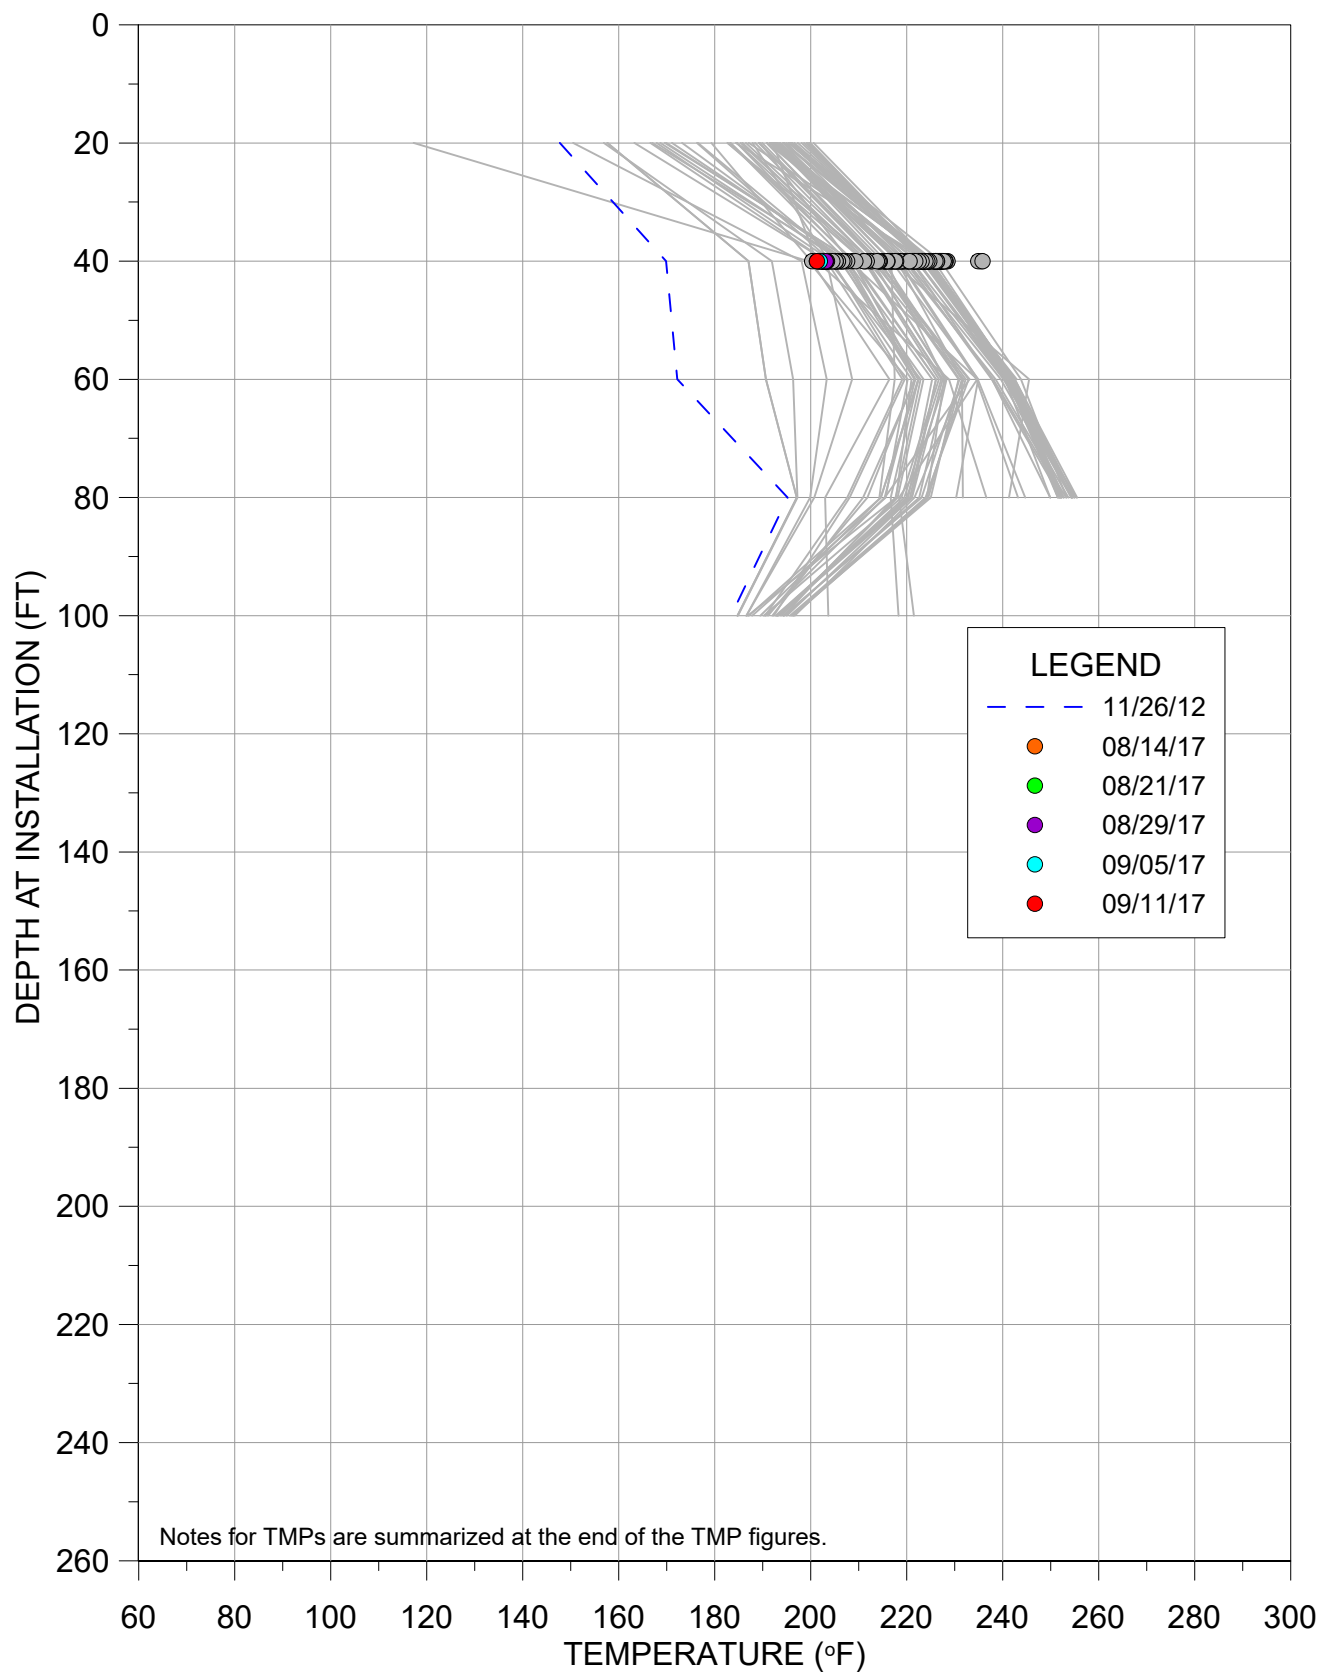
# TMP-9

1. Unit at 100 ft depth had an inaccurate temperature reading on 8/1/2013 and no reading since 8/6/2013.
2. The connectivity tests on 4/11/2014 conducted by CEC showed that units at 20, 60, 80, and 100 ft depths are no longer reliable.

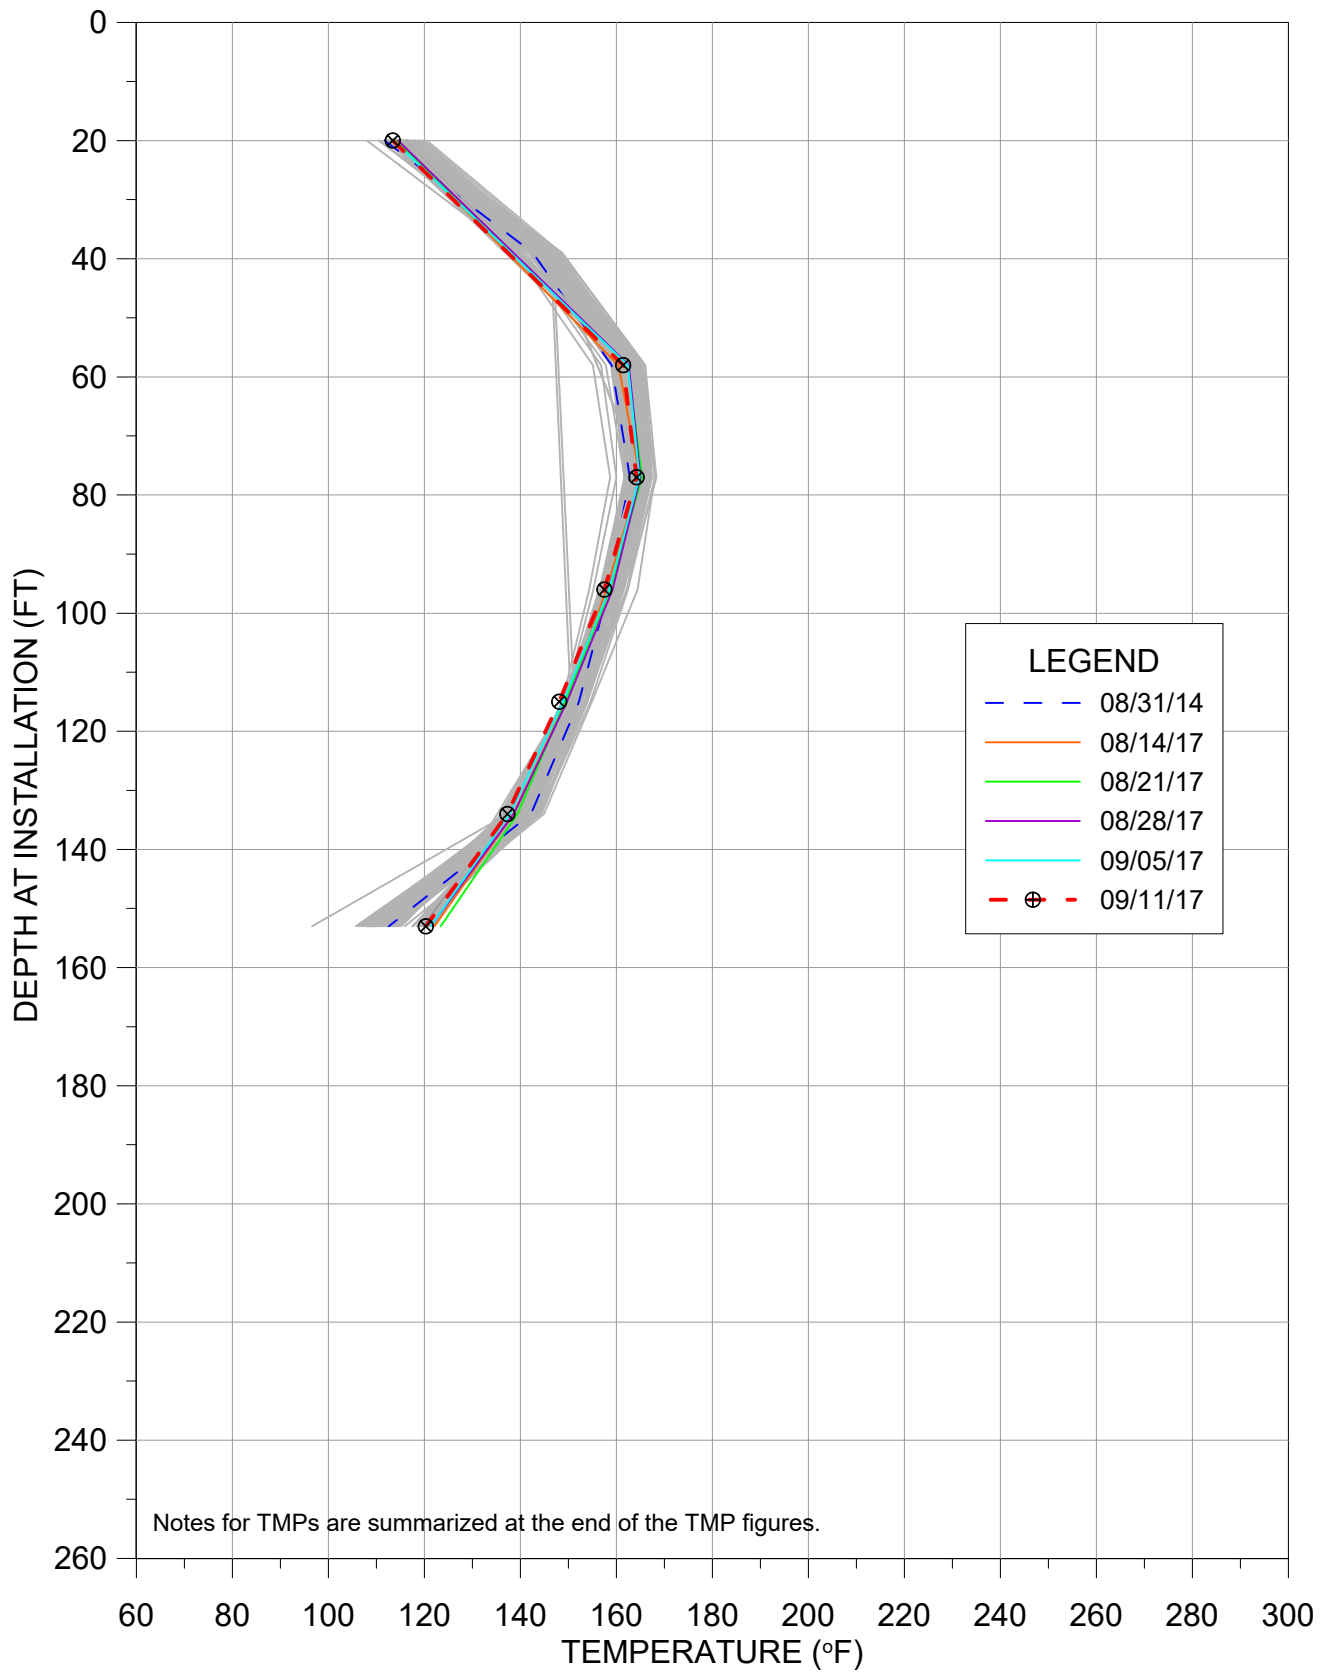
# TMP-16

1. A connectivity test conducted by Feezor Engineering showed that the units on TMP-16 may not be reliable since 9/9/2015. Further testing at the end of September 2015 showed possible connectivity on some of the units.
2. The unit at 153 ft depth had a low resistance reading and unreliable temperature since 12/21/2015.

3. The unit at 39 ft depth had a higher than acceptable resistance reading and unreliable temperature since 2/7/2017.
