# **Bridgeton Landfill, LLC**

## **Weekly Data Submittal**

**Week of September 10, 2017 – September 16, 2017**

**Required by Section 52.F of Agreed Order, Case No. 13SL-CC01088  
Effective May 13, 2013**

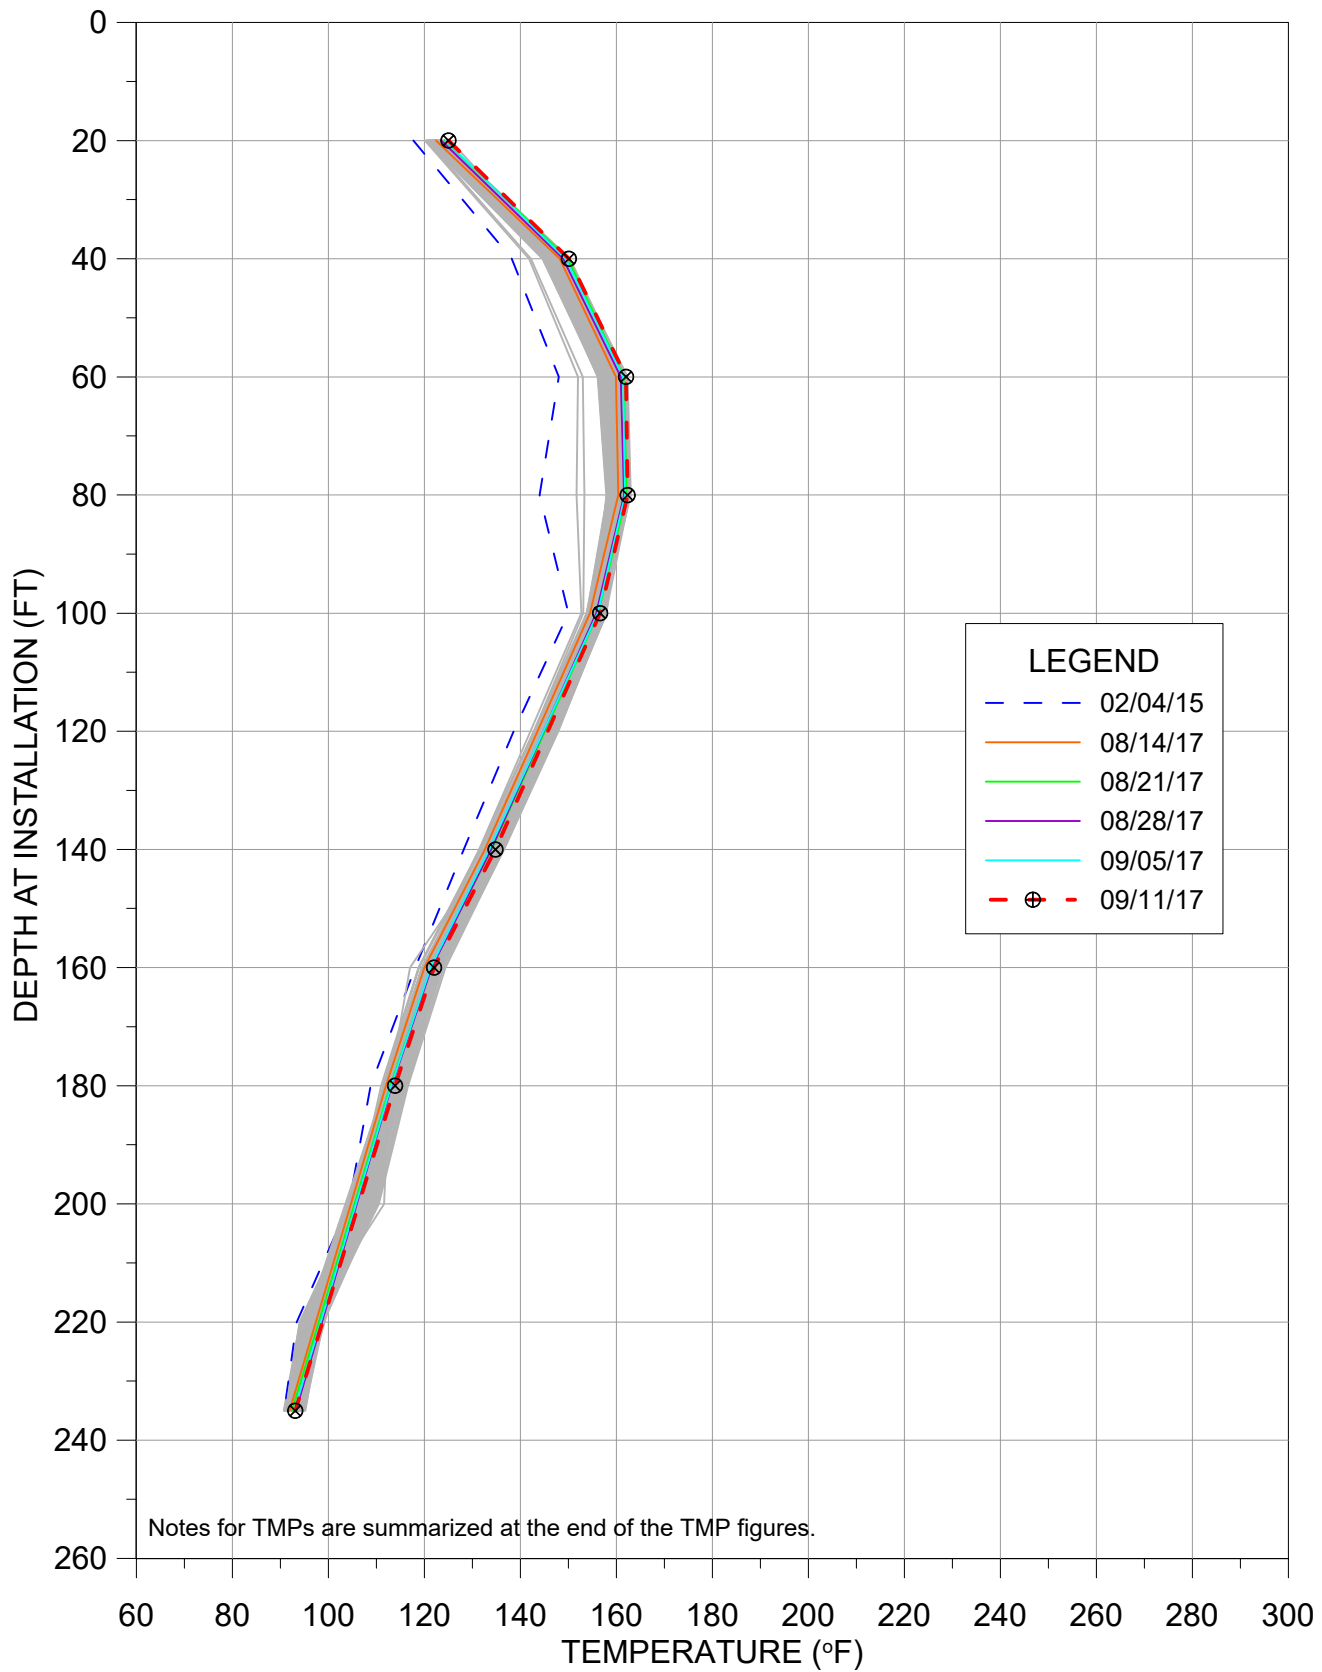
# TMP-25

1. The unit at 200 ft provided an apparent anomalous reading on 3/28/2017. Subsequent readings on 4/4/2017 showed the unit to have failed (see below). The unit is no longer working and the reading of 3/28/2017 was likely unreliable.

2. The unit at 200 ft depth had a resistance reading greater 4000 ohms on 4/4/2017. A connectivity test conducted by Feezor Engineering on 4/7/2017 showed that this unit also had cross-connectivity. The unit is therefore determined to be no longer working as of the 4/4/2017 reading.

3. The unit at 120 feet had a higher than acceptable limit on 7/10/2017. Also, a connectivity test conducted by Feezor Engineering on 4/7/2017 showed that this unit may be unreliable. Therefore, this unit is determined to be unreliable.

4. The unit at 220 ft has been reported as unable to attain a reading of any kind since June 19, 2017. The unit is considered to be no longer working as of that date.

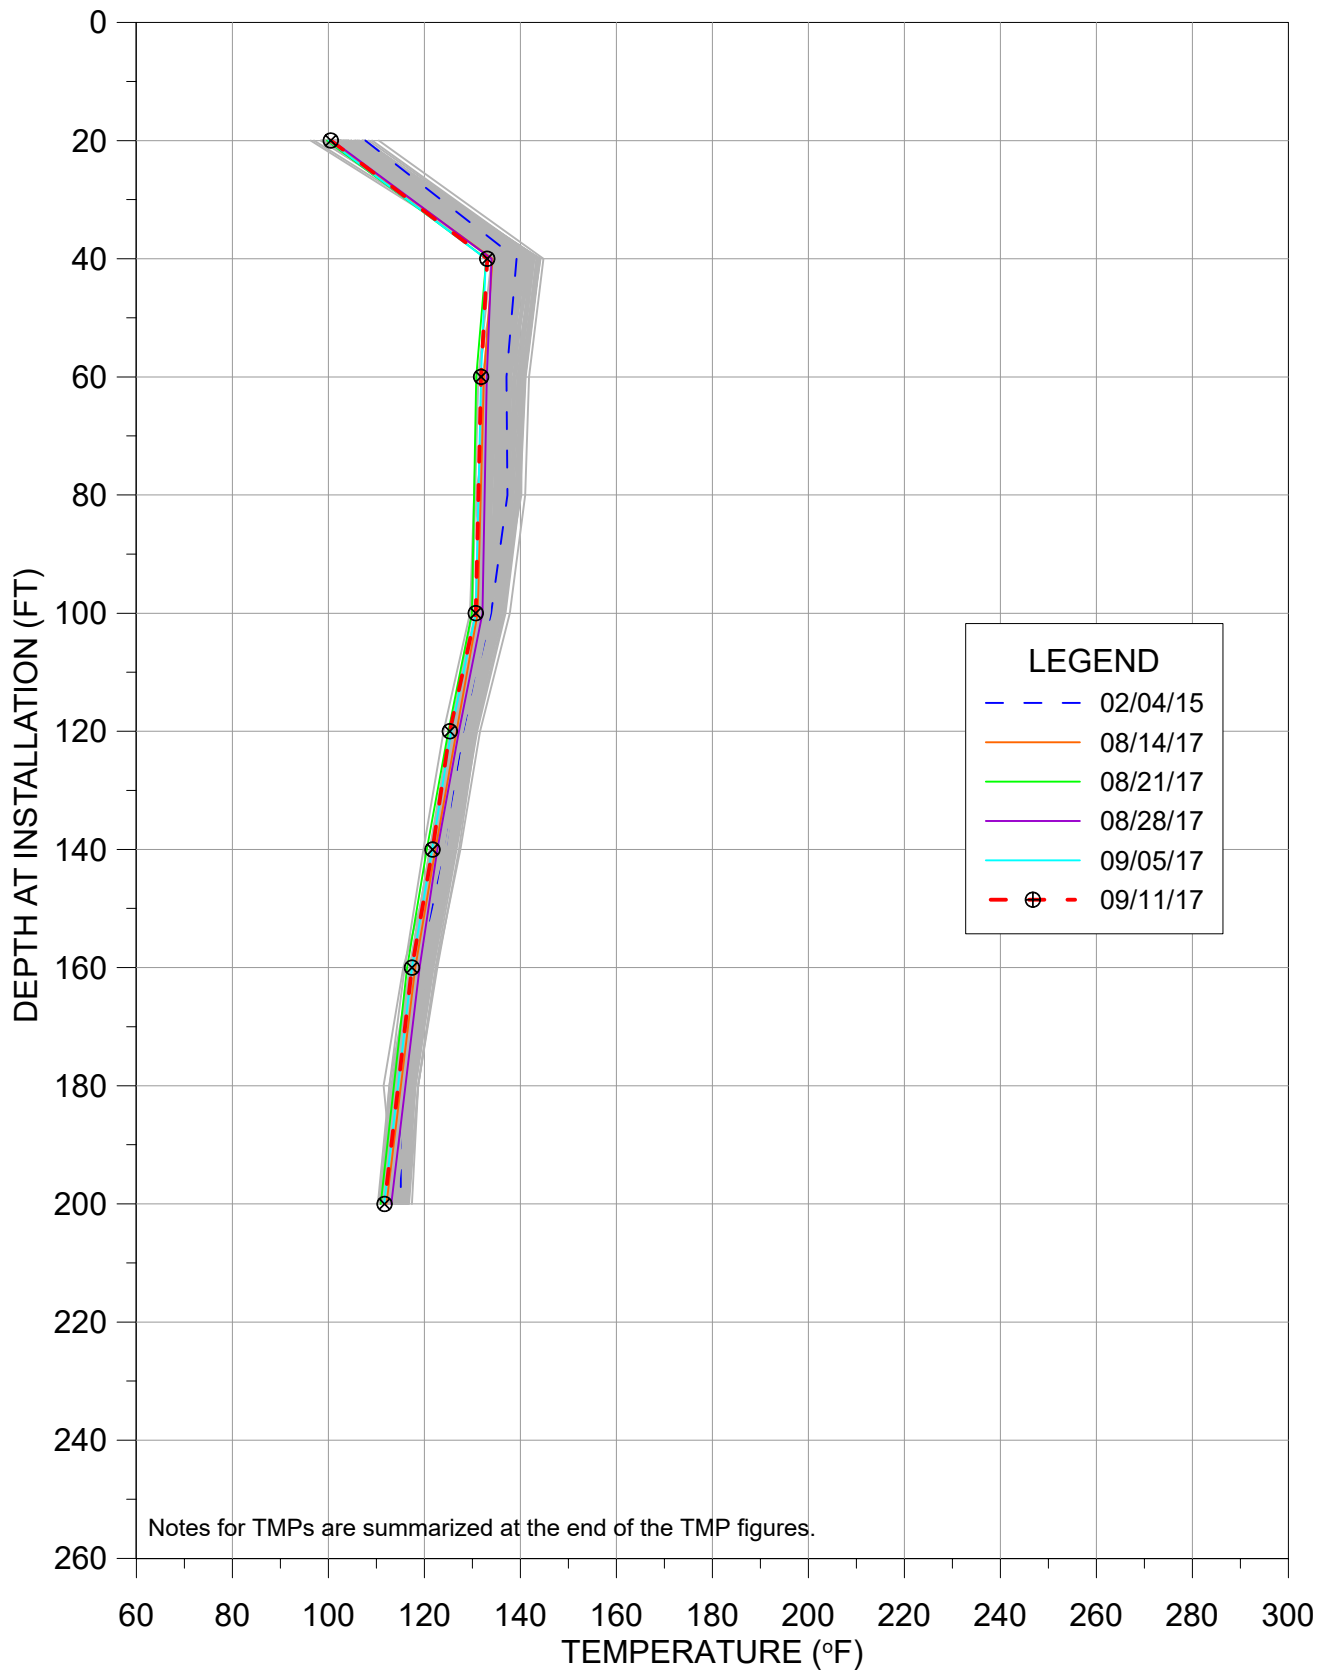
# TMP-28

1. The unit at 217 ft depth has had no resistance or temperature readings since installation.
2. The unit at 80 ft depth had a resistance drop and an unreasonable temperature decrease on 6/1/2016. The temperature has since fluctuated and is determined to be unreliable.
3. The unit at 180 feet has had a higher than acceptable limit since 3/28/2017 and is therefore determined to be unreliable as of the 4/4/2017 reading.

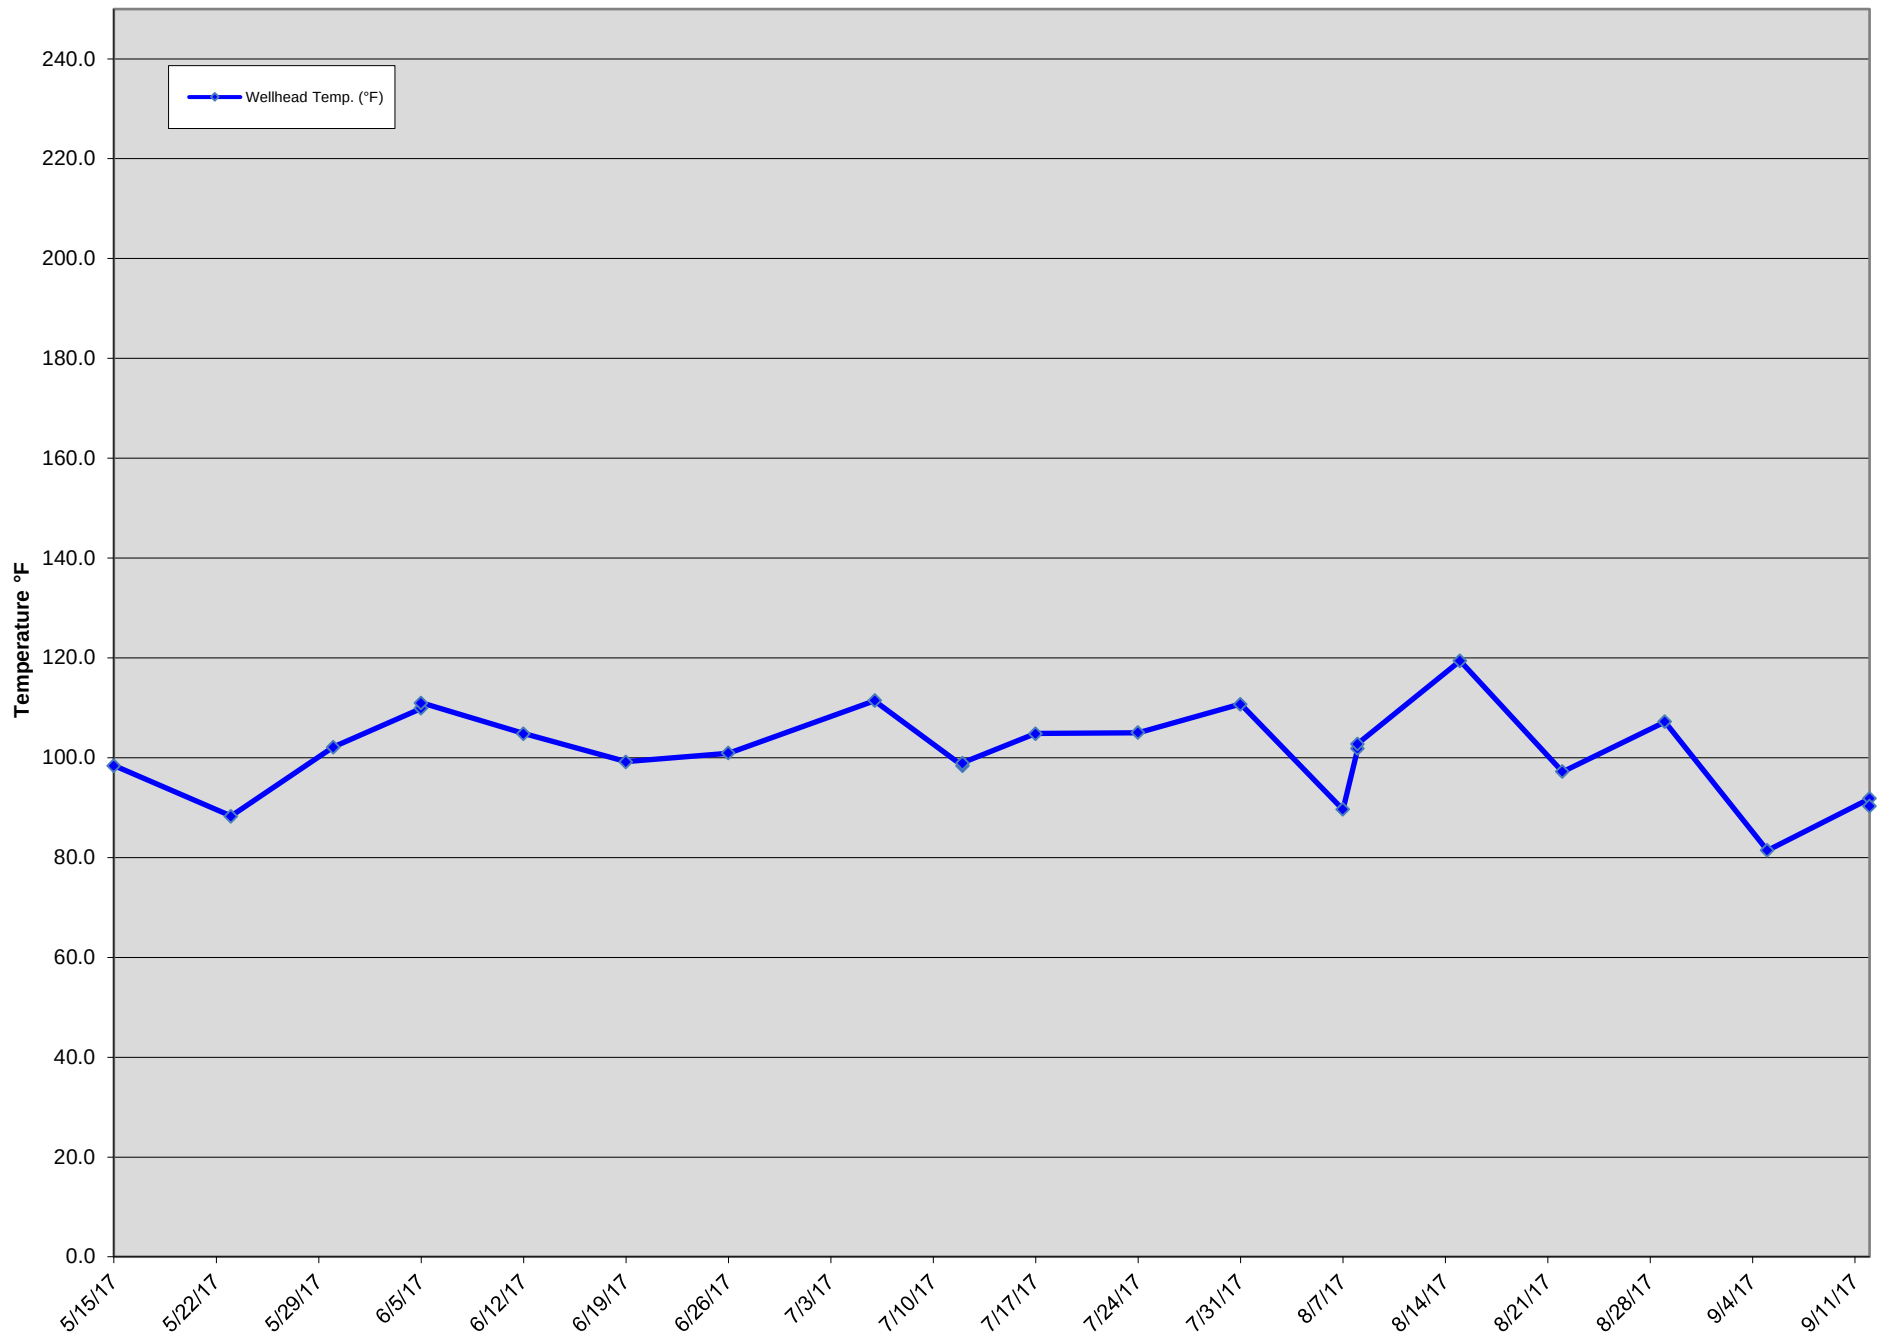
## GIW-1 Wellhead Temperatures

As part of the HES, there are currently cooling water circulation loops installed in twelve Gas Interceptor Wells (GIWs) (GIW-02 through GIW-13). The remaining well (GIW-01) had a measured gas temperature within its historical operating limits.
