# **Bridgeton Landfill, LLC**

## **Weekly Data Submittal**

**Week of October 9, 2016 – October 15, 2016**

**Required by Section 52.F of Agreed Order, Case No. 13SL-CC01088  
Effective May 13, 2013**

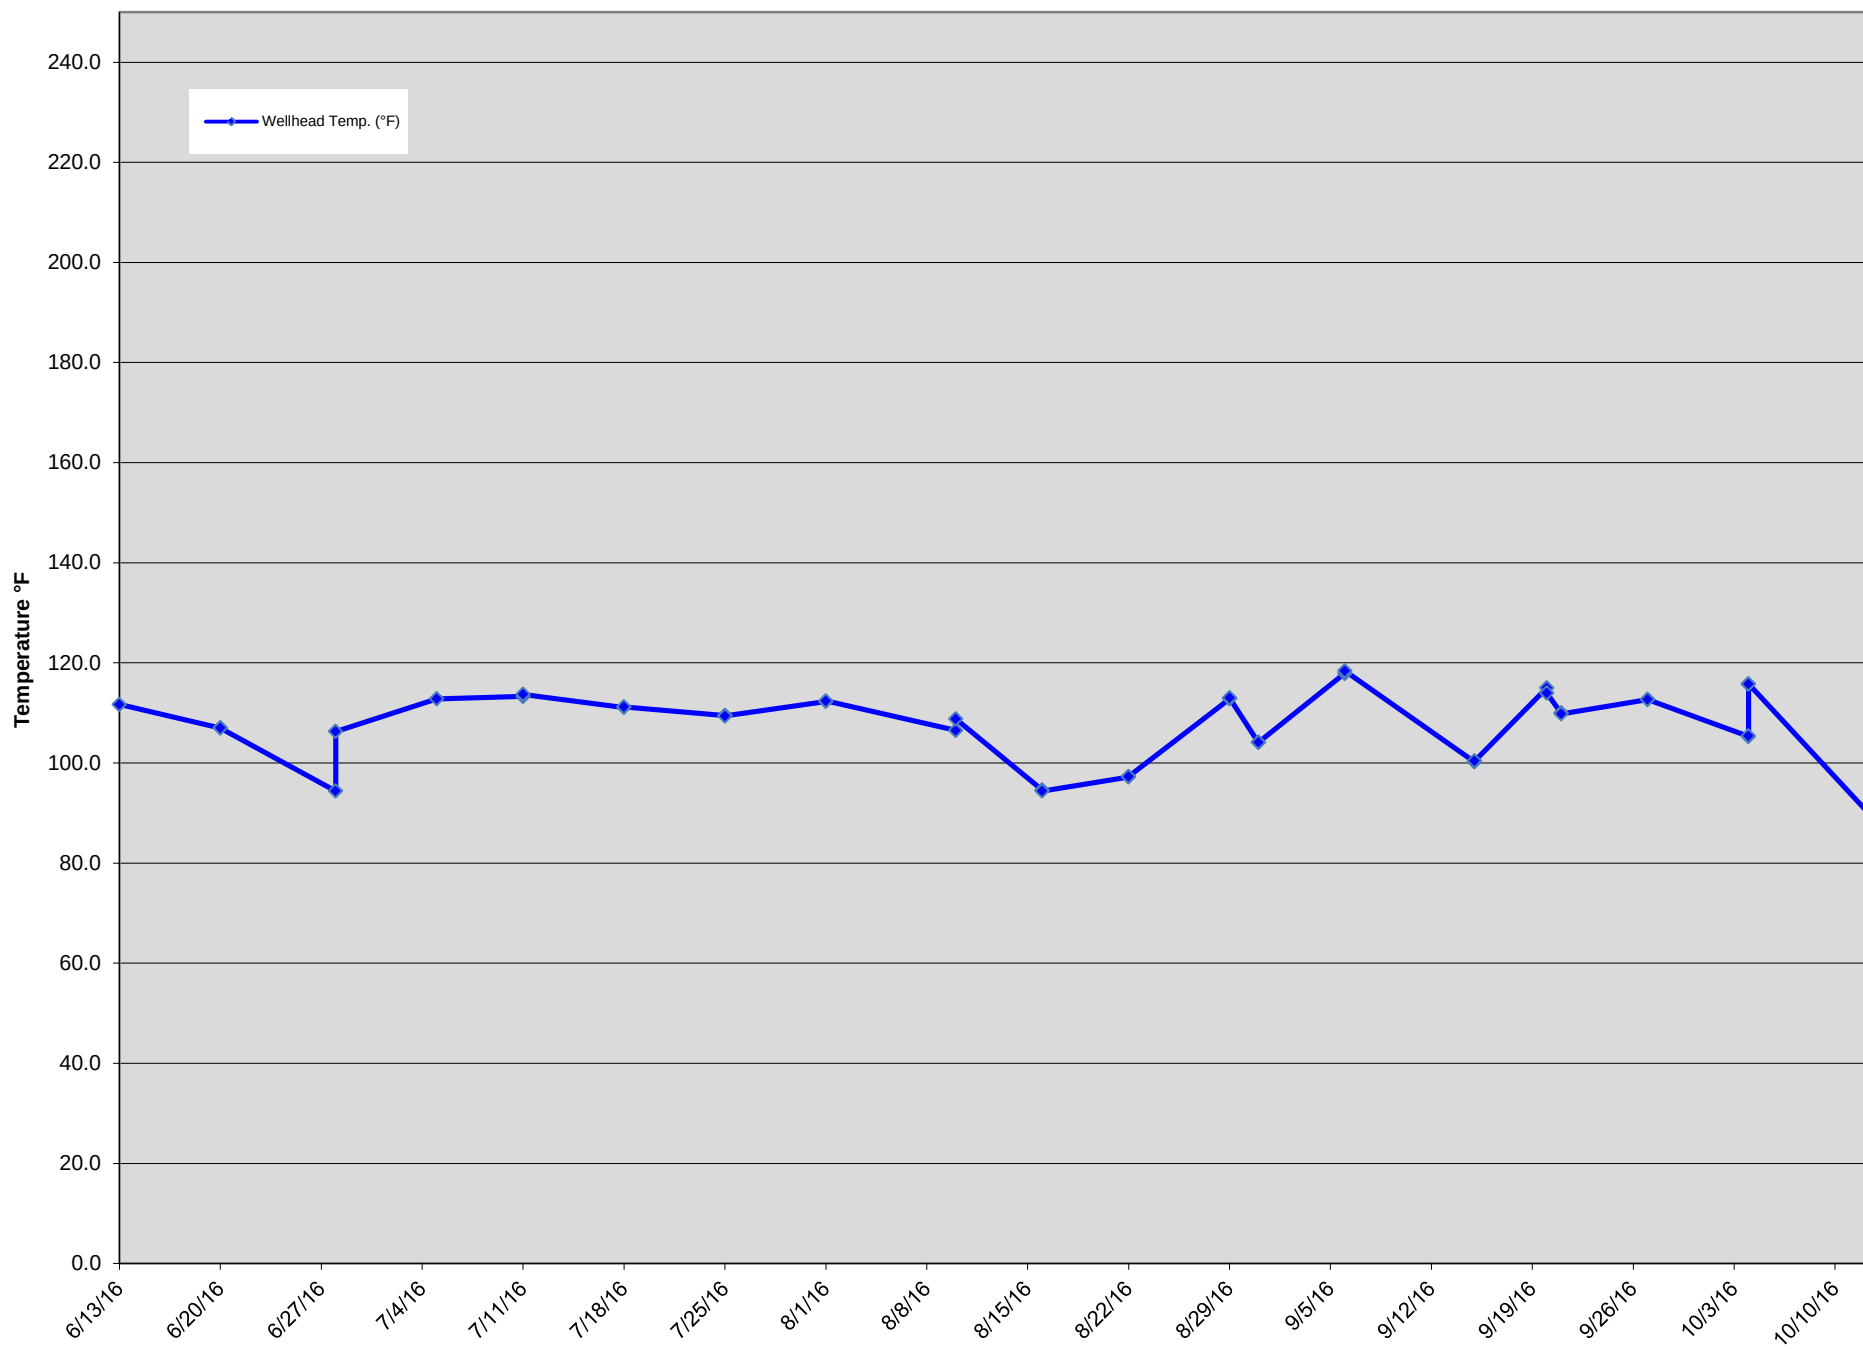
## GEW-110 Wellhead Temperatures

During the weekly monitoring event it was determined that GEW-110 was not operating efficiently. Site personnel will continue to work on optimizing gas extraction from this well.
