# **Bridgeton Landfill, LLC**

## **Weekly Data Submittal**

**Week of October 16, 2016 – October 22, 2016**

**Required by Section 52.F of Agreed Order, Case No. 13SL-CC01088  
Effective May 13, 2013**

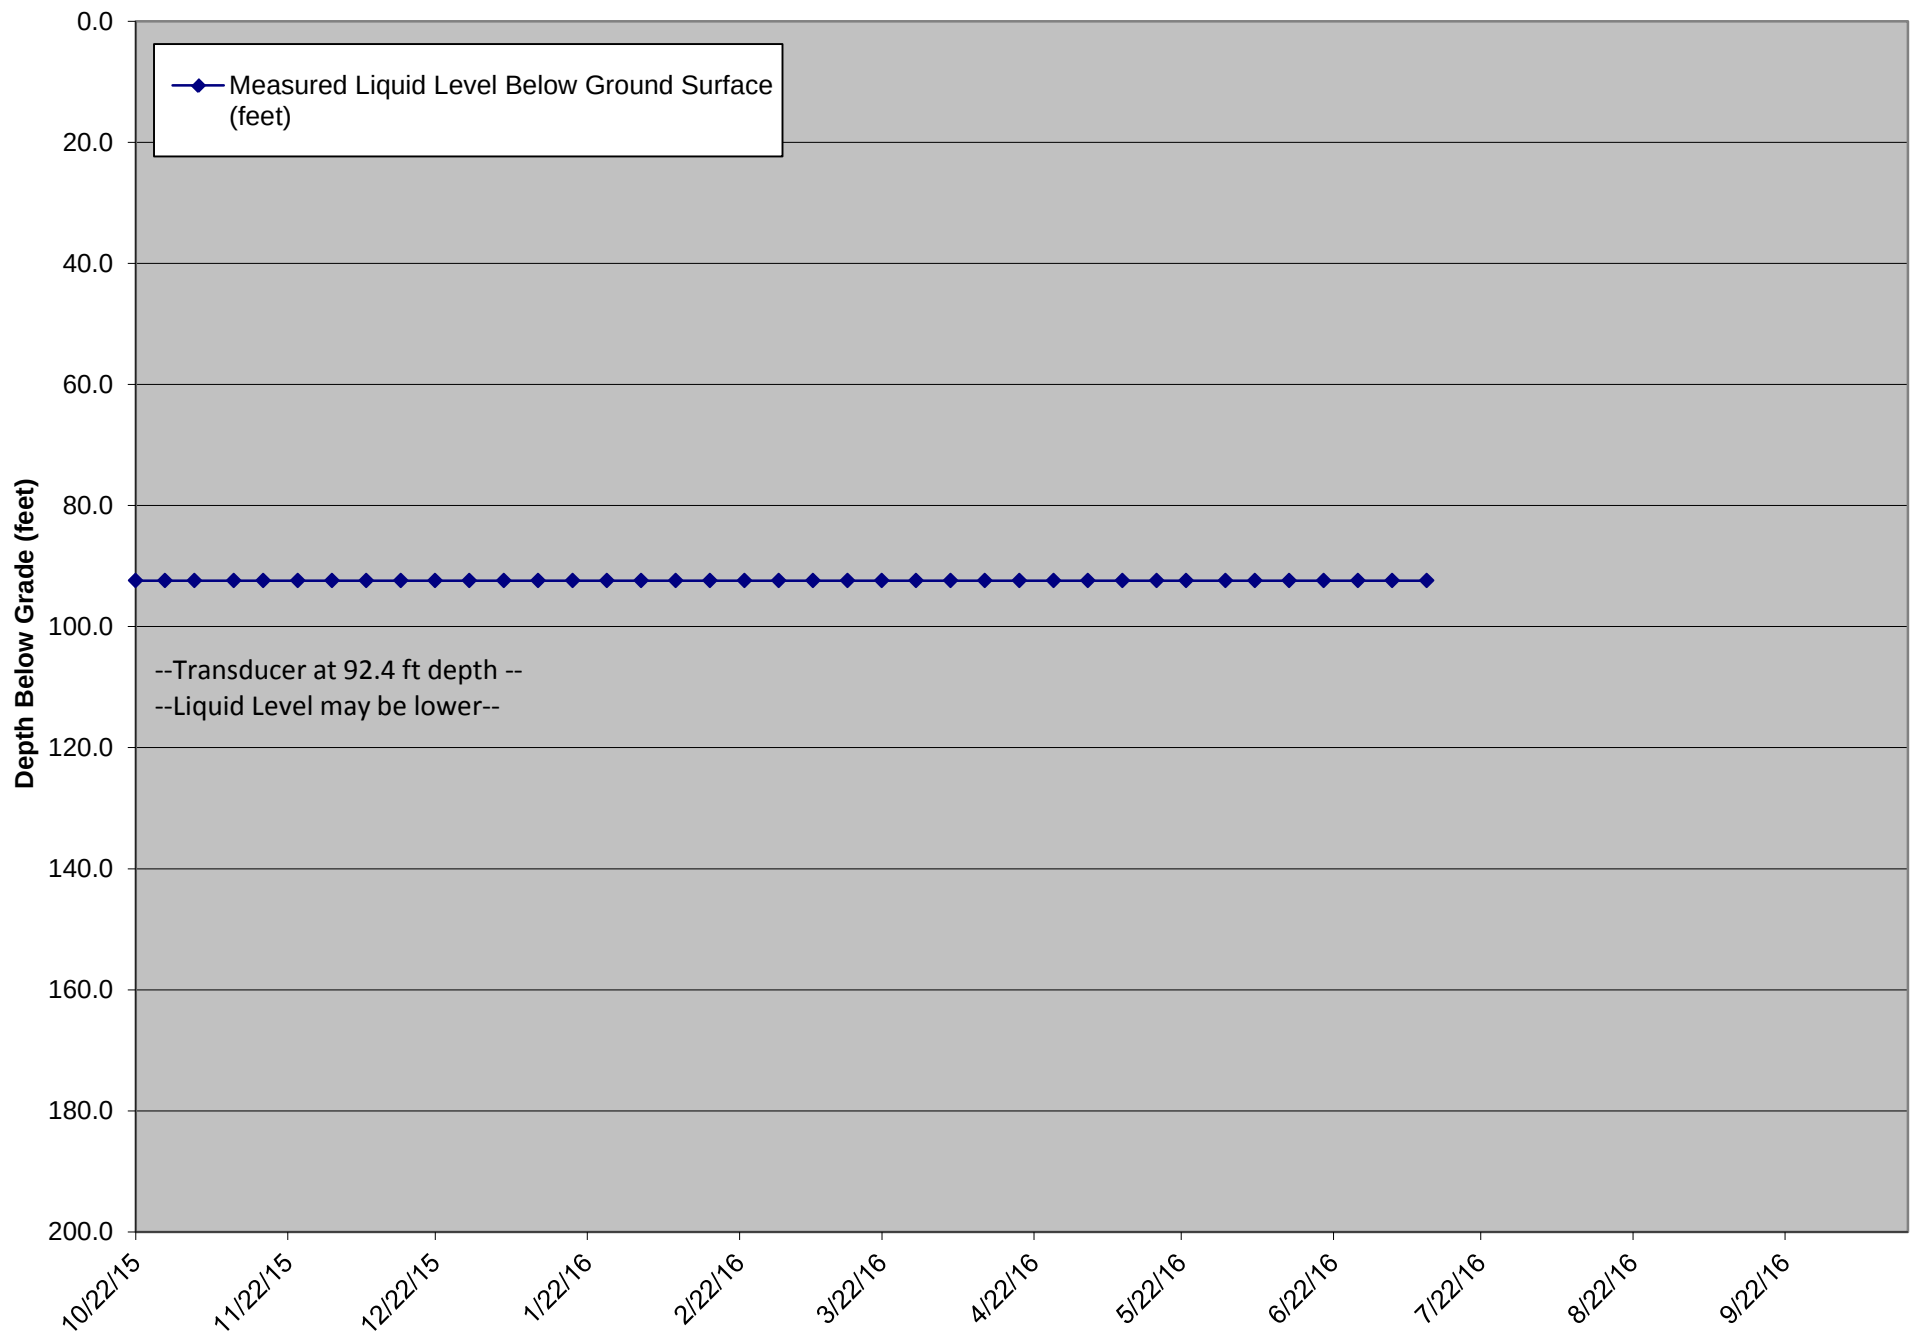
# LCS-1D Liquid Level Below Ground Surface

LCS-1D has been disconnected since 7/13/2016 due to construction for the HEB project. LCS-1D will be reconnected as soon as the construction for the HEB project allows it to be reconnected.

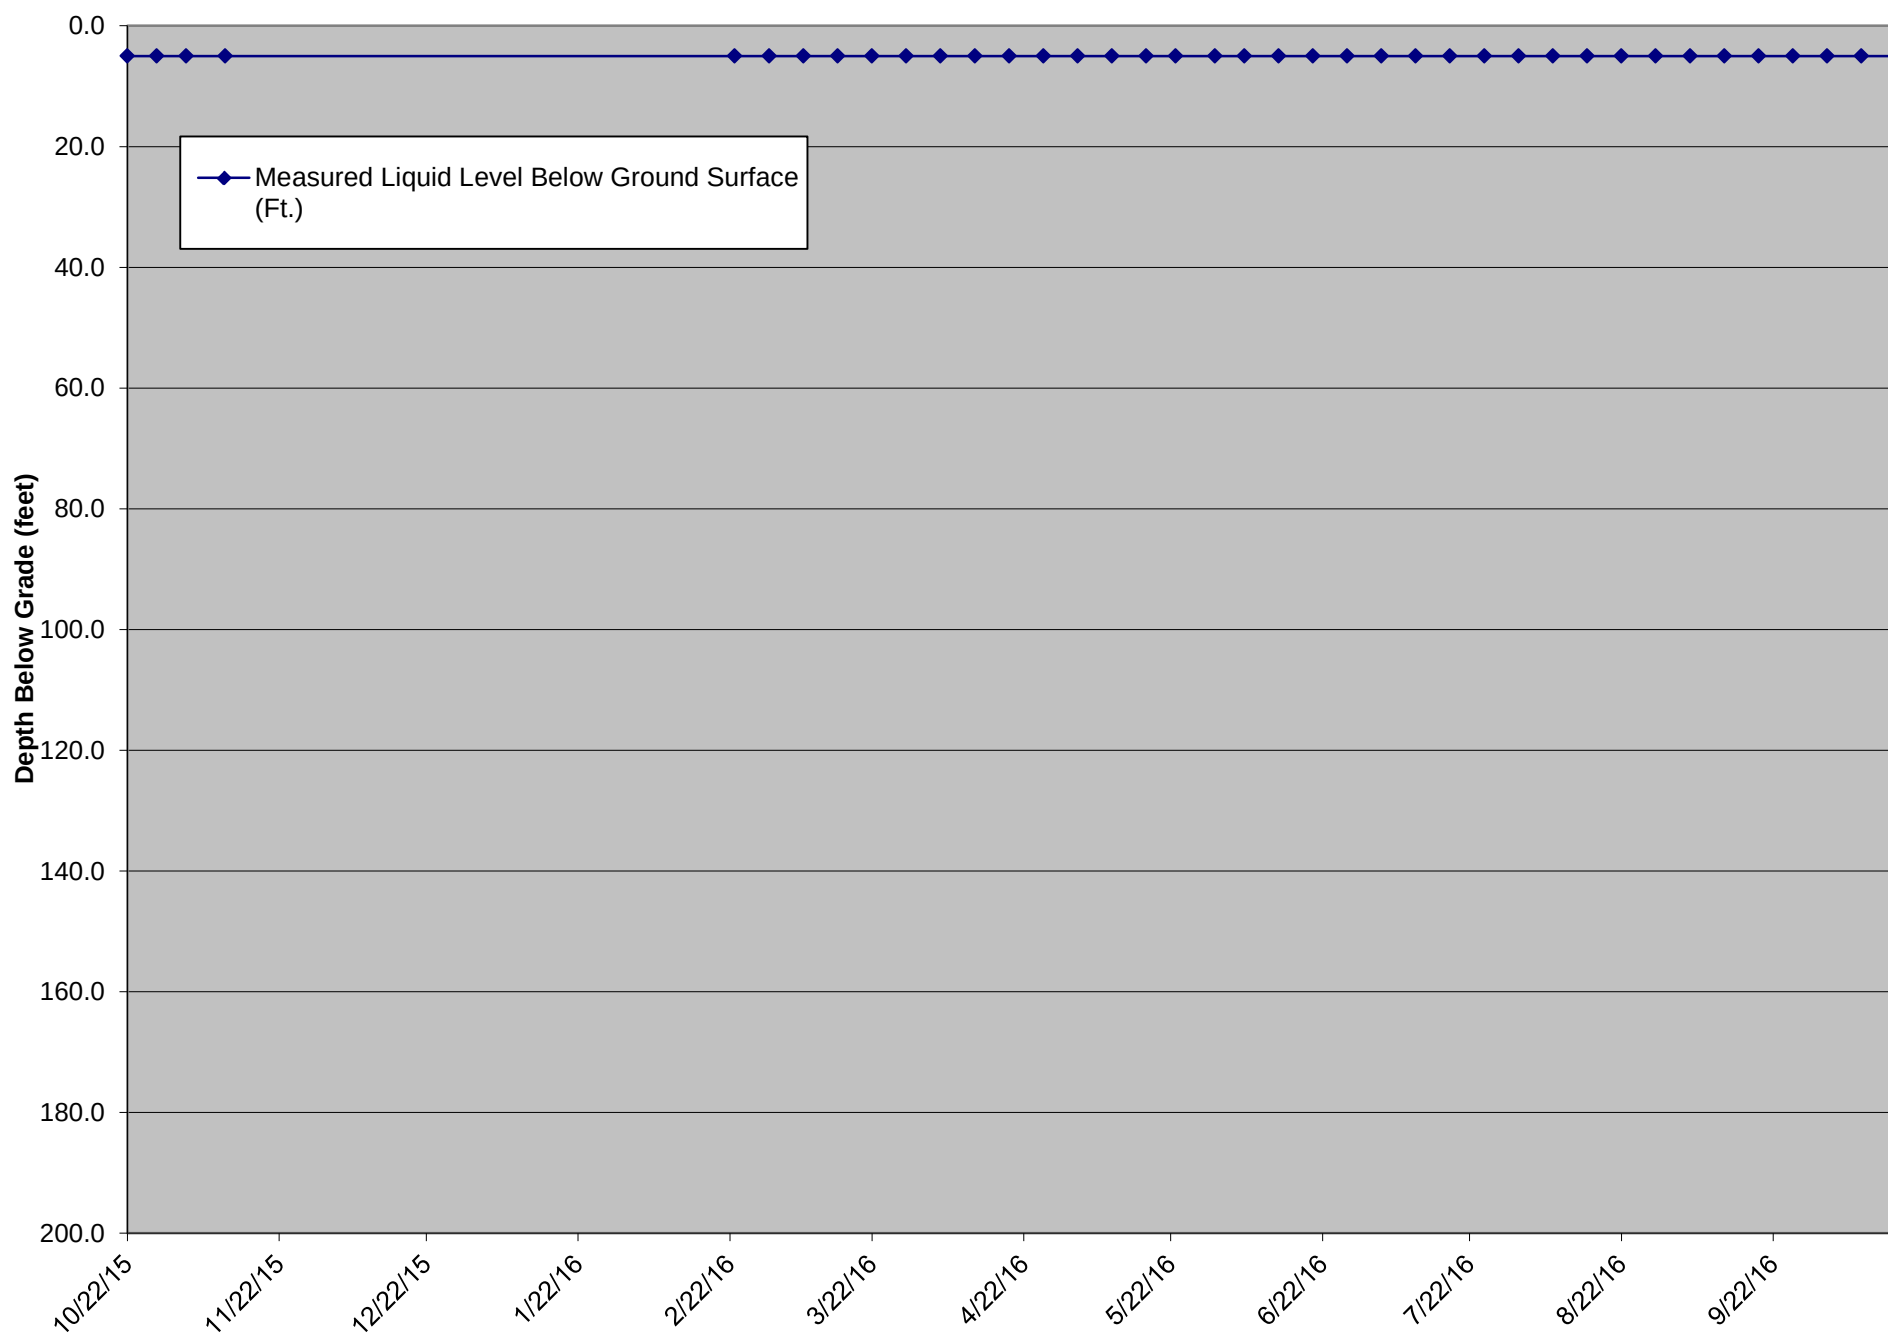
# LCS-3D Liquid Level Below Ground Surface

The pumps in LCS-2D and LCS-3D were non-operational during the weekly reporting period. The transducer in LCS-3D continued to report liquid levels.

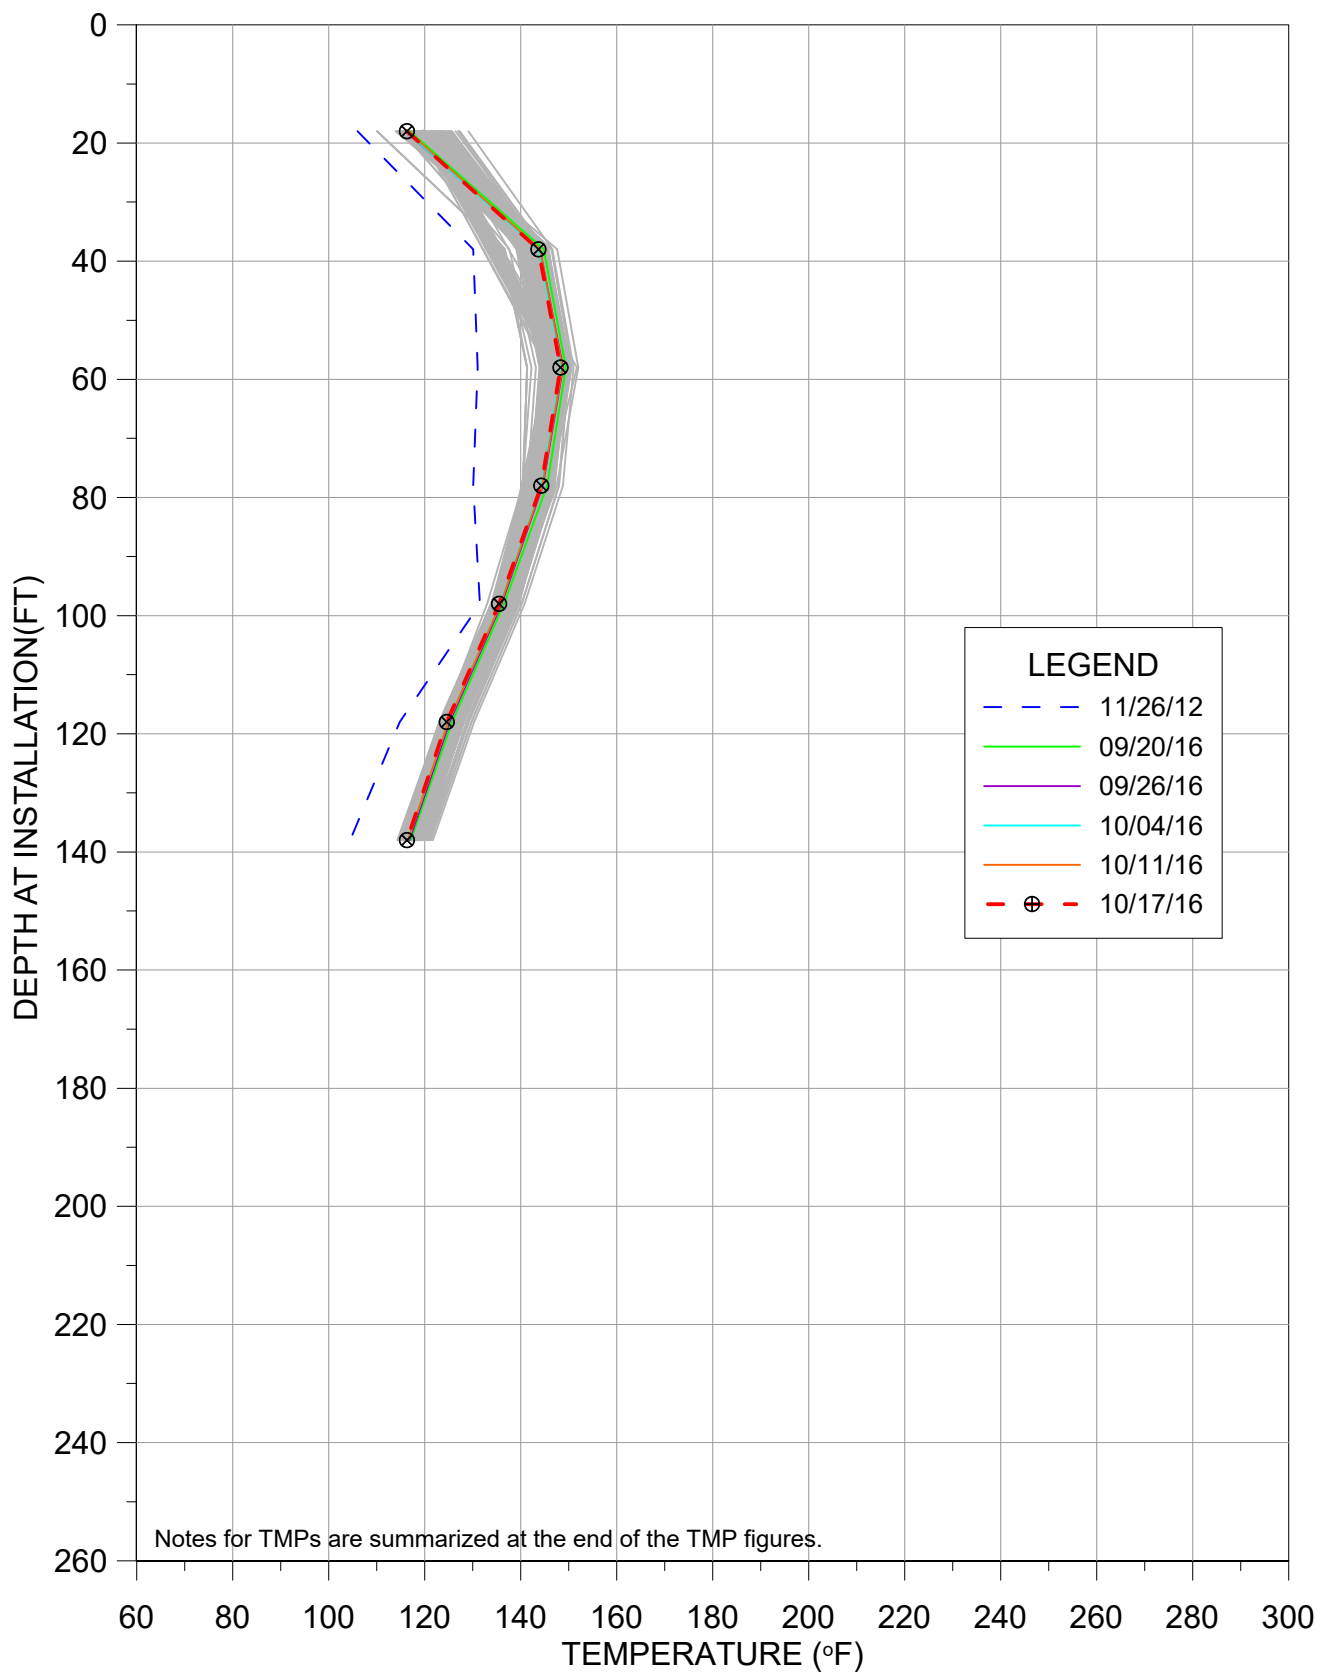
# TMP-1

TMP-1: NONE

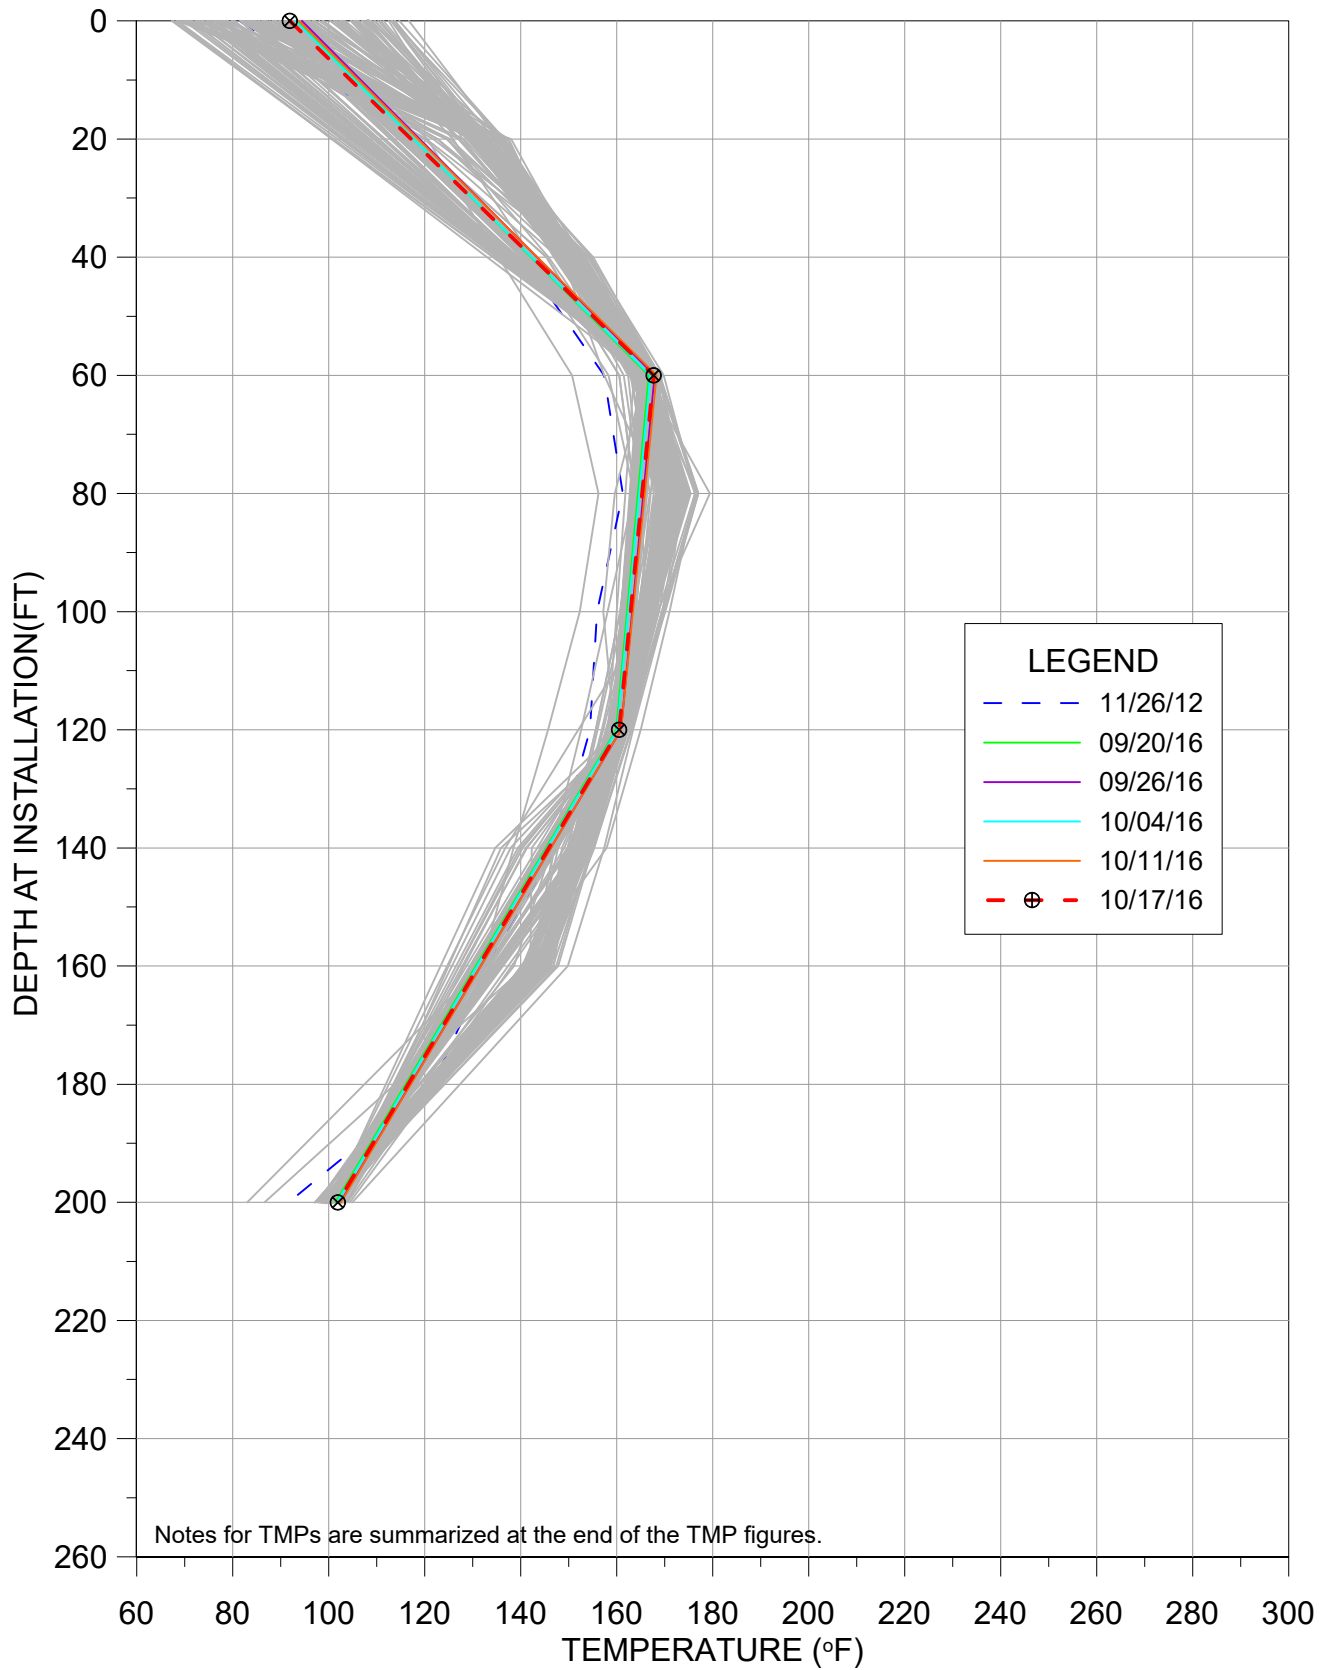
# TMP-2

1. Unit at 180 ft depth had resistance reading above allowable and is no longer working. No reliable reading has been obtained since 11/26/2012.
2. The resistance reading was high and no temperature readings were obtained at 160 ft depth since 6/19/2014.
3. The connectivity tests on 3/19/2015 conducted by Feezor Engineering showed that units at 20, 40, 80, 100, 140 ft depths are no longer reliable.

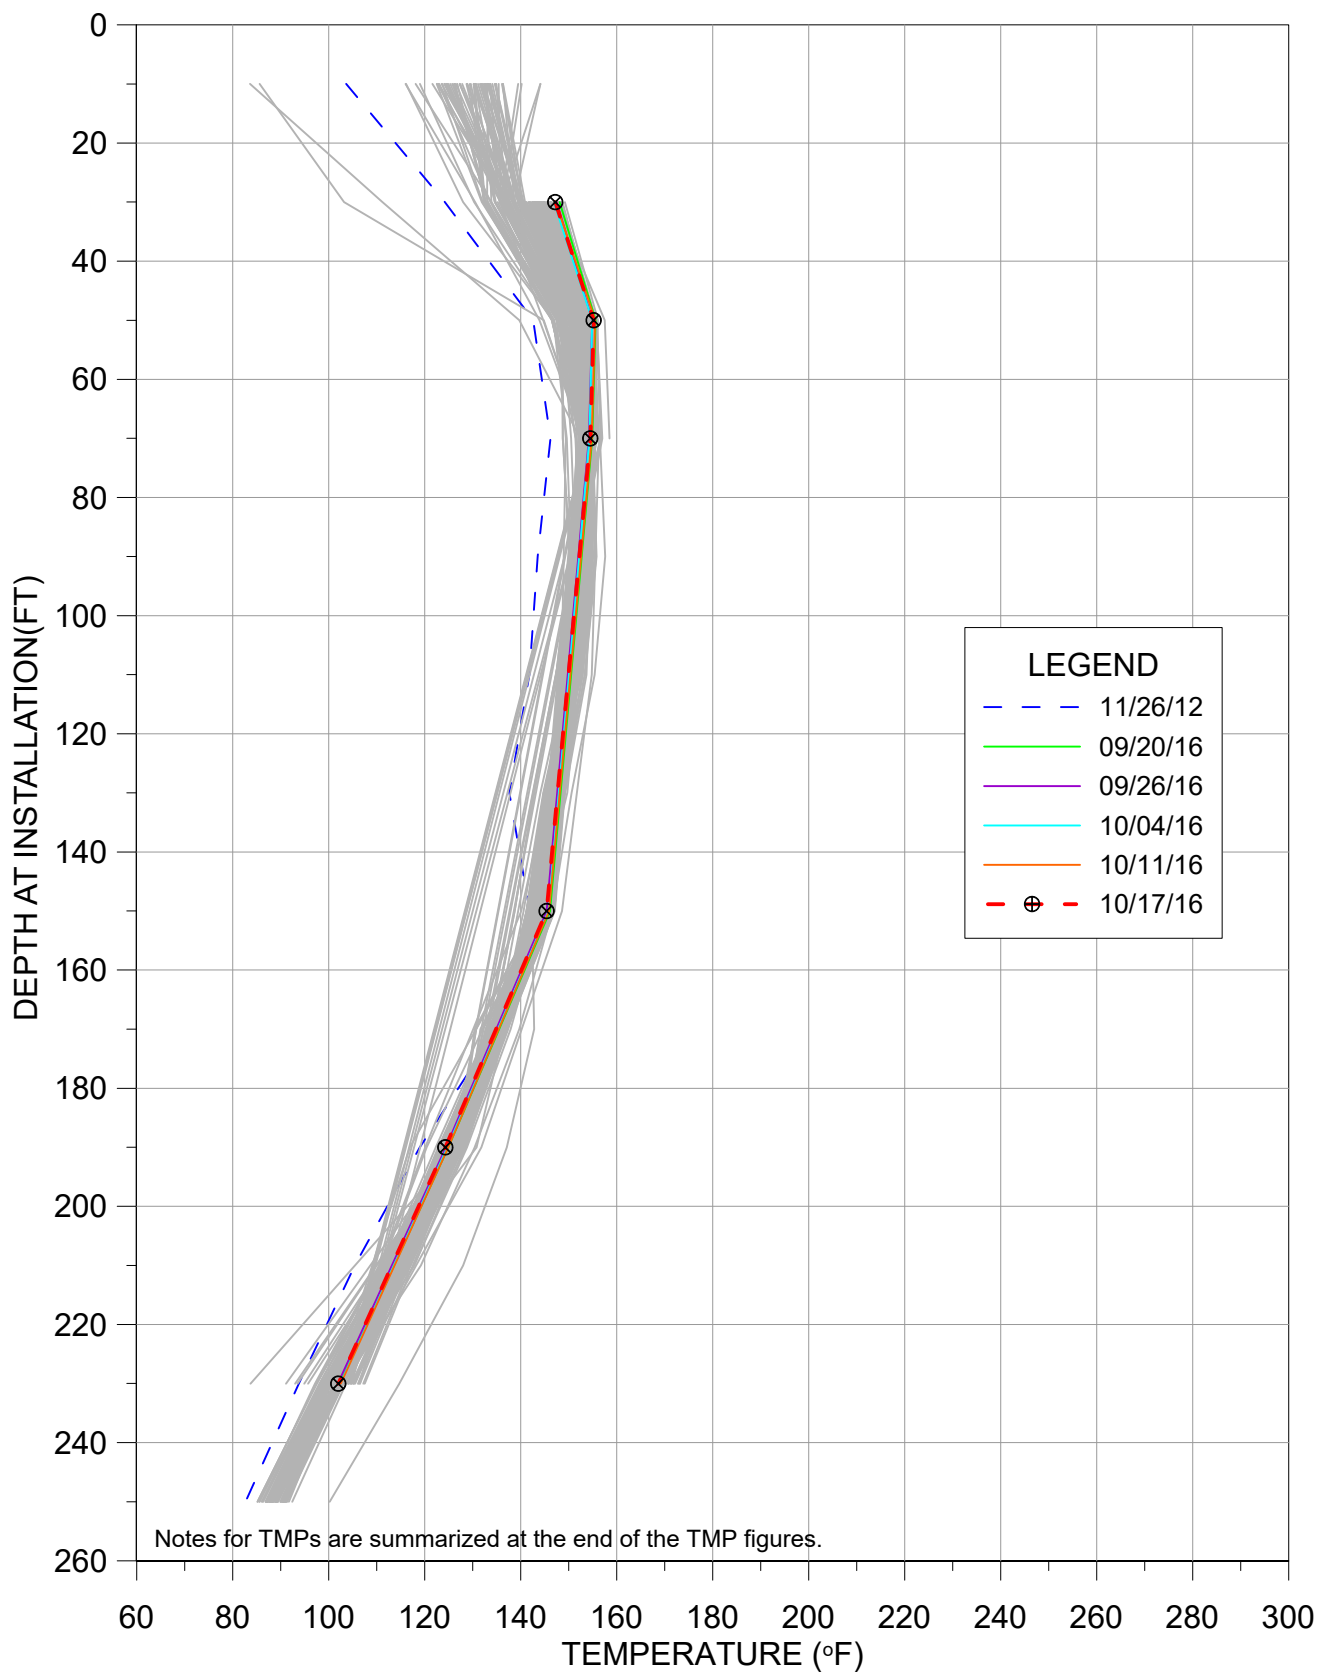
# TMP-3

1. No reliable temperature readings have been obtained at 170 ft depth since 1/29/2014, except on 3/13/2014.
2. The connectivity tests on 4/11/2014 conducted by CEC showed that units at 10, 90, 130, 210 and 250 ft depths are no longer reliable.
3. The connectivity tests on 10/28/2014 conducted by Feezor Engineering showed that units at 10, 90, 110, 130, 210 and 250 ft depths are not reliable.

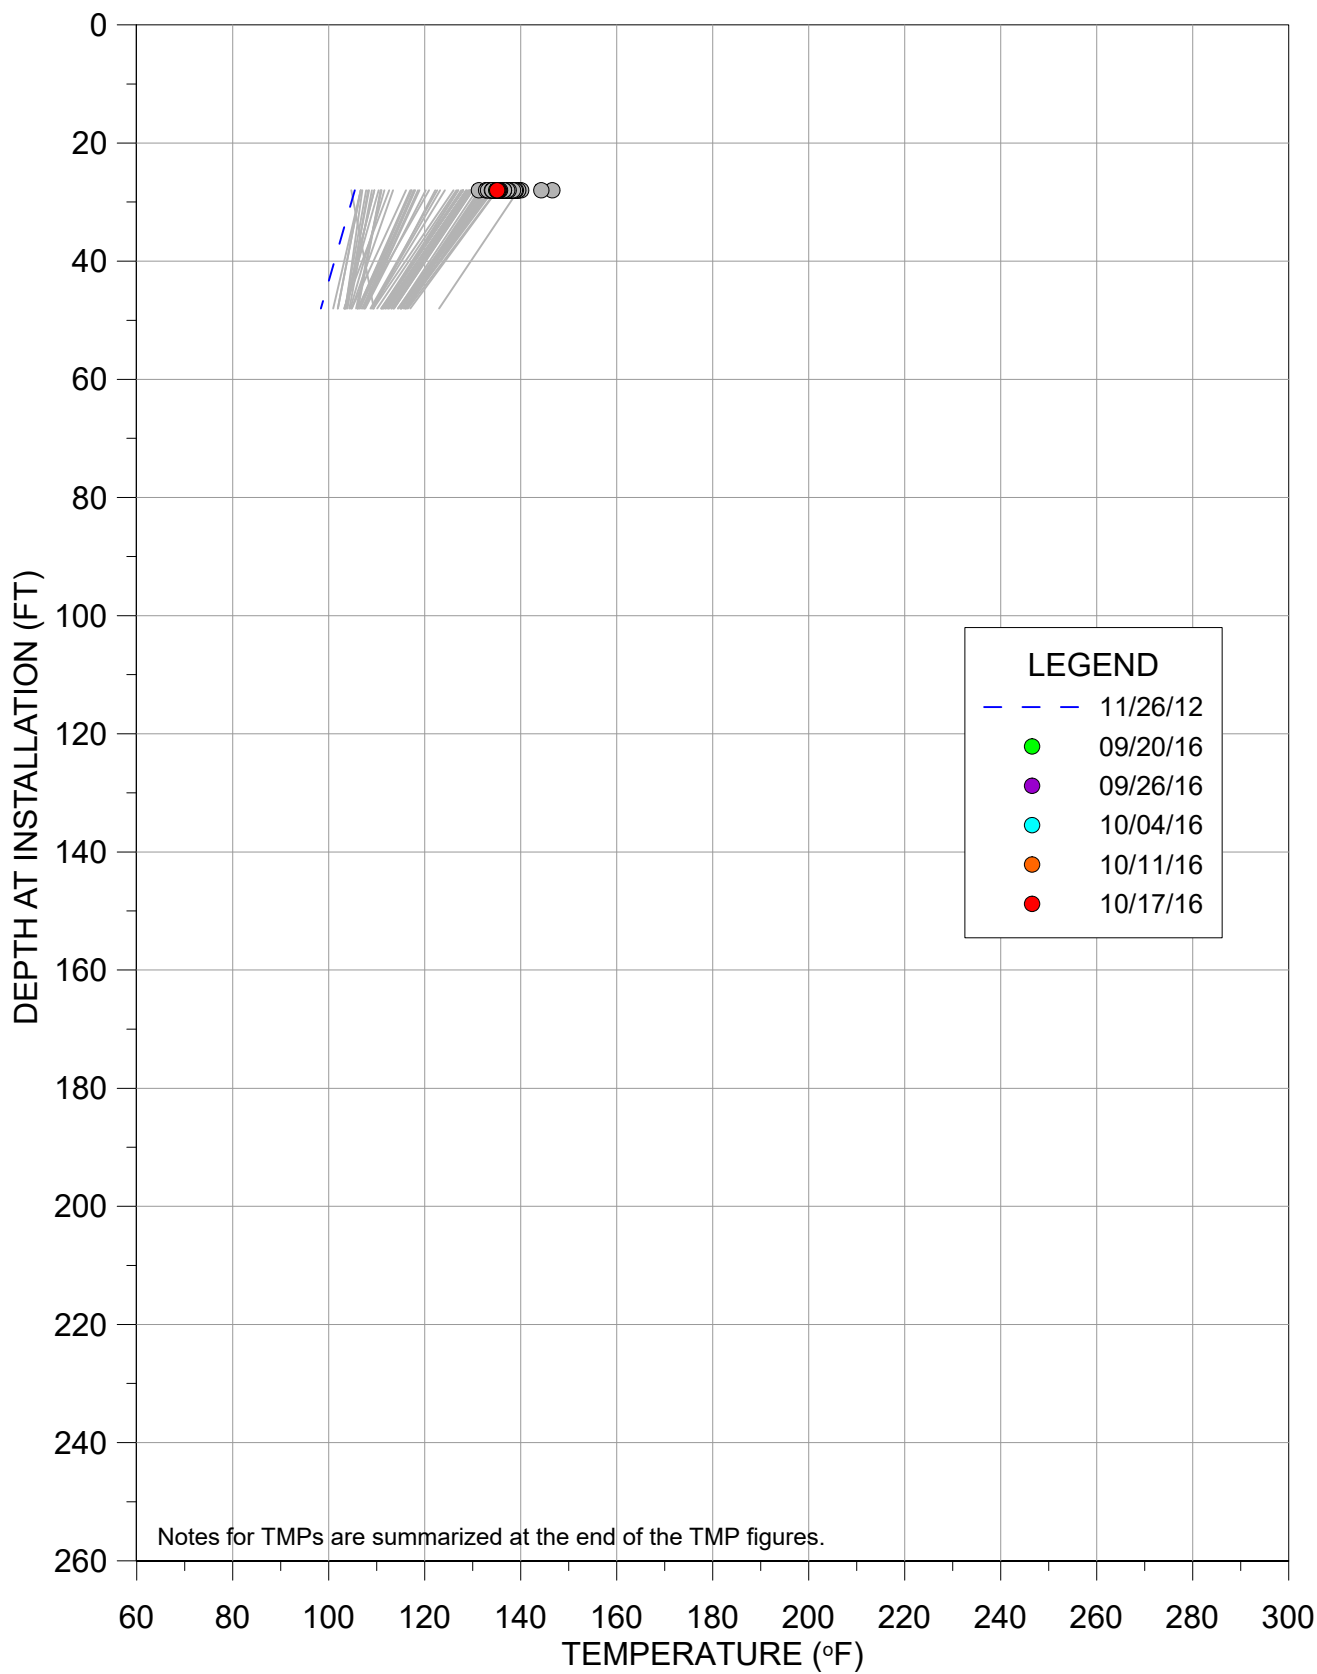
# TMP-4

1. The connectivity tests on 4/11/2014 conducted by CEC showed that the unit at 48 ft depth is no longer reliable.

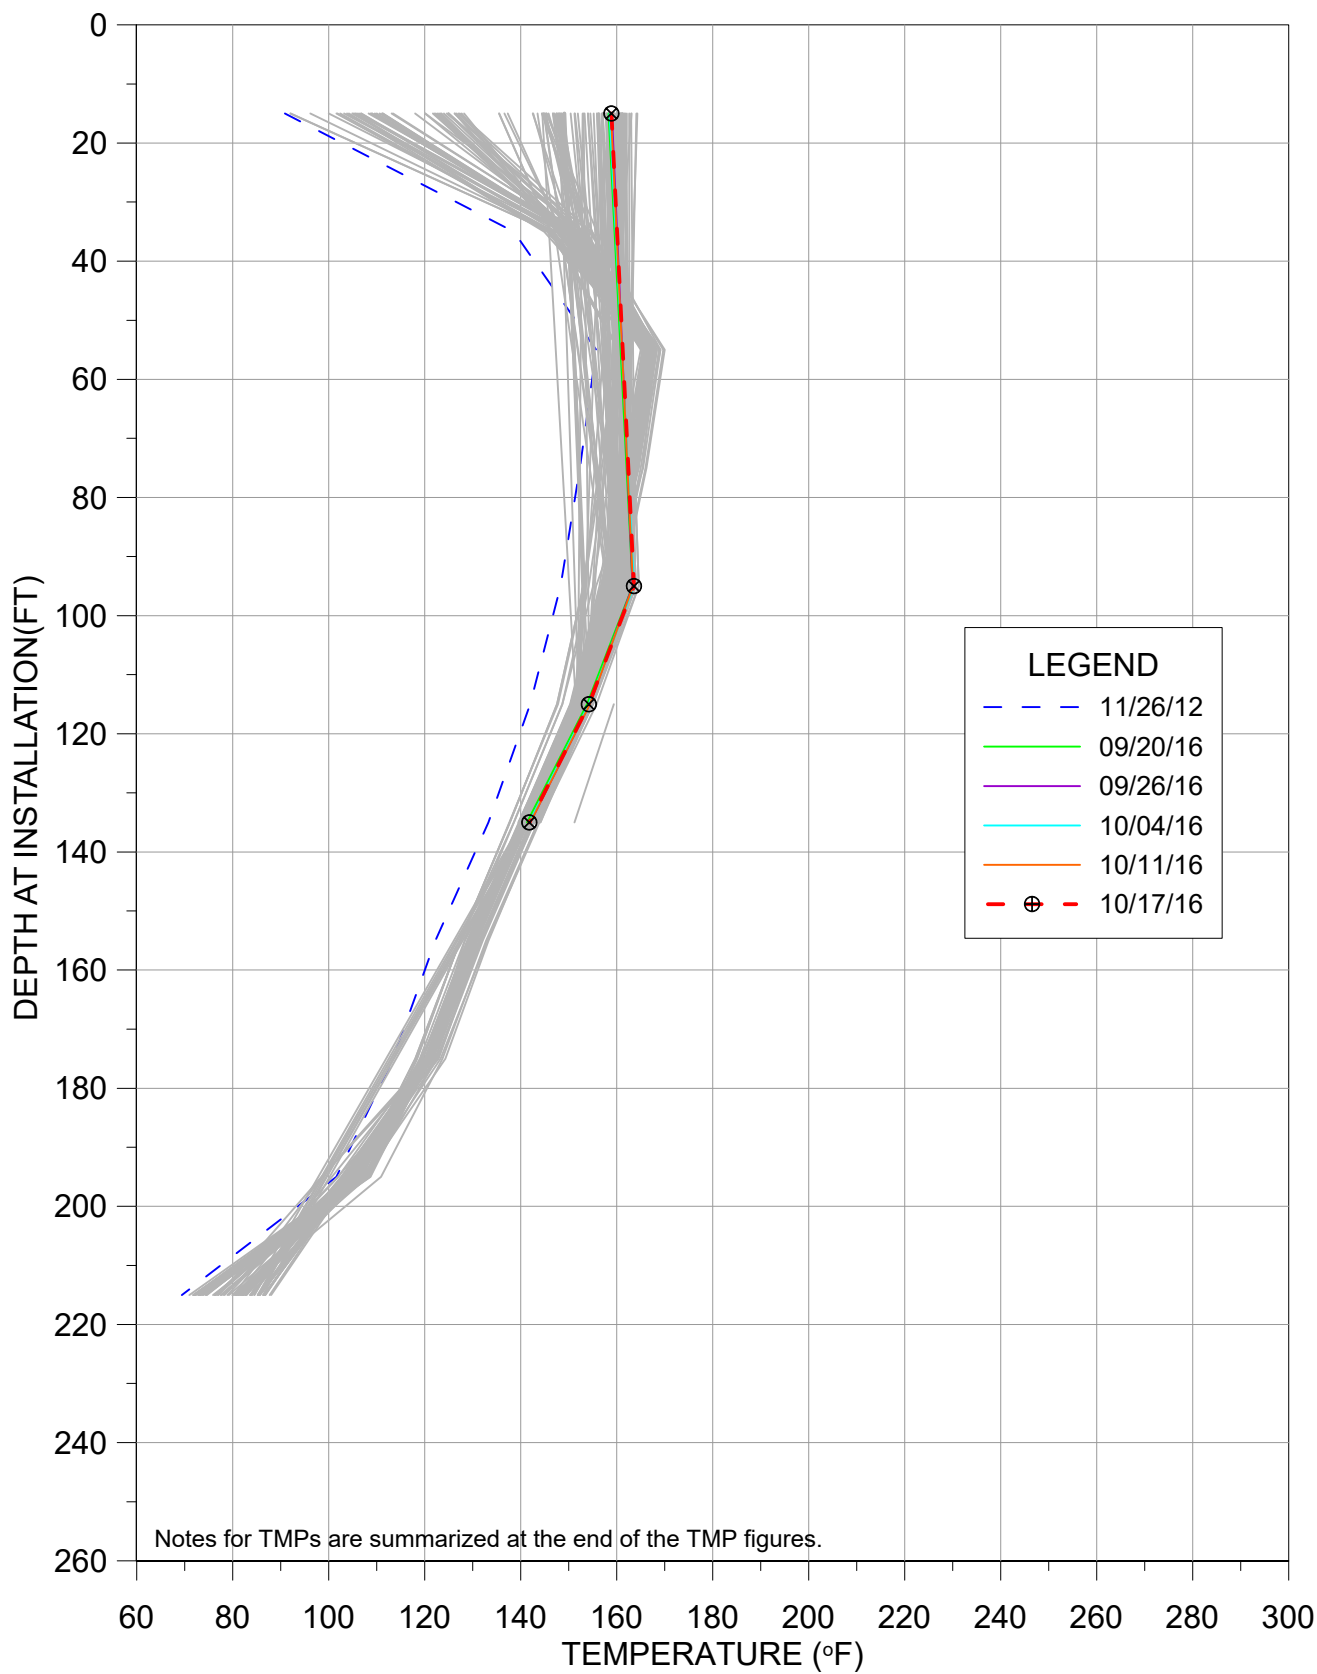
# TMP-6

1. The connectivity tests on 4/11/2014 conducted by CEC showed that units at 35, 55, 75, 155, 175, and 195 ft depths are no longer reliable.
2. No reliable temperature readings have been obtained at the unit at 215 ft depth since 6/13/2014.

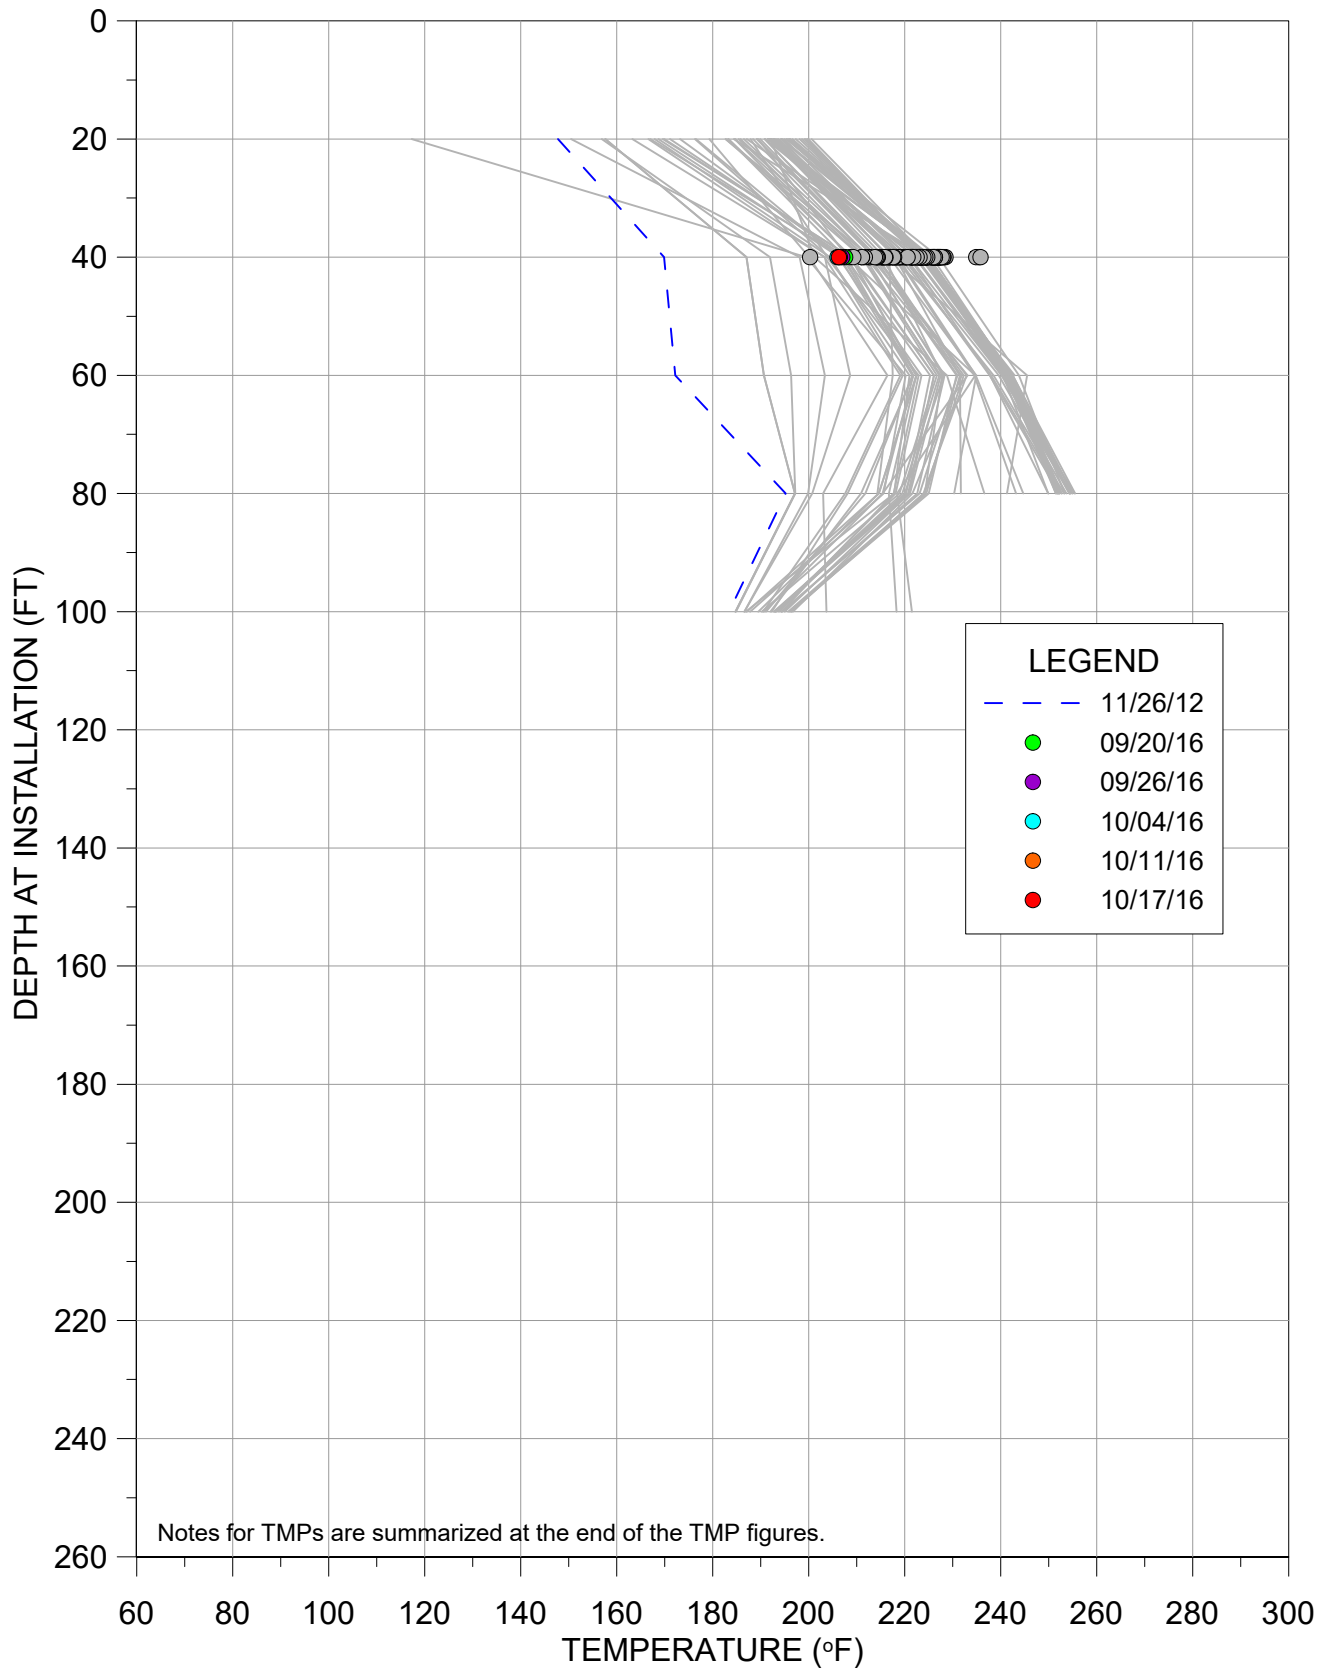
# TMP-9

1. Unit at 100 ft depth had an inaccurate temperature reading on 8/1/2013 and no reading since 8/6/2013.
2. The connectivity tests on 4/11/2014 conducted by CEC showed that units at 20, 60, 80, and 100 ft depths are no longer reliable.

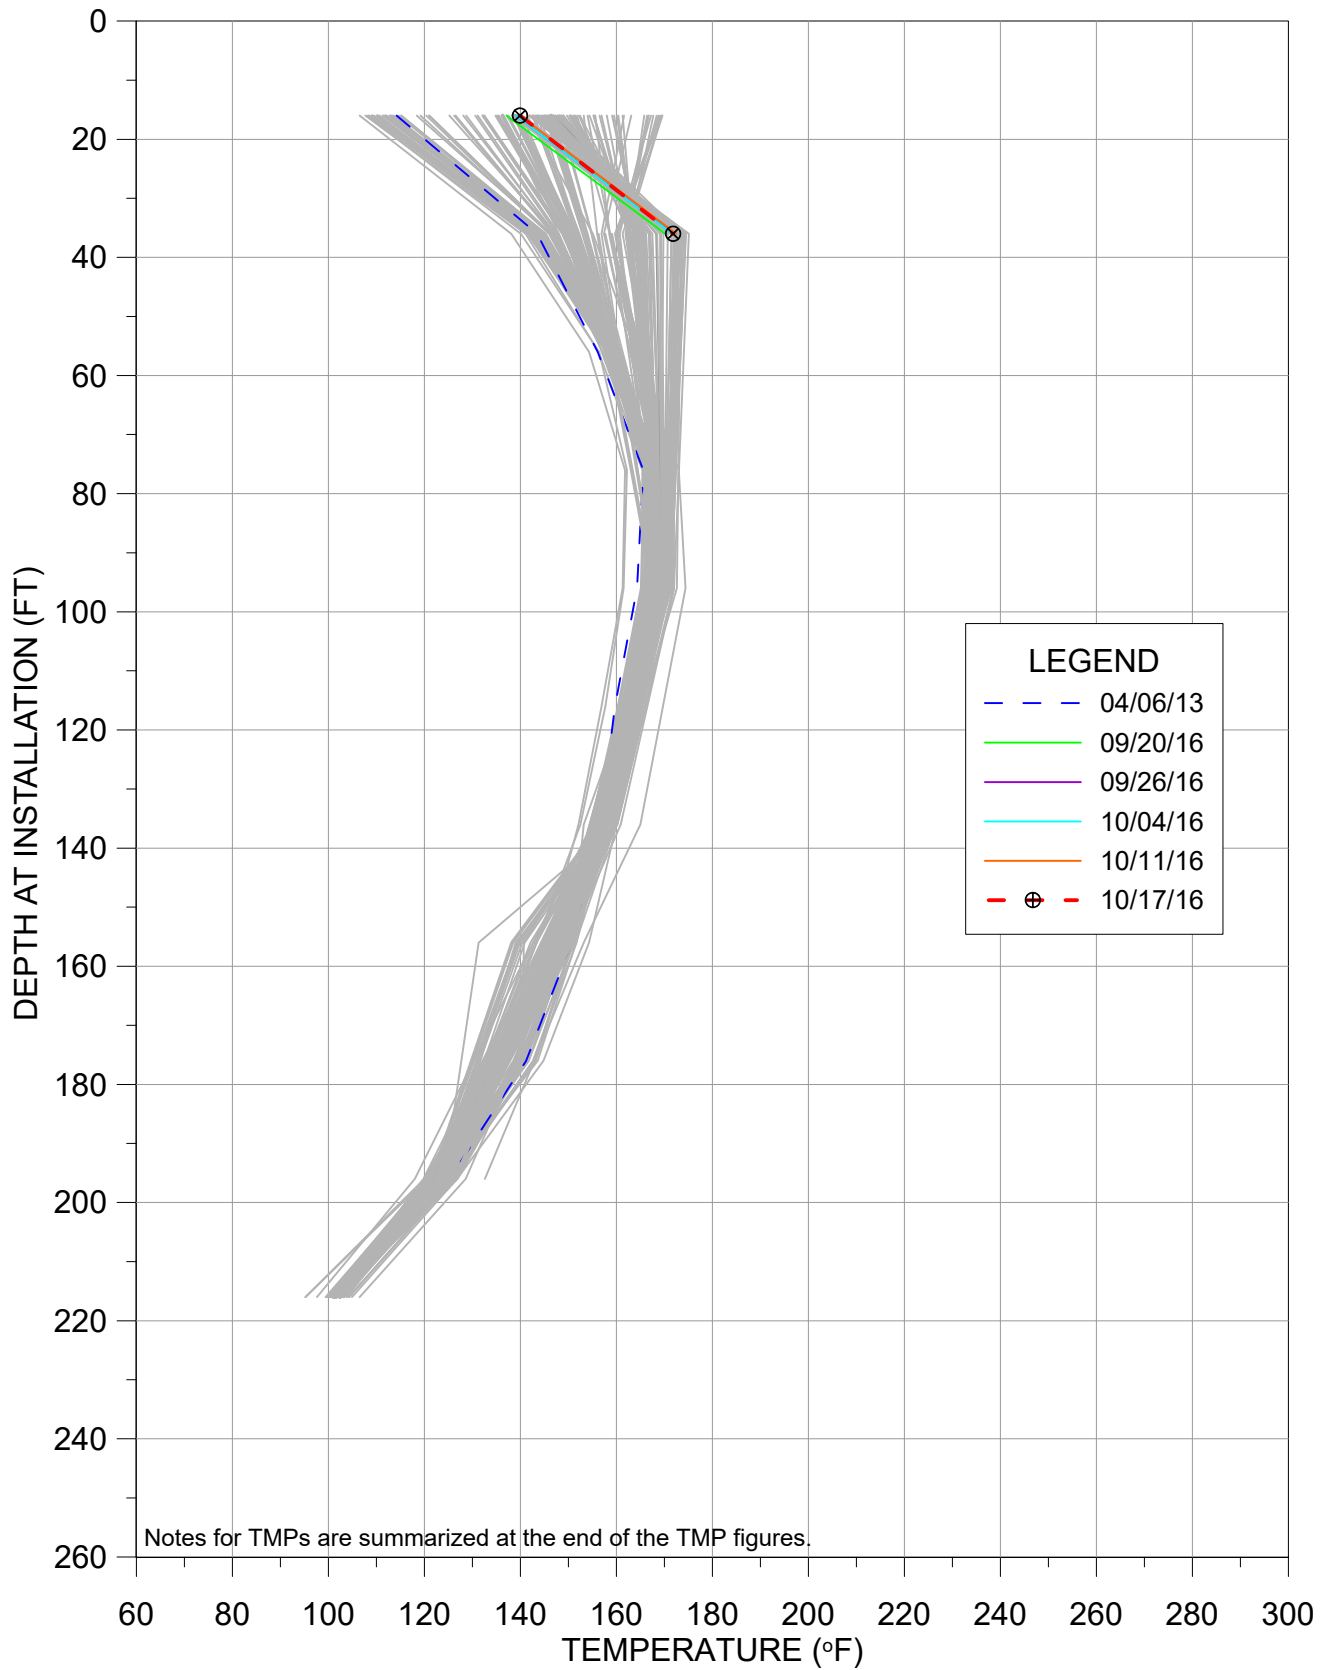
# TMP-11

1. All units had acceptable resistance readings starting on 7/25/2013, except a high resistance reading at 116 ft depth since 10/30/2013.
2. No temperature reading has been obtained at 176 ft depth since 1/17/2014.
3. The unit at 156 ft depth has had high or questionable resistance since 1/17/2014. The unit at 56 ft depth has had a high resistance reading since 3/19/2014 and no temperatures have been obtained since this time.
4. The connectivity tests on 4/11/2014 conducted by CEC showed that units at 56, 116, and 176 ft depths are no longer reliable.
5. The connectivity tests on 10/28/2014 conducted by Feezor Engineering showed that units at 56, 116 and 176 ft are not reliable.
6. No temperature or resistivity readings were obtained at a depth of 96 ft depth since 8/29/2016 despite multiple attempts.
